**New York City Department of Transportation
Office of School Safety Engineering**

School Safety Engineering Project

FINAL REPORT: St. Teresa School, Staten Island

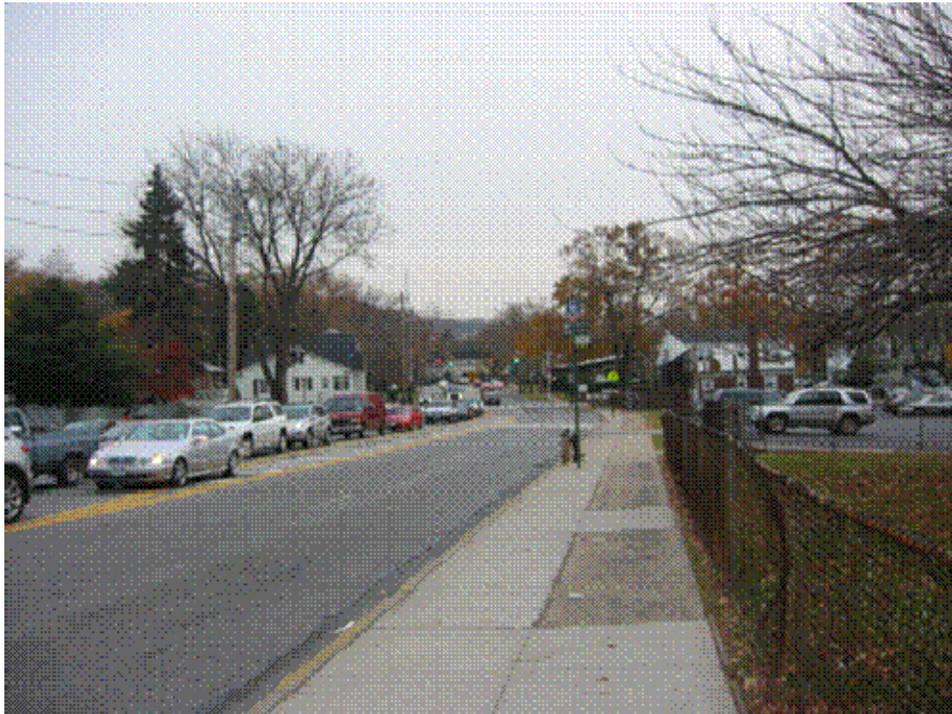
Figure 1: Looking south along Slosson Avenue towards the Staten Island Expressway from Victory Boulevard (St. Teresa School is to the right)

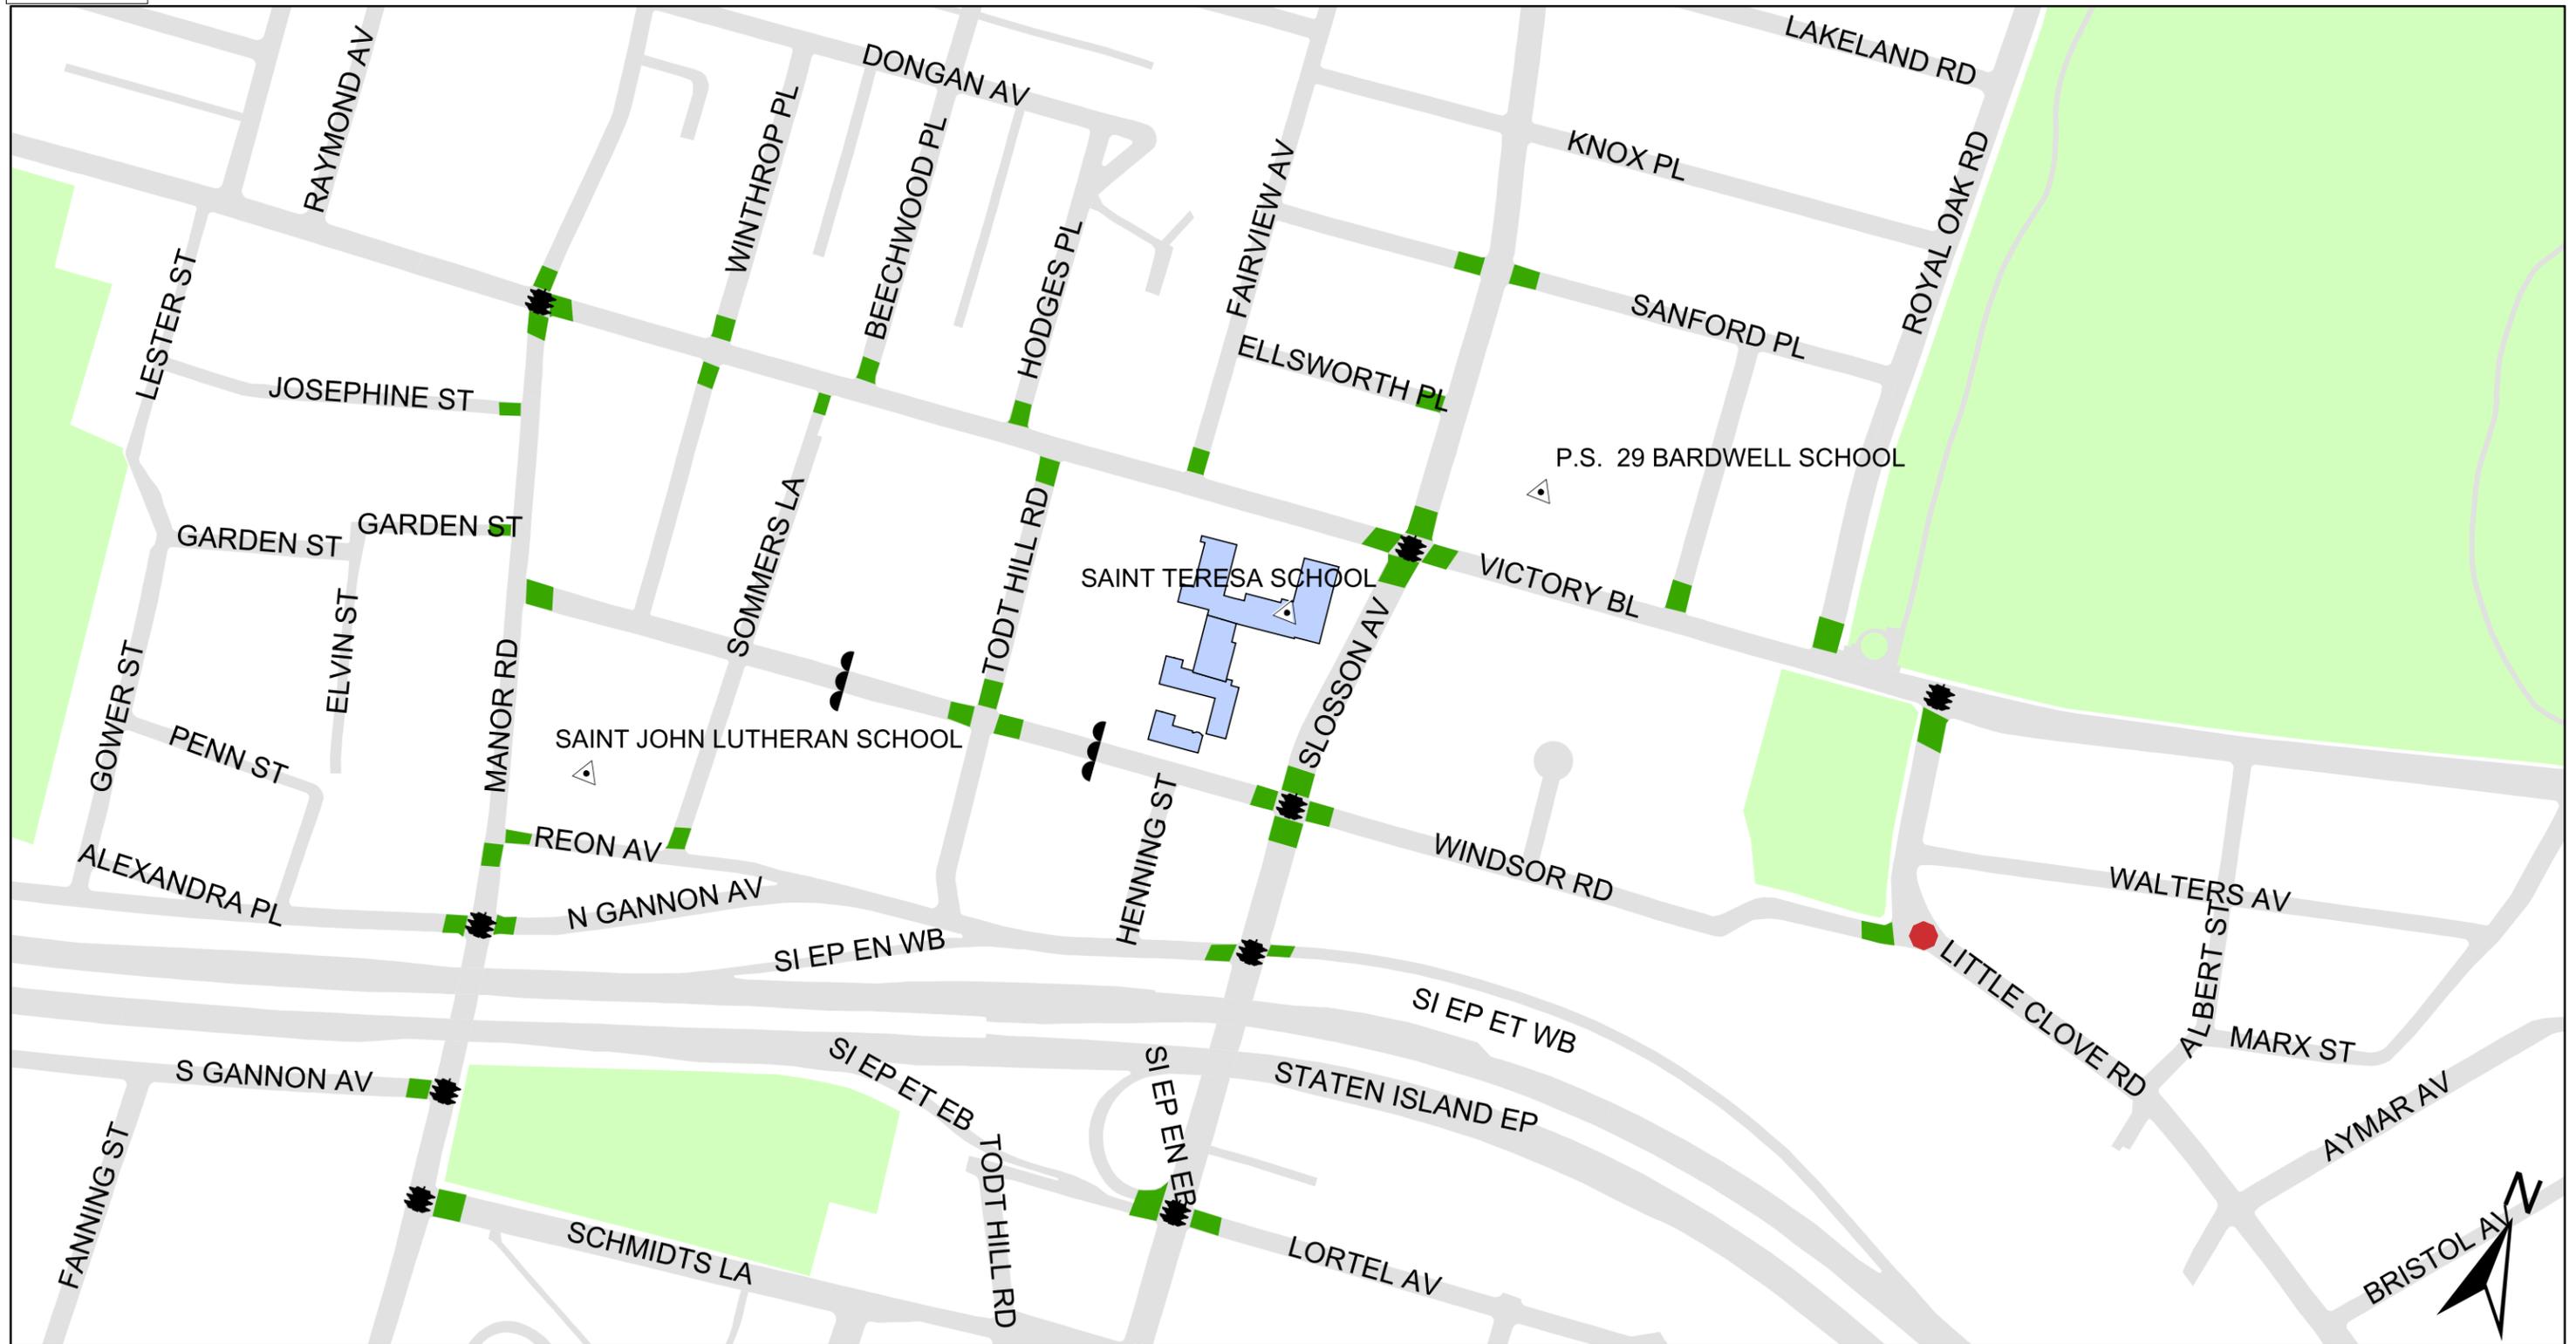
EXHIBIT 2

The School Traffic Safety Map was established to help provide the maximum degree of safety for children going to and from school - by indicating the location of speed reducers, school crosswalks and some traffic control devices. (While virtually all intersections in NYC benefit from traffic control devices - such as stop signs, traffic signals, yield signs, and all way stop signs - this map shows only traffic signals and all way stop signs.) The school crosswalks that are shown are ladder striped and make the crosswalk more visible to drivers and help make the intersection safer. These crosswalks are where school children are recommended to cross.

Exhibit 2 shows existing traffic signals and pavement markings around St. Teresa School. It should be noted that a citywide signage program is currently underway to upgrade school signage to the current edition of the Federal Manual of Uniform Traffic Control Devices (MUTCD) standards of fluorescent yellow-green signs accompanied by downward pointing arrows. (Signs scheduled to be installed under this program are shown as "existing" in Exhibit 7.)

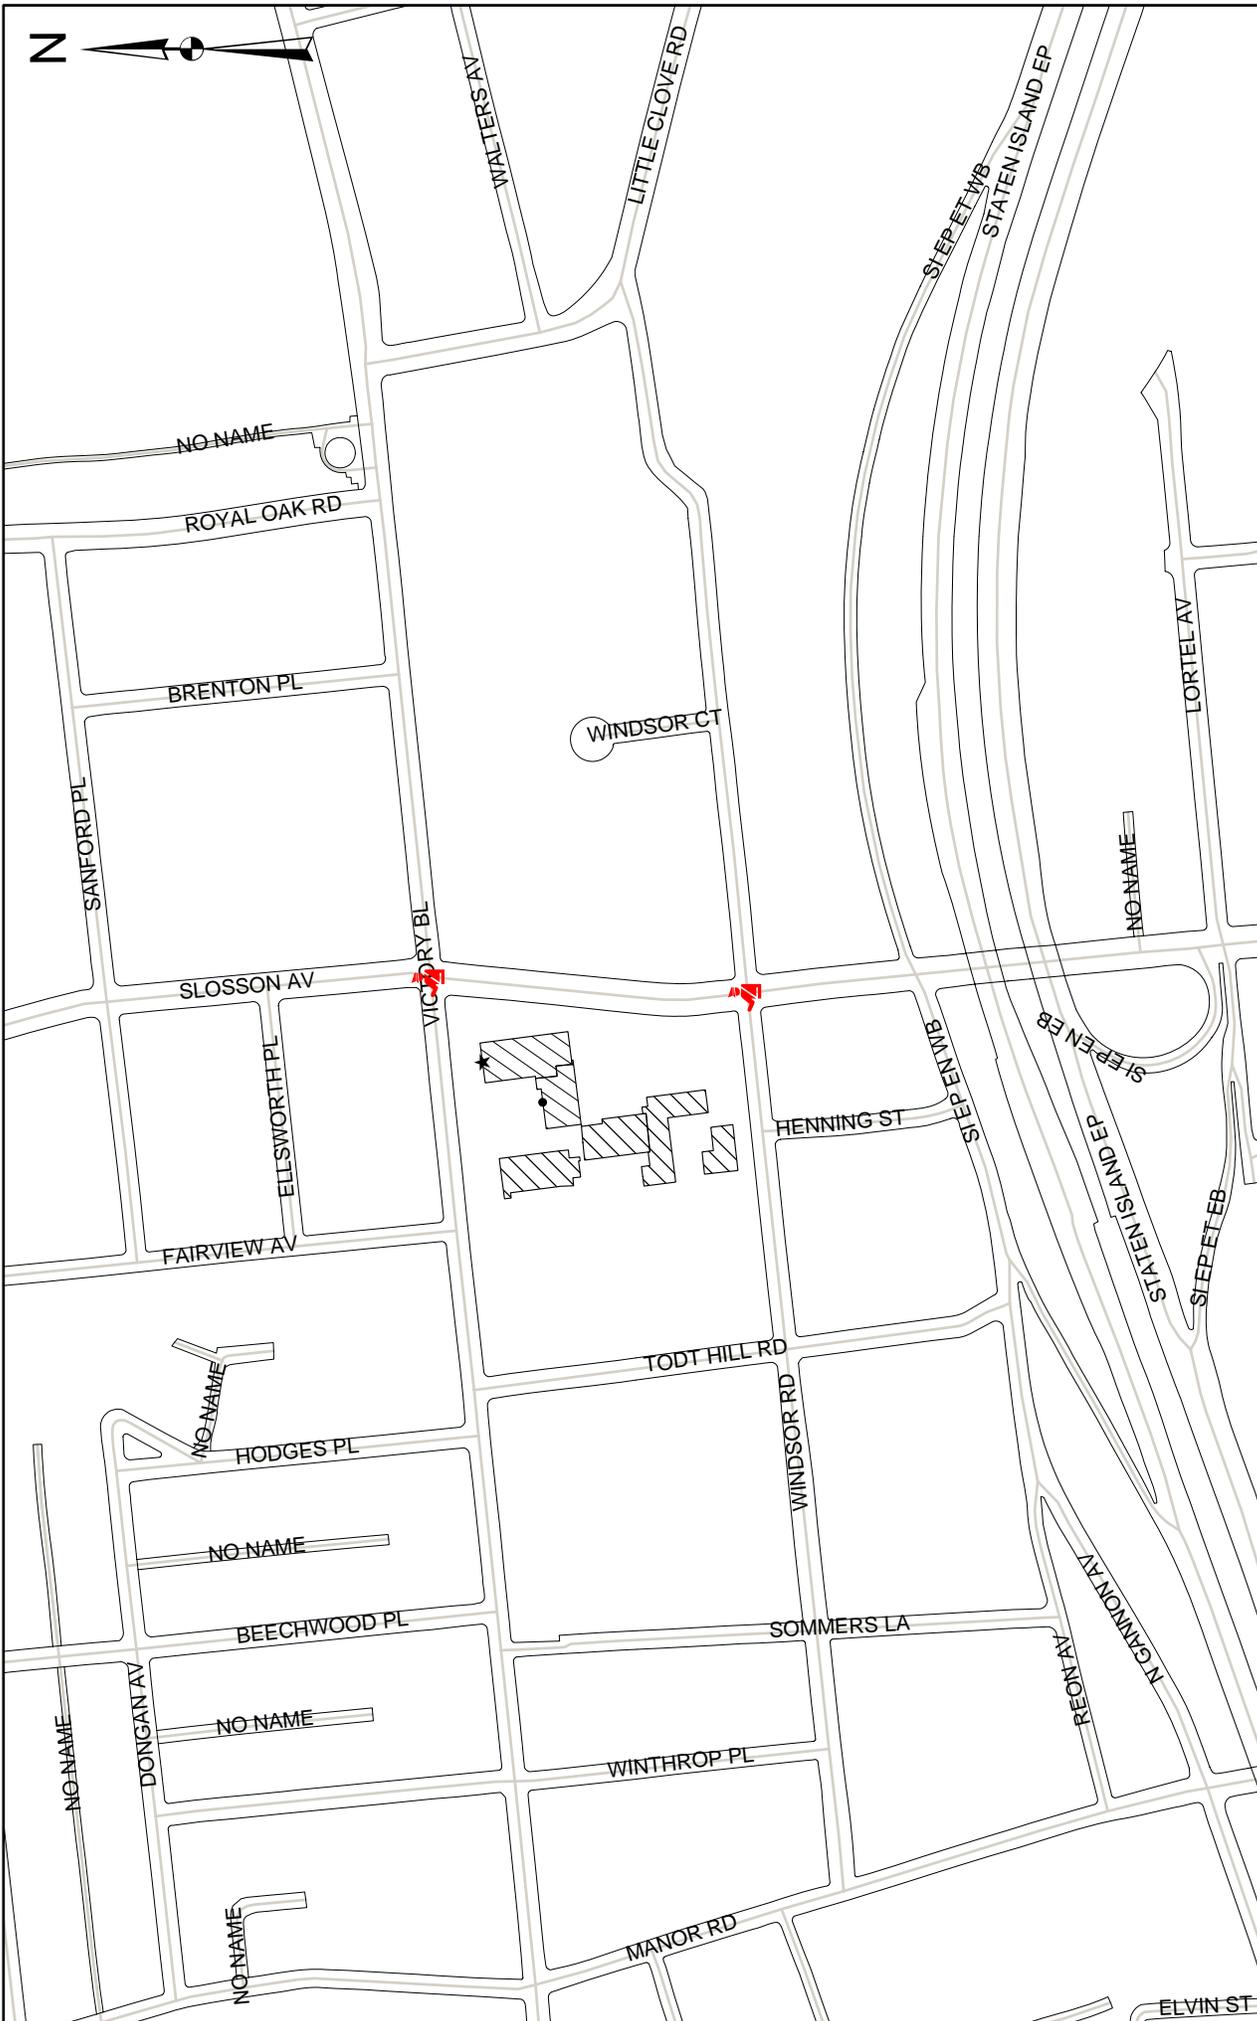
EXHIBIT 3

According to school officials, crossing guards are assigned to the following intersections:

- Two crossing guards at the intersection of Victory Boulevard and Slosson Avenue.
- One crossing guard at the intersection of Windsor Road and Slosson Avenue.

It should be noted that P.S. 29, a nearby school, also uses the school crossing guards assigned to the intersection of Victory Boulevard and Slosson Avenue.

**ST. TERESA SCHOOL
STATEN ISLAND
CROSSING GUARD LOCATIONS**

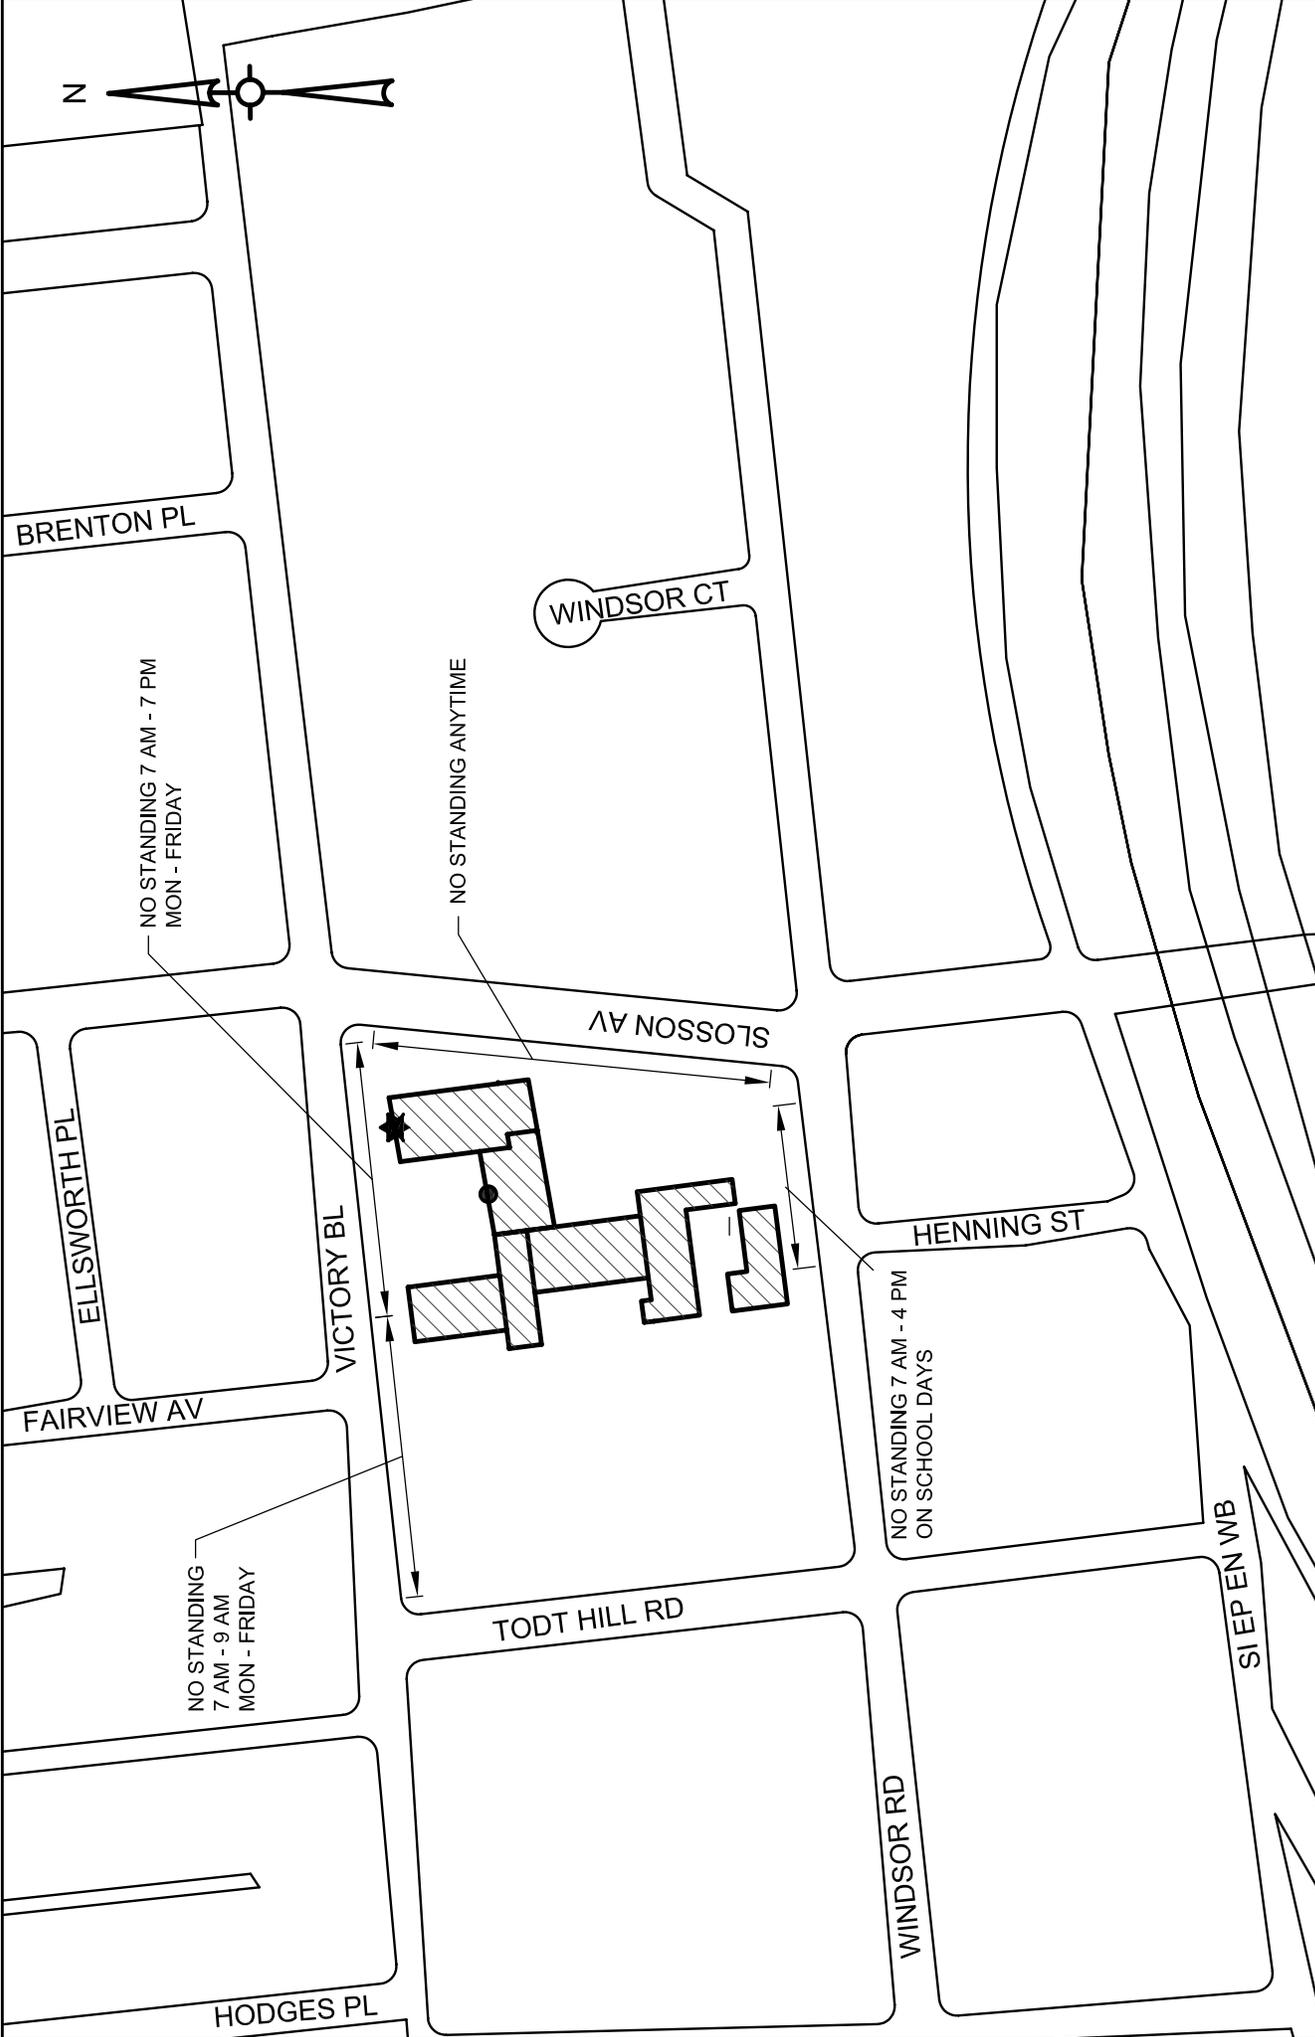
EXHIBIT 4

Parking regulations around the school are shown in Exhibit 4.

EXISTING PARKING REGULATIONS

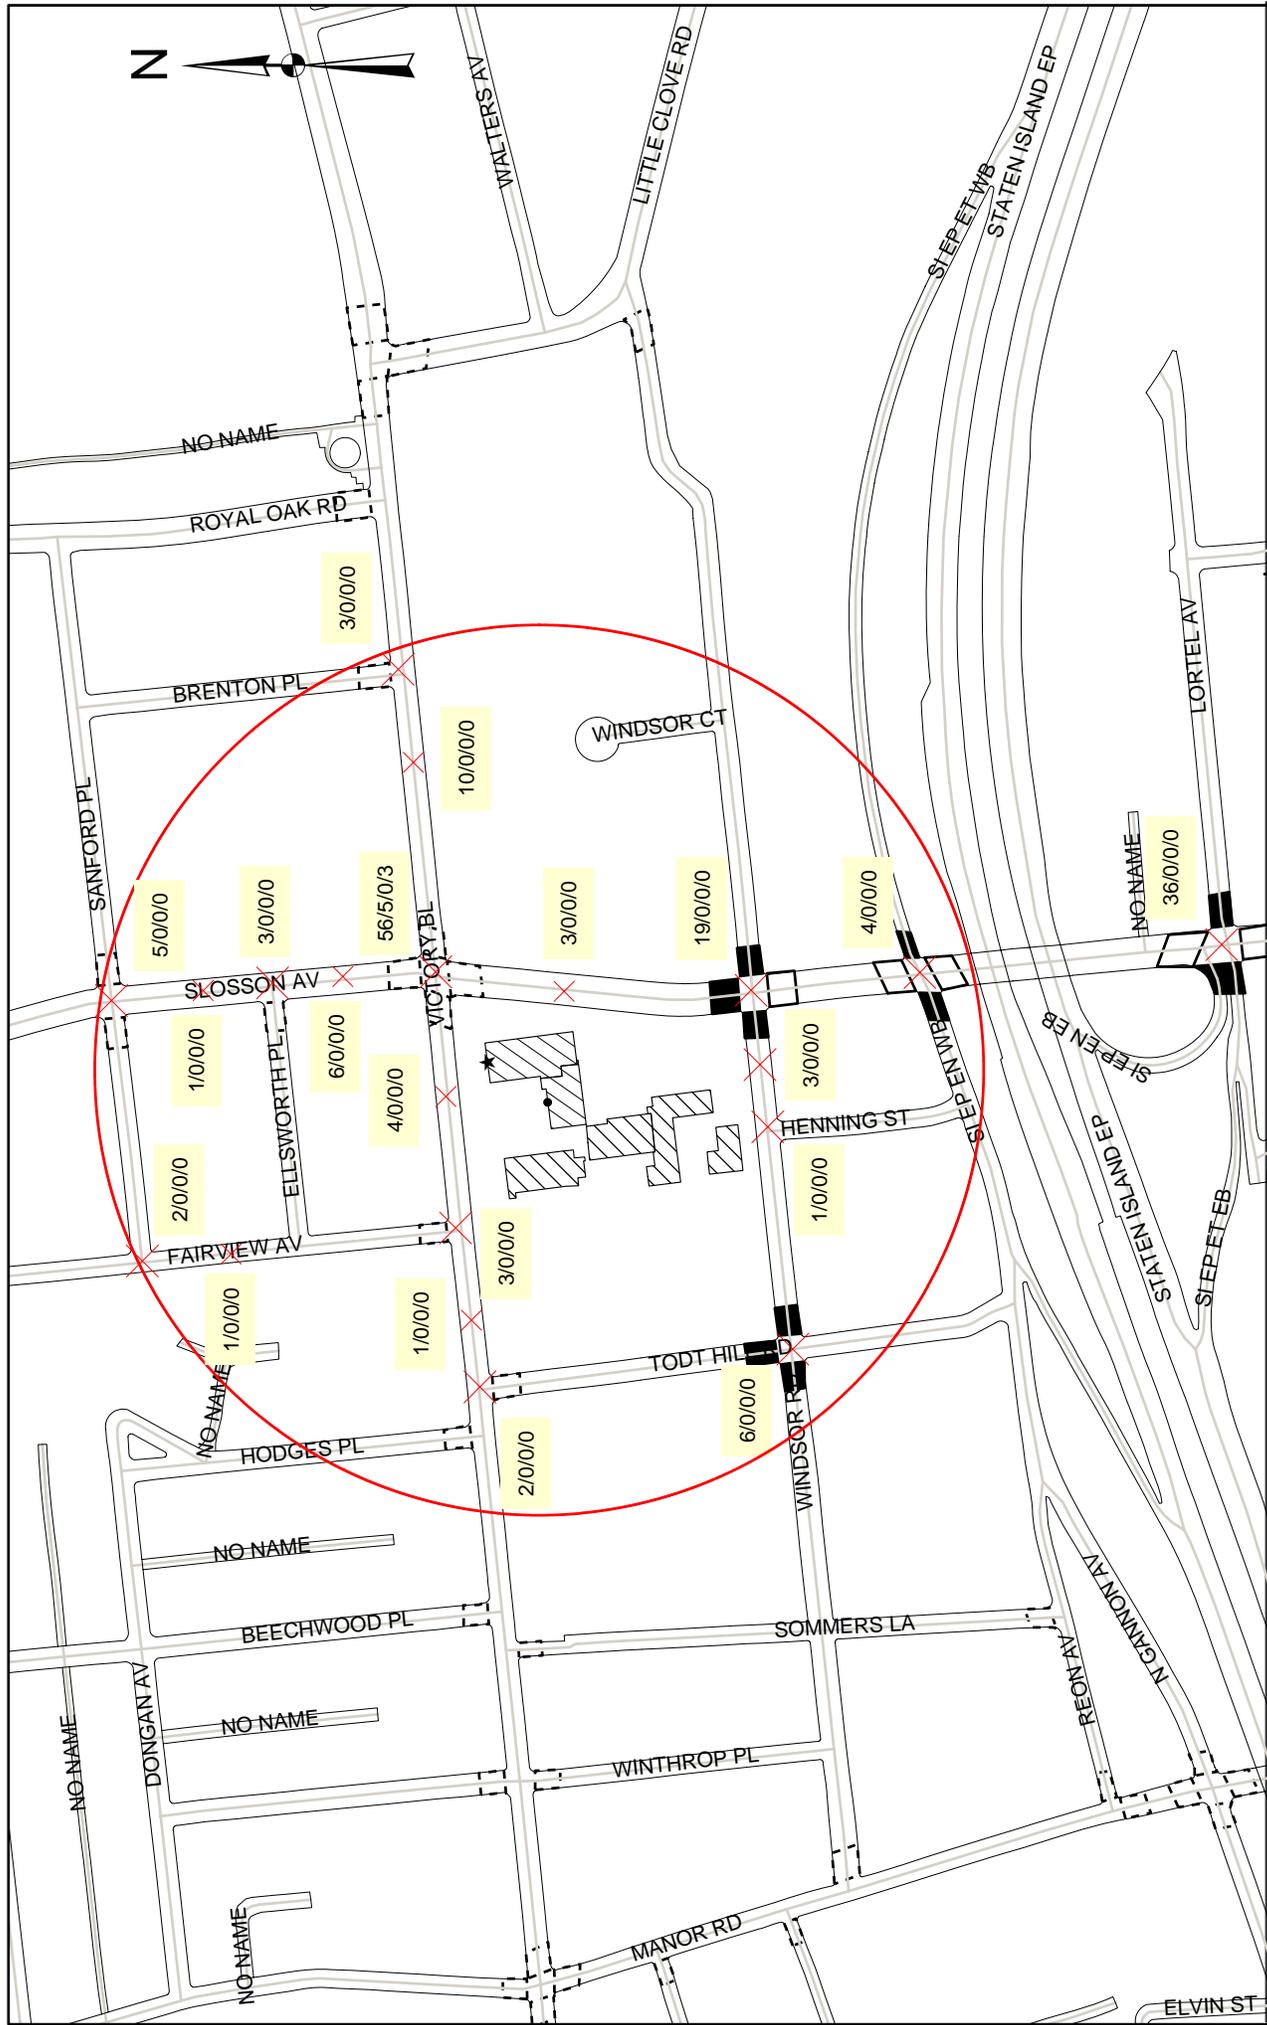
EXHIBIT 4
ST. TERESA SCHOOL
STATEN ISLAND
ACCIDENT SUMMARY (1998-2000)

Exhibit 5 and Table 2 show a summary of accidents, as obtained from the New York State Department of Motor Vehicles (DMV), in the vicinity of Saint Teresa School for a three-year period from January 1, 1998 through December 31, 2000. The DMV data provides some detail relating to the circumstances and cause of an accident. Table 3 is a summary of more recent accident data obtained from the NYC Police Department (NYPD). Though current through 2004, the NYPD data does not provide the same level of detail as the DMV data.

This intersection was the site of 56 accidents between 1998 and 2000 (Table 1), including five pedestrian accidents, three of which were school-related. The first of these school-related pedestrian accidents occurred at approximately 3:00 pm on January 11, 1999, when a ten-year-old pedestrian was reported to have sustained a “possible injury” while crossing with the signal at the intersection. The road surface was dry and the weather was clear at the time of the accident, which occurred during daylight conditions. The second school-related pedestrian accident occurred at approximately 5:00 pm on October 25, 1999, when a ten-year-old pedestrian was reported to have been struck at the intersection. The extent of the pedestrian’s injuries was unreported. The pedestrian’s actions were reported as “Crossing, No Signal, Marked Crosswalk”. It is uncertain what is meant by this, because the intersection is signalized. The road surface was dry and the weather was clear at the time of the accident, which occurred during daylight conditions. There were no pedestrian fatalities during this time period.

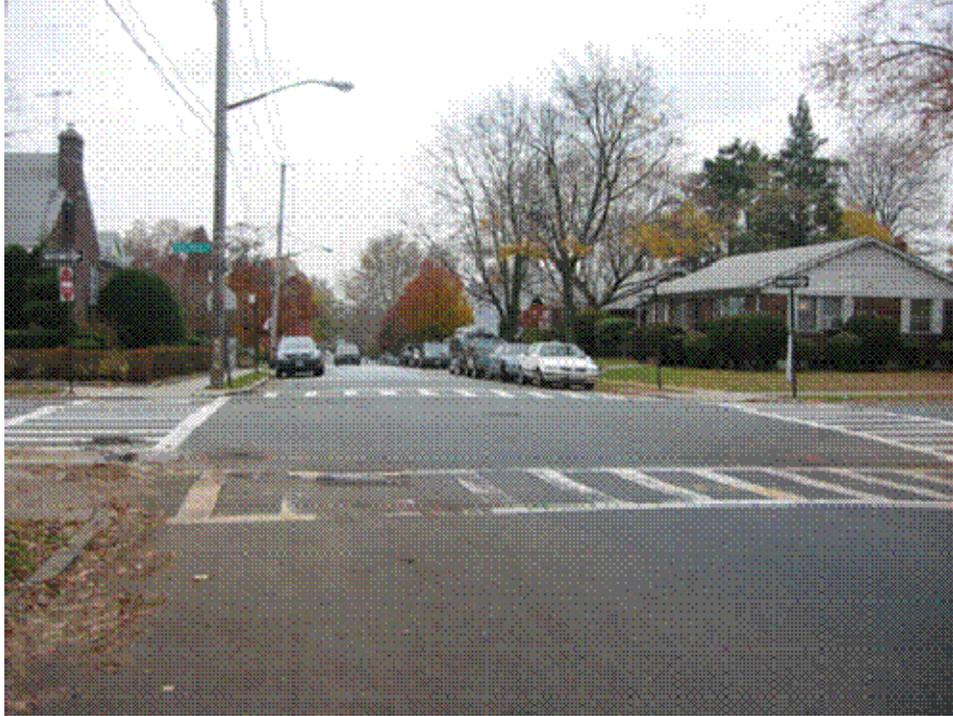
This is an unsignalized four-leg intersection with stop-control on the northbound Todt Hill Road approach. School crosswalks are located across all legs of the intersection (see Figure 4). Windsor Road is a one-way eastbound street with one travel lane and on-street parking on both sides of the roadway. Todt Hill Road is a one-way northbound street, with one travel lane and on-street parking on both sides of the roadway.

This intersection was the site of six accidents between 1998 and 2000 (Table 1), none of which involved pedestrians.

Figure 4: Looking west along Windsor Road across the intersection with Todt Hill Road

➤ Assign Crossing Guard to Windsor Road/Todt Hill Road intersection

This intersection has school crosswalks across Windsor Road and Todt Hill Road. The traffic and pedestrian counts conducted during the weekday morning peak hour indicated that multi-way stop-control would not be appropriate at this intersection. An alternate measure to provide protection for these school crosswalks would be to assign a crossing guard to the intersection during the school's morning arrival and afternoon departure times to accommodate student pedestrian crossings of the intersection.

- A crossing guard be assigned at the intersection of Windsor Road and Todt Hill Road during the morning arrival and afternoon departure times for St. Teresa School.
- Installation of Speed Reducers (Humps) on Windsor Road

- Two speed reducers (humps) should be installed along Windsor Road, one between Sommers Lane and Todt Hill Road and the second between Todt Hill Road and Slosson Avenue, to effectively control speeding on this block adjacent to the school. The speed reducers should be marked and signed per NYCDOT standards.

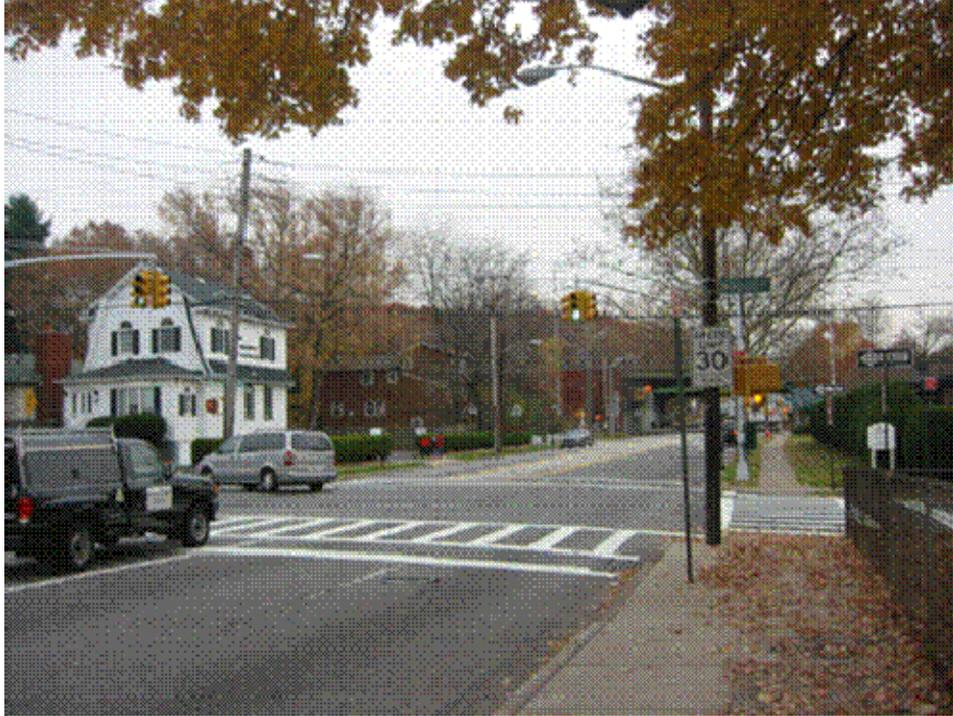
This is a signalized four-leg intersection with school crosswalks located across the north, east and west legs (see Figure 5). Slosson Avenue is a two-way street with two travel lanes in each direction, an exclusive left-turn lane on the southbound approach to Windsor Road, and no on-street parking. A painted median is located along the center of Slosson Avenue between Windsor Road and Reon Avenue. West of Slosson Avenue, Windsor Road is a one-way eastbound street with one travel lane and on-street parking on both sides of the roadway. East of Slosson Avenue, Windsor Road is a two-way street with one travel lane and one on-street parking lane on each side of the roadway.

This intersection was the site of 19 accidents between 1998 and 2000 (Table 1), none of which involved pedestrians. There were no pedestrian fatalities during this time period.

Figure 5: Looking southeast along Slosson Avenue toward the intersection with Windsor Road (St. Teresa School is to the right)

- The northwest and southwest corners of the Windsor Road and Slossen Avenue intersection for the crosswalk located across the west leg of the intersection.

The purpose of the curb extensions is to shorten the crossing distance for pedestrians, and to reduce speeds of vehicles approaching and turning at these heavily utilized school crosswalks. These curb extensions would not eliminate or reduce the width of any moving lanes.

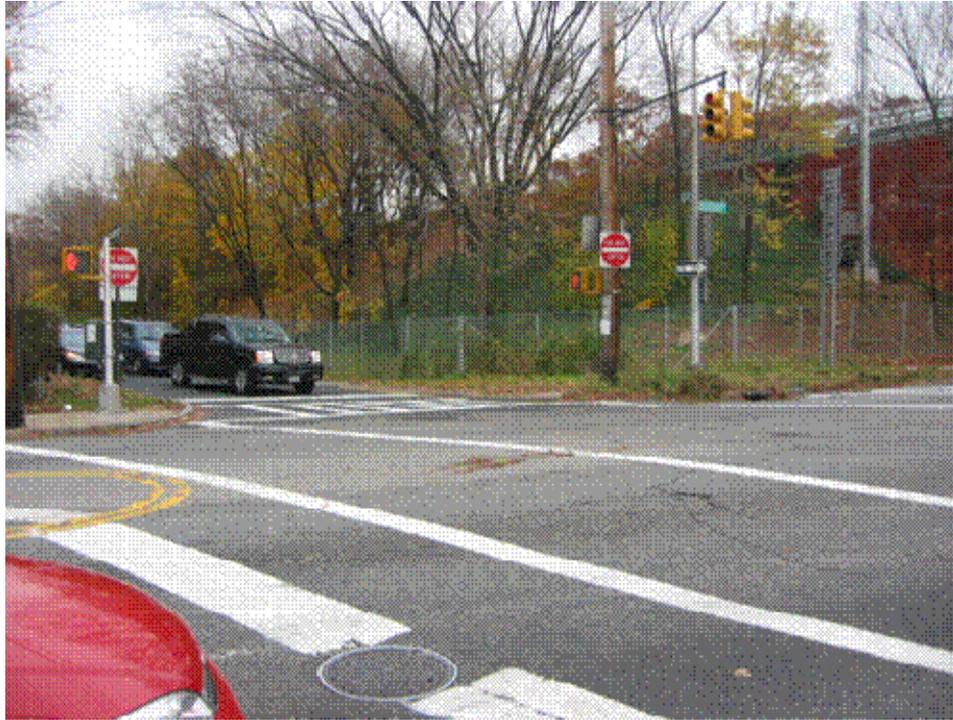
This is a signalized four-leg intersection with school crosswalks located across the east and west legs (i.e. the westbound exit ramp and Reon Avenue, respectively), and pedestrian crosswalks across the north and south legs. Slosson Avenue is a two-way street with two travel lanes in each direction, an exclusive northbound left-turn lane at the intersection with Reon Avenue/Staten Island Expressway westbound off-ramp, and no on-street parking. The westbound off-ramp for Exit 12 on the Staten Island Expressway intersects with Slosson Avenue from the east, and is one-way westbound (see Figure 6). Reon Avenue intersects Slosson Avenue on the west side and is also one-way westbound (see Figure 7). Reon Avenue is aligned between Slosson Avenue and Manor Road to the west. A westbound on-ramp to the Staten Island Expressway is located on the south side of Reon Avenue, just west of its intersection with Henning Street.

Figure 6: Looking southeast across Slosson Avenue at the westbound off-ramp from Exit 12 of the Staten Island Expressway

- On the northeast and southwest corners of the Slosson Avenue and Reon Avenue intersection, pedestrian ramps are missing and the sidewalk is broken (see Figures 6 and 8).

- Install pedestrian ramps on the northeast and southwest corners of the Slosson Avenue and Reon Avenue intersection, and repair the broken sidewalk.
- Install pedestrian ramps on the northwest and southwest corners of the Slosson Avenue and Lortel Avenue/Staten Island Expressway eastbound intersection ramps intersection, for the westerly crosswalk.
- Install a pedestrian ramp on the northeast corner of the Slosson Avenue and Lortel Avenue/Staten Island Expressway eastbound ramps intersection, for the easterly crosswalk.

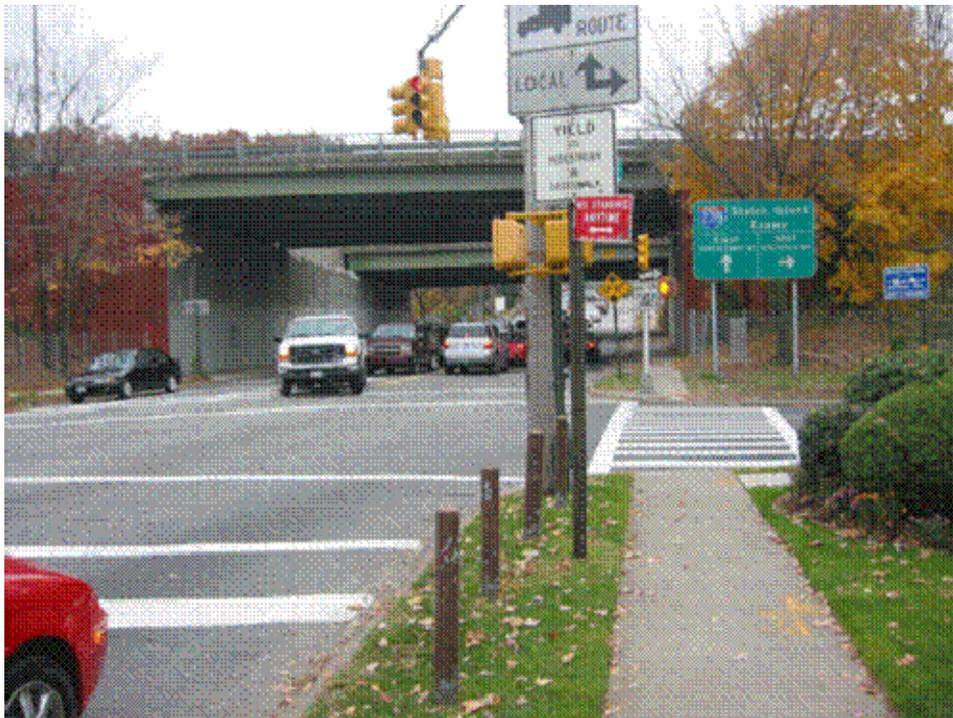
Figure 7: Looking south along the west side of Slosson Avenue toward the intersection with Reon Avenue

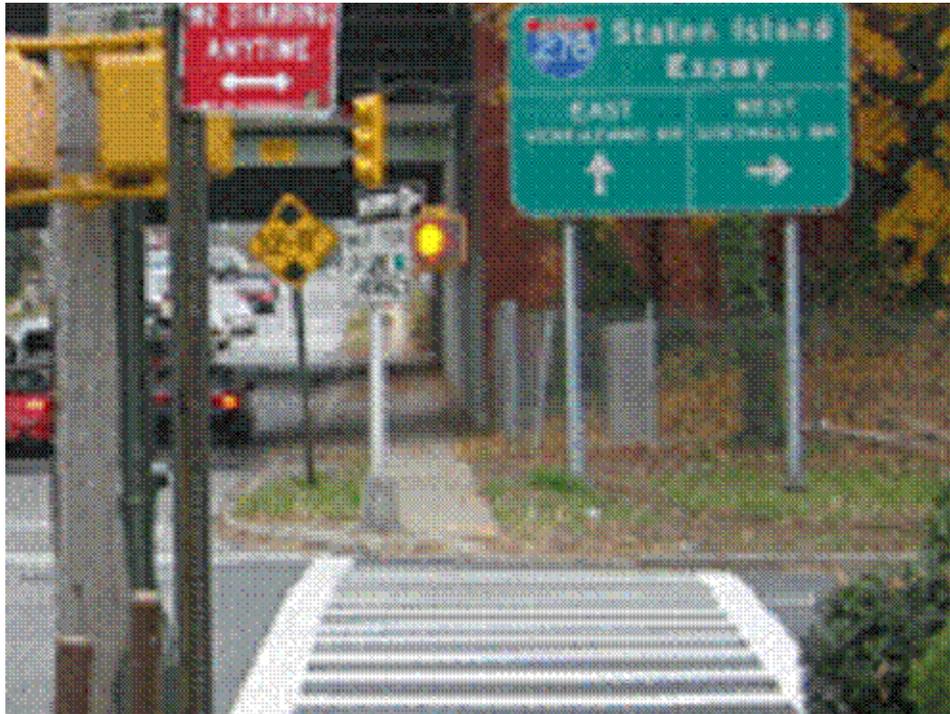
Figure 8: Looking south on Slosson Avenue to the southwest corner of the intersection with Reon Avenue

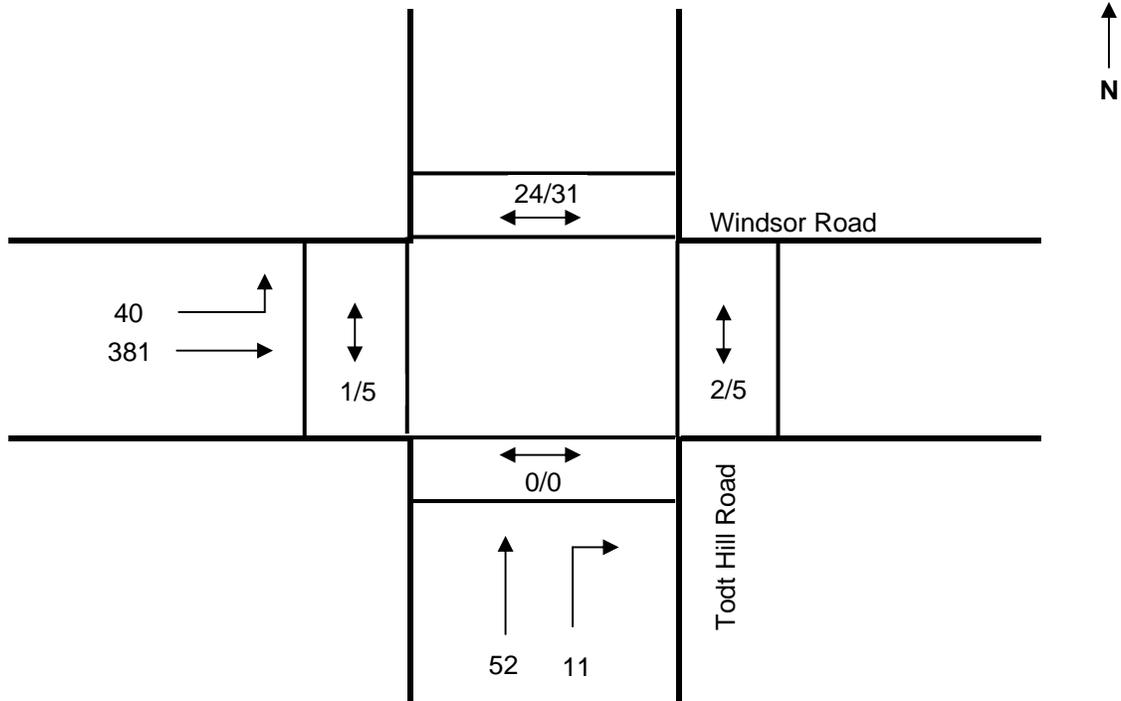
EXHIBIT 6
St. Teresa School Staten Island
TRAFFIC AND PEDESTRIAN COUNTS

The vehicular traffic count determined there were 421 vehicles eastbound on Windsor Road and 63 vehicles northbound on Todt Hill Road during the weekday morning peak hour (7:30 to 8:30 am). The pedestrian volume count determined there were six pedestrians (one adult and five students) utilizing the school crosswalk located across the west leg of Windsor Road, and seven pedestrians (two adults and five students) utilizing the pedestrian crosswalk located across the east leg of Windsor Road. This is a total of 13 pedestrians (three adults and ten students) crossing Windsor Road at the Todt Hill Road intersection during the weekday morning peak hour, which does not meet the warrant for an all way stop control at this time.

One Hour Traffic Volumes
Wednesday, October 19th, 2005 7:30 am - 8:30 am

Intersection of Windsor Road and Todt Hill Road

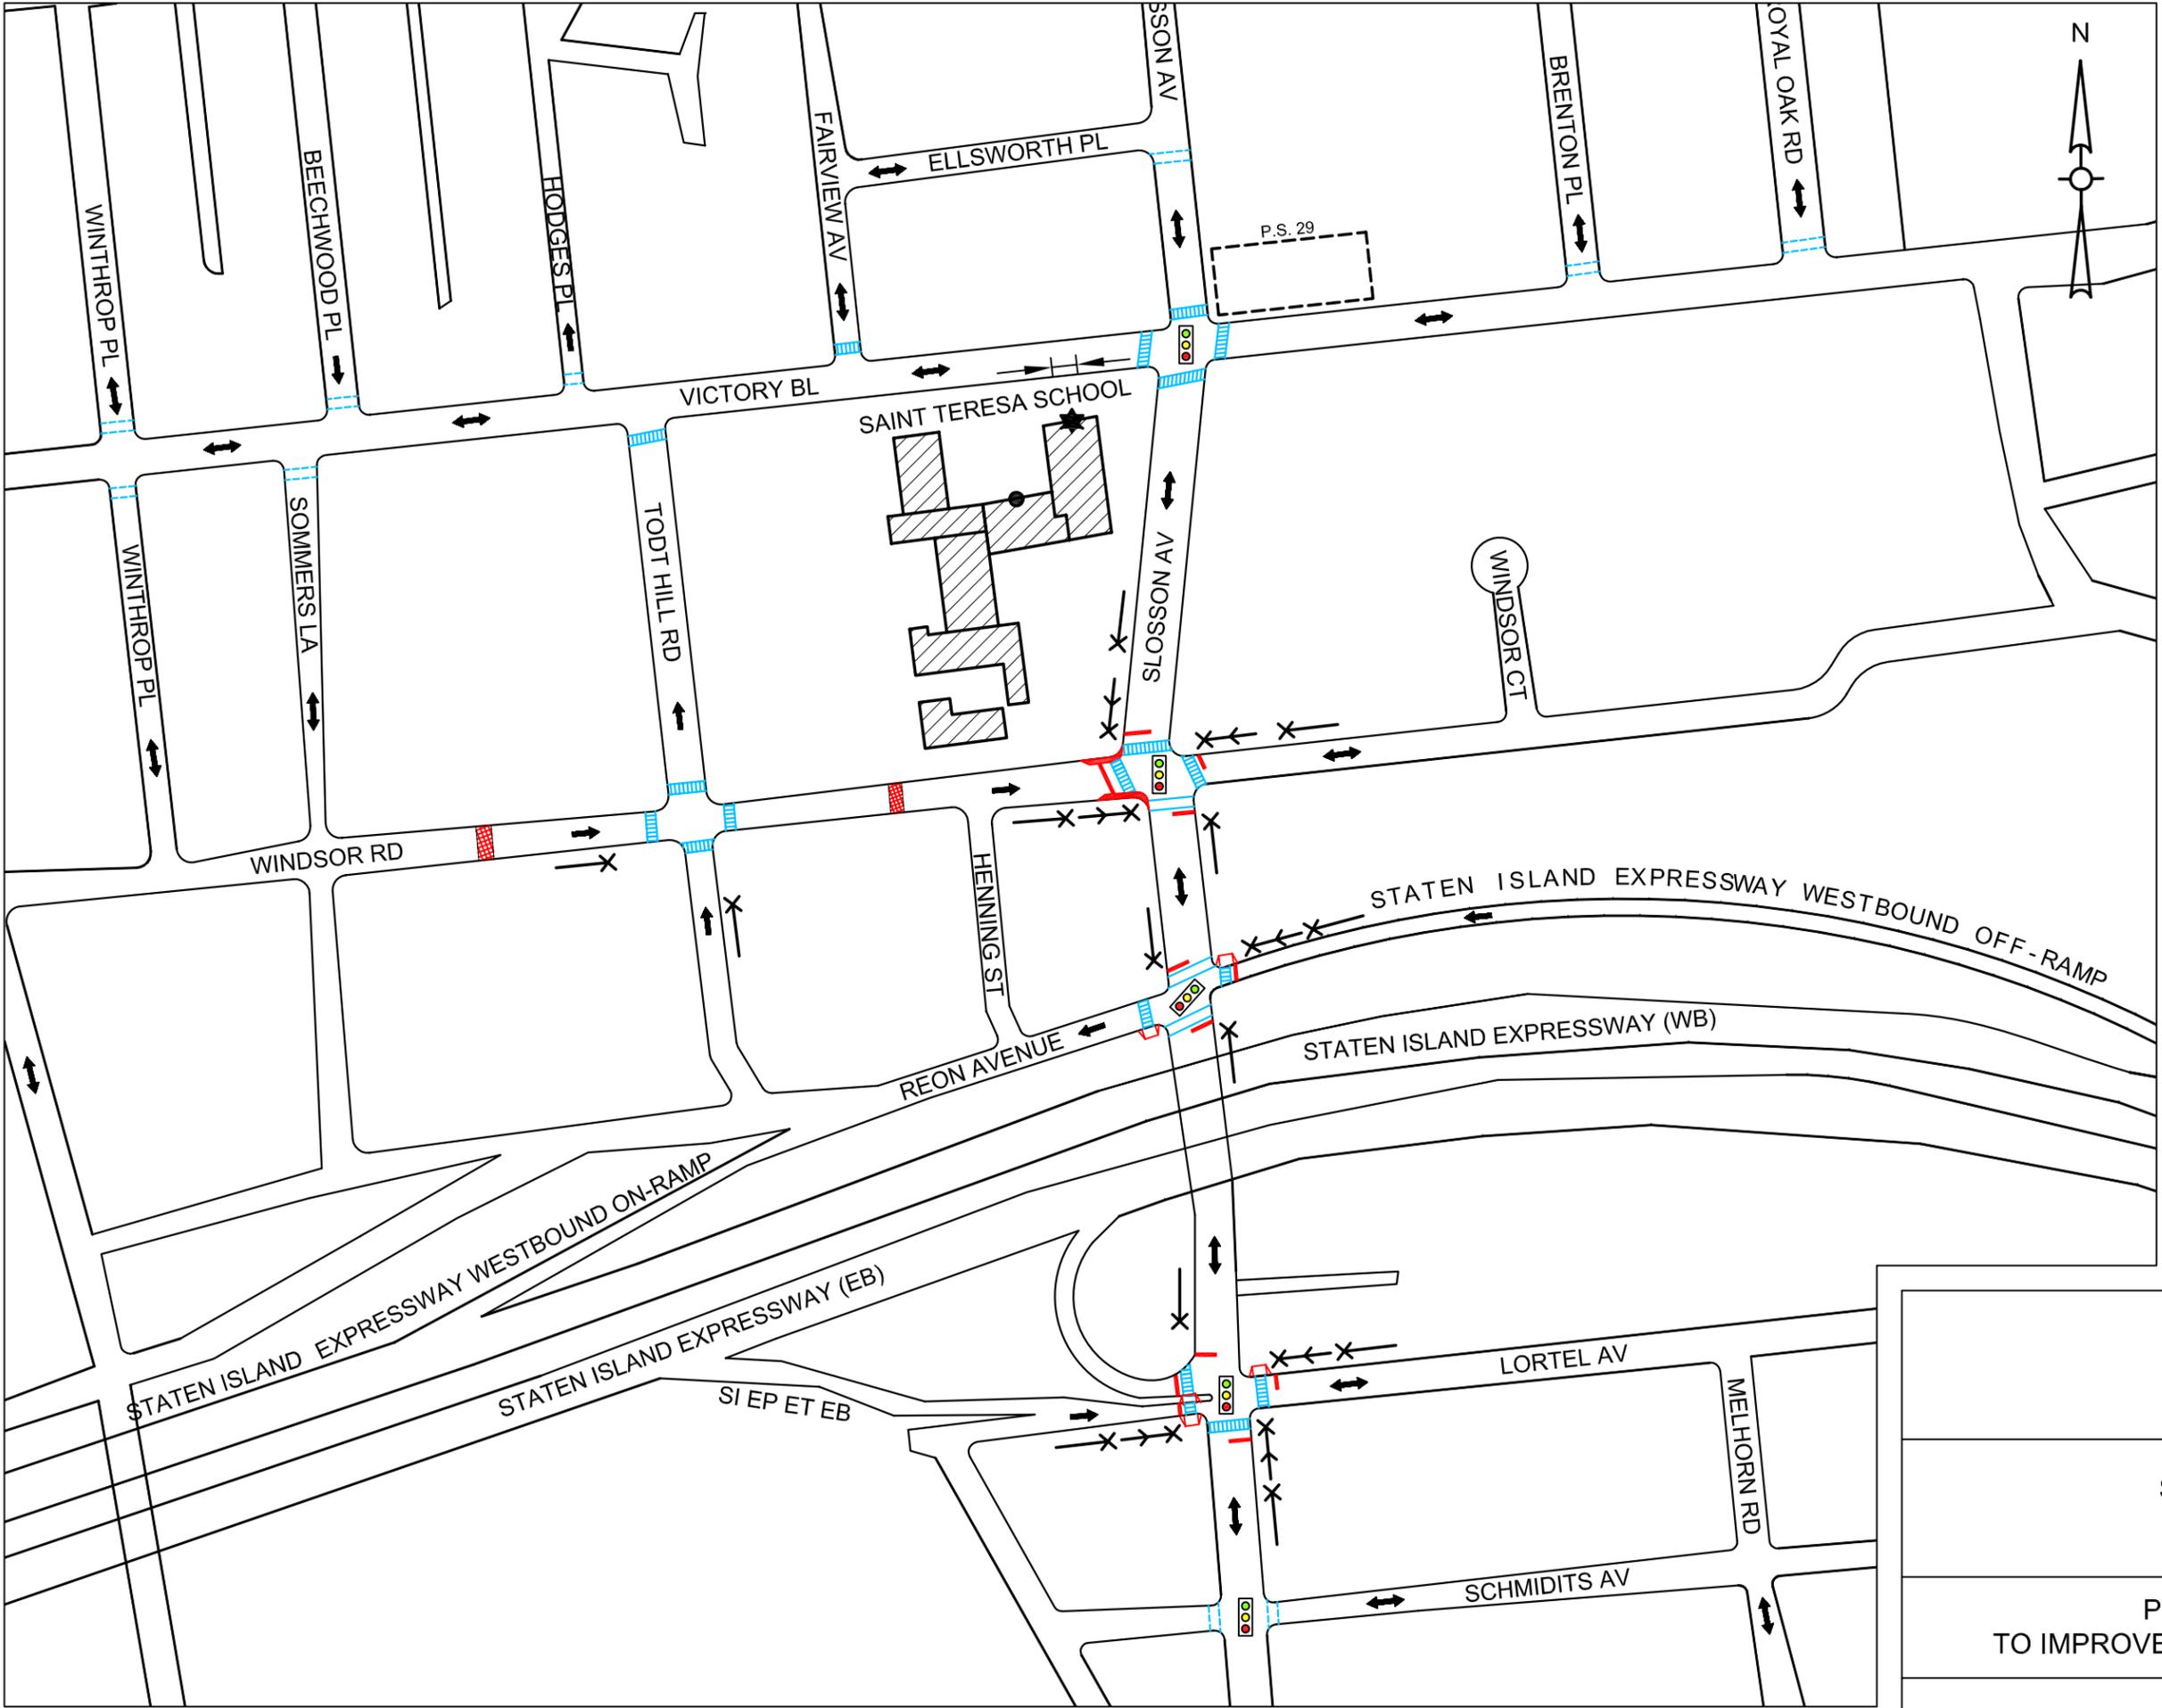
EXHIBIT 8

POTENTIAL MEASURES
TO IMPROVE STUDENT PEDESTRIAN SAFETY

➤ Place advance stop bars before school crosswalks

The MUTCD and New York City DOT standard for placement of a stop bar is four feet in advance of a marked crosswalk. At signalized (or stop controlled) crosswalks, the vehicle stop line can be placed farther back from the crosswalk in order to maximize visibility of pedestrians and to minimize the potential for pedestrian/vehicle conflicts. Therefore, it is recommended that stop bars be placed ten feet in advance of all school crosswalks.
