**New York City Department of Transportation
Office of School Safety Engineering**

School Safety Engineering Project

FINAL REPORT: St. Teresa School, Staten Island

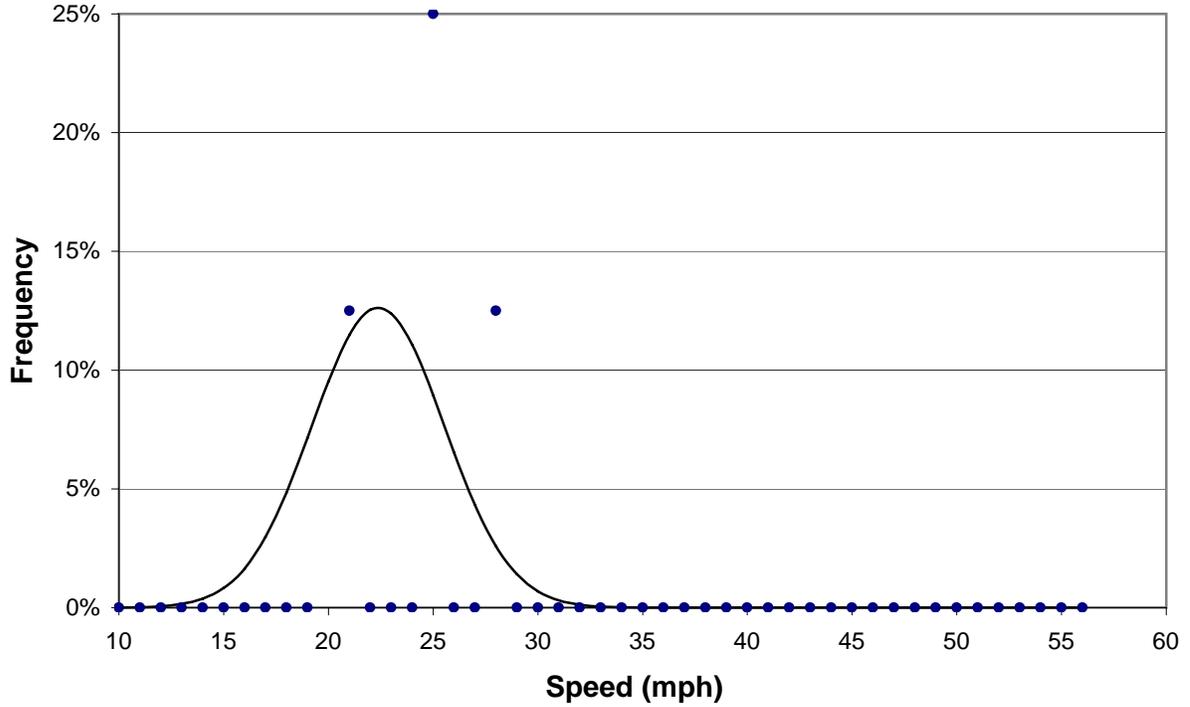
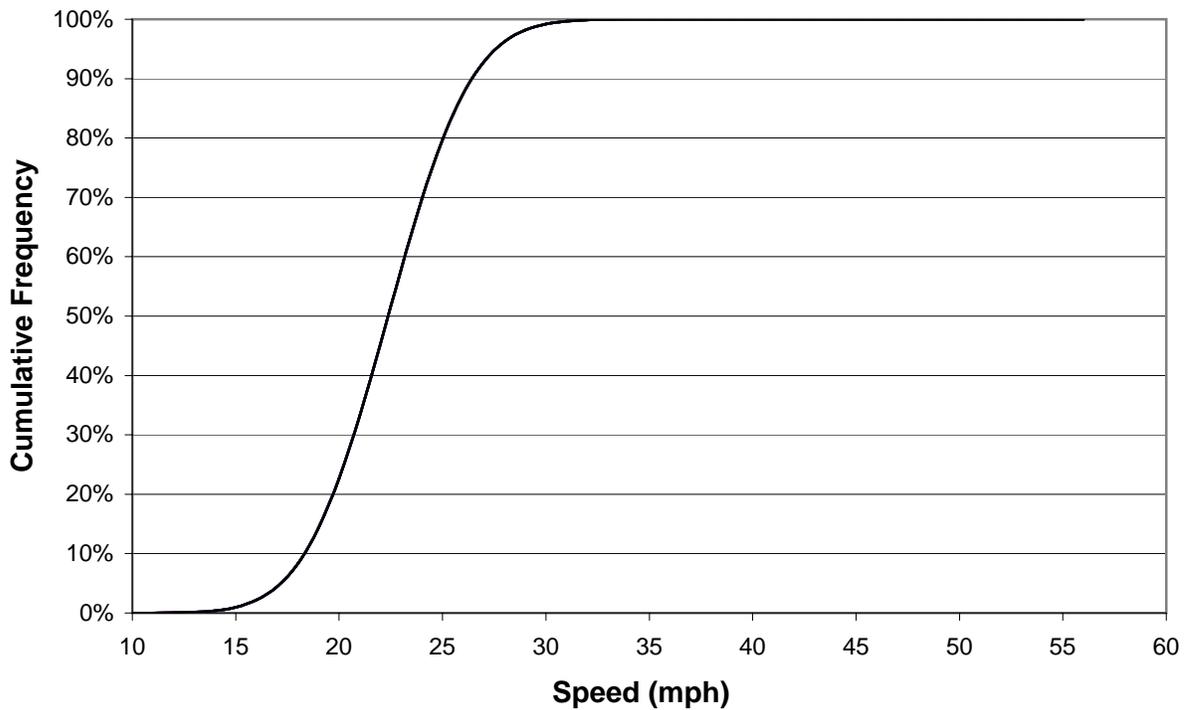
Date: 9-20-05
Location: Todt Hill Road between Reon Avenue & Windsor Road
Surveyor: R. Calvache/ H. Salinas

Mean Speed = 22.4 mph
Standard Deviation = 3.2 mph
Margin of Error (95% Confidence) = ± 2.2 mph

Median Speed = 22.4 mph
15th Percentile Speed = 19.1 mph
85th Percentile Speed = 25.6 mph

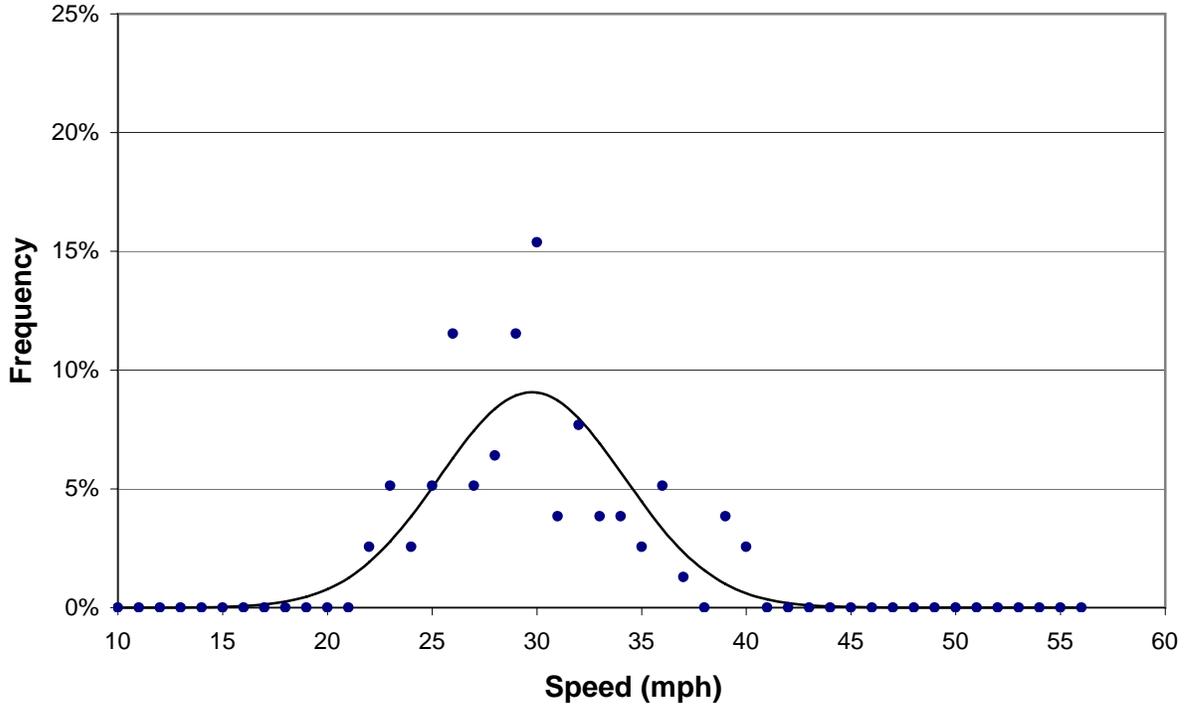
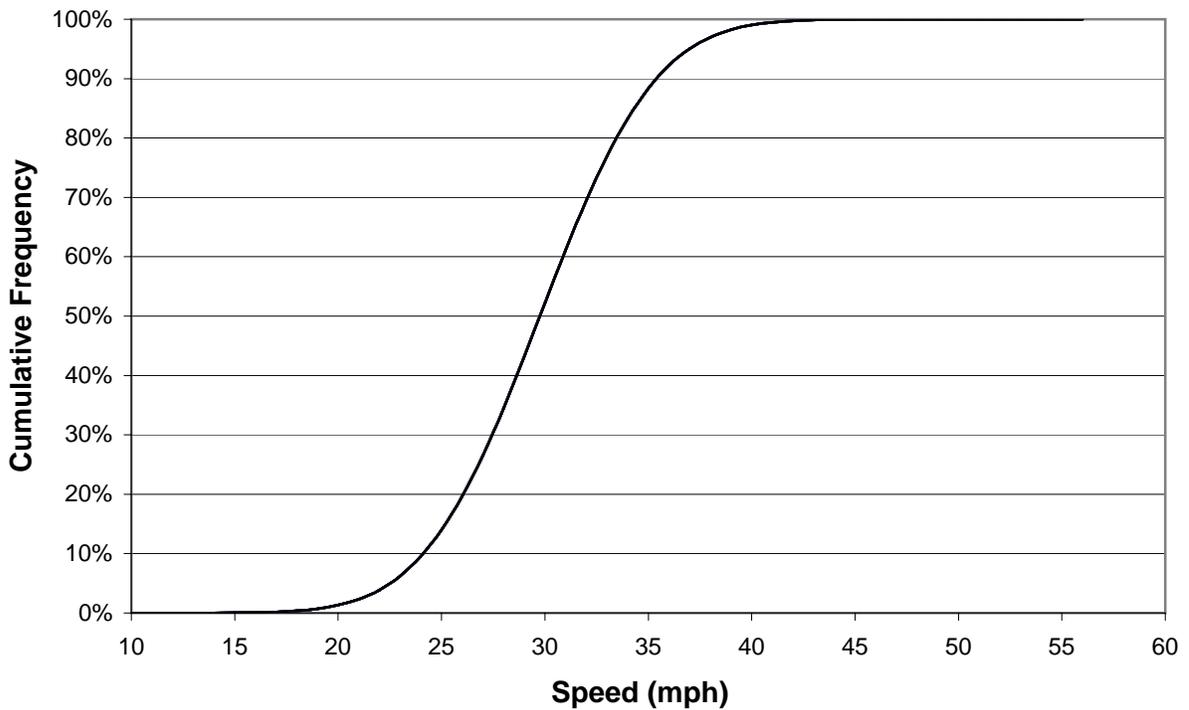
Date: 9-20-05
Location: Windsor Road between Todt Hill Road & Sommers La
Surveyor: R. Calvache/ H. Salinas

Mean Speed = 29.8 mph
Standard Deviation = 4.4 mph
Margin of Error (95% Confidence) = ± 1.0 mph

Median Speed = 29.8 mph
15th Percentile Speed = 25.2 mph
85th Percentile Speed = 34.3 mph

- Two speed reducers (humps) should be installed along Windsor Road, one between Sommers Lane and Todt Hill Road and the second between Todt Hill Road and Slosson Avenue, to effectively control speeding on this block adjacent to the school. The speed reducers should be marked and signed per NYCDOT standards.
