Columbus Avenue Parking-Protected Bicycle Path

West 96th to West 77th Streets

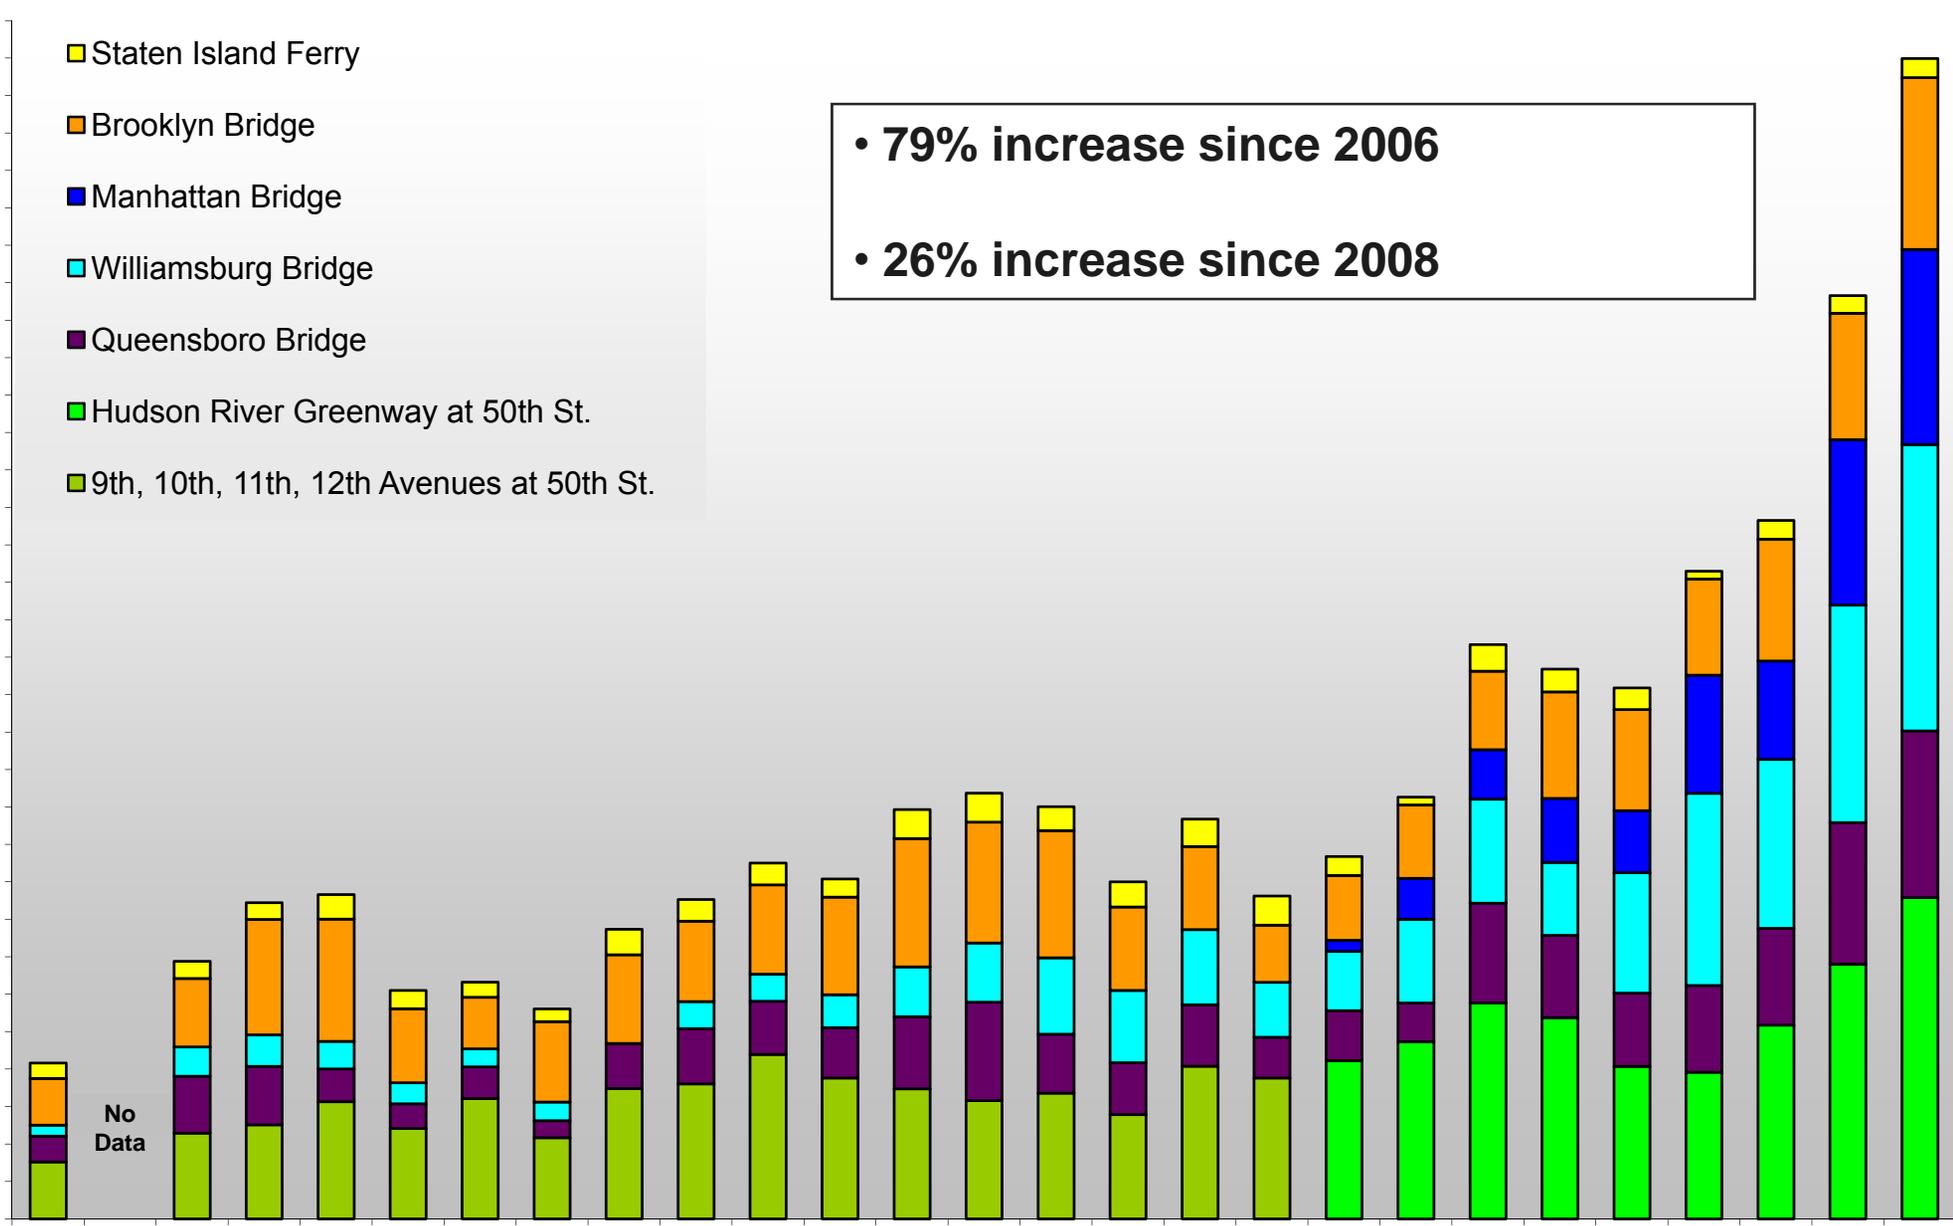
Ridership Rates

New York City Cyclist Counts at Selected Commuter Locations Weekday, 7AM to 7PM, 1980-2009

• **79% increase since 2006**
• **26% increase since 2008**

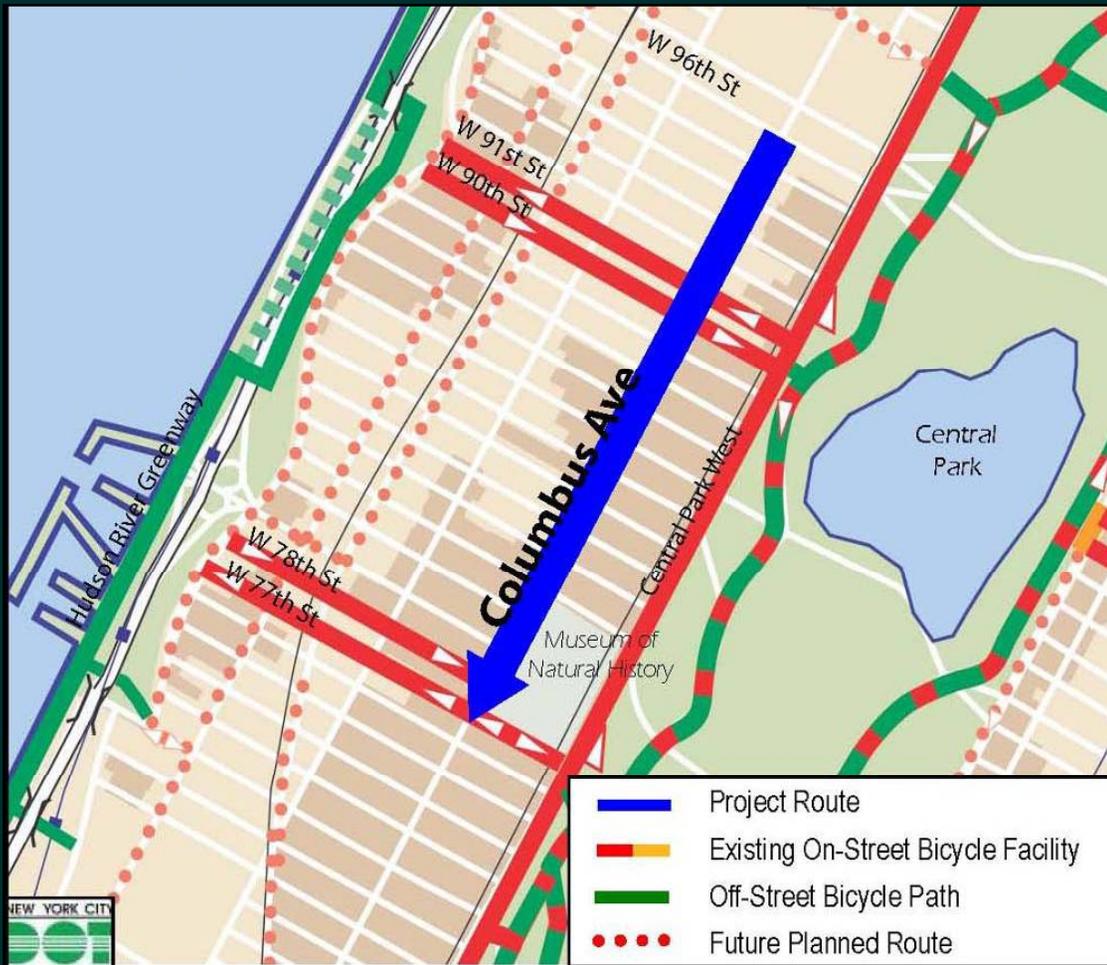
Project Background

- CB 7 requested DOT proposal for protected bicycle paths
- No existing on-street southbound bicycle facilities on Upper West Side
- 60-foot wide street with three travel lanes and curbside parking
- Opportunities for speeding and reckless driving

Bicycles	12-hour period	
	579	
Motor Vehicles	AM Peak Hour	PM Peak Hour
	1,409	1,390

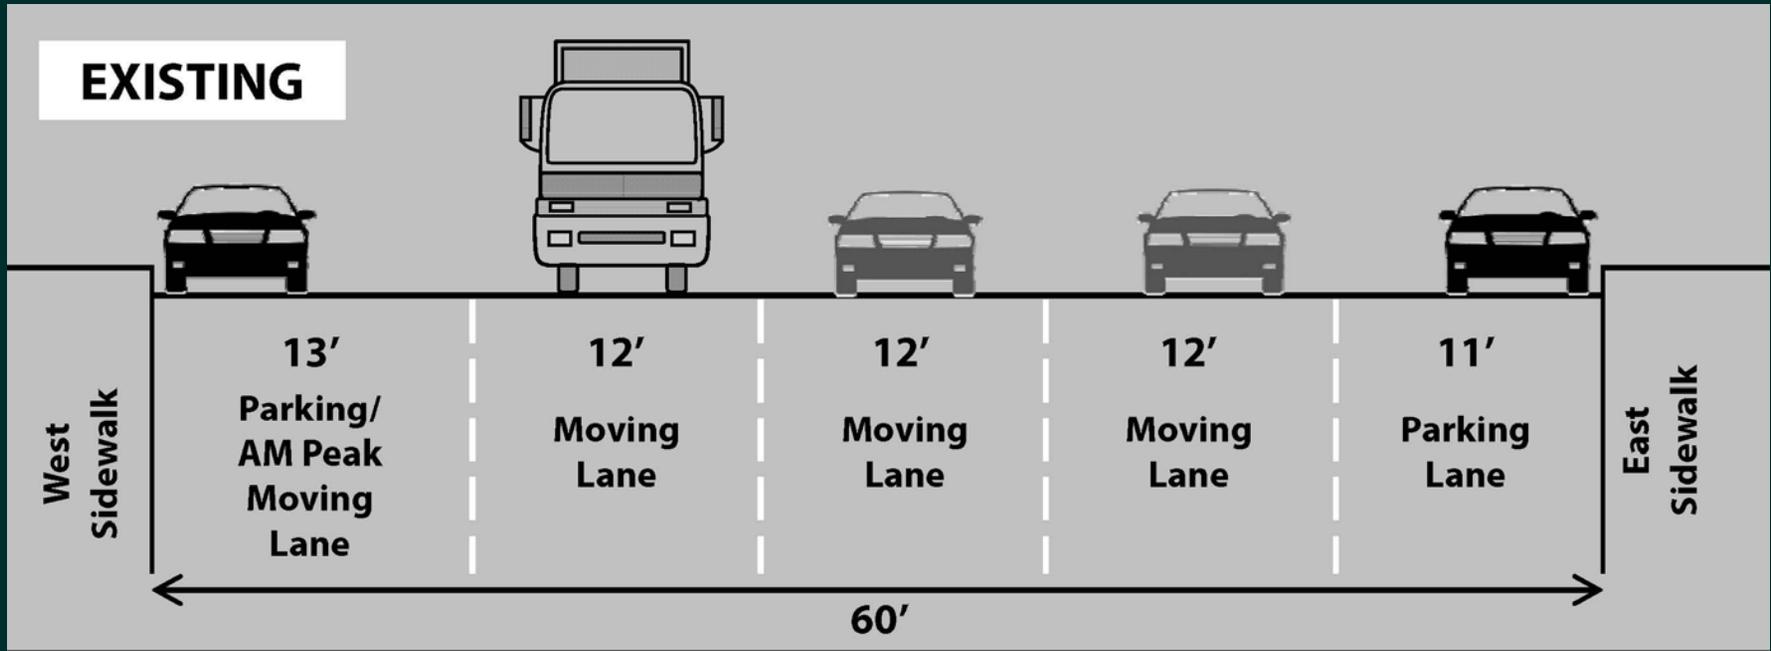
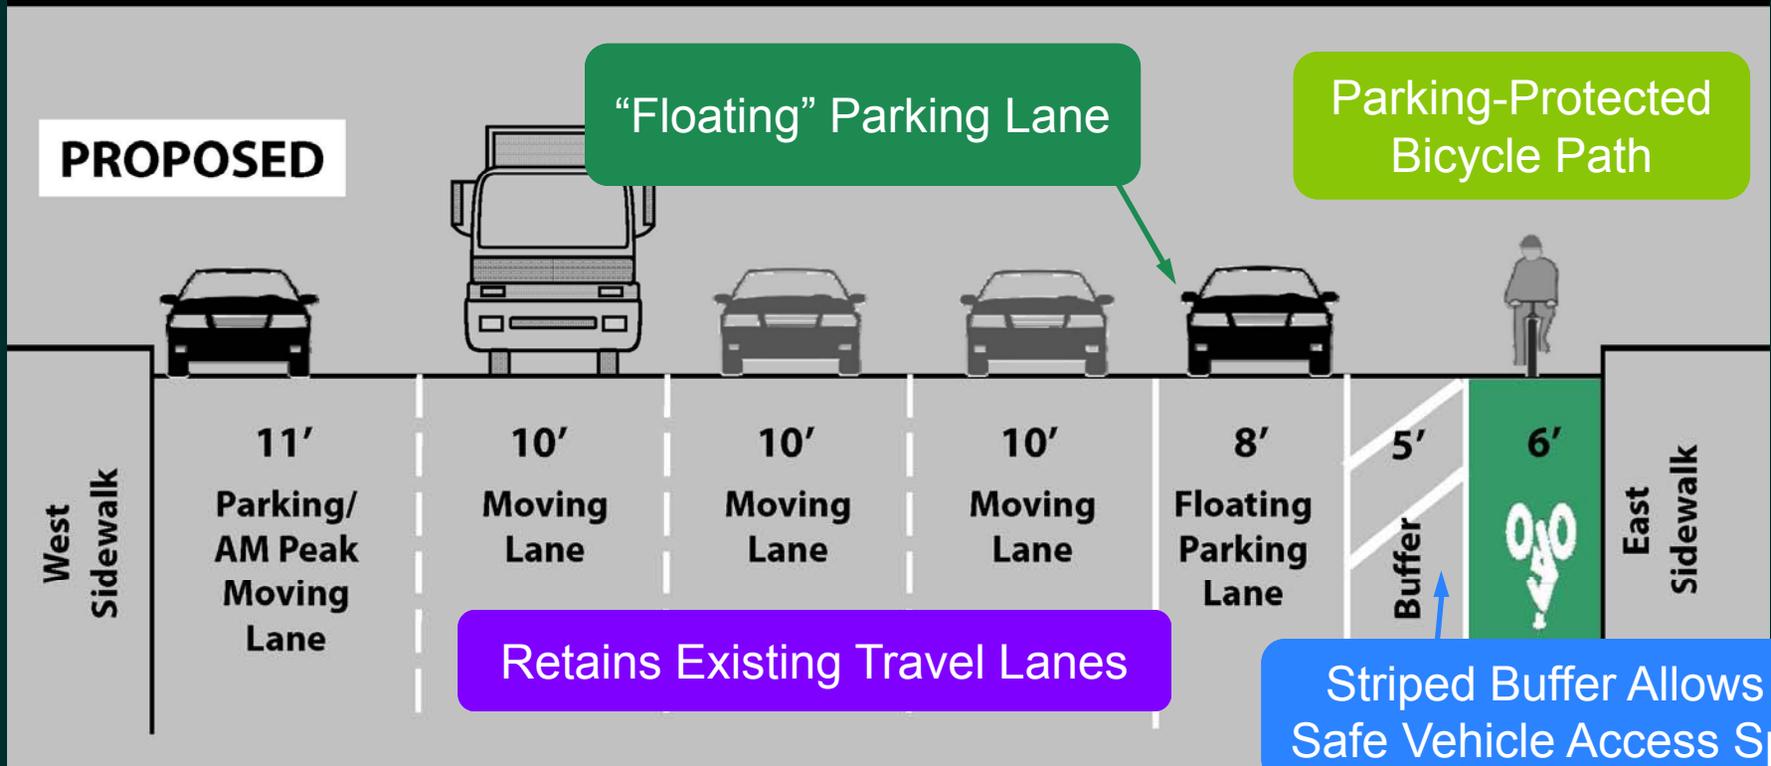
Existing
Conditions -
Columbus Ave

Proposed Configuration

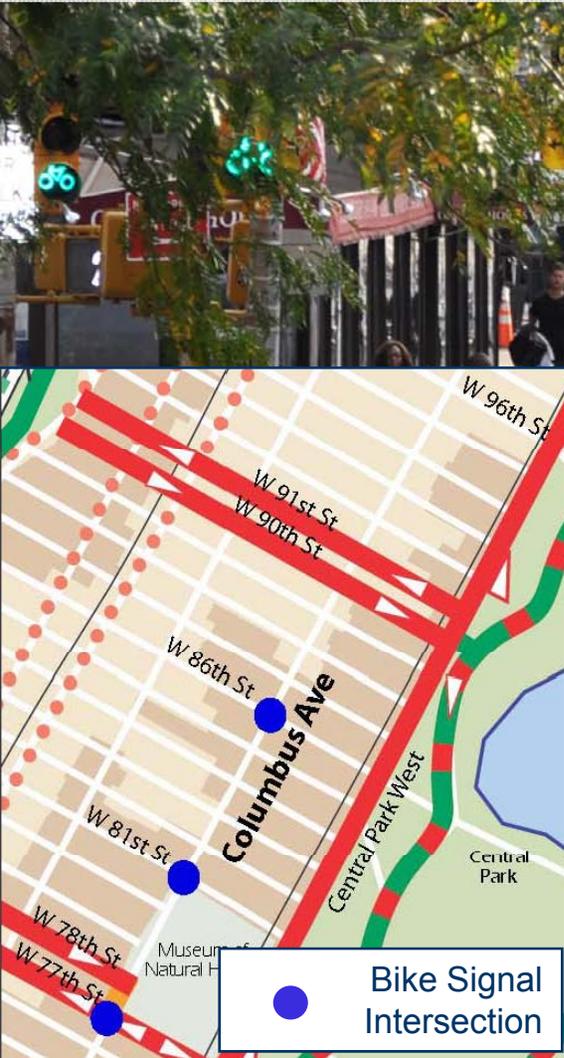
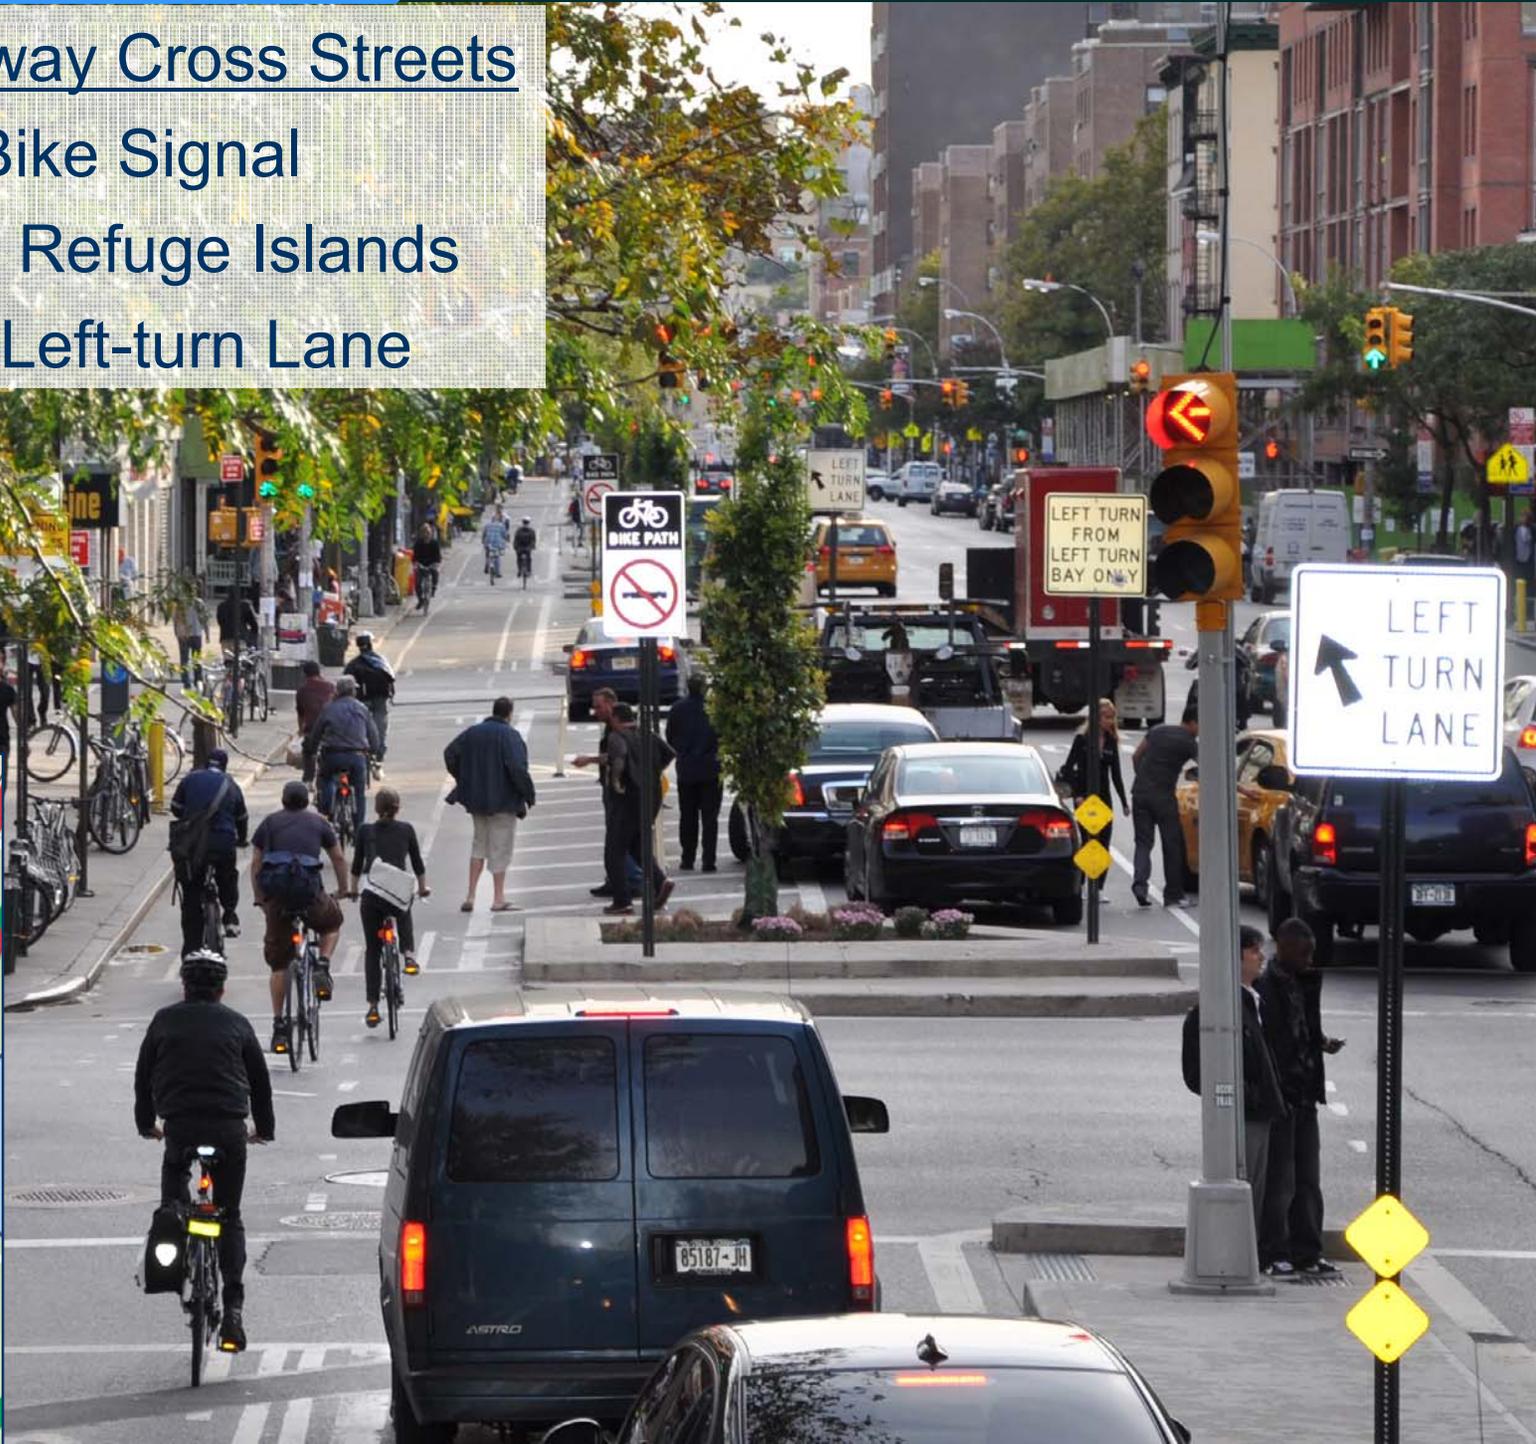
Safe Intersections

At Wide, Two-way Cross Streets

1. Separate Bike Signal
2. Pedestrian Refuge Islands
3. Dedicated Left-turn Lane

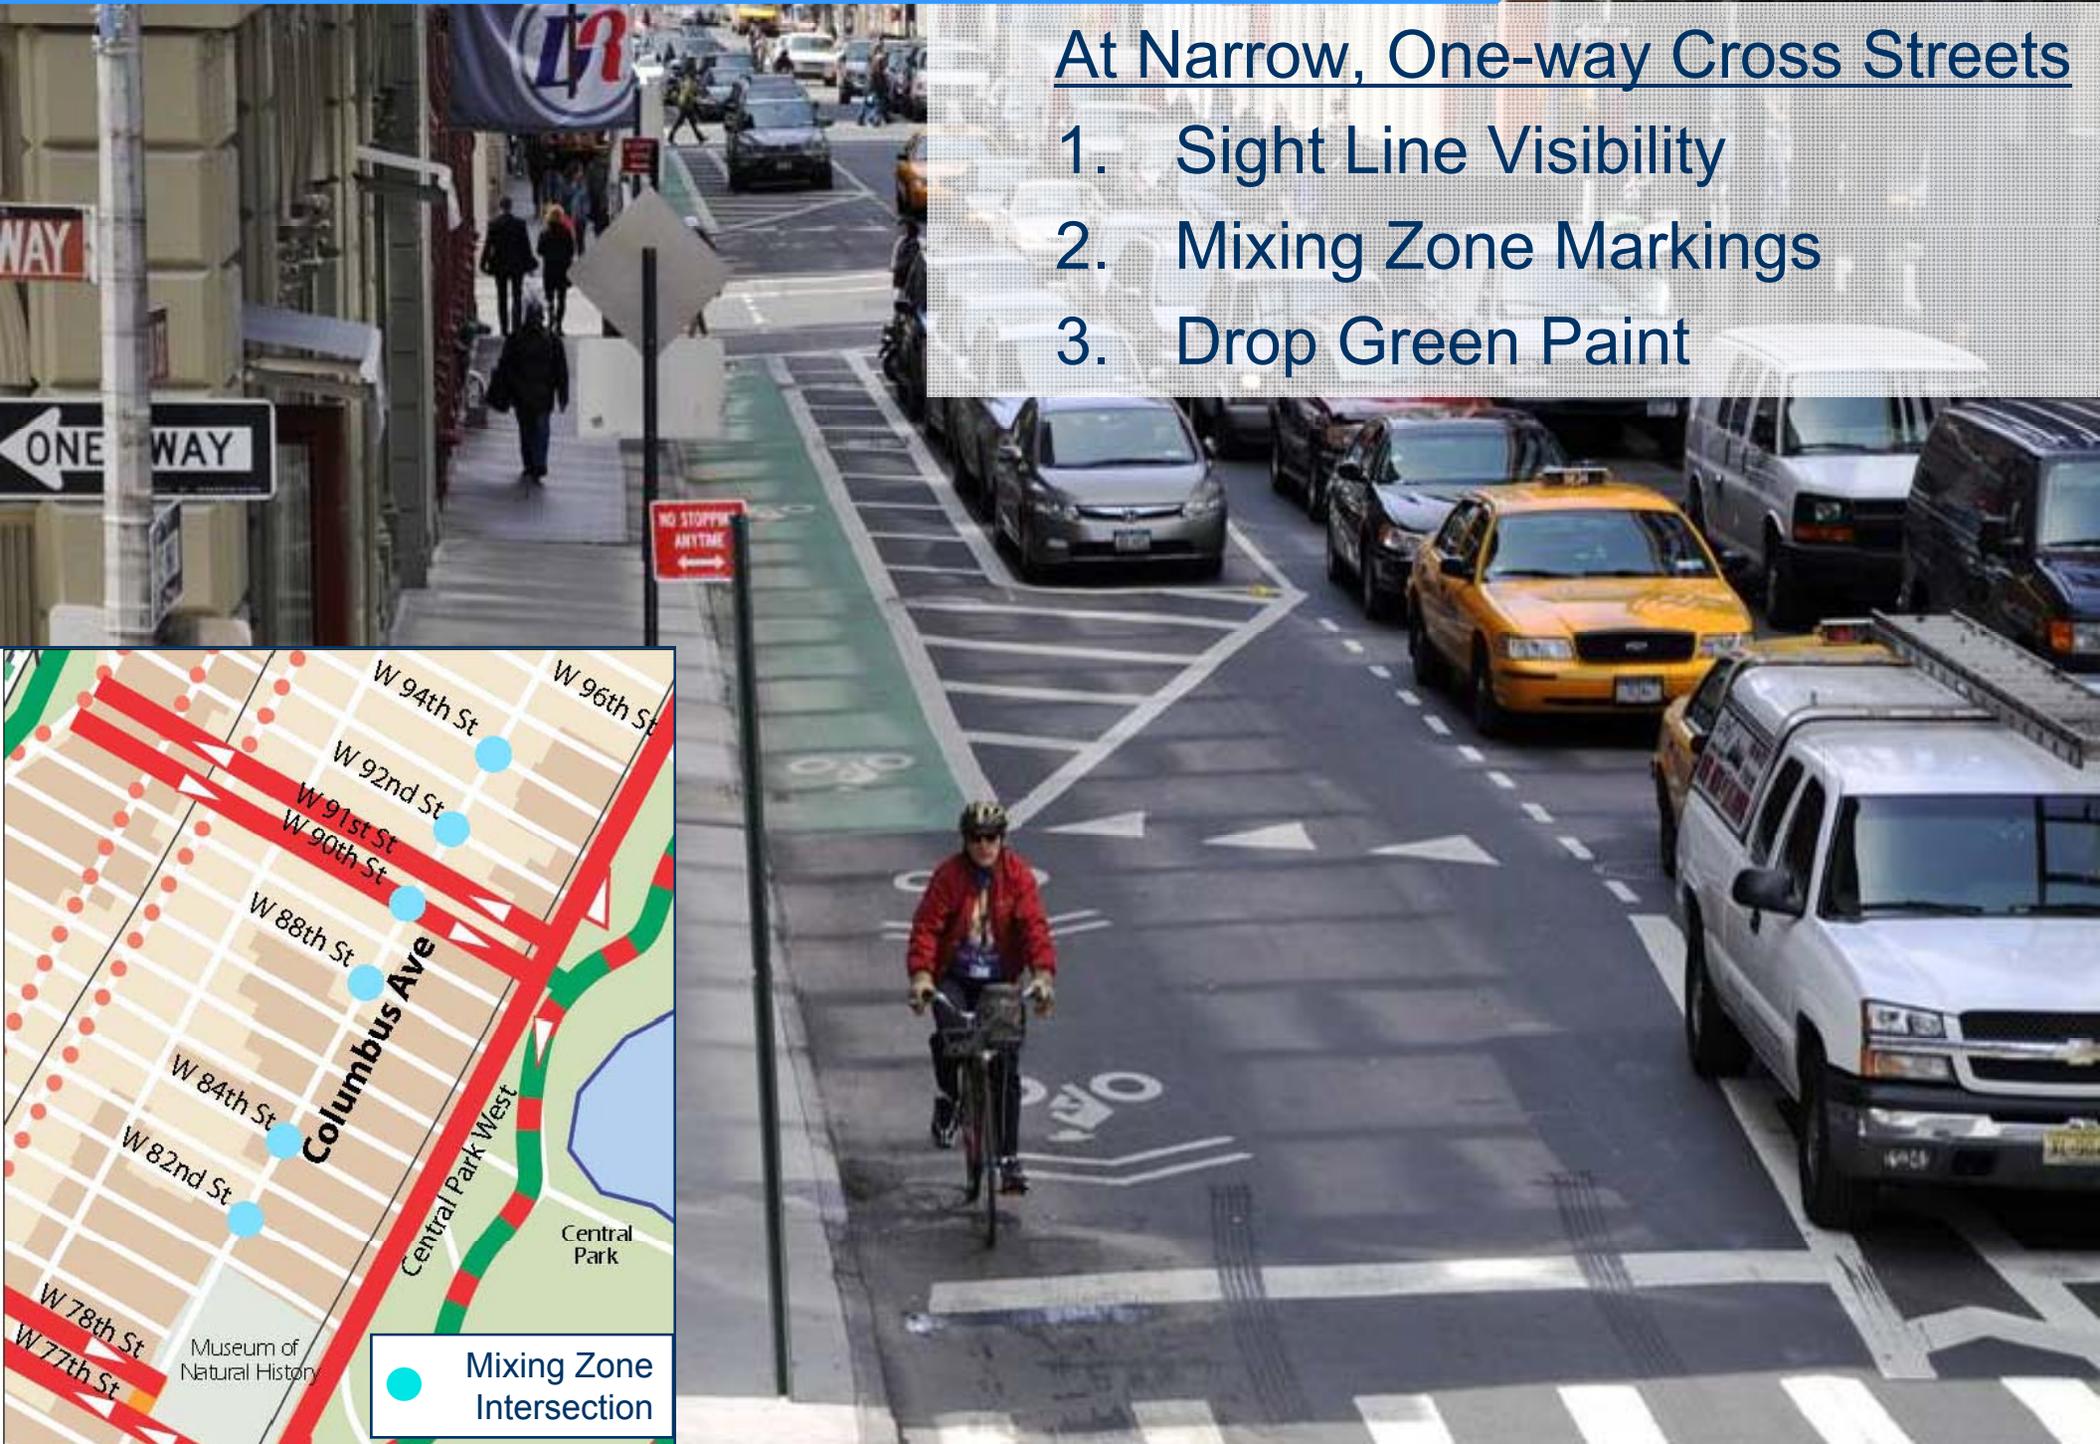
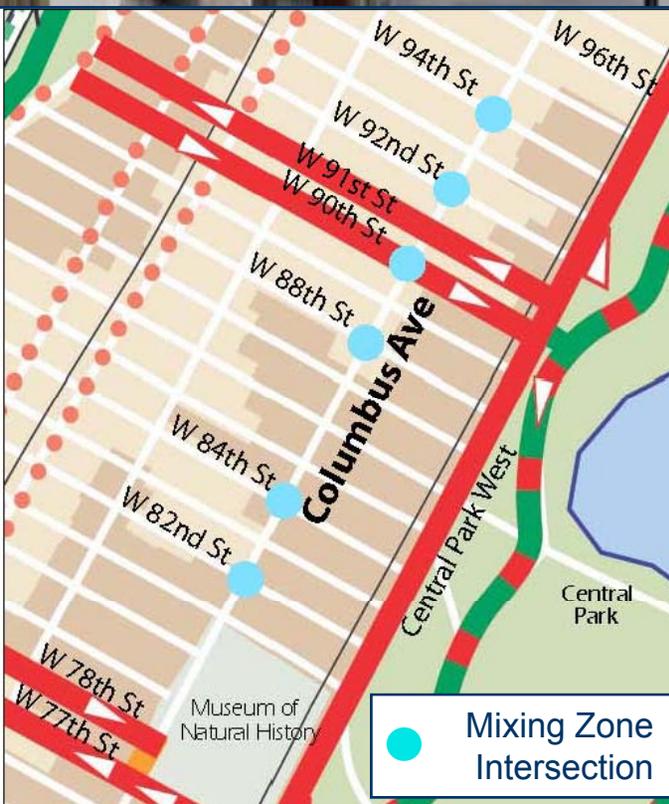
Safe Intersections – Mixing Zones

At Narrow, One-way Cross Streets

1. Sight Line Visibility
2. Mixing Zone Markings
3. Drop Green Paint

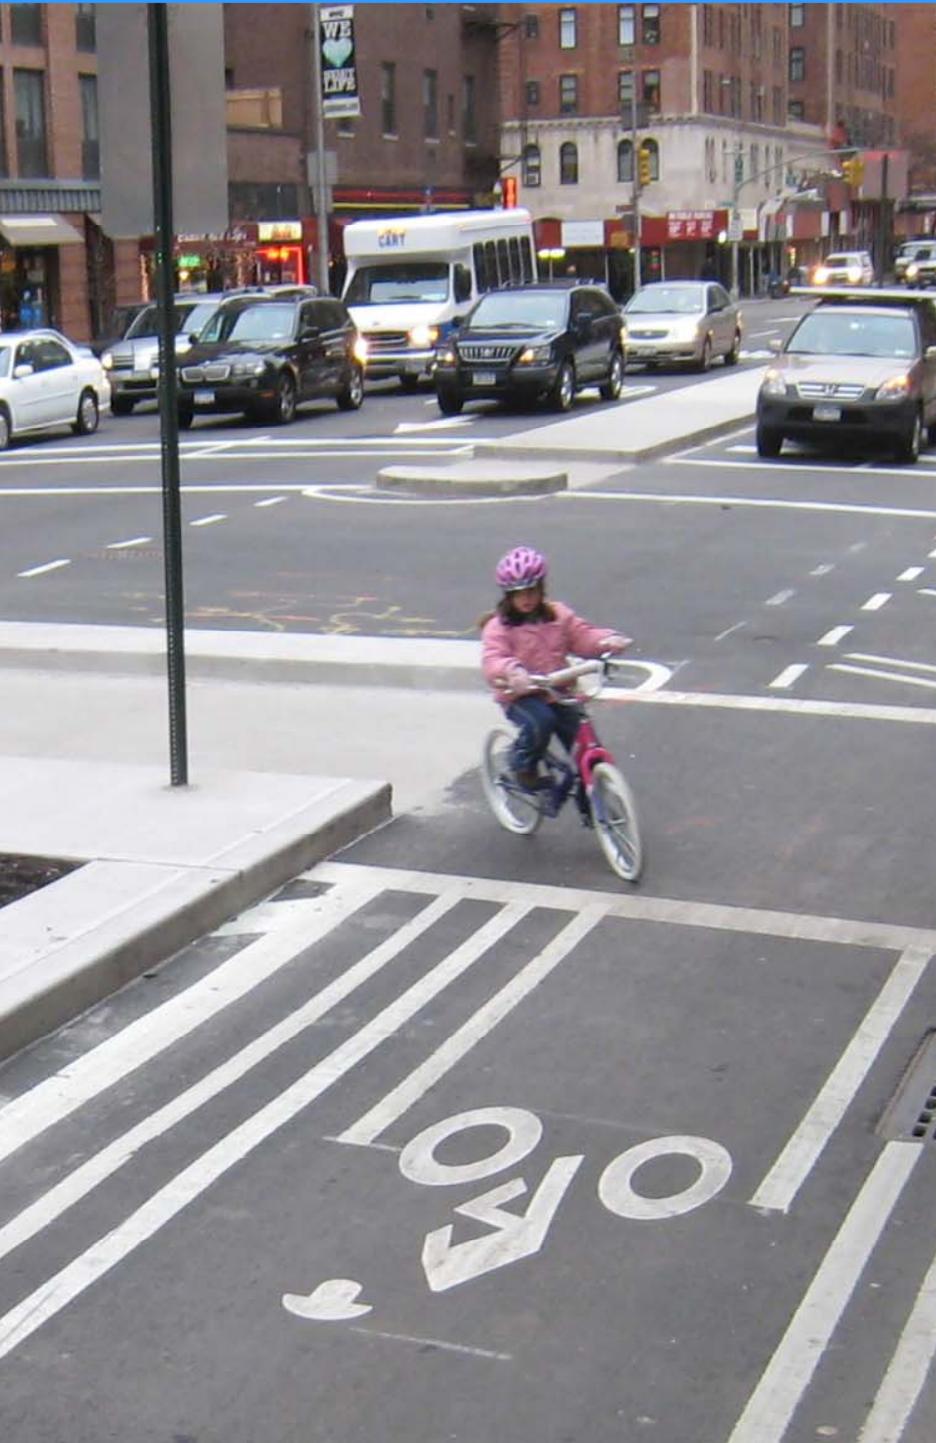
9th Avenue Bicycle Path:

- Injuries to all street users down 56%
- Injuries to pedestrians down 29%
- Injuries to cyclists down 57%
- Sidewalk riding down 84%
