Columbus Avenue Parking-Protected Bicycle Path Preliminary Assessment

Commissioner Janette Sadik-Khan New York City Department of Transportation **Presentation to Community Board 7** October 11, 2011

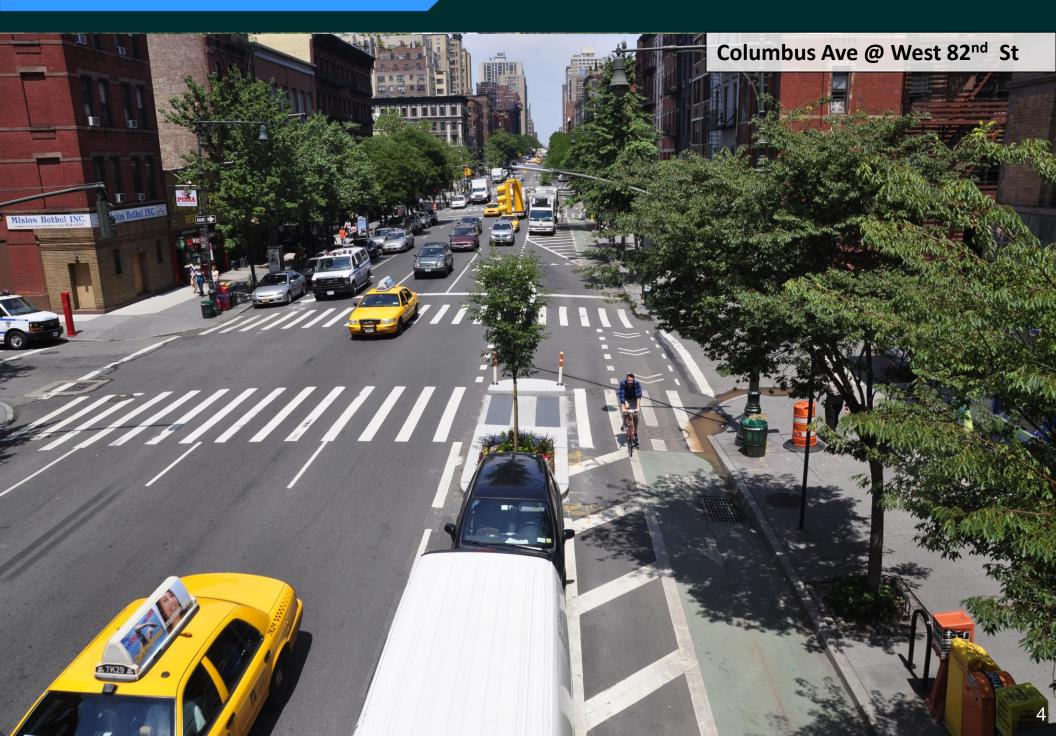
Project Summary

Improvements to Columbus Avenue:

Columbus Ave @ West 89th St

- Protected Bike Path
- Pedestrian Safety Islands
- Shorter Crossing Distance
- Mixing Zones
- Left-turn Lanes
- Freight Loading & Unloading Zones

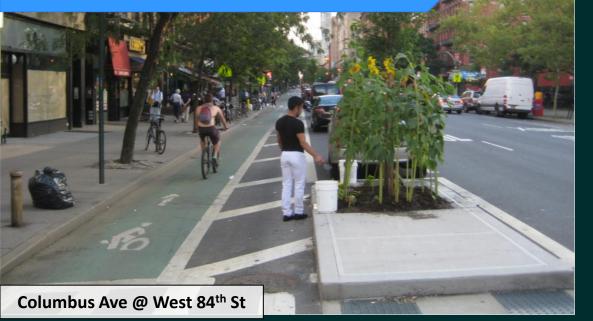
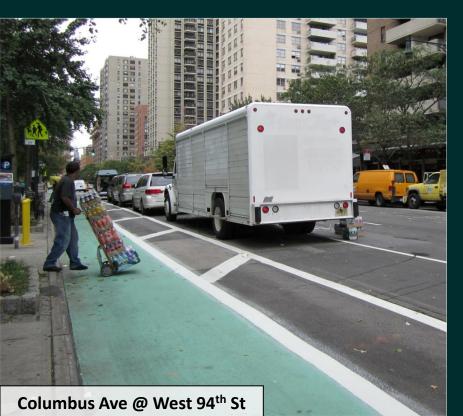
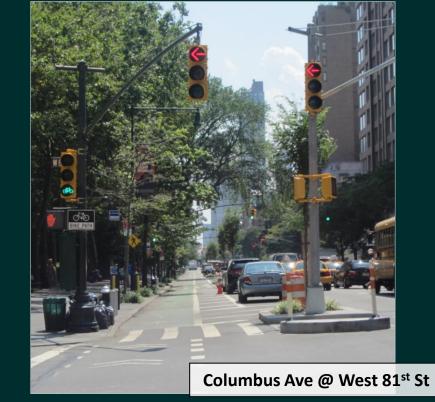
Columbus Ave @ West 90th St

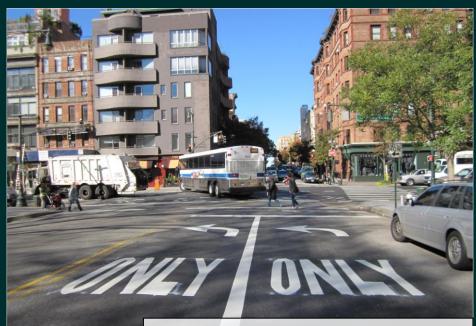
Columbus Ave @ West 81st St

- Parking/loading space added between W. 82 W. 81 Sts
- Eight commercial loading zones added/expanded
- Improved markings on West 81 St
- Split-phase signal installation

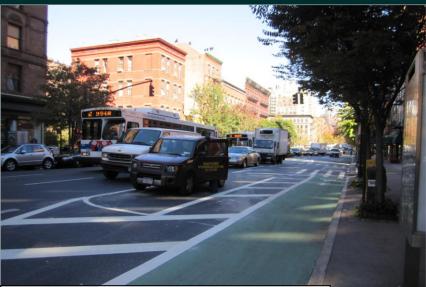
Columbus Ave @ West 82nd St

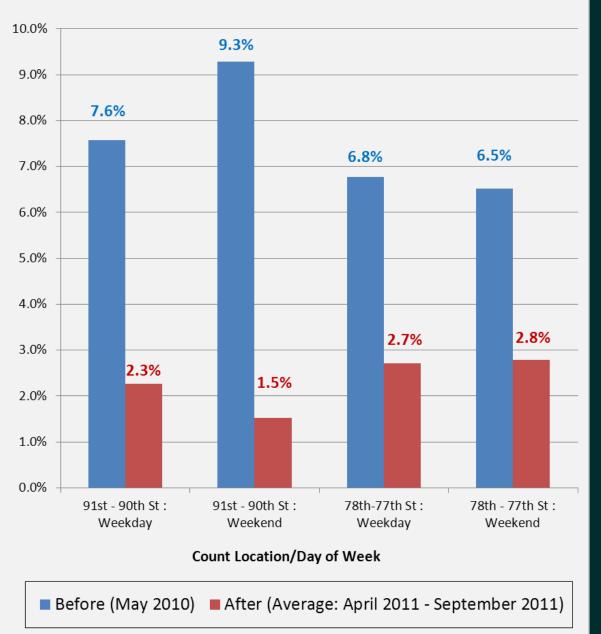
Columbus Avenue Before/After Sidewalk Ridership Rates

Decreased rates of sidewalk ridership at all monitored locations

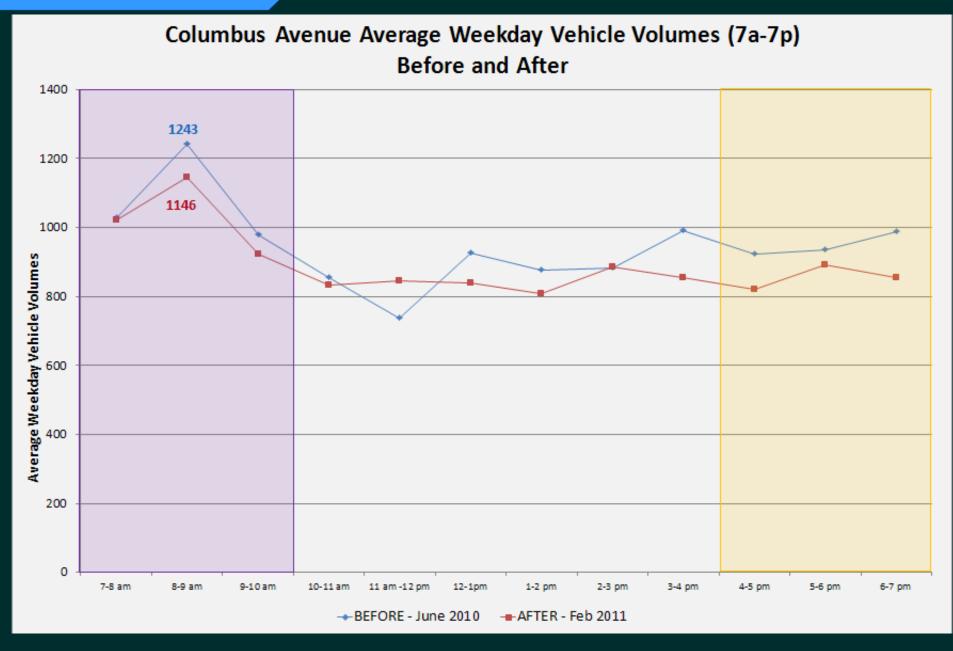
Traffic Data

Vehicle traffic volumes processed along avenue remain similar

Note: Traffic counts conducted 6/4/2010 – 6/10/2010; 2/23/2011 – 3/1/2011. Location: Between W. 96th and W. 95th Streets

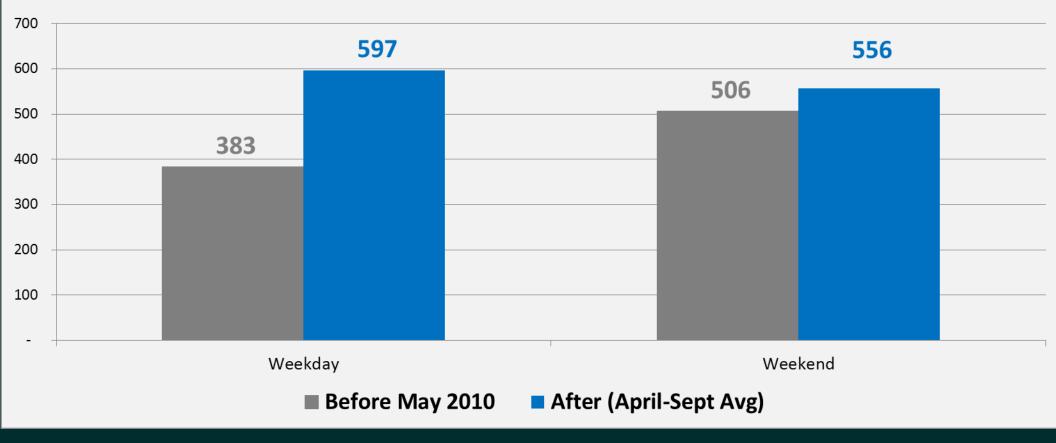
Columbus Avenue Bicycle Volumes (7a-7p) Before and After

56% increase in weekday volumes

Bicycle counts conducted: 5/25/2010; April – September 2011 average). Location: Bet. West 91st and West 90th Streets

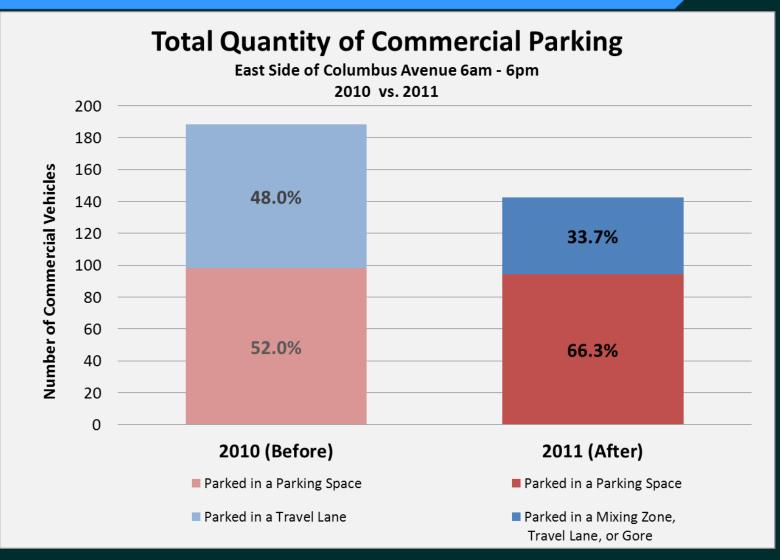
Double Parking – Before and After

Lower total number of commercial vehicles parked in travel lanes

Lower proportion of commercial vehicles parked in travel lanes

Commercial loading survey (6a-6p) average of two observation days 7/27/2010 & 7/30/2010 (before) and average of two observation days 7/19/2011 & 7/29/2011; Locations: Btw. W. 95th and W. 94th Sts, btw. W. 94th and W. 93rd Sts, btw. W. 91st and W. 90th Sts, btw. W. 90th and W. 89th Sts, btw. W. 83rd and W. 82nd Sts, btw. W. 82nd and W. 81st Sts.
