Project Summary

Goals

- Increase safety
- Increase awareness of midblock passageway
- Improve pedestrian circulation

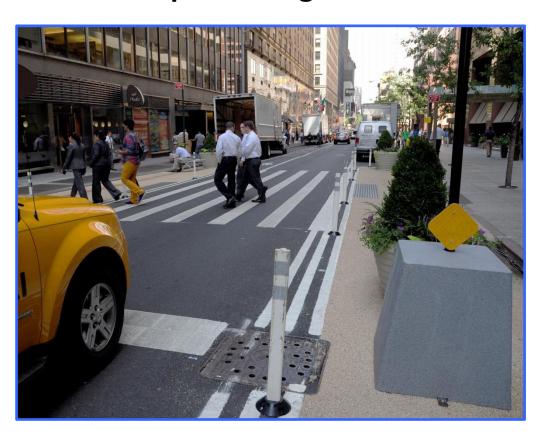
Pedestrian volumes up by 14% overall

Pedestrians Crossing Mid-Block		
	Before (July 2011) Peak Hour (Mid-day)	After (Oct. 2012) Peak Hour (Mid-day)
West 51st	1200	1359
West 52nd	1144	869
West 53rd	608	875
West 54th	482	392
West 55th	209	348
West 56th	231	497
TOTAL	3874	4340

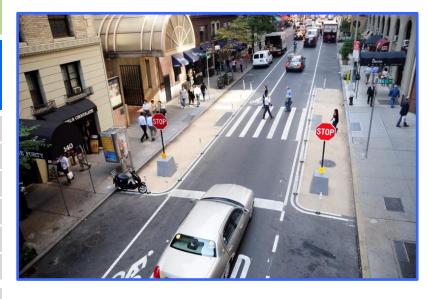
Pedestrians Crossing Mid-Block (Peak 1 Hour)

% of peds that waited for cars that did not stop	
		Before	After
51st Street	AM	88%	6%
	Mid	96%	7%
	PM	95%	5%
55th Street	AM	91%	6%
	Mid	85%	1%
	PM	100%	1%

- Before: Few vehicles stopped or yielded to pedestrians
- After: Majority of vehicles wait at stop sign for pedestrians to cross
- Vehicles that do not allow pedestrians to cross are usually part of a platoon
- These figures continue to improve

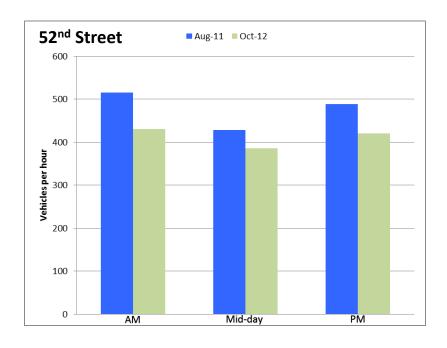
Crosstown Volumes

No significant change in traffic volumes

Before: Average midweek peak volume week of July 29-Aug 5, 2011 After: Average midweek peak volume week of October 16-22, 2012

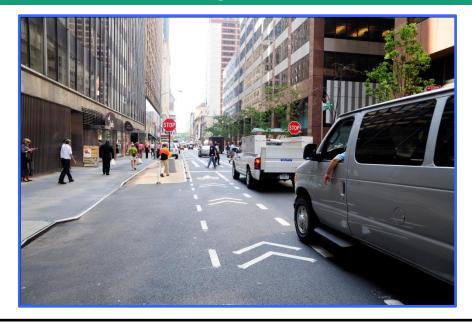
Travel Times

- Travel time runs were conducted on 51st, 52nd, 55th, and 56th Streets between 6th and 7th Avenues
- Crosstown travel speeds did not decline

Before data was collected 6/6/12, 6/7/12, 6/12/12, 6/14/12, 6/19,12 After data was collected 1/17/13, 1/23/13 & 1/24/13

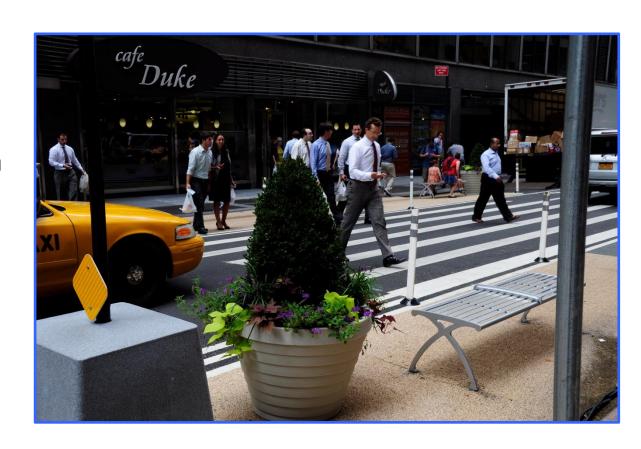
Changes in Response to Community

Shortened pedestrian areas on 56th Street,

South curb for NY City Center to aid loading and CitySpire to

improve drop off/pick up zone

- North curb for Metropolitan
 Tower to aid garbage collection
- Shifted stop signs into roadbed to increase visibility and compliance
- Added flares to asphalt ramps to improve stormwater flow

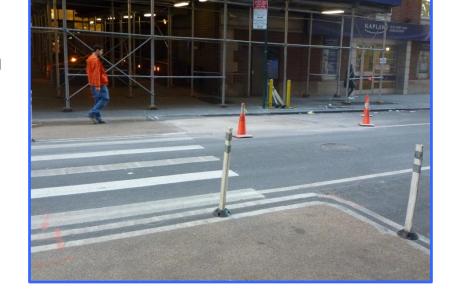
Additional flare work to be completed in spring
