Adam Clayton Powell Jr. Blvd Safety and Mobility Improvements Presentation to CB10

Commissioner Janette Sadik-Khan, New York City Department of Transportation
February 13, 2013

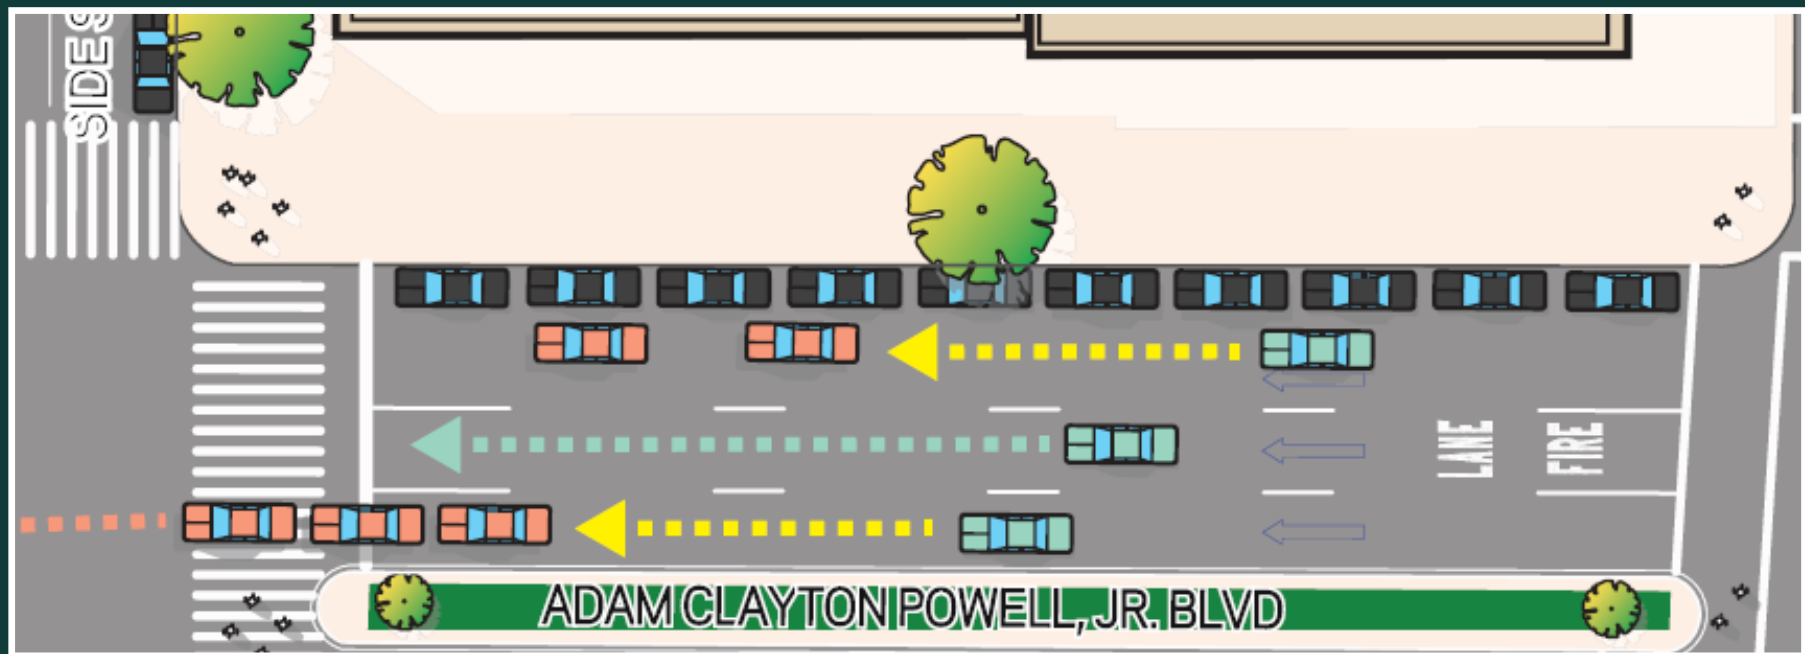
Existing Conditions: W 110 St to W 133 St

- Unorganized roadway
- Left turning vehicles block through movement
- Many lane changes

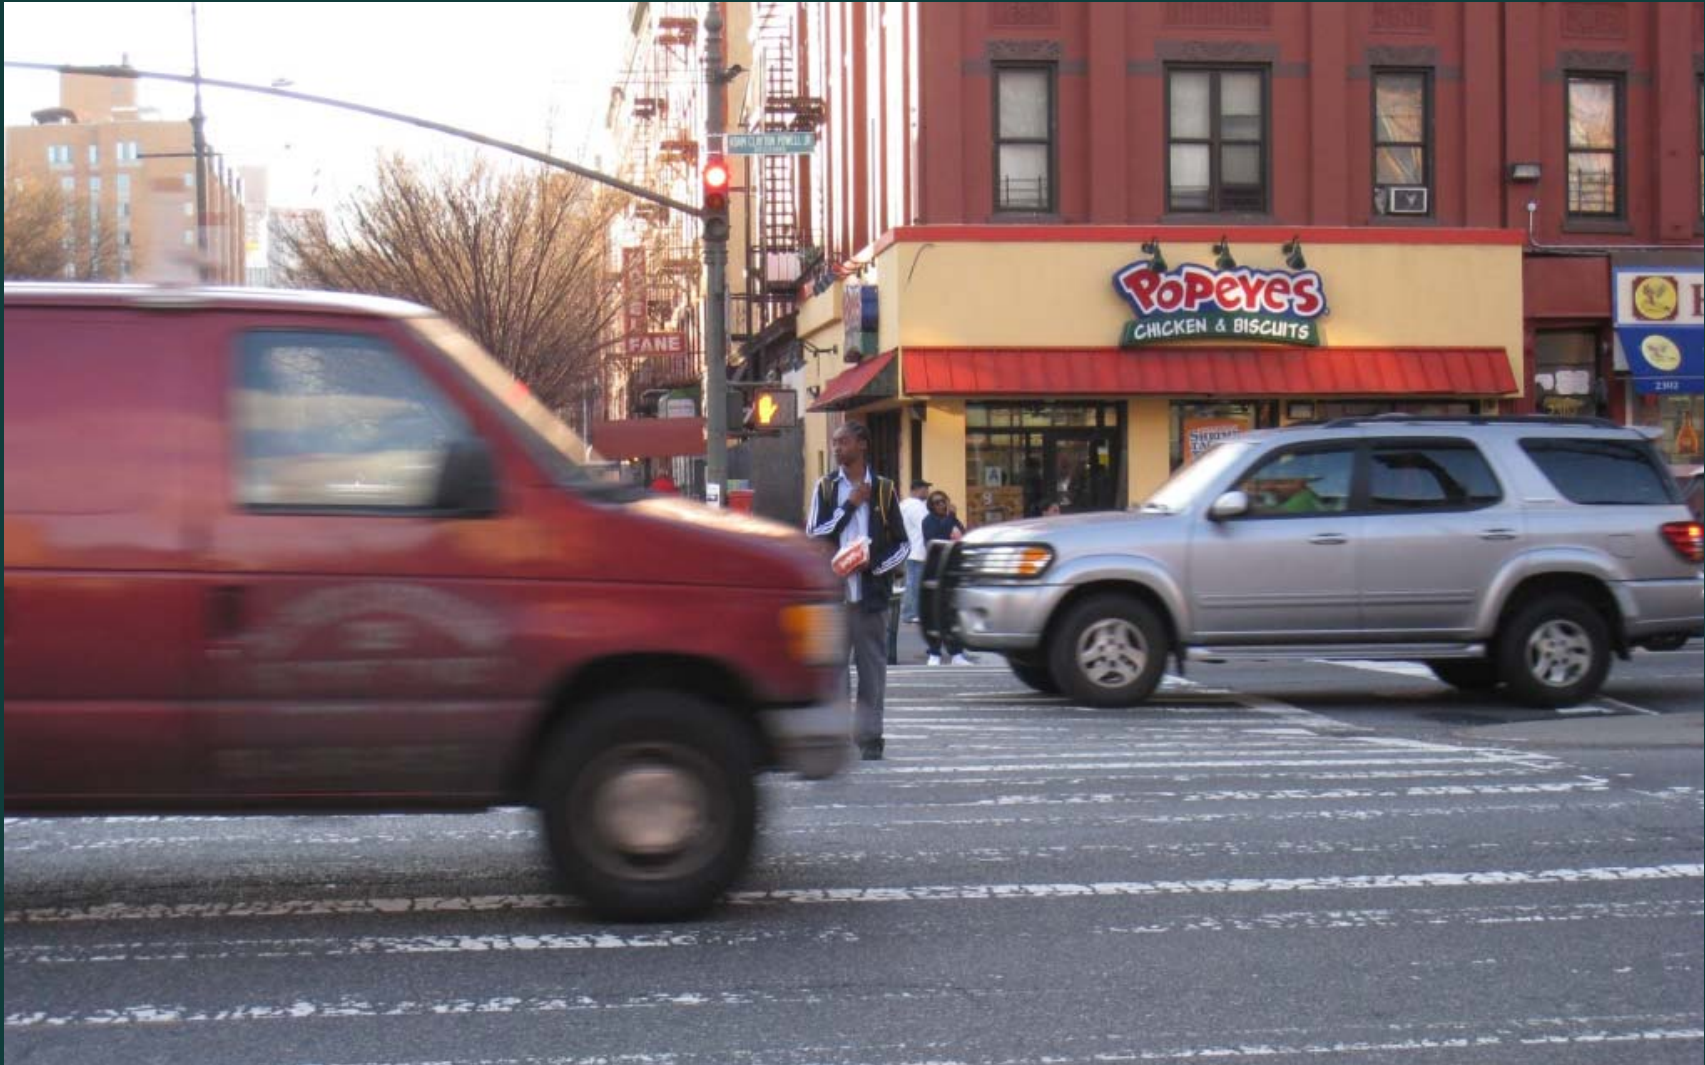
Difficult Crossings

Waiting to cross close to speeding vehicles

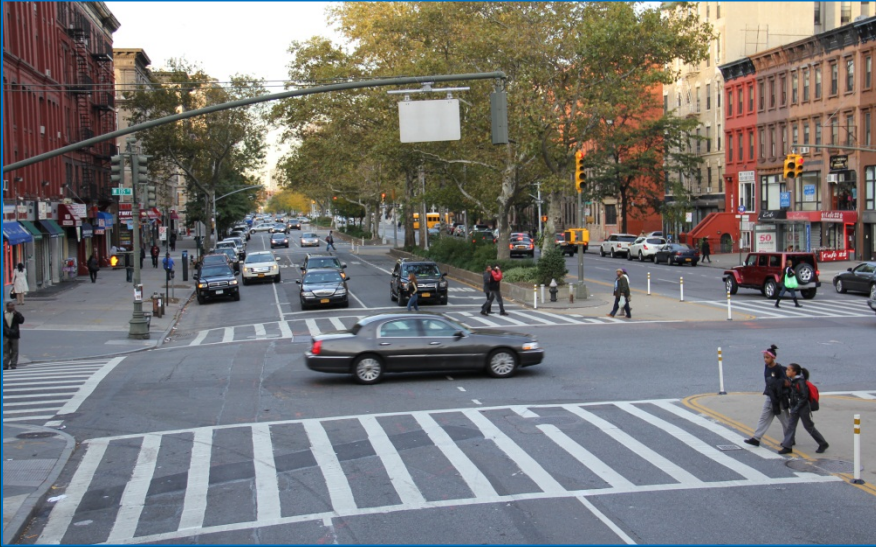
- Painted pedestrian islands

- Left-turn lanes

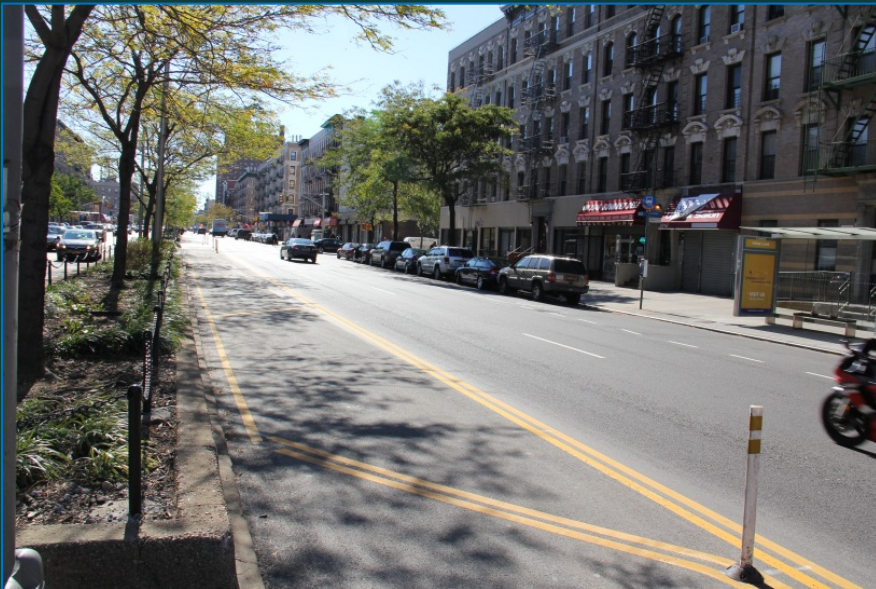
- Wide parking lanes

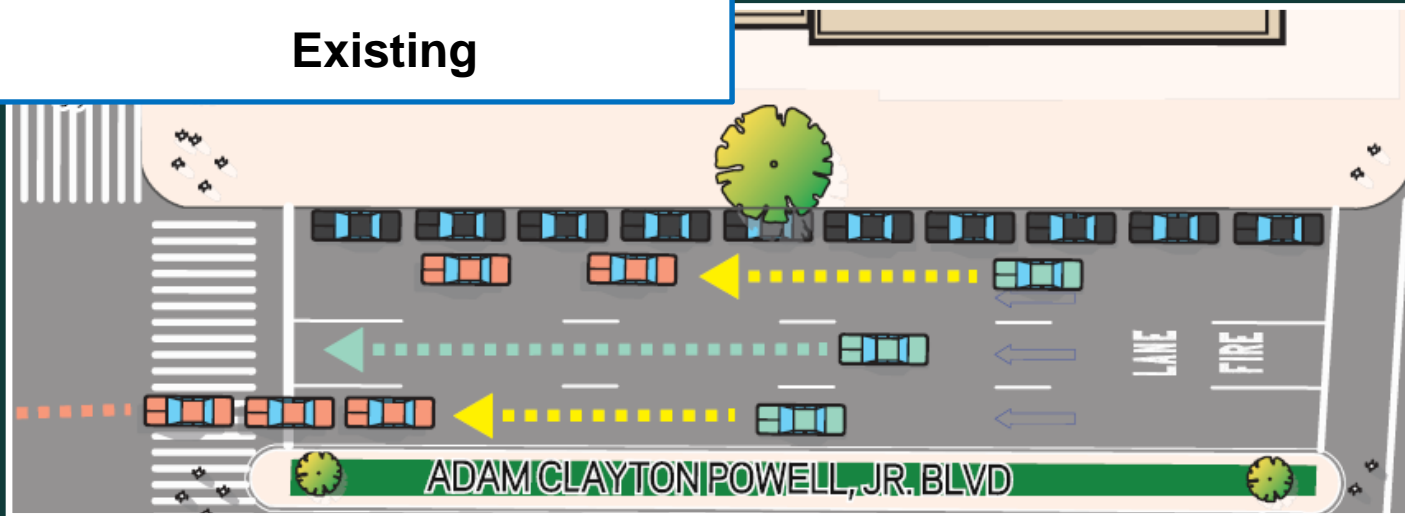
Existing

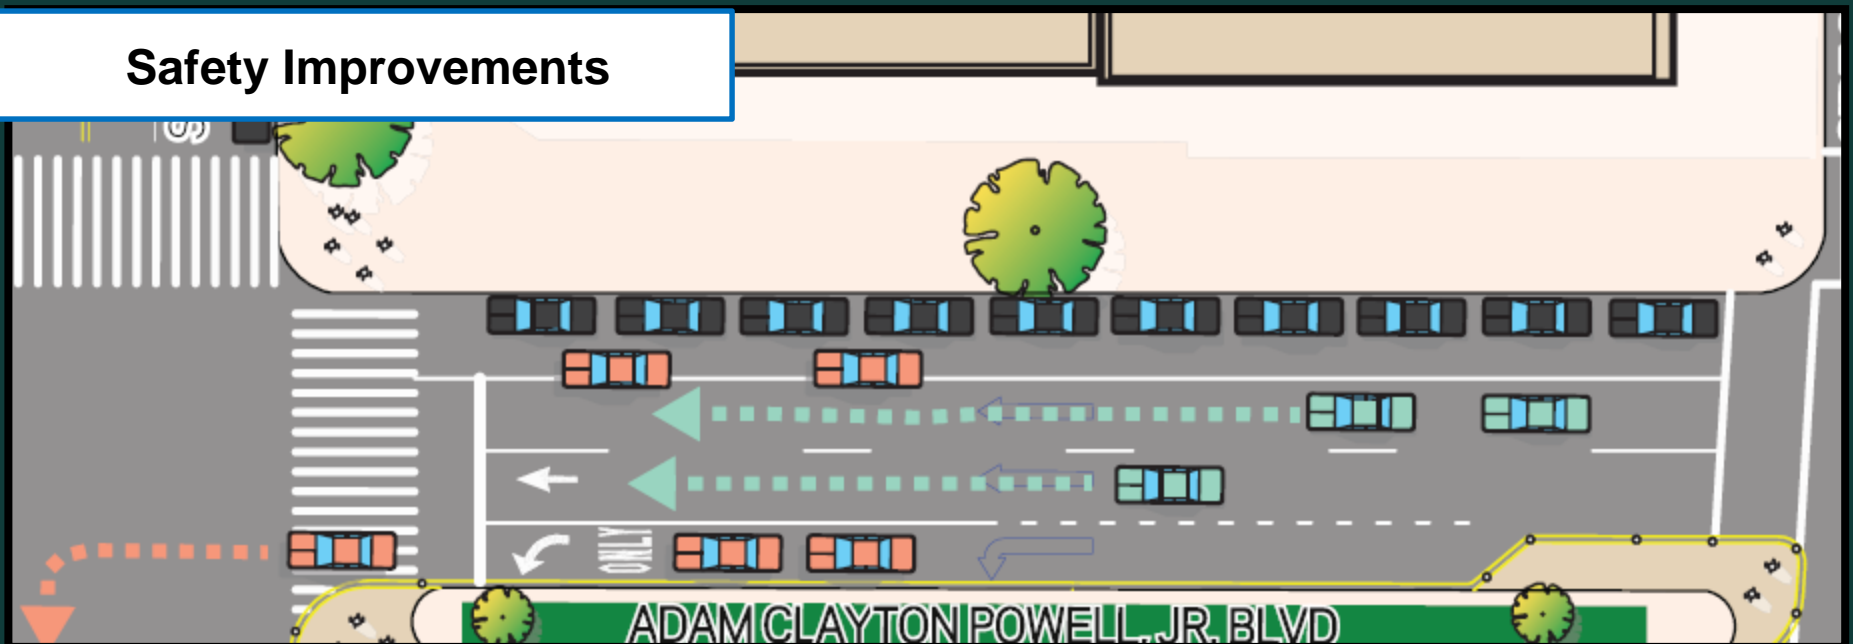
Safety Improvements

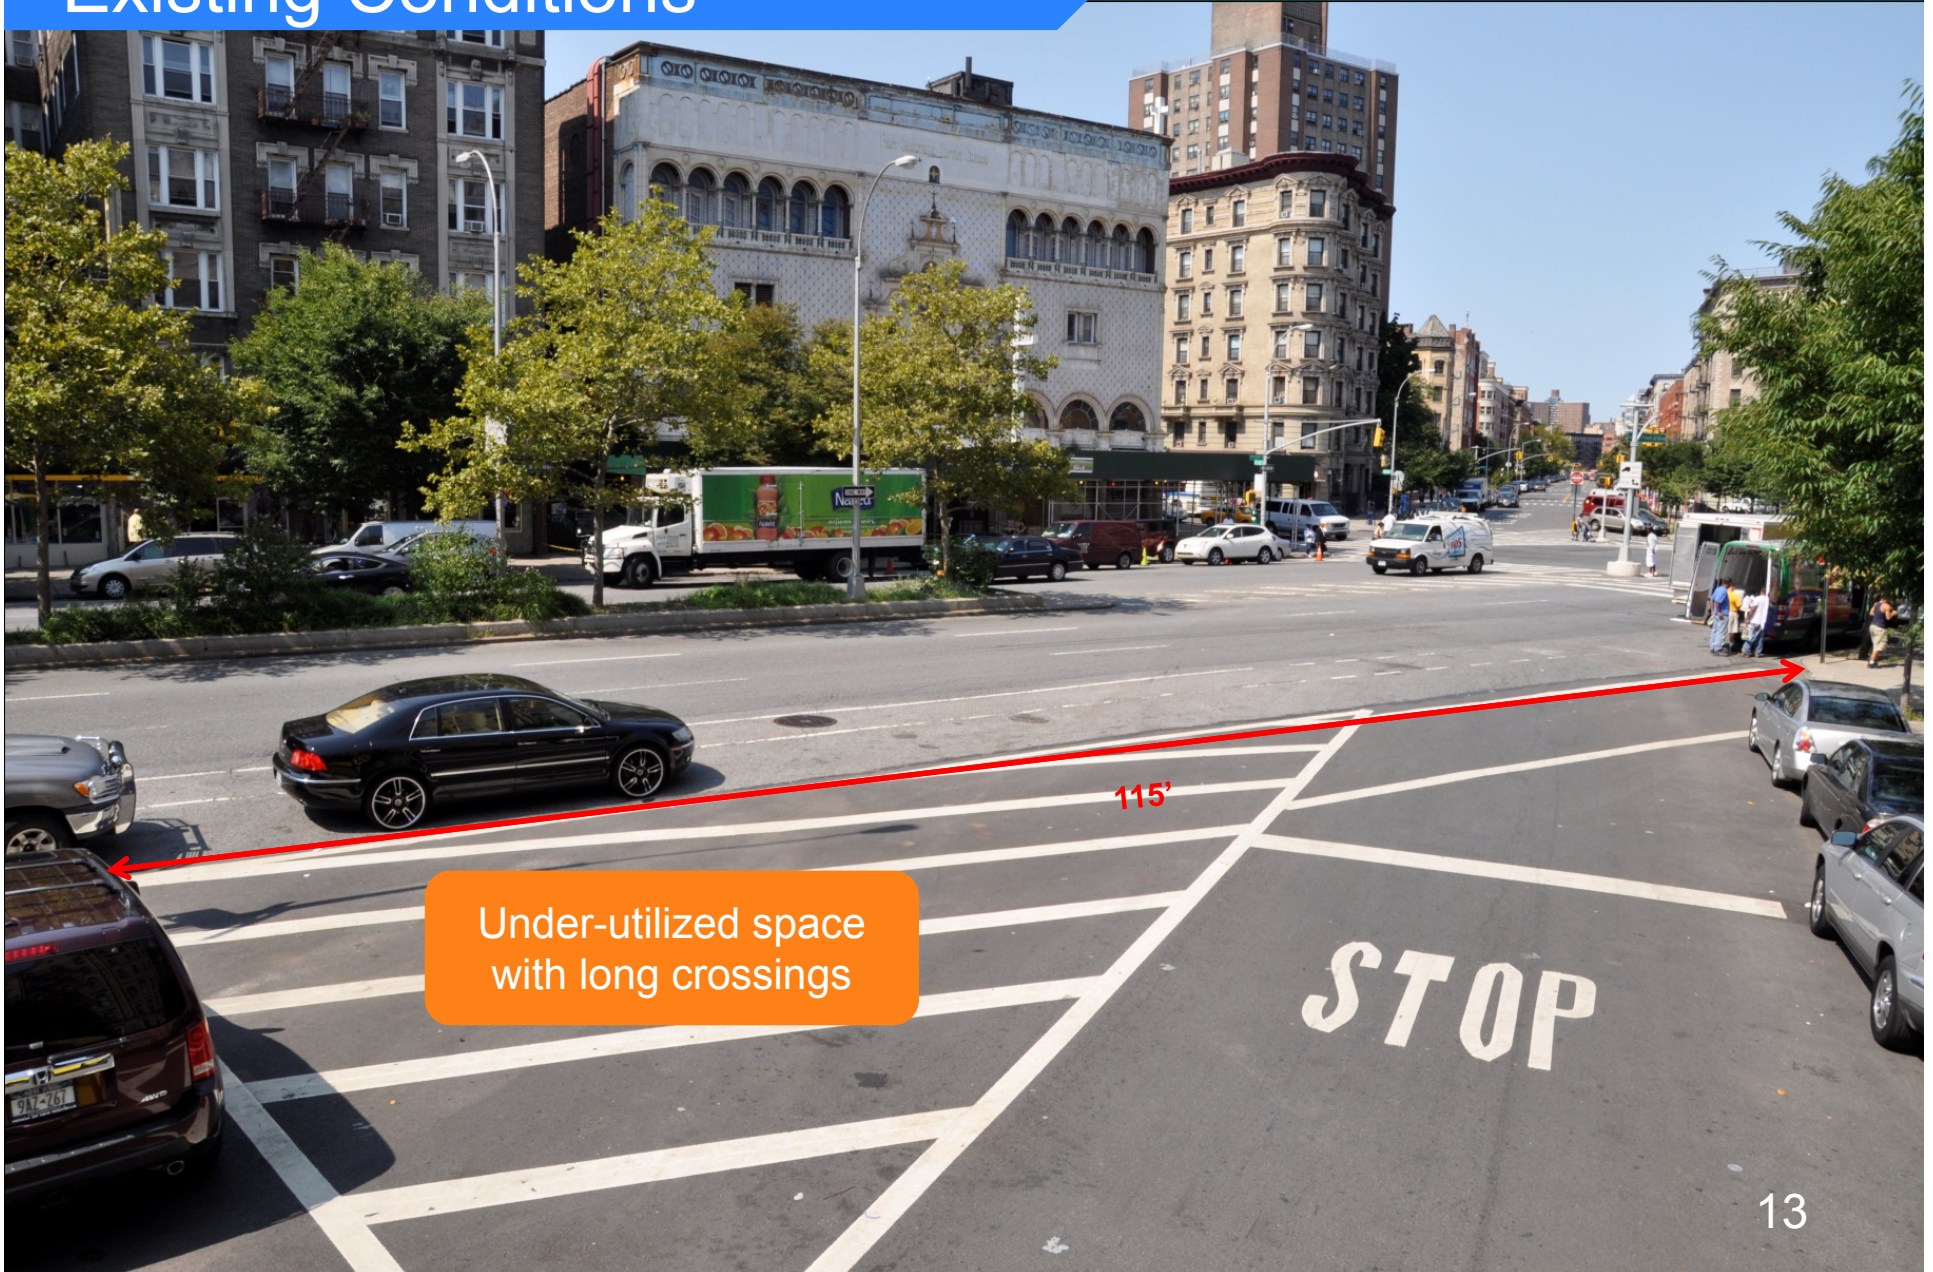
W 116th & St Nicholas Proposal

Paint extension prevents cars from accessing ACP from slip lane

Extend concrete tips with paint to provide pedestrian refuge at crossings

Expand triangle with paint to improve pedestrian circulation

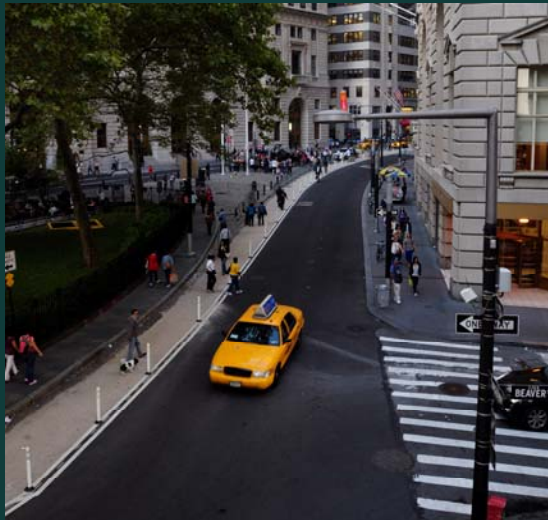
Similar proposed design treatment:

Crossing reduced by 58 feet

Crossing reduced by 75 feet
