Safe Streets for Seniors

Rego Park, Queens

FINAL REPORT

August 2013

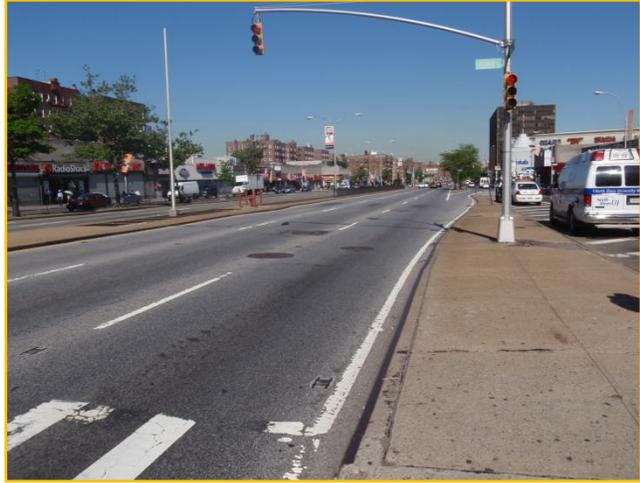
Photo No. 1: Queens Boulevard and 64th Road (looking west)

The Rego Park Study Area consists of one major east-west corridor, Queens Boulevard, between 67th Avenue and 63rd Avenue (Photo No. 1). There are also three north-south corridors: Junction Boulevard, 67th Avenue, and 63rd Avenue. The major corridor, Queens Boulevard, is a through truck route, while Junction Boulevard and a portion of 63rd Avenue are local truck routes (Exhibit 3). Queens Boulevard also carries several NYCT express bus lines including QM1, QM5, QM6, QM7, QM8, QM11, QM18, X63, X64 and X68, as well as local route Q60 (Exhibit 4). Many of the senior residents interviewed showed some concerns about these corridors, especially Queens Boulevard. The combination of heavy traffic volumes, operational factors and geometric factors make these corridors difficult for senior pedestrians to safely cross.

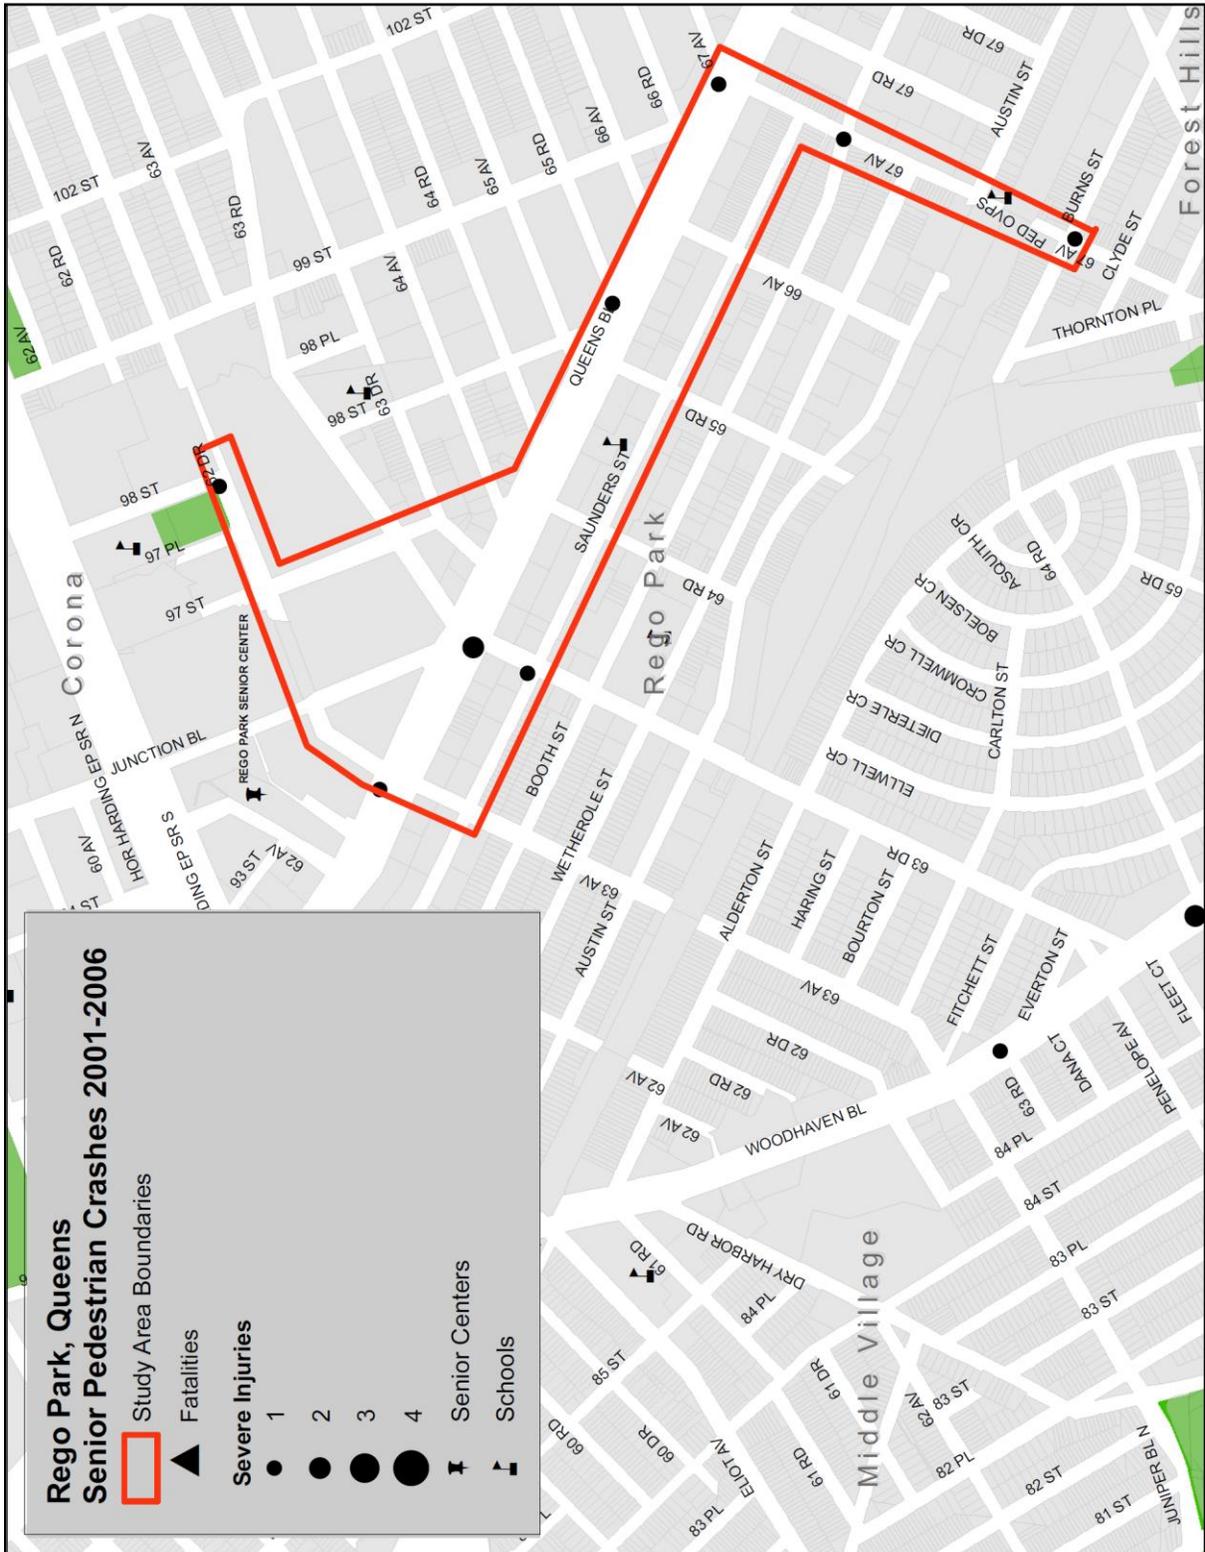
EXHIBIT 6 - PEDESTRIAN CRASH STATISTICS (2001-2006)

Crash data was obtained from the New York City Department of Transportation (NYCDOT) for the Rego Park study area from 2001 through 2006. This data provides some details relating to the circumstances and cause of each crash. Table 1 and Exhibit 6 show a summary of crashes.

INTERSECTION		SENIOR PEDESTRIAN CRASHES	SENIOR PEDESTRIAN FATALITIES
62nd Drive	98th Street	1	0
Queens Boulevard	63rd Avenue/62nd Drive	1	0
Queens Boulevard	63rd Drive/63rd Road	1	0
Queens Boulevard	65th Road	1	0
Queens Boulevard	67th Avenue	1	0
67th Avenue	Booth Street	1	0
67th Avenue	Burns Street	1	0
63rd Drive	Saunders Street	1	0
TOTAL		8	0

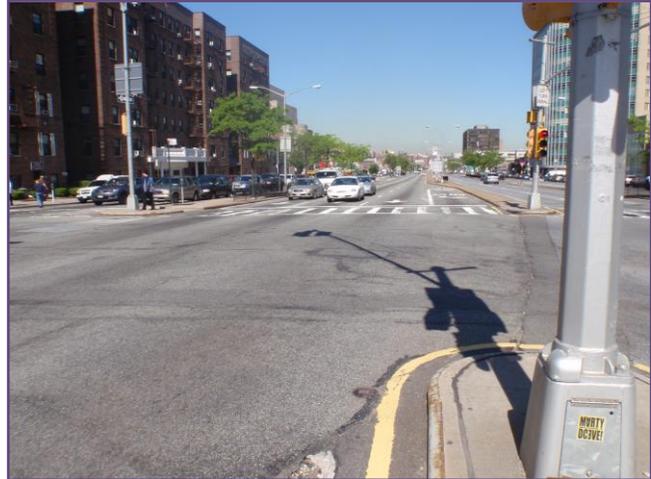
Photo No. 2: Queens Boulevard and 65th Road (looking west)

Within the study area, Queens Boulevard is the major east-west corridor, accommodating large volumes of traffic (Photo No. 2). The project limits of this corridor are 63rd Avenue in the west to 67th Avenue in the east, which is about 0.70 miles long. The width of Queens Boulevard varies from 170 to 175 feet throughout the study area. In addition, this corridor has both north and south service roads.

Neck-downs or curb extensions are recommended at the following intersection to shorten the crossing distance, slow down vehicular traffic and provide better visibility for senior pedestrians:

- Northwest corner of Queens Boulevard and 63rd Avenue/62nd Drive

Raised median island extensions or new raised median islands are recommended at the following intersections to shorten the crossing distance and to increase visibility and improve pedestrian safety:

- Queens Boulevard and 63rd Drive/63rd Road
- Queens Boulevard and 67th Avenue

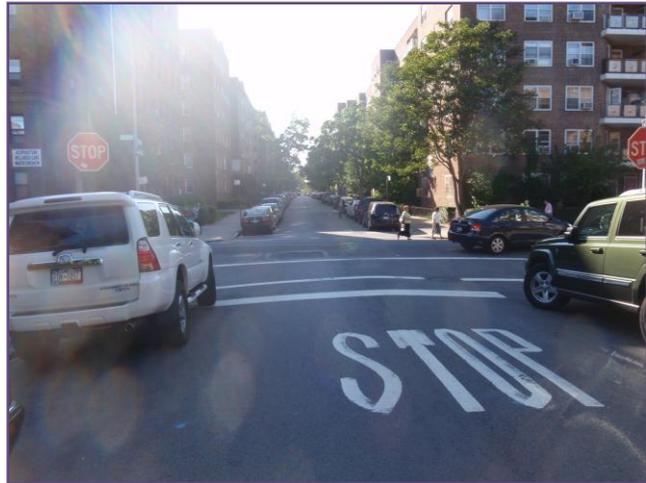
Photo No. 3: Saunders Street and 63rd Avenue (looking west)

Within the study area, Saunders Street is a one-way minor corridor accommodating westbound traffic (Photo No. 3). The project limits are from 63rd Avenue in the west to 67th Avenue in the east. The length of this corridor is 0.65 miles and its width varies from 31 to 33 feet within the study area. Parking is permitted on both sides of this street during most times of the day.

Yield to Pedestrian signs are recommended at the following intersection to warn drivers:

- Saunders Street and 63rd Drive

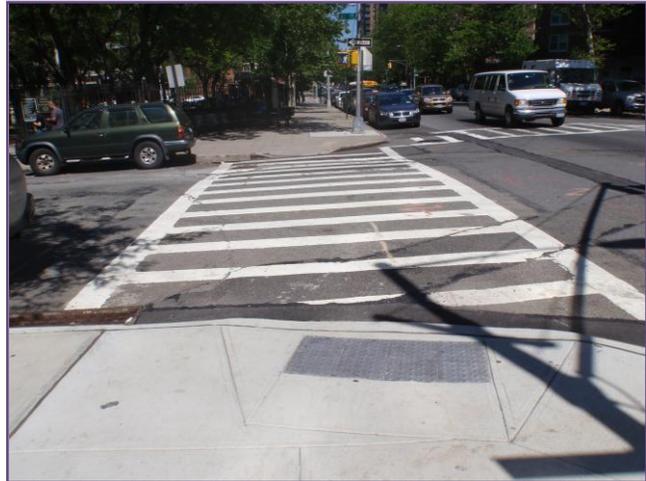
Photo No. 4: 62nd Drive and 97th Street (looking north)

62nd Drive is approximately 51 feet wide between 99th Street and 97th Street, and approximately 57 feet wide from 97th Street to Queens Boulevard. The width of 63rd Avenue from Queens Boulevard to Saunders Street is about 45 feet wide. The project limits of 62nd Drive/ 63rd Avenue is from 99th Street to Saunders Street (Photo No. 4). Traffic flow on this road is one-way southbound from 99th Street to Saunders Street, except from Junction Boulevard to 97th Street. Within this block, it is a two-way street with two travel lanes in each direction.

During various field visits, the opportunity of possible travel lane reduction along westbound direction on 62nd Drive was noted between Queens Boulevard and 99th Street. As a result, 24-Hour ATR counts were collected at various locations along 62nd Drive. This ATR count data is presented in Appendix A. Analysis of these counts showed following results:

As a result of this peak hour traffic count assessment, it is recommended that 62nd Drive from Junction Boulevard to Queens Boulevard be converted from 3-lane to 2-lane and 1-turn-bay and from 99th Street to 97th Street be converted from 2-lane to 1-lane in the westbound direction.

Supplementing the above noted lane reductions, a 13-foot wide parking lane be striped along the north curb side and 20-foot wide back-in angle parking stalls be installed along the south curb side of 62nd Drive from 99th Street to 97th Street. This will provide room for a 17-foot wide westbound travel lane. Additionally, 12-foot wide parking lane with 5-foot buffer is recommended on both sides of 62nd Drive from Junction Boulevard to Queens Boulevard. This will provide room for two 11-foot wide westbound travel lanes initially and will turn into three 11-foot wide moving lanes as it approaches Queens Boulevard. It is also recommended that 'right turn only', 'left turn only' and 'through' pavement markings/arrows be appropriately striped at the intersections of 62nd Drive with Queens Boulevard, Junction Boulevard and 97th Street.

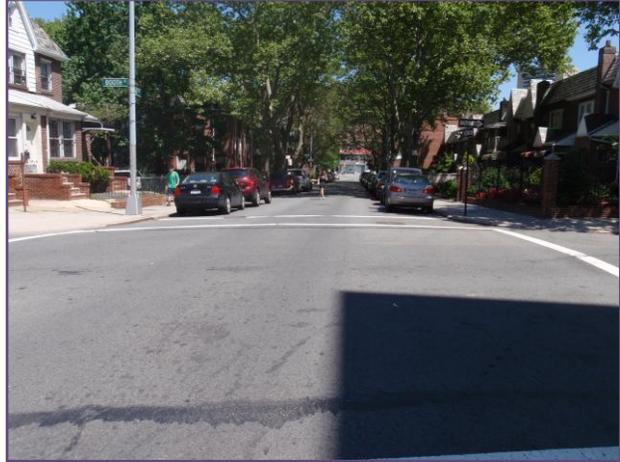
Photo No. 5: 67th Avenue and Booth Street (looking north)

Within the study area, 67th Avenue is a one-way northbound corridor (Photo No. 5). The width of this roadway is approximately 30 feet. Improvements along 67th Avenue include the installation of crosswalk striping at 67th Avenue and Wetherole Street and 67th Avenue and Austin Street intersections, as well as the installation of new pedestrian ramps at the intersection of 67th Avenue and Burns Street.

The study indicated that the 85th percentile speed on 67th Avenue was 19.9 mph for northbound traffic, which is below the statutory speed limit of 30 mph. See Table 4 below for a summary of the results. Detailed Spot Speed Survey data is presented in Appendix D – Additional Traffic Data and Analysis.

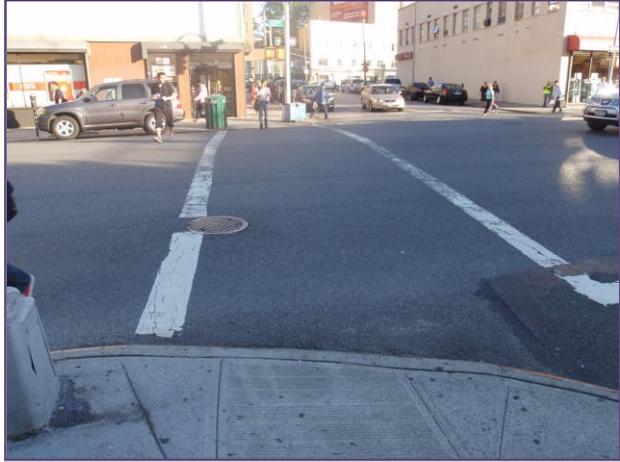
Photo No. 6: 97th Street and 63rd Road (looking east)

Within the study area, 97th Street is a north-south, two-way roadway. North of its intersection with 63rd Road, 97th Street is approximately 50 feet wide. South of this intersection, 97th Street reduces to approximately 41 feet wide (Photo No. 6). 63rd Road is one-way eastbound and 63rd Drive is one-way westbound.

At the intersection of 97th Street and 63rd Road, it is recommended that neck-downs be constructed at northwest and southeast corners. The southwest corner should also be provided with a new pedestrian ramp. In addition, high visibility crosswalks are recommended on all approaches of this intersection. Similarly, high visibility crosswalk

is also recommended on the 97th Street approach to 63rd Drive. Since 97th Street and 63rd Drive is a stop-controlled intersection, it is further recommended that “Stop Ahead” warning signs be installed on 63rd Drive east of the intersection. In addition to these recommendations, it is also proposed to stripe 14-foot wide parking lanes on the both sides along 63rd Road between Queens Boulevard and 98th Street. It is also recommended that 13-foot wide parking lanes be striped on both sides of 97th Street from Horace Harding Expressway South to 63rd Road.

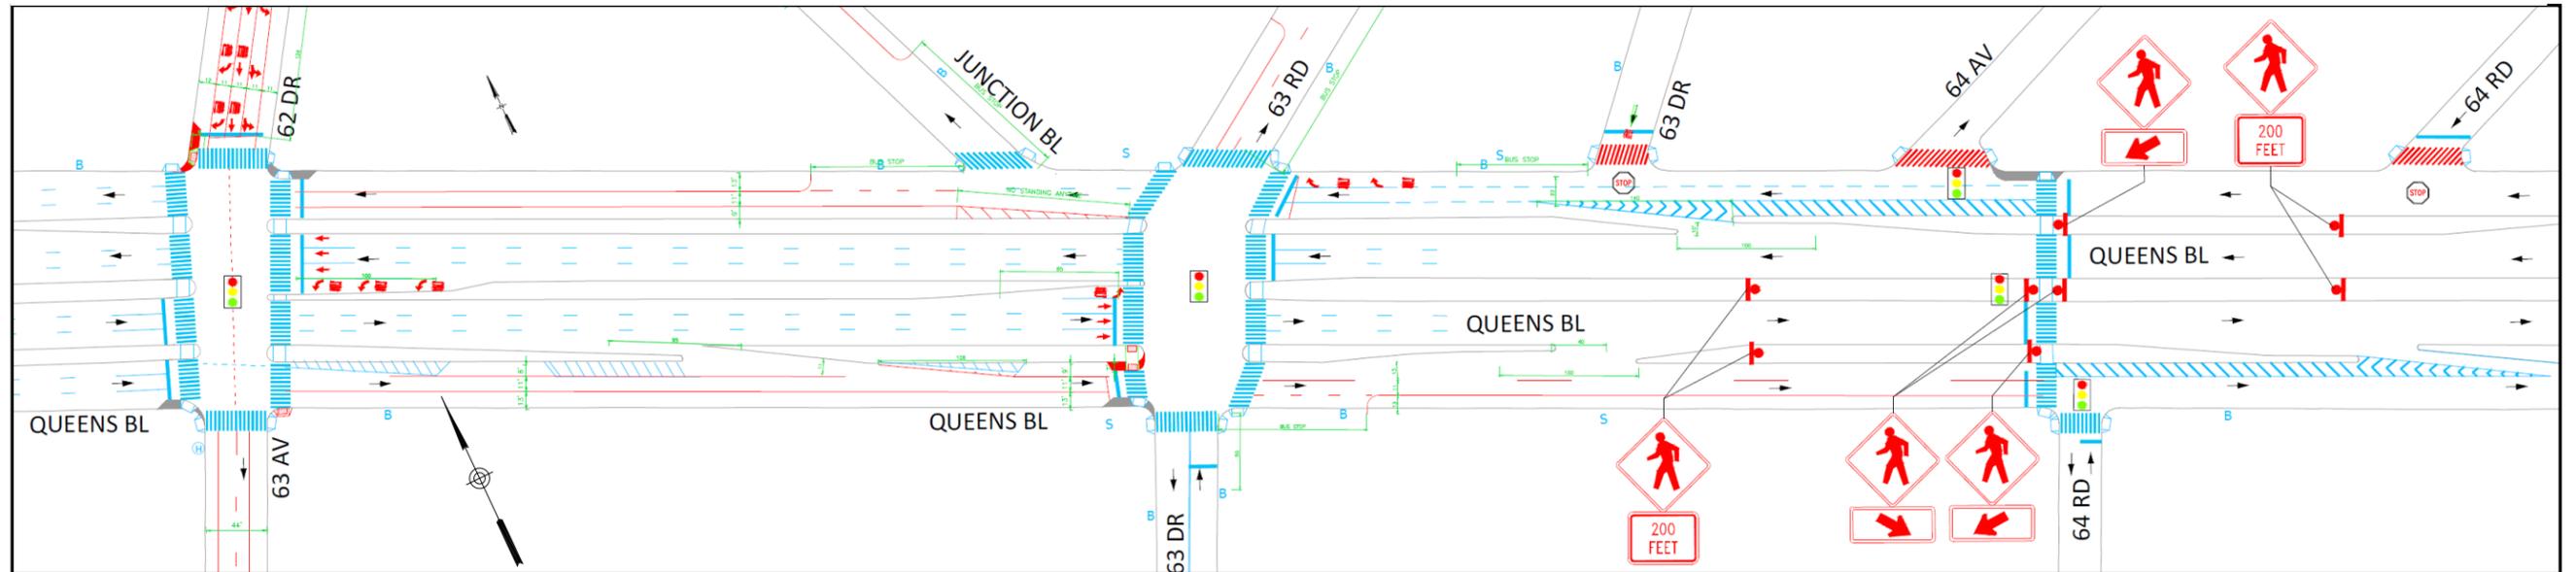
EXHIBIT 8 – QUEENS BOULEVARD (FROM 63RD AVENUE TO 64TH ROAD)

Pedestrian concerns in this area:

- Non-standard pedestrian ramps
- Turning vehicles not yielding to pedestrians
- Signal timing (insufficient crossing time)

Recommended improvements include:

- Time all signals for seniors and where feasible, the crossing time will be extended
- Install new high visibility crosswalks
- Install new parking lanes
- Install new channelization
- Install new pedestrian ramps. Where proposed, align the ramps with the crosswalks
- Install new "Pedestrian Crossing/(arrow)" and "Pedestrian Crossing/200 Feet" signs at the intersection shown in the illustration
- Install new pedestrian refuge island extensions
- Install neck-down or curb extensions
- Install new parking striping and lane configuration as shown in the illustration

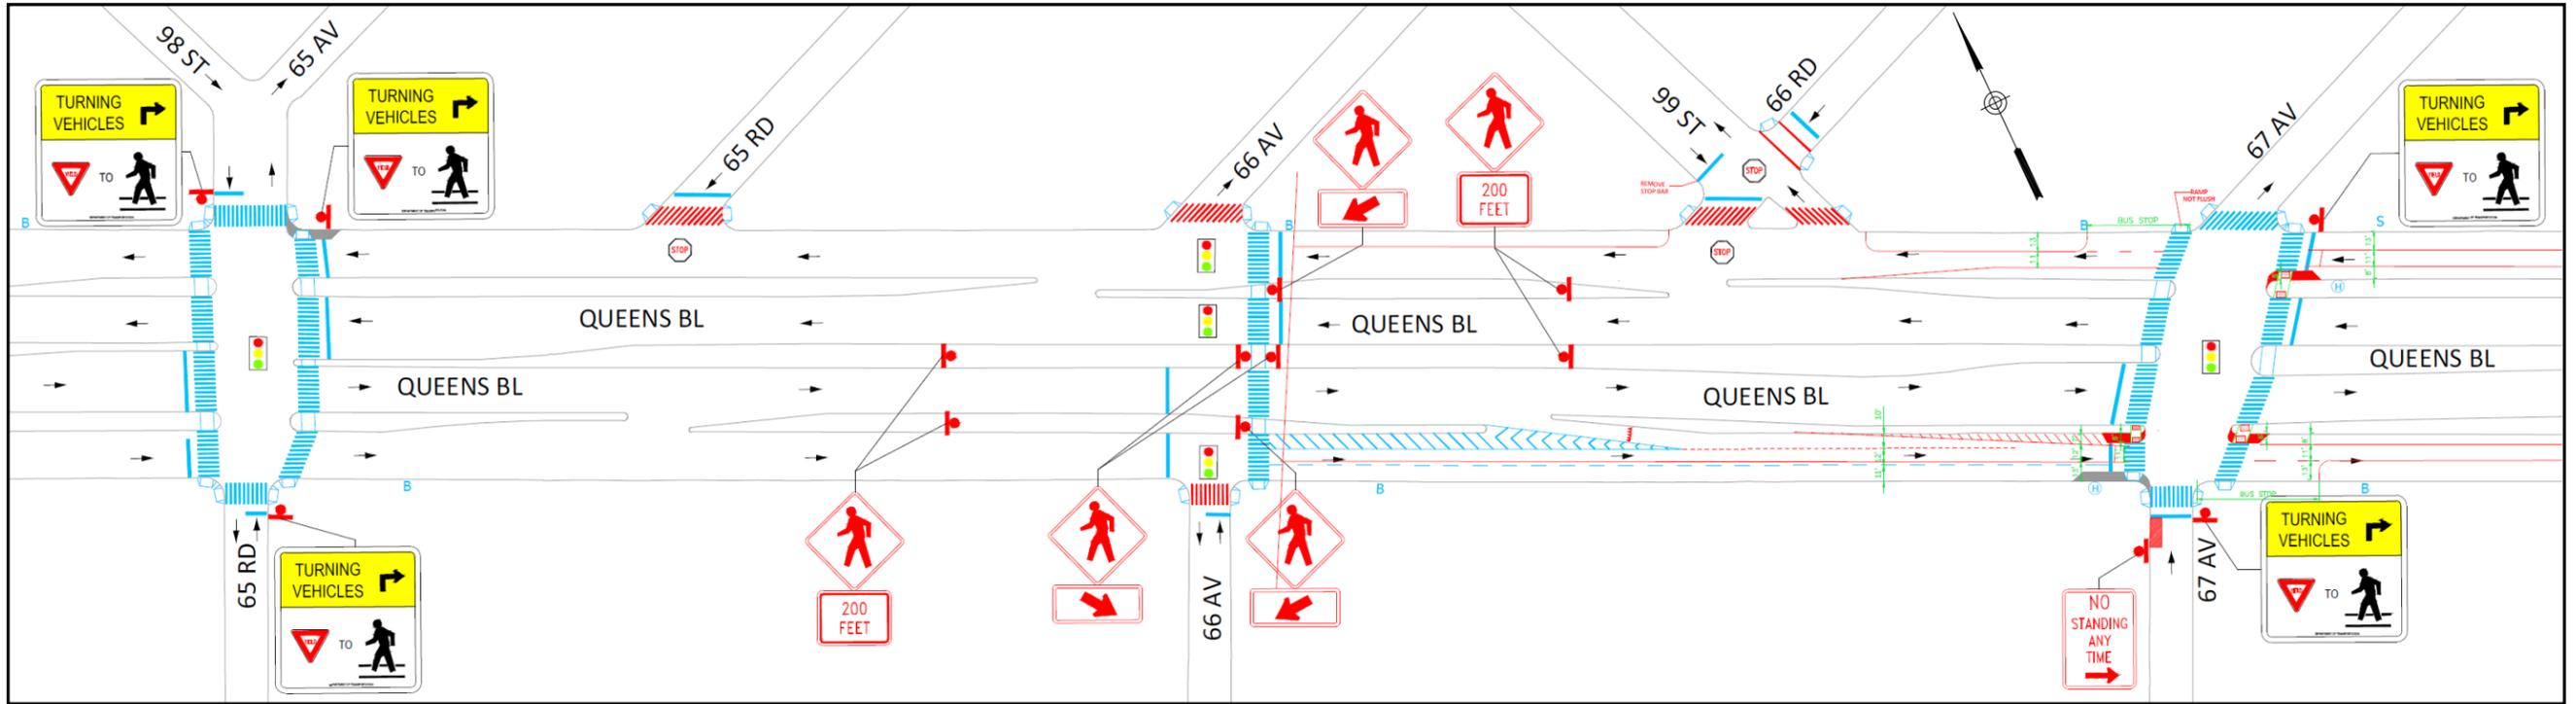
EXHIBIT 9 – QUEENS BOULEVARD (FROM 65TH ROAD TO 67TH AVENUE)

Pedestrian concerns in this area:

- Non-standard pedestrian ramps
- Turning vehicles not yielding to pedestrians
- Signal timing (insufficient crossing time)

Recommended improvements include:

- Time all signals for seniors and where feasible, the crossing time will be extended
- Install new high visibility crosswalks
- Install new channelization
- Install new pedestrian ramps. Where proposed, align the ramps with the crosswalks
- Install new "Yield to Pedestrian" signs at the intersections shown in the illustration
- Install new "Pedestrian Crossing/(arrow)" and "Pedestrian Crossing/200 Feet" signs at the intersection shown in the illustration
- Provide daylighting at the intersection shown in the illustration
- Install new pedestrian median refuge island extensions
- Install new parking striping and lane configuration as shown in the illustration

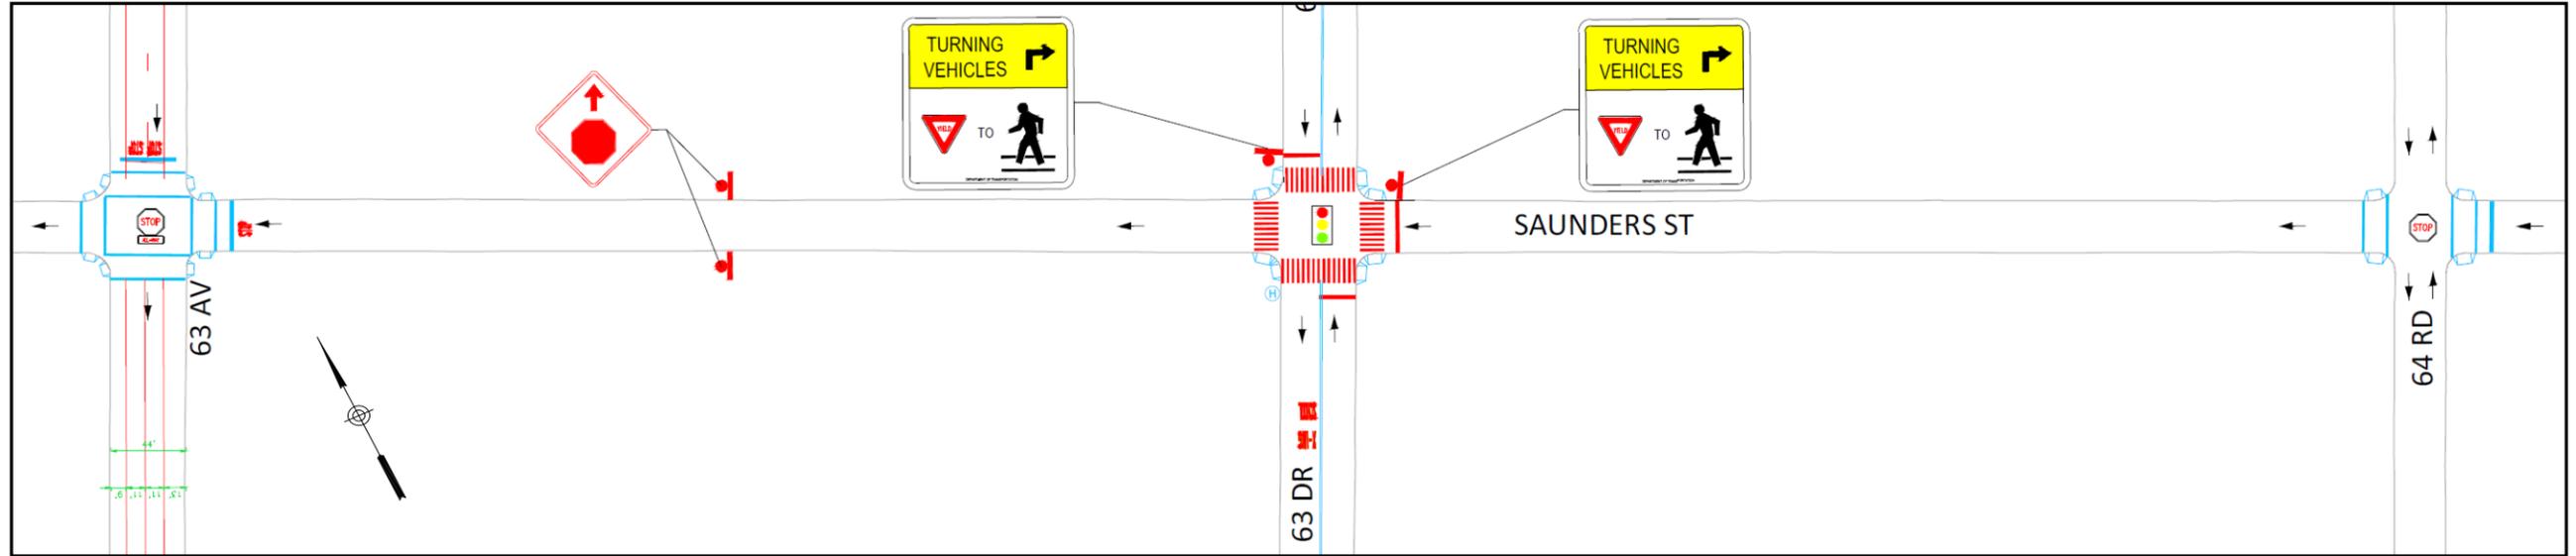
EXHIBIT 10 – SAUNDERS STREET (FROM 63RD AVENUE TO 64TH ROAD)

- Pedestrian concerns in this area:**
- Turning vehicles not yielding to pedestrians

- Recommended improvements include:**
- Install new high visibility crosswalks
 - Install new advanced stop bars
 - Install new parking lanes
 - Install new "Yield to Pedestrian" signs at the intersection shown in the illustration
 - Install new "Stop Ahead" signs
 - Install new parking striping and lane configuration as shown in the illustration

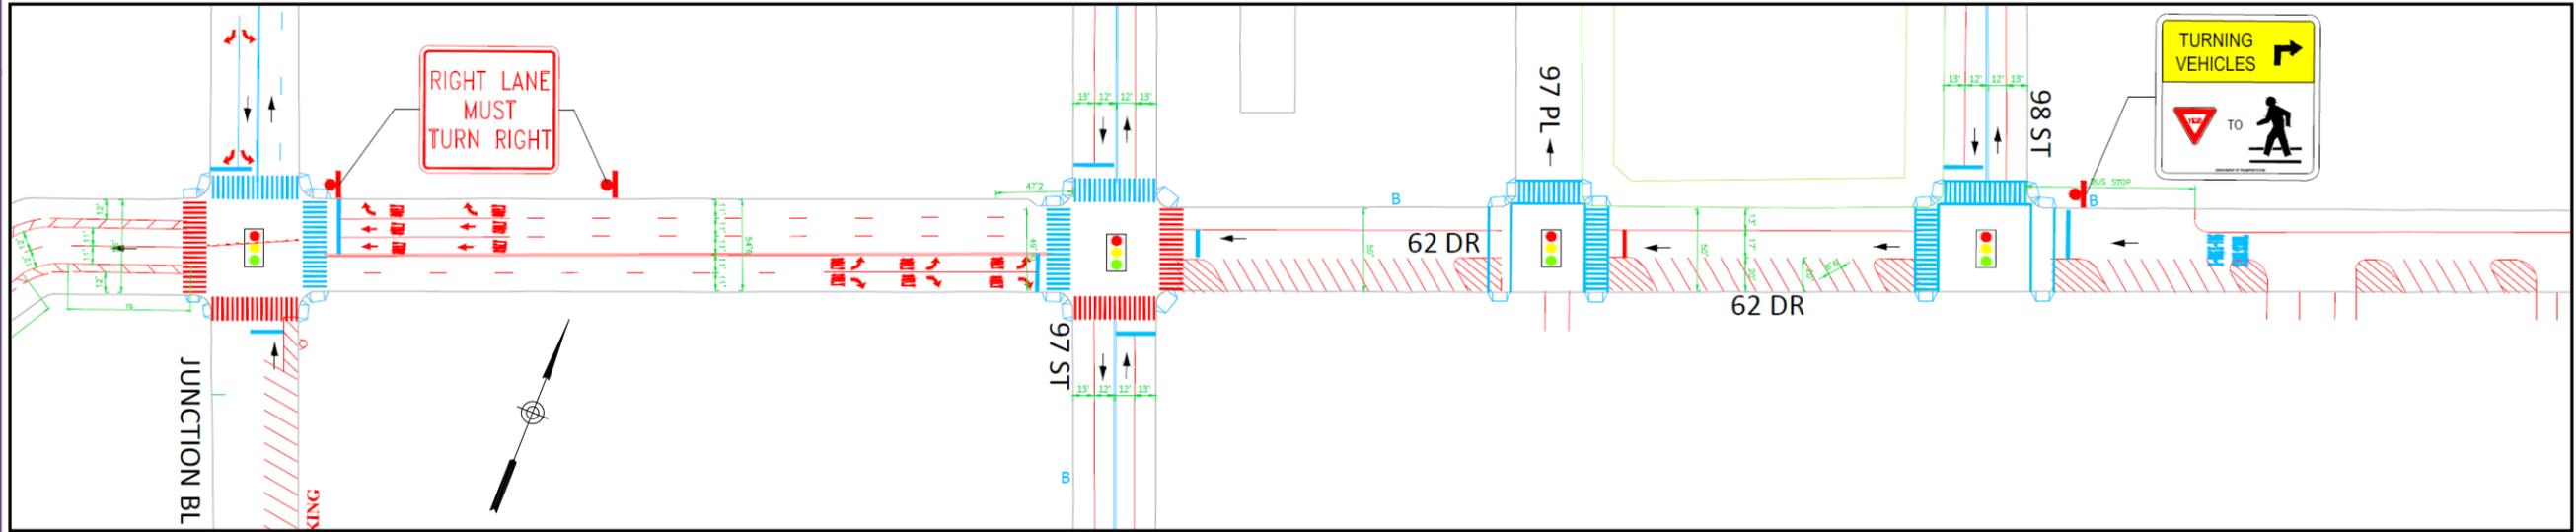
EXHIBIT 12 – 62ND DRIVE (FROM JUNCTION BOULEVARD TO 98TH STREET)

- Pedestrian concerns in this area:**
- Non-standard pedestrian ramps
 - Turning vehicles not yielding to pedestrians
 - Signal timing (insufficient crossing time)

- Recommended improvements include:**
- Time all signals for seniors and where feasible, the crossing time will be extended
 - Install new channelization
 - Install new high visibility crosswalks
 - Install new advanced stop bar
 - Install new parking lanes and lane configuration modifications including lane drops as shown in the illustration
 - Install new angular parking as shown in the illustration
 - Install a new "Yield to Pedestrian" sign at the intersection shown in the illustration
 - Install new "Right Lane Must Turn Right" signs
