Sherman Creek/Inwood Traffic Study

April 5, 2010

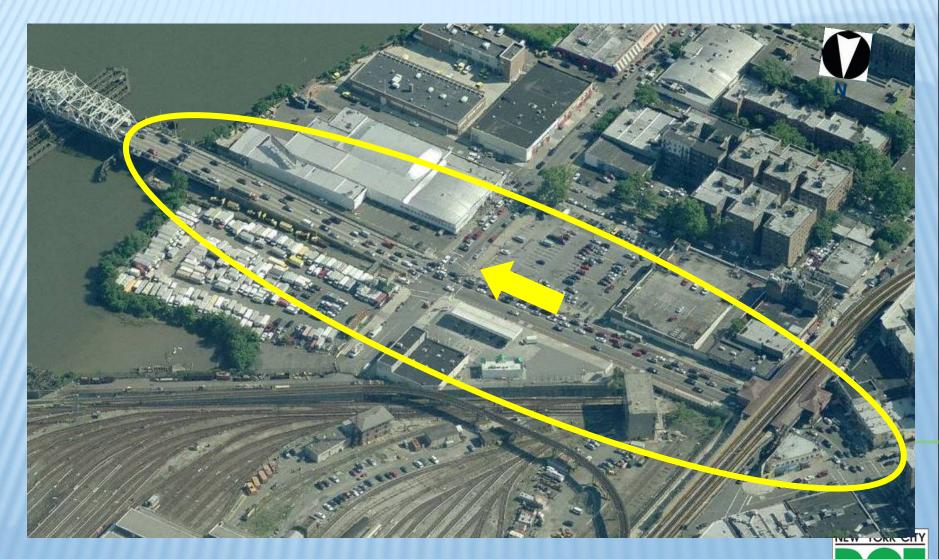
Congested Corridor -207th Street PM Peak Period

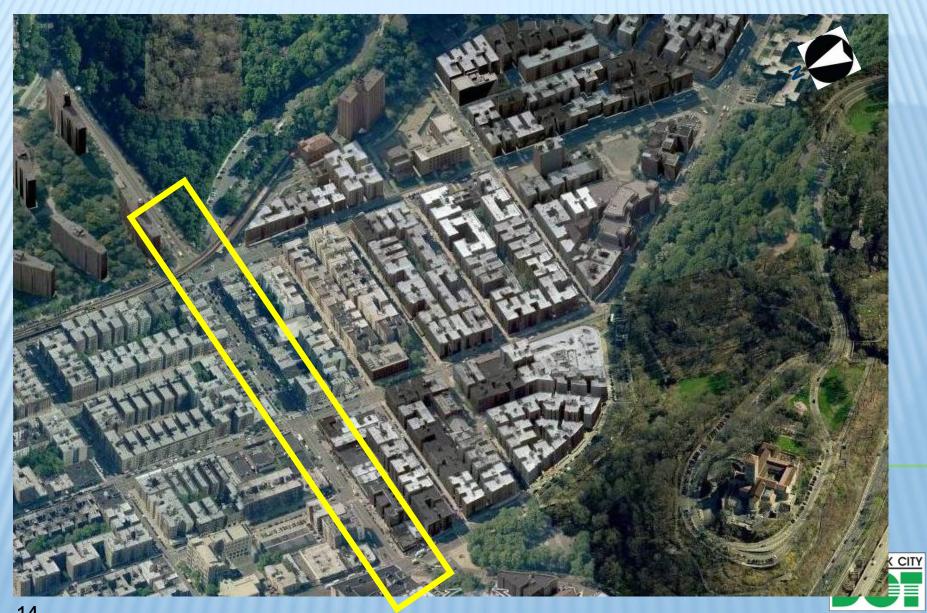
High Accident Corridor - Dyckman St

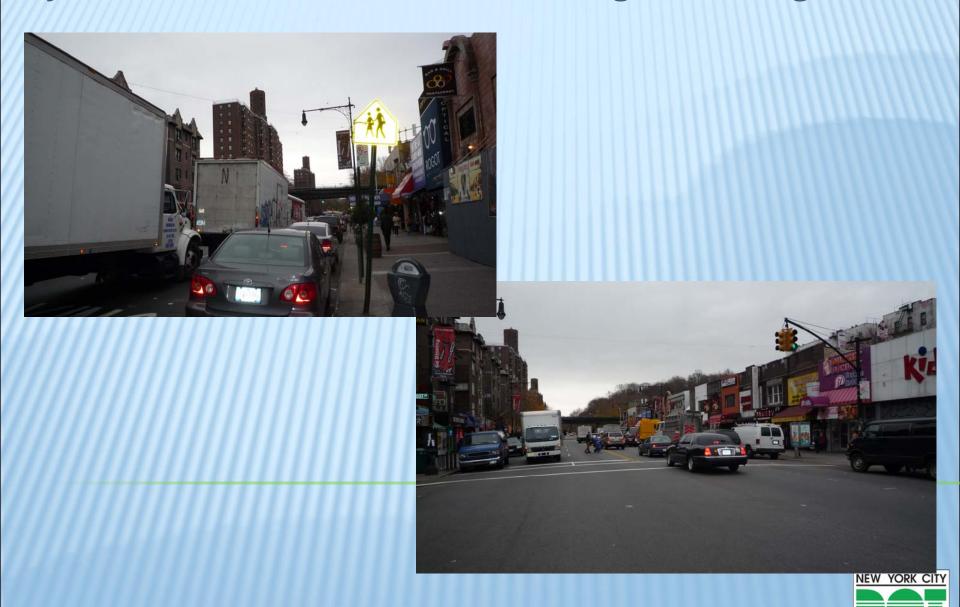
Dyckman St Corridor Double Parking & Loading issues

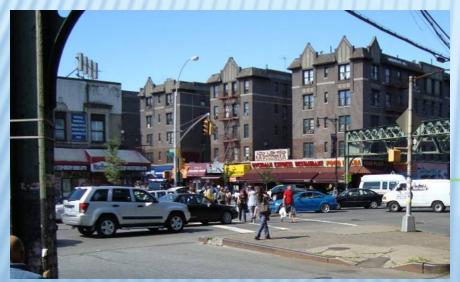
Conflicts between pedestrians and vehicle on Fort George Hill

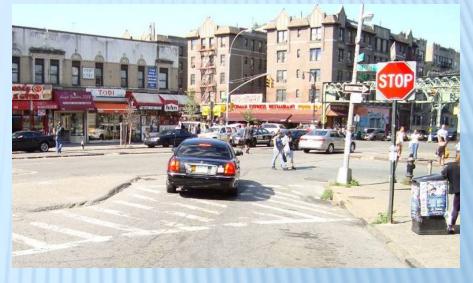
Conflicts between pedestrians and westbound left turn 18vehicle on Nagle Ave and Dyckman St

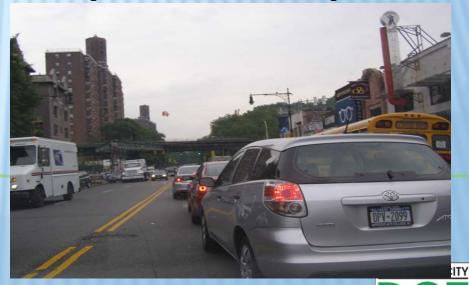
Conflicts between pedestrians and vehicle on the merge between Hillside Ave and Nagle Ave
