**New York City Department of Transportation
Office of School Safety Engineering**

School Safety Engineering Project

FINAL REPORT: J.H.S. 166, The George Gershwin School, Brooklyn

**Prepared by
The RBA Group/Urbitran Associates**

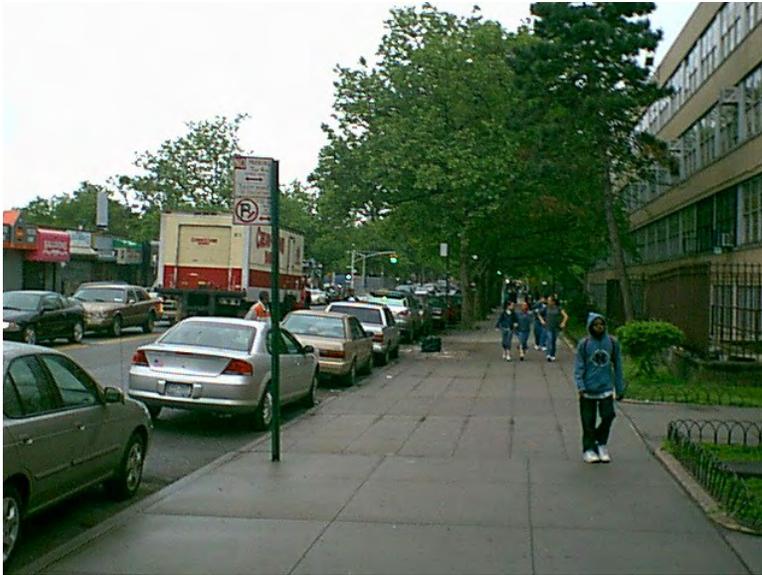
Figure 1: Looking south on Van Siclen, J.H.S. 166 is on right

The surrounding land use is primarily residential with mixed-use commercial on Linden Boulevard, Van Siclen Avenue, Stanley Avenue, and Vermont Street (Figure 1). A large urban park with athletic fields is located on the south side of Linden Boulevard to the west of J.H.S. 166. The B83 bus route operates on Van Siclen Avenue. In addition, there is a subway station located on Van Siclen Avenue at Livonia Avenue, four blocks away from J.H.S. 166.

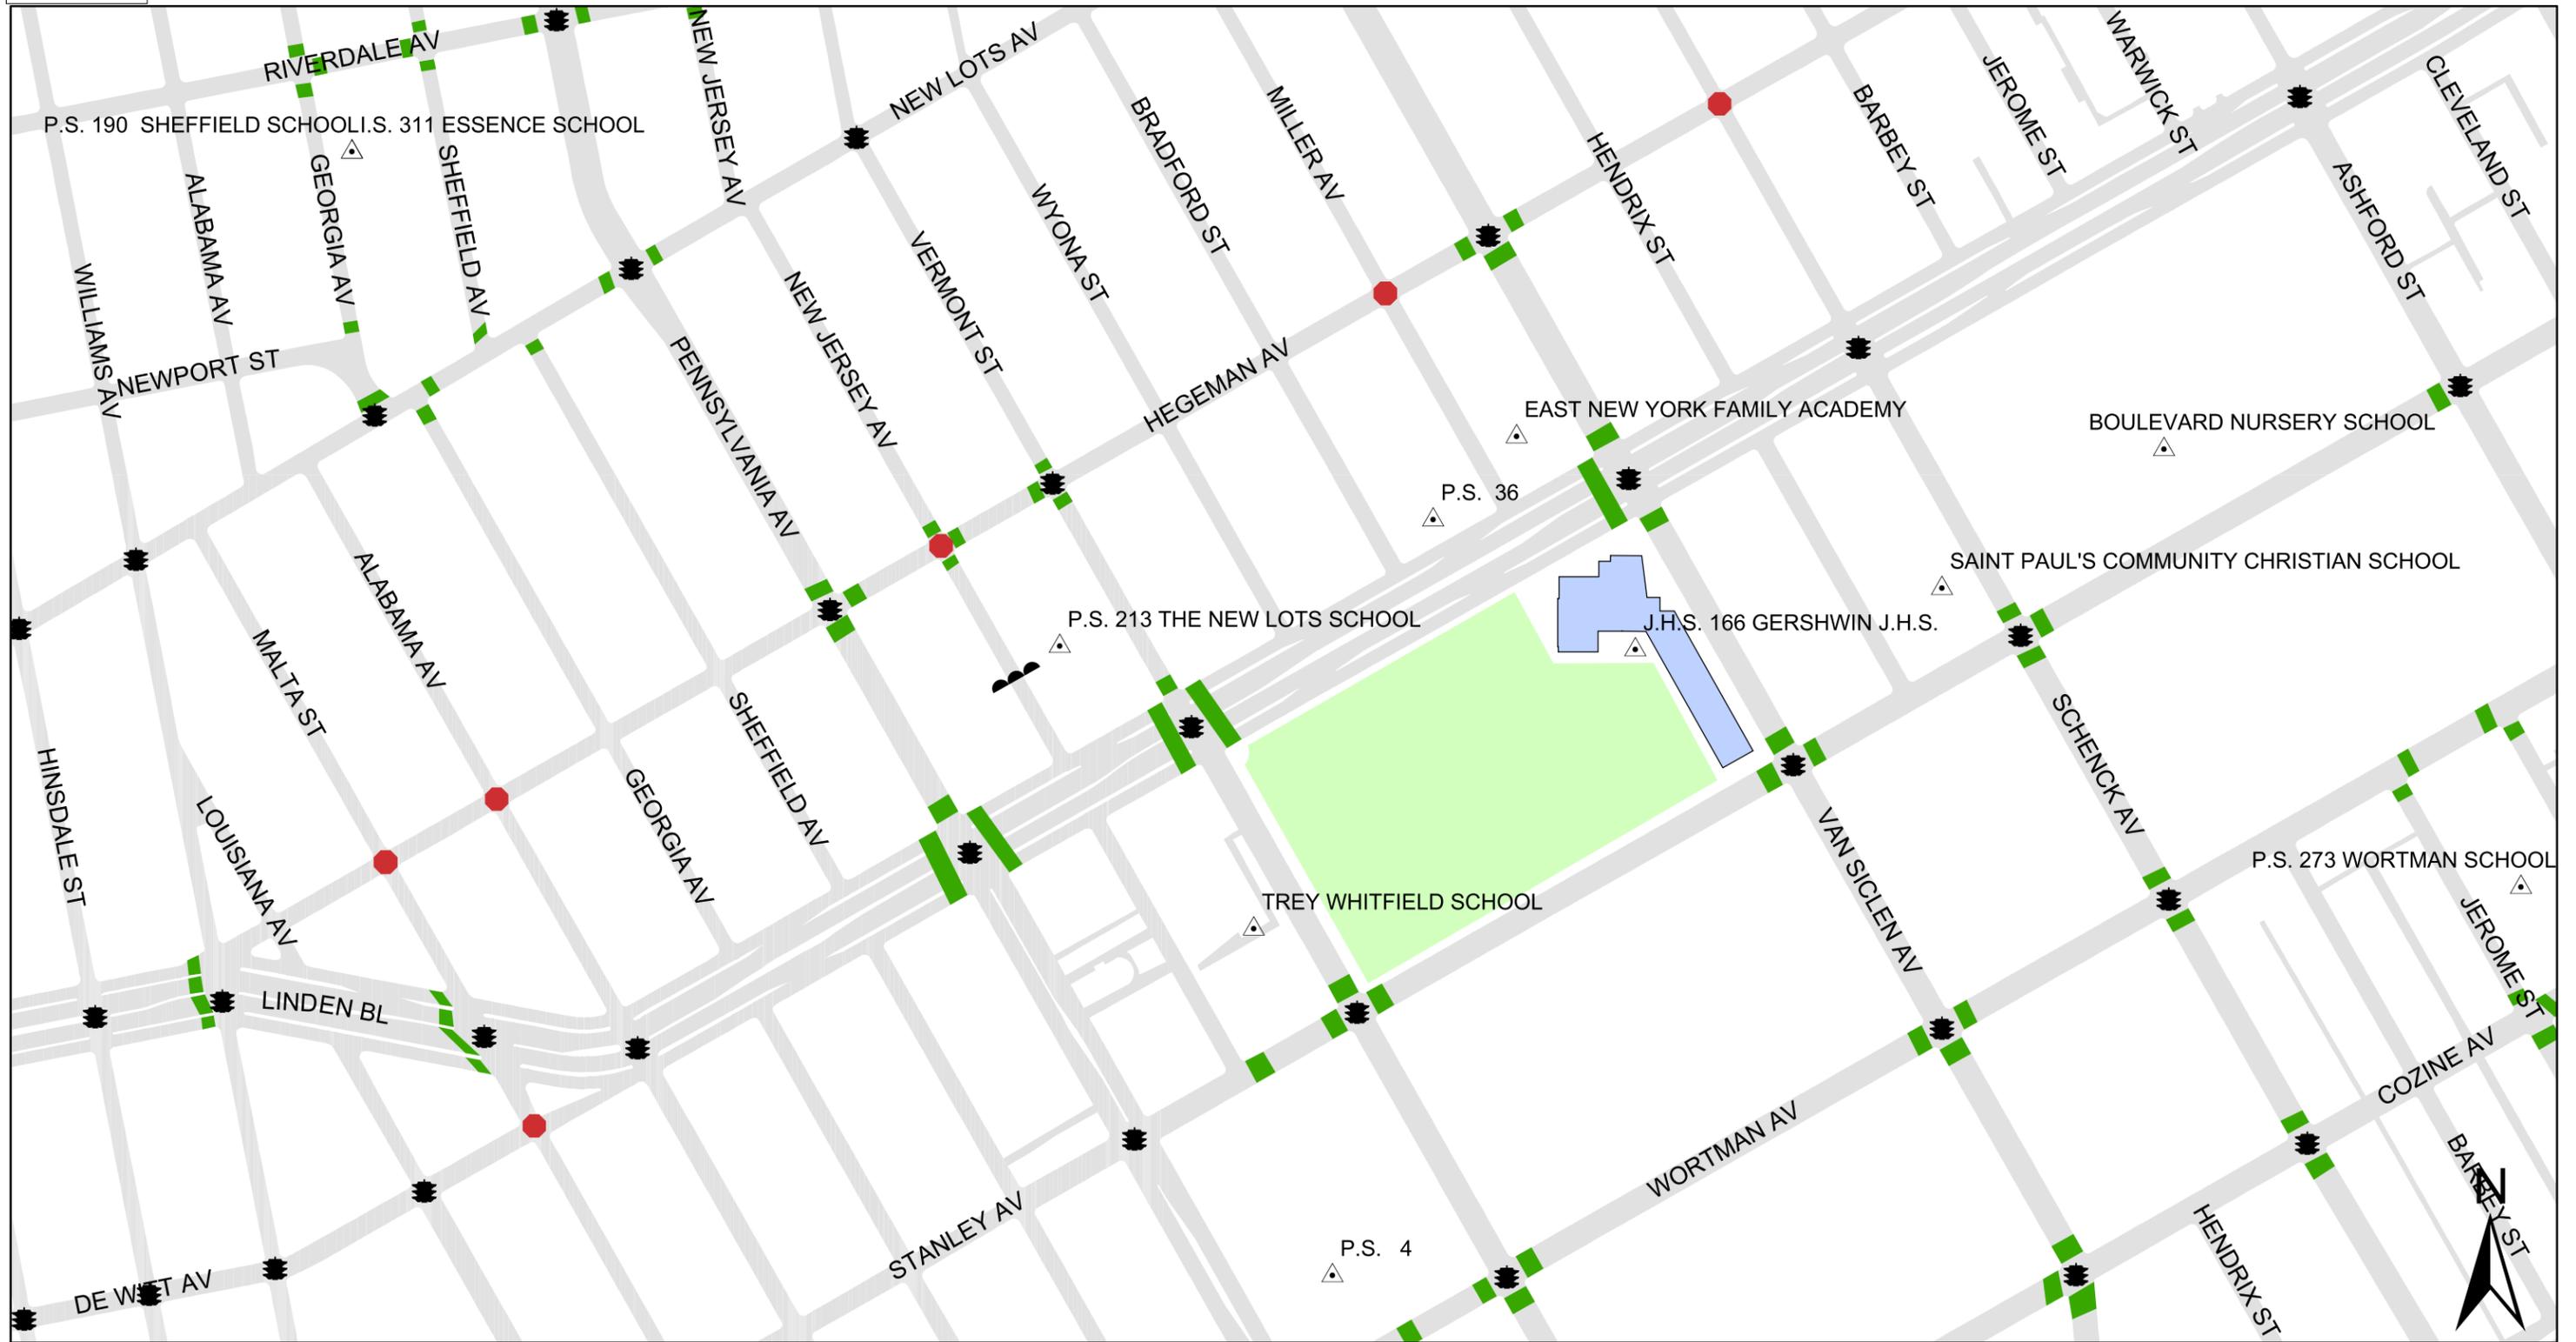
EXHIBIT 3

The School Traffic Safety Map was established to help provide the maximum degree of safety for children going to and from school - by indicating the location of speed reducers, school crosswalks and some traffic control devices. (While virtually all intersections in NYC benefit from traffic control devices - such as stop signs, traffic signals, yield signs, and all way stop signs - this map shows only traffic signals and all way stop signs.) The school crosswalks that are shown are ladder striped and make the crosswalk more visible to drivers and help make the intersection safer. These crosswalks are where school children are recommended to cross.

The Traffic Safety Map, Exhibit 3, shows existing crosswalk pavement markings. It is noted that a citywide signage program is currently underway to upgrade school signage to current Federal Manual of Uniform Traffic Control Devices (MUTCD) standards of fluorescent yellow-green signs accompanied by downward pointing arrows. Signs scheduled to be installed under this program are shown as “existing” on Exhibit 7.

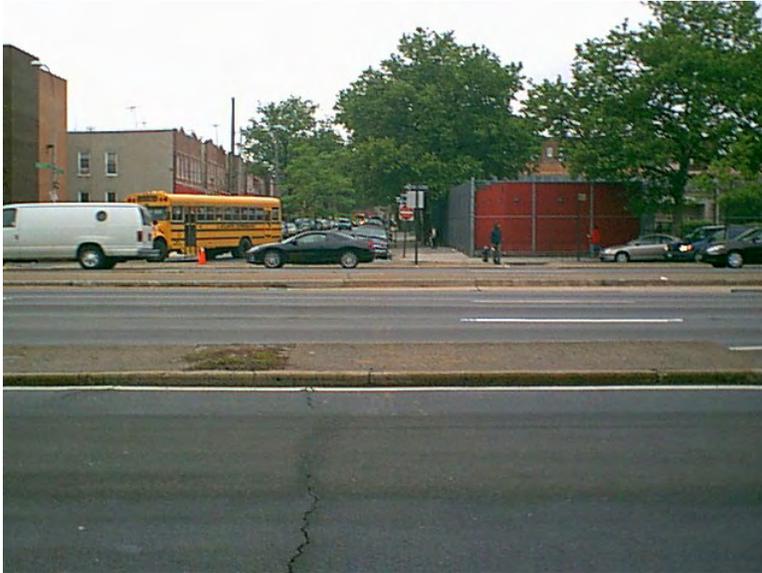
Figure 3: School bus turning onto Linden Boulevard

According to school representatives, four school buses transport J.H.S. 166 students. Three school buses serve special education students. One school bus drops off and picks up the students on Linden Boulevard in front of the school side door, and three other buses drop off and pick up the students on Van Siclen Avenue at the school's main entrance (Figure 3). School buses park or double-park, depending on traffic conditions, while dropping off or picking up students.

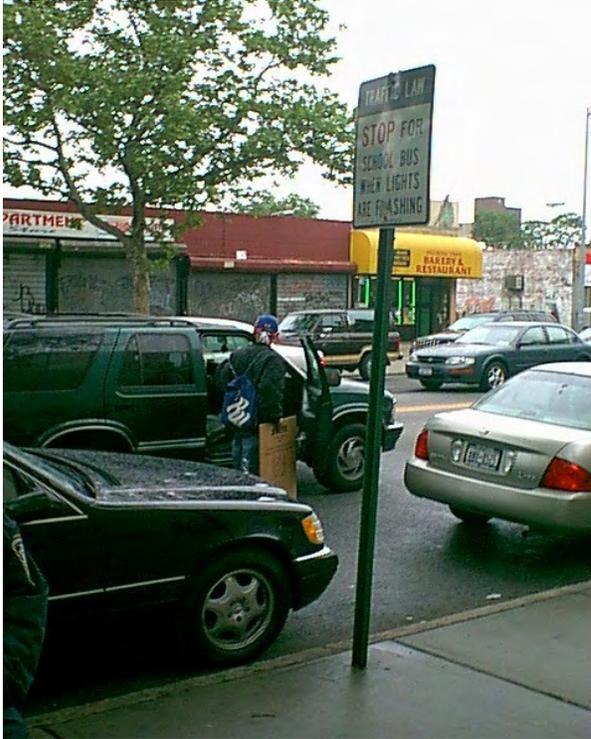
Figure 4: Student drop-off along Van Siclen Avenue

According to school officials, only one percent of J.H.S. 166 students are driven to and from school by parents or guardians. During arrival and dismissal times, vehicles typically park or double-park on Van Siclen Avenue to pick up or drop off students (Figure 4).

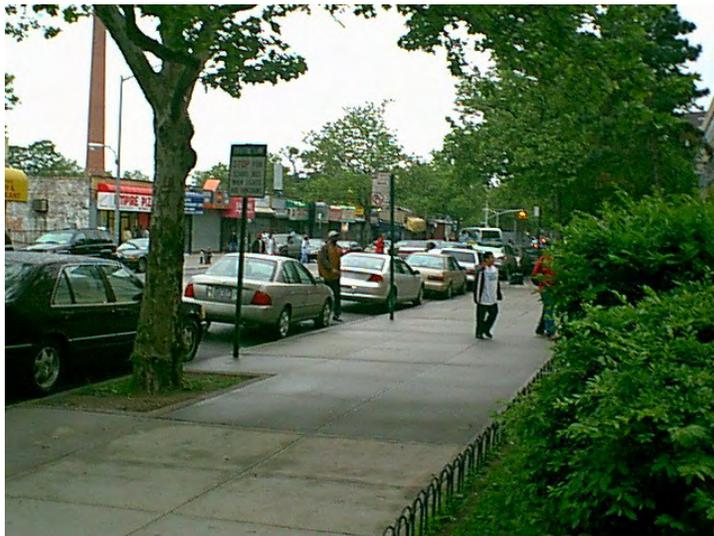
Figure 5: Looking south on Van Siclen Avenue

Exhibit 5 shows the parking regulations on the roadways surrounding the school. “NO PARKING, 7:00AM – 4:00PM, SCHOOL DAYS EXCEPT BOARD OF EDUCATION” signs are posted on Van Siclen Avenue. Teacher parking is allowed along the west side of Van Siclen Avenue (Figure 5).

“NO STANDING 7:00AM - 4:00 PM, SCHOOL DAYS” parking regulations should be provided on Van Siclen Avenue for a length of 60 feet in front of the school’s main entrance. This will allow school buses a place to load and unload students at the curb, and improve visibility of students arriving and leaving the school.

To preserve existing teacher parking capacity, an additional “NO PARKING 7:00AM - 4:00 PM SCHOOL DAYS, EXCEPT DEPARTMENT OF EDUCATION” parking regulation should be installed along the north side of Stanley Avenue, for a length of 60 feet west of Van Siclen Avenue (see Exhibit 7).

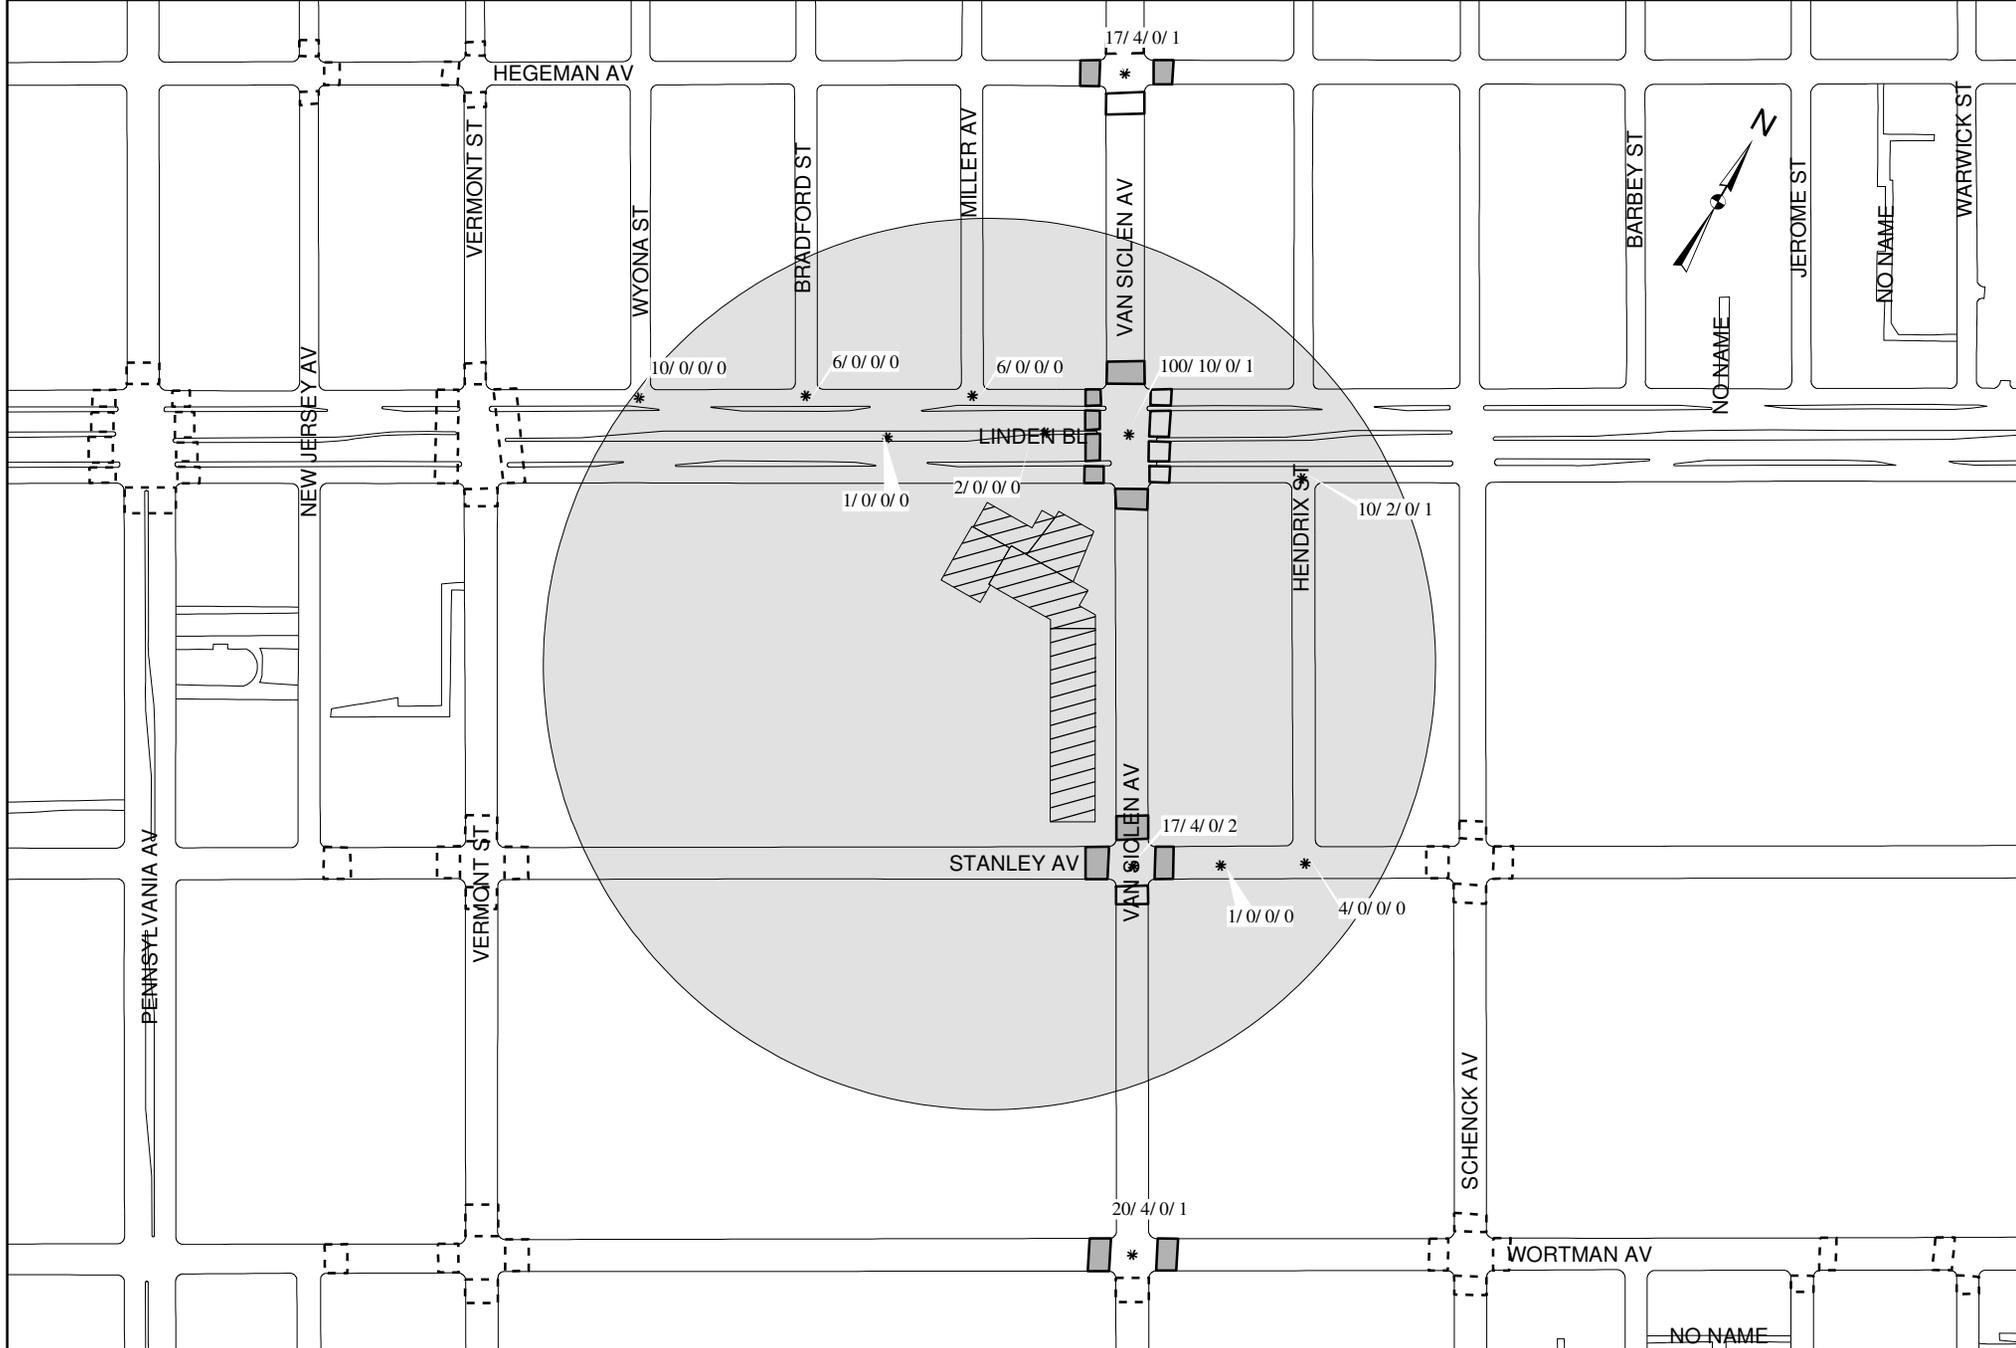
EXHIBIT 6

Exhibit 6 and Table 2 show a summary of accidents, as obtained from the New York State Department of Motor Vehicles (DMV), in the vicinity of J.H.S 166 for the three-year period from January 1, 1998 through December 31, 2000. The DMV data provides some detail relating to the circumstances and cause of the accidents. Table 2 is a summary of more recent accident data obtained from the NYC Police Department (NYPD). Though current through 2004, the NYPD data does not provide the same level of detail as the DMV data.

**ACCIDENT SUMMARY
THREE YEAR PERIOD
(1998-2000)**

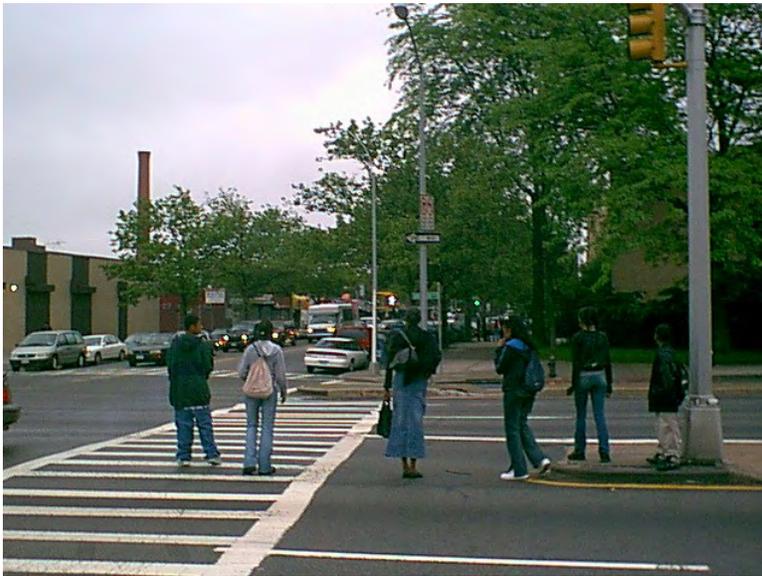
Figure 6 – Linden Boulevard at Van Siclen Avenue, looking south

Linden Boulevard is a 145-foot wide (including service roads) two-way arterial. The mainline is a two-way roadway with three through lanes and left turn bays in both directions. The roads are separated from the mainline by raised concrete medians. The eastbound and westbound service roads are 25-foot wide one-way roadways with one travel lane and parking on the right side. Van Siclen Avenue is a 50-foot wide two-way roadway with one travel lane in each direction south of Linden Boulevard, and a 60-foot wide with two travel lanes in each direction north of Linden Boulevard. Parking is allowed along both sides of the roadway. Several raised medians do not extend through the crosswalks (Figure 6). At-grade cut-throughs for the medians are positioned outside of the crosswalks (Figure 7). There are school crosswalks on the north, south and west legs of the intersection.

Review of the existing signal timing shows that the pedestrian phase does not provide adequate time for pedestrians to cross Linden Boulevard in one cycle at a walking rate of three feet per second plus a three second reaction time. A school-age pedestrian needs two signal cycles to cross at three feet per second, stopping at the center raised medians (refuge islands) separating eastbound and westbound traffic to wait between cycles. However, both east and west center raised medians do not extend through the crosswalks.

A total of 100 accidents occurred at this intersection during the 1998-2000 study period. Ten accidents involved pedestrians, one of which was school-related. Six pedestrians were struck while crossing against the signal. One pedestrian was struck by a vehicle making a left turn, and another by a vehicle failing to yield the right-of-way. Details of the two remaining pedestrian accidents were not available.

Review of the existing signal timing at the intersection of Linden Boulevard and Van Siclen Avenue indicates that the pedestrian phase does not provide adequate time for pedestrians to cross Linden Boulevard in one cycle at a walking rate of three feet per second plus a three second reaction time. A student pedestrian needs two cycles to cross Linden Boulevard as shown in Section 3.7 – Signal Timing.

- It is recommended that the center-raised medians be extended through the school crosswalks (as shown in Exhibit 7) at this intersection. This will provide a physically protected refuge area for pedestrians as they wait in the center for the second walk phase required to cross Linden Boulevard.

Review of the turning path of a Standard Unit Vehicle (SU) showed that these design vehicles would be able to complete a left turn movement with the new extended center medians.

ADA-compliant at-grade cut-throughs should be provided at all medians within the crosswalk.

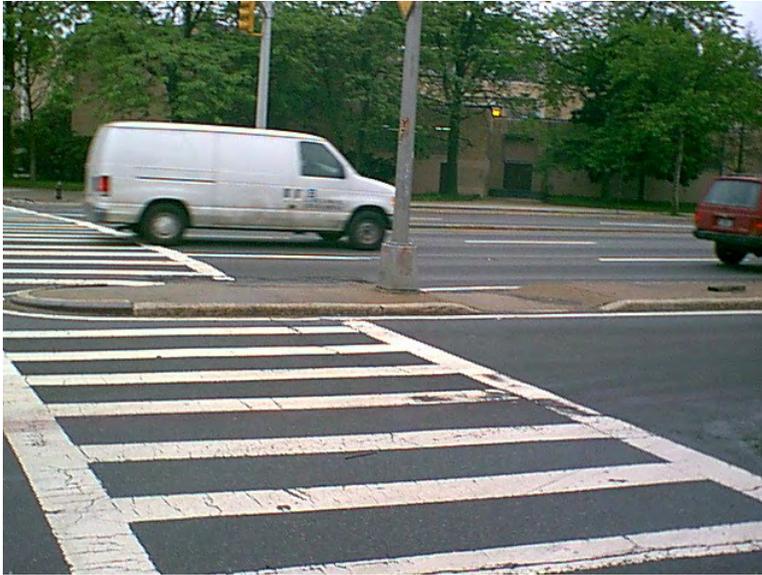
Figure 7 – Linden Boulevard at Van Siclen Avenue. At-grade cut-through is outside of the marked crosswalk

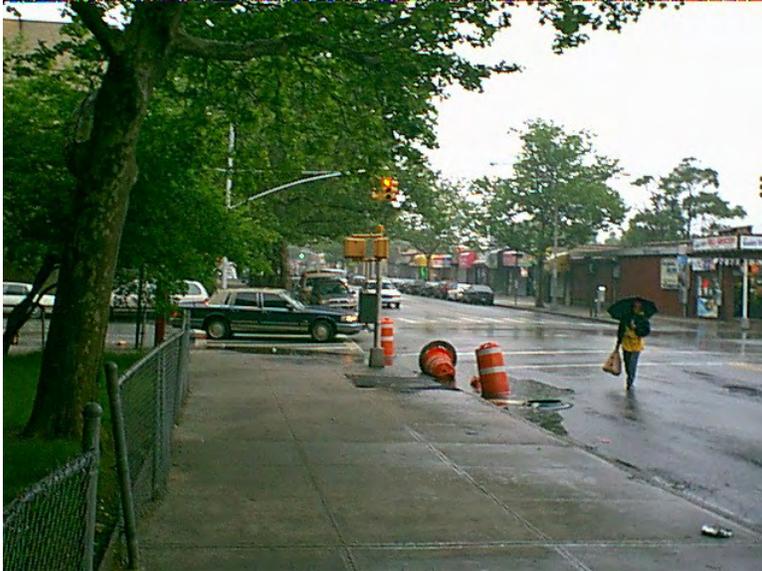
Figure 8 – Looking north on Van Siclen Avenue at the intersection of Stanley Avenue and Van Siclen Avenue

Stanley Avenue is a 50-foot wide two-way roadway with one travel lane in each direction and parking on both sides. The intersection of Van Siclen Avenue and Stanley Avenue is controlled by a two-phase signal. All corners were recently reconstructed to include new pedestrian ramps and catch basins (Figure 8). There are school crosswalks on the east, west and north legs of the intersection.

A total of 17 accidents occurred at this location during the 1998 and 2000 study period. Four were pedestrian accidents, two of which were school-related. Two children (ages 10 and 12 years old) were crossing Stanley Avenue with the signal when struck by vehicles traveling at unsafe speeds. A nine-year-old child was struck while crossing outside of the crosswalk (this accident occurred during non-school hours). Another pedestrian was working on the roadway when struck by a vehicle pulling out of a parking spot.

- Van Siclen Avenue and Stanley Avenue intersection

Curb extensions should be installed at the corners as shown in Exhibit 7.

The purpose of the curb extensions is to shorten the crossing distance for pedestrians, and to reduce speeds of vehicles approaching and turning at school crosswalks.

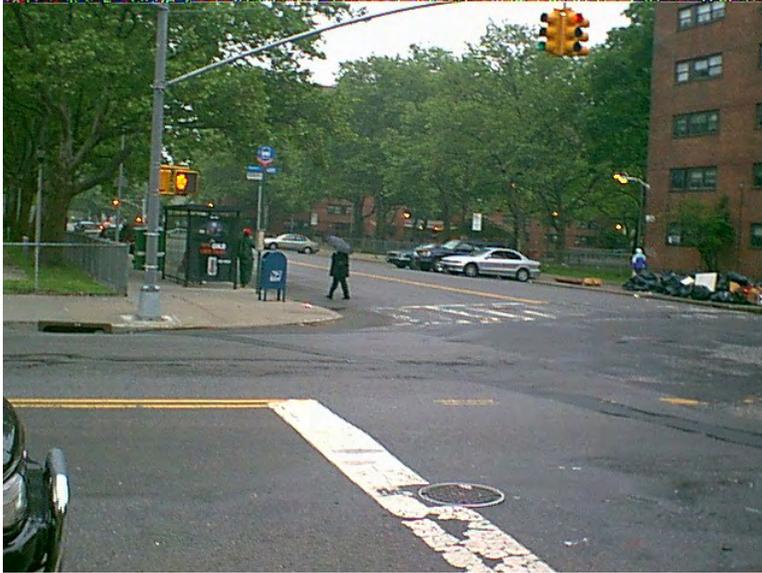
Wortman Avenue is a 50-foot wide two-way roadway with one travel lane in each direction and parking on both sides. Right-angle (90 degree) back-in parking is provided along the south side of Wortman Avenue (Figure 9) and along the east side of Van Siclen Avenue south of the intersection with Wortman Avenue. The intersection of Van Siclen Avenue and Wortman Avenue is controlled by a two-phase signal. There are school crosswalks on the east, west, and south legs of the intersection.

There are bus shelters for the B83 route on Van Siclen Avenue, and bus shelters for the B20 route on Wortman Avenue at this intersection. All pedestrian ramps are in fair condition.

Figure 9 – Looking east on Wortman Avenue, at the intersection of Van Siclen Avenue and Wortman Avenue, right-angle parking along the south curb

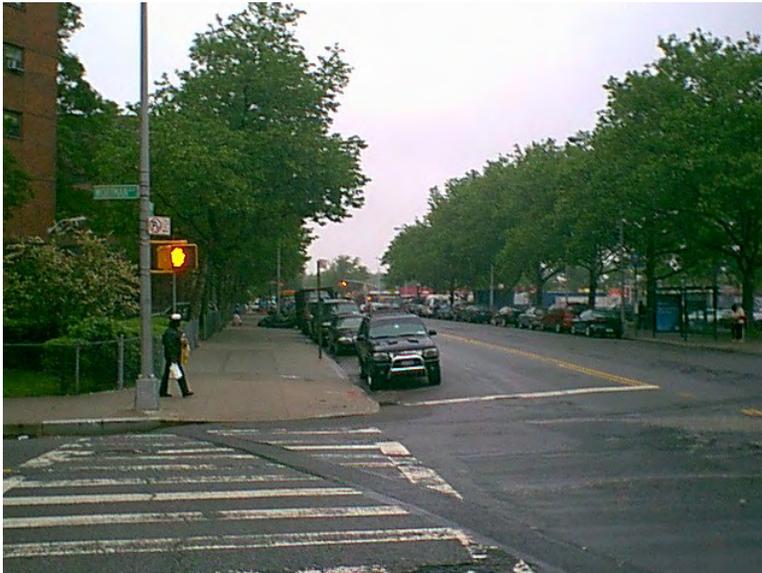
Figure 10 – Looking north on Van Siclen Avenue, at the intersection of Van Siclen Avenue and Wortman Avenue

There were 20 accidents at this intersection during the 1998-2000 study period. Four accidents involved pedestrians, one of which was school-related. All four pedestrian accidents occurred as a result of pedestrians crossing outside the crosswalk. An eleven-year-old pedestrian was struck by a vehicle that was pulling out of a parking spot. Two pedestrians were struck by through moving vehicles. The fourth pedestrian was struck by a vehicle making a right turn.

- Van Siclen Avenue and Hegeman Avenue – south leg
- Van Siclen Avenue and Wortman Avenue – north leg

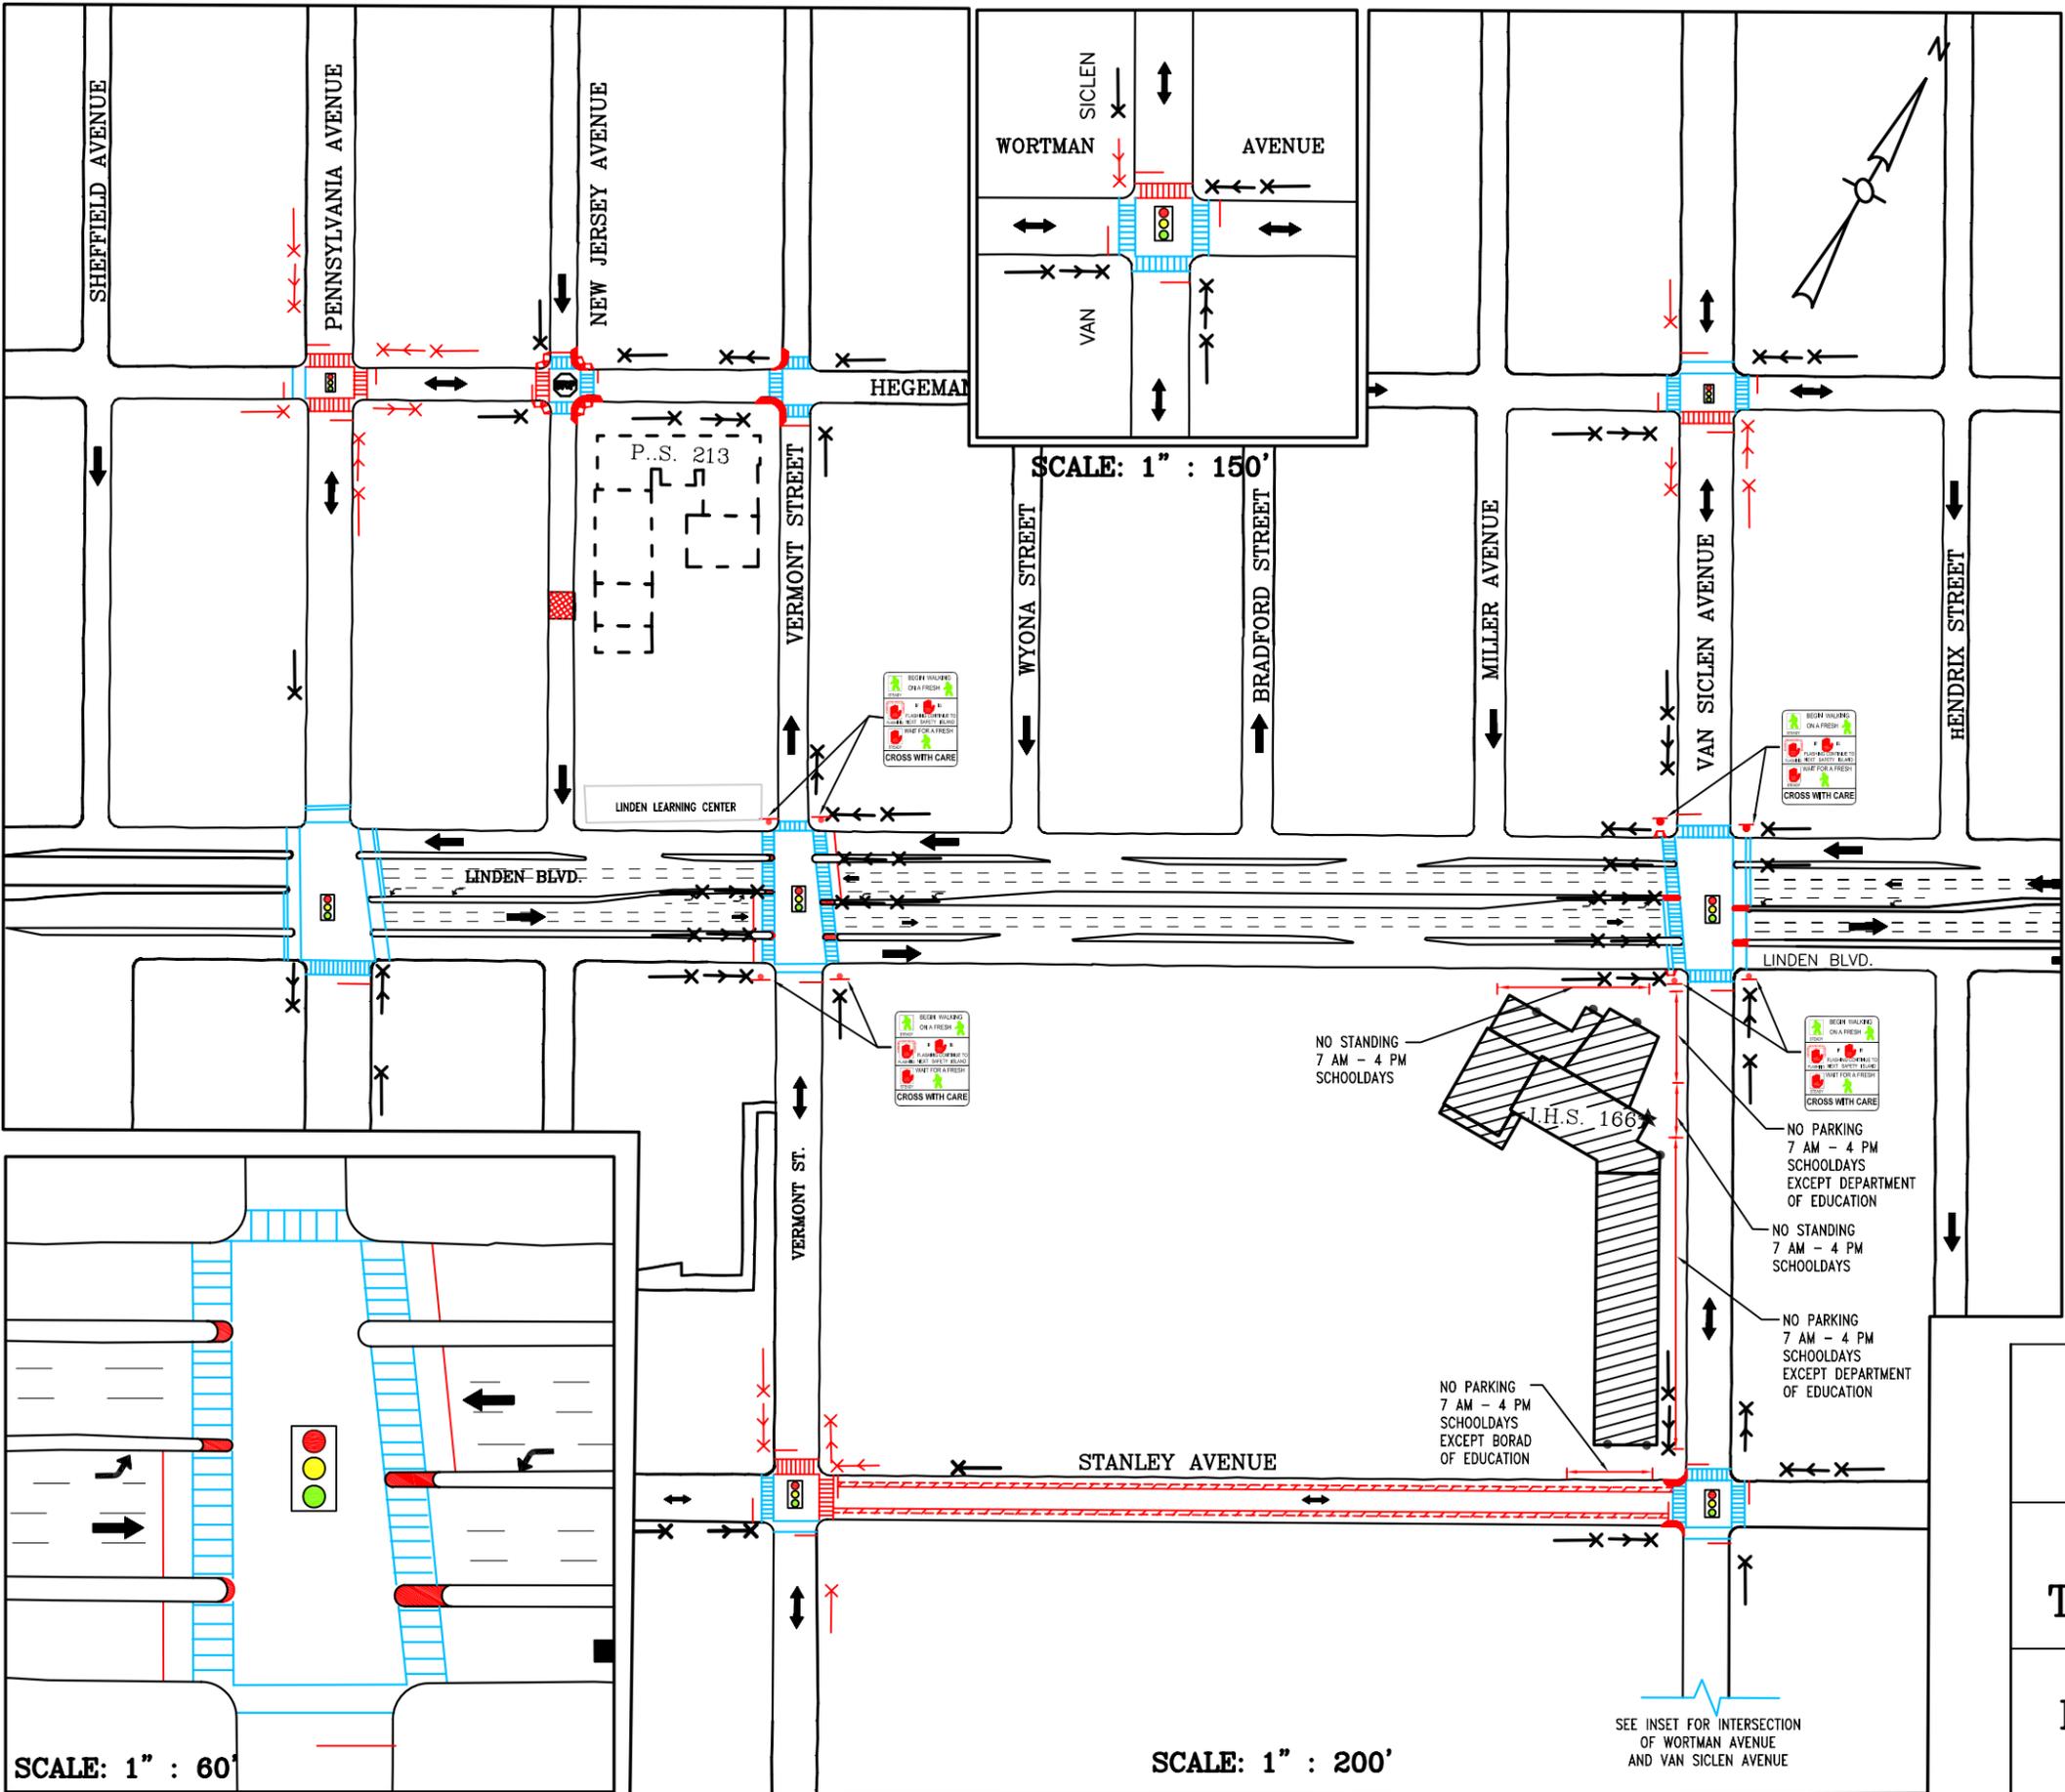
**PROPOSED MEASURES TO IMPROVE
STUDENT PEDESTRIAN SAFETY**
