NEW YORK CITY DEPARTMENT OF TRANSPORTATION
Office of School Safety Engineering

School Safety Engineering Project

FINAL REPORT: J.H.S. 275, (Thelma Hamilton School), Brooklyn

Prepared by
The RBA Group/Urbitran Associates

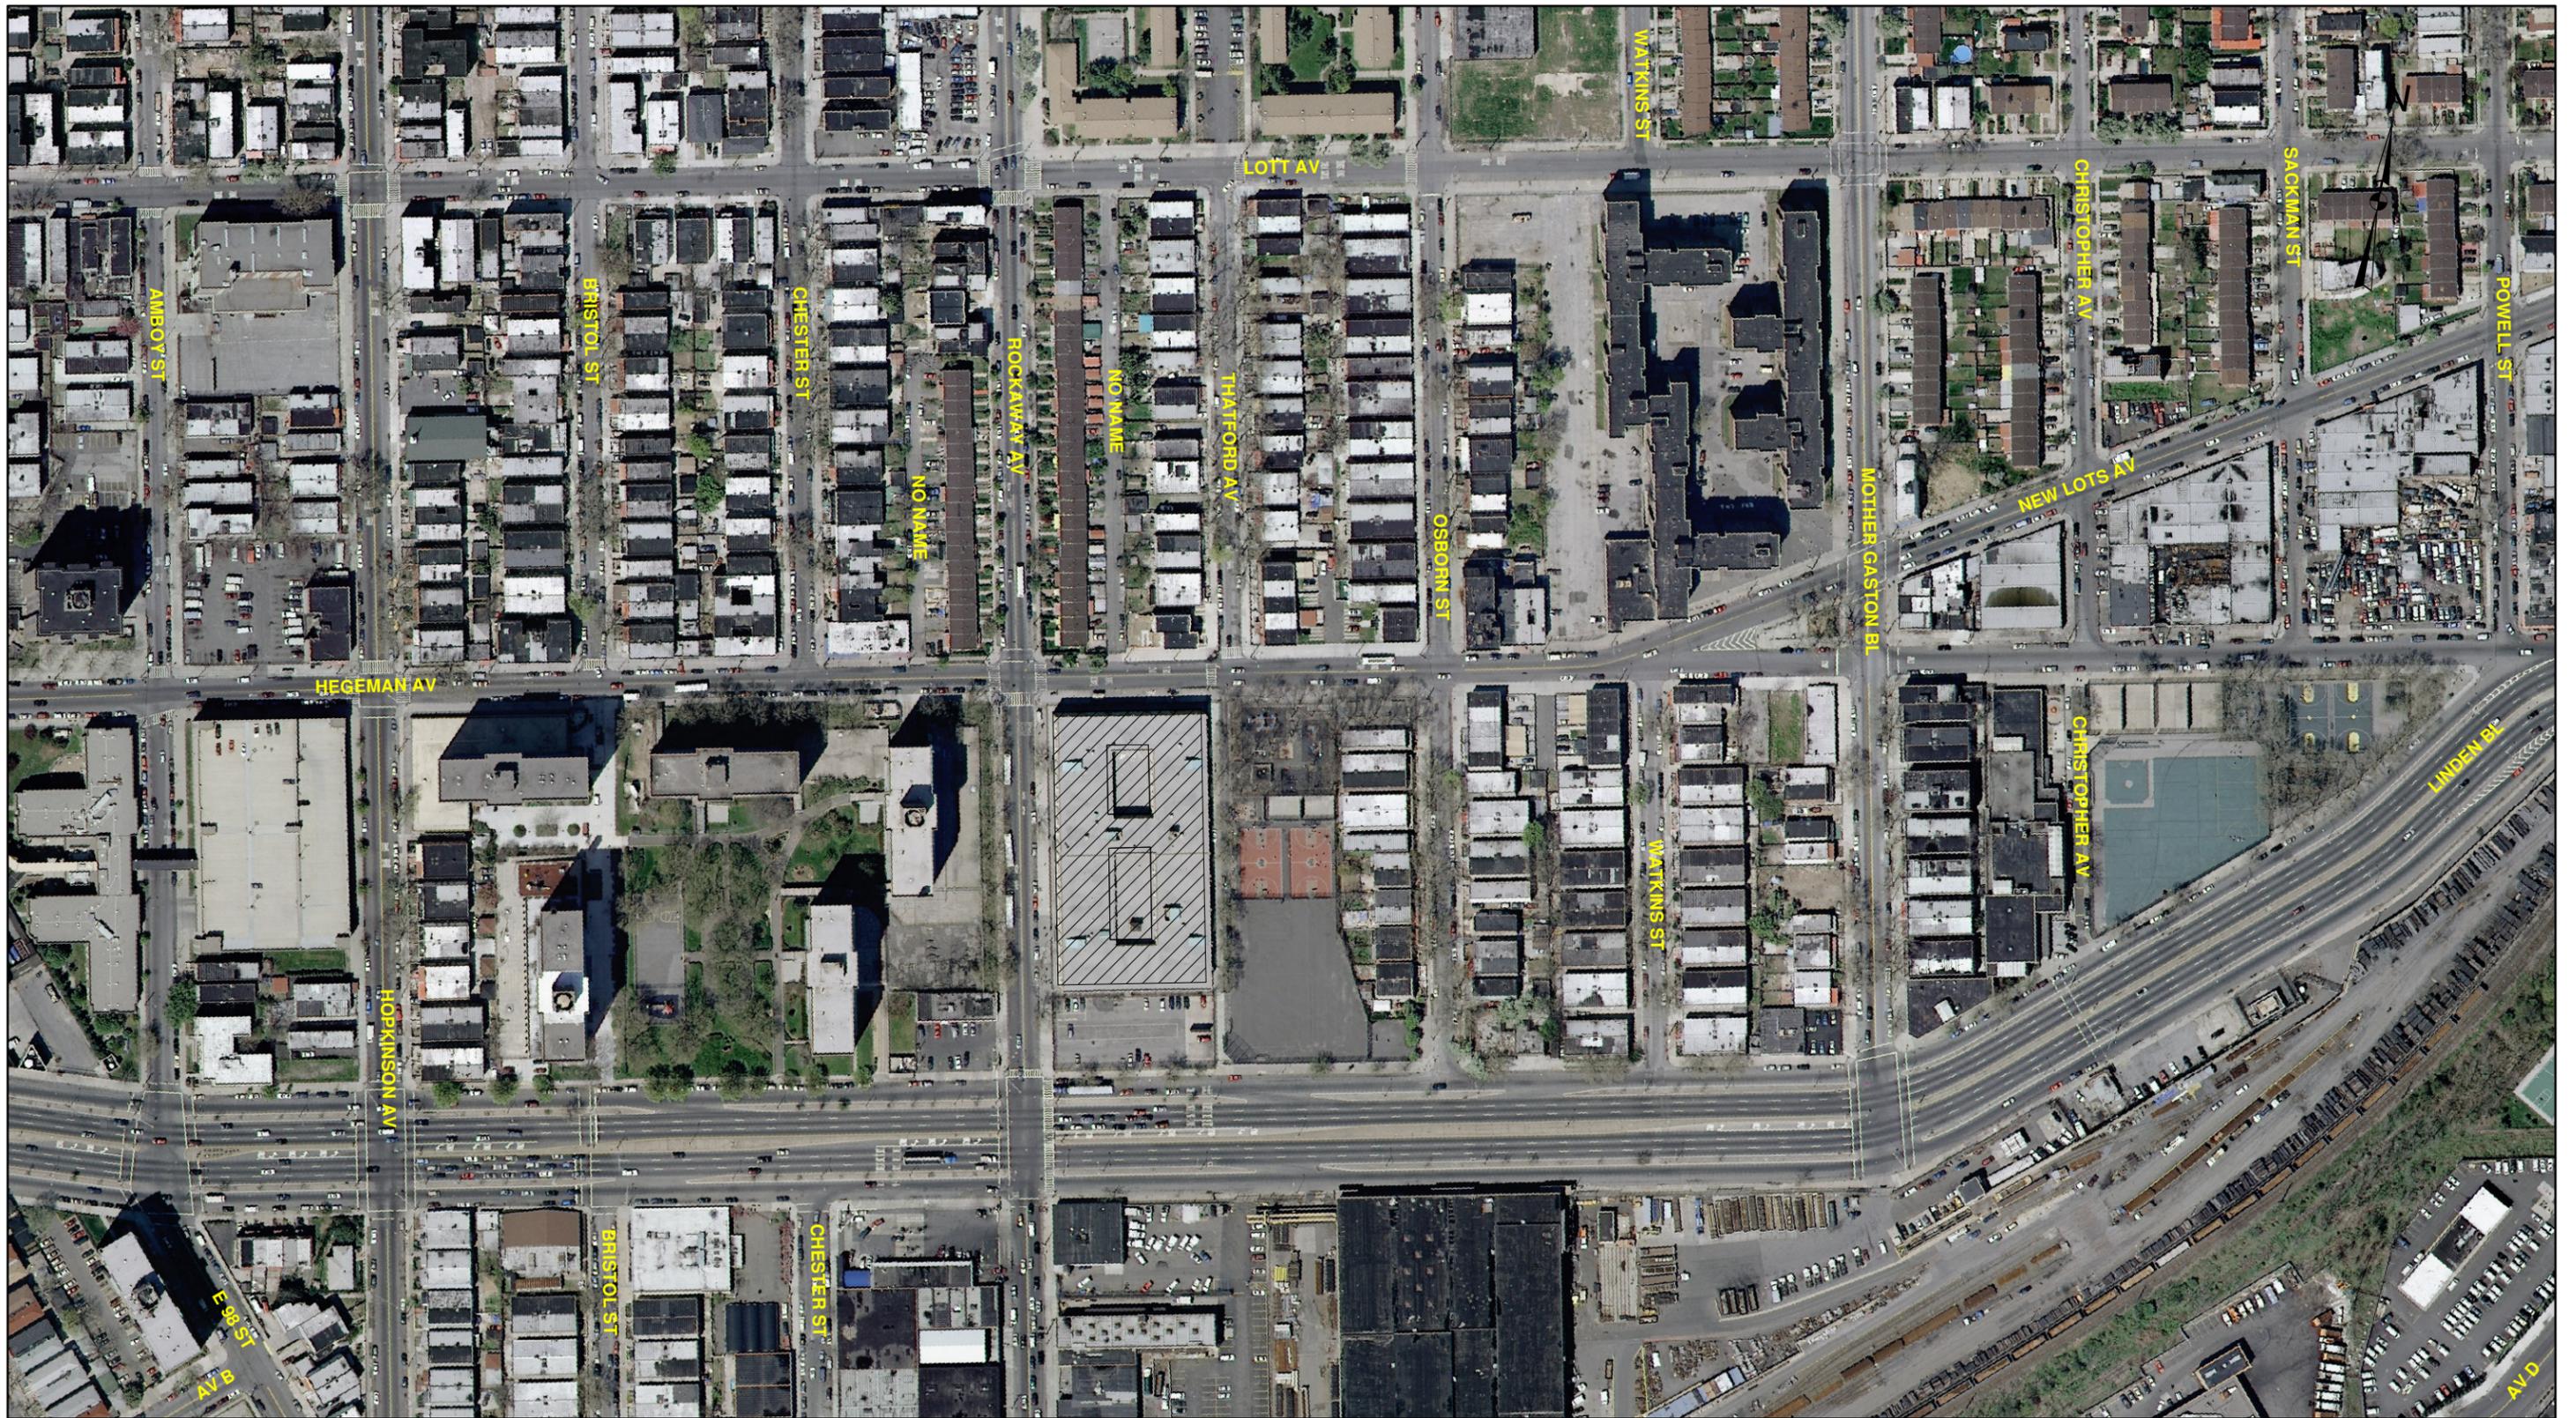
EXHIBIT 1

AERIAL PHOTOGRAPH

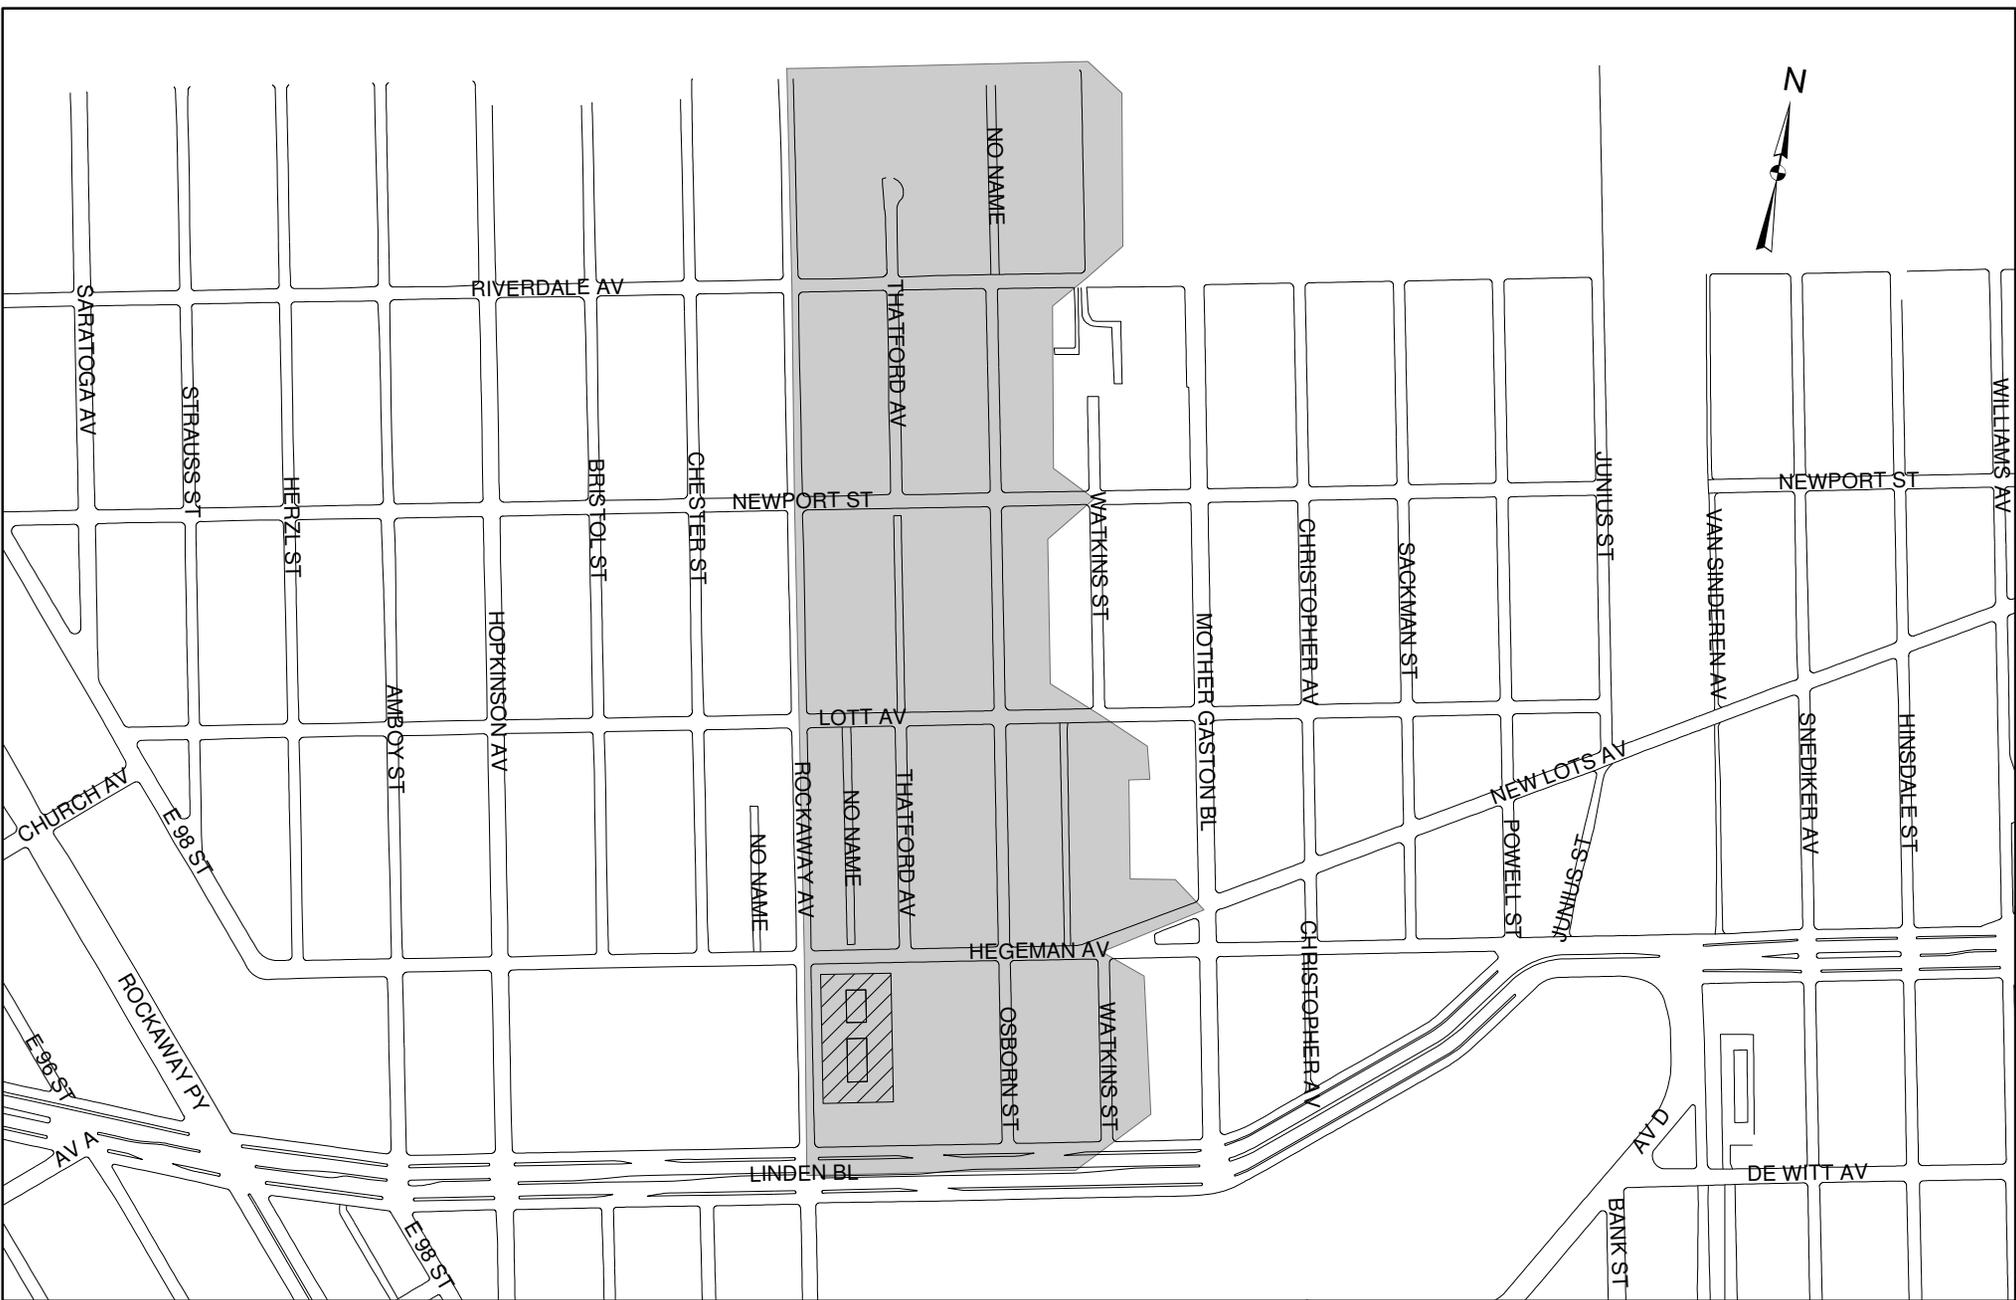
EXHIBIT 2
THELMA HAMILTON JHS
J.H.S. 275, BROOKLYN
CATCHMENT AREA

CATCHMENT AREA

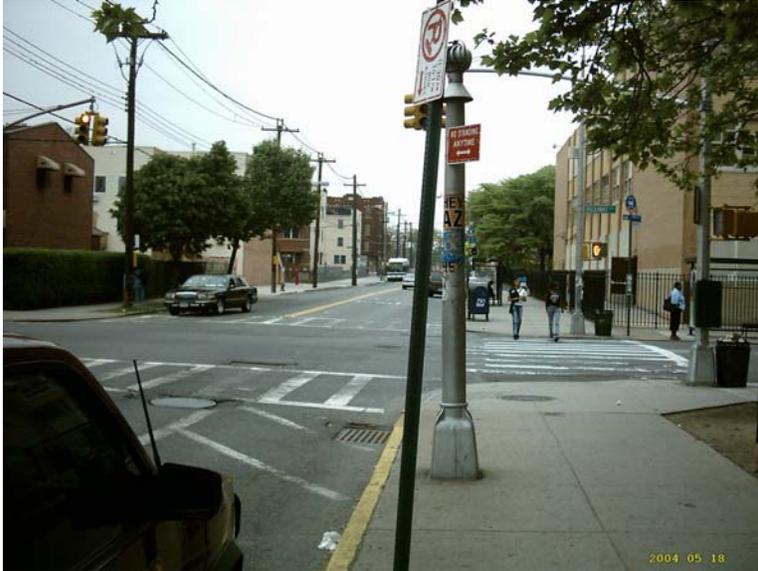
Figure 1: Hegeman Avenue at Rockaway Avenue (looking east)

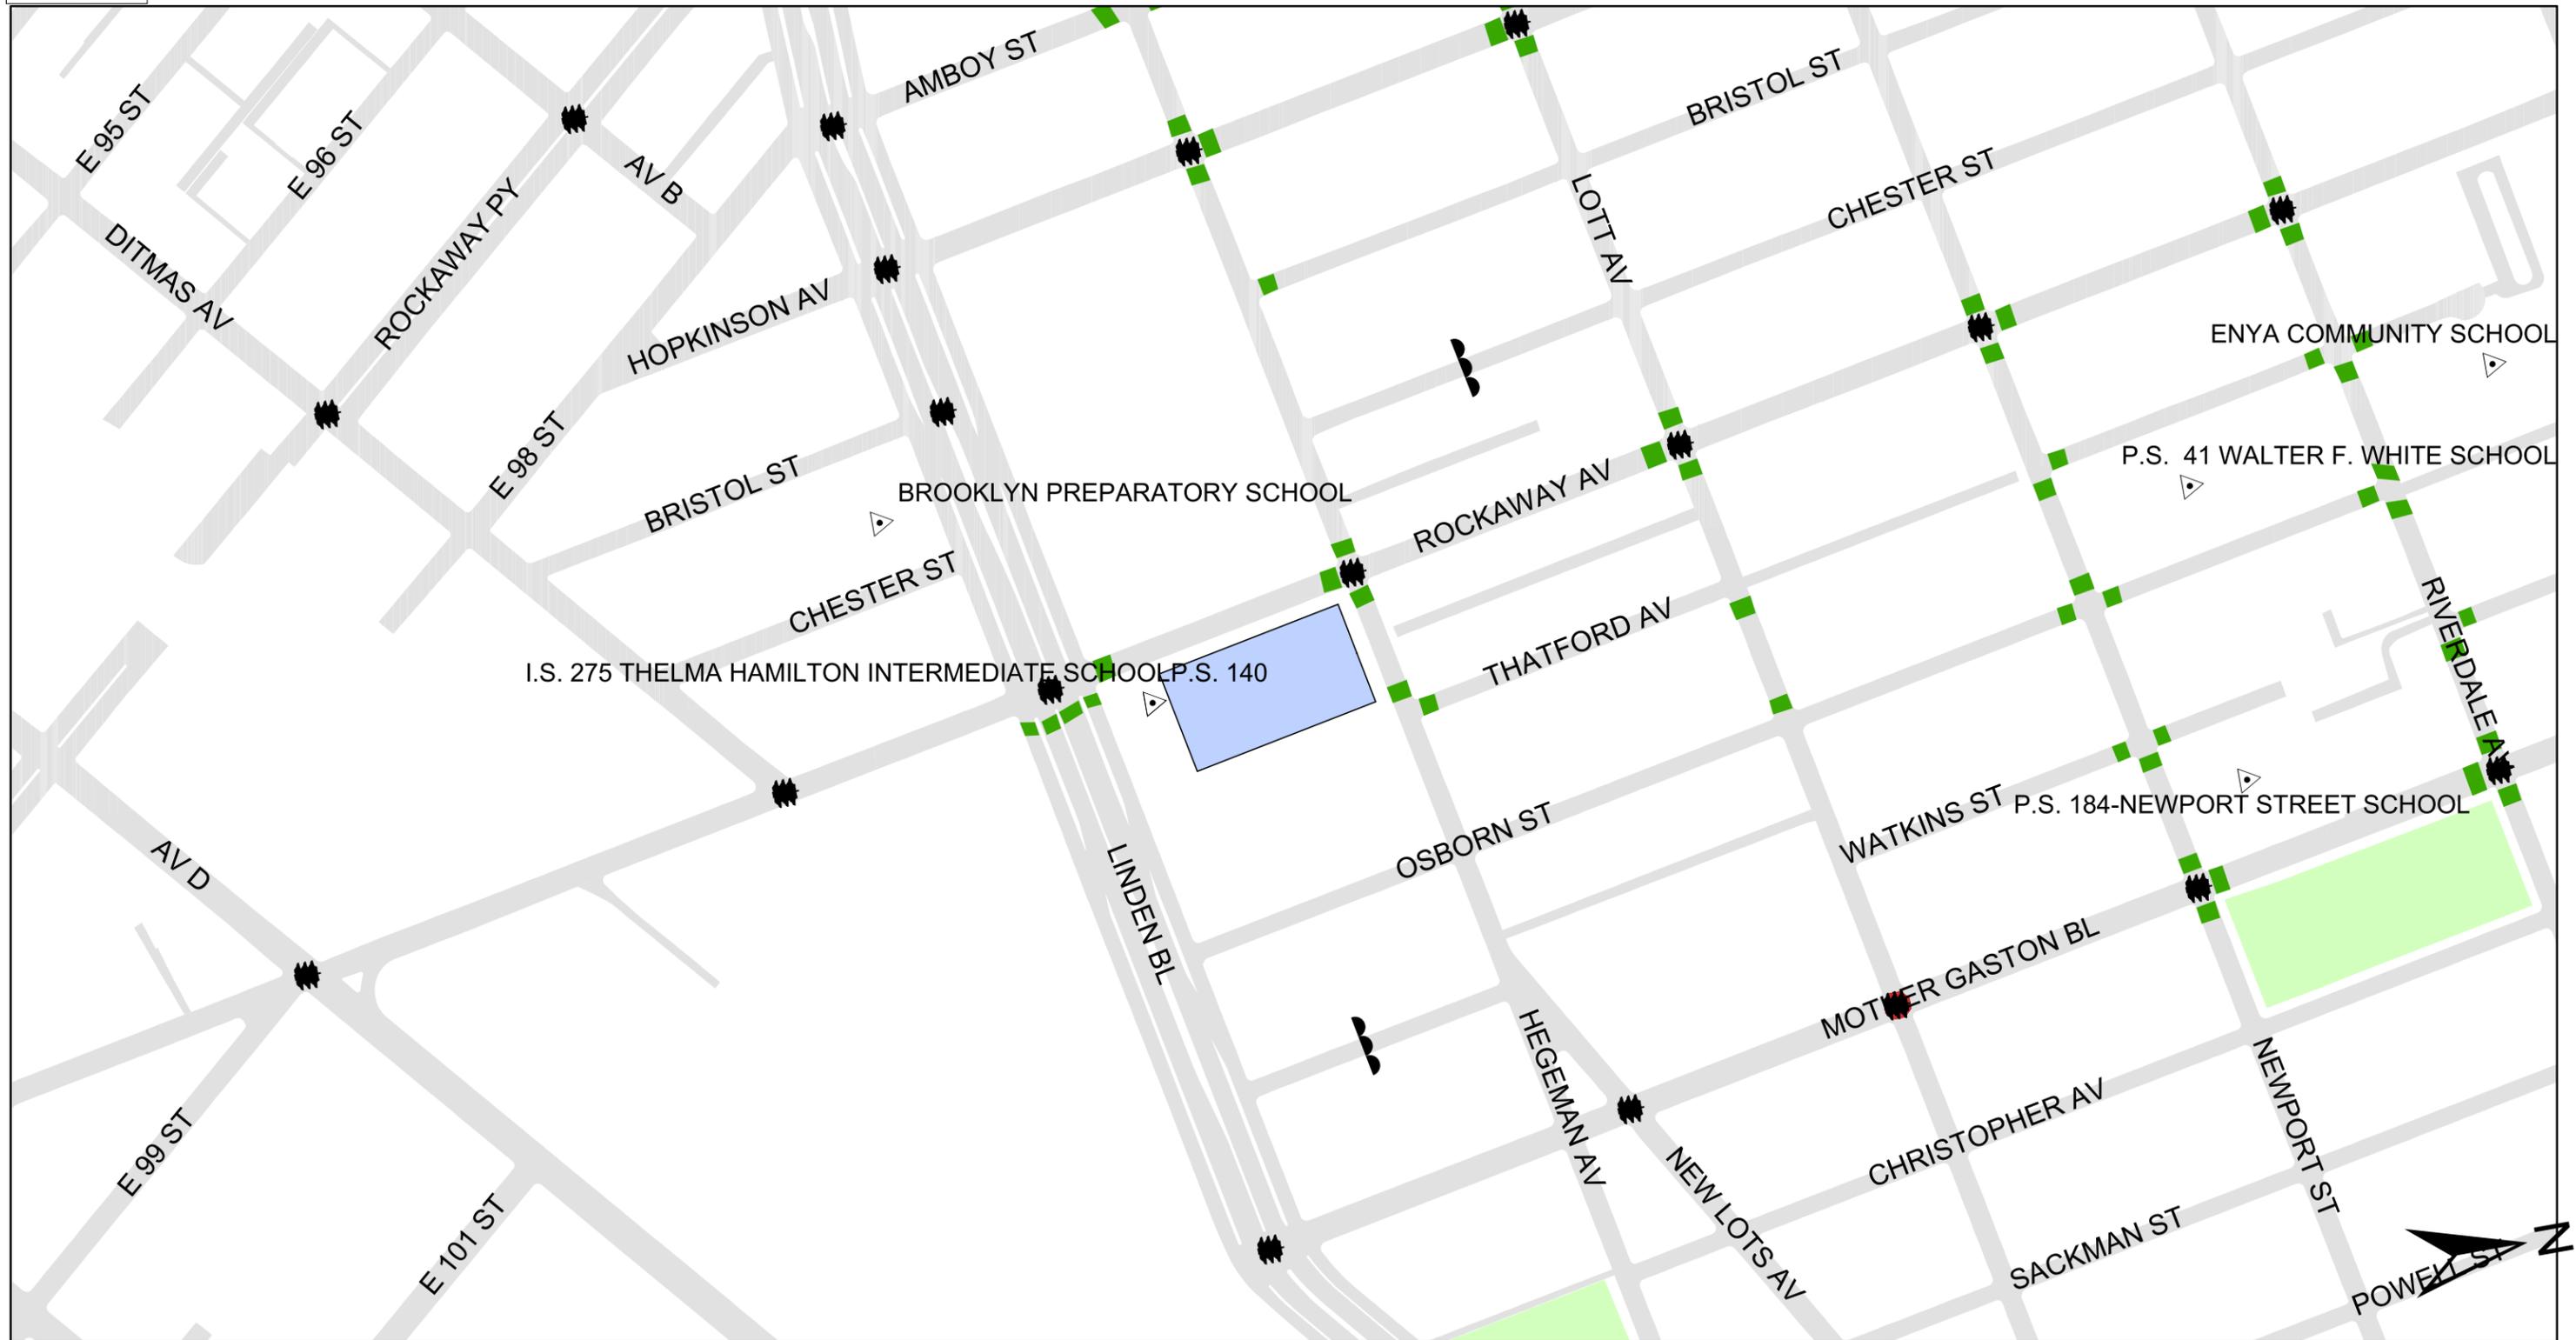
Map created on 11/16/2006 **EXHIBIT 3**

The School Traffic Safety Map was established to help provide the maximum degree of safety for children going to and from school - by indicating the location of speed reducers, school crosswalks and some traffic control devices. (While virtually all intersections in NYC benefit from traffic control devices - such as stop signs, traffic signals, yield signs, and all way stop signs - this map shows only traffic signals and all way stop signs.) The school crosswalks that are shown are ladder striped and make the crosswalk more visible to drivers and help make the intersection safer. These crosswalks are where school children are recommended to cross.

The Traffic Safety Map, Exhibit 3, shows existing signs, signals and pavement markings in the vicinity of the school. It is noted that a citywide signage program is currently underway to upgrade school signage to current MUTCD standards of fluorescent yellow-green accompanied by downward pointing arrows. Signs scheduled to be installed under this program are shown as "existing".

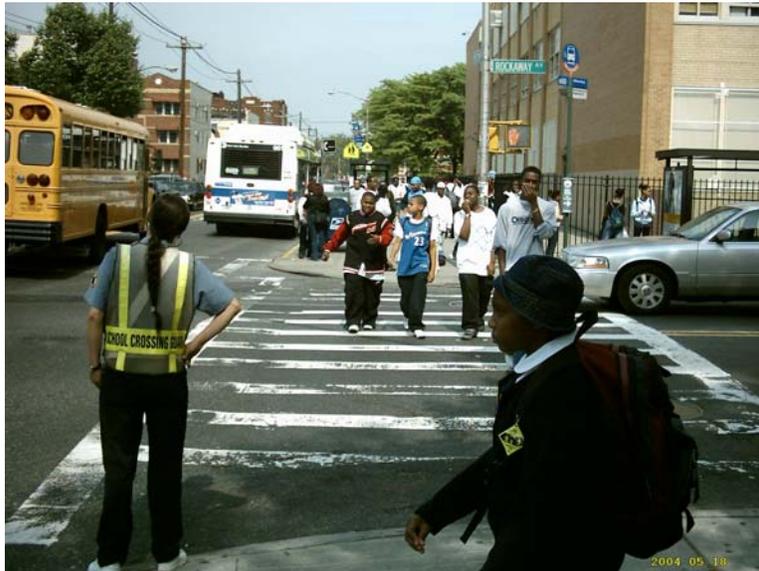
According to field observations and as confirmed by the school principal, there is currently one crossing guard assigned to this school, at the corner of Rockaway Avenue and Hegeman Avenue. Exhibit 4 shows the crossing guard locations.

Fig. 2 – Crossing guard at Rockaway Avenue and Hegeman Avenue intersection

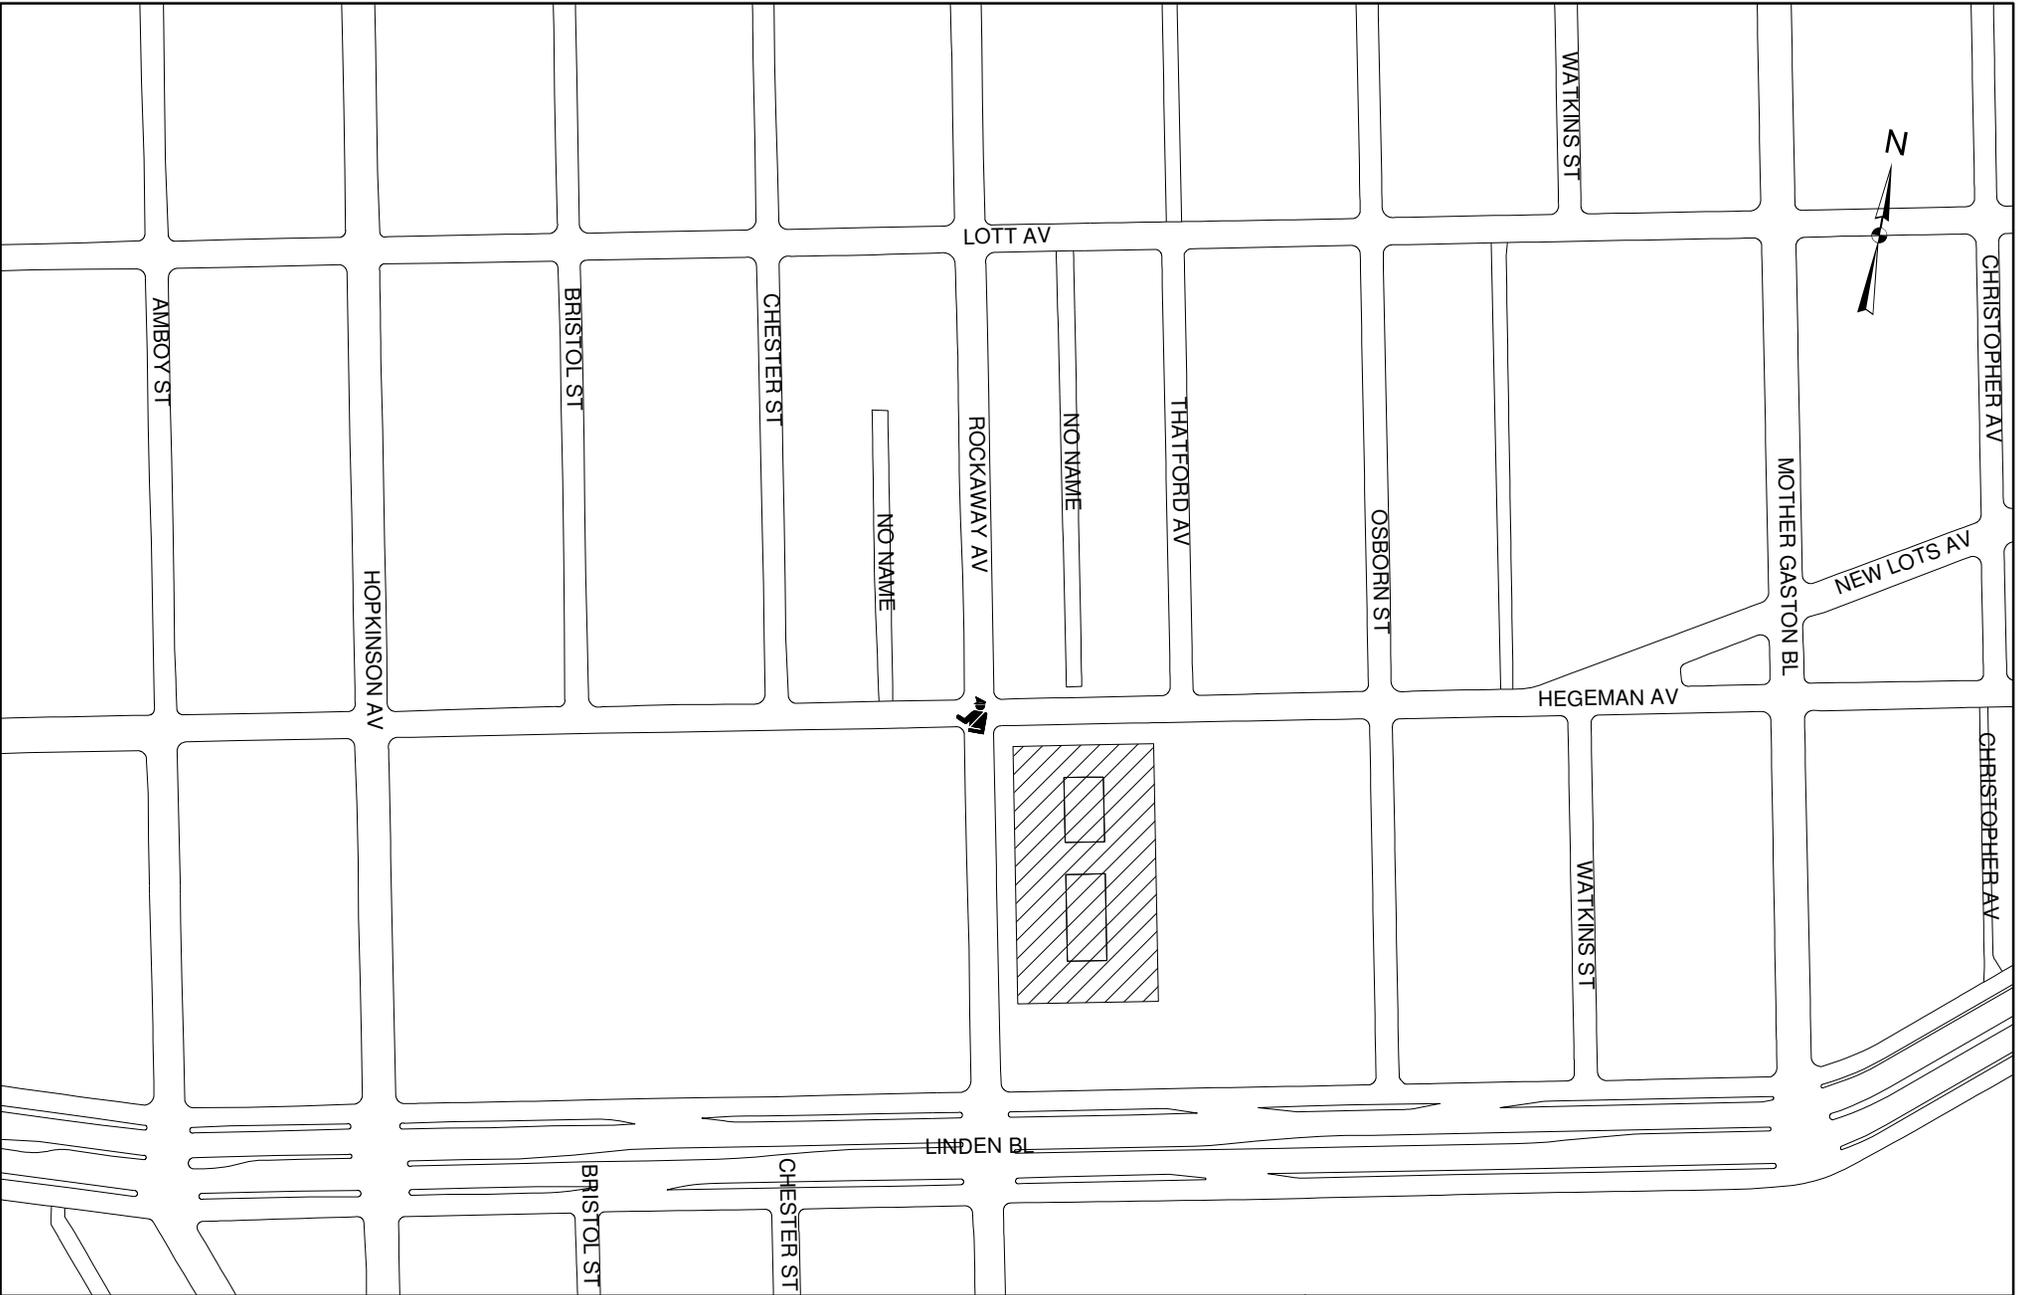
EXHIBIT 4

Crossing Guard Assigned to J.H.S. 275

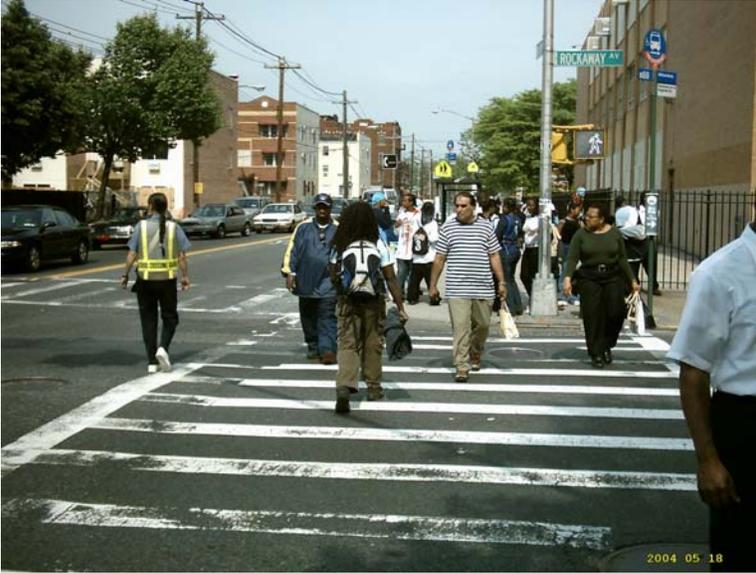
Figure 3: Crossing guards accompanying students across Rockaway Avenue along Hegeman Avenue

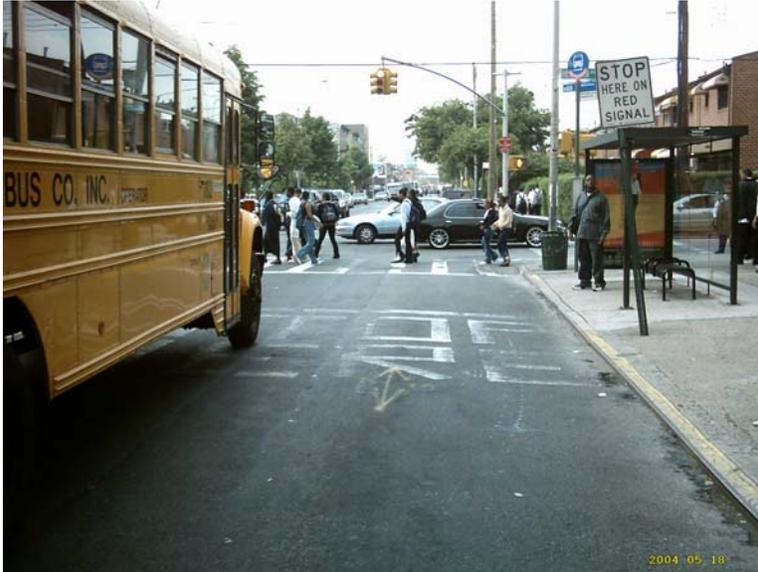
According to school representatives, 16 school buses (carrying special education students who attend PS 140) bring students to the school in the morning, and pick them up in the afternoon at dismissal time. Up to eight buses park at one time along Linden Boulevard on the south side of the school .

Figure 4: School buses circle the school to stage on Linden Boulevard during dismissal time

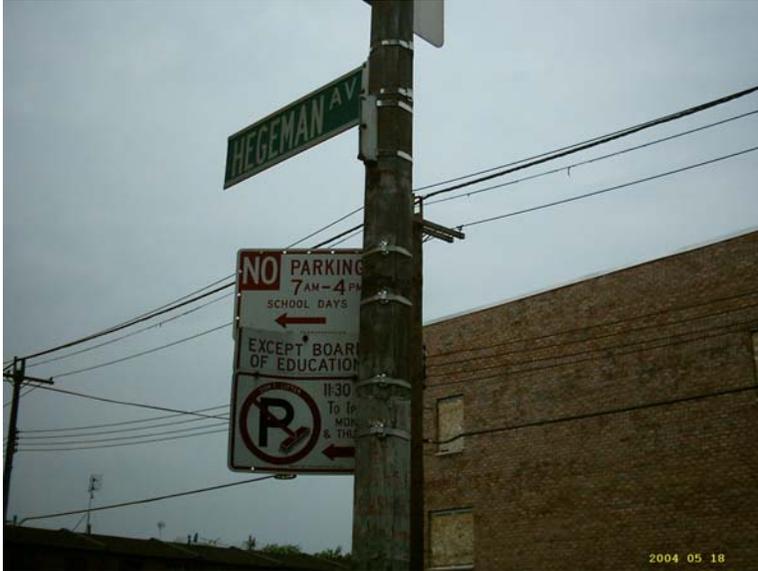
Exhibit 5 displays parking regulations around JHS 275. On Rockaway Avenue, “No Parking 7AM – 4PM School Days except Board of Education” parking regulation signs are posted in front of the school.

Figure 5: Parking regulations adjacent to the school

“No Standing 7AM-4PM, School Days” parking regulations should be considered in front of school entrance about 30 feet long on Rockaway Avenue to provide sufficient clear frontage to drop-off and pick-up students.

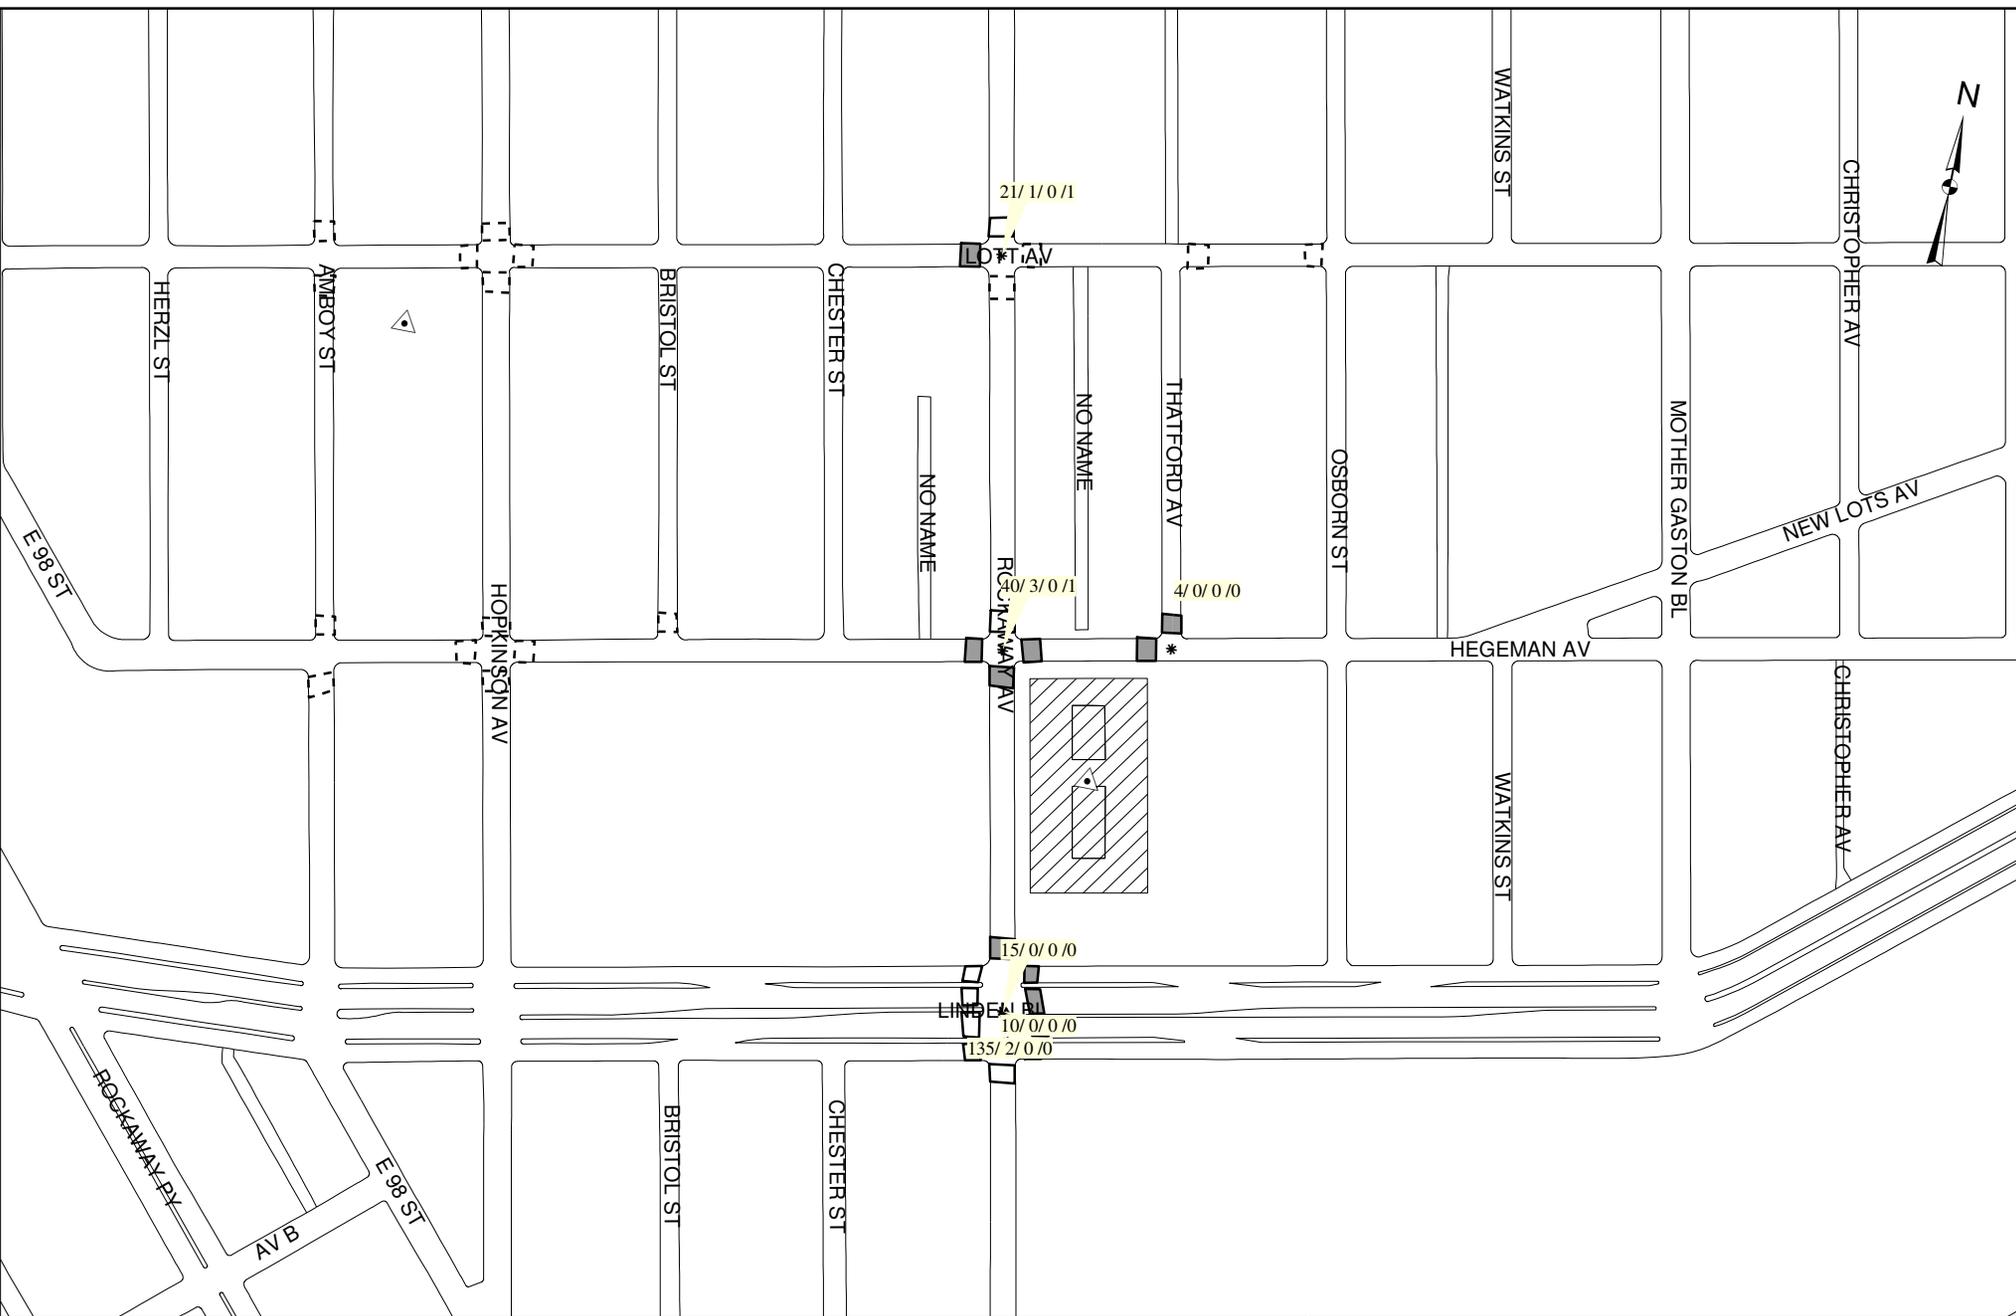
EXHIBIT 6
THELMA HAMILTON JHS
J.H.S. 275, BROOKLYN

Exhibit 6 and Table 2 show a summary of accidents, as obtained from NYS Department of Motor Vehicles (DMV) in the vicinity of J.H.S. 275 for the three-year period from January 1, 1998 through December 1, 2000. The DMV data provides some detail relating to the cause of the accident. Table 3 is a summary of more recent accident data obtained from the NYC Police Department (NYPD). Though current through 2004, the PD data does not provide the same level of detail as the DMV data. Accidents are discussed in Section 3.6, Traffic Operations and Issues.

ACCIDENT SUMMARY
THREE YEAR PERIOD
(1998-2000)

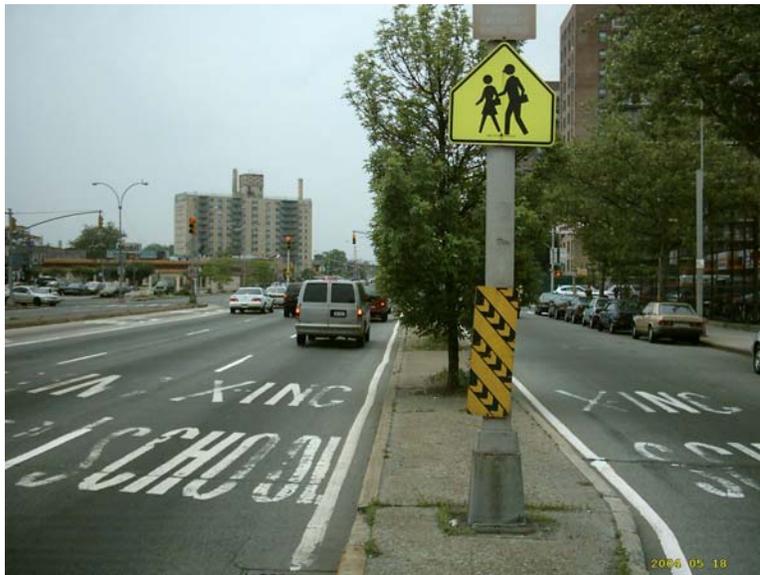
This signalized intersection had 135 accidents in the three-year period from 1998 to 2000 (Exhibit 6 and Table 2). Linden Boulevard is a major through route, carrying three travel lanes in each direction plus an east bound left turning lanes. These are separated from single lane frontage roads in each direction by a four-foot concrete median. The frontage roads each allow curbside parking. Rockaway Avenue is a two-way street running north-south through the school area. Neither of the two pedestrian accidents reported at this location were school related. One involved a pedestrian crossing against the traffic signal.

Figure 6: Linden Boulevard view westbound approaching Rockaway Avenue near JHS 275

Providing extended median refuge areas across the crosswalks will provide a safe area for pedestrians who do not make the entire 145-foot crossing during one pedestrian walk phase. These extended medians will provide a protected area for pedestrians. The proposed median extensions should extend 5 feet beyond the crosswalk, and should have a 5-foot at grade cut through section.

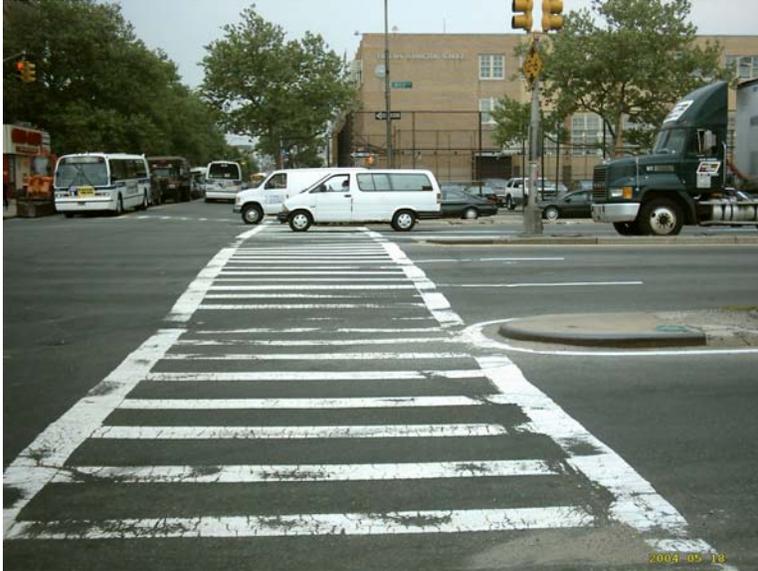
Figure 7: View northbound across Linden Boulevard along Rockaway Avenue

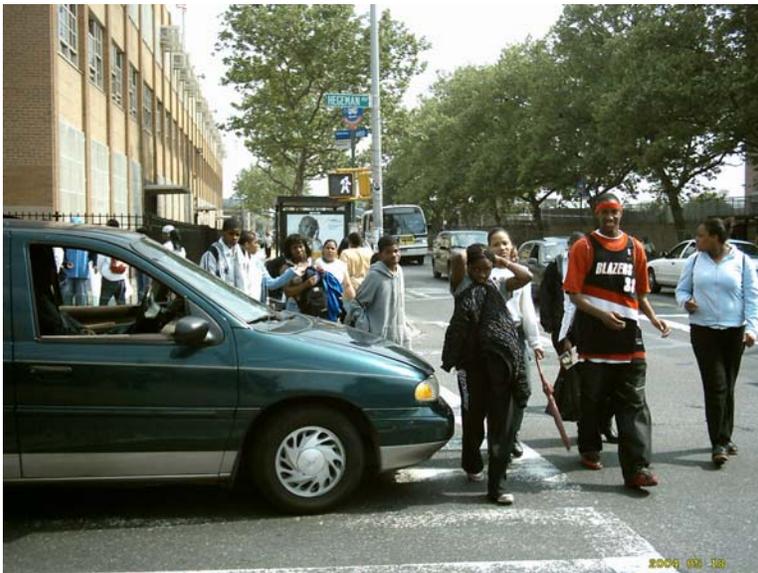
According to accident data shown in Table 2 and Exhibit 6, 40 accidents occurred at this intersection in the 1998-2000 time period, with no fatalities reported. There were three pedestrian accidents, one of which was school related involving the student crossing against the traffic signal. The other two pedestrian accidents involved the driver overtaking prior to the accident, and driver inattention.

Figure 8: The Rockaway Avenue and Hegeman Avenue intersection (looking south)

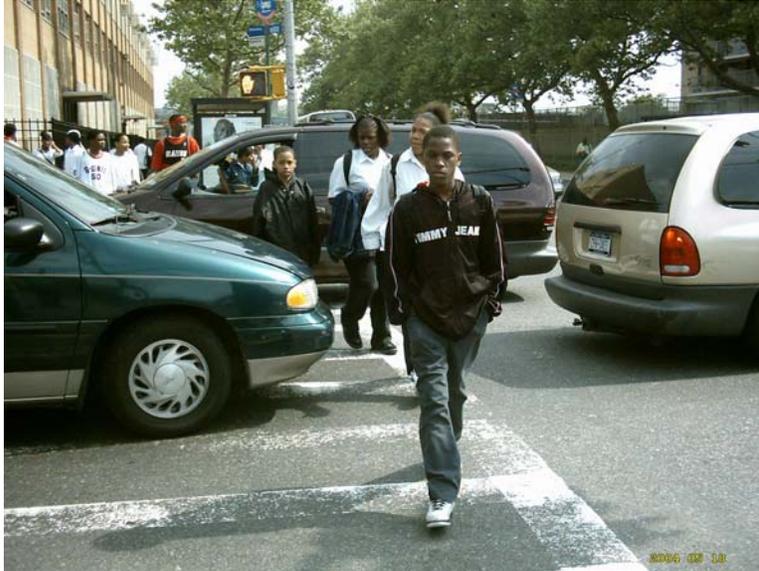
Figure 9: Rockaway Avenue at Hegeman Avenue intersection (view southbound)

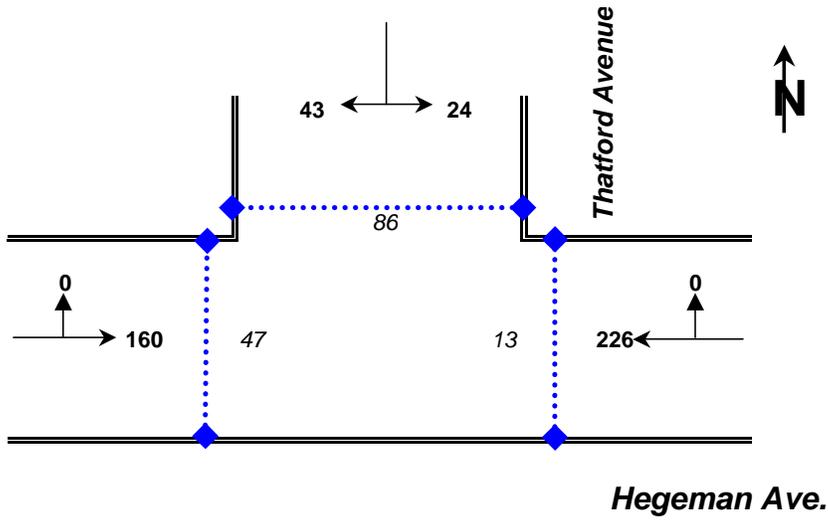
EXHIBIT 7
J.H.S. 275
TRAFFIC COUNTS

A one hour traffic count was performed at this intersection between the hours of 7:30 am-8:30 am on June 3, 2005, with the results shown in Exhibit 7. Collected traffic counts at this intersection indicate that turning vehicular volumes and crossing pedestrian volumes are moderate in all directions.

One Hour Traffic Count Volumes
 (7:30 - 8:30 am June 3, 2005)

Intersection of Hegeman Avenue and Thatford Avenue

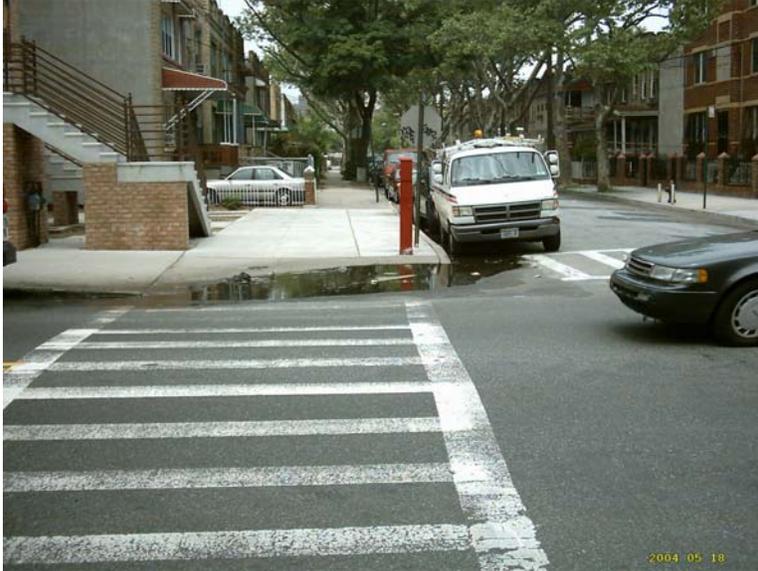
The roadways and sidewalks along the Rockaway Avenue and the Hegeman Avenue were in fair condition. There was ponding observed at the northwest quadrant of the Hegeman Avenue and Thatford Avenue intersection. During the school interviews it was reported that the pavement has a persistent ‘sink hole’ problem at the intersection of Rockaway Avenue and Linden Boulevard. This was not verified in the field.

Figure 10: Hegeman Avenue and Thatford Avenue intersection

Many students cross Hegeman Avenue at Thatford Avenue, as Thatford Avenue provides the most direct link to the school from the center of the catchment area. Since Hegeman Avenue is uncontrolled at the intersection students are using the uncontrolled school crosswalk en route to school. A traffic count performed on June 3, 2005 showed that 60 pedestrians were crossing Hegeman Avenue at this intersection, during the study hour.

The New York City Department of Transportation is currently conducting a signal warrant study for this intersection. The results of the study will be published in March 2006. Depending on the results of the study two alternatives have been developed. In both cases a neckdown has been recommended to shorten the crossing distance on Hegemean Avenue (see Long Term Recommendations).
