NEW YORK CITY DEPARTMENT OF TRANSPORTATION
Office of School Safety Engineering

School Safety Engineering Project

FINAL REPORT: J.H.S. 275, (Thelma Hamilton School), Brooklyn

Prepared by
The RBA Group/Urbitran Associates

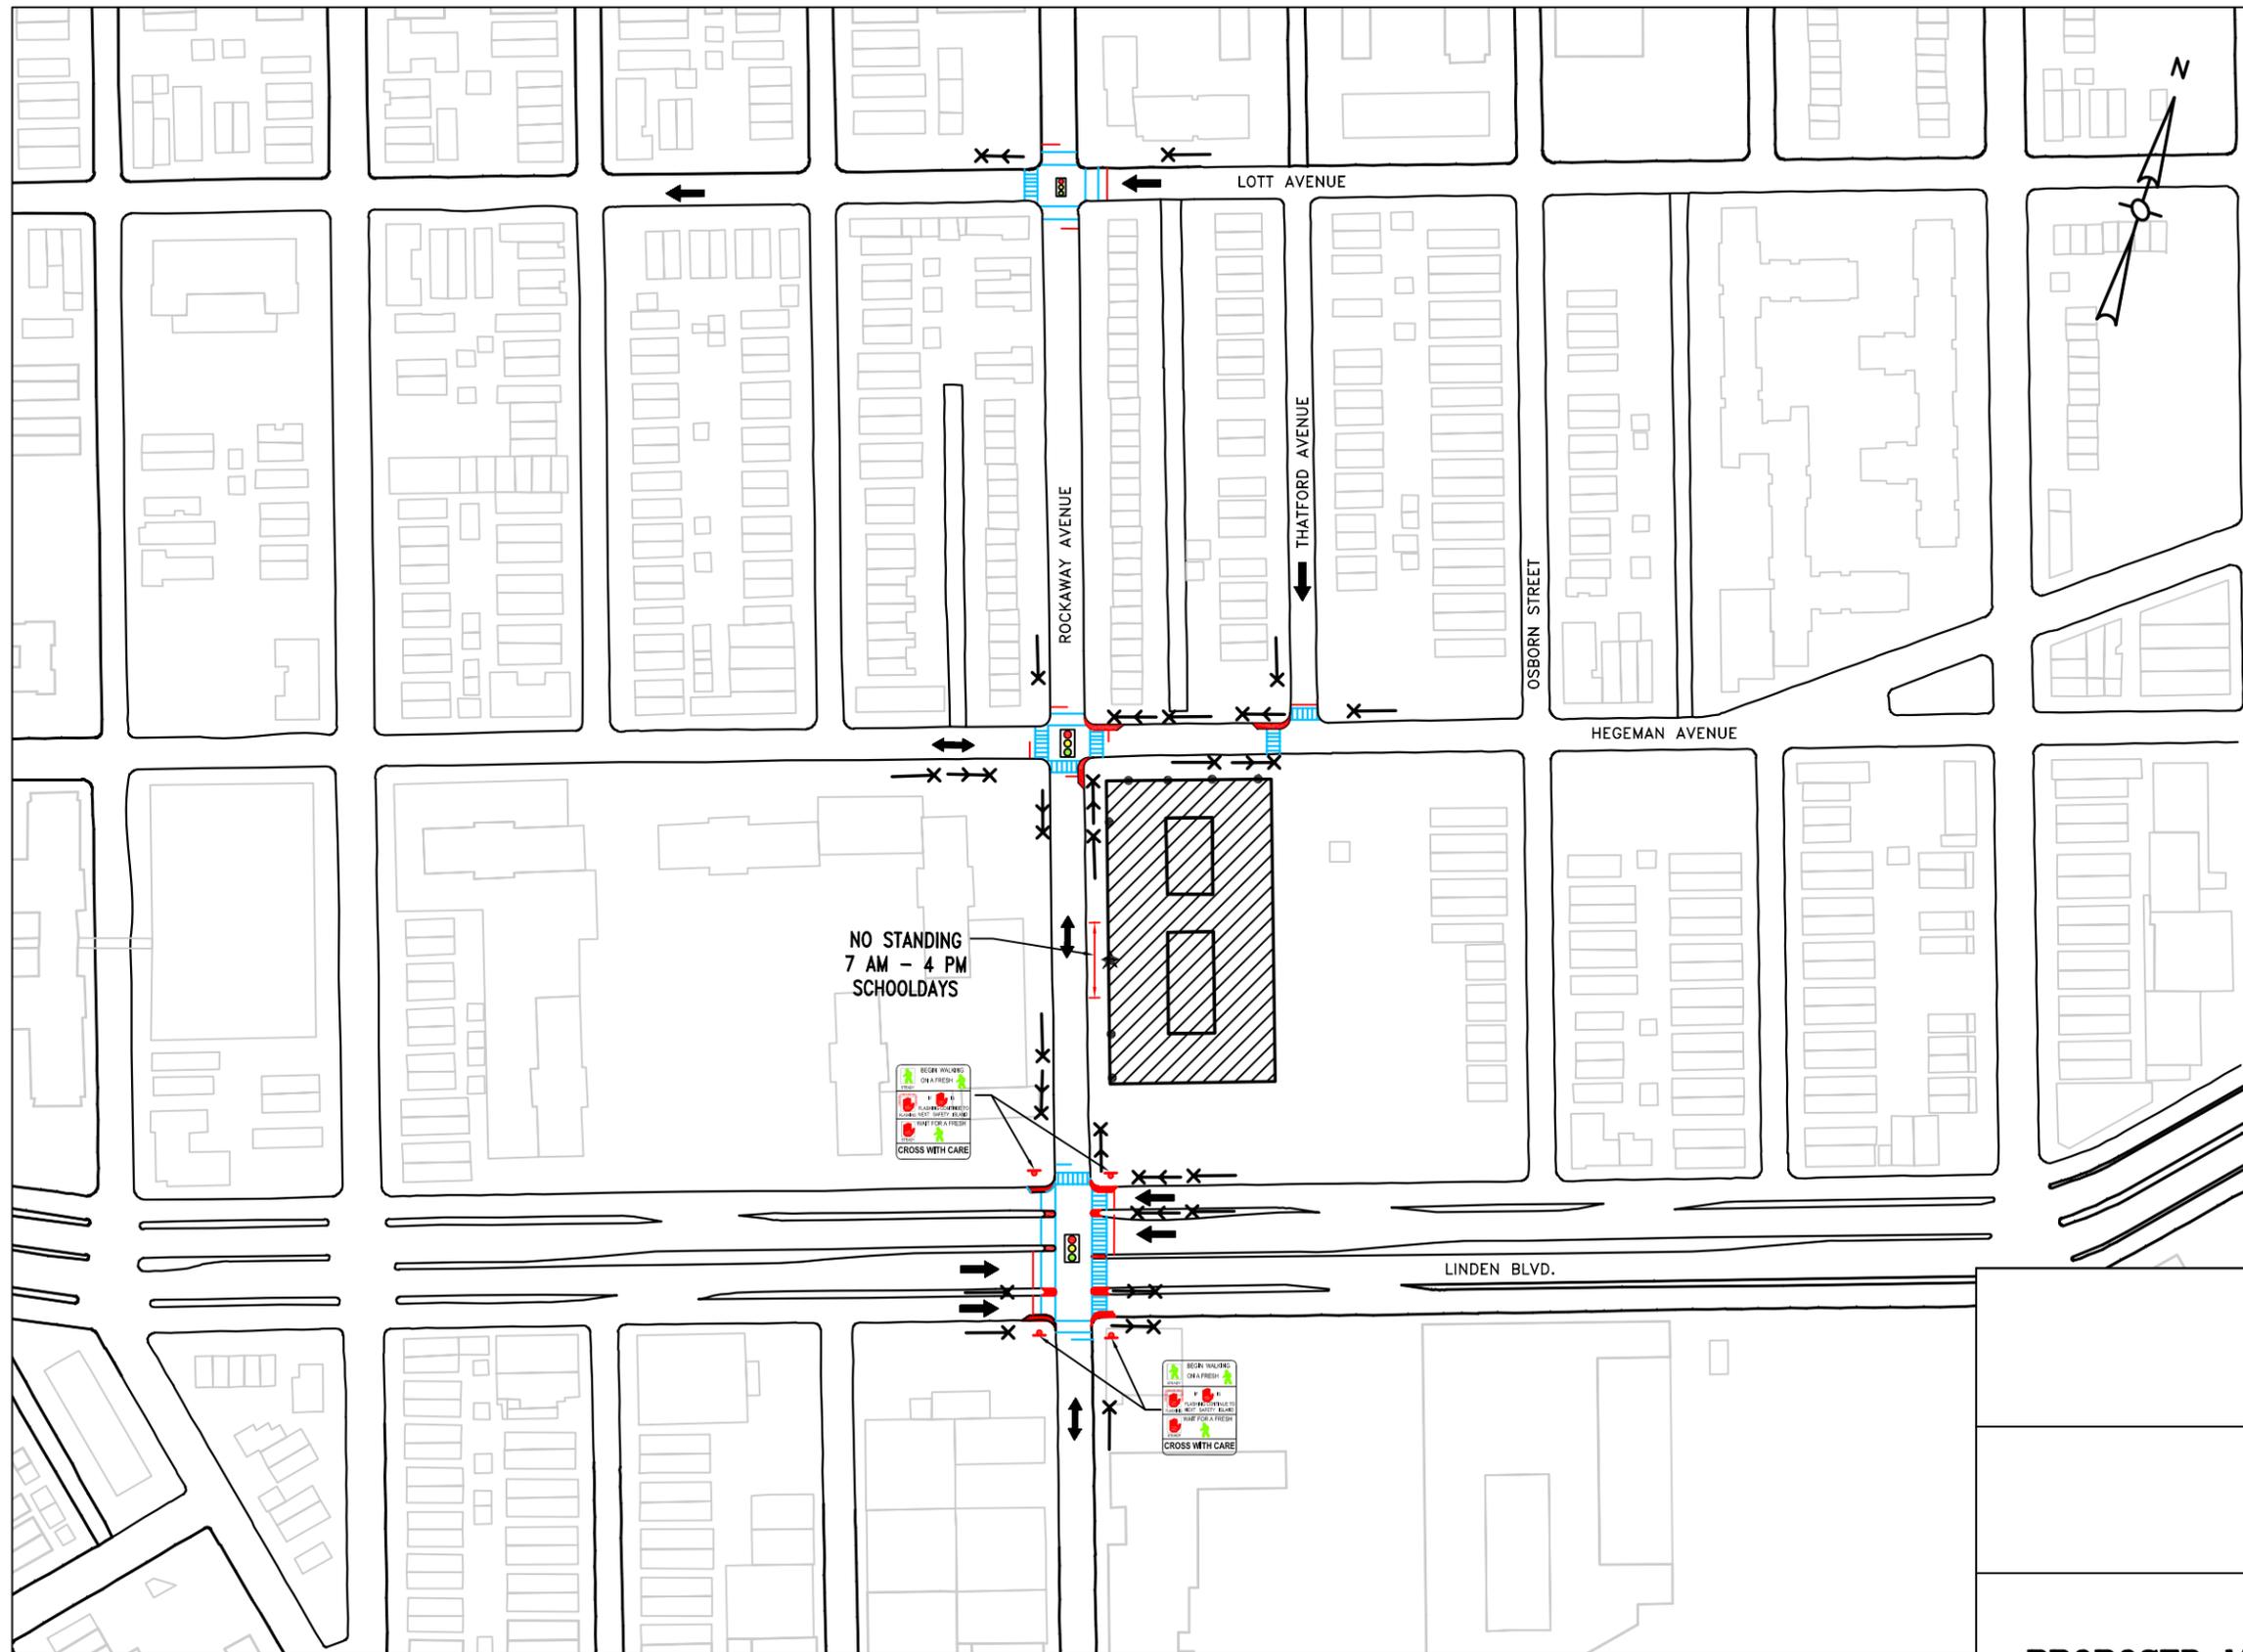
EXHIBIT 8

PROPOSED MEASURES TO IMPROVE SAFETY

Curb extensions should be installed at the corners as shown in Exhibit 8.

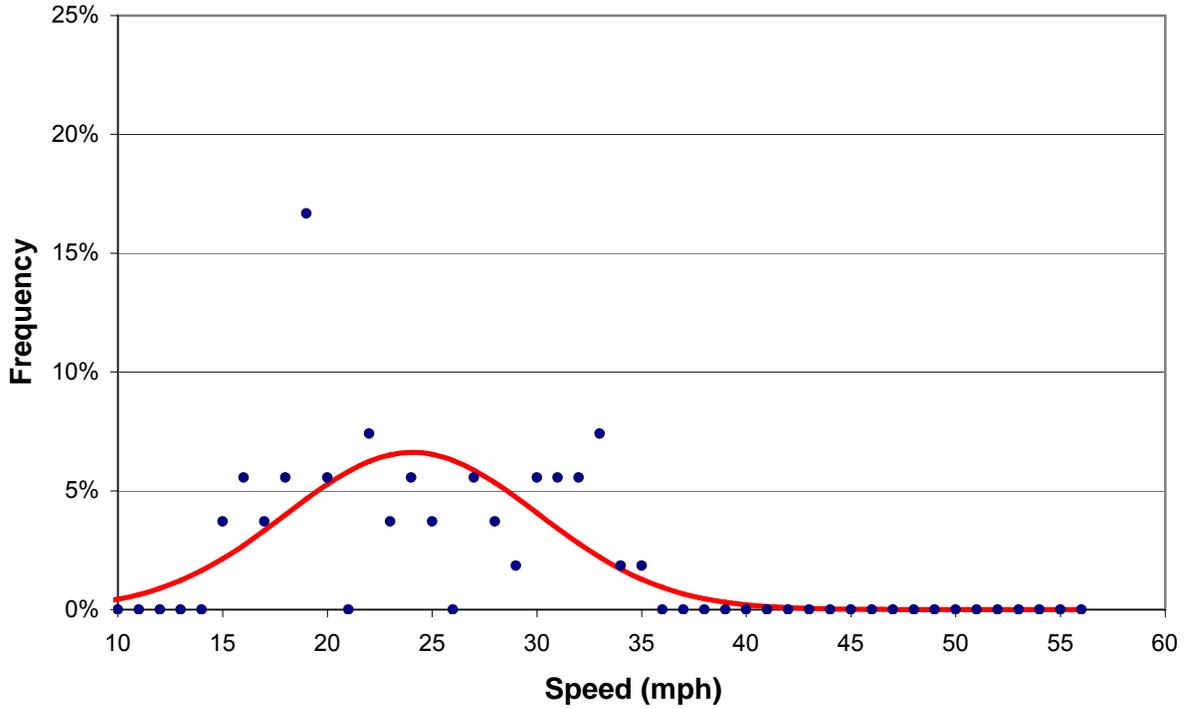
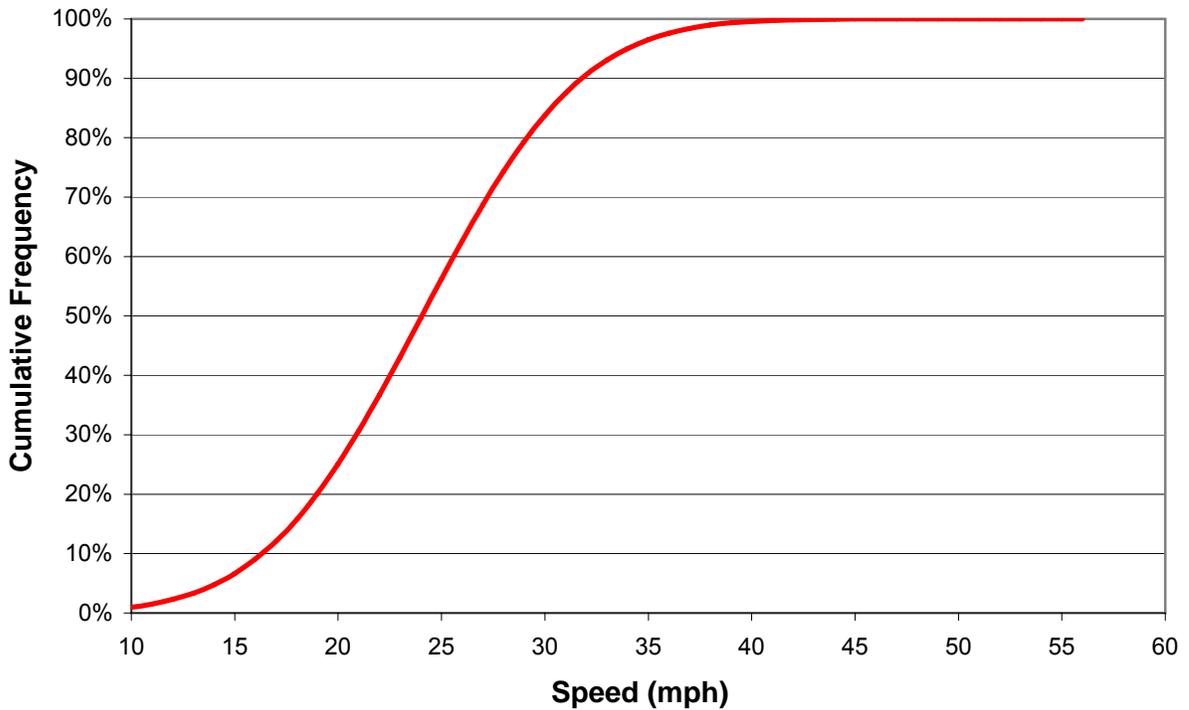
SPOT SPEED STUDY

Mean Speed = 24.1 mph
 Standard Deviation = 6.0 mph
 Margin of Error (95% Confidence) = ± 1.6 mph

Median Speed = 24.1 mph
 15th Percentile Speed = 17.8 mph
 85th Percentile Speed = 30.3 mph

The speed study results are shown in Table 4 and in the Appendix. Median speed on Rockaway Avenue is 24 mph.
