NEW YORK CITY DEPARTMENT OF TRANSPORTATION
Office of School Safety Engineering

School Safety Engineering Project

FINAL REPORT: Our Lady of Perpetual Help School, Brooklyn

NOVEMBER 10, 2006

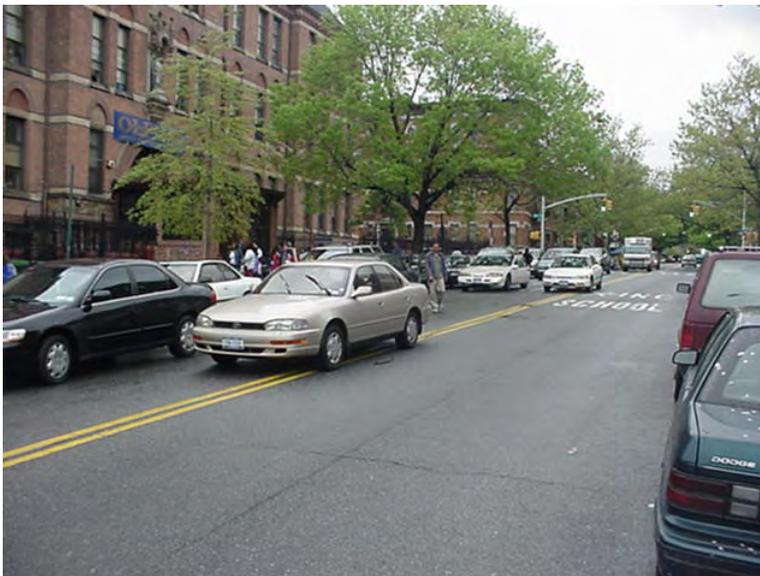
Figure 1- Sixth Avenue in front of Our Lady of Perpetual Help School

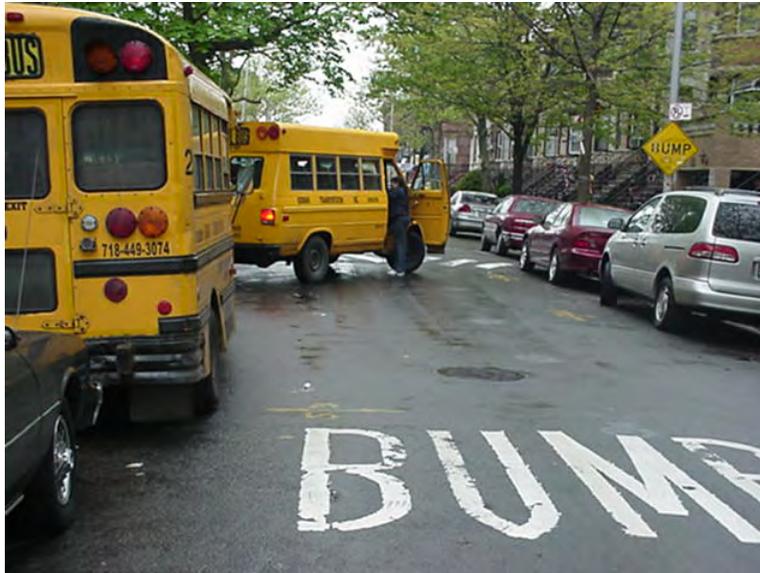
The Guild School for Exceptional Children is located on 59th Street immediately next to Our Lady of Perpetual Help. Buses drop off and pick up students every two to three hours between 8:00 am and 3:30 pm. All children attending the Guild School for Exceptional Children are transported by school bus. School buses intentionally block 59th Street while picking up and dropping off students (see Figure 3).

Figure 3 – School buses from Guild School picking up students on 59th Street

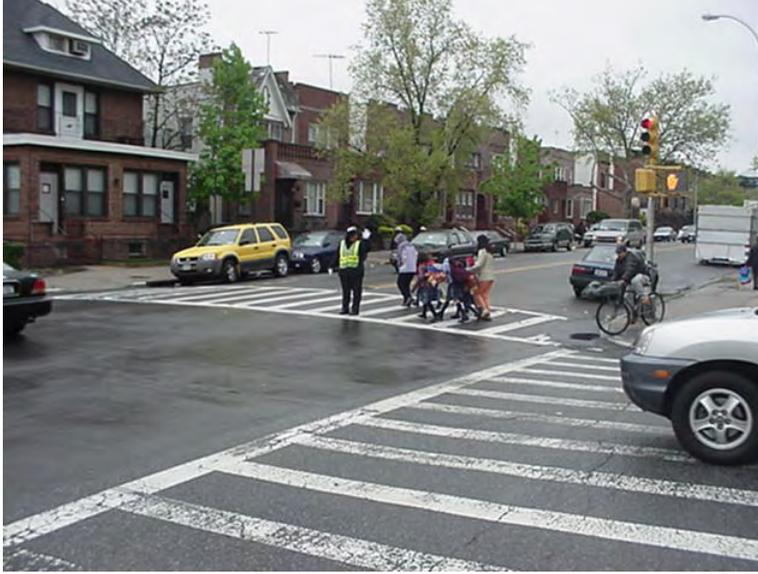
According to field observations, Our Lady of Perpetual Help School has one assigned crossing guard. The crossing guard is stationed at Sixth Avenue and 60th Street (see Figure 4).

The crossing guard is present at the intersection from 7:30 am – 9:00 am, 10:45 am – 12:00 pm, and 1:00 pm – 3:00 pm. The school crossing guard location is shown in Exhibit 3.

Figure 4 – Crossing guard at Sixth Avenue and 60th Street during dismissal time

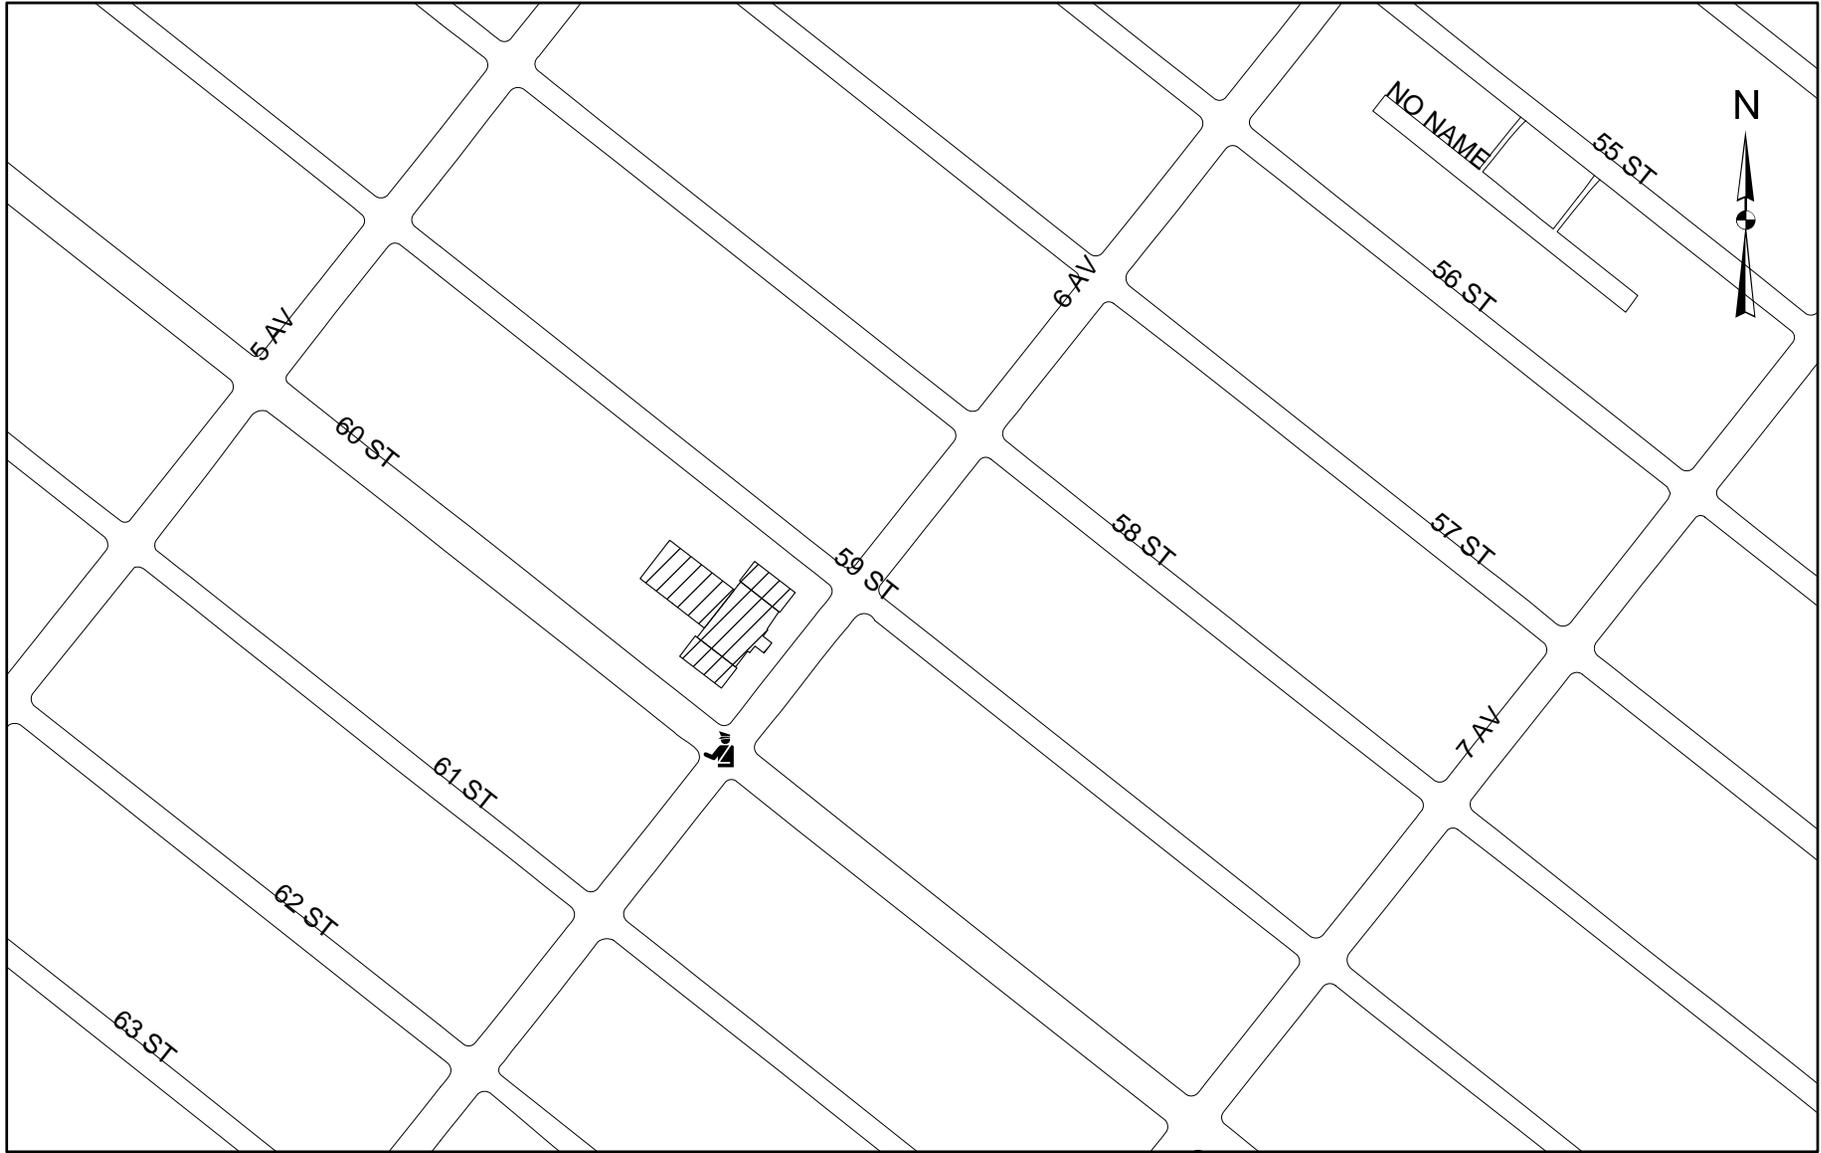
EXHIBIT 3
OUR LADY OF PERPETUAL HELP ES & ANNEX
BROOKLYN
CROSSING GUARDS

Crossing guard assigned to Our Lady of Perpetual Help

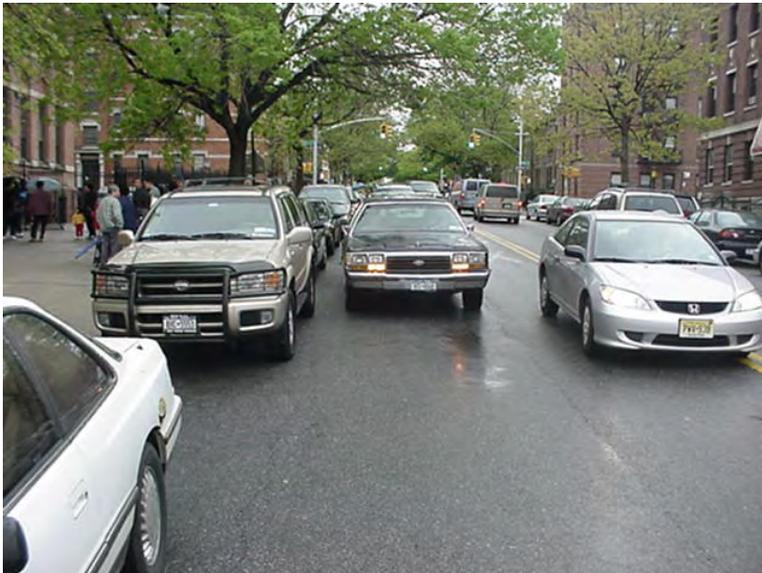
School officials have indicated that parents transport approximately 70% of students. There is no defined drop-off or pick-up area for this school. During school commuting times, vehicles typically double park along Sixth Avenue, 59th Street and 60th Street, on both sides of the street (see Figure 5). In cases of bad weather when all children are dismissed at the main entrance, double parked vehicles extend to adjacent intersections, which results in traffic congestion.

Figure 5 – Double parked parents on Sixth Avenue during dismissal time

Existing “No parking 7 am – 4 pm, school days” parking regulations on Sixth Avenue between 59th Street and 60th Street should be upgraded to “No standing 7 am – 4 pm, school days” from 59th Street to 60th Street to provide additional frontage for vehicles to drop-off and pick-up students during the morning arrival and afternoon dismissal times.

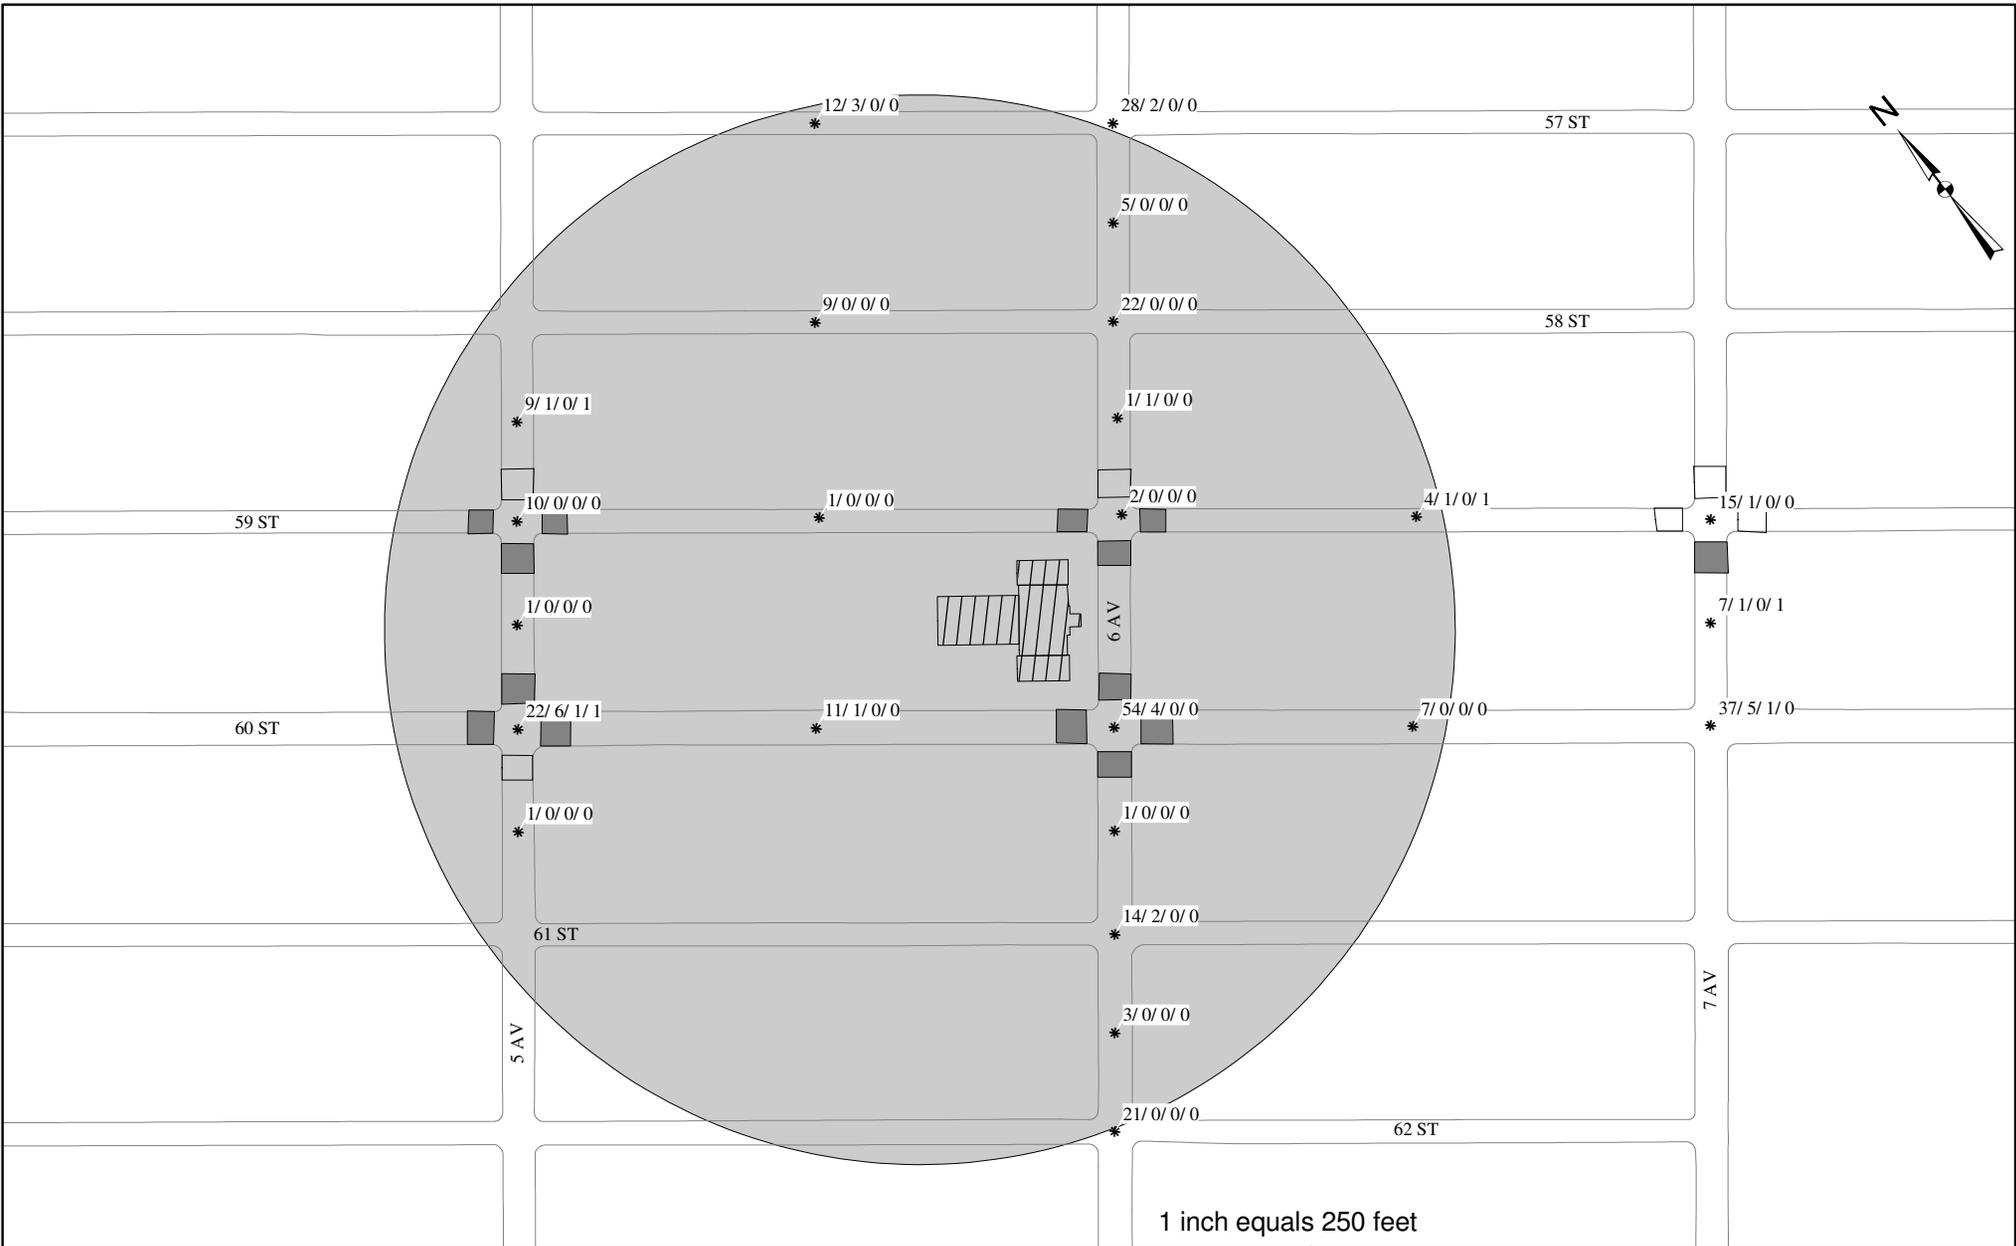
EXHIBIT 5

Exhibit 5 and Table 2 show a summary of accidents, as obtained from the New York State Department of Motor Vehicles (DMV), in the vicinity of Our Lady of Perpetual Help School for the three-year period from January 1, 1998 through December 31, 2000. The DMV data provides some detail relating to the circumstances and cause of the accidents. Table 3 is a summary of more recent accident data obtained from the NYC Police Department (NYPD). Though current through 2004, the NYPD data does not provide the same level of detail as the DMV data.

ACCIDENT SUMMARY

THREE YEAR PERIOD

1998-2000

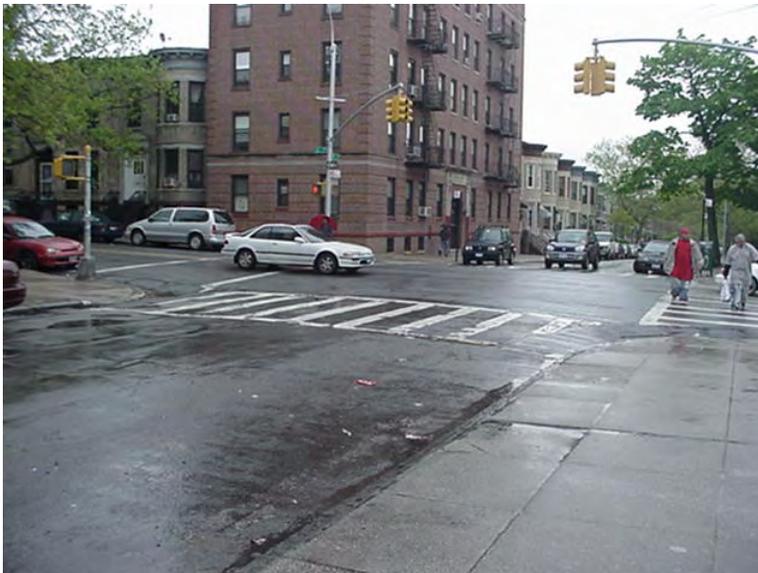
Sixth Avenue is a 43-foot wide, two-way roadway with one travel lane in each direction and parking on both sides. 59th Street is a 30-foot wide, one-way roadway with one travel lane and parking on both sides. This is a signalized intersection. There are school crosswalks on the east, west and south legs of the intersection.

Two accidents occurred at this intersection during the 1998-2000 study period. No pedestrians were struck during this time. However, school officials identified this intersection as a safety concern for pedestrians. It was noted that approximately two years ago (prior to meeting with the school) a schoolteacher was struck, while crossing Sixth Avenue with the signal. Although the pedestrian crossing time was determined to be sufficient for pedestrians to cross the street, school officials felt that vehicles turning left from 59th Street onto Sixth Avenue rarely yield to pedestrians. In addition, a 10-year old student pedestrian was struck in the mid-block of 59th Street between Sixth Avenue and Seventh Avenue. No further information is available regarding this accident.

To determine the level of pedestrian-vehicle conflict a one hour traffic count was performed at this intersection between the hours of 7:30 am and 8:30 am on September 15, 2004 with the results shown in Exhibit 6A. Traffic counts at this intersection indicate that there were 42 vehicles/hour turning left from 59th Street onto southbound Sixth Avenue. During the same period, 85 pedestrians crossed Sixth Avenue at the southern crosswalk. Installation of a Leading Pedestrian Interval (LPI) was considered at this intersection. However, existing moderate traffic and pedestrian volumes do not meet DOT's LPI criteria.

Figure 6 – Pedestrians crossing during “Don’t Walk” phase at Sixth Avenue and 59th Street intersection (looking east)

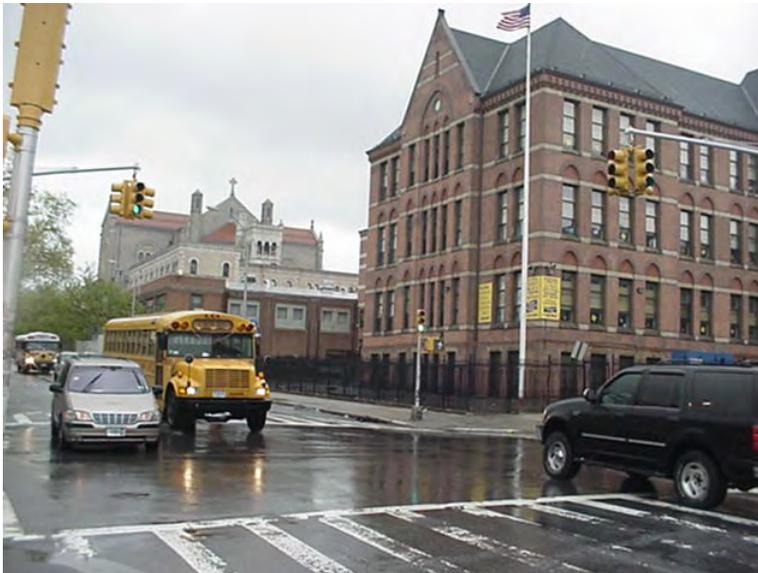
This intersection was noted as the principal area of concern by the school principal and the school crossing guard. A total of 54 accidents occurred at this location during the 1998-2001 study period. Four accidents involved pedestrians. There were no school related accidents during this time. According to the accident data, three pedestrians were struck by turning vehicles, while crossing with the signal. All three accidents were attributed to driver error due to inattention and/or failure to yield to pedestrians. The fourth pedestrian was struck while crossing against the signal.

This is a congested intersection with a high number of trucks turning south from 60th Street onto Sixth Avenue. Sixth Avenue is a designated truck route south of 60th Street. Pedestrian crossing times were observed to be sufficient in both the north-south and east-west pedestrian crossing directions. However, left-turning vehicles conflicting with crossing pedestrians represents the primary concern. Also, according to the crossing guard, unlicensed private passenger “dollar” vans use this intersection to load and unload their passengers. Occasionally, they block crosswalks or make illegal turns at the intersection. Currently, “YIELD TO PEDESTRIANS” signs are posted at both the east and west approaches to the intersection.

To determine the level of pedestrian-vehicle conflict a one-hour traffic count was performed at this intersection on September 15, 2004 between the hours of 7:30 –8:30 am with results as shown in Exhibit 6A. Traffic counts indicate that 138 vehicles/hour turned left from westbound 60th Street onto southbound Sixth Avenue. During the same hour, 77 pedestrians crossed the south leg of the intersection. Installation of a Leading Pedestrian Interval (LPI) was considered at this intersection. However, existing moderate traffic and pedestrian volumes do not meet DOT’s LPI criteria.

Figure 7 – The intersection of Sixth Avenue and 60th Street (looking west)

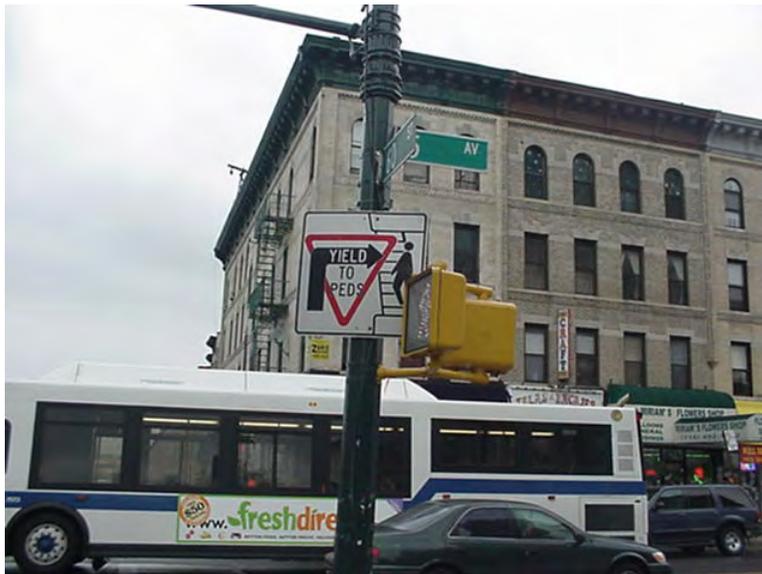
Figure 8 – “Yield to Peds” sign at Fifth Avenue and 60th Street

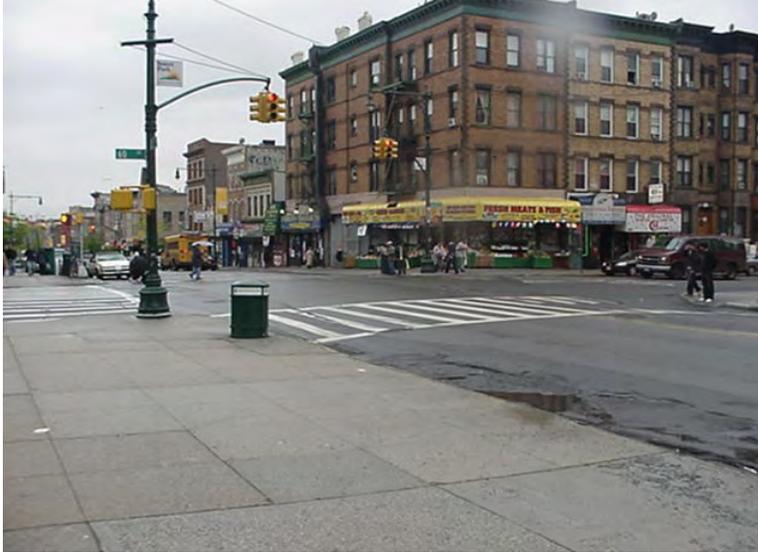
A total of 22 accidents occurred at this intersection during the 1998-2000 study period. Six accidents involved pedestrians, one of which was school-related. There was one fatal accident involving a 33-year old pedestrian. This accident occurred on January 20, 2000. According to the accident data, the pedestrian was crossing with the signal when struck and killed by a northbound right turning vehicle. Two pedestrians, including a 14-year-old student, were struck while crossing against the signal. Another two pedestrians were struck while crossing with the signal. The sixth pedestrian was struck by a right turning vehicle.

This is a busy intersection, with high vehicular and pedestrian volumes. It was observed during field observations that many pedestrians tend to jaywalk instead of waiting for the signal to cross the street. According to a Department of Transportation attendee at the meeting (see list of attendees in the Appendix), Fifth Avenue is scheduled for reconstruction in 2008, and curb extensions and LPIs (leading pedestrian interval) are considered as options at this intersection.

Figure 9 – The intersection of Fifth Avenue and 60th Street (looking south)

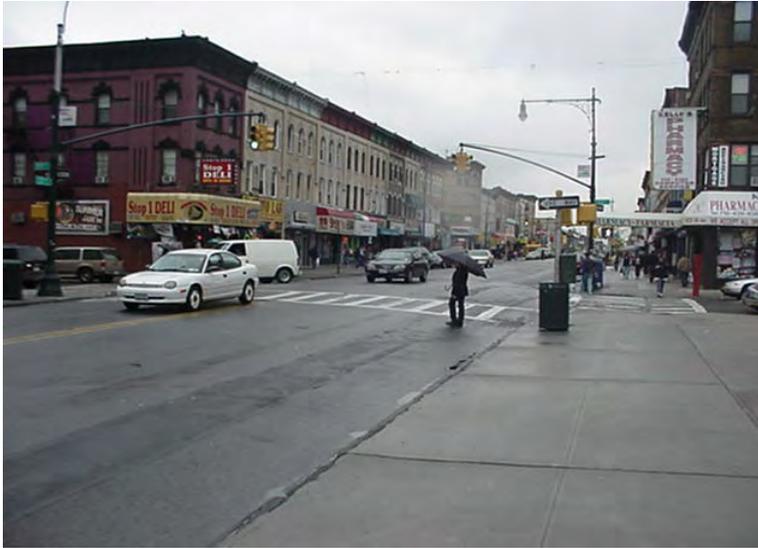
Ten accidents occurred at this intersection during the 1998-2000 study period. No pedestrians were struck during this time. However, an 11-year old student was struck in the mid-block of Fifth Avenue between 59th Street and 58th Street on September 15, 2006. According to the accident data, this pedestrian was struck by a vehicle attempting to back-up.

Figure 10 – Fifth Avenue and 59th Street

As noted previously Fifth Avenue is proposed for reconstruction in 2008, the recommendations proposed by NYCDDC in the Capital Project should be coordinated with the recommendations in this report.

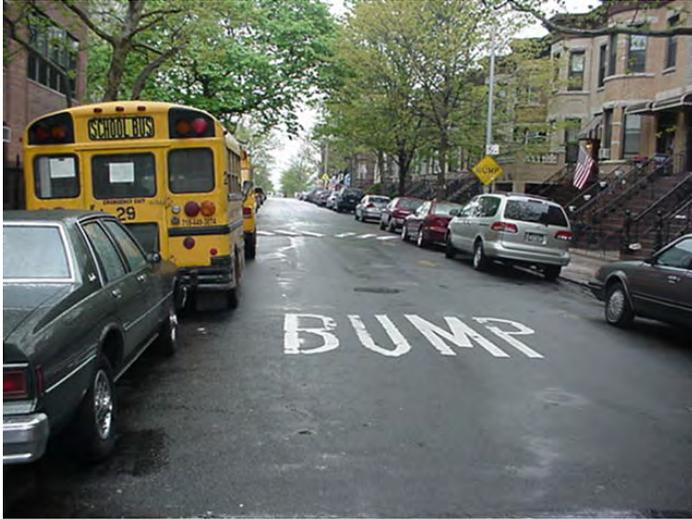
A speed reducer is in place on 59th Street between Fifth and Sixth Avenues. It is located in front of main entrance of the Guild School for Exceptional Children. All advance signs and pavement markings for the speed reducer were in place and in good condition at the time of field observations.

Figure 11 – Speed Reducer on 59th Street

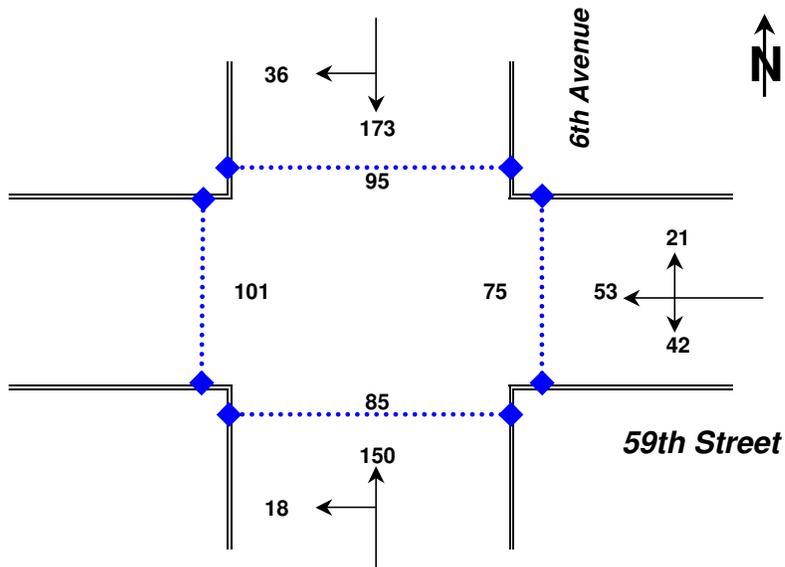
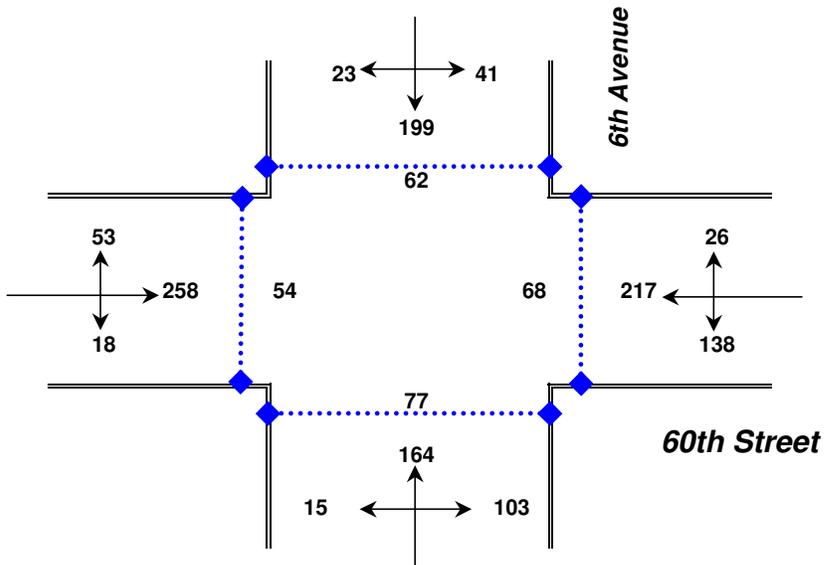
EXHIBIT 6A
OUR LADY OF PERPETUAL HELP SCHOOL
TURNING MOVEMENT COUNTS

One Hour Traffic Count Volumes
(7:30 AM - 8:30 AM September 15, 2004)

Intersection of 6th Avenue and 59th Street

Intersection of 6th Avenue and 60th Street

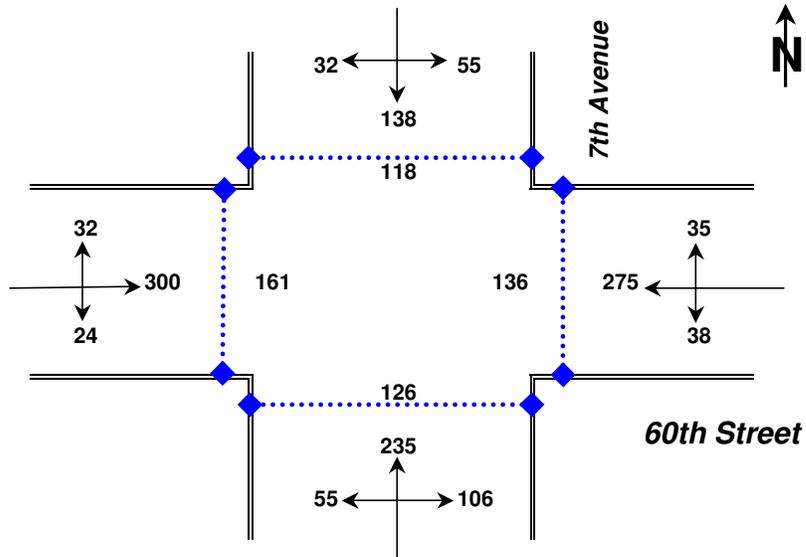
EXHIBIT 6B
OUR LADY OF PERPETUAL HELP SCHOOL BROOKLYN
TURNING MOVEMENT COUNTS

To determine the level of pedestrian-vehicle conflict a one-hour turning movement count was conducted on March 30, 2005. The sample count indicates that large numbers of vehicles and pedestrians use this intersection during the 7:30 am - 8:30 am time period. Exhibit 6B shows the traffic count results.

One Hour Traffic Count Volumes
 (7:30 AM - 8:30 AM March 30, 2005)

Intersection of 7th Avenue and 60th Street

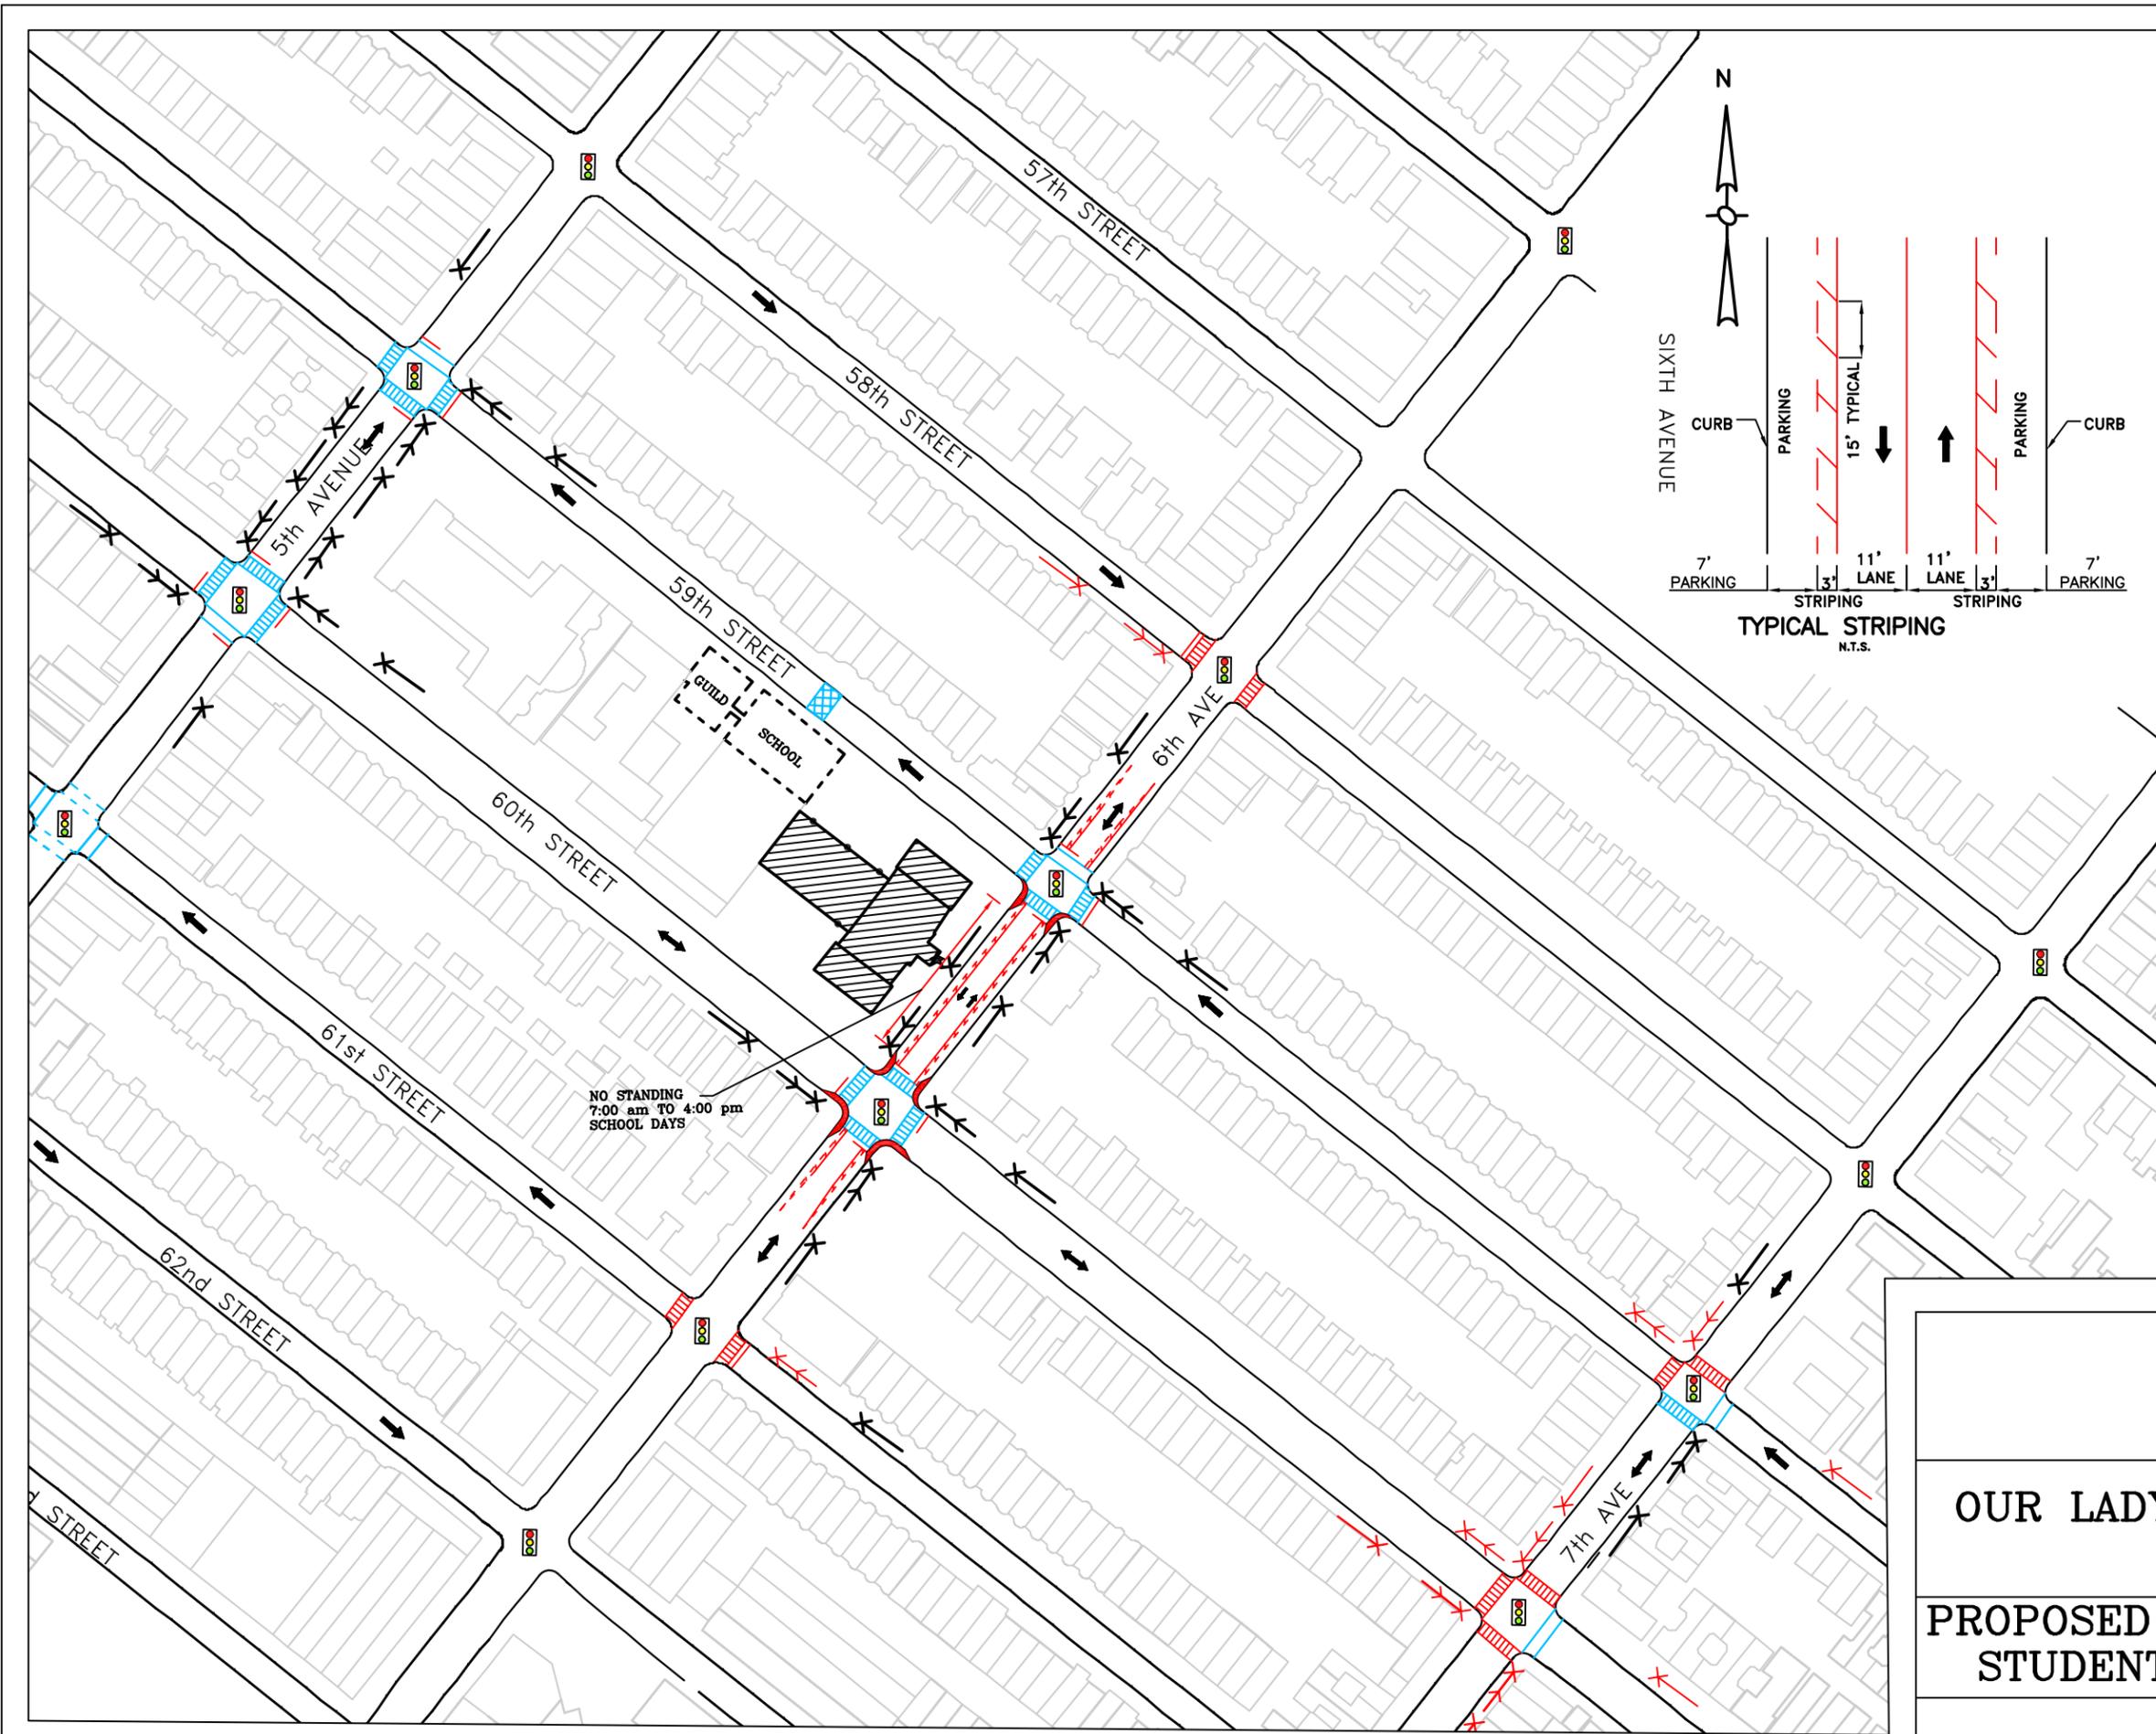
EXHIBIT 7

**PROPOSED MEASURES TO IMPROVE
STUDENT PEDESTRIAN SAFETY**

- Sixth Avenue and 58th Street – east and west legs
- Sixth Avenue and 61st Street – east and west legs
- Seventh Avenue and 59th Street – west leg
- Seventh Avenue and 60th Street – west and north legs

Based on feedback from school officials these intersections are utilized by Our Lady of Perpetual Help School students en route to school. Therefore, it is recommended that all four intersections have school crosswalks installed (see Exhibit 7 for detail). All four intersections are signalized.

- Sixth Avenue and 59th Street – southwest corner
- Sixth Avenue and 60th Street – northwest corner

Curb extensions should be installed at the corners as shown in Exhibit 7.

The purpose of the curb extensions is to shorten the crossing distance for pedestrians, and to reduce speeds of vehicles approaching and turning at these heavily utilized school crosswalks (or intersections). These curb extensions would not eliminate or reduce the width of any moving lanes.
