**New York City Department of Transportation
Office of School Safety Engineering**

School Safety Engineering Project

FINAL: P.S. 213, The New Lots School, Brooklyn

**Prepared by
The RBA Group/Urbitran Associates**

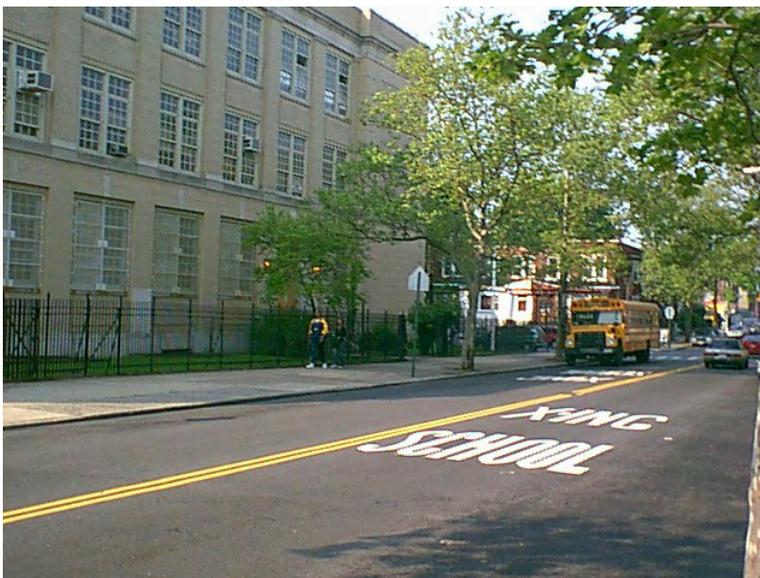
Figure 1: Looking west on Hegeman Avenue, P.S. 213 is on the left

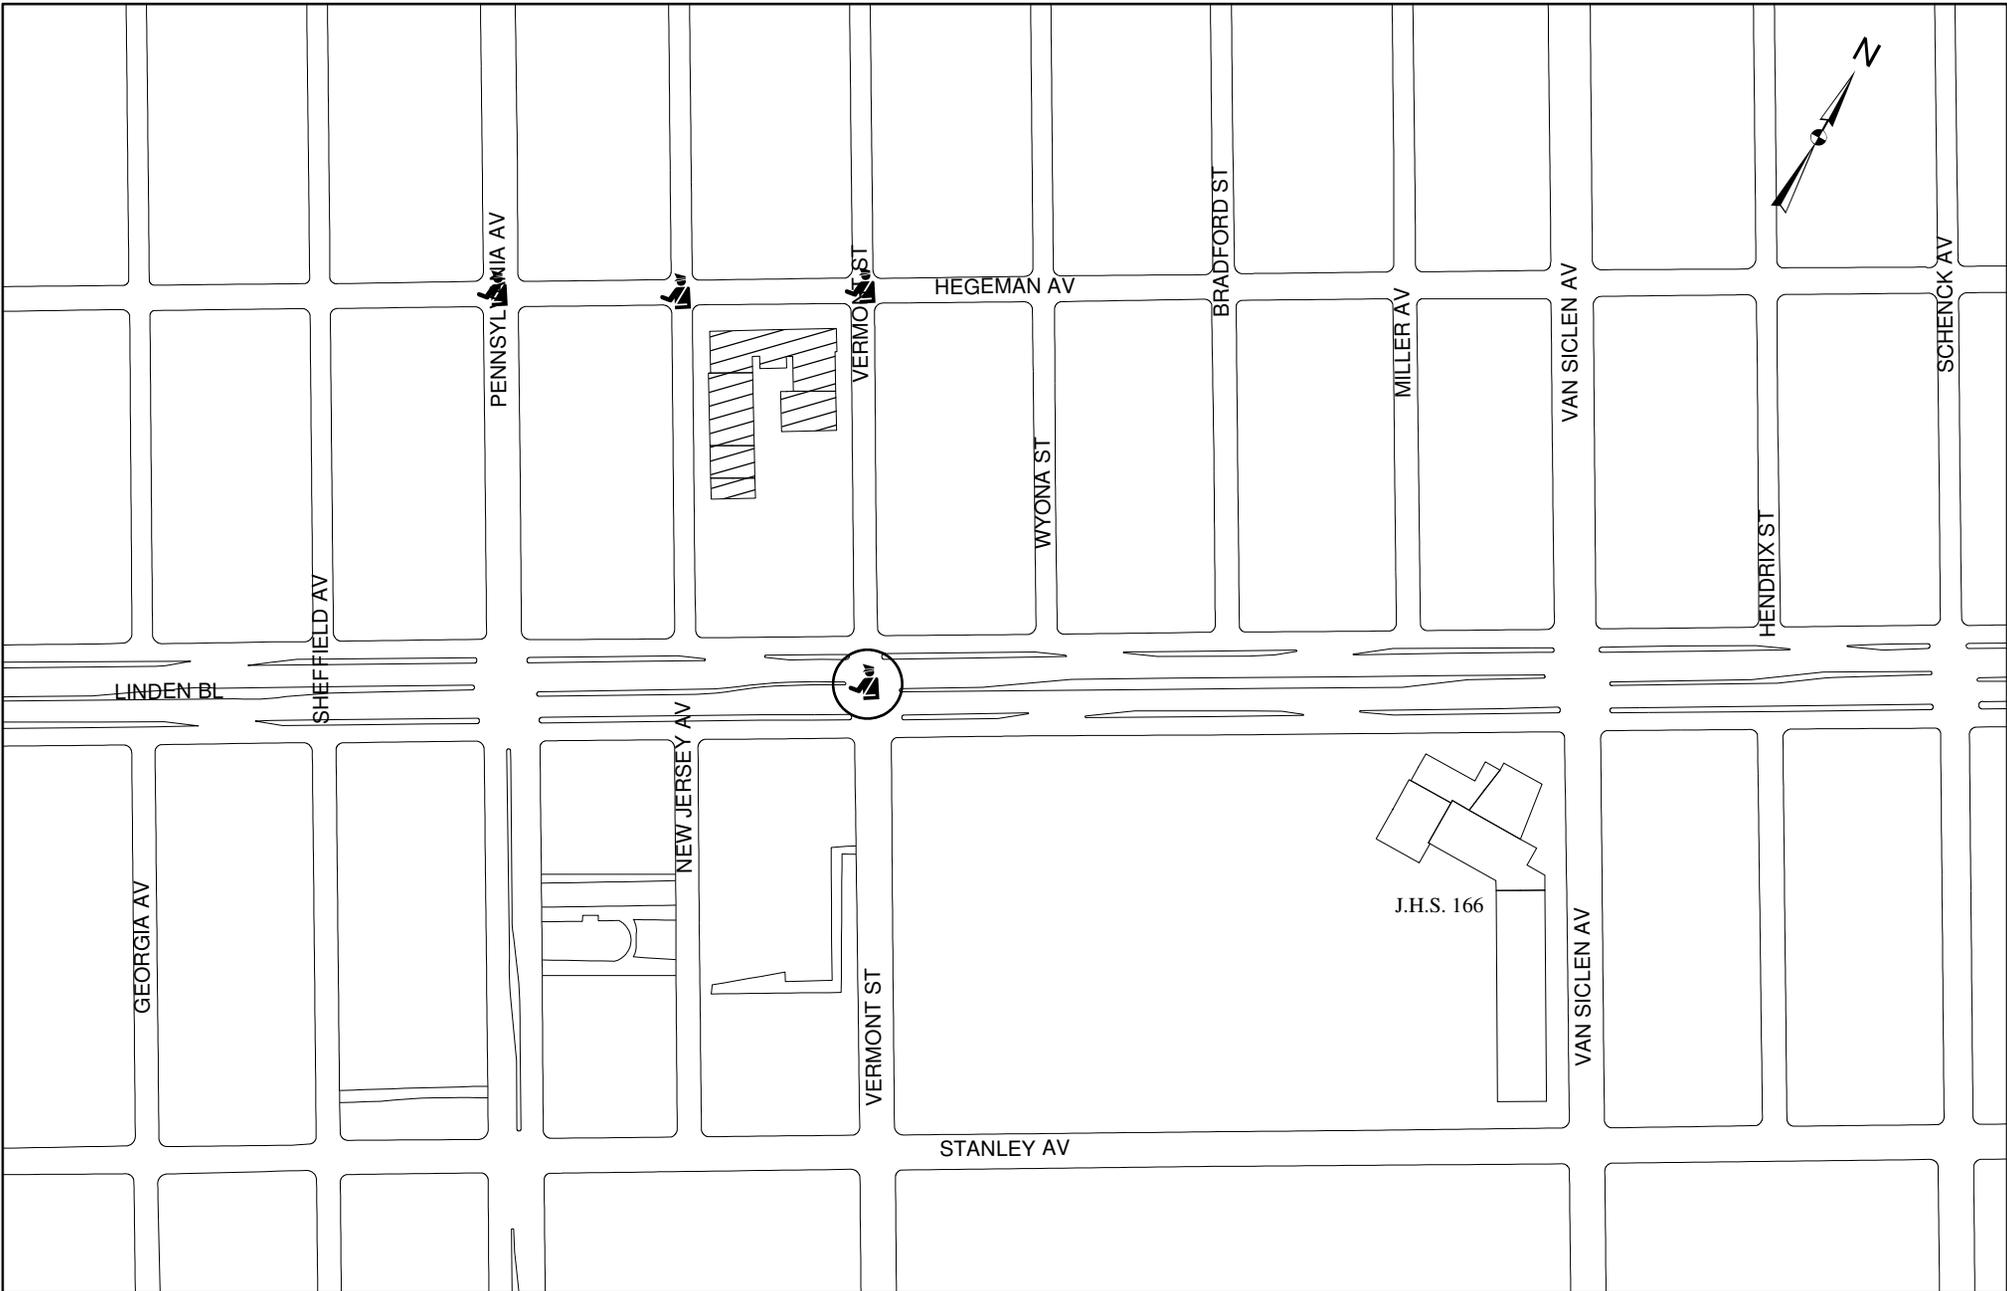
EXHIBIT 4

Three crossing guards are assigned to P.S. 213. They are stationed at the following intersections:

- Hegeman Avenue and Pennsylvania Avenue
- Hegeman Avenue and New Jersey Avenue
- Hegeman Avenue and Vermont Street

In addition, a crossing guard (assigned to P.S. 306) is stationed at Vermont Street and Linden Boulevard (see Exhibit 4).

CROSSING GUARD

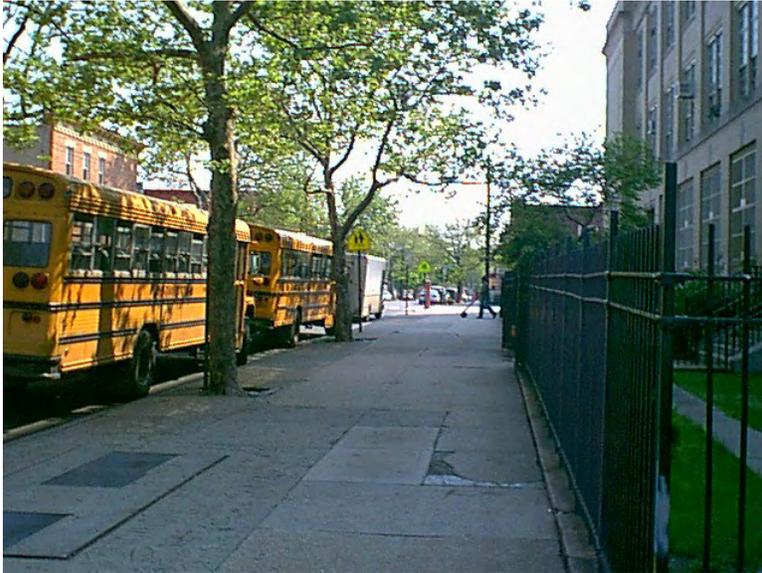
According to school officials, 6% of students from P.S. 213 are transported to and from school by school buses. Six school buses drop off students on New Jersey Avenue in front of the main school entrance. Two other buses drop off students on Hegeman Avenue. During dismissal time all school buses pick up students on Hegeman Avenue (Figure 3).

School buses park or double-park, depending on traffic conditions, while dropping off or picking up students.

Figure 3: School buses along Hegeman Avenue

- Review bus management / staging procedures

Curbside space has been provided for school bus operations on New Jersey Avenue and Hegeman Avenue. This may require some buses to stage at other locations until sufficient curbside space becomes available. School officials should review the bus operations at the school and consider the following:

- Restrict drop-off/pick-up of students from school buses except at the designated curbside fronting the school
- Define a staging area for buses to queue until they can pull into the curbside directly fronting the school for drop-off/pick-up operations.

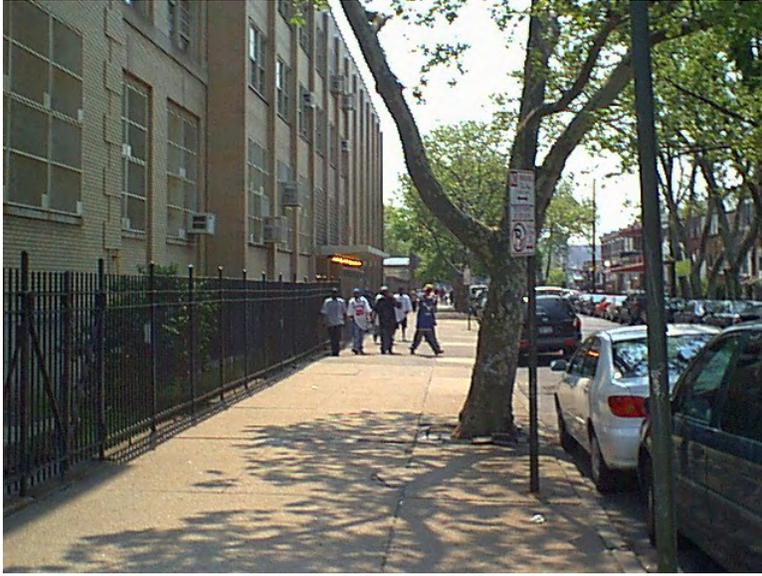
On Hegeman Avenue, “NO PARKING SCHOOL DAYS 7:00 AM – 4:00 PM” signs are posted in front of the school. Street cleaning regulations, which prohibit parking on alternating sides of the roadway, are in place near the school.

Figure 4: Parking regulation signs on Hegeman Avenue

- *Upgrade No Parking Zone to No Standing Zone on Hegeman Avenue*

“NO PARKING 7:00AM-4:00 PM, SCHOOL DAYS” parking regulations on Hegeman Avenue should be upgraded to “NO STANDING 7:00AM-4:00 PM, SCHOOL DAYS”. This will allow school buses a place to load and unload students at the curb, and improve visibility of students arriving and leaving the school.

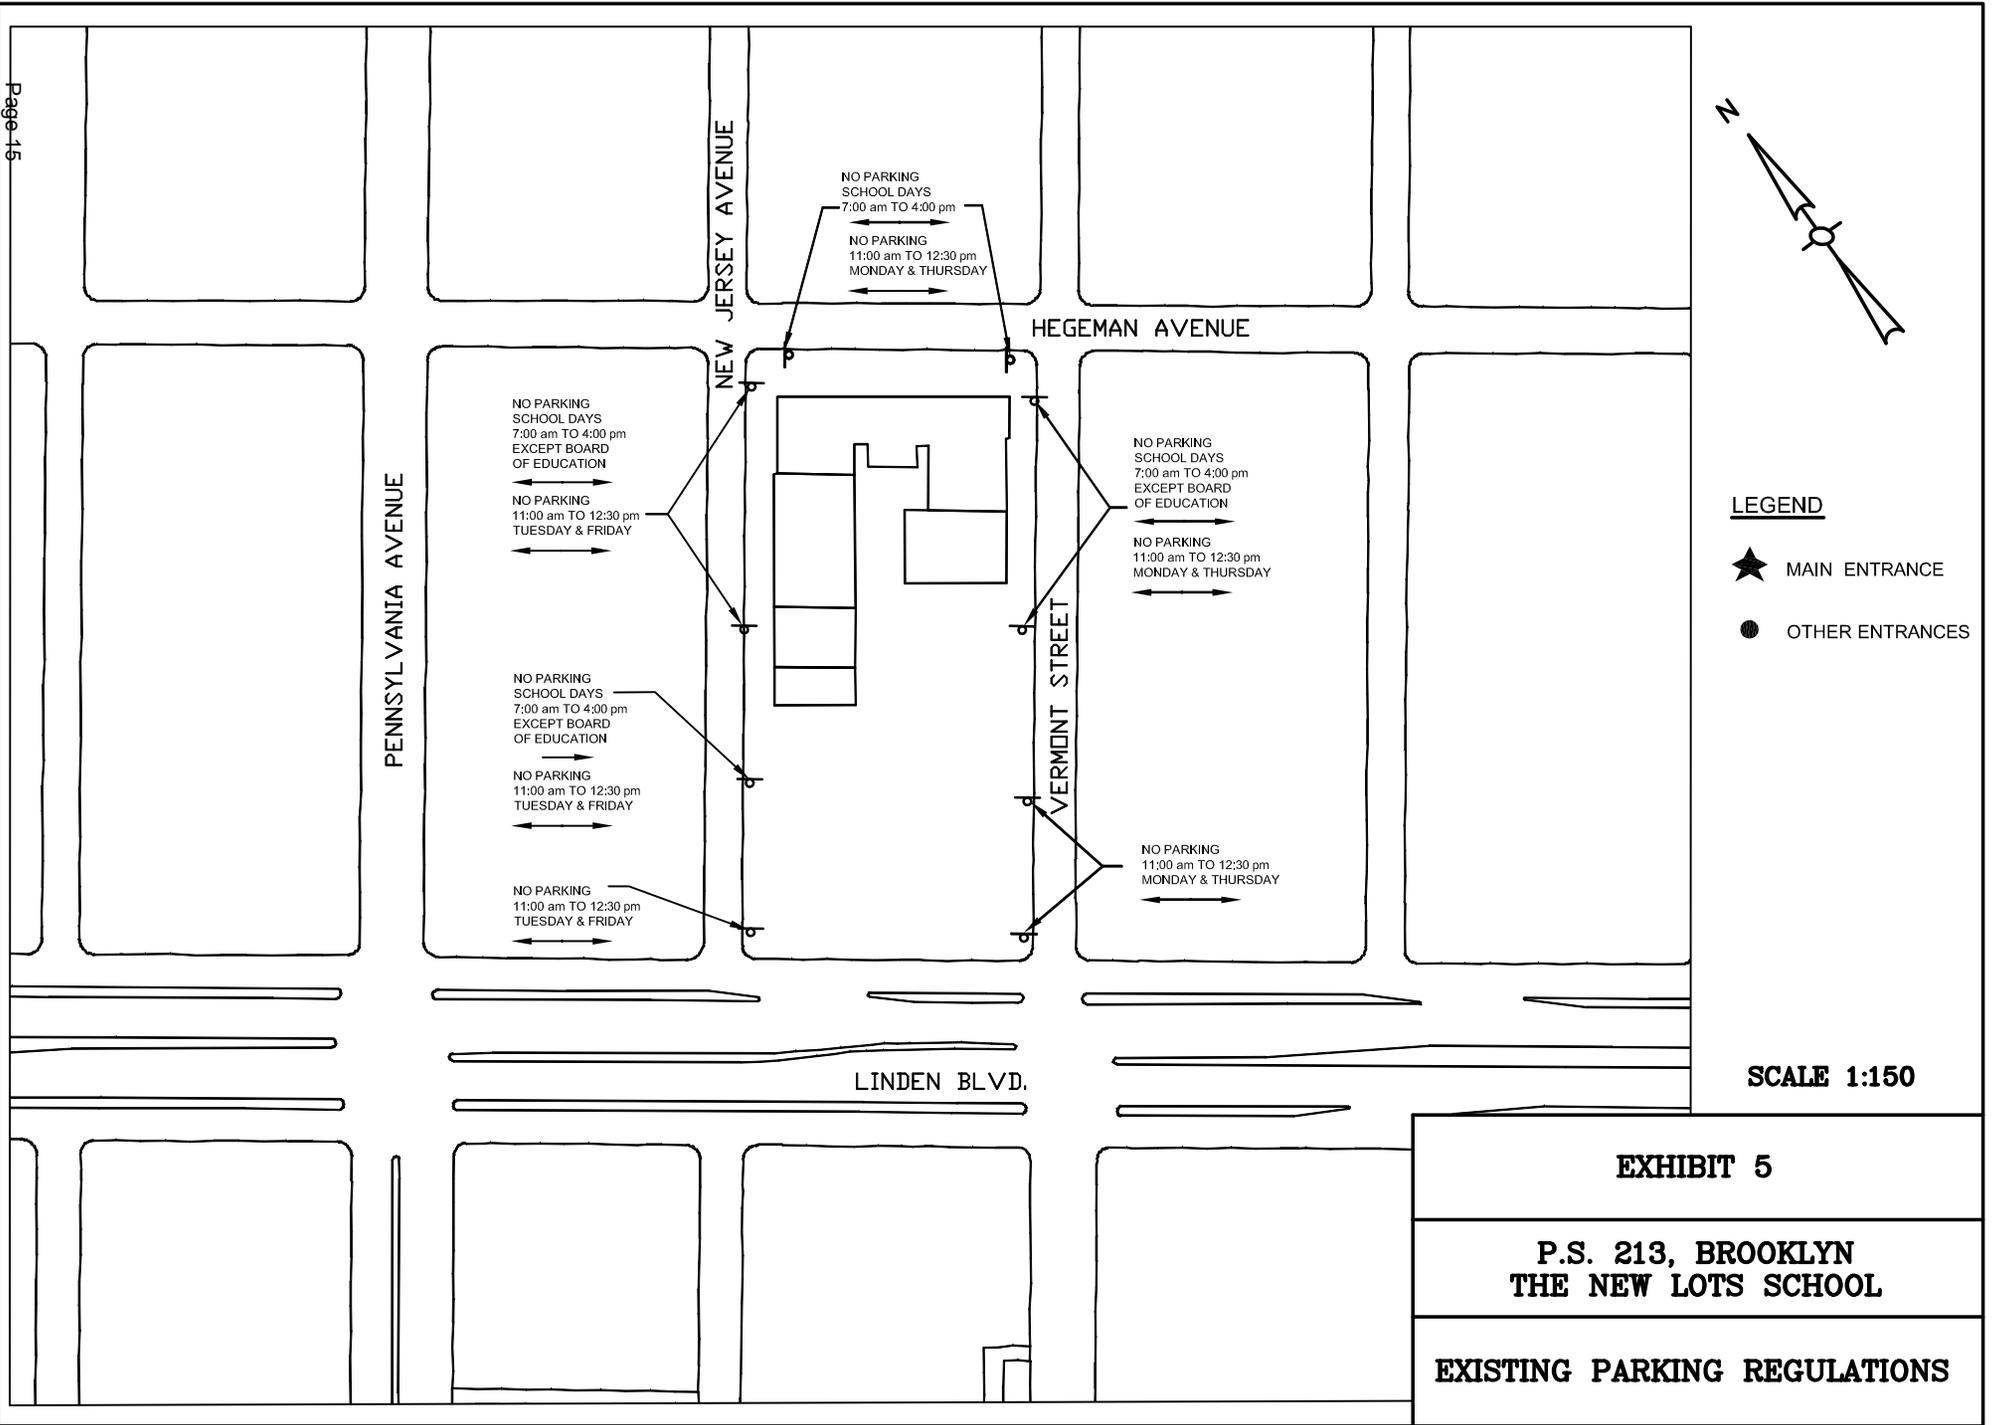
EXHIBIT 5

Exhibit 5 shows the parking regulations on the roadways surrounding the school. “NO PARKING, 7:00 AM – 4:00 PM SCHOOL DAYS, EXCEPT BOARD OF EDUCATION” parking regulation is posted on New Jersey Avenue and Vermont Street (Figure 5). Teacher parking is provided along the east curbside of New Jersey Avenue and the west curbside of Vermont Street.

EXISTING PARKING REGULATIONS

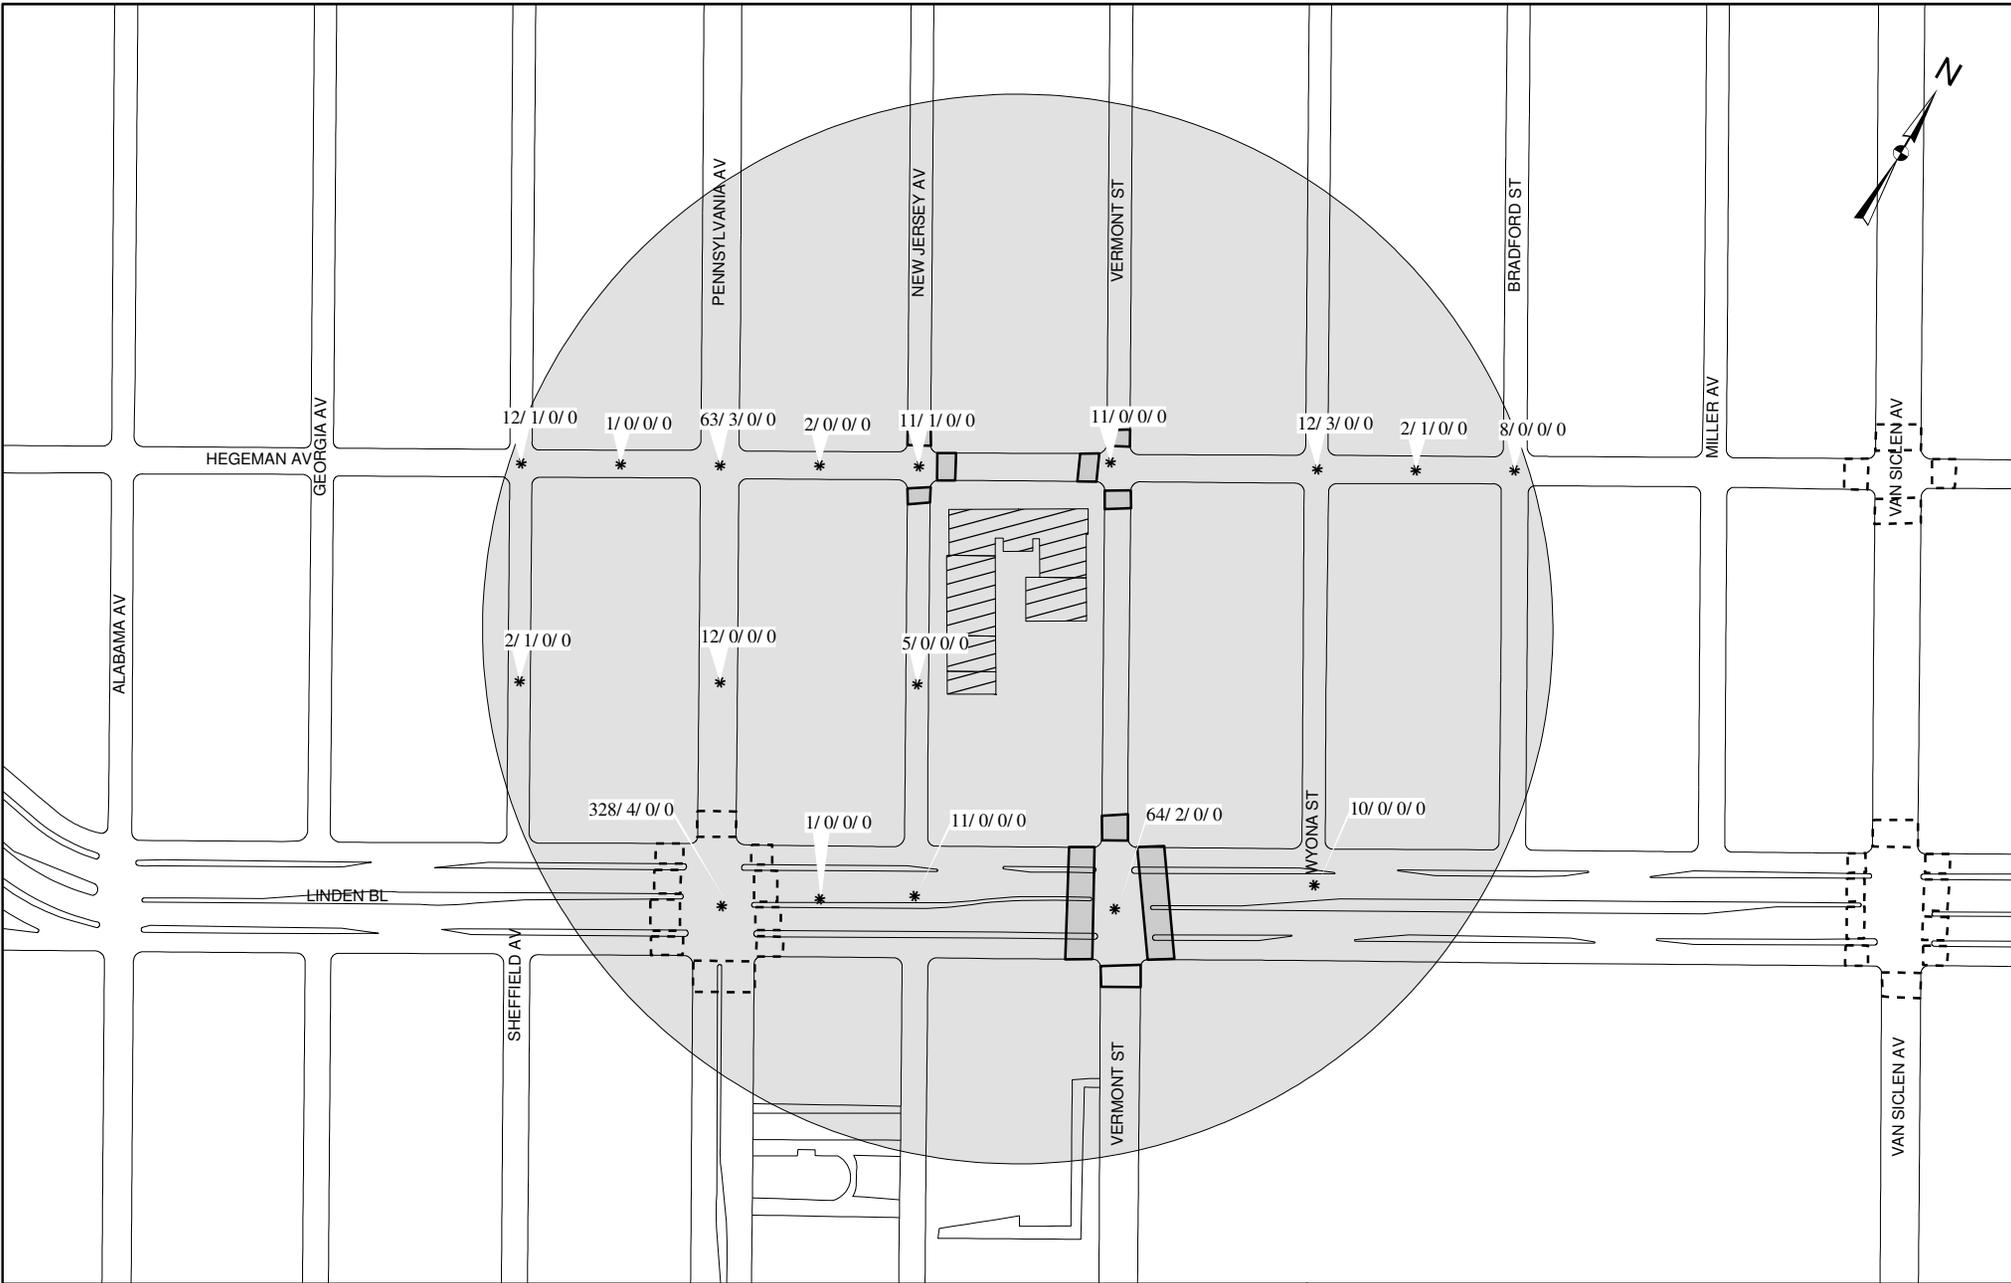
EXHIBIT 6

Exhibit 6 and Table 2 show a summary of accidents, as obtained from the New York State Department of Motor Vehicles (DMV), in the vicinity of P.S. 213 for the three-year period from January 1, 1998 through December 31, 2000. The DMV data provides some detail relating to the circumstances and cause of the accidents. Table 3 is a summary of more recent accident data obtained from the NYC Police Department (NYPD). Though current through 2004, the NYPD data does not provide the same level of detail as the DMV data.

ACCIDENT SUMMARY
THREE YEAR PERIOD
(1998-2000)

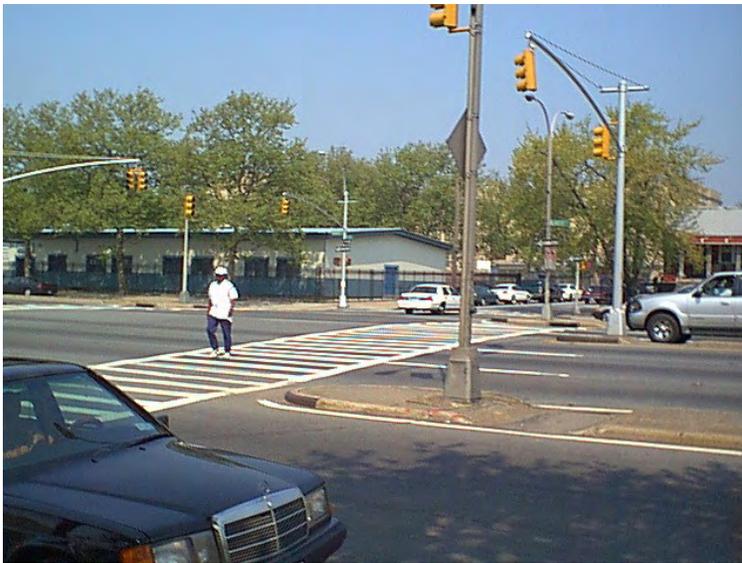
Vermont Street is a two-way roadway with one travel lane in each direction south of Linden Boulevard, and one-way (northbound) with one travel lane north of Linden Boulevard. Parking is allowed along both sides of the roadway. The mainline is a 145-foot wide (including service roads) two-way roadway. Linden Boulevard mainline is a two-way roadway with three through lanes and left turn bays in both directions. Two service roads are separated from the mainline traffic by raised concrete medians. Both eastbound and westbound service roads are 25-foot wide one-way roadways with one travel lane and parking on the right side. Several of the raised medians do not extend through the crosswalks (Figure 5). At-grade cut throughs for the medians are positioned outside of the crosswalks (Figure 6).

Figure 5: Looking northwest on Linden Boulevard, at the intersection of Vermont Street and Linden Boulevard

Review of existing signal timing indicates that the pedestrian phase does not provide adequate time for pedestrians to cross Linden Boulevard in one cycle at a walking rate of three feet per second plus a three second reaction time. A school age pedestrian needs two signal cycles to cross at three feet per second, stopping at the center raised medians (refuge) separating eastbound and westbound traffic to wait between cycles. However, both east and west center raised medians do not extend through the crosswalks.

Installation of a pedestrian information sign adjacent to each school crosswalk at the wide intersections of Linden Boulevard and Vermont Street is recommended. The sign will explain signal phases and inform the pedestrian to wait at the refuge between cycles.

- *Install enlarged signal lenses*

- Linden Boulevard and Vermont Street

- In order to provide a refuge that allows pedestrians to wait for the next walk phase and cross Linden Boulevard in two cycles, it is recommended that the center-raised medians be extended through the school crosswalks (as shown in Exhibit 8). This will provide a physically protected refuge location for pedestrians to wait between cycles.

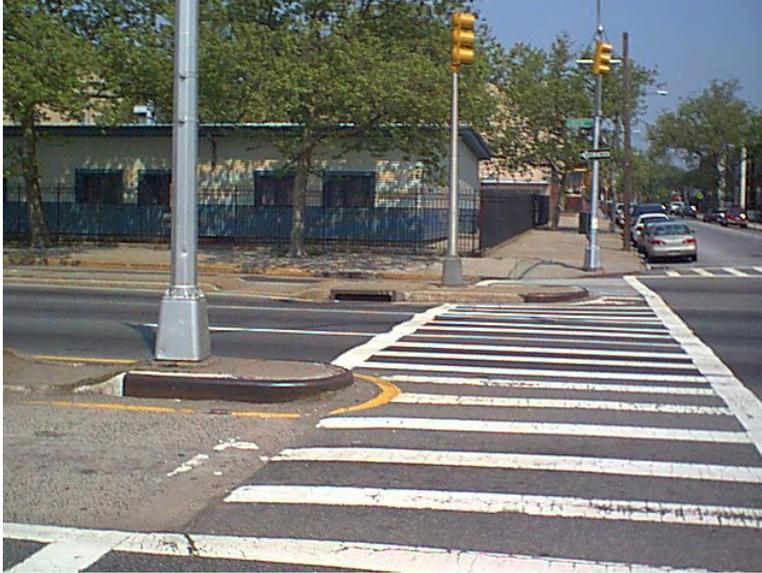
Figure 6: Linden Boulevard at Vermont Street, at-grade cut through is outside of crosswalk

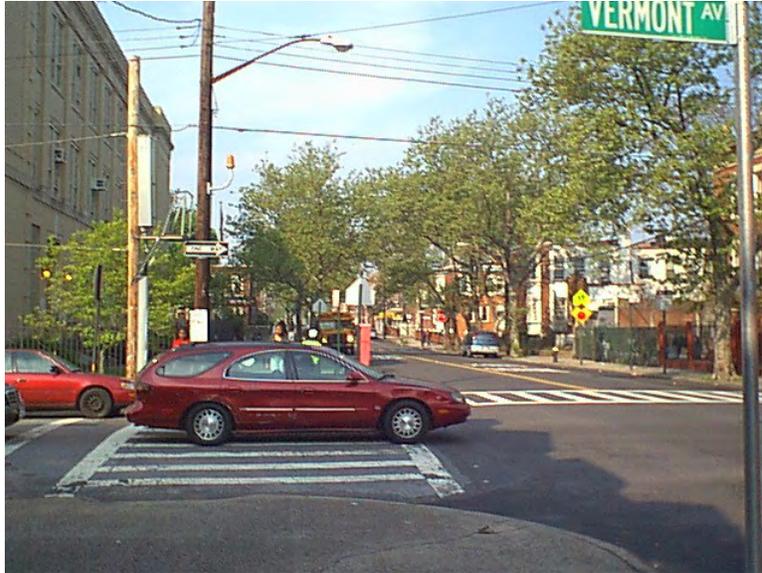
Vermont Street (north of Linden Boulevard) is a one-way (northbound) street. This intersection is stop controlled with a stop sign for northbound traffic on Vermont Street. Hegeman Avenue is a 35-foot wide two-way roadway with one travel lane in each direction and parking on both sides. Hegeman Avenue is not controlled at this intersection; therefore, the school crosswalk at the west leg is uncontrolled. There are school crosswalks on the west, north and south legs.

Eleven accidents occurred at this location between 1998 and 2000. None of the accidents involved pedestrians. There is a school crossing guard assigned to this location.

A one-hour traffic count was performed on Wednesday, June 15, 2005 from 7:30 am to 8:30 am. The results are shown in Exhibit 7. A total of 39 (21+18) pedestrians crossed Hegeman Avenue during this hour, while conflicting with 355 (129+158+48+20) vehicles. Based on MUTCD Section 4C.05 Signal Warrant 4 (Pedestrian Volume) the need for a traffic control signal at an intersection shall be considered if an engineering study finds that the pedestrian volume crossing the major street at an intersection during an average day is 190 or more during any one hour. Preliminary results show that existing conditions do not meet warrants (190 vs. 39 pedestrians/hour) for the installation of a traffic signal.

Figure 7: Looking west on Hegeman Avenue, at the intersection of Vermont Street and Hegeman Avenue

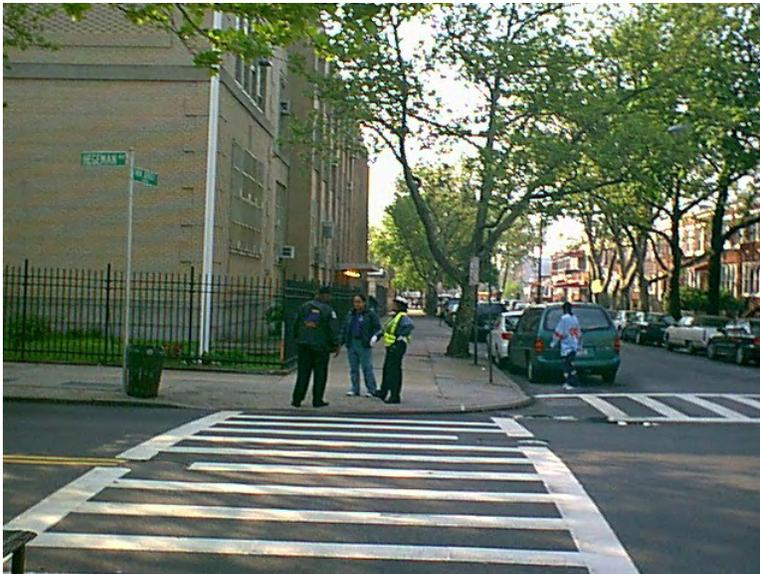
New Jersey Avenue is a one-way 30-foot wide southbound roadway with parking on both sides of the street. This is an all-way stop controlled intersection. There is a school crossing guard assigned to this location. Pedestrian ramps are either missing, or have sub-standard design. There are school crosswalks on the north, south, and east legs.

Figure 8: Looking south on New Jersey Avenue, at the intersection of New Jersey Avenue and Hegeman Avenue

There were 11 accidents between 1998 and 2000 at this location. There were no pedestrian accidents during this period.

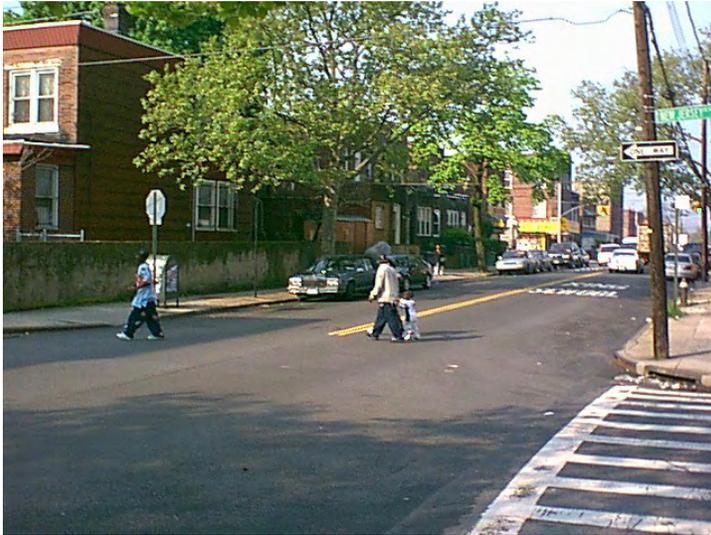
A one-hour traffic count was performed on Wednesday, June 15, 2005 from 7:30 am to 8:30 am (Exhibit 7). The results show that 20 pedestrians used the school crosswalk at the

east leg to cross Hegeman Avenue, and 103 pedestrians crossed the west leg of Hegeman Avenue, where no crosswalk is provided (Figure 9).

Figure 9: Looking west on Hegeman Avenue, at the intersection of New Jersey Avenue and Hegeman Avenue

- Install new school crosswalks, signs and roadway markings

Install new school crosswalk and associated signage at the following locations:

- New Jersey Avenue and Hegeman Avenue - west leg
- Pennsylvania Avenue and Hegeman Avenue – north, south, and east legs
- Stanley Avenue and Vermont Avenue – north and east legs

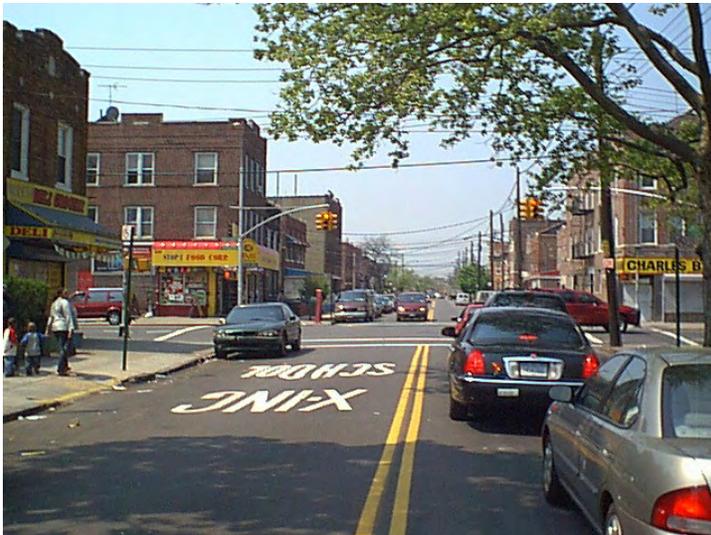
Pennsylvania Avenue is a 53-foot wide two-way roadway with one travel lane in each direction north of Hegeman Avenue and two travel lanes in each direction south of Hegeman Avenue (Figure 10). The intersection of Pennsylvania Avenue and Hegeman Avenue is controlled by a two-phase signal. There are crosswalks on all four legs at this intersection, but none of them are school crosswalks. A school crossing guard is assigned to this location. There are also bus stops for the B20 line along Pennsylvania Avenue.

Figure 10: Looking west on Hegeman Avenue, at the intersection of Pennsylvania Avenue and Hegeman Avenue

There were 63 accidents at this location between 1998 and 2000. There were three pedestrian accidents though none were school related. Two pedestrians were crossing

with the signal when struck by vehicles making a right turn. There is no information on the third accident.

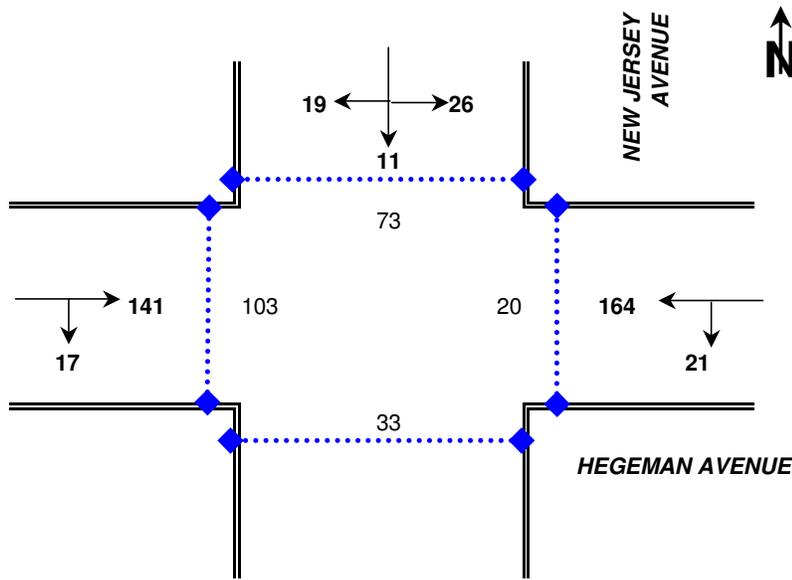
Intersection of Hegeman Avenue and New Jersey Avenue
(7:30 AM - 8:30 AM JUNE 15, 2005)

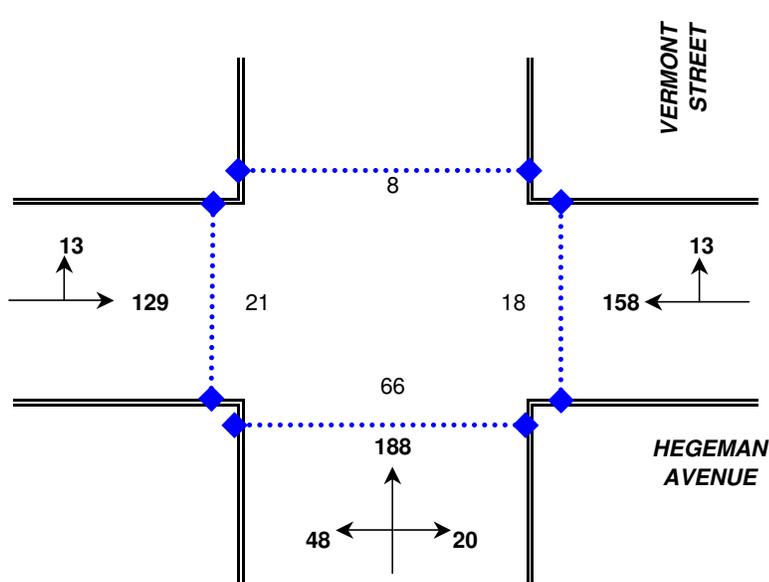
Intersection of Hegeman Avenue and Vermont Street
(7:30 AM - 8:30 AM JUNE 15, 2005)

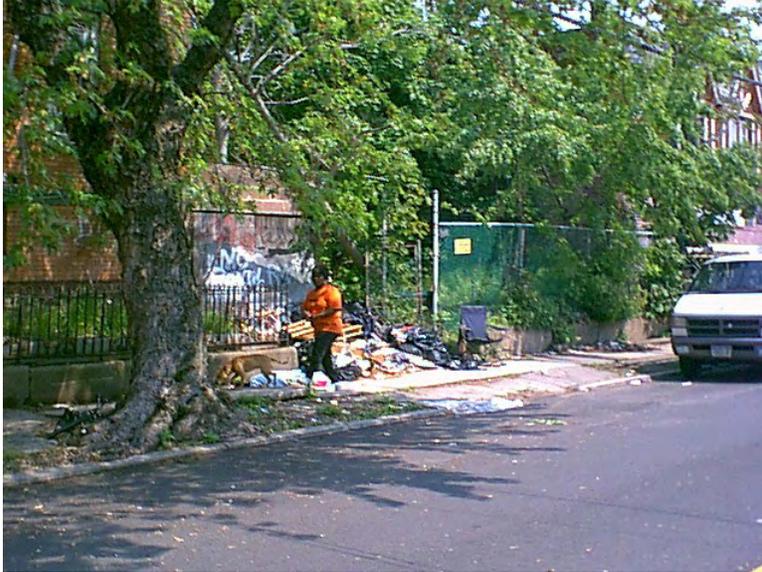
- On the north side of Hegeman Avenue, east of Vermont Street, there is an area of deteriorated sidewalk (Figure 11).
- Pedestrian ramps that are missing or sub-standard have been noted in Section 3.6.

Figure 11: North sidewalk on Hegeman Avenue, east of Vermont Street

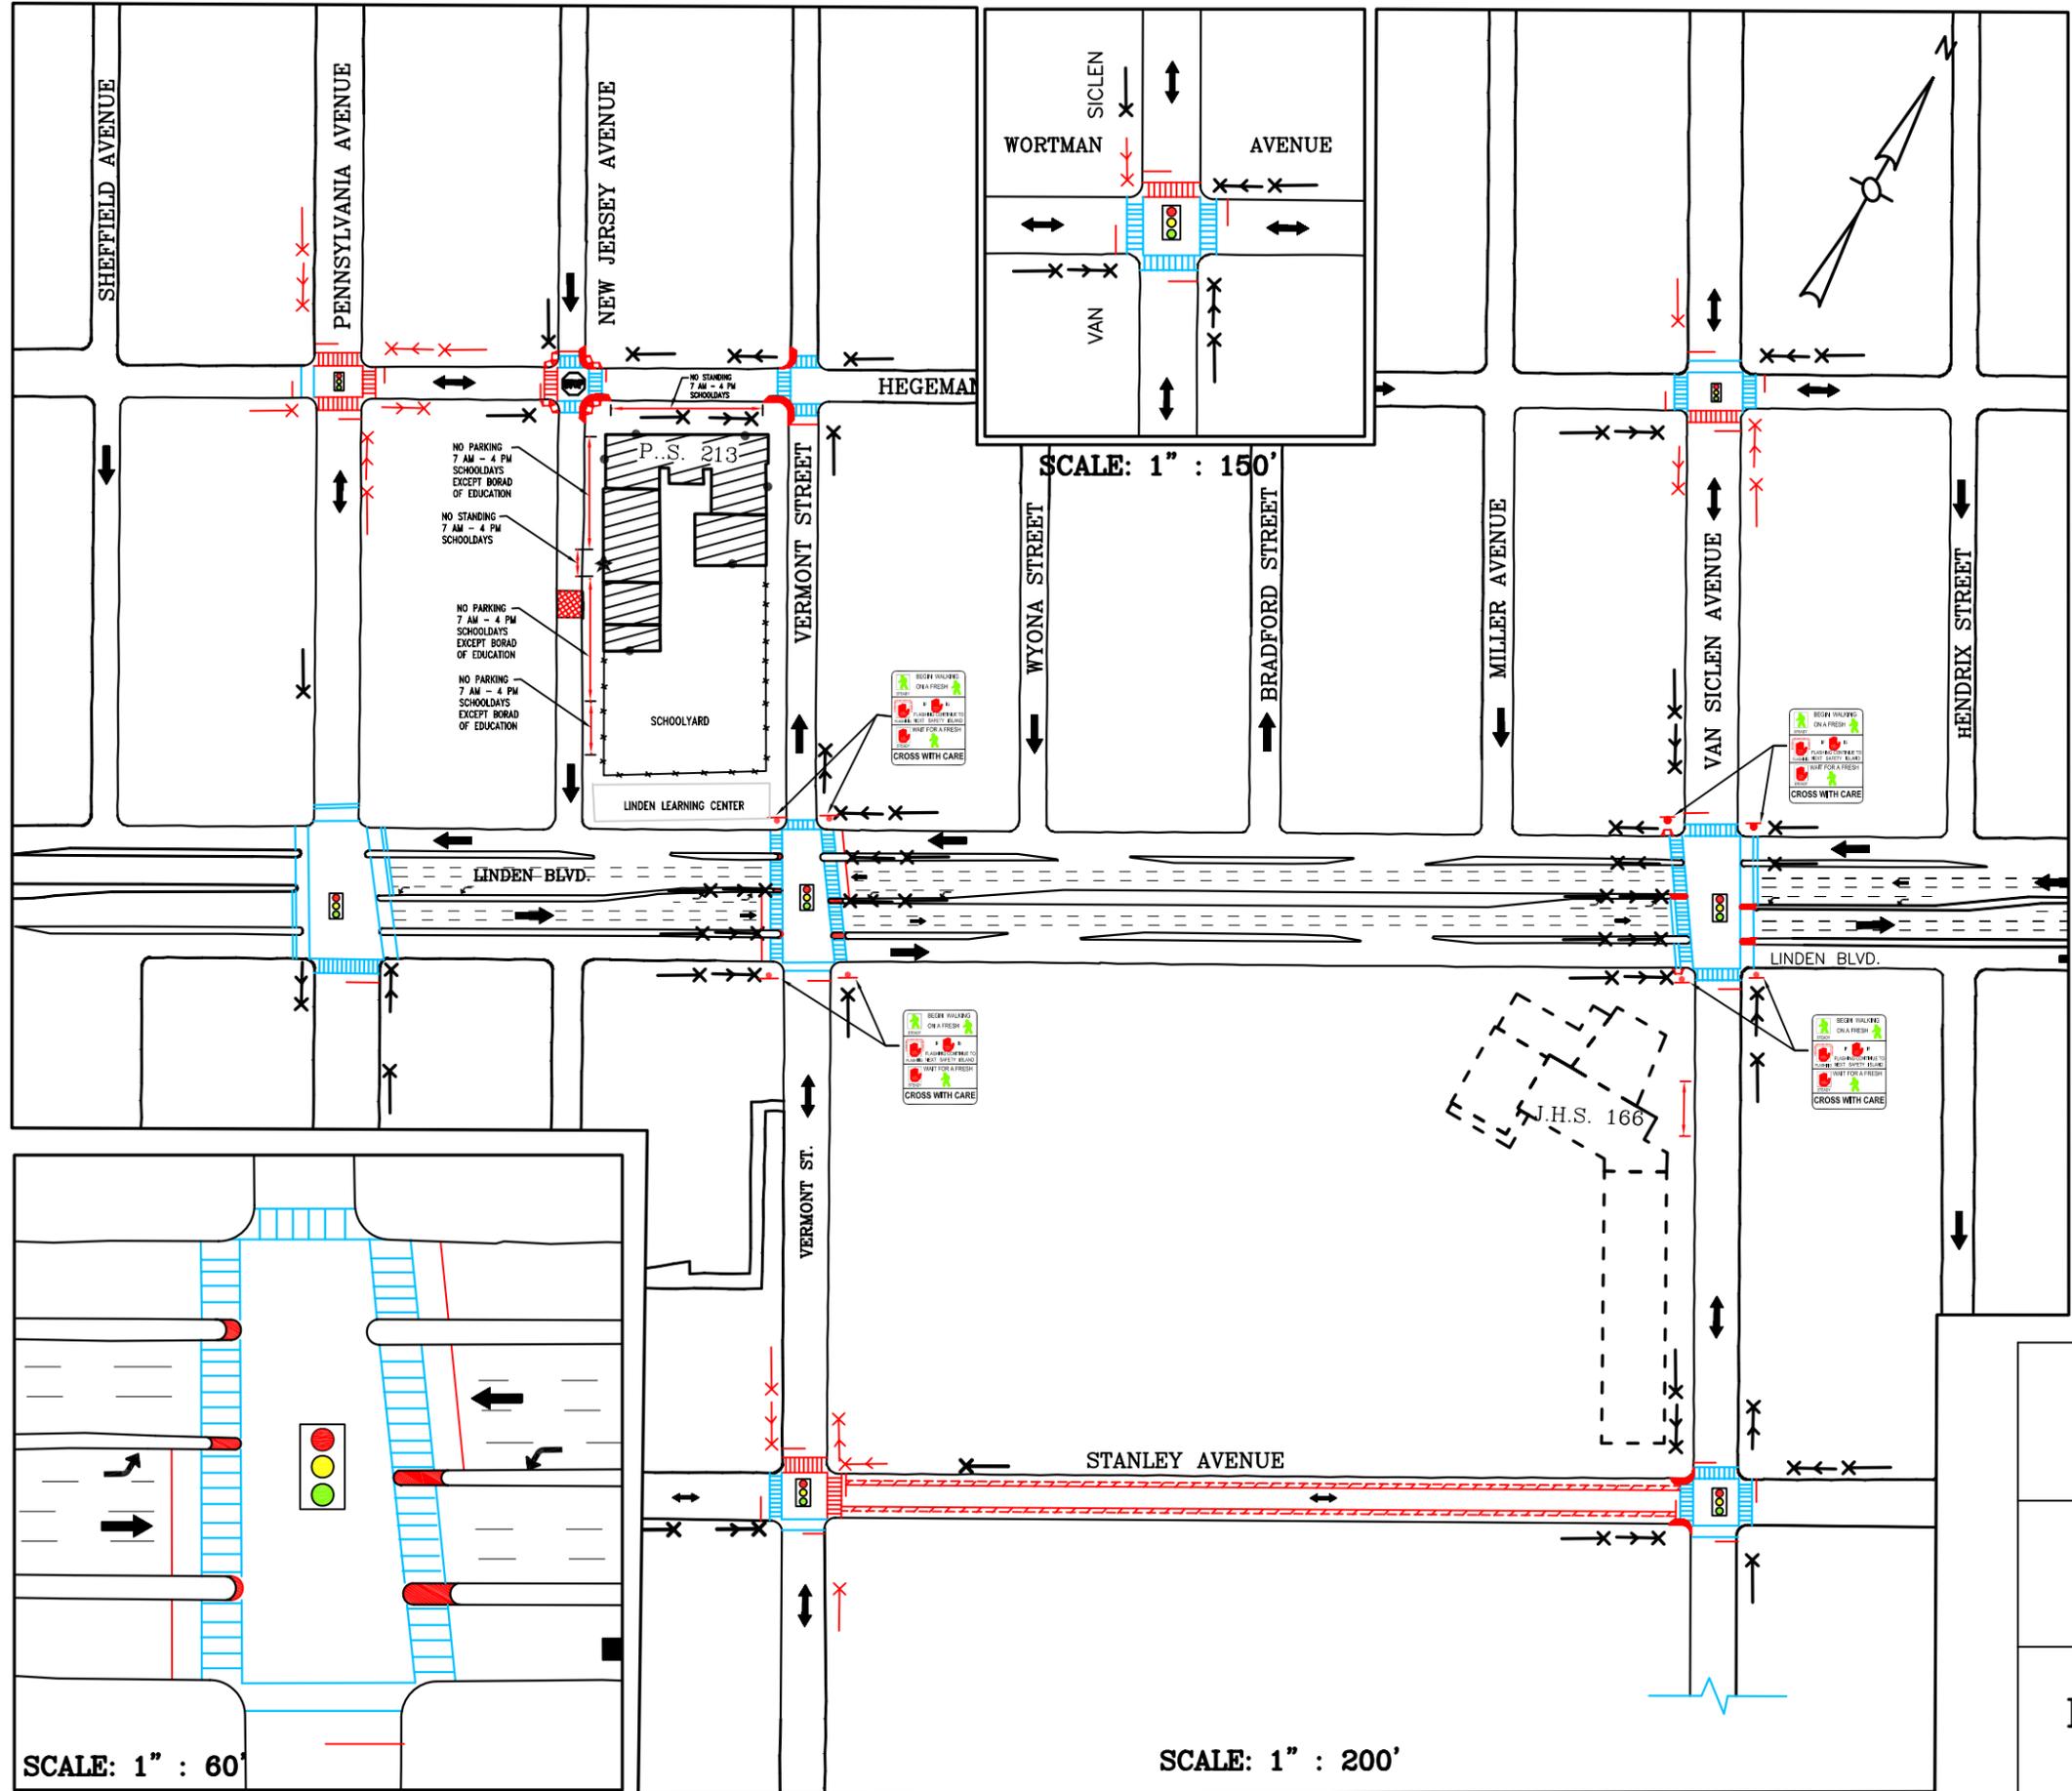
**PROPOSED MEASURES TO IMPROVE
STUDENT PEDESTRIAN SAFETY**

The purpose of the curb extensions is to shorten the crossing distance for pedestrians, and to reduce speeds of vehicles approaching and turning at school crosswalks.

These curb extensions will not eliminate or reduce the width of any moving lanes. Curb extensions are not proposed where they would hinder the ability of vehicles to turn. Final details pertaining to curb extensions will be developed during the Final Design/Contract Document preparation.
