NEW YORK CITY DEPARTMENT OF TRANSPORTATION  
**Office of School Safety Engineering**

**School Safety Engineering Project**

**FINAL: P.S. 93, The William H. Prescott School, Brooklyn**

**OCTOBER 6, 2006**

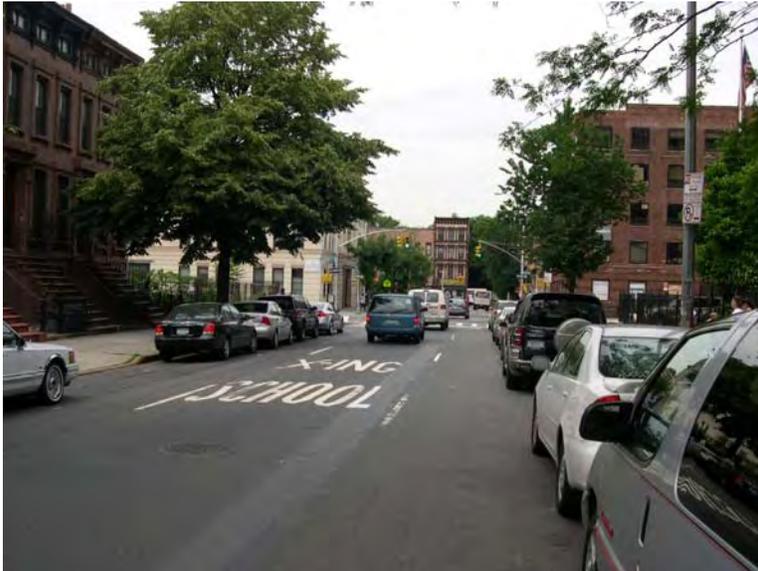
*Figure 1: New York Avenue in front of P.S. 93 (view northbound)*

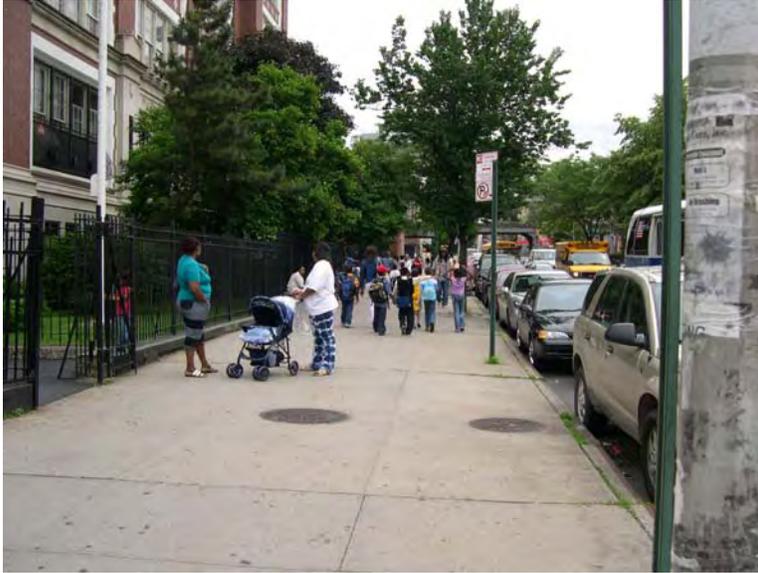
*Figure 2: New York Avenue in front of P.S. 93 (view southbound)*

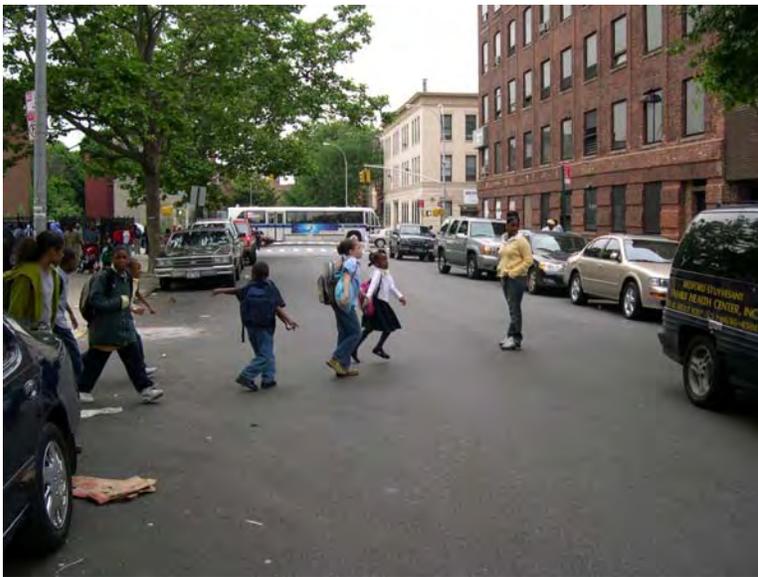
The shopping center located between Fulton Street and Herkimer Street is a major attraction to students of the school. Many students were observed heading directly to this area, crossing Herkimer Street at a mid-block location directly between the school exit and the shopping center area (Figure 3).

*Figure 3 – Mid-block crossings across Herkimer Street*

It is recommended that the NYCDOT Safety Education Program work with the school to educate the students on pedestrian safety, including crossing the street with the WALK phase, and the meaning of the WALK - FLASHING DON'T WALK - DON'T WALK pedestrian signal sequence. It is also recommended that the students be educated not to cross at mid-block locations.

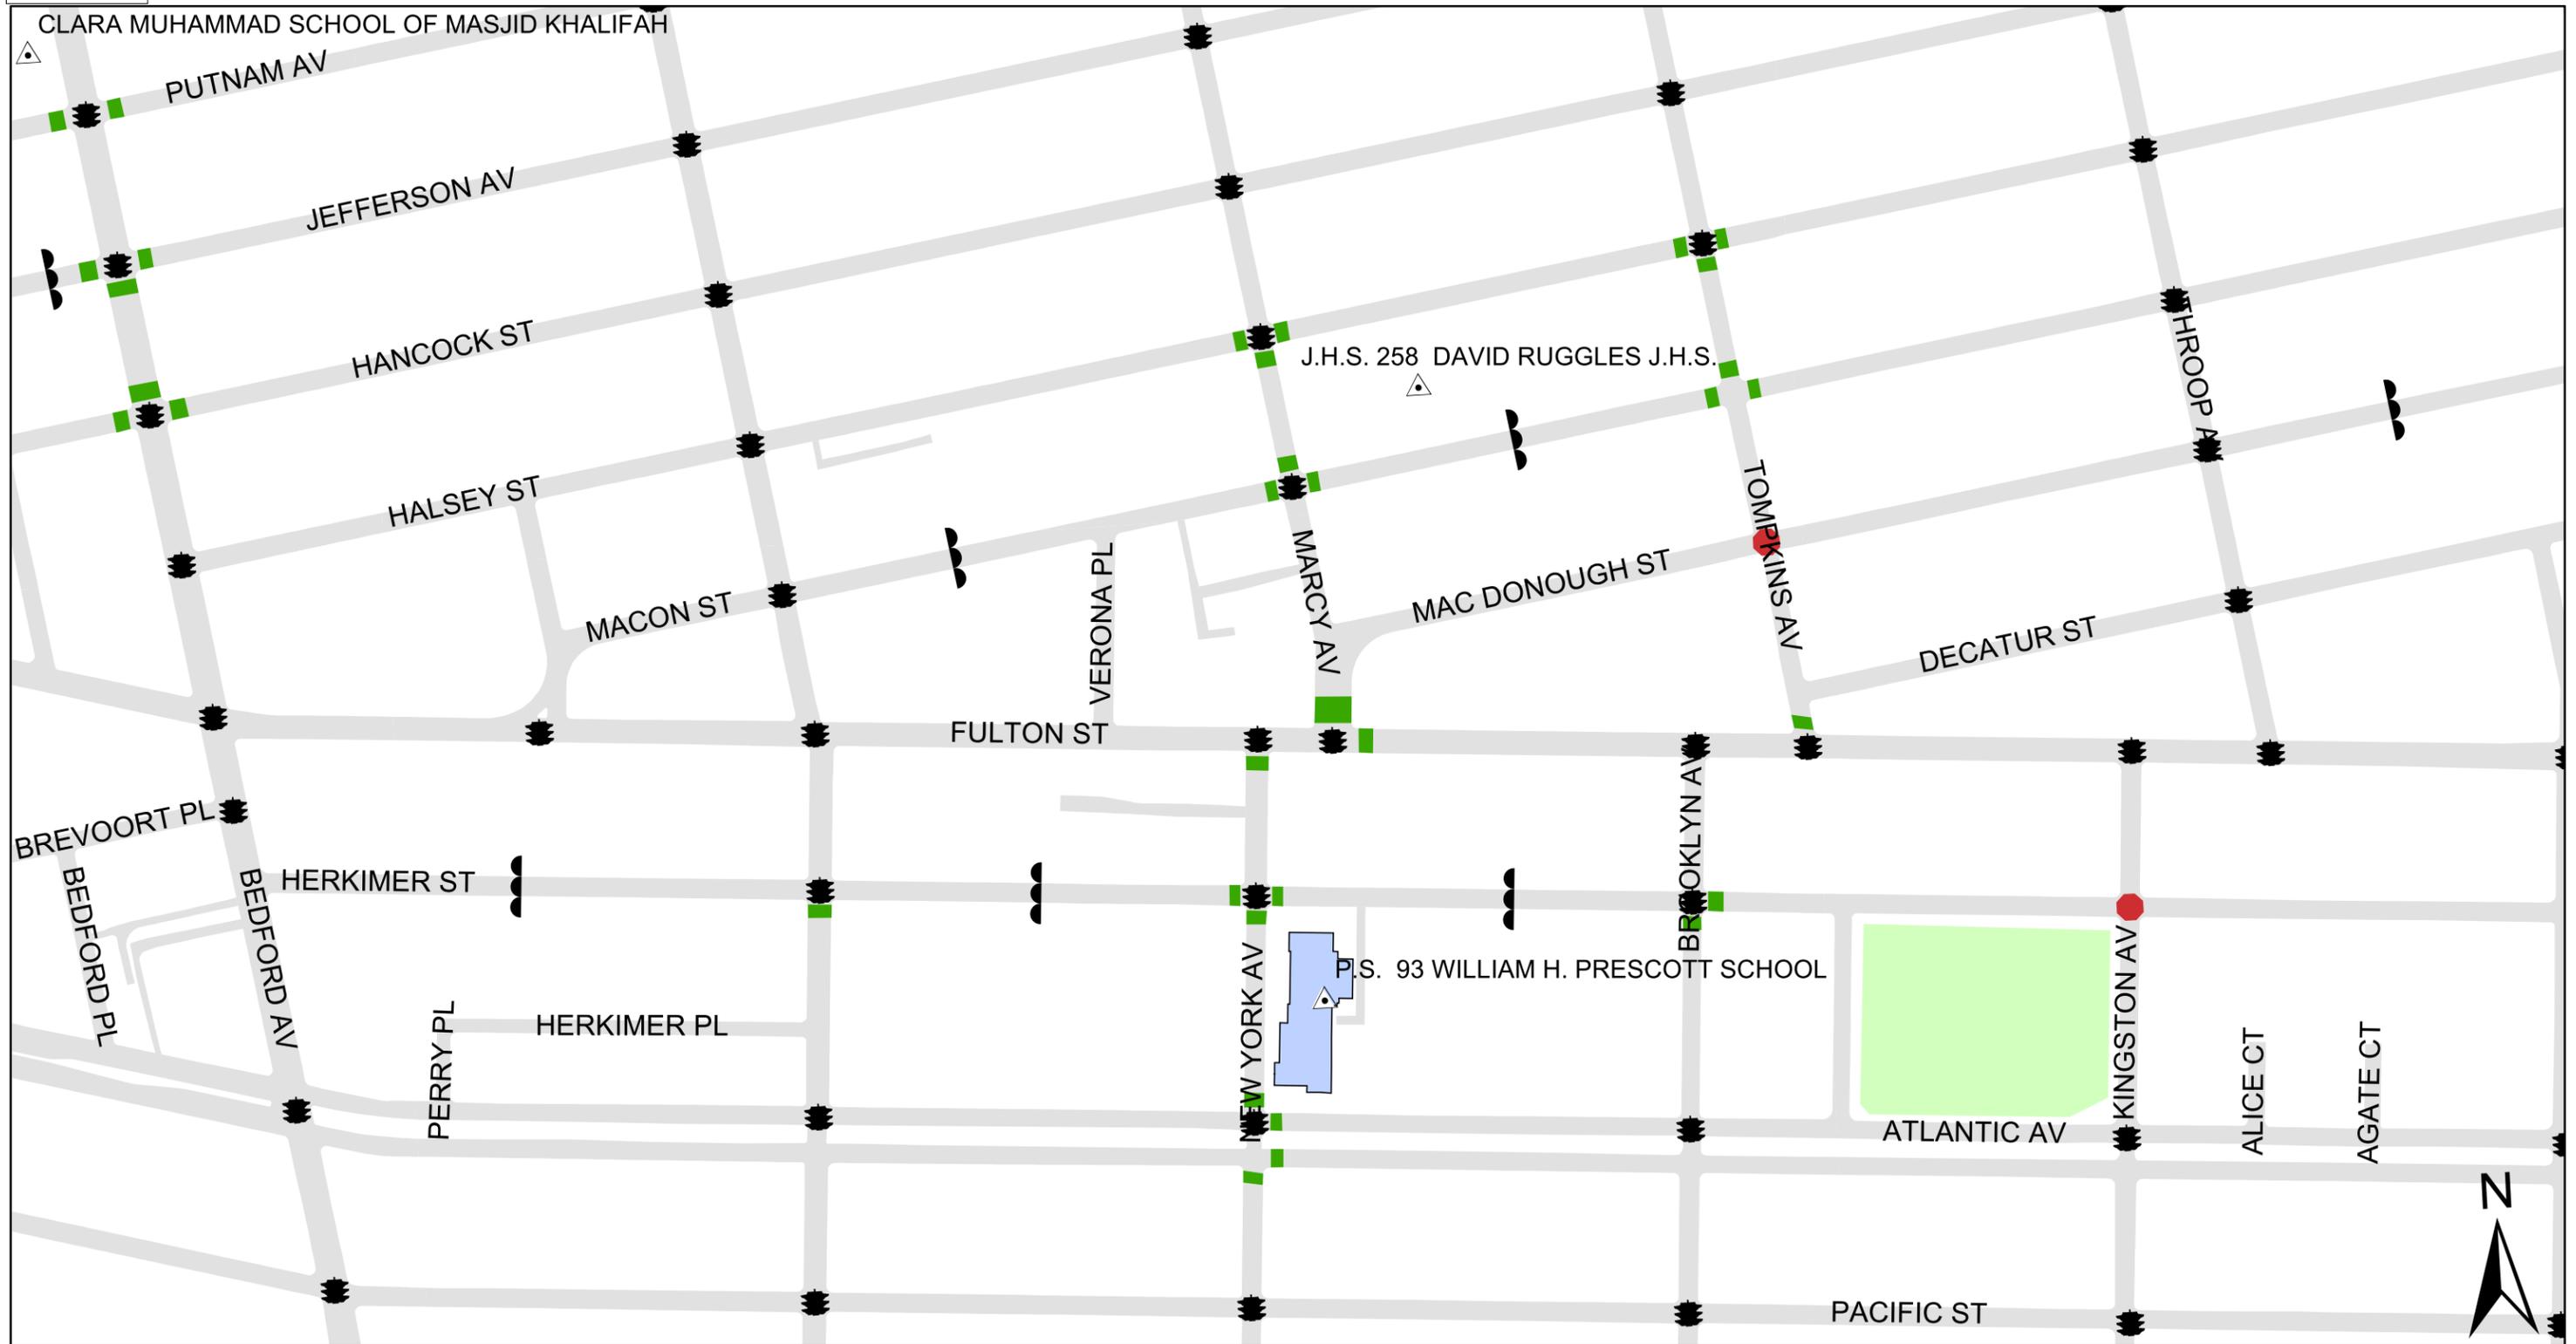
# School Traffic Safety Map

The School Traffic Safety Map was established to help provide the maximum degree of safety for children going to and from school - by indicating the location of speed reducers, school crosswalks and some traffic control devices. (While virtually all intersections in NYC benefit from traffic control devices - such as stop signs, traffic signals, yield signs, and all way stop signs - this map shows only traffic signals and all way stop signs.) The school crosswalks that are shown are ladder striped and make the crosswalk more visible to drivers and help make the intersection safer. These crosswalks are where school children are recommended to cross.

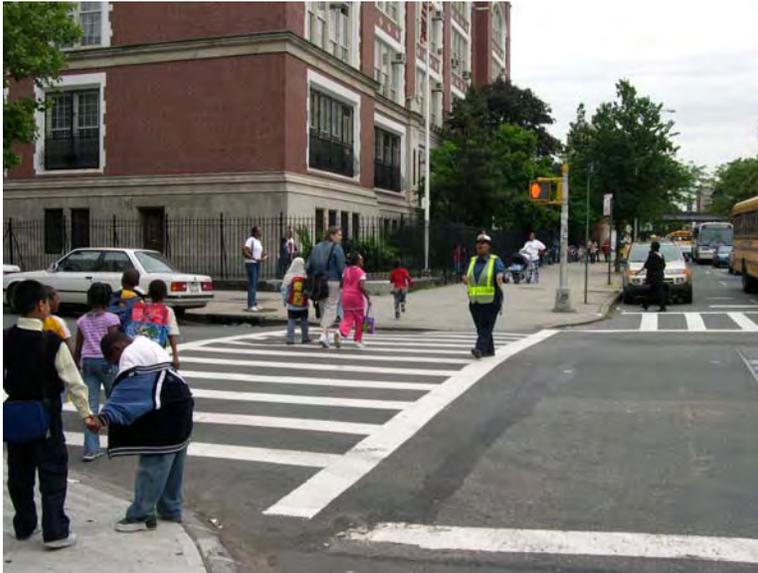
- New York Avenue and Atlantic Avenue
- New York Avenue and Fulton Street
- New York Avenue and Herkimer Street (Figure 4)

*Figure 4 – Crossing guard at New York Avenue and Herkimer Street*

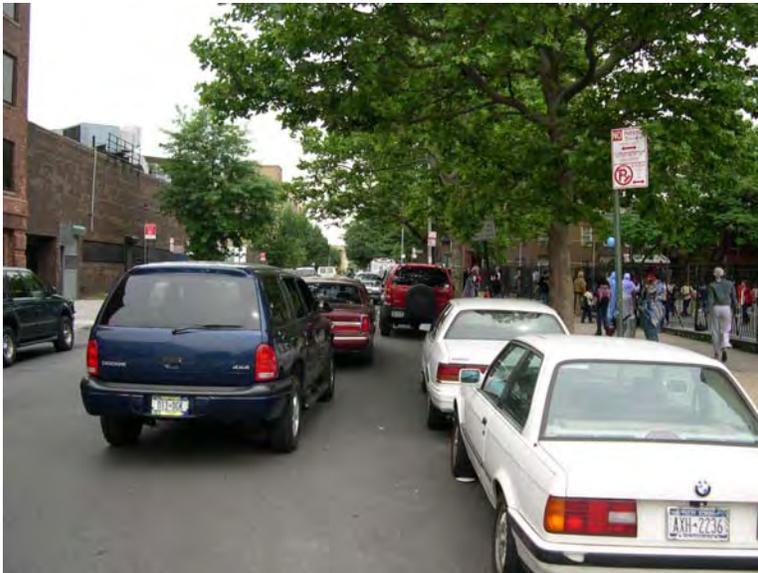
According to school representatives, school buses bring many students to school in the morning, and pick them up in the afternoon at dismissal time. All buses park or double-park in front of the school on New York Avenue.

*Figure 5: Double parking on Herkimer Street*

“NO STANDING 7 AM – 4 PM, SCHOOL DAYS” parking regulations should be considered in front of the school entrance on New York Avenue for a length of 30 feet to provide sufficient clear frontage for school buses to drop off and pick up students. This will reduce the available Department of Education parking on New York Avenue. To compensate for this, Department of Education parking along Herkimer Street should be extended easterly along Herkimer Street.

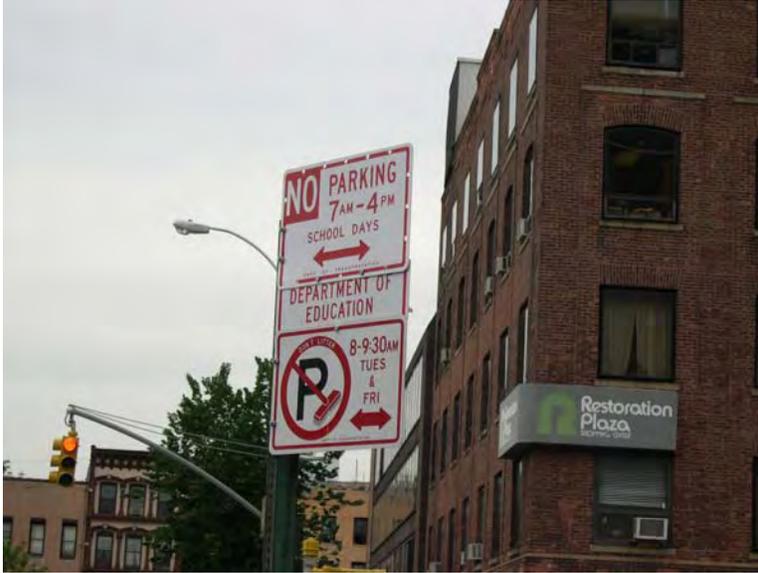
Exhibit 5 displays parking regulations around P.S. 93. On New York Avenue, “NO PARKING 7 AM – 4 PM SCHOOL DAYS EXCEPT BOARD OF EDUCATION” parking regulation signs are posted in front of the school, and to the side of the school on Herkimer Street (Figure 6).

*Figure 6: Parking restrictions on Herkimer Street*

Existing “NO PARKING, 7 AM – 4 PM, SCHOOL DAYS, EXCEPT BOARD OF EDUCATION” parking regulations on New York Avenue and Herkimer Street should be upgraded to “NO STANDING, 7 AM – 4 PM, SCHOOL DAYS, EXCEPT DEPARTMENT OF EDUCATION”.

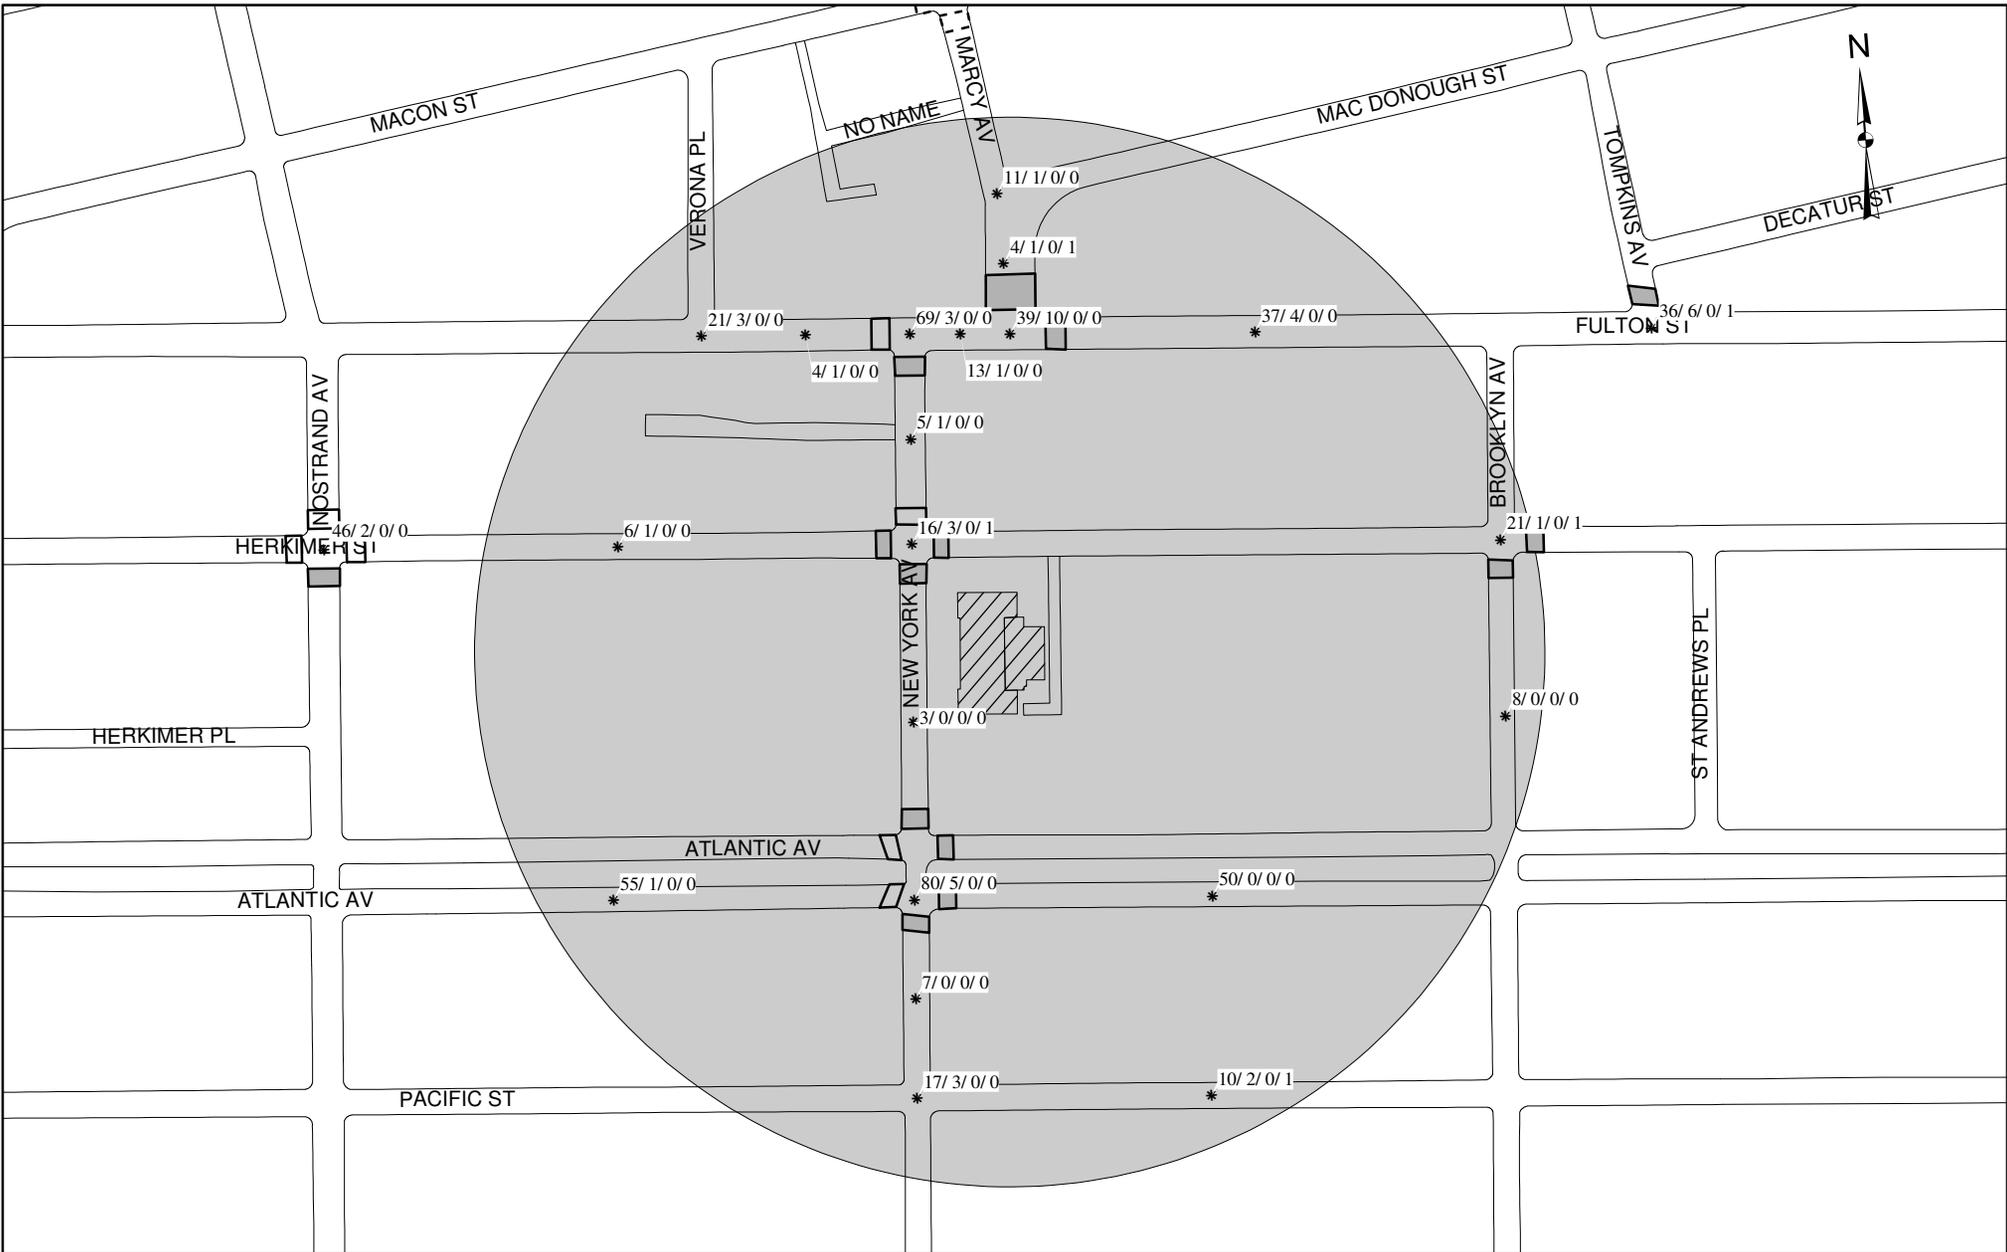
**EXHIBIT 6**

Exhibit 6 and Table 2 show a summary of accidents, as obtained from the New York State Department of Motor Vehicles (DMV), in the vicinity of P.S. 93 for the three-year period from January 1, 1998 through December 31, 2000. The DMV data provides some detail relating to the circumstances and cause of the accident. Table 3 is a summary of more recent accident data obtained from the NYC Police Department (NYPD). Though current through 2004, the NYPD data does not provide the same level of detail as the DMV data.

**ACCIDENT SUMMARY  
THREE YEAR PERIOD  
(1998-2000)**

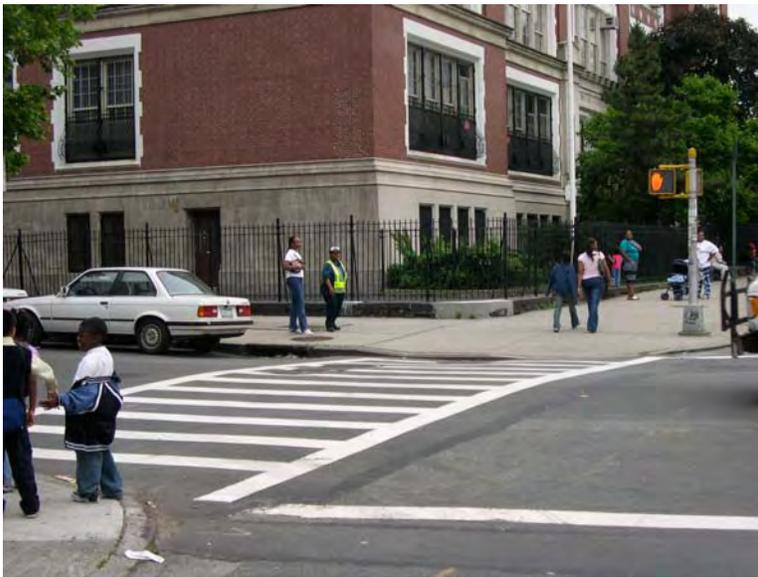
Herkimer Street is a one-way street running eastbound, with one travel lane and curbside parking on each side. New York Avenue is a one-way street running northbound with one travel lane and curbside parking on both sides of the street (Figure 7). There are school crosswalks on the south, east and west legs.

This signalized intersection had 16 accidents in the three-year study period from 1998 to 2000 (Exhibit 6 and Table 2). There were three pedestrian accidents, one of which was school related. The school related accident involved a 12-year-old student playing in the roadway. The second accident occurred when a pedestrian crossed against the signal, and the third one occurred when the driver disregarded the signal.

*Figure 7: New York Avenue at Herkimer Street view southbound toward school*

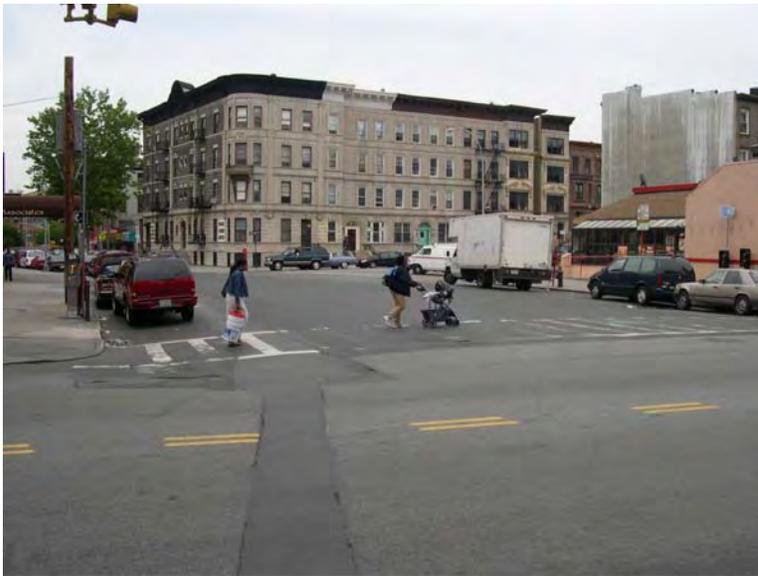
This is a signalized T-intersection with Marcy Avenue, which is a 65-foot wide, one-way northbound roadway with parking on both sides (Figures 8 and 9). There is an exclusive left turn on Fulton Street at the eastbound approach to Marcy Avenue. Marcy Avenue has a striped curb radius reduction at the next intersection to the north, with MacDonough Street. At this intersection Marcy Avenue reduces to a width of 35 feet. There are school crosswalks on the north and east legs (see Aerial Photograph- Figure 8A).

*Figure 8: Marcy Avenue looking northbound across Fulton Street*

New curbs, standard pedestrian ramps and concrete sidewalks should be constructed to narrow the traveled way along the southern end of Marcy Avenue. The existing roadway has only two receiving lanes but is 65-feet wide. This likely contributes to driver speeds through the intersection. Narrowing the intersection would better channelize the traffic and allow motorized traffic and pedestrians to better anticipate each others movements. The sidewalk should be extended to incorporate the existing channelized roadway at MacDonough Street and extend south to Fulton Street as shown in Exhibit 7.

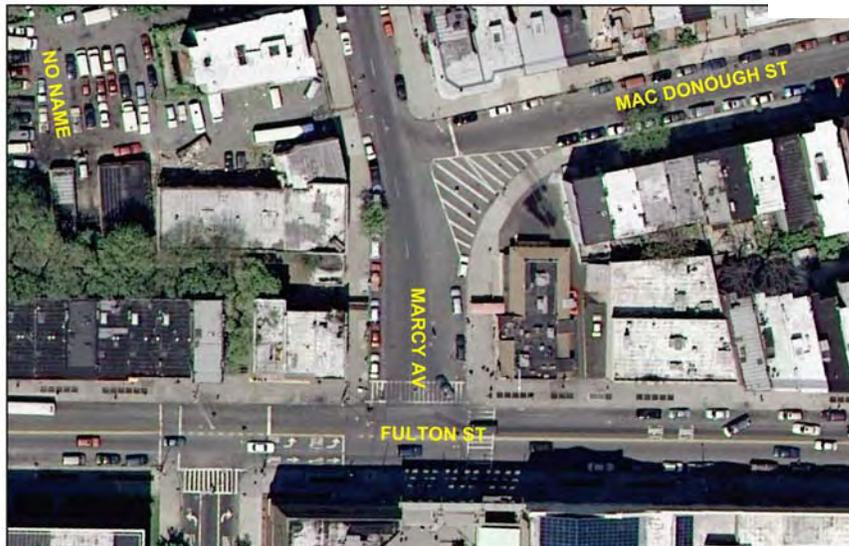
*Figure 8A: Fulton Street and Marcy Avenue*

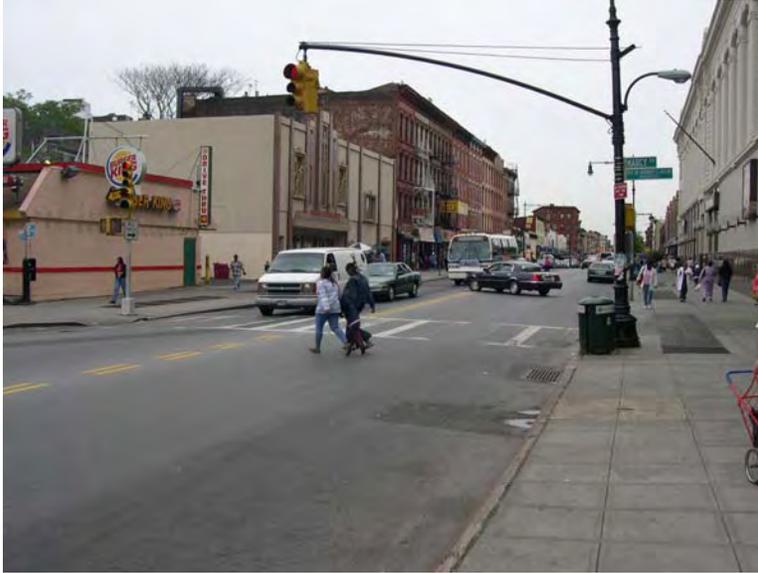
*Figure 9: Fulton Street looking eastbound across Marcy Avenue*

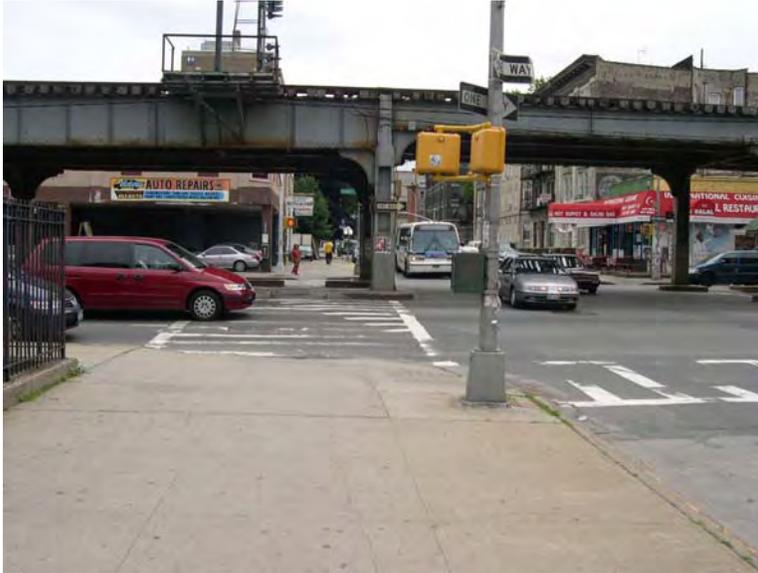
Atlantic Avenue has two moving lanes in each direction with curbside parking, running east - west. It has a dedicated left turn lane along the eastbound approach to New York Avenue. The Long Island Railroad also shares the corridor, running elevated above Atlantic Avenue (Figure 10). The support columns for the railroad are located along the two medians that separate the through travel lanes from the intermittent center turn lanes along Atlantic Avenue. There are no pedestrian ramps across the New York Avenue crosswalk on the south side of Atlantic Avenue (Figure 11). There are school crosswalks on the north, south and east legs.

A total of 80 accidents occurred at this intersection during the 1998-2000 study period, five of which involved pedestrians. Three pedestrians were crossing with the signal when struck by vehicles making right turns. The details for the other two pedestrian accidents were not reported.

*Figure 10: New York Avenue at Atlantic Avenue looking southbound*

Installation of a pedestrian information sign adjacent to each school crosswalk at the wide intersections of Atlantic Avenue and New York Avenue is recommended. The sign will explain signal phases and inform the pedestrian to wait at the refuge between cycles.

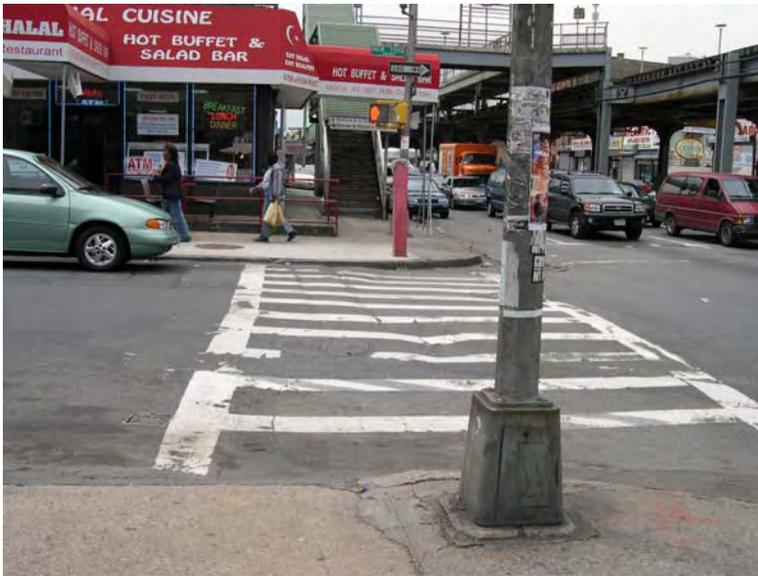
*Figure 11: Looking westbound across New York Avenue along the south side of Atlantic Avenue*

Atlantic Avenue has two five-foot wide medians, one on each side of the center eastbound left turn lane, under the railroad. Pedestrians attempting to cross Atlantic Avenue can make two thirds of the crossing in one movement during the 25 second available crossing time concurrent with the New York Avenue green phase, but must wait at the far median for the next cycle to complete the crossing. This is the same for northbound and southbound crossing movements.

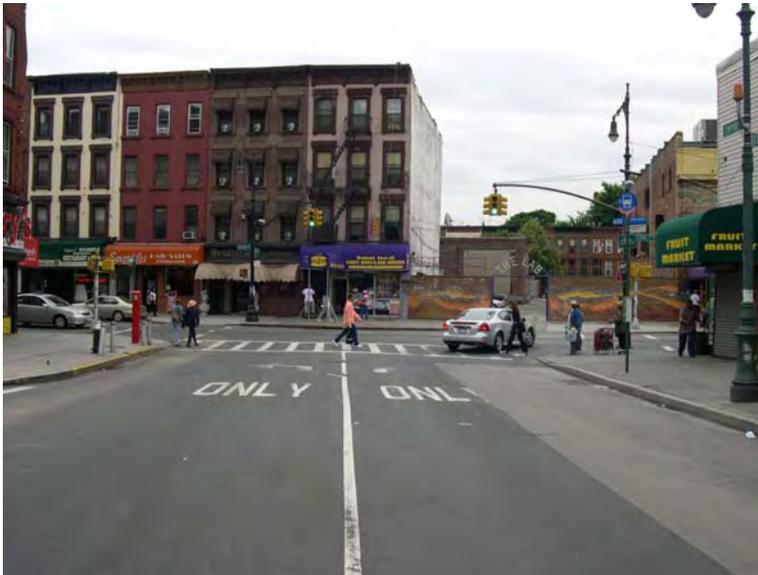
This is a signalized intersection. Fulton Street is a two-way street running east - west. Tompkins Avenue runs one-way southbound and has exclusive right and left turn lanes at the approach to its terminus at Fulton Street (Figure 12). There is a school crosswalk on the north leg.

*Figure 12: Looking southbound along Tompkins Avenue to Fulton Street*

36 accidents occurred at this intersection during the 1998-2000 study period. There were six pedestrian accidents, one of which was school related. A 12-year-old child was crossing with the signal when struck. The other five pedestrian accidents involved drivers making right turns or left turns, one of which struck three pedestrians.

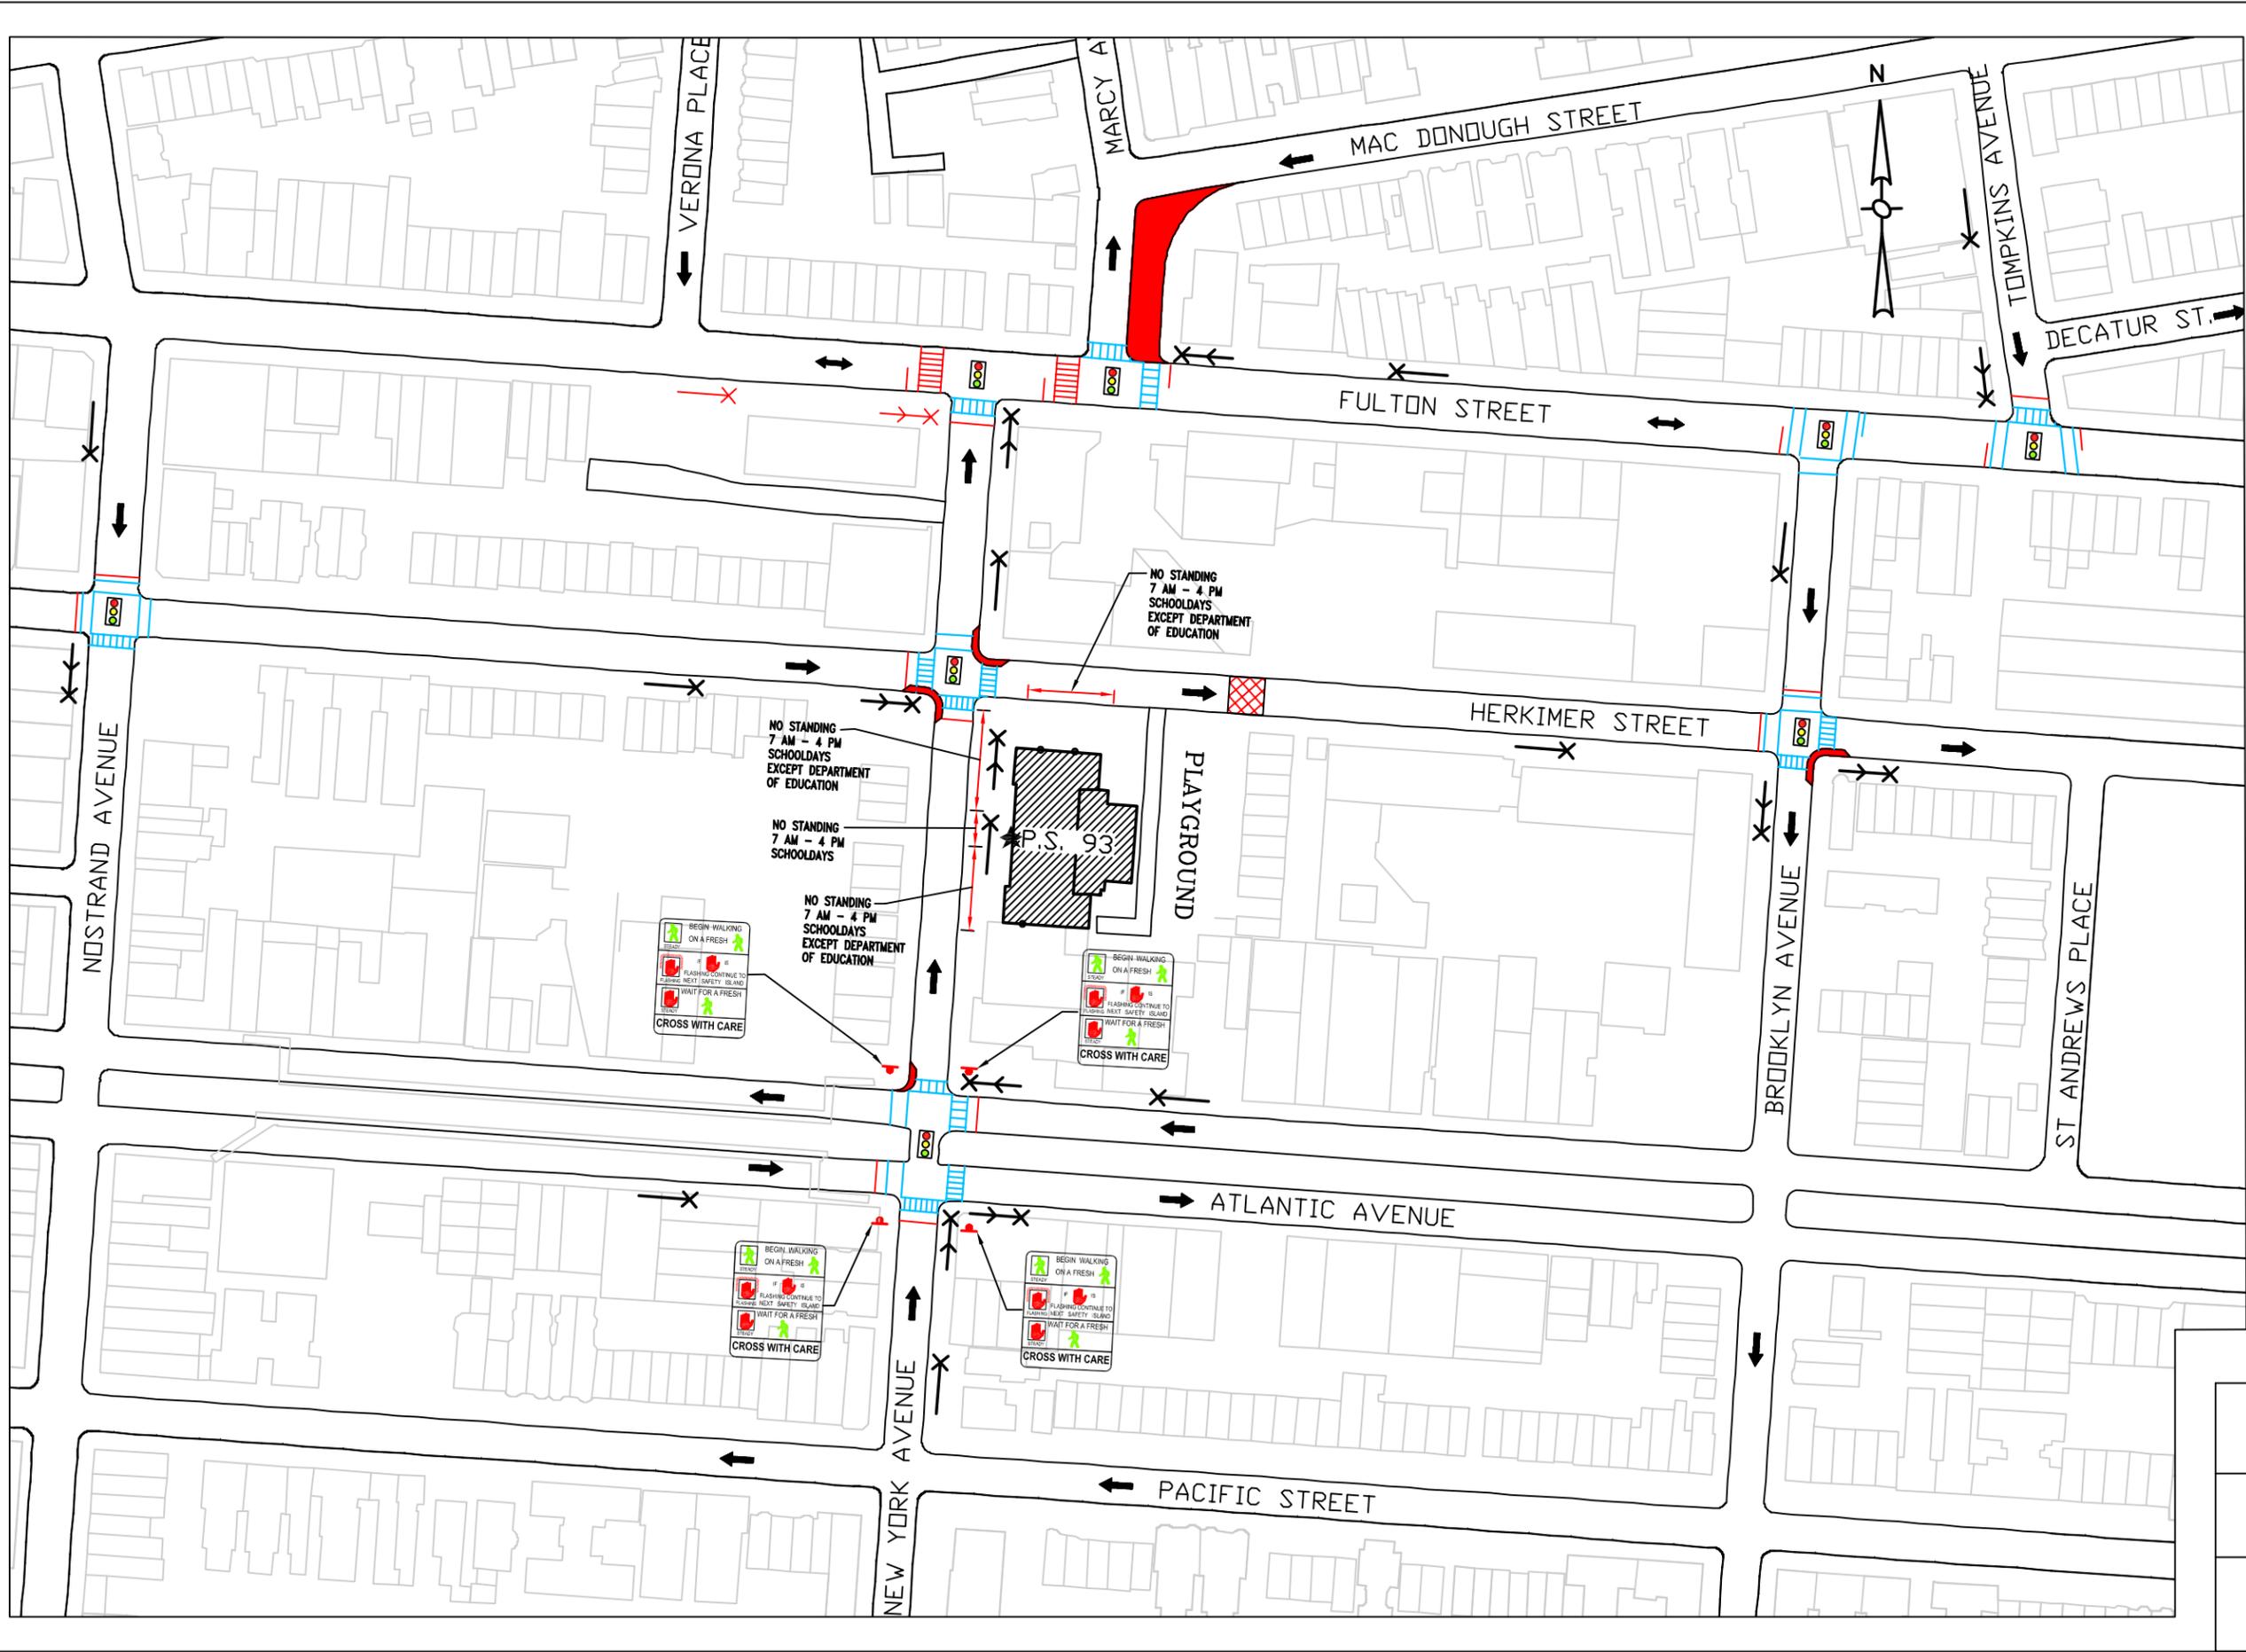
**EXHIBIT 7**

**PROPOSED MEASURES  
TO IMPROVE SAFETY**

According to feedback from school officials, students utilize these intersections en route to P.S. 93. Providing a new school crosswalk at these two locations will complete a network of contiguous school crosswalks in the immediate school vicinity. Therefore, it is recommended that school crosswalks be installed at these two intersections (see Exhibit 7 for detail).

Curb extensions should be considered at the corners as shown in Exhibit 7.

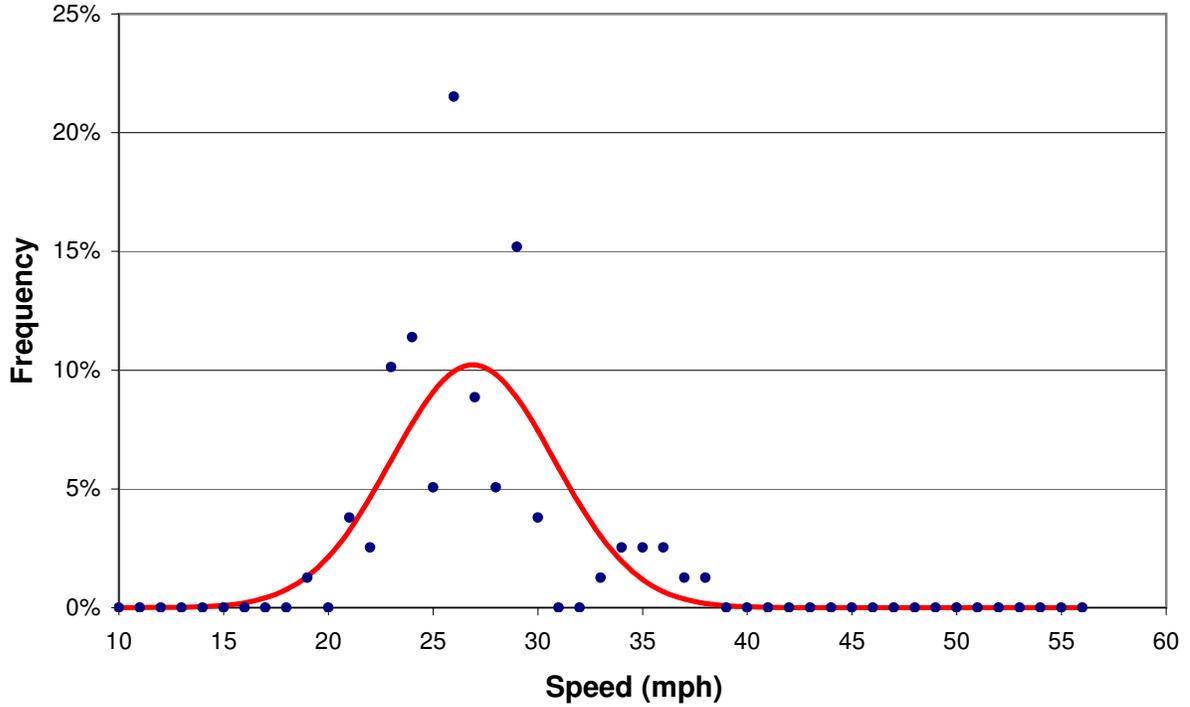
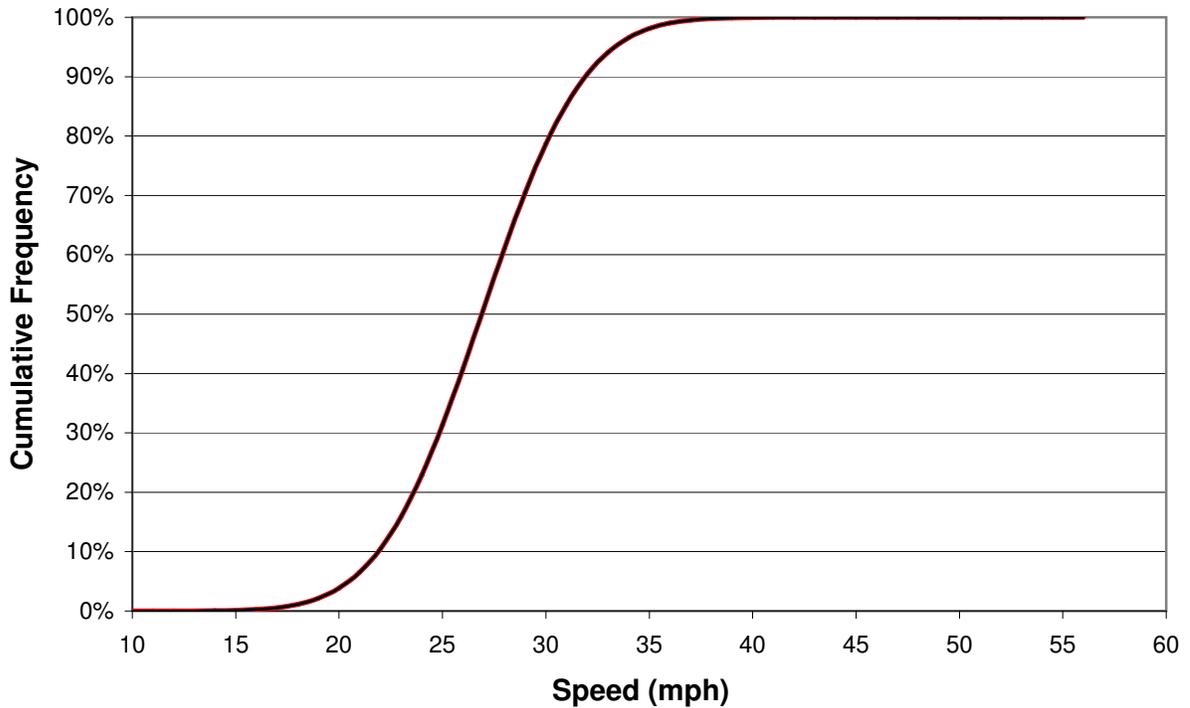
Mean Speed = 26.9 mph  
Standard Deviation = 3.9 mph  
Margin of Error (95% Confidence) =  $\pm 0.9$  mph

Median Speed = 26.9 mph  
15th Percentile Speed = 22.9 mph  
85th Percentile Speed = 30.9 mph

The spot speed study confirmed that the 85<sup>th</sup> percentile speed was 31 mph, which is above the statutory speed limit. To reduce speeding in the vicinity of the school, installation of a speed reducer (hump) is recommended on Herkimer Street. The exact location of the speed reducer (hump) will be determined by NYCDOT. See Table 5 for a summary of the results and the Appendix for further detail.
