**New York City Department of Transportation
Office of School Safety Engineering**

FINAL REPORT: Yeshivat Ateret Torah, Brooklyn

Prepared by
The RBA Group/Urbitran Associates

AUGUST 9, 2006

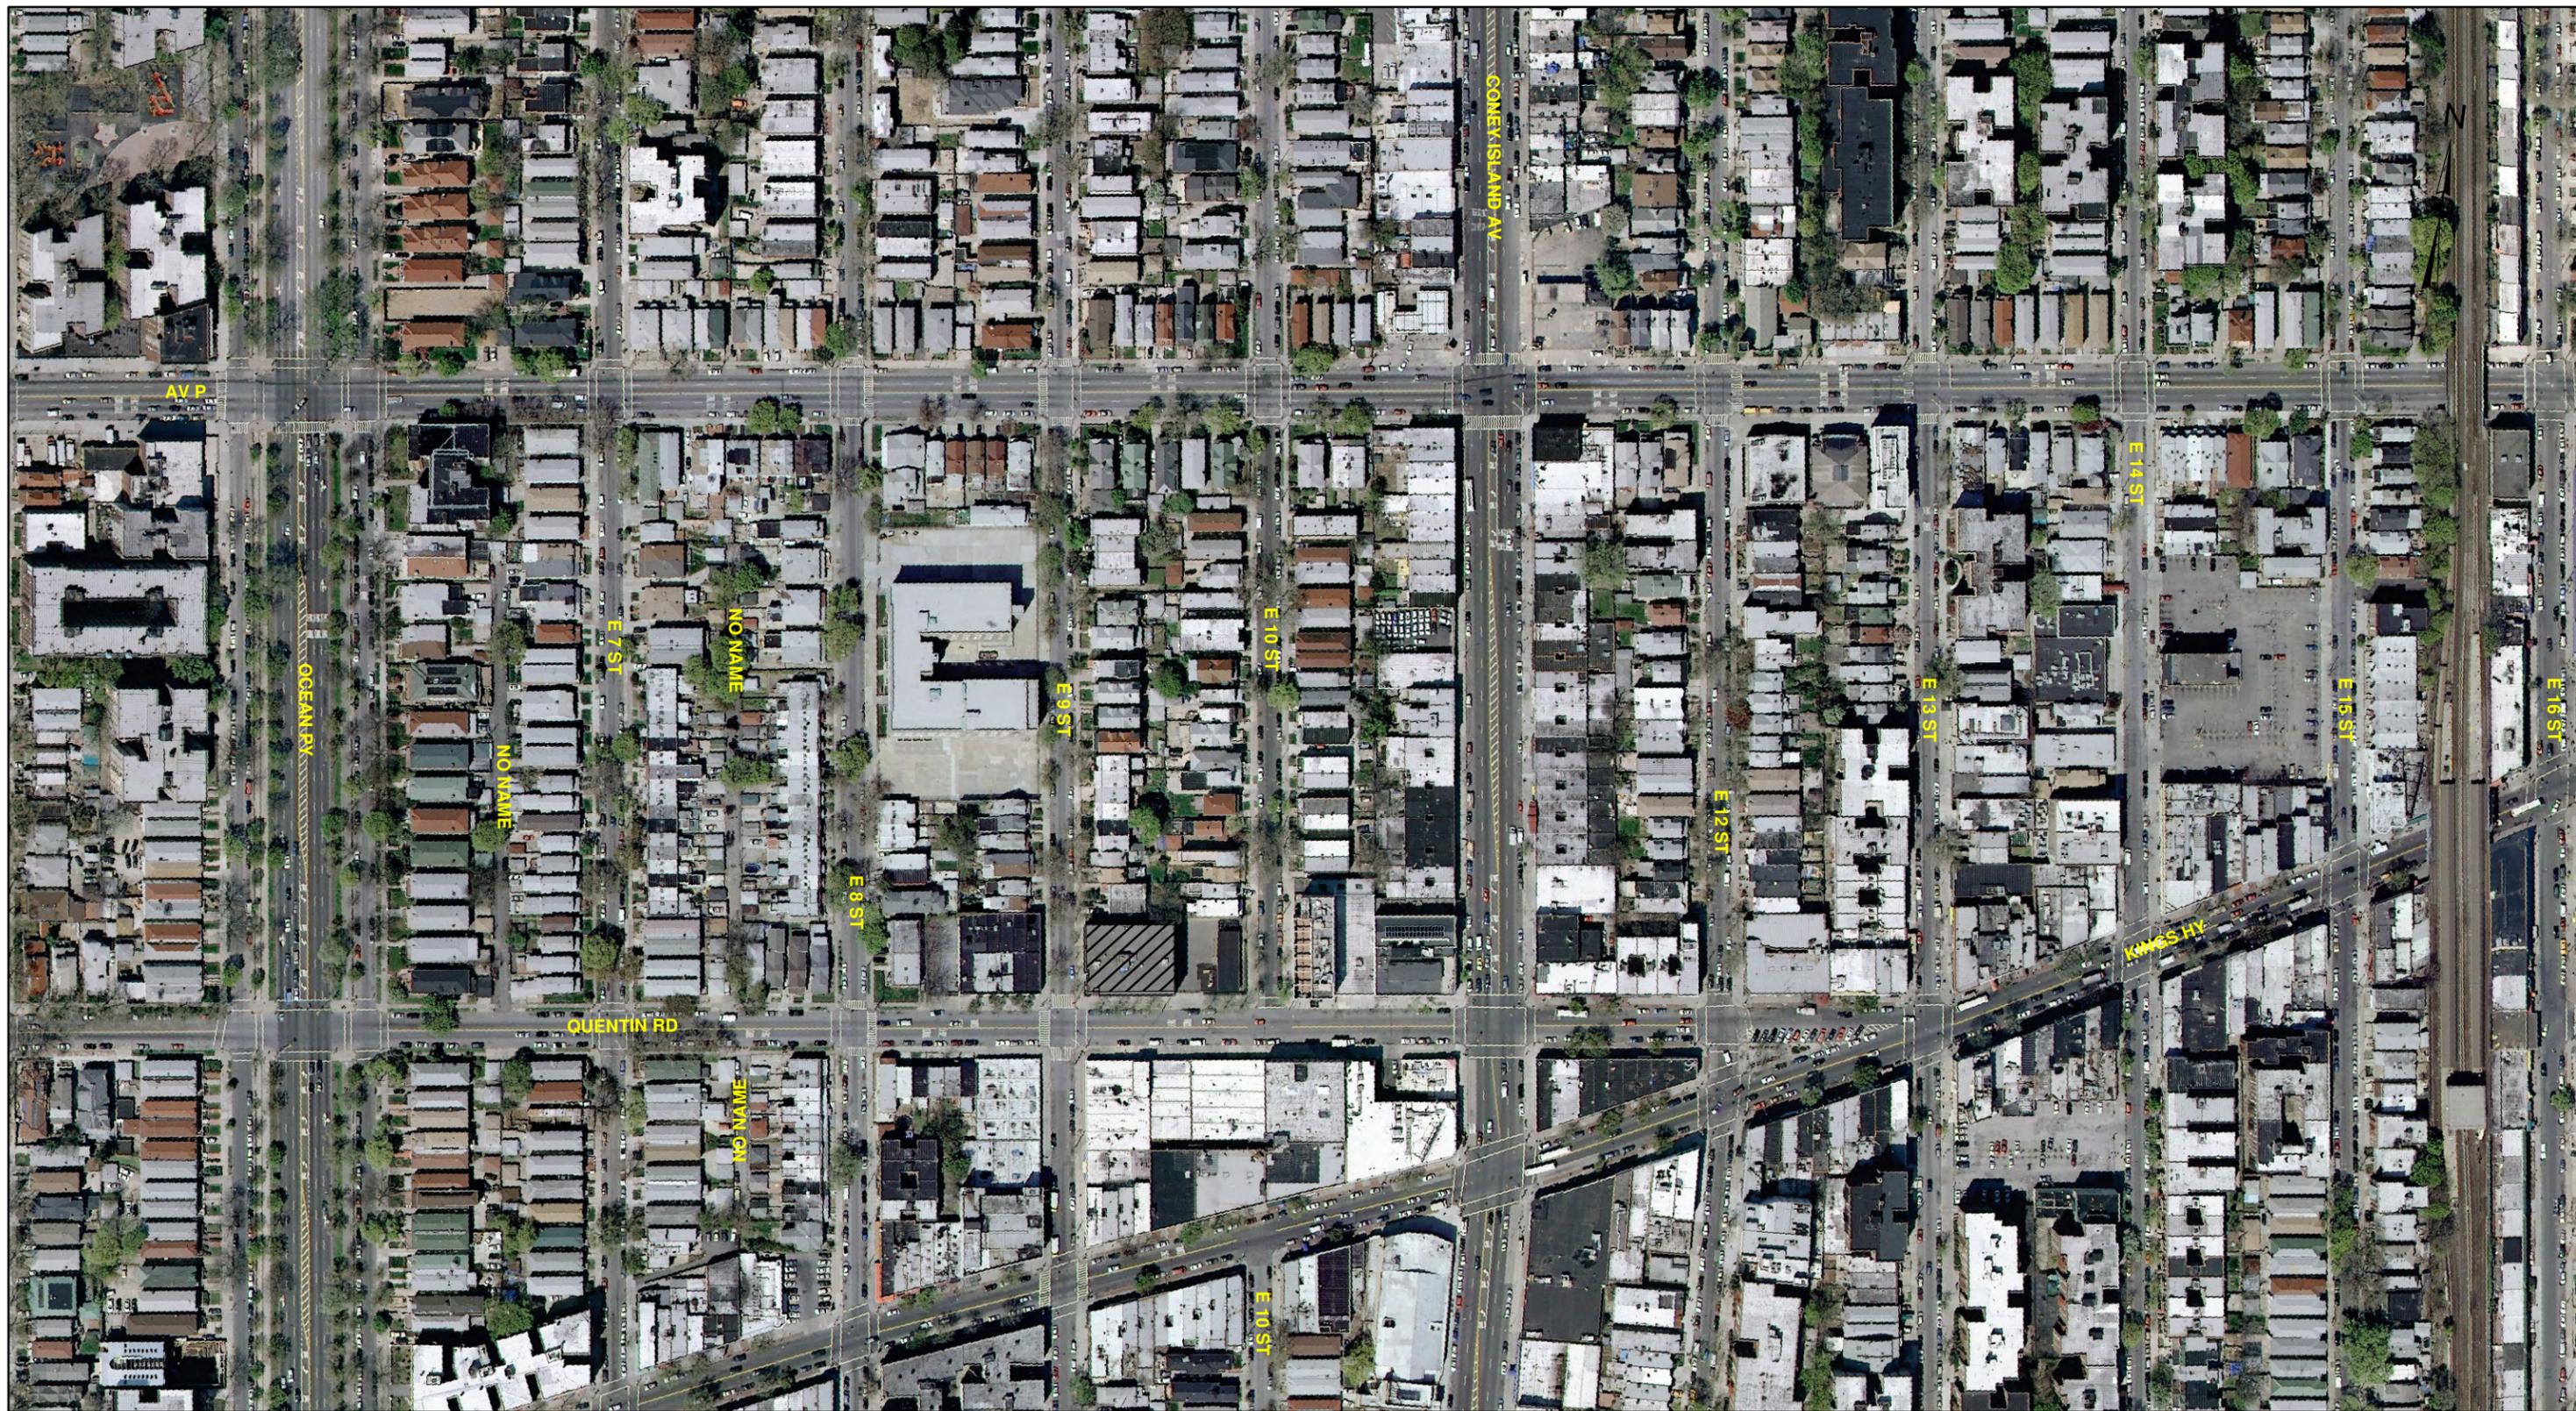
**EXHIBIT 1
YESHIVAT ATERET TORAH SCHOOL
BROOKLYN**

Yeshivat Ateret Torah is located at 901 Quentin Road. The immediate neighborhood surrounding the school building is a mixture of single-family homes and small commercial properties. Kings Highway, Quentin Road and Coney Island Avenue are mostly commercial and the cross streets are primarily residential. Directly across the street from the school are a couple of auto repair shops, some of which are no longer in business. (Exhibit 1, Aerial Photograph).

AERIAL PHOTOGRAPH

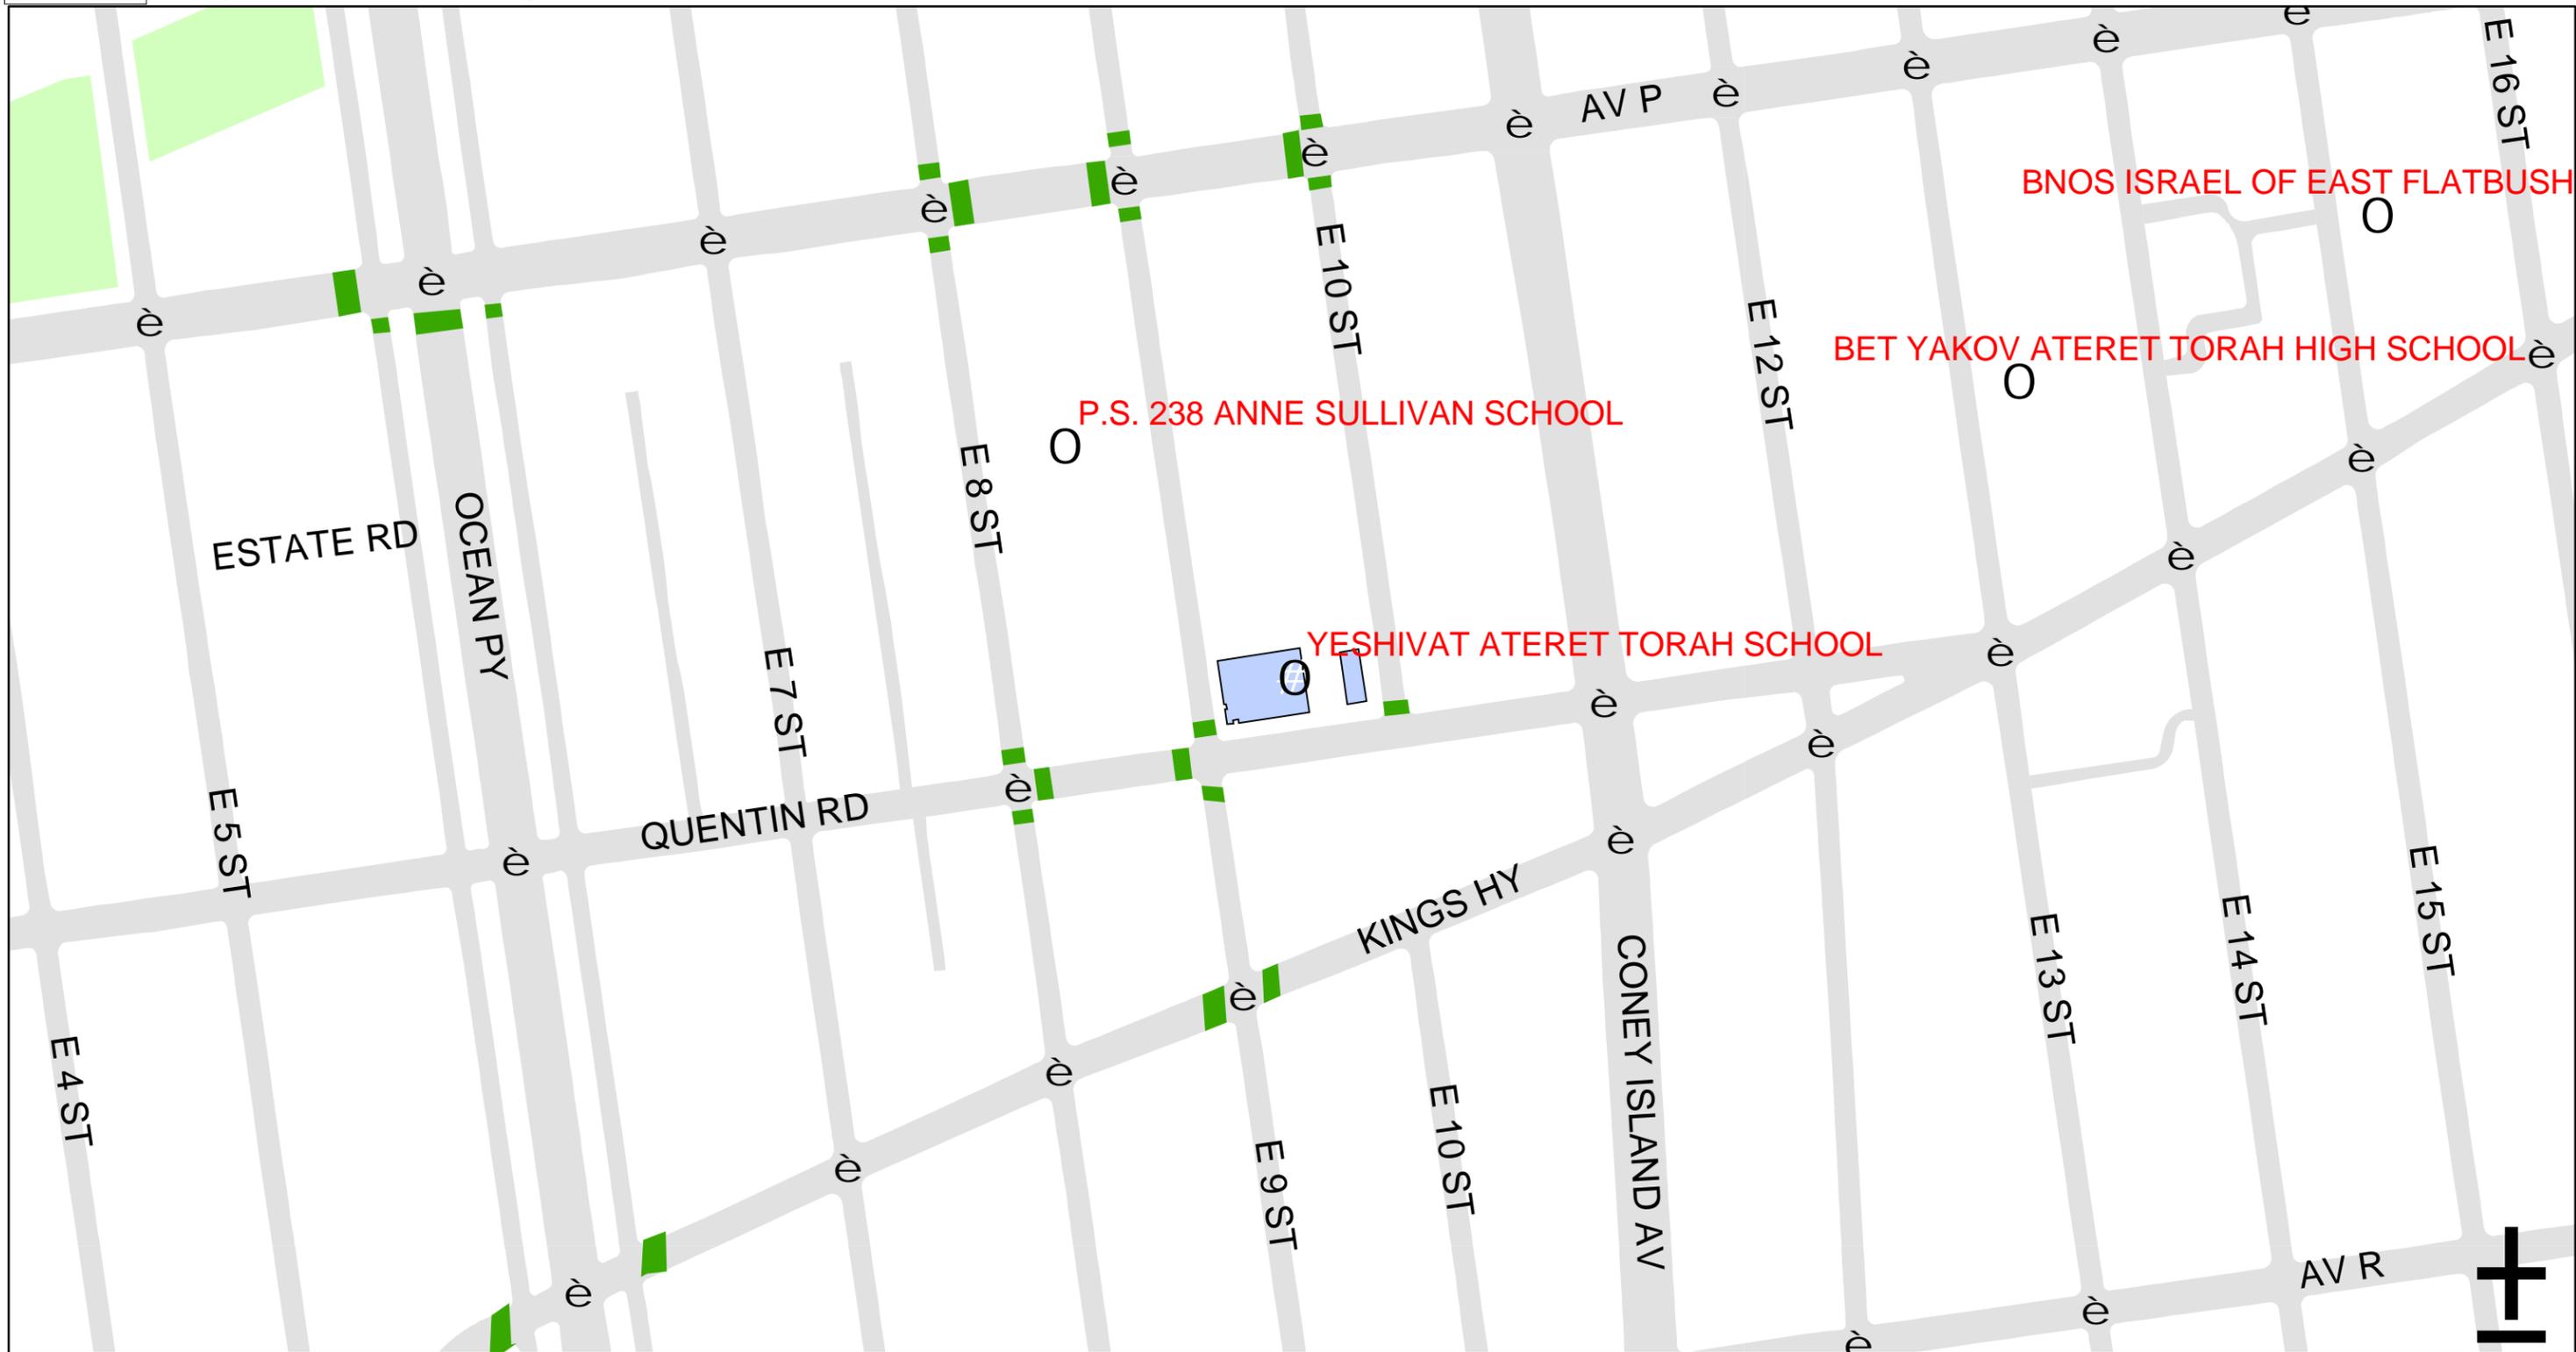
EXHIBIT 2

The School Traffic Safety Map was established to help provide the maximum degree of safety for children going to and from school - by indicating the location of advance warning signs, speed reducers, school crosswalks and some traffic control devices. (While virtually all intersections in NYC benefit from traffic control devices - such as stop signs, traffic signals, yield signs, and all way stop signs - this map only shows traffic signals and all way stop signs.) The school crosswalks that are shown are ladder striped and make the crosswalk more visible to drivers and help make the intersection safer. These crosswalks are where school children are recommended to cross.

The Traffic Safety Plan, Exhibit 2, shows existing signs, signals and pavement markings. It is noted that a citywide signage program is currently underway to upgrade school signage to current Federal Manual on Uniform Traffic Control Devices (MUTCD) standards of fluorescent yellow-green signs accompanied by downward pointing arrows. Signs scheduled to be installed under this program are shown as “existing” on Exhibit 7.

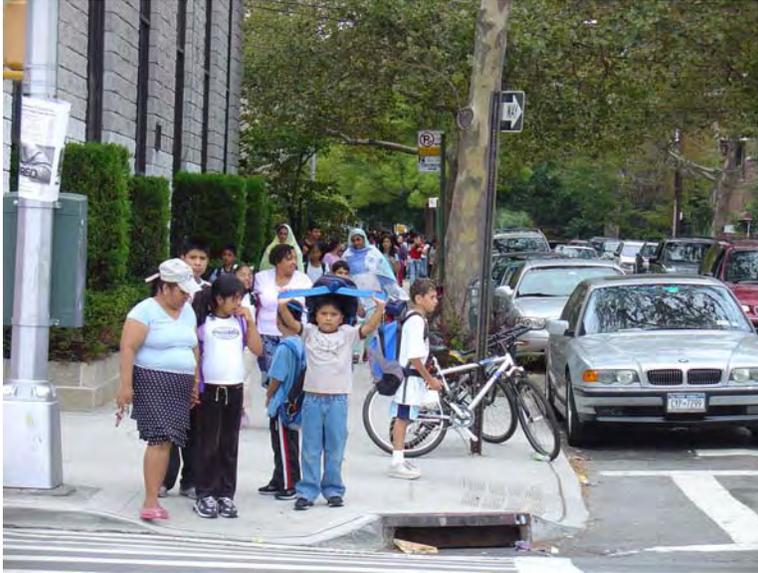
P.S. 238 is on the same block as Yeshivat Ateret Torah. P.S. 238 has an enrollment of approximately 600 students. Most of these students walk south to the intersection of East Ninth Street and Quentin Road (Figure 2) and cross East Ninth Street in front of Yeshivat Ateret Torah. Many of the students, along with their parents or guardians also cross at mid-block locations along East Ninth Street. The main entrance for P.S. 238 is approximately mid-block on East Ninth Street between Avenue P and Quentin Road.

Figure 2. Students from P.S. 238 walking towards Quentin Road and East Ninth Street during dismissal.

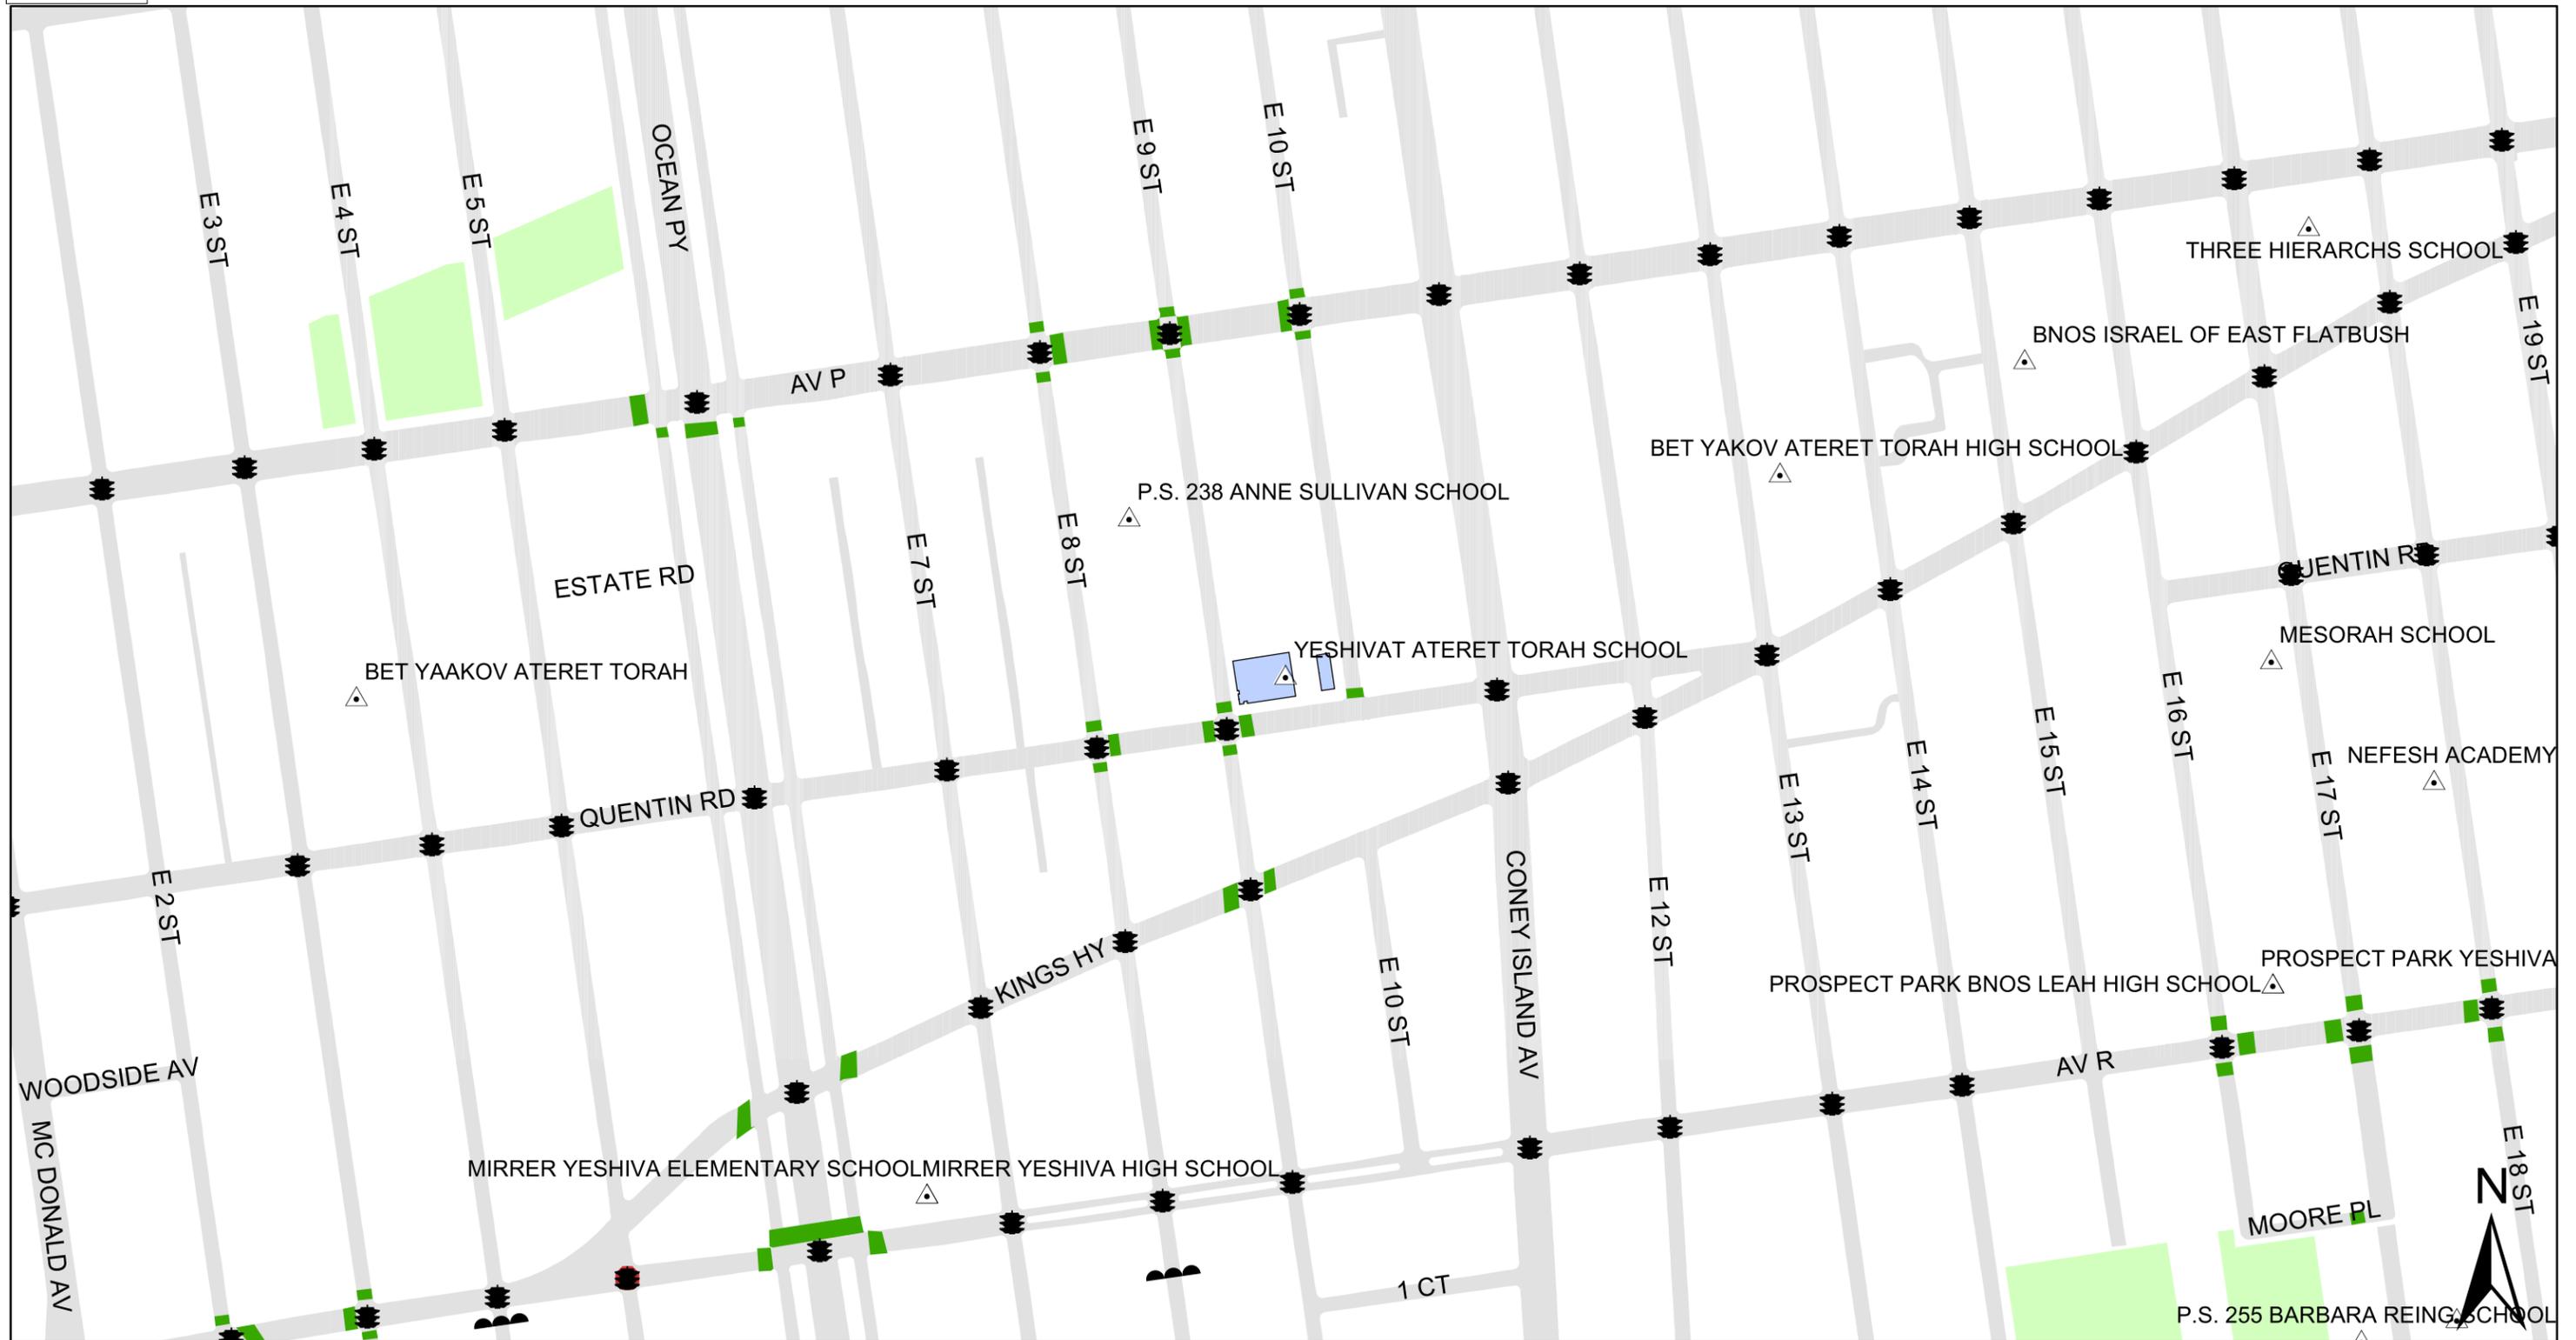
Map created on 11/16/2006 **EXHIBIT 3** COMM. BOARD: 315
PRECINCT: 61

There is no crossing guard assigned to Yeshivat Ateret Torah. One crossing guard (assigned to P.S. 238) was stationed at the intersection of East Ninth Street and Quentin Road (see Exhibit 3).

Currently there is a crossing guard assigned to the intersection of East Ninth Street and Quentin Road. This crossing guard is only there at the arrival and dismissal times corresponding with operations at P.S. 238. It is recommended that a request be submitted to the Police Department for this crossing guard to be present at the arrival and dismissal times of Yeshivat Ateret Torah also.

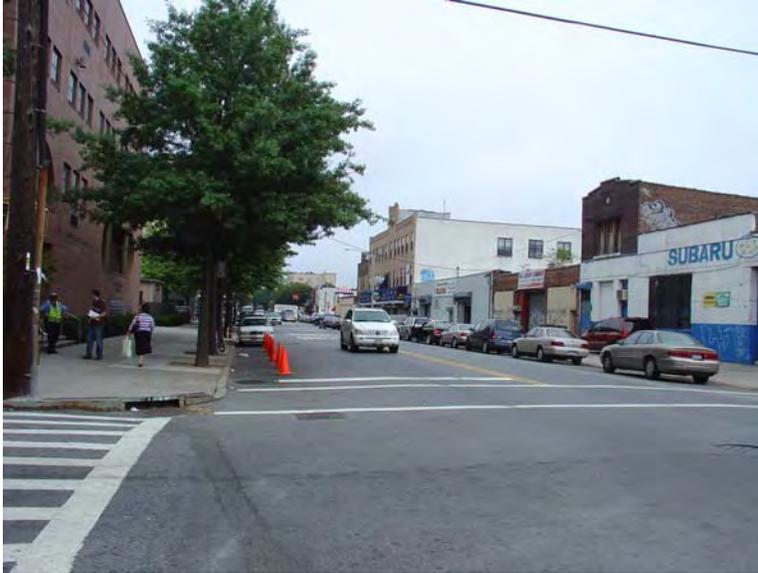
According to school officials approximately 15% of the students are transported by three school buses. The school officials place cones along the curb in front of the school on Quentin Road to restrict vehicle parking (Figure 3). When the school buses arrive school officials move the cones to allow the buses to pull up to the curb.

Figure 3. Cones along the curb prohibit vehicle parking to allow school buses to pick up students at the curb

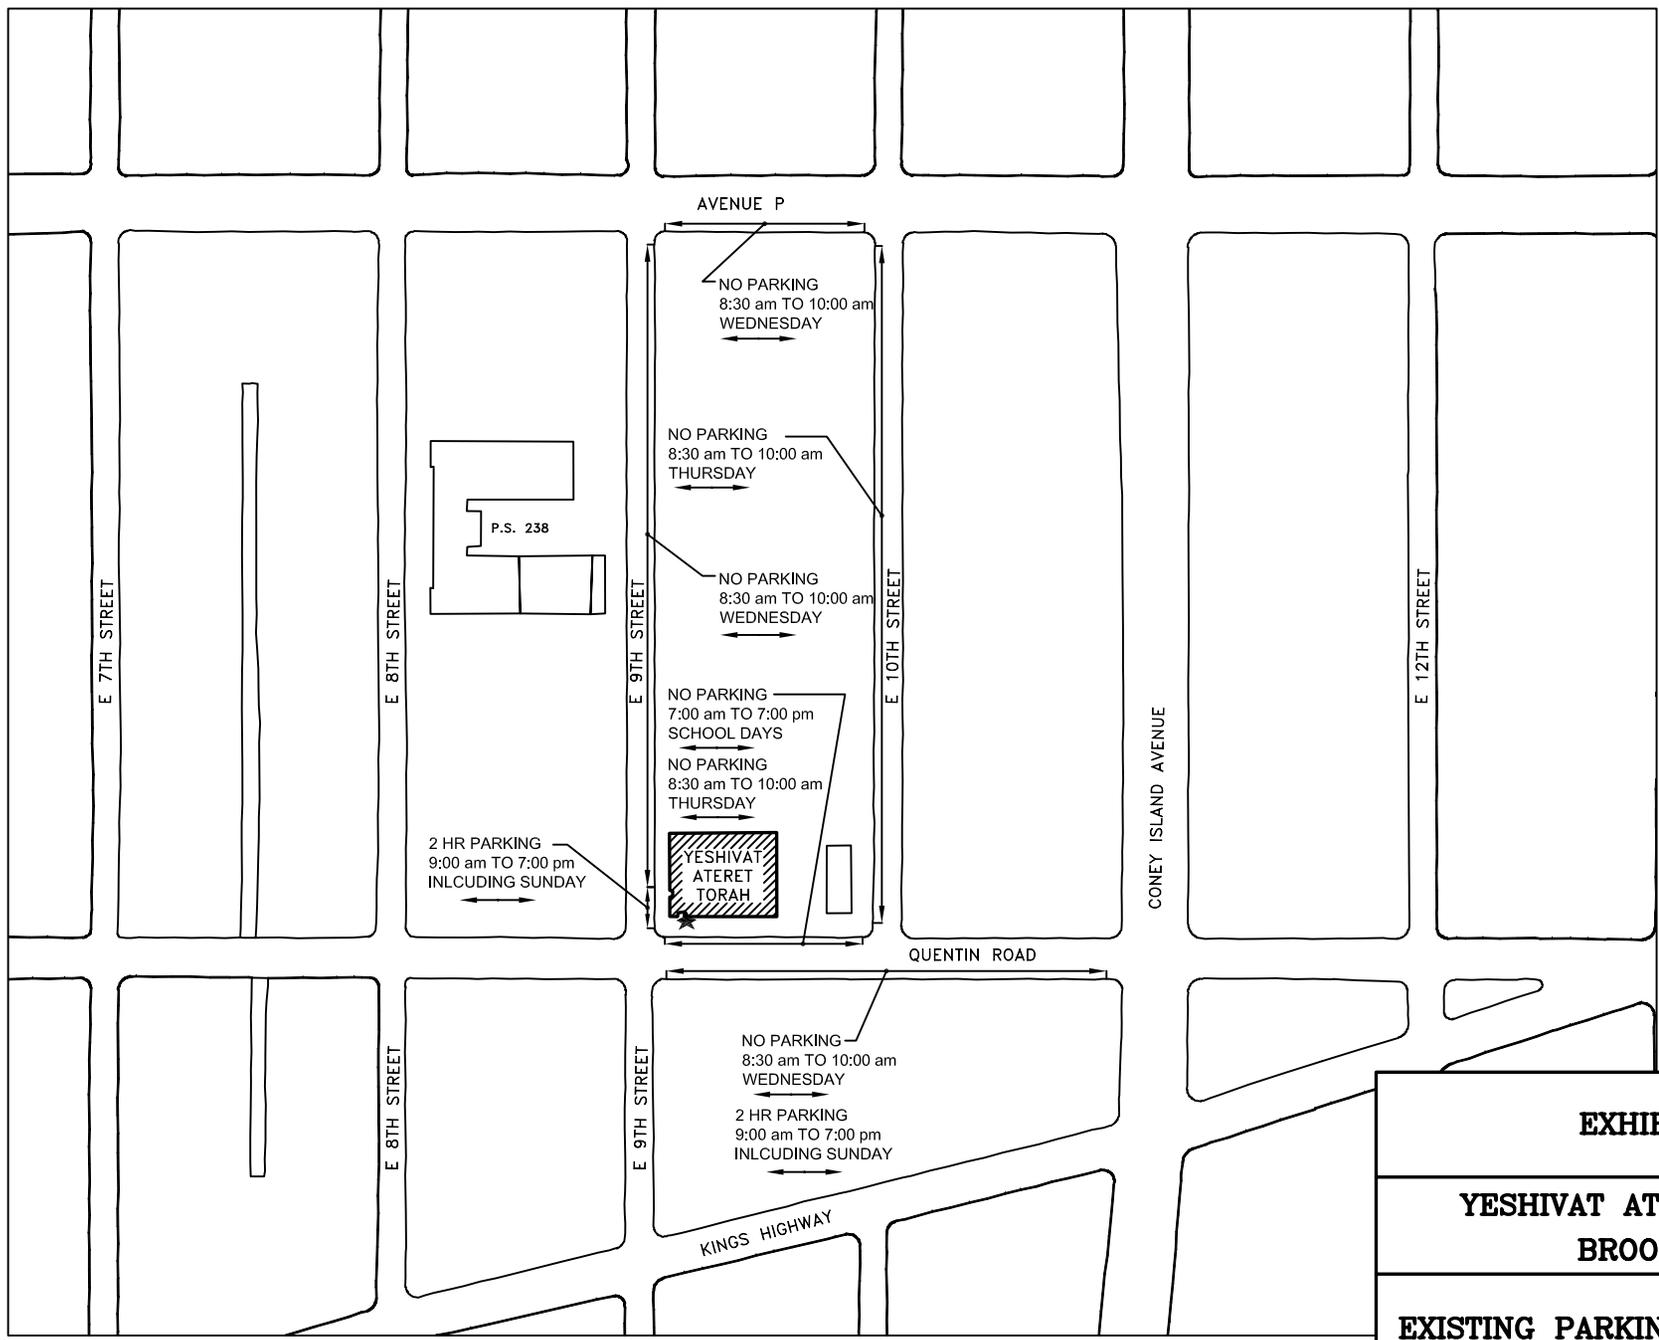
EXHIBIT 4

Exhibit 4 shows parking regulations on the roadways surrounding the school. On Quentin Road, “NO PARKING 7:00 AM – 7:00 PM, SCHOOL DAYS” parking regulations are posted in front of the school. On the other side of Quentin Road “2 HR PARKING, 9:00 AM – 7:00 PM” signs are posted. For approximately 50 feet north from the intersection of East Ninth Street and Quentin Road there is a “2 HR PARKING, 9:00 AM – 7:00 PM” sign on each side of East Ninth Street.

Along East Ninth Street, in front of P.S. 238 there is a “NO STANDING, 7:00 AM – 4:00 PM, SCHOOL DAYS” parking regulation.

EXISTING PARKING REGULATIONS

“NO PARKING, 7:00 AM TO 7:00 PM, SCHOOL DAYS” parking regulations on Quentin Road directly in front of the school should be upgraded to “NO STANDING, 7:00 AM TO 7:00 PM, SCHOOL DAYS” for a length of 100 feet (Exhibit 7).

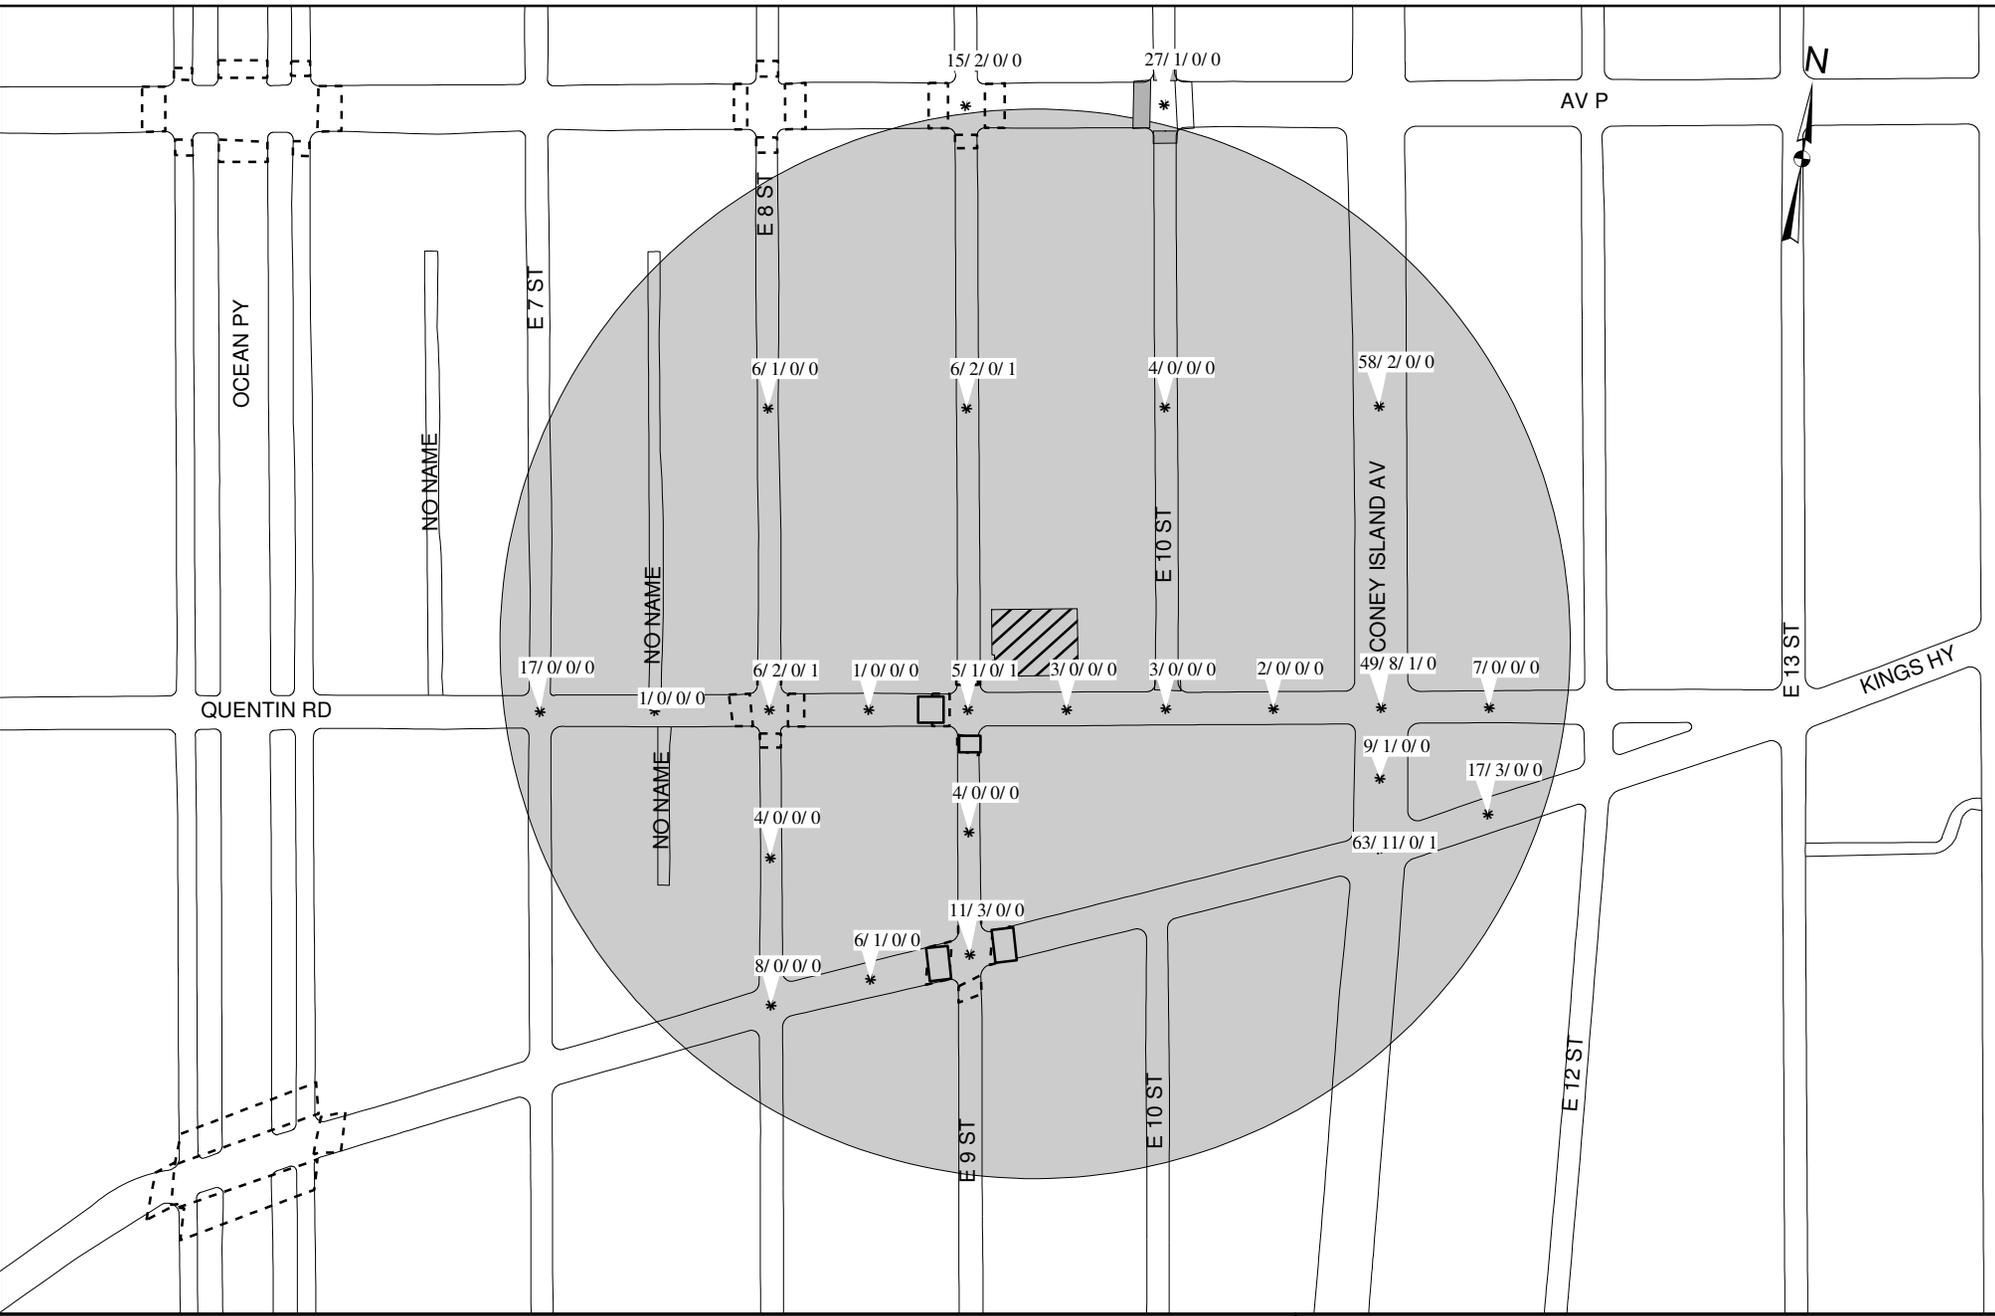
EXHIBIT 5

Exhibit 5 and Table 2 show a summary of accidents, as obtained from the New York State Department of Motor Vehicles (DMV), in the vicinity of Yeshivat Ateret Torah School for the three-year period from January 1, 1998 through December 31, 2000. The DMV data provides some detail relating to the circumstances and cause of the accidents. Table 3 is a summary of more recent accident data obtained from the NYC Police Department (NYPD). Though current through 2004, the NYPD data does not provide the same level of detail as the DMV data.

ACCIDENT SUMMARY

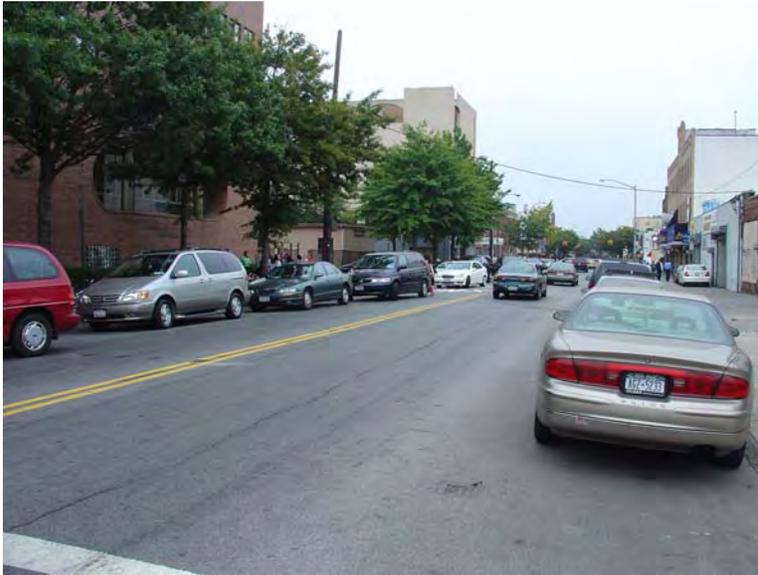
Quentin Road is a 45-foot wide, two-way (east-west) roadway with one travel lane in each direction and parking on both sides. Parking is not permitted 7:00 am to 7:00 pm on the north side of the street in front of the school. East Ninth Street is a 30-foot wide one-way (southbound) roadway with one travel lane and parking on both sides of the street. This intersection is controlled by a traffic signal. There are school crosswalks on the north, south and west legs of the intersection.

Figure 4. Quentin Road with Yeshivat Ateret Torah on the left.

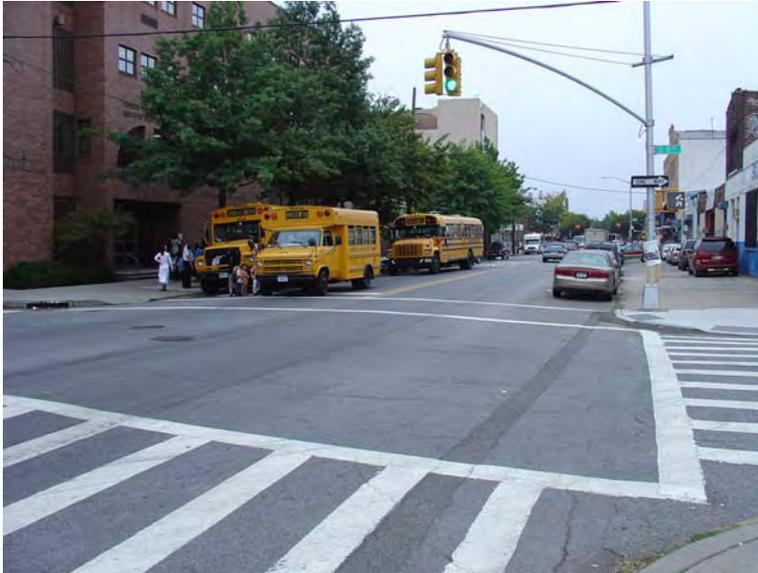
There is congestion on both Quentin Road and East Ninth Street during dismissal time. The school officials set cones along the curb to prevent vehicles from parking in front of the main entrance. This area, reserved for buses, is not sufficient to accommodate all the school buses, and therefore some buses still double-park (Figure 5). It was also observed that vehicles double-park or park in crosswalks to pick up students (Figure 6.)

Figure 5. Buses double-park at dismissal.

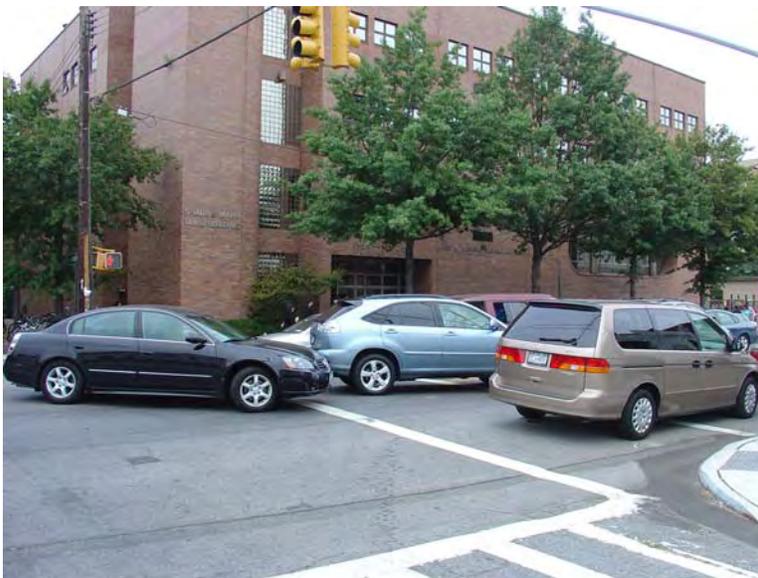
Figure 6. Intersection of Quentin Road and East Ninth Street during dismissal time.

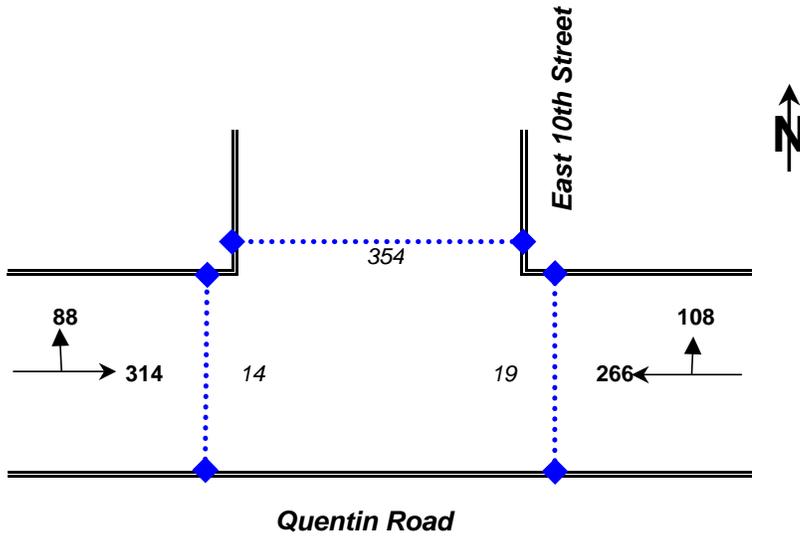
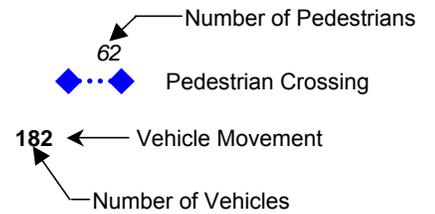
| EXHIBIT 6 |

A one-hour traffic count was performed on September 22, 2005 from 2:30 pm to 3:30 pm (Exhibit 6). The results show that the majority of pedestrians cross East 10th Street with the school crosswalk, 354 pedestrians total. Only a small number of pedestrians cross Quentin Road at this intersection.

One Hour Traffic Count Volumes
 (2:30 PM - 3:30 PM Sept. 22, 2005)
