**New York City Department of Transportation
Office of School Safety Engineering**

FINAL REPORT: Yeshivat Ateret Torah, Brooklyn

Prepared by
The RBA Group/Urbitran Associates

AUGUST 9, 2006

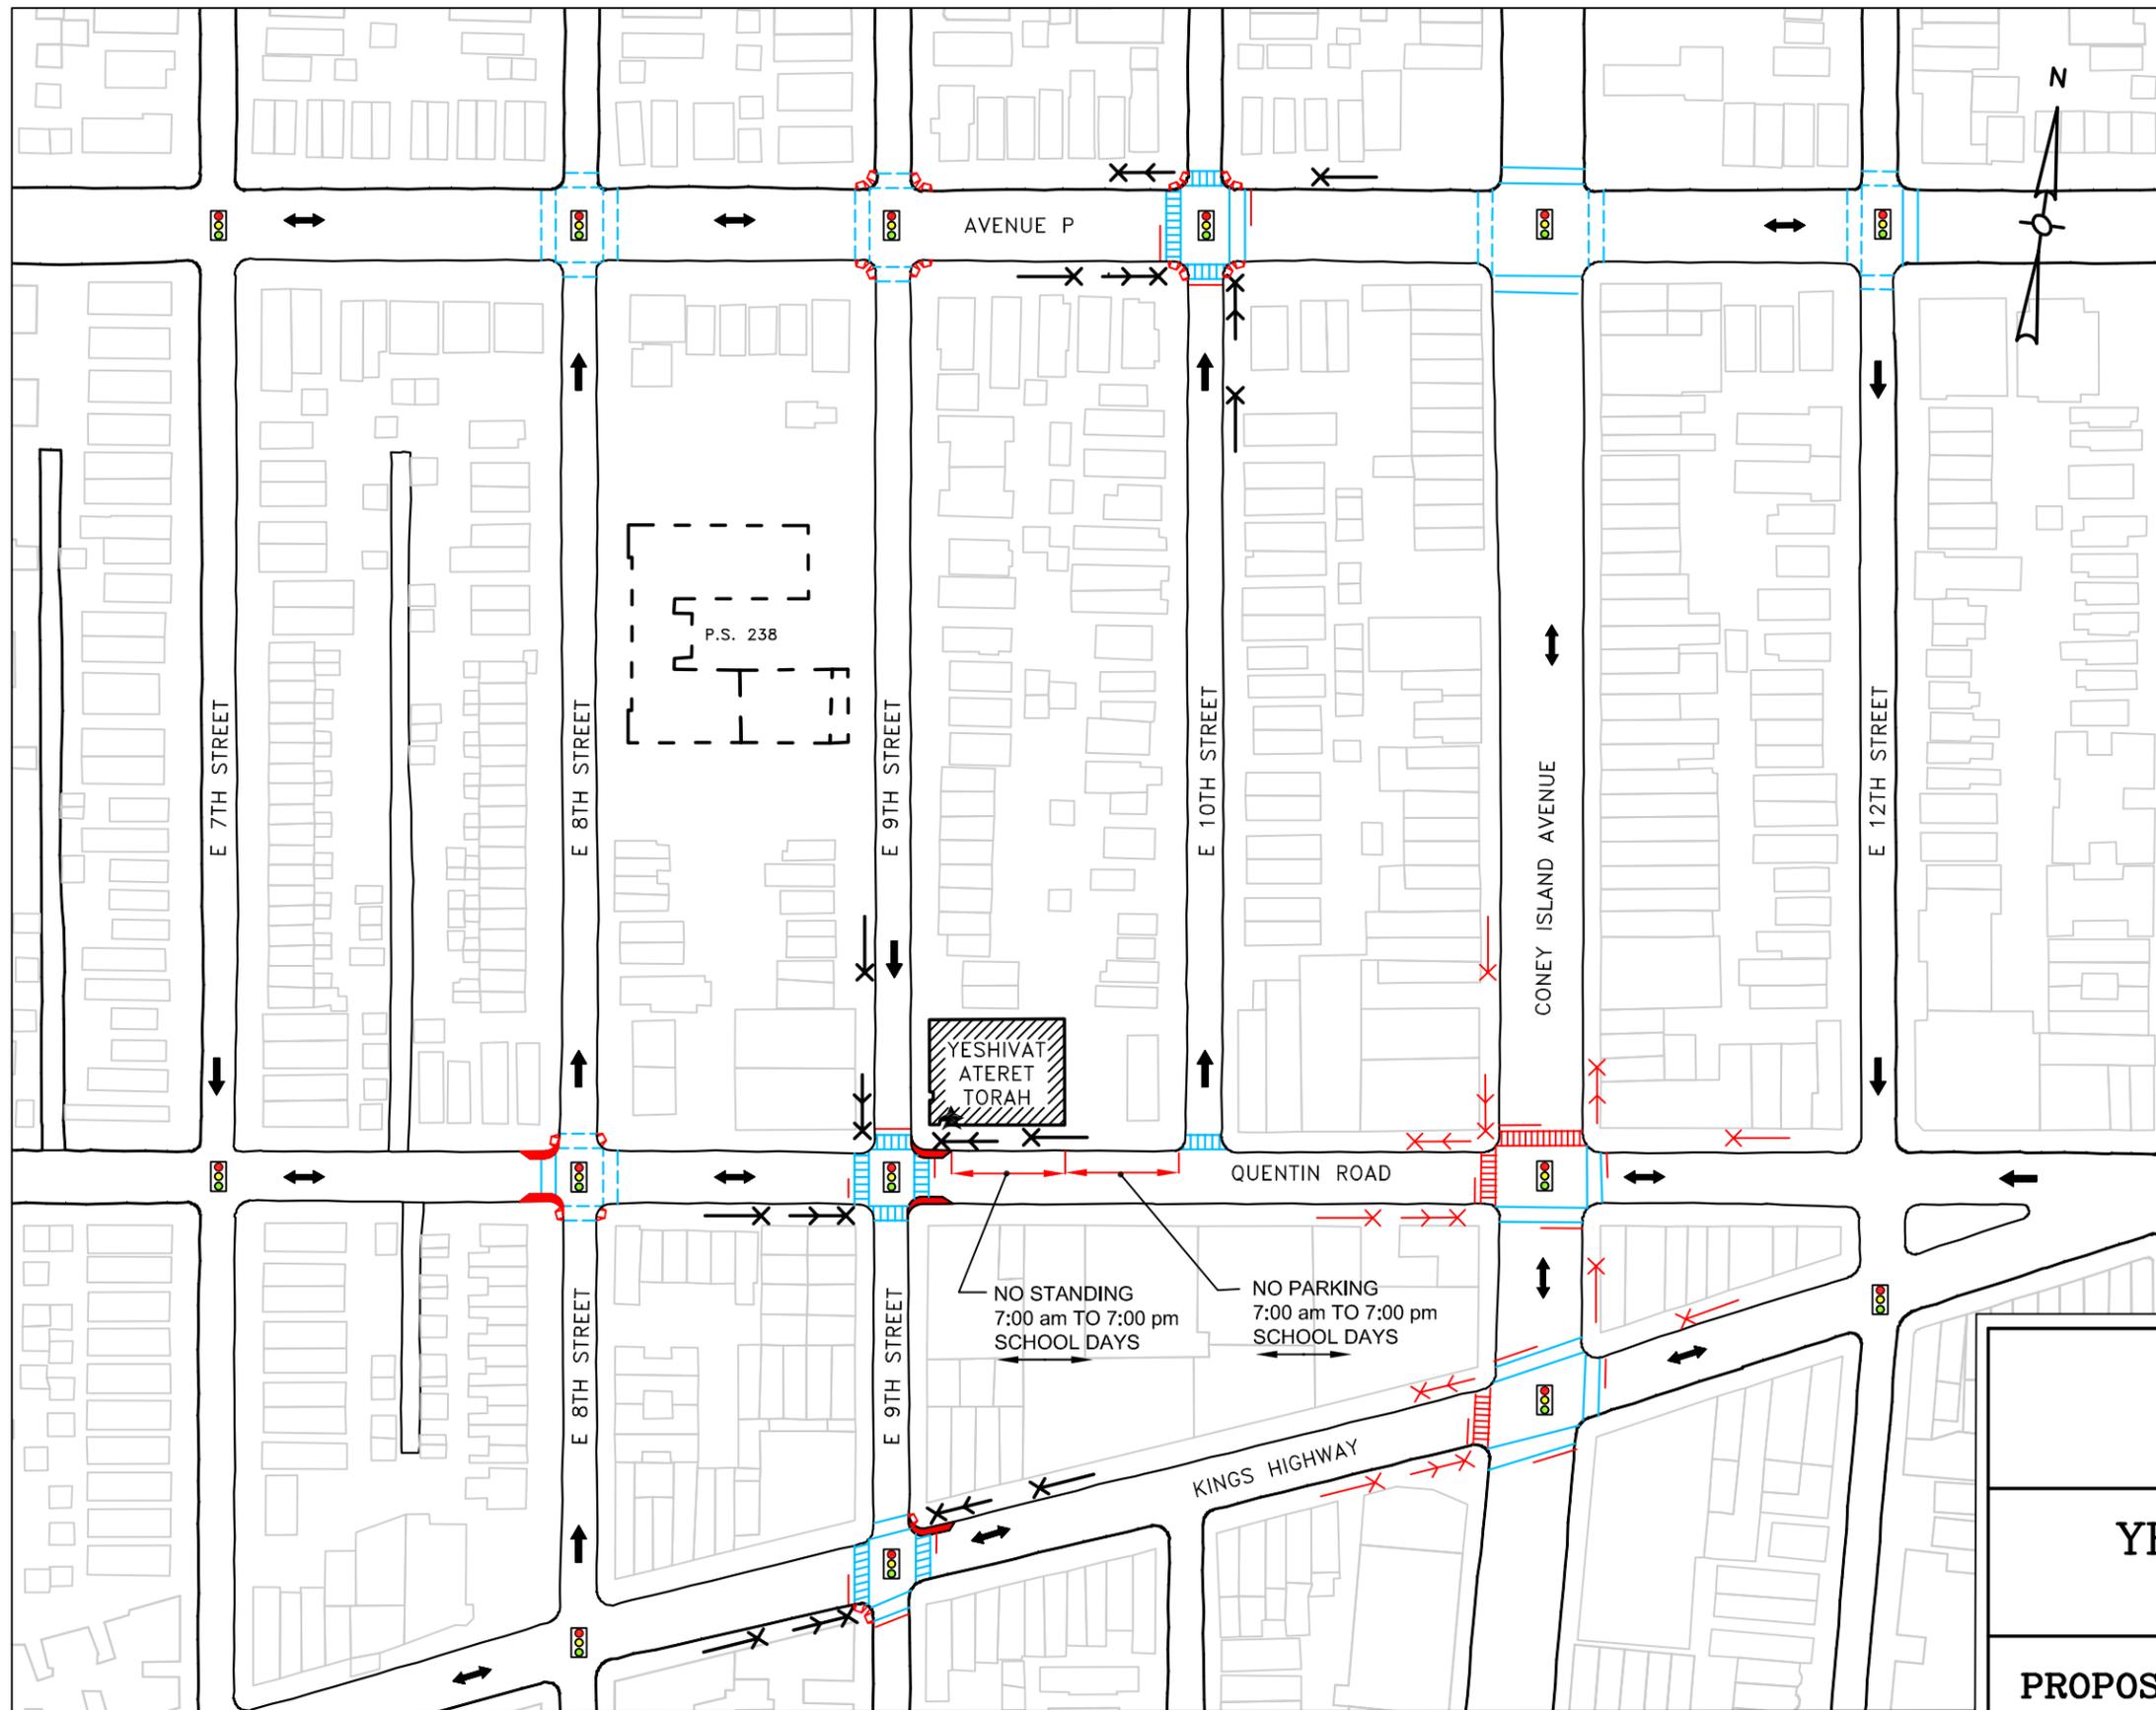
EXHIBIT 7

PROPOSED MEASURES TO IMPROVE SAFETY

“NO PARKING, 7:00 AM TO 7:00 PM, SCHOOL DAYS” parking regulations on Quentin Road directly in front of the school should be upgraded to “NO STANDING, 7:00 AM TO 7:00 PM, SCHOOL DAYS” for a length of 100 feet (Exhibit 7).

New pedestrian ramps should be installed at all locations where there are currently no pedestrian ramps, where only one ramp currently exists or where a pole requires relocation to facilitate the standard ramp installation. See Exhibit 7 for locations of proposed pedestrian ramps.

Curb extensions should be installed at the corners as shown in Exhibit 7.

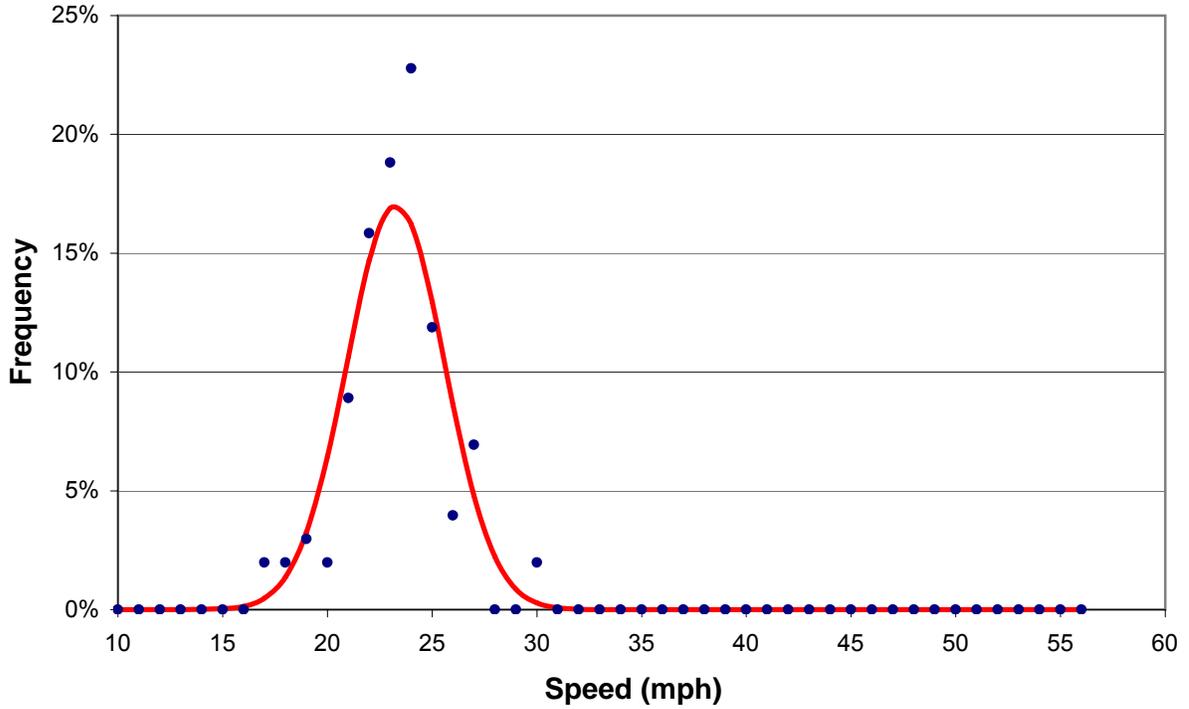
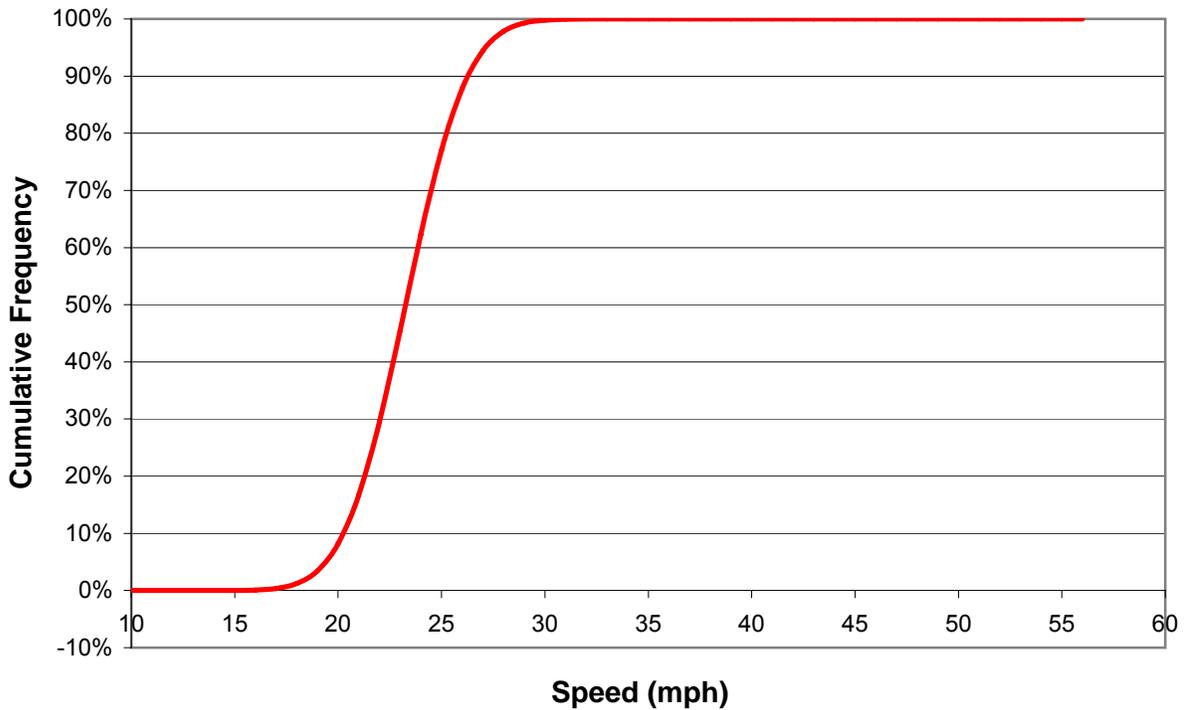
Mean Speed = 23.3 mph
Standard Deviation = 2.3 mph
Margin of Error (95% Confidence) = ± 0.5 mph

Median Speed = 23.3 mph
15th Percentile Speed = 20.8 mph
85th Percentile Speed = 25.7 mph
