**New York City Department of Transportation
Office of School Safety Engineering**

FINAL REPORT: Christ the King, Bronx

**Prepared by
The RBA Group and URBITRAN Associates Inc.**

July 14, 2006

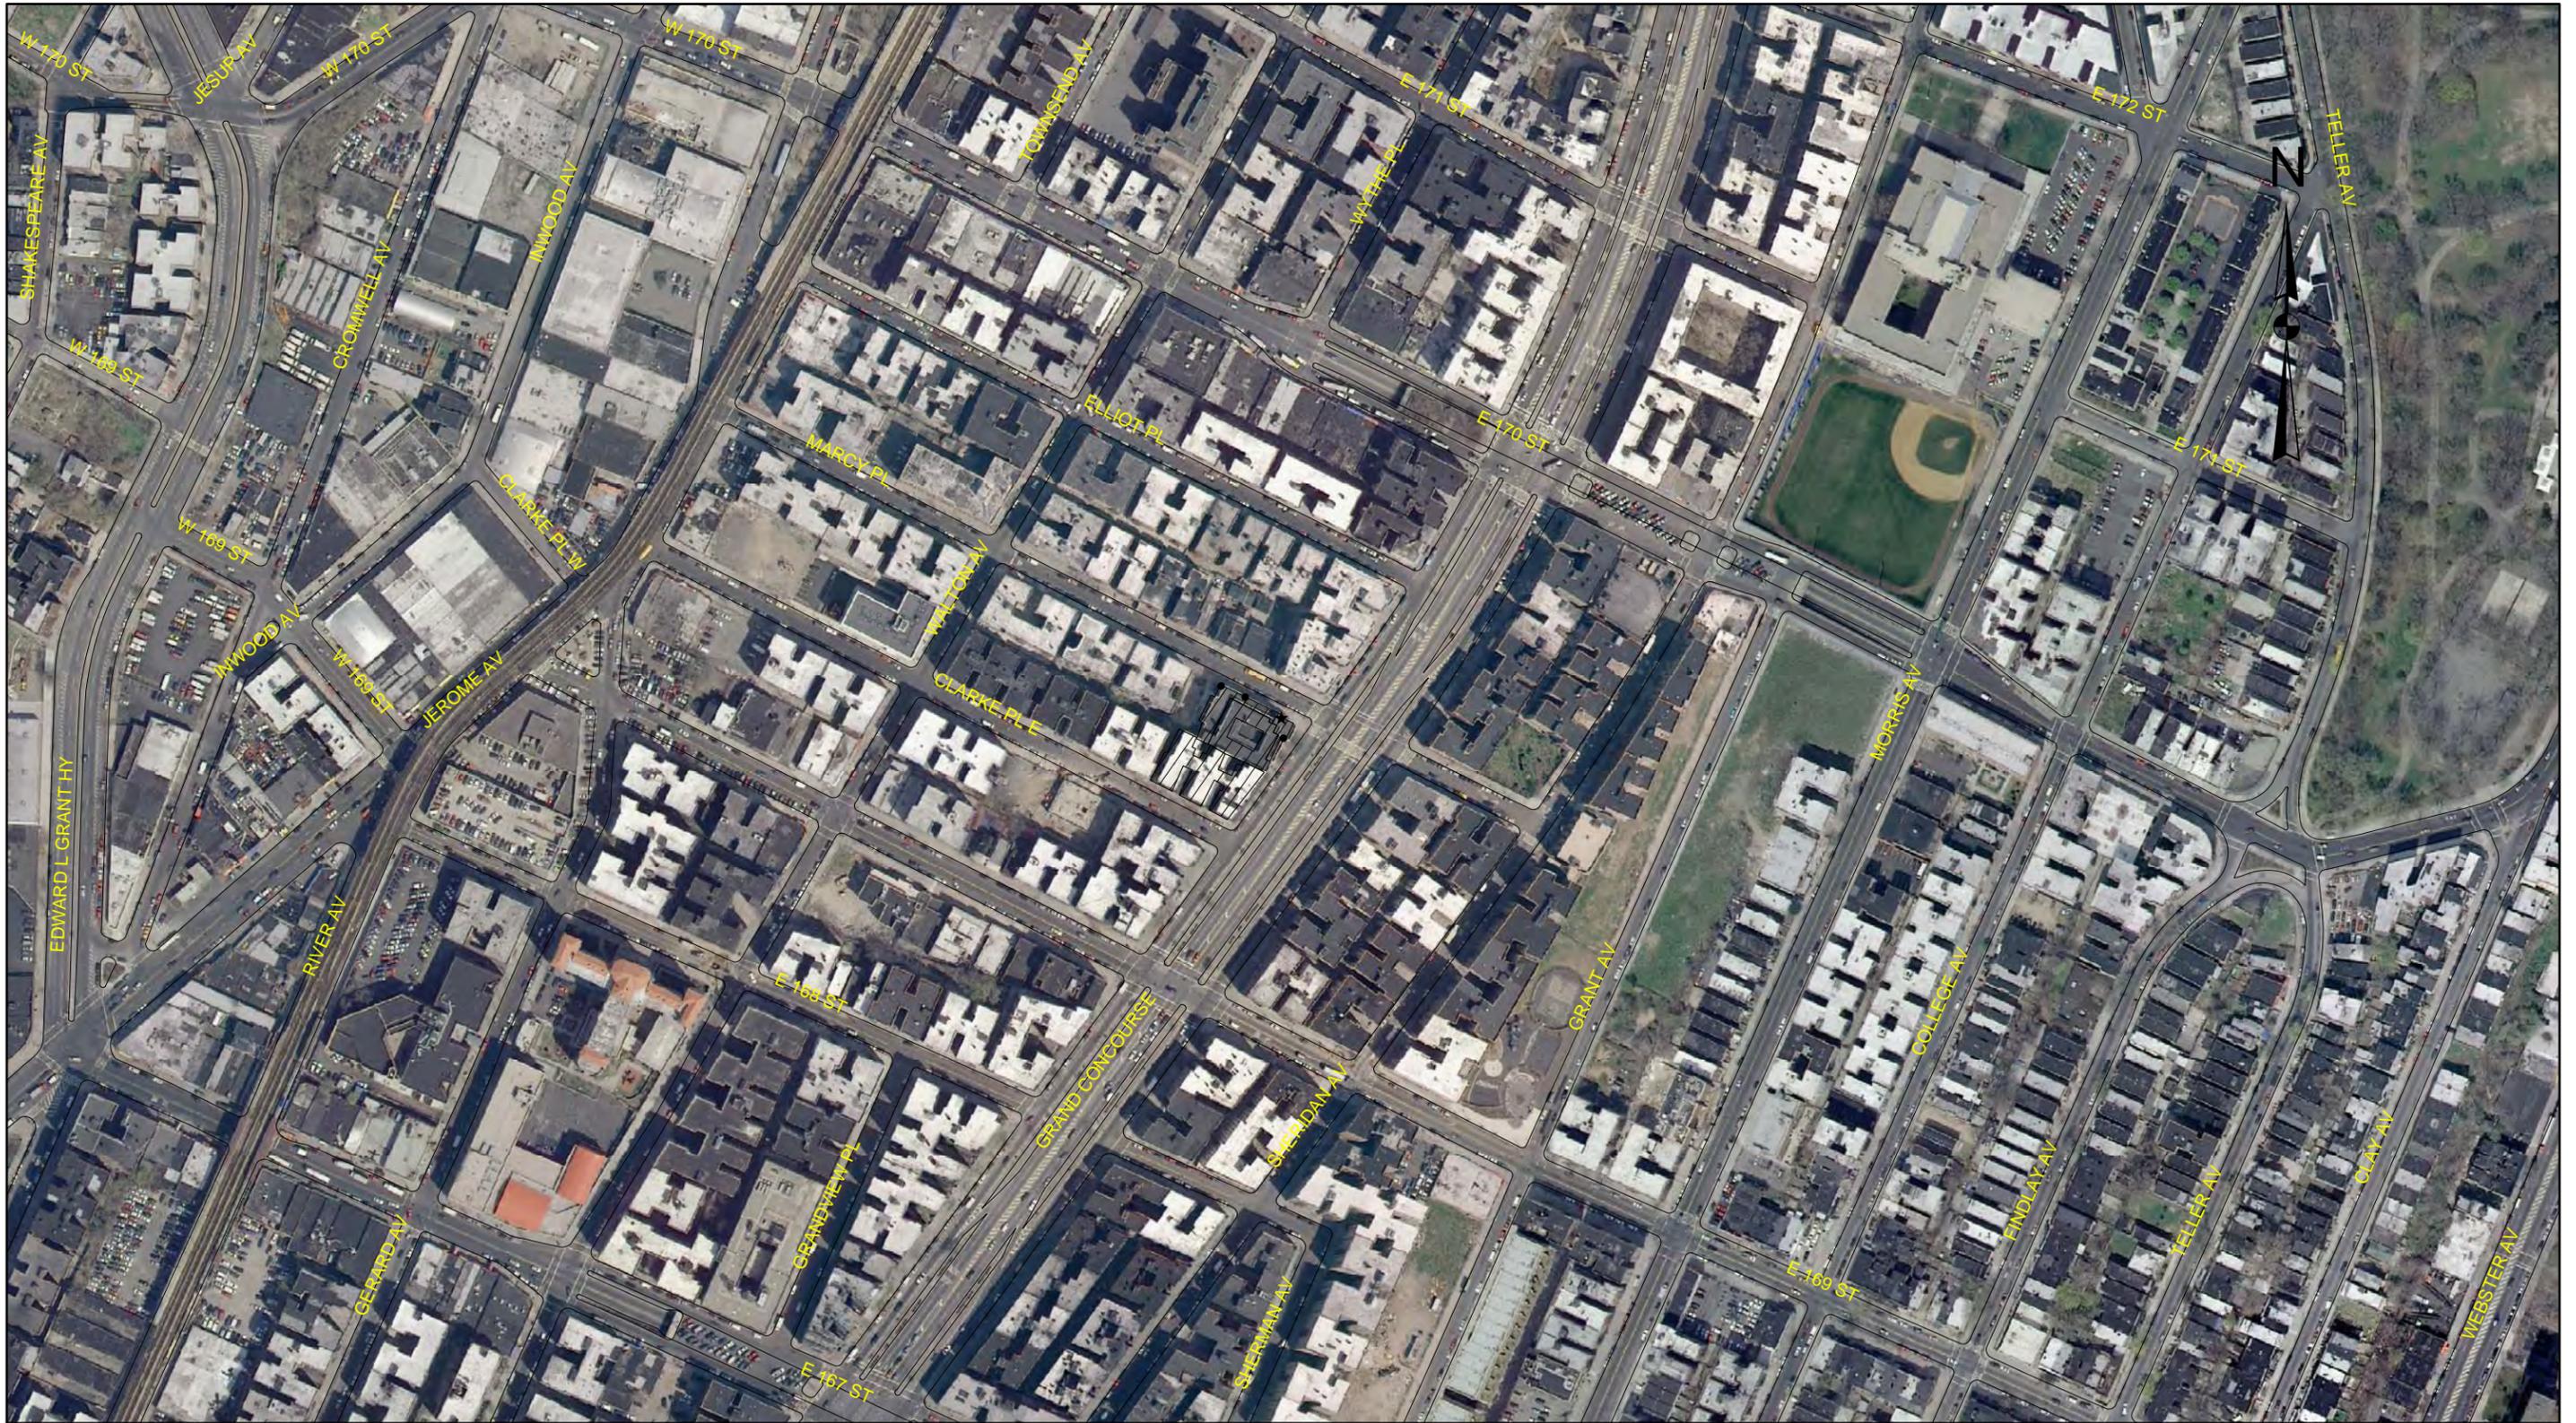
EXHIBIT 1

Exhibit 1 shows an aerial view of the neighborhood surrounding the school. Christ the King School is bounded by Marcy Place to the north, Clarke Place East to the south, Grand Concourse to the east, and Walton Avenue to the west. The area surrounding the school is generally residential in character with primarily high-density, multi-level, apartment buildings. The Grand Concourse is a major commercial corridor with significant vehicle and pedestrian traffic.

AERIAL PHOTOGRAPH

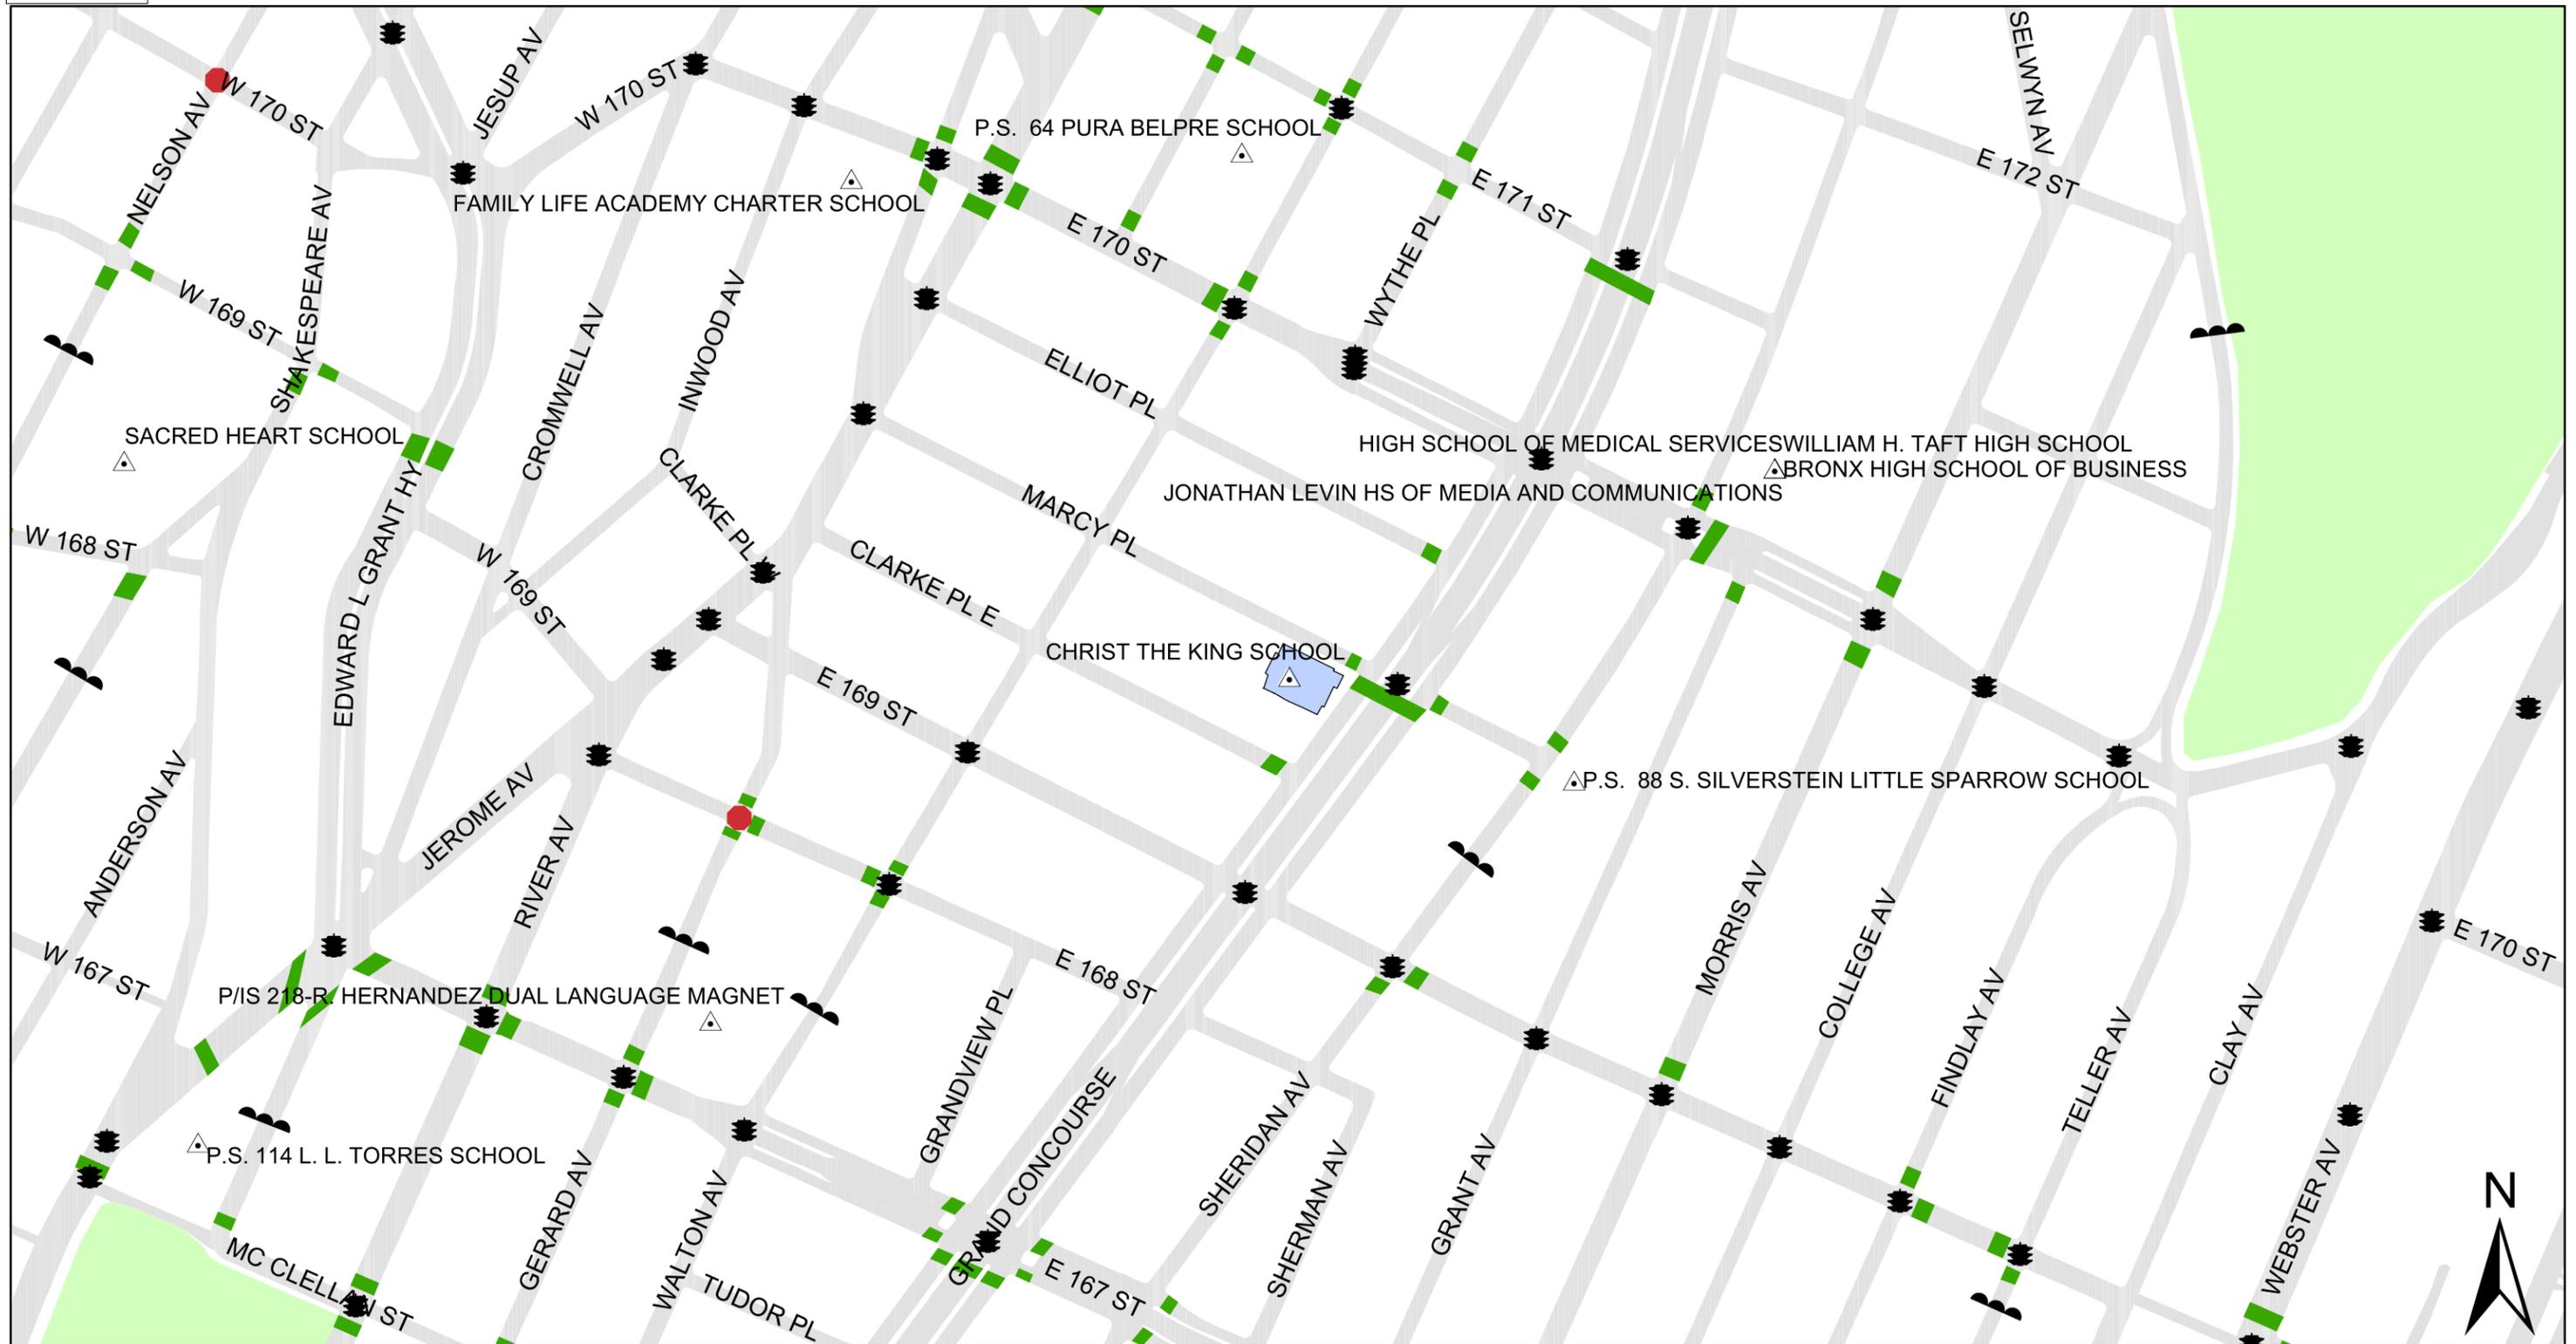
EXHIBIT 2

The School Traffic Safety Map was established to help provide the maximum degree of safety for children going to and from school - by indicating the location of speed reducers, school crosswalks and some traffic control devices. (While virtually all intersections in NYC benefit from traffic control devices - such as stop signs, traffic signals, yield signs, and all way stop signs - this map shows only traffic signals and all way stop signs.) The school crosswalks that are shown are ladder striped and make the crosswalk more visible to drivers and help make the intersection safer. These crosswalks are where school children are recommended to cross.

Exhibit 2 shows the existing school signals and pavement markings around the Christ the King School. It should be noted that a citywide signage program is currently underway to upgrade school signage to the current edition of the Federal Manual of Uniform Traffic Control Devices (MUTCD) standards of fluorescent yellow-green accompanied by downward pointing arrows. (Signs scheduled to be installed under this program are shown as "existing" in Exhibit 6.)

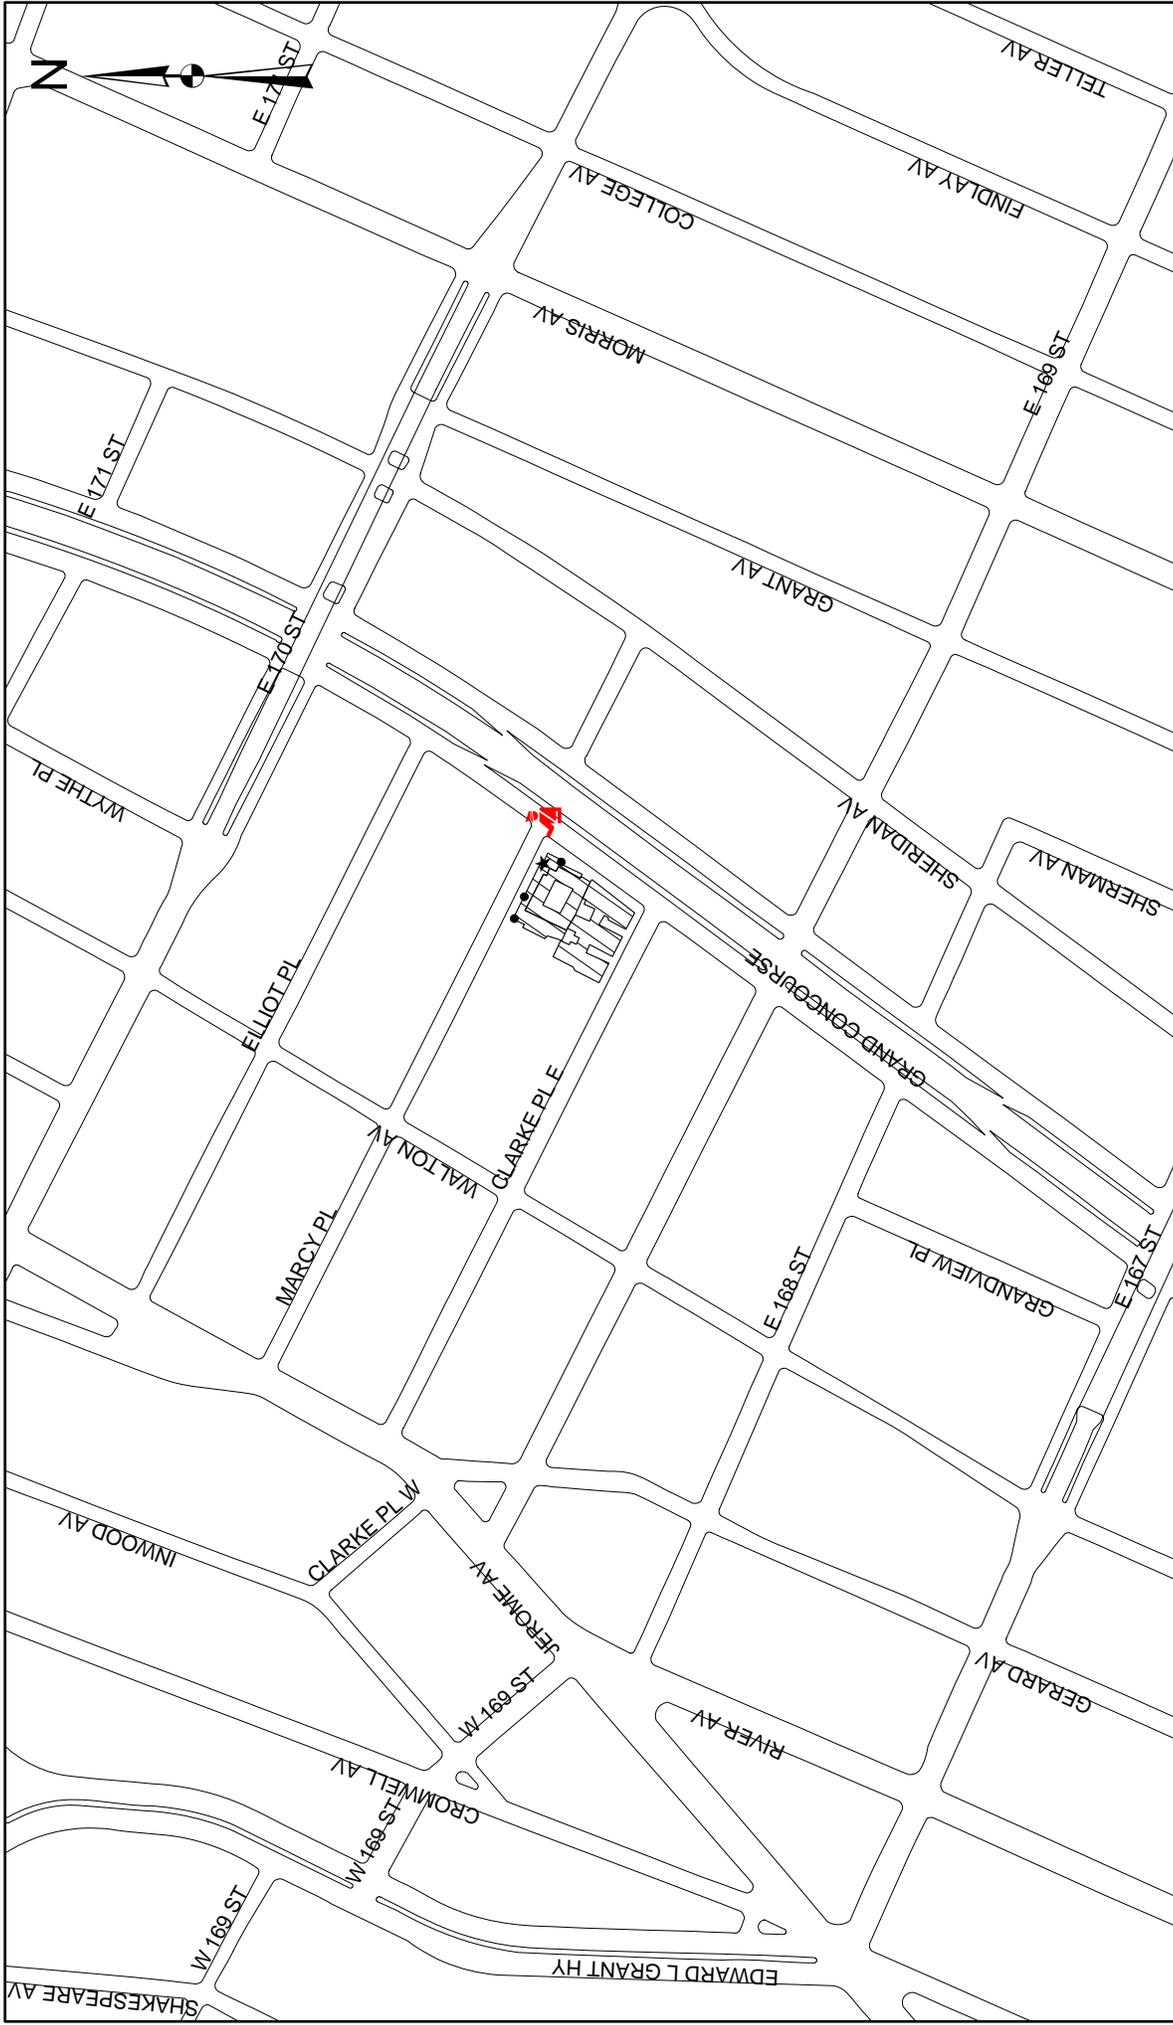
EXHIBIT 3
CHRIST THE KING SCHOOL BRONX
CROSSING GUARD LOCATION

According to the school principal, one school crossing guard is assigned to the intersection of Marcy Place & the Grand Concourse.

The crossing guard location is shown in Exhibit 3 at the end of this section.

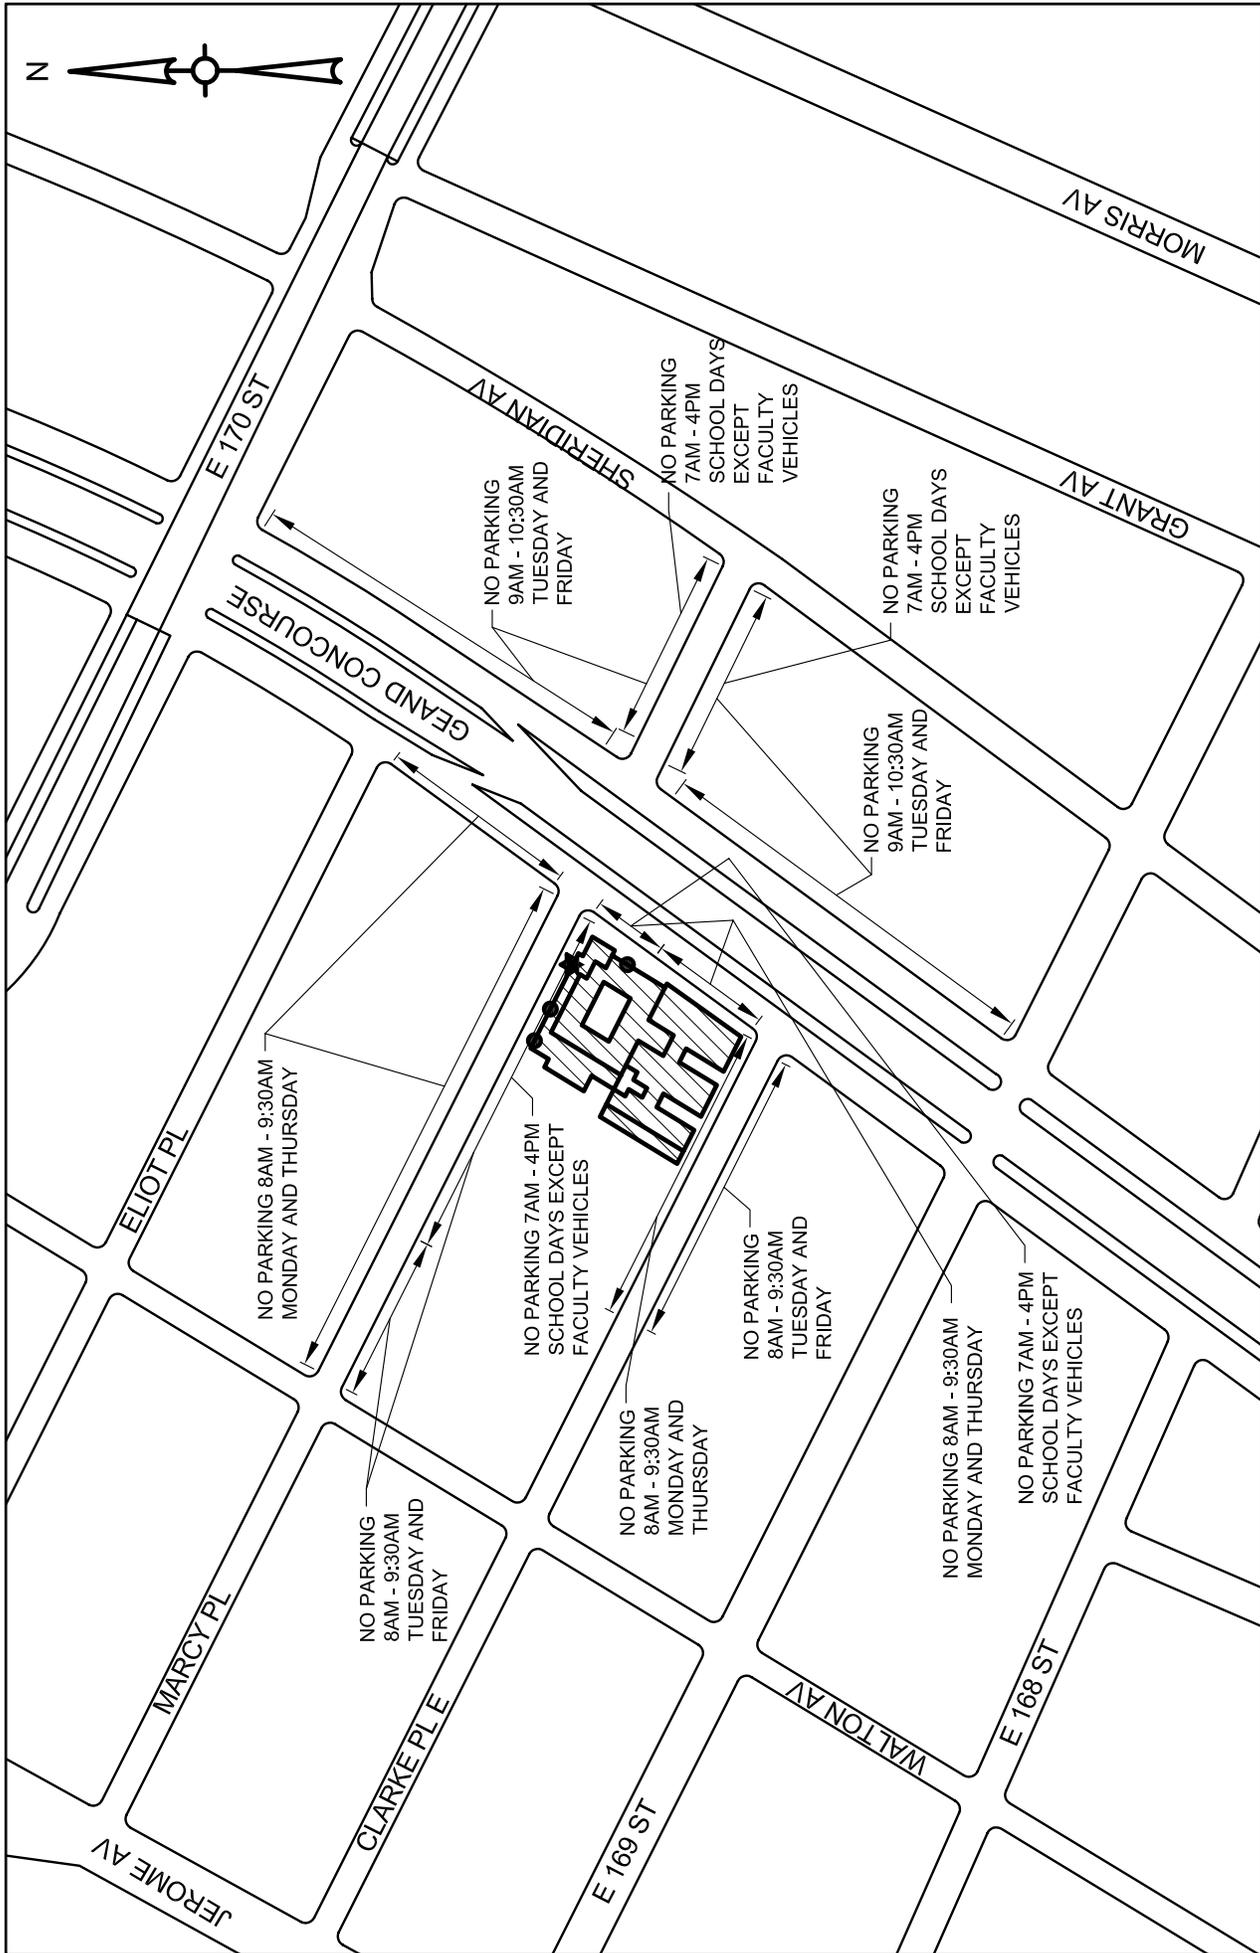
EXHIBIT 4

Parking regulations around the school block-faces are shown in Exhibit 4 in this section.

EXISTING PARKING REGULATIONS

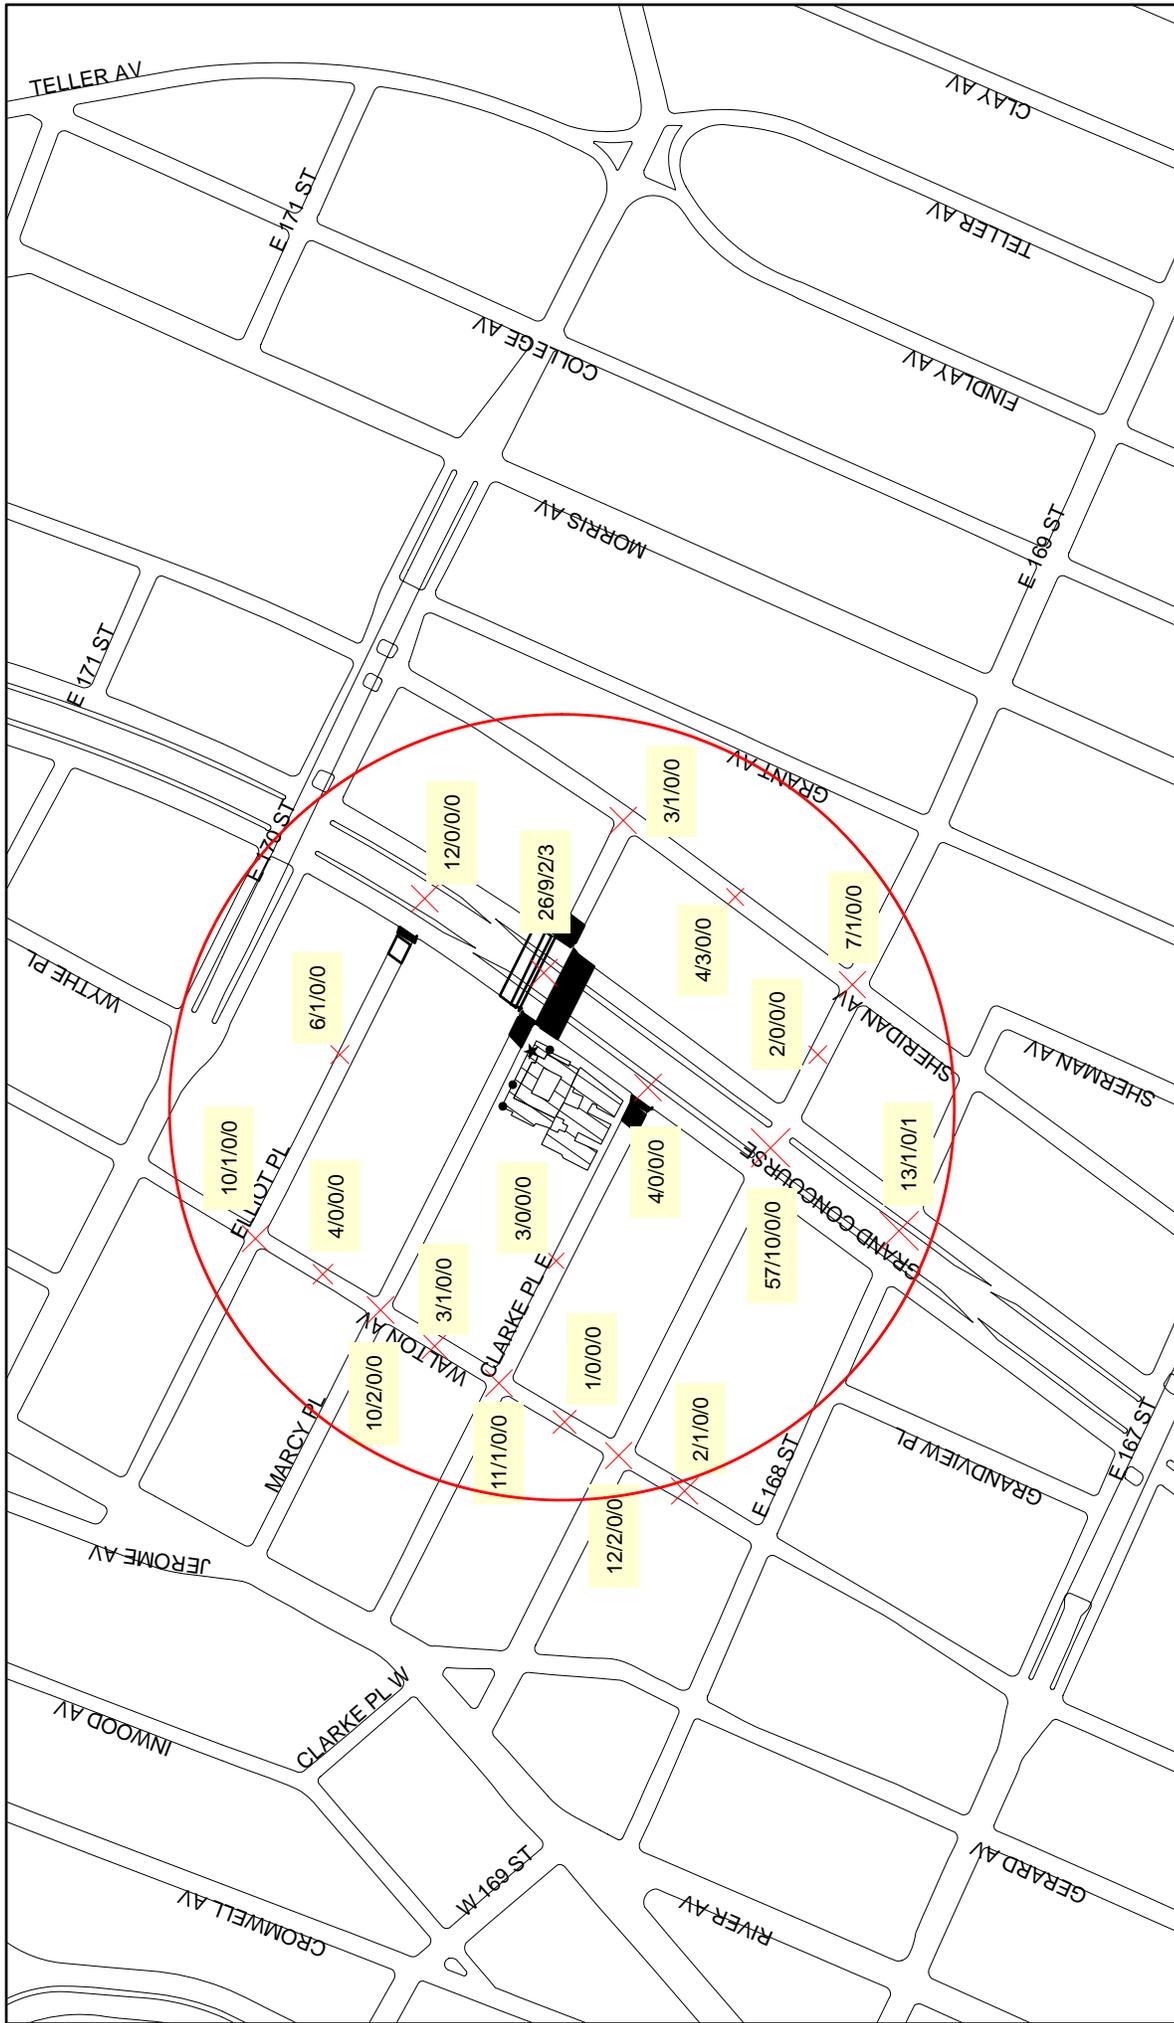
EXHIBIT 5

Exhibit 5 and Table 2 show a summary of accidents, as obtained from the New York State Department of Motor Vehicles (DMV), in the vicinity of Christ the King School for a three-year period from January 1, 1998 through December 31, 2000. The DMV data provides some detail relating to the circumstances and cause of an accident. Table 3 is a summary of more recent accident data obtained from the NYC Police Department (NYPD). Though current through 2004, the NYPD data does not provide the same level of detail as the DMV data.

ACCIDENT SUMMARY (1998-2000)

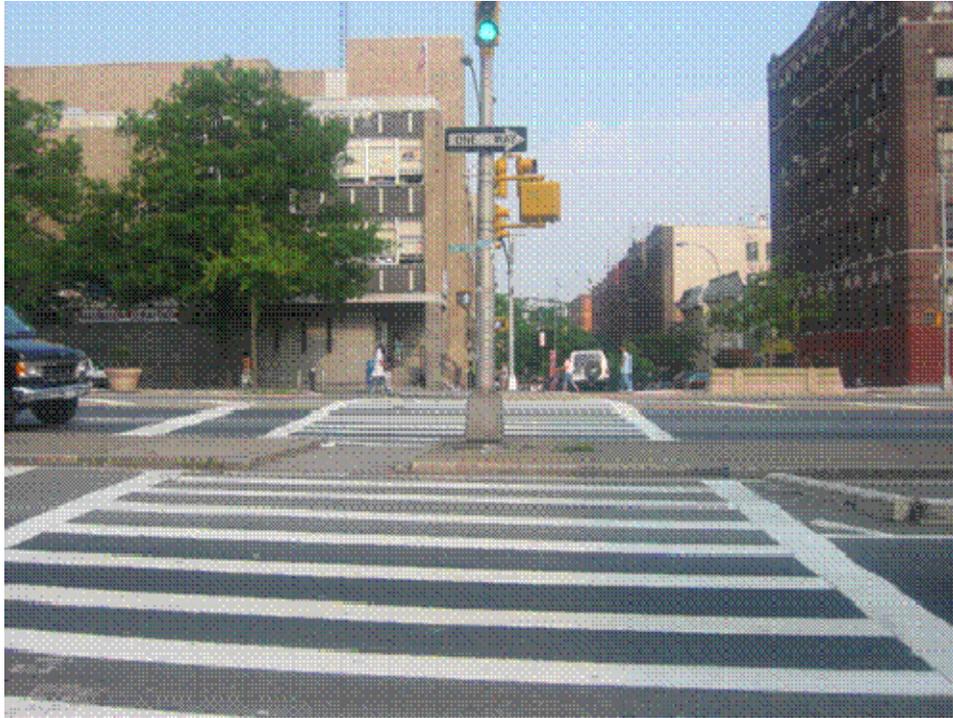
Marcy Place does not cross the Grand Concourse roadway, as in a typical four-leg intersection. There is no gap in the raised concrete median to allow vehicles to cross the Grand Concourse mainline roadways at this intersection. Marcy Place actually forms two T-intersections with the service roads, so all westbound Marcy Place vehicles must turn right to head northbound on the Grand Concourse service road, and no vehicles can turn to head westbound on Marcy Place from the Grand Concourse mainline roadway or northbound service roadway (see Figures 2 and 3).

Figure 2: Looking west across the Grand Concourse East Service Road toward Christ the King School

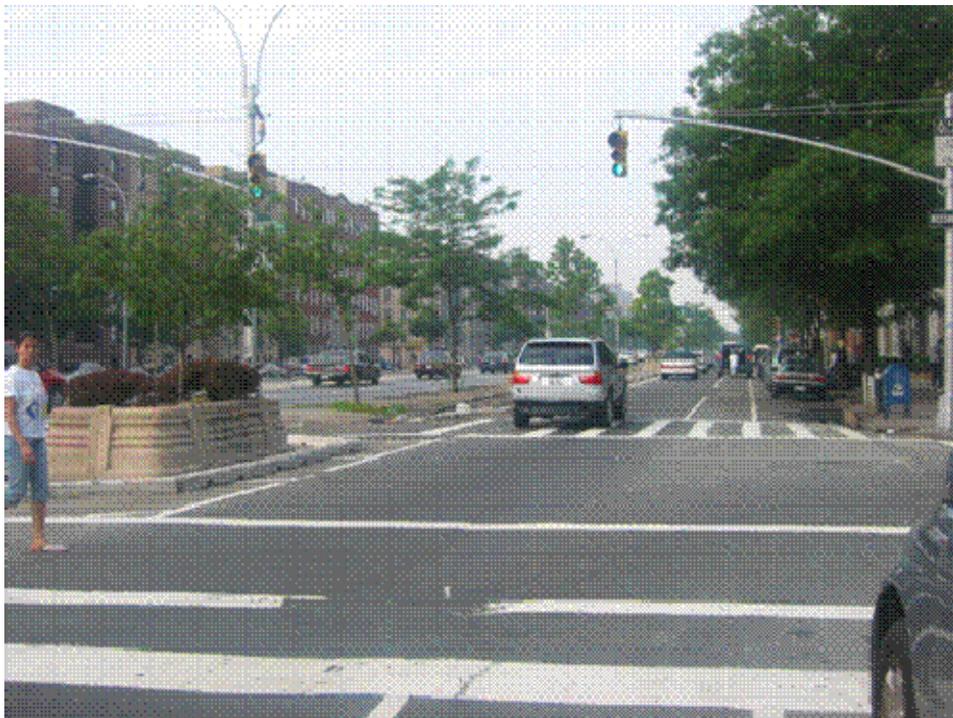
A pilot program for traffic calming devices was installed along the Grand Concourse Service Road in this area. The actual devices were concrete curb-stops placed along the right edge of the left lane, reducing the Service Roadway to one lane. Other streetscape type items, such as planters, were also then placed behind the concrete bumpers to enhance the visual aesthetic as well as make the closing of the left lane more apparent. The devices can be seen in Figures 3, 5, 7, and 8. The Service Roads originally had two traffic lanes and a parking lane in each direction, but the installation of these devices effectively transformed the Service Road to having one traffic lane, a bicycle lane, and a parking lane in each direction. The Community Board Chair explained the biggest problem they observed is that trash collects behind the concrete bumpers, and must be cleaned out.

Figure 3: As part of traffic calming measures, concrete curb-stops and planters are placed along the left lane of Grand Concourse West Service Road at Marcy Place

- Consideration should be given to make the interim measures permanent by widening the raised concrete medians.

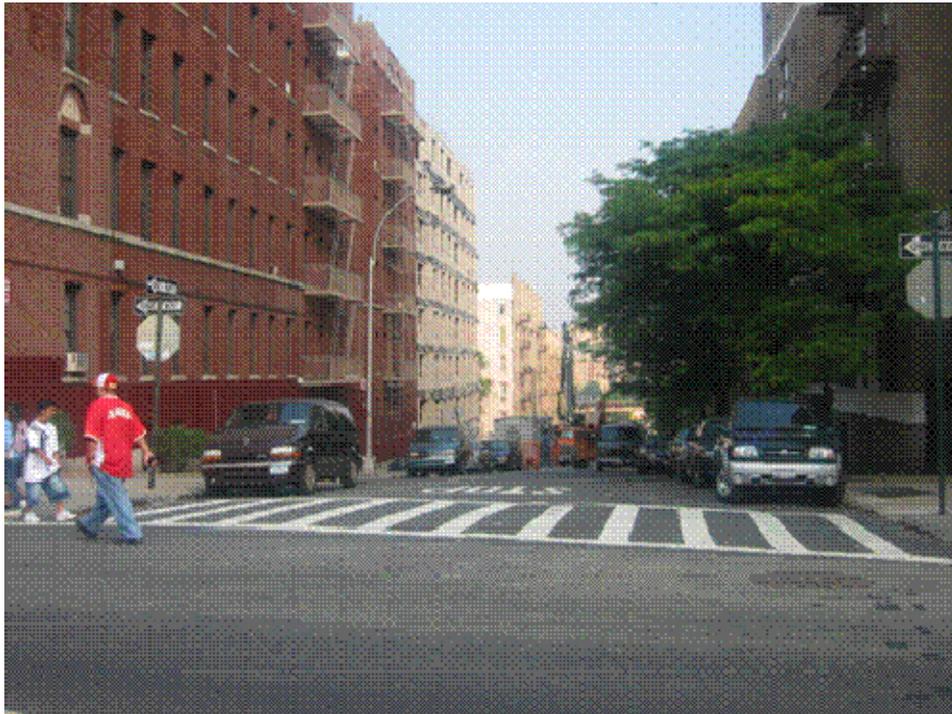
Clarke Place East does not connect with the Grand Concourse mainline roadway, as in a typical T-type intersection. There is no gap in the raised concrete median to allow vehicles to cross the Grand Concourse service roadway in order to access the mainline roadways at this intersection location. All eastbound Clarke Place East vehicles must turn right to head southbound on the Grand Concourse service road (see Figures 4 and 5).

Figure 4: Looking west on Clarke Place East from the Grand Concourse West Service Road

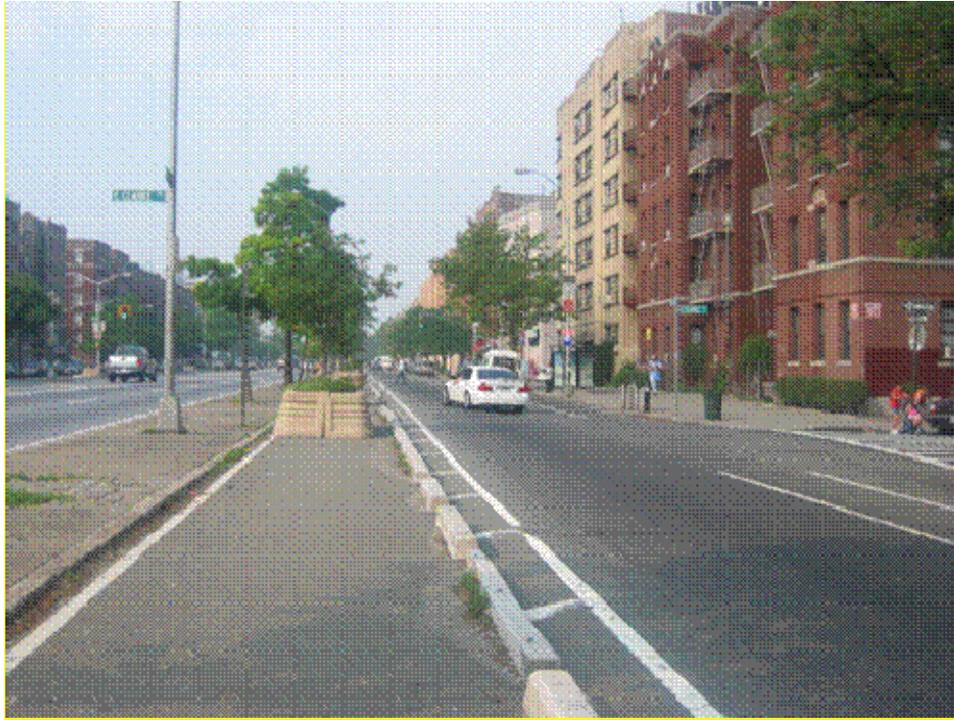
Figure 5: The recently implemented traffic calming measures including curb-stops and planter along the left lane of Grand Concourse West Service Road across Clarke Place East intersection

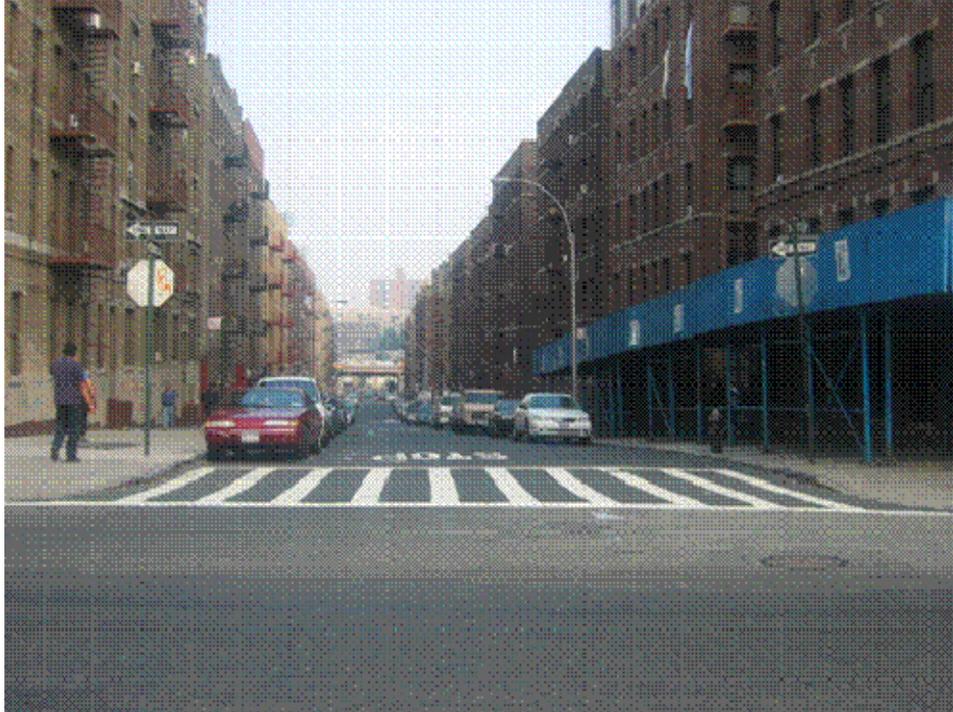
Elliot Place does not connect with the Grand Concourse mainline roadway, as in a typical T-type intersection. There is no gap in the raised concrete median to allow vehicles to cross the Grand Concourse service roadway, in order to directly access the mainline roadways at this intersection location. All eastbound Clarke Place East vehicles must turn right to head southbound on the Grand Concourse service road. There is, however, a

Figure 6: Looking west on Elliot Place from the Grand Concourse Service Road

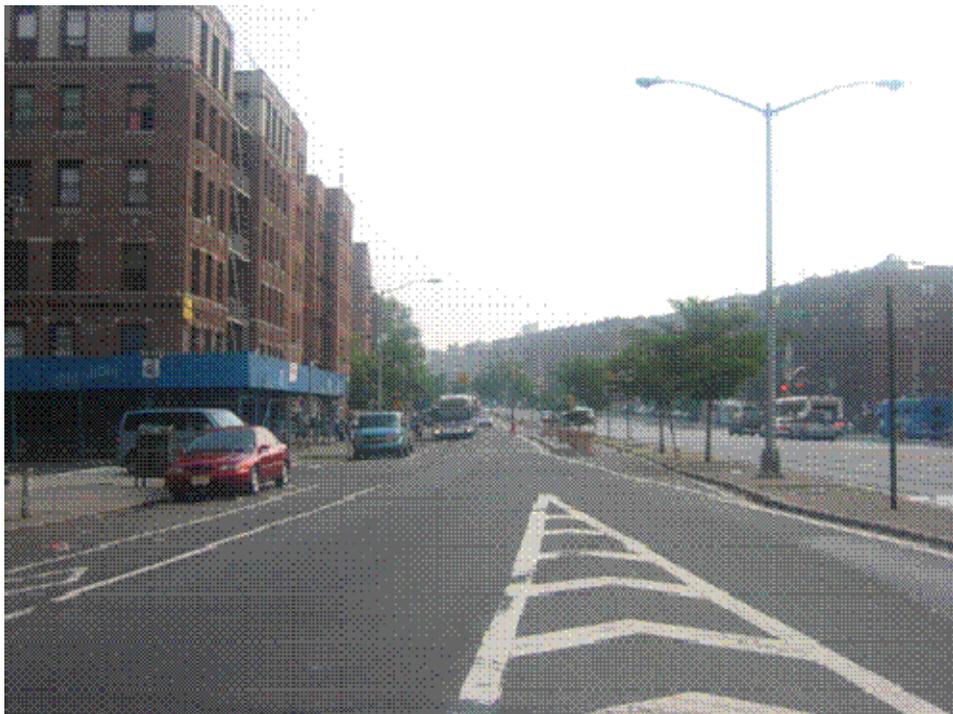
*Figure 7:
Looking north
along the Grand
Concourse
Service Road
toward Elliot
Place*

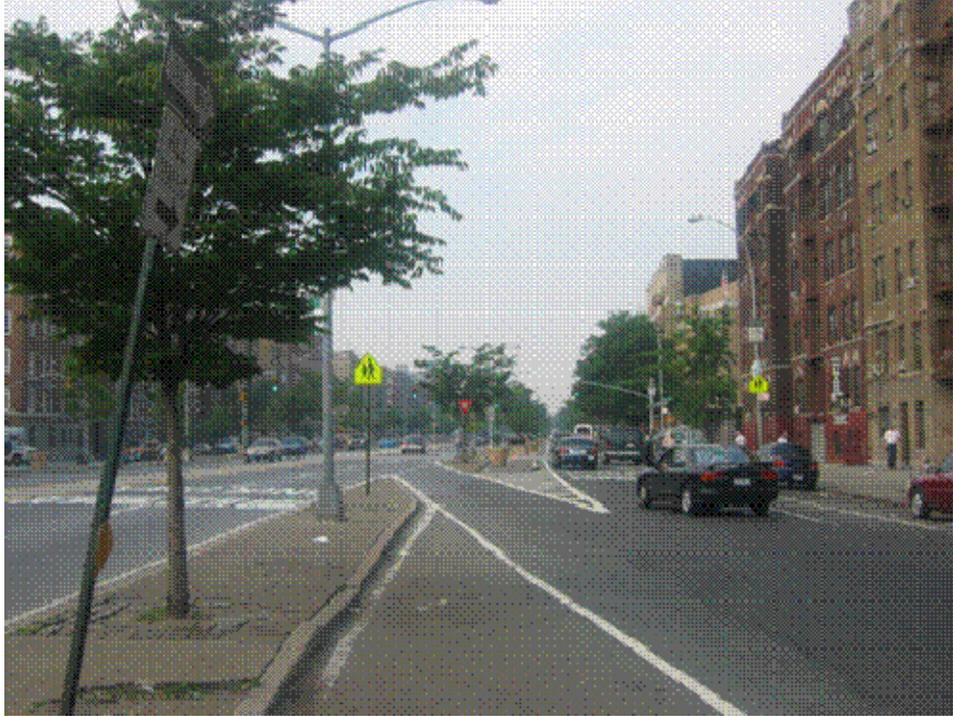
slip ramp to enable drivers to transition from the service road to the mainline roadway just south of the Elliot Avenue intersection (see Figures 6, 7, and 8).

Figure 8: Looking south along the Grand Concourse West Service Road at slip ramp to mainline roadway (South of Elliot Pl and north of Marcy Place)

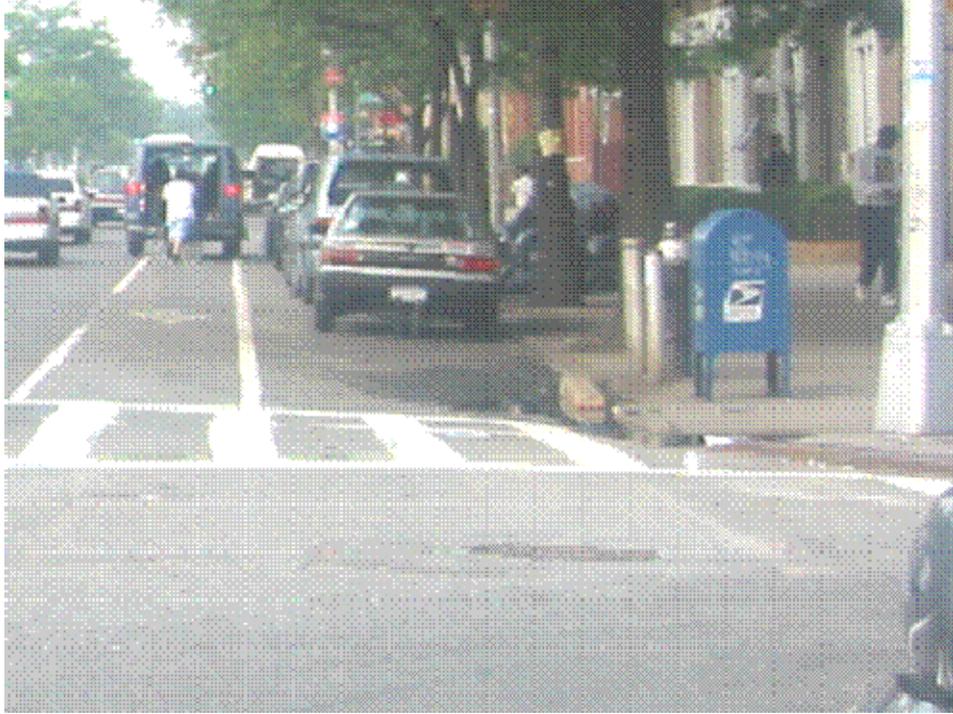
Overall, the pedestrian ramps in the vicinity of Christ the King were observed to be standard with one exception. The pedestrian ramp on the southwest corner of Grand Concourse and Marcy Place has a drainage problem for the south crosswalk located across Grand Concourse.

Figure 9: Drainage problem for pedestrian ramp for south crosswalk across Grand Concourse West Service Road at Marcy Place

- Reconstruct the pedestrian ramp at the southwest corners of the Grand Concourse & Marcy Place intersection for the school crosswalk located across Grand Concourse to eliminate the drainage problem.
