**New York City Department of Transportation
Office of School Safety Engineering**

FINAL REPORT: Christ the King, Bronx

**Prepared by
The RBA Group and URBITRAN Associates Inc.**

July 14, 2006

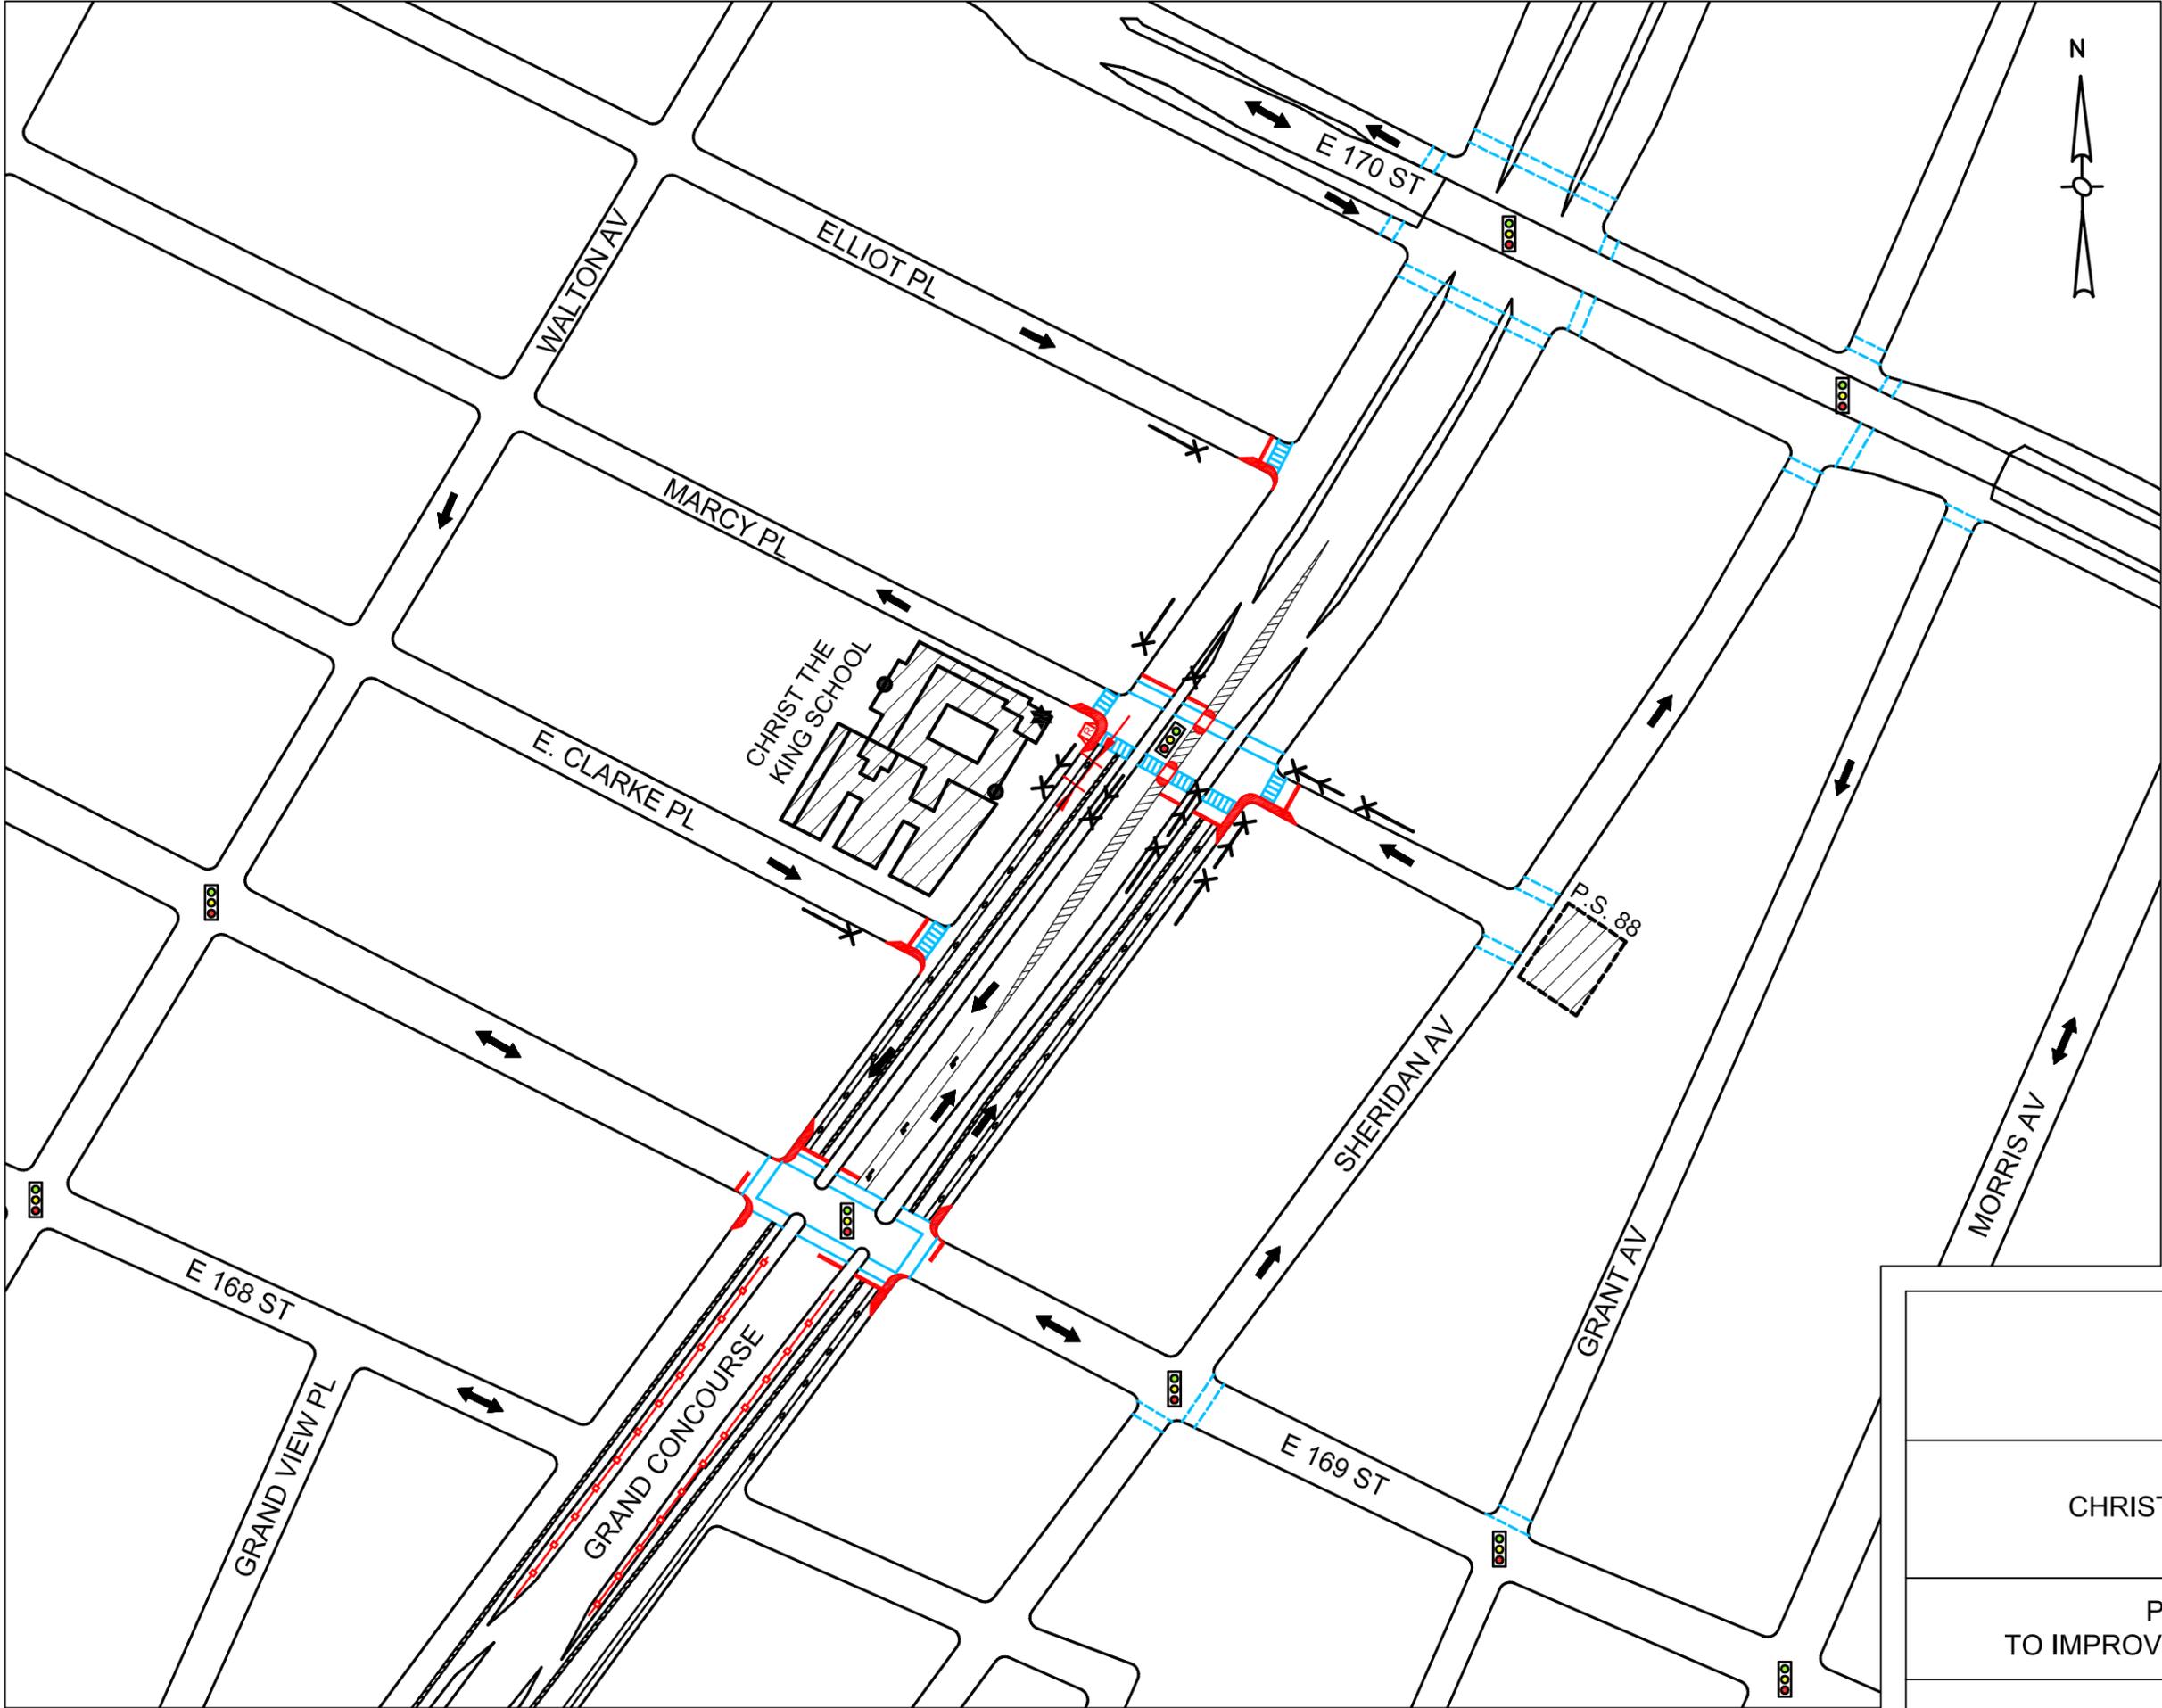
PROPOSED MEASURES
TO IMPROVE SCHOOL PEDESTRIAN SAFETY

This section describes the proposed measures to improve school pedestrian safety around Christ the King. The proposed recommendations are divided into short-term and long-term measures. Short-term measures are those that potentially can be performed in-house. Long-term measures involve capital improvements. Each of the short- and long-term measures recommended for Christ the King is discussed as follows, and is shown in more detail in Exhibit 6 at the end of this section.

➤ *Install “NO STANDING 7AM-4PM SCHOOL DAYS” sign*

Install “NO STANDING 7AM-4PM SCHOOL DAYS” signs for a distance of thirty feet in front of the school at the main entrance of the school. (This is a typical requirement for all NYC schools in order to provide for emergency access to and from the school.)

Ten foot advanced stop bars before school crosswalks are recommended on the following approaches of signalized intersections surrounding the Christ the King School:

- Northbound approach of Grand Concourse mainline and Service Roads at Marcy Place.
- Westbound approach of Grand Concourse mainline and Service Roads at Marcy Place.

- Consideration should be given to make the interim measures permanent by widening the raised concrete medians.

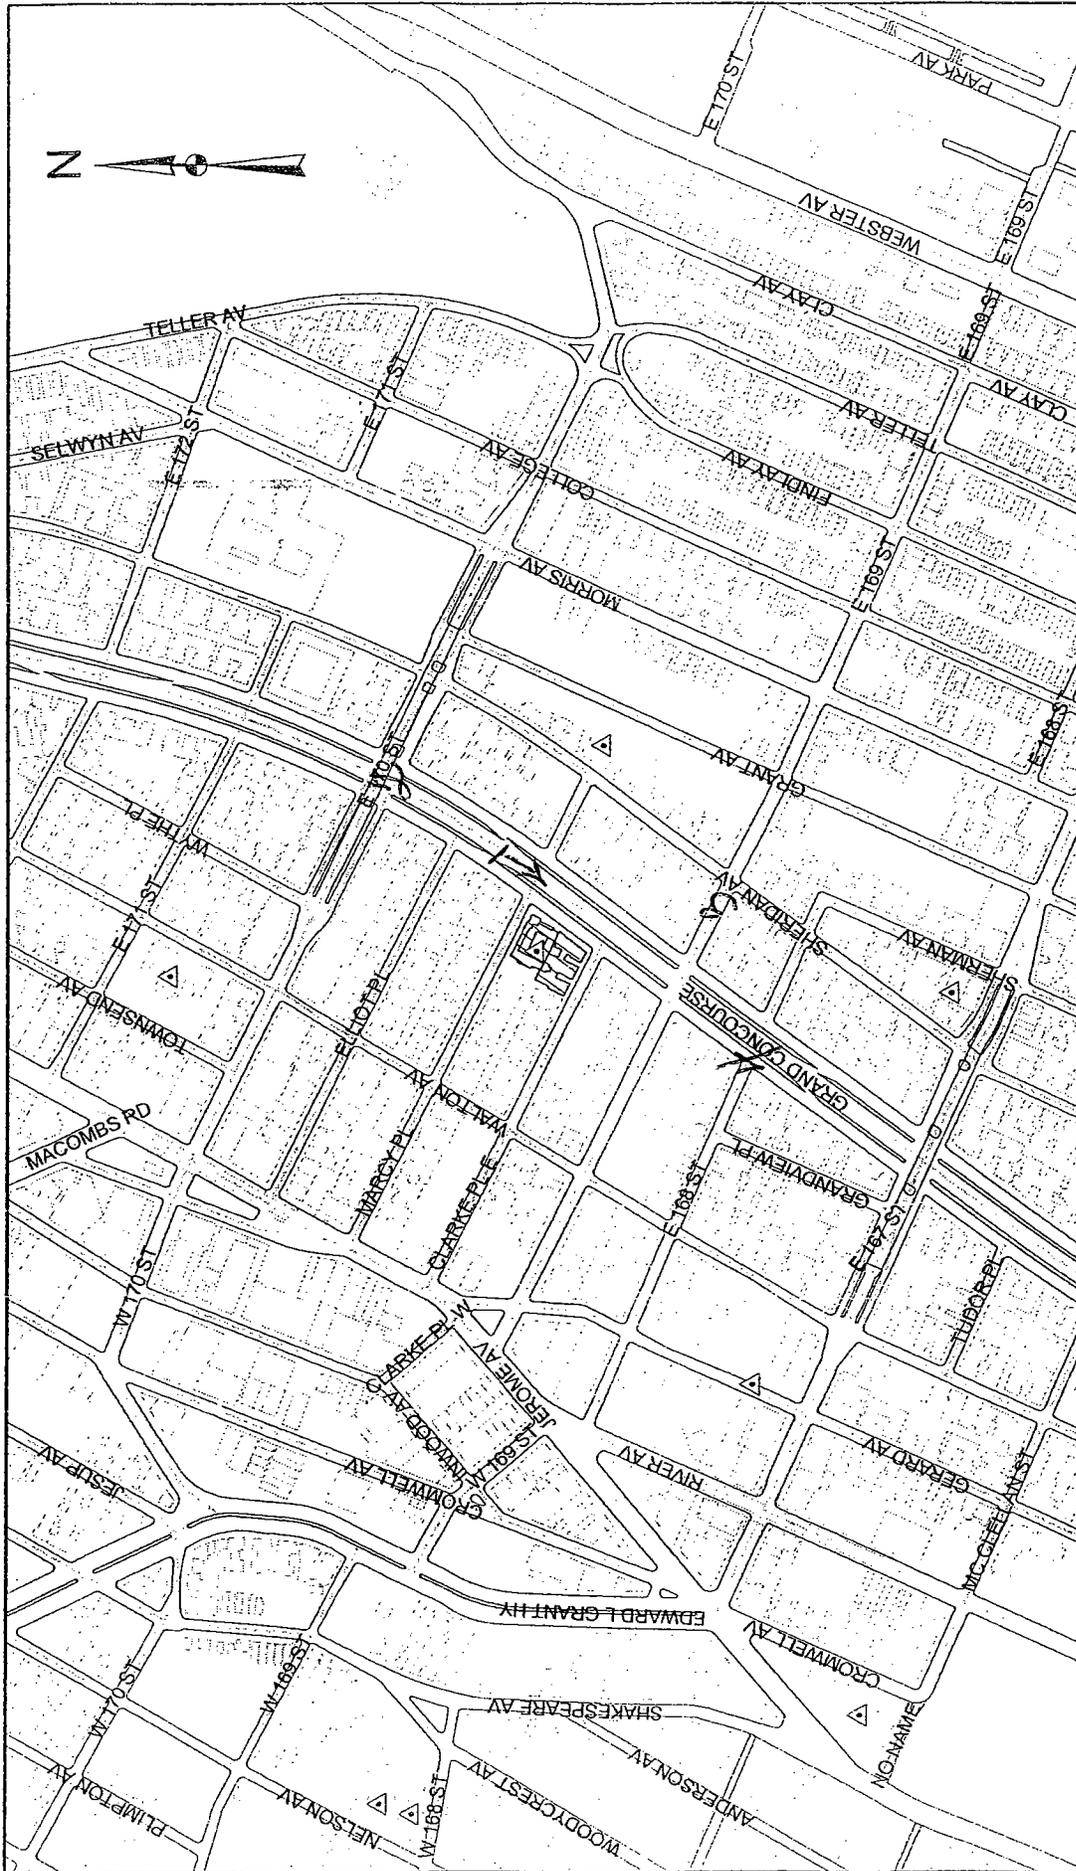
The TRAFFIC SAFETY PLAN shown on this map was established to provide the maximum degree of safety for children going to and from school. It is required that all children follow the prescribed routes and use the designated crosswalks.
