**New York City Department of Transportation
Office of School Safety Engineering**

School Safety Engineering Project

FINAL REPORT: I.S. 131 (Albert Einstein School), Bronx

February 15, 2006

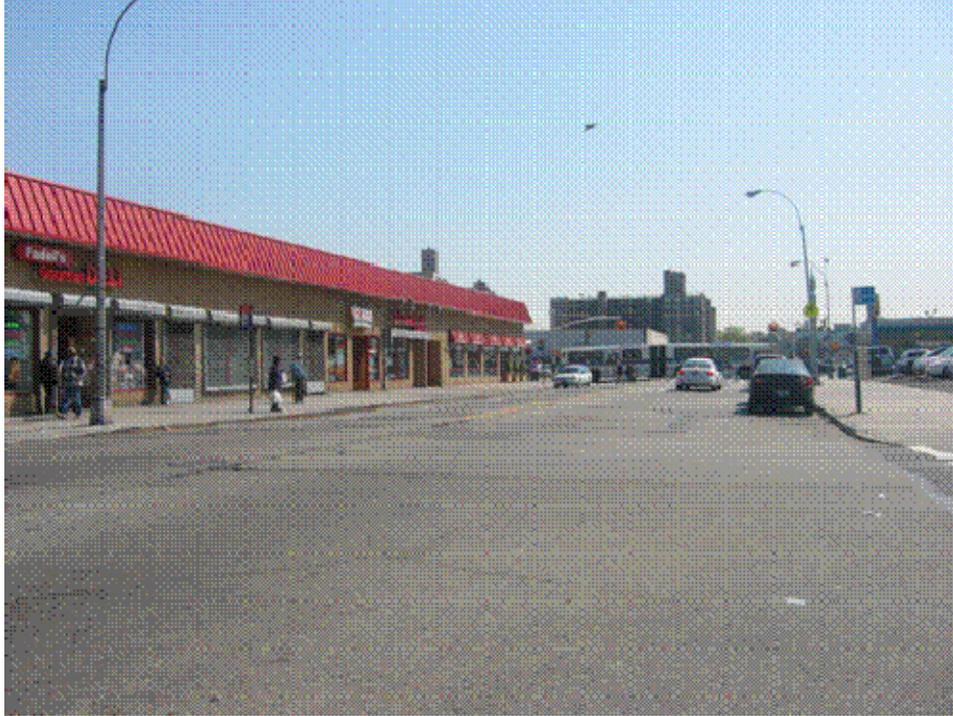
There is a Deli across the street to the northwest of the school, which is located in a line of stores. On the block to the west of the school is a large parking deck with stores along the street level, fronting on White Plains Road. There are also several other shopping centers and fast food restaurants along this section of White Plains Road.

Figure 2: Looking northeast at Deli and other stores across the street and east of I.S. 131

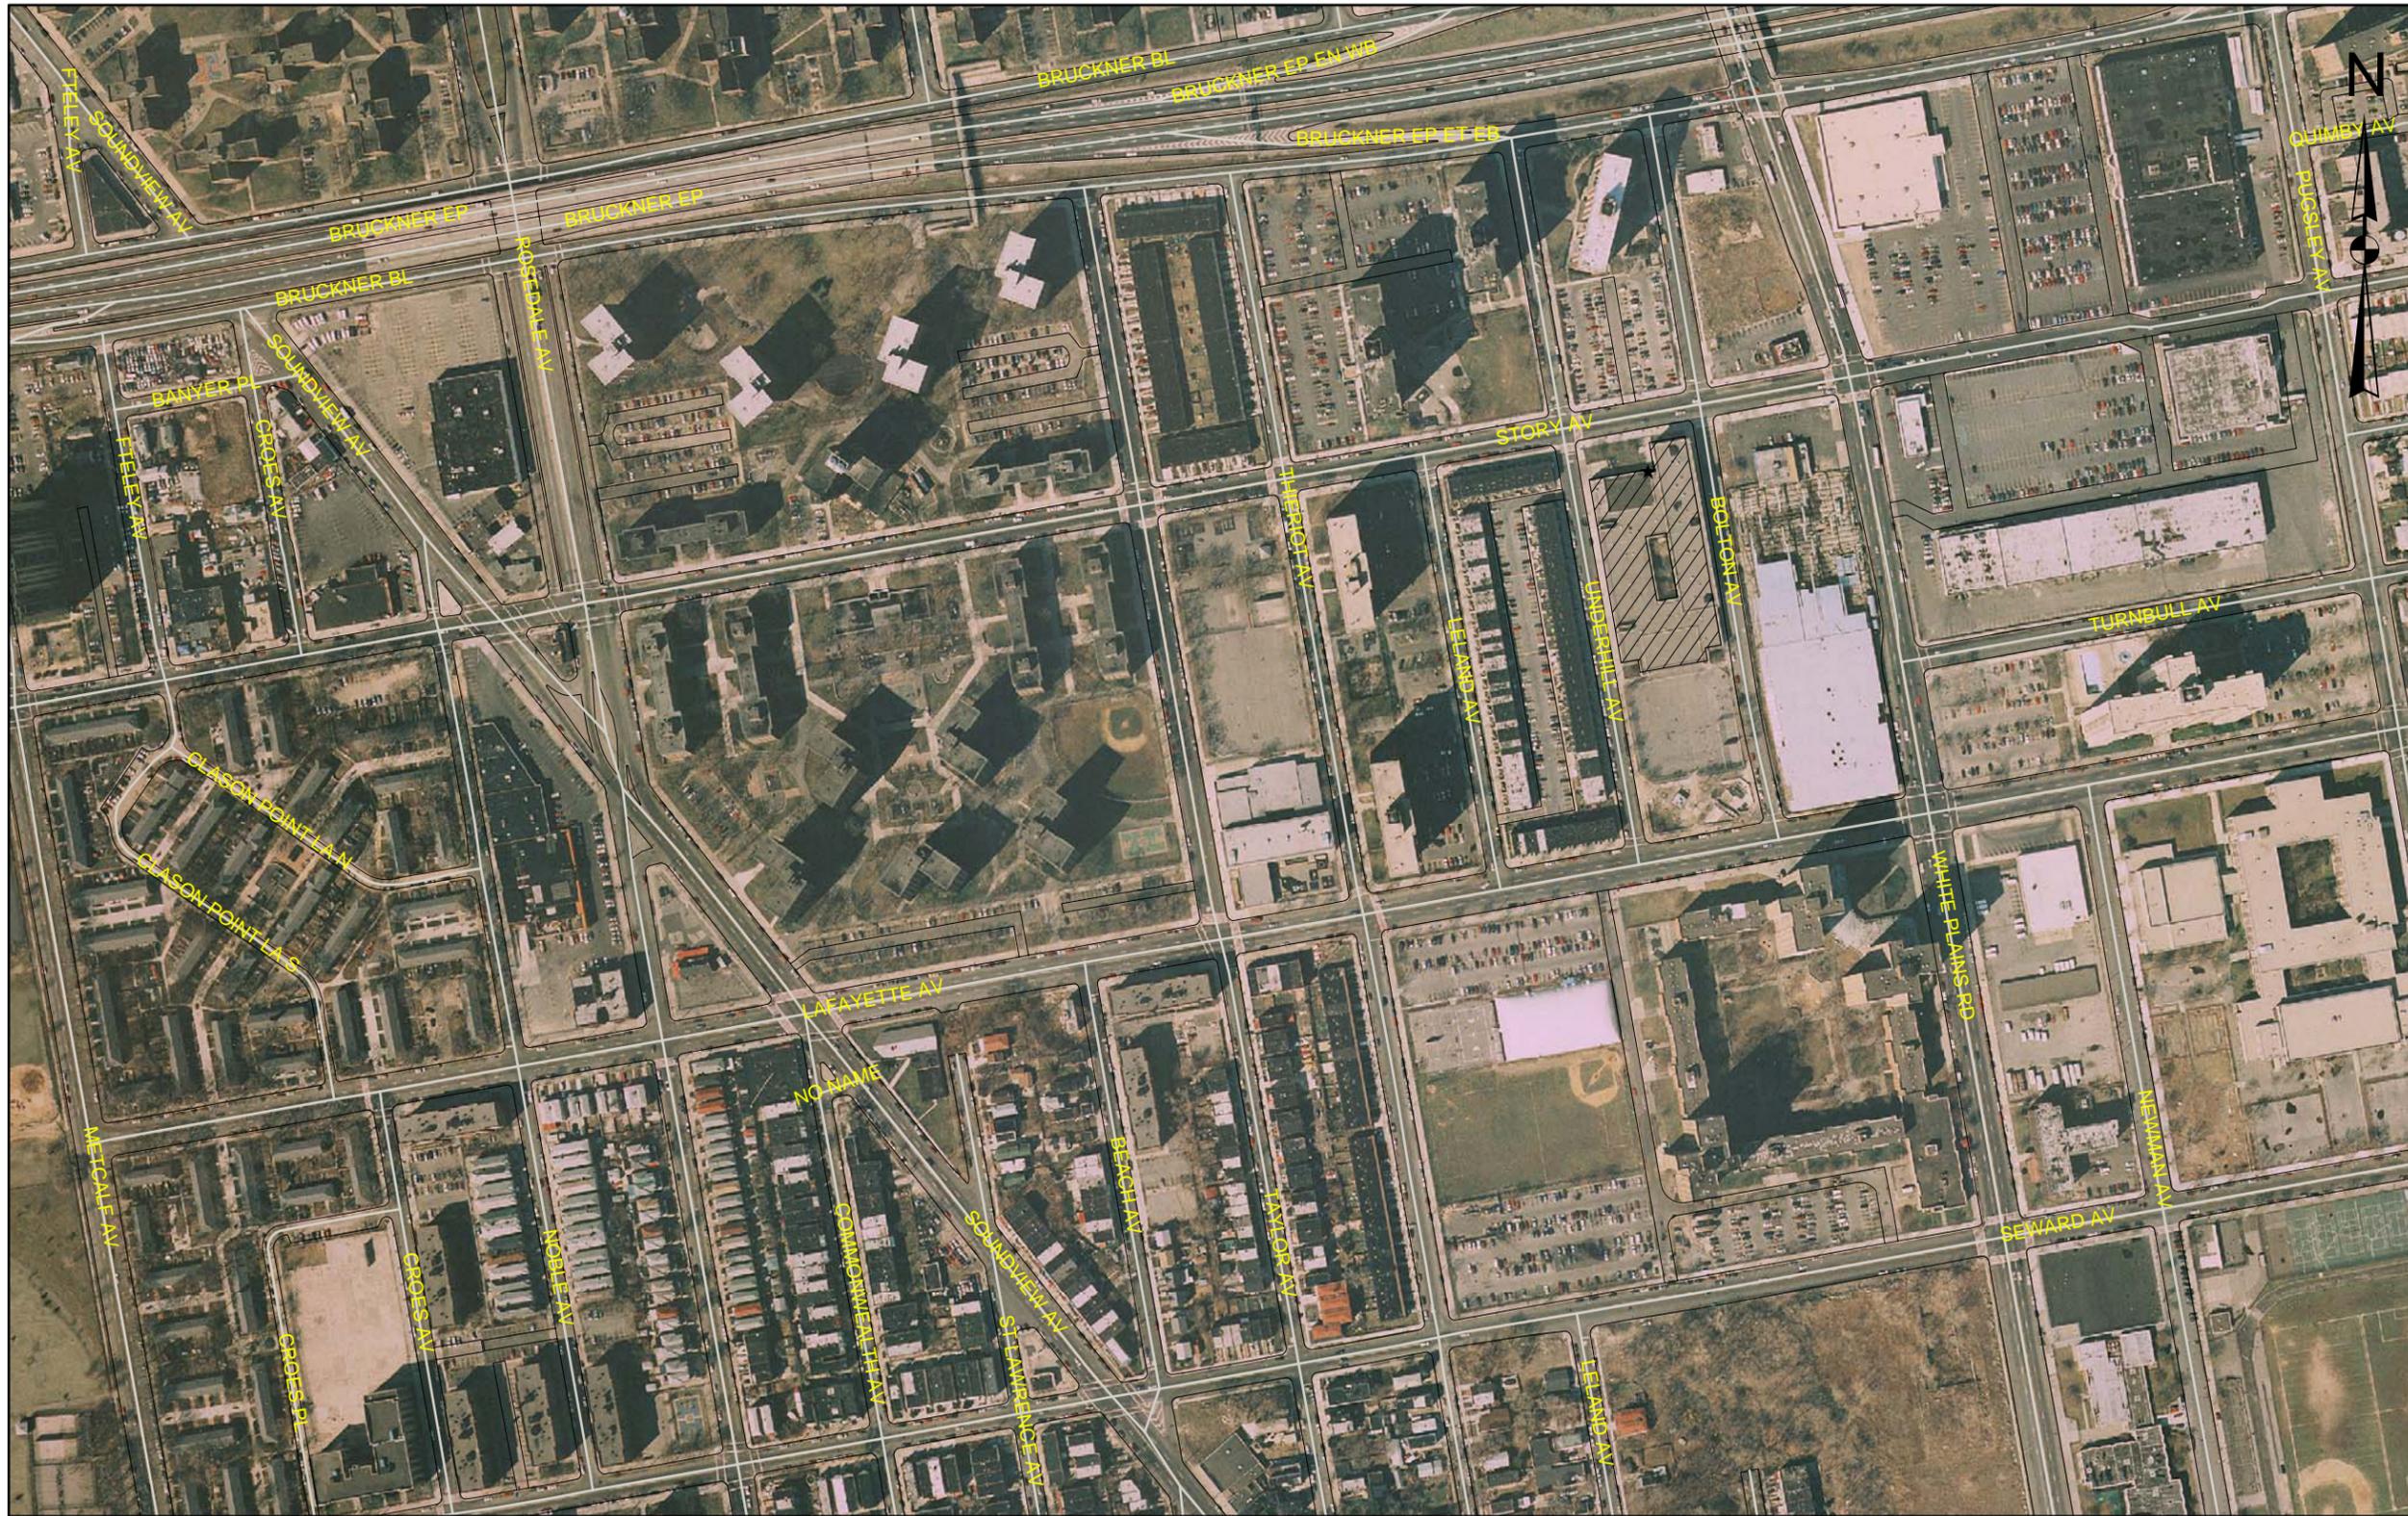
EXHIBIT 1
I.S. 131 BRONX
ALBERT EINSTEIN SCHOOL
AERIAL PHOTOGRAPH

Exhibit 1, at the end of this section, shows an aerial view of the neighborhood surrounding the school. I.S. 131 is bounded by Bolton Avenue to the east, Lafayette Avenue to the south, Underhill Avenue to the west, and Story Avenue to the north (as seen in Exhibit 1). The area surrounding the school is generally residential in character.

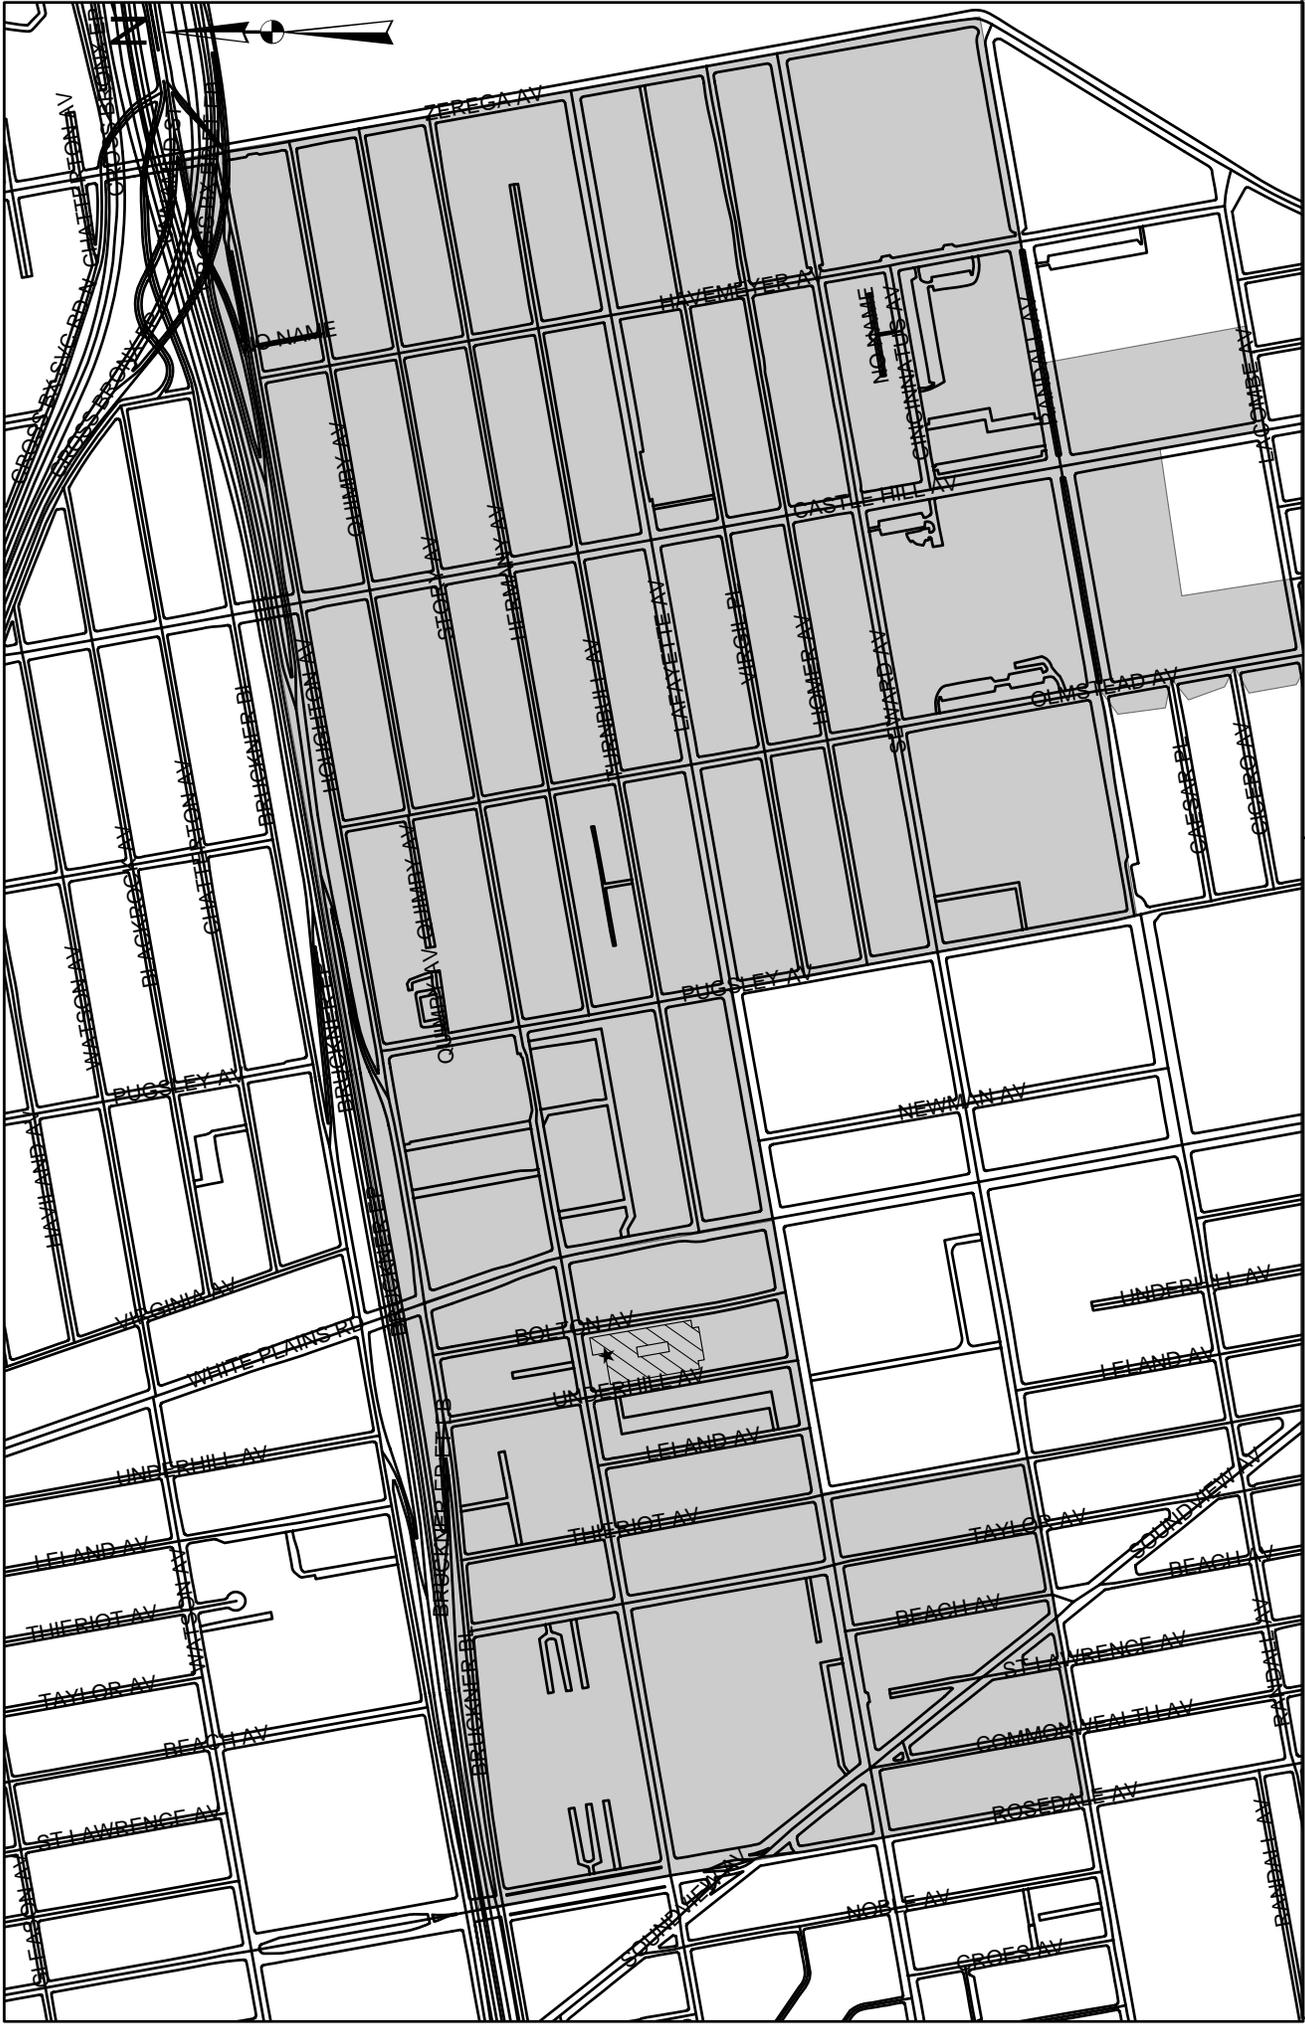
EXHIBIT 2

The school's "catchment area" as defined by the Department of Education is shown in Exhibit 2 at the end of this section. Based upon information gathered from school officials, the catchment area shown in Exhibit 2 was verified as accurate for I.S. 131.

The school's catchment area, verified by the school assistant principal, is roughly outlined by the Bruckner Expressway to the north; Zerega Avenue to the east; Seward Avenue to the South; and Rosedale Avenue to the west.

CATCHMENT AREA, (DEPARTMENT OF EDUCATION DESIGNATED AREA WITHIN WHICH STUDENTS ARE ENTITLED TO ATTEND I.S. 131)

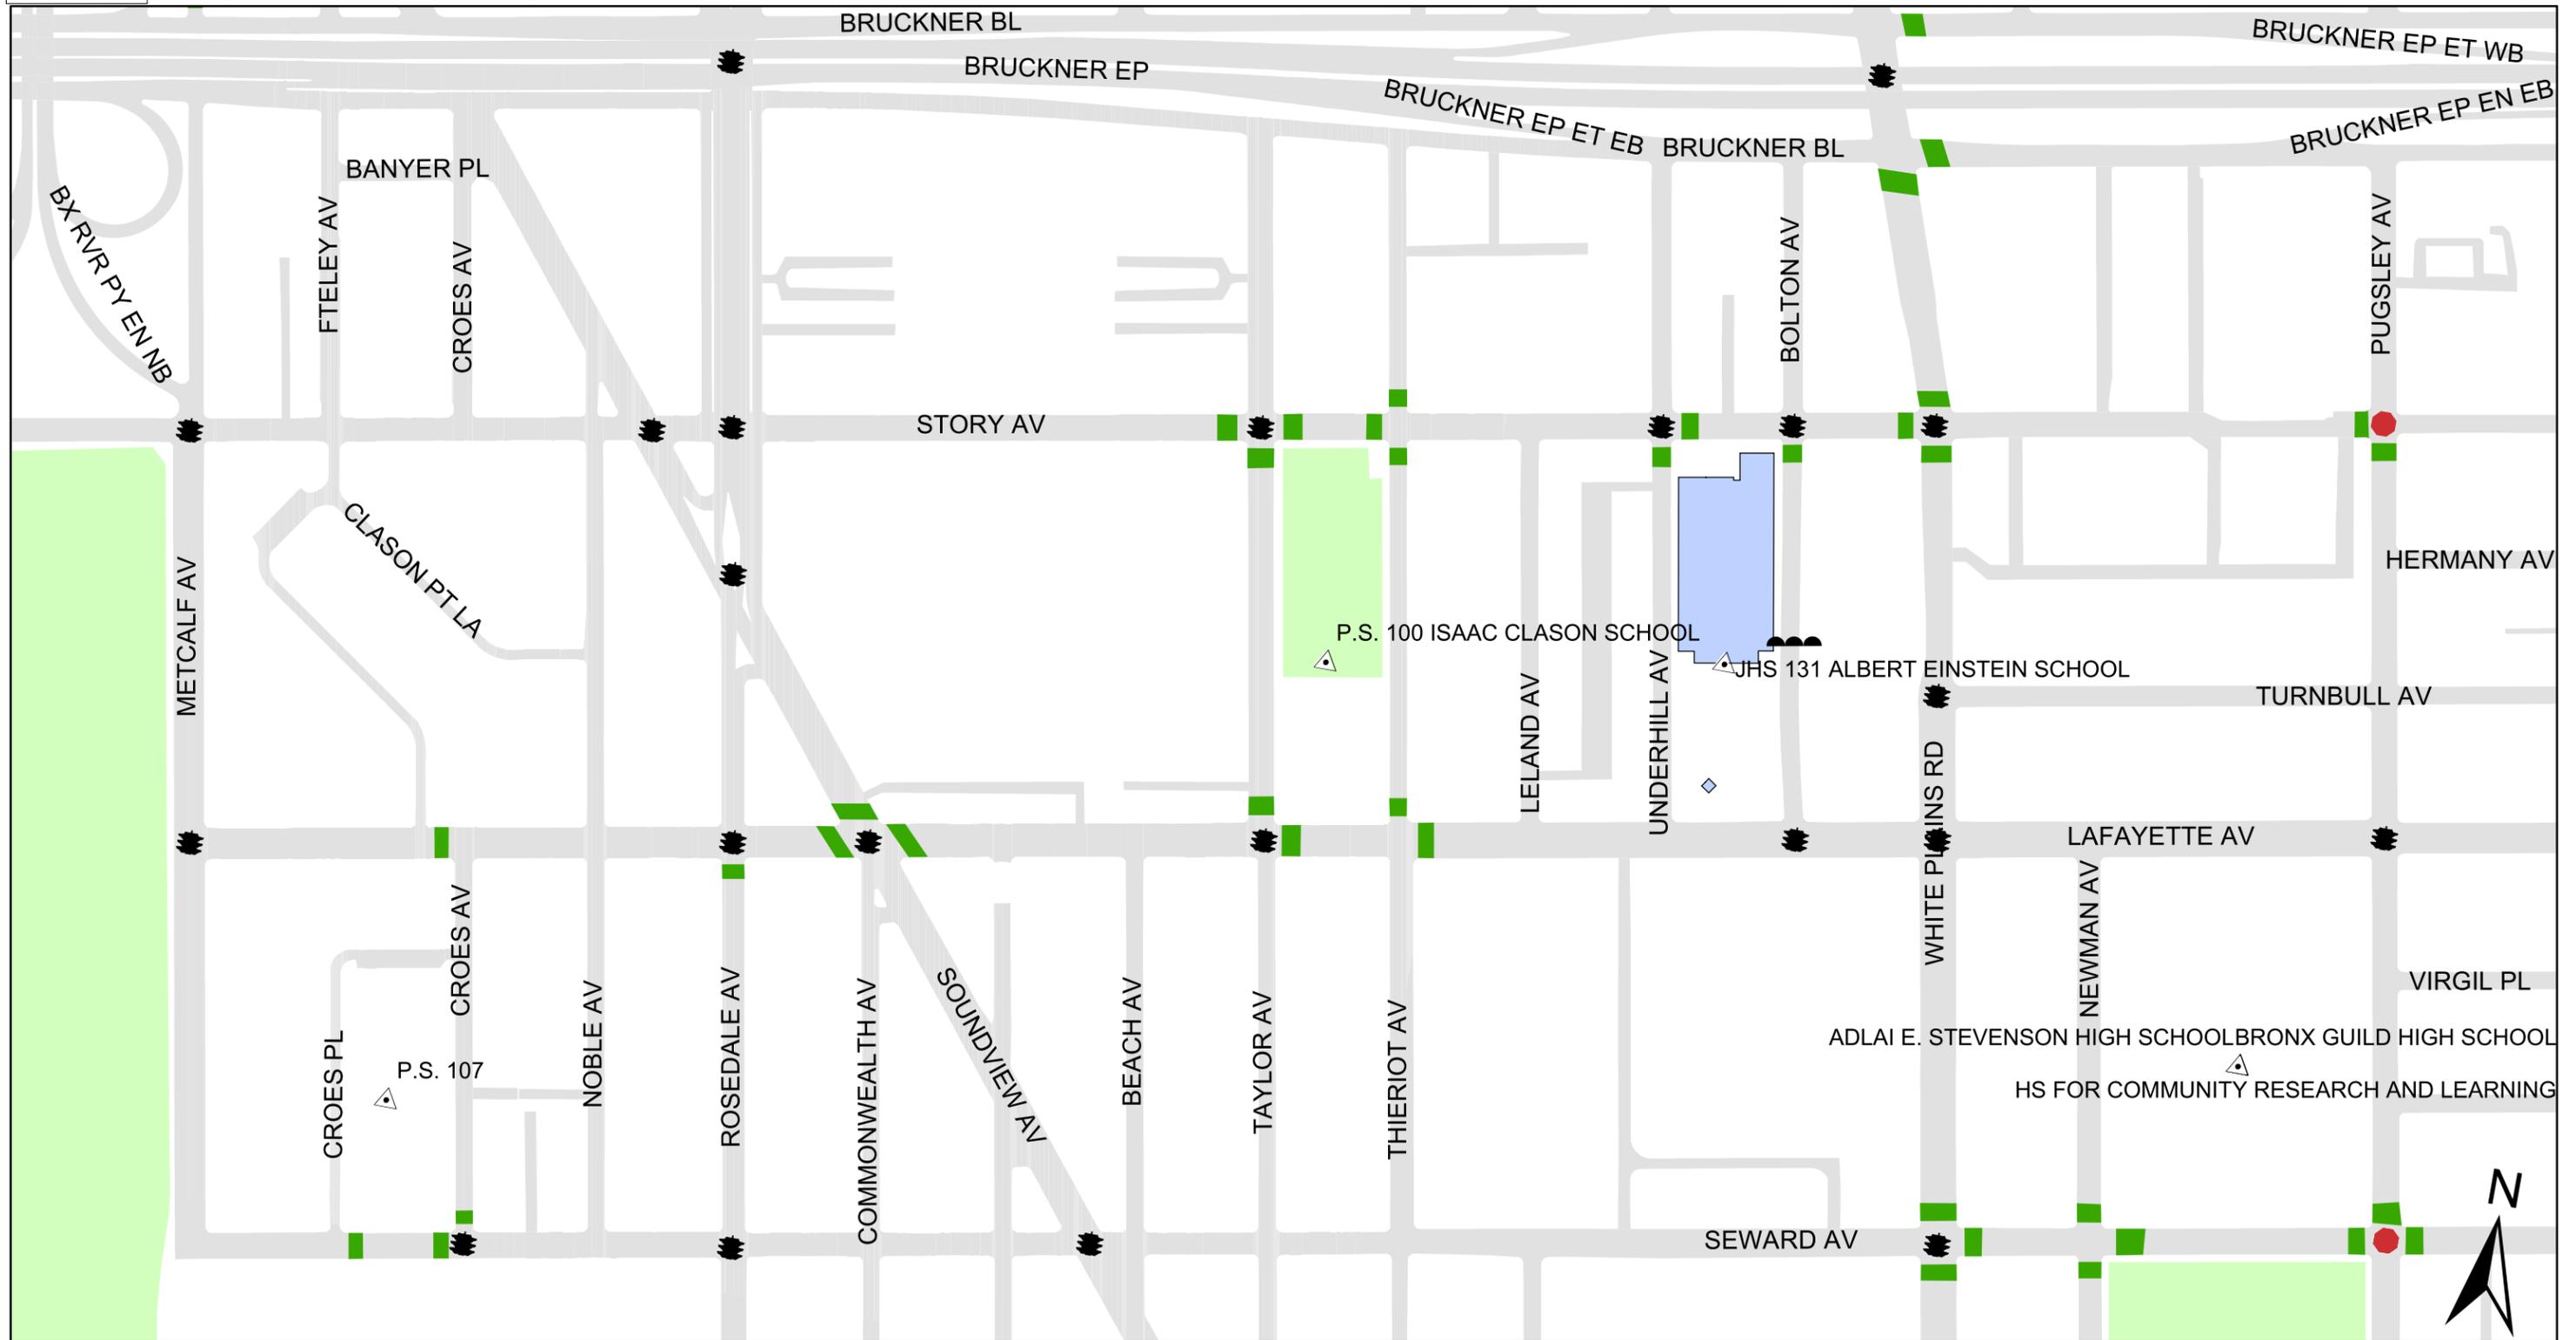
EXHIBIT 3

The School Traffic Safety Map was established to help provide the maximum degree of safety for children going to and from school - by indicating the location of speed reducers, school crosswalks and some traffic control devices. (While virtually all intersections in NYC benefit from traffic control devices - such as stop signs, traffic signals, yield signs, and all way stop signs - this map shows only traffic signals and all way stop signs.) The school crosswalks that are shown are ladder striped and make the crosswalk more visible to drivers and help make the intersection safer. These crosswalks are where school children are recommended to cross.

Exhibit 3, at the end of Section 2, shows the existing signals, school signs, and pavement markings assigned to Immaculate Conception School as of June 2004. It should be noted that a citywide signage program is currently underway to upgrade school signage to the current edition of the Federal Manual of Uniform Traffic Control Devices (MUTCD) standards of fluorescent yellow-green accompanied by downward pointing arrows. Signs scheduled to be installed under this program are shown as “existing” in Exhibit 7.

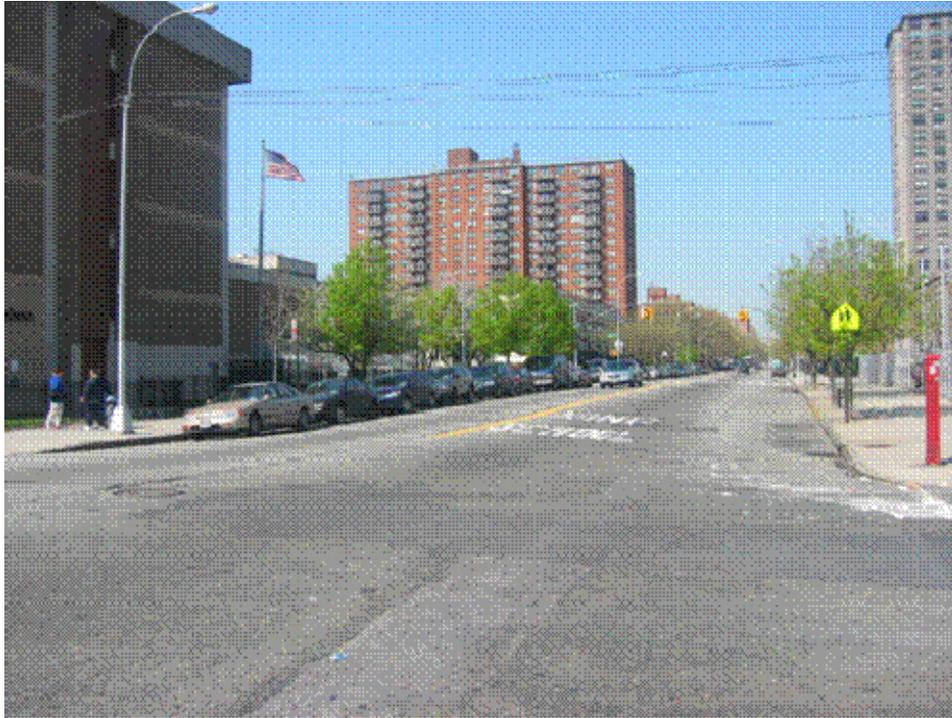
Figure 3: Looking west along Story Ave showing existing advance sign and markings (school is on left)

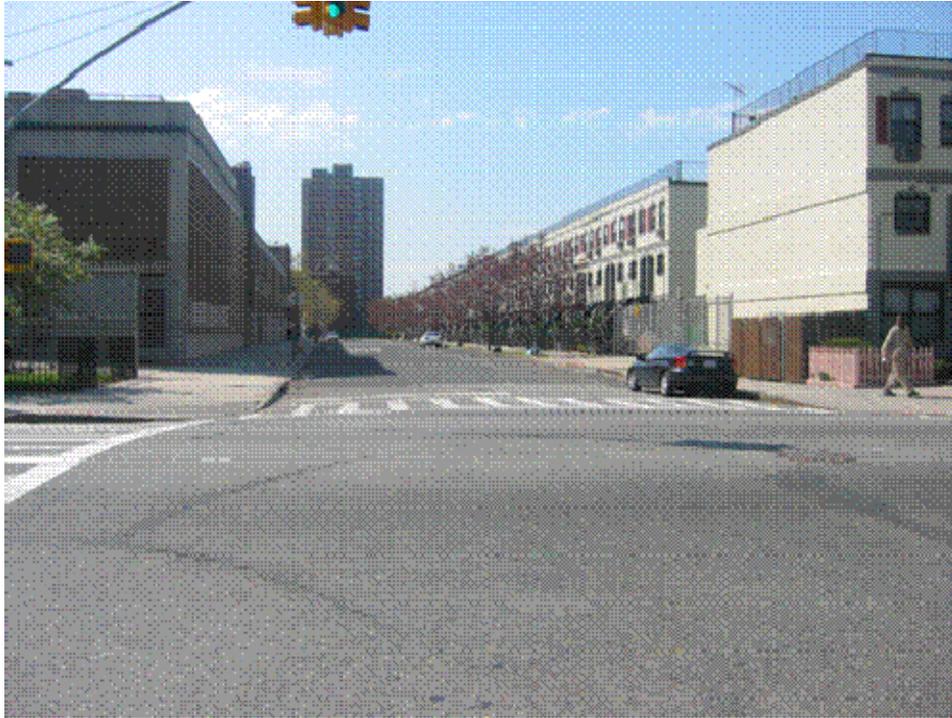
This is a signalized intersection with school crosswalks located across the east and south legs. Story Avenue and Underhill Avenues are both two-way streets with one traffic lane and a parking lane on each side of the roadway. Higher volumes of traffic are experienced on Story Avenue. The school official reports there is poor drainage on Underhill and ice often forms in winter. Although the school official recalled there was a

fatality at Underhill Avenue and Story Avenue in 1999, it must not have involved a pedestrian, since it did not appear in the accident data records. Some speeding was reported on both Bolton Avenue and Underhill Avenue. The school official questioned the possibility of speed tables on Bolton Avenue and Underhill Avenue.

There were six (6) accidents reported at this intersection between 1998 and 2000: none of the accidents were pedestrian accidents (Table 2). The NYPD accident data (Table 3) shows two pedestrian accidents with no fatalities reported at this intersection between 2001 and 2004; one of the accidents was school-related. No further information about the accident is available.

The 85th percentile speed for southbound vehicles on Underhill Avenue between Story Avenue and Lafayette Avenue was found to be 26.1 mile per hour (mph). The 85th percentile speed for northbound vehicles on Underhill Avenue between Lafayette Avenue and Story Avenue was found to be 25.9 mph.

Figure 4: Looking south along Underhill Avenue across Story Avenue (school is on the left)

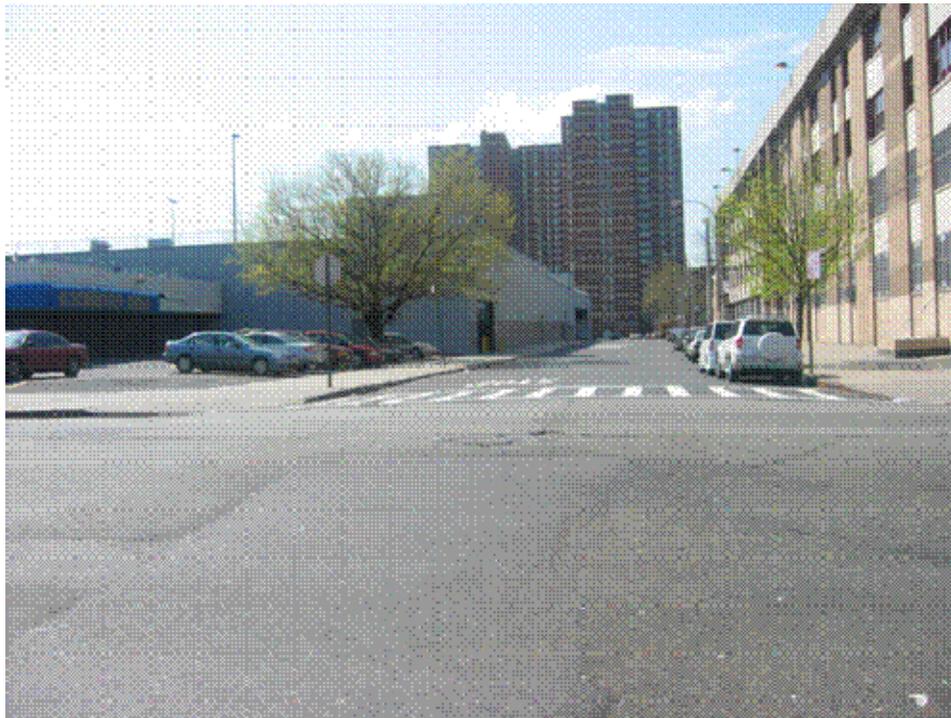
This is an unsignalized intersection with a school crosswalk located across the south leg. Story Avenue and Bolton Avenues are both two-way streets with one traffic lane and a parking lane on each side of the roadway.

This intersection has been the site of sixteen (16) accidents between 1998 and 2000; two of these were pedestrian accidents, both of which were school-related. In the first school-related accident, an eleven-year old pedestrian sustained a “non-incapacitating injury” on February 15, 2000 at 9:00 a.m. while crossing the roadway, with no crosswalk. The road was dry and the weather was clear. In the second school-related accident, an eleven-year old pedestrian sustained a “possible injury” on April 5, 2000 at 8:00 a.m., while performing “other actions in the roadway,” which would eliminate playing in, or crossing the roadway. The road was dry and the weather was cloudy. The NYPD accident data (Table 3) shows five pedestrian accidents, with no fatalities, between 2001 and 2004; two of the accidents were school-related.

The 85th percentile speed for southbound vehicles on Bolton Avenue between Story Avenue and Lafayette Avenue was found to be 30.7 mph. The 85th percentile speed for northbound vehicles on Bolton Avenue between Lafayette Avenue and Story Avenue was found to be 28.2 mph.

This unsignalized intersection experienced four (4) school-related accidents during a seven-year period between 1998 and 2004. To assess vehicle and pedestrian volumes on Story Avenue at its intersection with Bolton Avenue, a traffic count was conducted from 7:30 to 9:00 am on Tuesday, February 8, 2006. The results of the peak hour (7:30 to 8:30) count are shown in Tables 4 and 5 and in Exhibit 6A at the end of this section. In addition, a traffic signal warrant analysis was performed to determine the need of a traffic signal control at this intersection. The results of the preliminary assessment based on traffic signal warrant 4 (Pedestrian Volumes) and warrant 5 (School Crossing) of the Federal MUTCD are presented in Tables 6 and 7, respectively. Based on this assessment, a new signal is warranted.

Figure 5: Looking south along Bolton avenue across Story Avenue (school is on the right)

There is a pedestrian crosswalk located across the south leg of Bolton Avenue at Story Avenue, but no crosswalks located across Story Avenue. I.S. 131 students were observed crossing Story Avenue at Bolton Avenue. Therefore, it is recommended to provide a school crosswalk at the east and west legs of the intersection. In order to provide a school crosswalk, a preliminary traffic signal warrant assessment was performed to identify the traffic situation and determine what type of traffic control devices would be appropriate. The traffic data collected to assess a need of a traffic signal included pedestrian and vehicle counts and a pedestrian gap study. The results of the preliminary assessment based on traffic signal warrants 4 (pedestrian volumes) and 5 (school crossing) of the Federal MUTCD indicated the installation of a traffic signal might be warranted. The results of the warrant analysis are shown in Tables 4, 5, 6, and 7 and in Exhibit 6A. The intersection seems to meet the warrant for a signal, and we therefore recommend the following:

The school principal reported a speeding problem on Bolton Avenue between Lafayette Avenue and Story Avenue. Based on the spot speed survey, the 85th percentile speed for southbound vehicles on Bolton Avenue was found to be 31 mph.

- It is therefore recommended to install a speed reducer (hump) on Bolton Avenue between Lafayette and Story Avenues.

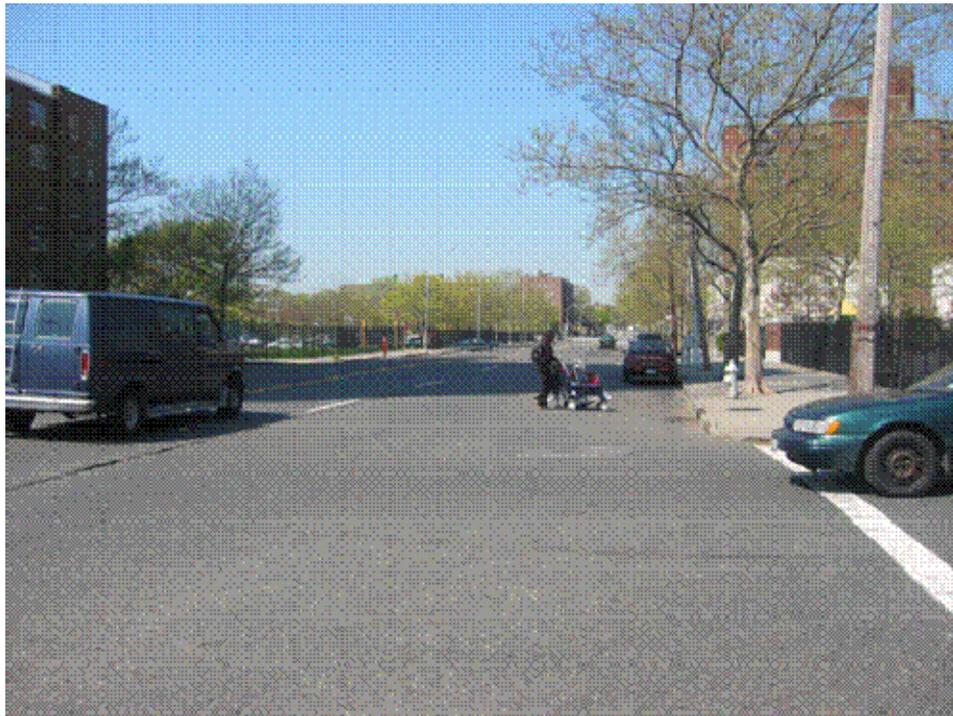
This intersection has been the site of eight (8) accidents between 1998 and 2000; one of these was a pedestrian accident, which was not school-related. The NYPD accident data (Table 3) shows no pedestrian accidents.

Figure 6: Looking west along Lafayette Avenue across Underhill Avenue

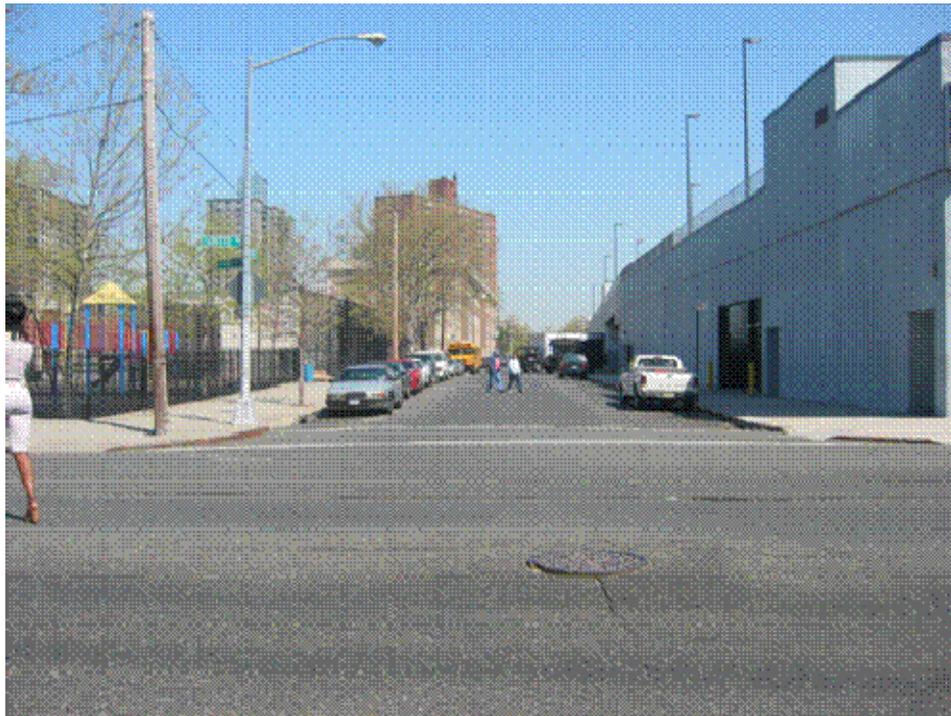
Figure 7: Looking north along Bolton Avenue across Lafayette Avenue (school is up the street on left)

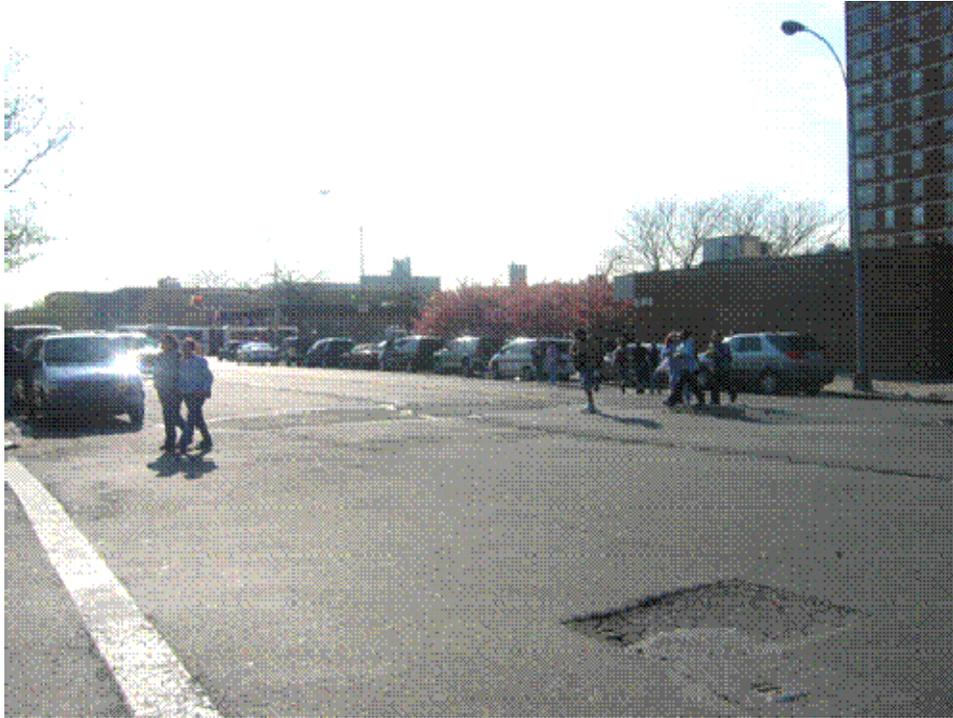
Figure 8: Looking east on Lafayette Avenue across Bolton Avenue (students crossing without crosswalk)

There is a pedestrian crosswalk located across the north leg of Bolton Avenue at Lafayette Avenue, but no crosswalks located across Lafayette Avenue. I.S. 131 students were observed crossing Lafayette Avenue at Bolton Avenue. Therefore it is recommended to provide a school crosswalk at the west leg of the intersection. In order to provide a school crosswalk, a preliminary traffic signal warrant assessment was performed to identify the traffic situation and determine what type of traffic control devices would be appropriate. The traffic data collected to assess a need of a traffic signal included pedestrian and vehicle counts and a pedestrian gap study. The results of the preliminary assessment based on traffic signal warrants 4 (pedestrian volumes) and 5 (school crossing) of the Federal MUTCD indicated the installation of a traffic signal might be warranted. The results of the warrant analysis are shown in Tables 12, 13, 14, and 15 and in Exhibit 6C. The intersection seems to meet the warrant for a signal, and we therefore recommend the following:

- Provide refuge islands at the east and west legs of Lafayette Avenue at its intersections with Bolton Avenue and White Plains Road in conjunction with a flush striped median between Bolton Avenue and White Plains Road.
- Provide refuge islands at the east and west legs of Story Avenue at its intersections with Bolton Avenue and White Plains Road in conjunction with a flush striped median between Bolton Avenue and White Plains Road.

The refuge islands with extended medians will provide a refuge for pedestrians who do not make the crossing in one cycle. The proposed median should be at least 5-foot wide, should extend beyond the crosswalk, and should have at least 5-feet at grade cut through section. These medians are not proposed where they would hinder the ability of vehicles to turn. Final details pertaining to proposed refuge islands, curb extensions, and striped medians will be developed during Final Design.

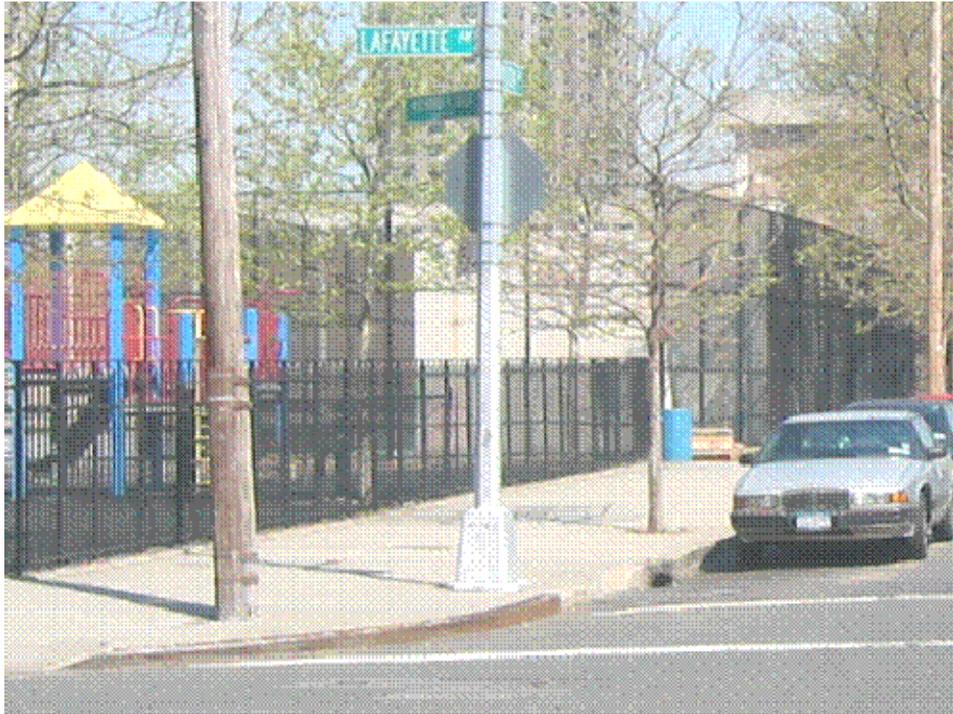
Overall, Pedestrian ramps in the area of the school appear to be standard except for the northwest corner of Bolton Avenue & Lafayette Avenue where the pedestrian ramp for the crosswalk located across the north leg of Bolton Avenue is situated outside of the crosswalk path, between a drainage inlet and a light pole.

Figure 9: Looking north at misaligned pedestrian ramp to north of crosswalk located across north leg of Bolton Avenue at Lafayette Avenue and utility pole obstructing the path for the same crosswalk

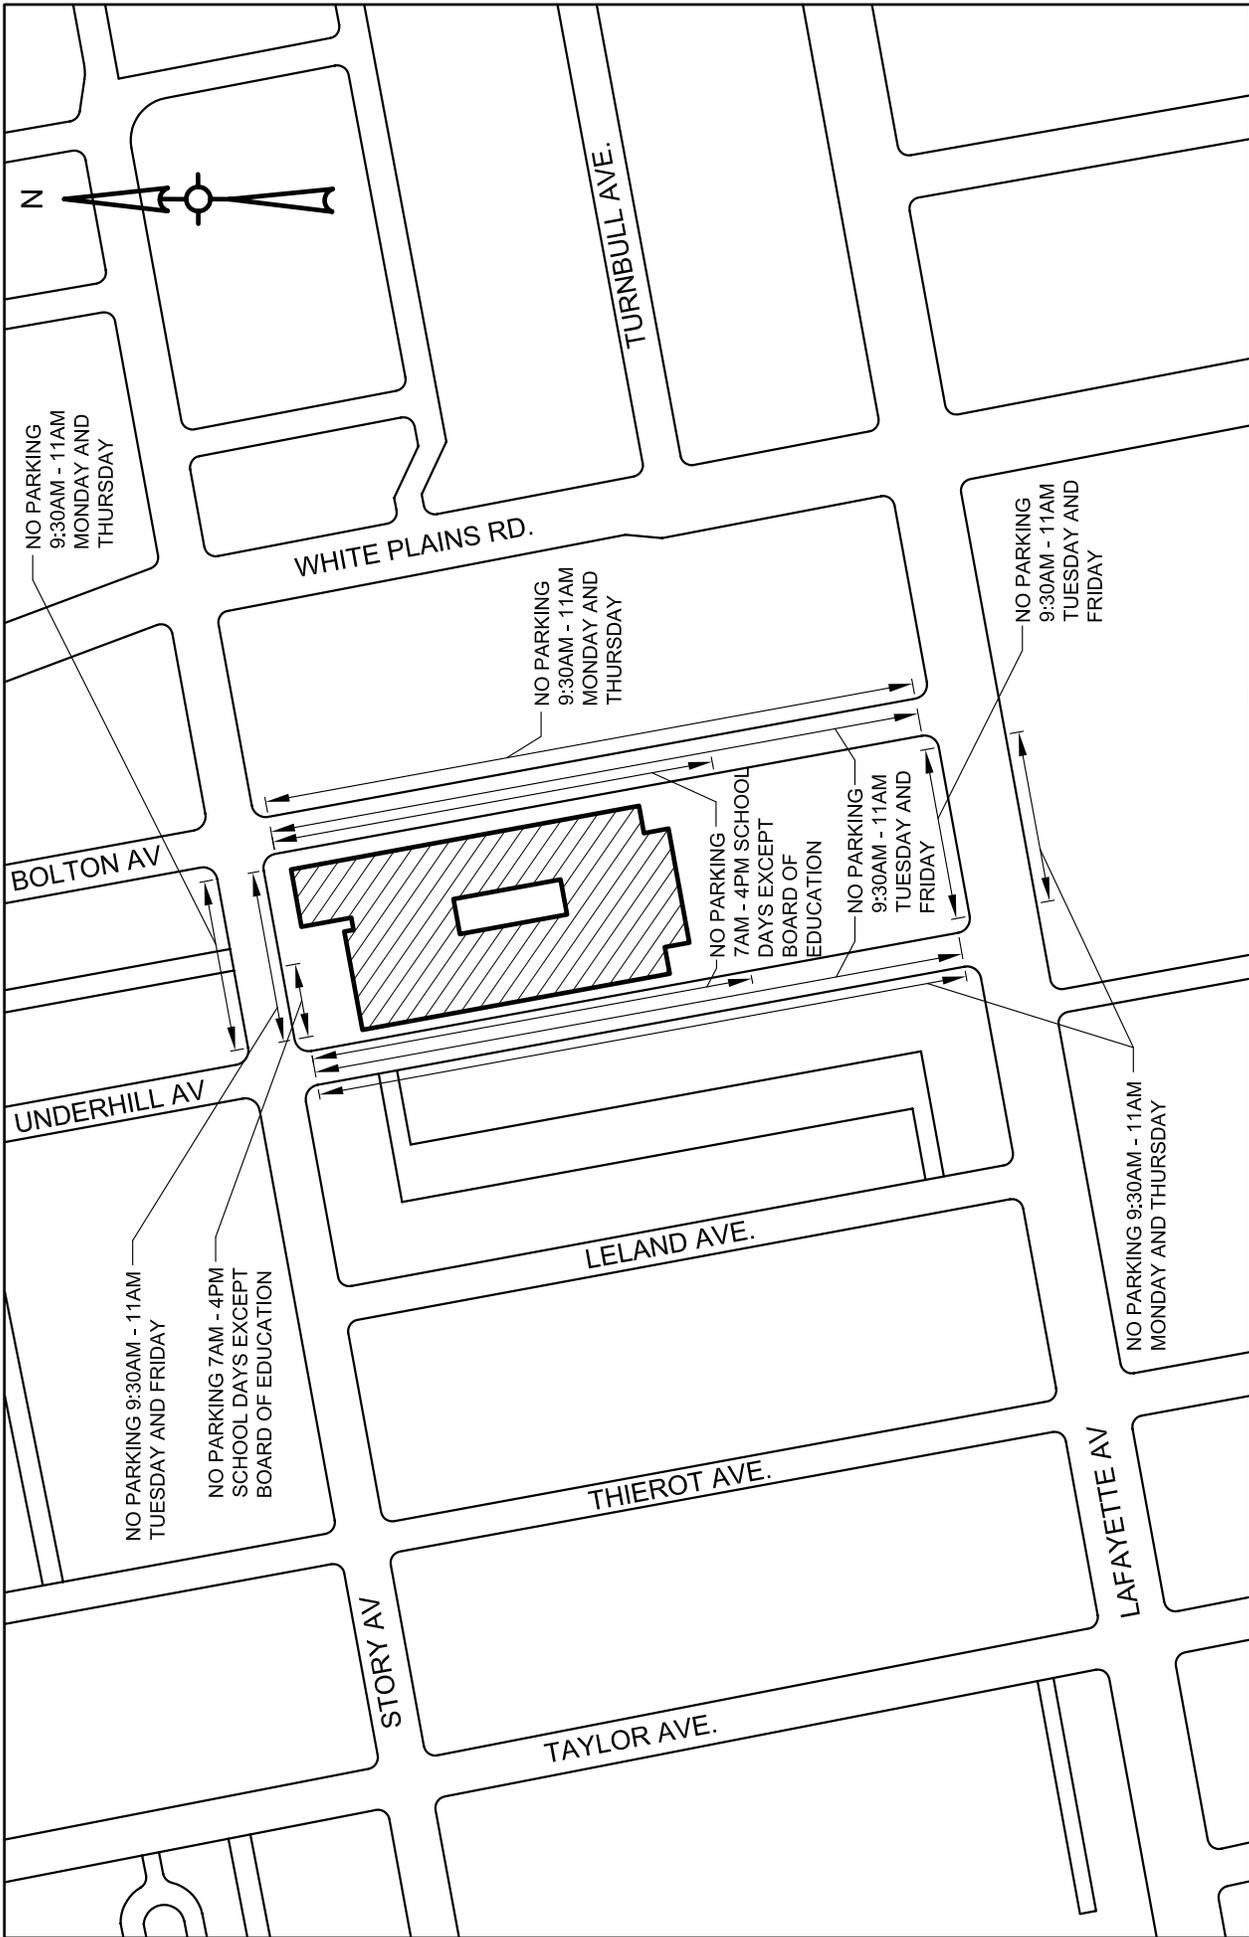
EXHIBIT 4
 I.S. 131 BRONX
 ALBERT EINSTEIN SCHOOL
 EXISTING PARKING REGULATIONS

Parking regulations around the school block are shown in Exhibit 4 at the end of this section.
