**New York City Department of Transportation
Office of School Safety Engineering**

School Safety Engineering Project

FINAL REPORT: I.S. 131 (Albert Einstein School), Bronx

February 15, 2006

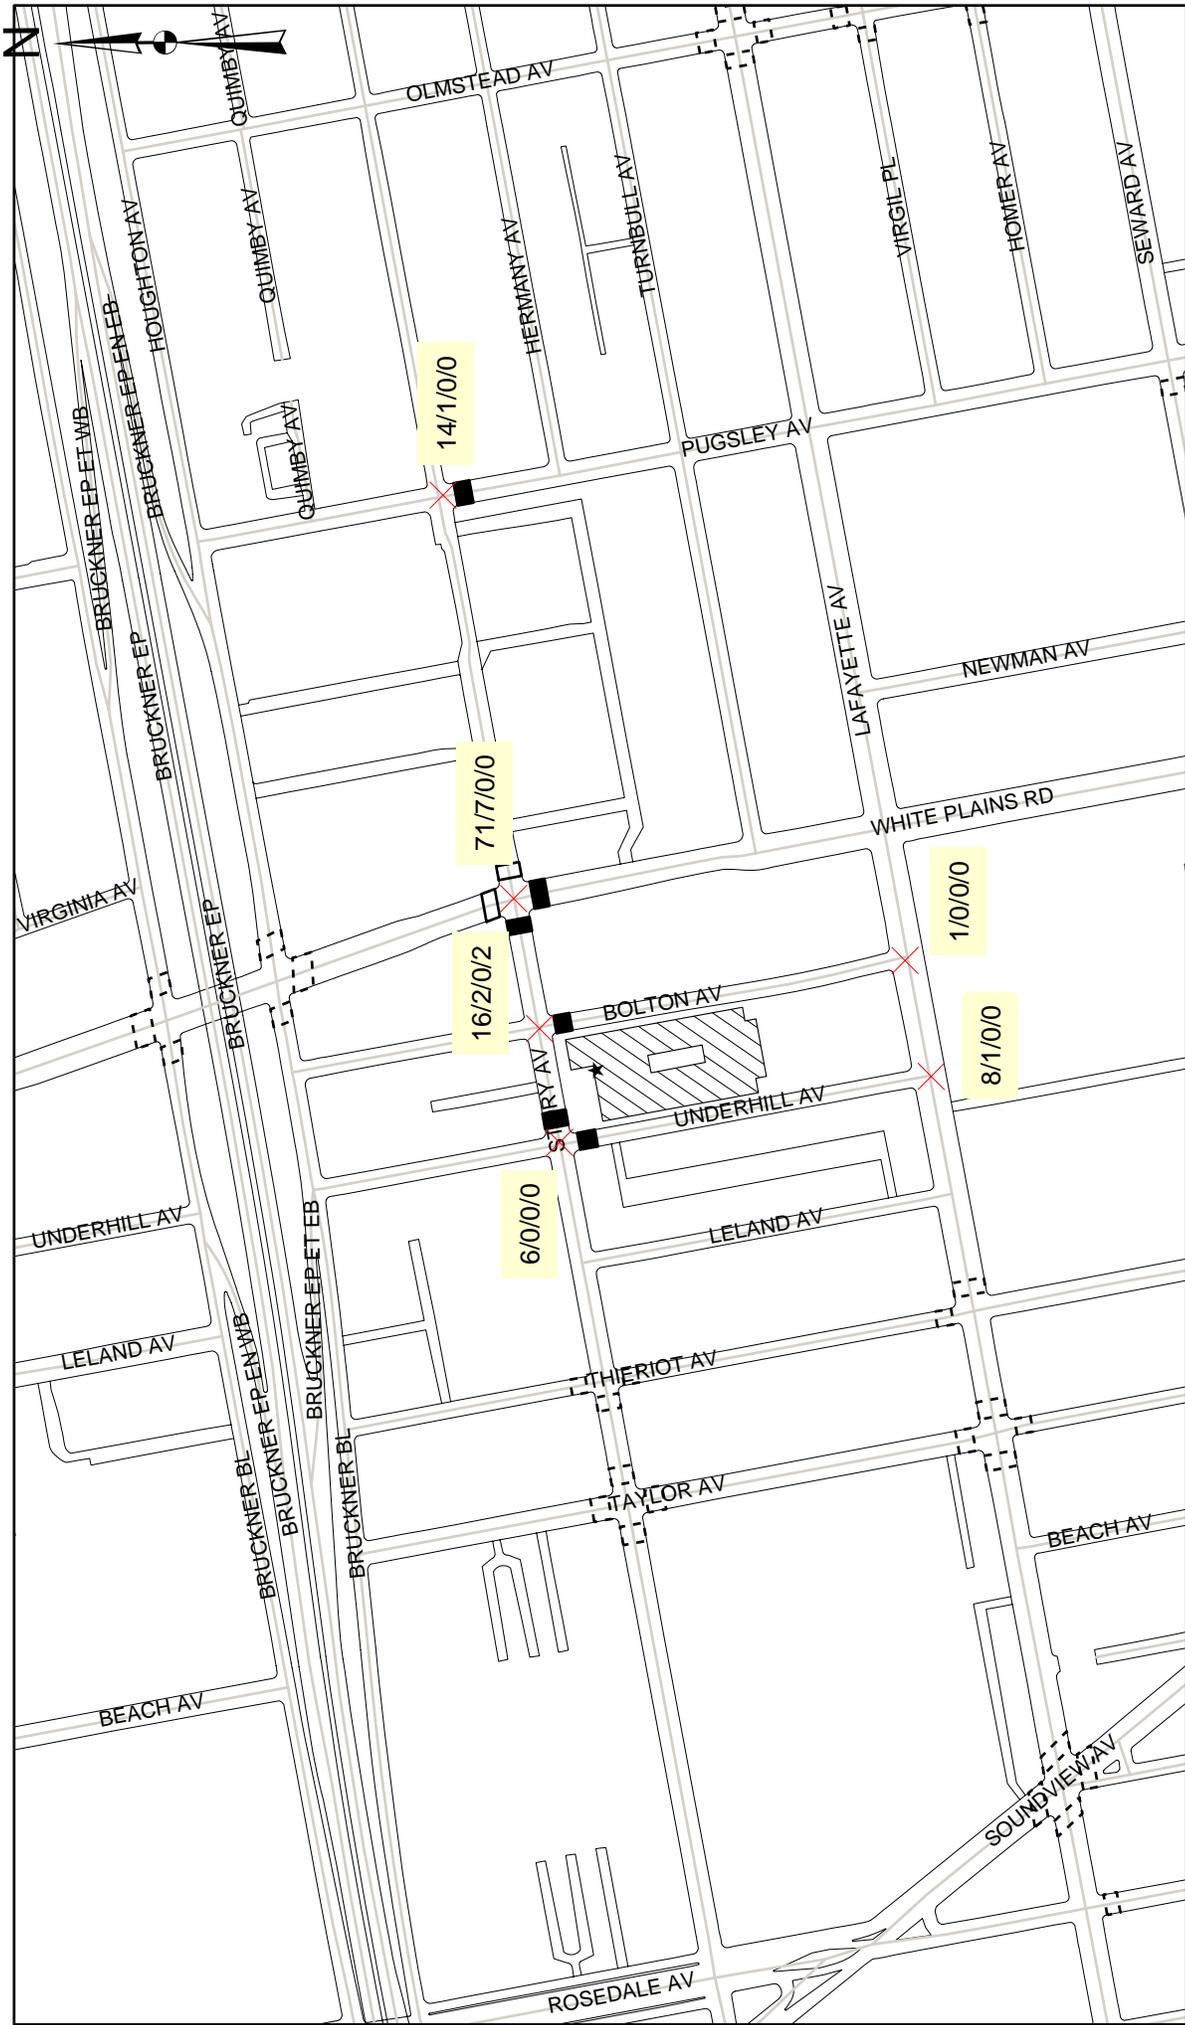
EXHIBIT 5
I.S. 131 BRONX
ALBERT EINSTEIN SCHOOL
ACCIDENT SUMMARY (1998-2000)

Exhibit 6, at end of this section, and Table 2 show a summary of accidents, as obtained from the New York State Department of Motor Vehicles (NYS DMV) in the vicinity of I.S. 131 for a three-year period from January 1, 1998 to December 1, 2000. The NYS DMV data provides some detail relating to the cause of the accident. Table 3 is a summary of more recent accident data obtained from the New York City Police Department (NYPD). Though current through 2004, the NYPD data does not provide the same level of detail as the NYS DMV data.

In the vicinity of I.S. 131 (within a 700-foot radius around the school), there were one hundred two (102) accidents reported between 1998 and 2000 (Table 2); ten (10) were pedestrian accidents, two of which were school-related accidents that occurred at the intersection of Story Avenue & Bolton Avenue. A school-related accident is defined as an accident involving a school-age pedestrian (age 4 through 14), occurring on a weekday during the school year. There were no pedestrian fatalities during this period. The NYPD accident data (Table 3) shows there were one hundred thirty-seven (137) accidents between 2001 and 2004; eighteen (18) were pedestrian accidents. Of these, there were four school-related accidents. There were no pedestrian fatalities during this period. Two school-related accidents occurred at Story Avenue & Bolton Avenue; one occurred at Story Avenue & Underhill Avenue; and one occurred at Lafayette Avenue & Bolton Avenue.

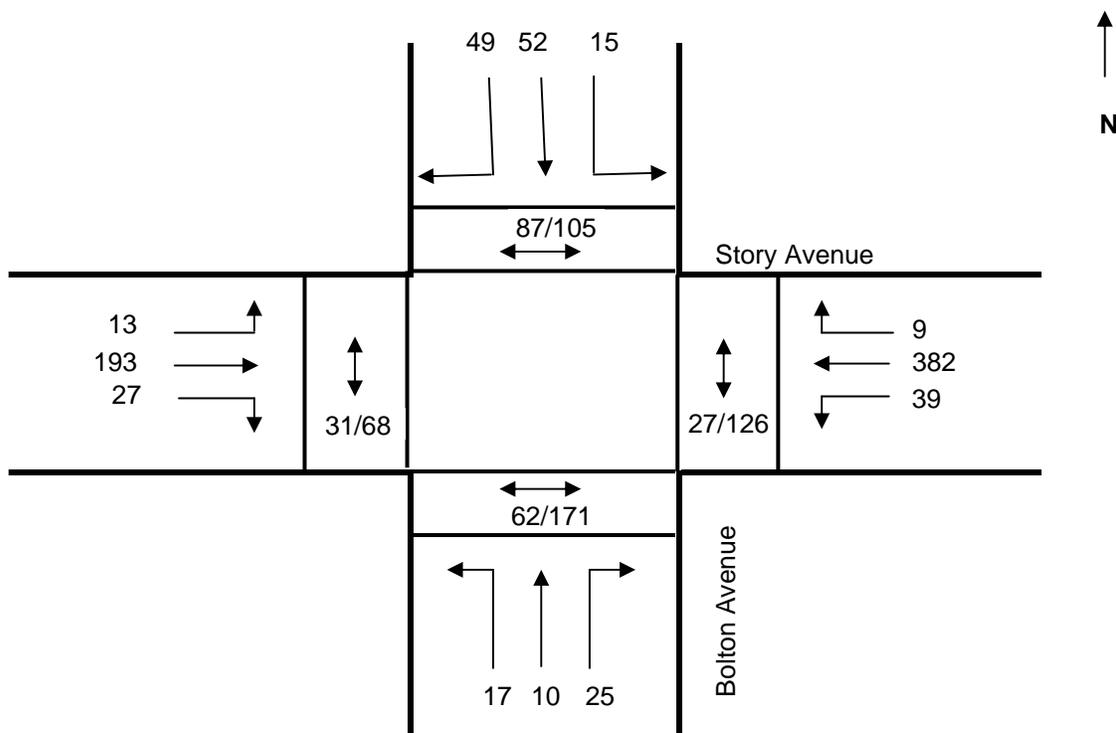
EXHIBIT 6A
I.S. 131 BRONX
ALBERT EINSTEIN SCHOOL
TRAFFIC AND PEDESTRIAN COUNTS

One Hour Traffic Volumes
Tuesday, Feb 08, 2006 7:30 am - 8:30 am

Intersection of Story Avenue and Bolton Avenue

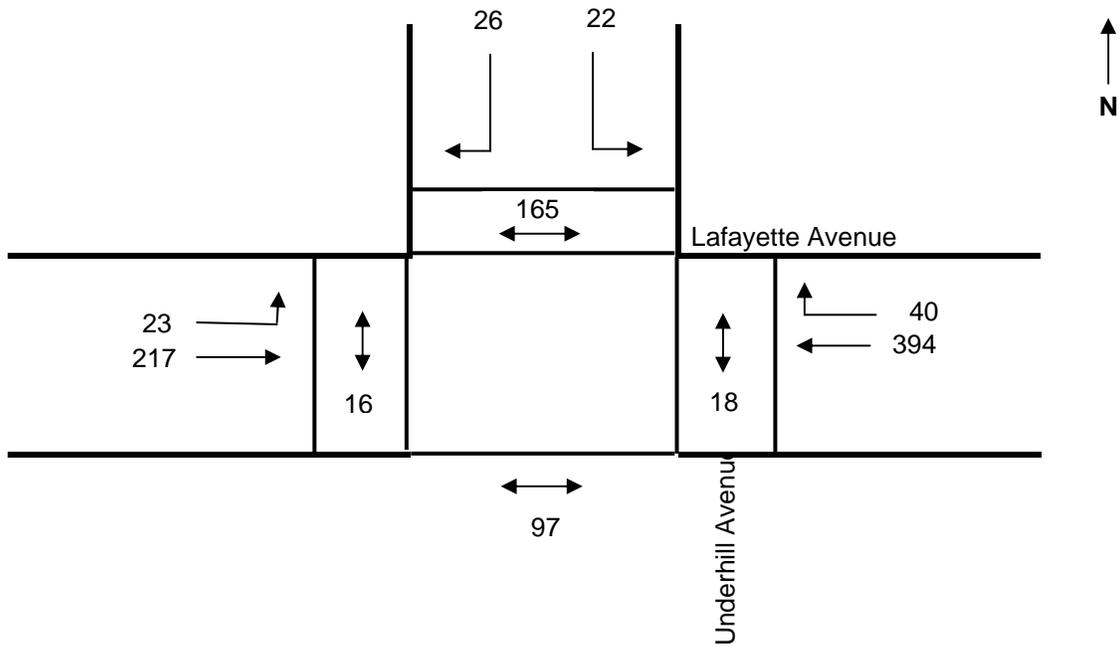
EXHIBIT 6B
I.S. 131 BRONX ALBERT EINSTEIN SCHOOL
TRAFFIC AND PEDESTRIAN COUNTS

One Hour Traffic Volumes
Tuesday, June 14th, 2005 7:30am - 8:30am

Intersection of Lafayette Avenue and Underhill Avenue

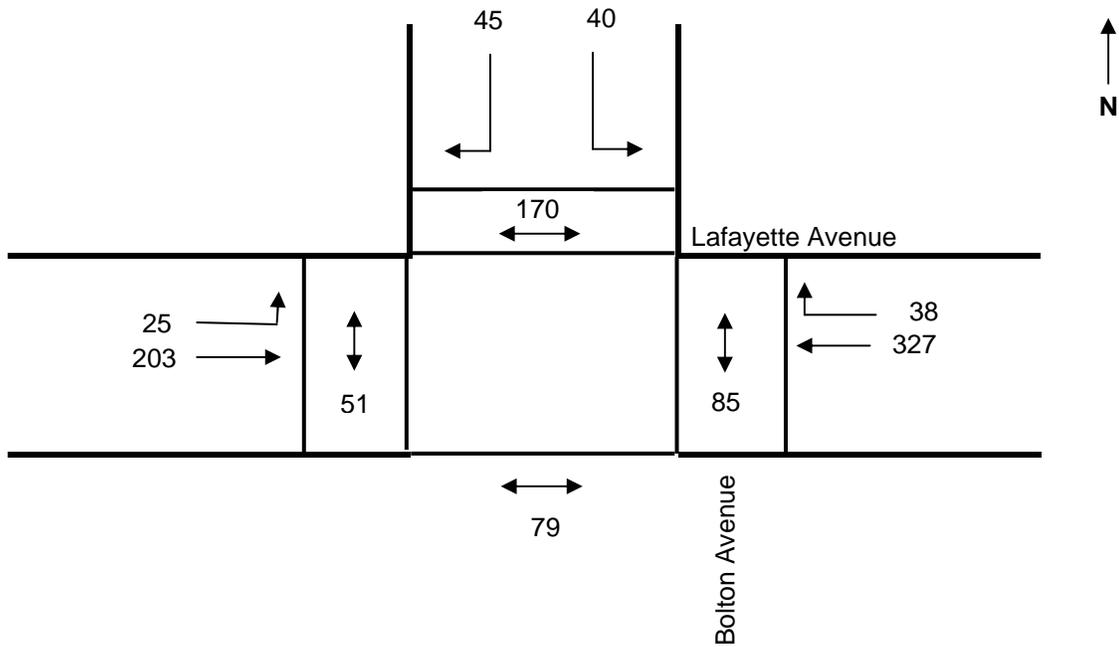
One Hour Traffic Volumes
Wednesday, June 15th, 2005 7:30am - 8:30am

Intersection of Lafayette Avenue and Bolton Avenue

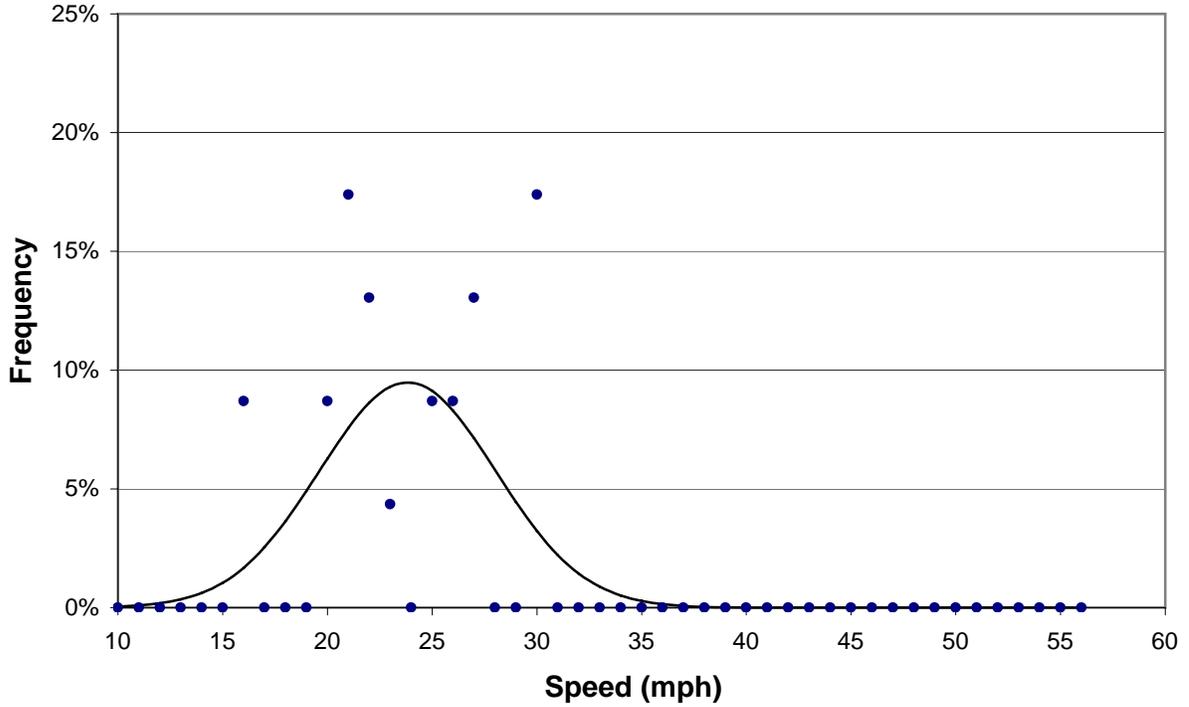
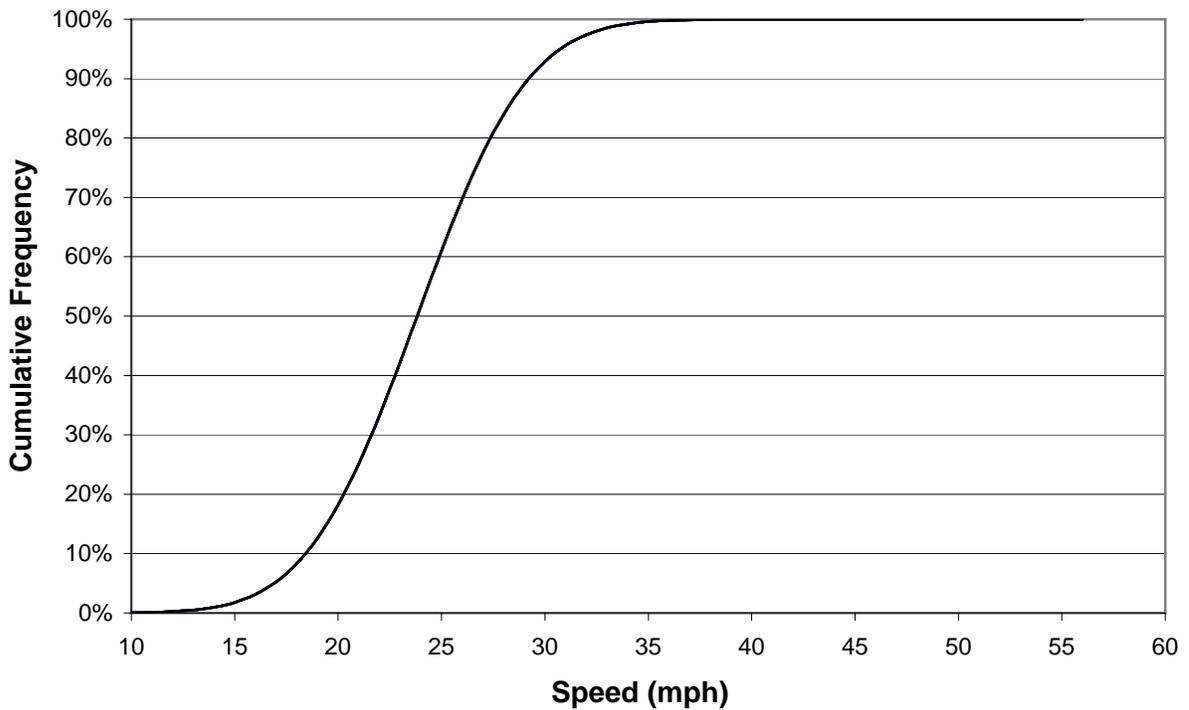
Date: **June 15, 2005**
 Location: **Bolton Avenue between Lafayette Avenue & Story Avenue**
 Surveyor: **Richard Calvache & Hugo Salinas**

Mean Speed = 23.8 mph
 Standard Deviation = 4.2 mph
 Margin of Error (95% Confidence) = ± 1.7 mph

Median Speed = 23.8 mph
 15th Percentile Speed = 19.5 mph
 85th Percentile Speed = 28.2 mph

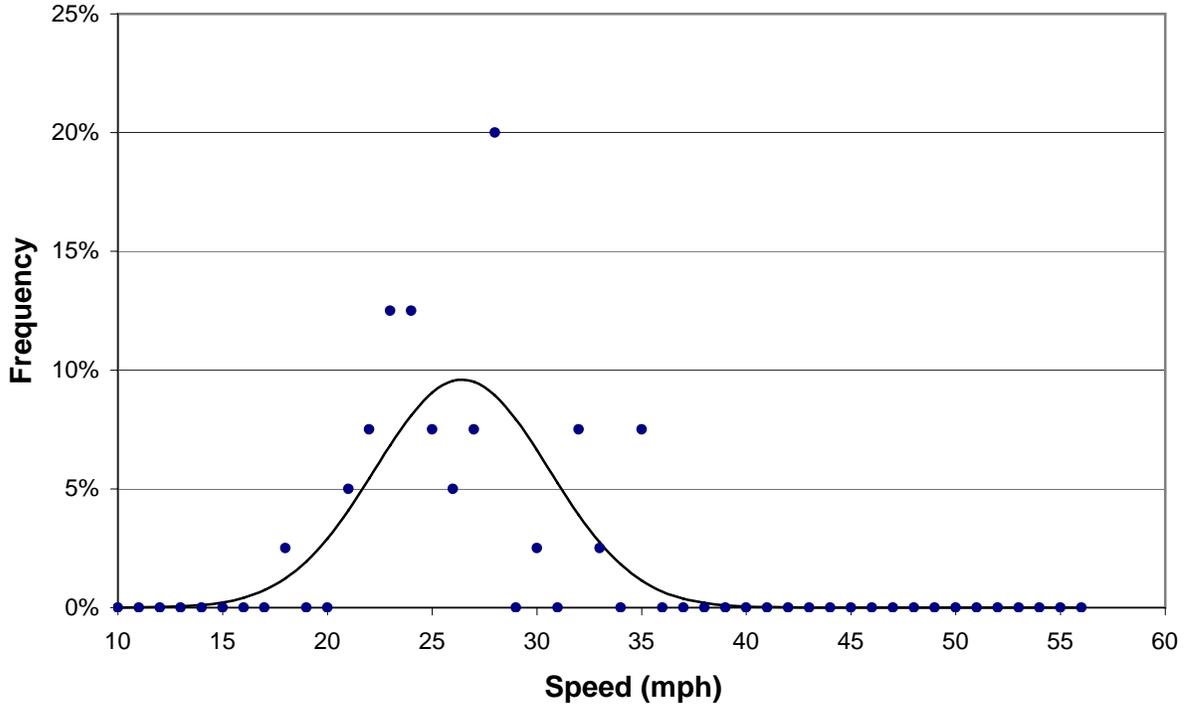
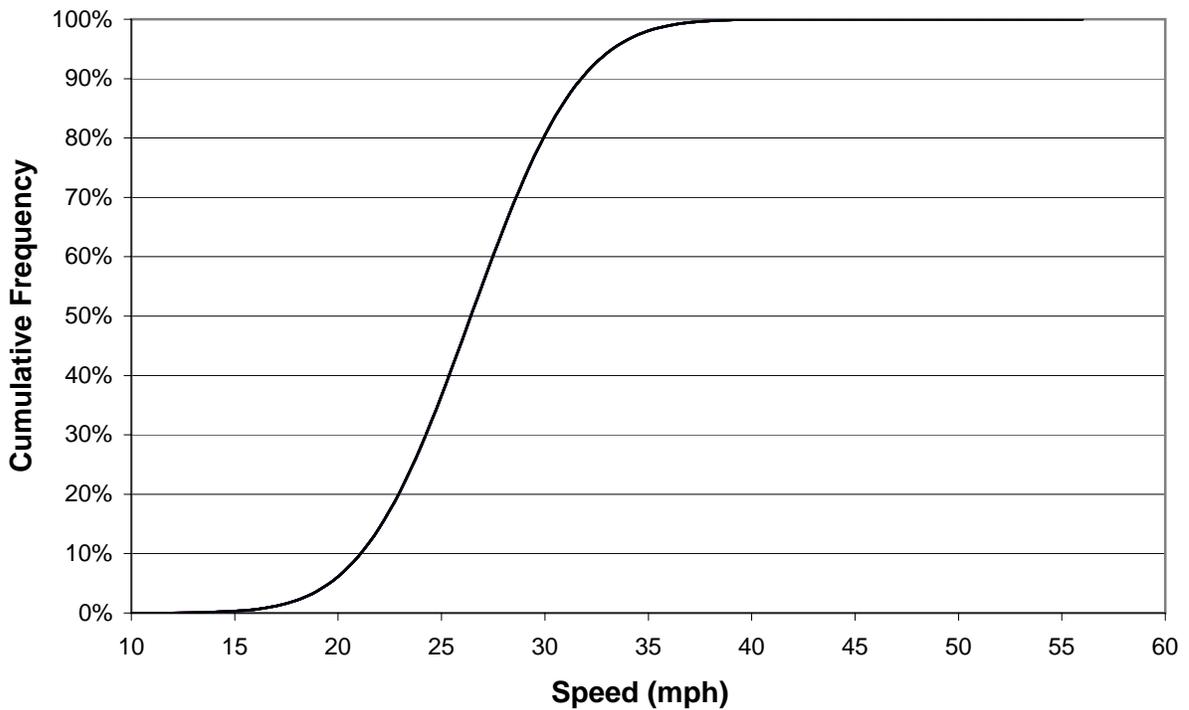
Date: **June 15, 2005** Time: **10:15am**
 Location: **Bolton Avenue between Lafayette Avenue & Story Avenue**
 Surveyor: **Richard Calvache & Hugo Salinas**

Mean Speed = 26.4 mph
 Standard Deviation = 4.2 mph
 Margin of Error (95% Confidence) = ± 1.3 mph

Median Speed = 26.4 mph
 15th Percentile Speed = 22.1 mph
 85th Percentile Speed = 30.7 mph

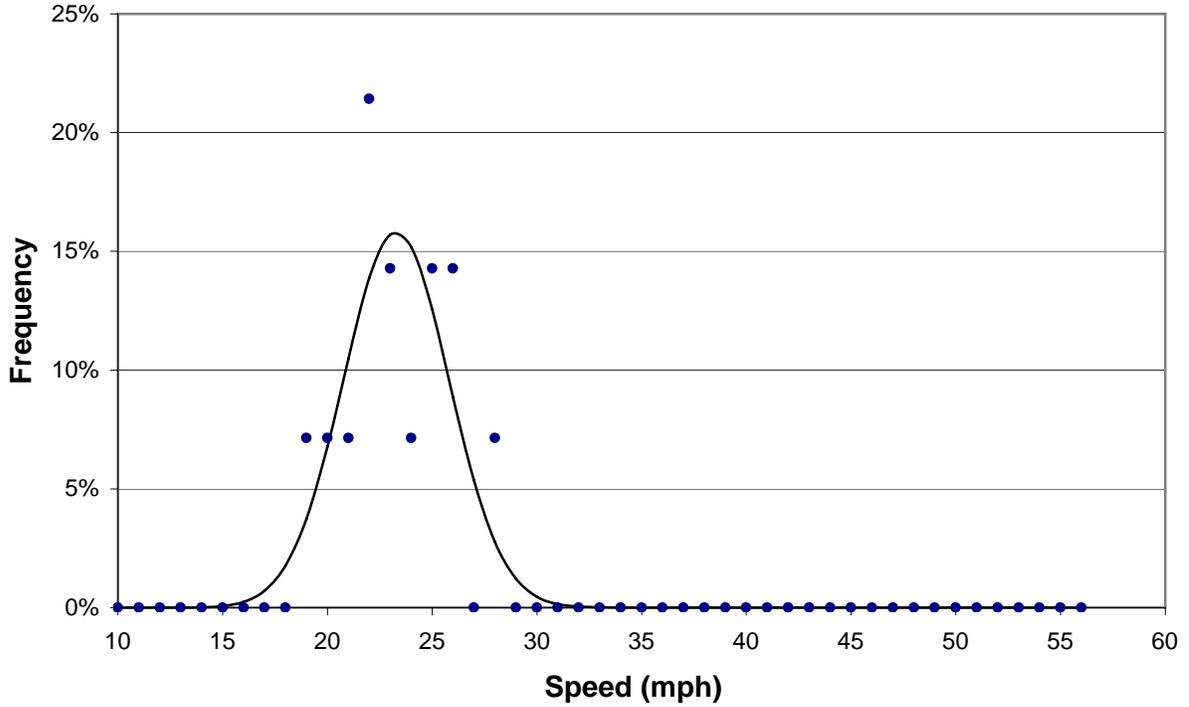
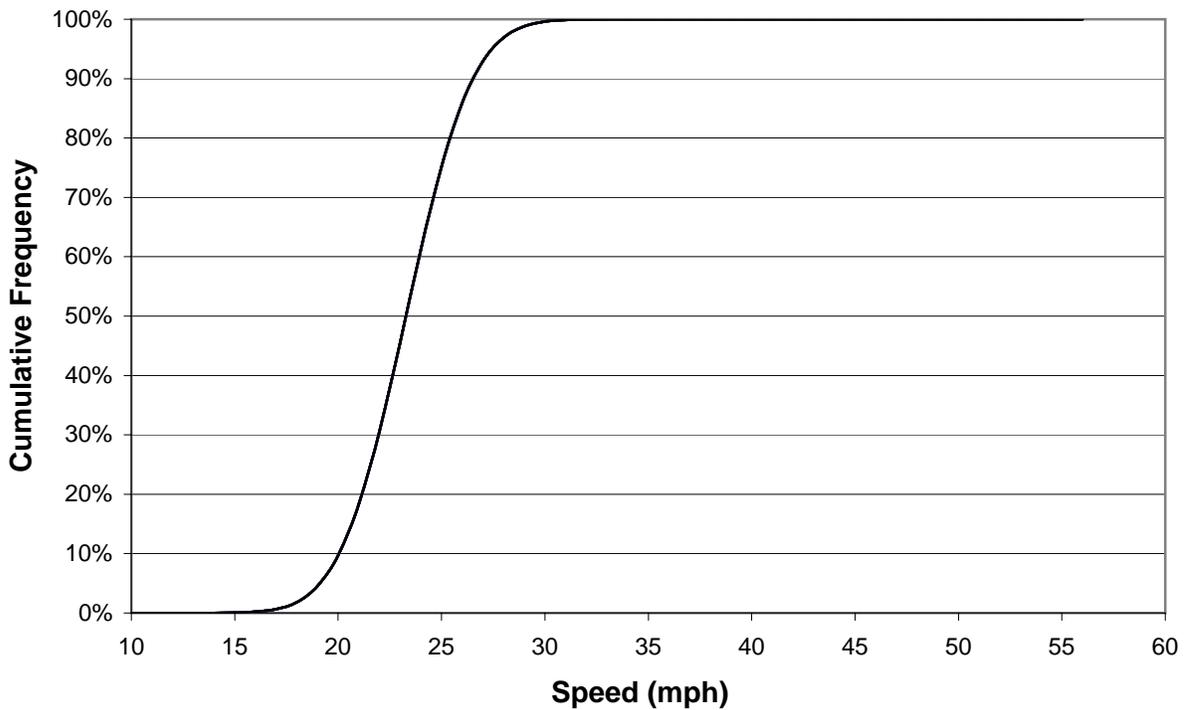
Date: **6-15-05** Time: **11:30am**
 Location: **Underhill Avenue between Lafayette Avenue & Story Avenue**
 Surveyor: **Richard Calvache & Hugo Salinas**

Mean Speed = 23.3 mph
 Standard Deviation = 2.5 mph
 Margin of Error (95% Confidence) = ± 1.3 mph

Median Speed = 23.3 mph
 15th Percentile Speed = 20.7 mph
 85th Percentile Speed = 25.9 mph

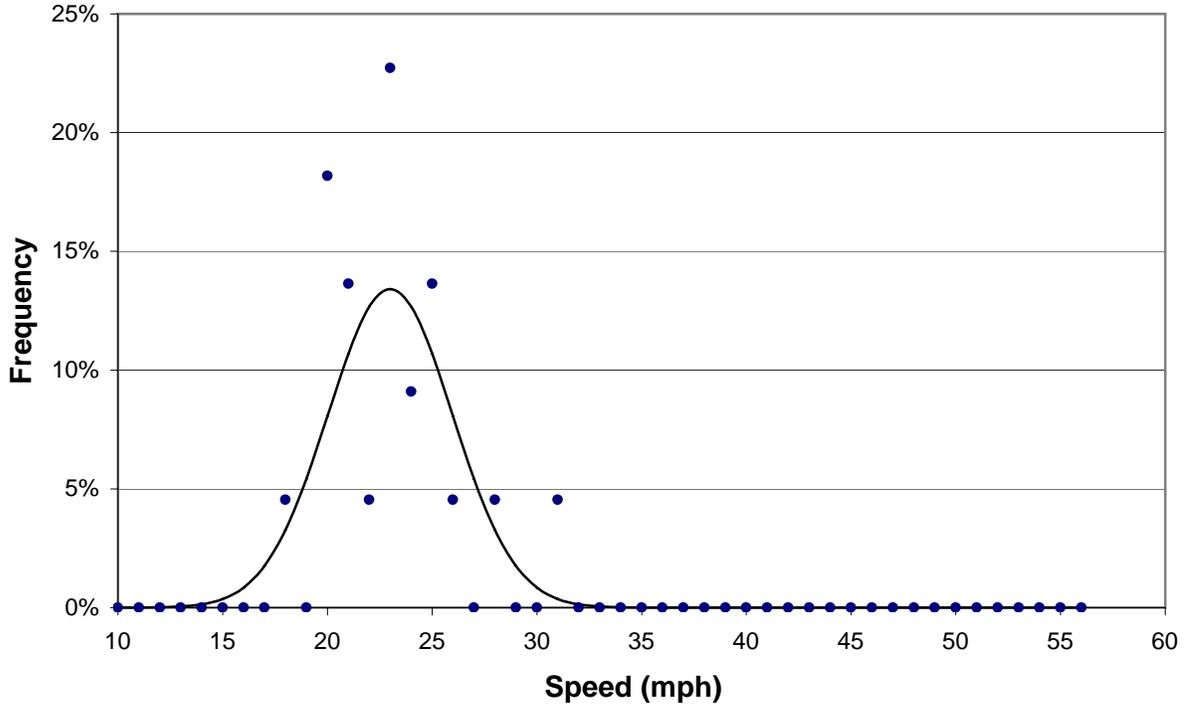
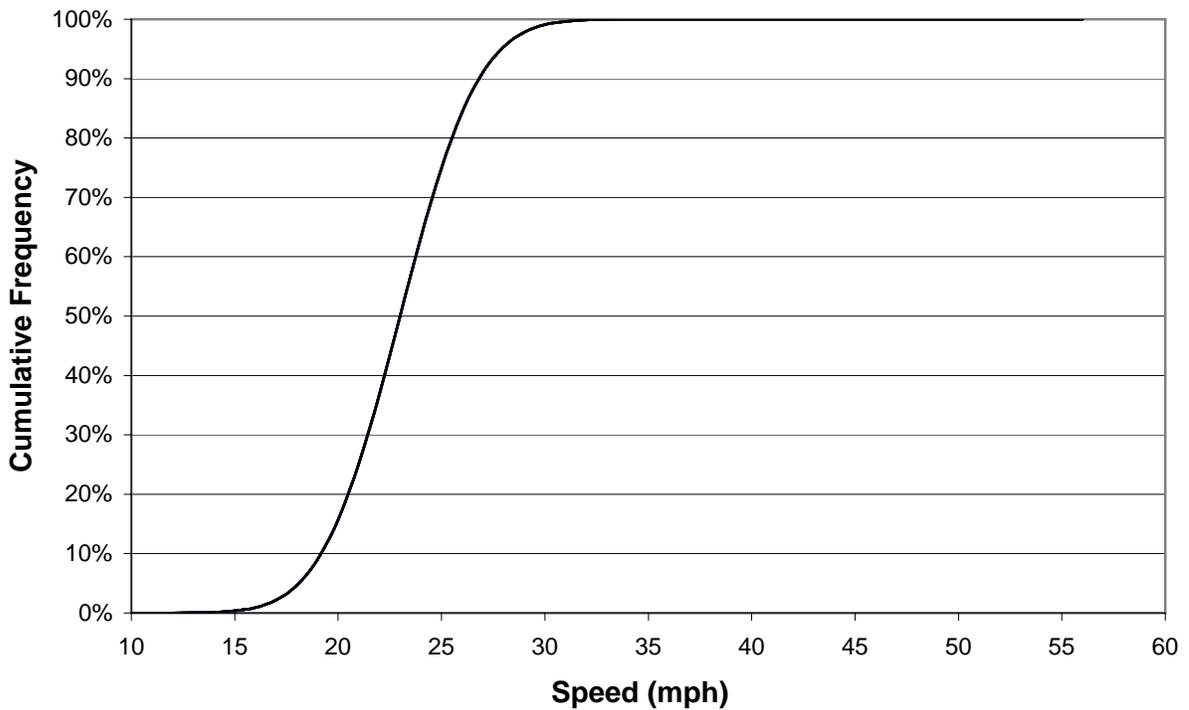
Date: **6-15-05** Time: **10:15am**
 Location: **Underhill Avenue between Lafayette Avenue & Story Avenue**
 Surveyor: **Richard Calvache & Hugo Salinas**

School: **I.S. 131**
 Direction: **Southbound**
 Comments:

Mean Speed = 23.0 mph Median Speed = 23.0 mph
 Standard Deviation = 3.0 mph 15th Percentile Speed = 19.9 mph
 Margin of Error (95% Confidence) = ± 1.2 mph 85th Percentile Speed = 26.1 mph
