**New York City Department of Transportation
Office of School Safety Engineering**

School Safety Engineering Project

FINAL REPORT: P.S. 9 (Ryer Avenue Elementary School), Bronx

**Prepared by
The RBA Group/Urbitran Associates**

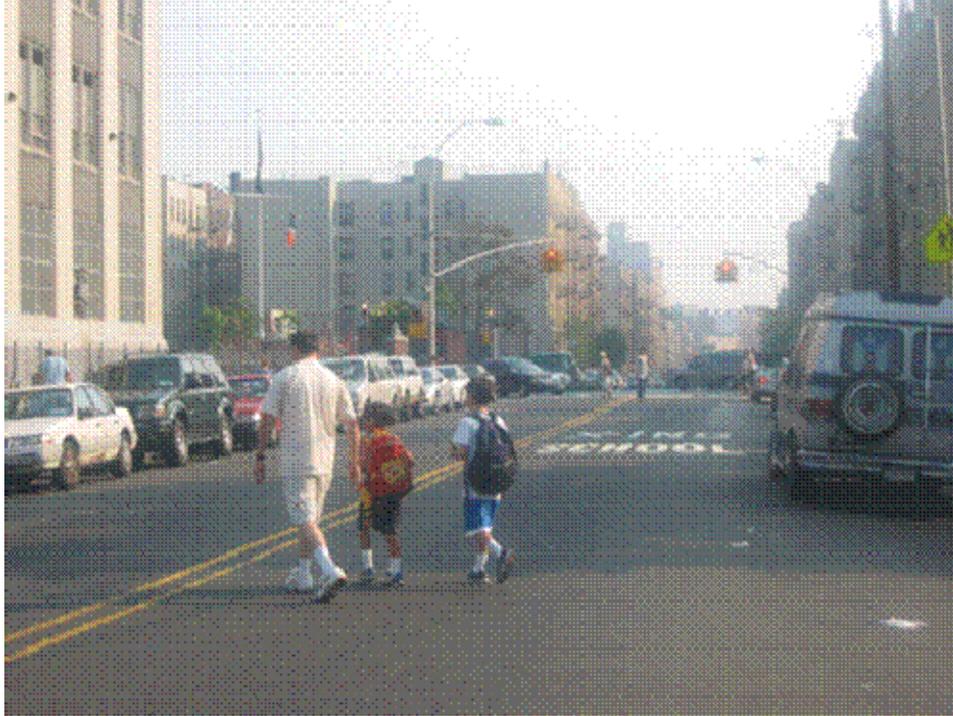
Figure 2: Pedestrians crossing mid-block on Valentine Avenue at arrival (school is on the left)

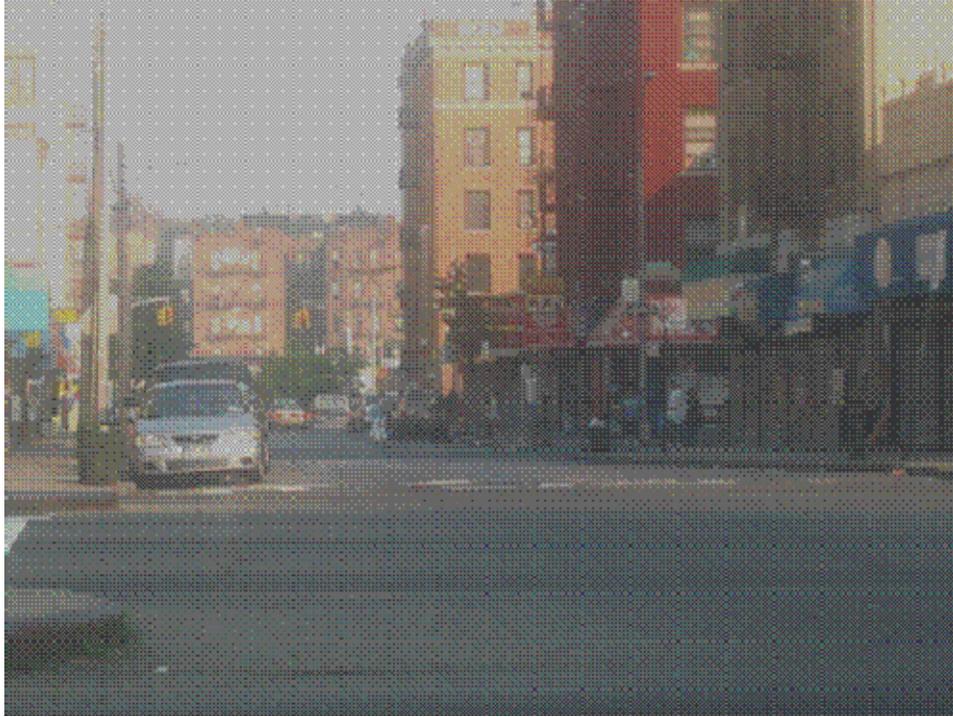
A local delicatessen on the northwest corner of the East183rd Street and Ryer Avenue intersection, and several other stores and restaurants located along East 183rd Street and

the Grand Concourse, generate significant vehicle and pedestrian traffic around P.S. 9 (see Figure 3). The Slattery Playground situated on the north side of East 183rd Street also generates pedestrian traffic.

Figure 3: Looking west along East 183rd Street from Ryer Avenue to the Grand Concourse

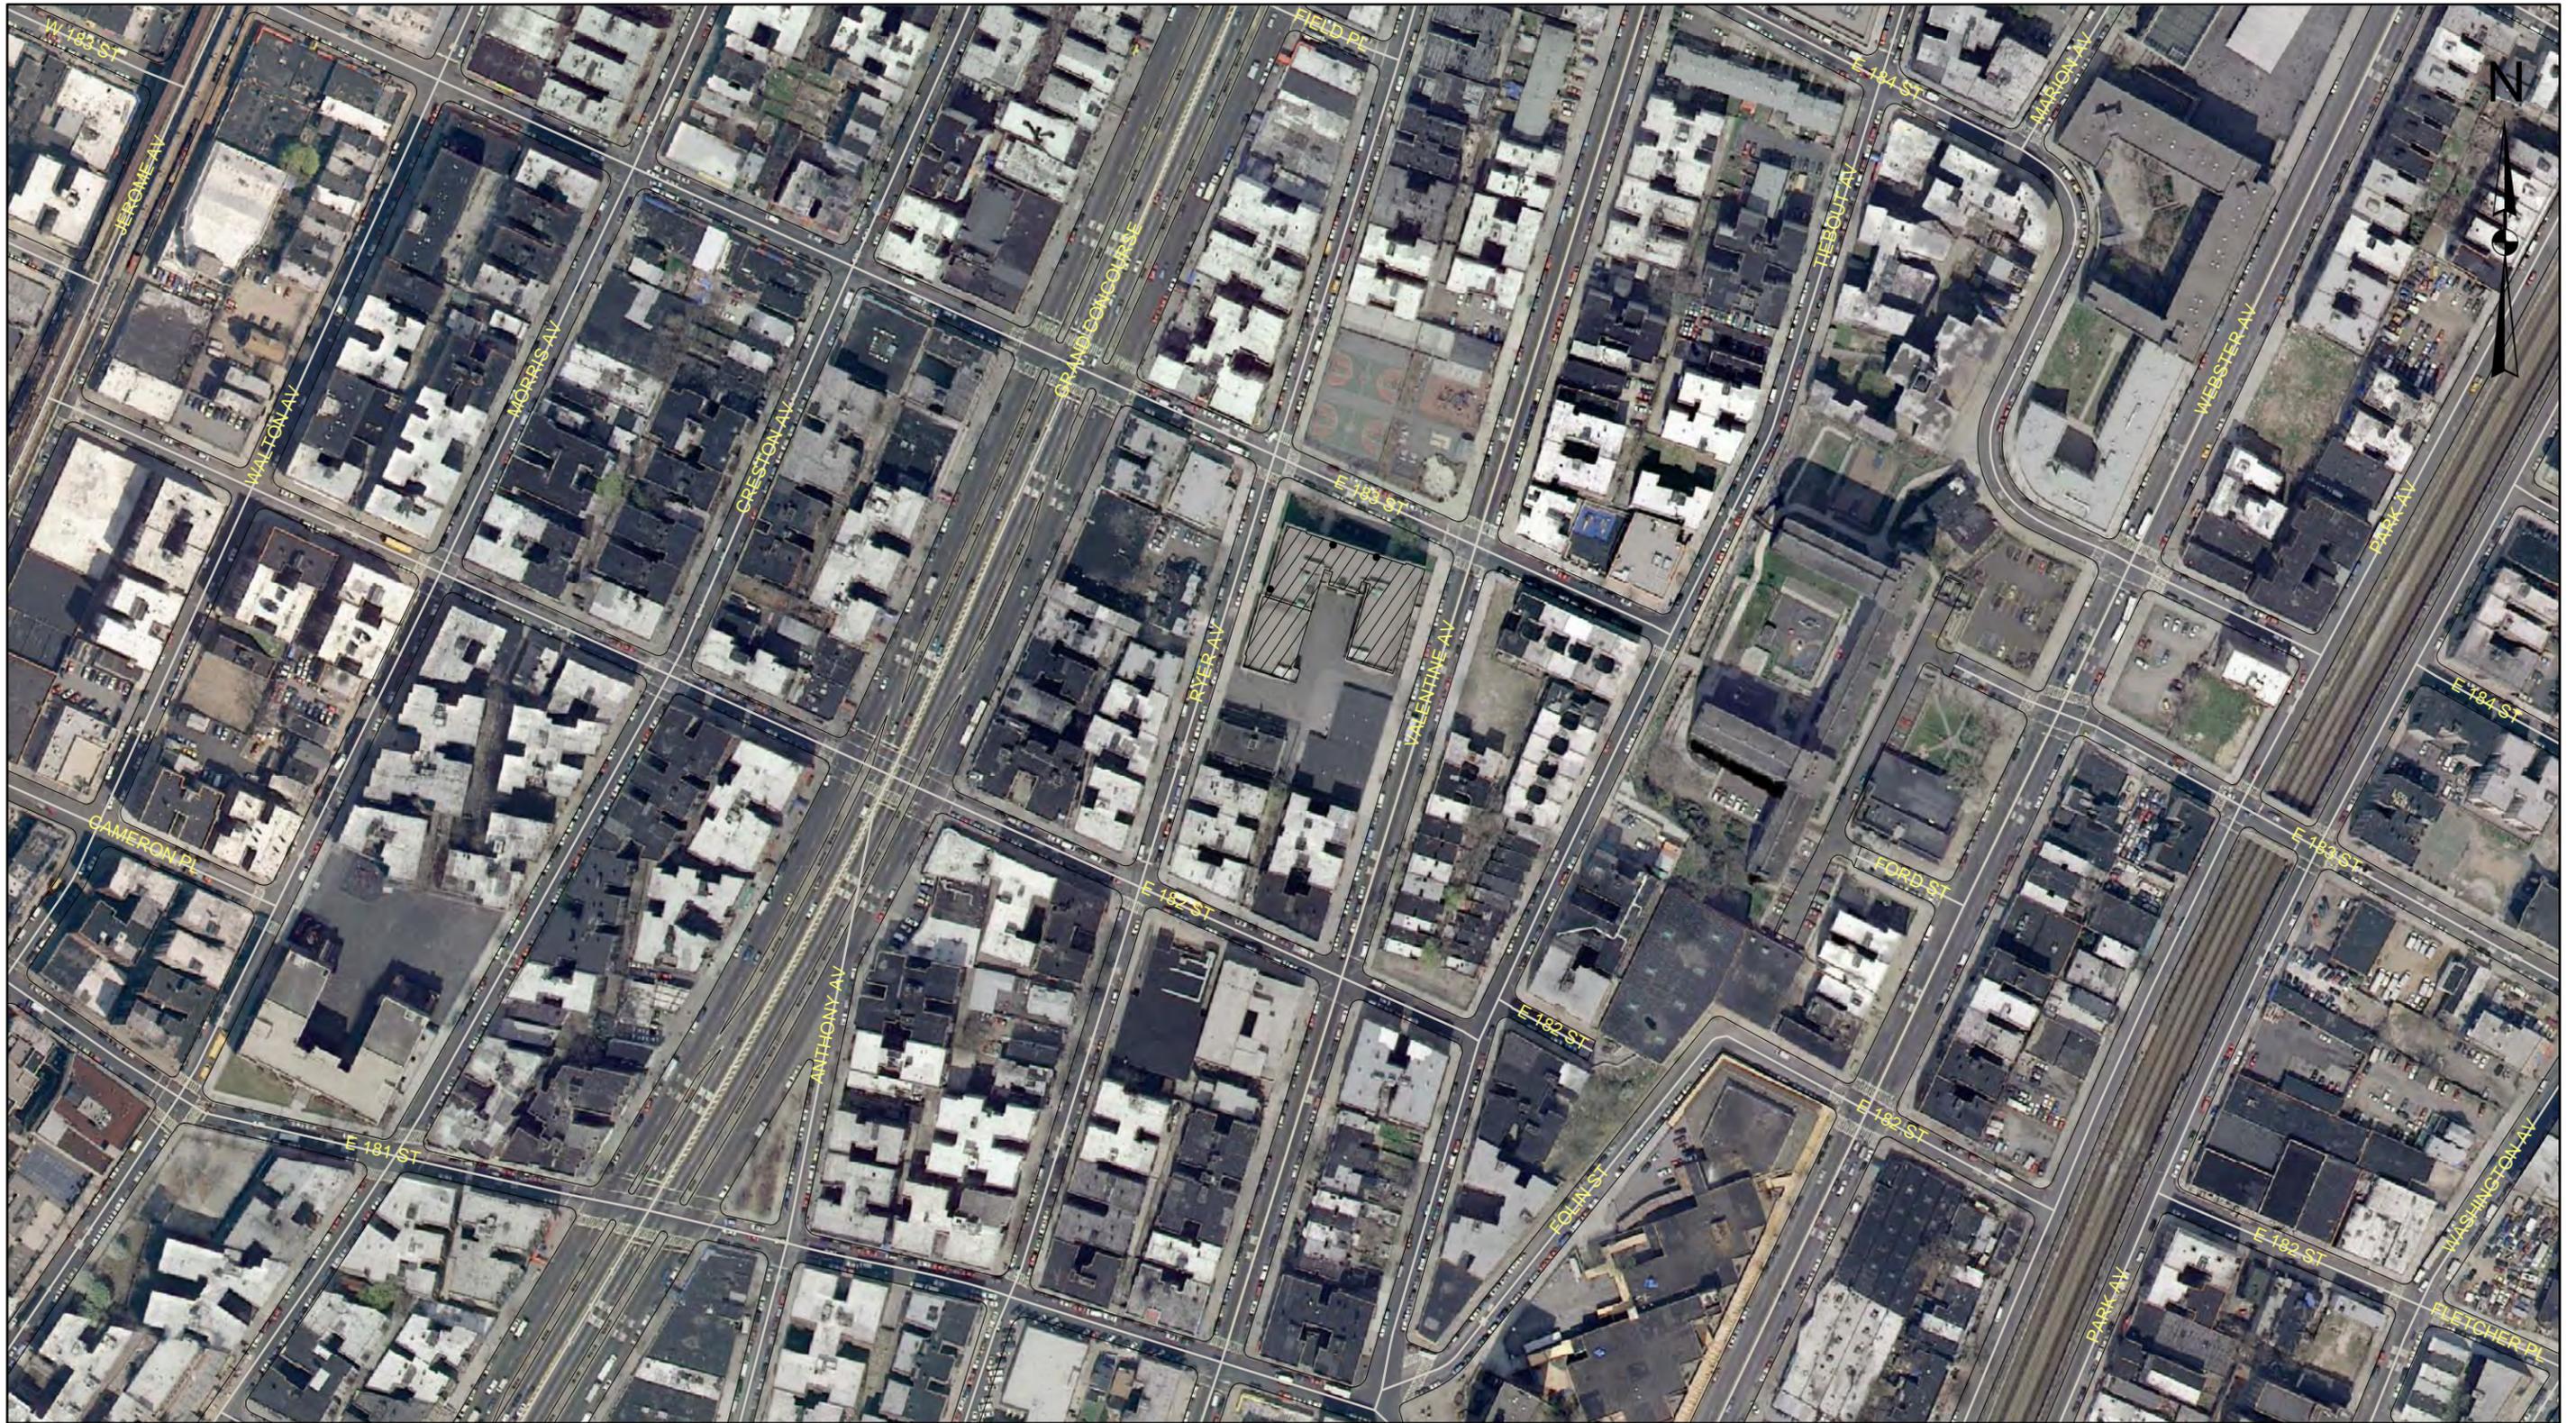
EXHIBIT 1
P.S. 9 BRONX
RYER AVENUE ELEMENTARY SCHOOL
AERIAL PHOTOGRAPH

Exhibit 1 shows an aerial view of the neighborhood surrounding the school. P.S. 9 is bounded by East 183rd Street to the north, East 182nd Street to the south, Valentine Avenue to the east, and Ryer Avenue to the west. The area surrounding the school is generally residential in character with primarily high-density, multi-level, apartment buildings. The Grand Concourse, a major commercial corridor with significant vehicle and pedestrian traffic, is located one block to the west of P.S. 9. Commercial activity is also found on East 184th Street, one block to the north of the school. Slattery Playground is situated on the north side of East 183rd Street between Ryer and Valentine Avenues. The 46th Precinct is located south of the school on Ryer Avenue between East 180th and East 181st Streets.

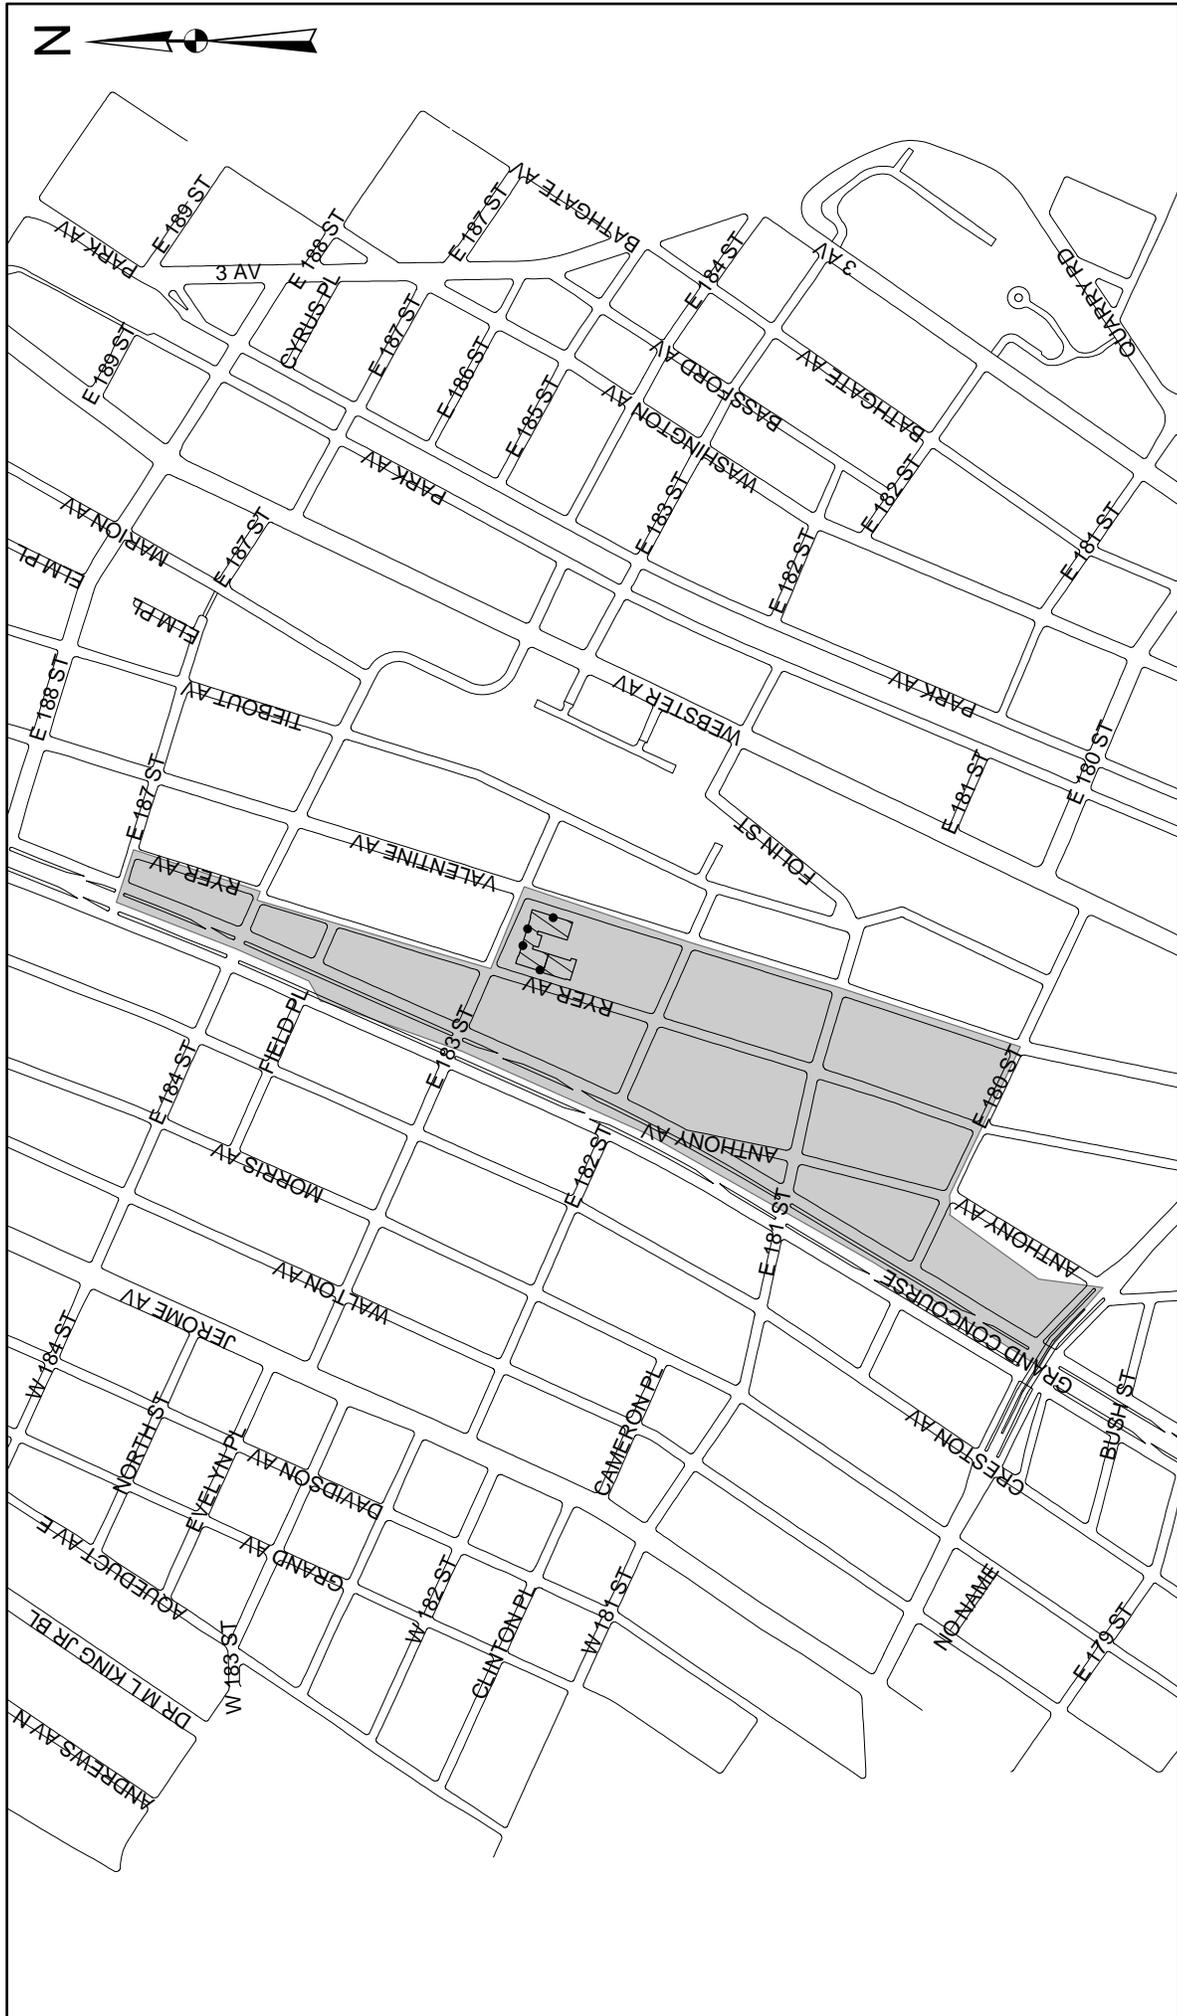
The school’s catchment area, as defined by the Department of Education (DOE), is shown in Exhibit 2. The school’s catchment area is defined generally by the following roadways: East 187th Street and East 183rd Street to the north, East Burnside Avenue and East 180th Street to the south, Anthony Avenue, Valentine Avenue and Ryer Avenue to the east and Grand Concourse to the west.

CATCHMENT AREA, (DEPARTMENT OF EDUCATION DESIGNATED AREA FROM WITHIN WHICH STUDENTS ARE ENTITLED TO ATTEND P.S. 9)

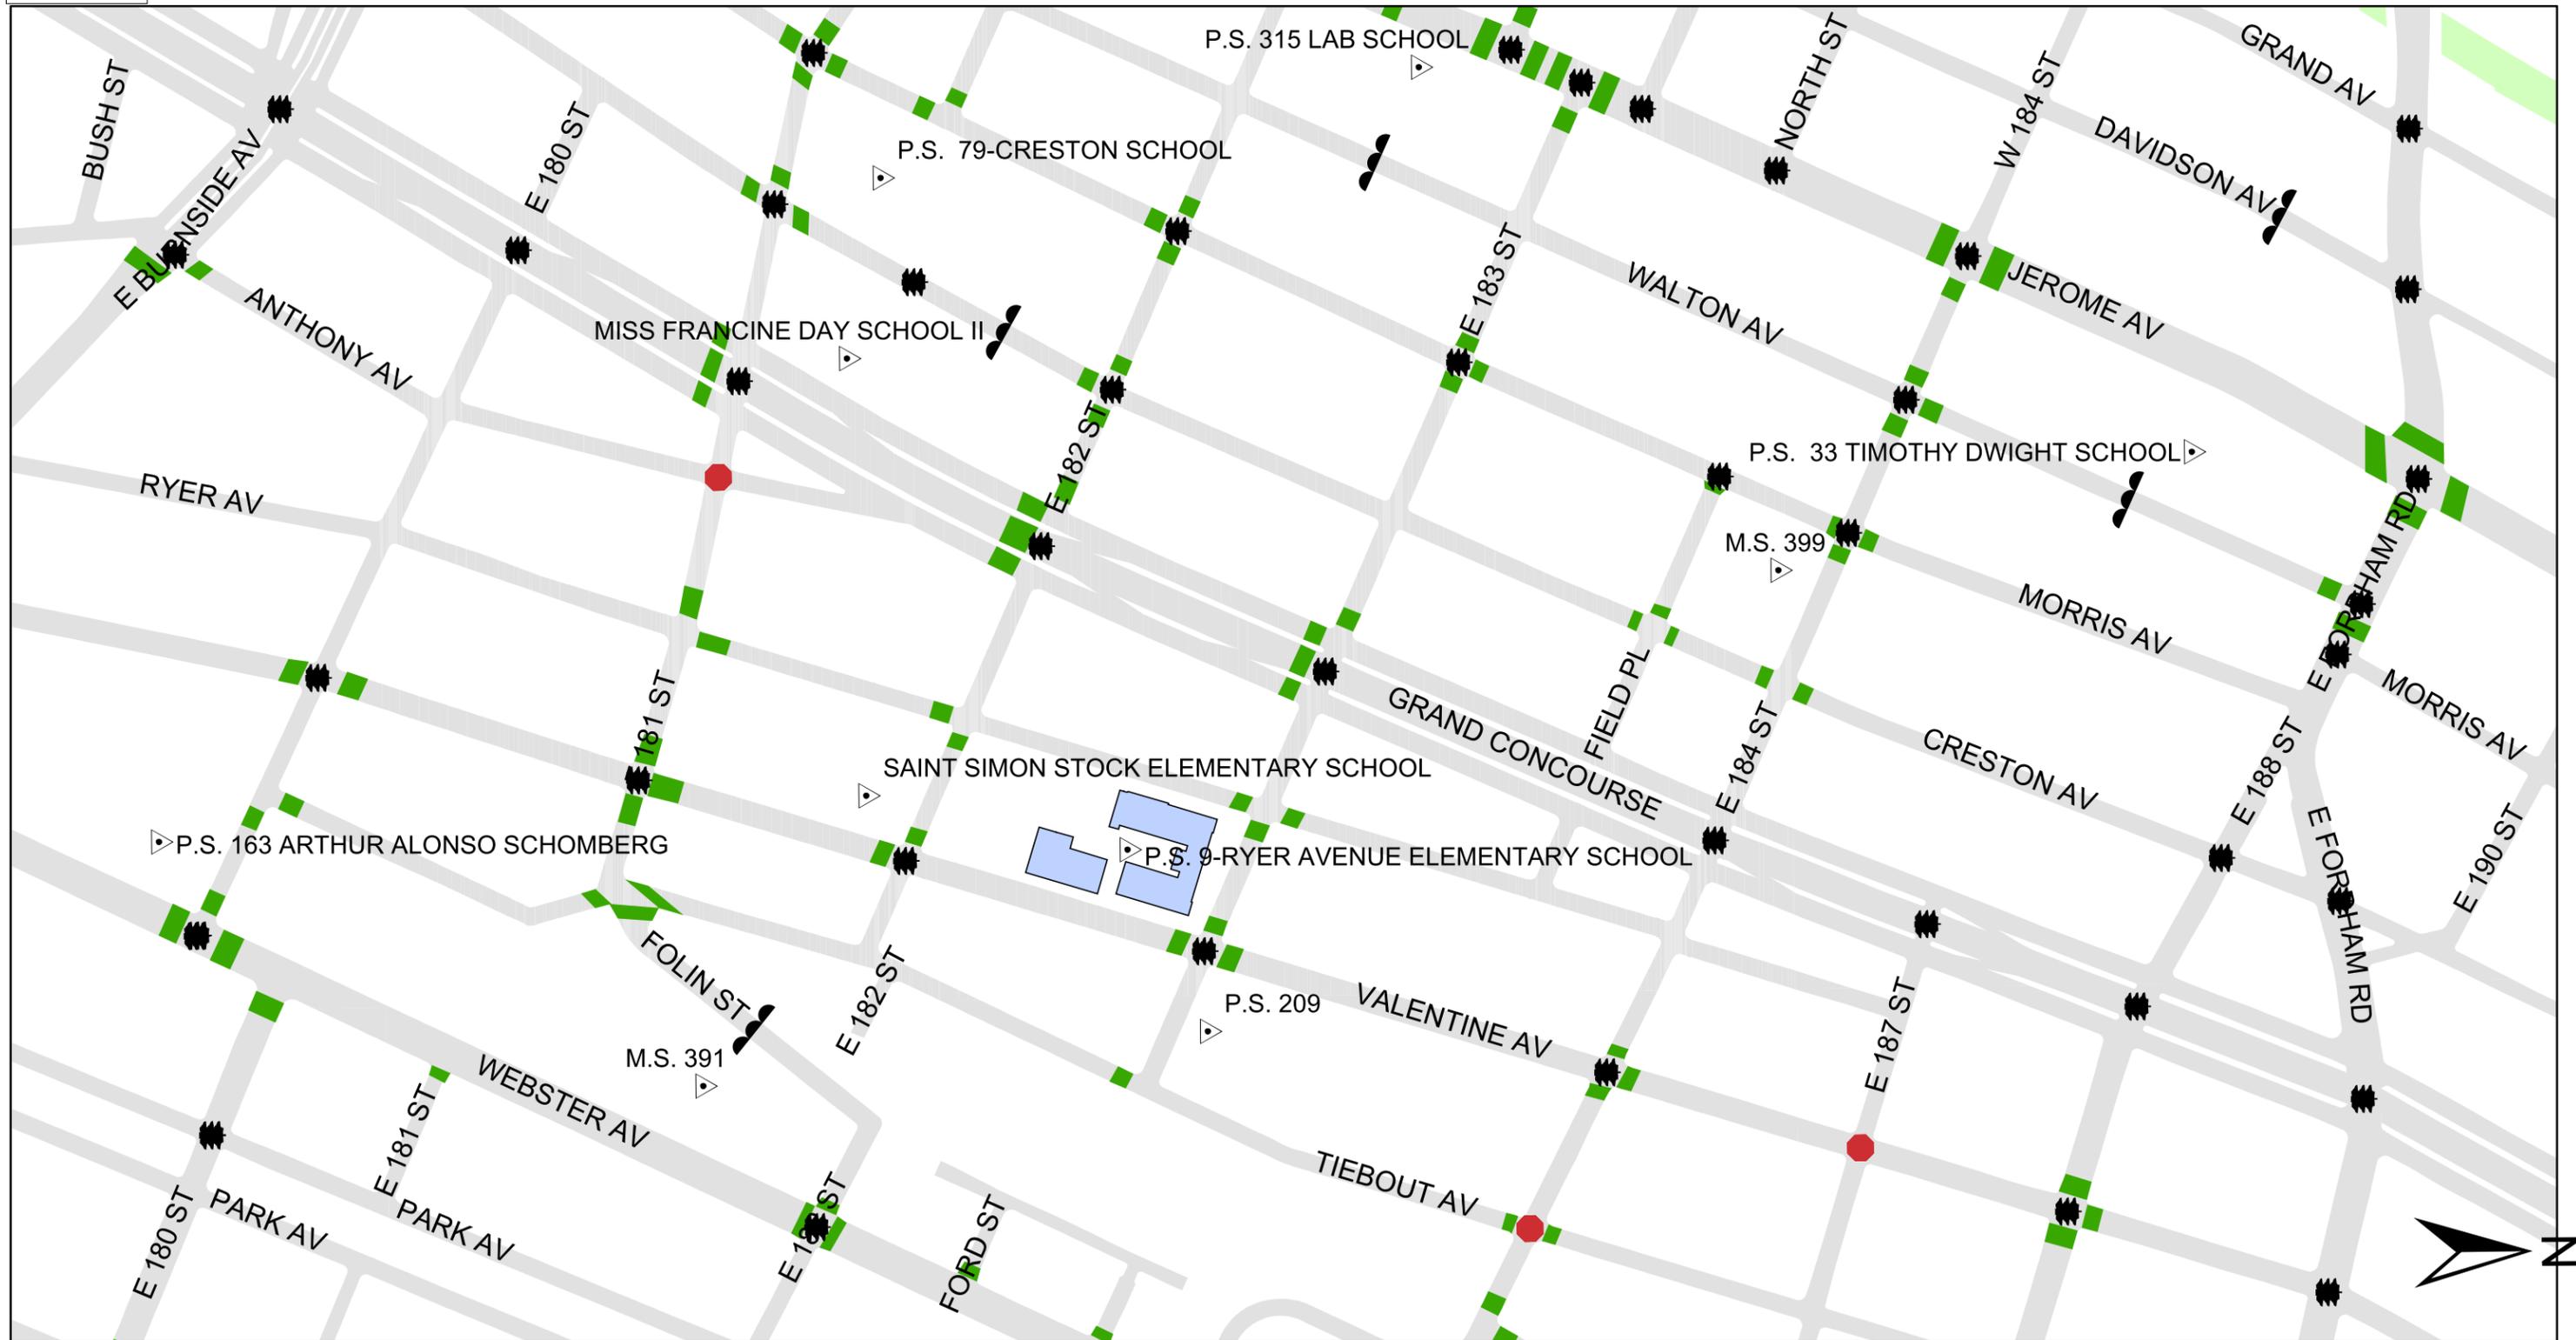
EXHIBIT 3

The School Traffic Safety Map was established to help provide the maximum degree of safety for children going to and from school - by indicating the location of speed reducers, school crosswalks and some traffic control devices. (While virtually all intersections in NYC benefit from traffic control devices - such as stop signs, traffic signals, yield signs, and all way stop signs - this map shows only traffic signals and all way stop signs.) The school crosswalks that are shown are ladder striped and make the crosswalk more visible to drivers and help make the intersection safer. These crosswalks are where school children are recommended to cross.

Exhibit 3 shows the existing school signals and pavement markings around P.S. 9. It should be noted that a citywide signage program is currently underway to upgrade school signage to current Federal Manual on Uniform Traffic Control Devices (MUTCD) standards of fluorescent yellow-green signs accompanied by downward pointing arrows. This will make the school crossing warning signs more visible to motorists. Signs scheduled to be installed under this program are shown as “existing” in Exhibit 8.

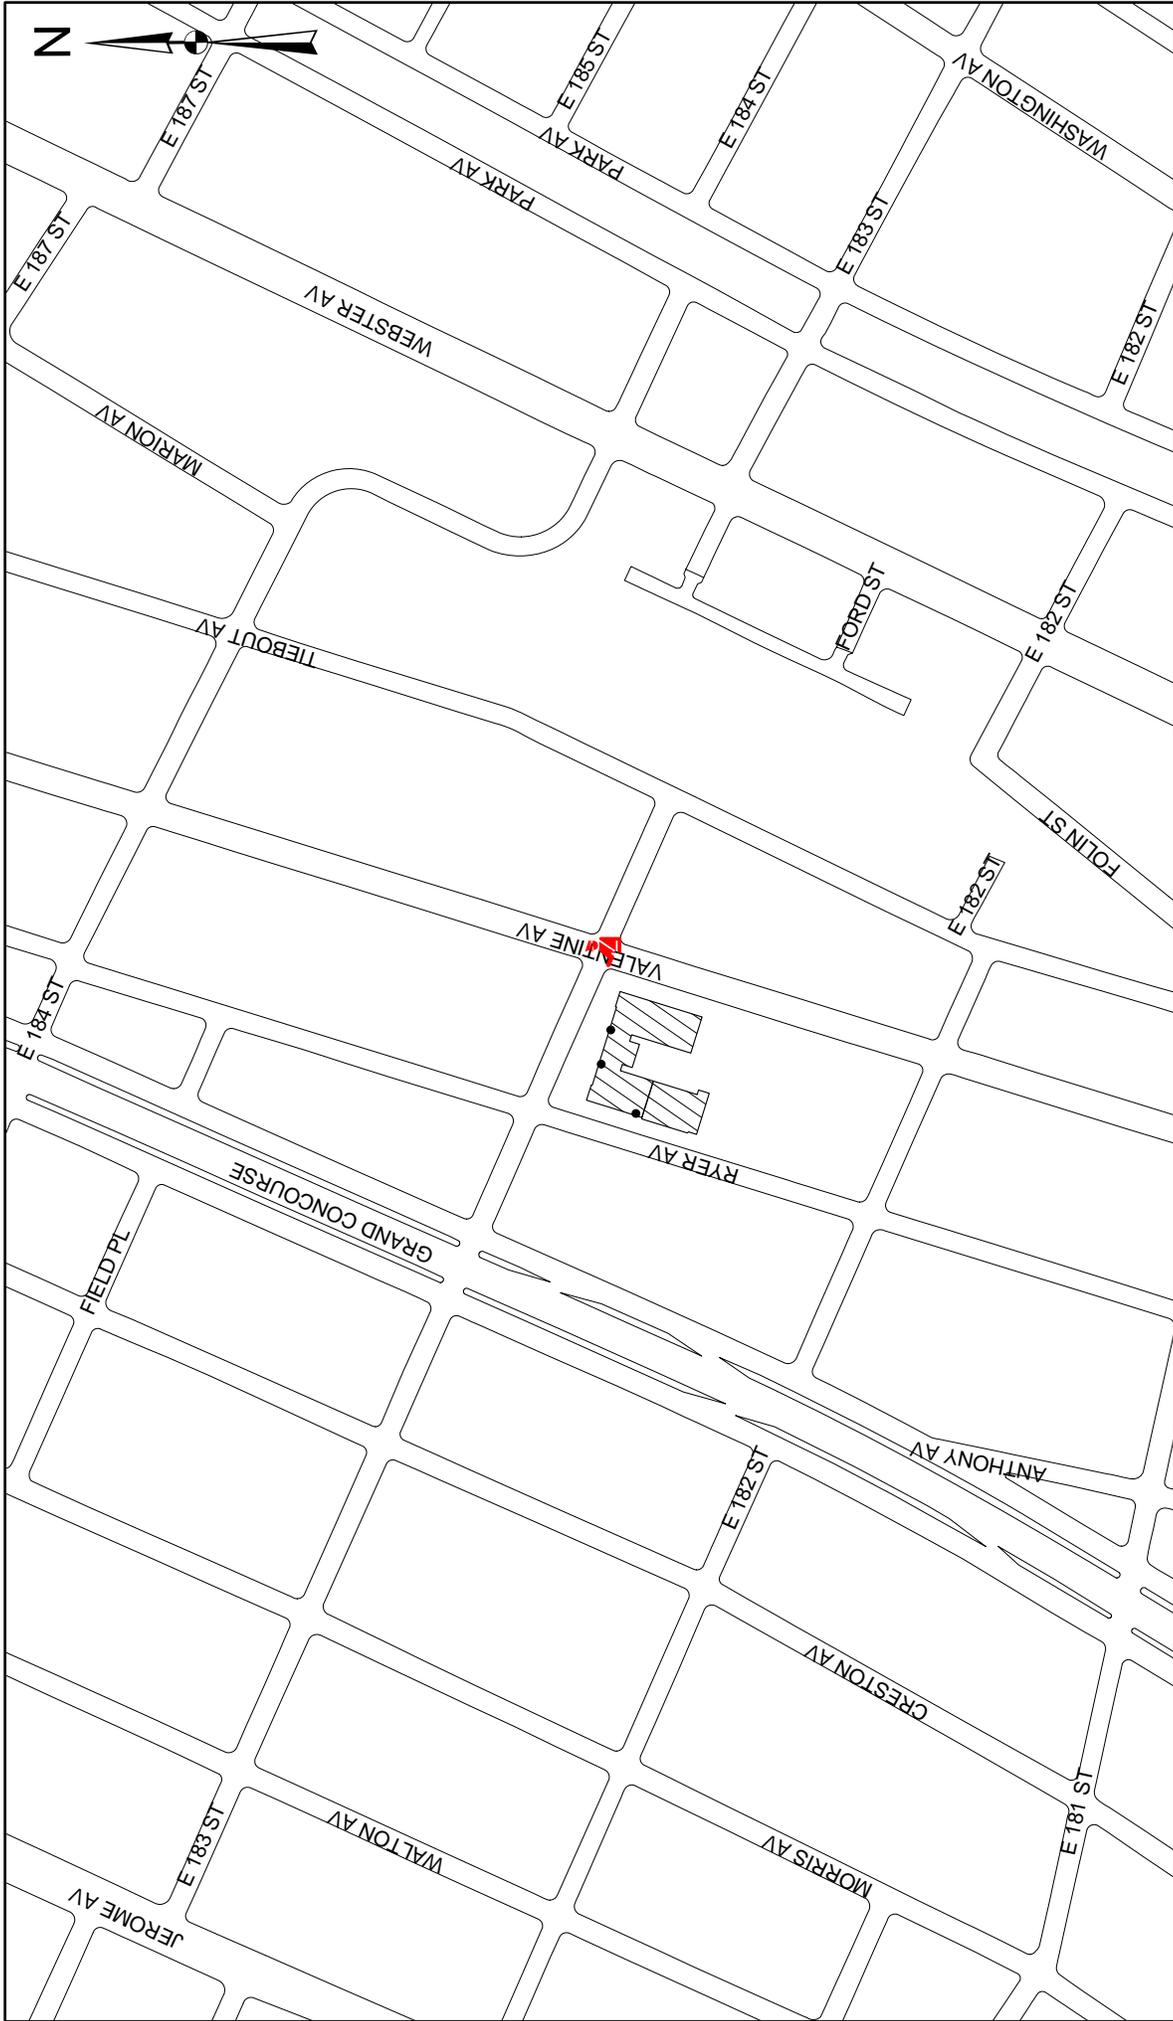
EXHIBIT 4

According to the school principal, a school crossing guard is assigned to the intersection of East 183rd Street and Valentine Avenue. The crossing guard location is shown in Exhibit 4.

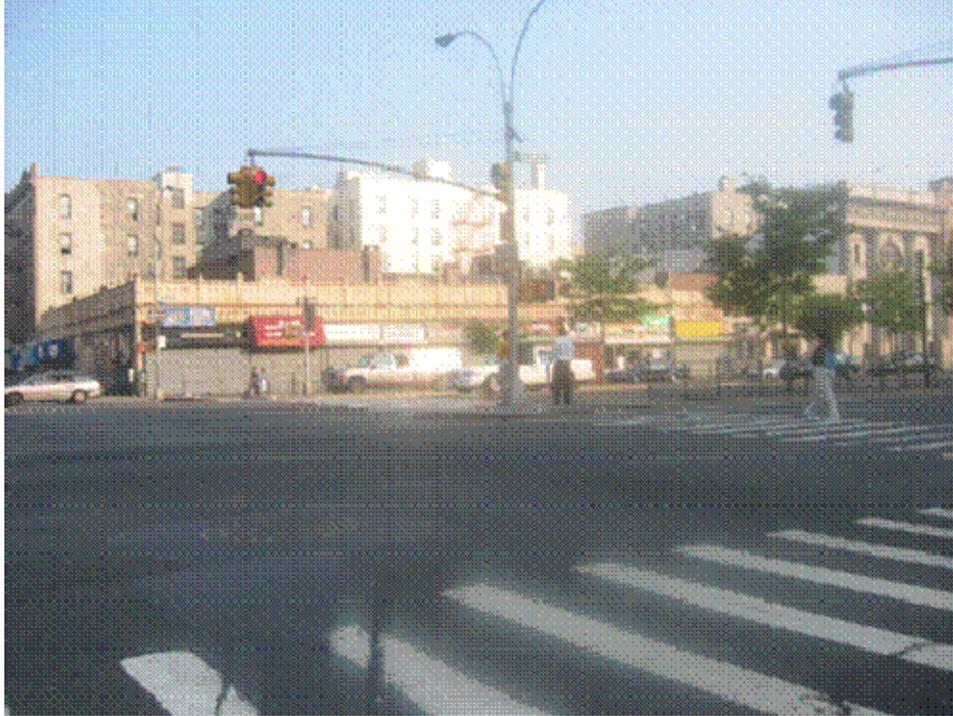
This is a four-leg signalized intersection with school crosswalks located across the southern leg of Grand Concourse's mainline and service roads and west leg of East 183rd Street (see Figures 4 and 5). The Grand Concourse is a major, north-south, corridor in the Bronx, extending from Mosholu Parkway at its northern terminus to East 138th Street/Madison Avenue Bridge/Major Deegan Expressway at its southern terminus. In the vicinity of P.S. 9, the mainline section of the Grand Concourse carries two travel lanes in both the northbound and southbound directions. A painted striped median, approximately ten feet wide, separates the northbound and southbound roadways. Exclusive left turn lanes are provided on both the northbound and southbound mainline approaches. The north and south service roads carry two travel lanes and one right-side parking lane. A raised concrete buffer separates the mainline and service roadways in both directions. Approaching East 183rd Street in the northbound direction, there are slip ramps to and from the Grand Concourse mainline and the service road. East 183rd Street is a two-way east-west street with one travel lane and an on-street parking lane on each side of the roadway. The intersection of Grand Concourse and East 183rd Street is within the "Special Grand Concourse Preservation District" designated by the Department of City Planning (DCP).

There were 110 accidents reported at this intersection between 1998 and 2000 (Table 2); 18 of which were pedestrian accidents. None of the eighteen pedestrian accidents were school-related. There was one pedestrian fatality reported at this intersection during the same three-year period. This fatal accident occurred on Wednesday, December 30, 1998 at 5:00 pm. The accident involved a pedestrian, whose age is not known, who was reported struck by a vehicle while crossing the Grand Concourse against the signal. The accident location was reported as a straight and level segment, and the roadway and weather conditions were dry and clear, respectively.

Figure 4: Looking northwest across the Grand Concourse at its intersection with East 183rd Street

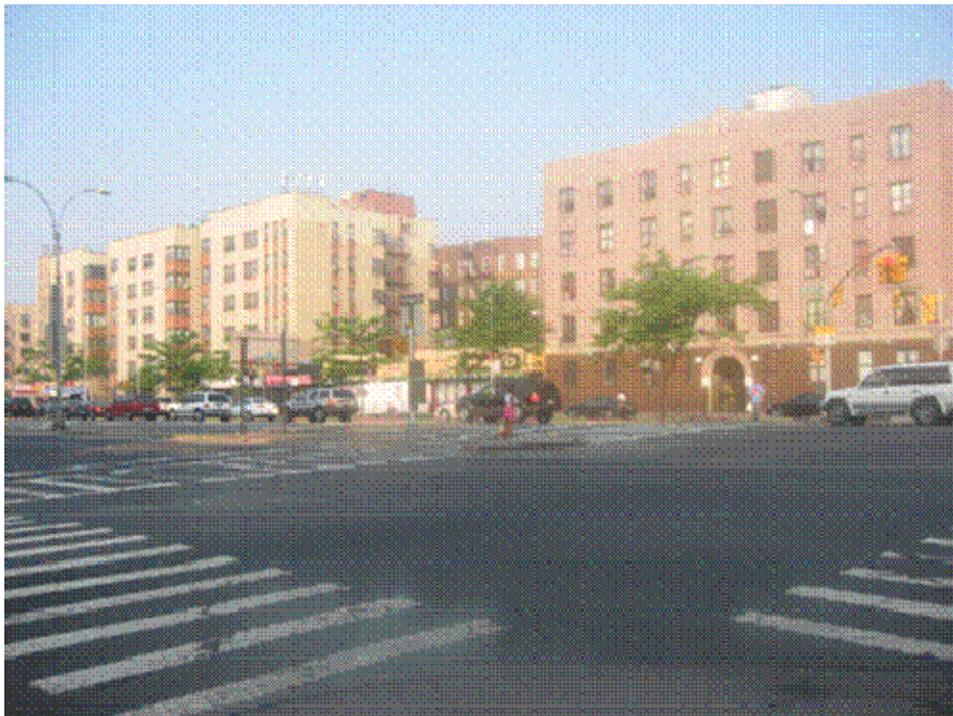
Figure 5: Looking southwest across the Grand Concourse at its intersection with East 183rd Street

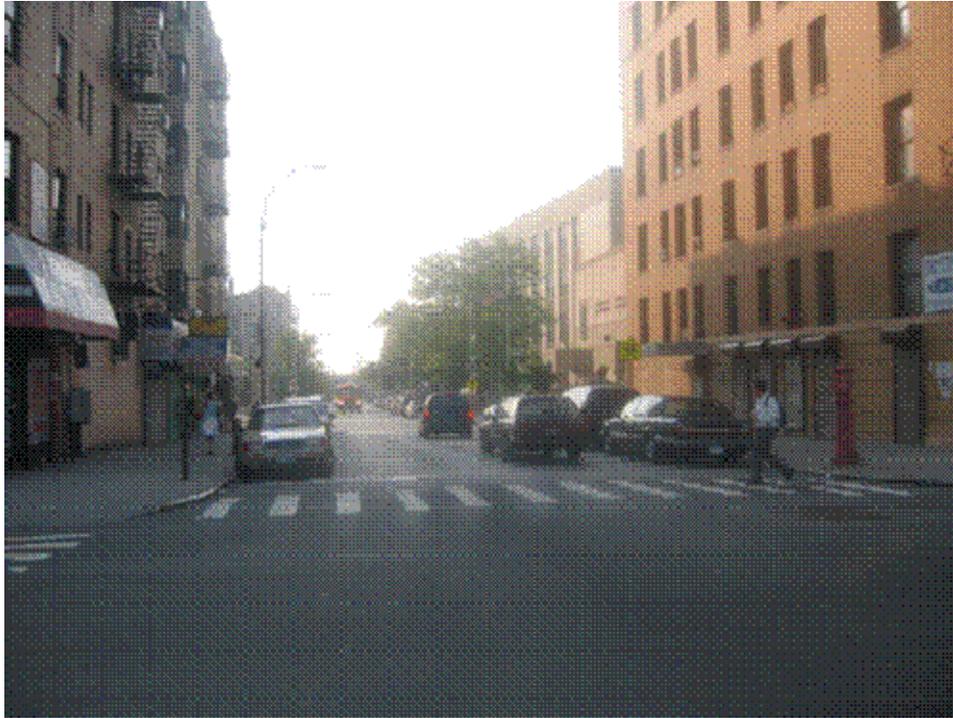
- Missing pedestrian ramps on both sides of the crosswalk located on the eastern leg of East 183rd Street at Grand Concourse (see Figure 7).
- Light pole on the northeast corner of the East 183rd Street and Ryer Avenue intersection obstructs the crosswalk (see Figure 8).

Figure 7: Looking west at crosswalk on east leg of East 183rd Street at the Grand Concourse (pedestrian ramps missing at both ends of crosswalk)

- Install missing pedestrian ramps on the northeast and southeast corners of the east leg of East 183rd Street at its intersection with Grand Concourse.
- Redesign the pedestrian ramp at the northeast corner of the East 183rd Street and Ryer Avenue intersection where a utility pole is obstructing the pedestrian path.

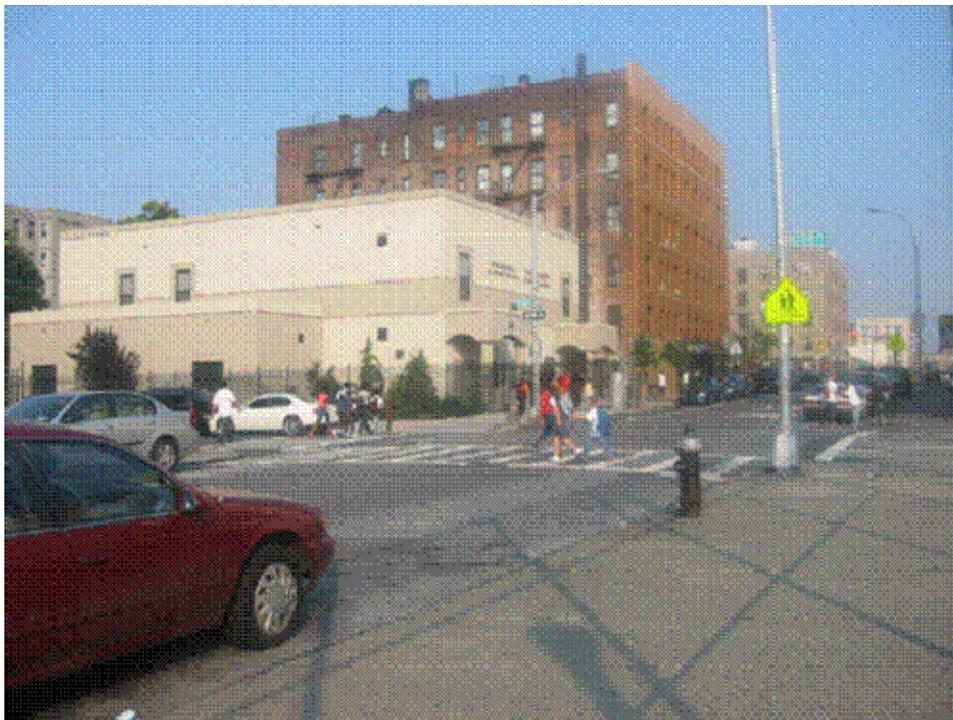
Figure 8: Light pole obstructing crosswalk on northeast corner of East 183rd Street/ Ryer Avenue intersection

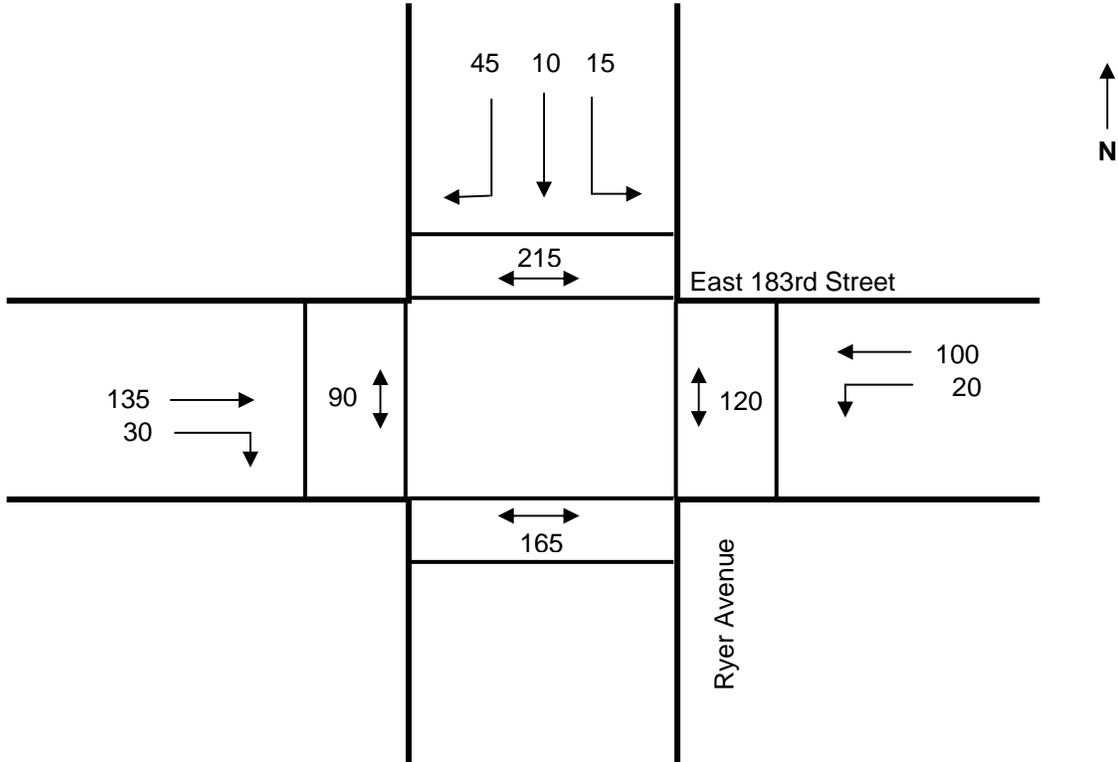
One-Hour Traffic Count Summary
Wednesday, June 1, 2005 7:30am - 8:30am

In addition, a traffic count was conducted at the intersection of East 183rd Street and Ryer Avenue from 7:30 to 9:00 am on Wednesday, June 1, 2005 in order to assess vehicle and pedestrian volumes in the vicinity of P.S. 9. The results of the vehicle and pedestrian counts are shown in Tables 4 and 5 and in Exhibit 7 at the end of this section.

TABLE 4: ONE-HOUR VEHICLE VOLUMES (7:30-8:30 AM)			
INTERSECTION	East 183RD STREET EASTBOUND	East 183RD STREET WESTBOUND	RYER AVENUE SOUTHBOUND
East 183 RD Street and Ryer Avenue	165	120	70

TABLE 5: ONE-HOUR PEDESTRIAN VOLUMES (7:30-8:30 AM)				
INTERSECTION	CROSSING East 183rd STREET EAST-LEG X-WALK	CROSSING East 183rd STREET WEST-LEG X-WALK	CROSSING RYER AVENUE NORTH-LEG X-WALK	CROSSING RYER AVENUE SOUTH-LEG X-WALK
East 183 RD Street and Ryer Avenue	120	90	215	165

Intersection of East 183rd Street and Ryer Avenue

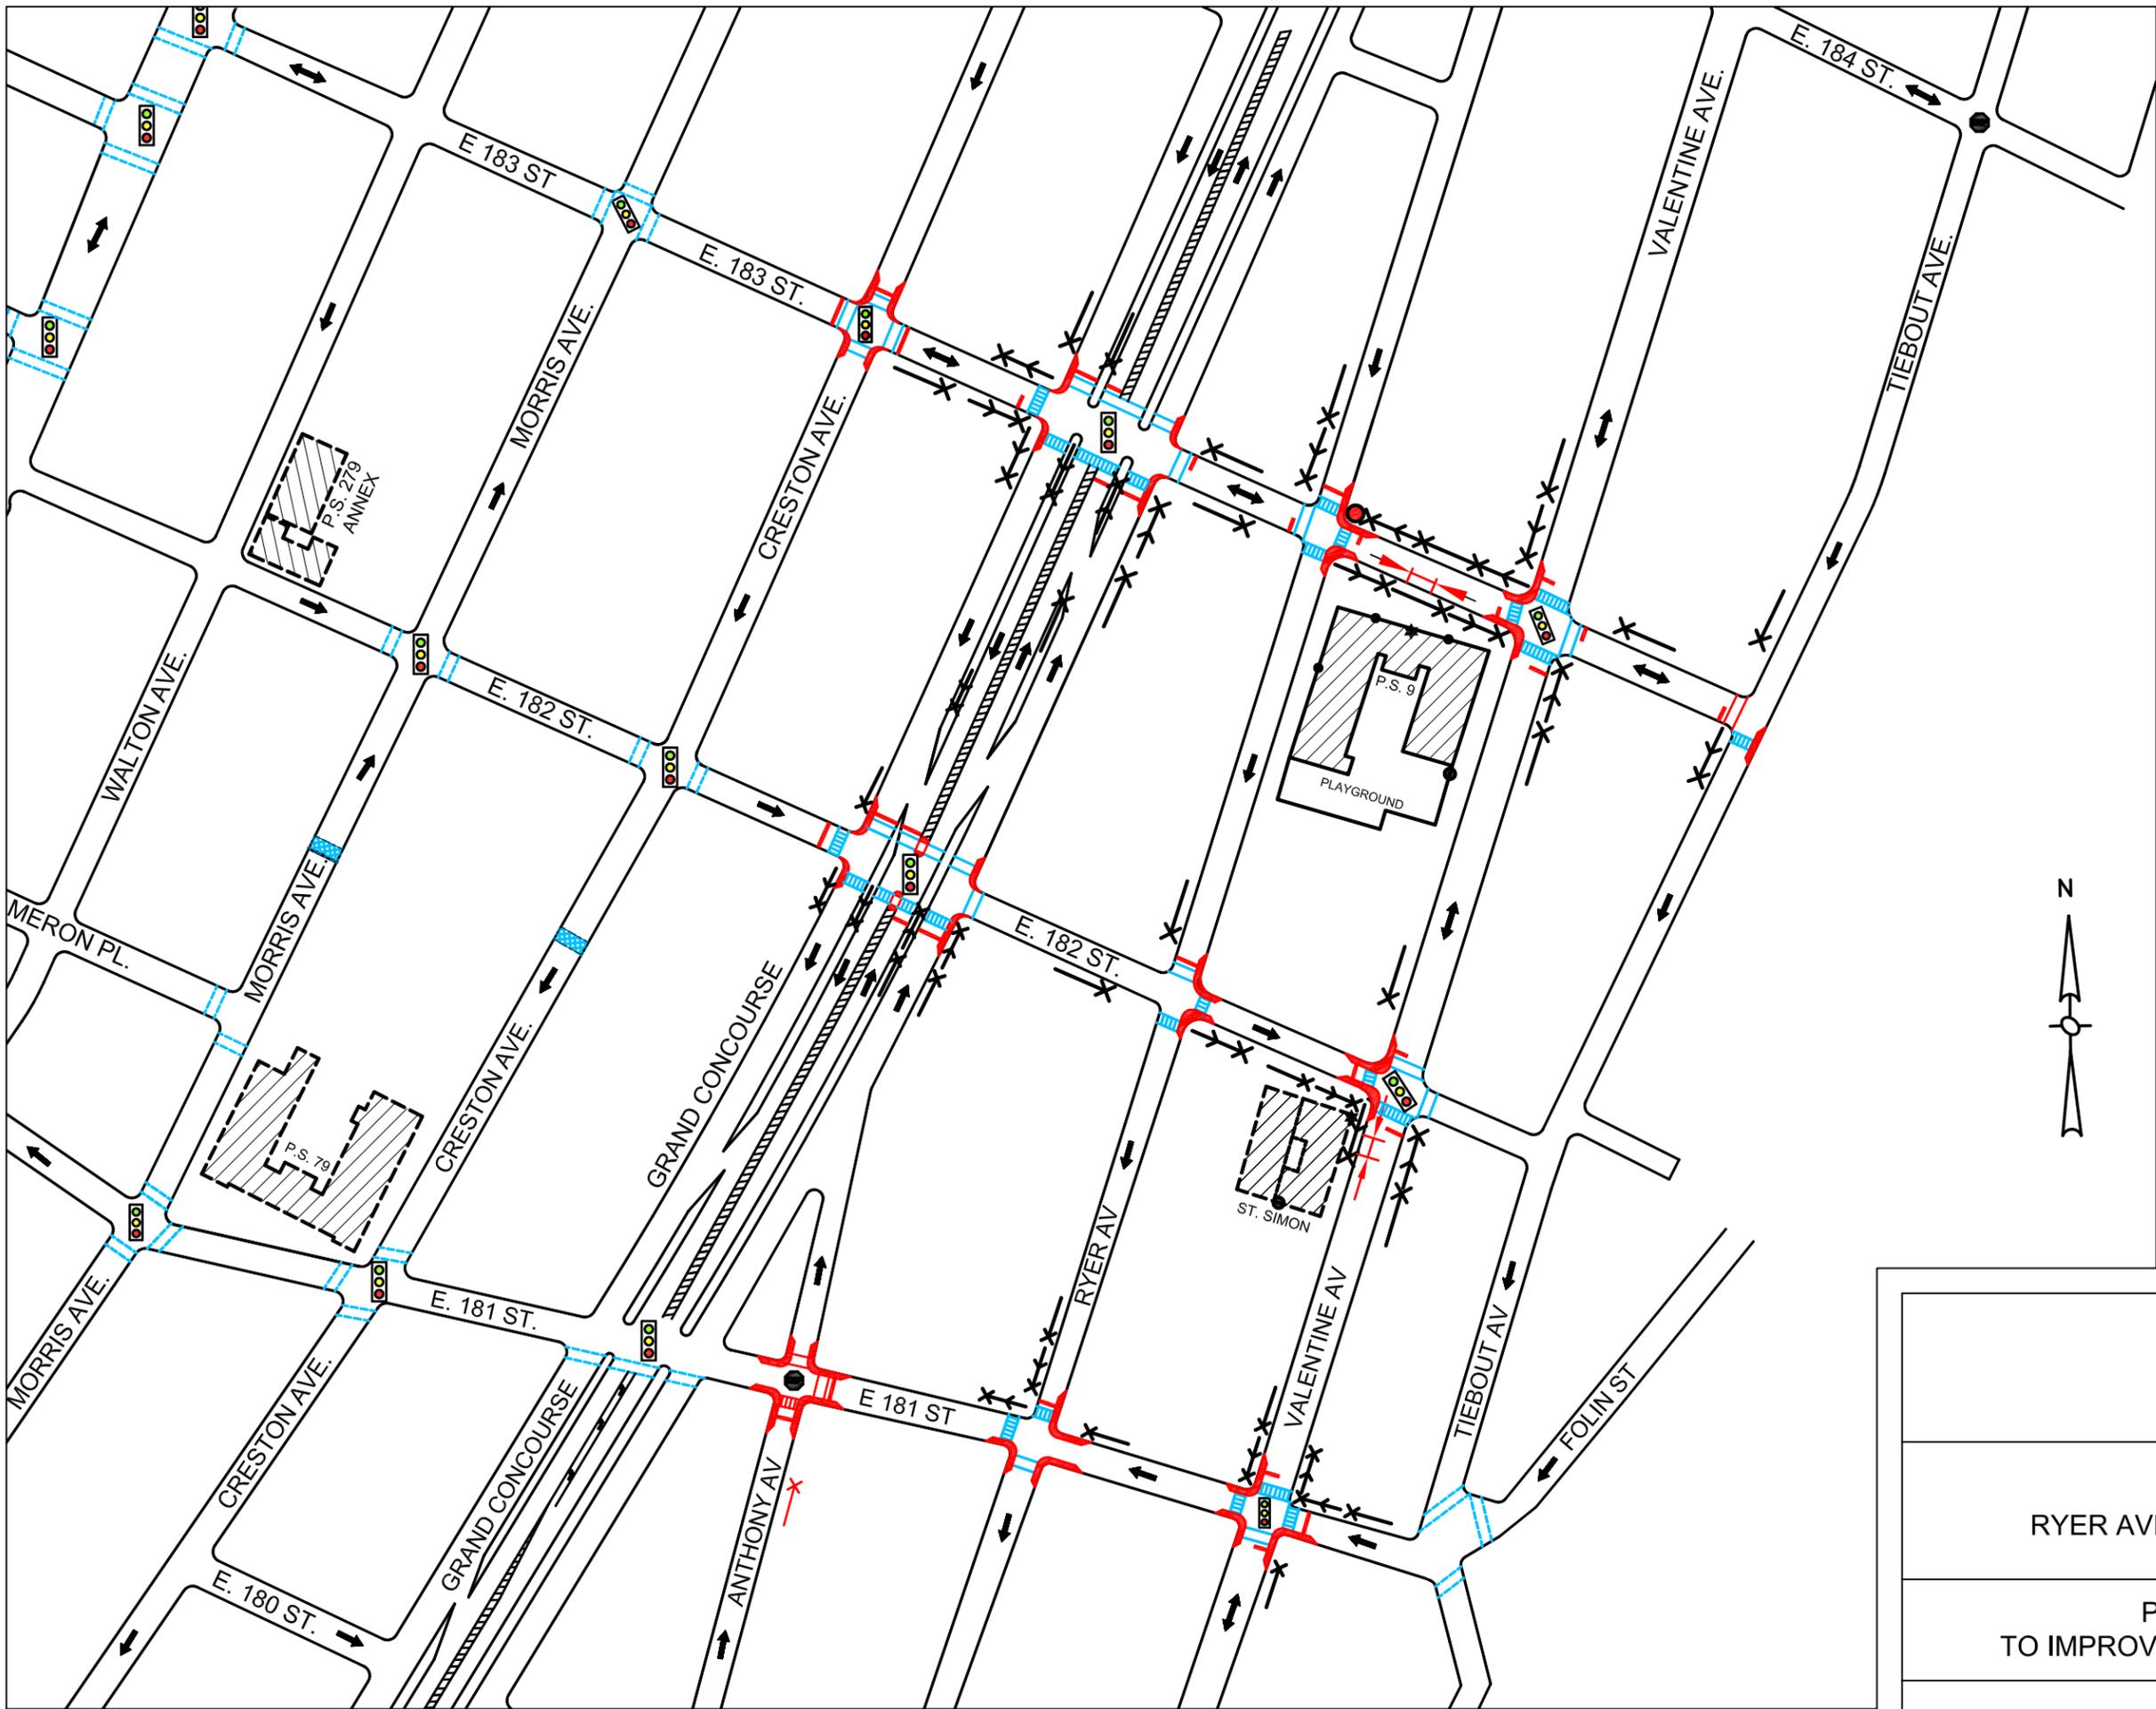
PROPOSED MEASURES
TO IMPROVE SCHOOL PEDESTRIAN SAFETY

This section describes the proposed measures to improve school pedestrian safety around P.S. 9. The proposed recommendations are divided into short-term and long-term measures. Short-term measures are those that potentially can be performed in-house. Long-term measures involve capital improvements. Each of the short- and long-term measures recommended for P.S. 9 is discussed as follows, and is shown in more detail in Exhibit 8 at the end of this section. See section 4.3 for additional recommendations for this area from the report on Saint Simon Stock, a nearby priority school.

Construct a pedestrian ramp at the southwest corner of the Valentine Avenue and East 181st Street intersection, for the crosswalk located across the south leg of Valentine Avenue.
