**New York City Department of Transportation
Office of School Safety Engineering**

School Safety Engineering Project

FINAL REPORT: P.S. 9 (Ryer Avenue Elementary School), Bronx

**Prepared by
The RBA Group/Urbitran Associates**

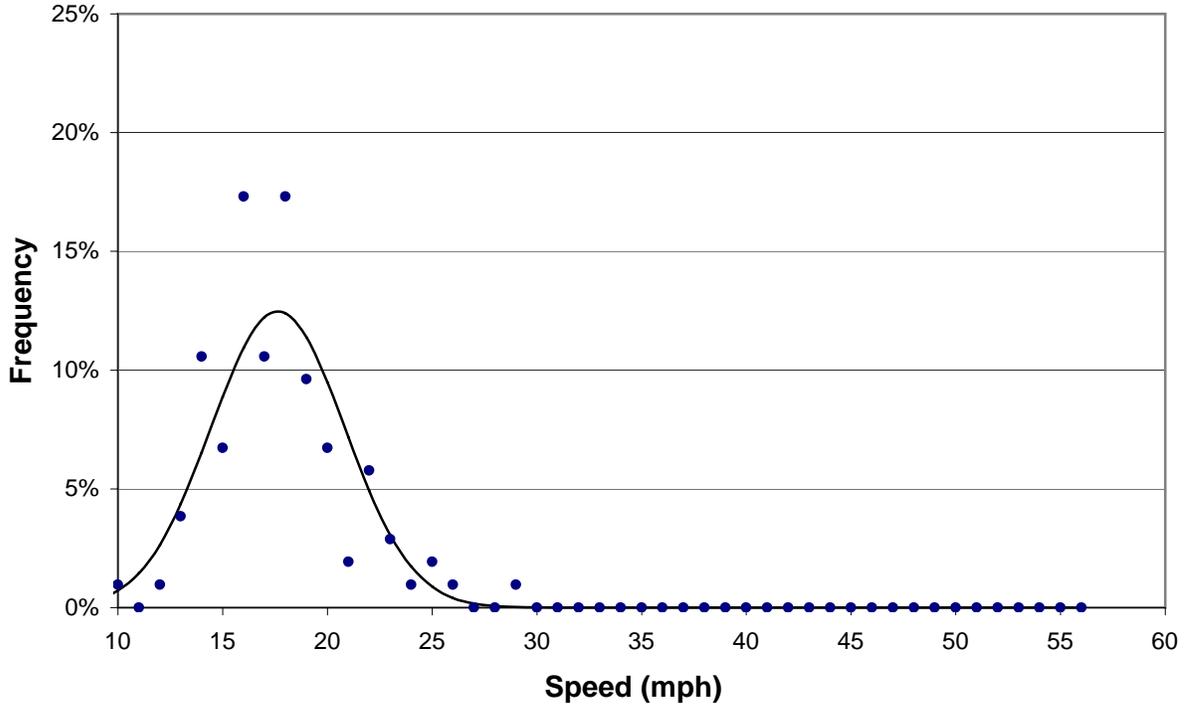
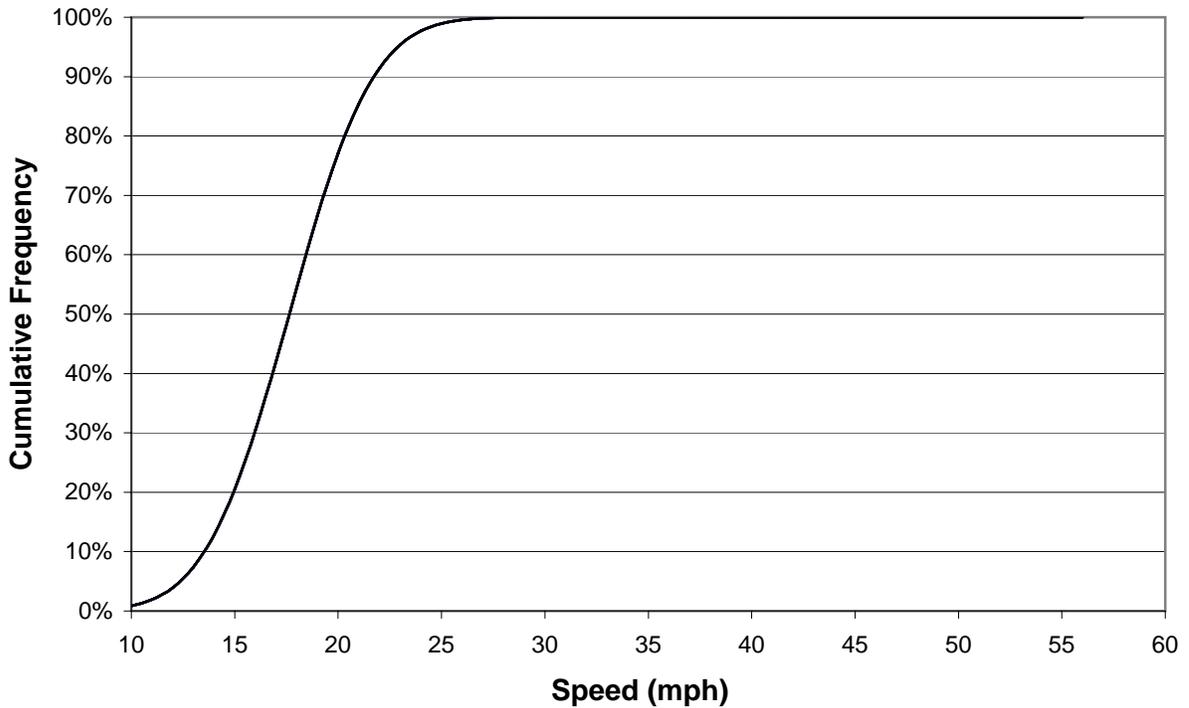
SPOT SPEED STUDY

In summary, the eastbound vehicles on East 183rd Street between Ryer and Valentine Avenues were found to be traveling with an 85th percentile speed of 21 mph. The westbound vehicles on East 183rd Street between Ryer and Valentine Avenues were found to be traveling with an 85th percentile speed of 20 mph.

Date: 8/11/05 Time: 11:35 AM
Location: E.183rd St Between Ryer Ave and Valentine Ave
Surveyor:

Mean Speed = 17.6 mph
Standard Deviation = 3.2 mph
Margin of Error (95% Confidence) = ± 0.6 mph

Median Speed = 17.6 mph
15th Percentile Speed = 14.3 mph
85th Percentile Speed = 21.0 mph

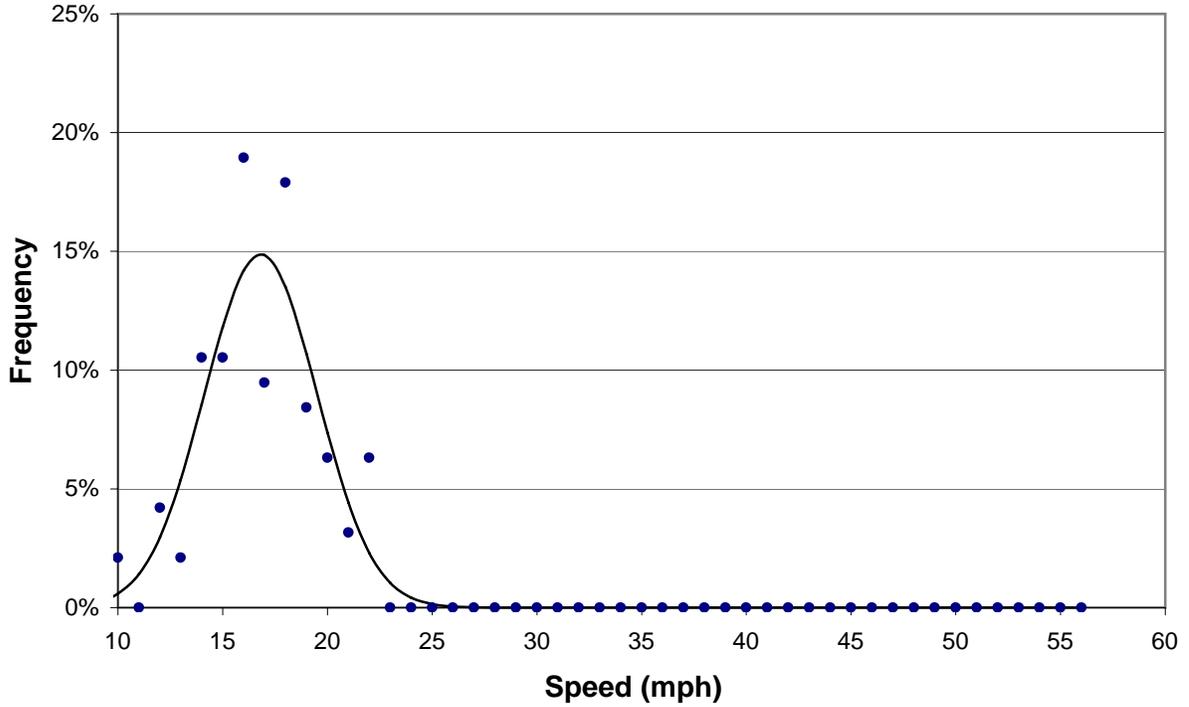
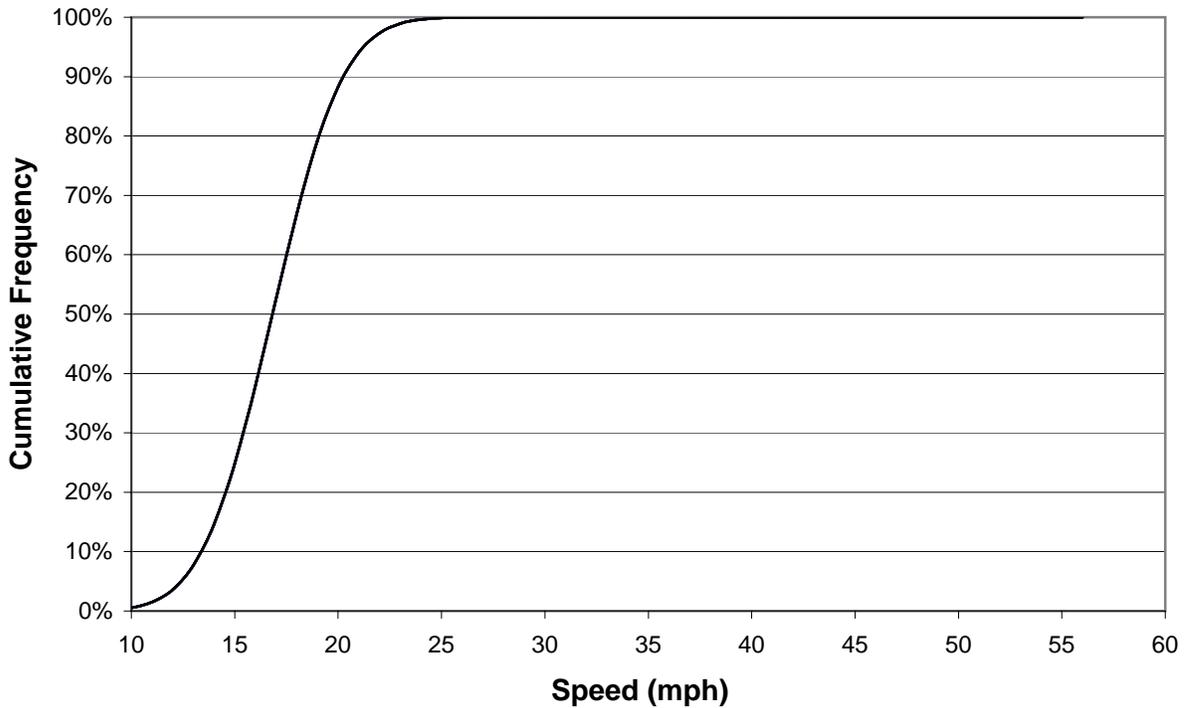
SPOT SPEED STUDY

Date: **8/11/05** Time: **11:35 AM**
 Location: **E.183rd St Between Ryer Ave and Valentine Ave**
 Surveyor:

Mean Speed = 16.8 mph Median Speed = 16.8 mph
 Standard Deviation = 2.7 mph 15th Percentile Speed = 14.0 mph
 Margin of Error (95% Confidence) = ± 0.5 mph 85th Percentile Speed = 19.6 mph

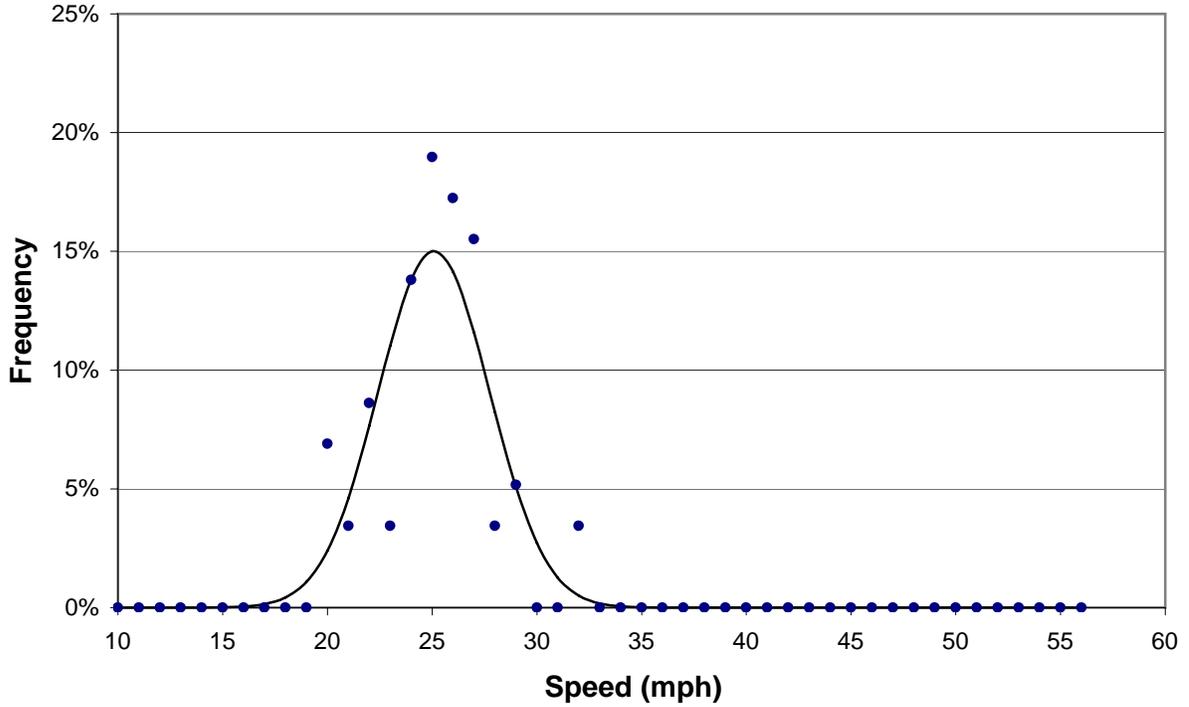
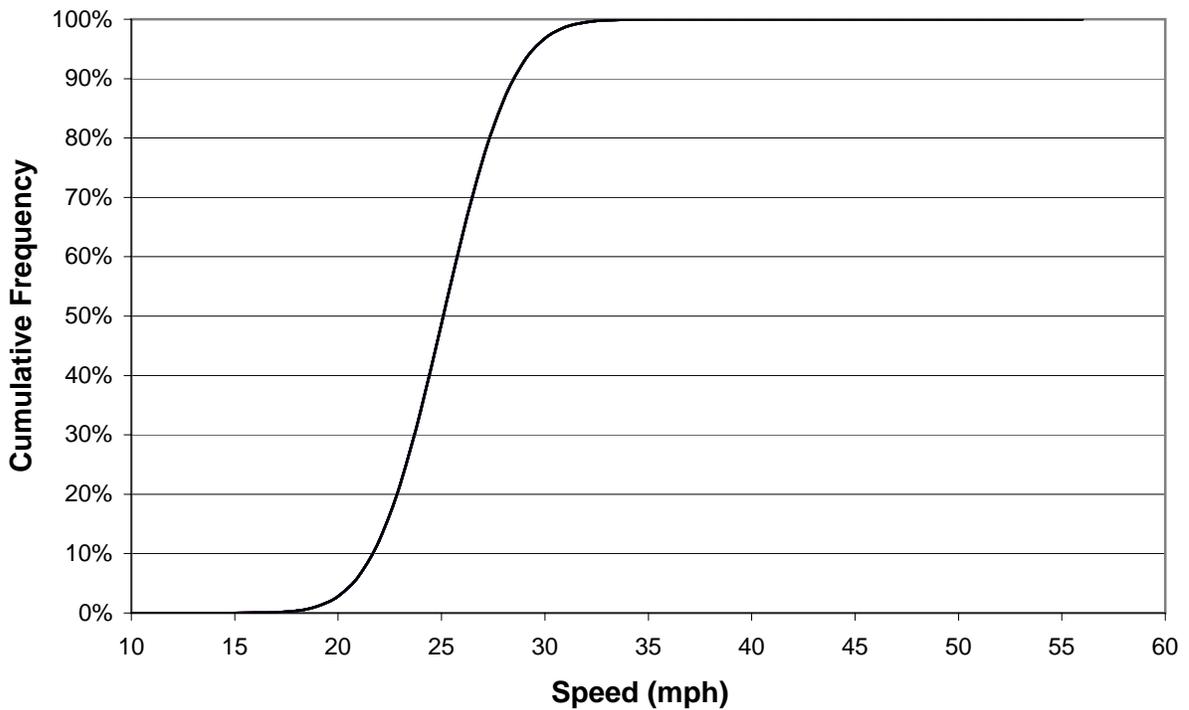
SPOT SPEED STUDY

In summary, the northbound vehicles on Valentine Avenue, between East 182nd and East 183rd Streets were found to be traveling with an 85th percentile speed of 28 mph. The southbound vehicles on Valentine Avenue, between East 182nd and East 183rd Streets were found to be traveling with an 85th percentile speed was 30 mph.

Date: **June 1, 2005** Time: **10:00 am**
 Location: **Valentine Avenue between 182nd Street & 183rd Street**
 Surveyor: **Richard Calvache & Hugo Salinas**

Mean Speed = 25.1 mph
Standard Deviation = 2.7 mph
Margin of Error (95% Confidence) = ± 0.7 mph

Median Speed = 25.1 mph
15th Percentile Speed = 22.3 mph
85th Percentile Speed = 27.8 mph

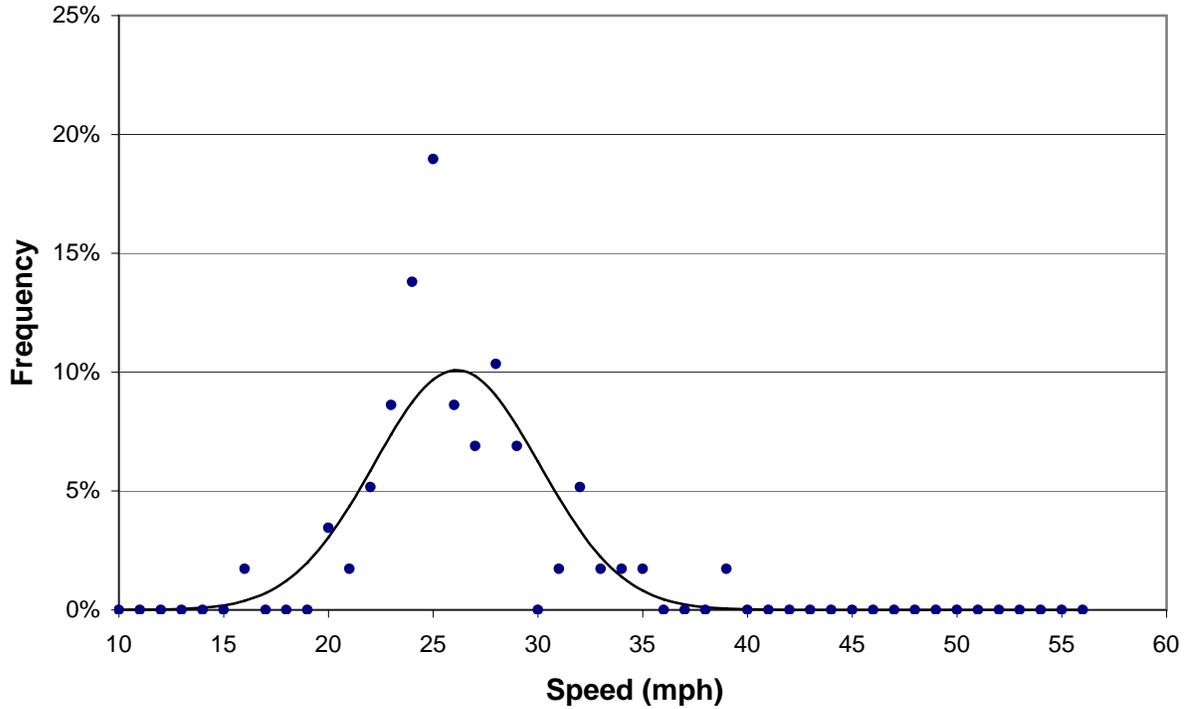
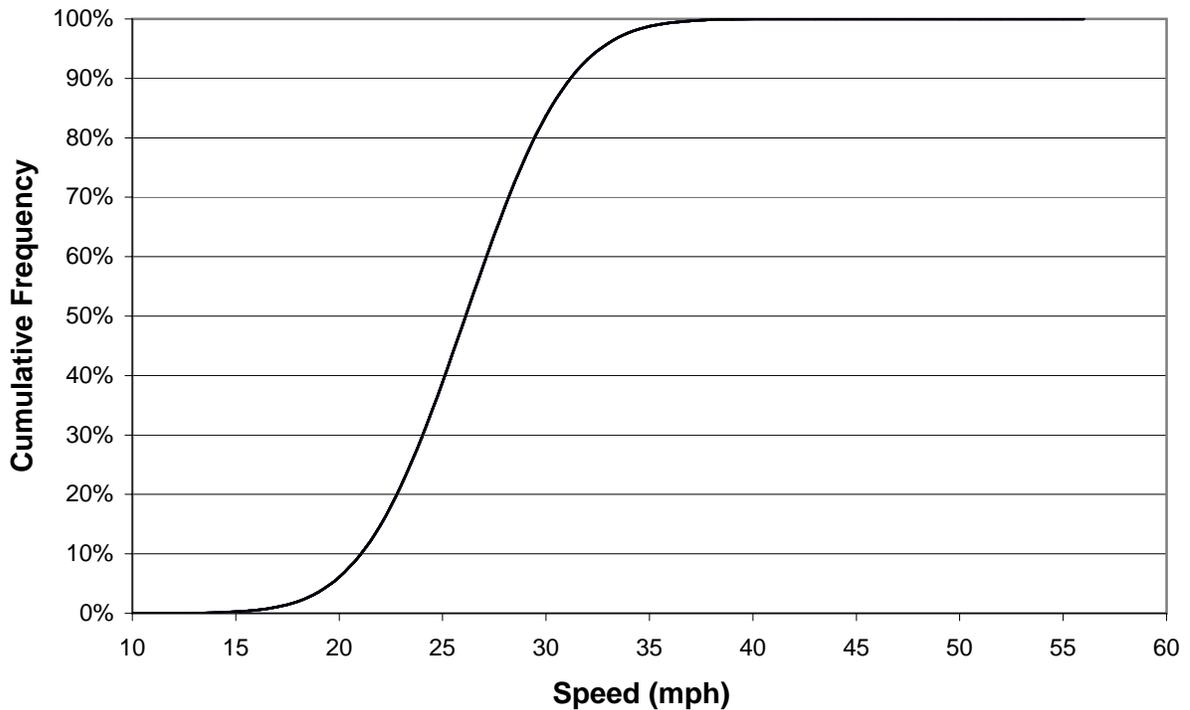
SPOT SPEED STUDY

Date: **June 1, 2005**
 Location: **Valentine Avenue between 182nd Street & 183rd Street**
 Surveyor: **Richard Calvache & Hugo Salinas**

Mean Speed = 26.1 mph
Standard Deviation = 4.0 mph
Margin of Error (95% Confidence) = ± 1.0 mph

Median Speed = 26.1 mph
15th Percentile Speed = 22.0 mph
85th Percentile Speed = 30.2 mph
