**New York City Department of Transportation
Office of School Safety Engineering**

School Safety Engineering Project

FINAL REPORT: P.S. 33 (Timothy Dwight School), Bronx

**Prepared by
The RBA Group/Urbitran Associates**

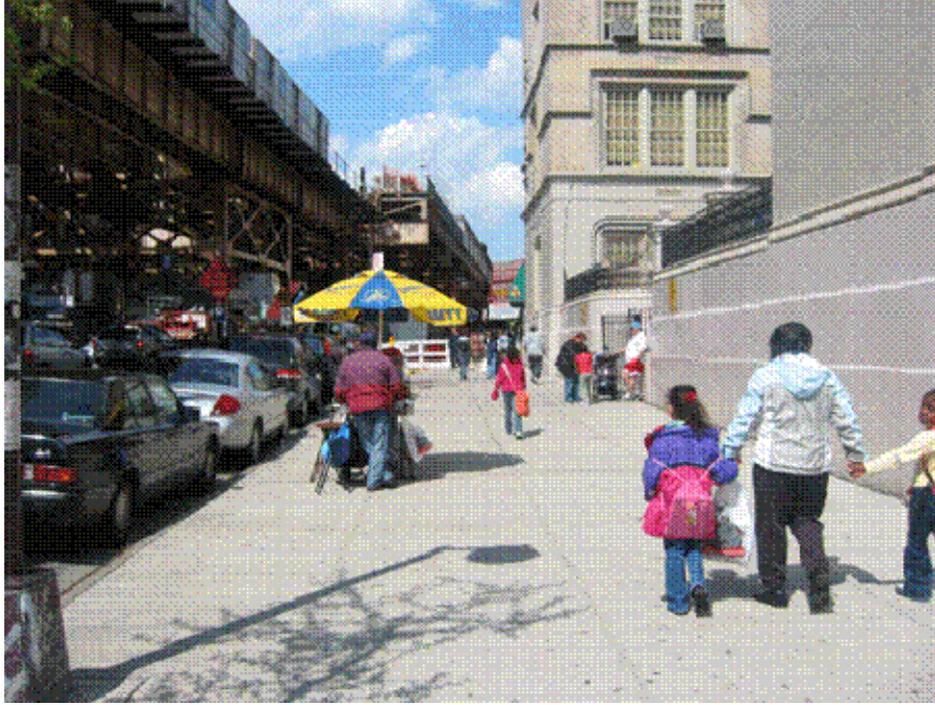
Figure 2: Additional food vendors in front of the school on Jerome Avenue, away from the school exit gate

Stores located near the school on Jerome Avenue and north of the school on East Fordham Road generate pedestrian and vehicular traffic around the school. Food vendors located in front of the school are an additional attraction for students (see Figures 1, 2 and 5).

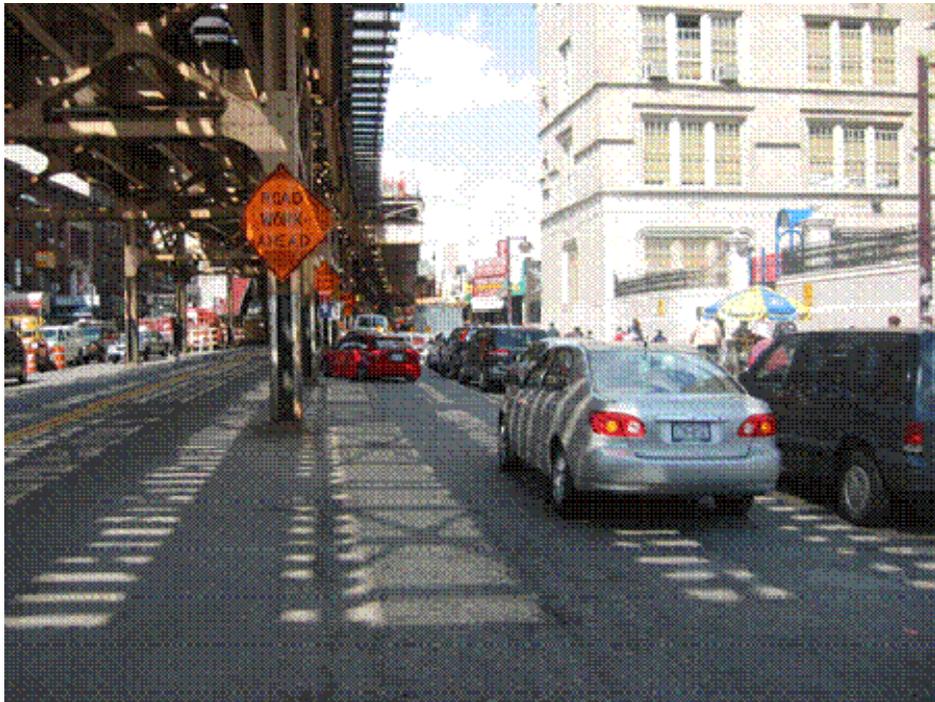
Figure 3: Looking north on Jerome Avenue at dismissal time (school building to the right)

According to school representatives, approximately ten percent of the students are being dropped off. Parents usually double park on Jerome Avenue in the area of the school. Truck pick-up and delivery operations, in addition to the double parking, contribute to congestion on Jerome Avenue (see Figure 3).

➤ Create time-specific “NO STANDING 2PM – 4PM SCHOOL DAYS” (“NO LOADING OR UNLOADING ZONE”)

Truck pick-up and delivery operations, coinciding with dismissal time and double-parking, lead to congestion around the Jerome Avenue entrance of the school.

- Install signs reading “NO STANDING 2PM – 4PM SCHOOL DAYS” for the area on the west side of the roadway for a distance of 60 feet across from the main entrance of the school on Jerome Avenue.

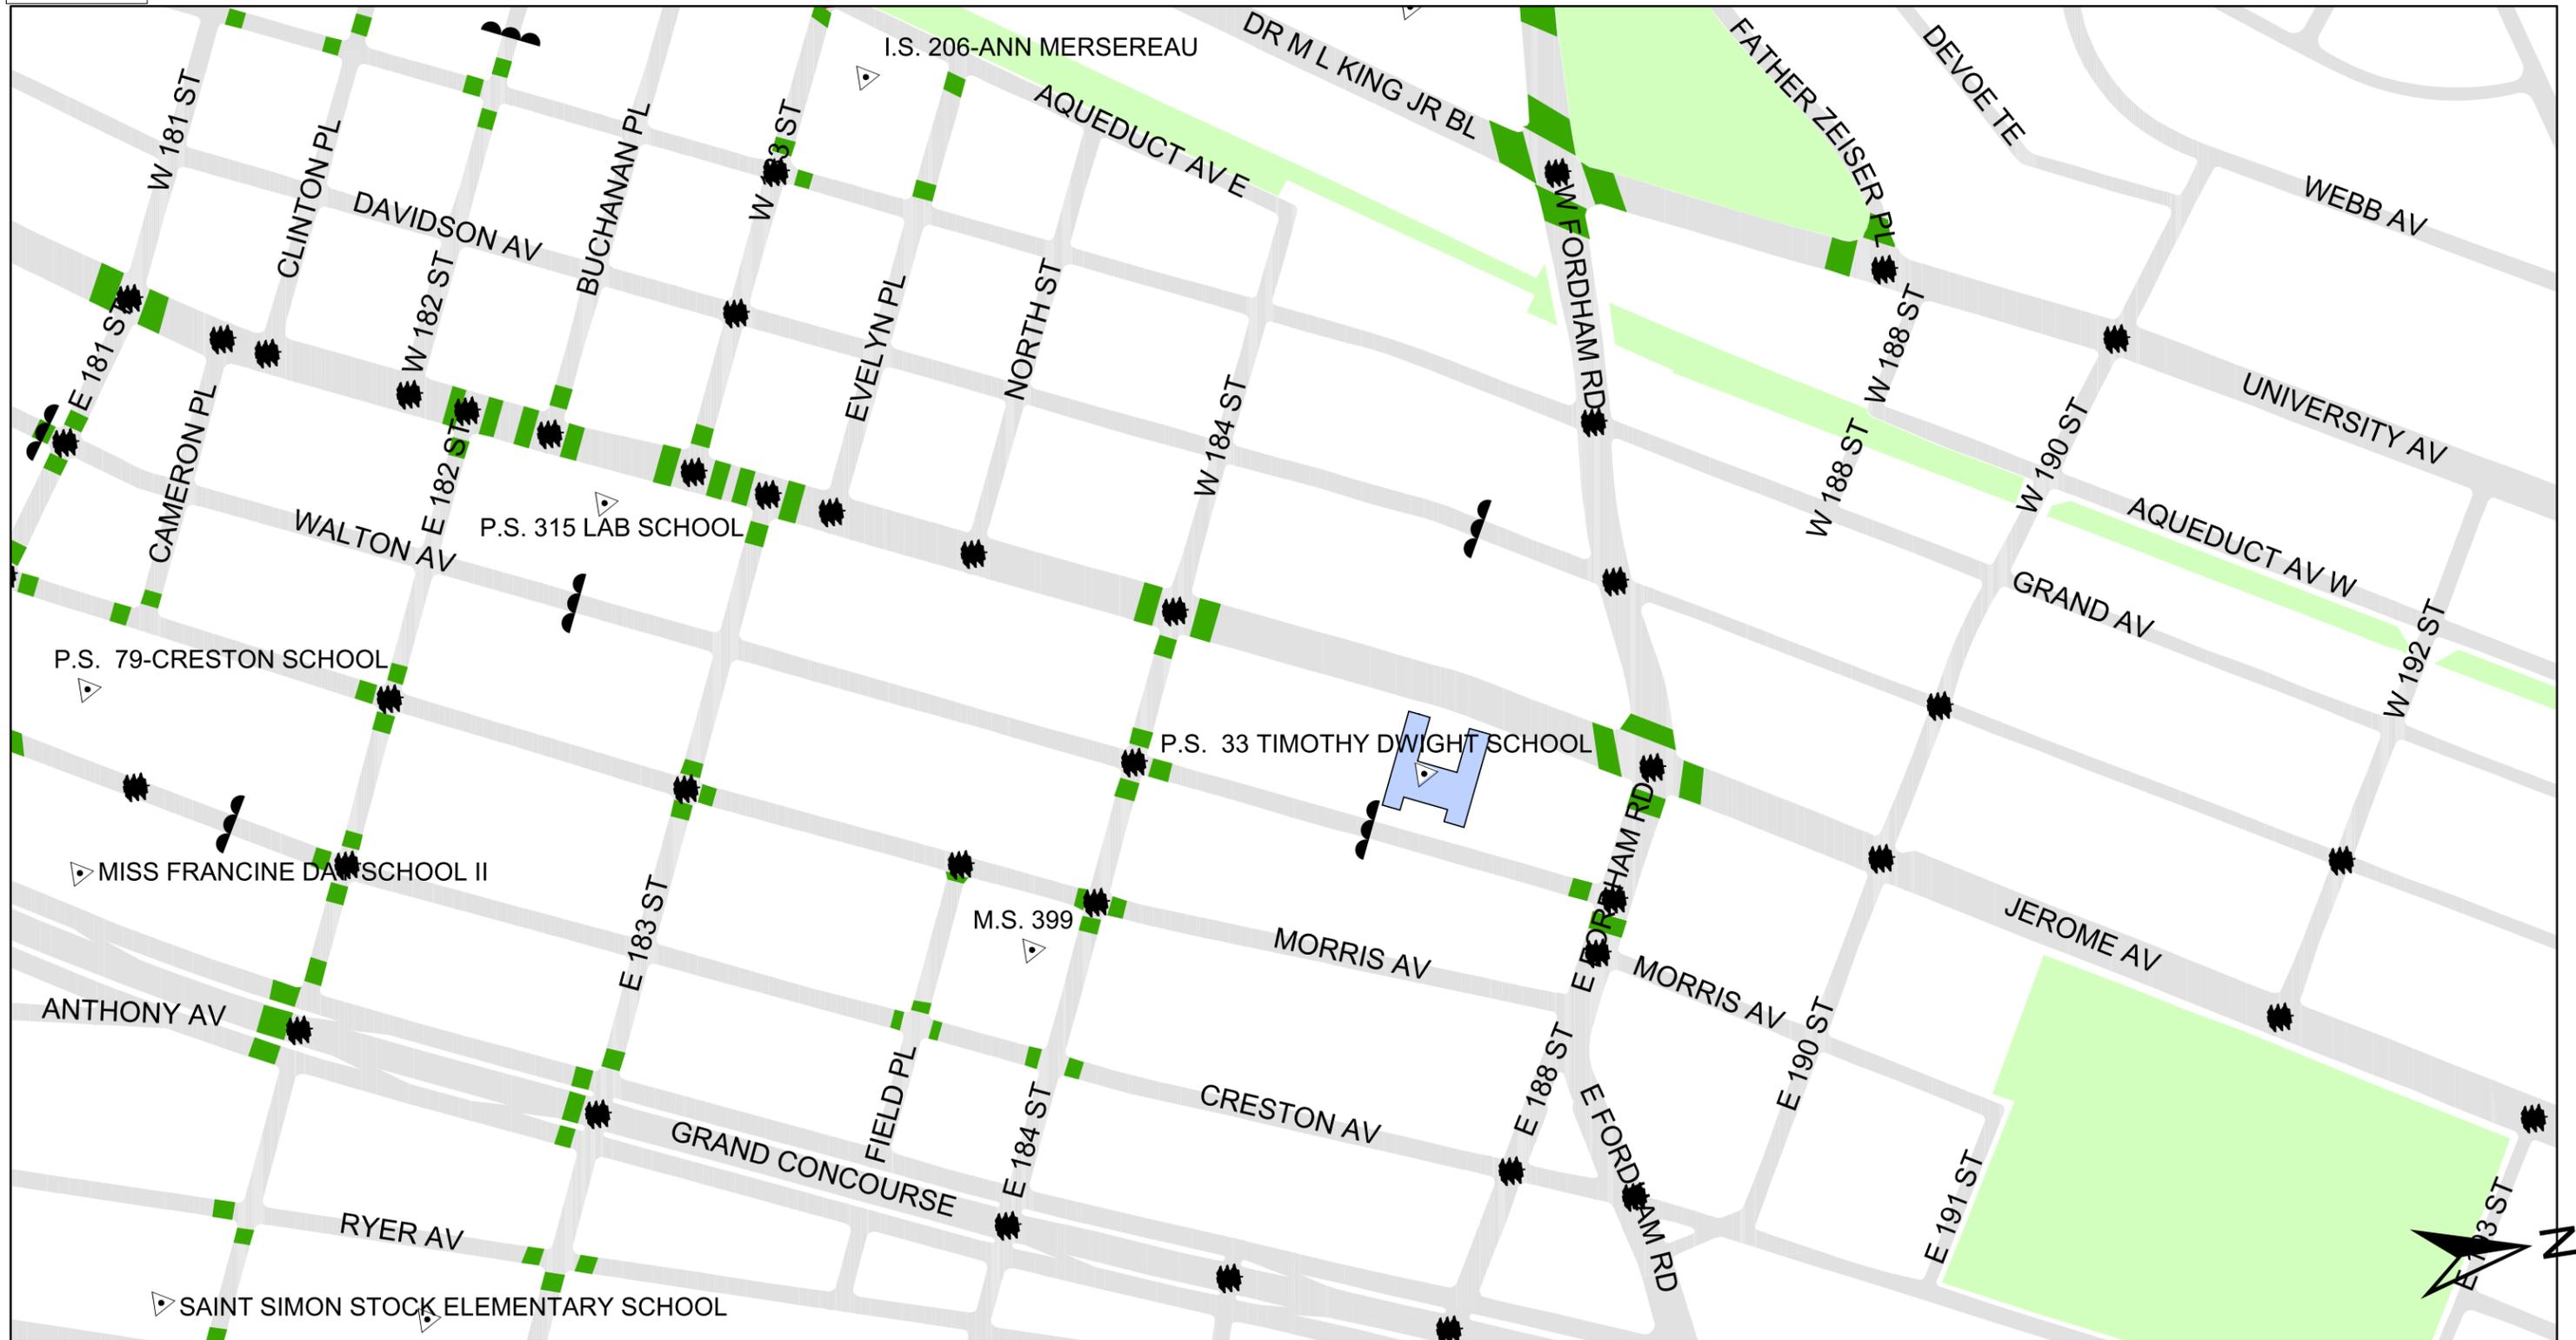
EXHIBIT 3

The School Traffic Safety Map was established to help provide the maximum degree of safety for children going to and from school - by indicating the location of speed reducers, school crosswalks and some traffic control devices. (While virtually all intersections in NYC benefit from traffic control devices - such as stop signs, traffic signals, yield signs, and all way stop signs - this map shows only traffic signals and all way stop signs.) The school crosswalks that are shown are ladder striped and make the crosswalk more visible to drivers and help make the intersection safer. These crosswalks are where school children are recommended to cross.

Exhibit 3 shows the existing school signals and pavement markings around P.S. 33. It should be noted that a citywide signage program is currently underway to upgrade school signage to current Federal Manual on Uniform Traffic Control Devices (MUTCD) standards of fluorescent yellow-green signs accompanied by downward pointing arrows. This will make the school crossing warning signs more visible to motorists. Signs scheduled to be installed under this program are shown as “existing” in Exhibit 7.

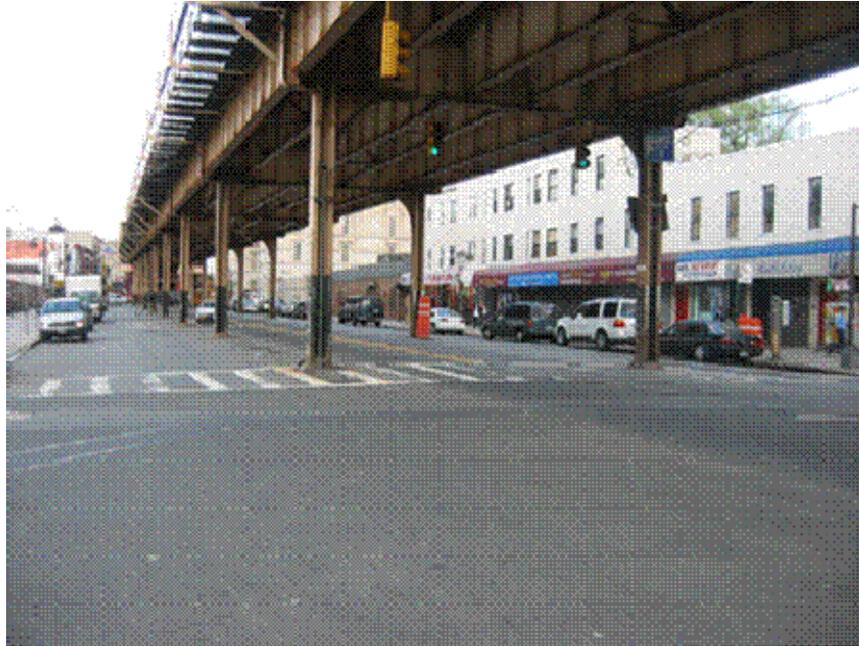
This is a four-leg signalized intersection with school crosswalks located on the north leg of Jerome Avenue and east leg of East 184th Street. Jerome Avenue is two-way street with two travel lanes and a parking lane on each side of the roadway. Jerome Avenue also has an elevated train running over the center of the roadway. The supports for the train are located so that they provide an inner and an outer lane for each direction of travel (see Figures 3 and 6).

Figure 6: Looking north along Jerome Avenue across East 184th Street (school is up on far right)

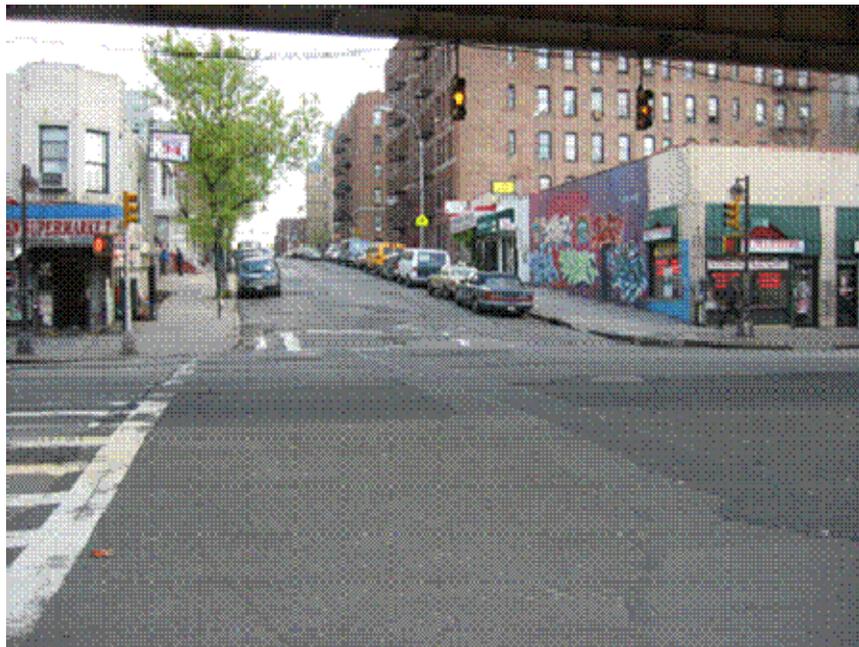
East 184th Street is a two-way street with one travel lane and one parking lane on each side of the roadway. The street has commercial activity near Jerome Avenue; otherwise it is mostly residential in character (see Figure 7).

Figure 7: Looking east along East 184th Street from Jerome Avenue (south end of school block)

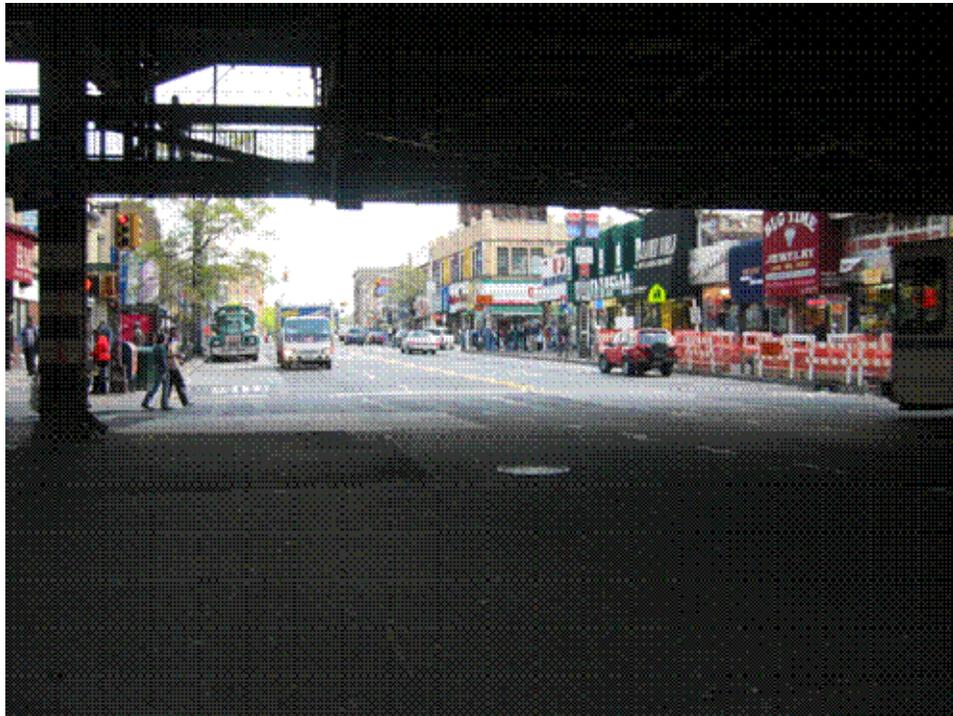
East Fordham Road is a two-way street with two travel lanes and a parking lane on each side of the roadway. East Fordham Road is a major connector roadway for this area, carrying significant traffic volumes (see Figures 8 and 10).

Figure 8: Looking east along East Fordham Road from Jerome Avenue

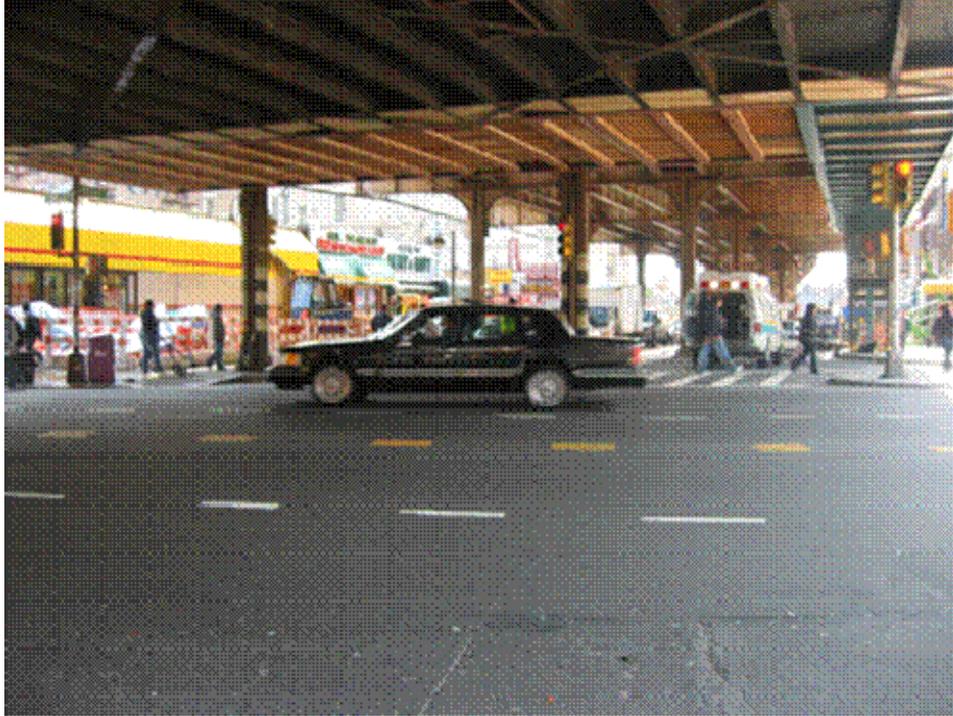
Figure 9: Looking south along Jerome Avenue from across East Fordham Road

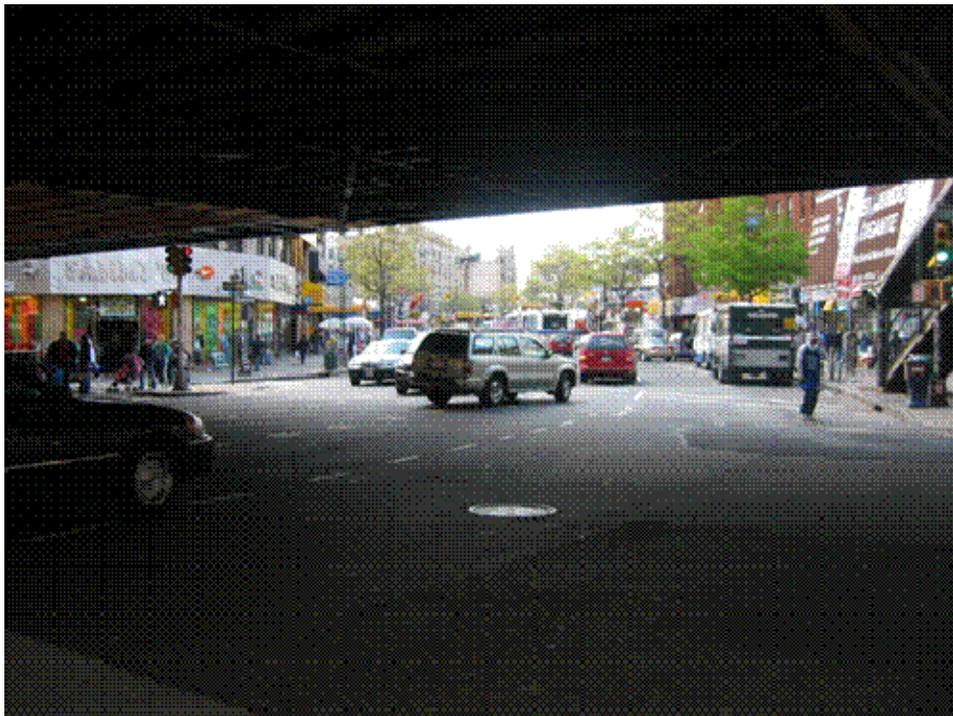
Figure 10: Looking west along West Fordham Road from Jerome Avenue

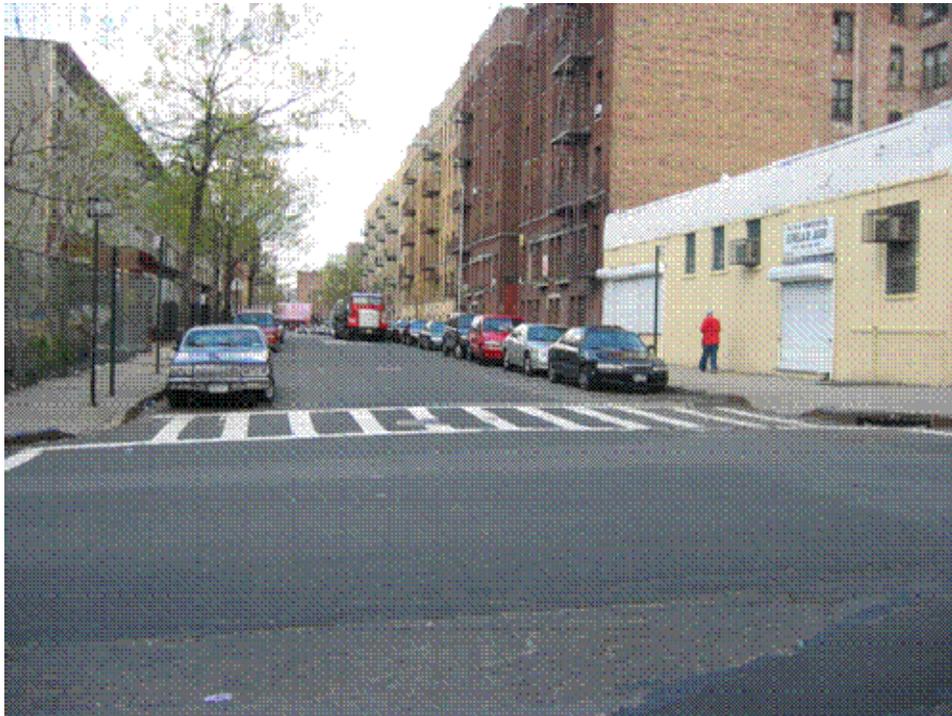
This is a four-leg signalized intersection with school crosswalks located across the north, west, and east legs. A pedestrian crosswalk is located across the south leg of Walton Avenue. Walton Avenue is a one-way southbound street with one travel lane and parking on both sides of the roadway (see Figure 10).

Figure 11: Looking north along Walton Avenue from across East 184th Street (P.S. 33 is up on the far left)

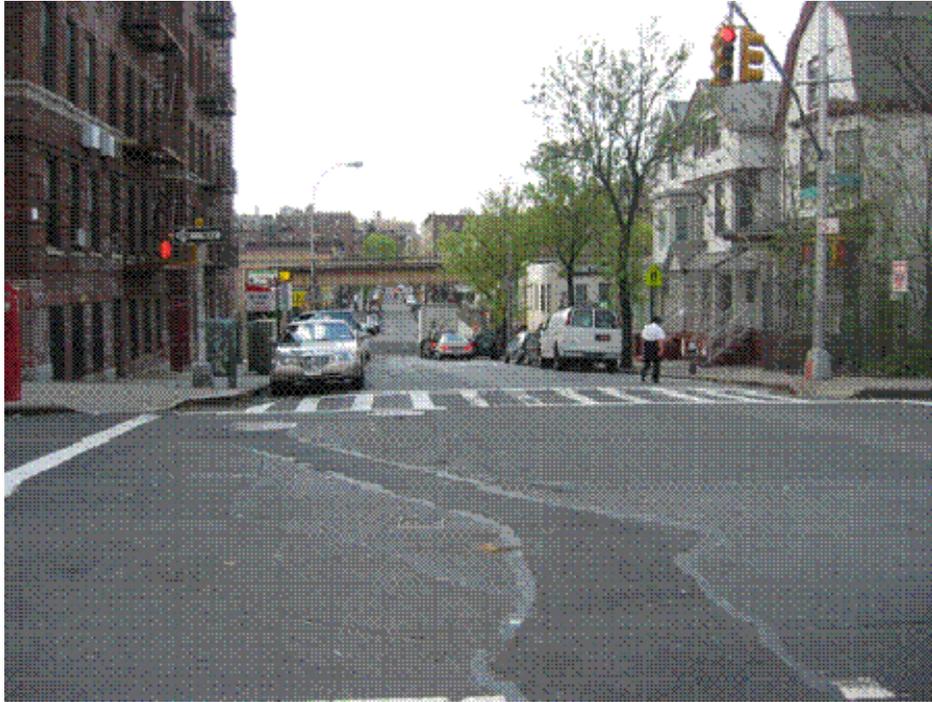
East 184th Street is a two-way street with one travel lane and a parking lane on each side of the roadway (see Figure 11).

Figure 12: Looking west along East 184th Street from across Walton Avenue (P.S. 33 is on the left)

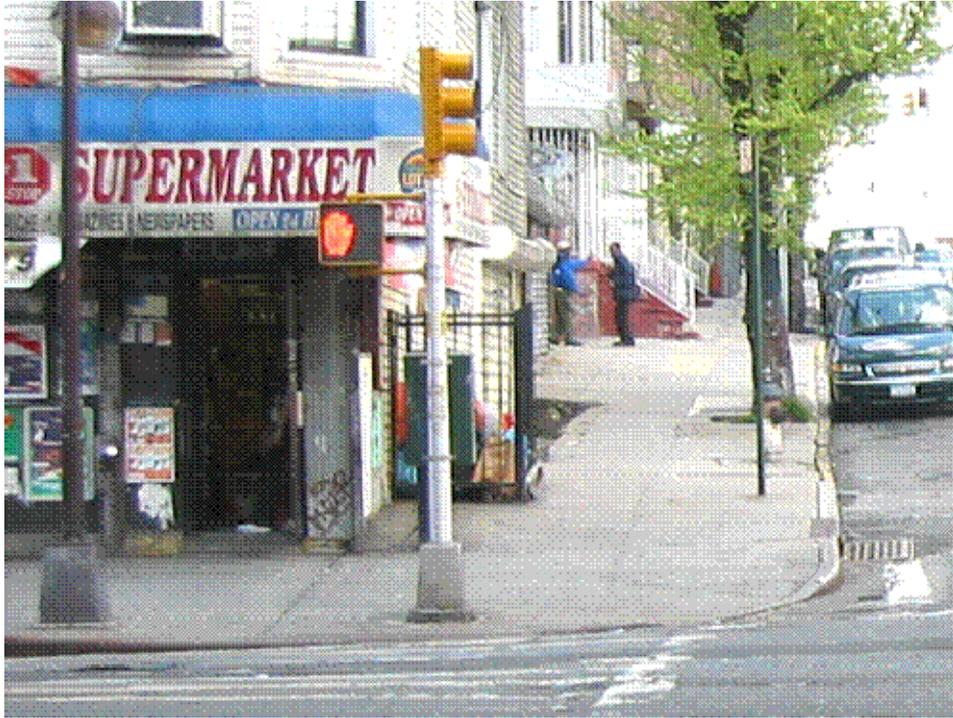
Overall, pedestrian ramps in the area of the school appear to be standard, except at the northeast corner of East 184th Street and Jerome Avenue, where a pole is situated so that it impedes the use of the crosswalk. The pole is near the curb and centered in the extension of the northerly crosswalk (see Figures 7 and 13).

Figure 13: Looking east at traffic signal pole in area of pedestrian ramp

There is no pedestrian ramp at the northwest corner of Jerome Avenue and East 184th Street for eastbound pedestrians. The traffic signal pole presently at the northeast corner is in conflict with the pedestrian crosswalk at this intersection.

- Relocate the signal pole at the northeast corner.
