**New York City Department of Transportation
Office of School Safety Engineering**

School Safety Engineering Project

FINAL REPORT: ST. MARGARET MARY, Bronx

**Prepared by
The RBA Group and URBITRAN Associates Inc.**

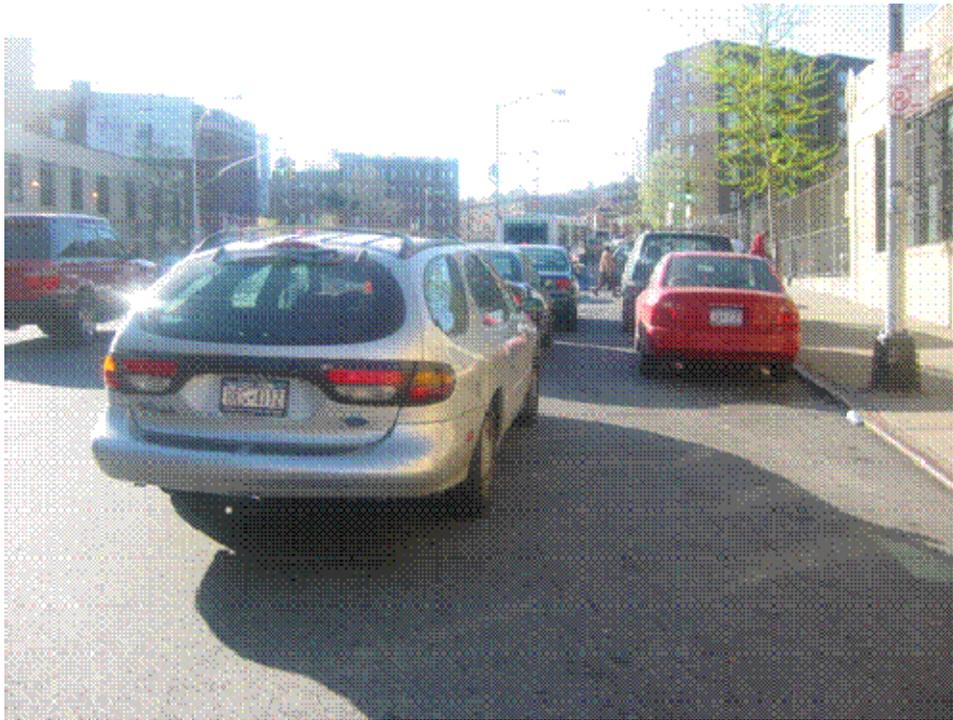
Approximately ten percent of the students are dropped off. Double parking often occurs at arrival and dismissal times (see Figure 2). The school does not allow parents to drive into the parking lot in the back for the safety of the children (see Figure 3). The school would like to see parking regulations that make the curbside space on East Tremont Avenue adjacent to the school available for dropping off and picking up children, rather than for double parking.

Figure 2: Looking east at congestion and double parking at arrival time along East Tremont Avenue in front of the schoolyard for St. Margaret Mary

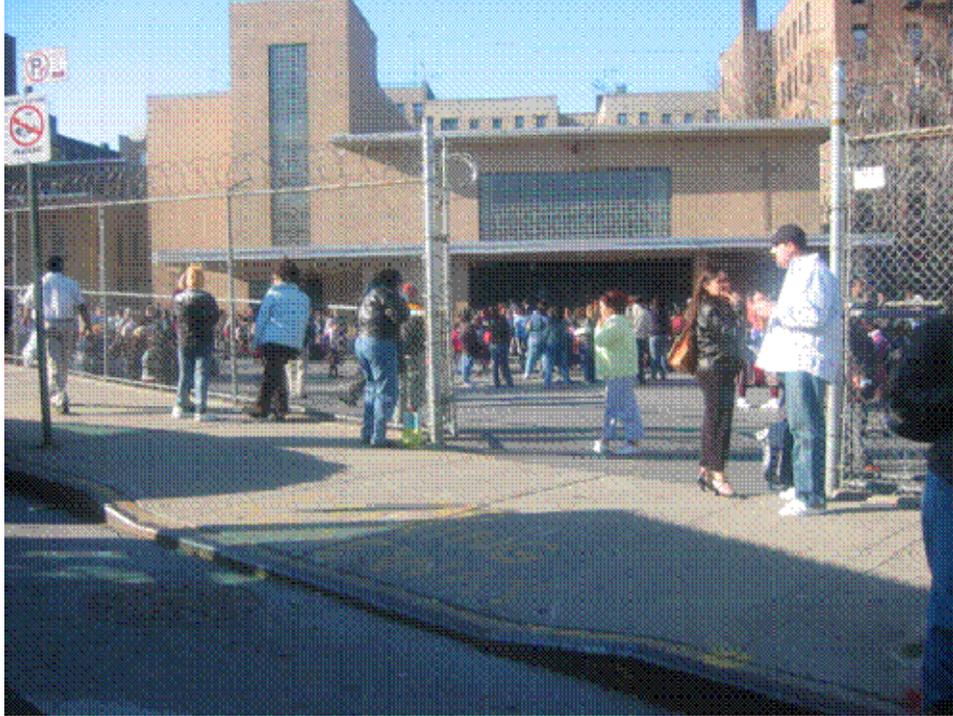
Figure 3: Looking south from East Tremont Avenue at the schoolyard/driveway for St. Margaret Mary

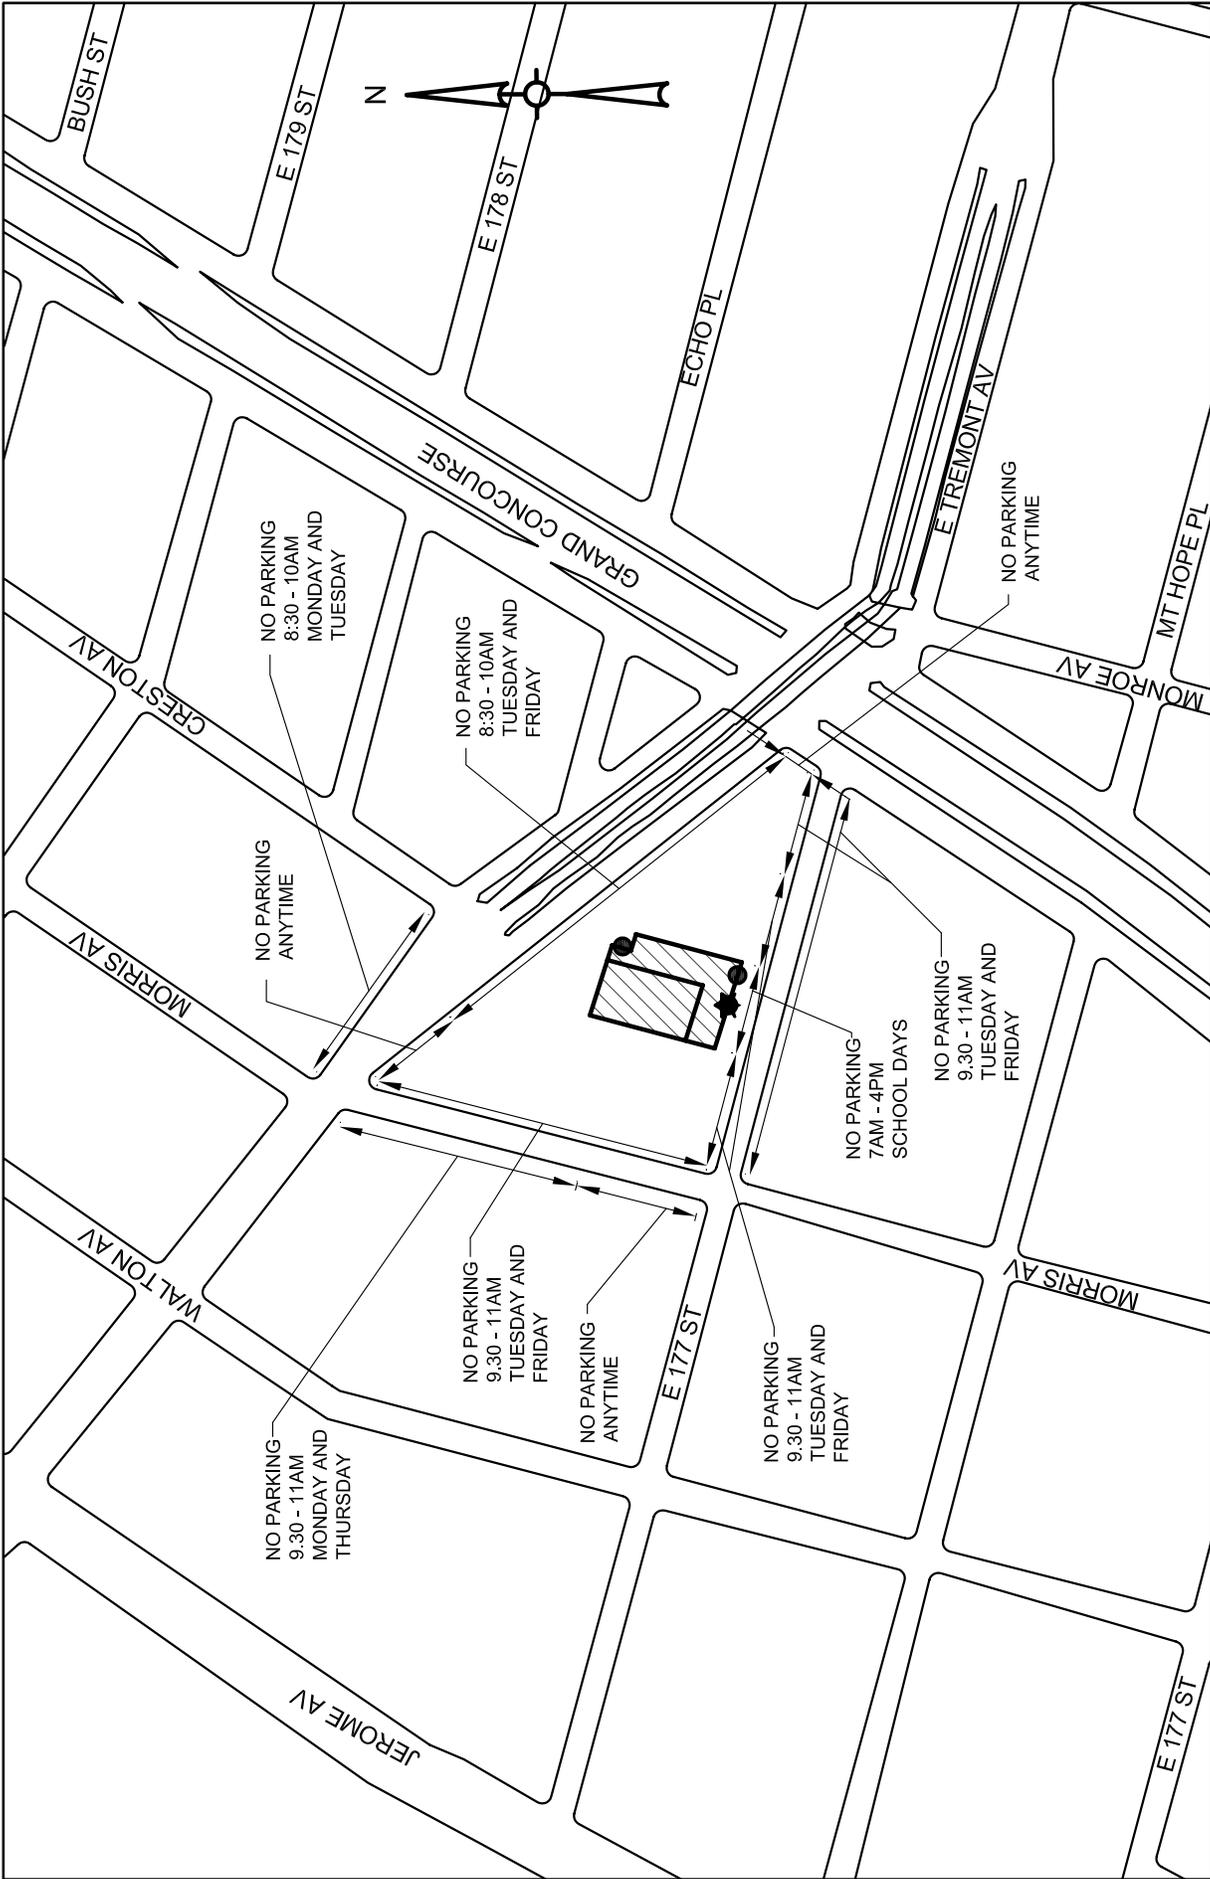
EXHIBIT 3

Parking regulations around the school block are shown in Exhibit 3.

EXISTING PARKING REGULATIONS

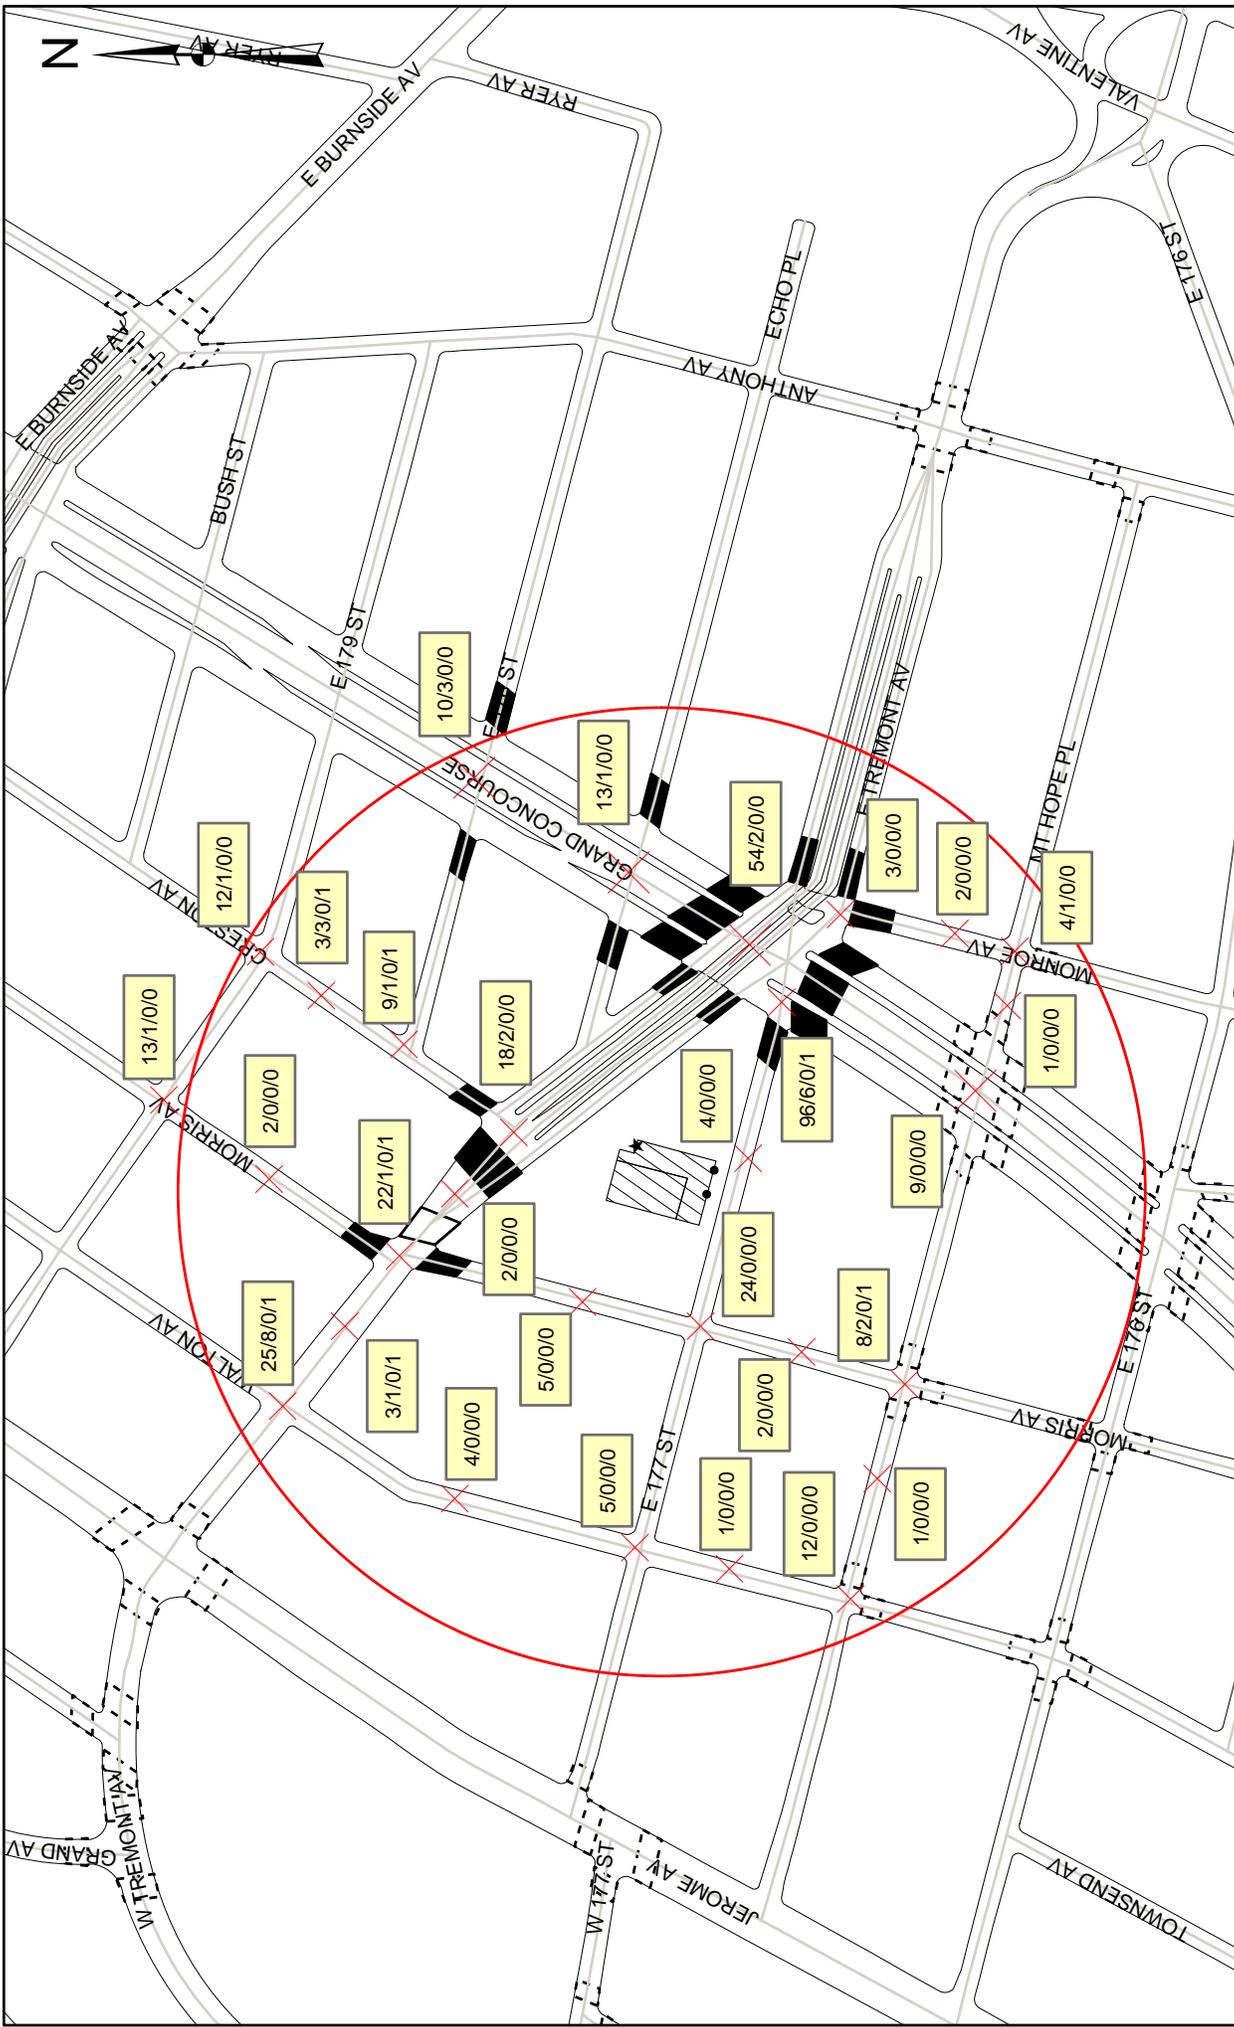
EXHIBIT 4

Exhibit 4 and Table 2 show a summary of accidents, as obtained from the New York State Department of Motor Vehicles (DMV), in the vicinity of St. Margaret Mary School for the three-year period from January 1, 1998 through December 31, 2000. The DMV data provides some detail relating to the circumstances and cause of the accident. Table 3 is a summary of more recent accident data obtained from the NYC Police Department (NYPD). Though current through 2004, the NYPD data does not provide the same level of detail as the DMV data.

**ST. MARGARET MARY SCHOOL BRONX
ACCIDENT SUMMARY (1998 - 2000)**

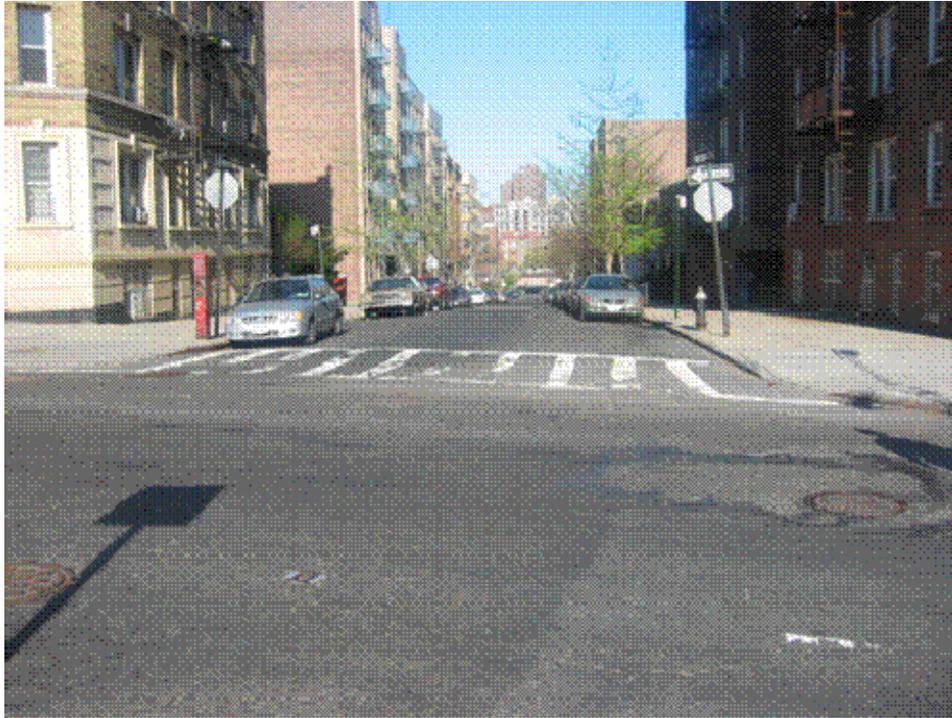
East 177th Street is a one-way eastbound street with one travel lane and on-street parking on both sides of the roadway (see Figure 4). East Tremont Avenue intersects the Grand Concourse at a signalized intersection located immediately north of the intersection of East 177th Street and the Grand Concourse. Due to the raised concrete median on the Grand Concourse, all traffic from East 177th Street must turn right to travel south on the Grand Concourse service road. There is no gap in the raised concrete median to allow vehicles to access the Grand Concourse mainline roadways at this intersection. The intersection of Grand Concourse and East 178th Street is within the "Special Grand Concourse Preservation District" designated by the Department of City Planning (DCP).

Figure 4: Looking west along East 177th Street from the southbound Grand Concourse service road

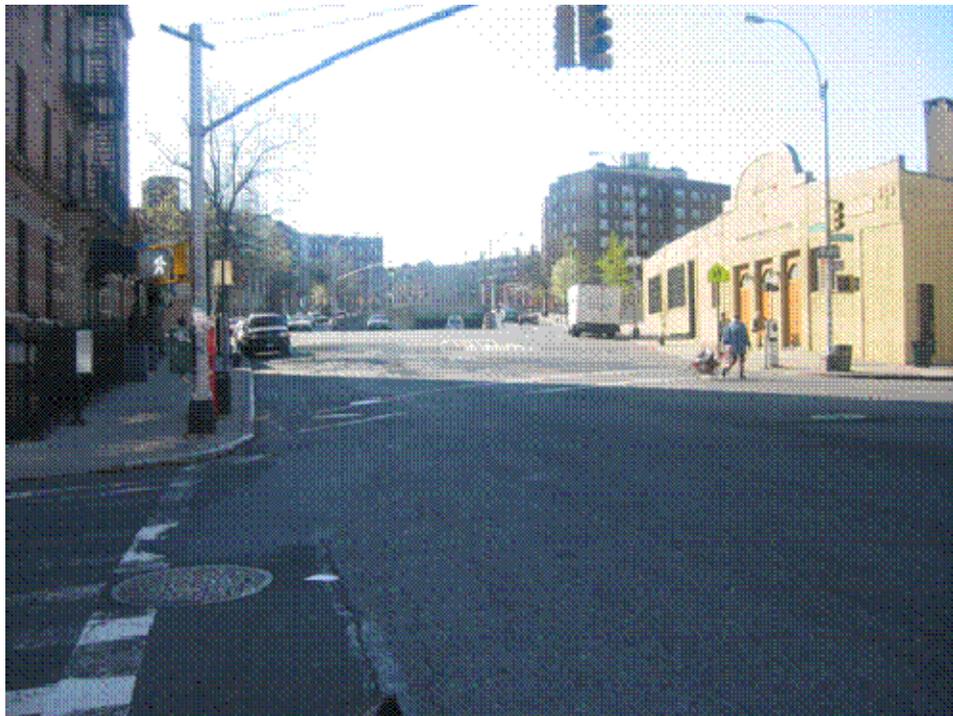
some residential uses. Morris Avenue is a one-way northbound street, with one travel lane and parking on both sides of the roadway. Land uses along Morris Avenue are primarily residential (see Figures 5 and 6).

Figure 5: Looking east on East Tremont Avenue across the intersection with Morris Avenue

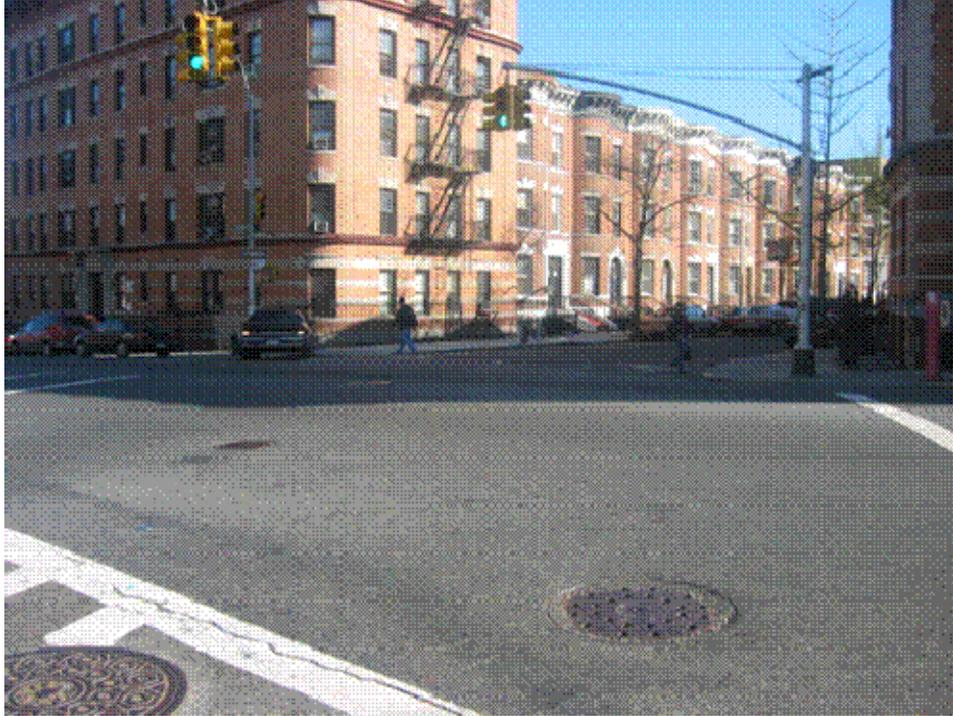
Figure 6: Looking northwest across the intersection of East Tremont Avenue and Morris Avenue

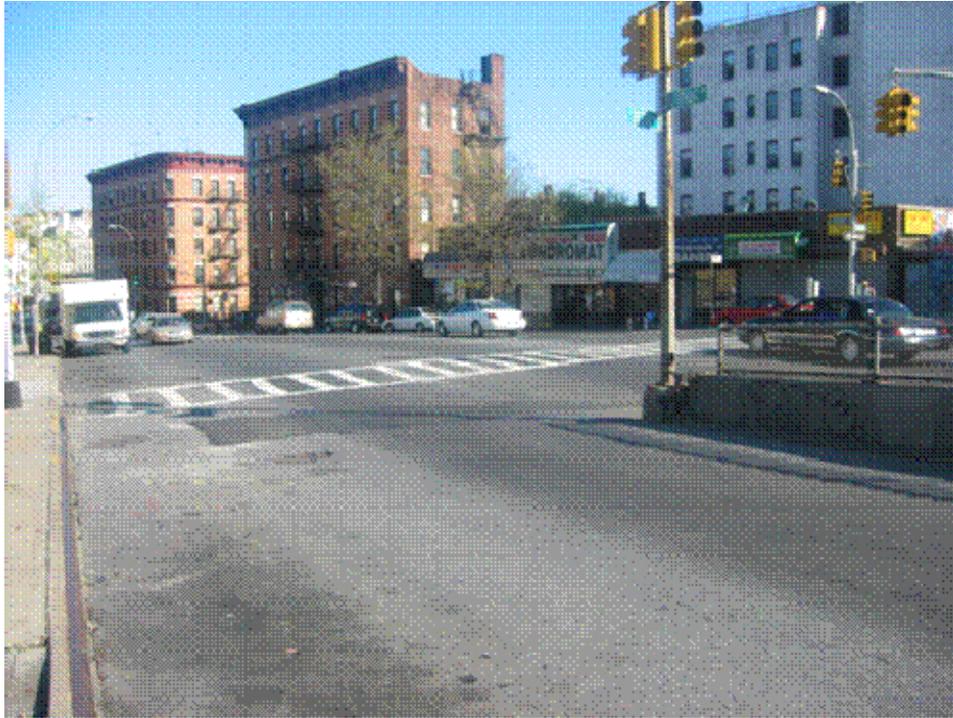
West of the intersection with Creston Avenue, East Tremont Avenue is a two-way street with two travel lanes and a parking lane on each side of the roadway. On the east side of this intersection, East Tremont Avenue splits: the mainline continues as a two-way roadway under the Grand Concourse through an underpass (tunnel), with one travel lane in each direction separated by a concrete divider, and no on-street parking. In addition, eastbound and westbound service roads are located on either side of the mainline roadway and rise to intersect with the Grand Concourse at-grade. Each of the service roads has one travel lane and one on-street parking lane along the right side of the traveled way. Land uses along East Tremont Avenue are primarily commercial, with some residential uses. Creston Avenue is a one-way southbound street, with one travel lane and one on-street parking lane on both sides of the roadway. Land uses along Creston Avenue are primarily residential (see Figures 7, 8, and 9).

Figure 7: Looking west on the south side of East Tremont Avenue from the eastbound service road towards the Creston Avenue intersection

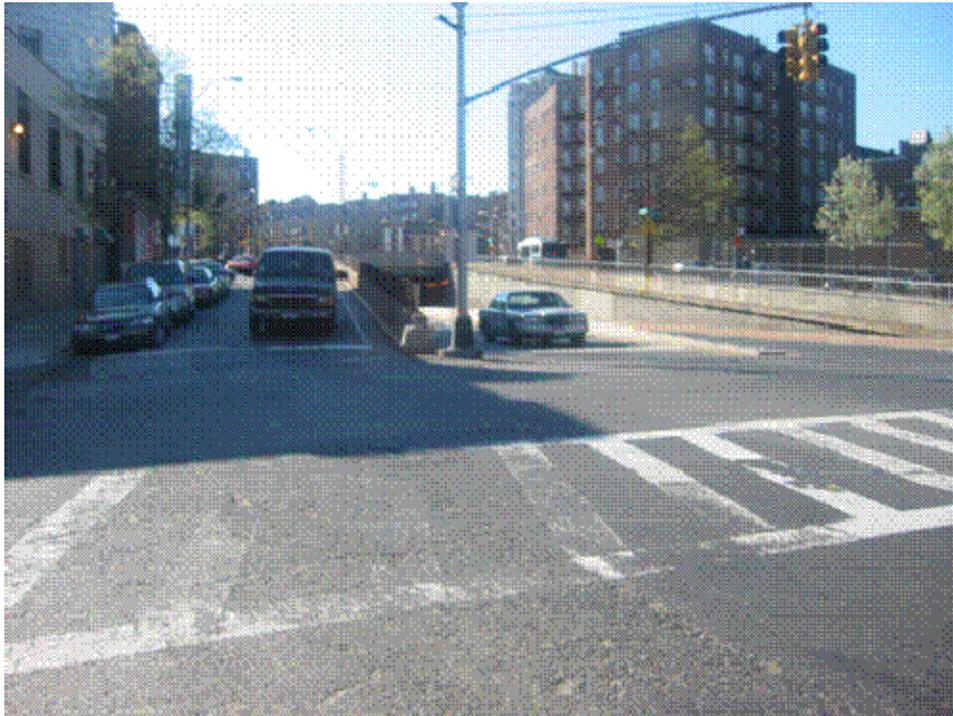
Figure 8: Looking east along East Tremont Avenue across the intersection with Creston Avenue

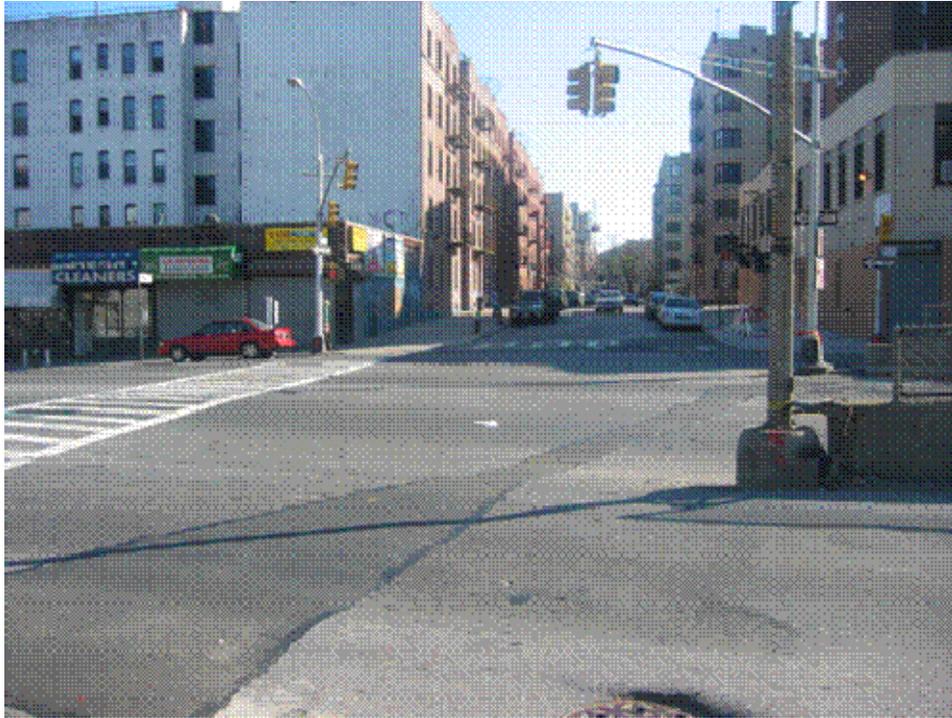
Figure 9: Looking north along Creston Avenue across the intersection with East Tremont Avenue

- East Tremont Avenue and Creston Avenue – Provide curb extensions on the northeast and northwest corners. In addition, extend the sidewalk along the south side of East Tremont Avenue, in the vicinity of the crosswalk across Creston Avenue, by six feet in order to reduce the crossing distance.
- Grand Concourse service roads and Echo Place – Provide curb extensions on both the north and south sides of Echo Place for the crosswalks spanning the east and west legs of these intersections.
- Grand Concourse northbound service road and East 178th Street – Provide curb extensions on the north and south sides of East 178th Street for the crosswalk spanning the east leg of the intersection.

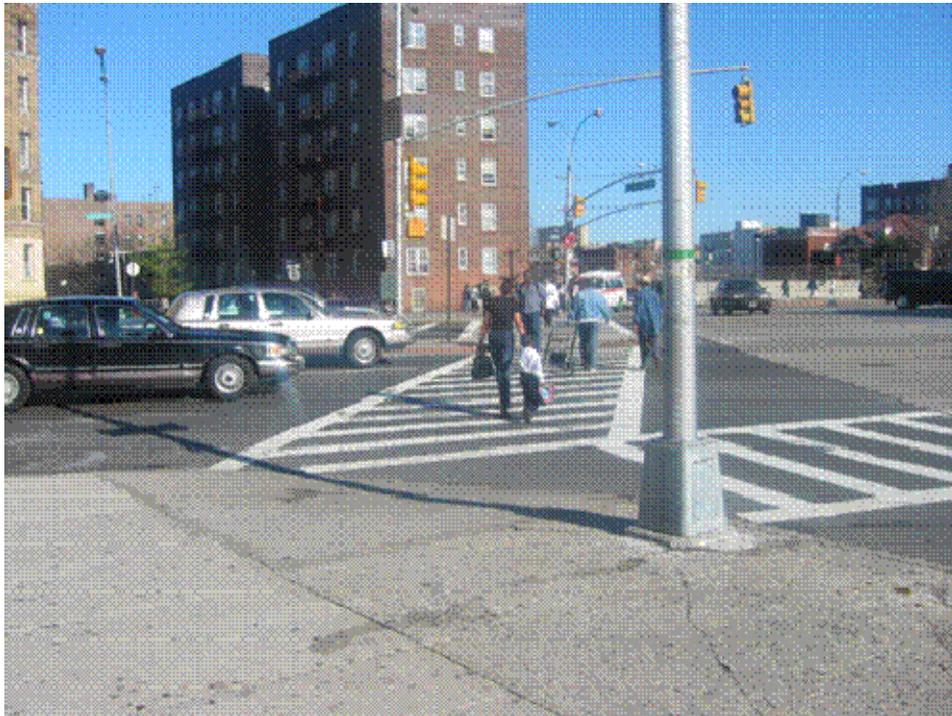
On the both sides of the Grand Concourse, East Tremont Avenue splits: the mainline continues as a two-way roadway under the Grand Concourse through an underpass (tunnel), with one travel lane in each direction separated by a concrete divider, and no on-street parking. In addition, eastbound and westbound service roads are located on either side of the mainline roadway and rise to intersect with the Grand Concourse at-grade. Each of the service roads has one travel lane and one on-street parking lane along the right side of the traveled way. The eastbound and westbound service roads intersect with the Grand Concourse approximately 50 feet apart, due to the underpass structure carrying the mainline East Tremont Avenue traffic underneath the Grand Concourse. East of the Grand Concourse, East Tremont Avenue curves approximately 30 degrees to the east. Land uses along East Tremont Avenue are primarily commercial, but include some residential uses (see Figures 10 and 11).

Figure 10: Looking northwest along East Tremont Avenue at the south crosswalk across the Grand Concourse

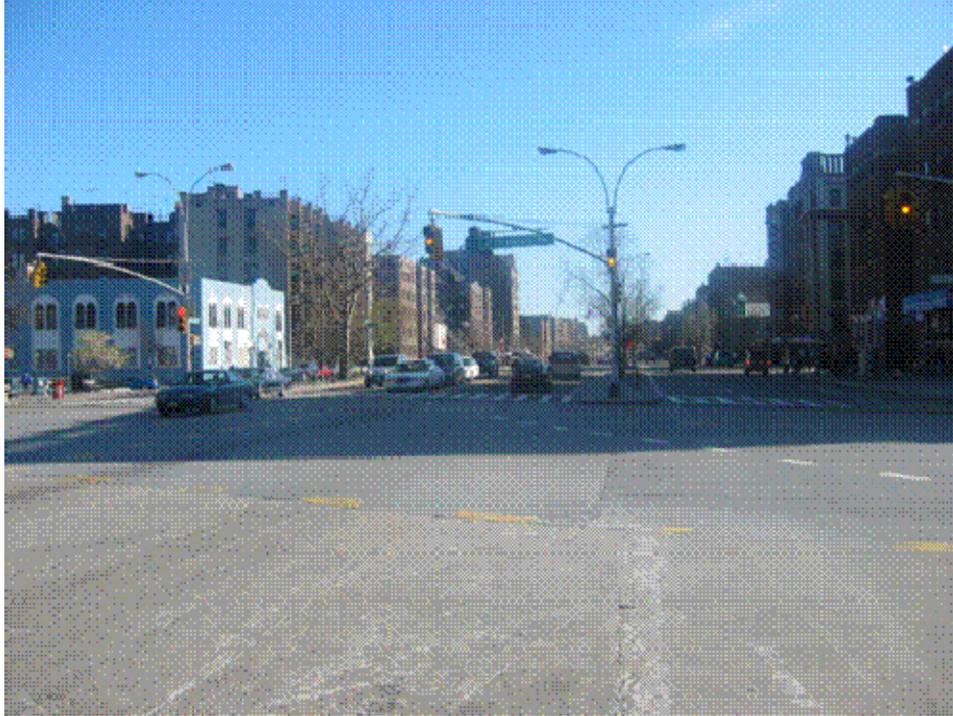
Figure 11: Looking north on the Grand Concourse across the intersection with East Tremont Avenue

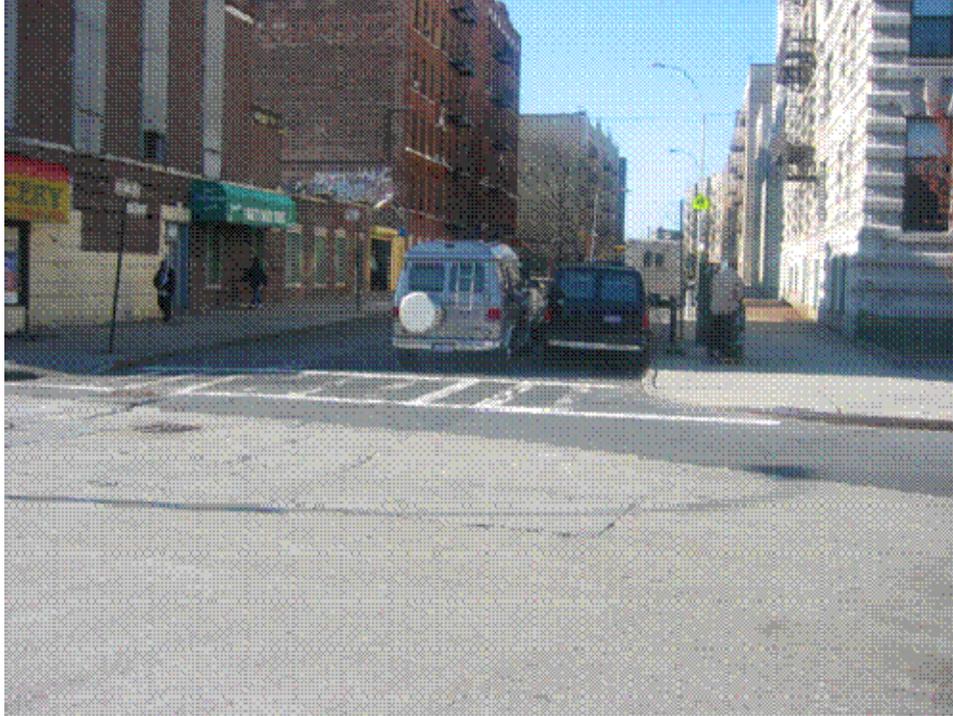
Figure 12: Looking south along Monroe Avenue from the eastbound service road on East Tremont Avenue

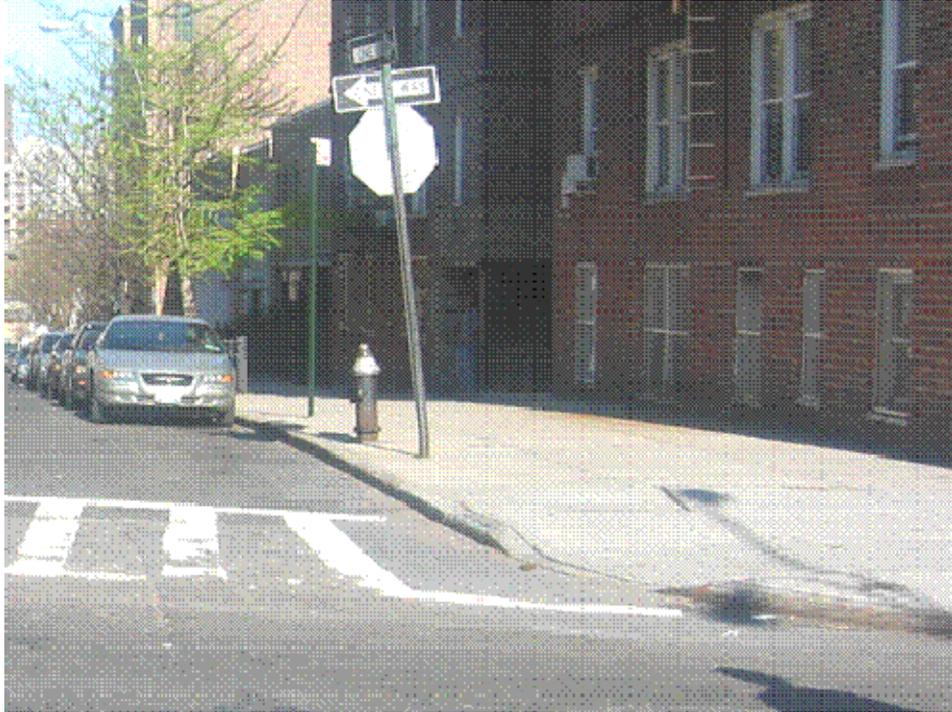
The roadways and sidewalks in the vicinity of St. Margaret Mary were observed to be in fair condition (see Figure 13) and are generally 10 to 12 feet wide.

Figure 13: Looking west at sidewalk along East 177th Street in the vicinity of St. Margaret Mary school

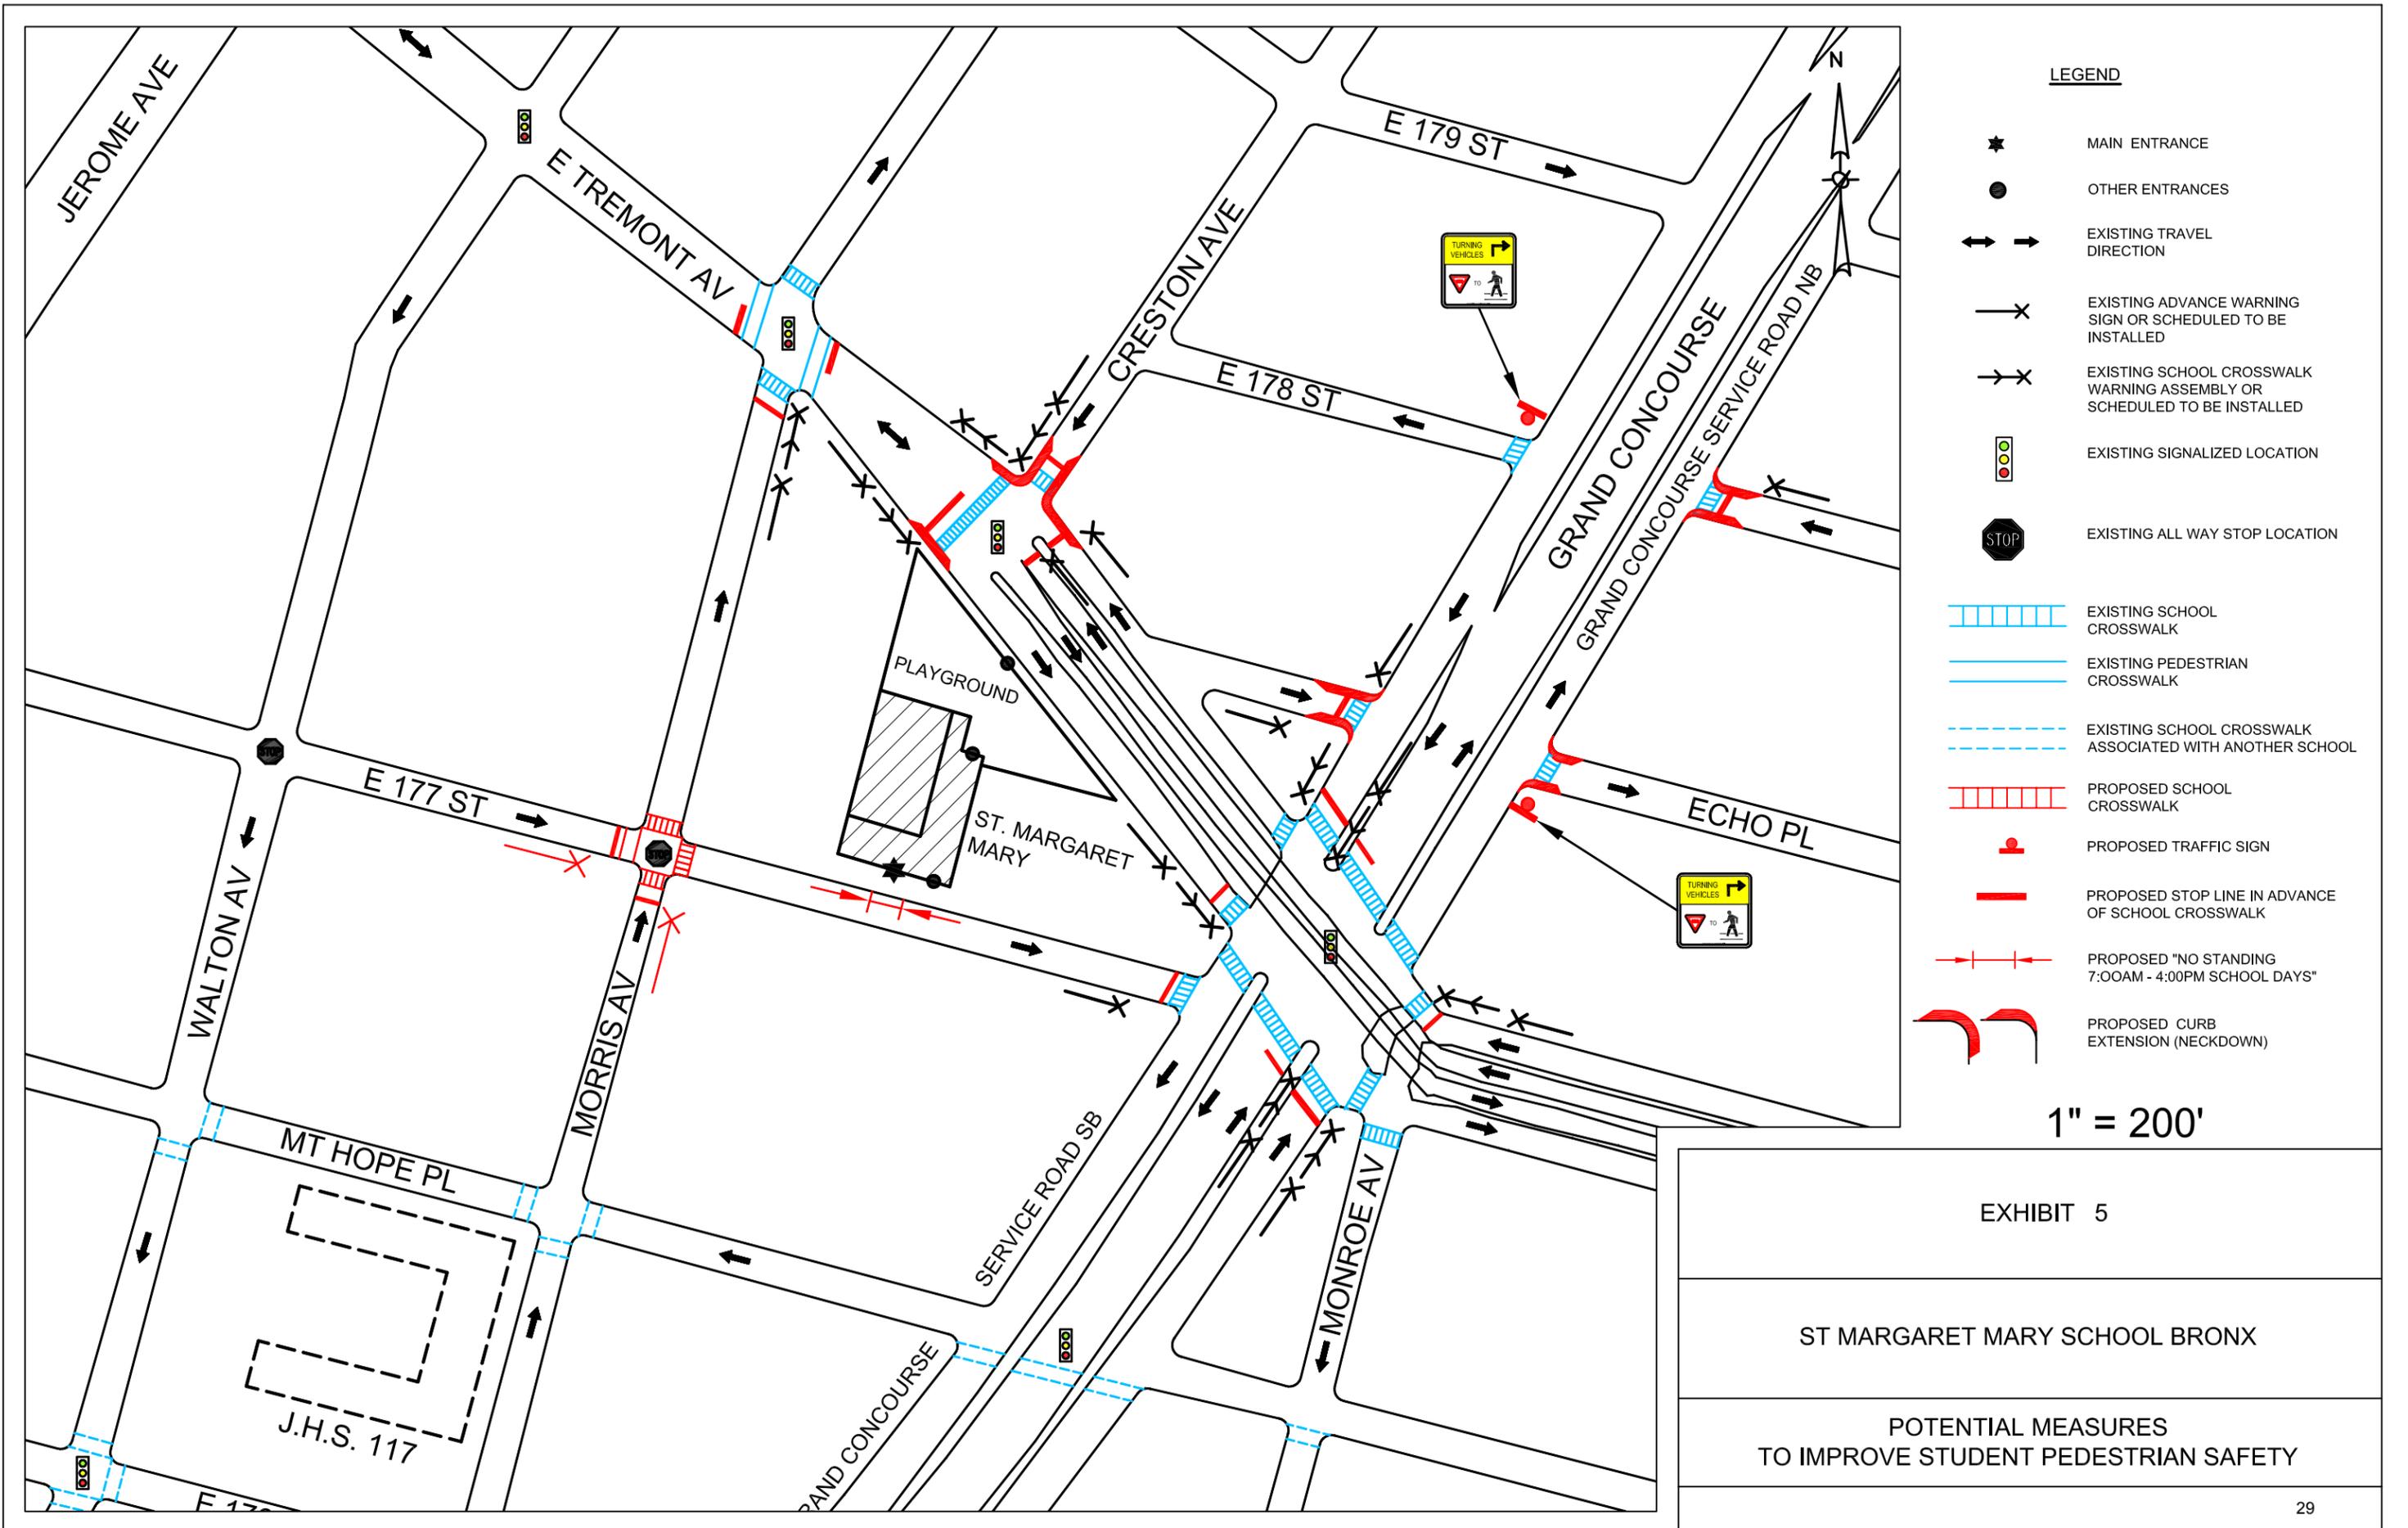
POTENTIAL MEASURES TO IMPROVE STUDENT PEDESTRIAN SAFETY

This section describes the proposed measures to improve student pedestrian safety around St. Margaret Mary School. The proposed recommendations are divided into short-term and long-term measures. Short-term measures are those that potentially can be performed in-house. Long-term measures involve capital improvements. Each of the short- and long-term measures recommended for St. Margaret Mary School is discussed as follows, and is shown in more detail in Exhibit 5 at the end of this section.

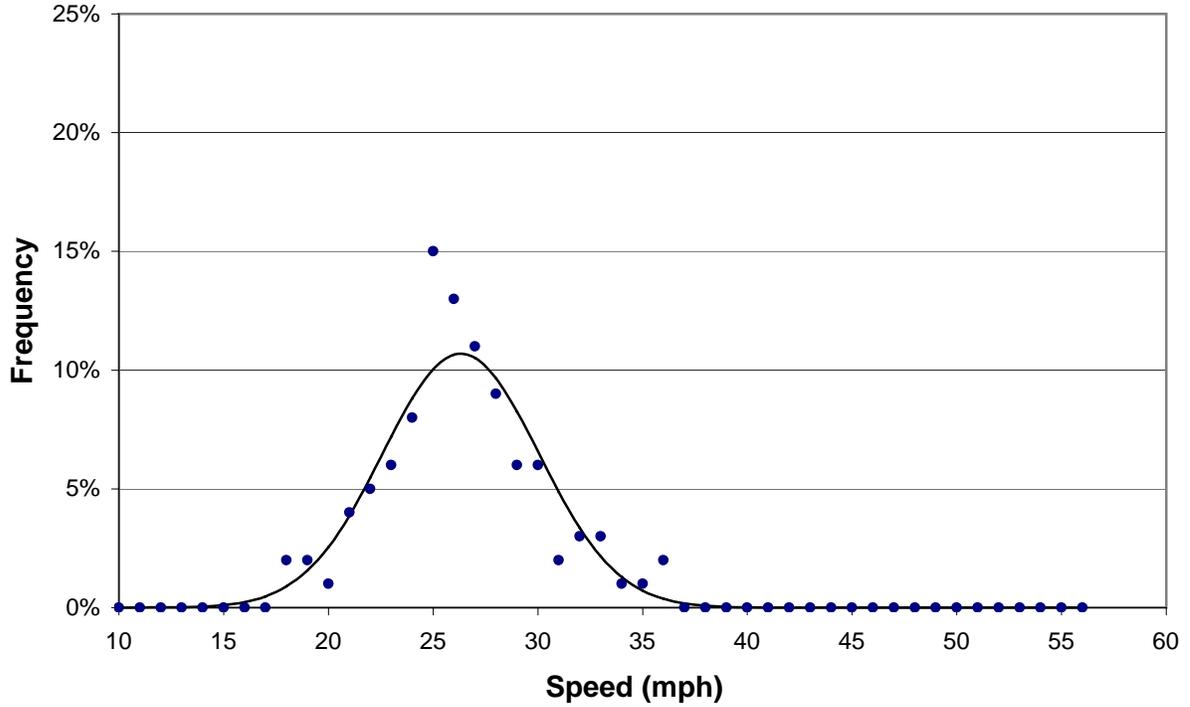
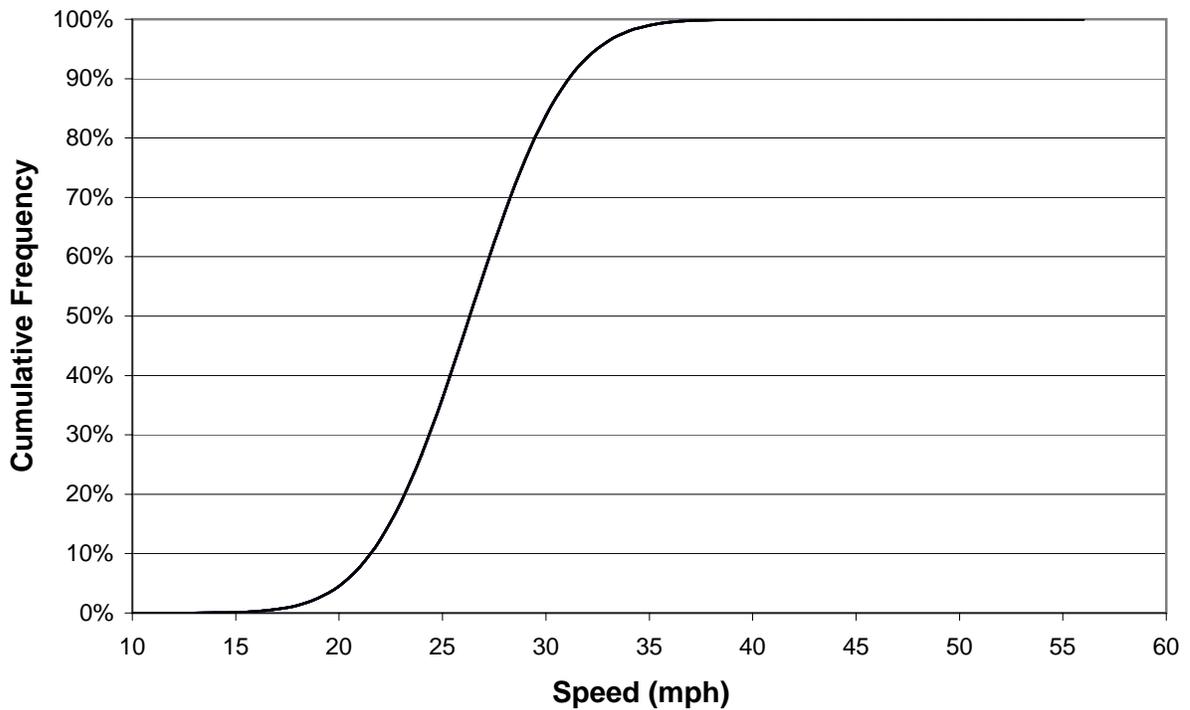
Mean Speed = 26.3 mph
Standard Deviation = 3.7 mph
Margin of Error (95% Confidence) = ± 0.7 mph

Median Speed = 26.3 mph
15th Percentile Speed = 22.5 mph
85th Percentile Speed = 30.2 mph

The results of the spot speed survey indicated that westbound vehicles on Tremont Avenue were traveling at an 85th percentile speed of 30 mph. Because Tremont Avenue is a bus route, speed reducers on Tremont Avenue are not recommended in this section.
