As an integral part of New York City's Department of Transportation, the Division of Bridges has a two-fold mission: to maintain an optimal transportation network by ensuring smooth mobility on the city's bridges, and to ensure the safety of the public.

The New York City Department of Transportation's Division of Bridges is comprised of four major bureaus. The **Chief Bridge Officer** is responsible for formulating policy and providing executive direction. He oversees all aspects of the design, construction, rehabilitation and reconstruction, maintenance, operation and administration of the 789 bridges (including 5 tunnels), and 53 culverts presently under the jurisdiction of the New York City Department of Transportation (NYCDOT). In addition to broad supervision, the Chief Bridge Officer also provides overall executive and administrative direction for the Division of Bridges, and ensures that all contractors are promptly paid.

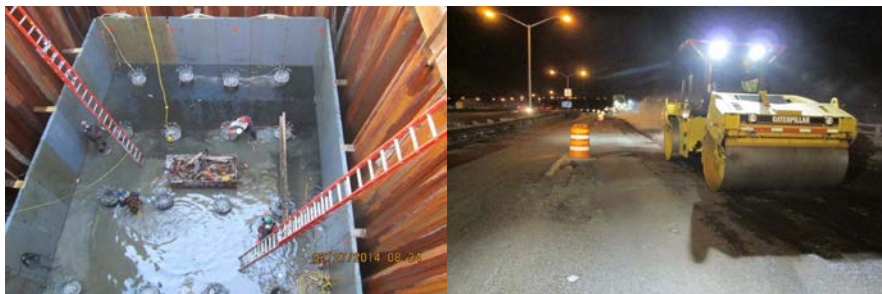
Workers Preparing to Dewater Cofferdam at Pier No. 1. . Steel Wheel Roller Compacting Hot Mix Asphalt During Nighttime Operation on Eastbound Belt Parkway West Side.

In February 2014, the contractor dewatered the Pier #1 cofferdam and made pothole repairs.

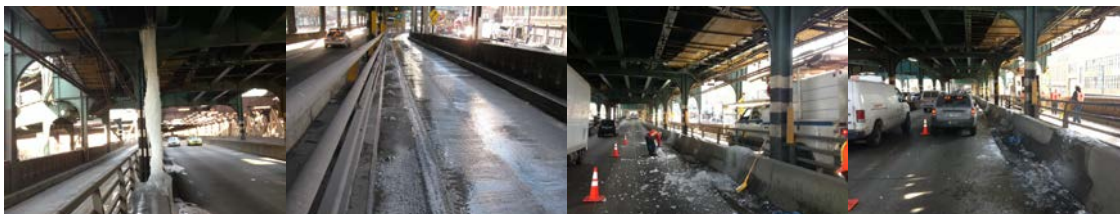
Huge Icicle (Caused by a Broken Water Pipe) Between the South Outer Roadway and the Inner Roadway at the Queens Approach of the Ed Koch – Queensboro Bridge. Icing on the South Outer Roadway. Division Engineers Closed Parts of the Roadway Until NYCTA Crews Completed the Removal of the Icicle and All of the Ice From the Roadway Surface and Barrier. Salt was Placed on the Remaining Ice on the Roadway. (Credit: Artemio Angeles)

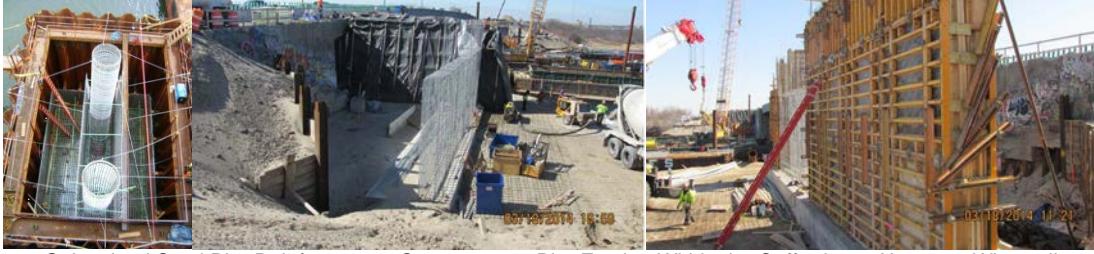
Galvanized Steel Pier Reinforcement Cages, set on Pier Footing Within the Cofferdam. Abutment Wingwall Reinforcement Steel, Prior to Setting Wall Forms on Previously Placed Wall Footing at Northeast Corner of the Abutment. 3/18/14 Wingwall Forms at North-West Abutment Wingwall. The existing bridge is at right.

In March 2014, the contractor continued installation of forms and rebar at both east and west abutments.

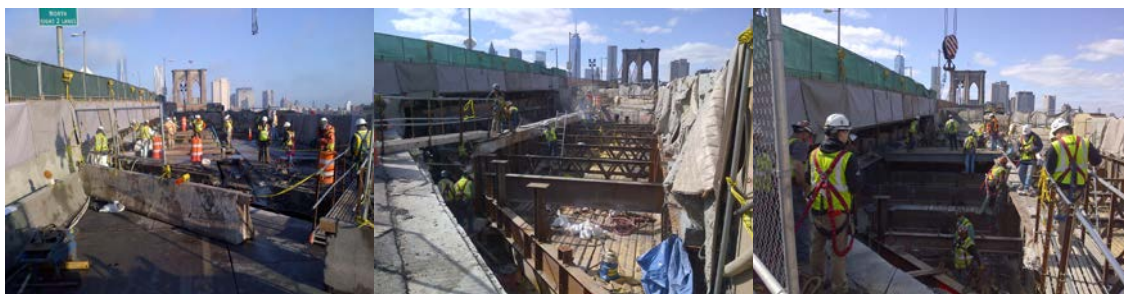
April 2014: Saw Cutting of the York Street Deck.

As part of the contract to rehabilitate the Brooklyn Bridge ramps and approaches, a full closure of the Manhattan-bound lanes of the bridge was performed from 11:59 PM April 4 to 6:00 AM April 7. Among other operations, this full weekend closure enabled the contractor to complete demolition and install a temporary deck unit on the Manhattan-bound roadway of the York Street structure in Brooklyn.

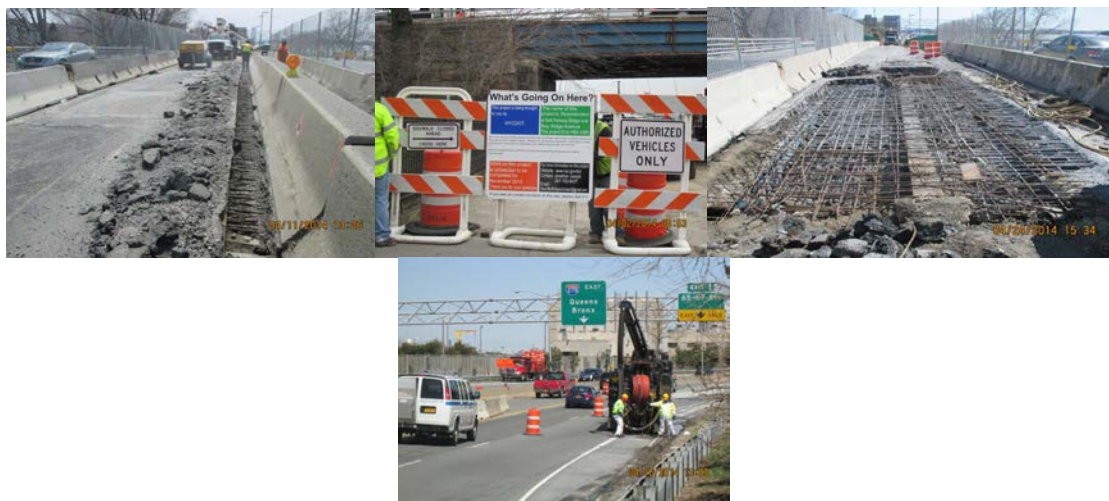
April 2014: Laborers Removing the Bridge Deck to Facilitate Removal of the Existing Concrete Median Barrier at Right Side of Trench During Stage I MPT. Stage I MPT Work Area After Removal of Structural Deck Concrete and Asphalt Wearing Courses, Exposing Deck Rebars and Structural Beams. Workers Cleaning out Catch Basins Using a High Pressure Water Hose and Vacuum Pipe for Debris Removal.

In April 2014, the contractor completed demolition of center median and removal of the structural deck concrete and asphalt wearing courses during Stage I.

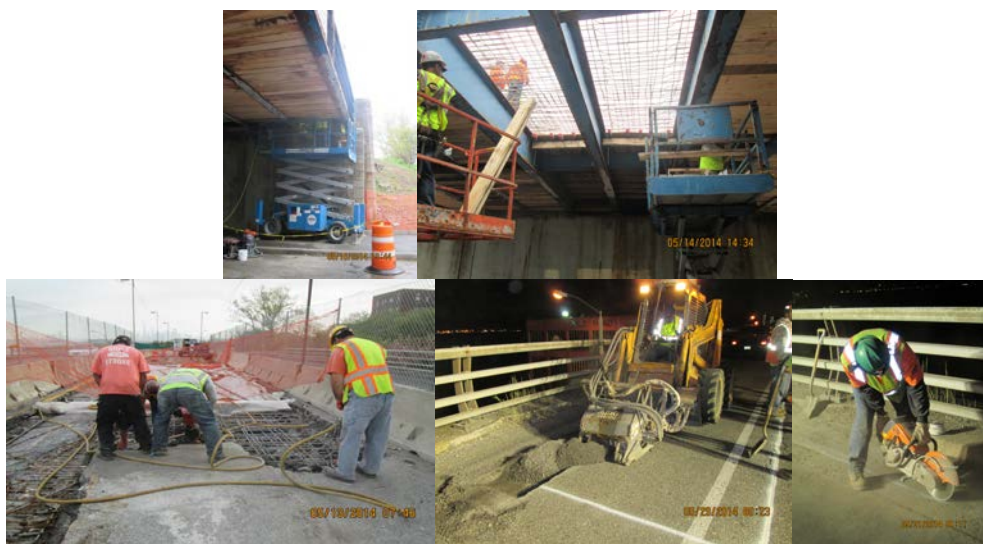
May 2014: Installing Wood Under Deck Shielding to Prevent Debris from Falling Onto the Sidewalk and Roadway at Southwest Abutment During Deck Demolition. Demolishing Bridge Deck With Pavement Breakers on Westbound Roadway. Temporary Deck Repair of Eastbound Roadway.

In May 2014, the contractor demolished more of the superstructure deck.

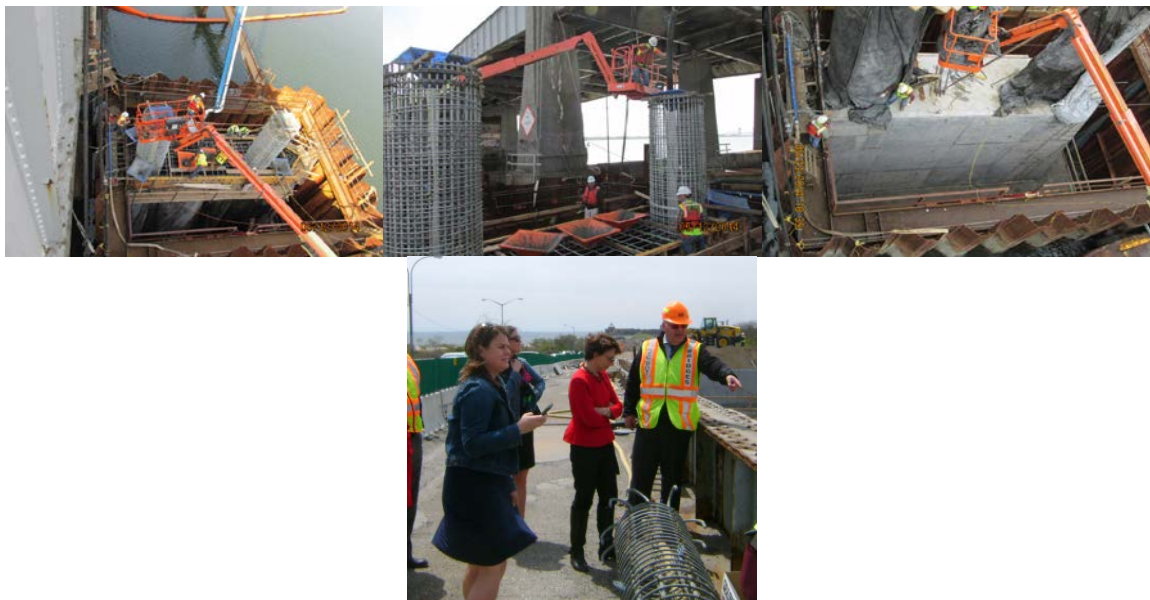
Pier 1 Plinth and Footing Inside the Cofferdam in May 2014. Commissioner Polly Trottenberg (in Red Jacket) and Chief Bridge Officer Robert O. Collyer Inspecting the Gerritsen Inlet Bridge Project in May 2014.
(Credit: Moshin Rizvi)

In May 2014, the contractor completed installation of concrete at the Pier 1 plinth.

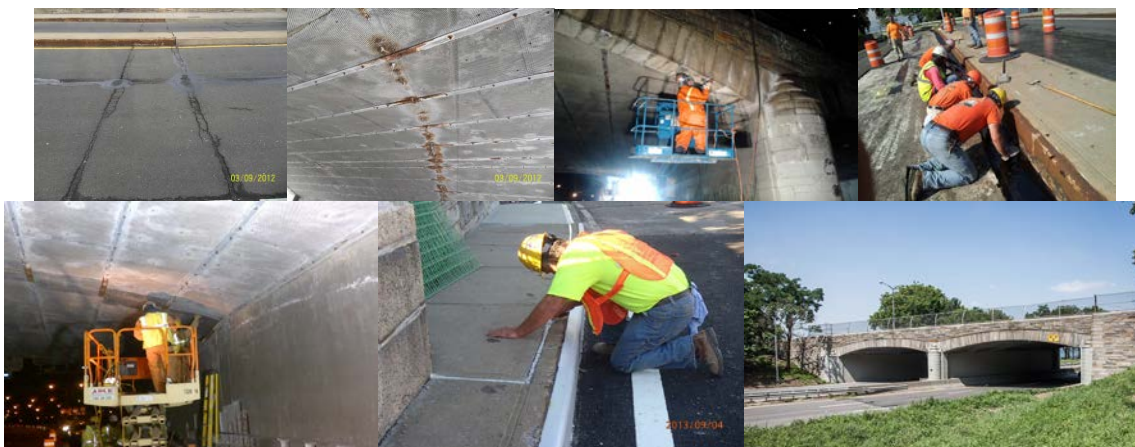
4th Avenue Bridge Before, During, and After Construction

The component rehabilitation of this bridge was substantially completed on June 27, 2014.

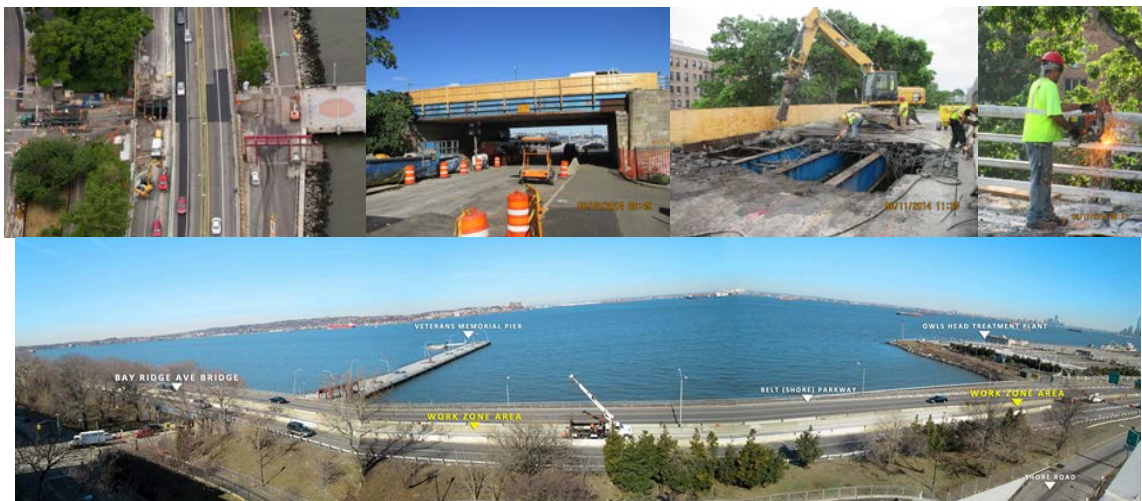
June 2014: Stage II Configuration. Bridge Deck Removed on Westbound Roadway. Panoramic View - Veteran's Pier at Right Above the Entrance to the NYCDEP Wastewater Treatment Plant. NYCDPR Bicycle/Pedestrian Promenade at Upper Right.

In June 2014, the contractor completed Stage II deck demolition.

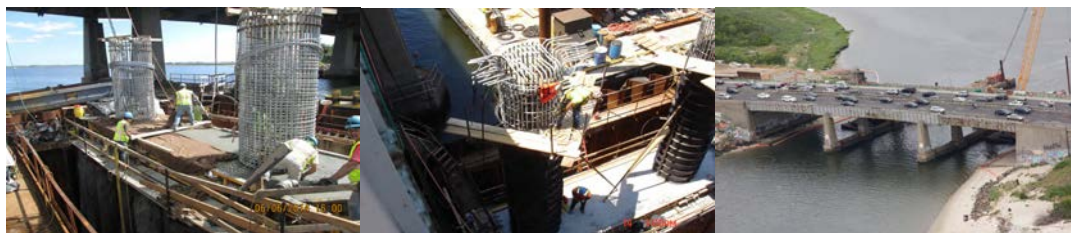
Finishing and Covering Plinth Concrete at Pier #1 in June 2014. Setting Rebars and Forms for Columns at Pier #2. Jamaica Bay at Left. Construction Barges and Cranes Constructing new Piers #1 and #2. Eastbound Traffic at Bottom.

In June 2014, the contractor installed concrete at pier #1 columns and pier #2 plinth and columns.

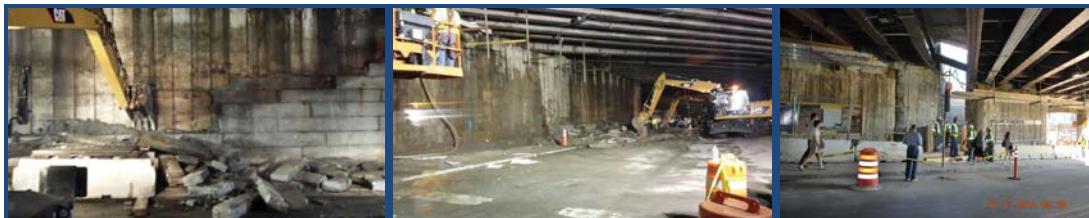
On the night of July 2, 2014, non-structural fascia stones lining the walls of the Brooklyn Bridge in the vicinity of Prospect Street and Washington Place fell onto the sidewalk. These stones are not a structural component of the bridge and are believed to have been installed approximately 60+ years ago. This area was isolated with jersey barriers and the material was removed as part of the immediate response. The scene was fully cleared and all roads reopened by 6:00 AM on July 3. After the immediate clean up, similar non-structural stones in the area were inspected. Several were determined to require removal. The contractor continued to remove the stone facade at the Washington and Prospect Streets abutment walls through the early part of August.

Removing the Stone Façade.

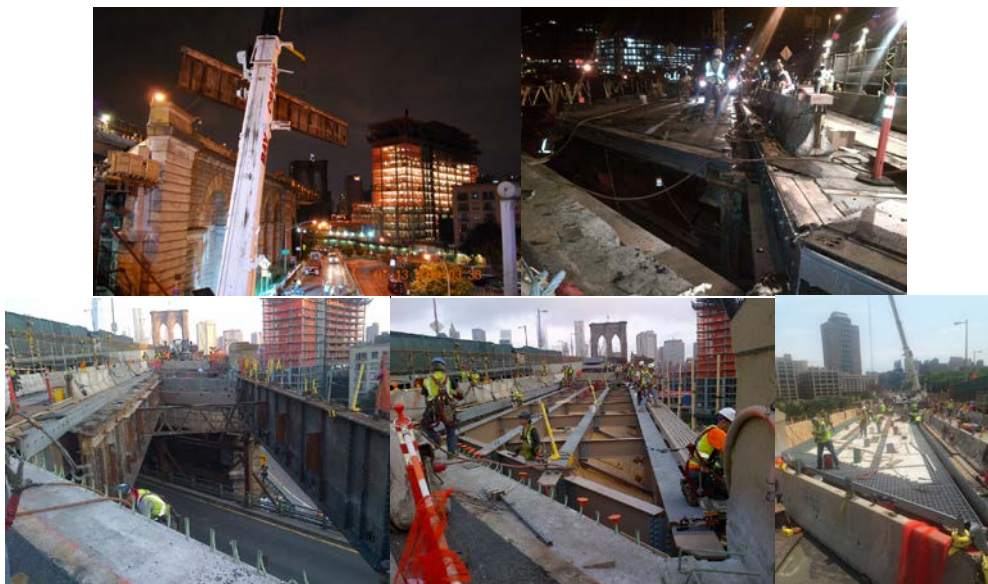
July 2014: Replacing the Second Half of the York Street Structure. Removal of the Manhattan-Bound Girder. Old Deck and Most of the Steel Removed. New Steel and Prefabricated Deck in Place.

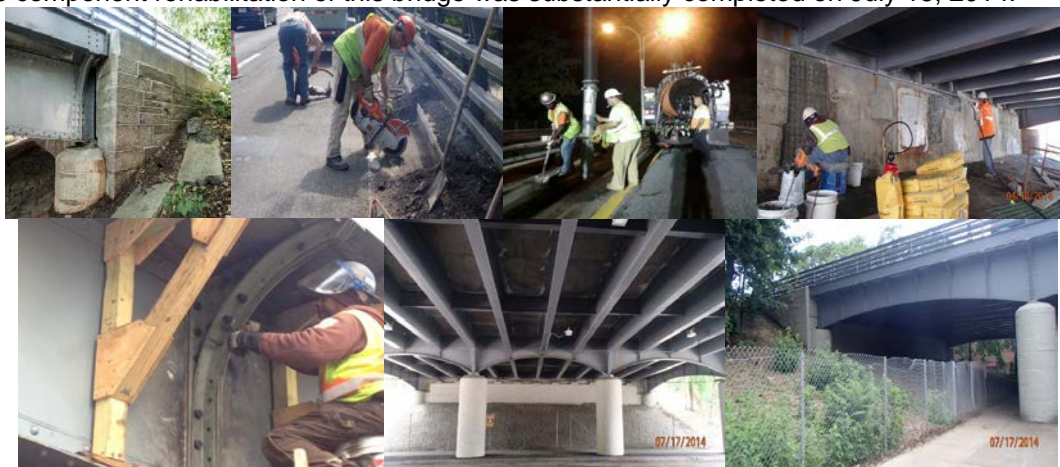
Bedford Avenue Bridge Before, During, and After Construction.

The component rehabilitation of this bridge was substantially completed on July 15, 2014.

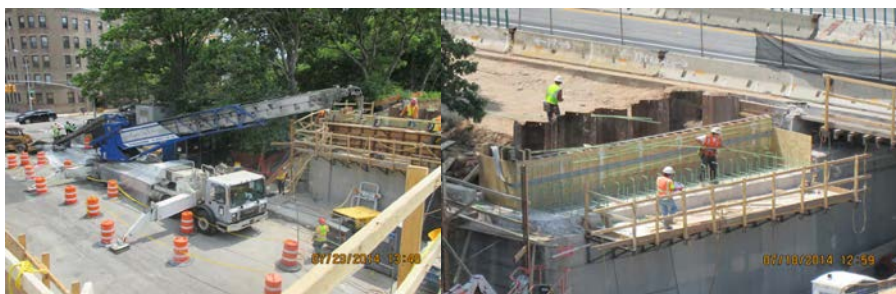
July 2014: Placing Concrete for Northeast Abutment Using a Conveyor. Setting Rebars at the Northeast Abutment.

In July 2014, the contractor completed the installation of concrete for the Stage II upper stem wall sections of the east and west abutments.

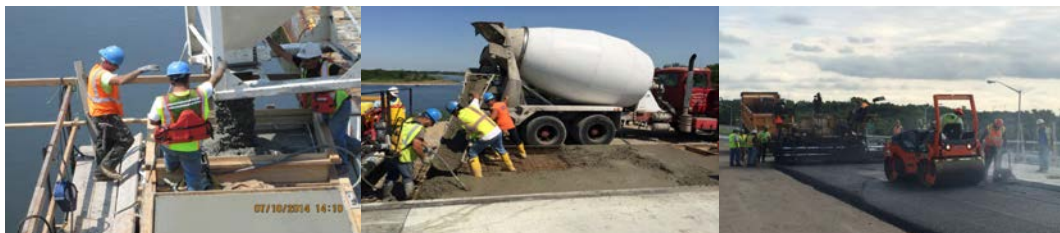
July 2014: Bottom Dump Bucket Used to Place Concrete for Pedestals at Pier #1 Cap Beam. Placing PCC Pavement at East Approach. Spreading and Compacting Hot Mix Asphalt on Belt Parkway East Side of Bridge.

In July 2014, the contractor installed concrete for the east abutment and pier #1 cap beam pedestals and pavement for the east approach.

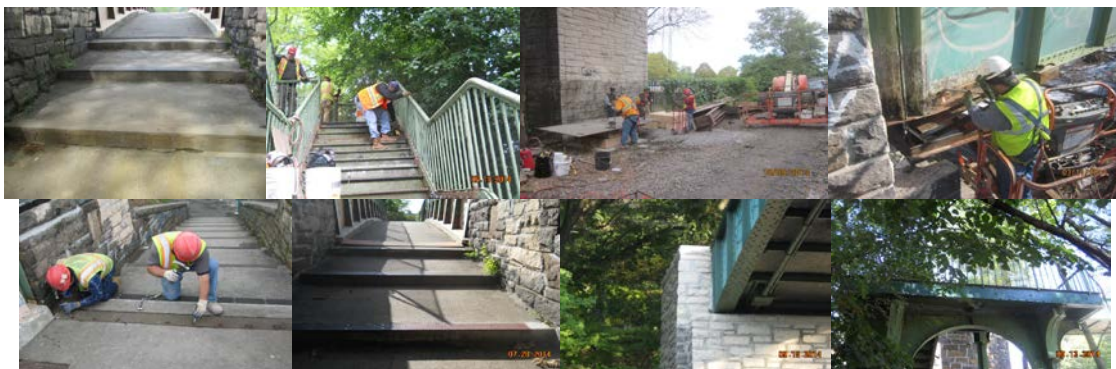
This is a six span bridge. The main bridge is constructed of steel plate girders with a reinforced concrete deck. The east-west oriented main span is over the Amtrak railroad tracks. The staircases are constructed of steel stringers and a pier along with metal steps lined with anti-slip treads and landing platforms. The bridge serves as the only access for pedestrians to walk across the Amtrak rail road, which divides the park into two halves, in order to reach the playground on the west side of the park. The scope of rehabilitation work included the following: installing and removing a containment system for paint removal; painting the steel girders, fencing, and staircases; repairing the steel girders, staircases, abutments, piers, deck and underdeck; installing and removing the temporary support; repairing and replacing bearings, and installing a bicycle railing on the staircase. The component rehabilitation of this bridge began in July 2013 and was substantially completed on August 11, 2014.

Inwood Hill Park Footbridge Before, During, and After Construction.

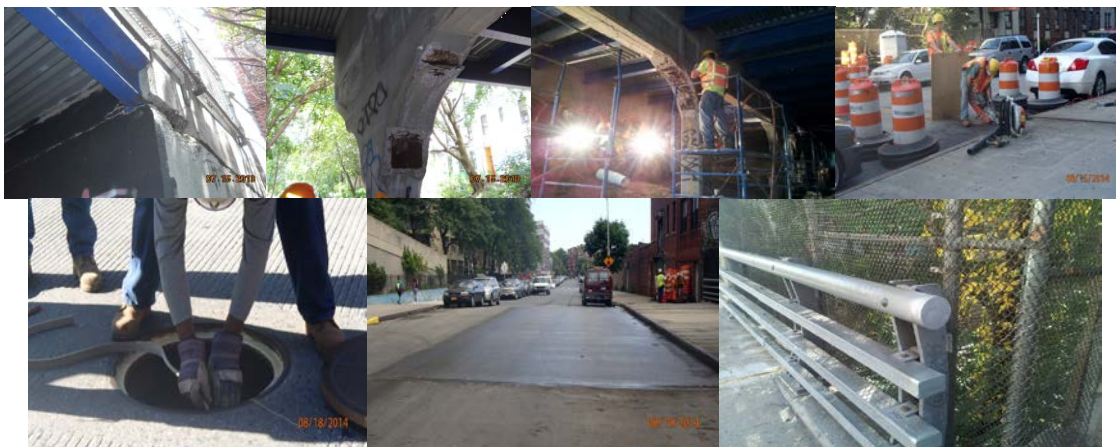
Crown Street Bridge Before, During, and After Construction.

The component rehabilitation of this bridge was substantially completed on August 20, 2014.

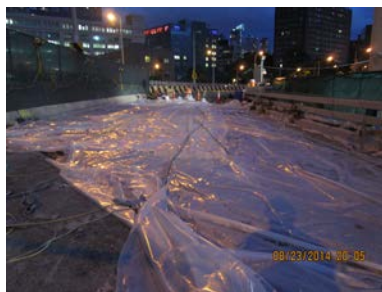
August 2014: Brooklyn-Bound Sands Street Structure Curing After Closure Pour Concrete Placement.

As part of the contract to rehabilitate the Brooklyn Bridge ramps and approaches, a full closure of the Brooklyn-bound lanes of the bridge was in place from 11:59 PM August 22 to 5:00 AM August 25, 2014. This facilitated the concrete placement of the armored joints and curbs at the Brooklyn and Manhattan approaches and the closure pour at the Sands Street structure. Additional work included painting at Ramp A, power-tool cleaning and painting of two-rail safety barrier and touchup paint application at the Manhattan main and side spans, new railing installation at the Brooklyn approaches and waterproofing membrane installation at the Franklin structure orthotropic deck joints.

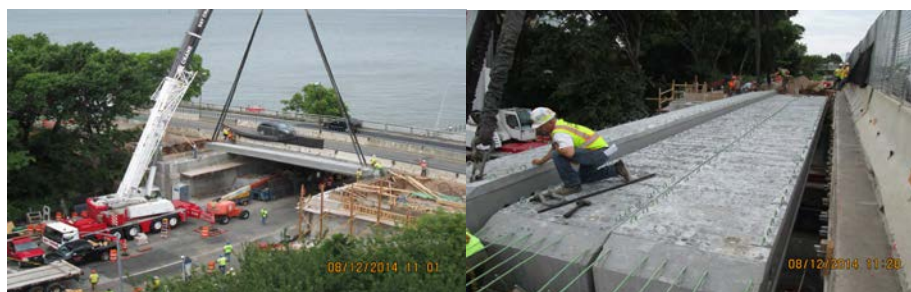
August 2014: Unloading and Placing the Pre-cast Concrete Box Beam on the North Side Abutments. Lowering the Third Pre-cast Concrete Box Beam.

In August 2014, the contractor installed seven precast box beams on the north side abutments.

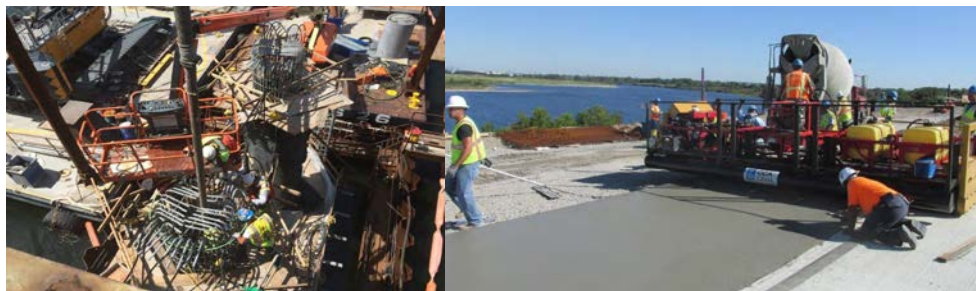
August 2014: Pumping Concrete Into Column Cage at Pier #2. Finishing Pavement at West Approach.

In August 2014, the contractor demolished and rebuilt the pier #2 columns and installed pavement at the west approach to the bridge.

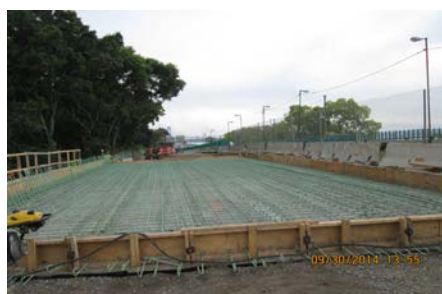
September 2014: Rebars in Place Prior to Placing Concrete Deck on Precast Concrete Beams on the North Side.

In September 2014, the contractor placed the rebars for the deck slab.

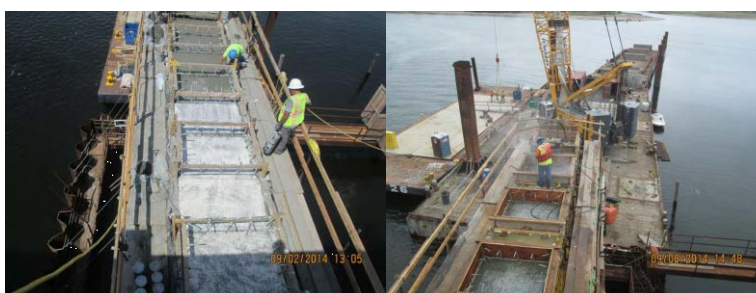
September 2014: Finishing Concrete on Pier Cap at Pier #2. Setting Forms for Concrete Pedestals at Pier #2 Cap Beam. Work Barge and Crane in Background.

In September 2014, the contractor completed installing the pier #2 cap beam concrete.

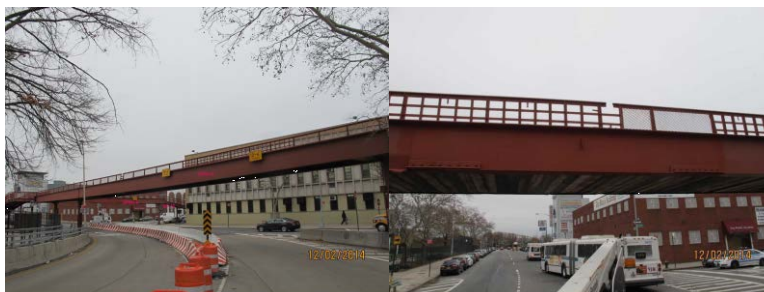
On October 9, 2014, a boom-truck travelling west struck the bridge, creating structural safety flag conditions: the middle portion of the bridge was pushed out about one and a half feet, the end girders and diaphragms were twisted, and a concrete slab was displaced. Crews made the area safe with jersey barriers and reinforcements of the girders and concrete slab. The ramp was closed from 5:00 AM until 6:00 PM the following day. Additional repairs were performed on the nights of October 15 and 16: crews installed additional diaphragms, shielding, and longitudinal supports.

East 128th Street Pedestrian Bridge Strike and Emergency Repairs. Left Elevation of Bridge. Timber Shielding Installed on Underside of Span #9 to Prevent Loose Concrete From Falling on the Road. Right Girder at Span #9 After Repair.

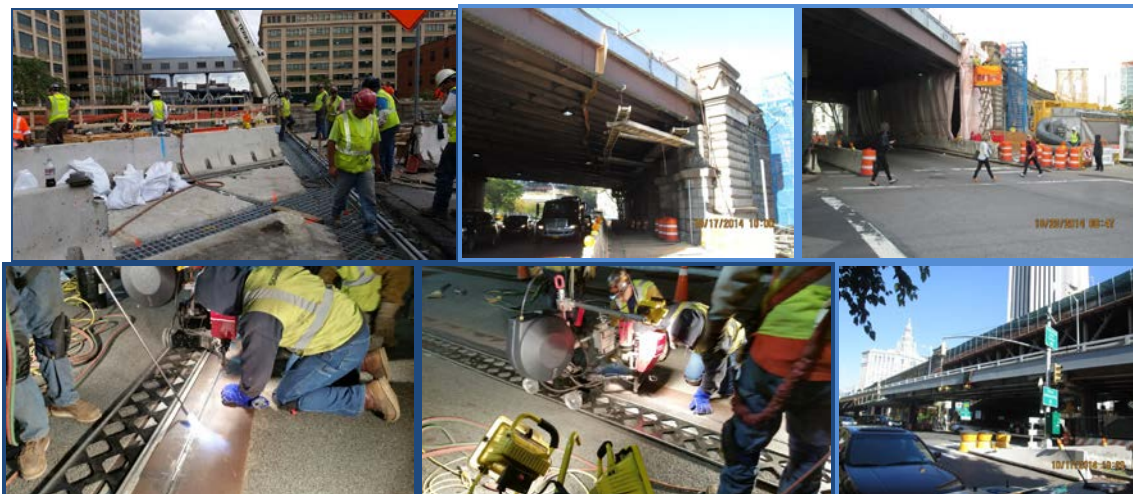
October 2014: Sands Street Structure – Preparing for Closure Pour. Containment Installation at Brooklyn Approach Structures. October 2014: Franklin Square Structure – Deck Alignment and Welding. Painted Manhattan Ramp.

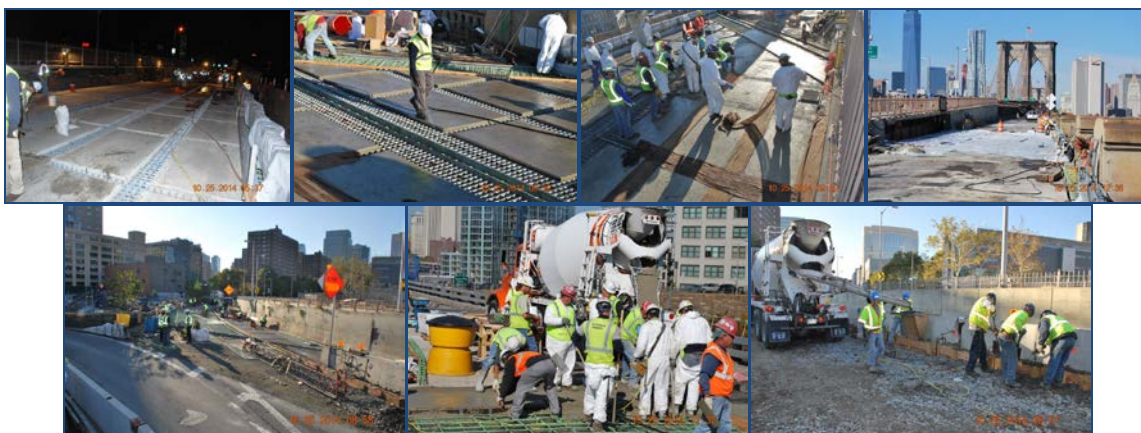
October 2014: York Street Structure – Closure Pour. Sands Street Structure – Curb Mall.

As part of the contract to rehabilitate the Brooklyn Bridge ramps and approaches, a full closure of the Manhattan-bound lanes of the bridge was in place from 11:59 PM October 24 to 6:00 AM October 27, 2014. This facilitated the completion of rehabilitation work on the Manhattan-bound Sands Street and York Street structures.

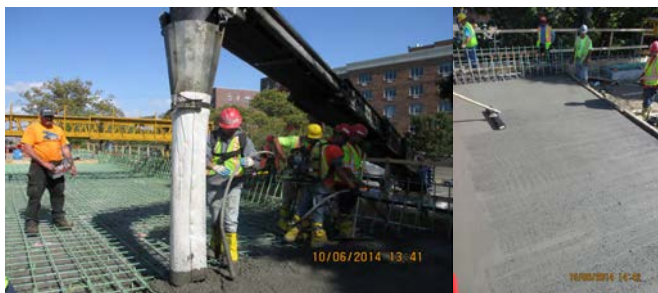
October 2014: Placing and Vibrating the Concrete Deck at the Bridge Facing West. Applying a Broom Finish Texture to the Deck Concrete.

In October 2014, the contractor installed a cast-in-place concrete deck wearing surface on the new precast beams.

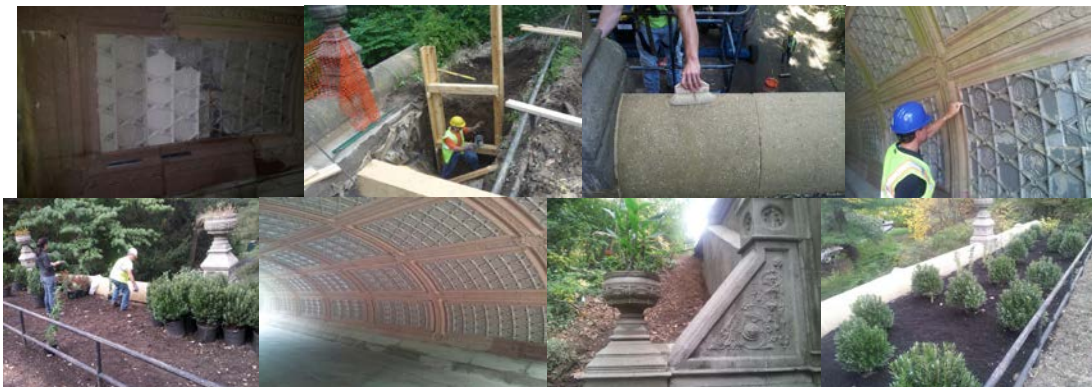
Cleft Ridge Span Before, During, and After Construction.

The component rehabilitation of this bridge was substantially completed on November 5, 2014.

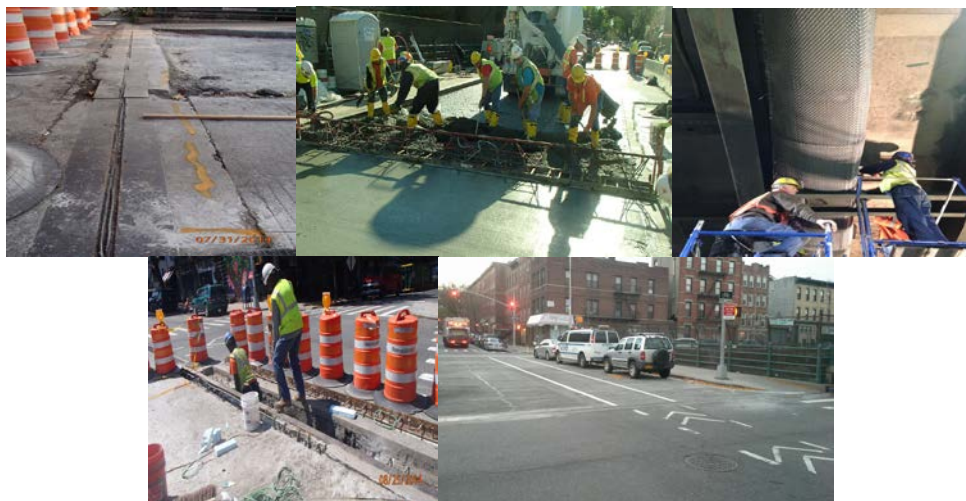
Union Street Bridge Before, During, and After Construction.

The component rehabilitation of this bridge was substantially completed on November 13, 2014.

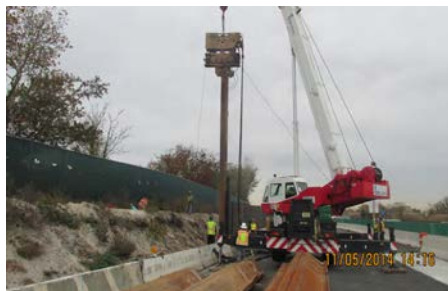
November 2014: Driving Steel Sheetting at East Approach for the Future Temporary Access Roadway.

In November 2014, the contractor drove steel sheeting for temporary access road at the east approach.

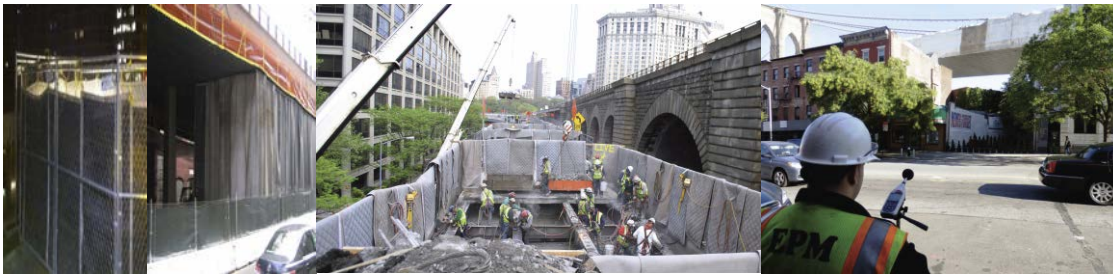
Noise Reduction Along the Sound Pathway – Acoustical Barriers on the Bridge During Night Construction Activities. Acoustical Curtains Along Frankfort Street. Two Crews Work Along Frankfort Street in April 2012. Cranes (On Left) Lift Material In And Out of Walled Enclosures of Sound Blankets. Inspector Taking Noise Measurements.

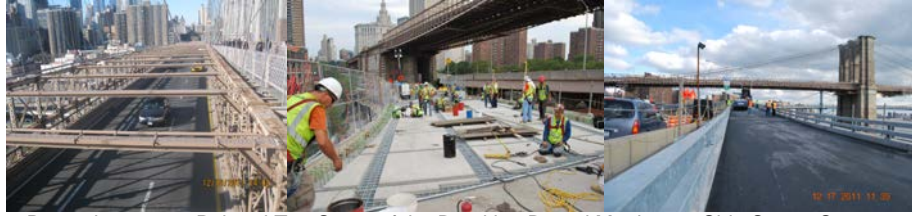
December 2011: Painted Top Struts of the Brooklyn-Bound Manhattan Side Span. Summer 2011: Manhattan Approach - Ramp C Deck Replacement.
December 2011: Ramp C.

In 2011, painting was completed at the Franklin Square structure and continued at the Manhattan ramps and Brooklyn main and Brooklyn side spans with continuous installation of protective shielding and containment. Painting of the truss top struts was also started at the Brooklyn-bound Manhattan side span. The following construction work was started in 2011: on the Manhattan approach, activities included Brooklyn-bound roadway removal, waterproofing and super slab installation, Franklin Square floor beam replacement, south cantilever beam excavation and repair, and arch block strengthening. On the Manhattan ramps, work included bearing replacement, widening, and deck replacement, and fascia removal. Asbestos abatement work took place in the Brooklyn maintenance shop. Electrical work was also in progress with activities that included light pole and abandoned equipment removal, temporary lightning installation, and temporary power provisions. Other activities included detailed surveying, testing and repairing of dry-standpipe system, fabrication of precast and steel members.

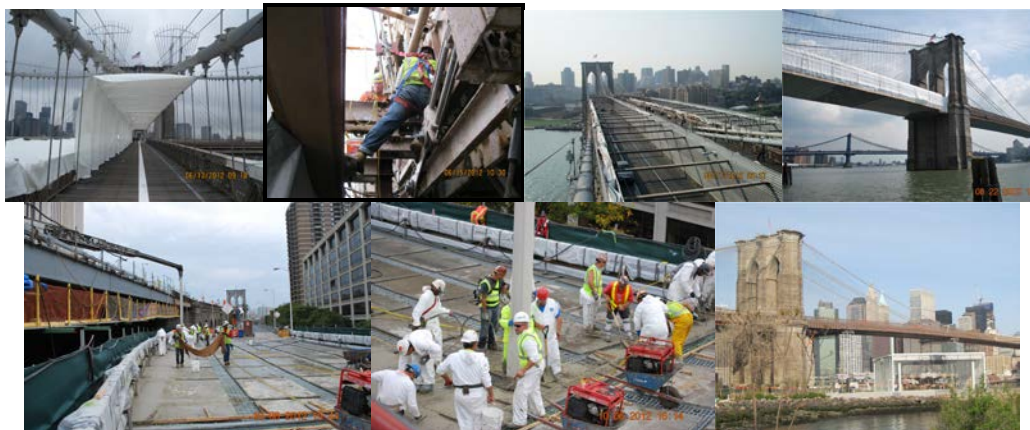
June 2012: Brooklyn Side Span Netting Protection for Main Cable and Suspender Rope Painting. June 2012: Structural Steel Repairs. 2012: Manhattan Main Span Vertical Wall. August 2012: Manhattan Side Span Containment at Manhattan Tower. First Full Roadway Closure: Ramp A Concrete Placement. Second Full Roadway Closure: Brooklyn Approach. December 2012: Brooklyn Main Span in Finish Coat.

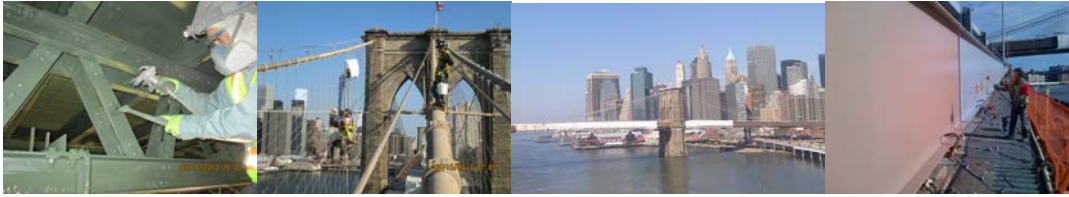
May 2013: Painter Applying Primer Stripe Coat on the Manhattan Main Span. June 2013: Painter on Sway Bracing on the Brooklyn Side Span. (View Credit: Earlene Powell) November 2013: Painting Fascia Steel on Ramp C.

complete. In addition to the Main Bridge painting, paint removal and coating application continues on the Manhattan side ramps and was also approximately 70% complete.

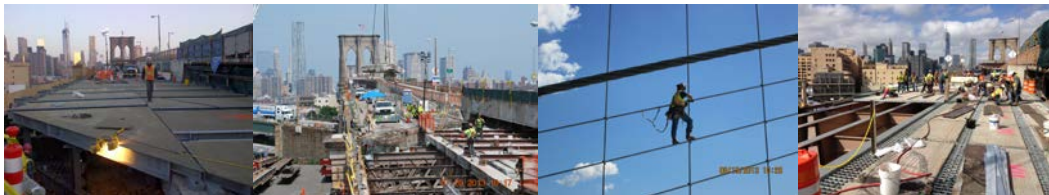
April 2014: Installation of Temporary Deck Units at the York Street Structure Over Brooklyn-Queens Expressway. July 2013: Removal of the Existing Concrete Slab on the Eastbound Main Street Structure. August 2013: Ironworker Replacing Cable Clamp Assemblies on the Suspended Span. October 2013: Grid Deck Panel Installation at the Eastbound Park Row Structure.

2013 saw significant progress for structural rehabilitation work, which included: completion of the Brooklyn-bound orthotropic deck panel installation at the Franklin Square Structure; the installation of the new concrete-filled grid deck systems at the outbound York Street, Main Street and Park Row structures as well as Prospect Street, Washington Street and the maintenance shop deck systems for both inbound and outbound directions. Concrete-filled grid deck installation for the inbound York Street, Main Street, North Cantilever and Franklin Square structures was begun. The approach super slab installation was completed in the outbound direction and was about 20% complete inbound. The main bridge structural steel flag repairs continued to be identified by biennial and special inspections.

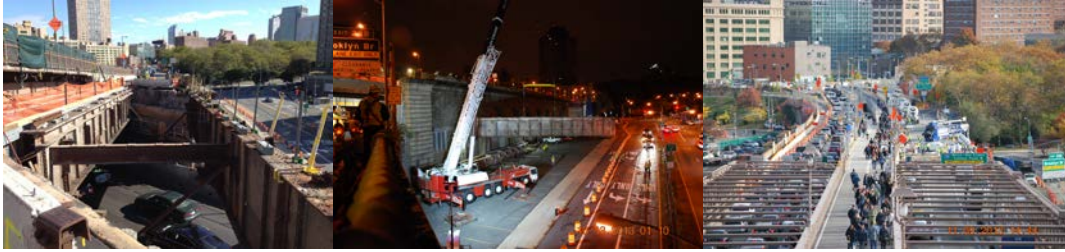
October 2013: Eastbound Brooklyn-Queens Expressway Traffic Flowing Under the Exposed Steel of the Eastbound York Street Structure. Removing the Fascia Steel From the Eastbound York Street Structure.
November 2013: Concrete Placement at the Eastbound York Street Structure.

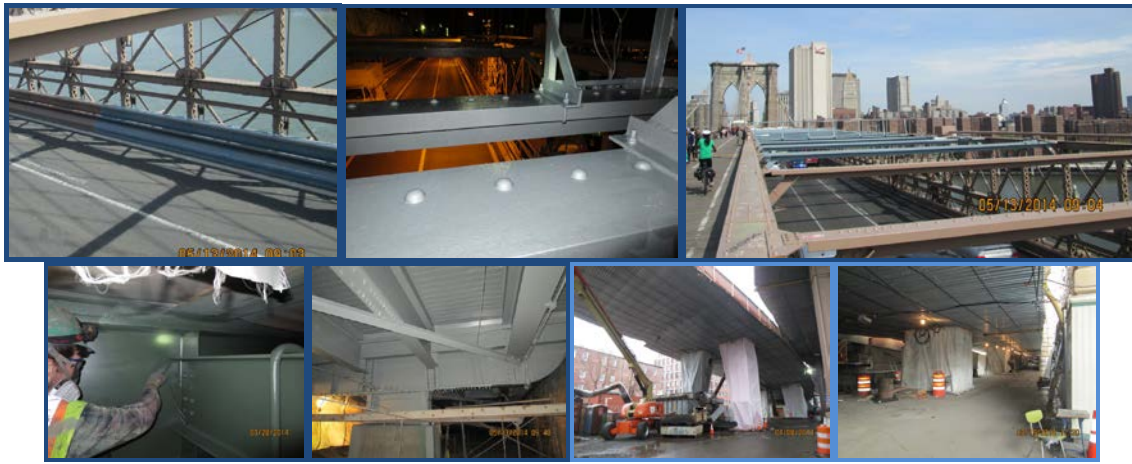
Spring 2014: Painting at Main Bridge – Safety Barrier and Top Struts. Painting at Manhattan Ramps. April 2014: Containment at Manhattan Ramps and Approaches.

In 2014, lead-based paint removal and new coating applications were completed at the Manhattan ramps and approach structures. Subsequently, primary protective shield removal commenced at the Manhattan ramps and is in progress. Painting of the overhead struts and promenade approach railing was completed, while painting of the main cables and suspender cables continues and is at approximately 80% complete. Additionally, abrasive blast cleaning and painting have begun at the Brooklyn approach structures, with a portion of the Prospect Street structure completed.

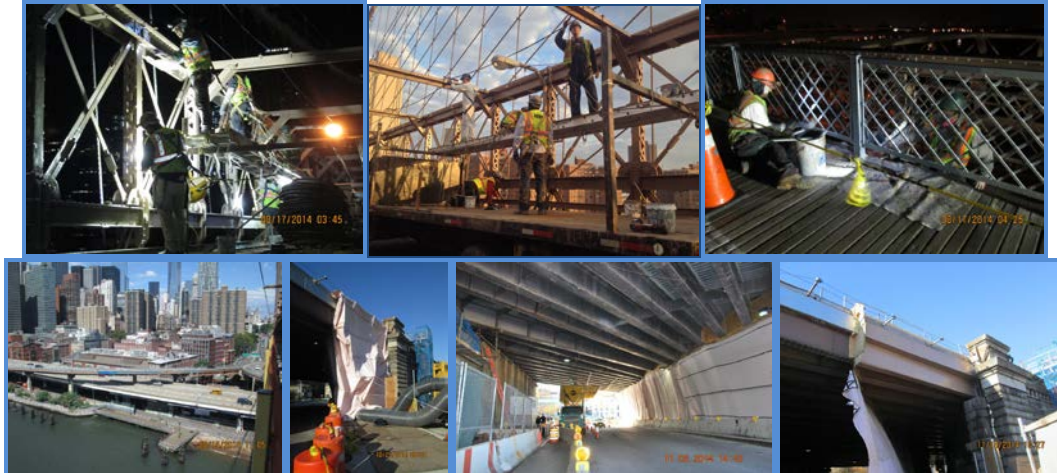
August 2014: Main Bridge Touch-Up Painting, and Painting Manhattan Main Span Promenade Railing.
August 2014: Painted Manhattan Ramps. October and November 2014: Blasting and Painting – Brooklyn Approach Structures.

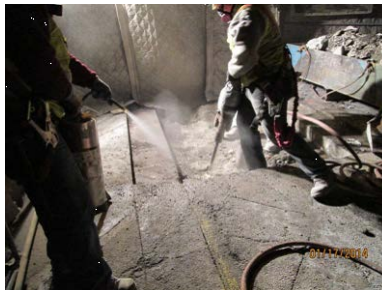
Respirable Dust & Airborne Silica Monitoring.

In response to residents' concerns about airborne silica, a type of dust that is emitted during concrete demolition operations, the project team conducted a series of tests to monitor the levels of this substance in the air in January 2014. In addition to three types of silica, the tests also monitored for general respirable dust. Monitors were placed in four locations near concrete demolition operations occurring at the Main Street and York Street structures on the Brooklyn approach. Two monitors were placed within 50 feet of the construction activities themselves, one was placed at ground level north of the activity, and another placed directly in front of a residential building just south of the work. Analysis was undertaken by the project's environmental experts using procedures established by the Occupational Safety and Health Administration (OSHA) and the National Institute for Occupational Safety & Health (NIOSH). All results were well below the permissible exposure levels as established by the NYS Department of Labor Public Employee Safety and Health and threshold limit values established by the American Conference of Governmental Industrial Hygienists.

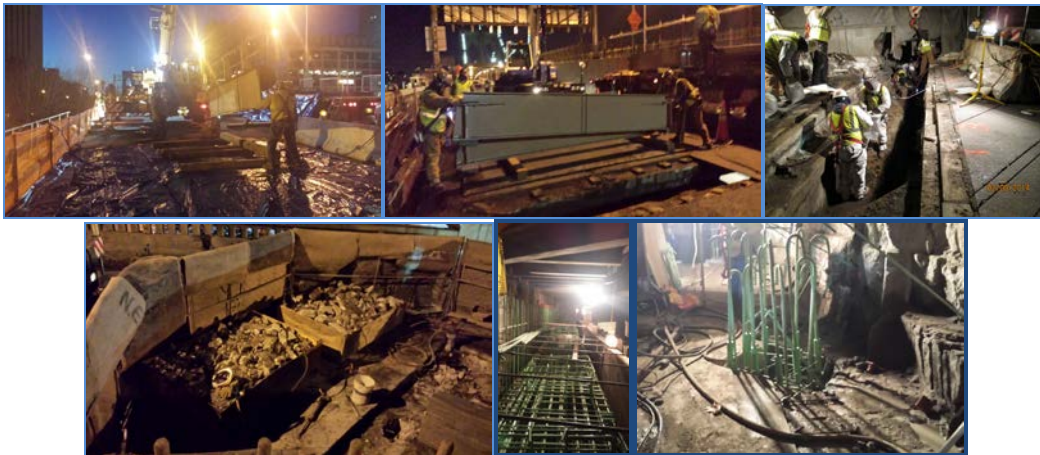
February 2014: Fascia Removal – Park Row Structure. Franklin Square Structure – Floorbeam Installation. York Street Structure – Demolition and Steel Removal. Main Street Structure – Cap Beam Installation.

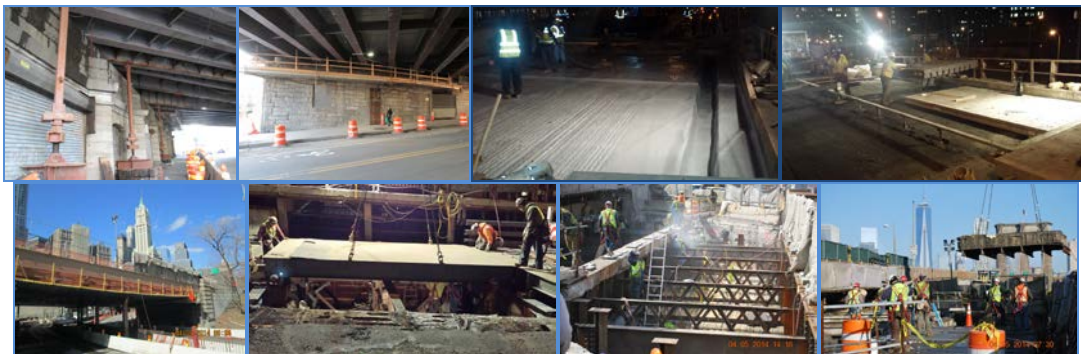
February 2014: Prospect Street Structure – Temporary Steel Installation. April 2014: Superslab Installation – Manhattan-Bound Lanes. April 2014: Fascia Installation – Park Row Structure. Franklin Square Structure Deck Replacement During Full Weekend Closure. York Street Structure Deck Replacement During Full Weekend Closure.

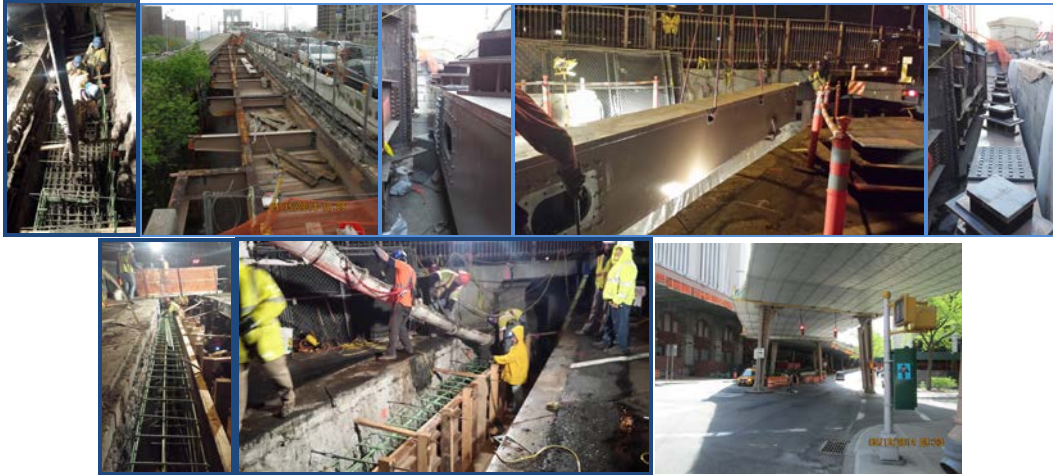
April 2014: Main Street Structure – Cap Beam Concrete Placement. May 2014: North Cantilever Demolition. York Street Structure – East Abutment Cap Beam. May 2014: Main Street Structure – Abutment Concrete Placement. Protective Shield and Work Platform at Manhattan Ramps and Approaches.

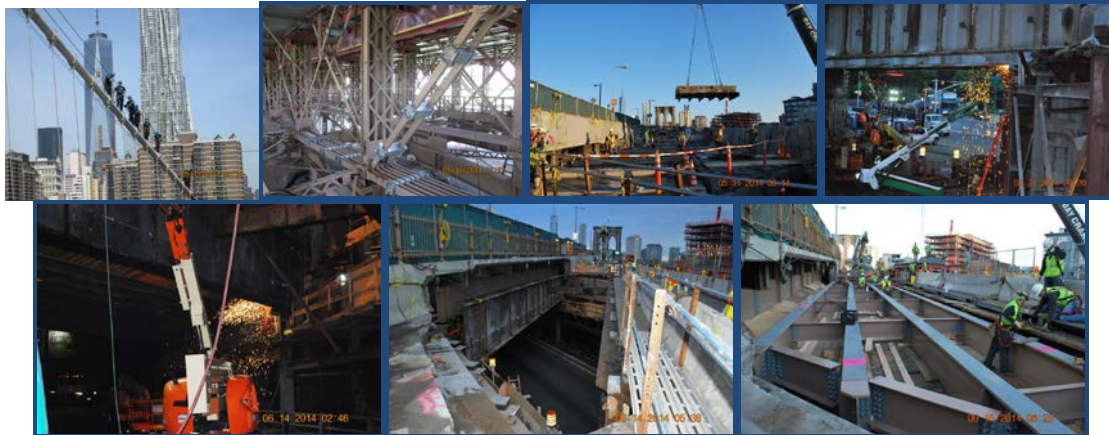
May 2014: Ascending the Cable. Installing Clamping Assemblies at the Franklin Square Structure. May 2014: Main Street Structure Westbound Overpass Replacement During Full Weekend Closure. June 2014: York Street Structure Stage II Westbound Overpass Replacement During the Full Weekend Closure.

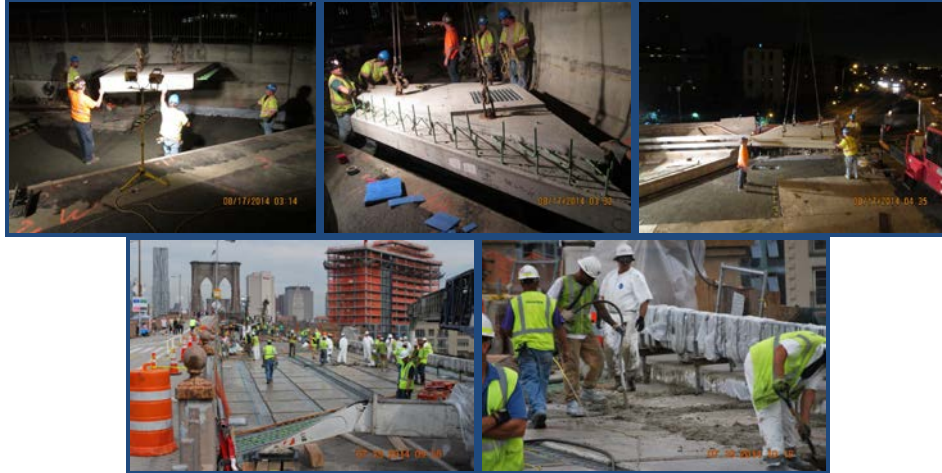
August 2014: York Street Structure – Installation of Brooklyn-Bound Approach Slabs. July 2014: Main Street Structure – Manhattan-Bound Closure Pour.

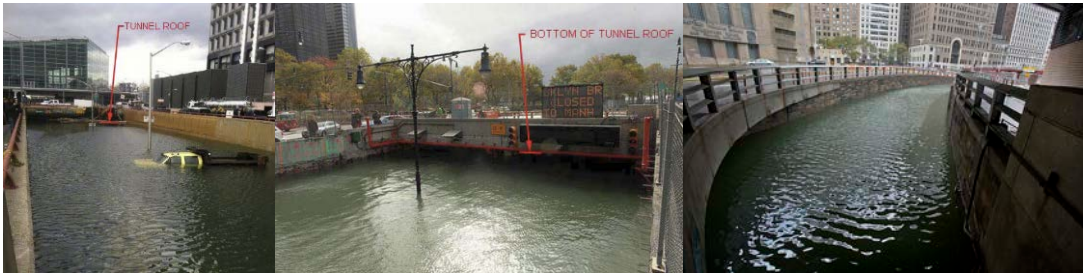
October 2012 - Battery Park Underpass - View Looking West at the South Portal Entrance Near the FDR Drive. View Looking South at the North Portal Entrance Near West Street. West Street Underpass – Approach at South Portal Looking Southeast. Both Tunnels Were Flooded to Their Roofs, Which Means That all Tunnel Ventilation, Electrical, and Mechanical Systems Were Entirely Submerged in Saltwater.

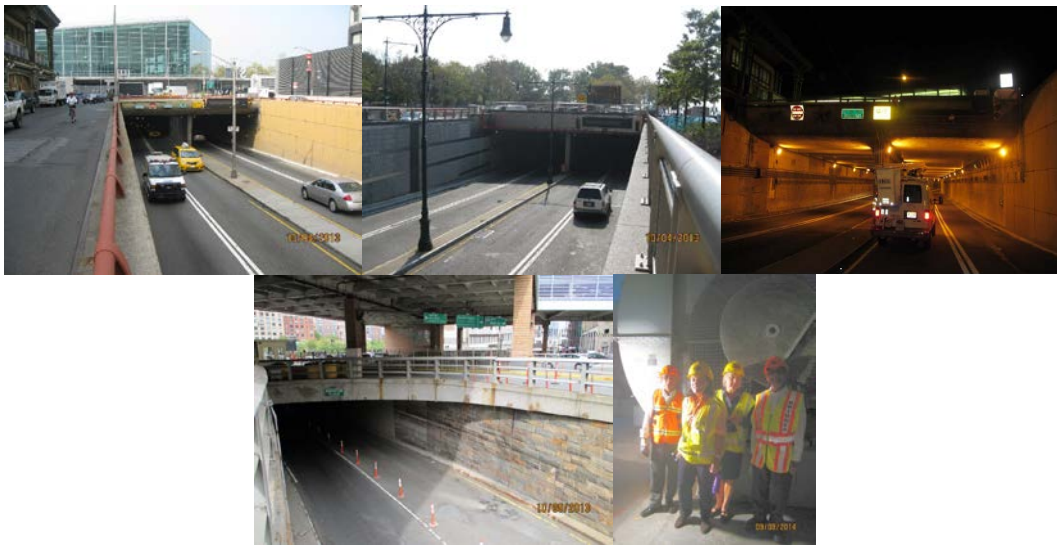
October 2013 – Battery Park Underpass – Elevation Right Span 1 and Left Span 1. (Credit: NYSDOT) September 2013 - Span 2 Looking Westbound (FDR Drive to West Street) West Street Underpass - Elevation Right Span. (Credit: NYSDOT) September 2014: Project Team in the Battery Park Underpass – Mechanical Engineer Bidyut Niyogi, Construction Project Manager Beatriz Duran, Project Manager Tamara Berlyavsky and Administrative Engineer Bhaskar Gusani.

On October 29, 2012, the New York Metropolitan area was impacted by Hurricane Sandy, causing flooding, loss of power and damage to many components of New York City's infrastructure. On October 30, 2012, a site inspection by the Department revealed major damage to both underpasses. Specifically, certain electrical, mechanical and structural issues with regard to the tunnels had to be addressed.

Salt water penetrated the electrical and mechanical equipment in both underpasses, including but not limited to, motors, lighting and pumps. It is therefore, necessary to solicit the services of a specialty contractor to perform all necessary repairs.

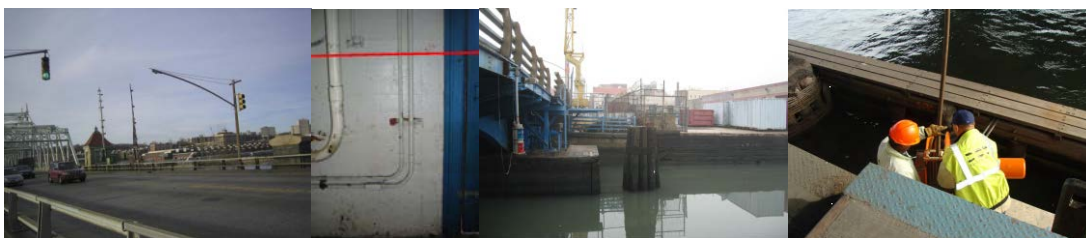
Inspection in Late 2012: East End of the West 207th Street Bridge - Missing Traffic Signal was Knocked Down by the Hurricane Winds. Borden Avenue Bridge Operator's House Basement Level - Depicted Flood Line was Approximately 5 Feet Above the Floor. Third Street Bridge - Northwest Channel Light Missing. Ninth Street Bridge - Manually Pulling the Cable Reel Because the Motor Failed.

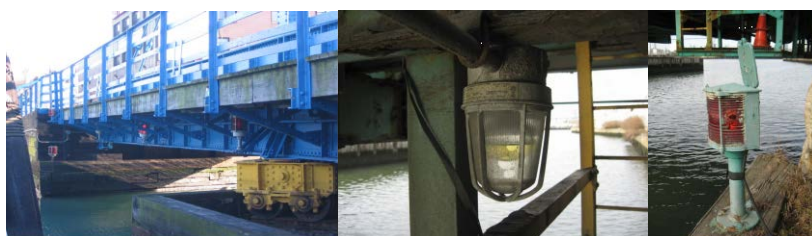
Inspection in Late 2012: Carroll Street Bridge - Navigational Fixtures on North Side of Span - Only the Center Span Fixture was Operational. Grand Street Bridge - Standing Water in the Access Light Fixture at the East Wedge Walkway. Typical impact damage to pier light.
