As an integral part of New York City's Department of Transportation, the Division of Bridges has a two-fold mission: to maintain an optimal transportation network by ensuring smooth mobility on the city's bridges, and to ensure the safety of the public.

The New York City Department of Transportation's Division of Bridges is comprised of four major bureaus. The **Chief Bridge Officer** is responsible for formulating policy and providing executive direction. He oversees all aspects of the design, construction, rehabilitation and reconstruction, maintenance, operation and administration of the 789 bridges (including 5 tunnels), and 53 culverts presently under the jurisdiction of the New York City Department of Transportation (NYCDOT). In addition to broad supervision, the Chief Bridge Officer also provides overall executive and administrative direction for the Division of Bridges, and ensures that all contractors are promptly paid.

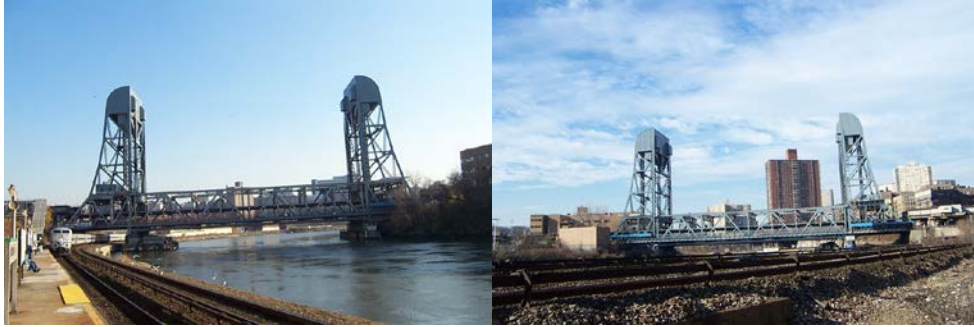
Broadway Bridge – West and East Elevations. (Credit: Bhaskar Gusani)

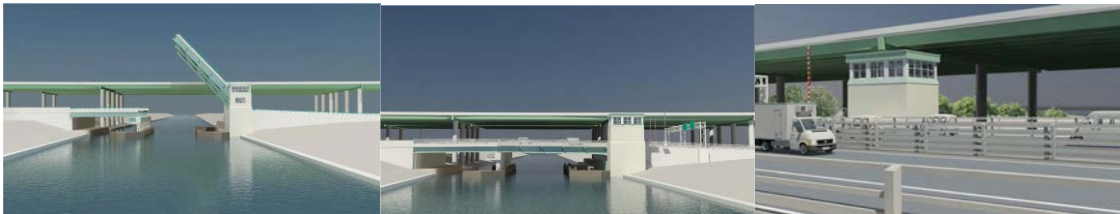
Proposed Twin Single Leaf Bascule (Looking North). Proposed Control House.

The project is in its final design phase for the replacement of the existing bridge with a new wider bridge. The project's new scope of work includes: a complete replacement of the bascule, flanking, and approach substructures and superstructures, providing six 12-foot travel lanes with shoulders on both sides of the bridge; a new 12-foot bicycle/pedestrian path and a 8-foot sidewalk, separated from traffic with a barrier; replacement of the existing mechanical and electrical systems for the bascule span; reconstruction of the bridge operator and control houses, and replacement of the existing fender system, drainage system, street lighting, traffic signal facilities, and gates. Construction is anticipated to start in fall 2016.

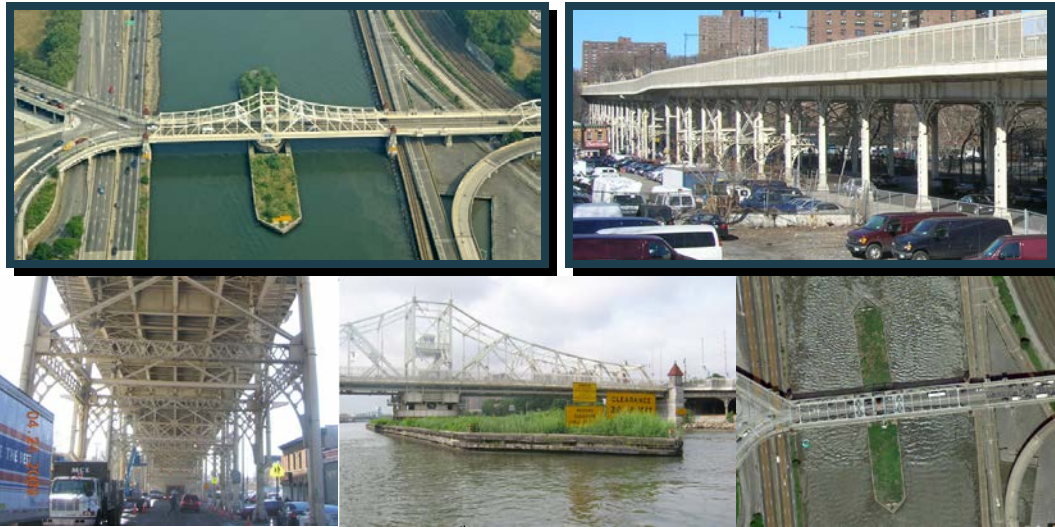
Aerial View. West 155th Street Viaduct. The Timber Fender.

A new project will rehabilitate the West 155th Street Viaduct and the fender system. The viaduct serves as the western approach to the bridge in Manhattan and provides connections to West 155th Street, Macombs Place, and Adam Clayton Powell Jr. Boulevard. The scope of work includes replacement of columns, floorbeams, girder ends, bearings, expansion deck joints above floorbeams, cross frames and lateral bracings, and the ornamental brackets. The existing swing span fender is misaligned with the swing span in open position, and the timber cribbing is under attack by marine borers which could lead to the failure of the timber cribbing and the collapse of the stone fill. The project's scope of work includes installing formwork around the perimeter of the existing fender, filling the voids in the fender sand-cement grout, bonding the existing timber and rock into one solid mass, and constructing a fender extension on the northeast corner. In addition, in connection with the fender repair, the work activities will include removal of debris located on the river bottom in the channels adjacent to the swing spans. The debris piles pose potential hazards to navigation. The rehabilitation project is currently scheduled to start in summer 2015 and end in fall 2017.

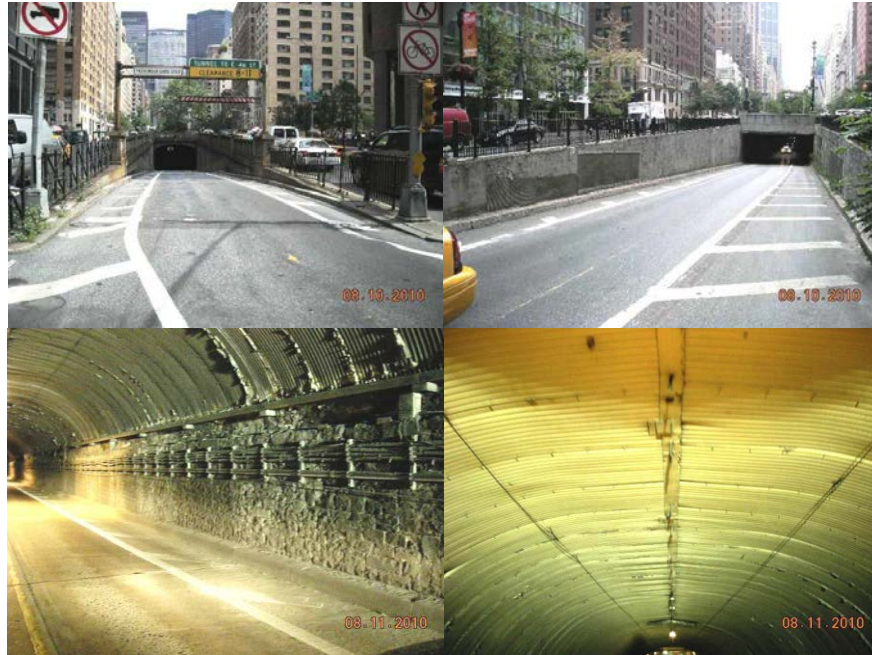
Two Views of Park Avenue Tunnel in 2010. Abutment Beginning. Underside of South Arch. (Credit: NYSDOT)

Some rehabilitation work was completed on the tunnel in November 2005. That contract included the rehabilitation of the fans and the ventilation system. The new project is currently in its final engineering design phase. The scope of work includes complete rehabilitation of civil and structural components of the tunnel. It will also include safety improvements at the East 33rd, 34th, and 39th Street intersections. Construction is expected to start in May 2016 and be complete in May 2018.

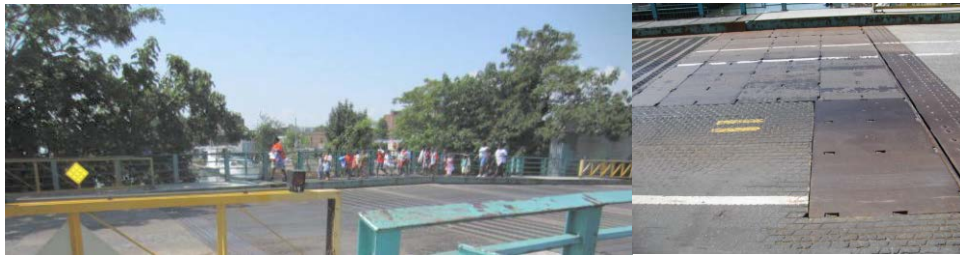
Union Street Bridge - Schoolchildren Crossing in 2012. (Credit: NYSDOT) 2014: Eleven Steel Plates Covering the Steel Grid Deck.

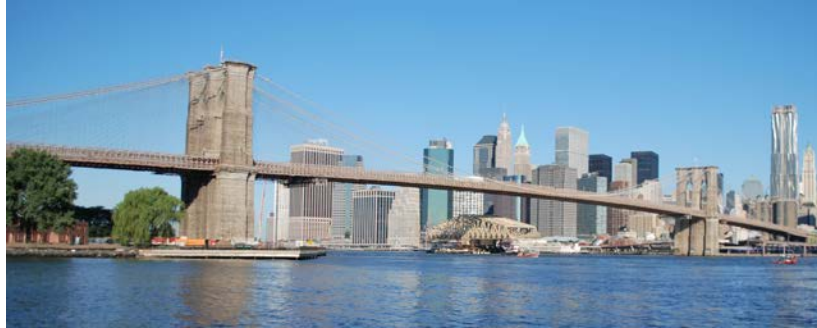
Voyage up the East River on July 26, 2010. New Willis Avenue Bridge Span Passing Under the Brooklyn Bridge. (Credit: Douglas Reese)

The swing span was floated down the river and towed to the bridge site on July 26, 2010. The new swing span was floated on to the new pier on August 9, 2010.

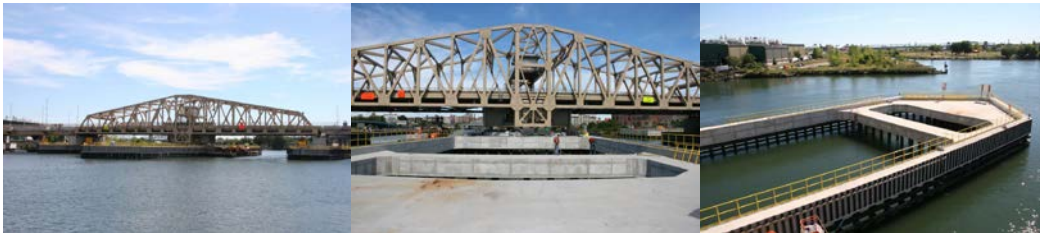
September 2012: Bridge Fender North Elevation Looking South. Bridge South Elevation Looking North.
Pier 6 South Fender Looking South.

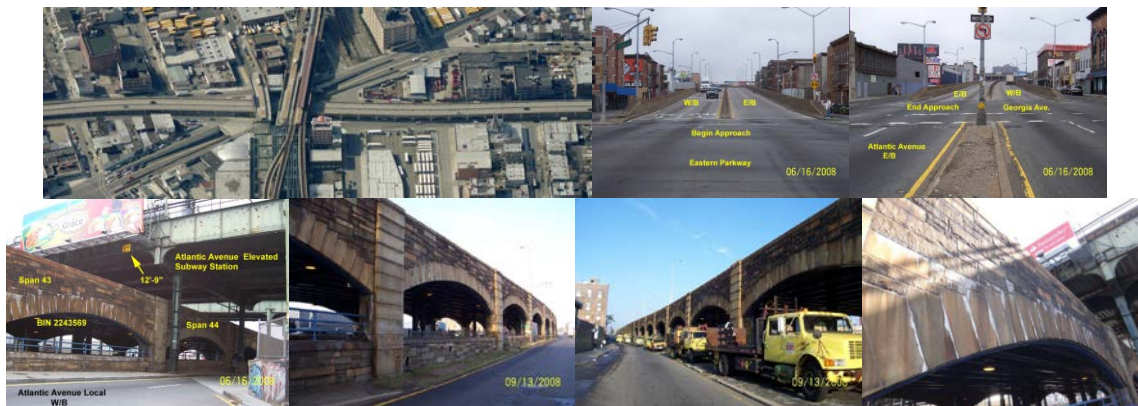
Aerial View in 2009. Beginning and End Approaches. Elevation Right – Spans 43 – 44. Elevation Left Spans 38 -43 and Elevation Right Spans 20 – 34. (Credit: NYSDOT) Span 43 South Arch Shows Typical Efflorescence at Mortar Joints of Ring Stones.

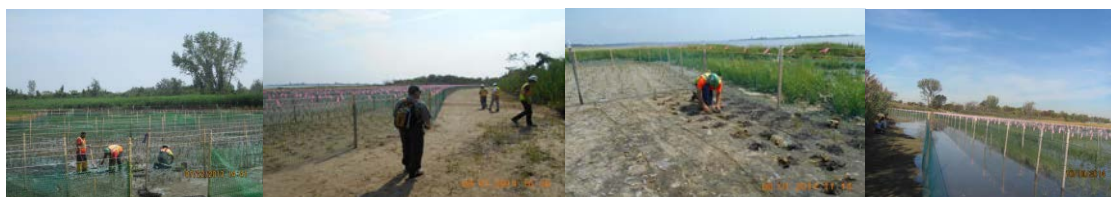
July 2013: Phase I Planting at the Bergen Beach Mitigation Area. August 2014: Grass Plantings Protected by Waterfowl Exclusion Fence. Placing the Plantings. Fence in October 2014.

Planting at the intertidal wetland and the high marsh zones was completed in summer 2011. The installation of cabled concrete erosion control revetment was started in June 2011 and completed in July 2011. In fall 2012, all replacement and final upland tree plantings were completed. Monitoring of the wetland mitigation project, as mandated by the New York State Department of Environmental Conservation, is expected to be complete in early 2017.

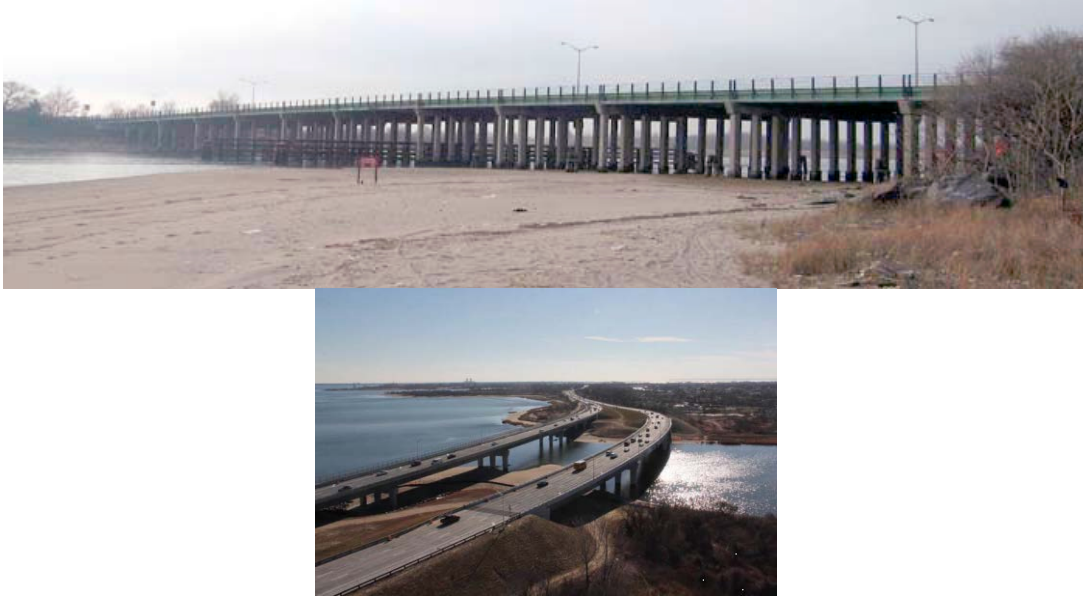
Old Paerdegat Basin Bridge. New Bridges in November 2013.

The old Paerdegat Basin Bridge was a 692-foot long, 13 span, multi-girder, simple supported steel superstructure, supported on reinforced concrete pier cap beams and abutments supported on reinforced concrete piles. The bridge had two 34-foot wide roadways carrying three lanes of traffic in each direction; with a 3-foot safety walk on the north side, a 4-foot wide center median/barrier, and an 8-foot wide south pedestrian/bicycle sidewalk. The existing structure and immediate approaches were demolished and replaced by two new bridges and new approach roadways on split alignments. The existing structure was permanently closed to traffic on December 20, 2012, upon opening of the new westbound structure. Demolition of the existing structure was completed in May 2013.

The two replacement bridges consist of trapezoidal steel box girder structures: the 825-foot, 3 span westbound bridge, north of the existing structure, and the 1,227-foot, 5 span eastbound bridge, south of the existing structure, remaining at 28 feet over the navigable channel. Both bridges have a 36-foot wide roadway with a 12-foot wide right shoulder. The eastbound bridge has a 4-foot wide left shoulder, while the westbound bridge has a 10-foot wide left shoulder. The southern structure carries eastbound traffic while the northern structure accommodates westbound traffic. Both the horizontal and vertical alignments changed resulting in improved sight distances on the bridge and its approach roadways. The bridge carrying eastbound traffic also has a dedicated pedestrian/ bicycle path along the south side. The pedestrian/bicycle path is separated from traffic lanes by a concrete barrier on the bridge, and by a 15-foot wide grass mall on the approach roadways.

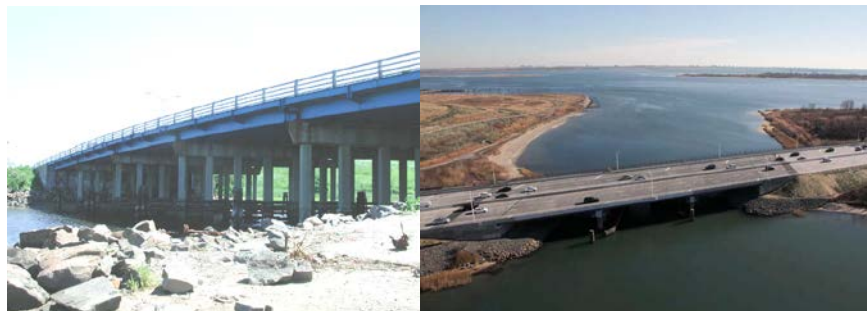
Old Fresh Creek Bridge. New Bridge in November 2013. (2002 Credit: NYSDOT)

The Fresh Creek Bridge was a 264.5 foot, 5 span, multi-girder, simple supported steel superstructure, supported on pre-cast concrete columns founded on four reinforced concrete piers on concrete piles with concrete gravity abutment walls on timber piles. One navigation channel crossed under the bridge. The bridge had two 34'-2" wide roadways, a 5-foot wide center median/barrier, and a 10-foot wide south sidewalk. The parkway, east and west of the bridge, has a 10-foot wide bicycle/pedestrian path on the south side. The existing structure and immediate approaches were demolished in spring 2012, and the replacement structure was fully opened in August 2013.

The replacement bridge is a 316-foot, 3 span structure; the new structure has only two support piers, resulting in a wider channel. The bridge deck and approaches were widened to 126 feet from the former 86 feet to accommodate three 12-foot lanes in each direction, 12-foot wide right shoulders, and a 12-foot wide bicycle/pedestrian path, separated from the traffic lanes by a barrier system. The profiles of the approach roadways and bridge structure accommodate stopping sight distances for a design speed of 60 miles per hour. The remainder of the construction resulted in improved landscaping on the bridge approaches. The existing pedestrian and bicycle pathway were maintained and open at all times during construction.

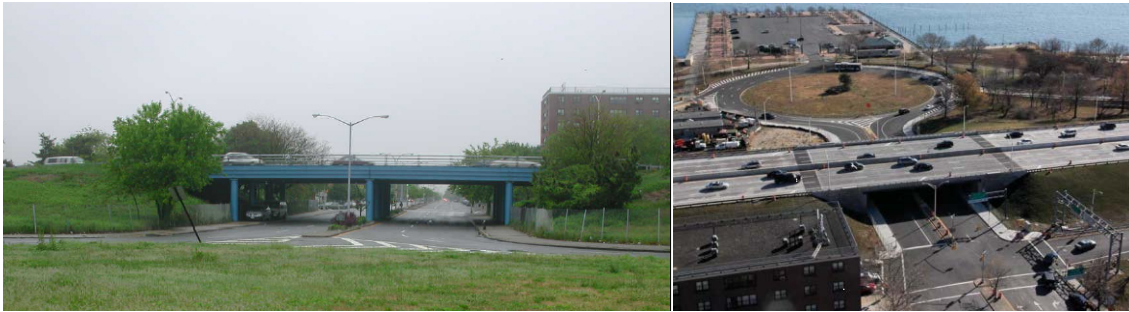
Old Rockaway Parkway Bridge. New Bridge in November 2013. (2002 Credit: NYSDOT)

The Rockaway Parkway Bridge was a 150-foot, 4 span, multi-stringer, simple supported steel superstructure, supported on steel cap beams on concrete filled steel pipe columns, and reinforced concrete abutment walls supported by concrete pile foundations. The bridge had two 34'-2" wide roadways, a 5-foot wide center median/barrier, and a 10-foot wide south sidewalk. The existing structure and immediate approaches were demolished in fall 2012, and the replacement structure was fully opened in August 2013.

The replacement bridge is a single span structure to improve visibility along Rockaway Parkway. The new structure was built in the same alignment as the existing bridge. The bridge deck was widened to 109 ½ feet from the former 84 feet to accommodate three 12-foot lanes with a 12-foot wide right shoulder and 4-foot left shoulder in each direction, including 5 ½ feet for median and parapet width. The right shoulder on each approach is 10 feet wide (while the width of the right shoulders on the bridge structure are 12 feet), with the other dimensions the same width as those on the bridge. In addition to reconstruction of the bridge, four access ramps were also reconstructed as was Rockaway Parkway in the vicinity of the Belt Parkway.

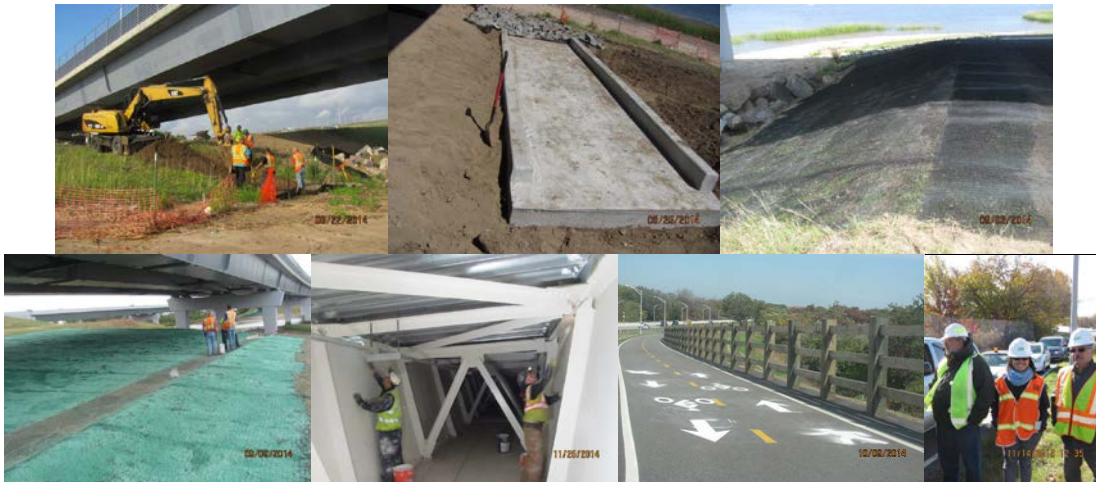
August and September 2014: Erosion Control at the Eastbound Paerdegat Bridge. Placing Fabric and Hydro-Seeding Under the Bridge. November 2014: Tub Girder Touchup Painting. October 2014: Bike Symbols on the Bicycle/Pedestrian Path East of Rockaway Circle. Three Rail Wood Fence. Associate Staff Analyst Kim Mulcahy, Civil Engineering Intern Jessica Wang, and Civil Engineer Reza Sharif at the Final Landscaping Inspection in November 2014.

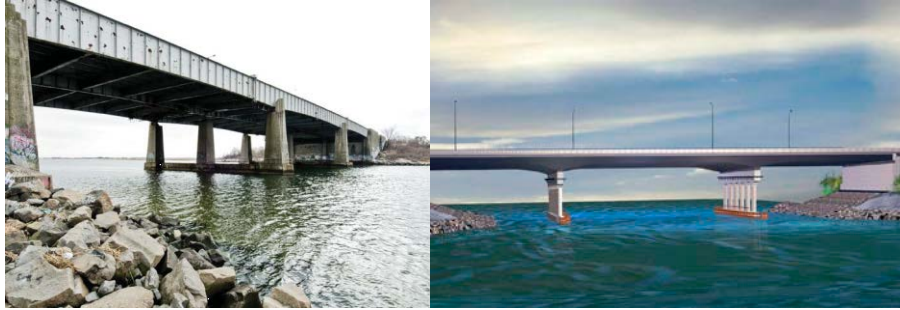
Gerritsen Inlet Bridge in 2013. Proposed Gerritsen Inlet Bridge.

The existing Gerritsen Inlet Bridge is a 520-foot long, 9 span, steel girder and reinforced concrete beam superstructure, supported on reinforced concrete piers, and abutments supported on timber piles. The existing structure and immediate approaches will be demolished and replaced.

The replacement bridge will consist of a 496-foot, 3 span bridge, aligned 10'-6" north of the centerline of the existing structure, and remaining 35 feet over the navigable channel. The bridge will have a 36-foot wide roadway with a 12-foot wide right shoulder and a 4-foot wide left shoulder in each direction. The eastbound side will carry a dedicated pedestrian/bicycle path along the south fascia. A Notice to Proceed was issued to the contractor with a start date of February 25, 2013.

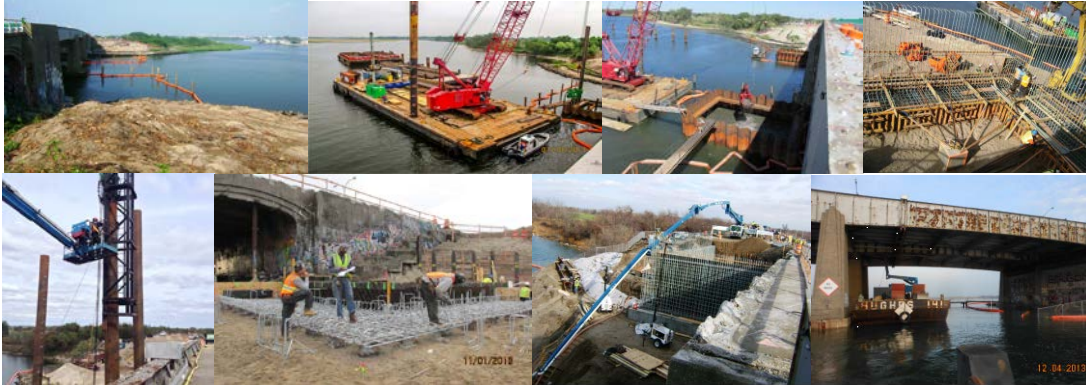
June 2013: North Side of Gerritsen Bridge - Turbidity Curtains Placed on Both Sides of Navigable Channel. July 2013: Work Barges Driving Steel Sheet Piling for Pier #1 Cofferdam. September 2013: October 2013: Rebars and Form Work for Footing and Walls at the Northwest Abutment. Stage 1 Piles. November 2013: Inspecting Rebar. December 2013: Tremie Concrete Pour at Pier #2. Inspecting Spans 7 & 8 of the Existing Bridge From a Barge. (Inspection Credit: NYSDOT)

Construction operations performed in spring 2013 included the installation of temporary concrete barriers as part of the Stage 1 maintenance and protection of traffic; the installation of construction fences and tree protection; clearing and grubbing along the north side of the parkway including the removal of existing trees as specified in the contract; and the installation of soil stabilization and erosion control measures. As the summer and Stage 1 progressed, the contractor installed earth embankments for the new eastbound and westbound approach roadways; installed new drainage structures and pipe; and repaired bridge flags on the existing bridge structure. In the fall, the Stage I abutment piles and footings were constructed, as were the two deep foundation cofferdams for the new water piers. The pier pile installation work was completed in December 2013, in advance of the substructure work, including the pier footings, plinths, columns and pier caps.

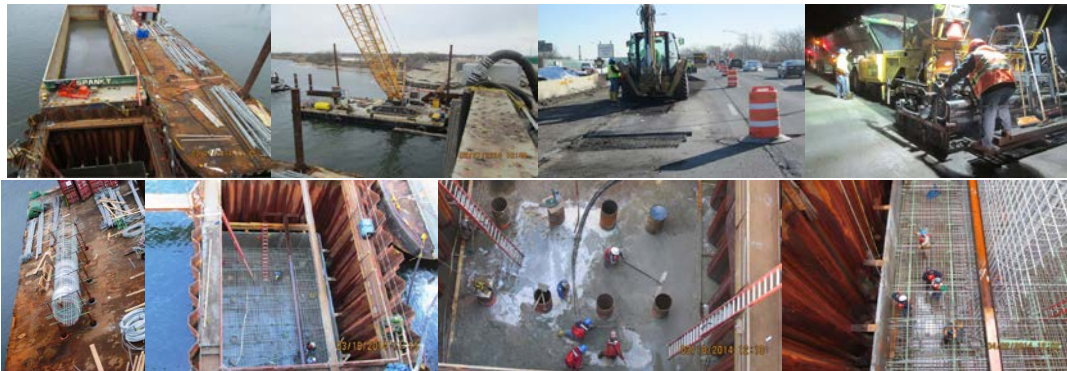
February 2014: Dewatering Cofferdam at Pier No. 1. A Work Barge With Pile Rebar Cages is Moored at Right. Crawler Crane on Work Barge at Pier No. 2 Cofferdam on North Side. Temporary Spud Piles That Anchor Work Barges are Visible. Pavement Repair Operation on Eastbound Belt Parkway West of the Bridge – Pavement Prepared to Receive Hot Mix Asphalt. Asphalt Paving Machine Placing Hot Mix Asphalt on Eastbound Belt Parkway Right lane, West Side. March 2014: Galvanized Steel Rebar Cage in Fabrication on

In February 2014, the contractor dewatered the Pier #1 cofferdam and made pothole repairs.

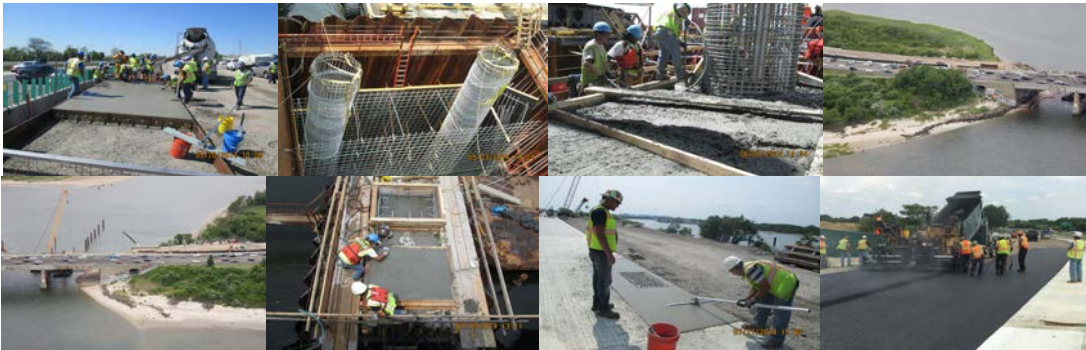
May 2014: Placing and Finishing the Portland Cement Concrete Pavement on Grade at Westbound Approach to the Gerritsen Inlet Bridge. Plinth and Column Reinforcement Inside the Cofferdam for Pier 2. June 2014: Placing and Vibrating Concrete for Plinth at Pier #1. Rebars for Column in Place. West Abutment of Bridge. New Roadway Under Construction at top Next to Westbound Lanes. East Abutment of Bridge. Crane on Barge at Cofferdam for New Pier #2. July 2014: Finishing Plastic Concrete for Pedestal at Pier #1 Cap Beam. Placing PCC Pavement at East Approach. Finishing PCC Pavement Around Catch Basin at East Approach. Spreading Hot Mix Asphalt on Belt Parkway East Side of Bridge.

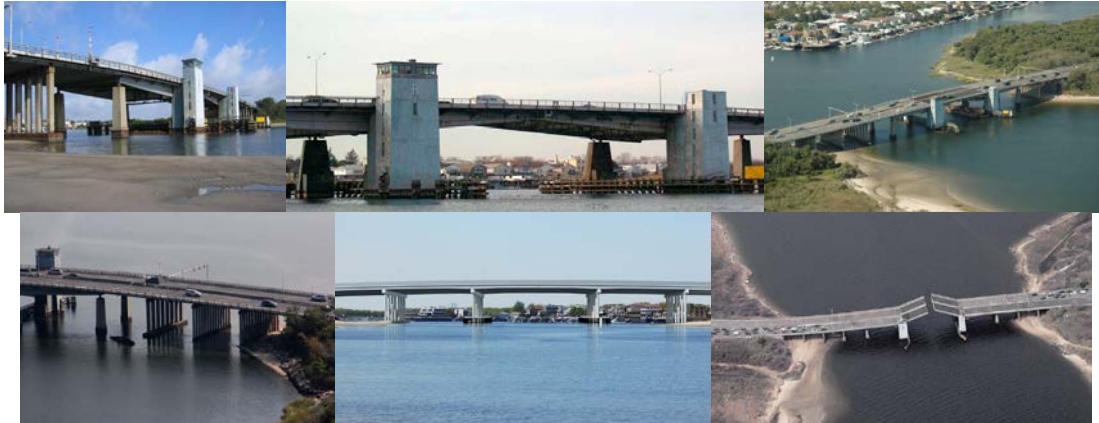
Current Belt Parkway Bridge Over Mill Basin. Aerial Views. Proposed Bridge. Open Bridge.

The existing Mill Basin Bridge is 864-feet long and 14 spans, including double movable leaf bascule spans and a steel superstructure, supported on reinforced concrete piers on timber piles, and abutments supported on pre-cast concrete piles. The existing structure and immediate approaches will be demolished and replaced.

The replacement will be a 2,645-foot long, 17 span, 60-foot high fixed bridge. It will consist of a steel composite superstructure and reinforced concrete substructure on piled footings, and will be constructed on a new alignment set on the north side of the existing bridge and partially overlapping with the existing bridge. The new bridge and approach will have three 12-foot wide

traffic lanes, a 12-foot wide right shoulder on the bridge, a 10-foot wide right shoulder on the approaches, and a minimum left shoulder in each direction. The eastbound side will carry a dedicated pedestrian/bicycle path along the south fascia. The new bridge will be a fixed structure with a 60-foot vertical clearance over Mean High Water, obviating the need for opening and closing the structure to accommodate tall vessels. The channel will remain navigable during construction, and the clear channel width will remain the same after the new structure is in place. A new fender system will be installed to protect the bridge substructure from marine traffic. The contract will be completed in four stages of work (including two additional sub-stages) and will maintain three lanes of vehicular traffic in each direction, as well as pedestrian and bicycle traffic during all construction stages. Construction is expected to begin in the summer of 2015 and last for 4 ½ years, including demolition of the existing bridge.

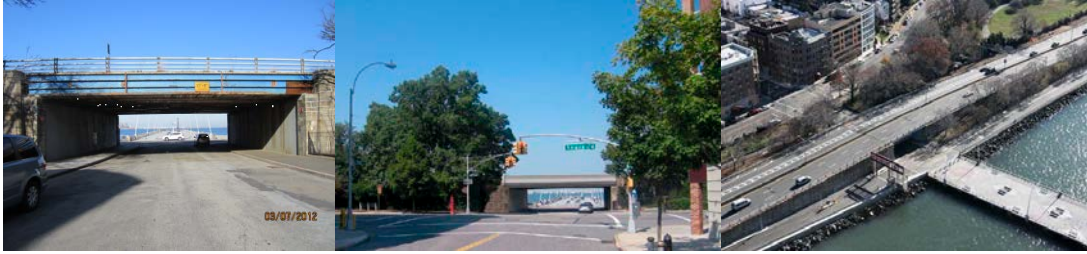
Bay Ridge Avenue Bridge in 2012. (Credit: NYSDOT) Proposed Bay Ridge Avenue Bridge. Current Aerial View.

The existing Bay Ridge Avenue Bridge is a 58-foot long, single span, reinforced concrete deck on a multi-girder system superstructure over Bay Ridge Avenue. The superstructure is supported by concrete gravity type abutments on pile foundations. There is pedestrian access under the bridge to both the American Veterans Memorial Pier and the Shore Parkway Seawall pedestrian and bicycle paths. The underpass is also access to the NYCDEP Owl's Head Wastewater Treatment Plant. The existing superstructure will be demolished and replaced.

The replacement bridge superstructure will consist of precast, pre-stressed concrete box beams and a reinforced concrete slab. The bridge will have three 12-foot wide lanes in the eastbound direction and two 12-foot wide lanes separated by a 4-foot wide painted stripe flush median in the westbound direction. There is no pedestrian/bicycle path on the structure. The clearance will be increased to 14-feet 6-inches, which removes the need for clearance signs currently posted for a substandard condition and will obviate the need for underdeck wood shielding. A Notice to Proceed was issued to the contractor with a start date of November 4, 2013. The only construction operations performed in fall 2013 were the survey and stake out of the project.

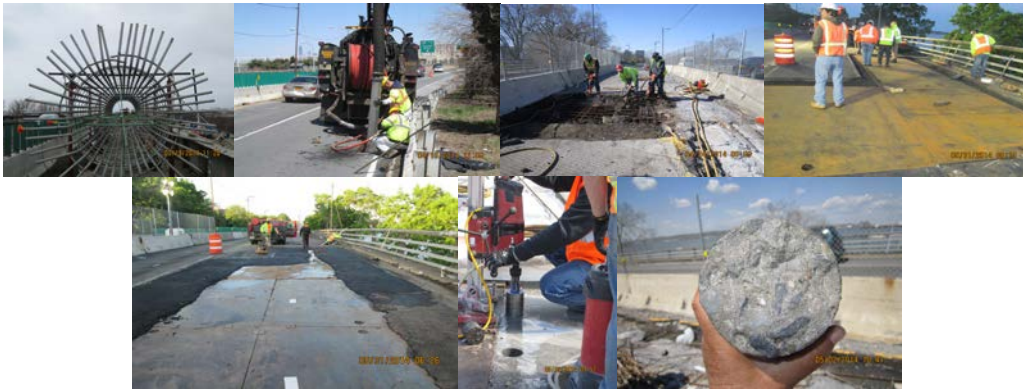
March 2014: Rebar Cage. April 2014: Workers Cleaning out Catch Basins Using a High Pressure Water Hose and Vacuum Pipe for Debris Removal. Pavement Breakers used to Demolish the Existing Bridge Deck During Preparation for Stage I MPT. May 2014: Temporary Deck Repair of Eastbound Roadway Using Steel Plates. Placing and Compacting Hot Asphalt Over Steel Plate Deck Repair at Eastbound Bridge. May 2014: Core Sampling.

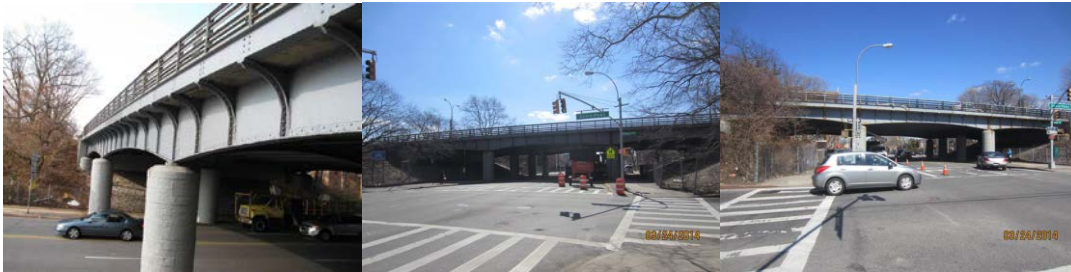
Nostrand Avenue Bridge Right Girder in November 2012. Left and Right Elevations in 2014.
(2014 Credit: NYSDOT)

The existing Nostrand Avenue Bridge is a 140-foot long, 3 span, multi-girder superstructure, consisting of a concrete deck with an asphalt overlay over Nostrand Avenue. The superstructure is supported by concrete pier columns with a steel cap beam, and abutments on concrete filled steel pile foundations. The existing structure and immediate approaches will be demolished and replaced. Reconstruction is anticipated to start in 2021. The condition rating of this bridge is better than the other remaining bridges in this program; rescheduling will not negatively impact the bridge users.

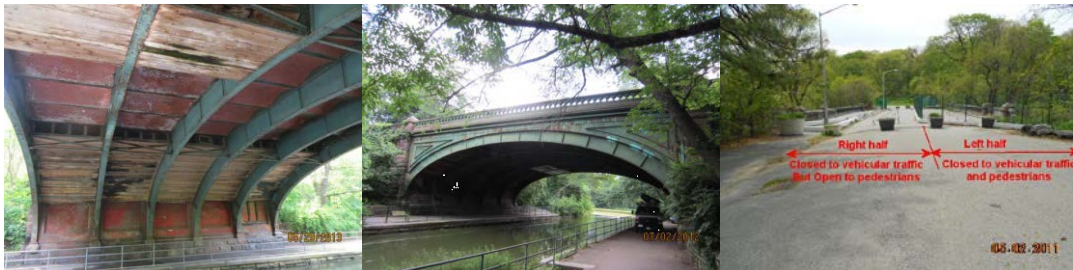
Hill Drive Bridge Span 2 Pier 1 End Face in 2013. View of Bridge in 2012. End Approach in May 2011: The Bridge is Closed to Vehicular Traffic. The Left Half of the Bridge is Closed to Pedestrians. (Credit: NYSDOT)

This project will include the replacement of the existing masonry cellular abutments with new reinforced concrete abutments clad with existing stone and new brick masonry; the removal, storage, and reinstallation of the existing stone wing walls with a new reinforced concrete core; the replacement of the existing stringers and floor beams with new steel stringers; the reinforcement of the existing arch girders with new cover plates; the reinstallation of the steel arch girders at their current locations to replicate original construction; and the replacement of the existing masonry arches spanning between floor beams by masonry cladding on the underside of the new arched concrete deck. The concrete deck, approaches, sidewalk, and roadway will be replaced within the project limits.

The ornamental cast iron and stones will be rehabilitated and reinstalled, replicating all the historic features and aesthetics of the original bridge. New bridge lighting and drainage systems will be installed. The park landscape will be restored, and trees identified by the Prospect Park Alliance as rare and/or historic shall remain undisturbed during construction.

The project to reconstruct the bridge has been suspended until such time as Parks funding is available. Repairs requiring immediate attention are performed by the When and Where contractor. This bridge is closed to vehicular traffic.

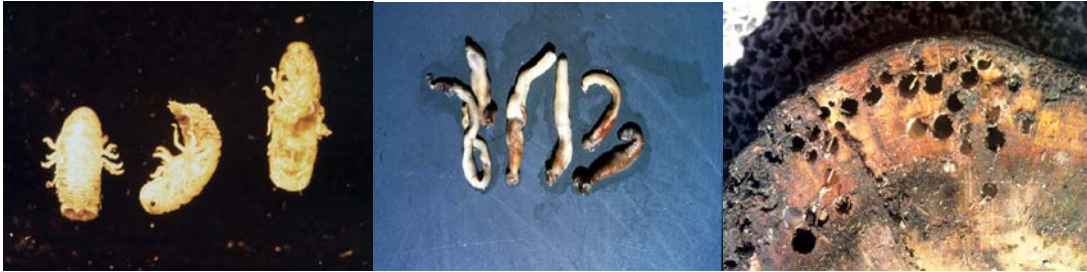
Marine Borer – Limnoria Species (the Common “Gribble,” a Genus of Crustacea Borers). Marine Borer – Teredo Species (a Genus of Molluscan Borers, Commonly Called the “Shipworm”). Teredo Damage (Holes up to ¼” Diameter).

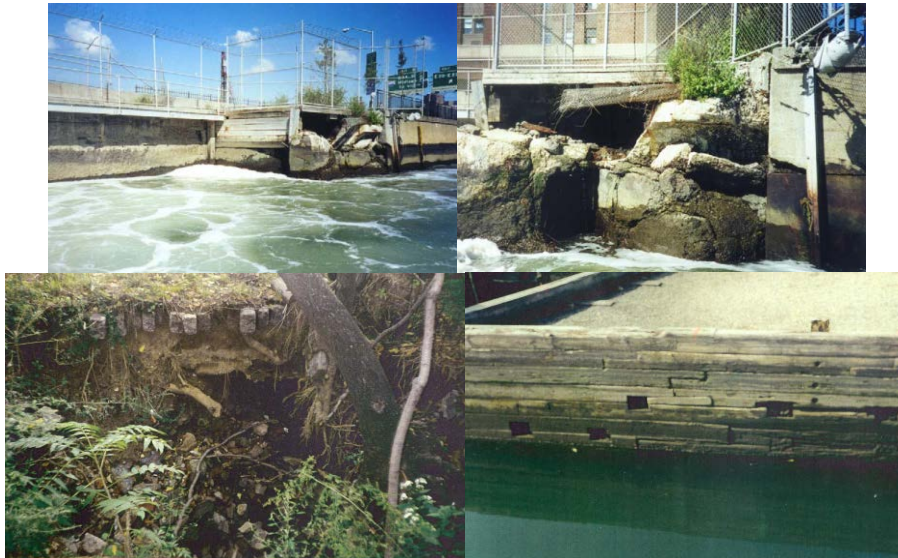
From Study of FDR Drive: Location #2 – Damaged Seawall at Segment #5. Sinkhole at Location #6 at East 59th Street. From Study of Carroll Street Bridge: General View of the Southwest Crib Wall With the Delamination of the Timber Stretchers in the Tidal Zone.

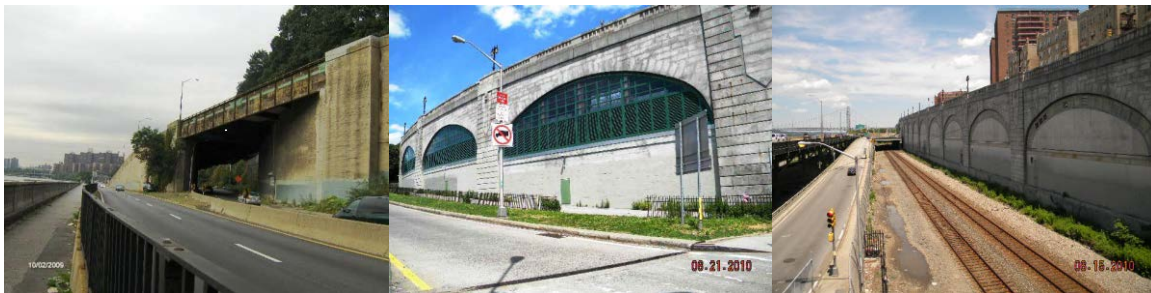
Trans-Manhattan Expressway Connector Ramp in 2009: Elevation Right Spans 1 – 25. 2010 – Elevation Right Spans 13 to 1, and 43 to 13. (Credit: NYSDOT)

The Trans-Manhattan Expressway Connector Ramp is an elevated viaduct that consists of a multi-span steel superstructure supporting a concrete deck. The ramp connects the Trans-Manhattan Expressway to the Harlem River Drive and it was built in 1939. It is a 2,080 foot long and 57 foot wide structure, consisting of 14 steel spans and 41 reinforced concrete spans, carrying two lanes of traffic in each direction, northbound and southbound. In 2008, New York State DOT completed an approximately \$4.5 million “top-side” repair project of the wearing surface, joints, median, parapets, and other above-deck elements. The NYCDOT project will rehabilitate the bridge steel and concrete components. Several locations of spalls are currently protected by mesh and/or netting. Construction is expected to begin in mid-2015.

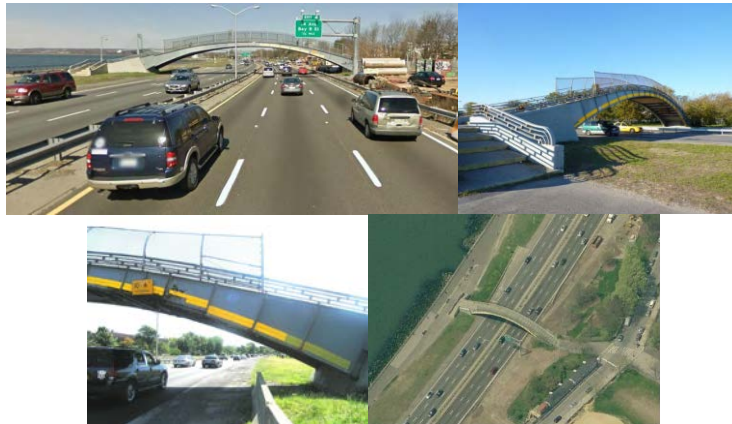
17th Avenue Bridge – Existing Conditions. Deteriorated Left Girder.

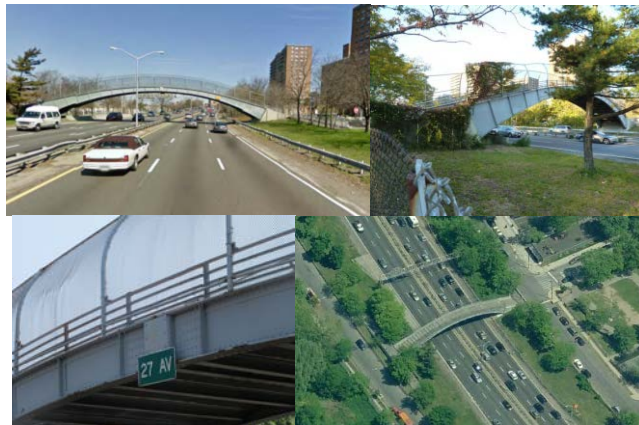
27th Avenue Bridge – Existing Conditions.

The 17th Avenue and 27th Avenue Bridges are three-hinged, steel arch girder bridges with granite-faced concrete abutments and Art Deco steel railings. These two pedestrian overpasses have deteriorated over time, and due to low vertical clearance, have suffered impact damage from overheight vehicle traffic on the Belt Parkway below. The 17th Avenue Bridge has a vertical clearance of 10'-8", at its lowest point, and the 27th Avenue Bridge a 12'-4" vertical clearance at its lowest point. Both bridges have an overall span length of approximately 125 feet, and a bridge deck width of 15 feet. In addition, these structures are not in compliance with American Disability Act (ADA) requirements.

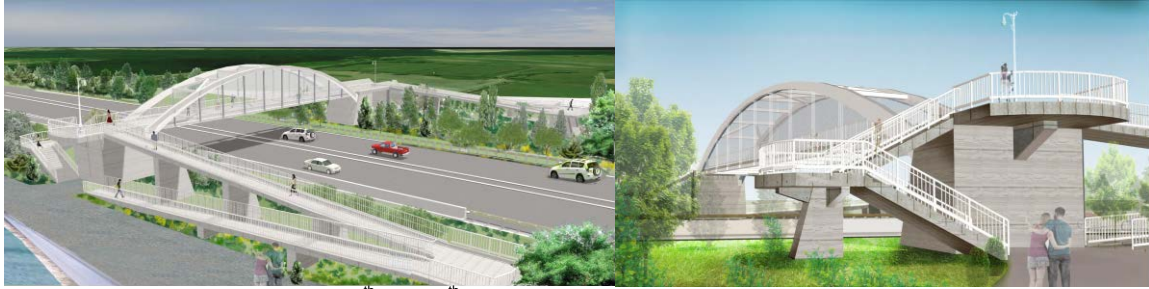
17th And 27th Avenue Bridges – Proposed Bridges.

In this project, the overpasses at 17th and 27th Avenues will be completely replaced. The structures will be designed to current codes and standards and all substandard features will be eliminated. Additionally, as the existing bridges were constructed under the Robert Moses era Master Plan for NYC, the proposed bridge designs will follow the Shore (Belt) Parkway Design Guidelines which were developed in November 2006, in order to preserve and reestablish the historic character of the parkway for drivers and pedestrians while enhancing and strengthening the visual cohesiveness of the greenspace connected to the adjacent park and recreation land. Construction is anticipated to begin in 2016, and is expected to be complete in 2018.

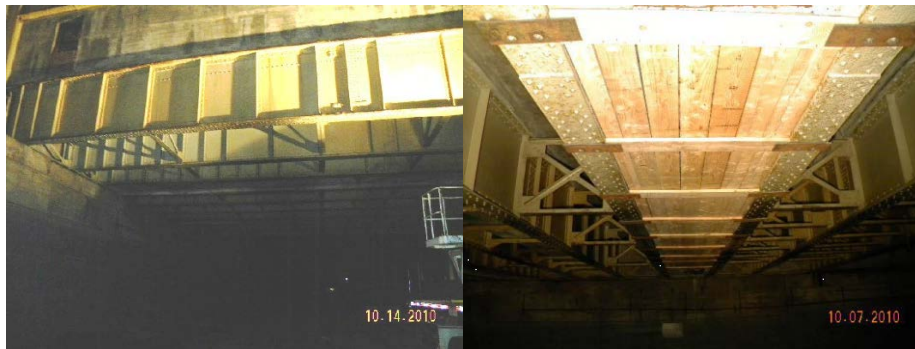
West 79th Street Bridge Over Amtrak in 2010. Underside of Bay 7. (Credit: NYSDOT)

The West 79th Street Bridge over Amtrak, built in 1937, is a single span structure, with steel, non-composite girders and a reinforced concrete slab. The bridge carries two lanes of traffic in each direction and has a sidewalk on each side. The project work will include the removal of the existing concrete deck, sidewalks and the pedestrian safety barrier. The deck will be replaced with a 9.5 inch concrete slab with integral wearing surface, a new sidewalk and safety barriers on a rehabilitated superstructure. Construction is expected to begin in 2018.

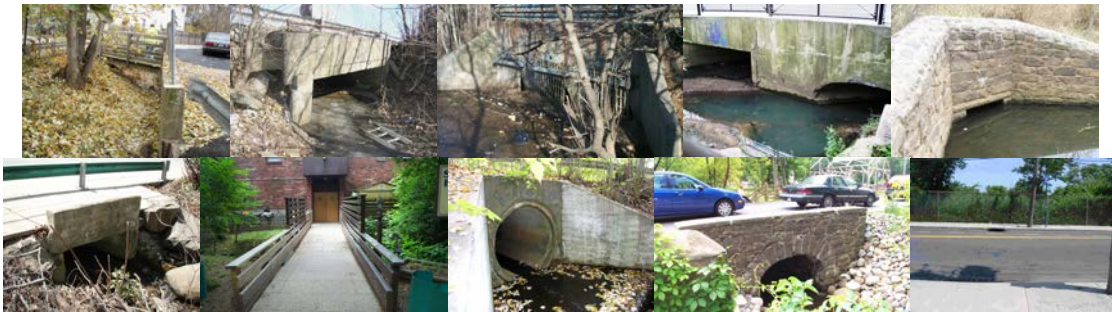
Galloway Avenue over Marianne Street, Forest Avenue over Crystal Avenue. Naughton Avenue over Patterson Avenue, Midland Avenue over Hylan Boulevard. Rockland Avenue over Brielle Avenue, Forest Avenue over Randall Avenue. Gregg Place over Randall Avenue, Arthur Kill Road over Muldoon Avenue. Richmond Hill Road over Richmond Road, Arthur Kill Road over Ridgewood Avenue.

The Forest Avenue culvert over Crystal Avenue is a single span reinforced concrete box culvert. It is located approximately 230' east of the intersection of Forest Avenue with Crystal Avenue. The reconstruction will consist of the demolition of the existing culvert, clearance of debris from the channel, replacement of the culvert with a concrete deck slab supported on steel beams on reinforced concrete abutment and wingwalls. The construction work is planned to be performed in four stages with proposed four traffic lanes being maintained at all times.

The Naughton Avenue culvert consists of three parallel reinforced concrete pipes at the north and south ends separated by a twin barrel box culvert. It is barricaded at the east end by guide rail and bordered at the west by a wooded area. The rehabilitation will include repairing the concrete cracks and spalls, cleaning the debris, and replacing the missing anchor bolts for the retractable steel grates. The construction is planned to be performed in one stage and no lane closure is required during construction.

The Midland Avenue culvert consists of a single span reinforced concrete box, which will be replaced with a new pre-cast box culvert. It is located on Midland Avenue between Boundary Avenue and Mason Avenue. The rehabilitation will include replacing the existing concrete box structure with a new concrete box structure, new sidewalk, curb, pipe railing, chain link fence and asphalt wearing surface. The work will be performed in three stages, with one lane of traffic maintained in each direction at all times.

The Rockland Avenue reinforced concrete culvert project will include concrete repair and a lined and stabilized north embankment. It is located approximately 361' west of the intersection of Rockland and Manor Avenue. The rehabilitation work includes clearing the debris and vegetation from the channel and installing a structural lining. The construction is planned to be performed in one stage and no street closures will be required during construction.

The Forest Avenue culvert over Randall Avenue is a single span concrete box culvert, located at Forest Avenue between Randall Avenue and University Place. It will be replaced with a new precast concrete box culvert with new sidewalks and asphalt pavement. The work will take place in three stages while maintaining one traffic lane in each direction during construction.

The Richmond Hill Road culvert consists of a single span stone masonry arch, built in 1845 according to a sign posted by the wingwall of the culvert. It is located on Richmond Hill Road between Richmond and Old Mill Roads. The rehabilitation work will include removing and re-pointing the stone masonry, removing and replacing the fill and asphalt wearing surface above the arch, and cleaning the vegetation and sedimentation. The work is proposed to be completed in one stage and no road closures will be necessary.

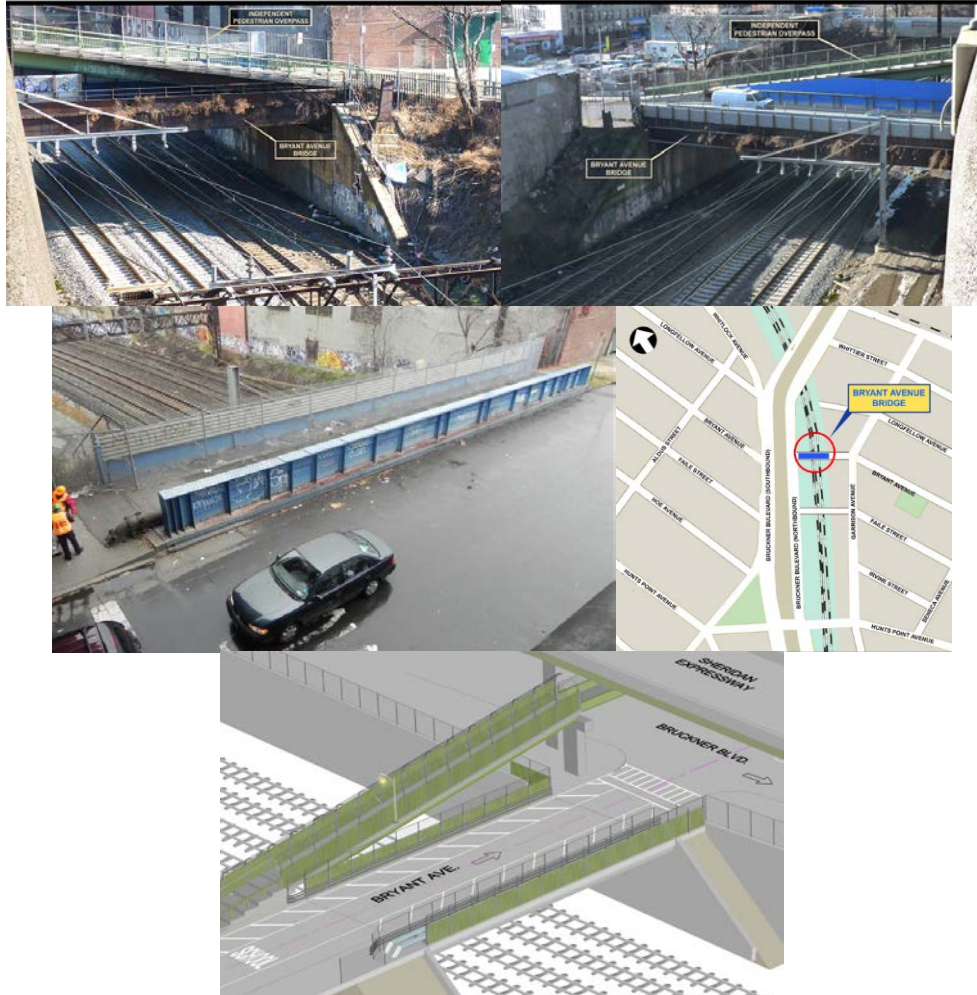
Bridge Views Looking North and South. Bridge View From the Pedestrian Overpass. Location Map. Rendering of the Bridge After Construction.

The Bryant Avenue Bridge, oriented east to west between Buckner Boulevard and Garrison Avenue, is a one span structure constructed in 1908. It spans 90 feet over four railroad tracks. This project includes replacement of the steel superstructure, bearings, approaches, water mains and rehabilitation of the existing substructures by removing and replacing the top portion of the concrete abutments to accommodate the new superstructure. The abutments will be retrofitted to meet seismic criteria. The proposed superstructure will consist of a reinforced concrete deck over pre-stressed concrete adjacent box beams. The two existing water mains will be removed and replaced. Both water mains will be installed on top of the north sidewalk in a fenced-off area. The Division's in-house design staff completed the design for this project. A Notice to Proceed for the project was issued to the contractor with a start date of August 18, 2014. The bridge will be completely closed to vehicles during its construction, however, pedestrian access will be maintained. This project is expected to be complete in February 2016.

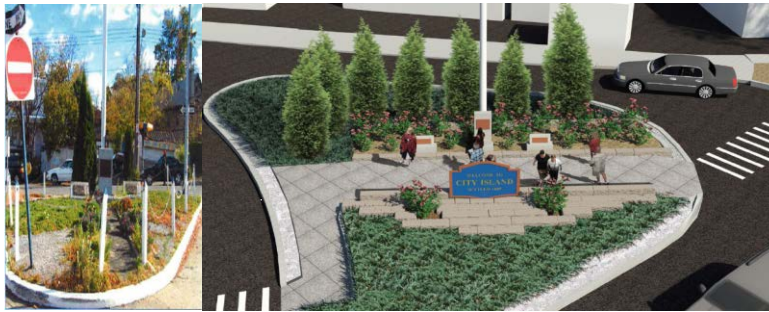
Current Legion Triangle and Rendering. The Design is Slightly Larger Than the Existing Triangle, Features a Wide Variety of Flora, and Will Provide Ample Space for Visitors who Come to Pay Homage to the Veteran's Memorial.

As part of the bridge replacement project, the Legion Triangle at the intersection of City Island Avenue, City Island Road and Bridge Street will be modified.

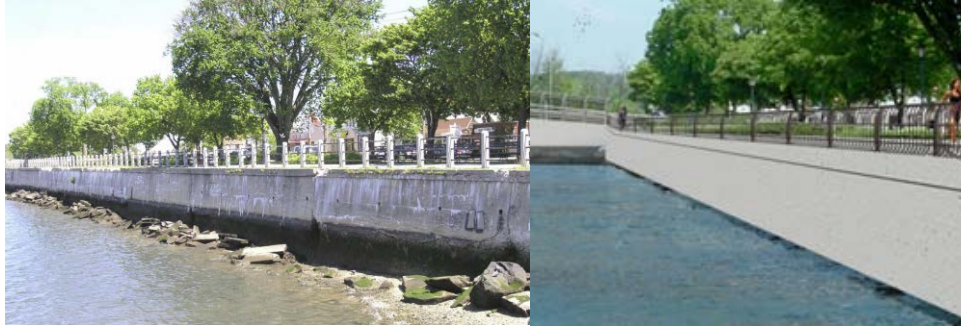
Existing Seawall. Proposed Treatment.

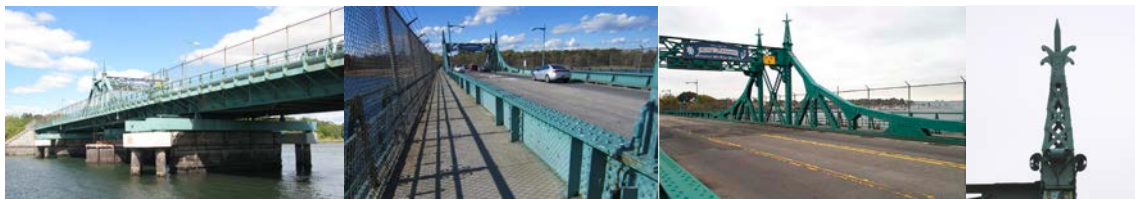
City Island Road Bridge in 2010. (Credit: Bojidar Yanev) Span 4, Right Sidewalk Near Pier 4 in October 2013. Vertical Clearance Posting. (Credit: NYSDOT) 9 Foot Tall Ornamental Finial.

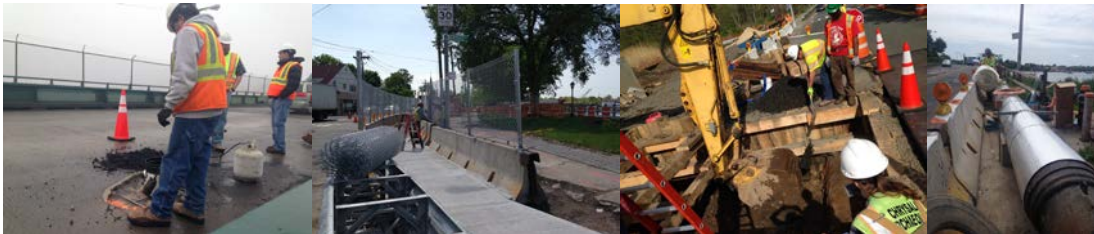
February 2014: Pothole Repair. August 2014: Contractor Constructing a 5-Foot Wide Walkway to Protect and Guide Pedestrians Around the Designated Work Zone on the Esplanade. Excavating on the West Side of the Bridge in the Presence of an Archeologist. Insulating the Temporary Water Main to Protect Against Low Temperatures and Accidental Impact.

A Notice to Proceed for the project was issued to the contractor with a start date of September 30, 2013. At the end of 2013, the contractor was preparing to proceed with test pits, staging area work, building surveys, and the installation of construction signing. During 2014, the contractor surveyed the area, set up temporary work zone traffic control devices, installed temporary signals, relocated the 16 inch water main on the existing bridge, and started the foundation work for the temporary bridge.

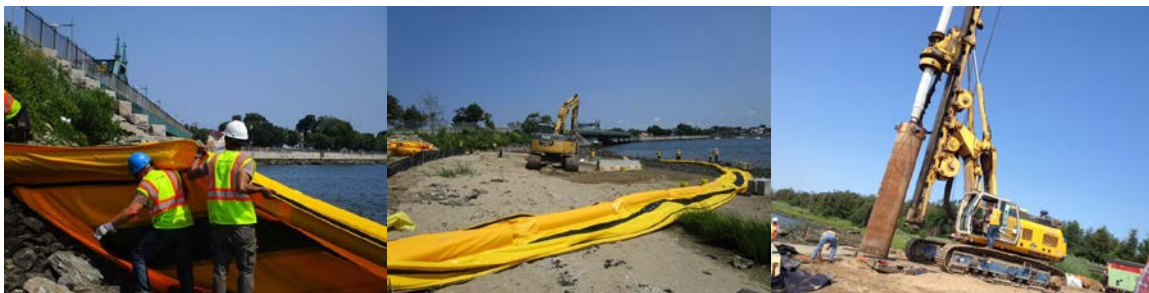
Approximately 300 Linear Feet of a Turbidity Curtain was Installed on the Southwest Side of the Bridge to Protect the Shore During Construction. A Turbidity Curtain is a Floating Barrier Designed to Contain and Control the Dispersion of Sediment. Drilling in the Southwest Side of the Bridge to Install the Footings and the Piers of the Temporary Structure.

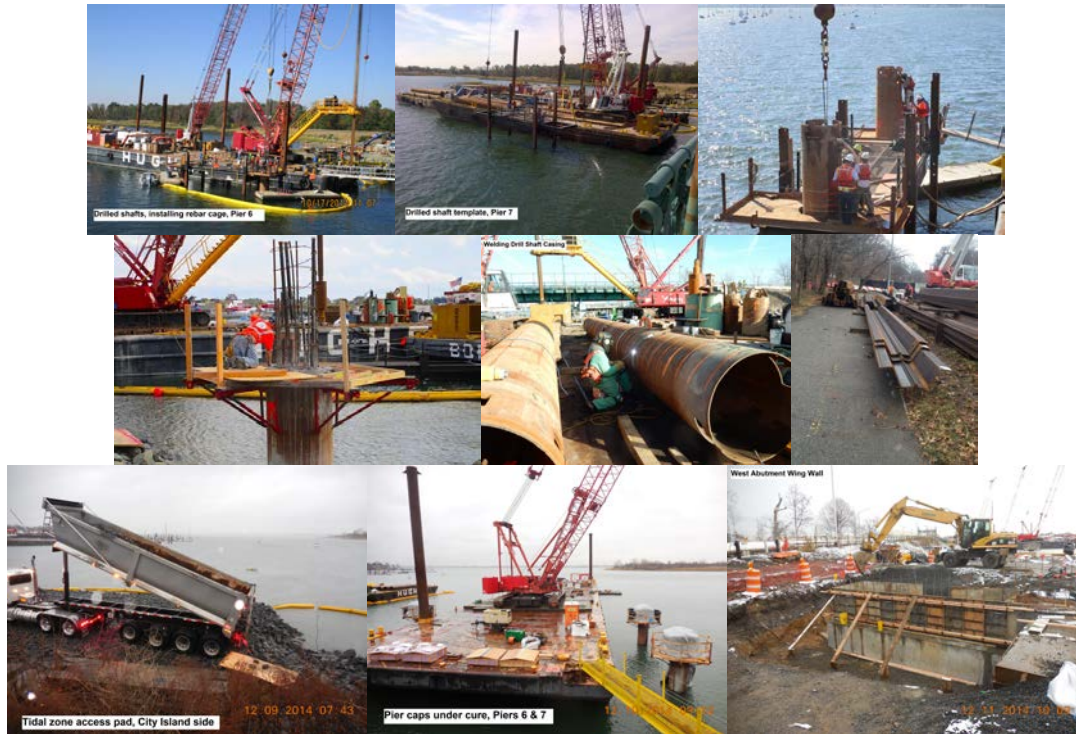
October 2014: Drilled Shafts – Installing Rebar Cage at Pier 6. Template at Pier 7. The Contractor Airlifted Drilled Shaft Casings Into Position on a Platform Constructed Beside a Construction Barge. Fresh Pier Caps Being Prepared for Installation Atop Completed Drilled Shafts. These Will Serve as the Support Structures Once the Temporary Bridge is Seated. Welding Drill Shaft Casing. Sheeting at Turtle Cove. December 2014: Tidal Zone Access Pad, City Island Side. Pier Caps Under Cure at Piers 6 and 7. West Abutment Wing Wall.
