As an integral part of New York City's Department of Transportation, the Division of Bridges has a two-fold mission: to maintain an optimal transportation network by ensuring smooth mobility on the city's bridges, and to ensure the safety of the public.

The New York City Department of Transportation's Division of Bridges is comprised of four major bureaus. The **Chief Bridge Officer** is responsible for formulating policy and providing executive direction. He oversees all aspects of the design, construction, rehabilitation and reconstruction, maintenance, operation and administration of the 789 bridges (including 5 tunnels), and 53 culverts presently under the jurisdiction of the New York City Department of Transportation (NYCDOT). In addition to broad supervision, the Chief Bridge Officer also provides overall executive and administrative direction for the Division of Bridges, and ensures that all contractors are promptly paid.

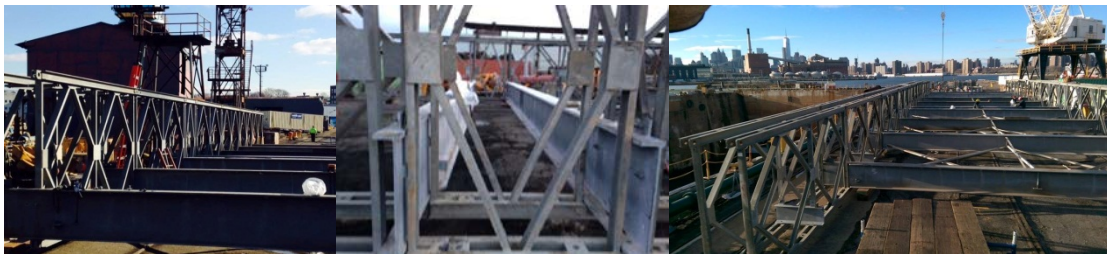
The Contractor Assembled the Temporary Bridge Segments at the Brooklyn Navy Yard. The Pieces Were Transported to City Island by Barge.

Temporary bridge foundations were installed and the superstructure was assembled in the Brooklyn Navy Yard for installation in the early part of 2015. The construction of the new bridge is expected to start shortly thereafter, and it will be completed within the original contract schedule end date of December 30, 2016.

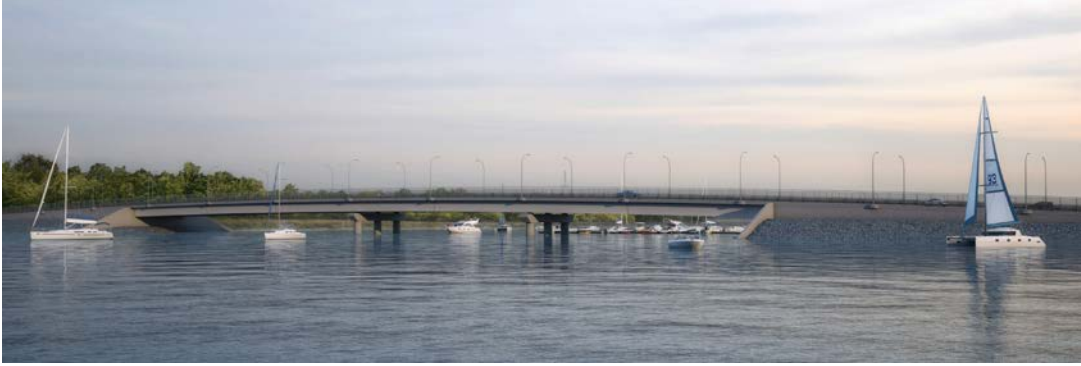
Existing and Proposed City Island Road Bridge Furnishings: Lighting, Fence, and Rail. Side View Rendering of New Bridge.

The existing bridge will be replaced along the same alignment with a new three span bridge with two piers in the water. The new bridge will be approximately 17 feet wider than the existing one to accommodate three standard 12-foot wide traffic lanes, a 6-foot wide bicycle lane and a 6-foot wide pedestrian walkway on each side. The bridge will be a multi-girder continuous bridge with an integral deck. Galvanized steel stay-in-place forms will be used for the deck to both facilitate deck placement and shield the concrete from the corrosive environment of the saltwater bay below. The stainless steel rebar will also not be vulnerable to the deicing salt in the same way that epoxy coated rebar is. Therefore, the deck will have a much longer life expectancy since rebar corrosion is a primary factor in the deterioration of concrete. The new bridge will be designed to current standards and with its wider roadway width, will allow future repair and rehabilitation to be carried out while maintaining one 12-foot lane in each direction. It will also eliminate the vehicle height restriction caused by the existing overhead truss. In order to maintain traffic during the demolition of the existing bridge and construction of the new bridge, a temporary bridge will be constructed on the south side of the existing bridge. Marine traffic will remain undisturbed beneath the bridge during peak boating season.

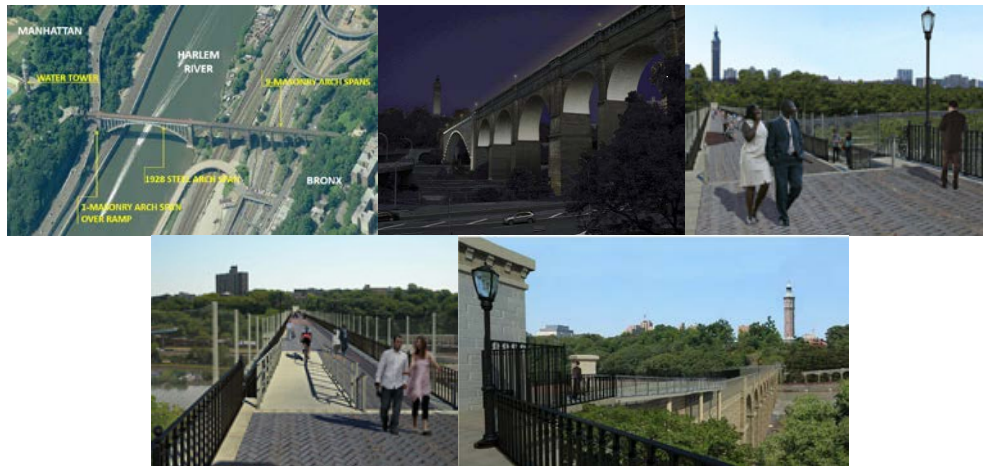
Project Overview. Rendering of the Restored High Bridge, View From the Bronx to Manhattan, View From Manhattan to the Bronx, and ADA Access Area.

Both the central steel span and the stone arches will be cleaned and repaired; the steel span will be repainted and the masonry structure will be repointed and strengthened. Architectural lighting will be installed beneath both spans. The brick paver walkway on top of the structure will be removed and reconditioned, new waterproofing and concrete will be installed, then the historic brickwork will be reinstalled. The aqueduct running beneath the structure will be repaired and stabilized. New lampposts and safety fencing will be installed and the original iron railing will be repaired. Barrier-free access ramps will be built on both sides of the bridge to allow access for the disabled. Three viewing platforms with bench seating will be installed along the length of the bridge.

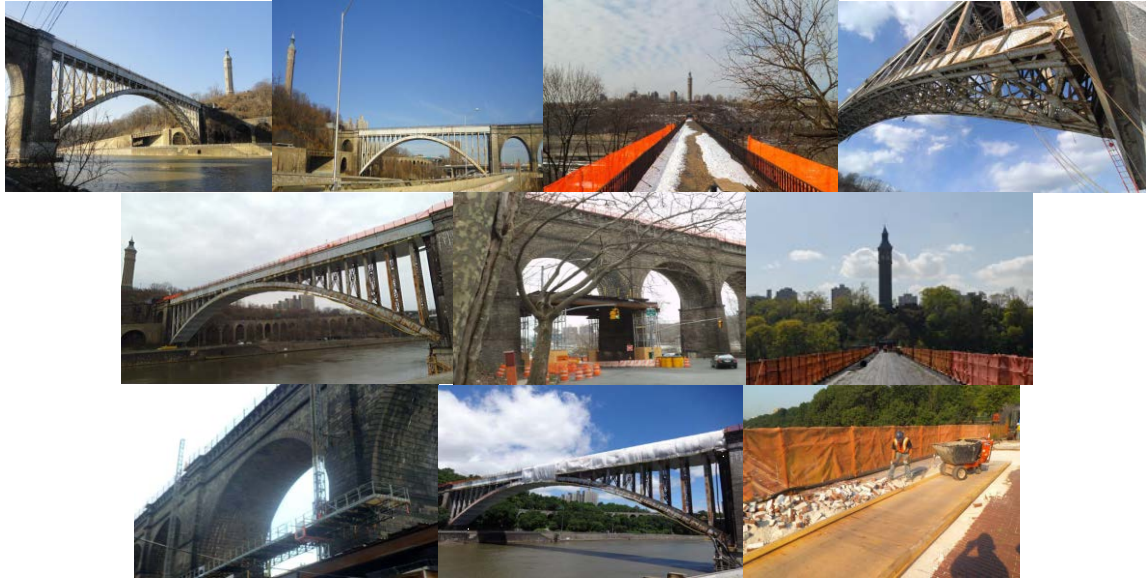
Northern and Southern Views of High Bridge in 2013. Winter 2013: Installation of Safety Shield Materials on the Walkway. Winter 2013: Safety Cables Installed on the Bridge. Early Spring 2013: Temporary Work Platform on the Bridge. Temporary Work Platform on Sedgwick And Undercliff Avenues. Spring 2013: Mast Climber and Lead Abatement Containment on the Bridge. Summer 2013: Brick Paver Removal. (Credit: NYCDDC)

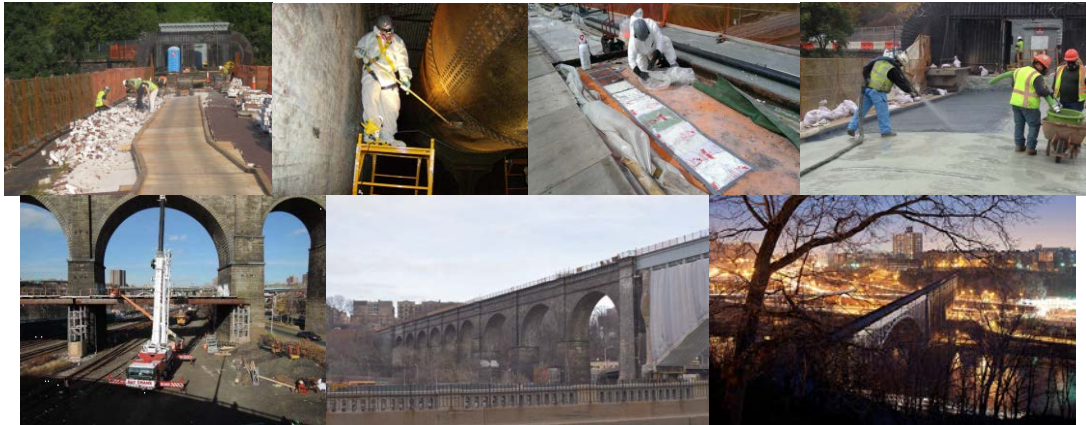
Summer 2013: Brick Paver Removal and Preservation. Fall 2013: Aqueduct Pipe Preservation. Reconstruction of the Walkway. Late Fall 2013: Water Proofing Operations on the Bridge Deck. Mast Climber Removal. Winter 2014: South View of the Bridge. (Credit: NYCDDC)

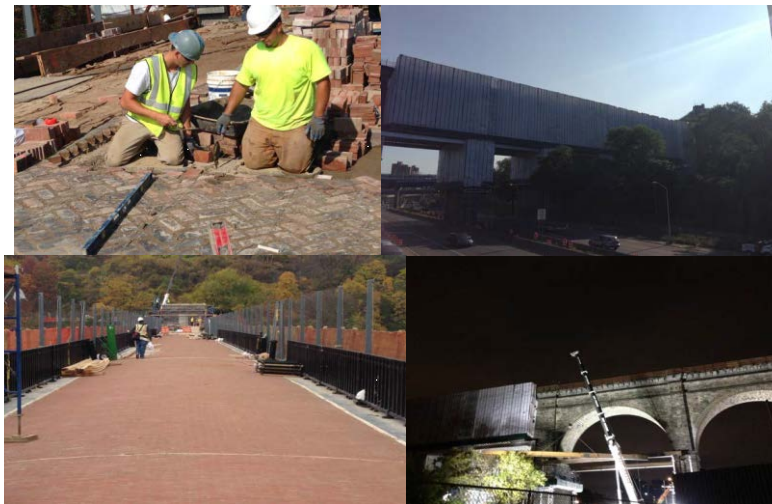
Summer 2014: Brick Installation. Containment System. Late Fall 2014: Completing Brick Installation. Scaffold Installation. (Credit: NYCDDC)

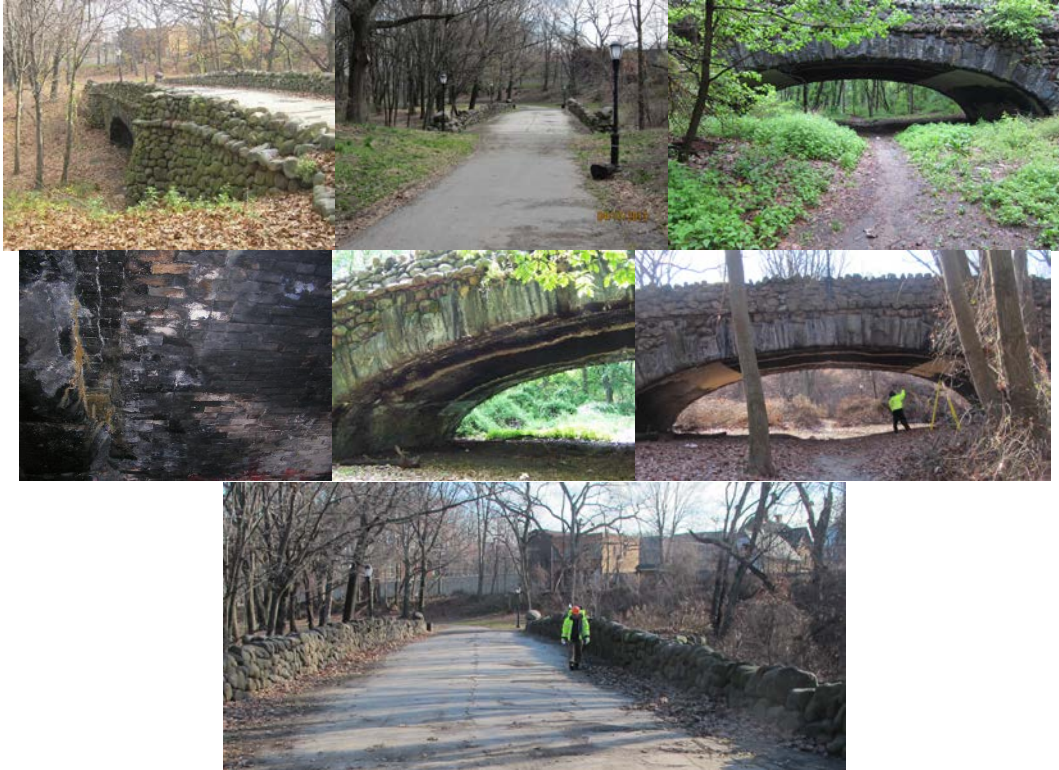
Highland Park Bridge. Dirt Pathway Under Bridge. Under-Deck Cracks and Missing Bricks - North-East Side. Under-Deck Arch Wall Showing Efflorescence Along the Cladding Stone and Brick Arch. Inspecting the Bridge in December 2014.

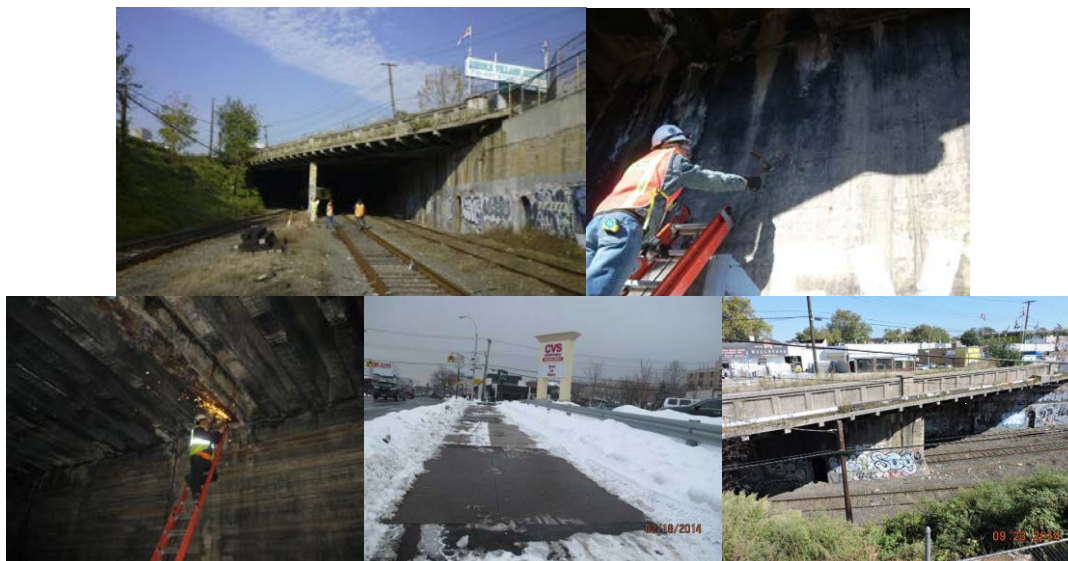
Metropolitan Avenue Bridge in 2009. (Credit: NYSDOT) 2010 Inspection - Hands-On Inspection of A Pier. Obtaining a Steel Coupon Sample From a Stringer. February 2014: View of Plates on Left Sidewalk (Fresh Pond Road). September 2014: Spans 1 and 2 Right Concrete Parapet. (Parapet Credit: NYSDOT)

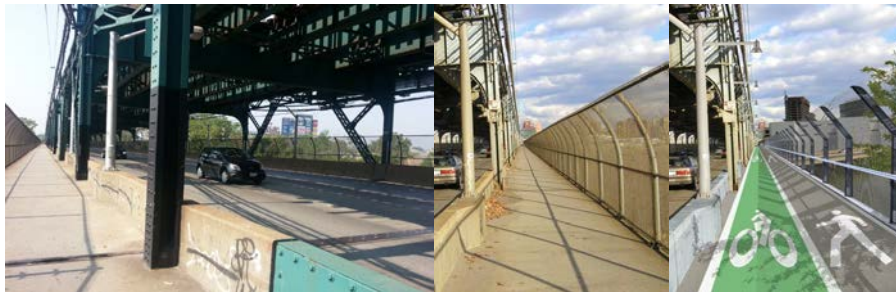
Roosevelt Avenue Bridge – Looking East. Existing and Proposed Bicycle/Pedestrian Path.

The project, currently in the final design phase, will include the construction of a new concrete-filled steel grid deck, rehabilitation of the existing east and west viaduct sections, bascule span, piers, abutments, and painting of the entire bridge. In addition, a new bicycle/pedestrian path will be constructed on the north and south sides of the bridge.

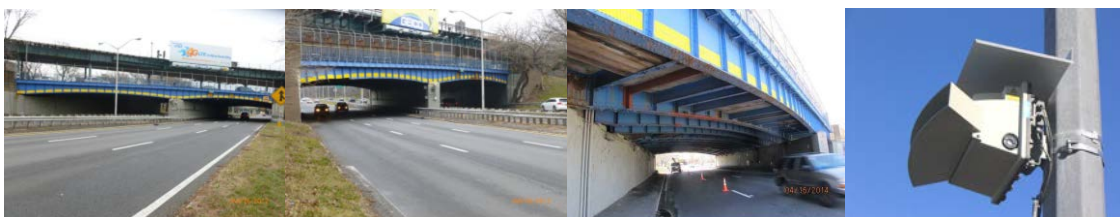
Westchester Avenue Bridge Elevation Left and Right in 2012. (Credit: NYSDOT) April 2014: Span 2 – Deteriorated Areas Shielded With Planks. Overheight Sensor Unit on the Hutchinson River Parkway. (Sensor Credit: Roly Parroco)

The bridge spans over the Hutchinson River Parkway and it supports the NYCT elevated subway structure of the Pelham Bay Line. Six of the transit columns are supported by the bridge girders. The bridge is located between Waters Place and Middletown Avenue. It has four travel lanes with parking lanes and sidewalks on both sides. This two span continuous multi-stringer bridge is supported by reinforced piers and abutments. It was built in 1940 by the Triborough Bridge and Tunnel Authority in conjunction with the construction of the Bronx-Whitestone Bridge approach. No major modifications to the bridge are recorded except for minor repairs at the south approach sidewalk and temporary flag repairs to bridge girders damaged by vehicle impacts in the southbound and northbound roadway. A project to install an ITS solution, which includes an overheight vehicle detection system that flashes signs directing vehicles identified as being over 9' in height to exit the parkway, was substantially completed on December 3, 2004. This Vehicle Height System, consisting of cameras, flash boxes, conduit, and power cabinet, that was erected in the early 2000's, is still attached to the bridge piers, girders and abutments but is not in working order. The contractor completed extra work associated with landscaping in the spring of 2006. The underdeck at both spans is currently covered by approximately 154 square feet of timber planking. In addition, the underdeck at span 1 is covered with approximately 18 square feet of steel wire mesh netting.

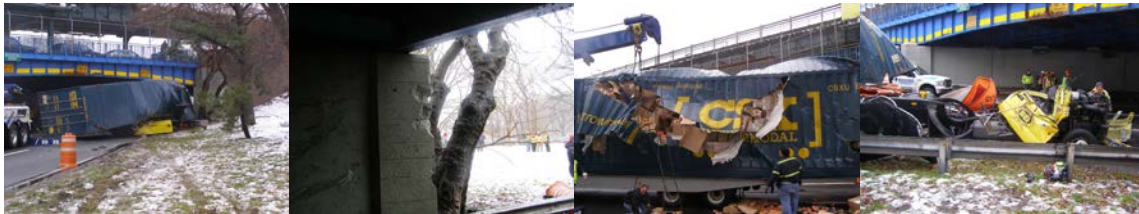
Damaged Bridge, Cargo Container, and Contractor Truck After An Over-Height Trailer Struck the Bridge in January 2012.

The Westchester Avenue Bridge's vertical clearance over the Hutchinson River Parkway is sub-standard. Due to the number of truck and bus vehicles that mistakenly enter the Hutchinson River Parkway, where commercial vehicles are not allowed, the fascia steel girders of the bridge have been severely impacted and damaged numerous times.

The rehabilitation of the bridge will include the replacement of the existing reinforced concrete deck slab with a new reinforced concrete deck, steel faced curbs, a new parapet wall and protective screenings, concrete sidewalks, rehabilitation of the damaged steel fascia girders, and replacement of the diaphragms and other bridge elements, including a new steel water main.

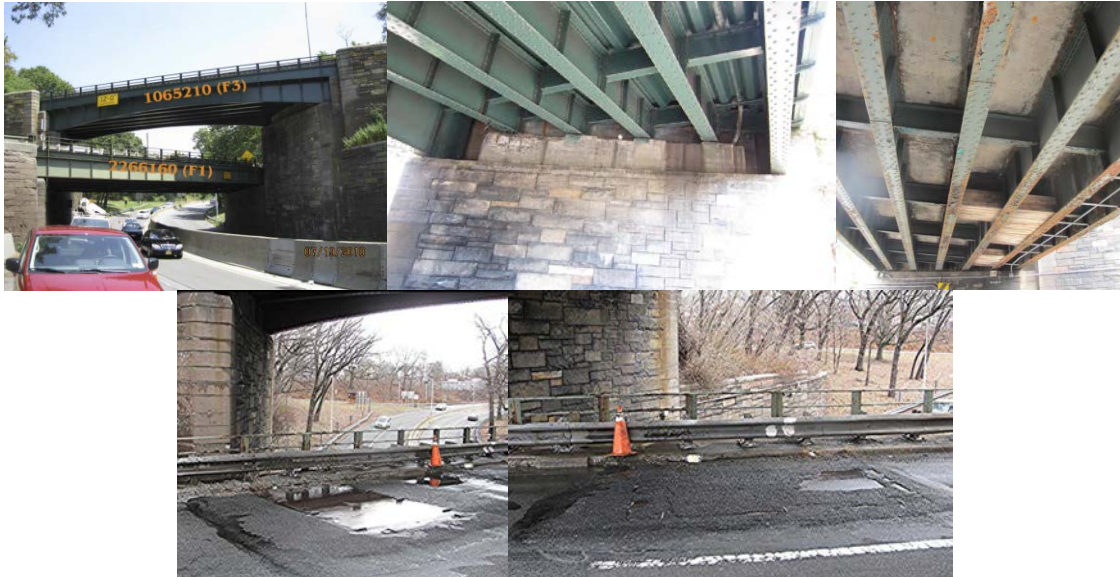
Bridge (Lower Structure) in 2010. (Credit: NYSDOT) Bridge Detail. August 2013: Span 1 Underside of Deck from End Abutment, Looking Northwest - Areas of Spalled Concrete Deck Are Protected With Timber Planks. March 2014: Steel Plates on Wearing Surface.

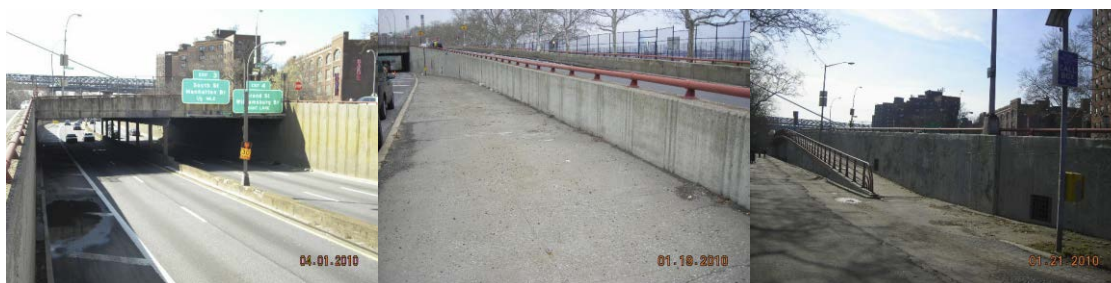
The Three Structures of the FDR Drive at Houston Street Overpass. (Credit: NYSDOT)

The overpass consists of three bridge structures. The main bridge is a two-span reinforced concrete slab structure spanning over the FDR Drive's northbound and southbound roadways. Two approach ramp structures provide access to and from the FDR Drive northbound roadway and the main bridge. Each of these structures is also a reinforced concrete slab structure supported on longitudinal concrete walls that run adjacent to the FDR Drive's northbound roadway. These bridges were constructed circa 1953, and are thus almost 60 years old. On the main bridge, the superstructure slab is supported on bearing wall abutments continuously founded on piles, and on one pier at the center of the FDR Drive that consists of a steel cap beam supported on multi-steel columns continuously founded on piles. The structural slabs have asphalt overlays, and the main bridge has three sections of concrete sidewalks.

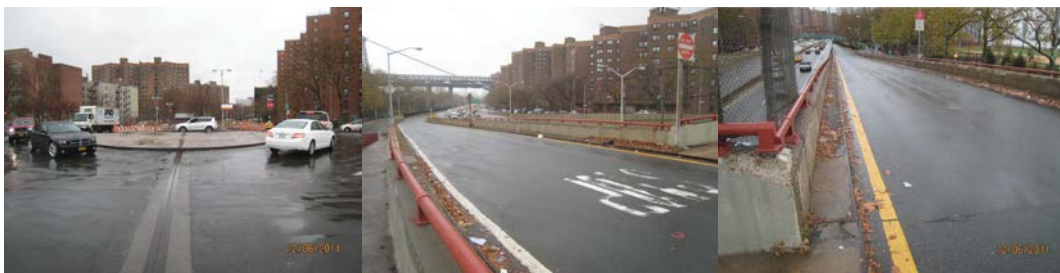
2011: Main Bridge – Top of Deck Looking West. South Approach Ramp – Top of Deck Looking South. North Approach Ramp – Top of Deck Looking North.

Project work will include the removal and replacement of the existing bridge superstructure, including deck slab, sidewalks, center median island, and parapets. The substructure (abutments and pier) will be modified at their top to support the new superstructure. Other rehabilitation work will include the removal of hollow and spalled underdeck concrete, cleaning and repair of corroded rebar, removal of asphalt overlay, installation of waterproofing membrane, installation of new signals and an ADA-compliant pedestrian ramp, and placement of new asphalt overlay over the existing deck slabs. The reconstruction of the main bridge will be performed in two main stages, with half the bridge being replaced at a time. The project is in the final design stage, and construction is expected to begin in fall 2015.

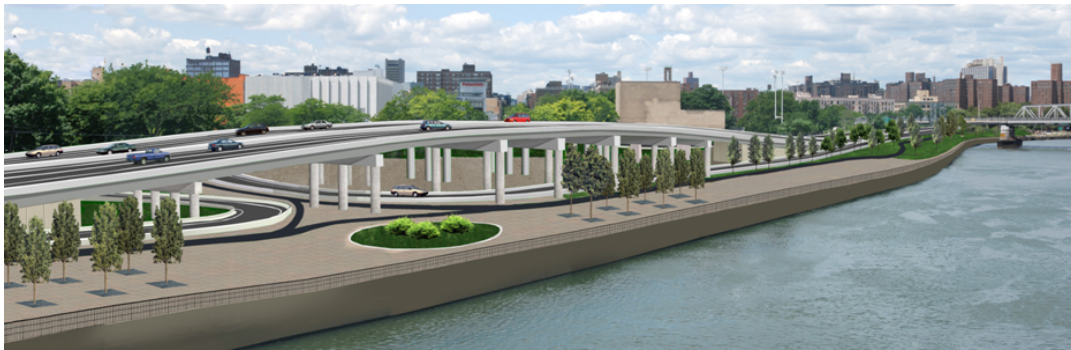
Rendering of New Harlem River Drive Bridge.

This project includes over \$82 million in Federal funds. Construction will follow the on-line bridge replacement with auxiliary exit and entrance lanes and left-lane exit to Second Avenue. It involves the replacement of the existing 11 span bridge and the reconstruction of the Harlem River Drive between the Willis Avenue and Third Avenue Bridges, in addition to various highway improvements. The proposed replacement structure will consist of two adjacent bridges, with the bridge located to the west dedicated to southbound traffic and the bridge located to the east dedicated to northbound traffic. The new structures will be approximately 1,027 feet long.

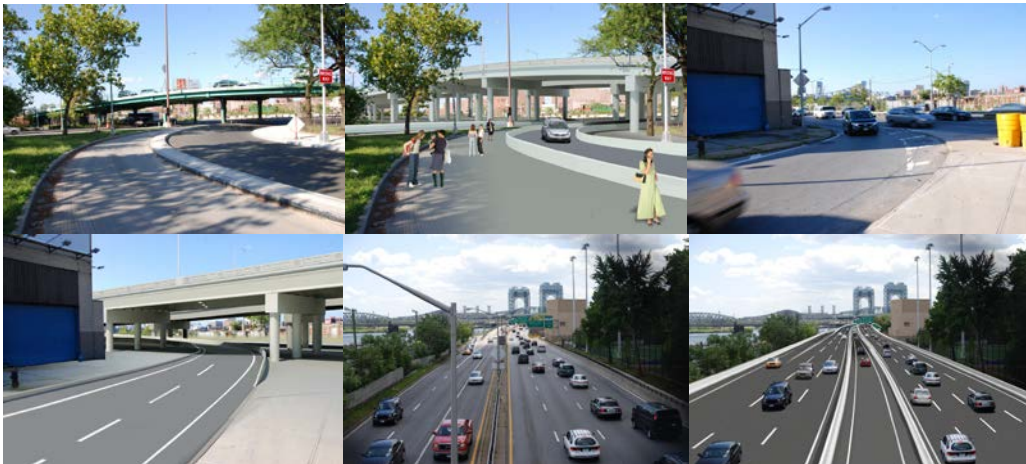
Looking East at the 127th Street Off-Ramp: Current and Proposed View. Looking East at 2nd Avenue: Current and Proposed View. Looking South From 3rd Avenue Bridge: Current Harlem River Drive and 2nd Avenue Exit and Proposed Harlem River Drive With Left Lane Exit to 2nd Avenue.

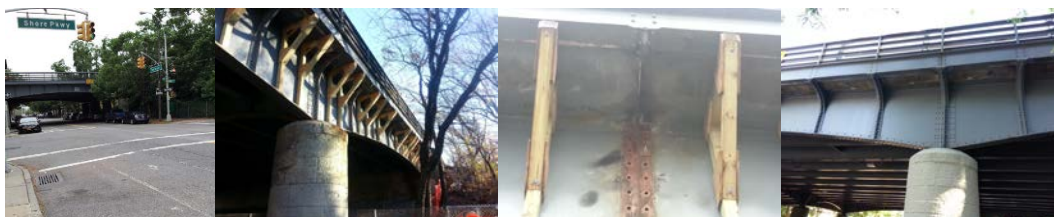
Replacing Deteriorated Fascia Brackets From the North and South Girders of the Belt Parkway Bridge Over Bedford Avenue. Temporary Supports Were Installed at the Bracket Location. Bracket was Removed. New Brackets Were Installed and Painted. (Credit: Vadim Sokolovsky)

The Belt Parkway Bridge over Bedford Avenue is a three span steel stringer structure. The bridge carries three travel lanes in each direction. There is a shoulder and a safety walk on each side of the bridge. The concrete median that divides the eastbound and westbound traffic has guide railing on both sides. The scope of rehabilitation work included the following: replace asphalt concrete over expansion joints and seal cracks in asphalt overlay; clean and paint replaced or rehabilitated steel items; replace seals at abutments; replace deteriorated structural steel; repair concrete deteriorated areas; clean masonry; apply an anti-graffiti protective coating on abutments, wingwalls and piers; and clean scuppers. The Belt Parkway Bridge over Bedford Avenue was substantially completed on July 15, 2014.

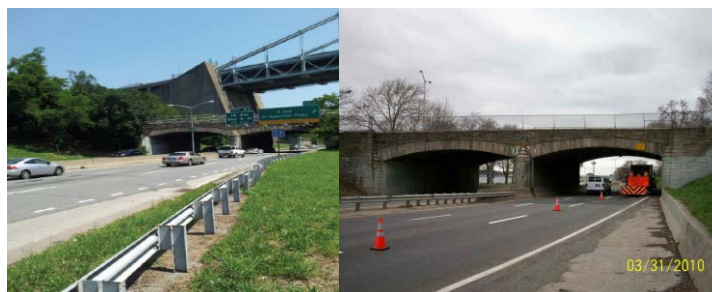
4th Avenue Bridge. March 2010: Right Elevation. (Credit: NYSDOT)

The 4th Avenue Bridge over the Belt Parkway is a two span concrete rigid frame. The bridge carries a travel lane in each direction, divided by a concrete median. There are no parking lanes on the bridge and approaches. The west sidewalk is wide and the east sidewalk is narrow. There is a concrete parapet on each side of the bridge. The scope of rehabilitation work included the following: remove and the existing asphalt concrete on bridge and approaches; clean pressure relief joints; repair concrete deteriorated areas at sidewalks and median and apply a sealing protective coating; repair concrete deteriorated areas at abutments, pier, and underdeck; and clean masonry surfaces and apply an anti-graffiti protective coating. The 4th Avenue Bridge was substantially completed on June 27, 2014.

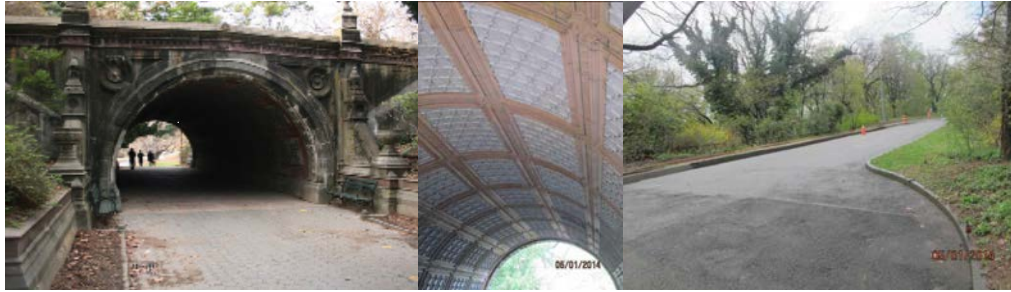
The Hill Drive Bridge (Cleft Ridge Span) Bridge is a one span semi-circular arch type structure. The bridge carries one travel lane in each direction. There are no parking lanes on the bridge. The scope of rehabilitation work included the following: repair the asphalt wearing surface; repair spalled and cracked concrete at the wingwalls; clean the bridge and provide an anti-graffiti

protective coating; and restore the under drain system behind the bridge fascias. The Hill Drive Bridge (Cleft Ridge Span) Bridge was substantially completed on November 5, 2014.

Hill Drive Bridge (Cleft Ridge Span) Bridge. May 2014: Tiles on Underside of Span 1. Top of Bridge.

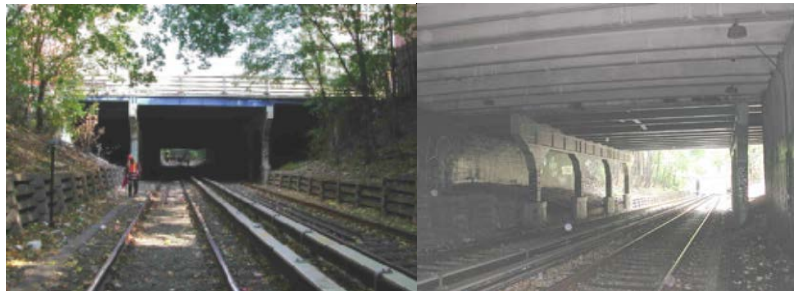
Crown Street Bridge. Right Elevation in 2011. (2011 Credit: NYSDOT)

The Crown Street Bridge is a 3 span bridge that carries one travel lane and one parking lane in each direction. The bridge has protective screening and a bridge railing on the south side. There is a building adjacent to the bridge north fascia. The scope of rehabilitation work included the following: seal cracks in the concrete overlay; replace seals above abutments; repair, clean, and apply an anti-graffiti protection coating to the abutments, piers, and crashwalls; and clean existing gutters. The Crown Street Bridge was substantially completed on August 20, 2014.

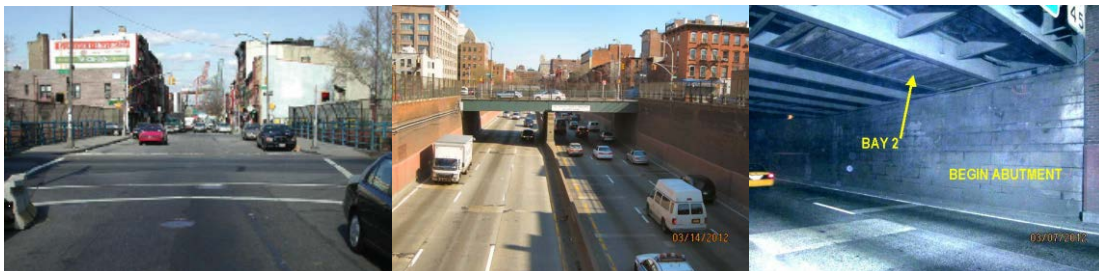
The Union Street Bridge is a two span steel continuous stringer structure. The bridge carries eastbound two travel lanes. There is an unmarked parking lane on each side of the bridge. There is a sidewalk, a railing and protective screening on each side of the bridge. The scope of rehabilitation work included the following: remove and replace concrete overlay; replace seals at abutments; repair concrete deteriorated areas; replace corroded rivets; paint structural steel; clean abutments and pier walls; and restore bearings. The Union Street Bridge was substantially completed on November 13, 2014.

Union Street Bridge. March 2012: Right Elevation. Timber Shielding in Bay 2 of Span 1. (2012 Credit: NYSDOT)

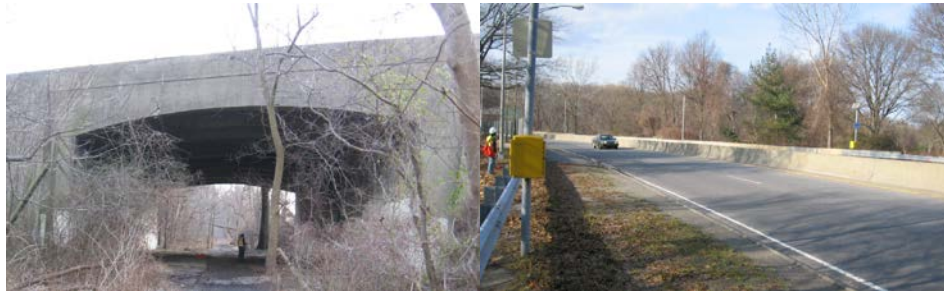
Mosholu Parkway Bridge over Conrail (Abandoned).

The Mosholu Parkway Bridge over Conrail (Abandoned) was built in 1939. It is a single span concrete arch bridge. There is a concrete parapet along both the north and south fascia of the bridge. The existing bridge geometry consists of two travel lanes and a shoulder in each direction, divided by a 4'-0" wide concrete median barrier, as well as a 15'-wide asphalt path for golf carts and pedestrians on the south side of the bridge. The scope of rehabilitation work shall include the following: removing and replacing the asphalt overlay, waterproofing, pavement striping, north fascia barrier and median barrier, corrugated guide rail transition, and wingwall joint filler; removing, storing and reinstalling lighting lamp posts on north fascia barrier and replacing luminaires with new luminaires; installing a temporary lighting system; excavating, backfilling and paving the local depression in the asphalt golf cart path; repairing chain link fence section and concrete on the underdeck and abutment walls; installing weepholes in the abutments and preformed joint seal in the concrete parapet; cleaning and flushing catch basins; and removing graffiti by power wash and applying anti-graffiti protective coating. Vehicular and pedestrian access will be maintained during the estimated 5-month rehabilitation period.

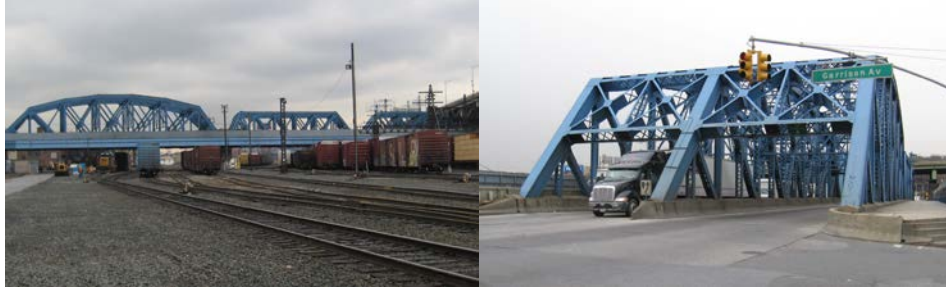
Leggett Avenue Bridge over Amtrak.

The Leggett Avenue Bridge over Amtrak was built in 1906. It is a three span steel truss. There is a corrugated metal fence along both the east and west fascias of the bridge. The existing bridge geometry consists of two travel lanes and a sidewalk in each direction, divided by a 4'-10" wide concrete median barrier. The scope of rehabilitation work shall include the following: removing and replacing deck joint, deck joint seals and portions of the concrete sidewalk; repairing concrete on the abutment and approach slab; repairing structural steel members and existing fuse box; installing pavement striping; and cleaning and painting steel surfaces and bottom of stay-in-place form. Vehicular and pedestrian access will be maintained during the estimated 5-month rehabilitation period.

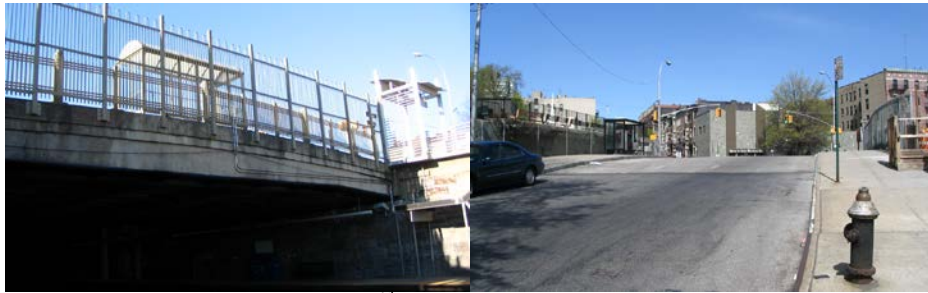
East 162nd Street Bridge over MNRR.

The East 162nd Street Bridge over Metro North was built in 1888. It is a single span steel jack arch bridge with built-up steel beams encased in concrete. There is a fence along both the north and south fascia of the bridge as well as a non-standard decorative bridge rail along the north fascia. The existing bridge geometry consists of one travel lane, a parking lane and a sidewalk in each direction. The scope of rehabilitation work shall include the following: locally removing and replacing the asphalt and concrete overlays and sidewalk; installing pavement striping; repairing guide railing, concrete on the underdeck and abutment, and cracks in the asphalt overlay and sidewalk; cleaning and painting steel surfaces locally; resealing sidewalk joints; and repointing stone masonry. Vehicular and pedestrian access will be maintained during the estimated 4-month rehabilitation period.

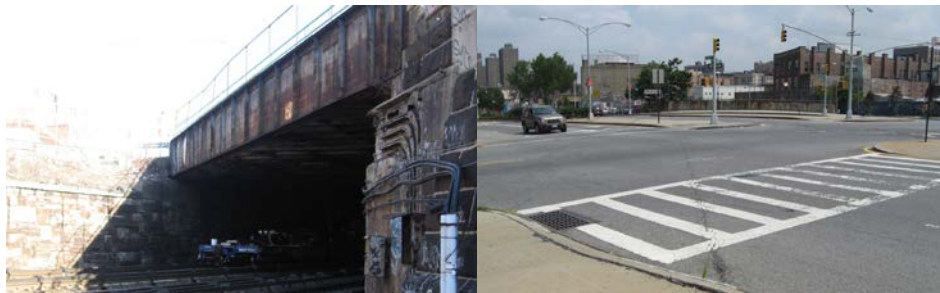
East 165th Street Bridge over MNRR.

The East 165th Street Bridge over Metro North was built in 1897. It is a single span steel jack arch bridge with built-up steel beams encased in concrete. . A chain link fence runs in front of steel railing atop both the west and east fascia of the bridge. The existing bridge geometry consists of one travel lane in each direction on East 165th Street, and one travel lane, a turning lane and a sidewalk in each direction on Melrose/Webster Avenue. The scope of rehabilitation work shall include the following: locally removing and replacing the asphalt overlay and sidewalk; repairing the concrete underdeck; cleaning and painting steel surfaces; resealing sidewalk joints; installing new multi-rotational bearings at the south abutment; partially removing and replacing the bridge seat at the new bearing locations; installing a temporary support system; and performing jacking operations. Vehicular and pedestrian access will be maintained during the estimated 8-month rehabilitation period.

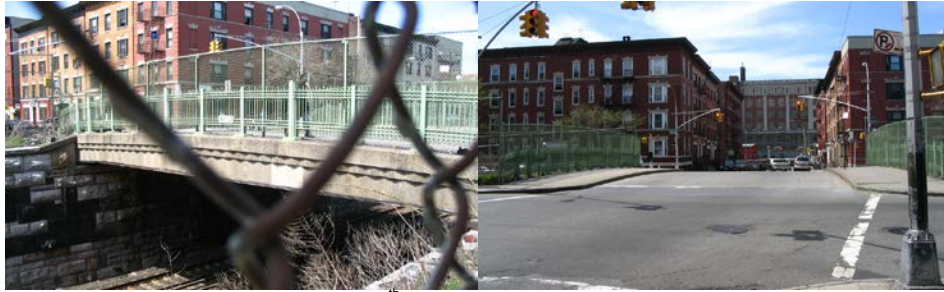
East 187th Street Bridge over MNRR.

The East 187th Street Bridge over Metro North was built in 1889. It is a single span steel jack arch bridge with built-up steel beams encased in concrete. The bridge has a chain link fence and a non-standard decorative bridge rail along both the north and south fascia. The existing bridge geometry consists of one 17' travel lane and an 11' sidewalk in each direction. The scope of rehabilitation work shall include the following: removing and replacing concrete overlay and waterproofing membrane, concrete sidewalk, corrugated guide rail, bridge railing, chain link fence wire mesh, and steel faced curb and handicap ramp at sidewalk corners; sealing the deck overlay; repairing the concrete underdeck; and cleaning and painting the steel surfaces locally. Vehicular and pedestrian access will be maintained during the estimated 5-month rehabilitation period.

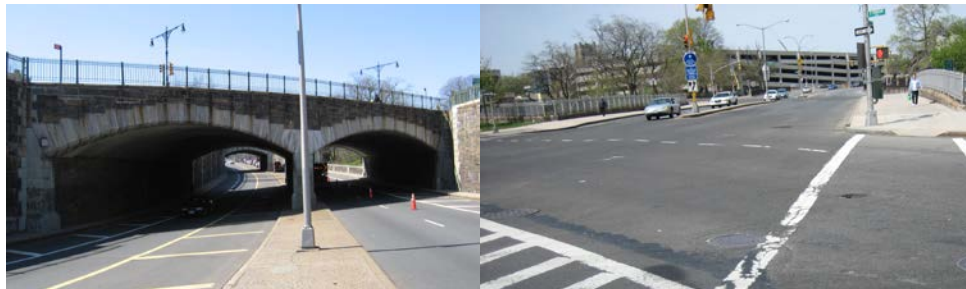
Southern Boulevard Bridge over East Fordham Road.

The Southern Boulevard Bridge over East Fordham Road was built in 1962. It is a two span concrete arch bridge with stone masonry facing on the abutments and spandrel walls. The bridge has a concrete parapet with stone facing topped with a non-standard decorative bridge rail at both the east and west fascia. The existing bridge geometry consists of two travel lanes, a turning lane and a sidewalk in each direction, divided by a 4'-3" wide concrete median. The scope of rehabilitation work shall include the following: removing and replacing asphalt overlay, waterproofing membrane and pavement striping; repairing bridge railing, light fixtures and concrete on the underdeck and sidewalk; resealing sidewalk joints and vertical fascia joint at abutment; repointing and repairing cracks in stone masonry; installing weep holes in the underdeck and guide railing; and cleaning fascia stone masonry and catch basins. Vehicular and pedestrian access will be maintained during the estimated 5-month rehabilitation period.

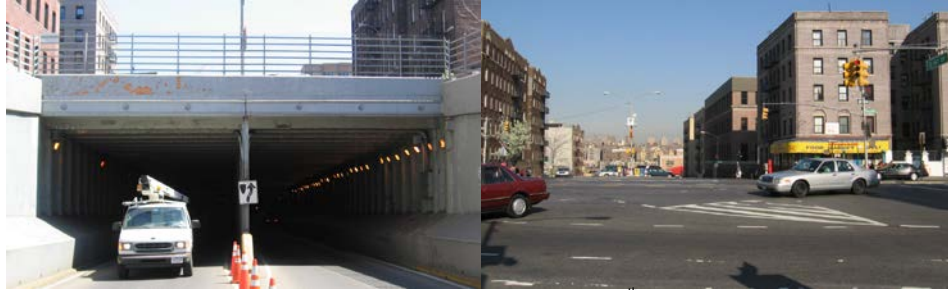
Grand Concourse Bridge over East 167th Street.

The Grand Concourse Bridge over East 167th Street was built in 1923. It is a two span steel girder bridge. The bridge has a concrete sidewalk and concrete parapet topped with a chain link fence at each fascia. The existing bridge geometry consists of two travel lanes and a turning lane in each direction on the Grand Concourse, and one travel lane, a parking lane and a sidewalk in each direction on the Grand Concourse service road. The overall structure extends several blocks to the north and south of the Grand Concourse where it carries a two-aisle parking area between the eastbound and westbound ramp lanes of East 167th Street. There is an NYCTA subway station under the Grand Concourse. Both the subway station and the railroad tracks are above East 167th Street. The subway station structures are not included in the scope of the bridge project. The scope of rehabilitation work shall include the following: removal and

replacement of asphalt overlay; repairing concrete on the underdeck, abutments, piers, wingwalls and sidewalks; repairing underdeck light fixtures and drain pipe; resealing sidewalk and parapet joints; grouting the gap below the parapet curb along the pavement; and removing graffiti by power wash and applying anti-graffiti protective coating. Vehicular and pedestrian access will be maintained during the estimated 4-month rehabilitation period.

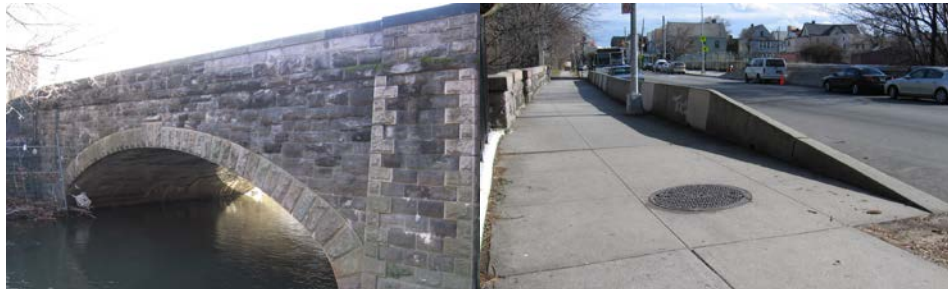
East 180th Street Bridge over Bronx River.

The East 180th Street Bridge over Bronx River was built in 1925. It is a single span concrete arch bridge with stone masonry facing. The bridge has a parapet at both the north and south fascia. The existing bridge geometry consists of one travel lane, a parking lane and a sidewalk in each direction; the sidewalks on both sides are protected from the roadway by a concrete barrier. The scope of rehabilitation work shall include the following: replacing pedestrian railing; repairing concrete underdeck, crack, spall and joint seal in concrete barrier, and the retaining wall at the northwest corner of the bridge; resealing sidewalk joints; repointing stone masonry and stone coping mortar joint; cleaning drain holes in the concrete barrier; removing a tree from the south fascia and northwest retaining wall; and removing graffiti by power wash and applying anti-graffiti protective coating. Vehicular and pedestrian access will be maintained during the estimated 4-month rehabilitation period.

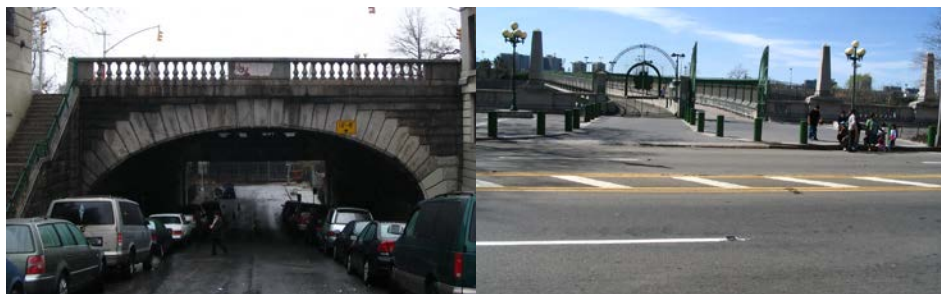
Riverside Drive Bridge over West 138th Street.

The Riverside Drive Bridge over West 138th Street was built in 1920. It is a single span concrete arch bridge with stone masonry facing on the abutments and spandrel walls. There is a stone parapet on the east and the west side of the bridge. The existing bridge geometry consists of two travel lanes and a parking lane in each direction; the bridge also contains a sidewalk on the east side and an entrance to Riverbank State Park on the west side. The scope of rehabilitation work shall include the following: removing and replacing the asphalt overlay; repairing granite and brick pavers and concrete on the underdeck and sidewalk; repointing and repairing cracks in stone masonry joints; resealing underdeck joints; installing weepholes in the concrete underdeck; installing pavement striping; removing graffiti by power wash and applying anti-graffiti protective coating; cleaning and painting steel staircase railing and bollards; and replacing lighting fixture and refurbishing existing fuse box. Vehicular and pedestrian access will be maintained during the estimated 4-month rehabilitation period.

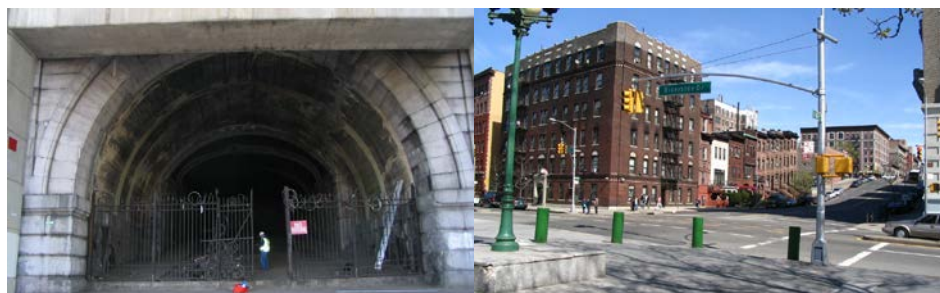
Riverside Drive Bridge over West 145th Street.

The Riverside Drive Bridge over West 145th Street was built in 1930. It is a single span concrete arch bridge with stone masonry facing on the abutments and west spandrel wall. There is only one fascia on this bridge; the east side of the arch bridge is a filled backwall. There is a stone parapet on the west side of the bridge. The existing bridge geometry consists of two travel lanes and a parking lane in each direction; the bridge also contains an entrance to Riverbank State Park on the west side. The scope of rehabilitation work shall include the following: clearing and grubbing; removing and replacing the asphalt overlay, concrete overlay, waterproofing membrane and granite and brick pavers; repairing concrete on the underdeck; repointing and repairing cracks in stone masonry joints; resealing underdeck joints; installing pavement striping; removing graffiti by power wash and applying anti-graffiti protective coating; removing and resetting steel gate; and cleaning and painting bollards. Vehicular and pedestrian access will be maintained during the estimated 4-month rehabilitation period.

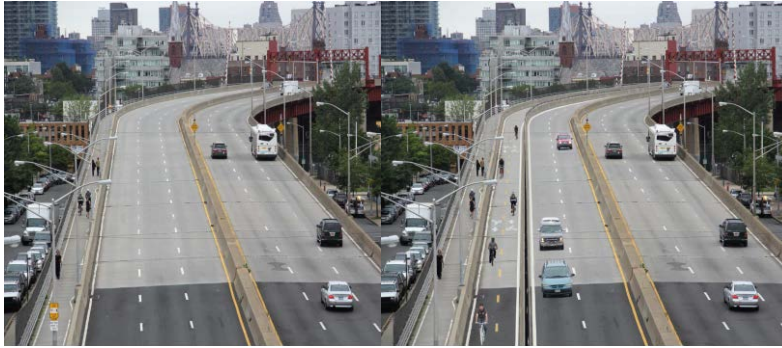
Bicycle use has grown at an unprecedented rate over the last five years in New York City. Currently, the Pulaski Bridge, which connects Greenpoint, Brooklyn with Long Island City, Queens, merges pedestrian and bicycle traffic into a shared travel lane creating dangerous conditions for both pedestrians and bicyclists. The Pulaski Bridge project will convert one southbound car lane (between Jackson Avenue in Queens and Eagle Street) on the bridge into a protected bicycle lane, giving more room to pedestrians on what is now a shared-use path and calming traffic headed toward McGuinness Boulevard in Brooklyn. A \$2.5 million Federal Transportation Enhancements grant awarded by the State will cover some of the \$4.2 million costs. The new pathway is expected to open in late 2015.

Existing and Planned Condition.

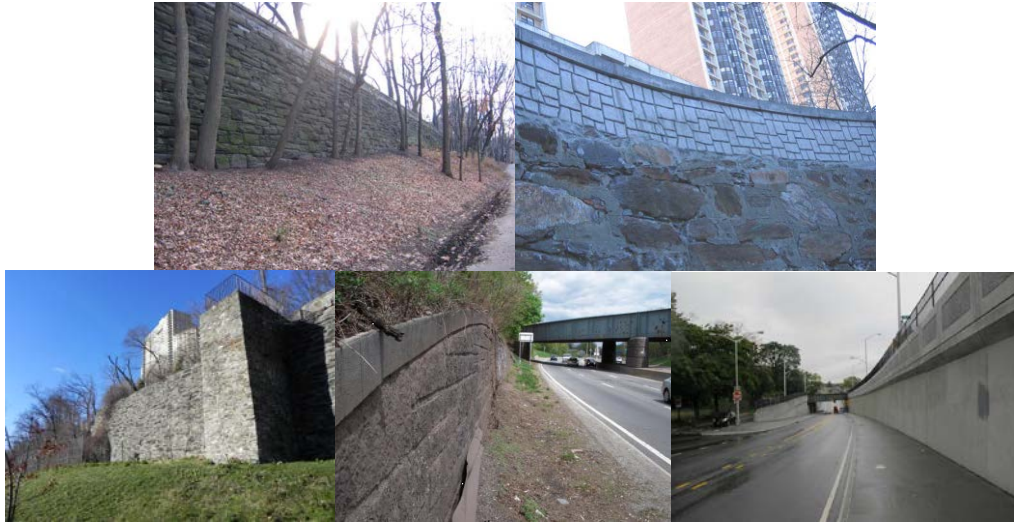
Retaining Walls: Southeast Corner of West 108th Street and Riverside Drive. Left Side of Ramp From Riverside Drive to George Washington Bridge. Irwin Avenue. Cross Island Parkway Southbound Before 100th Avenue. Cooper Avenue.

In May 2005, the Department started a program for the periodic inspection of City-owned retaining walls. The City currently owns 634 retaining walls. Those retaining walls were built during the interstate construction program between the 1940's and 1970's and are an important part of the city's street infrastructure. However, some of them are approaching the end of their service lives and are falling into poor condition due to various factors such as spalling/cracking of concrete, loosened mortar joints, broken stone masonry, falling coping stones, deteriorated joints, leakage through the walls due to improper drainage arrangements (clogged weep holes), bulging of walls due to hydrostatic pressure build-up on the back of the walls, and many other problems. In order to protect the infrastructure they support, the retaining walls require regular inspections and monitoring, and depending upon the condition of the walls, rehabilitation/replacement is required. Since 2005, 17 retaining walls have completed rehabilitation/replacement, and 18 retaining walls are in various stages of design and construction. The retaining walls which are in fair to poor condition will be in a capital program for future rehabilitation.

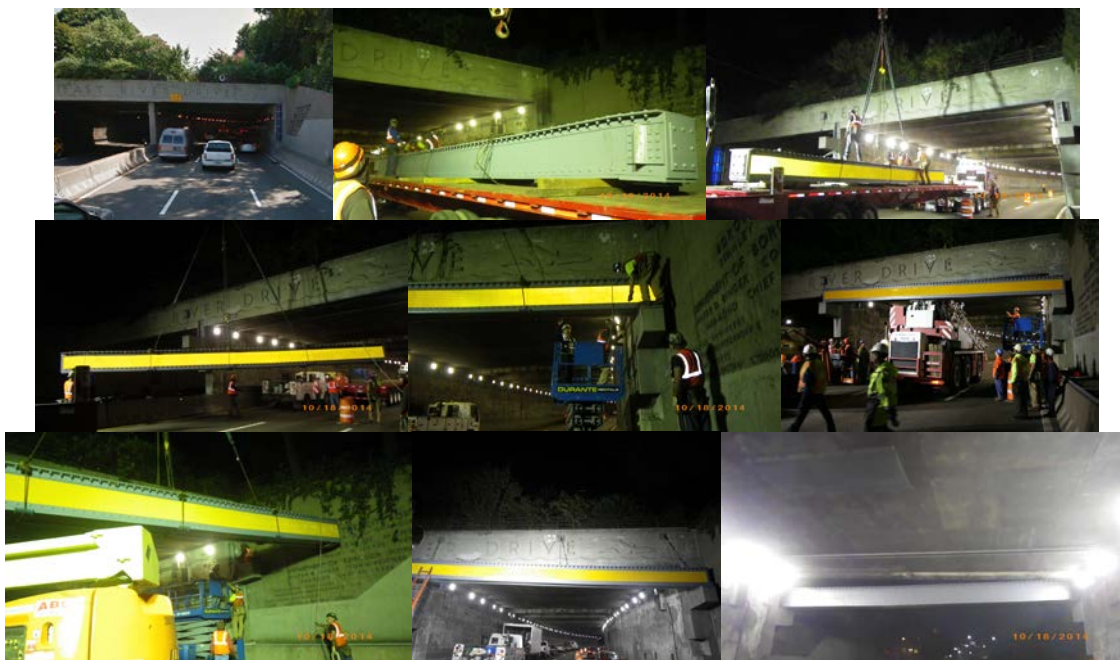
FDR Drive Structure. Installation of the Protection Beam.

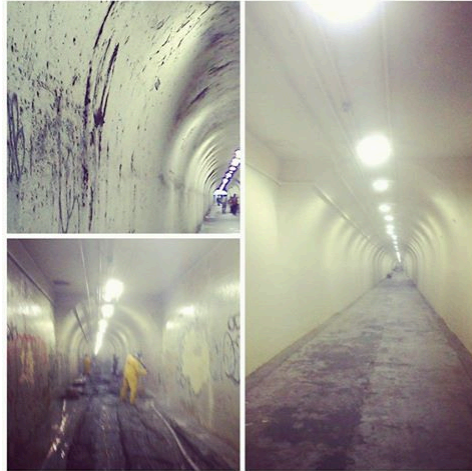
West 191st Street Tunnel - Before and After.

The 191st Street underpass to the NYCTA IRT line was found to have areas of mold and peeling paint. On the weekend of November 7-9, 2014, the tunnel was closed while the contractor performed mold remediation and graffiti removal and repainted the entire interior surface.

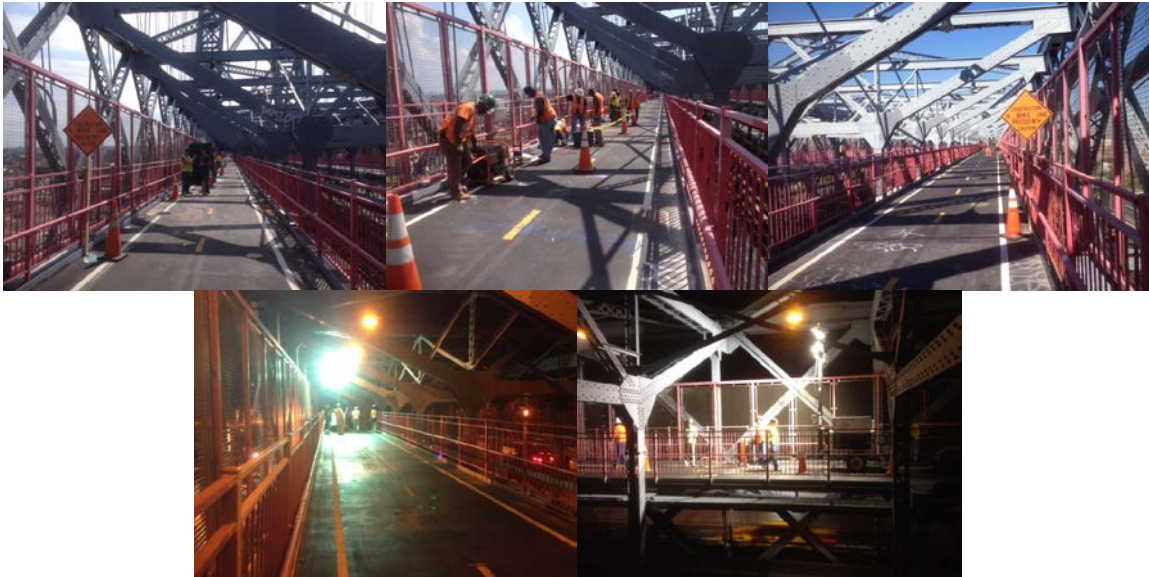
Overlay Patch Repairs of the Williamsburg Bridge Bicycle and Pedestrian Path Began in July 2014 and Were Completed in October. (Credit: Thomas Leung)

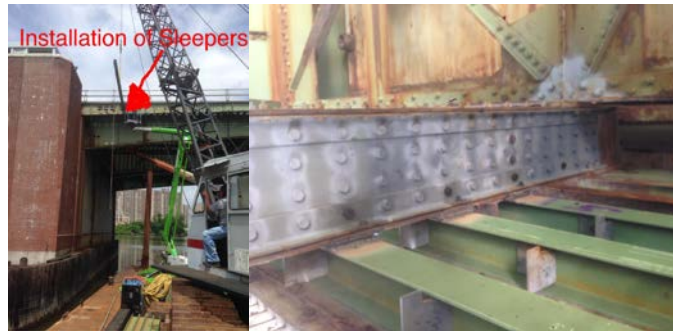
Hutchinson River Parkway Bridge - Installation of Sleeper Steel Beams to Directly Support the Steel Grating.

On the heavily traveled Hutchinson River Parkway Bridge over Hutchinson River, severe deterioration of key structural steel elements supporting the steel grid deck of the southeastern quadrant of the span forced urgent measures to be taken, first, by providing immediate temporary replacements to take over part of the lost support capability, and subsequently, by installing new steel replacement “sleeper” beams and heavy local support at deteriorated stringer sections.

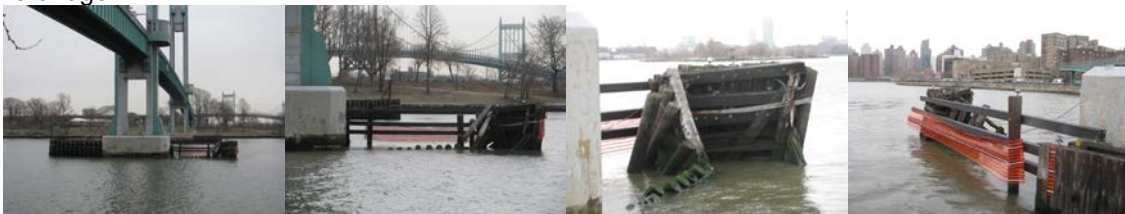
Wards Island Pedestrian Bridge – Collapsed Fender.

The southwest fender system of the Wards Island Pedestrian Bridge was severely battered by an impact from a large barge, leaving its timber structure dislocated, damaged and incapable of providing the designed protection from future barge hits. It was immediately necessary to temporarily provide safety measures to warn off mariners from coming too close to the debris field created as a result of that impact. Construction of a complete replacement fender system commenced in 2014 after a series of temporary measures were taken to protect the west tower of the bridge.
