As an integral part of New York City's Department of Transportation, the Division of Bridges has a two-fold mission: to maintain an optimal transportation network by ensuring smooth mobility on the city's bridges, and to ensure the safety of the public.

The New York City Department of Transportation's Division of Bridges is comprised of four major bureaus. The **Chief Bridge Officer** is responsible for formulating policy and providing executive direction. He oversees all aspects of the design, construction, rehabilitation and reconstruction, maintenance, operation and administration of the 789 bridges (including 5 tunnels), and 53 culverts presently under the jurisdiction of the New York City Department of Transportation (NYCDOT). In addition to broad supervision, the Chief Bridge Officer also provides overall executive and administrative direction for the Division of Bridges, and ensures that all contractors are promptly paid.

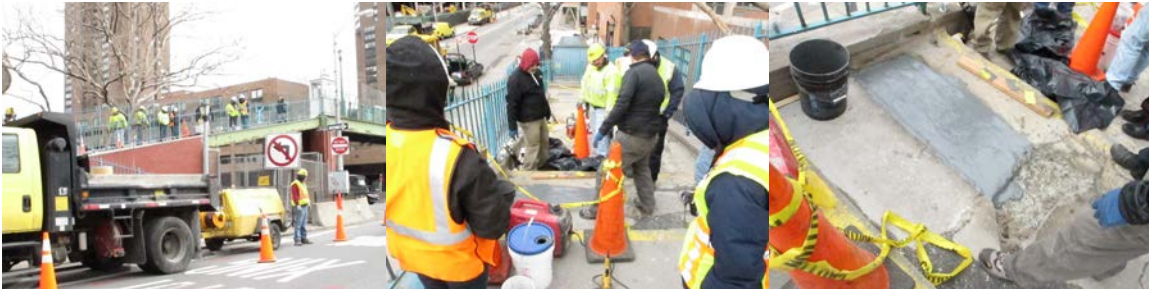
Division Staff Testing a New Patch Material on the East 25th Street Pedestrian Bridge Over the FDR Drive in March 2014.
(Credit: Bojidar Yanev)

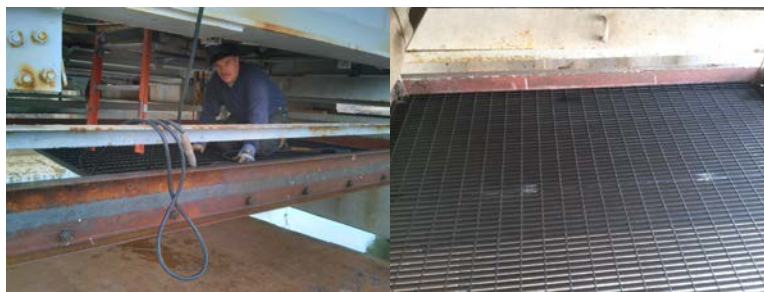
March 2014: Bridge Repairer & Riveter Daniel Jaderlinic Welding New Steel Grating and Support Framework on the Rikers Island Bridge.
(Credit: Steve Havemann)

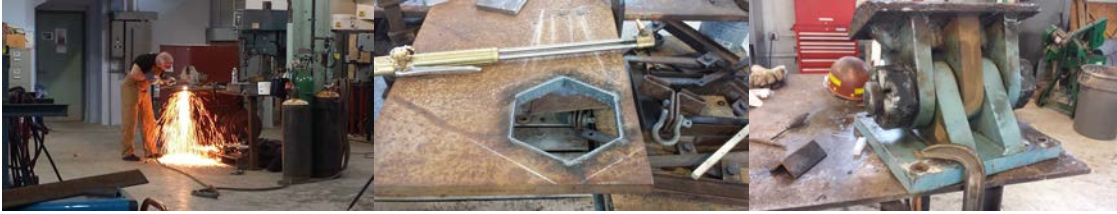
July 2014: Supervisor Bridge Repairer and Riveter Steve Havemann Fabricating a Wrench to Remove Nuts From a Seized Rocker Bearing.

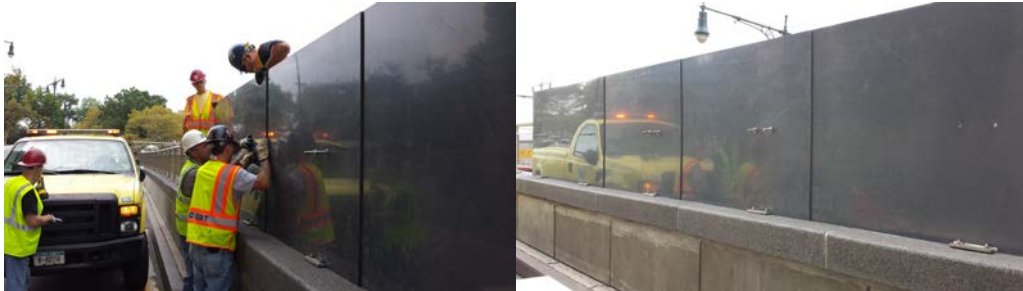
August 2014: Carpenters Stephen Buckley and William Sic, Supervisor Carpenter Joseph Vaccaro (in White Hard Hat), and Carpenters Gregory Nolan and Edward Alfano Jr. Testing the Installation of Polyvinyl Chloride Protection Boards Around the West Street Portal of the Battery Park Underpass. These Would be Placed in the Event the Coastal Storm Plan is Activated. (Credit: Paul Schwartz)
