**School Safety Engineering Project**

**FINAL REPORT: P.S. 124, Yung Wing School, Manhattan**

**Prepared by  
The RBA Group/Urbitran Associates**

**SEPTEMBER 29, 2006**

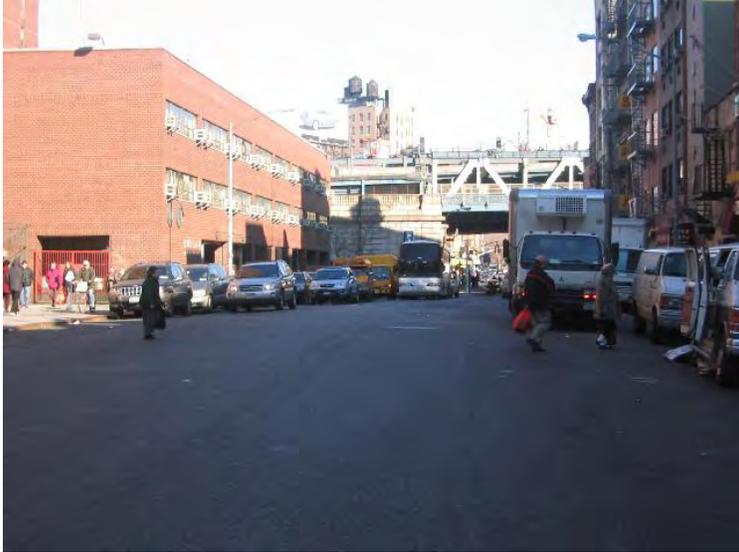
*Figure 1: Looking east on Division Street*

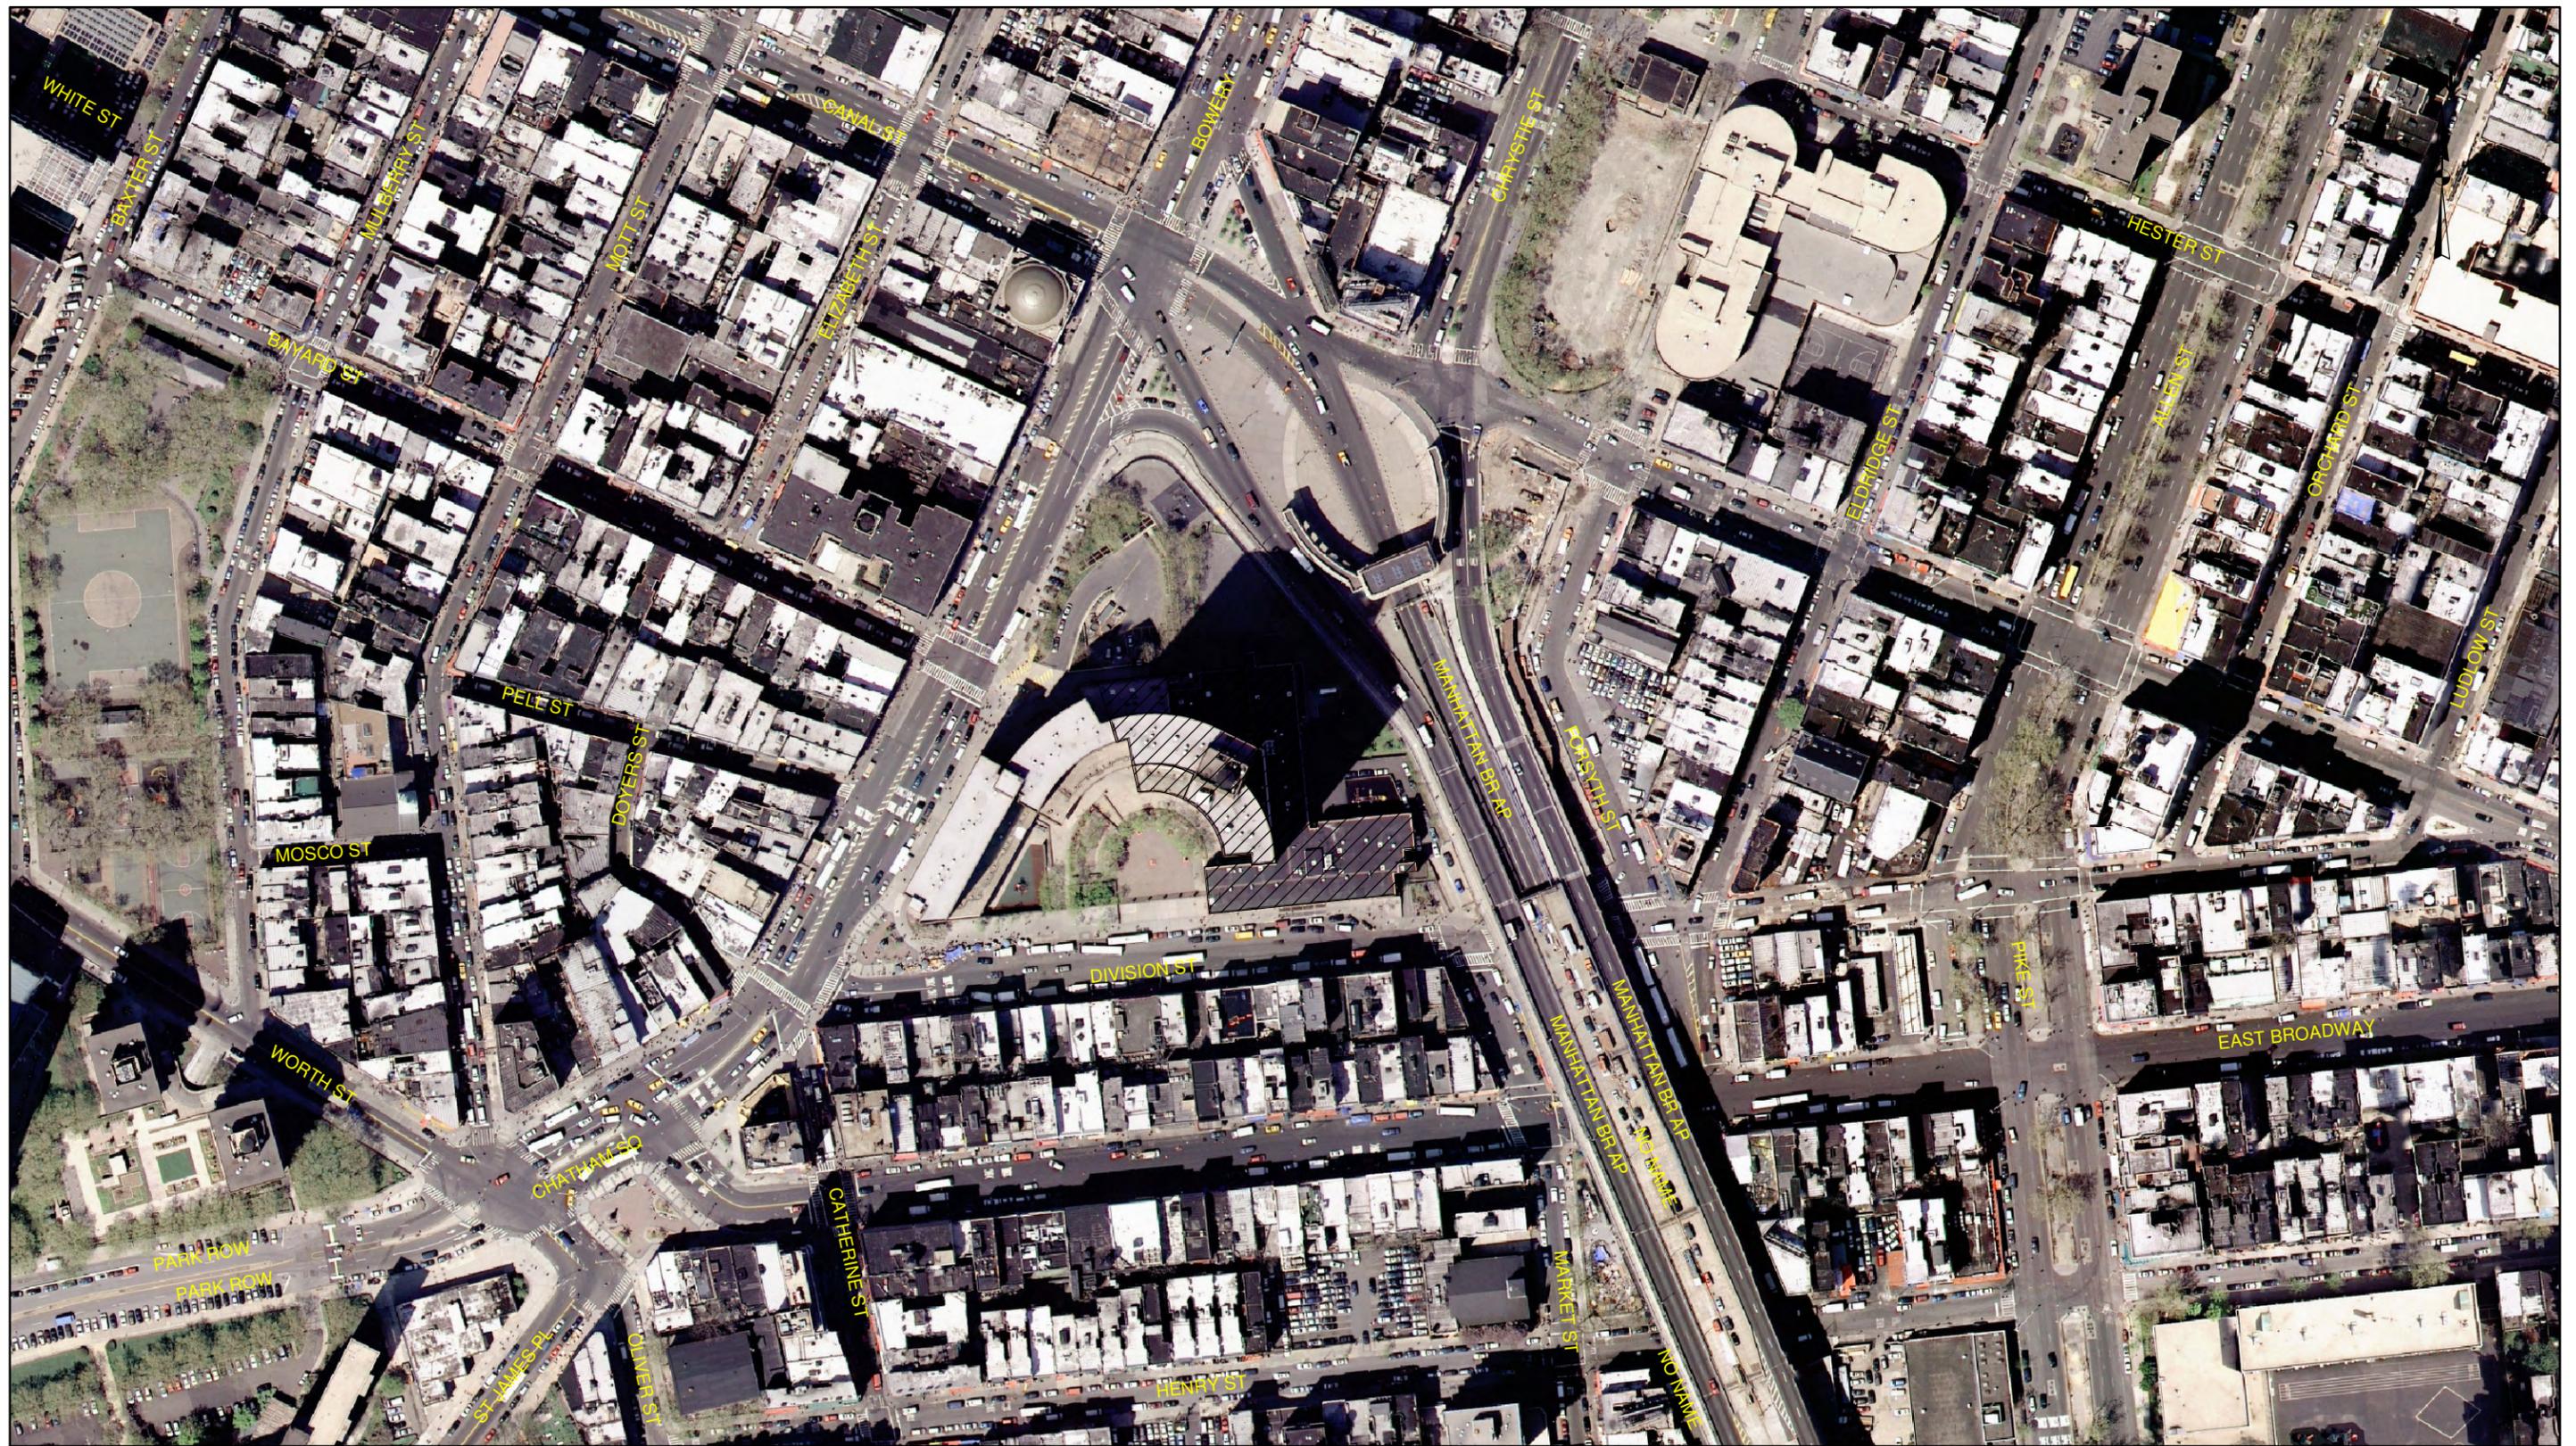
**EXHIBIT 1**  
**P.S. 124, MANHATTAN**  
**YUNG WING SCHOOL**  
**AERIAL PHOTOGRAPH**

1 inch equals 175 feet

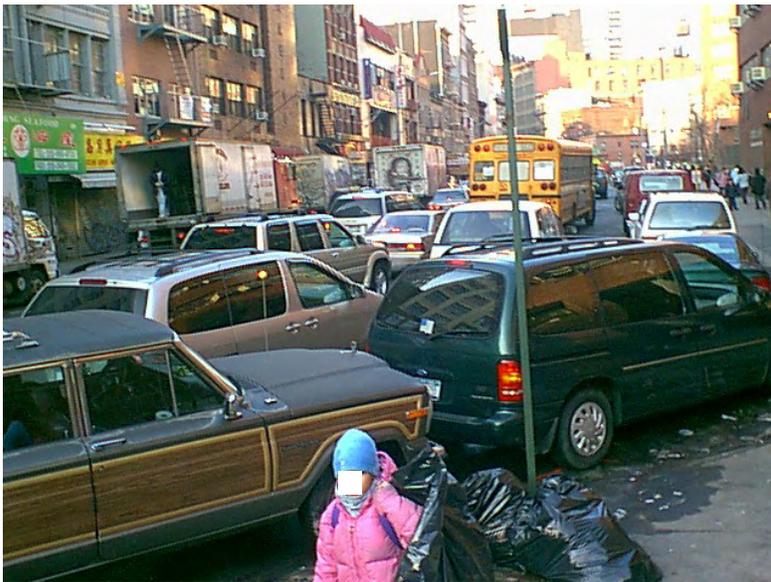
*Figure 2: Morning arrival time at P.S. 124.*

Although school representatives noted that only about five percent of P.S. 124 students are dropped off by parents or guardians, field observations taken on the morning of February 10, 2004, indicated that approximately twice that many, or about 100 students, were dropped off at the school. During the morning arrival period, it was not uncommon that private vehicles and school buses were parked or standing four abreast at the entrance to the school, as students disembarked from buses or emerged from private vehicles (see Figures 2, 3, and 4). Division Street is at times reduced to a single moving lane, as trucks, buses, and private vehicles double-, triple-, and quadruple-park in front of P.S. 124.

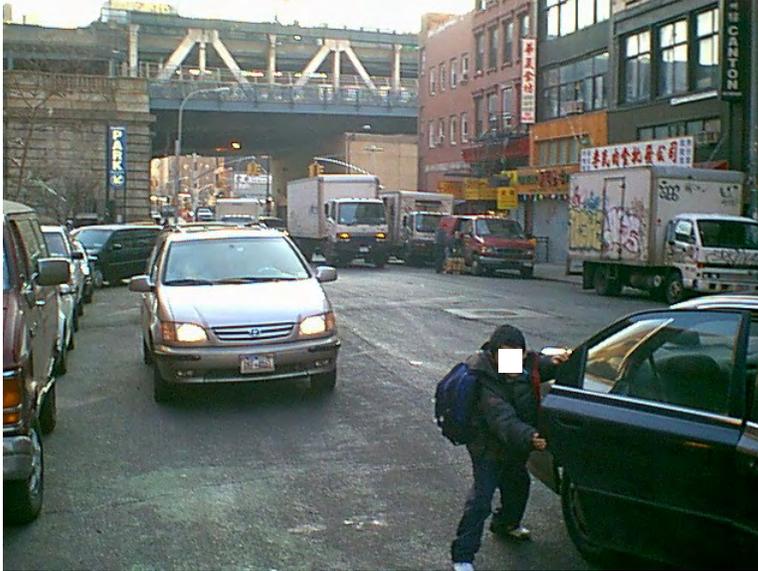
*Figure 3: A young student emerges from a private car in front of the school's main entrance*

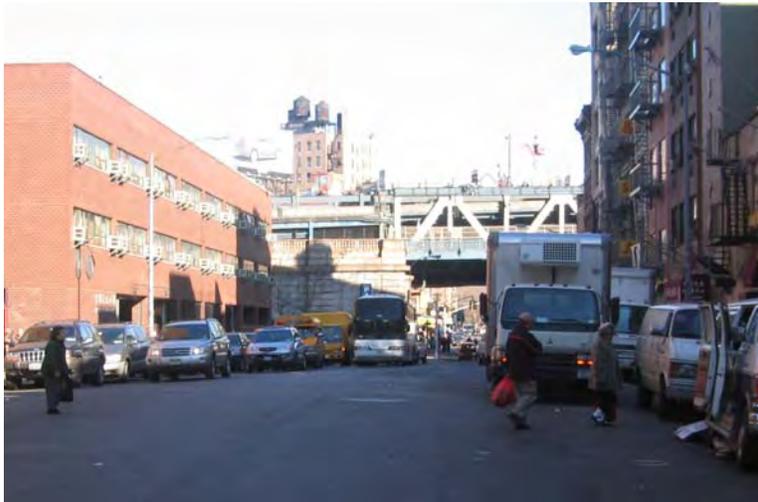
*Figure 4: Looking east on Division Street. Vehicles double- and triple-park in front of P.S. 124, and are double-parked on the south side of Division Street.*

It is recommended that all buses assigned to P.S. 124 load and unload students at a designated school bus area in front of the Division Street entrance. The installation of “No Standing 7AM - 4 PM, School Days” signs should be installed for a length of 60 feet in front of the school’s main entrance to provide sufficient frontage for school buses to drop off and pick up students. The existing teacher parking now located in front of the school's main entrance should be relocated to the west of the No Standing Zone (see Exhibit 8).

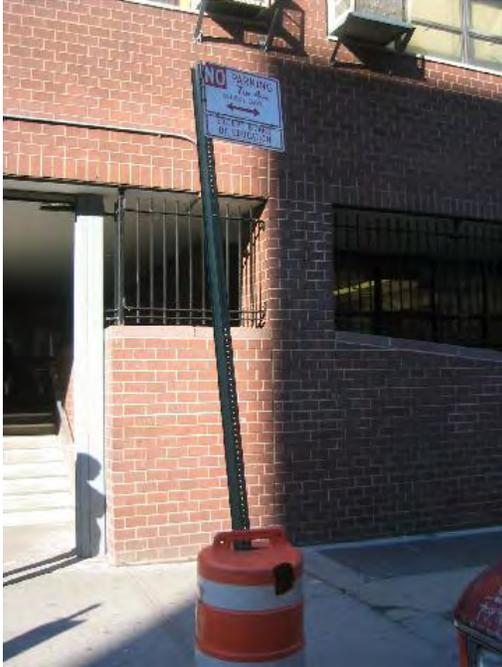
*Figure 5: Parking restriction sign in front of P.S. 124*

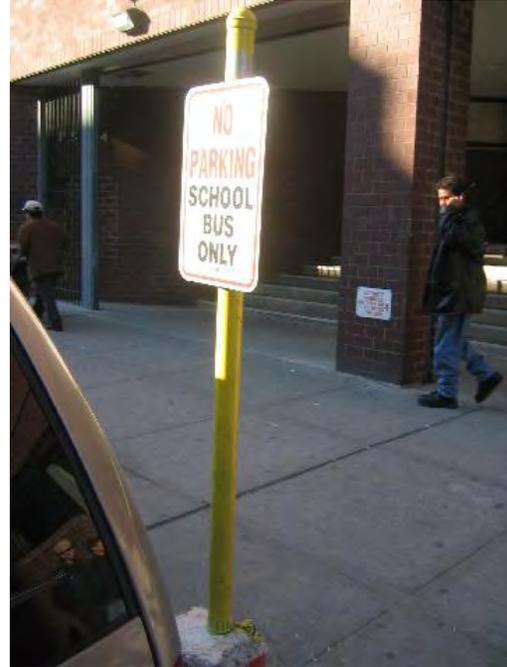
*Figure 6: Temporary parking restriction sign in front of P.S. 124*

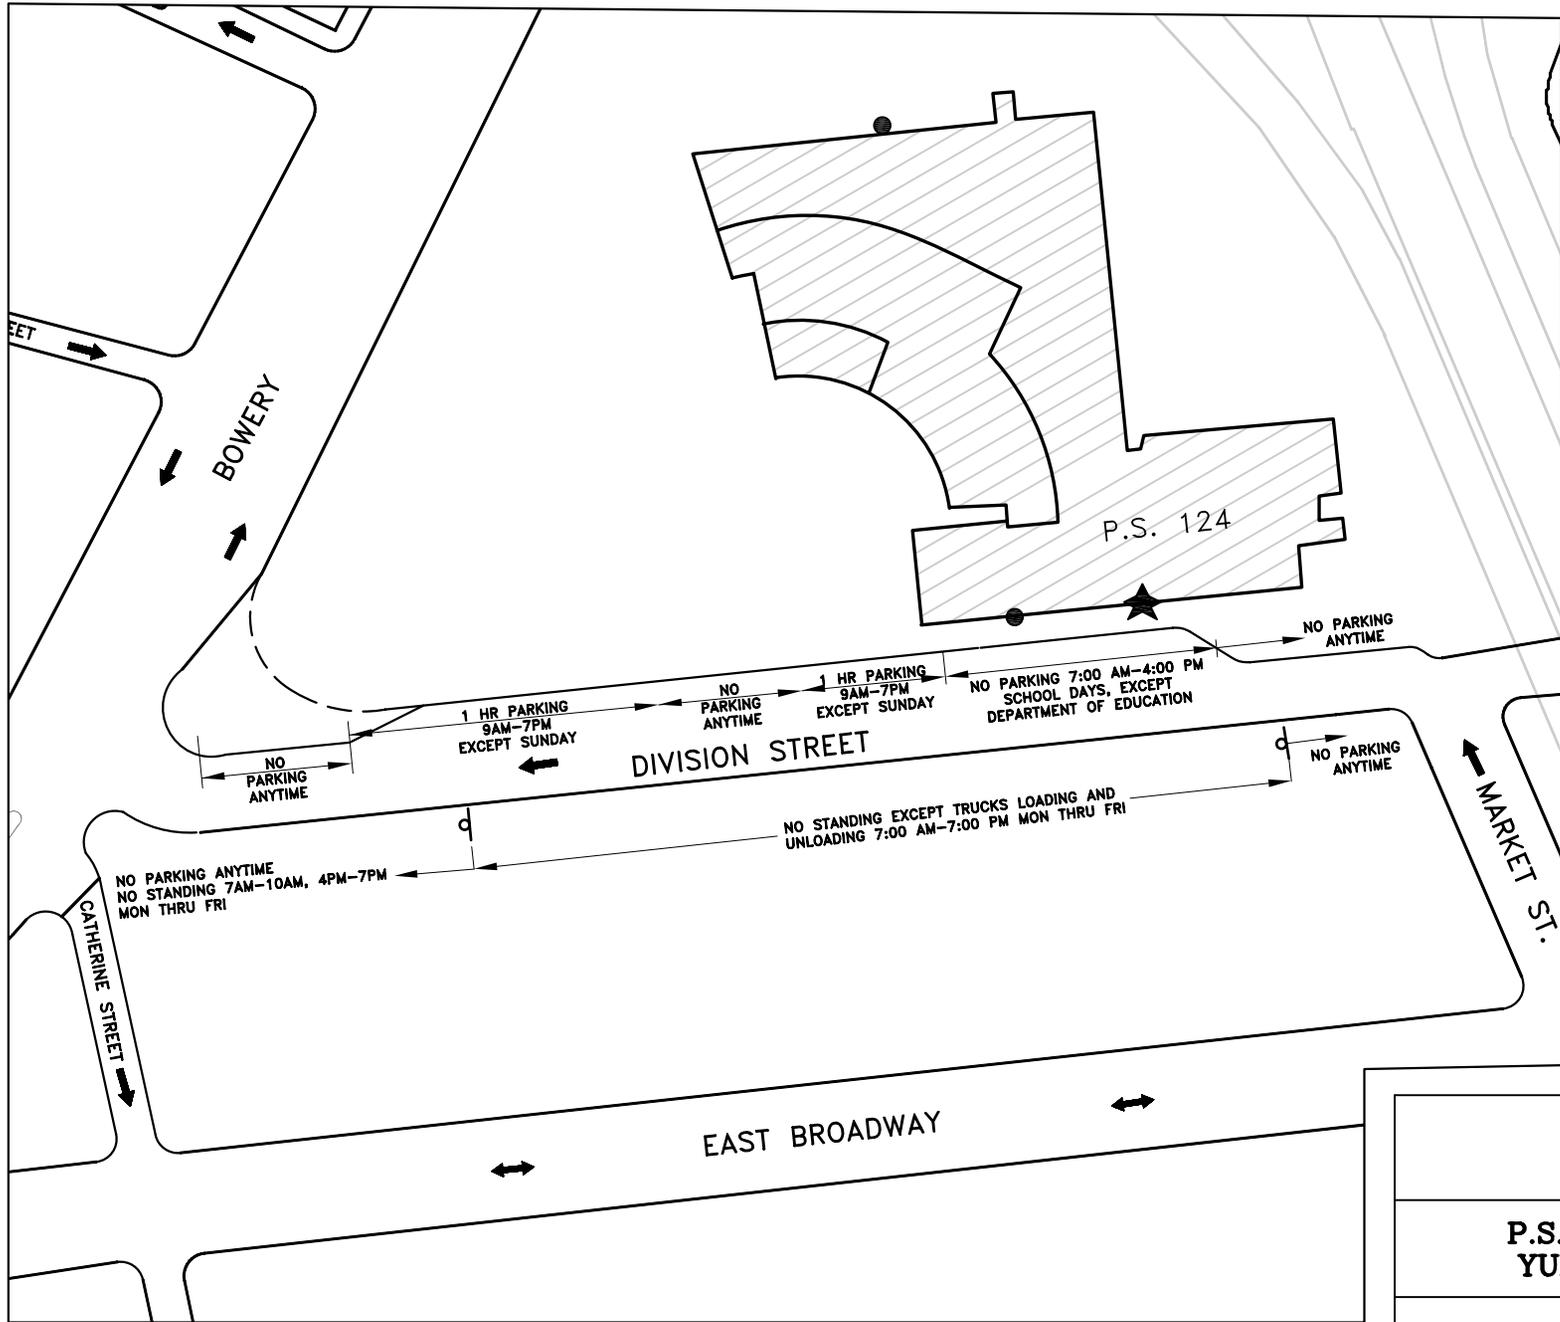
**EXHIBIT 5**

Parking regulations on the south side of Division Street are posted as “NO STANDING EXCEPT TRUCKS LOADING AND UNLOADING.”

On the north side of Division Street in front of P.S. 124 “NO PARKING, SCHOOL DAYS, 7 AM - 4 PM, EXCEPT FOR BOARD OF EDUCATION” signs are posted. Further west, “NO PARKING ANYTIME” regulations are posted, and a “NO STANDING ANYTIME” sign is posted in the vicinity of the intersection with Bowery. See Exhibit 5 for a map of parking regulations on Division Street.

**PARKING REGULATIONS**

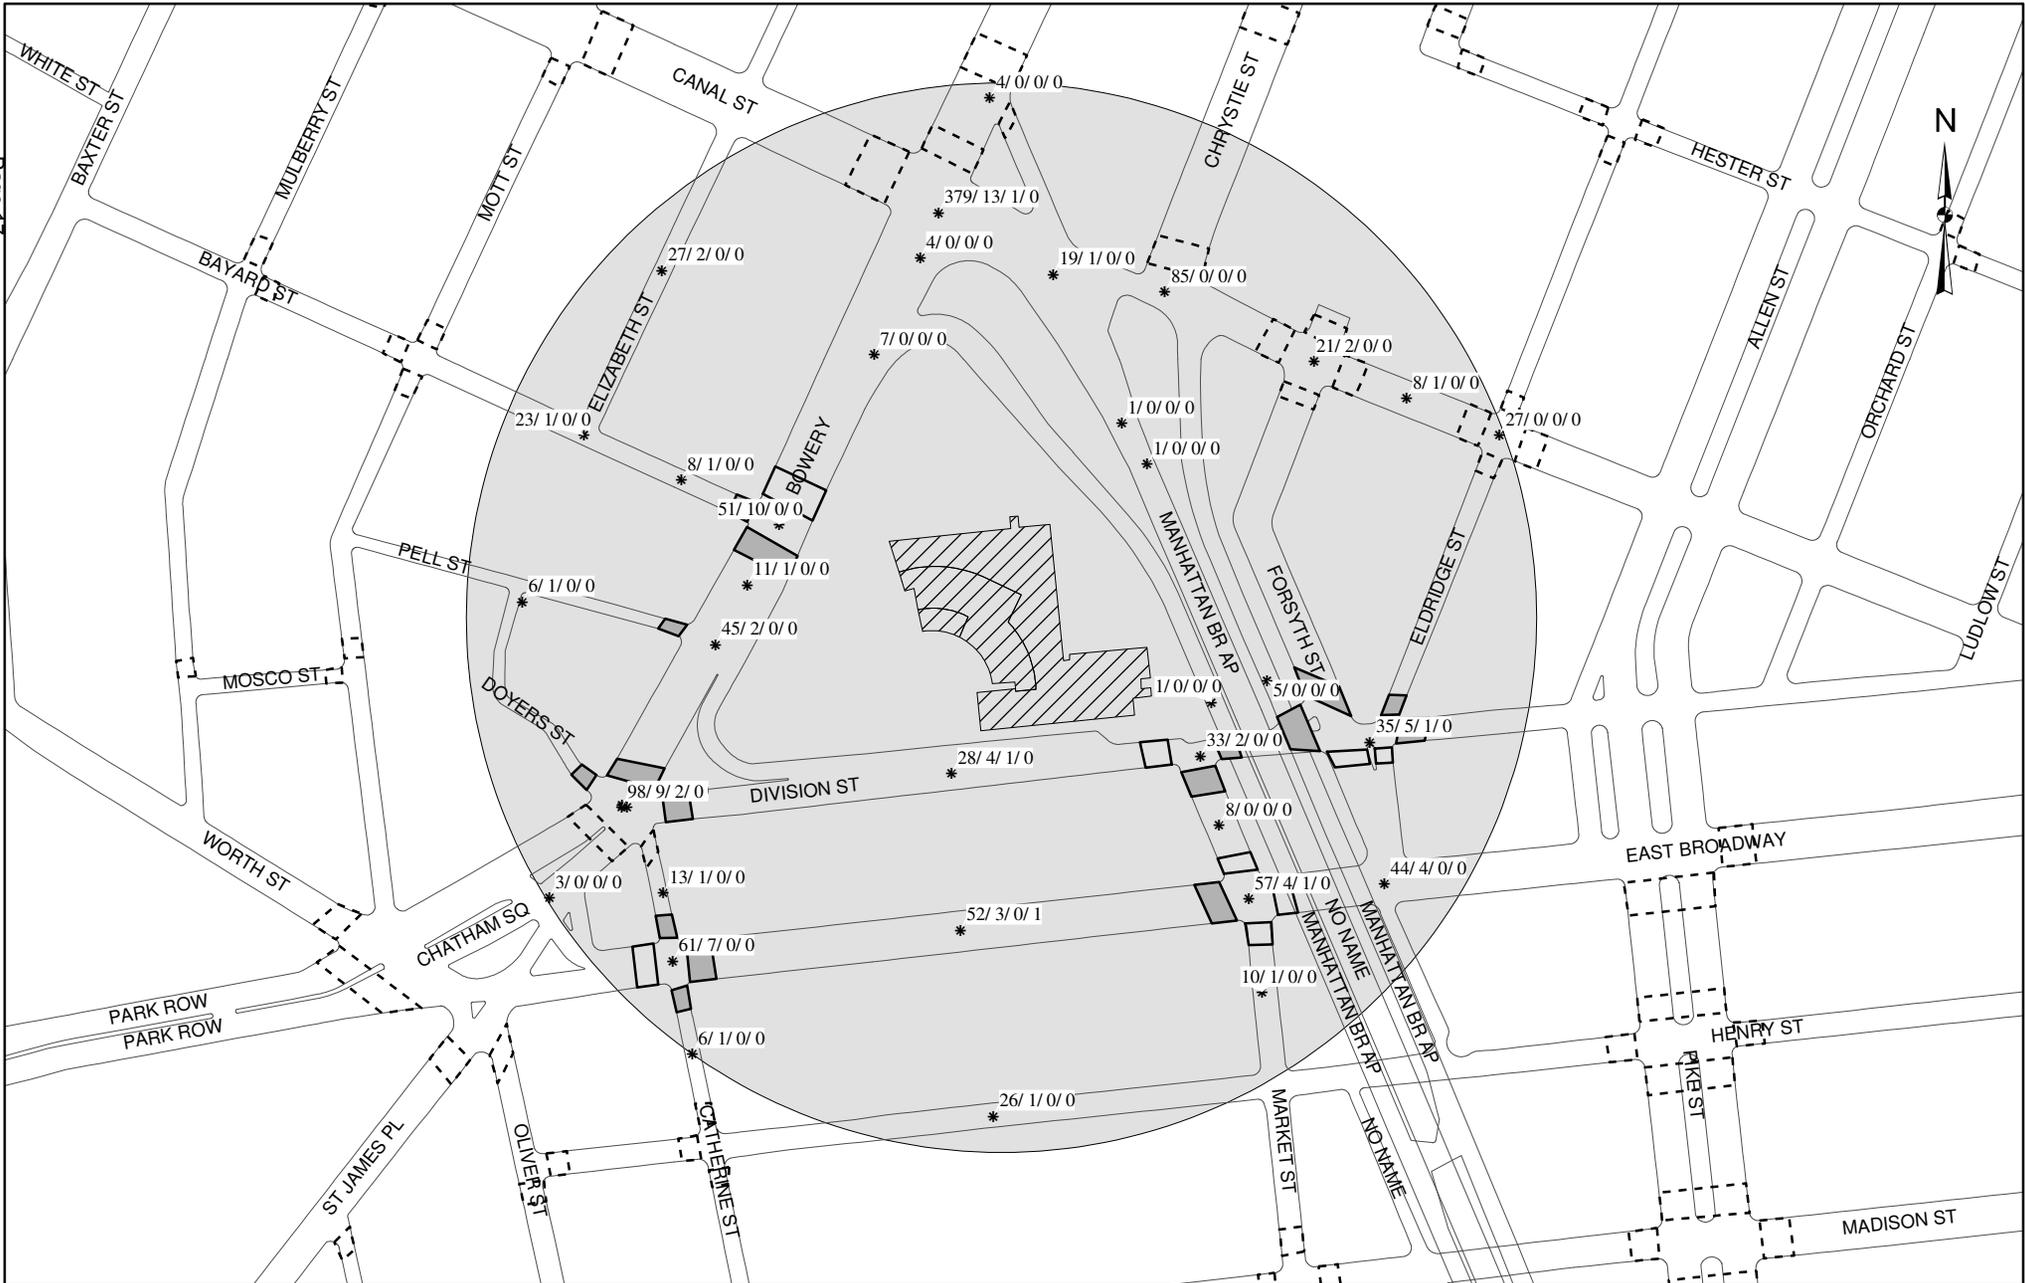
**EXHIBIT 6**

Exhibit 6 and Table 2 show a summary of accidents, as obtained from the New York State Department of Motor Vehicles (DMV), in the vicinity of P.S. 124 for the three-year period from January 1, 1998 through December 31, 2000. The DMV data provides some detail relating to the circumstances and cause of the accidents. Table 3 is a summary of more recent accident data obtained from the NYC Police Department (NYPD). Though current through 2004, the NYPD data does not provide the same level of detail as the DMV data.

**ACCIDENT SUMMARY  
THREE YEAR PERIOD  
(1998-2000)**

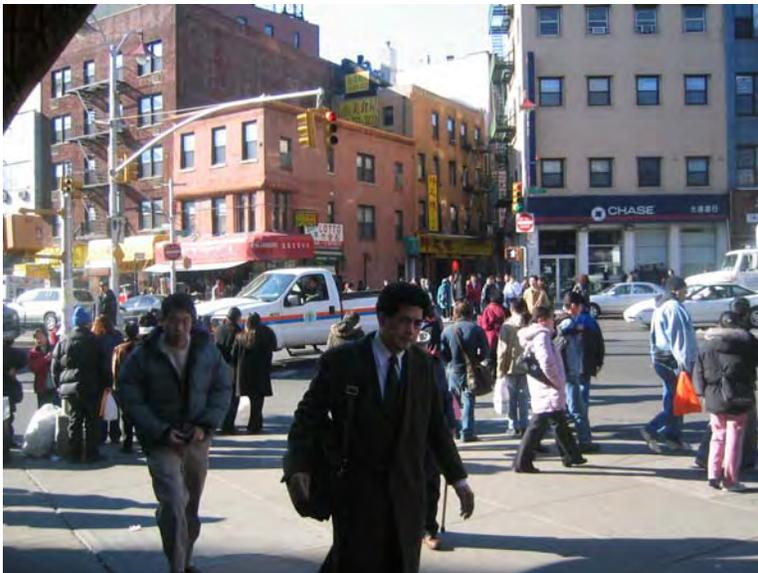
This is a six-way signalized intersection that has high volumes of both vehicular and pedestrian traffic. This intersection has been reconfigured as part of the Chatham Square reconstruction project, DDC Contract No. HWM 780. Chatham Square was reconstructed in 2000. It should be noted that the existing TSP (Traffic Safety Plan, Exhibit 3) shows the old intersection geometry and does not show the new alignment of curbs and crosswalks. However, the newly constructed intersection geometry, sidewalks and curb extensions are illustrated in Exhibit 8.

With the recent construction, the uncontrolled right turn from Division Street northbound onto Bowery has been eliminated by removing the turn lane, bringing right-turning vehicles to the signalized intersection, and providing a right turn-only signal phase for this movement. To avoid a conflict point between right-turning vehicles and pedestrians crossing Bowery, the pedestrian crossing has been eliminated. Pedestrians wishing to cross between the west side of Bowery and the northeastern corner of Division Street cross from Bowery to the southeastern corner of Division Street, and then continue, in the next signal phase, to the north side of Division Street. There are school crosswalks on the east and south legs of the intersection.

*Figure 7: Looking west on Division Street at Bowery*

This intersection has been the site of 98 accidents between 1998 and 2000, including nine pedestrian accidents, of which two were fatal. According to accident data, one victim was a 33-year-old pedestrian who was crossing against the signal when struck by a southbound left-turning vehicle. The second fatality occurred when a 70-year-old pedestrian crossed the street against the signal outside of the marked crosswalk area.

Remove the existing “NEW- NO TURN” sign from the signal pole, and replace it with a “NO LEFT TURN” sign for vehicles traveling south on Bowery. This sign should be placed on the same signal pole, but not higher than seven feet from the top of the median. Prohibiting this movement will eliminate the pedestrian-vehicle conflict point between pedestrians crossing Catherine Street and southbound left turning vehicles from Bowery (see Exhibit 8).

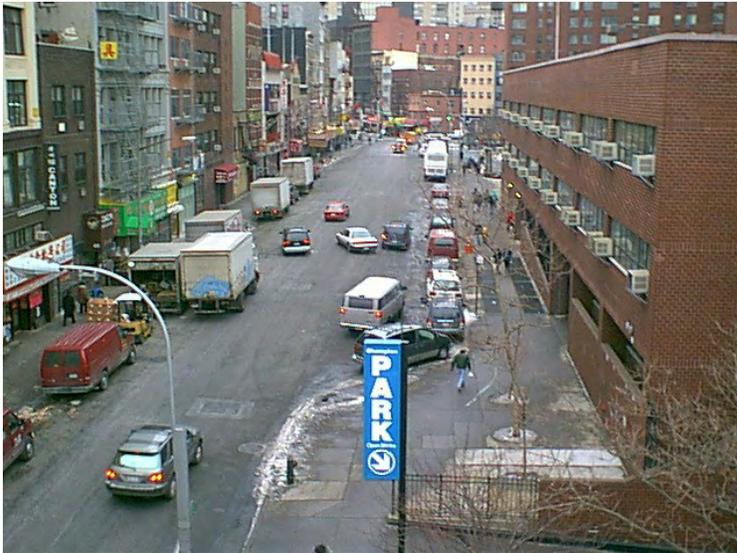
This is a signalized T-intersection that is utilized by a large number of P.S. 124 students en route to school. Division Street is a one-way (westbound) street that varies in width from 30 feet at the intersection to 50 feet in front of P.S. 124. Because of the high level of commercial activity, trucks routinely double-park on the south side of Division Street for loading and unloading activities. Restrictions on the south side of the street limit parking to trucks loading and unloading. On the north side, vehicles double- and triple-park in front of the school when dropping off students at the school in the morning. As described previously, tour buses lay over on the north side of Division Street adjacent to Confucius Plaza.

*Figure 8: Looking west on Division Street in front of P.S. 124 from the Manhattan Bridge*

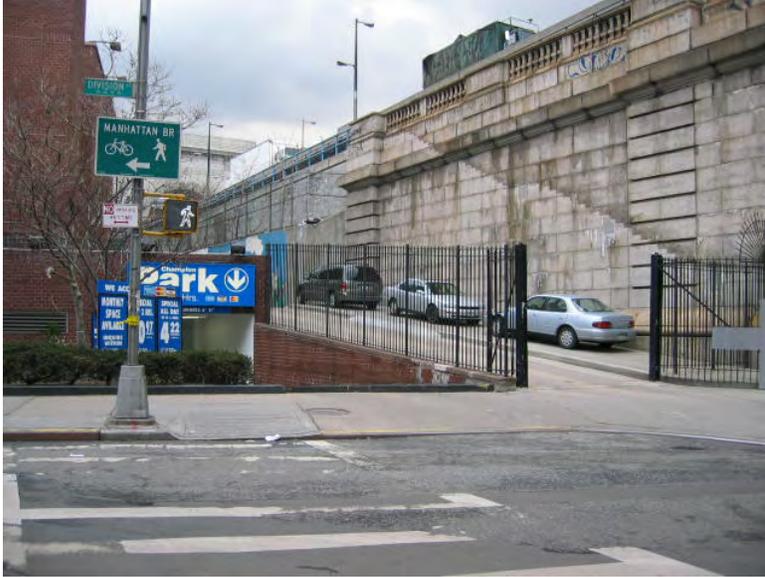
The intersection is adjacent to the Manhattan Bridge approach, and all traffic from Market Street must turn left onto Division Street. Immediately to the east of the school, and forming part of the Confucius Plaza complex, are an underground commercial parking garage and an above-ground parking lot used by P.S. 124 teachers (see Figure 9). Driveways for both of these parking facilities are located immediately opposite the three-way intersection with Market Street. There are curb cuts for both facilities on the north side of Division Street. While there are relatively few above-ground parking spaces, there are a significant number of users of the underground parking garage, and a car exiting the garage may block the sidewalk as pedestrians and schoolchildren are going to or from P.S. 124.

*Figure 9: Entrance to parking garage and parking ramp on Division Street at Market Street.*

It is recommended that the owners of the Confucius Plaza underground parking garage install a mirror and stop sign so that vehicles exiting the parking garage on Division Street at Market Street are required to stop before driving onto the sidewalk.

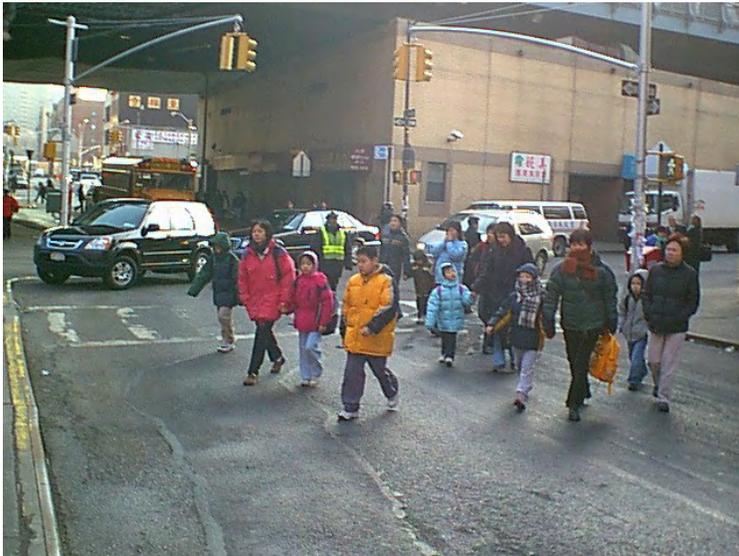
A total of 33 accidents occurred at this intersection during the 1998 – 2000 study period. Two accidents involved pedestrians. One pedestrian was struck while crossing against the signal. The second pedestrian was crossing with the signal when struck by a vehicle improperly backing up.

*Figure 10: Division Street at Market Street during morning rush hour*

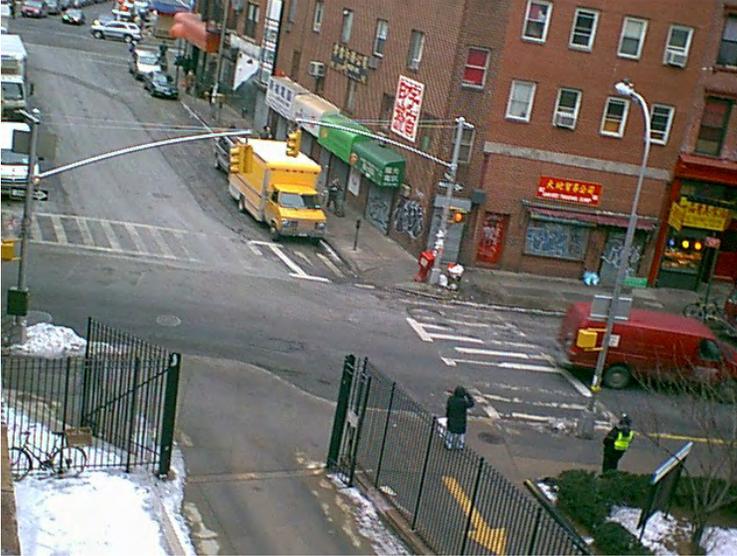
In addition, 28 accidents occurred on Division Street between Market Street and Bowery during the 1998 - 2000 study period. Four pedestrians were struck, and one pedestrian was killed, during this period. All four accidents are attributed to pedestrians crossing at areas not marked for pedestrian crossings.

Figure 11: Division Street at Market Street (looking from the Manhattan Bridge)

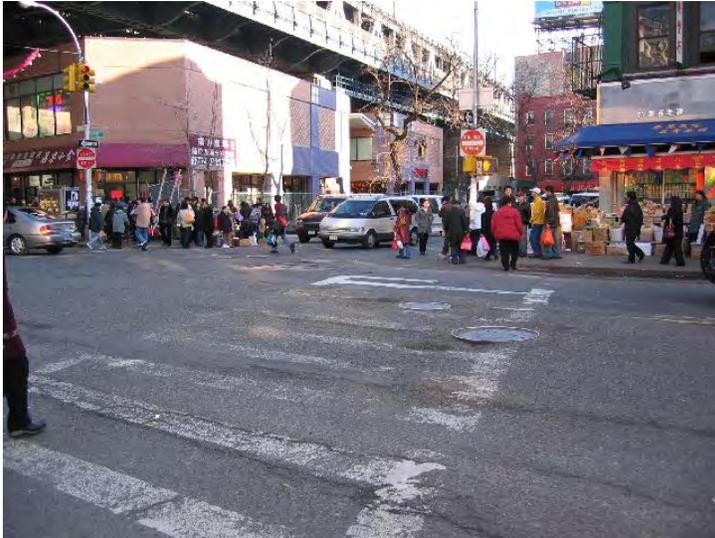
The East Broadway-Market Street intersection is a four-way signalized intersection. East Broadway is a 52-foot wide, two-way (east-west) street with two travel lanes in each direction and parking on both sides. There is a school crosswalk on the west leg of the intersection. Because of numerous retail stores and other activities along Market Street and East Broadway, this intersection is utilized by many pedestrians traveling in all directions.

A total of 57 accidents occurred during the 1998-2000 study period, including four that involved pedestrians. One pedestrian was killed during this period. According to the accident data, the pedestrian was not in the roadway when struck by a northbound vehicle; the accident was attributed to driver error and wet roadway conditions. The second accident occurred when a pedestrian who was crossing with the signal was struck by a driver that failed to yield to the pedestrian. Two other accidents were the result of pedestrians crossing against the signal.

*Figure 12: Looking east on East Broadway at Market Street (looking south on Market Street)*

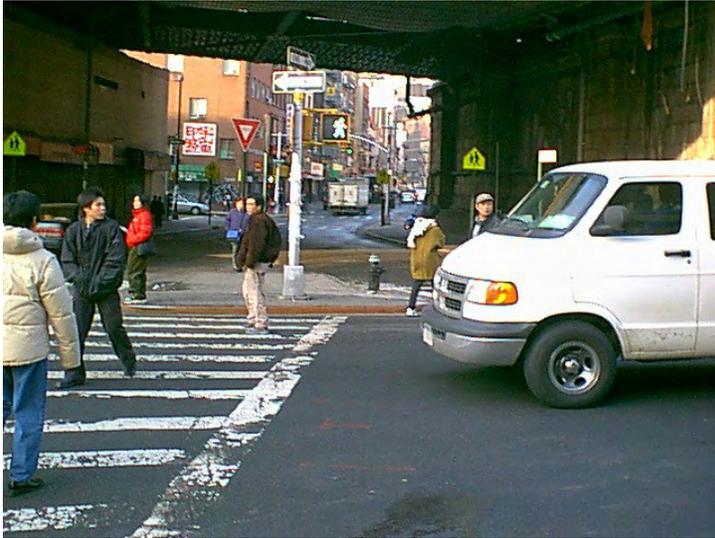
This is a five-way intersection where Forsyth Street, Eldridge Street, and Division Street meet. Forsyth Street is a 45-foot wide, one-way (southbound) street with two travel lanes and parking on both sides. Forsyth Street becomes a two-way street south of Division Street. Eldridge Street is 20-foot wide, one-way (northbound) street with one travel lane and parking on both sides. There are school crosswalks on all legs of the intersection.

This intersection was the site of 35 accidents during the 1998 - 2000 study period. Five pedestrians were struck, and one pedestrian was killed, during this time period. According to accident data, an 80-year-old pedestrian was struck and killed by a northbound vehicle; the primary cause of this accident was the driver's obstructed view. Another pedestrian was hit while crossing with the signal. All other pedestrian accidents were attributed to pedestrian error with pedestrians crossing against the signal or outside of marked pedestrian crosswalks.

*Figure 13: looking west on Division Street at Forsyth Street*

It is also recommended that the existing island dividing Forsyth Street (south of Division Street) be widened to increase its capacity for pedestrian storage and to shorten the crossing distance for pedestrians.

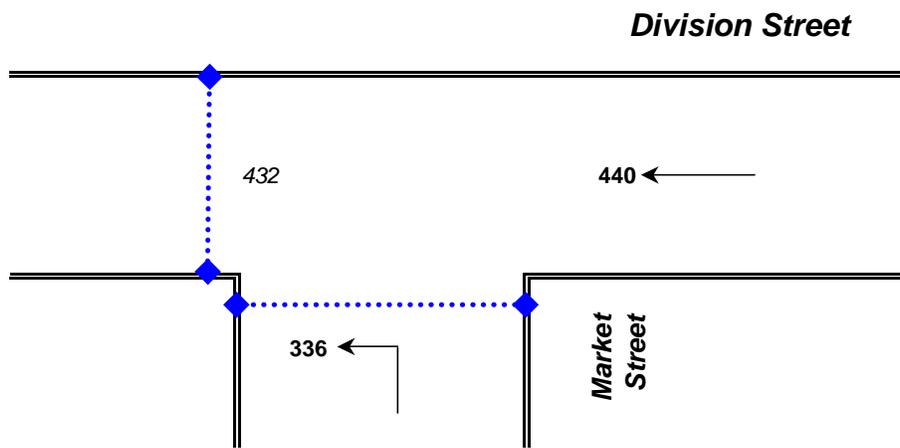
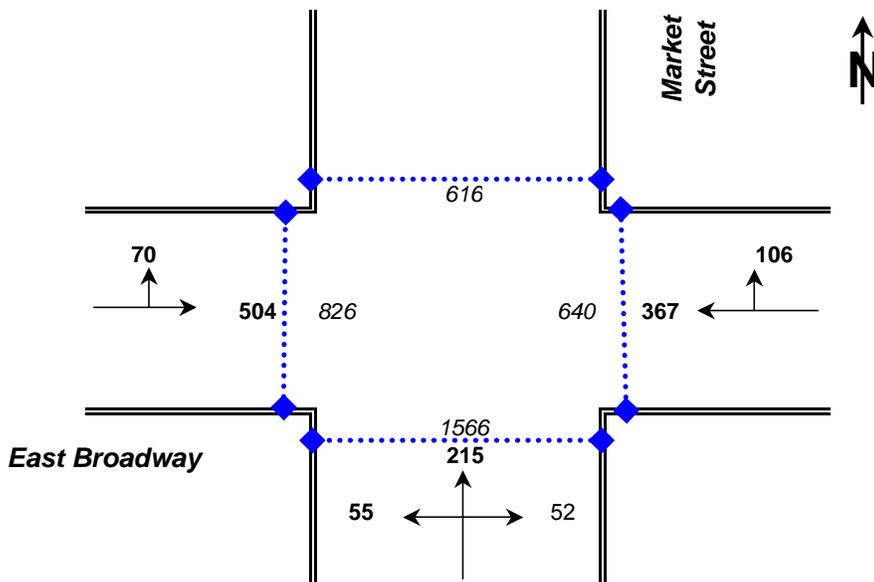
EXHIBIT 7A
P.S. 124 YUNG WING SCHOOL
TRAFFIC COUNTS

A traffic count was conducted at the intersection on September 19, 2005 to better understand vehicle/pedestrian conflicts at this intersection. A total of 3,648 pedestrians crossed at this intersection between 2:30 p.m. and 3:30 p.m. At the same time, 1,369 vehicles utilized this intersection (see Exhibit 7A and Appendix for details). During field data collection efforts, many pedestrians were observed disregarding traffic rules, crossing against the signal and outside of the marked pedestrian crosswalk.

*Intersection of Division Street and Market Street - (7:30 AM - 8:30 AM May 10, 2005)*

*Intersection of East Broadway and Market Street - (2:30 PM - 3:30 PM, September 19, 2005)*

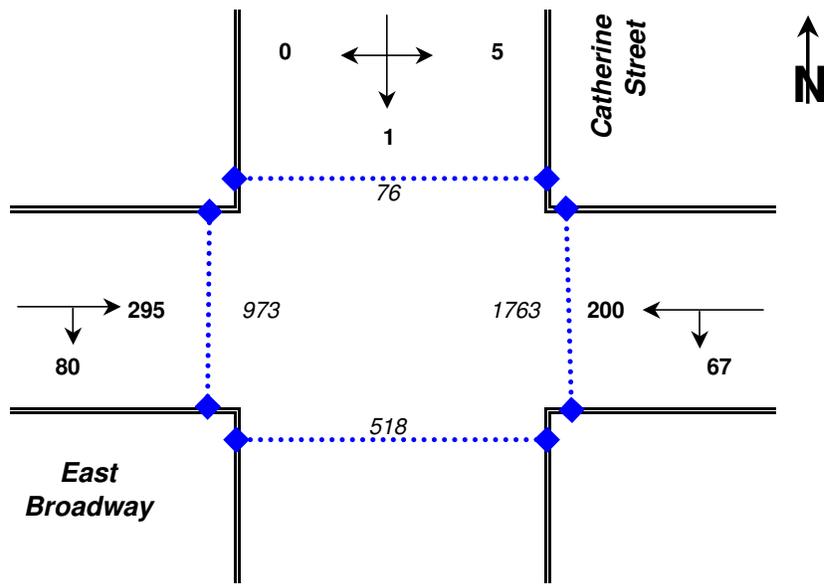
<b>EXHIBIT 7B</b>
<b>P.S. 124 YUNG WING SCHOOL</b>
<b>TRAFFIC COUNTS</b>

*Intersection of East Broadway and Catherine Street - (2:30 PM - 3:30 PM, September 19, 2005)*

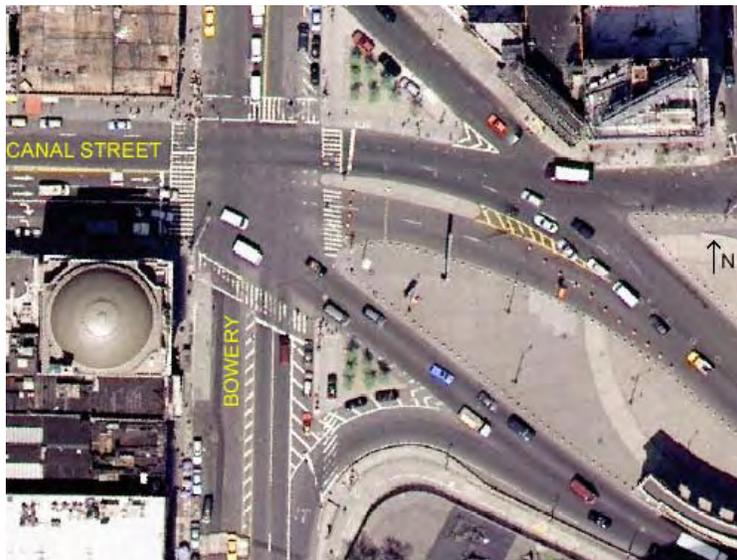
This is a very heavily traveled intersection as it serves as the entrance to the Manhattan Bridge. West of Bowery, Canal Street has two lanes traveling westbound with parking permitted along the north curb. East of Bowery, Canal Street is divided to facilitate vehicles entering and exiting the Manhattan Bridge (see Figure 14). There is no parking permitted on Canal Street between Bowery and Chrystie Street.

*Figure 14: Intersection of Canal Street and Bowery*

The accident data from 1998-2000 indicates that there were 379 accidents at this intersection; 13 of these involved pedestrians, one of which was fatal. An 87-year-old pedestrian was crossing against the signal while the driver was traveling east. Most of the accidents at this intersection occurred while the pedestrian was crossing against the signal; two were caused by drivers reversing their vehicles.

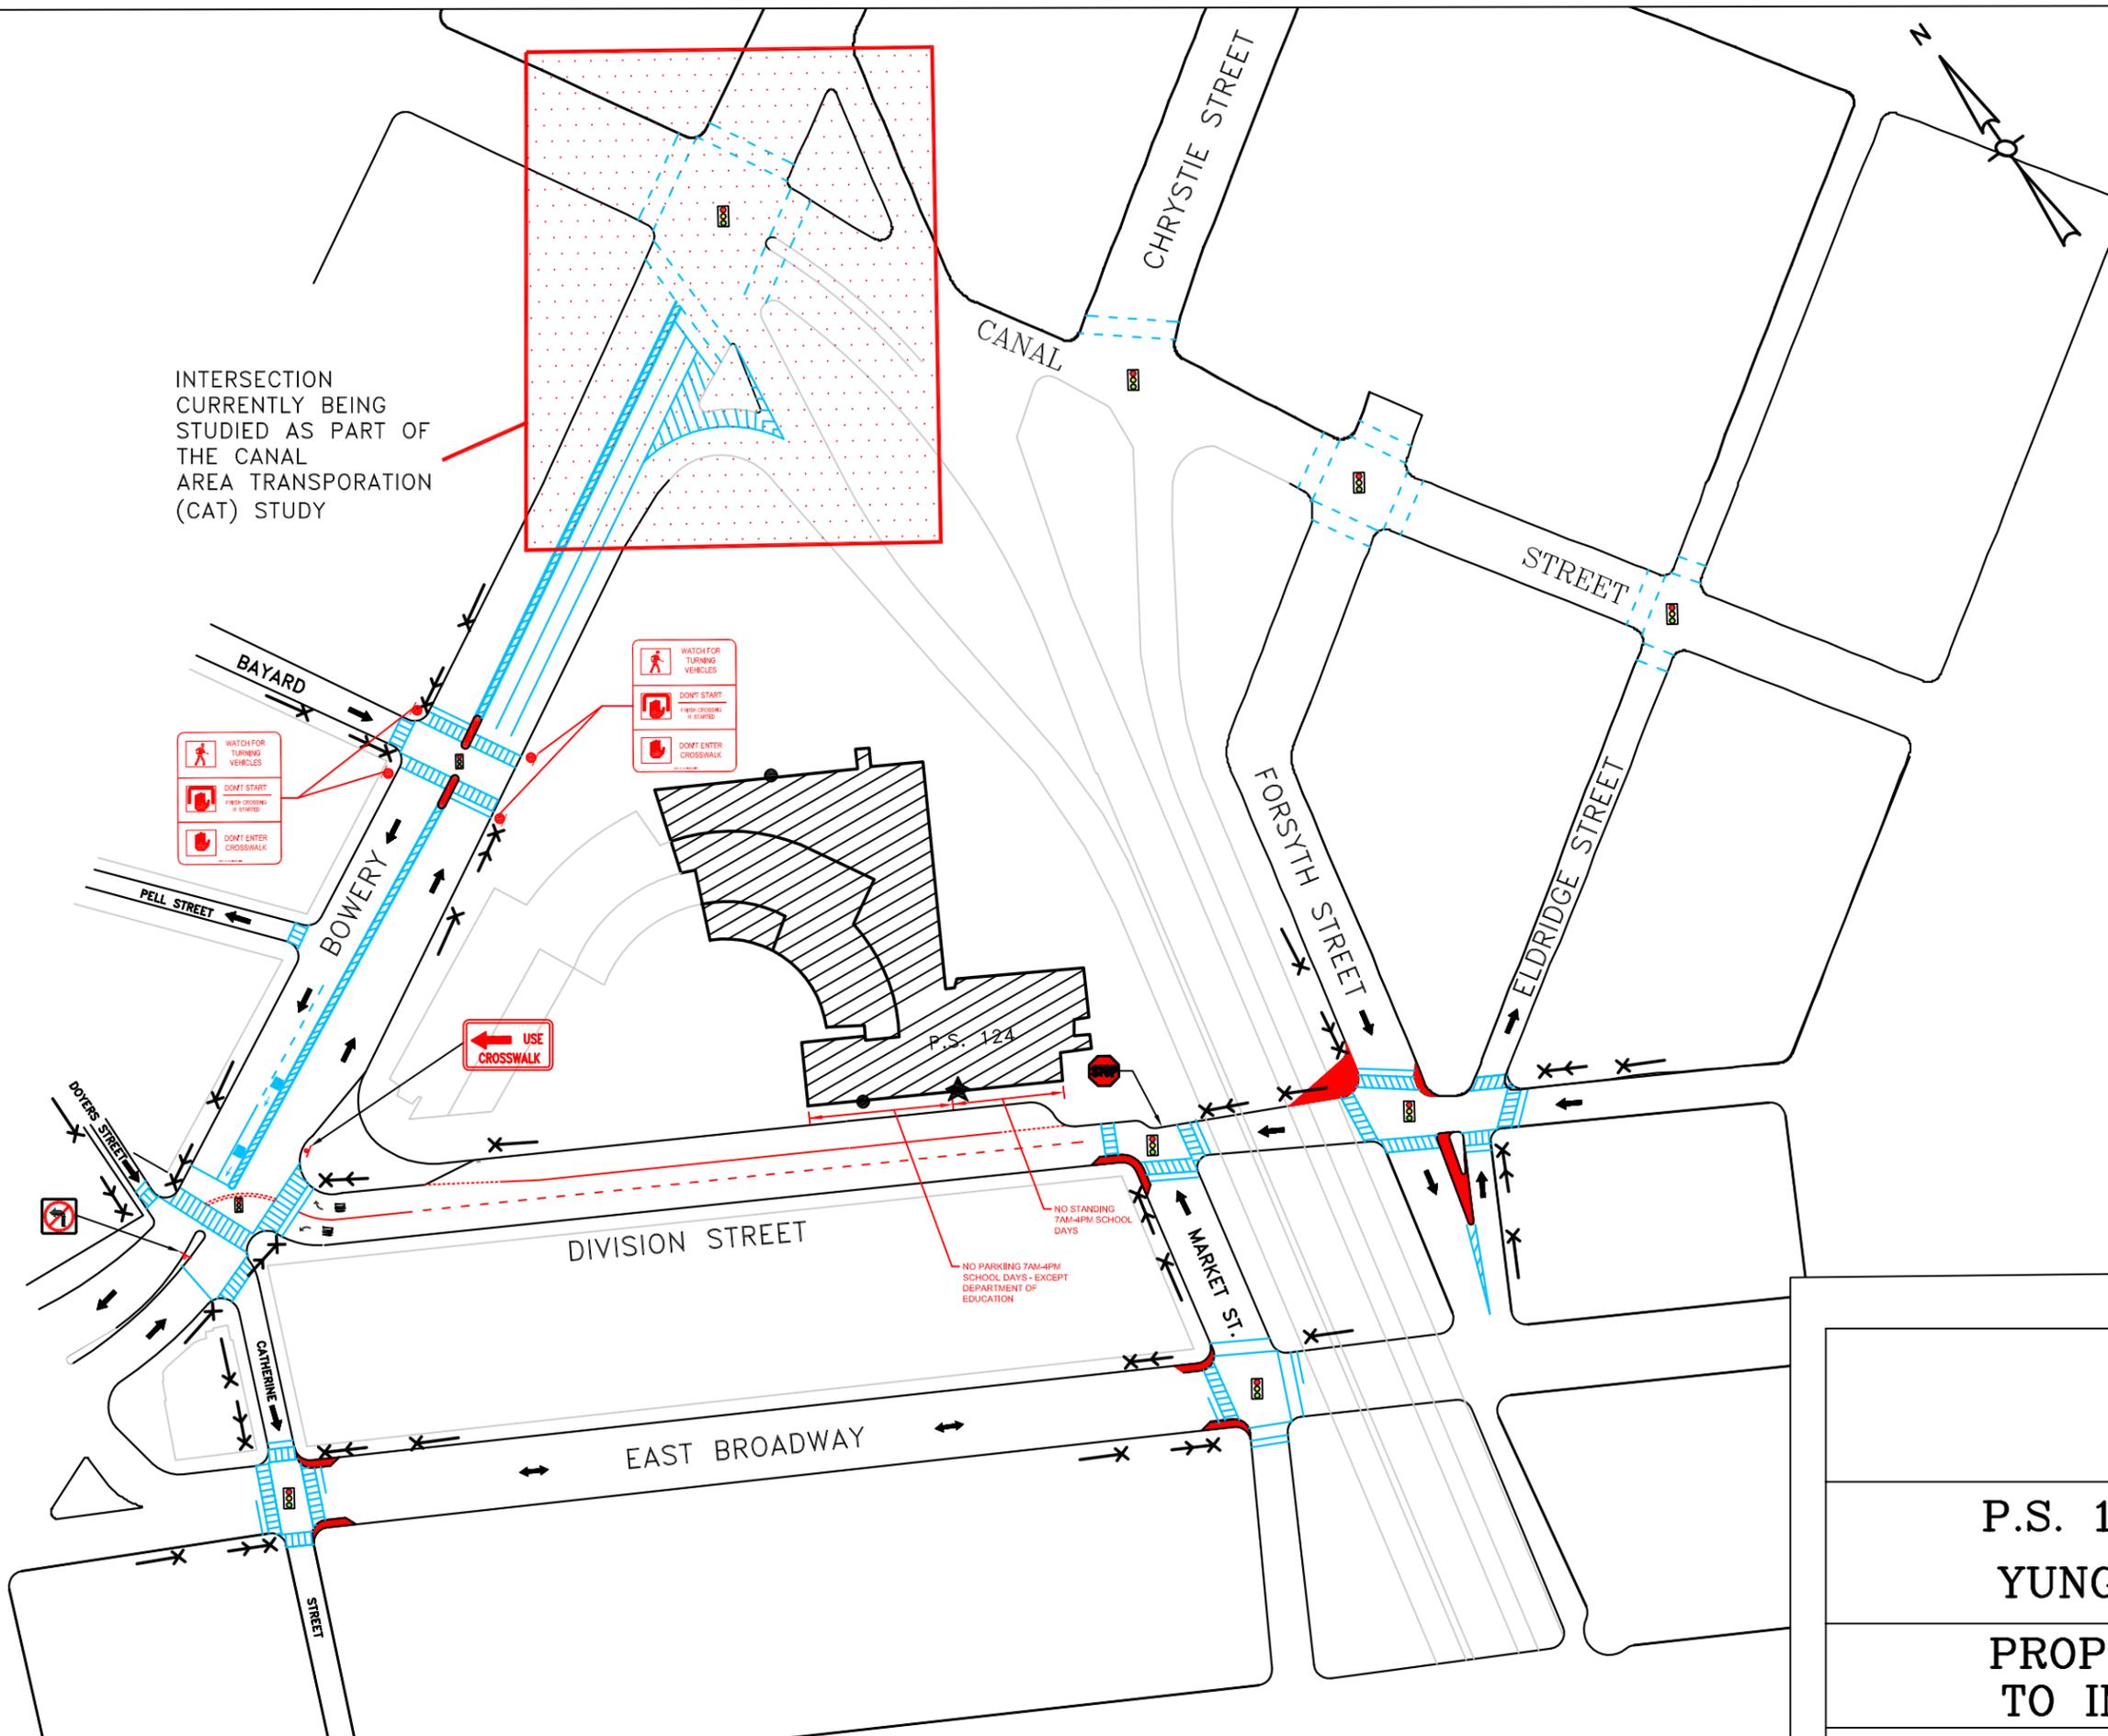
**P.S. 124, MANHATTAN  
YUNG WING SCHOOL  
PROPOSED MEASURES  
TO IMPROVE SAFETY**

INTERSECTION CURRENTLY BEING STUDIED AS PART OF THE CANAL AREA TRANSPORTATION (CAT) STUDY

Division Street does not currently have pavement markings that delineate the appropriate vehicle travel path. It is therefore recommended that NYCDOT install pavement markings as indicated on Exhibit 8 and the Appendix.

To improve safety conditions for pedestrians crossing at Bowery and Bayard Street, raised concrete medians should be considered. The raised medians will replace existing striped medians provided that the Final Design confirms that construction of the recommended medians would be feasible and would not interfere with traffic operations (See Exhibit 8).
