NEW YORK CITY DEPARTMENT OF TRANSPORTATION

School Safety Engineering Project

FINAL REPORT: P.S. 72, East Harlem Technical, Manhattan

NOVEMBER 17, 2006

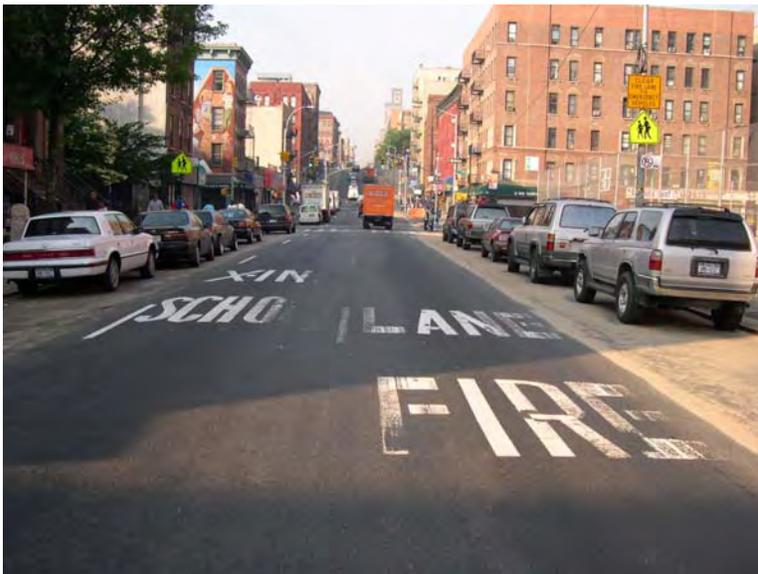
Figure 1: Lexington Avenue in front of P.S. 7 (looking south)

The surrounding land use is a mixture of four to six story residential apartment buildings, brownstones, and single story commercial establishments. Many of the larger residential buildings on East 104th and East 105th Street have first floor retail.

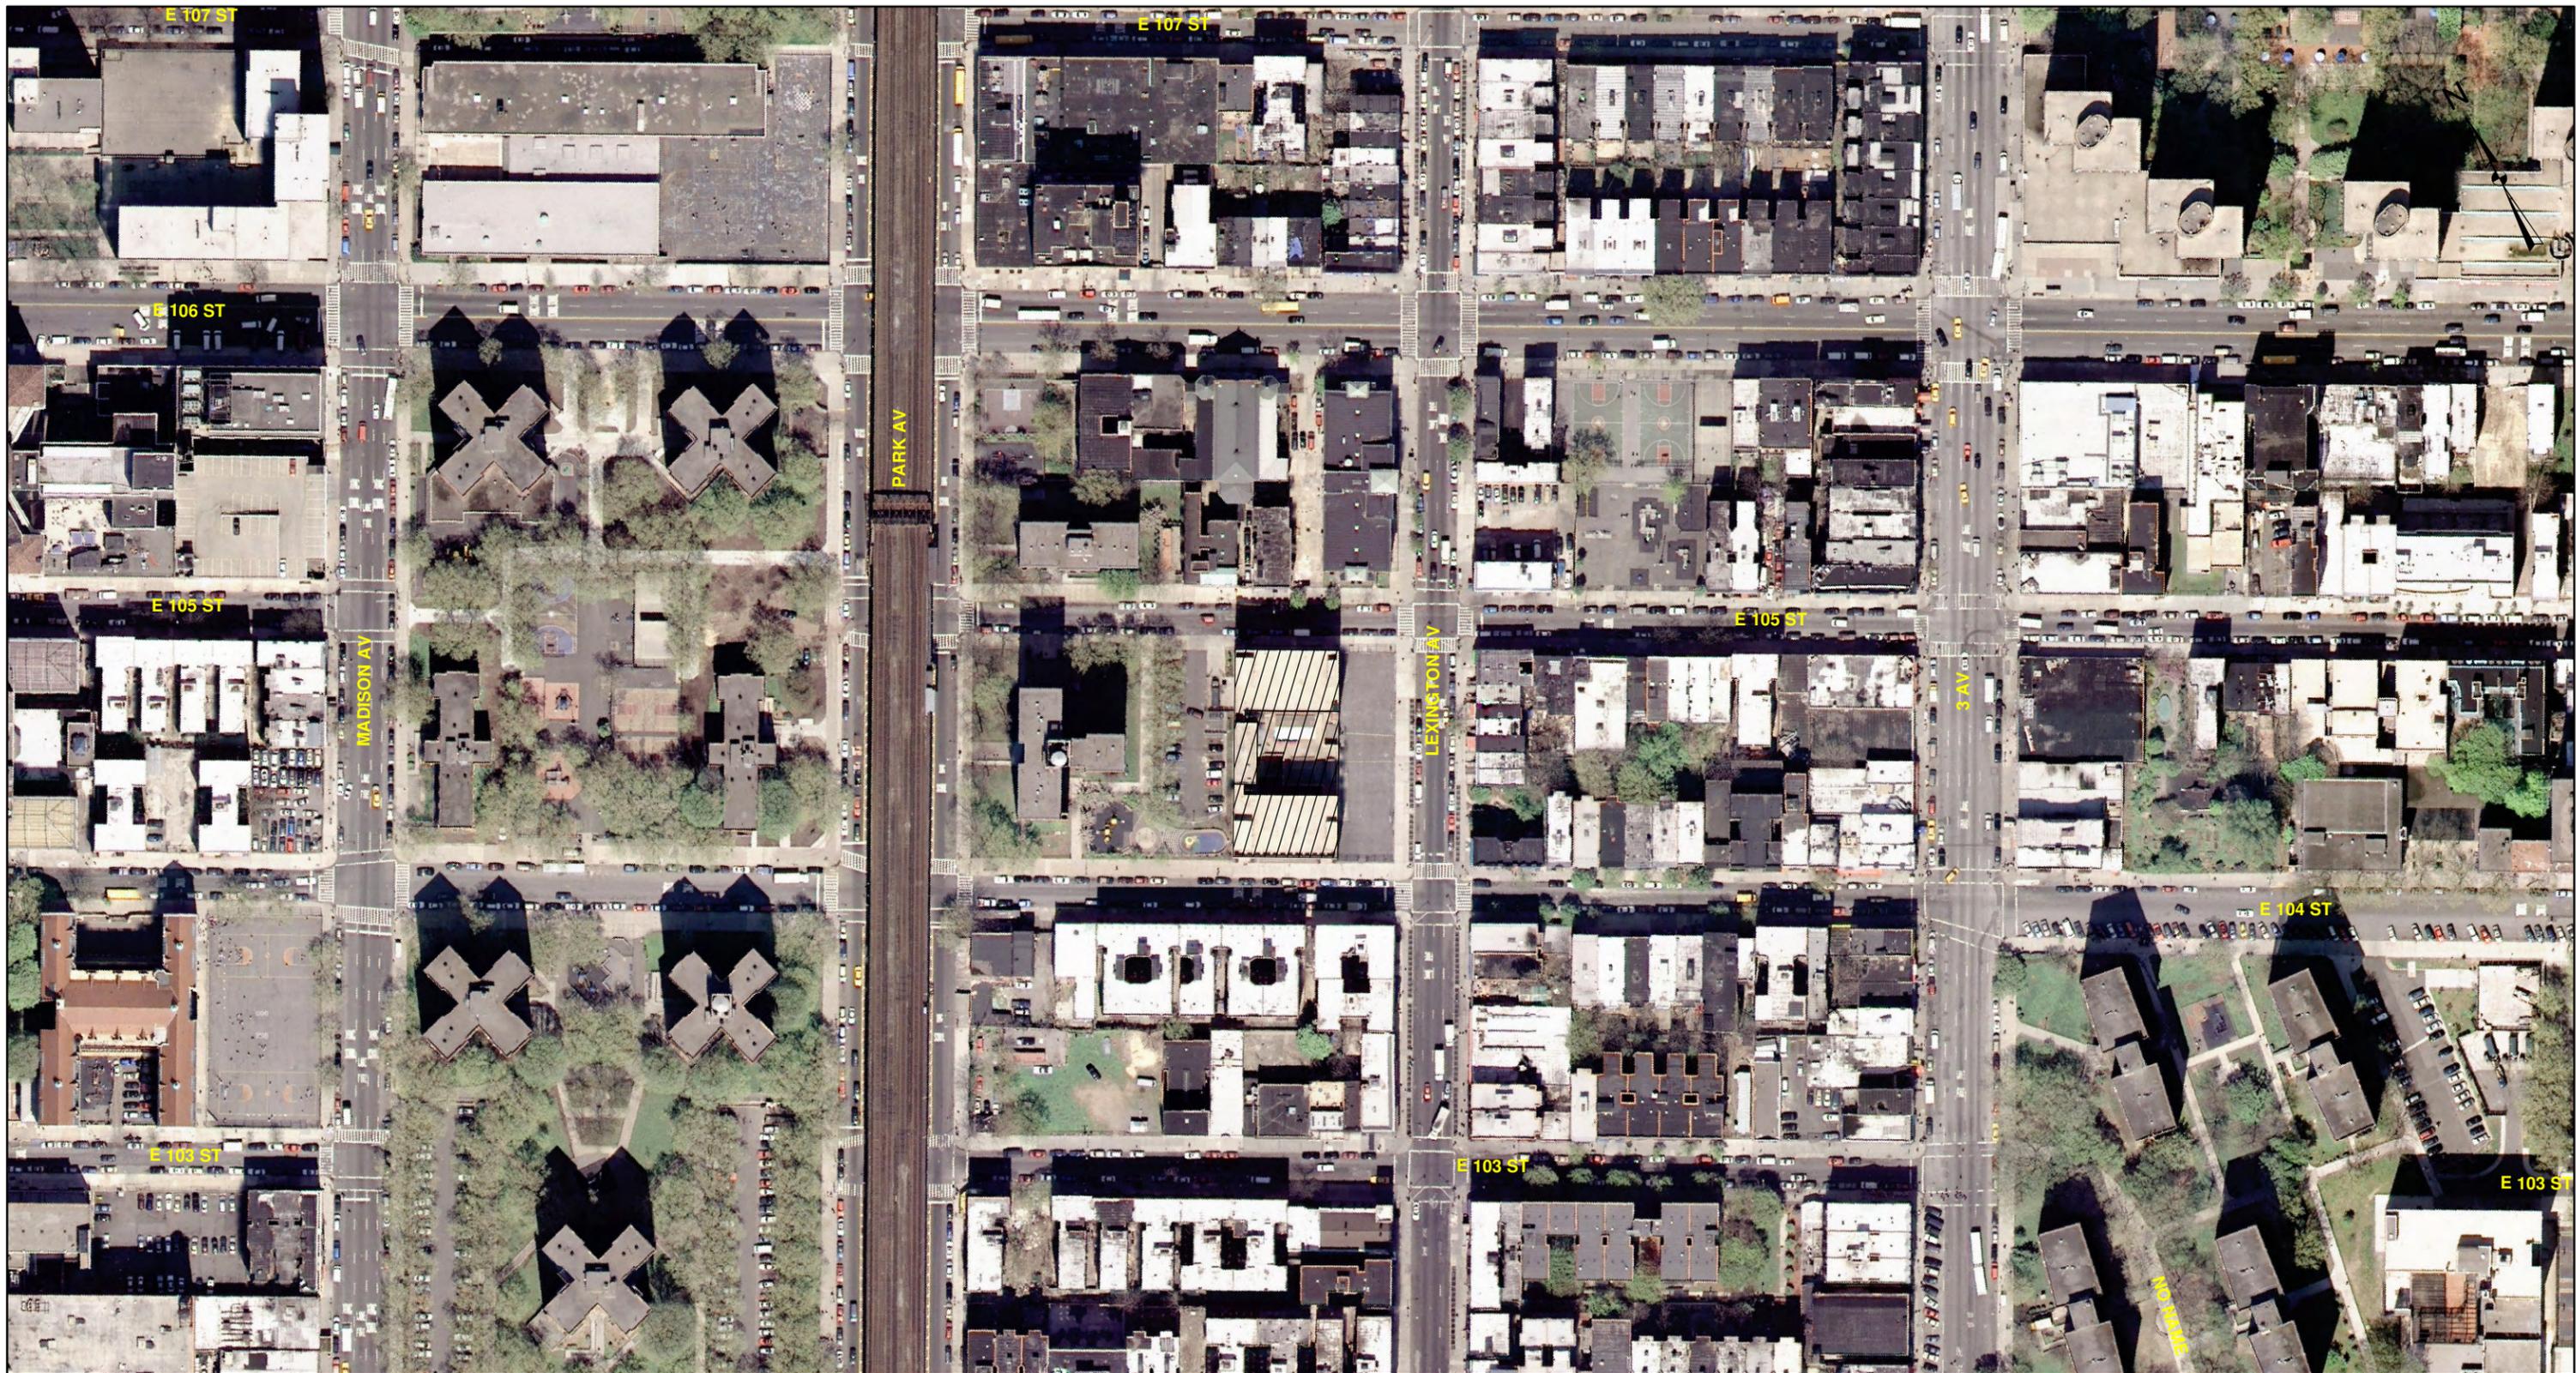
EXHIBIT 1

Located at 131 East 104th Street in Manhattan, P.S. 72 is situated between Lexington Avenue and Park Avenue and the building spans the block from East 104th Street to East 105th Street. All four surrounding intersections are signalized; see Exhibit 1 for an Aerial Photograph of the area.

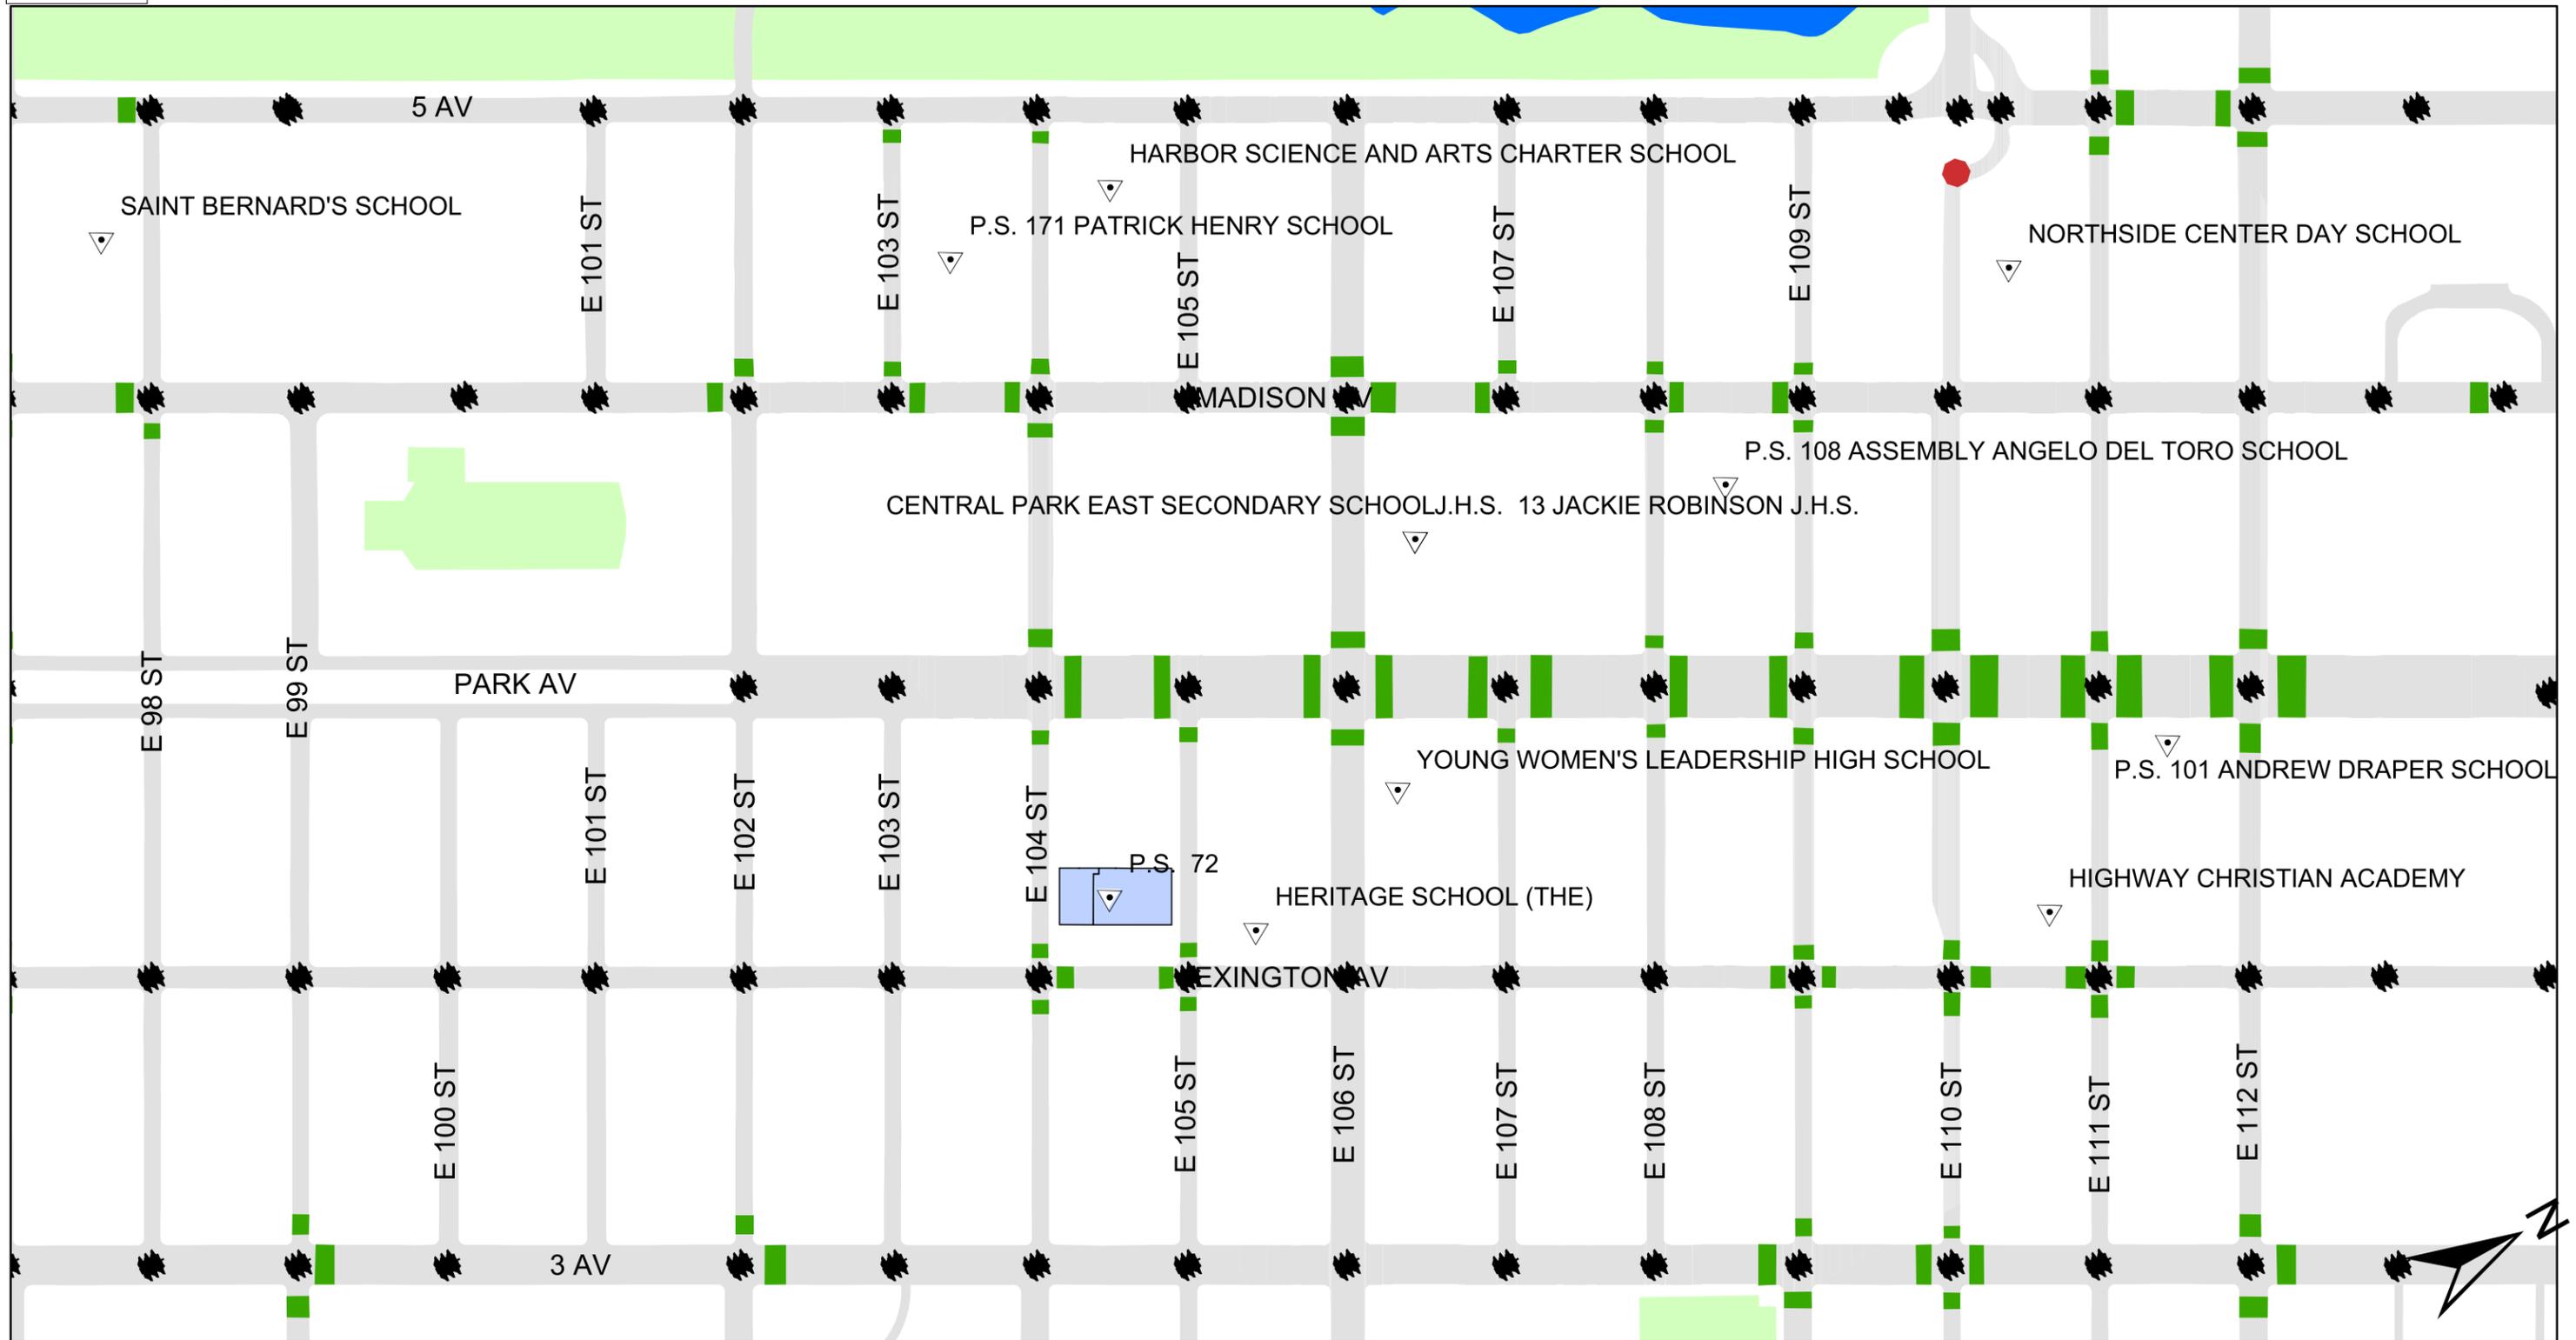
The School Traffic Safety Map was established to help provide the maximum degree of safety for children going to and from school - by indicating the location of speed reducers, school crosswalks and some traffic control devices. (While virtually all intersections in NYC benefit from traffic control devices - such as stop signs, traffic signals, yield signs, and all way stop signs - this map shows only traffic signals and all way stop signs.) The school crosswalks that are shown are ladder striped and make the crosswalk more visible to drivers and help make the intersection safer. These crosswalks are where school children are recommended to cross.

The Traffic Safety Plan, Exhibit 2, shows existing signals and school crosswalk pavement markings. It is noted that a citywide signage program is currently underway to upgrade school signage to current Federal Manual of Uniform Traffic Control Devices (MUTCD) standards of fluorescent yellow-green signs with downward pointing arrows. Signs scheduled to be installed under this program are shown as "existing" on Exhibit 7.

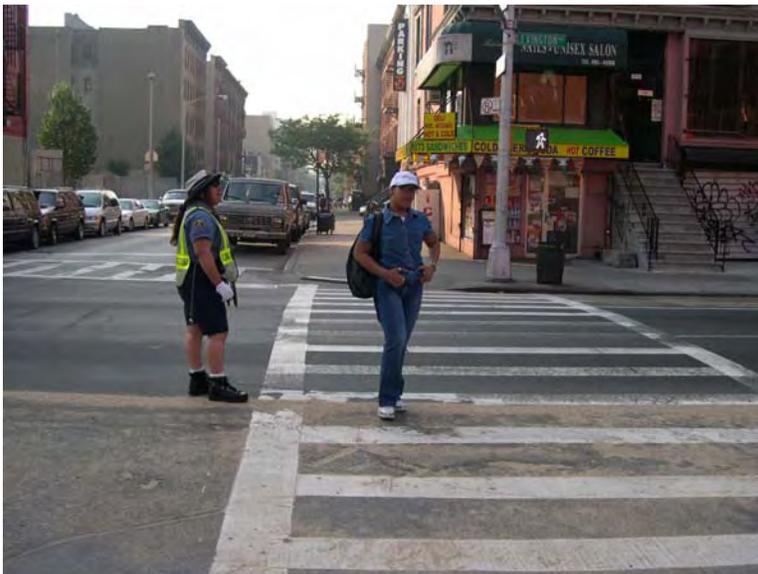
Fig. 2 – Crossing guard at the intersection of Lexington Avenue and East 105th Street (looking east)

According to field observations and as confirmed by the school principal, there are currently three crossing guards assigned to this school. The guards are stationed at the intersections of Lexington Avenue with East 104th and East 105th Streets (Figure 2), and at the intersection of Park Avenue and East 104th Street.

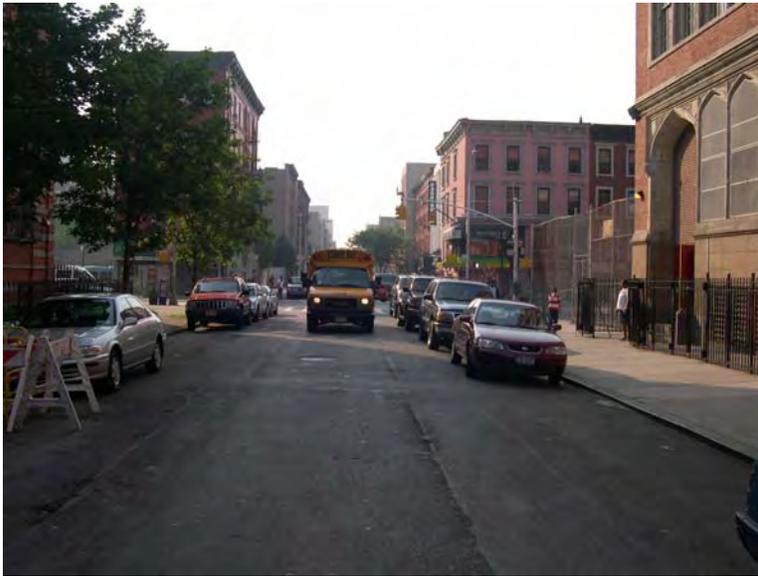
Figure 3: School buses double parked on East 105th Street during arrival time (looking east on 105th Street)

According to school representatives there are typically two school buses that transport approximately 30 special education students. The school buses bring students to the school in the morning, and pick them up in the afternoon during the school dismissal time. If full size buses are used, they typically park or double park in front of the school on Lexington Avenue. When smaller mini buses are used, they typically park on the school side of East 105th Street (Figure 3).

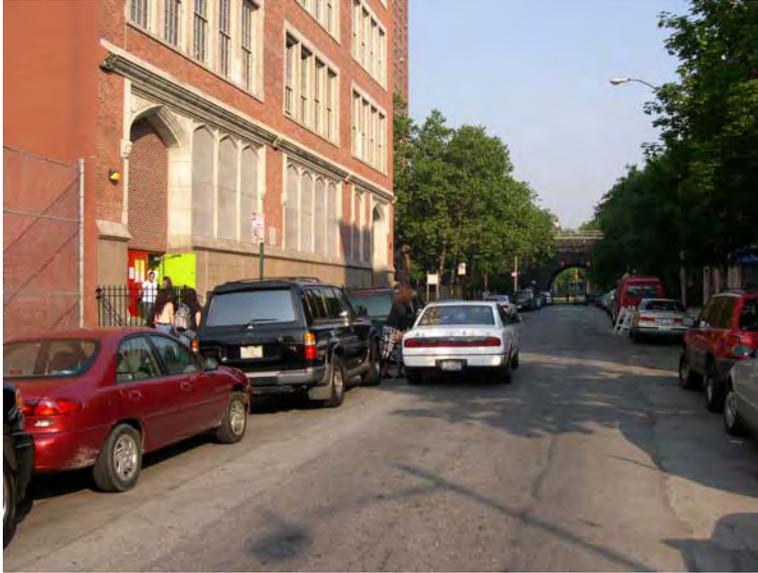
Figure 4: Parents and guardians double park on East 105th Street during arrival time (looking west on East 105th Street)

One percent of students arriving at P.S. 72 were reported to be dropped off by a parent or guardian. There is no defined drop-off/pick-up area for this. Field observations taken in the morning of June 8, 2004 indicated that most area parking spaces around the perimeter of the school were typically occupied during the student arrival times forcing parents or guardians to double-park along East 105th Street or Lexington Avenue (Figure 4).

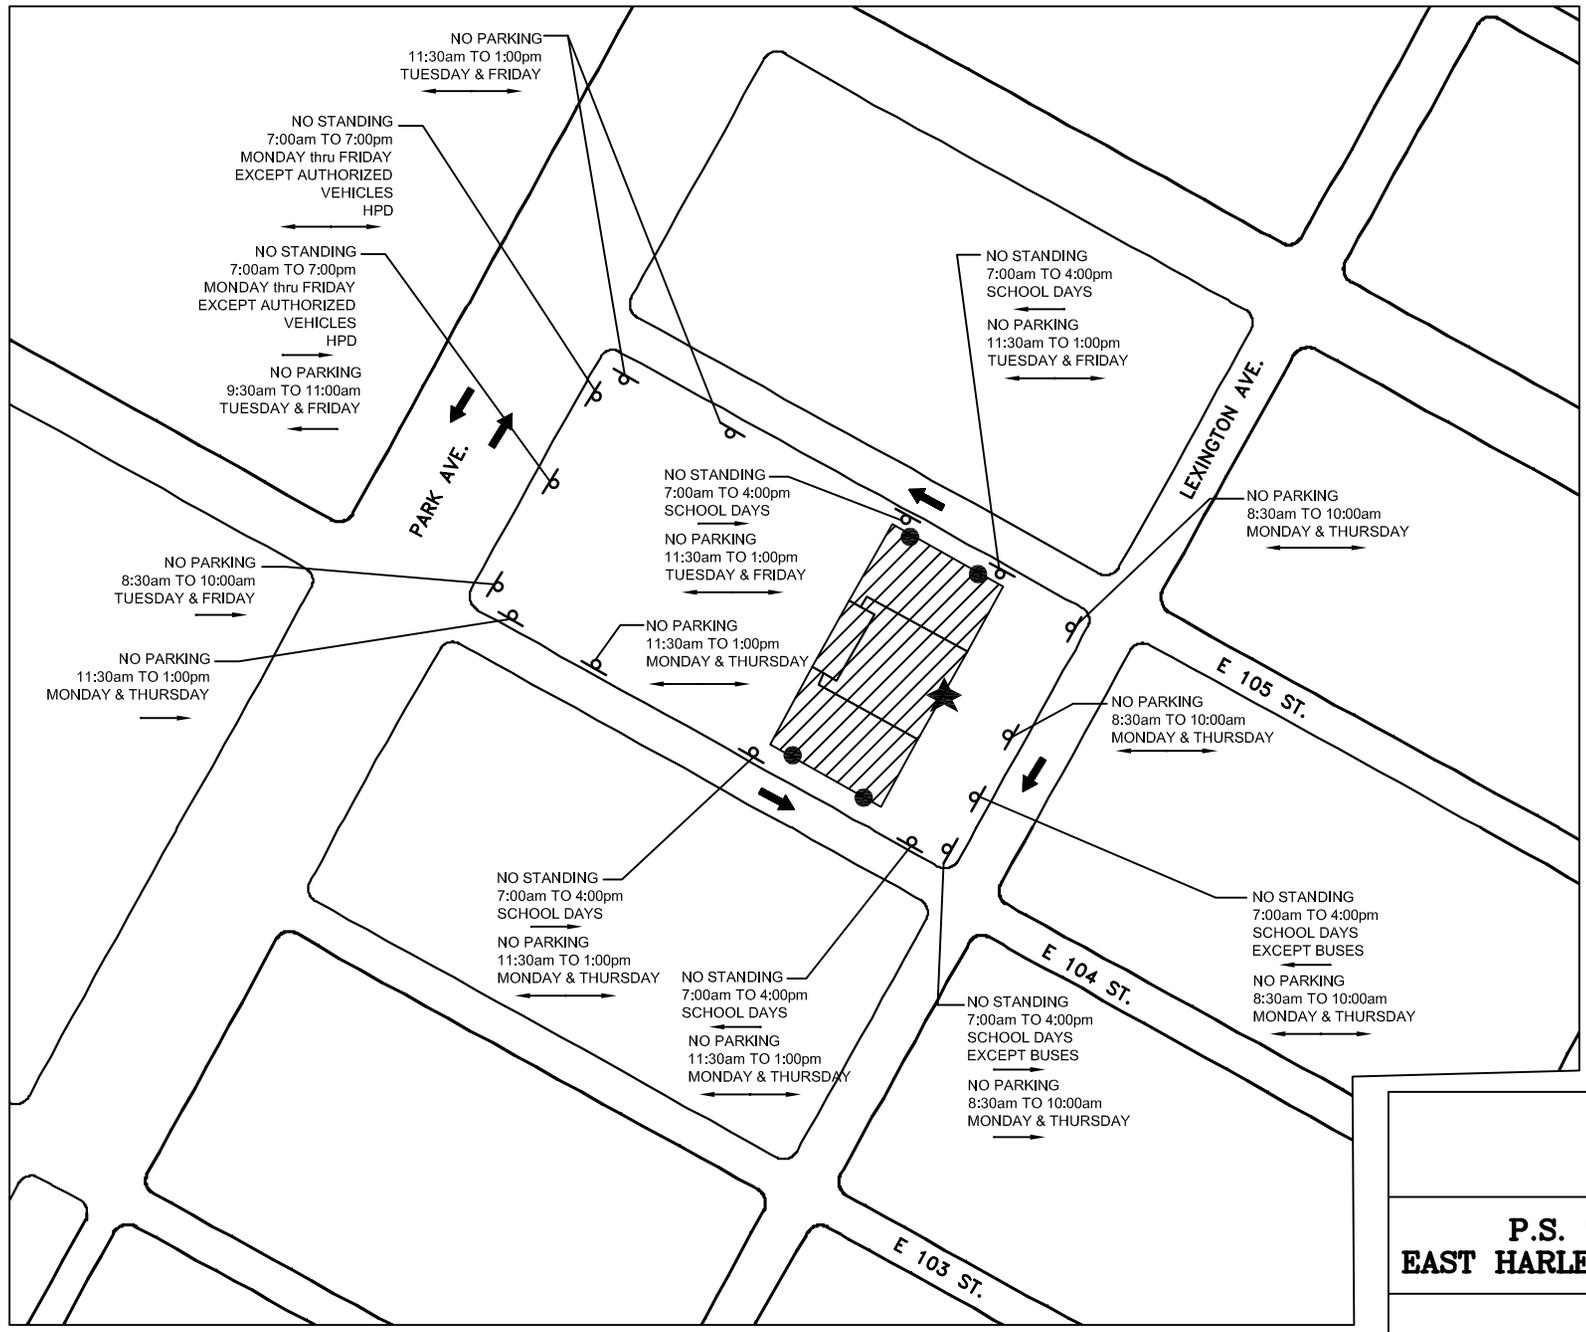
EXHIBIT 5
P.S. 72, MANHATTAN EAST HARLEM TECHNICAL SCHOOL
EXISTING PARKING REGULATIONS

“NO STANDING 7 AM – 4 PM, SCHOOL DAYS” parking regulation are posted on East 104th Street and on East 105th Street in front of the school entrances. “NO STANDING 7 AM – 4 PM, SCHOOL DAYS, EXCEPT BUSES” is posted on Lexington Avenue (near the intersection with East 104th Street). Exhibit 5 displays parking regulations on the streets surrounding P.S. 72.

- Extend No-Standing Zone on Lexington Avenue in front of P.S. 72
“NO STANDING 7 AM – 4 PM, SCHOOL DAYS” parking regulations should be extended for a length of 30 feet in front of the school entrance on Lexington Avenue to provide sufficient clear frontage for school buses to drop-off and pick-up students.

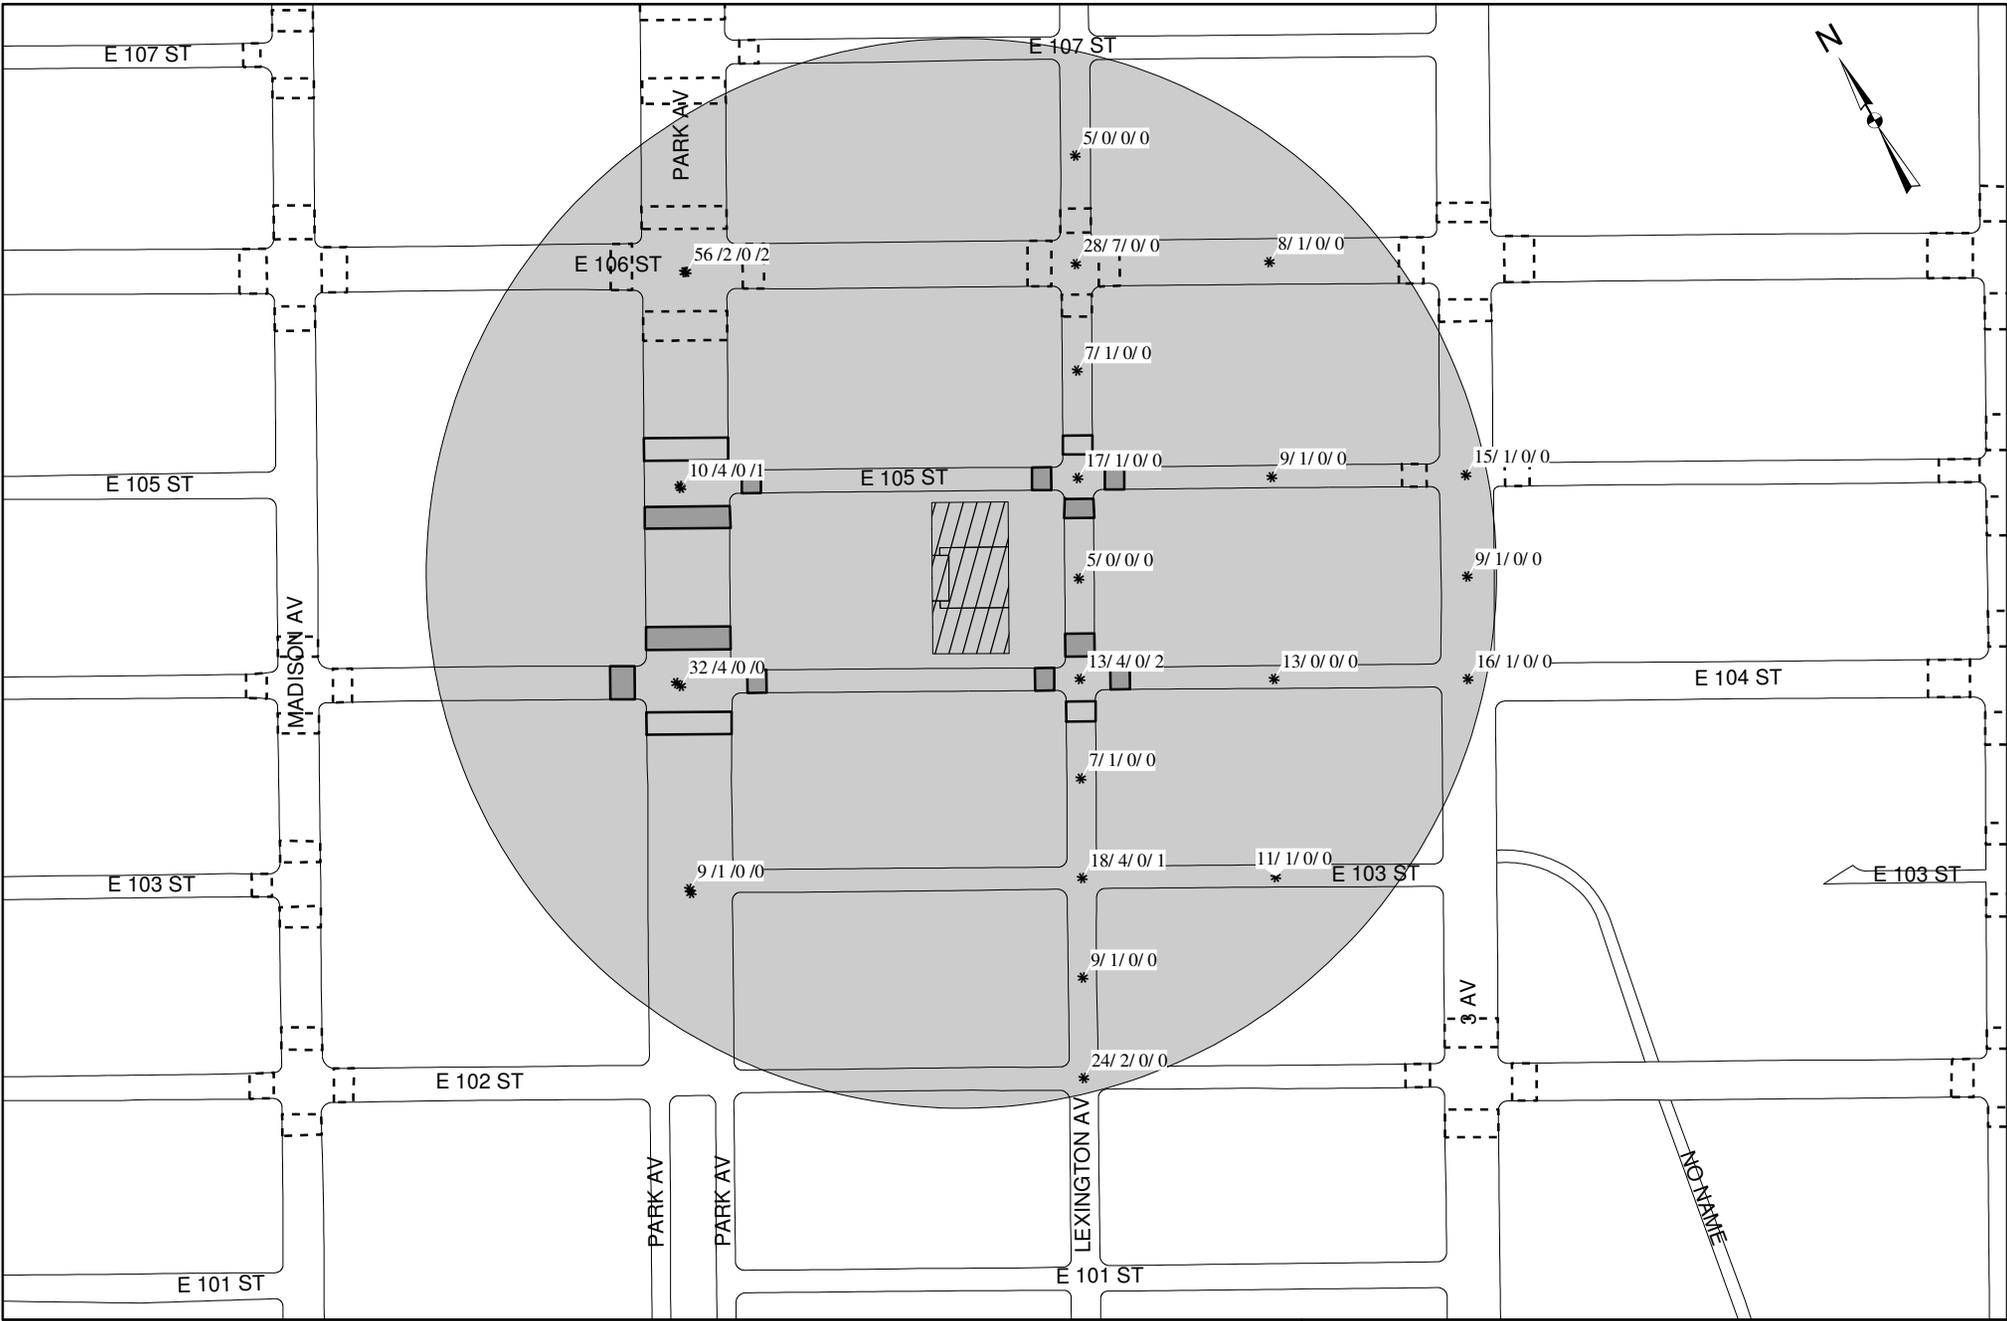
EXHIBIT 6
P.S. 72, MANHATTAN
EAST HARLEM TECHNICAL SCHOOL
ACCIDENT SUMMARY
THREE YEAR PERIOD
(1998-2000)

Exhibit 5 and Table 2 show a summary of accidents, as obtained from the New York State Department of Motor Vehicles (DMV), in the vicinity of P.S. 72 for the three-year period from January 1, 1998 through December 31, 2000. The DMV data provides some detail relating to the circumstances and cause of the accident. Table 3 is a summary of more recent accident data obtained from the NYC Police Department (NYPD). Though current through 2004, the NYPD data does not provide the same level of detail as the DMV data.

TABLE 2: DMV THREE-YEAR ACCIDENT SUMMARY (1998-2000)				
INTERSECTION	TOTAL ACCIDENTS	PEDESTRIAN ACCIDENTS	PEDESTRIAN FATALITIES	SCHOOL-RELATED ACCIDENTS*
East 104th St. and Lexington Av.	13	4	0	2
East 104th St. and Park Av.	32	4	0	0
East 105th St. and Lexington Av.	17	1	0	0
East 105th St. and Park Av.	10	4	0	1
East 103rd St. and Lexington Av.	18	4	0	1
East 106th St. and Park Av.	56	2	0	2
TOTAL	146	19	0	6

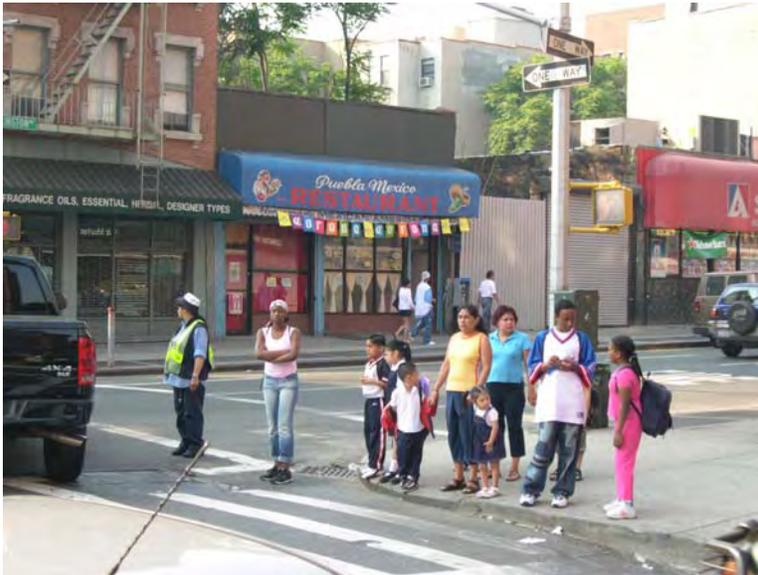
Figure 5: Looking south on Lexington Avenue at the intersection with East 104th Street

Lexington Avenue is a 38-foot wide one-way southbound street with two moving lanes and parking on both sides of the roadway. East 104th Street is a 30-foot wide one-way eastbound street with one travel lane, and parallel parking on both sides of the roadway (Figure 5 and 6). The intersection is controlled by a two-phase signal. School crosswalks are on the east, west and north legs. However, The northeast, northwest, and southwest corners at this intersection do not have standard pedestrian ramps.

This signalized intersection had 13 accidents during the 1998-2000 study period (Exhibit 6 and Table 2). Four accidents involved pedestrians, including two that were school related. One of the school related pedestrian accidents occurred while the pedestrian was crossing with the signal and the driver slowed or stopped in traffic. The other school related pedestrian accident occurred while the pedestrian was crossing against the signal. The third pedestrian accident involved a driver making a left turn and the last accident was attributed to the pedestrian crossing against the signal.

Due to existing utility conflicts, the following pedestrian ramps are considered complex and will require relocation of utility pole or drainage structures in order to install ramps to NYCDOT standards. Consideration should be given to the installation of pedestrian ramps per NYCDOT standards at the following locations.

- East 104th Street and Lexington Avenue – northeast, northwest, and southwest corners

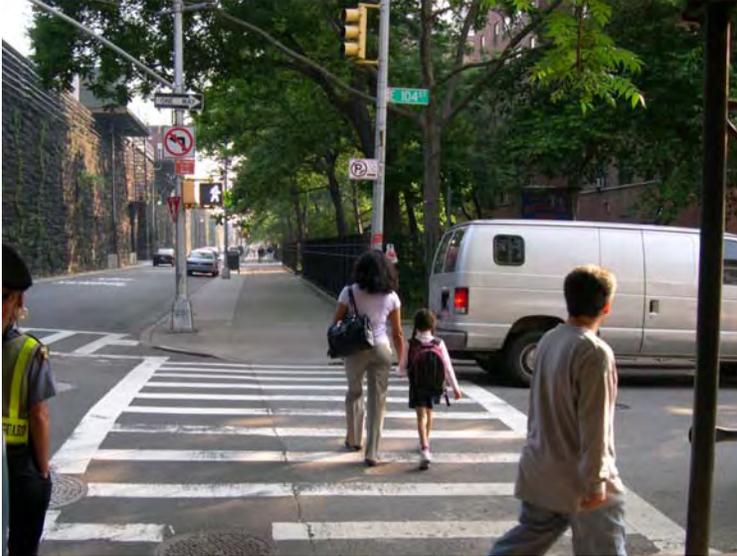
Figure 7: The intersection of Park Avenue and 104th Street (looking north)

Park Avenue is a two-way divided north-south street with one travel lane and parking along outer curb of the roadway (Figure 7). Both the north and south roadways are 26 feet wide and the MTA viaduct is 58 feet wide. The intersection of East 104th Street and Park Avenue is controlled by a two-phase signal. School crosswalks are on the east, west and north legs.

The pedestrian crossings of Park Avenue at East 104th Street and East 105th Street utilize stone arch underpasses beneath the elevated MTA rail line. Plaques in the roadway caution pedestrians to wait for the signal (see Figures 8 and 9). There is no inside shoulder at the face of the rail line abutment wall and therefore very limited sight distance for pedestrians crossing Park Avenue or traffic on Park Avenue.

There were 32 accidents reported at this intersection in the 1998-2000 study period, including four pedestrian accidents, none of which were fatal or school related. Two pedestrian accidents occurred while the pedestrian was crossing against the signal, one while the driver was headed north, and the other when the driver was headed south. The third accident occurred while the pedestrian was crossing with the signal and the driver, who was headed east, failed to yield. The fourth pedestrian accident occurred while the pedestrian was working in the roadway, and the driver was headed northbound. Additional information was not available for the last accident.

There is no inside shoulder at the face of the rail line abutment wall and therefore very limited sight distance for pedestrians crossing Park Avenue or for traffic on Park Avenue. To improve the sight distance for pedestrians and vehicles on Park Avenue it is proposed to install curb extensions with bollards to protect pedestrians, along the abutment at the following intersections:

- Park Avenue and East 104th Street
- Park Avenue and East 105th Street

In accordance with MUTCD, striped tapers should be installed to alert motorists of the change in the roadway alignment. This proposed striping will help alert drivers to the presence of the curb extensions and help to narrow the effective width of the roadway. Narrowing the roadway slightly is expected to help reduce the effects of speeds on this street.

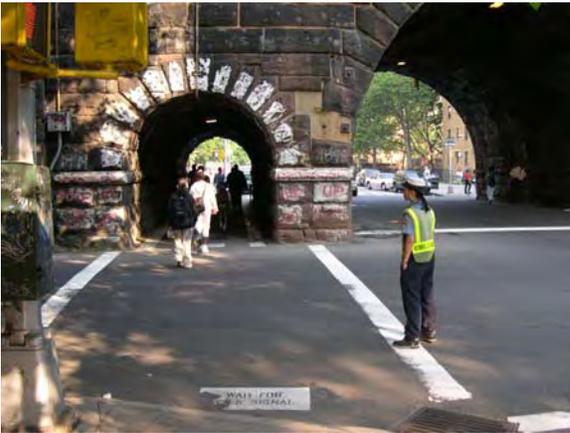
Figure 8: Looking west on the south side of East 104th Street across Park Avenue

The lighting provided in the pedestrian underpasses along the Park Avenue median does meet standards for lighting level requirements. However, on sunny days, the contrast between the lighting level outside and inside the underpass can be difficult for pedestrians to adjust to.

In conjunction with the curb extensions, sidewalks need to be constructed beneath the pedestrian underpasses to minimize drainage issues or pedestrian tripping hazards in the underpasses.

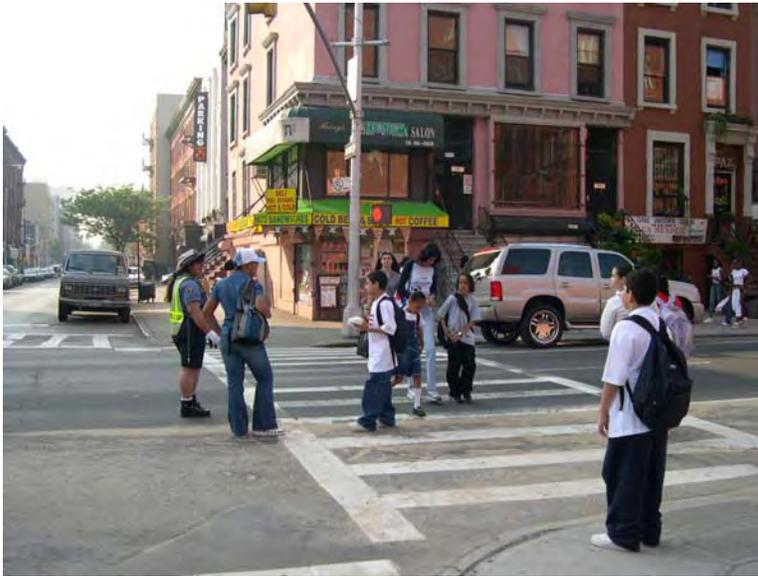
Figure 10: At the intersection of East 105th Street and Lexington Avenue (looking east)

East 105th Street is a one-way westbound street with one travel lane and parking on both sides. School pick-up and drop-off often occurs along this side of the school (Figure 10). This intersection is controlled by a two-phase signal. School crosswalks are on the east, west and south legs.

17 accidents occurred at this location between 1998 and 2000. One accident involved a pedestrian, but this was not fatal or school related. According to the accident records, the pedestrian was struck when walking along the roadway with traffic.

- Lexington Avenue and East 104th Street - northwest corner
- Lexington Avenue and East 105th Street - southwest corner

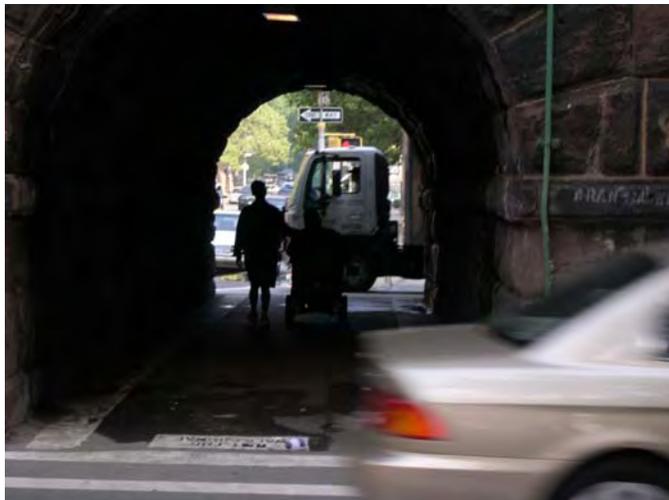
Figure 11: East 104th Street and Park Avenue (looking east)

Park Avenue has a 58-foot wide elevated railroad viaduct. Pedestrian crossings occur via stone arch underpasses at grade level. Crossing the northbound and southbound sides of Park Avenue is assumed to occur during separate signal cycles. Pedestrians have ample queuing area within the viaduct underpass (Figure 11).

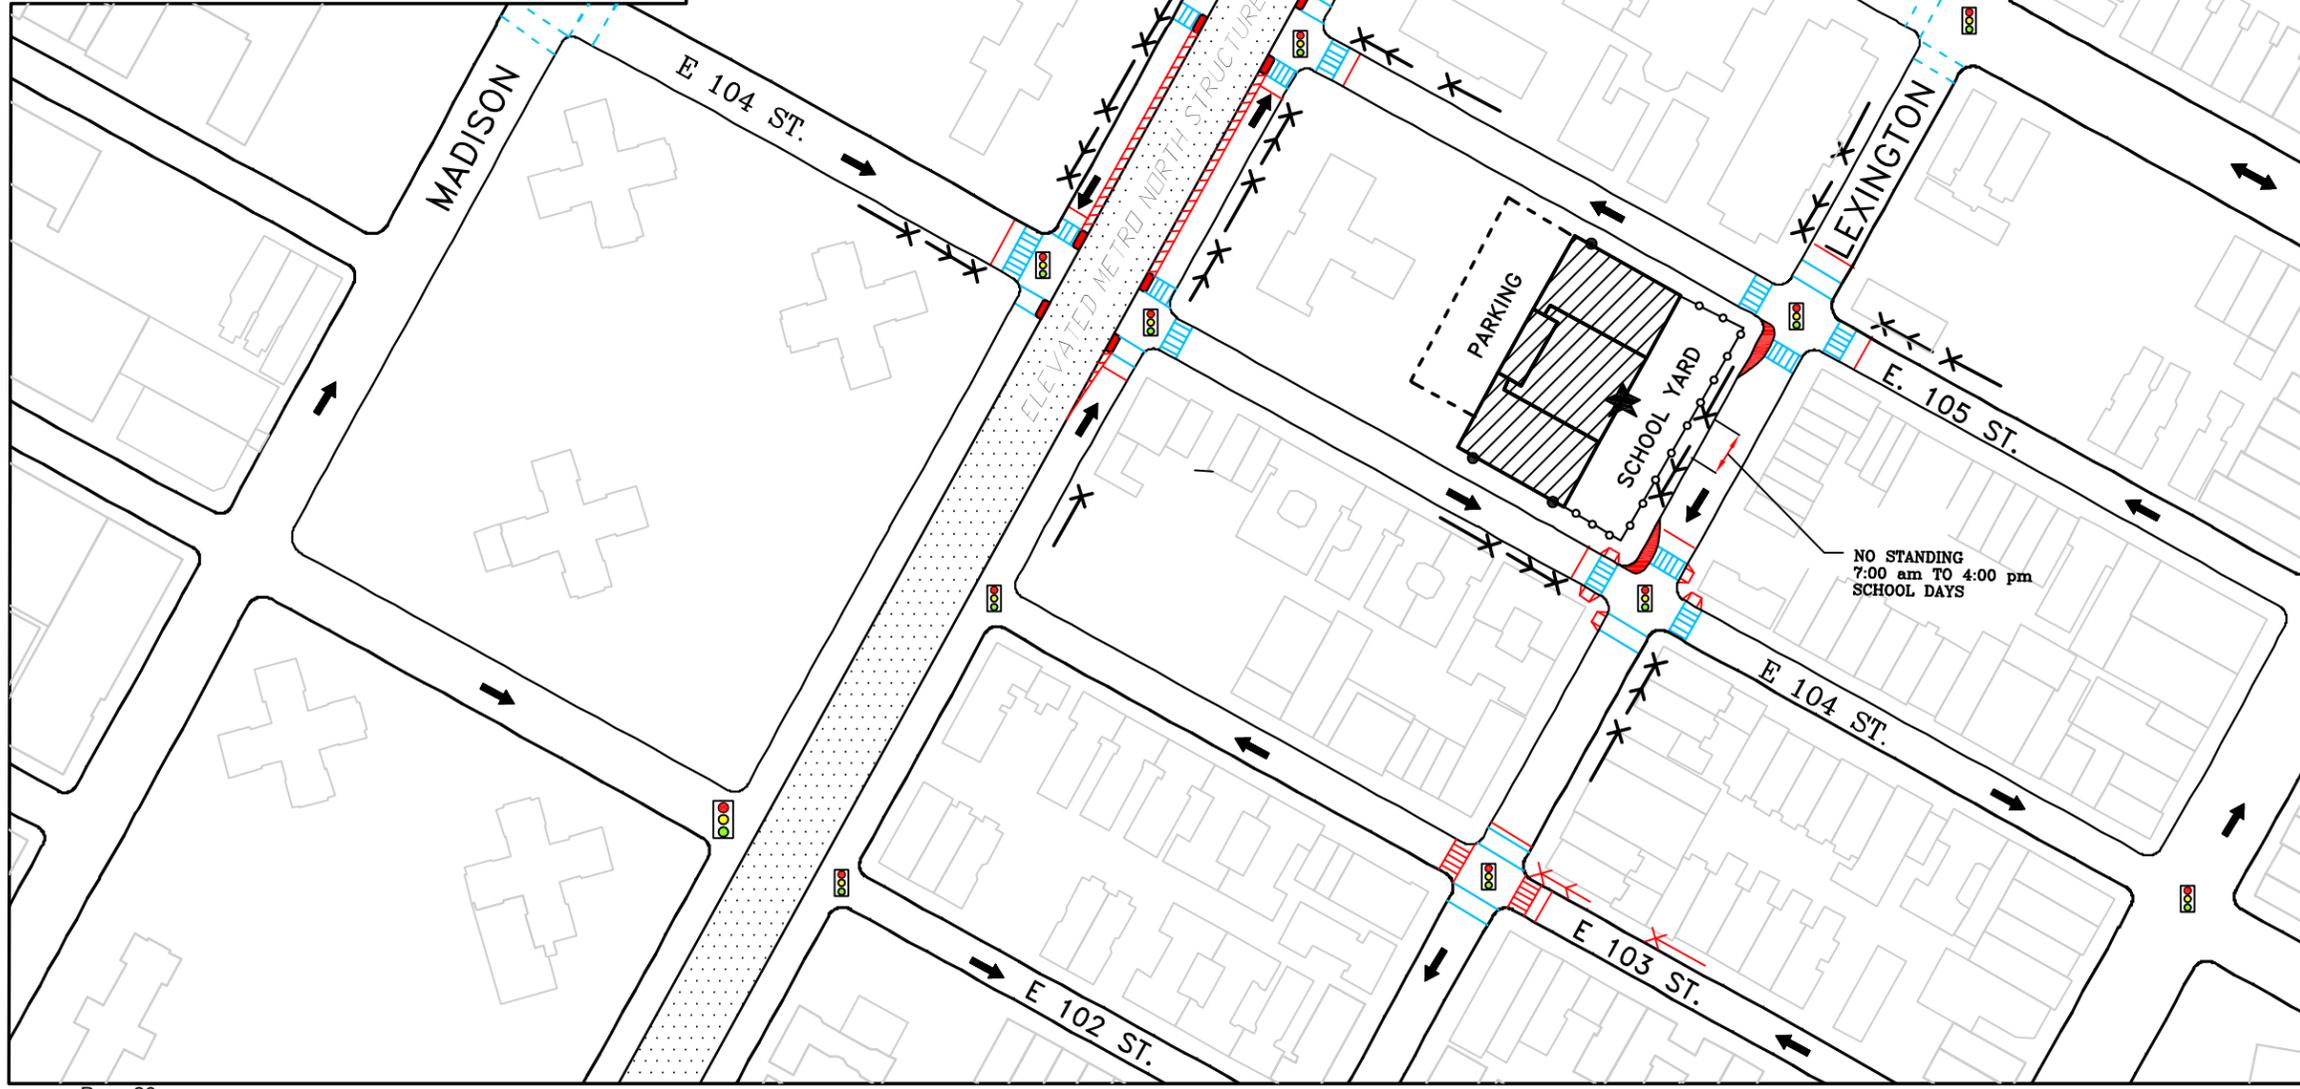
EXHIBIT 7

**PROPOSED MEASURES TO IMPROVE
STUDENT PEDESTRIAN SAFETY**

Curb extensions should be installed at the corners as shown in Exhibit 7.

The purpose of the curb extensions is to shorten the crossing distance for pedestrians, and to reduce speeds of vehicles approaching and turning at these heavily utilized school crosswalks (or intersections). These curb extensions would not eliminate or reduce the width of any moving lanes.

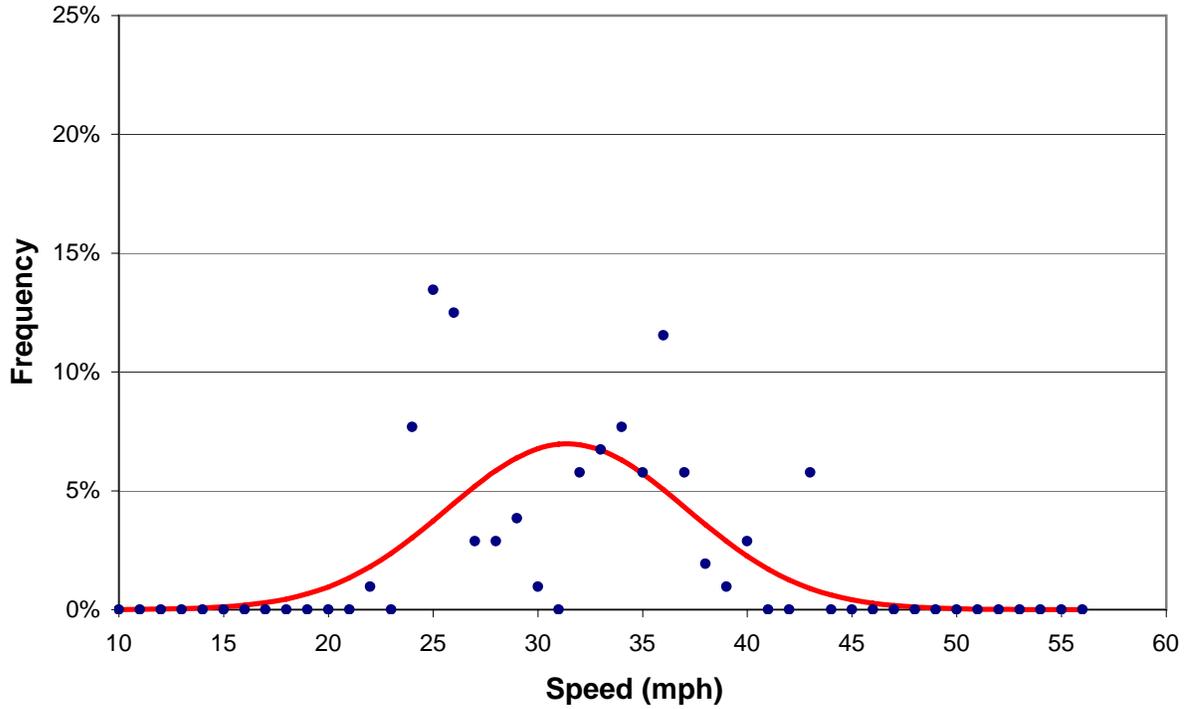
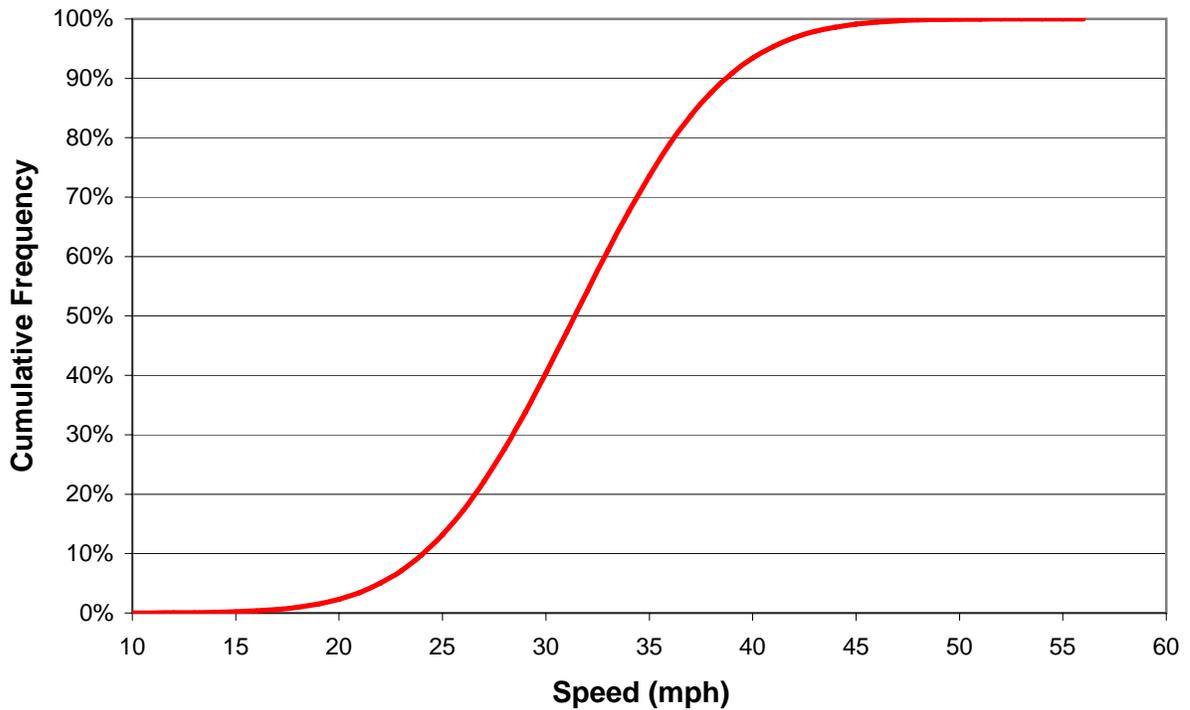
SPOT SPEED STUDY

Mean Speed = 31.4 mph
Standard Deviation = 5.7 mph
Margin of Error (95% Confidence) = ± 1.1 mph

Median Speed = 31.4 mph
15th Percentile Speed = 25.5 mph
85th Percentile Speed = 37.3 mph

The speed study results are shown Table 4 and in the Appendix. The median speed on Park Avenue is 31 mph, and the 85% speed is 37 mph, 55% of the surveyed vehicles were exceeding the legal speed limit of 30 mph.
