**New York City Department of Transportation
Office of School Safety Engineering**

School Safety Engineering Project

FINAL REPORT: P.S. 108 (The Vincent G. Fowler School), Queens

**Prepared by
The RBA Group and URBITRAN Associates Inc.**

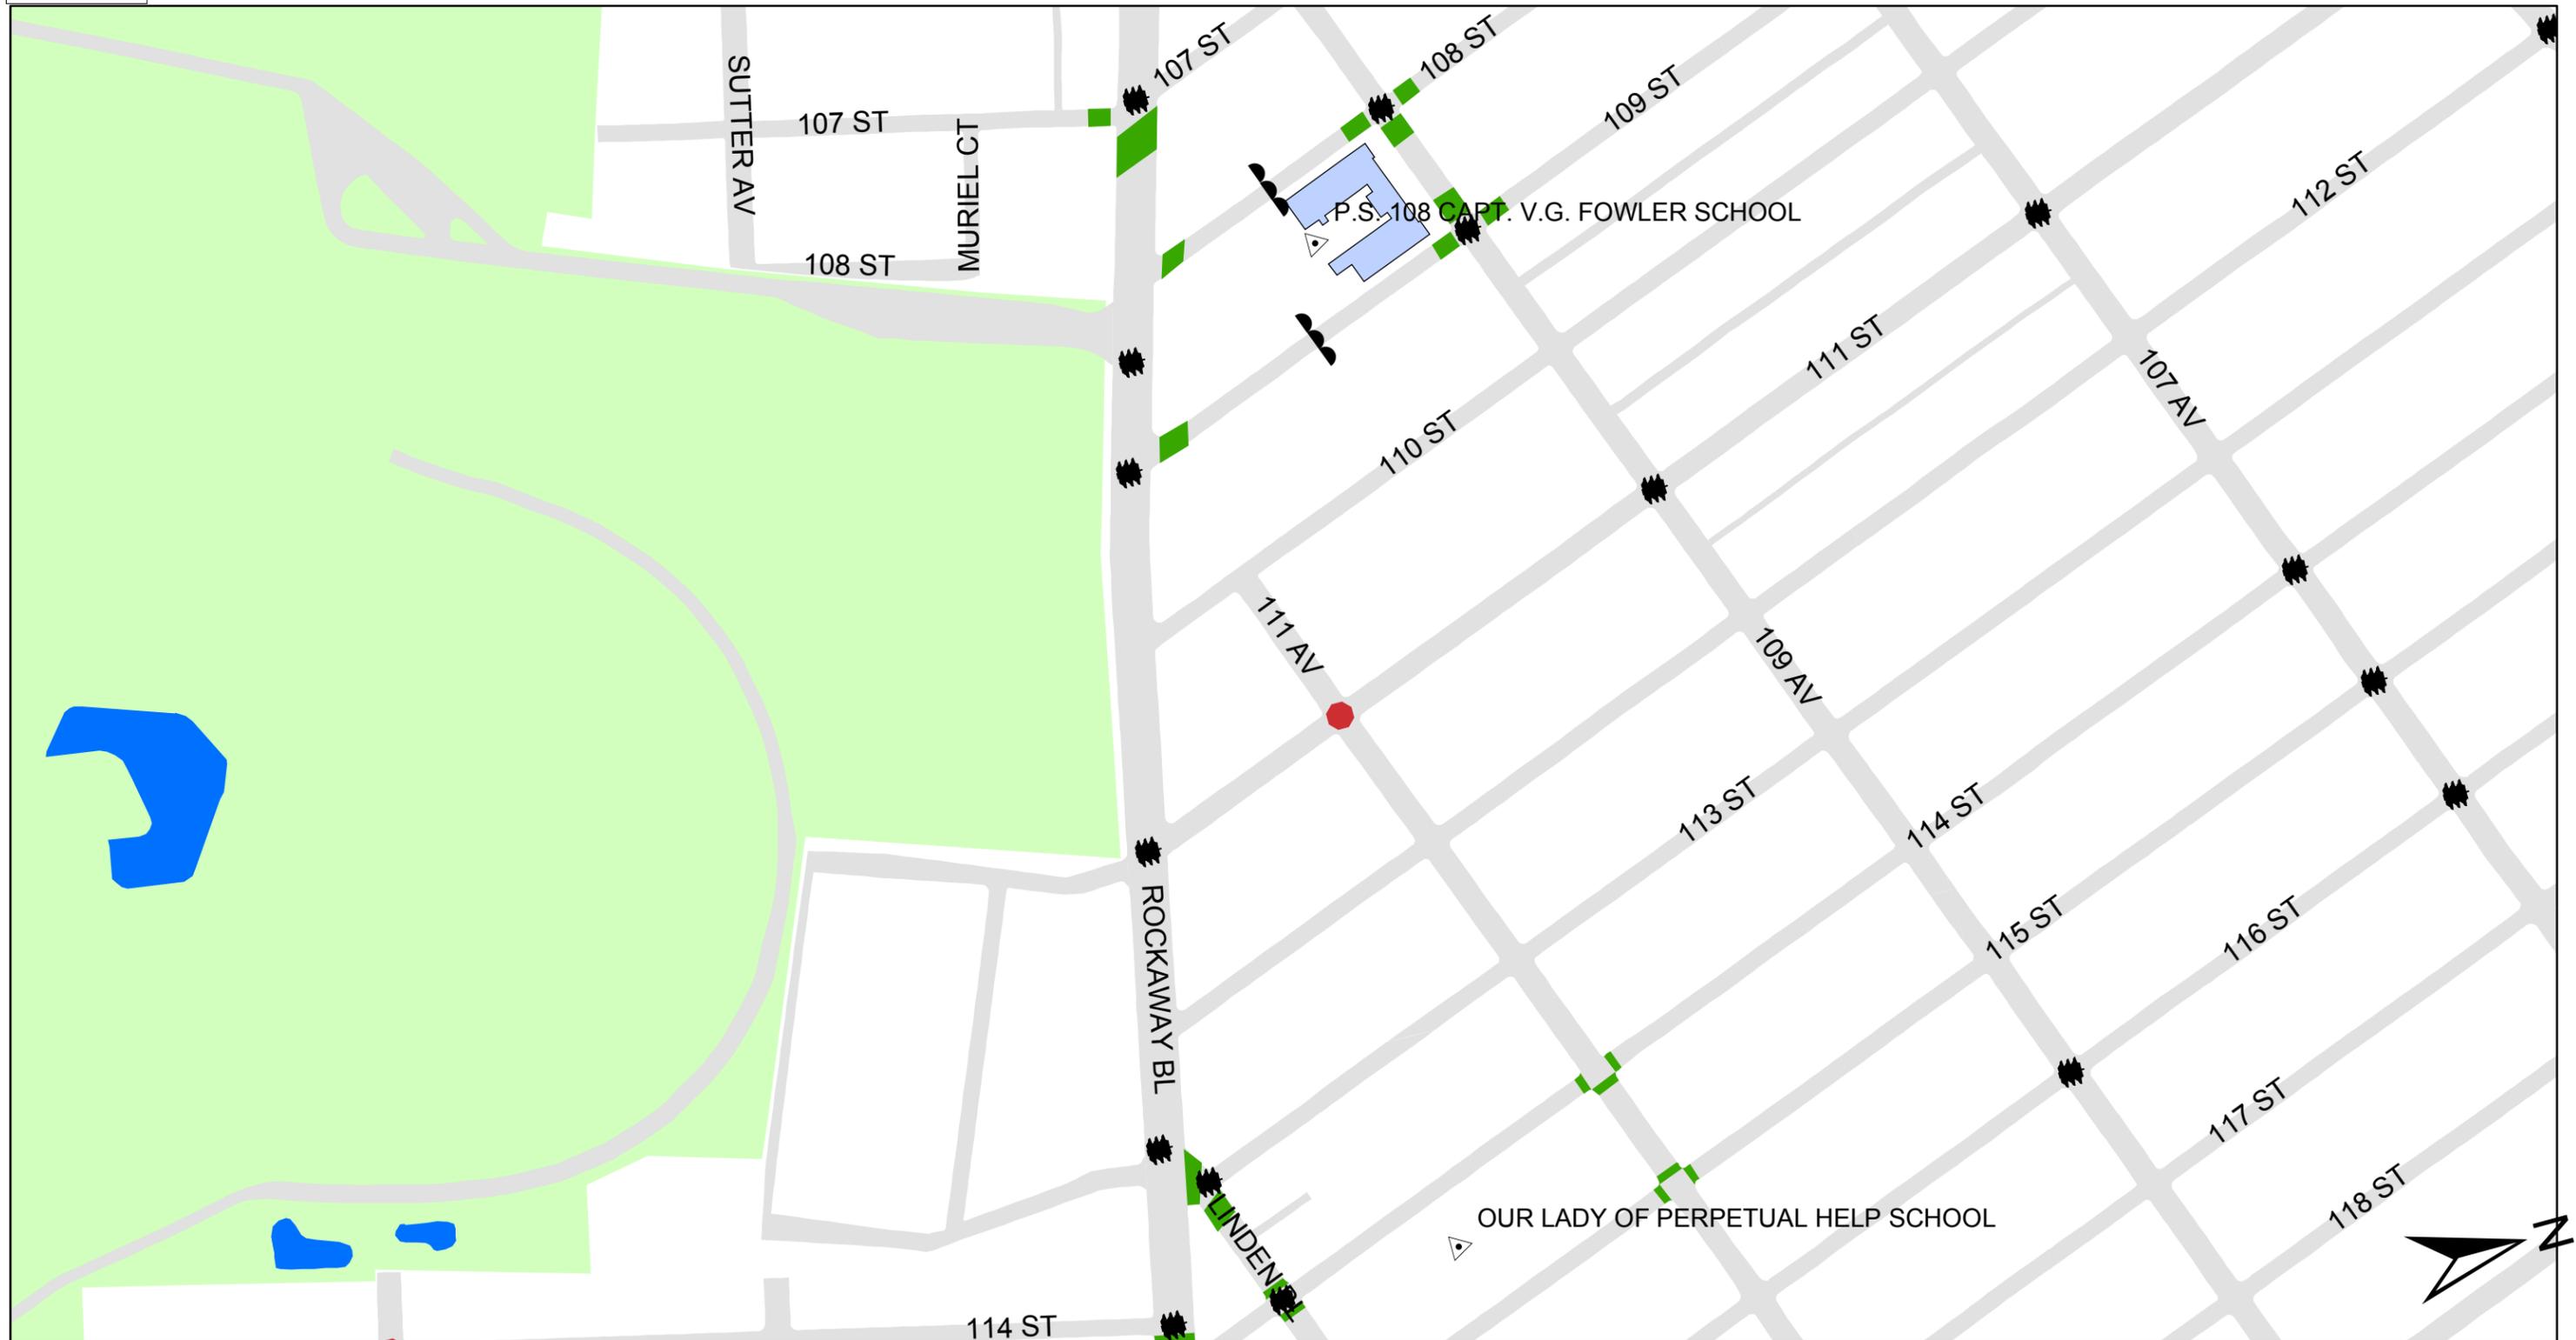
EXHIBIT 3

Exhibit 3 shows the existing school signals and pavement markings around P.S. 108. It should be noted that a citywide signage program is currently underway to upgrade school signage to current Federal Manual on Uniform Traffic Control Devices (MUTCD) standards of fluorescent yellow-green signs accompanied by downward pointing arrows. Signs scheduled to be installed under this program are shown as “existing” in Exhibit 6.

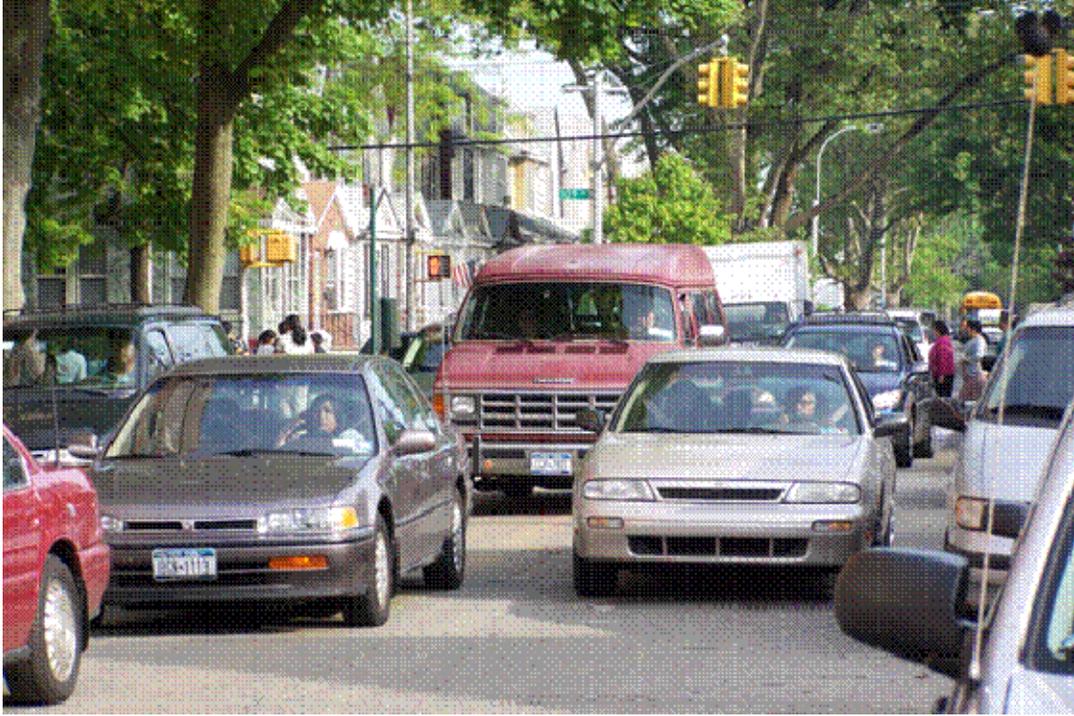
According to the principal, approximately nine percent of the students at P.S. 108 are currently being dropped off. During the field visit, parents were observed dropping off students on 108th Street, 109th Street, and 109th Avenue around the school perimeter (see Figures 1 and 2). Congestion and double parking occur frequently during both arrival and dismissal times.

Figure 1: Looking north from the east side of 109th Street toward the intersection with 109th Avenue, during dismissal time (note double parking and resultant congestion)

➤ *Install “NO STANDING 7AM - 4PM SCHOOL DAYS” signs*

There are existing “NO STANDING 7AM-4PM SCHOOL DAYS EXCEPT FOR SCHOOL BUSES” signs along the south side of 109th Avenue west of the school’s main entrance, and “NO PARKING 7AM-4PM SCHOOL DAYS” signs east of the school’s main entrance on 109th Avenue. “NO STANDING 7AM-4PM SCHOOL DAYS” signs should be installed for a distance of 30 feet in front of the main entrance to the school. (This is a typical requirement for all NYC schools in order to provide for emergency access to and from the school). Signs indicating “NO STANDING 7AM-4PM SCHOOL DAYS EXCEPT FOR SCHOOL BUSES” should be installed along the remaining length of this block face.

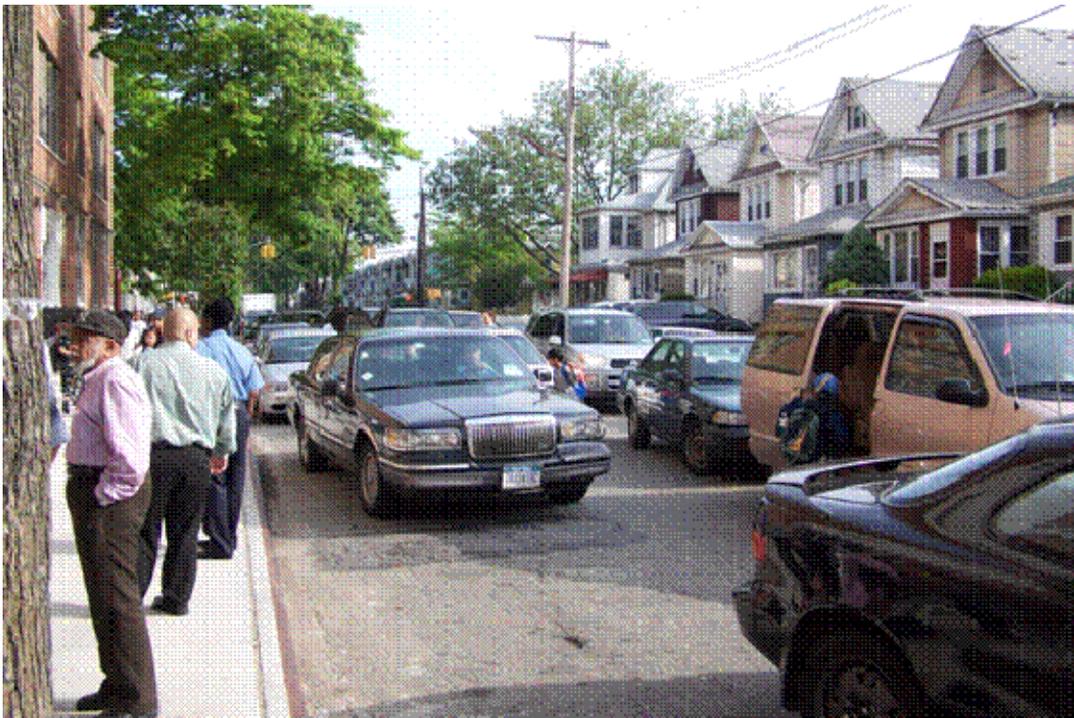
Figure 2: Looking north from the west side of 109th Street toward the intersection with 109th Avenue during dismissal time (note double parking and resultant congestion)

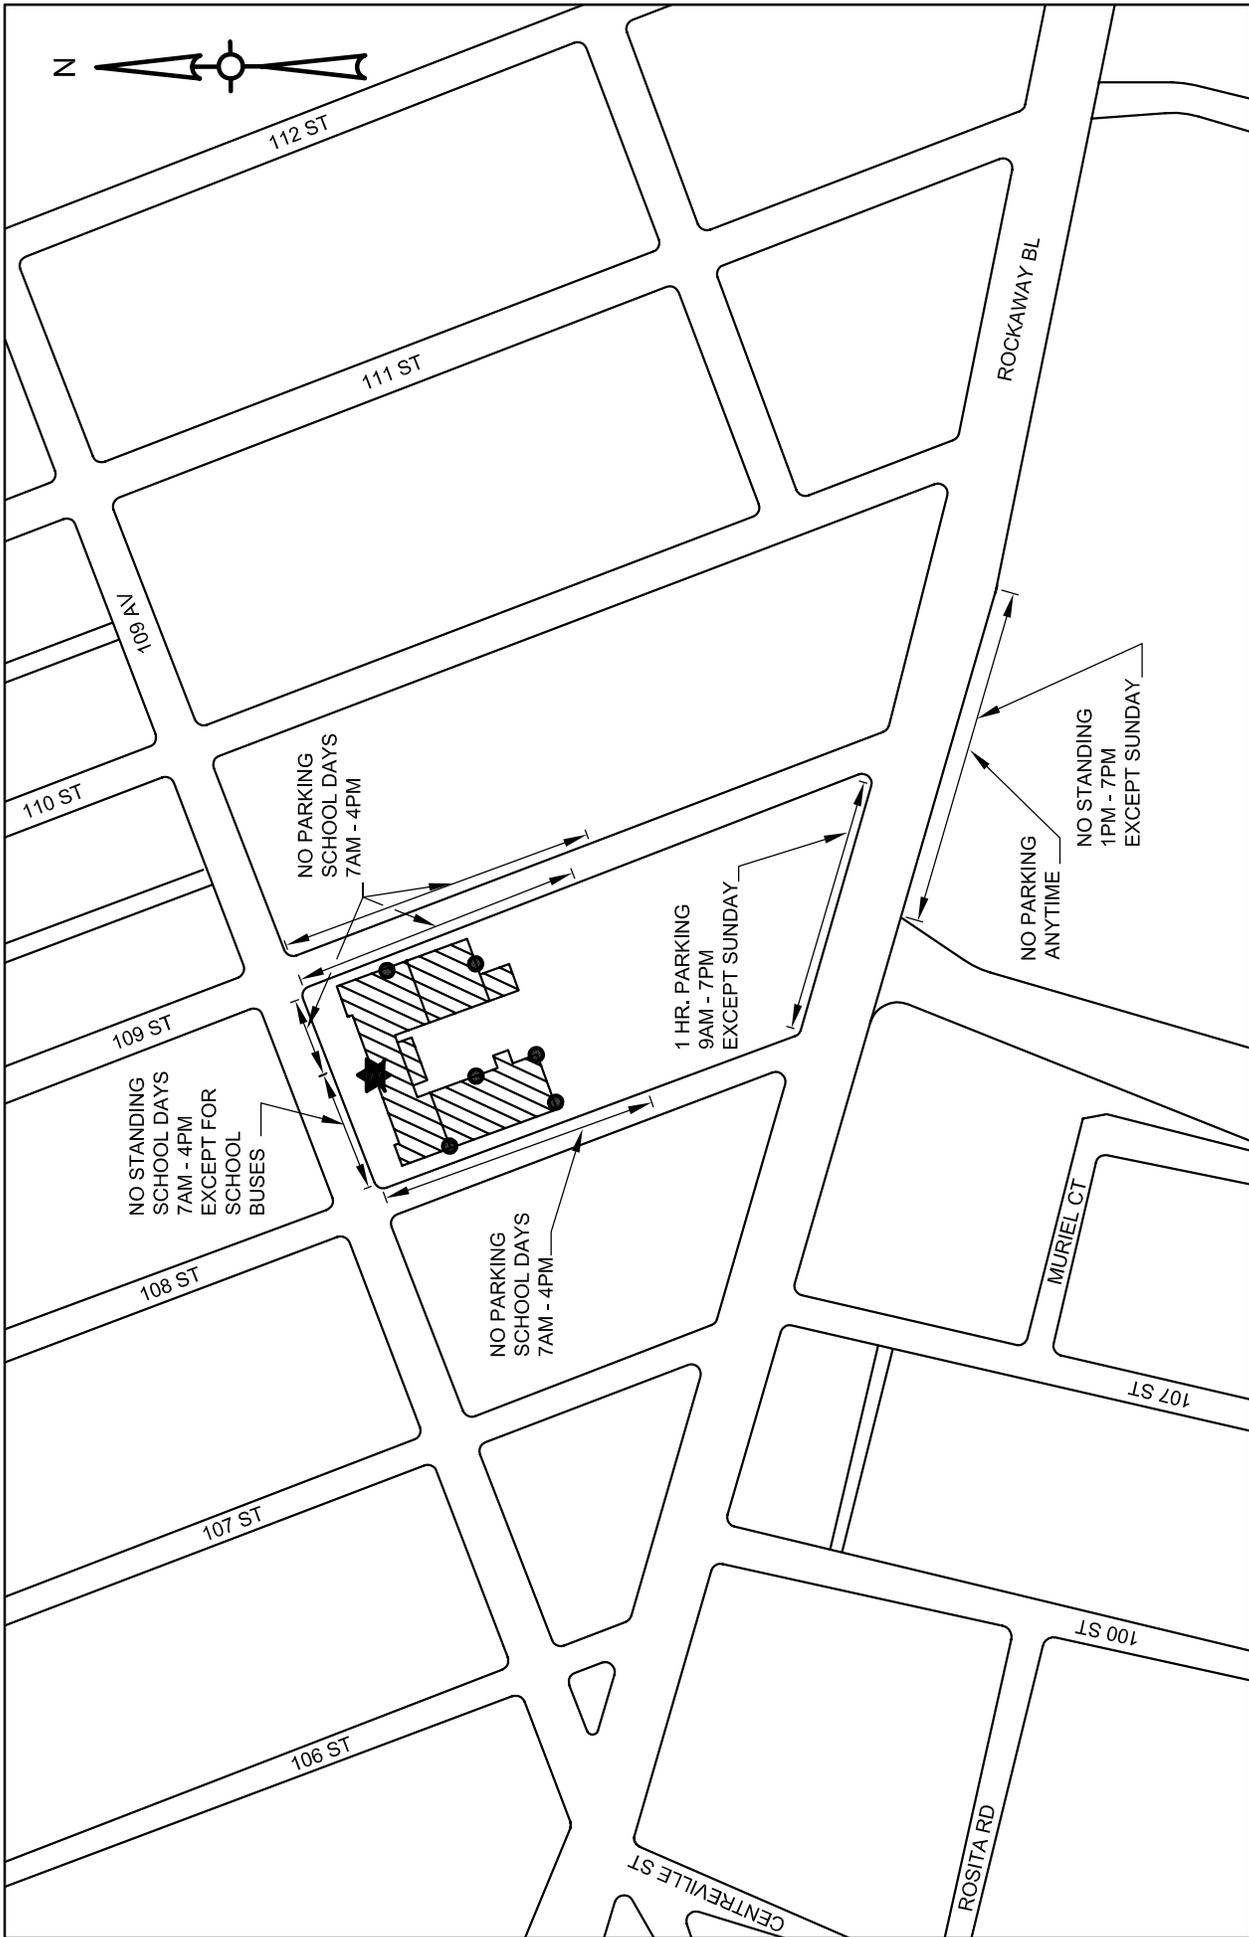
EXHIBIT 4
P.S. 108 QUEENS

Parking regulations around the school block are shown in Exhibit 4.

EXISTING PARKING REGULATIONS

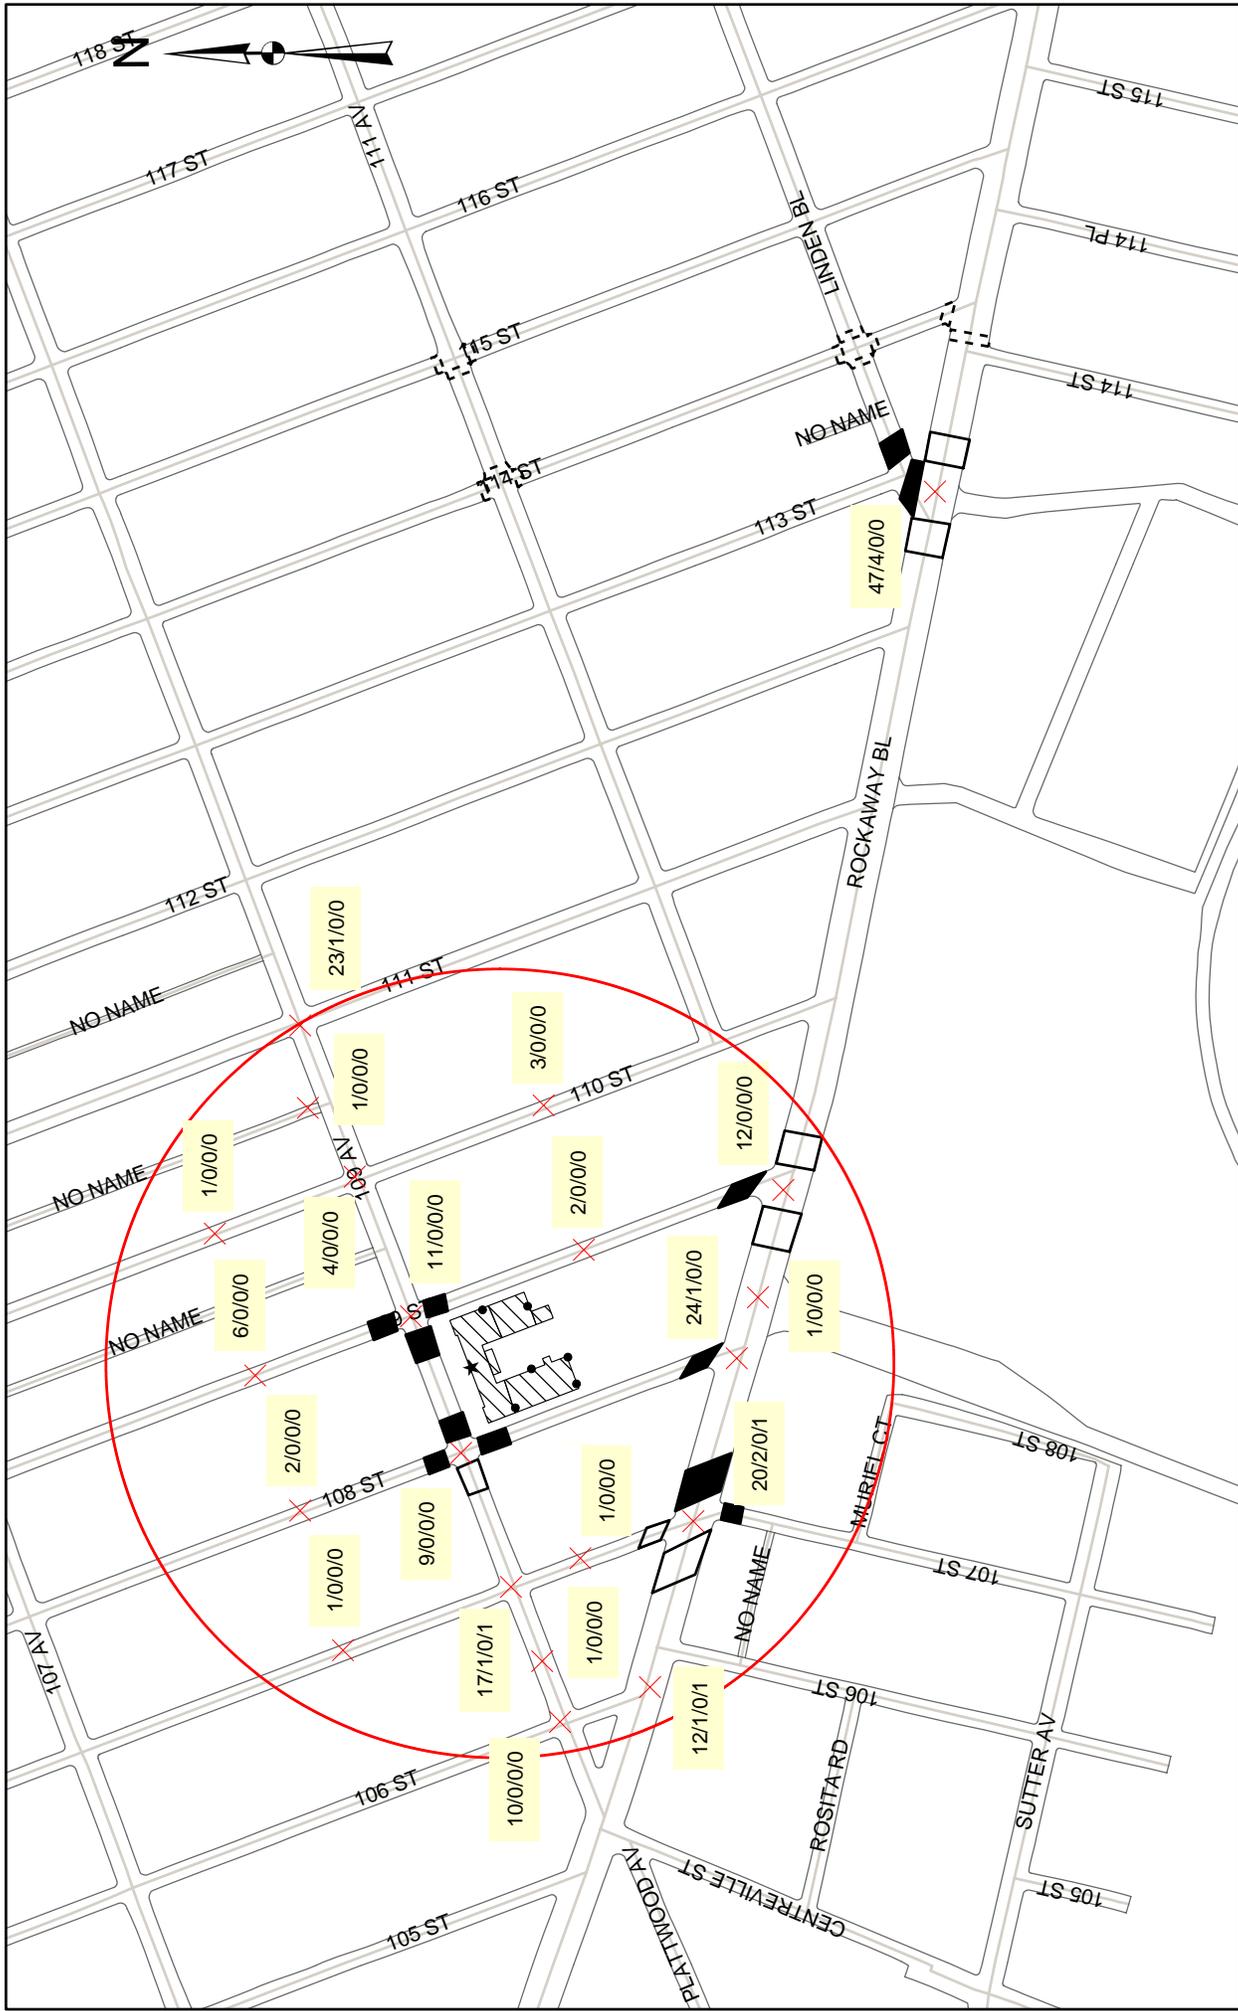
EXHIBIT 5

Exhibit 5 and Table 2 show a summary of accidents, as obtained from the New York State Department of Motor Vehicles (DMV), in the vicinity of P.S 108 for the three-year period from January 1, 1998 through December 31, 2000. The DMV data provides some detail relating to the circumstances and cause of the accident. Table 3 is a summary of more recent accident data obtained from the NYC Police Department (NYPD). Though current through 2004, the NYPD data does not provide the same level of detail as the DMV data.

ACCIDENT SUMMARY (1998-2000)

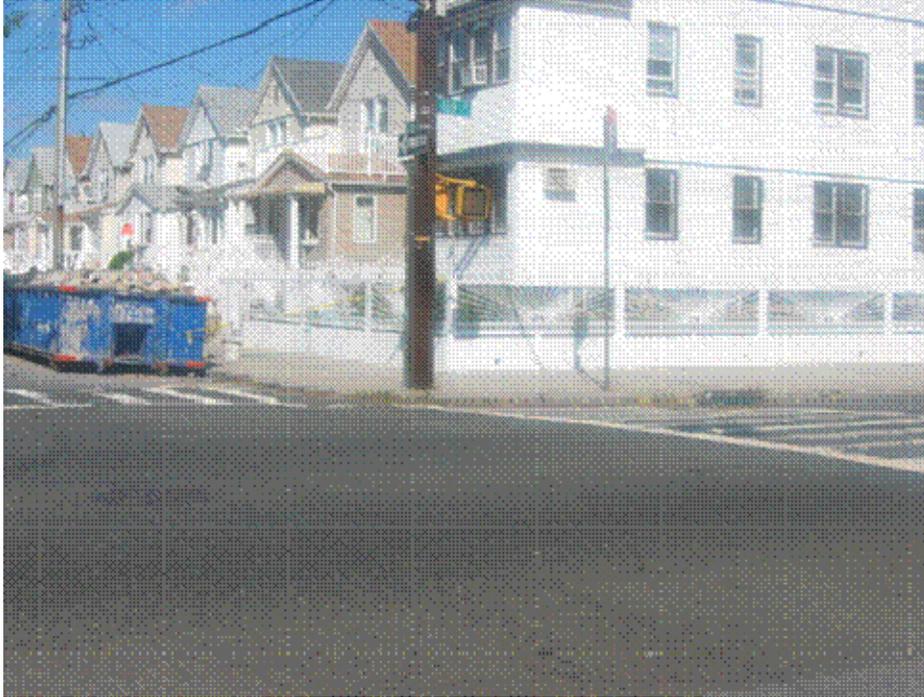
In general, pedestrian ramps in the vicinity of the school were observed to be standard. However, pedestrian ramps were found to be missing at the following locations:

- The northeast and northwest corners of the 108th Street and 109th Avenue intersection (see Figure 3).

Figure 3: Looking north towards the missing pedestrian ramps on the northeast corner of the 108th Street and 109th Avenue intersection

There were several locations where pedestrian ramps were missing or needed some modification. Therefore, it is recommended to:

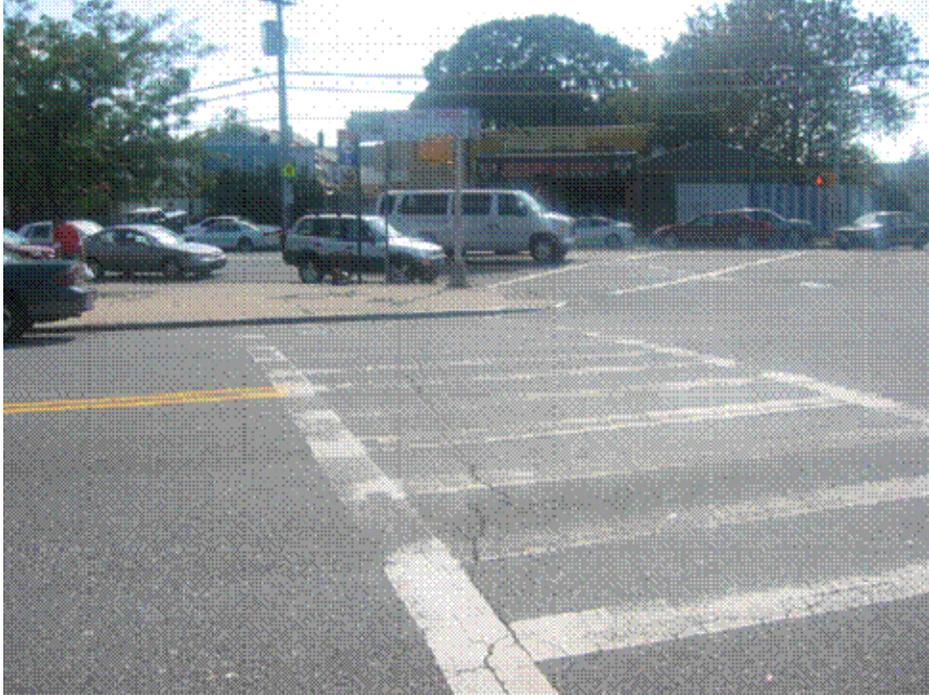
- The northwest corner of the Rockaway Boulevard and 108th Street intersection, for the school crosswalk located across the north leg of the intersection.
- The northeast and southeast corners of the 113th Street-Linden Boulevard and Rockaway Boulevard intersection (see Figure 4)

Figure 4: Looking south towards the missing pedestrian ramp on the northeast corner of the 113th Street-Linden Boulevard and Rockaway Boulevard intersection

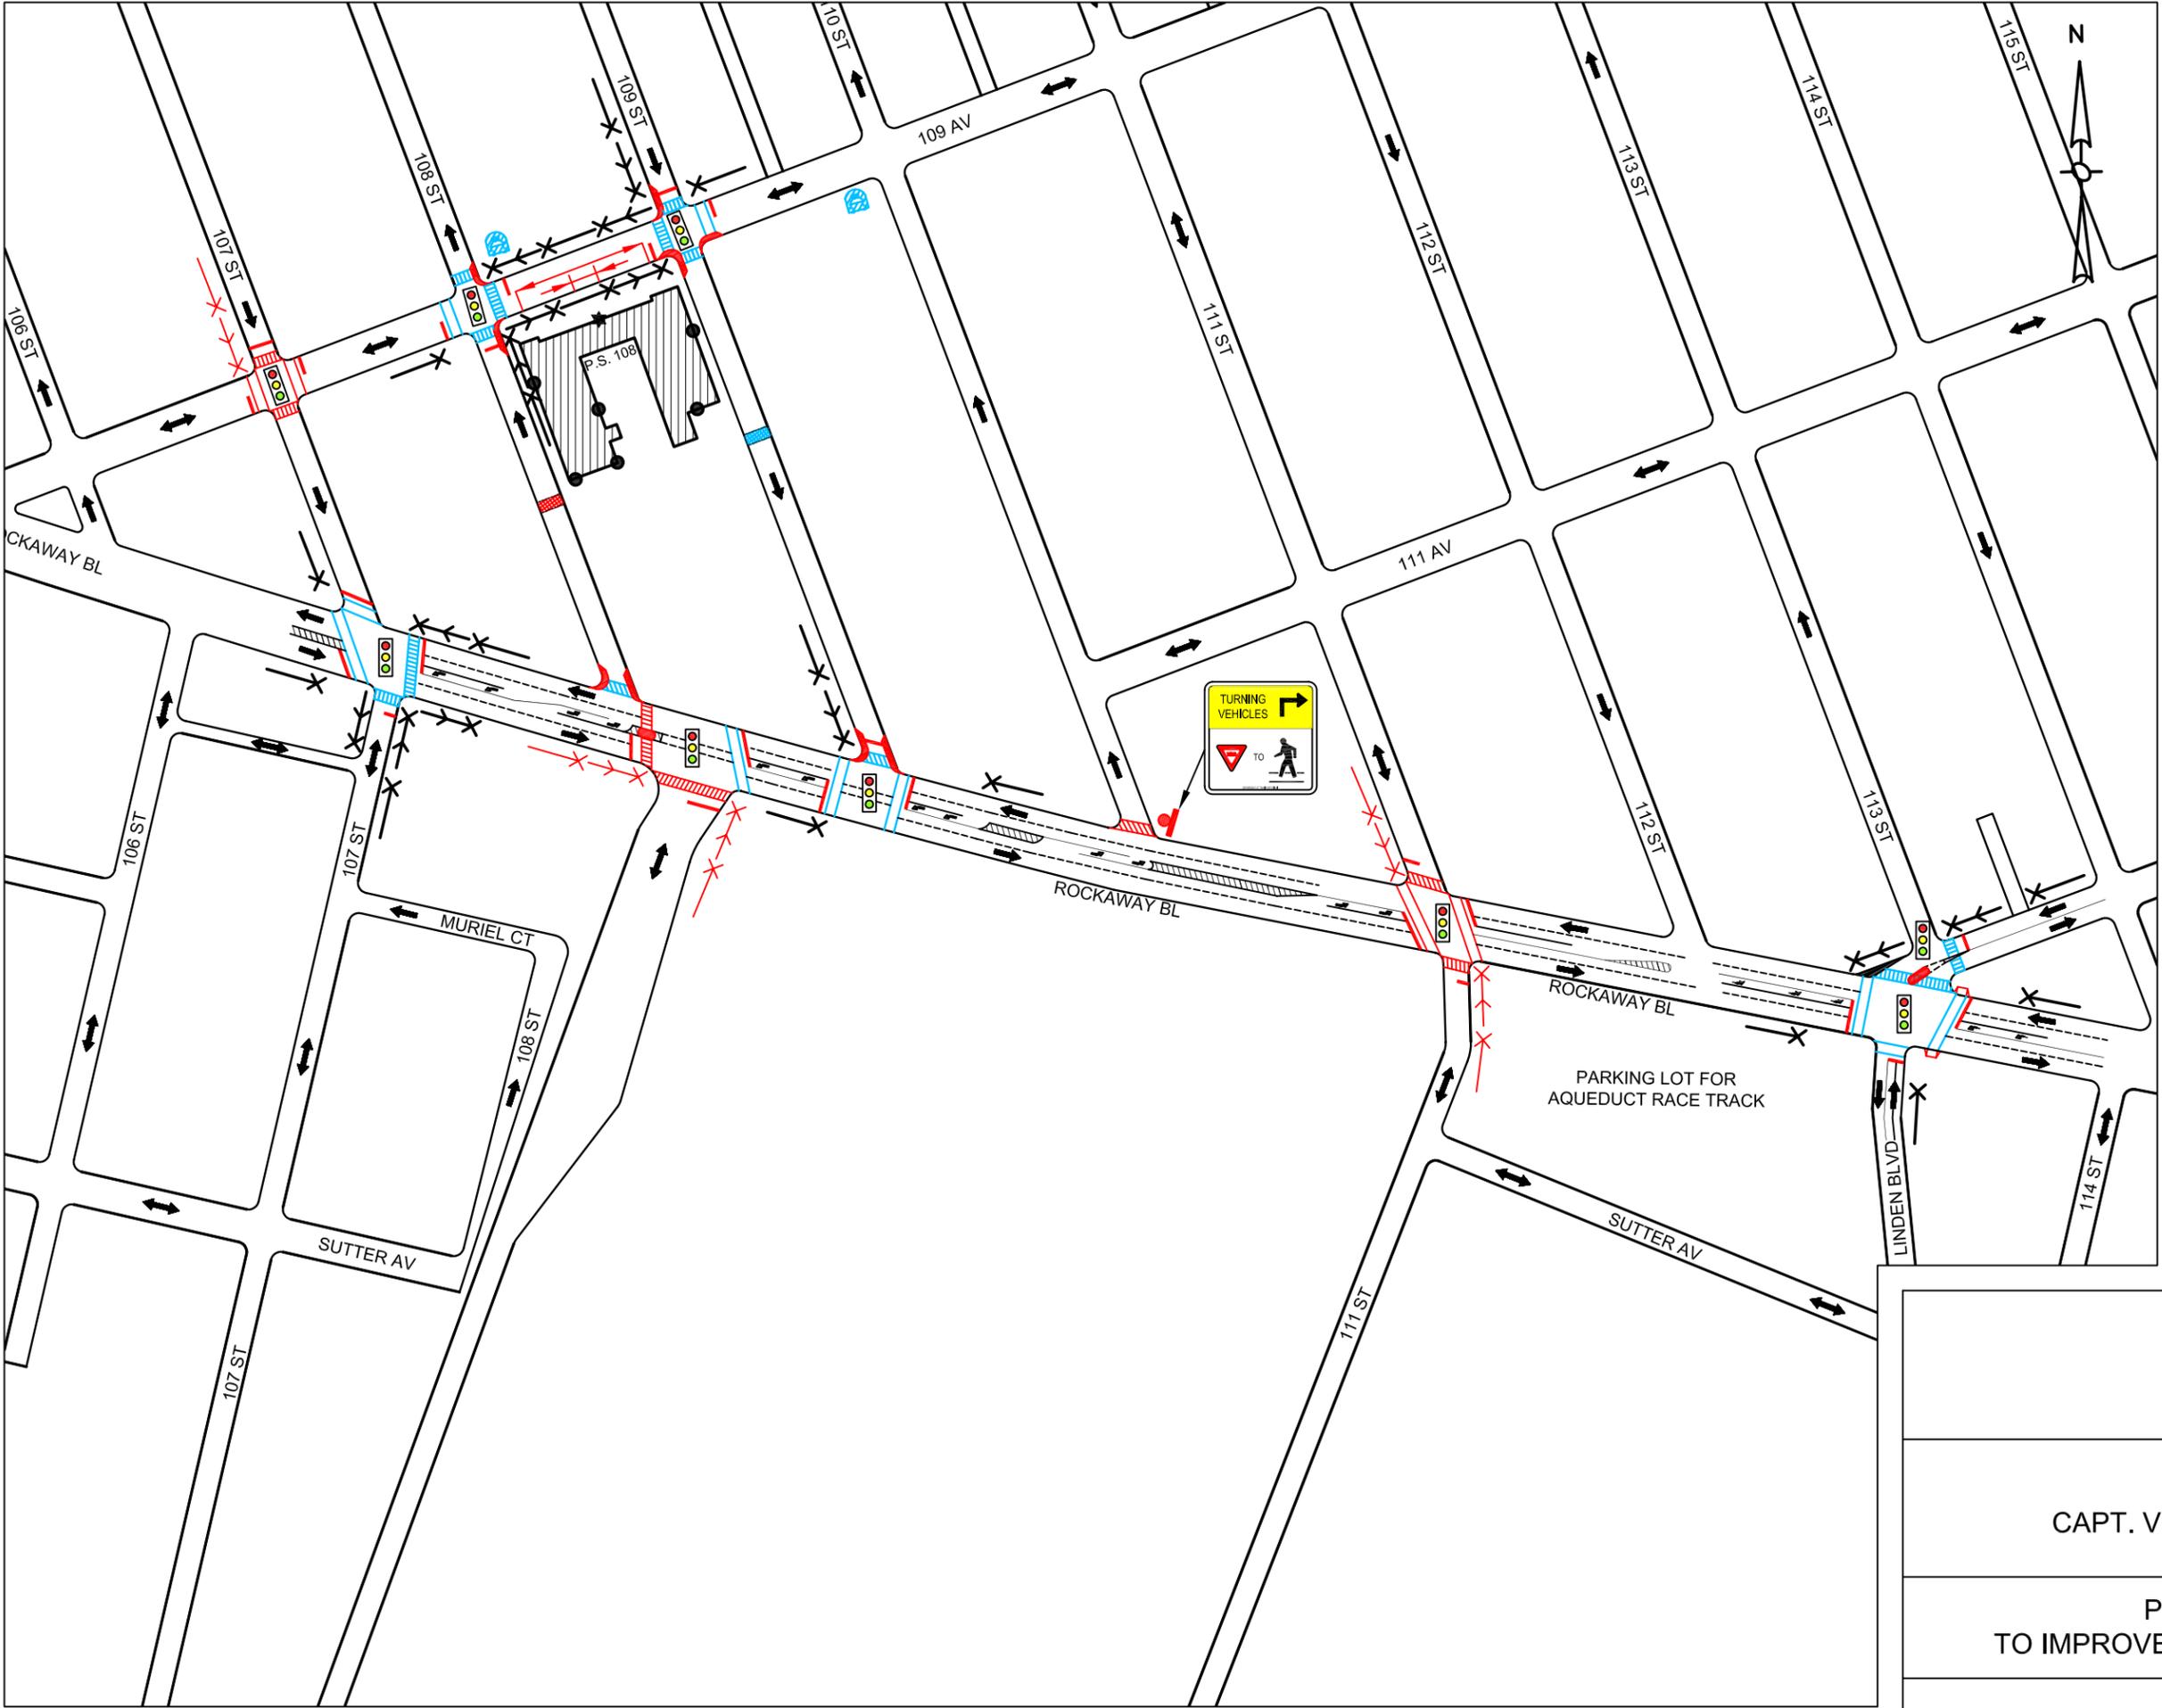
This section describes proposed measures to improve school pedestrian safety around P.S. 108. The proposed recommendations are divided into short-term and long-term measures. Short-term measures are those that potentially can be performed in-house by DOT. Long-term measures involve capital improvements. Each of the short- and long-term measures recommended for the P.S. 108 is discussed as follows, and is shown in more detail in Exhibit 6 at the end of this section.

There are striped medians on Linden Boulevard north of its intersection with Rockaway Boulevard, and also along Rockaway Boulevard east of its intersection with 108th Street. At the former intersection, a school crosswalk exists across the north leg (Linden Boulevard). At the latter intersection, a school crosswalk is proposed across Rockaway Boulevard. It is recommended that pedestrian refuge islands be installed at these intersections, as follows:

- Provide a concrete refuge island on Linden Boulevard, north of its intersection with Rockaway Boulevard.
- Provide a concrete refuge island on Rockaway Boulevard, east of the intersection with 108th Street, for the proposed school crosswalk.

The refuge islands will provide a refuge for pedestrians who do not complete the crossing during the flashing “DON’T WALK” indication. The proposed refuge islands should be the same width as the existing striped median, should extend through the crosswalk, and should have at least a five-foot at-grade cut-through section. These medians are not proposed where they would hinder the ability of vehicles to turn. Final details pertaining to proposed refuge islands, curb extensions and striped medians will be developed during Final Design.

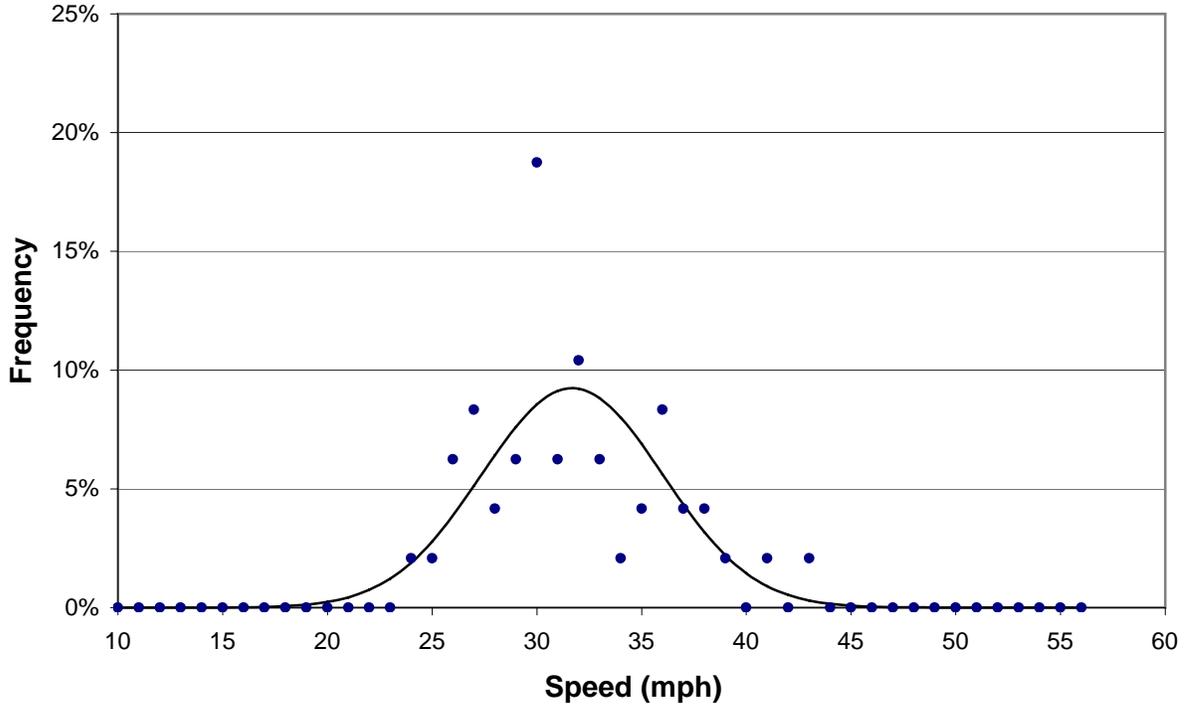
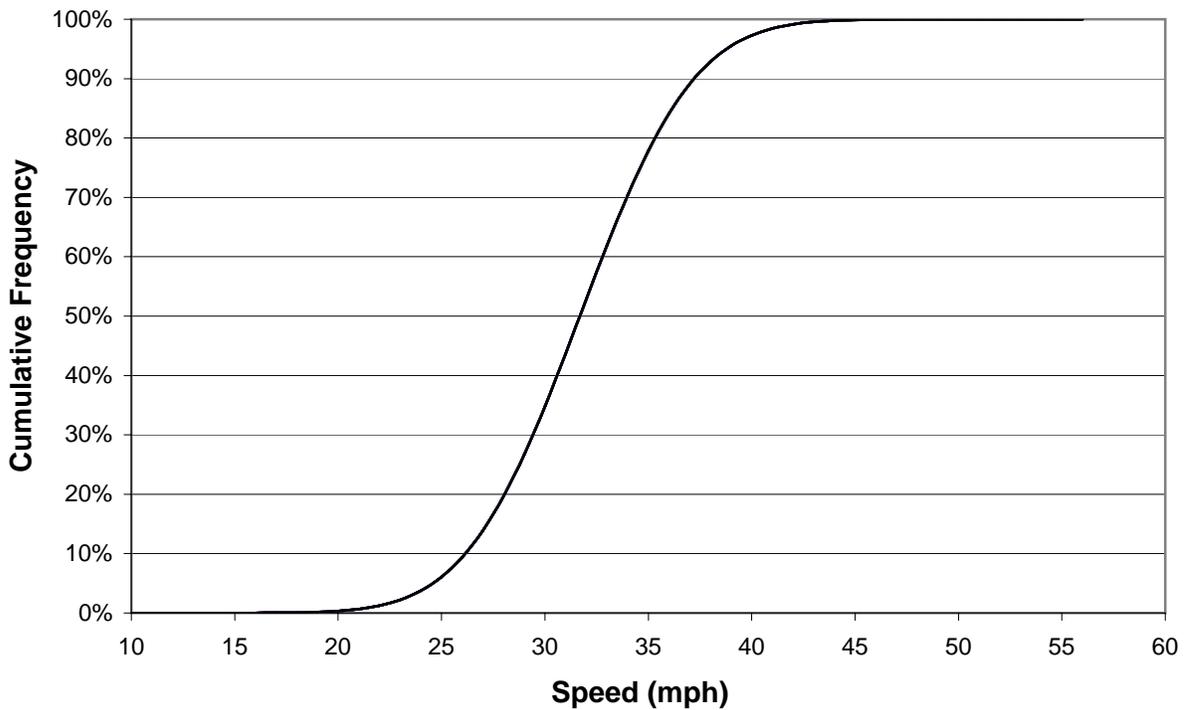
SPOT SPEED STUDY

Spot speed surveys are used to identify the 85th percentile speed, which is considered to be the representative speed for a specified street segment. By definition, 85 percent of the surveyed vehicles are traveling below this speed and 15 percent of the surveyed vehicles are traveling above this speed. 85th percentile speeds above 30 mph indicate a potential speeding problem that may require appropriate traffic calming measures. The results of the spot speed survey revealed that eastbound vehicles on 109th Avenue were found to be traveling with an 85th percentile speed of 35 mph, and westbound vehicles on 109th Avenue were found to be traveling with an 85th percentile speed of 36 mph.

Date: **October 17, 2005** Time: **11:10 am - 12:10 pm**
 Location: **109 Avenue between 108 Street & 109 Street**
 Surveyor: **R. Calvache/H. Salinas**

Mean Speed = 31.7 mph
 Standard Deviation = 4.3 mph
 Margin of Error (95% Confidence) = ± 1.2 mph

Median Speed = 31.7 mph
 15th Percentile Speed = 27.2 mph
 85th Percentile Speed = 36.2 mph

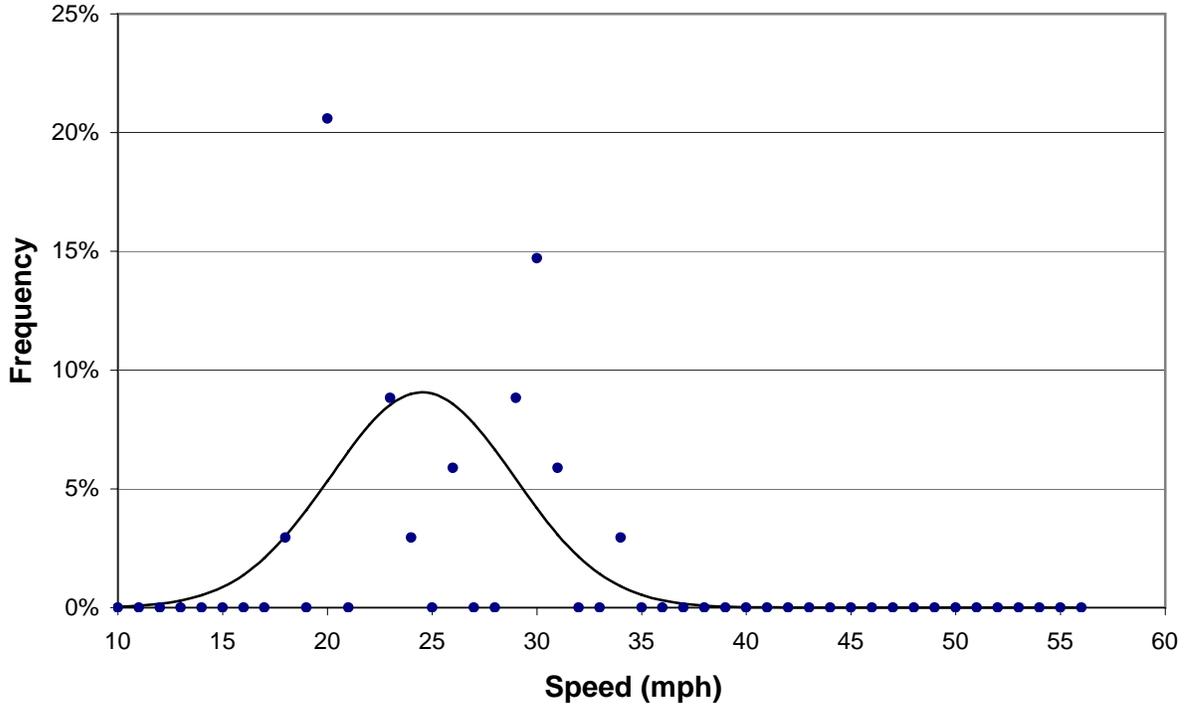
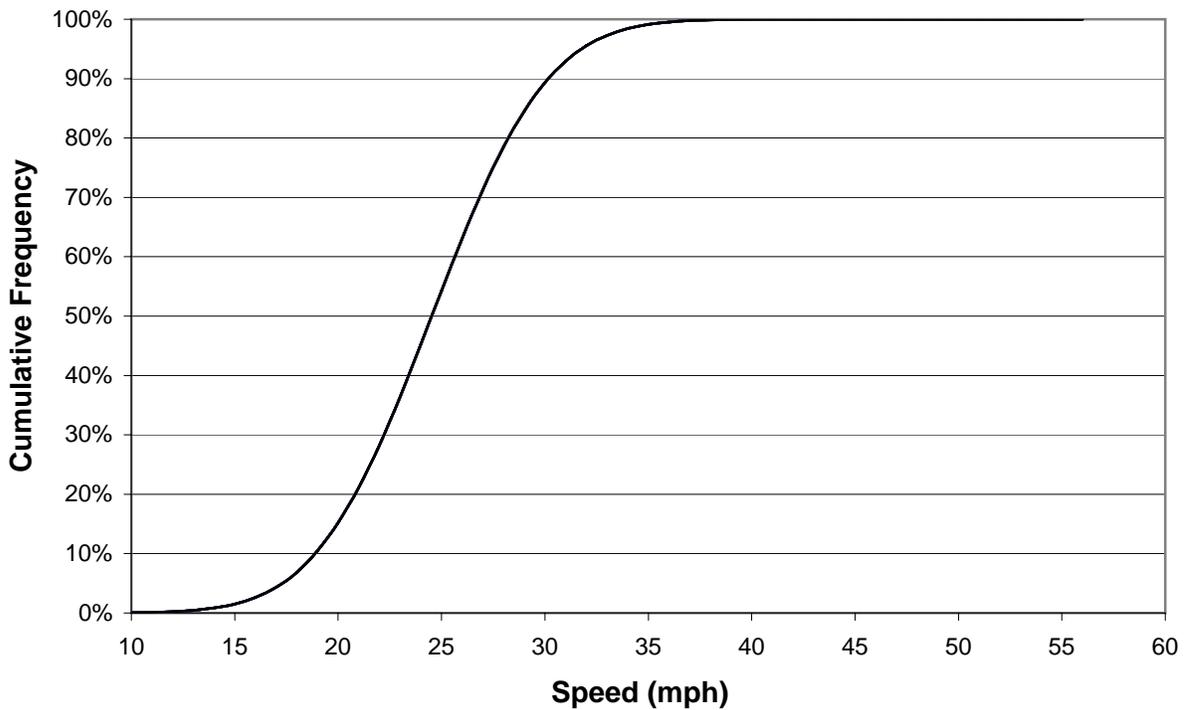
SPOT SPEED STUDY

The 85th percentile speed for northbound vehicles on 108th Street between Rockaway Boulevard and 109th Avenue was found to be 29 mph. The 85th percentile speed for

Date: **October 17, 2005**
Location: **108 Street between Rockaway Boulevard & 109 Avenue**
Surveyor: **R. Calvache/H. Salinas**

Mean Speed = 24.5 mph
Standard Deviation = 4.4 mph
Margin of Error (95% Confidence) = ± 1.5 mph

Median Speed = 24.5 mph
15th Percentile Speed = 20.0 mph
85th Percentile Speed = 29.1 mph

The spot speed surveys on 108th Street between Rockaway Boulevard and 109th Avenue showed an 85th percentile speed of 29 mph. Therefore it is recommended to:

- Install one speed reducer on 108th Street between 109 Avenue and Rockaway Boulevard.

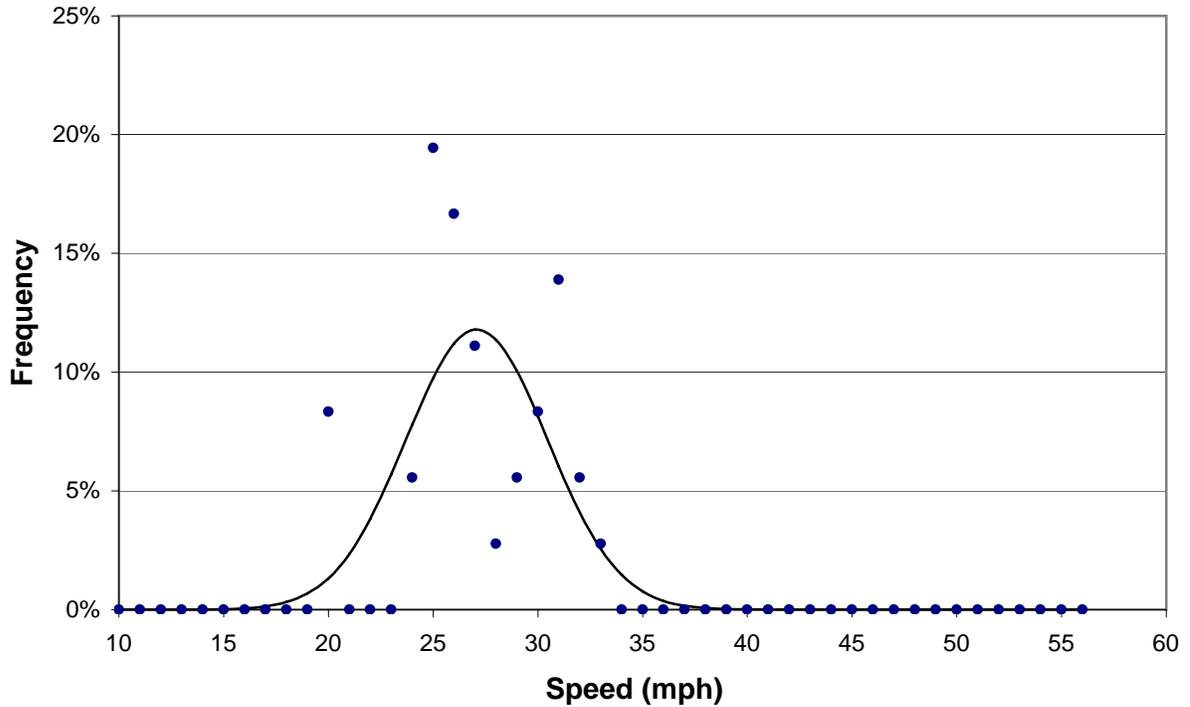
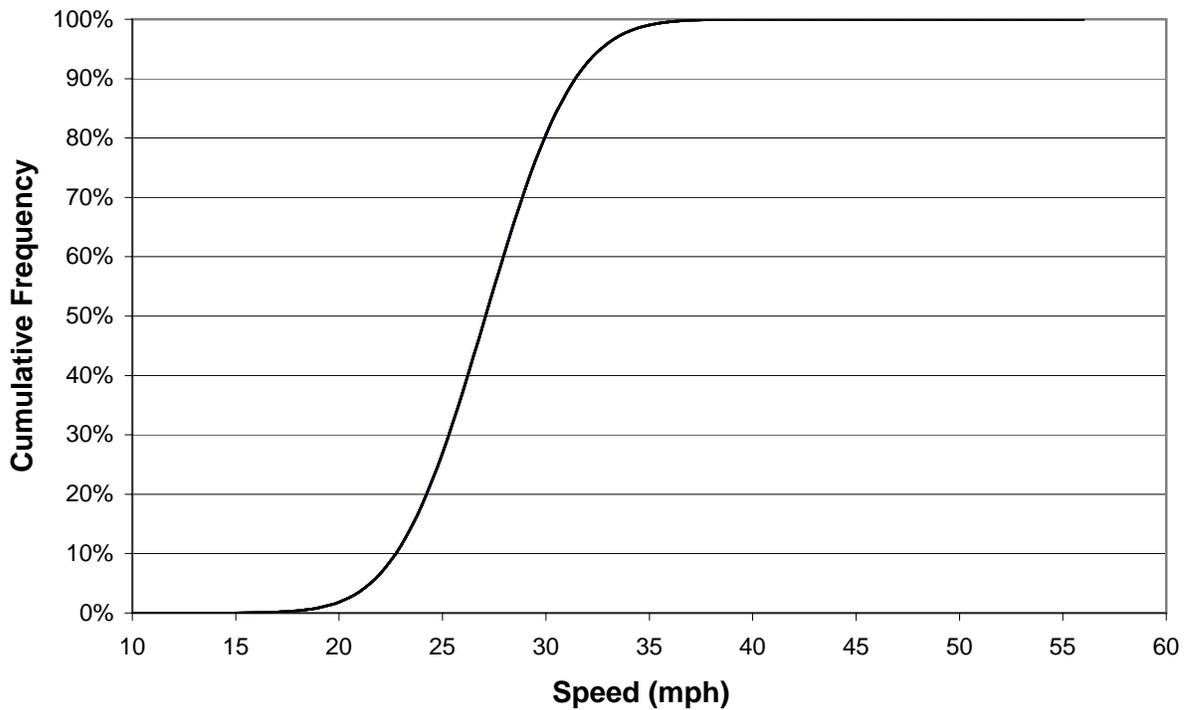
SPOT SPEED STUDY

Date: **October 17, 2005** Time: **12:20 pm - 1:20 pm**
 Location: **108 Street between Rockaway Boulevard & 109 Avenue**
 Surveyor: **R. Calvache/H. Salinas**

Mean Speed = 27.1 mph
Standard Deviation = 3.4 mph
Margin of Error (95% Confidence) = ± 1.1 mph

Median Speed = 27.1 mph
15th Percentile Speed = 23.6 mph
85th Percentile Speed = 30.6 mph
