**New York City Department of Transportation  
Office of School Safety Engineering**

**School Safety Engineering Project**

**FINAL REPORT: Saint Benedict Joseph Labre, Queens**

**Prepared by  
The RBA Group and URBITRAN Associates Inc.**

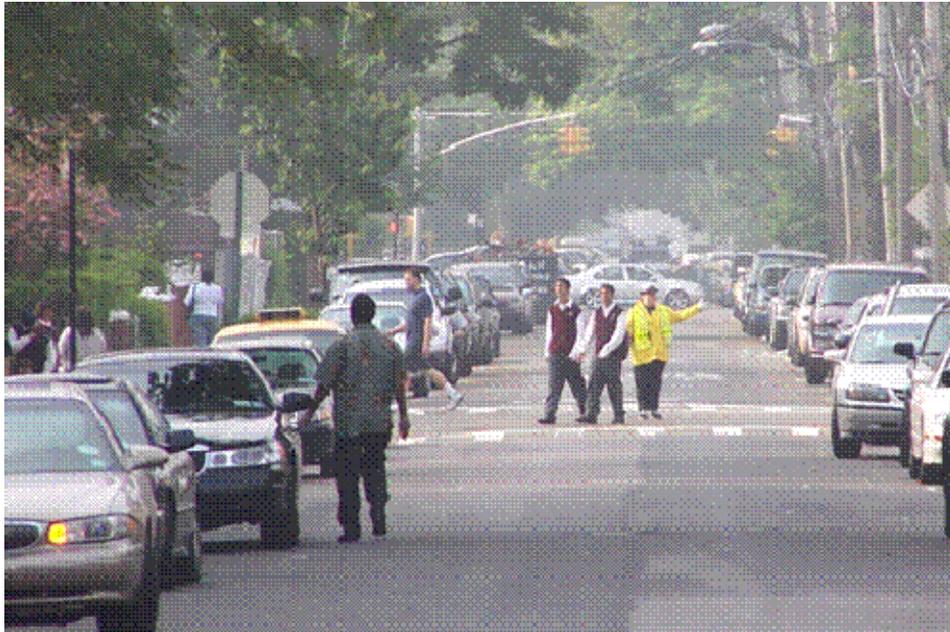
According to the school principal, one crossing guard is assigned to the all-way stop-controlled intersection of 95<sup>th</sup> Avenue and 117<sup>th</sup> Street.

*Figure 2: Crossing guard is shown on duty at the intersection of 117<sup>th</sup> Street and 95<sup>th</sup> Avenue*

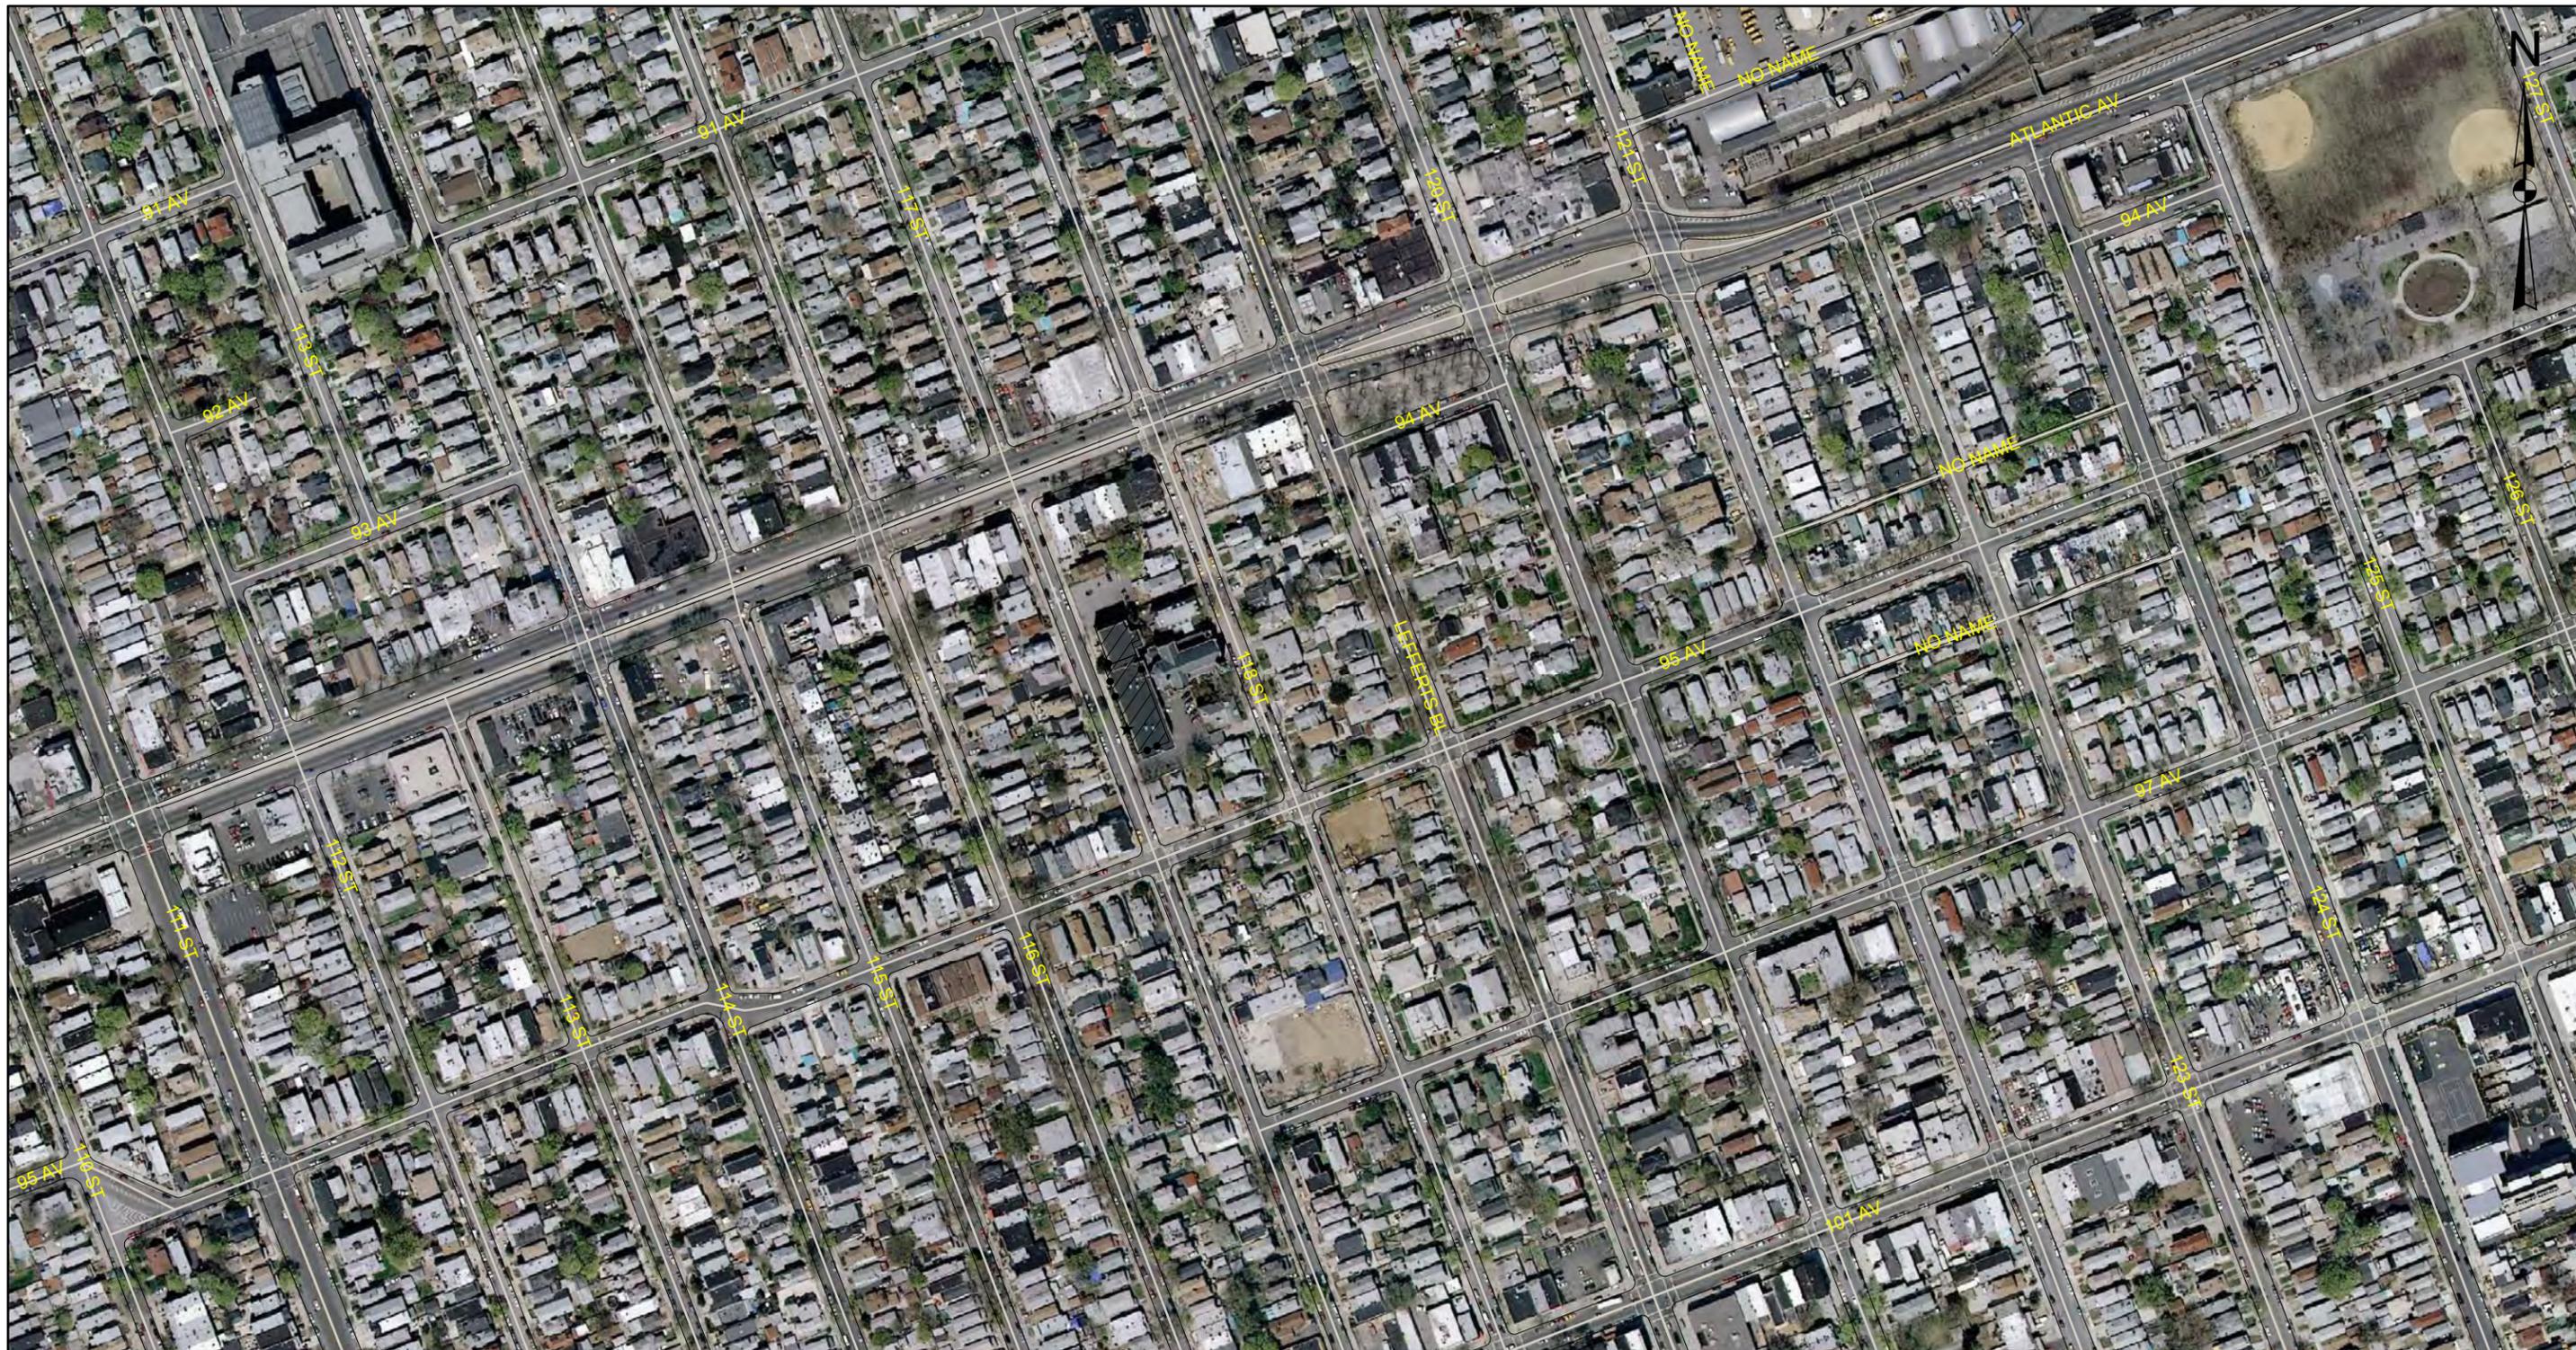
**EXHIBIT 1**  
**ST. BENEDICT JOSEPH LABRE SCHOOL QUEENS**

Exhibit 1 shows an aerial view of the neighborhood surrounding Saint Benedict Joseph Labre School, which includes a combination of residential and commercial uses. Saint Benedict Joseph Labre is located on the east side of 117<sup>th</sup> Street, and is bounded by Atlantic Avenue to the north, 95<sup>th</sup> Avenue to the south, and 118<sup>th</sup> Street to the east. Lefferts Boulevard is located one block east of the school.

**AERIAL PHOTOGRAPH**

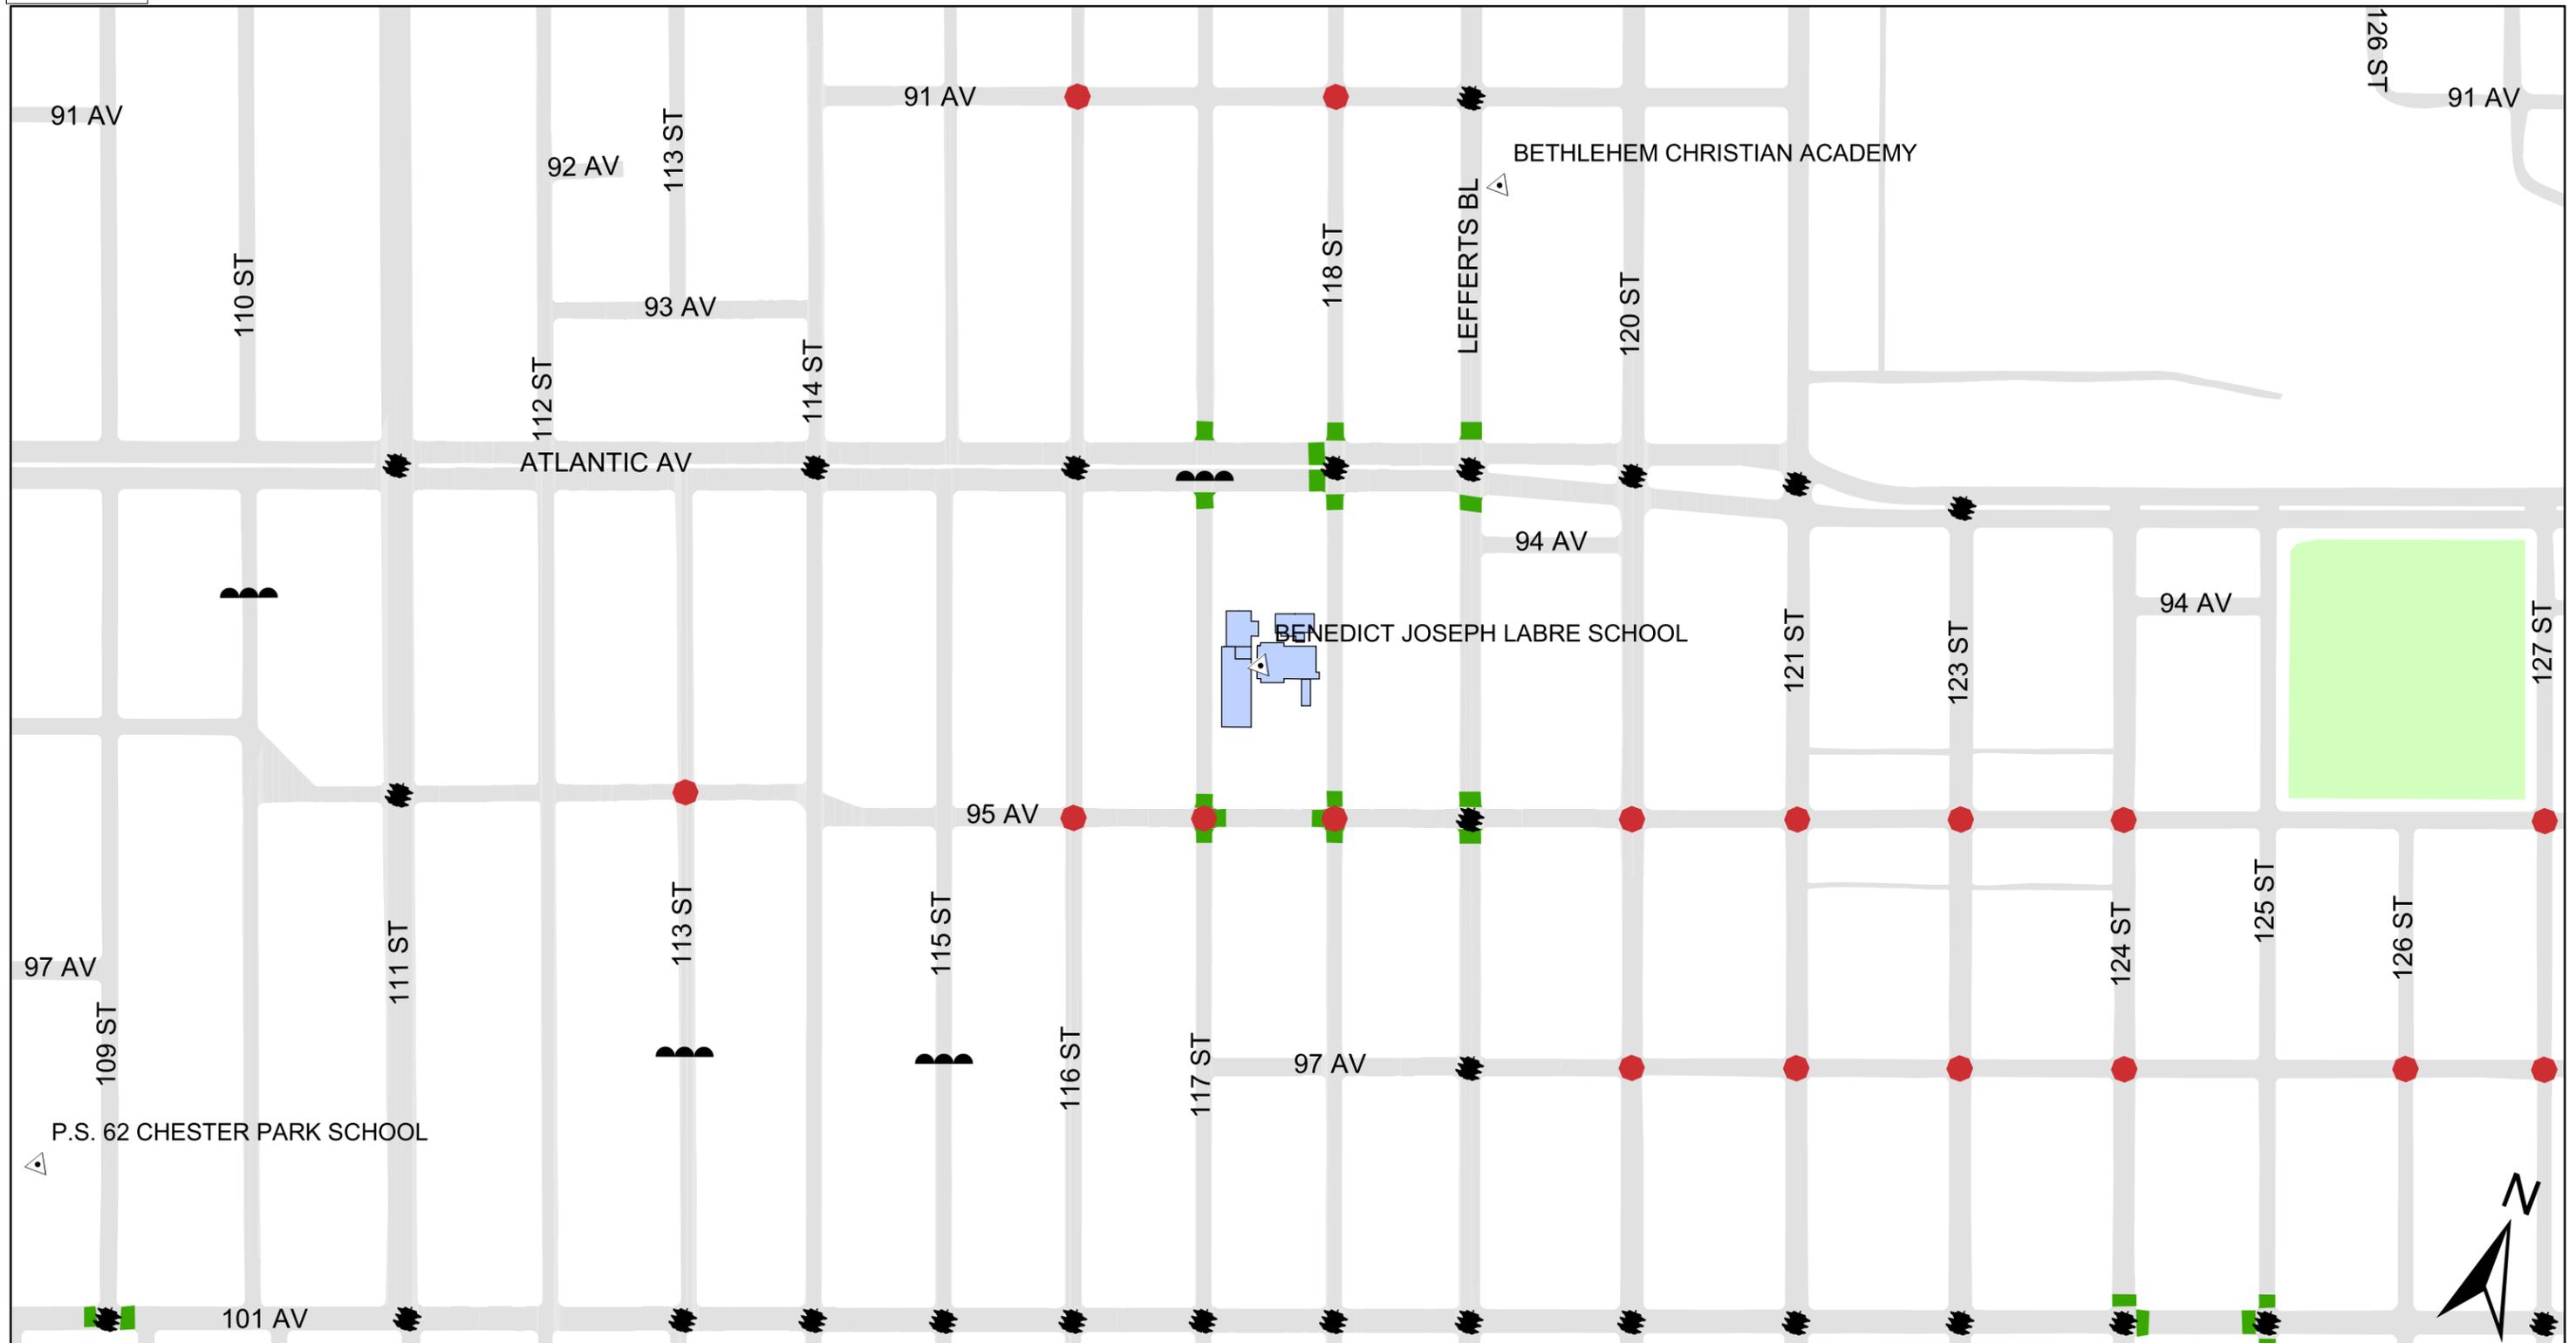
**EXHIBIT 2**

The School Traffic Safety Map was established to help provide the maximum degree of safety for children going to and from school - by indicating the location of speed reducers, school crosswalks and some traffic control devices. (While virtually all intersections in NYC benefit from traffic control devices - such as stop signs, traffic signals, yield signs, and all way stop signs - this map shows only traffic signals and all way stop signs.) The school crosswalks that are shown are ladder striped and make the crosswalk more visible to drivers and help make the intersection safer. These crosswalks are where school children are recommended to cross.

Exhibit 2 shows the existing signals and pavement markings around Saint Benedict Joseph Labre. It should be noted that a citywide signage program is currently underway to upgrade school signage to current Federal Manual on Uniform Traffic Control Devices (MUTCD) standards of fluorescent yellow-green signs accompanied by downward pointing arrows. Signs scheduled to be installed under this program are shown as “existing” in Exhibit 6.

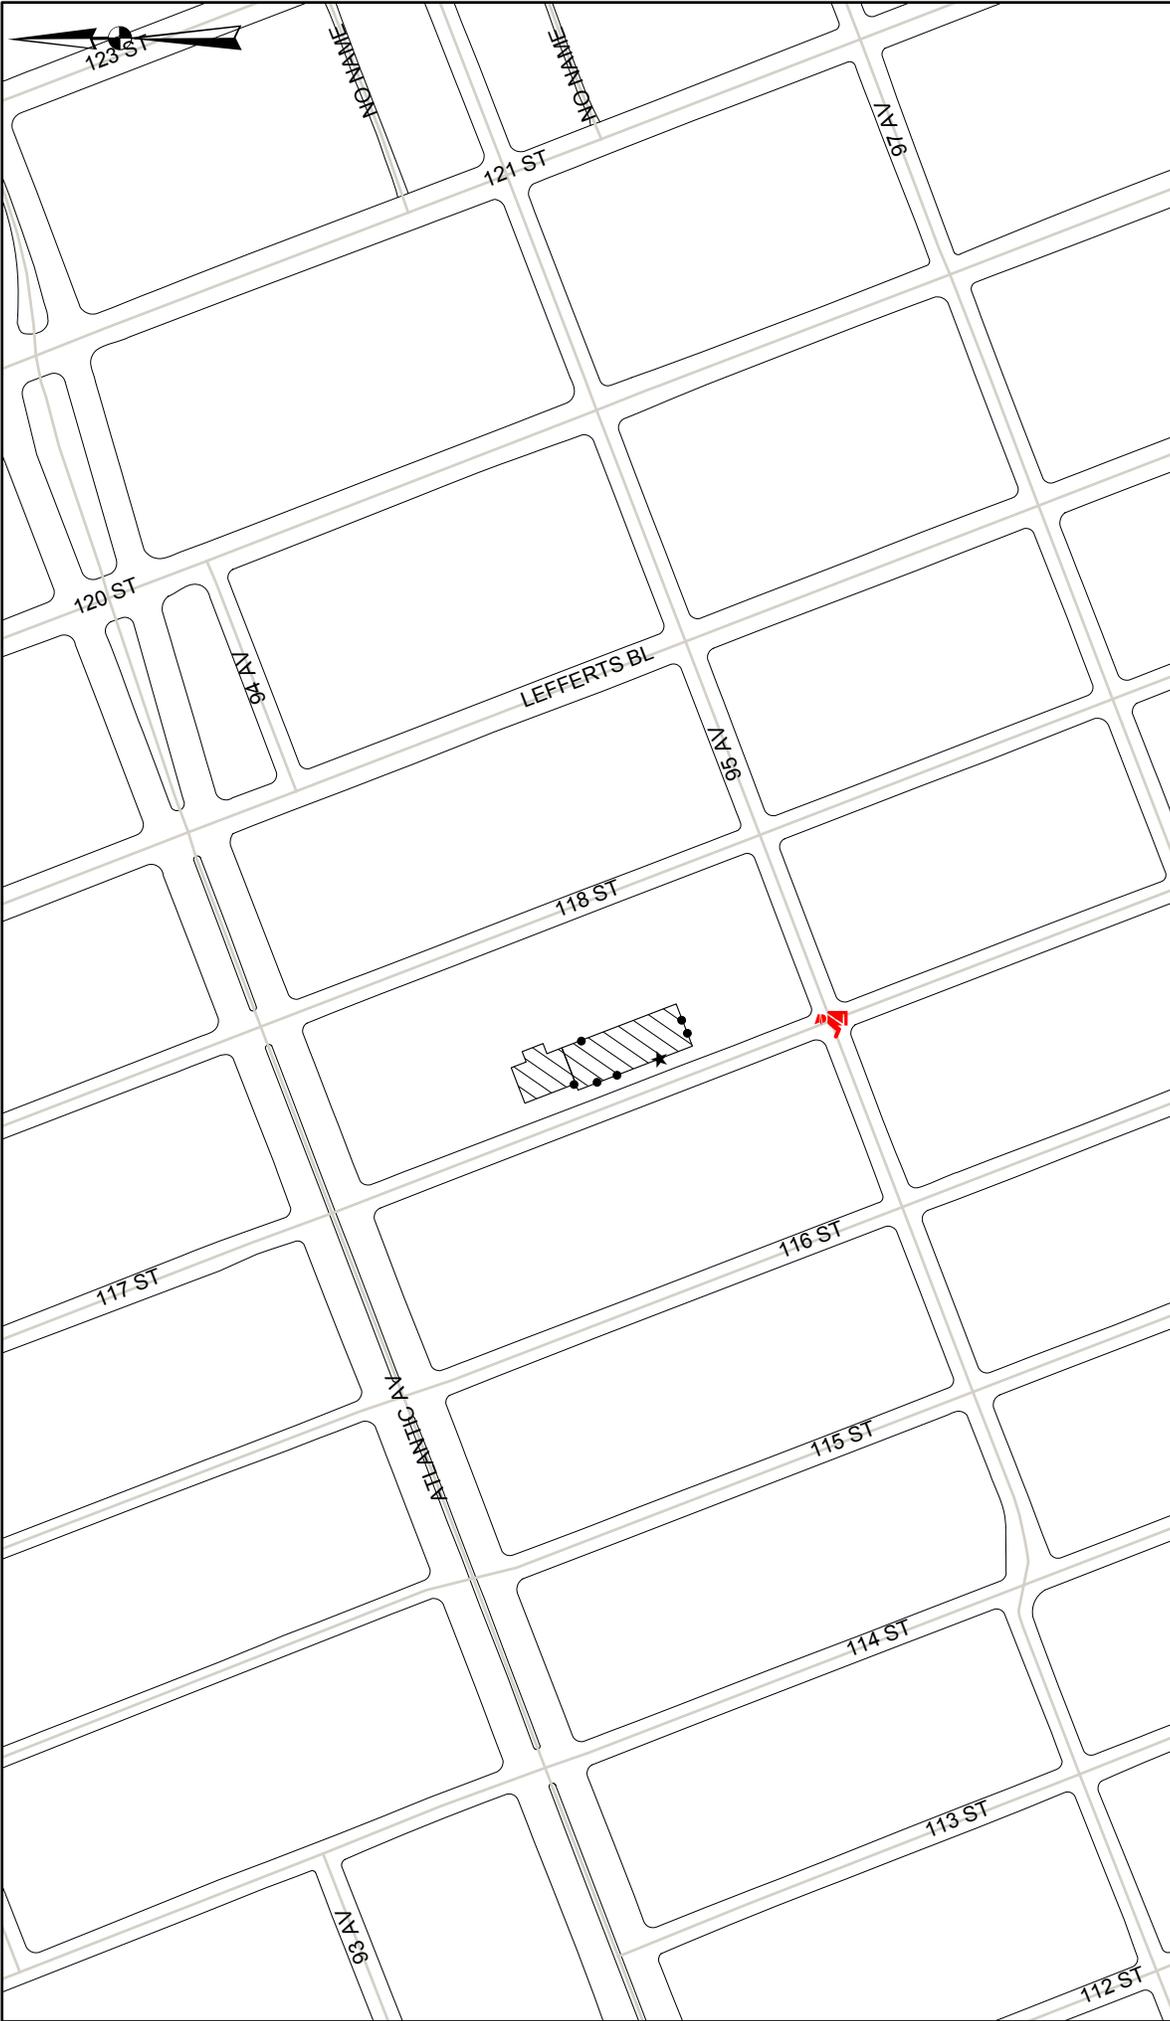
**EXHIBIT 3**

**CROSSING GUARD LOCATION**

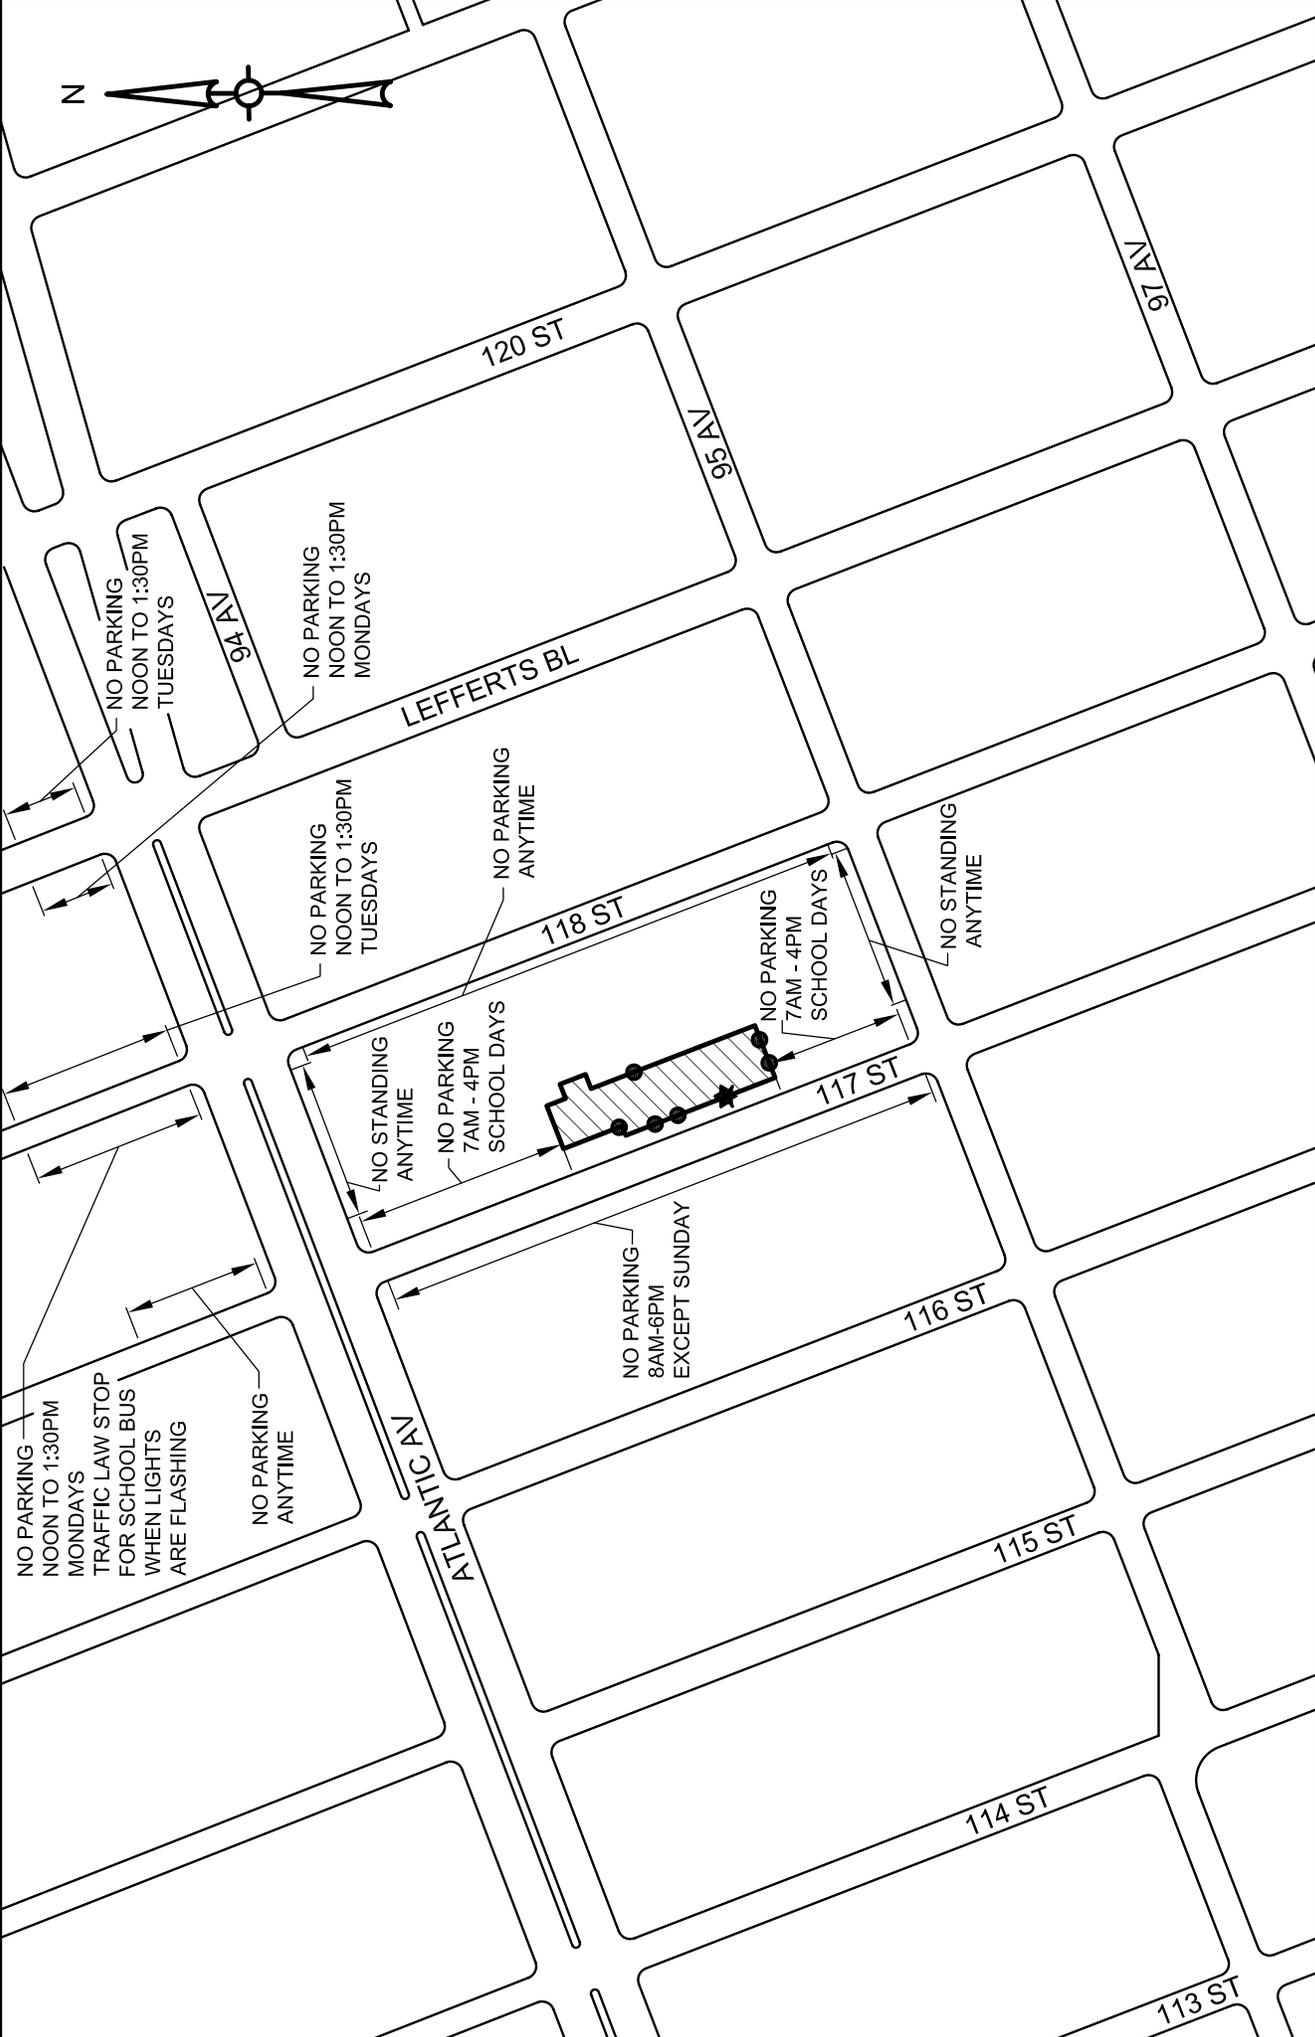
EXHIBIT 4

Parking regulations in the vicinity of the school are shown in Exhibit 4. Atlantic Avenue is a designated “Snow Route,” which prohibits vehicles from standing on the street during an emergency weather condition.

EXISTING PARKING REGULATIONS

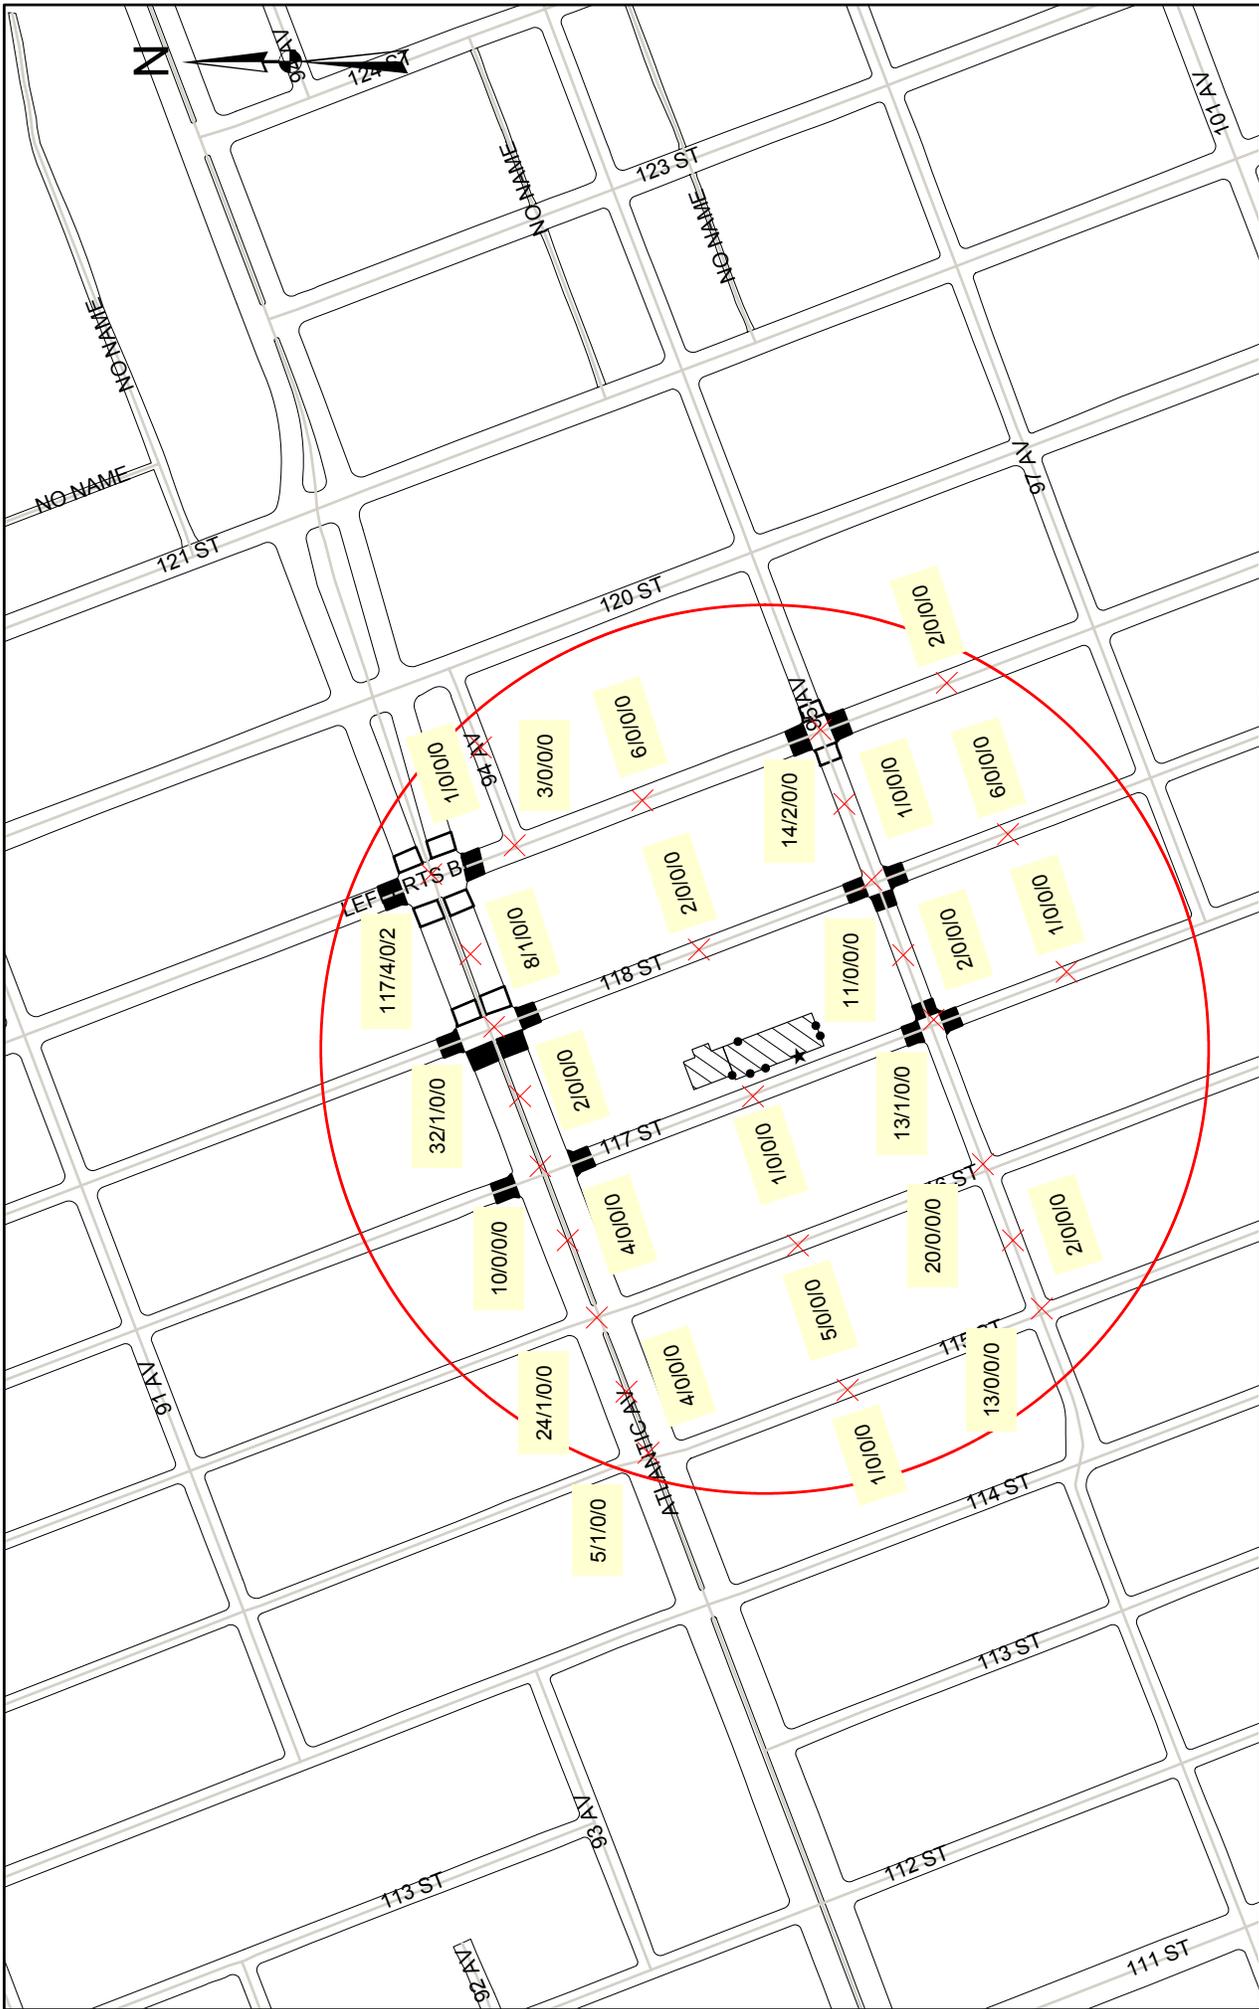
**EXHIBIT 5**

Exhibit 5 and Table 2 show a summary of accidents, as obtained from the New York State Department of Motor Vehicles (DMV), in the vicinity of St. Benedict Joseph Labre School for the three-year period from January 1, 1998 through December 31, 2000. The DMV data provides some detail relating to the circumstances and cause of the accident. Table 3 is a summary of more recent accident data obtained from the NYC Police Department (NYPD). Though current through 2004, the NYPD data does not provide the same level of detail as the DMV data.

**ACCIDENT SUMMARY (1998-2000)**

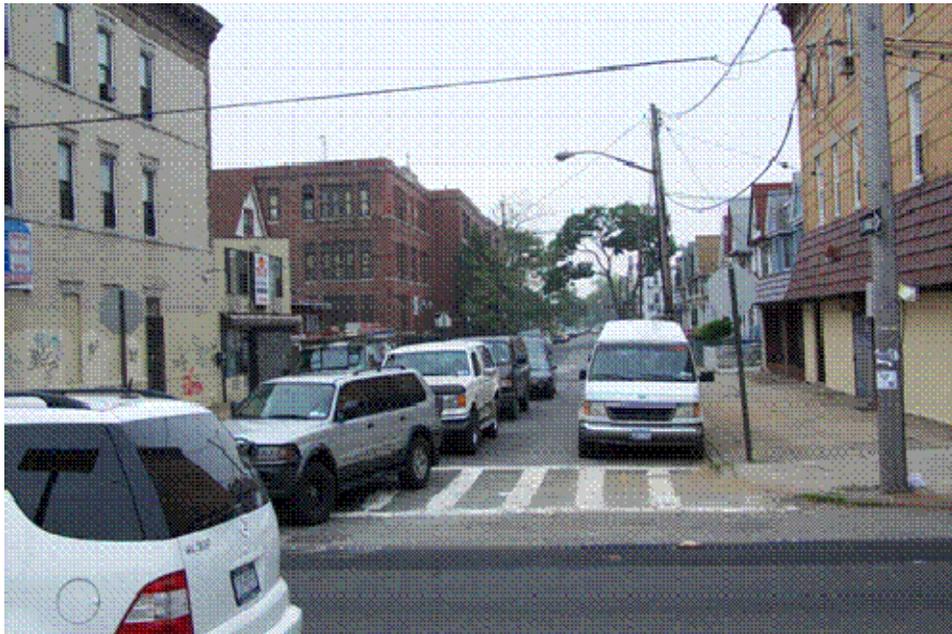
This is an unsignalized stop-controlled intersection with school crosswalks located across the north and south legs of 117<sup>th</sup> Street. Atlantic Avenue is a two-way east-west street with two travel lanes and one on-street parking lane in each direction, separated by a raised concrete median approximately 27 feet wide. 117<sup>th</sup> Street is a one-way northbound street with one travel lane and on-street parking permitted on both sides of the roadway (see Figures 3 and 4). The northbound approach of 117<sup>th</sup> Street is stop-controlled at its intersection with Atlantic Avenue.

There was a total of ten accidents reported at this intersection between 1998 and 2000, but none of these were pedestrian accidents (Table 2). No pedestrian fatalities were reported at this intersection between 1998 and 2000.

*Figure 3: Looking south along 117<sup>th</sup> Street from the intersection with Atlantic Avenue*

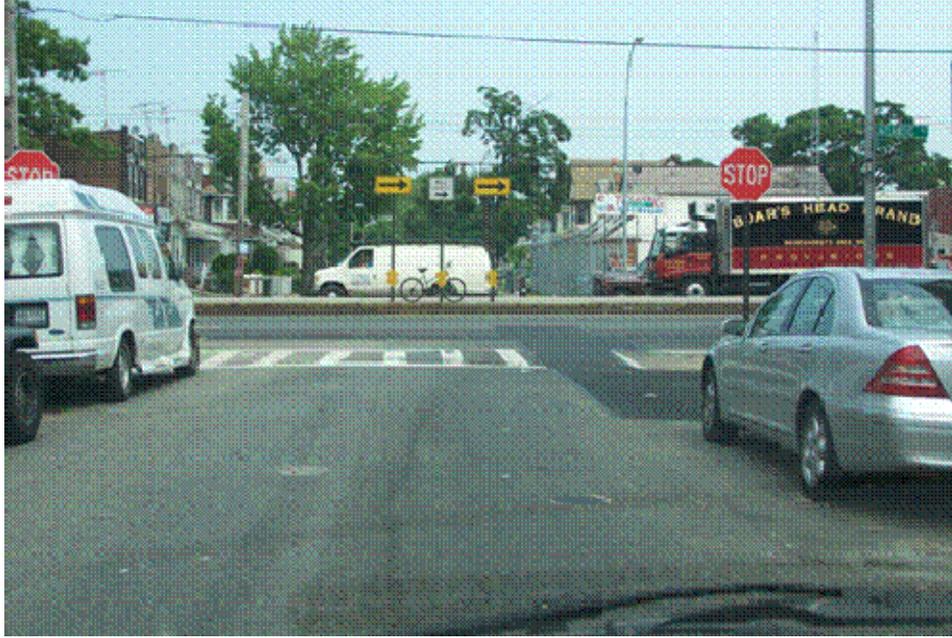
*Figure 4: Looking north on 117<sup>th</sup> Street to the intersection with Atlantic Avenue*

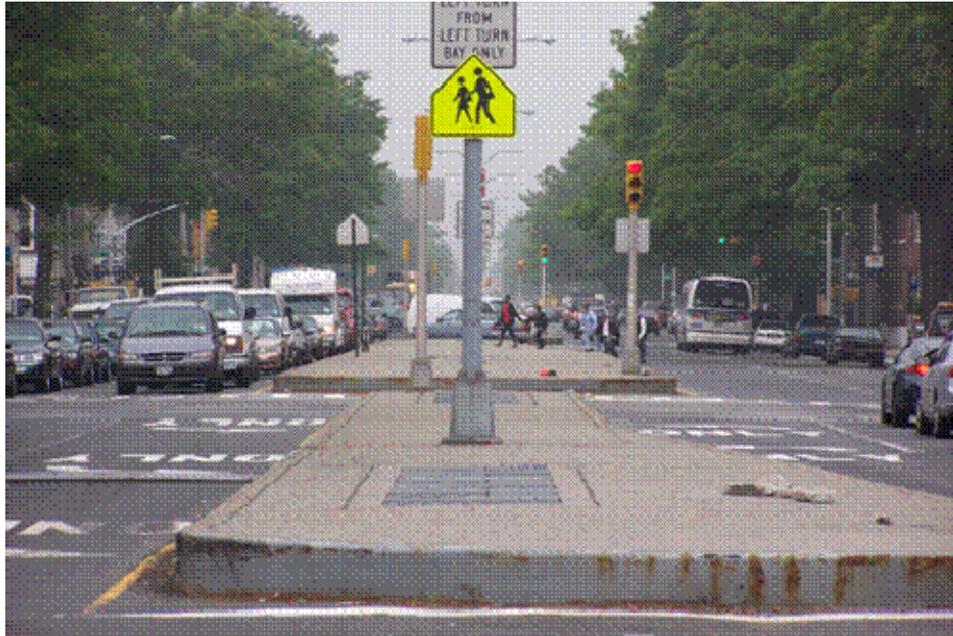
Atlantic Avenue is a two-way east-west street with two travel lanes and one on-street parking lane in each direction, separated by a raised concrete median. At the intersection with 118<sup>th</sup> Street, the concrete median narrows to accommodate an exclusive westbound

left-turn lane on Atlantic Avenue. 118<sup>th</sup> Street is a one-way southbound street with one travel lane and on-street parking permitted on both sides of the roadway (see Figure 5).

There was a total of 32 accidents reported at this intersection between 1998 and 2000, including one pedestrian accident that was not school-related (Table 2). There were no pedestrian fatalities reported at this intersection between 1998 and 2000.

*Figure 5: Looking west along Atlantic Avenue at the intersection with 118<sup>th</sup> Street*

- Extend the existing median through the school crosswalk across the west leg and the pedestrian crosswalk across the east leg of Atlantic Avenue at the intersection with 118<sup>th</sup> Street.
- Extend the existing median through the pedestrian crosswalks across the east and west legs of Atlantic Avenue at the intersection with Lefferts Boulevard.

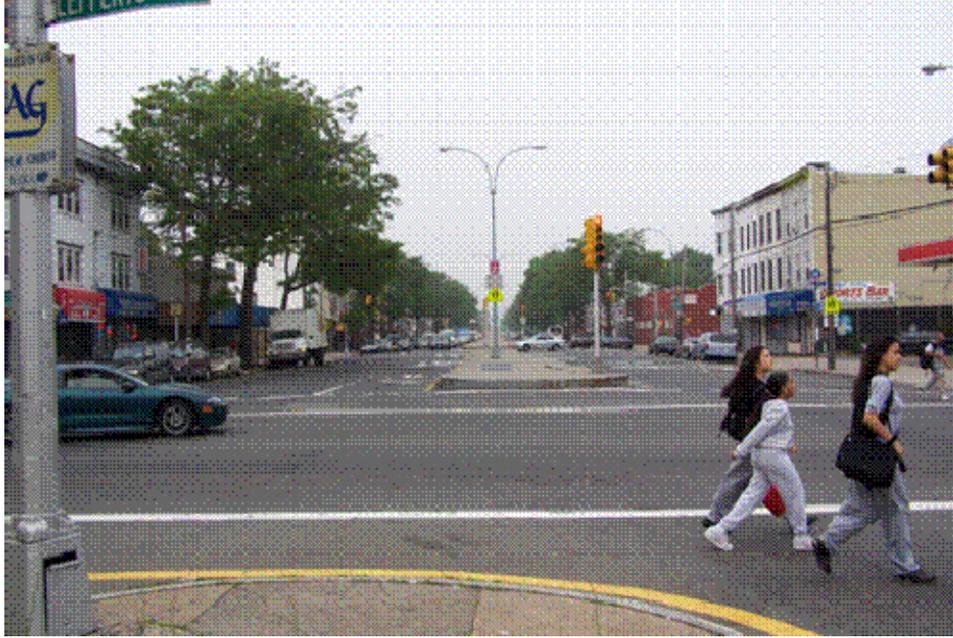
Atlantic Avenue is a two-way east-west street with two travel lanes and one on-street parking lane in each direction, separated by a raised concrete median approximately 18 feet wide, and exclusive eastbound and westbound left-turn lanes. Lefferts Boulevard is a two-way north-south street with one travel lane and one on-street parking lane in each direction (see Figure 6).

There was a total of 117 accidents reported at this intersection between 1998 and 2000, including four pedestrian accidents, two of which were school-related. In the first school-related accident, a nine-year-old pedestrian suffered an incapacitating injury on Friday, September 24, 1999 at approximately 5:00 pm while crossing against the signal. The roadway surface and weather were reported as dry and clear, respectively. In the second school-related accident, a 13-year-old pedestrian suffered a non-incapacitating injury on Friday, June 16, 2000 at approximately 8:00 am while crossing against the signal. The roadway surface and weather were reported as dry and cloudy, respectively. There were no pedestrian fatalities reported at this intersection between 1998 and 2000.

Figure 6: Looking west along Atlantic Avenue to the intersection with Lefferts Boulevard.

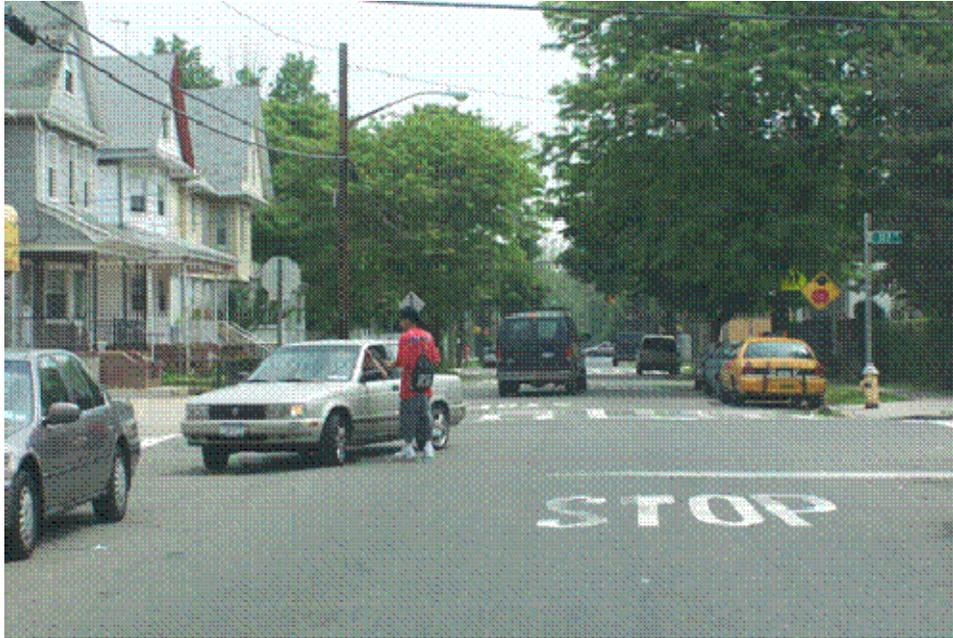
117<sup>th</sup> Street is a one-way northbound street with one travel lane and on-street parking on the west side of the roadway and a “NO PARKING 7AM-4PM SCHOOL DAYS, on the east side of the roadway. 95<sup>th</sup> Avenue is a two-way east-west street with one travel lane and one on-street parking lane on each side of the roadway (see Figures 7 and 8).

There was a total of 13 accidents reported at this intersection between 1998 and 2000, including one pedestrian accident which was not school-related. There were no pedestrian fatalities reported at this intersection between 1998 and 2000.

*Figure 7: Looking east on 95<sup>th</sup> Avenue to the intersection with 117<sup>th</sup> Street*

- A pedestrian crosswalk should be designated across the west leg of the 117<sup>th</sup> Street and 95<sup>th</sup> Avenue intersection, and all appropriate advance warning signs should be installed.

- Northwest and southwest corners of the 95<sup>th</sup> Avenue and 117<sup>th</sup> Street intersection.
- Southeast corner of 117<sup>th</sup> Street at Atlantic Avenue.

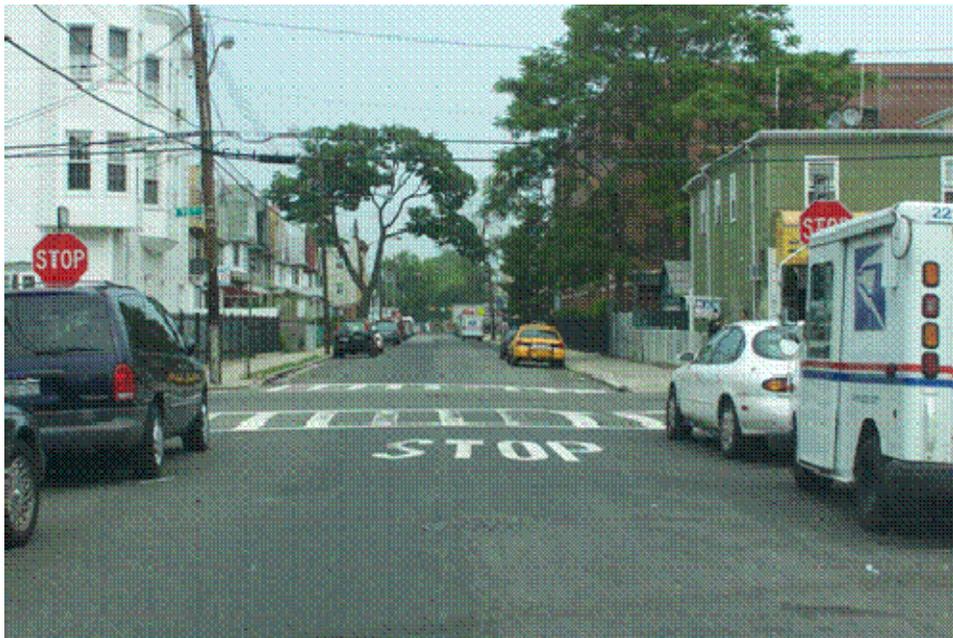
*Figure 8: Looking north on 117<sup>th</sup> Street to the intersection with 95<sup>th</sup> Avenue*

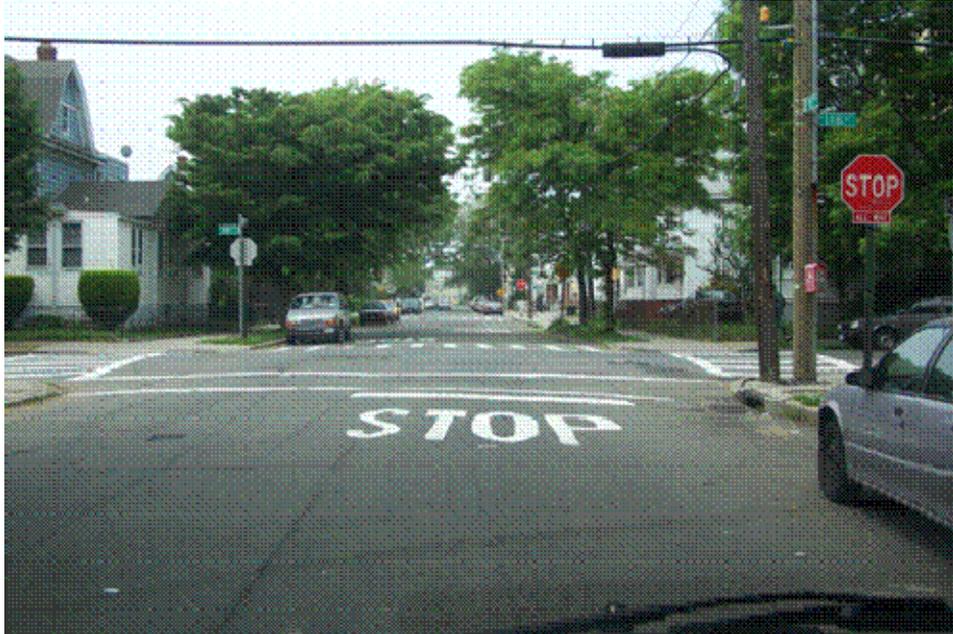
118<sup>th</sup> Street is a one-way southbound street with one travel lane and on-street parking permitted on both sides of the roadway. 95<sup>th</sup> Avenue is a two-way east-west street with one travel lane and one on-street parking lane on each side of the roadway (see Figures 9 and 10).

There was a total of 11 accidents reported at this intersection between 1998 and 2000, but none of these were pedestrian accidents.

*Figure 9: Looking west on 95<sup>th</sup> Avenue to the intersection with 118<sup>th</sup> Street*

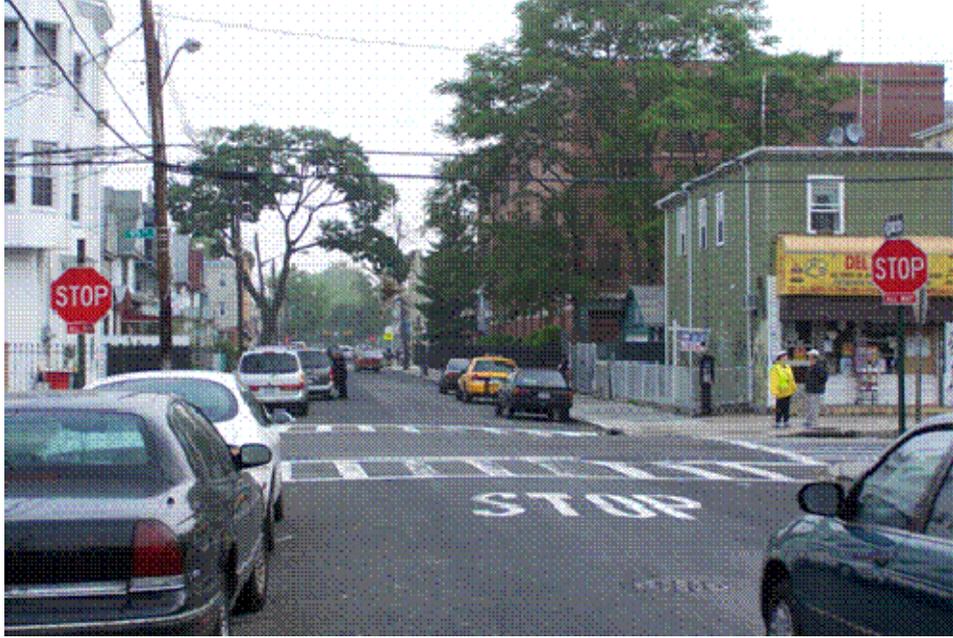
*Figure 10: Looking south on 118<sup>th</sup> Street to the intersection with 95<sup>th</sup> Avenue*

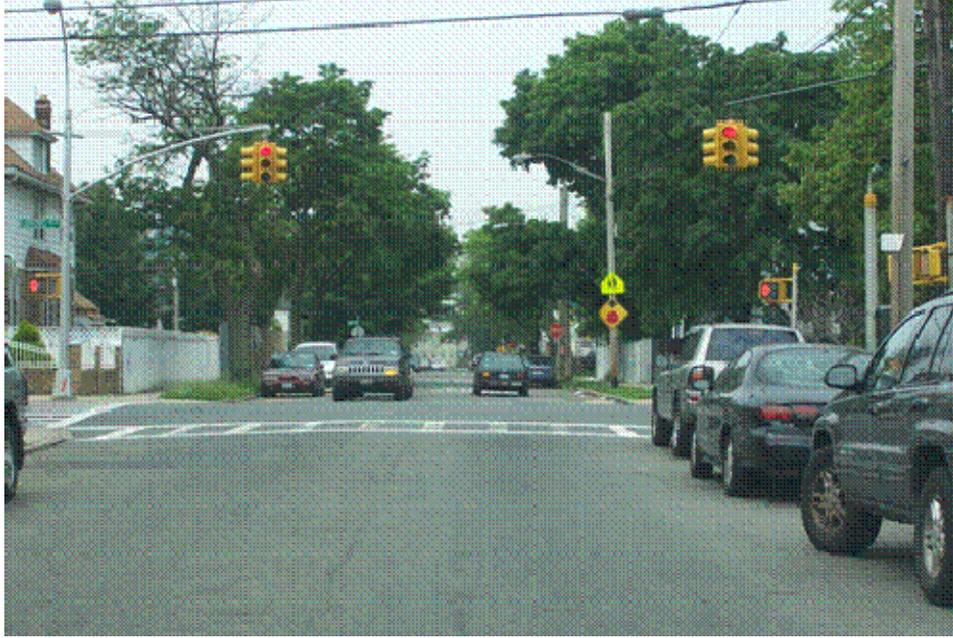
This is a four-leg signalized intersection with school crosswalks located across all four legs of the intersection. Although school officials reported that the pedestrian walk signal does not operate at the intersection of 95<sup>th</sup> Avenue and Lefferts Boulevard, at the time of the field visit, the pedestrian walk signals at this intersection appeared to be operating properly.

95<sup>th</sup> Avenue is a two-way east-west street with one travel lane and one on-street parking lane on each side of the roadway. Lefferts Boulevard is a two-way north-south street with one travel lane and one on-street parking lane on each side of the roadway (see Figure 11).

There was a total of 14 accidents reported at this intersection between 1998 and 2000, including two pedestrian accidents, neither of which were school-related. There were no pedestrian fatalities reported at this intersection between 1998 and 2000.

*Figure 11: Looking west on 95<sup>th</sup> Avenue to the intersection with Lefferts Boulevard*
