**New York City Department of Transportation  
Office of School Safety Engineering**

**School Safety Engineering Project**

**FINAL REPORT: Saint Benedict Joseph Labre, Queens**

**Prepared by  
The RBA Group and URBITRAN Associates Inc.**

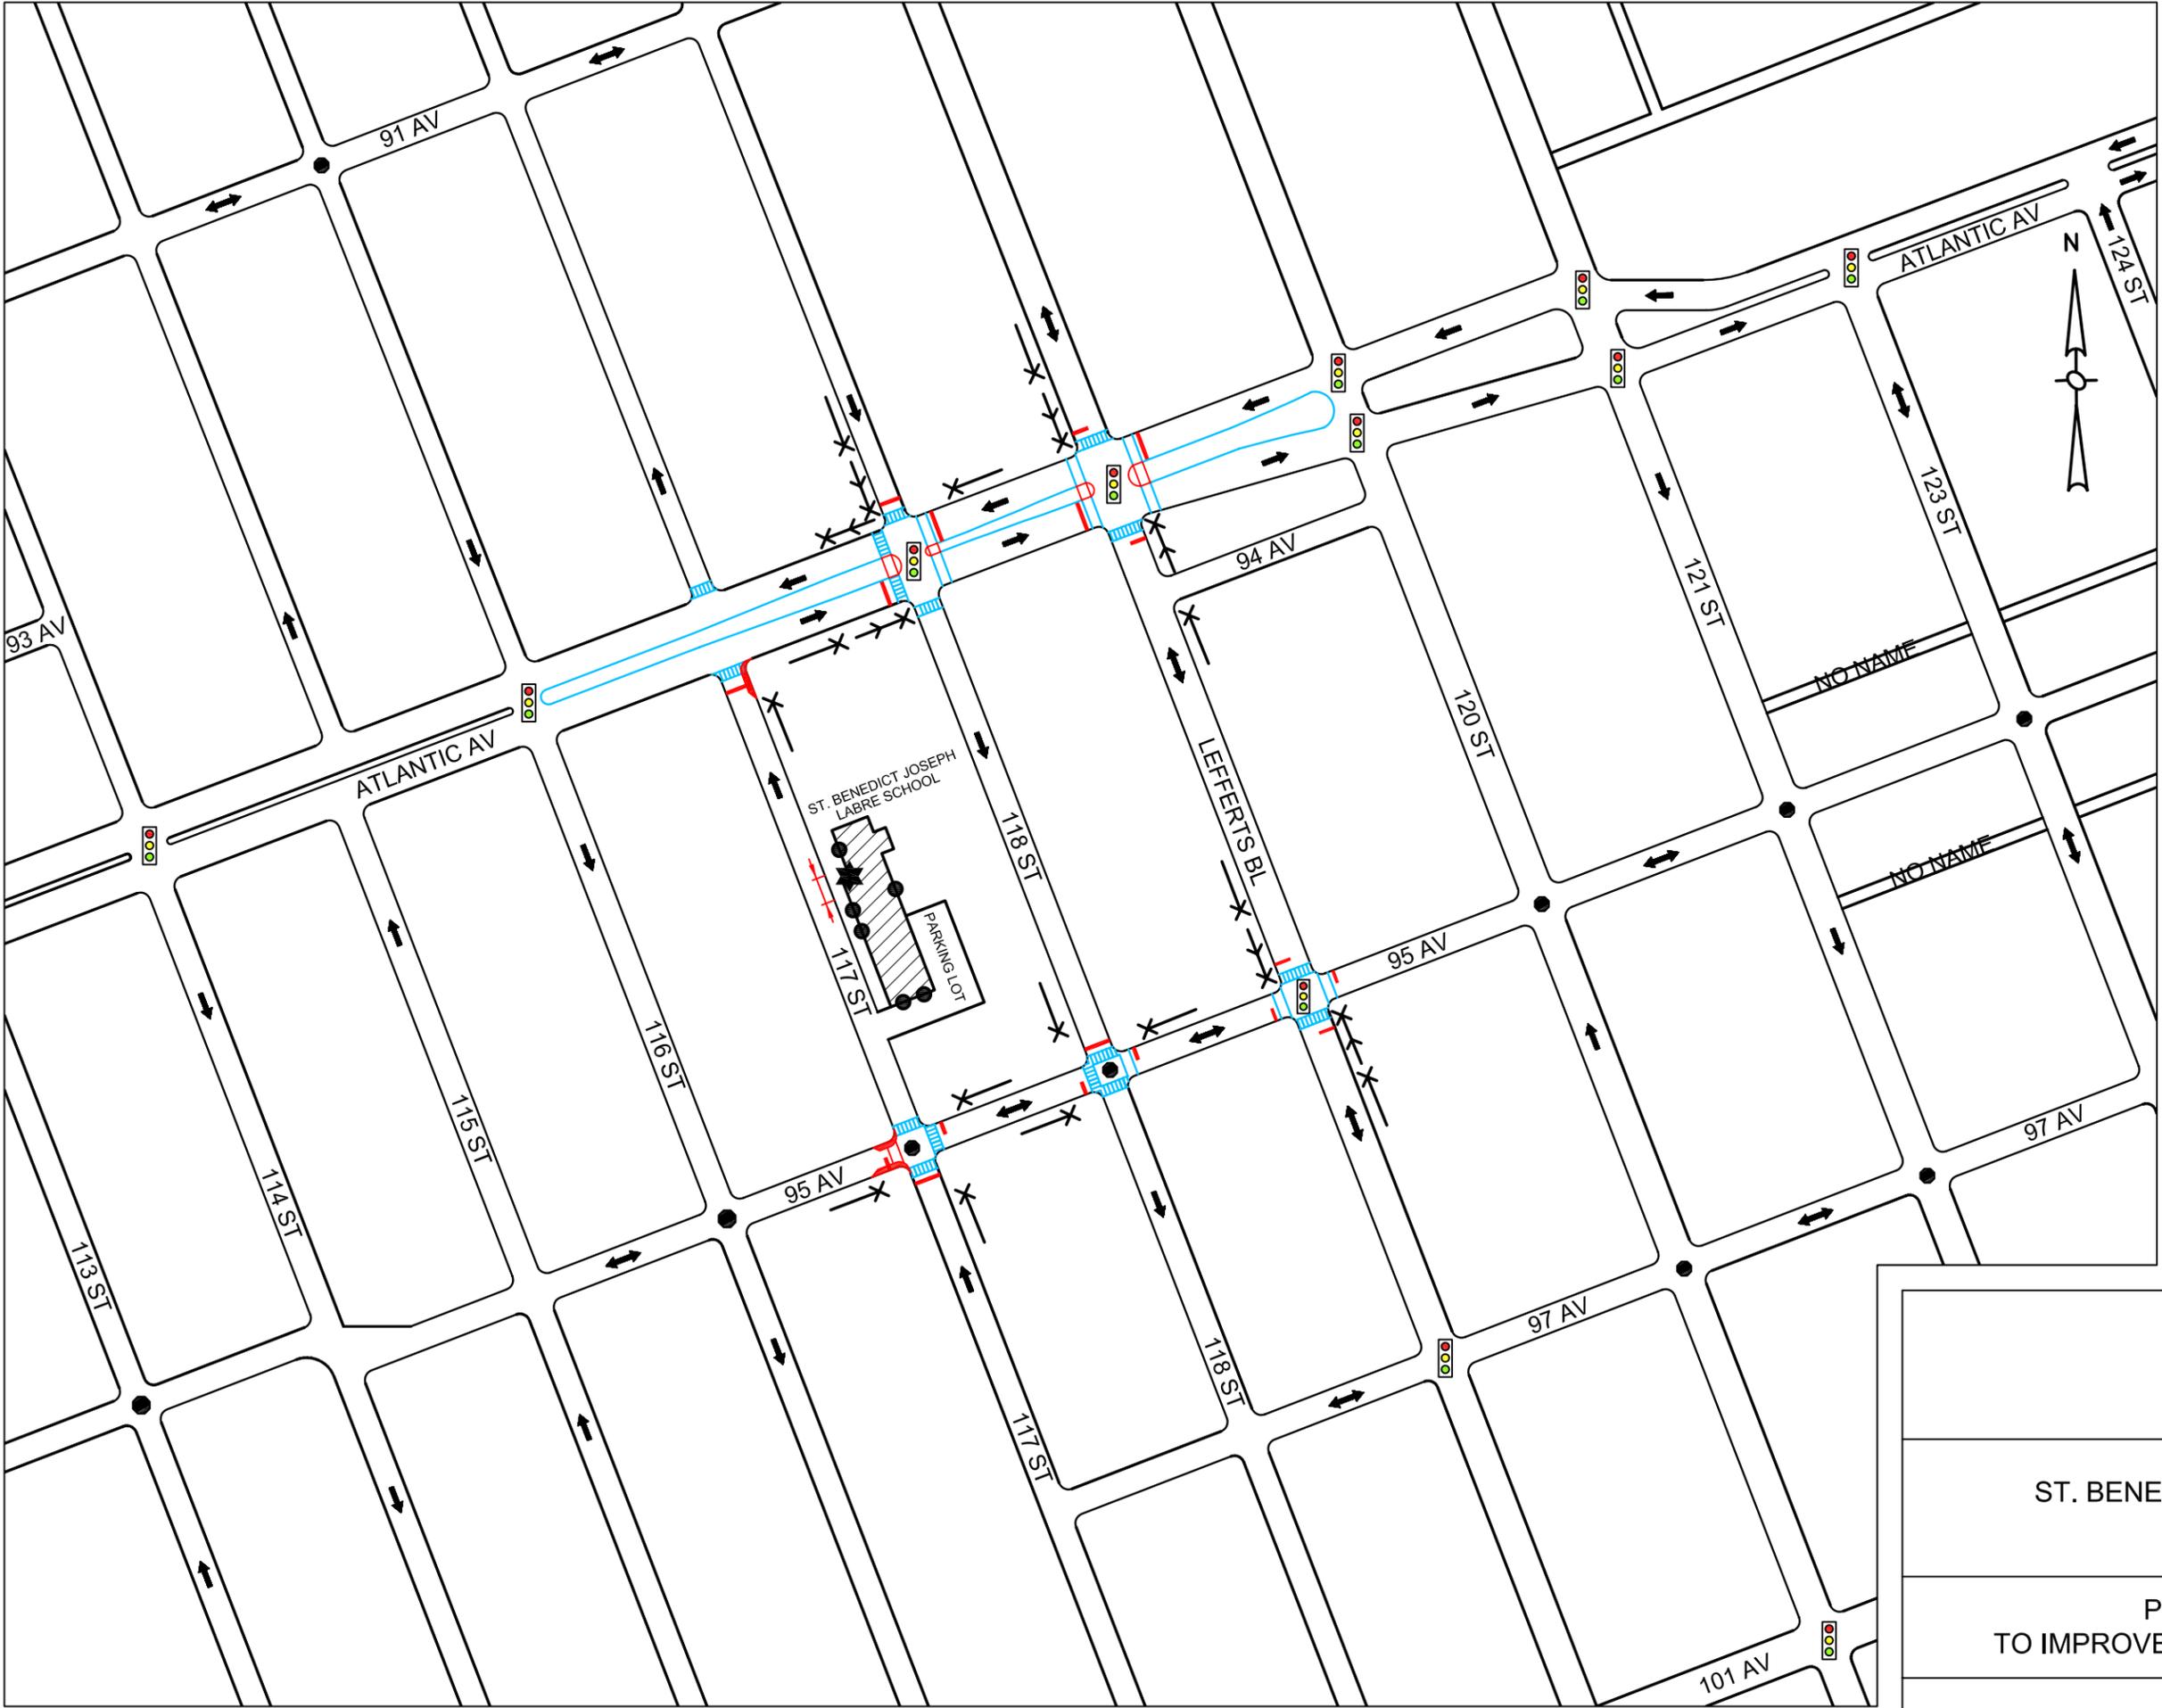
EXHIBIT 6

This section describes the proposed measures to improve student pedestrian safety around Saint Benedict Joseph Labre School. The proposed recommendations are divided into short-term and long-term measures. Short-term measures are those that potentially can be performed in-house. Long-term measures involve capital improvements. Each of the short-term and long-term measures recommended for Saint Benedict Joseph Labre School is discussed as follows, and is shown in more detail in Exhibit 6.

POTENTIAL MEASURES  
TO IMPROVE STUDENT PEDESTRIAN SAFETY

➤ *Install “NO STANDING 7AM - 4PM SCHOOL DAYS” signs*

➤ *Place stop bars ten feet in advance of school crosswalks*

- A pedestrian crosswalk should be designated across the west leg of the 117<sup>th</sup> Street and 95<sup>th</sup> Avenue intersection, and all appropriate advance warning signs should be installed.

➤ Consider extending median to provide pedestrian refuge islands

➤ Consider installing curb extensions at the following locations

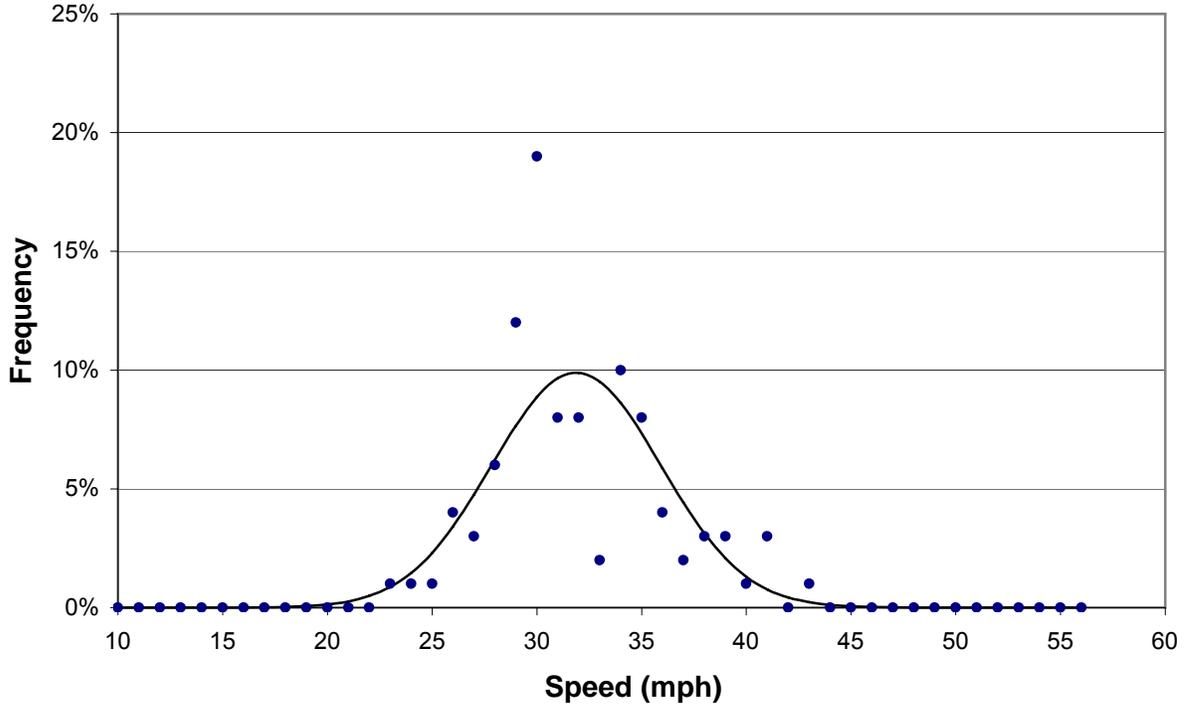
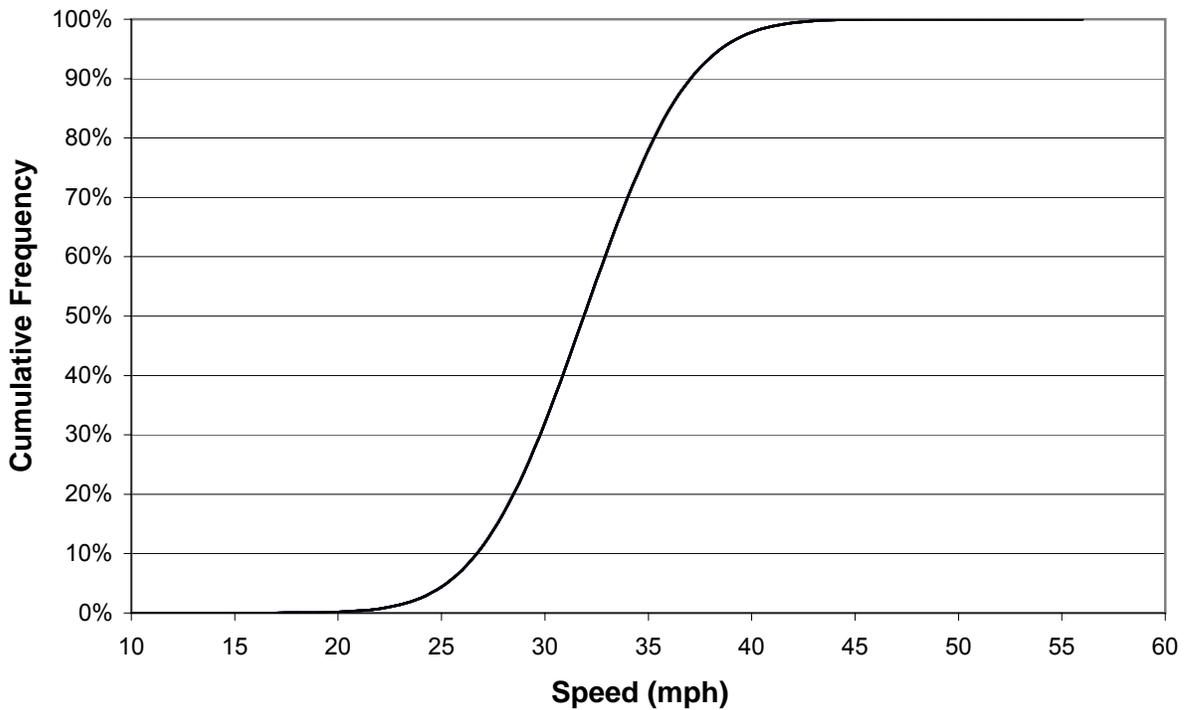
## SPOT SPEED STUDY

Date: **October 18, 2005**                      Time: **10:00 am**  
 Location: **Atlantic Avenue between 117th Street & 118th Street**  
 Surveyor: **R. Calvache/ H. Salinas**

Mean Speed = 31.9 mph  
Standard Deviation = 4.0 mph  
Margin of Error (95% Confidence) =  $\pm 0.8$  mph

Median Speed = 31.9 mph  
15th Percentile Speed = 27.7 mph  
85th Percentile Speed = 36.1 mph

Eastbound and westbound vehicles on Atlantic Avenue were found to be traveling at 85<sup>th</sup> percentile speeds of 36 mph and 38 mph respectively, between 117<sup>th</sup> Street and 118<sup>th</sup> Street.

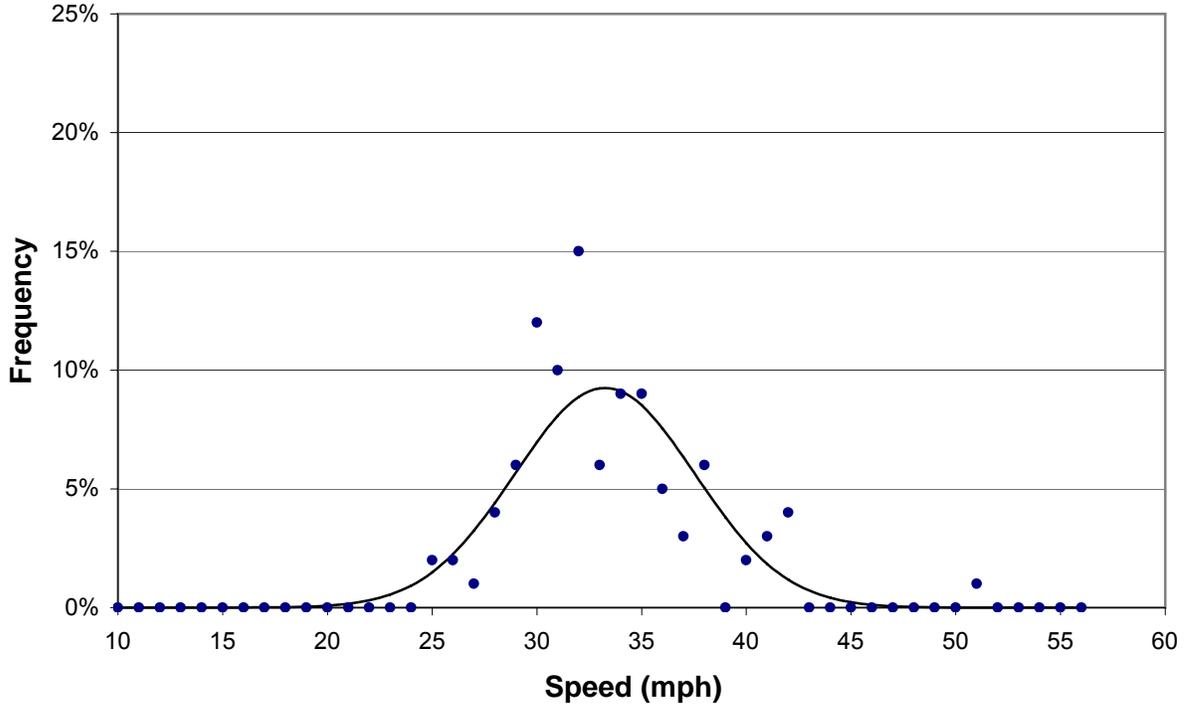
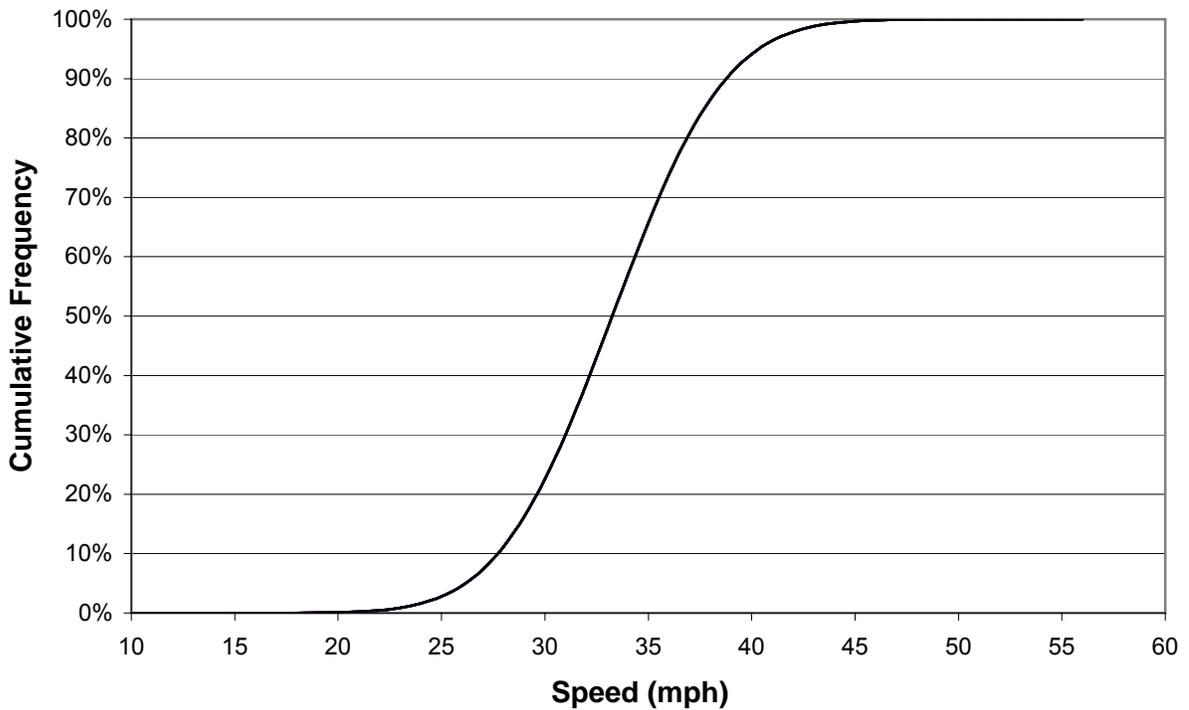
## SPOT SPEED STUDY

Date: **October 18, 2005**                      Time: **11:00 am**  
 Location: **Atlantic Avenue between 117th Street & 118th Street**  
 Surveyor: **R. Calvache/ H. Salinas**

Mean Speed = 33.3 mph  
Standard Deviation = 4.3 mph  
Margin of Error (95% Confidence) =  $\pm 0.8$  mph

Median Speed = 33.3 mph  
15th Percentile Speed = 28.8 mph  
85th Percentile Speed = 37.7 mph
