NEW YORK CITY DEPARTMENT OF TRANSPORTATION

# SAFE STREETS NYC

TRAFFIC SAFETY IMPROVEMENTS  
IN NEW YORK CITY

APRIL 2006

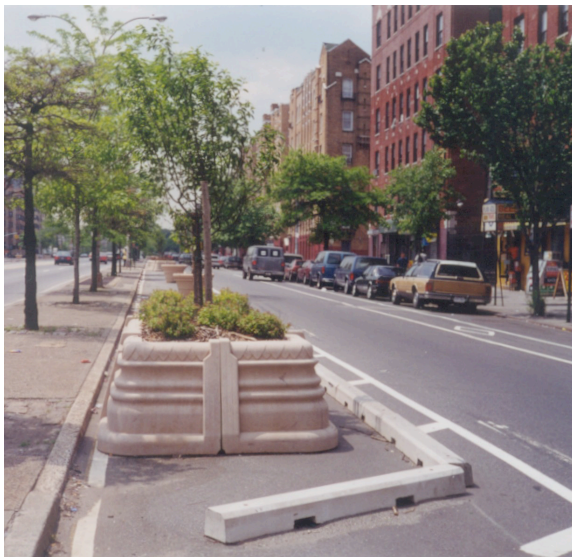
Example of innovative treatment used as part of the Pedestrian Safety Demonstration Project

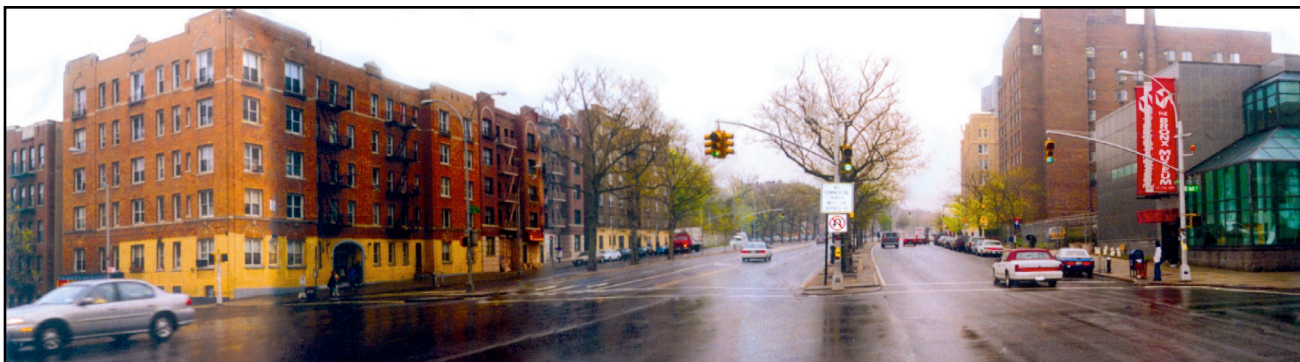
Panoramic View of Grand Concourse prior to implementation of Pedestrian Safety Demonstration Project

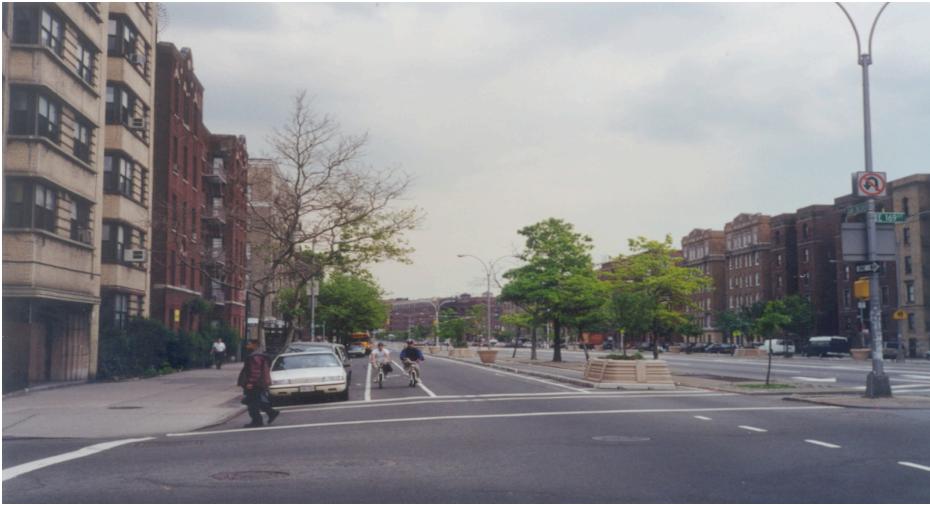
Grand Concourse/East 169<sup>th</sup> Street Service Road after implementation of safety project with planters and bike lane

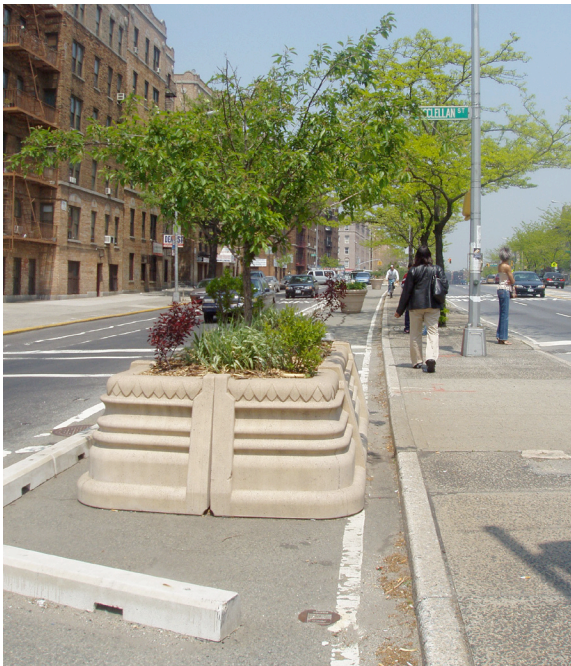
Typical roadway planter and parking stops along the Grand Concourse

- Placement of 42 large plastic planters with three inches of stone placed in the bottom of each planter.
- Placement and bolting down of concrete (495 pieces) and plastic (367 pieces) parking stops.
- Fork lifts and flat bed trucks were used to install the planters and parking stops. Landscaping, including soil was provided by the Parks Department’s “GreenStreets” Program. DOT provided gravel/millings for drainage.

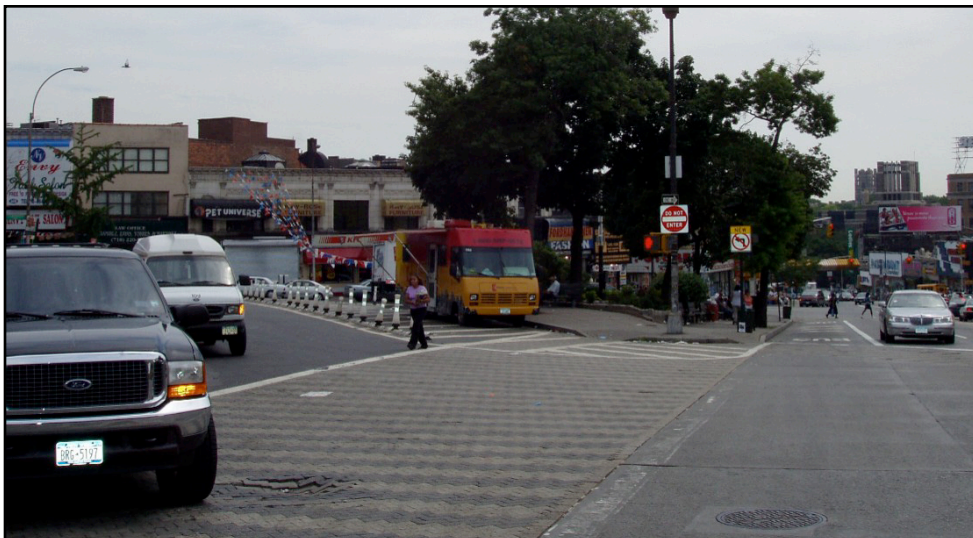
Detailed view of several of the improvements including one-way conversion of slip ramp, modified neckdown and flexible delineators surrounding the park

- Converted the East Kingsbridge Road slip roadway to one-way westbound from East Kingsbridge Road to East Fordham Road mainline to reduce conflicts and improve safety.
- Widened the triangular park to the west and north with pavement markings and flexible delineators to narrow the street, discourage double parking, increase pedestrian sidewalk space, and decrease crossing distance.
- Installed a modified neckdown on the northwest corner of the East Kingsbridge Road slip/East Fordham Road intersection to increase pedestrian sidewalk space and decrease crossing distance.
- Widened the East Fordham Road north sidewalk (and installed delineators) approaching Bainbridge Avenue/East Kingsbridge Road and widened the east sidewalk of East Kingsbridge Road west of Bainbridge Avenue to reduce pedestrian crossing distance and provide more sidewalk

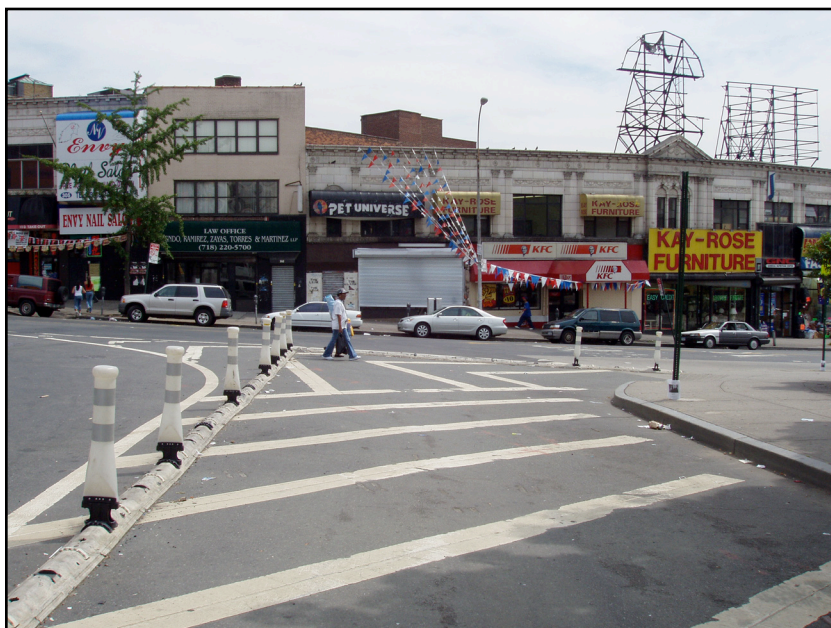
Flexible delineators and markings for increased pedestrian and vehicular safety

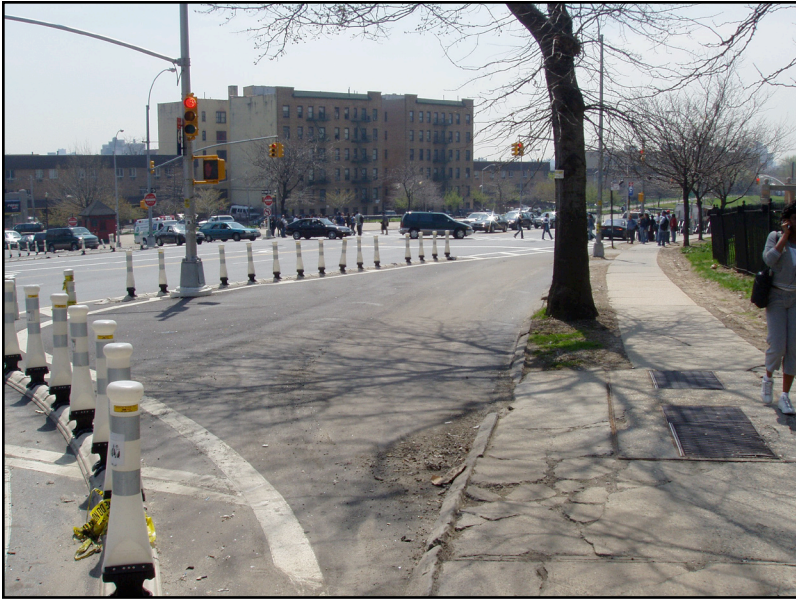
Detailed view of additional pedestrian space created by the use of curb mounted delineators and markings

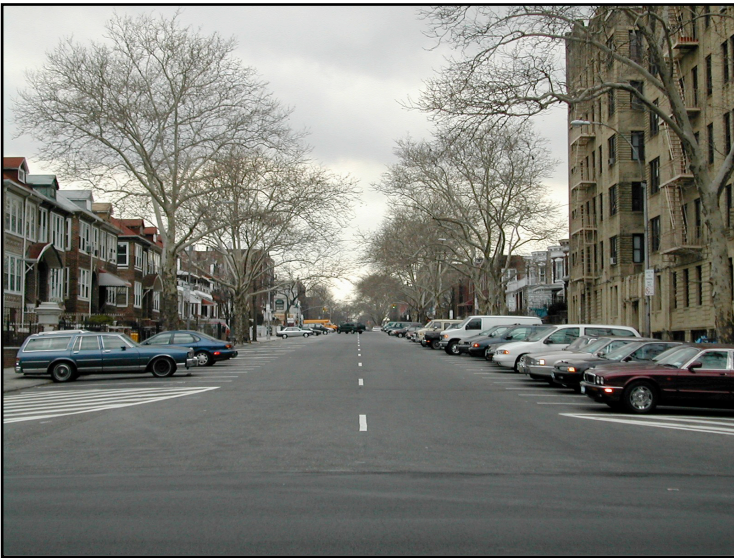
Angle Parking on President Street

- Angle parking was installed on both the north and south curbs of President Street between Utica Avenue and Rochester Avenue to provide 52 additional parking spaces (from 56 to 108). This work was completed in July 2001.

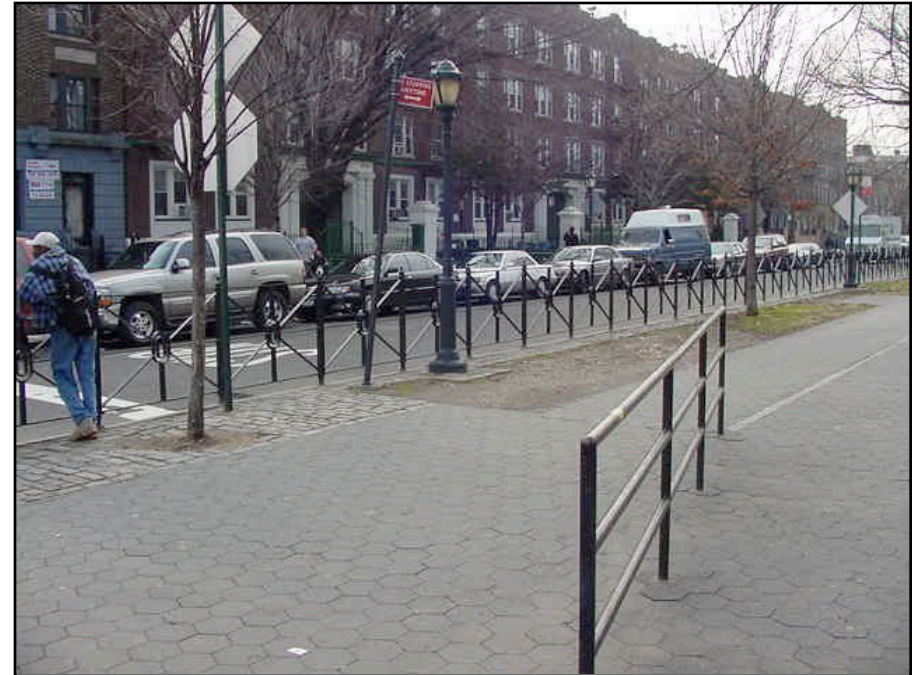
Pedestrian barriers along the service road island prevent individuals from crossing the service road midblock

- Installed mid-block crosswalks on the Eastern Parkway Service Roads (approximately 150 feet west of Utica Avenue) to improve access to the subway station. All work was completed in July 2002.

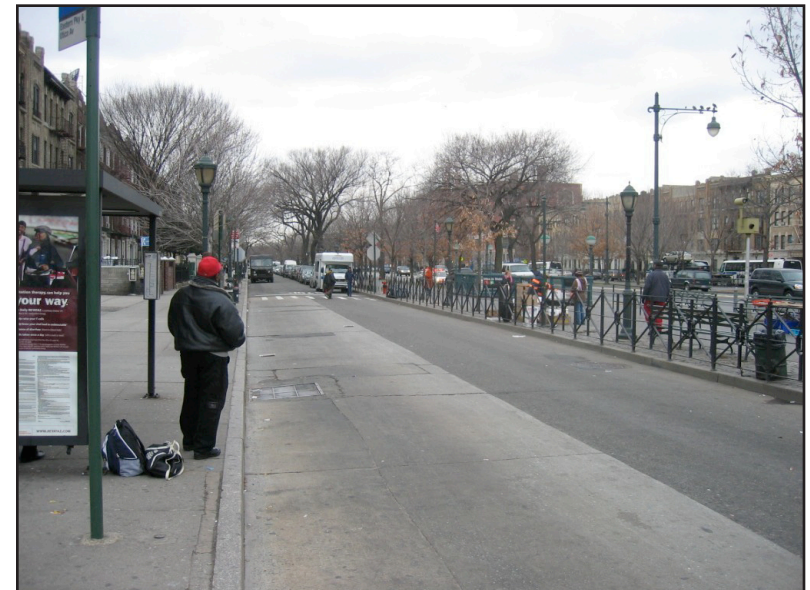
View of extended bus stop along Eastern Parkway Service Road, pedestrian barriers and additional travel lane created by removal of parking along barrier

- *Installed and widened crosswalks (42x35 feet) on Utica Avenue between the east and west malls of Eastern Parkway and between the main and service roads to provide adequate space for pedestrian and bicycle crossings and prohibit cars from standing/stopping in this area.*

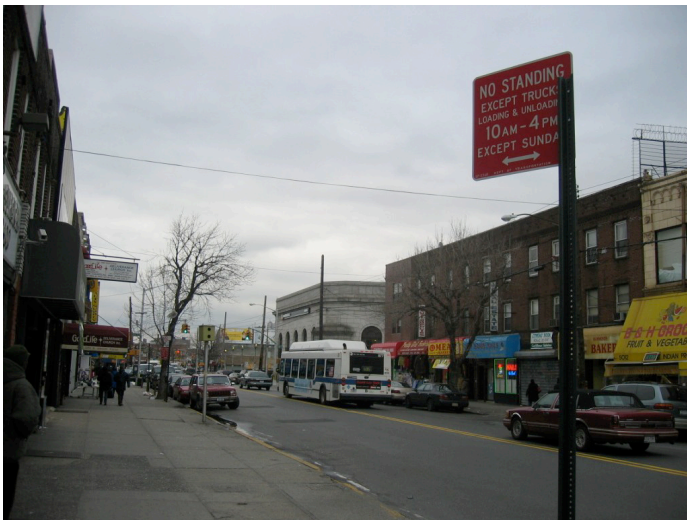
Example of new loading zone along Church Avenue

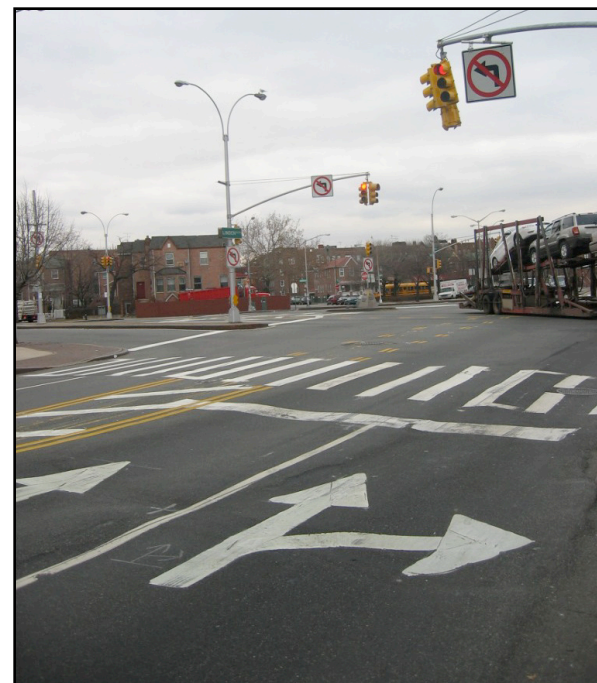
New markings and signage were installed to improve safety and operation of the intersection

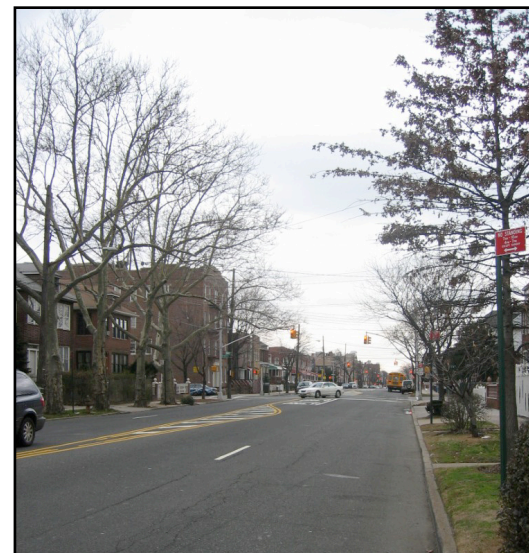
No Standing regulations during the peak periods provide for additional lane capacity

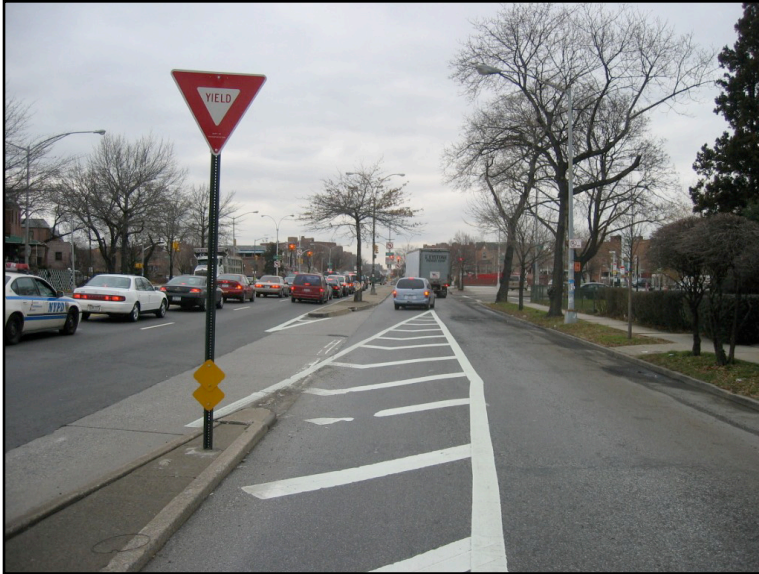
New markings to prevent illegal maneuvers between main line and service road

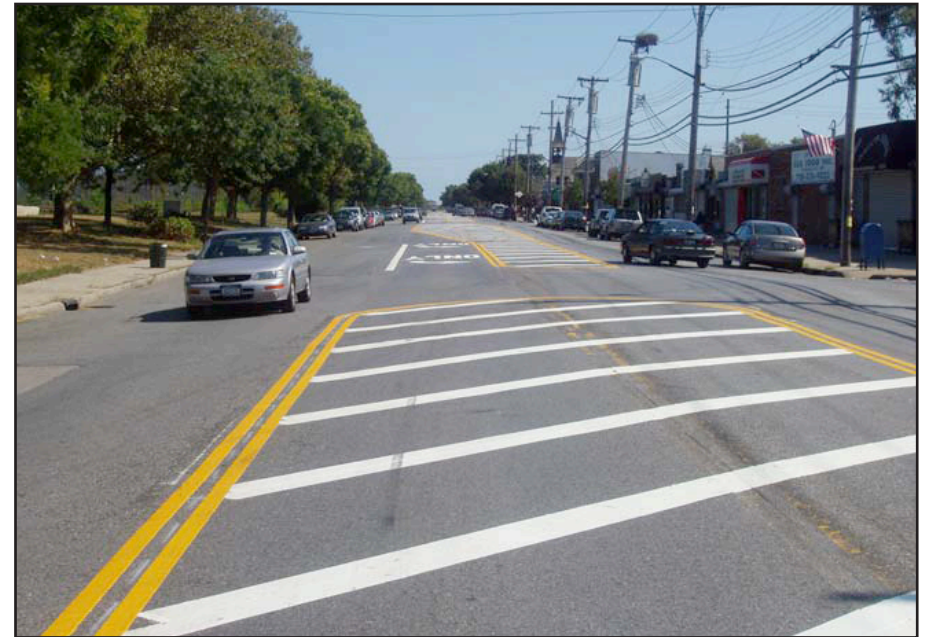
New painted center median and turning bays

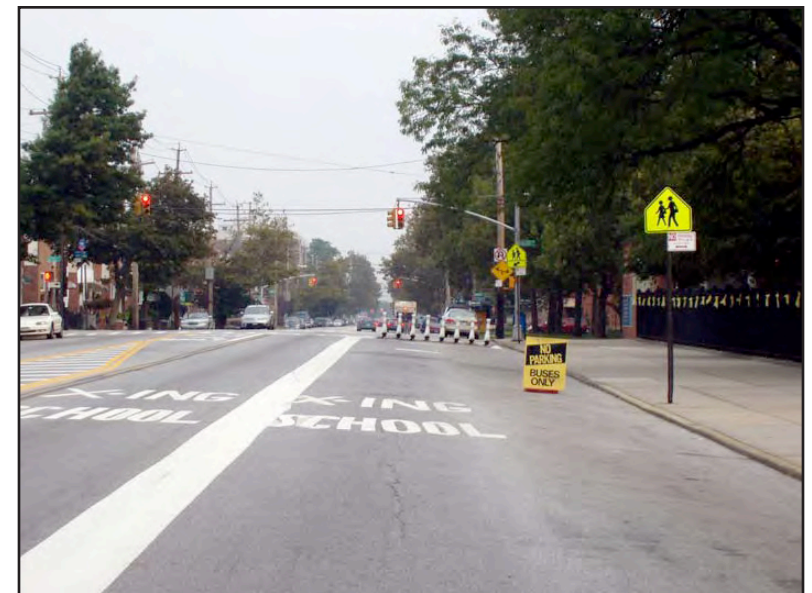
Supplemental signs and markings around P.S. 277 to improve safety

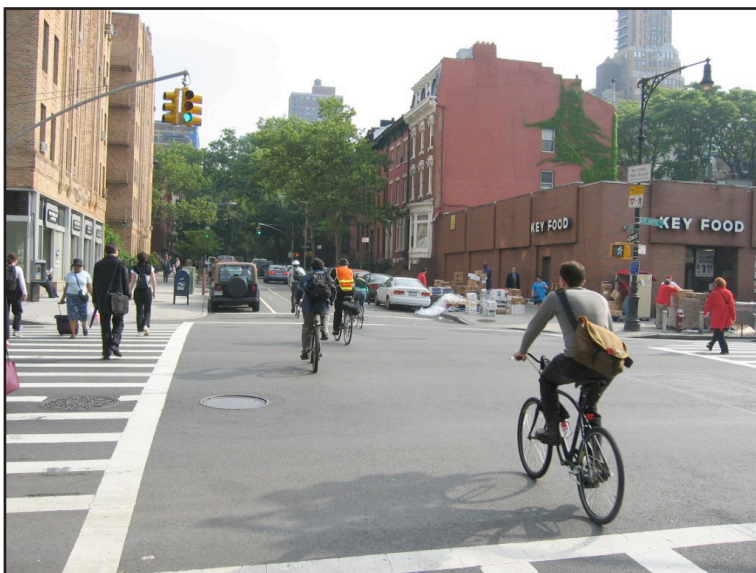
Example of street activity in Downtown Brooklyn. At this location, the intersection of Atlantic Avenue and Clinton Street, the Department installed an LPI for pedestrians as part of the DBTC project.

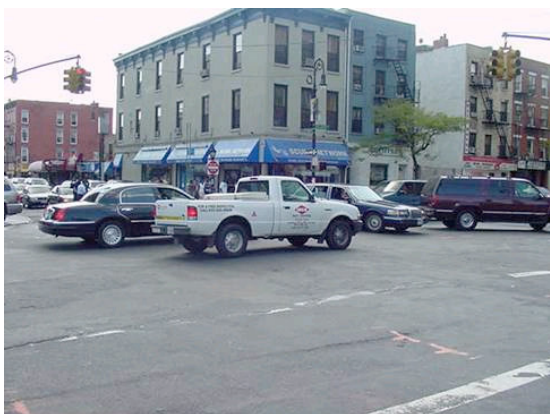
Vehicular conflicts at the intersection of Smith Street and Atlantic Avenue prior to improvements

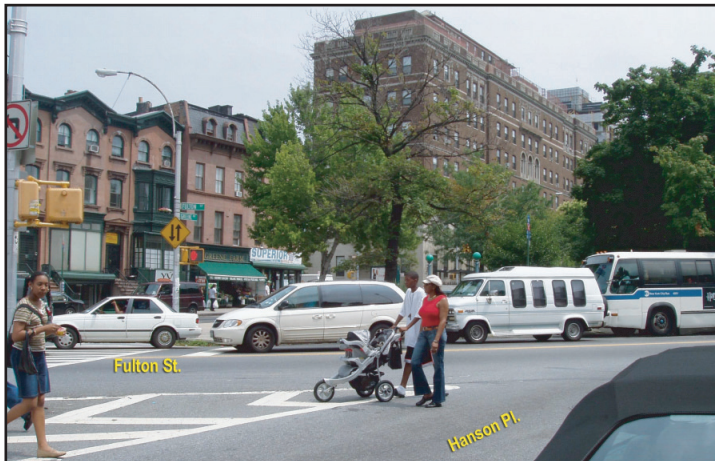
On eastbound Hanson Place approaching Fulton Street, the right-turn slip created difficult, unprotected crossing for pedestrians

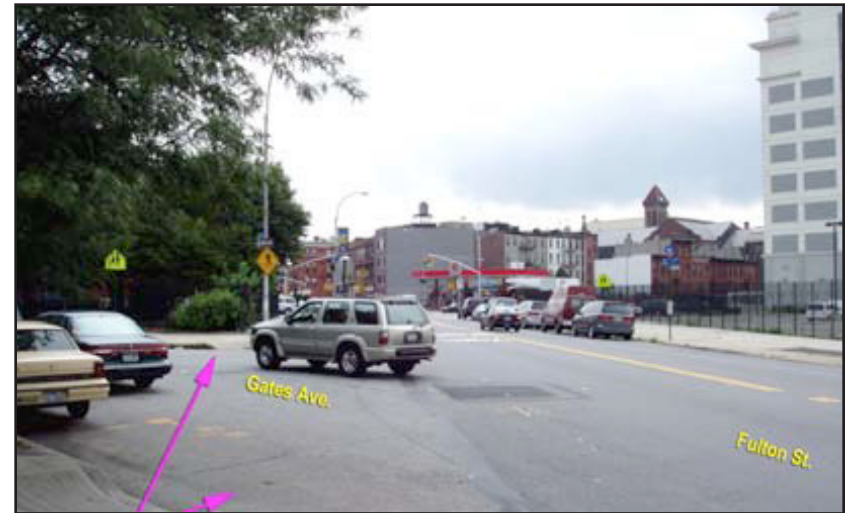
At Gates Avenue and Fulton Street, the offset geometry contributed to speeding, as well as a long crossing for pedestrians

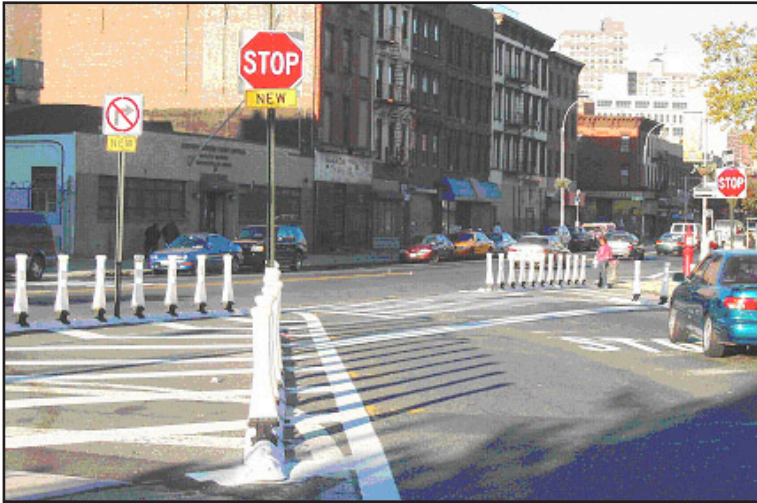
Gateway treatment and street-direction conversion at Putnam Avenue and Fulton Street

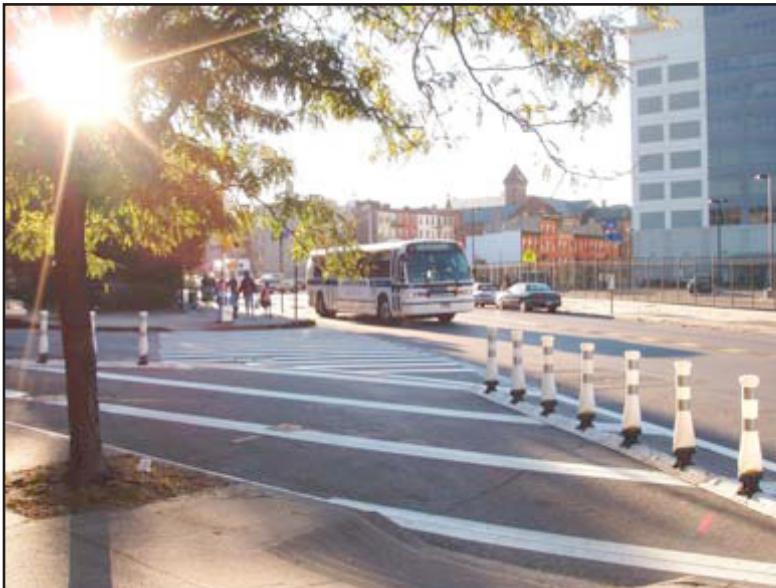
Through the use of flexible bollards and markings, the Department normalized the intersection and significantly shortened the crossing distance across Gates Avenue

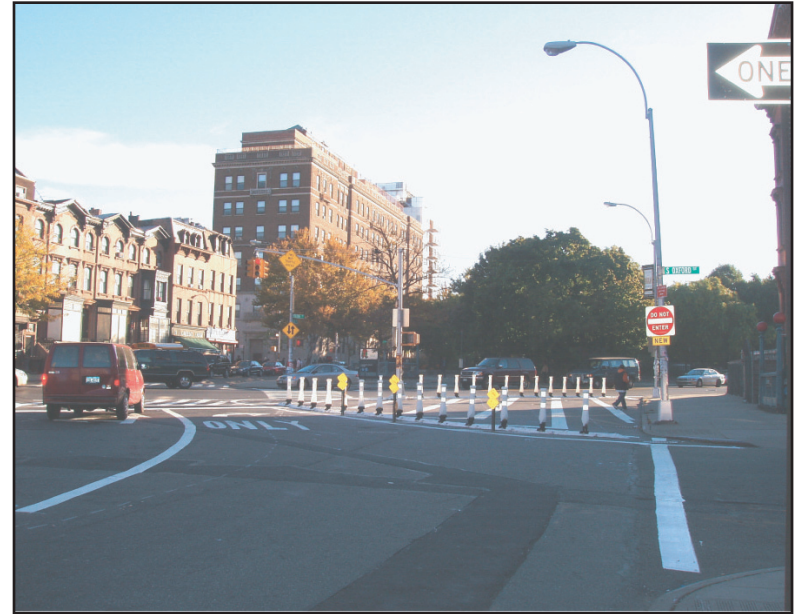
At Hanson Street, the Department eliminated the “free right turn” through the use of markings and flexible bollards, as well as shortening the crossing distance by half

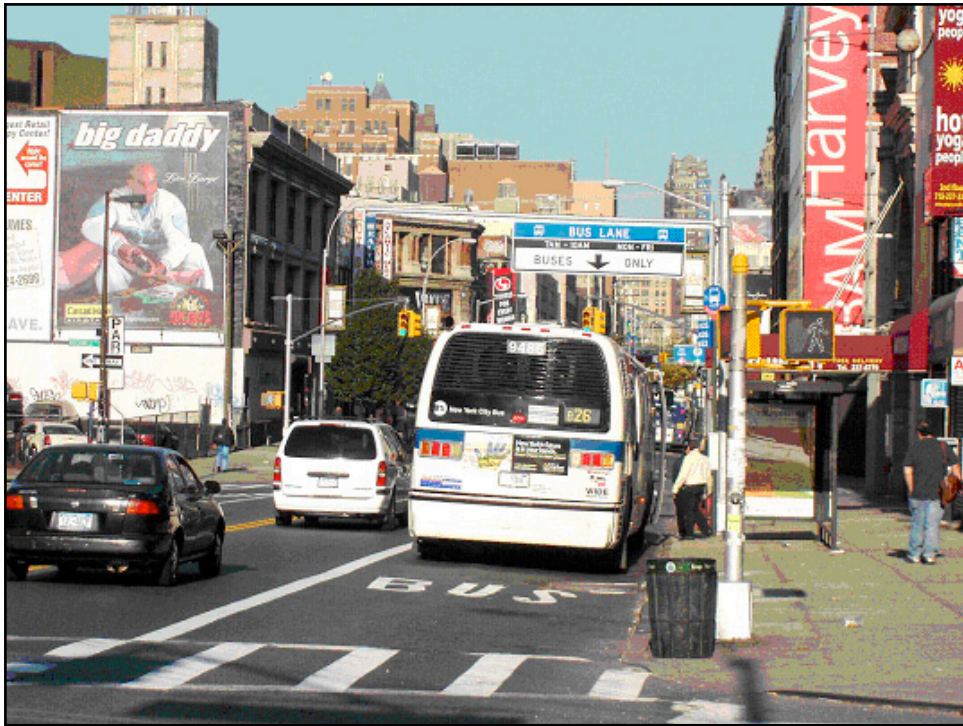
Dedicated bus lanes and newly designed overhead signs were installed to make bus lanes more prominent.

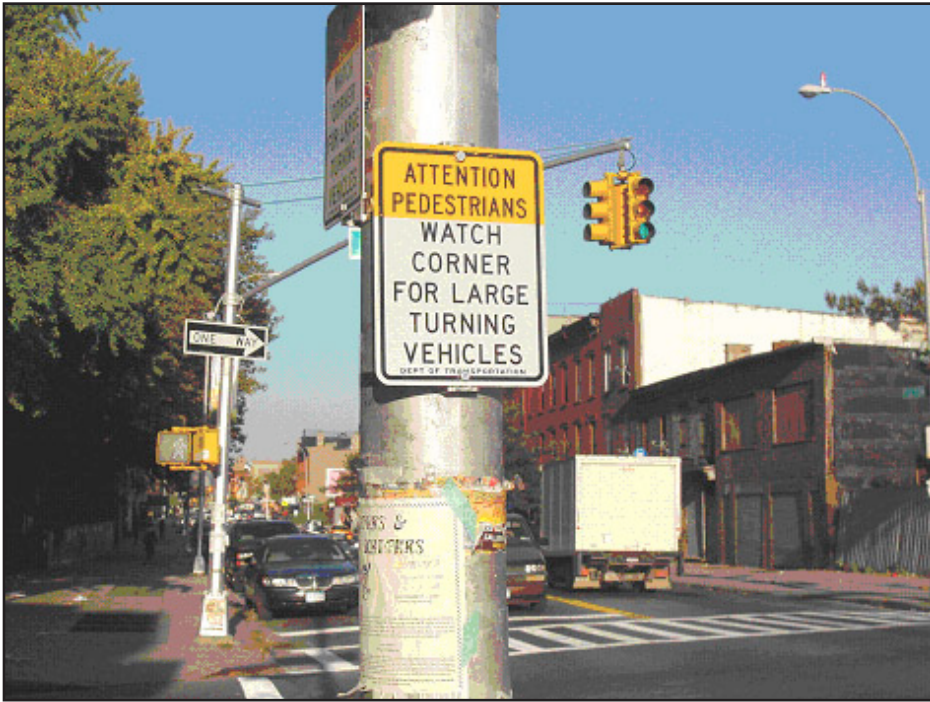
Unique signage advises pedestrians of turning vehicles at Wide Turn Zones
