**BROOKLYN**

# GRAND ARMY PLAZA

# IMPROVEMENTS IN THE VICINITY OF EASTERN PARKWAY/UTICA AVENUE & KINGS HIGHWAY/LINDEN BOULEVARD/REMSEN AVENUE

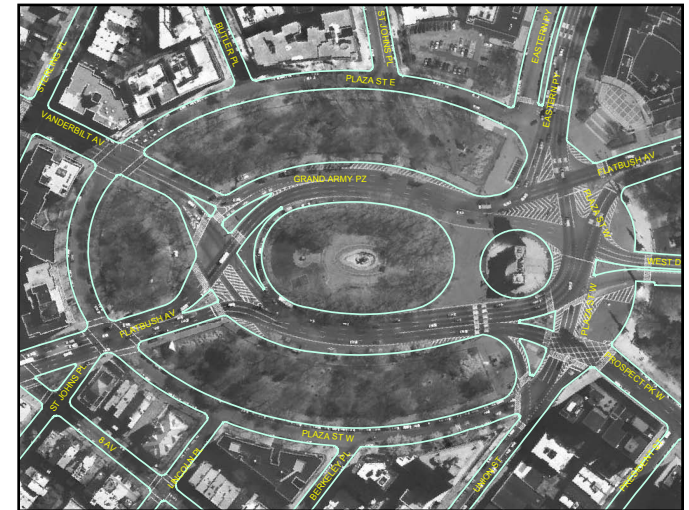
Aerial view of reconfigured intersection

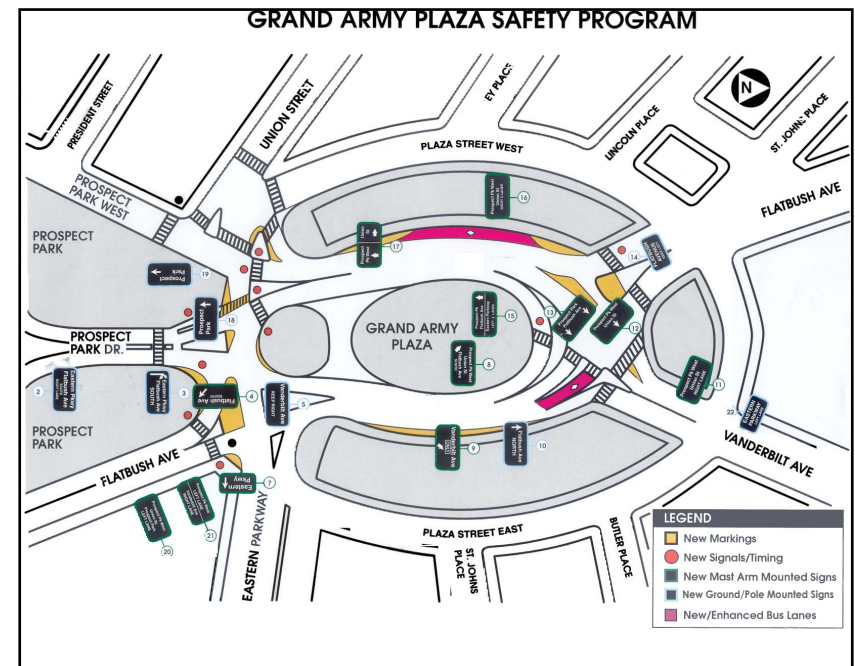
- Installed 20 signs (12 on mast arms) in advance of and around the Plaza. These are directional signs to properly guide motorists, reduce conflicts and minimize weaving movements. The locations of these signs are shown in the illustration to the right.

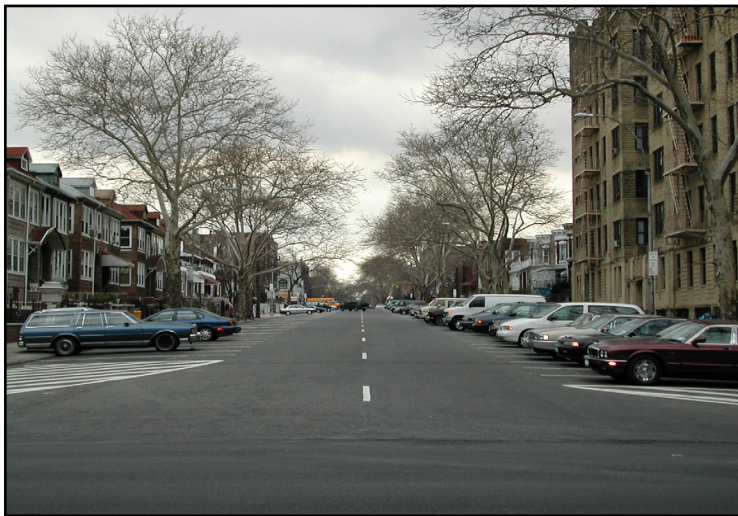
Angle Parking on President Street

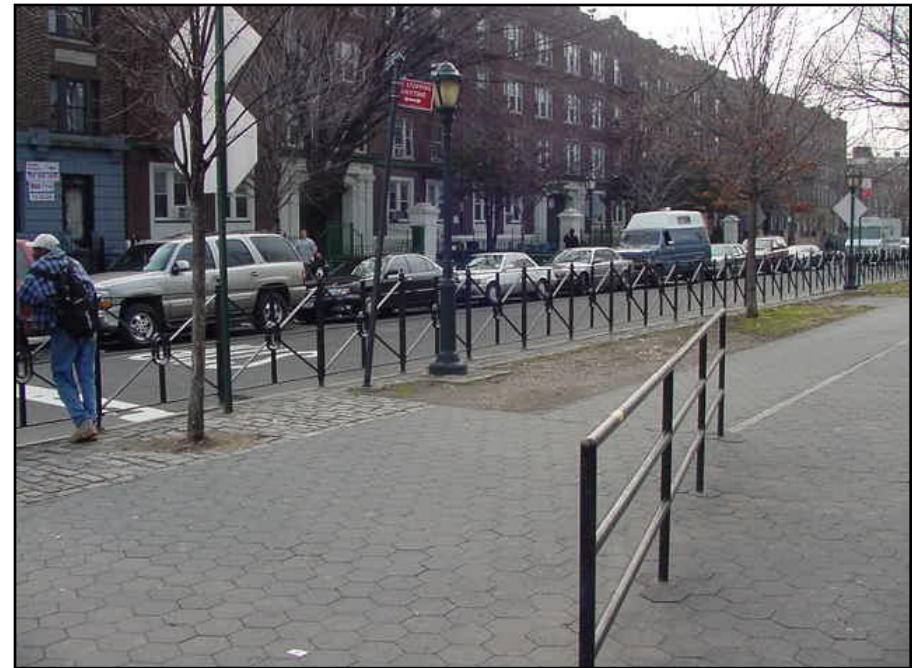
Pedestrian barriers along the service road island prevent individuals from crossing the service road midblock

- In coordination with the Department of Parks & Recreation, installed pedestrian barriers on the Eastern Parkway north and south medians for 320 feet west of Utica Avenue to discourage pedestrians from crossing midblock and to direct them to the intersection. This work was completed in April 2002.

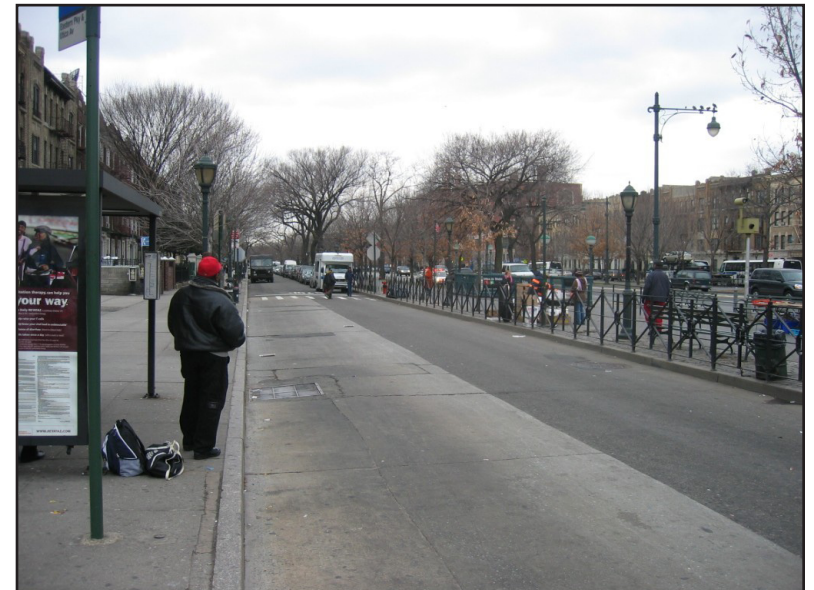
View of extended bus stop along Eastern Parkway Service Road, pedestrian barriers and additional travel lane created by removal of parking along barrier

- Extended the bus stop/layover location for the B14 and B17 routes on the south curb of Eastern Parkway between Utica and Schenectady Avenues from 169 to 224 feet to allow the buses to pull up closer to the curb and make pedestrian movements safer. The work was completed in June 2001.

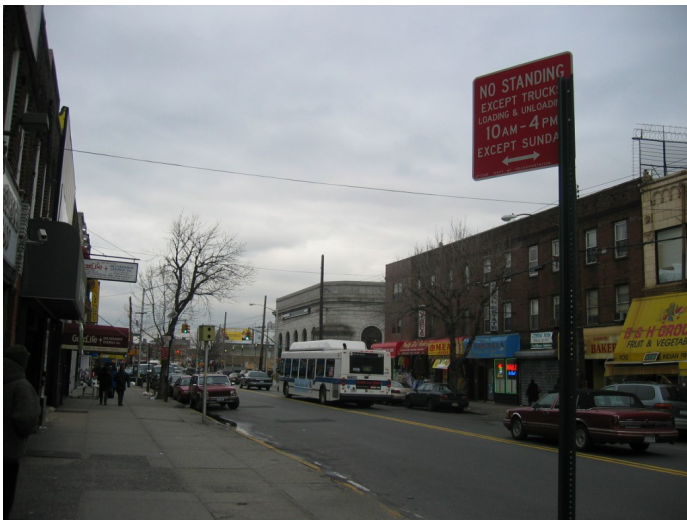
Example of new loading zone along Church Avenue

- Created a truck loading/unloading zone on Church Avenue in the westbound direction (for approximately 100 feet) between Utica Avenue and East 52<sup>nd</sup> Street. This was accomplished through the installation of “No Standing Except Truck Loading/Unloading 10AM - 4 PM” regulations.
- Installed a Leading Pedestrian Interval (LPI) to reduce conflicts between pedestrians and motorists.
- Relocated the near side bus stops to far side and eliminated four curbside meter parking spaces to accommodate relocated bus stop, as well as assist in facilitating through traffic in the eastbound and westbound directions on Church Avenue

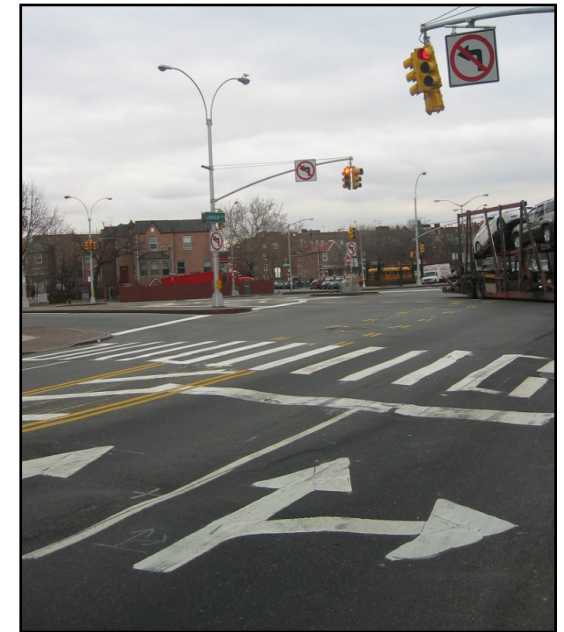
New markings and signage were installed to improve safety and operation of the intersection

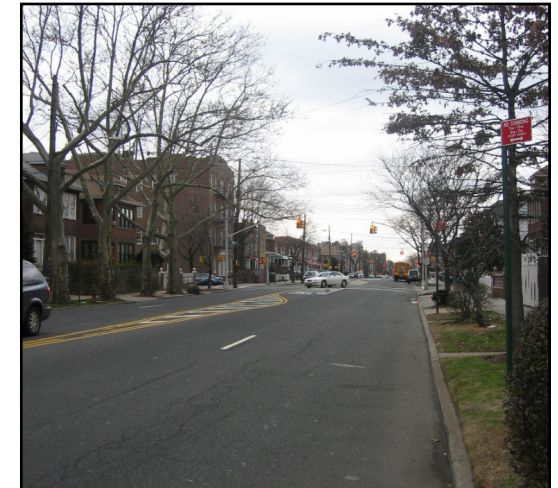
No Standing regulations during the peak periods provide for additional lane capacity

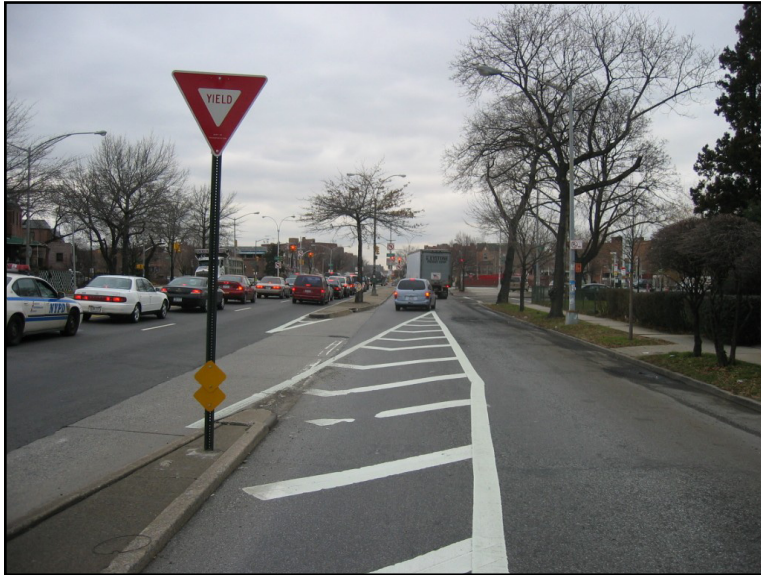
New markings to prevent illegal maneuvers between main line and service road

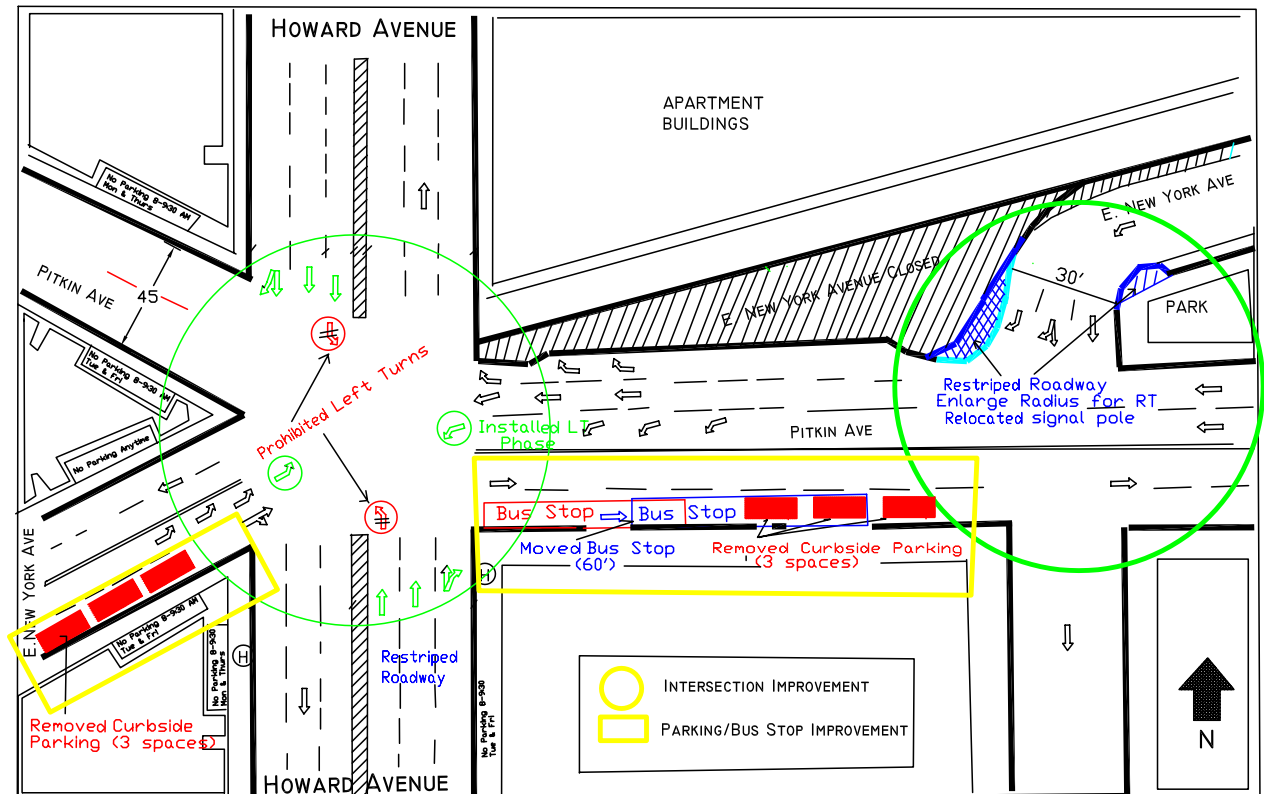
Detailed improvements at the intersection of Pitkin Avenue, East New York Avenue and Howard Avenue

The improvements are depicted in the figure to the right.

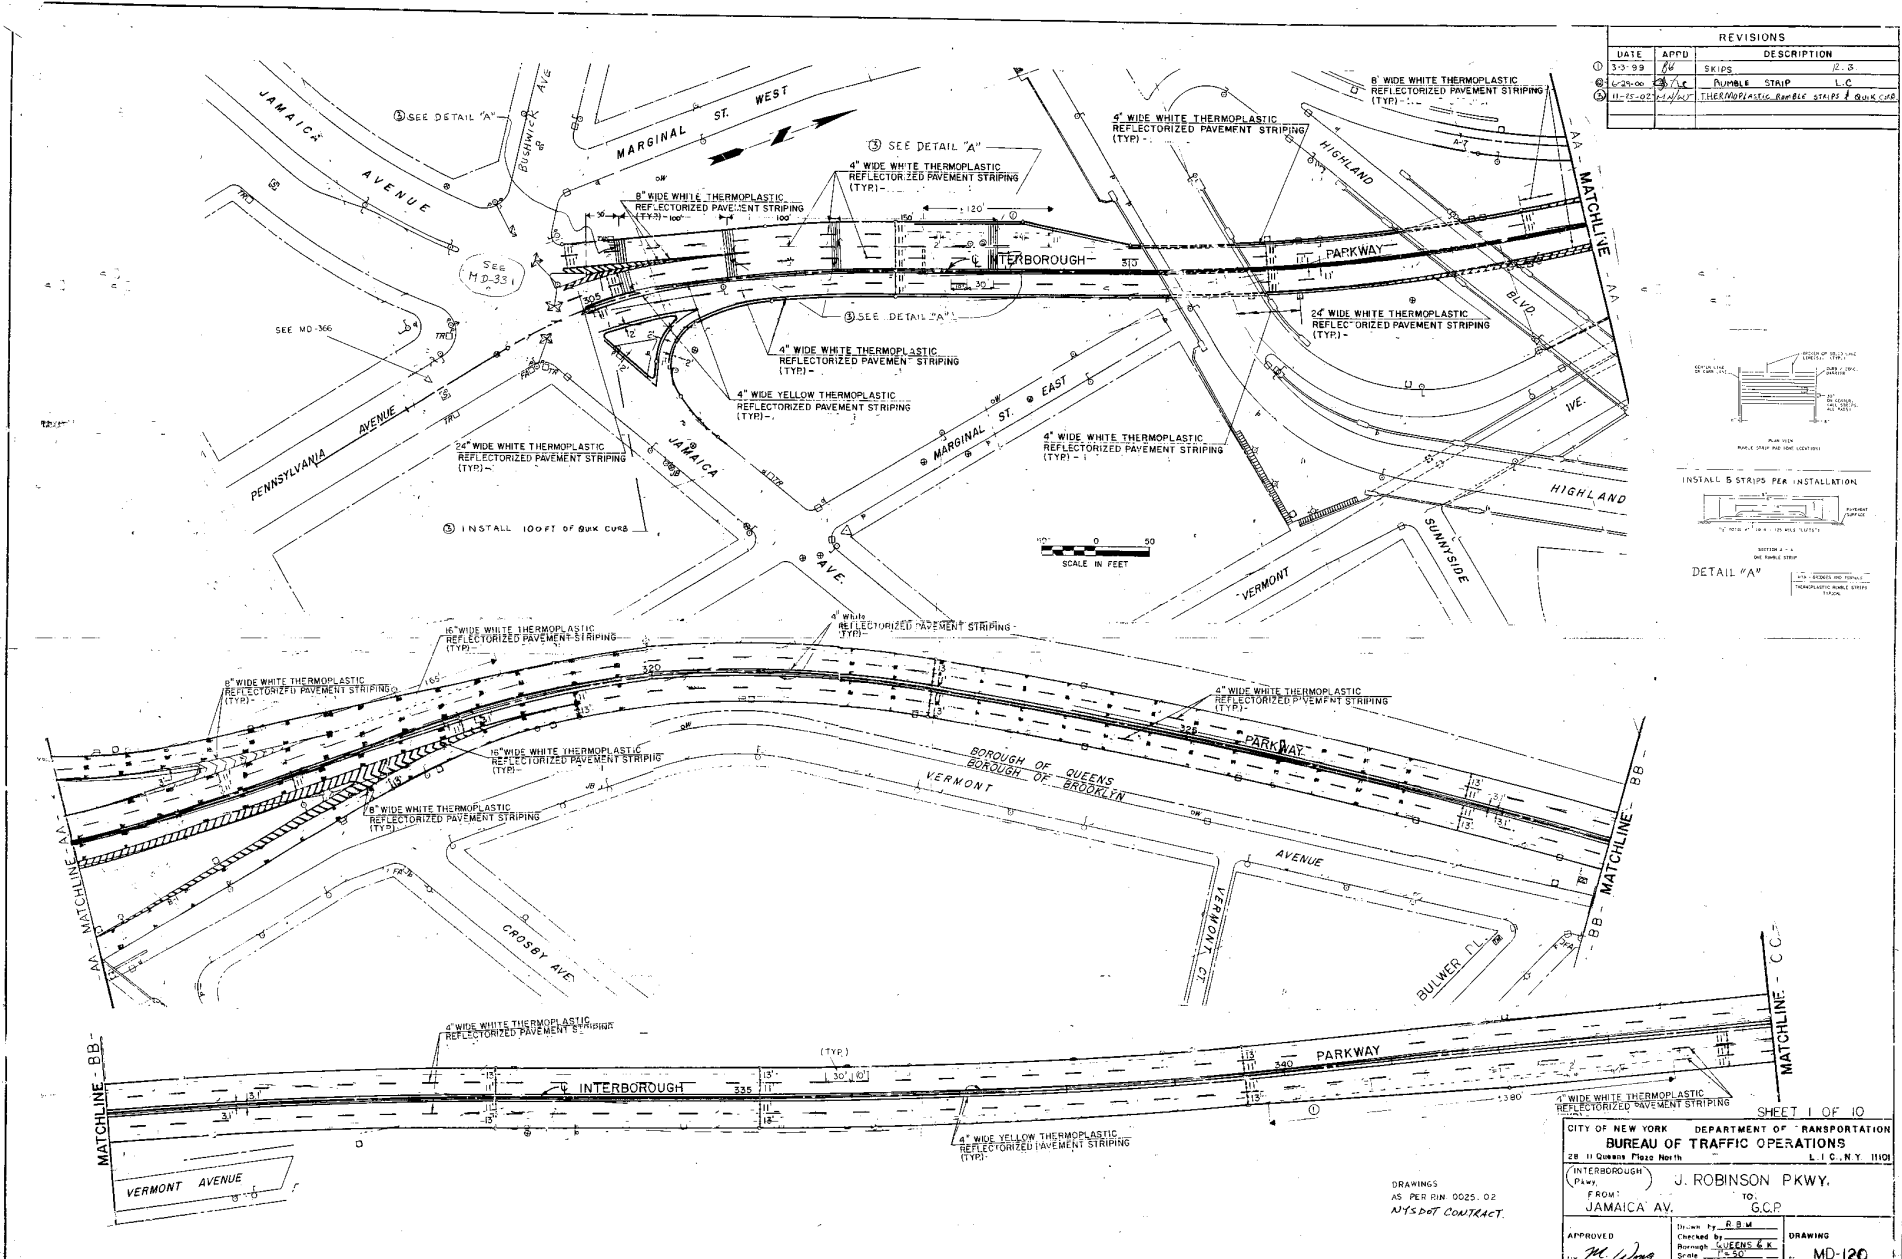
DRAWING: MD-120

REVISIONS		
DATE	APPD	DESCRIPTION
3-3-99	AW	SKIPS
6-20-00	AW	PUMBLE STRIP
11-25-02	AW	THERMOPLASTIC BEARER STRIPS & GUK CURB

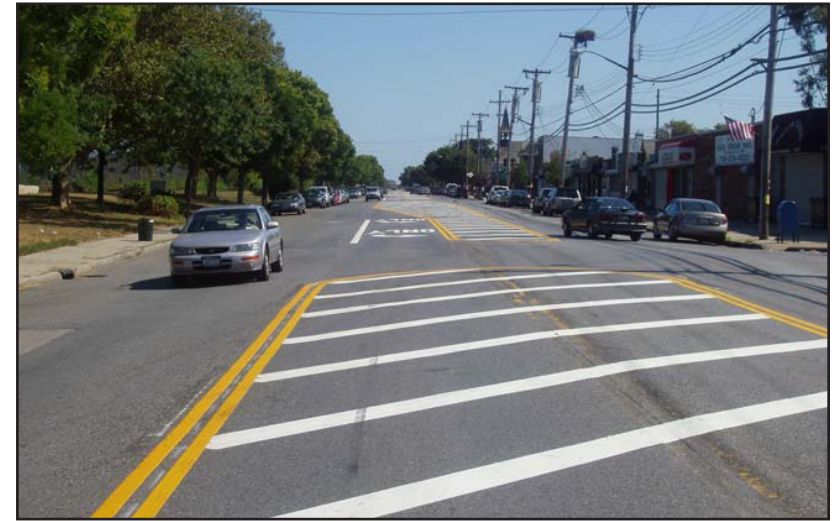
New painted center median and turning bays

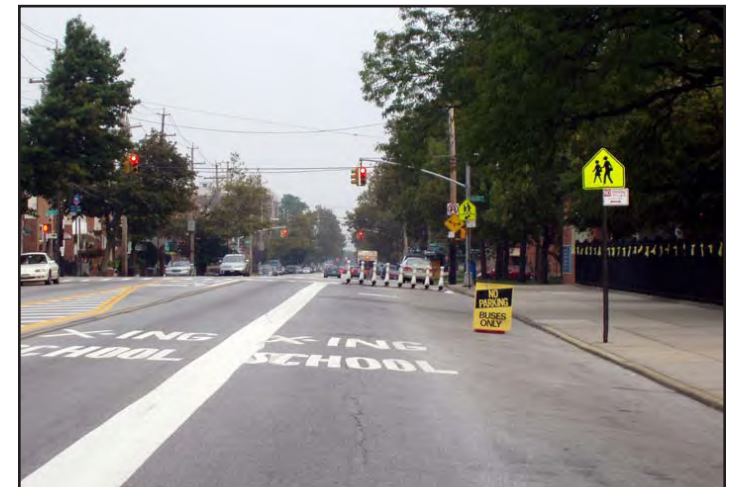
Supplemental signs and markings around P.S. 277 to improve safety

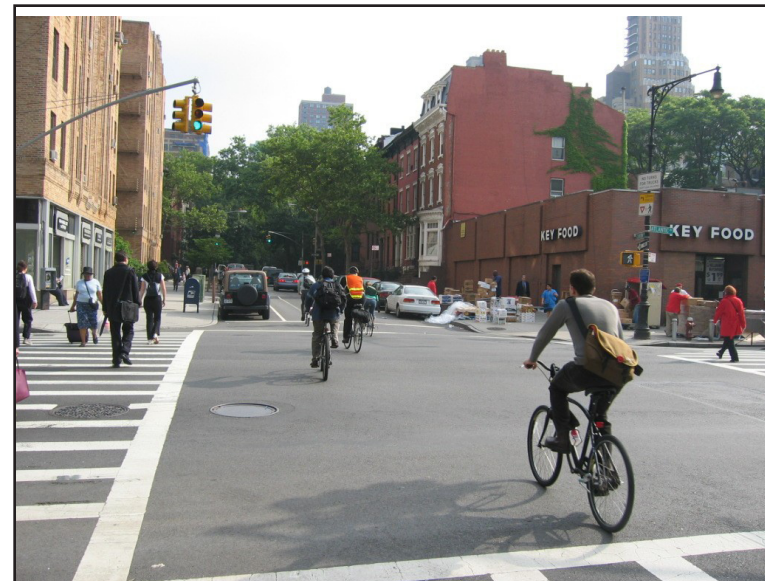
Example of street activity in Downtown Brooklyn. At this location, the intersection of Atlantic Avenue and Clinton Street, the Department installed an LPI for pedestrians as part of the DBTC project.

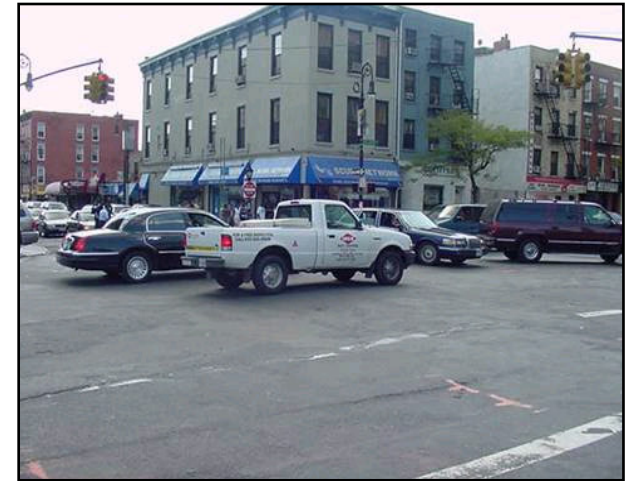
Vehicular conflicts at the intersection of Smith Street and Atlantic Avenue prior to improvements

Smith Street was identified as a problematic corridor during the DBTC Project. This corridor provides northbound connectivity through the same corridor in the morning peak period that southbound Court Street provides in the evening peak period. However, the conflicts between motorists and street users is not as pronounced as on Court Street because vehicular demand occurs primarily during the morning peak commuting period. Prior to the Department's improvements along this corridor, Smith Street experienced substantial congestion on its approaches to Atlantic Avenue, due to the existing off-set configuration of the intersection. This configuration, where Smith Street operated two-way north of Atlantic Avenue, and one-way south of Atlantic Avenue, created a head-on situation.

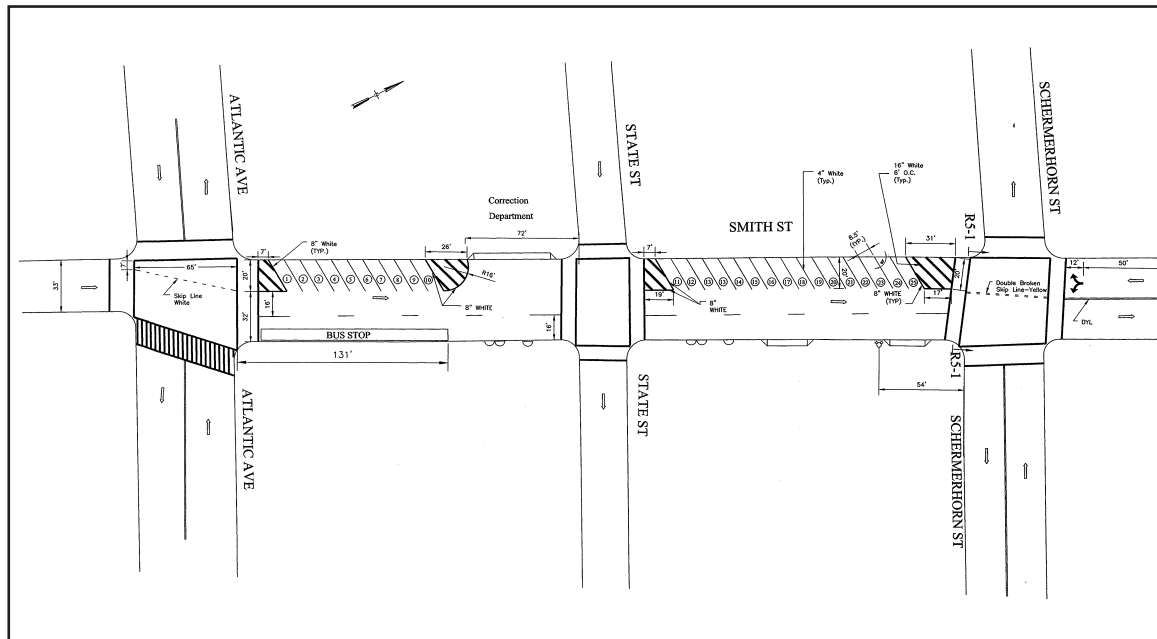
Detailed diagram of Smith Street improvements

In November 2003, Smith Street was converted from a two-way to one-way northbound operation between Atlantic Avenue and Schermerhorn Street. In addition, back-in only parking was provided to narrow the roadway and normalize the approach at Schermerhorn Street. This measure reduced potential vehicles conflicts and improved the overall operation at the intersection of Smith Street and Atlantic Avenue. In addition, rush hour regulations were removed south of Atlantic Avenue to discourage “cut-through” traffic and provide more parking for residents. These improvements also required the rerouting of the B61 bus and are depicted below.

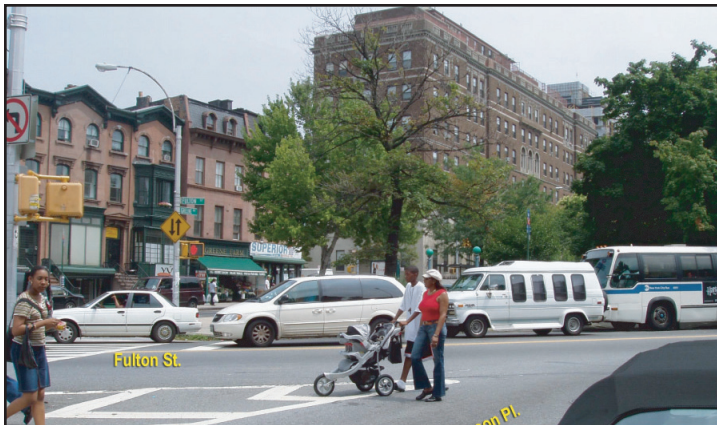
On eastbound Hanson Place approaching Fulton Street, the right-turn slip created difficult, unprotected crossing for pedestrians

Fulton Street is a major east-west commercial corridor in Brooklyn serving the communities of Fort Greene and Bedford-Stuyvesant and is host to numerous street users. Land use along this corridor includes commercial, retail and residential developments. Additionally, four bus lines utilize the corridor. Because of the orientation of Fulton Street in relation to the surrounding street grid, many of the intersections along Fulton Street have irregular geometry. The “oblique” angles at these intersections created safety and operational issues for pedestrians, buses, trucks and general traffic alike. This alignment allowed turning vehicles to proceed through the intersection at speeds that were incompatible with the high pedestrian activity and the residential and commercial land uses of the corridor. An example of one of these locations, Hanson Place approaching Fulton Street, is depicted to the left.

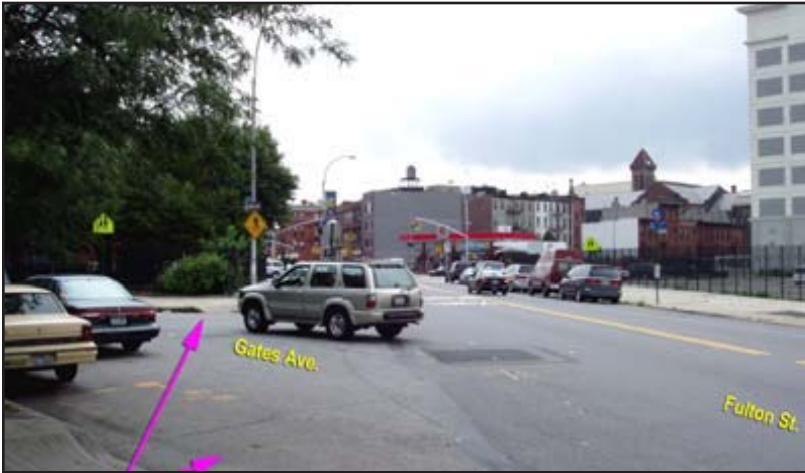
At Gates Avenue and Fulton Street, the offset geometry contributed to speeding, as well as a long crossing for pedestrians

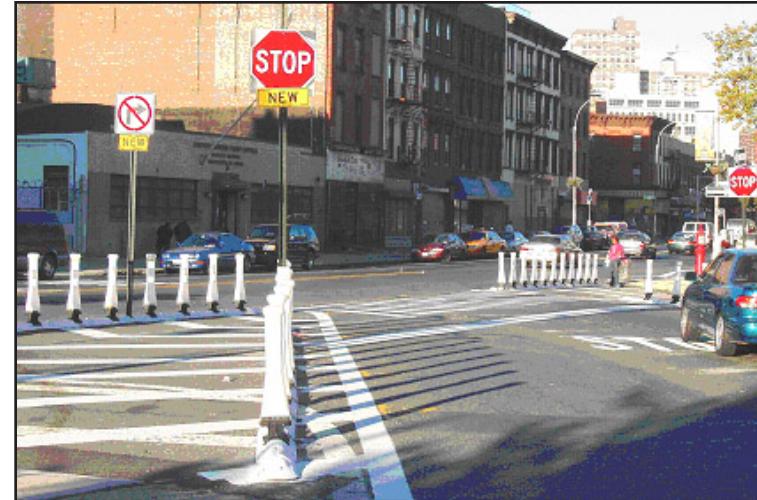
Gateway treatment and street-direction conversion at Putnam Avenue and Fulton Street

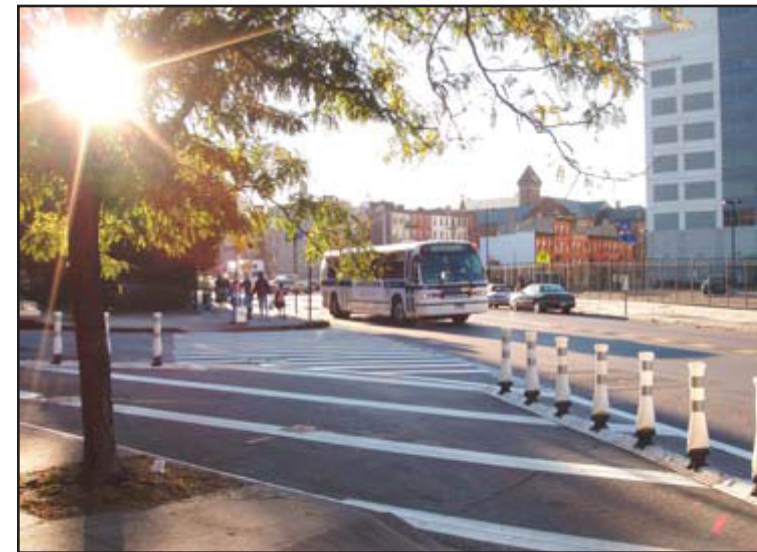
Through the use of flexible bollards and markings, the Department normalized the intersection and significantly shortened the crossing distance across Gates Avenue

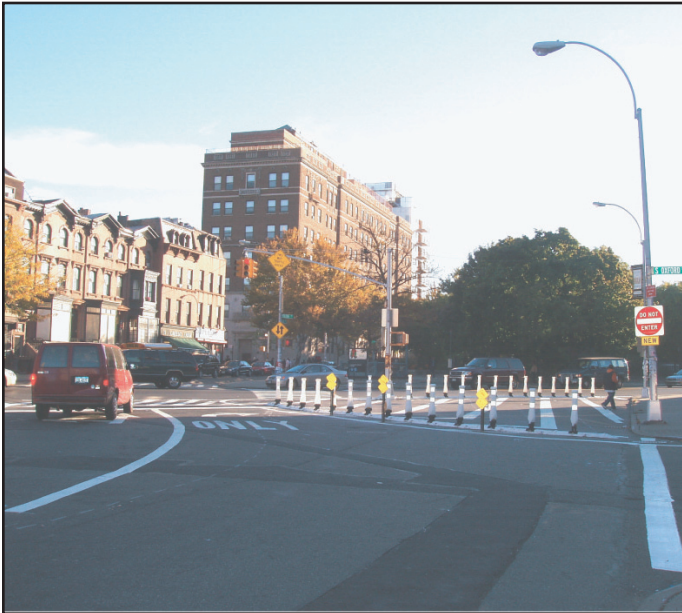
At Hanson Place, the Department eliminated the “free right turn” through the use of markings and flexible bollards, as well as shortening the crossing distance by half

At Hanson Place, this unusually wide intersection left pedestrians on Fulton Street in conflict with an unsignalized right turn, which vehicles could negotiate at high speeds. The “free right turn” lane was eliminated through the use of markings and flexible bollards. This new alignment forces all Hanson Place traffic to proceed to the traffic signal at Fulton Street, shortens the pedestrian crossing distance by half and eliminates the pedestrian-vehicle conflict. In addition, angle

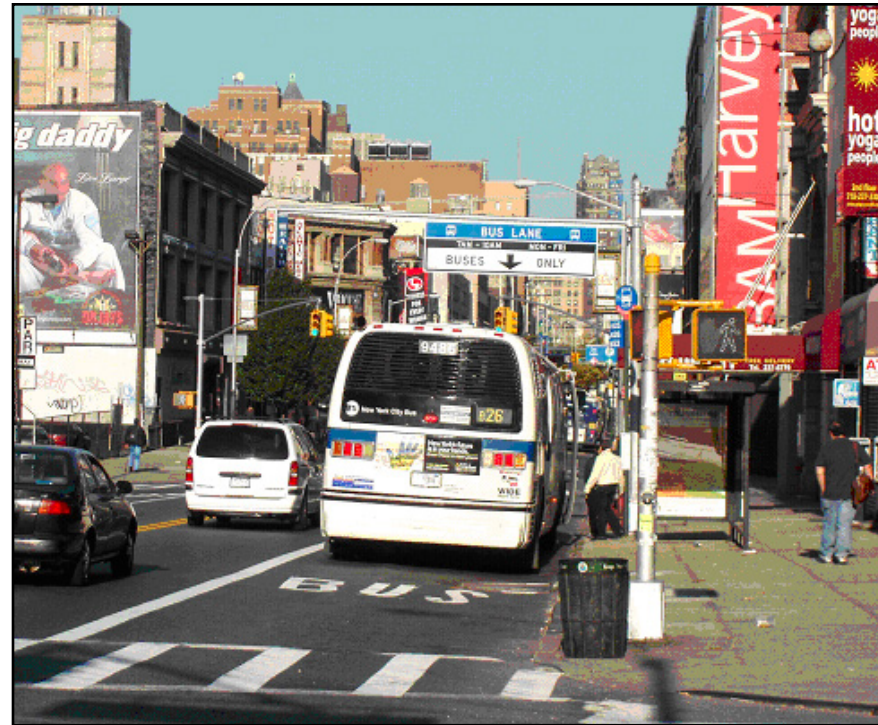
Dedicated bus lanes and newly designed overhead signs were installed to make the bus lanes more prominent.

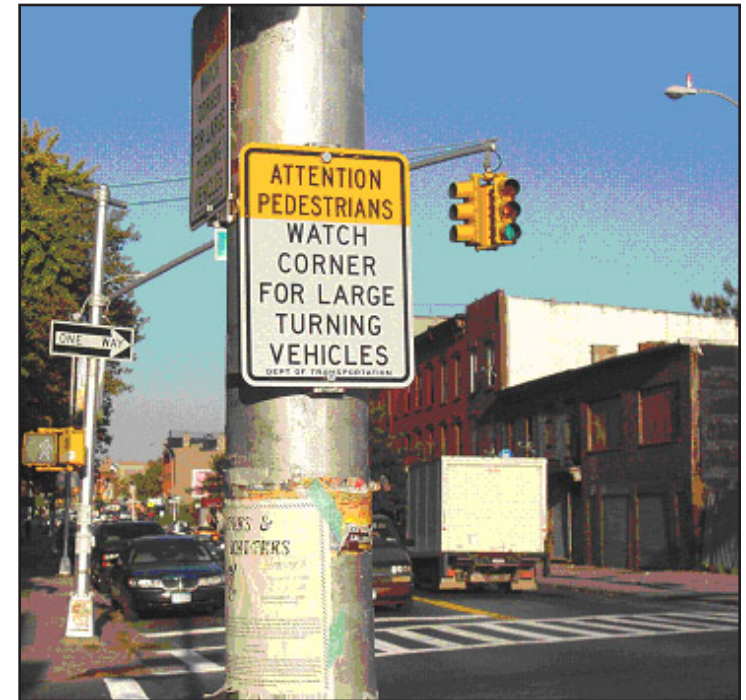
Unique signage advises pedestrians of turning vehicles at Wide Turn Zones
