Safe Streets for Seniors

Pelham Gardens, Bronx

FINAL REPORT

September 7, 2010

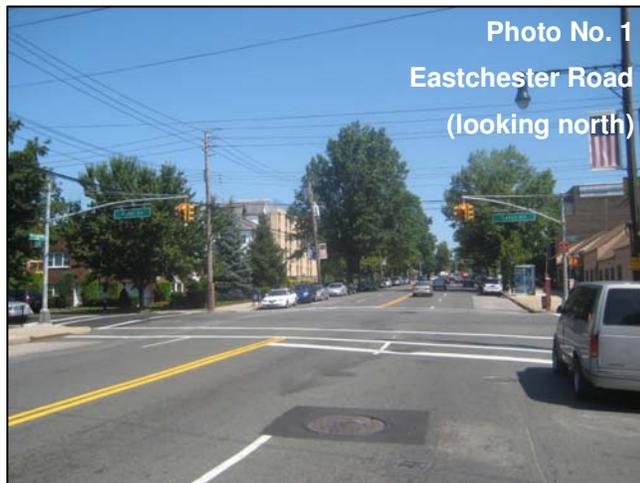
At the intersection of Eastchester Road and Waring Avenue, the crosswalks at all four legs have standard striping (Photo No. 1). To increase visibility of crosswalks on the major street, it is recommended that high visibility crosswalks be installed

on the north and south legs of Eastchester Road. A neckdown is recommended for the southeast corner along Eastchester Road to slow turning vehicles and shorten the pedestrian crossing distance and 13-feet south of the neckdown should have the parking regulations reinstated. A “Stop Here on Red” sign is also recommended 40-feet from the crosswalk for the westbound traffic along Waring Avenue.

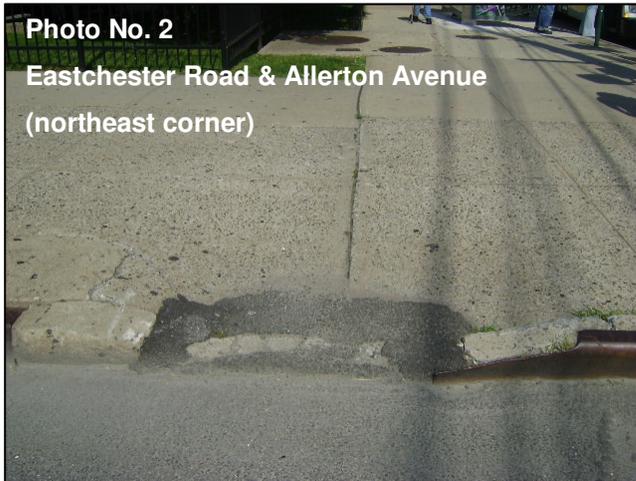
Traffic and pedestrian volumes were moderate in all directions. This was confirmed with a traffic count completed on Wednesday, July 30, 2008 in both the AM and PM. Results of the study can be found in Appendix C. A pedestrian ramp along Eastchester Road on the northeast corner is substandard and needs to be replaced with a new standard ramp with safety surface (Photo No. 2). A raised median that extends through the

crosswalk is recommended for the west leg of the intersection. The raised medians should be sufficiently wide to offer a minimal pedestrian refuge area. The median should be constructed with an at-grade cut through within the striped crosswalk. The medians will help to slow down vehicles turning from Eastchester Road onto Allerton Avenue and effectively shorten the crossing distance by allowing pedestrians to cross in two cycles. Construction details have been provided in Appendix E.

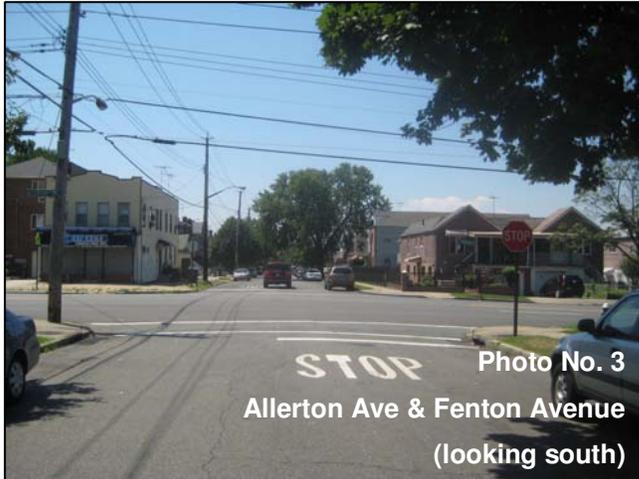
During the data collection and field observations, it was noted that vehicles traveling along Eastchester Road were perceived to be traveling at higher than the posted speed limit of 30 mph. To determine the operating speeds, a speed study was performed on Eastchester Road between Waring Avenue and Allerton Avenue on 08/07/08. The study showed that the 85th percentile speed was between 34 mph and 39 mph in all directions. Complete results are located in Appendix D. The results indicate the 85th percentile speeds exceeds the 30 mph speed threshold during both AM and PM Peaks in both the southbound and northbound directions. It is recommended that signal progression along Eastchester Road be adjusted so, the 85th percentile speeds along Eastchester Road are reduced.

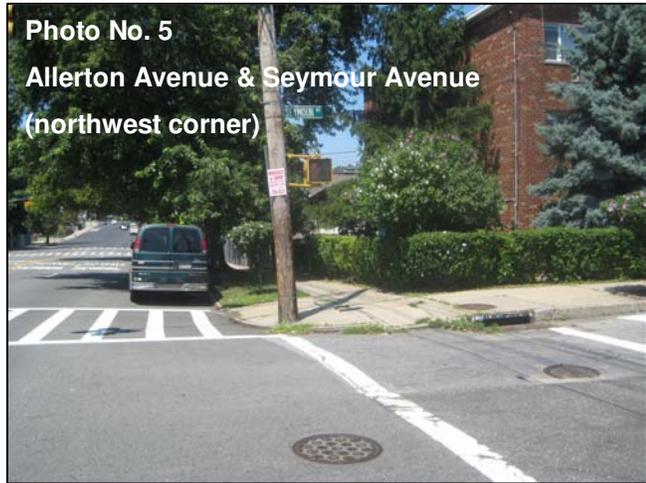
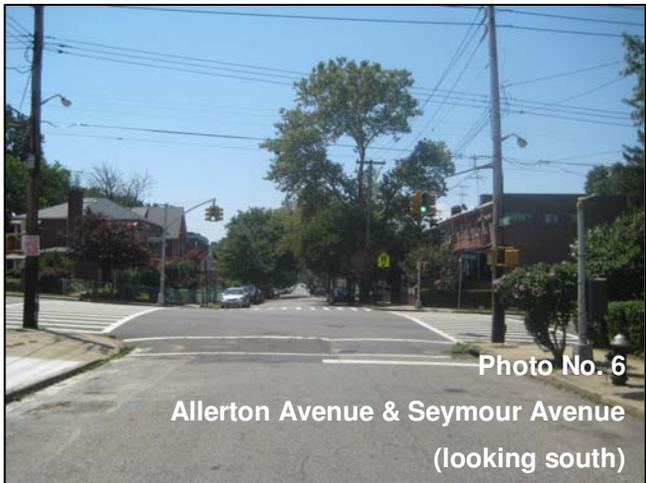
The intersection of Allerton Avenue and Seymour Avenue is signalized and has crosswalks on all four legs, of which three are school crosswalks. The northwest (Photo No. 5), southwest and southeast corners of the intersection have substandard pedestrian ramps. It is recommended that these pedestrian ramps be replaced with standard ADA pedestrian ramps with safety surface. Raised medians are recommended for the west and east legs of Allerton Avenue and Seymour Avenue (Photo No. 6). The median should be constructed with an at-grade cut through within the striped crosswalk. The medians will help to slow down vehicles turning from Seymour Avenue onto Allerton Avenue and effectively shorten the crossing distance by allowing pedestrians to cross in two cycles. Construction details have been provided in Appendix E.

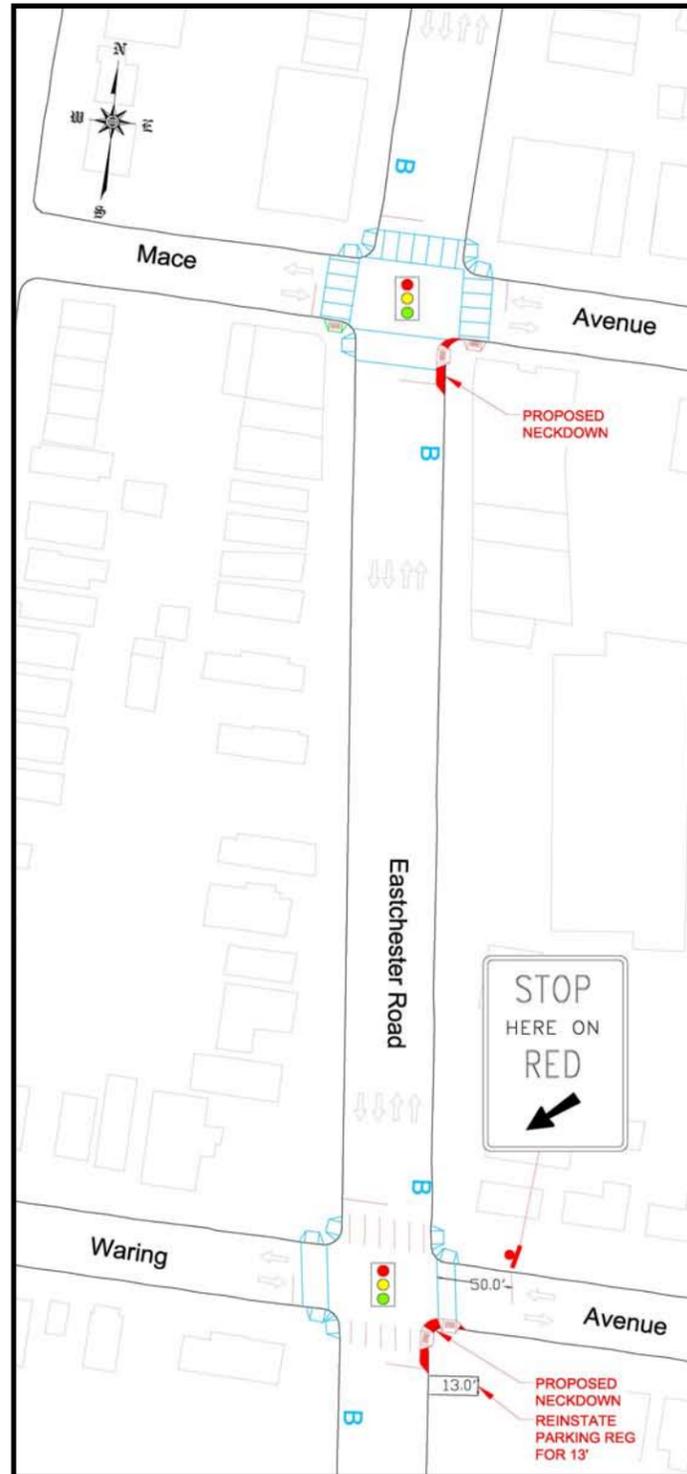
SITE 1: EASTCHESTER ROAD (MACE AVENUE AND WARING AVENUE)

Pedestrian concerns in this area:

- Signal timing (insufficient crossing time)
- Traffic failing to yield to pedestrians

*Speed study on Eastchester Road (Thursday August 7, 08)
(between Allerton Avenue & Waring Avenue)*

- 85th Percentile = 34.0 - 39.0 mph

- Time all signals for seniors and where feasible, the crossing time will be extended
- Install new advanced stop bars
- Install new sign
-stop here on red sign on Waring Ave. & Eastchester Rd.
- Install a neckdown
-on the southeast corner of Mace Ave. & Eastchester Rd.
-on the southeast corner of Waring Ave. & Eastchester Rd.
- Stripe new high visibility crosswalk
-on the north & south leg of Waring Avenue
- Reinstate parking regulation for 13' south of the proposed neckdown on Waring Ave. & Eastchester Rd.
