# Safe Streets for Seniors

## Stuyvesant, Manhattan

**FINAL REPORT**

September 8, 2010

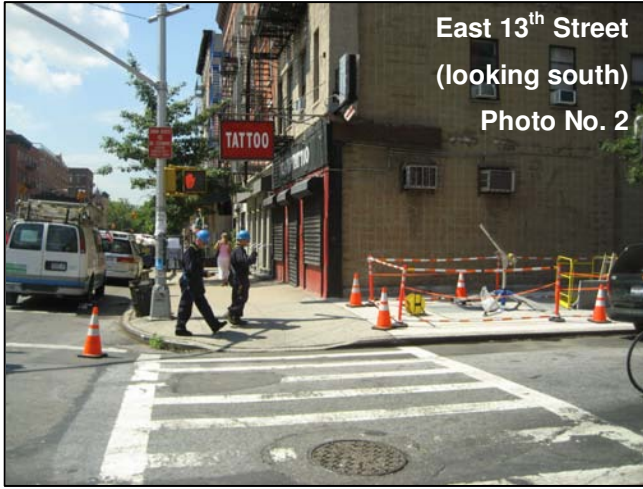
The southwest corner of Avenue A and East 13<sup>th</sup> Street is missing a pedestrian ramp on the west side of Avenue A (Photo No. 2). It is recommended that this

ramp be replaced with a NYCDOT standard pedestrian ramp and ADA safety surface. A signal pole may need to be relocated to accommodate the ramp. The pedestrian ramp on the northwest corner along Avenue A is in poor condition and should be replaced with a new one.

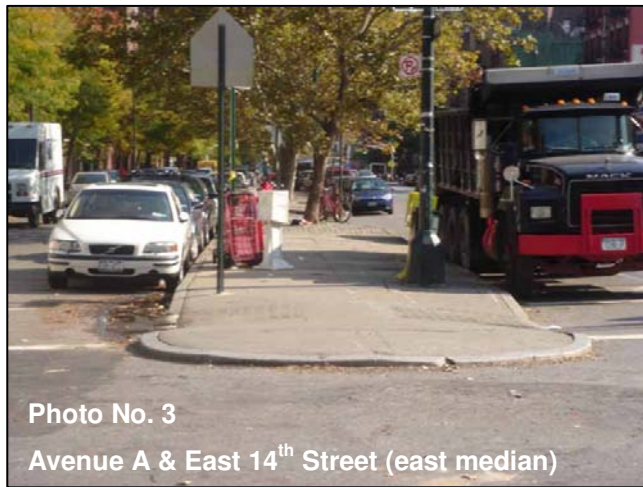
Photo No. 3

14<sup>th</sup> Street and heavy pedestrian volumes, including a significant number of seniors. Many seniors indicated they do not feel safe crossing the street at this intersection. Medians along East 14<sup>th</sup> Street do not have at-grade cut throughs for pedestrians, making it more difficult for seniors to cross East 14<sup>th</sup> Street (Photo No. 3). It is recommended that the east median have at-grade cut

Avenue A & East 14<sup>th</sup> Street (east median)

through with an ADA safety surface installed. It is also recommended that pedestrian signals be installed on the median islands. Sight lines to the current signals are not direct and the signals can be difficult to detect.

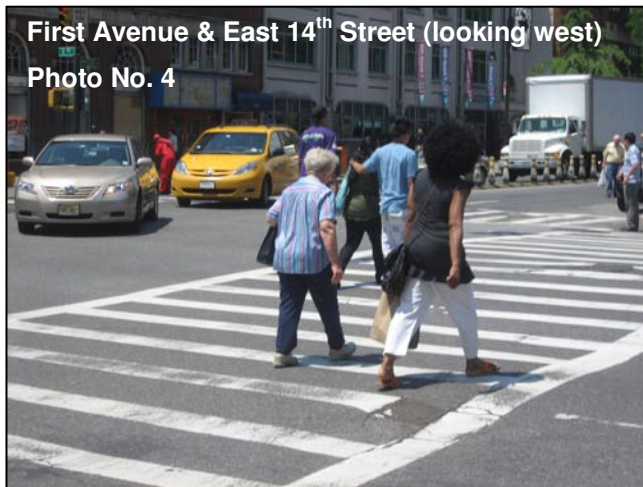
The intersection of First Avenue and East 14<sup>th</sup> Street has heavy vehicular and pedestrian volumes with an exclusive left turn signal for eastbound to northbound traffic (Photo No. 4). The exclusive left turn shortens the crossing time and many

seniors raised concerns about this particular intersection. Additional pedestrian traffic is generated from the 'L' Train entrances/exits at this intersection and the three bus stops. A new yield to pedestrian sign is recommended for the eastbound traffic. The pedestrian ramp along the north side of the median should be replaced with a NYCDOT standard pedestrian curb configuration and ADA safety surface. A new East 14<sup>th</sup>

Street sign is recommended to be hung over First Avenue. The oversized sign will allow motorists to determine their location so they can concentrate on the traffic/pedestrian conditions.

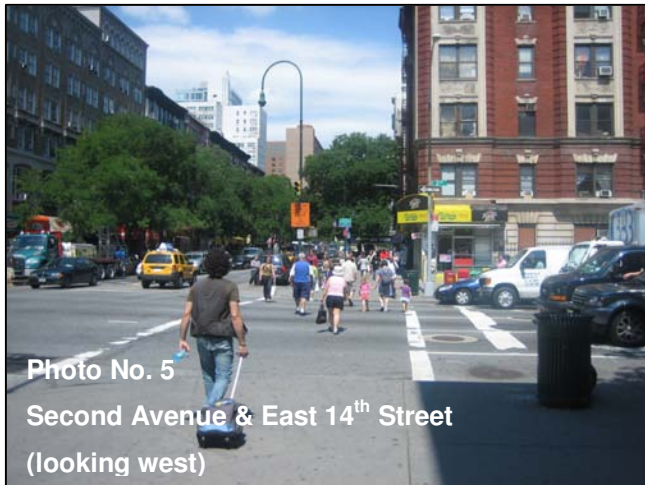
Many of the senior residents interviewed, indicated that there was not enough time to cross Second Avenue. It was observed that vehicles speed to the intersection to make both left and right turns from Second Avenue onto East 14<sup>th</sup> Street, before pedestrians could cross. This further shortens the crossing time, as pedestrians need to wait for vehicles to clear the intersection (Photo No. 5).

Turning movement counts for the AM and PM peak periods were performed on 06/08/08. For southbound traffic turning right, the PM peak counts indicated that 491 pedestrians conflict with 85 vehicles turning per hour. For southbound traffic turning left, the AM peak counts indicated that 294 pedestrians conflict with 197 vehicles turning per hour (see Appendix C for complete traffic count). A Leading Pedestrian Interval (LPI) is recommended at this intersection to minimize this conflict. Another alternative would be to evaluate changing the leading left turn phase to a lagging left turn phase. The existing dedicated left turn signal for westbound traffic along East 14<sup>th</sup> Street will be eliminated and the westbound to southbound turn will be banned at this intersection. Pedestrians often ignore the DON'T WALK signal when westbound East 14<sup>th</sup> Street has the dedicated left arrow, and this modification could help to eliminate pedestrian/vehicle conflict and also process more traffic.

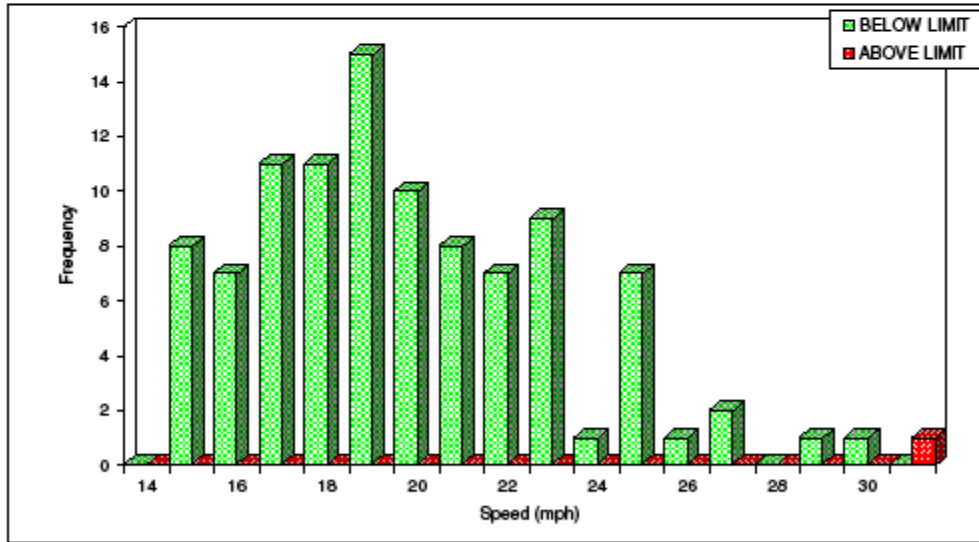
**APPENDIX D – SPEED STUDY  
EAST 12<sup>TH</sup> STREET BETWEEN FIRST AVENUE & SECOND AVENUE**

Boro:	Manhattan	Average Speed:	20.0 mph
Date:	07/21/08	15th Percentile:	16.9 mph
Day:	Mon.	50th Percentile:	19.0 mph
Weather:	Clear	85th Percentile:	23.0 mph
Time:	12:45PM-1:45PM		
Speed Limit:	30 mph	Above Speed Limit:	1.0 %
Sample Size:	100	Minimum Speed	15.0 mph
		Maximum Speed	31.0 mph
Type of Roadway:	One-Way	Pace:	15.0 - 25.0 mph
Width of Road by Direction:	30'	In Pace:	94.0 %
Number of Moving Lanes:	1	Below Pace:	0.0 %
Number of Parking Lanes:	2	Above Pace:	6.0 %
Observer:	B. Patel	Standard Deviation:	3.5 mph
