Safe Streets for Seniors

Upper West Side, Manhattan

FINAL REPORT
January 31, 2011

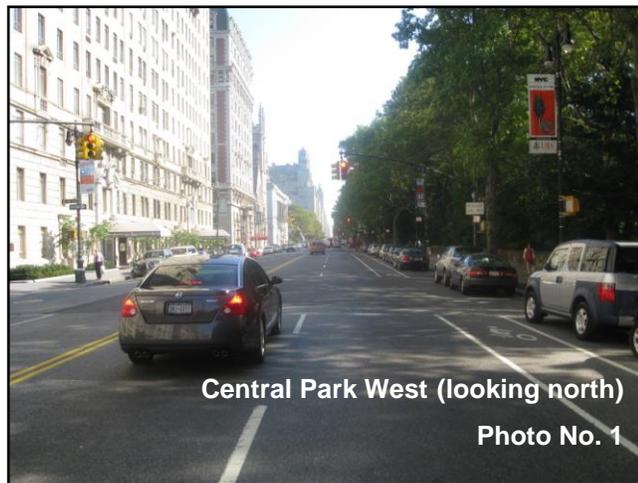
The study segment of Central Park West is approximately 1.06 miles long and intersects 18 cross streets. Within the study segment, Central Park West is predominantly a two-way arterial with two moving lanes in each direction and a parking lane along each curb side (Photo No. 1). This corridor provides north-south access. Between Columbus Circle and West 62nd Street, Central Park West provides one-way northbound access. Parking is generally permitted on both sides of the arterial within the study area. This

corridor also provides a designated bicycle path along its northbound approach. The cross streets, which follow the typical grid pattern and intersect Central Park West, are mostly one-way streets providing east-west access in this urban area. Central Park West is not a designated truck route. It provides mass transit services to the M10 and M72 bus lines and the A, B, C and D subway lines. The neighborhood surrounding the Central Park West corridor consists predominantly of high-rise residential and commercial buildings along its west side, with Central Park located along its east side. Due to the numerous activities which take place in Central Park, especially in the summer, the park attracts a significant number of pedestrians, including senior citizens.

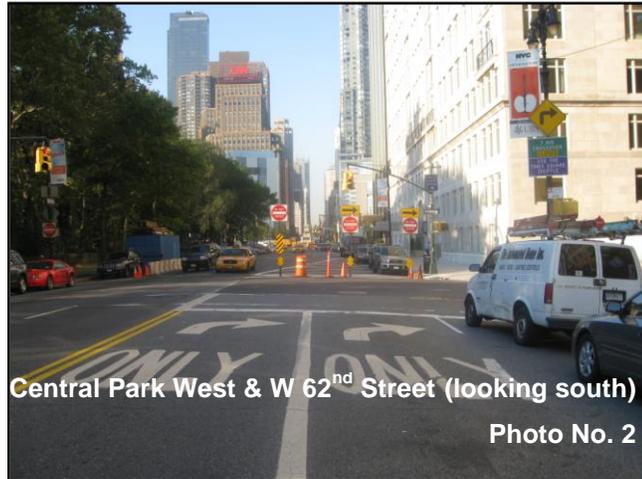
Photo No. 2

- Currently, this “T” intersection is signalized with standard crosswalks located on the north, south and west sides of this intersection (Photo No. 2). It is recommended that the existing crosswalk striping be replaced by high-visibility crosswalk striping. In addition, field observations have indicated the northbound approach of this

Central Park West & W 62nd Street (looking south)

intersection is one-way while the southbound approach accommodates two-way traffic. In order to prevent drivers from the southbound approach entering the one-way northbound leg of this intersection, pavement markings in the form of a neck-down along with corresponding traffic signs are presently in place. It is recommended that the existing neck-down pavement markings located on the northbound approach be replaced by a raised concrete neck-down. The schematics of the proposed intersection recommendations are presented below. It is further recommended that oversized street name signs be installed for W 62nd Street and that “Yield to Pedestrian” signs be installed at this intersection. These measures are anticipated to improve pedestrian safety and provide positive guidance to drivers.

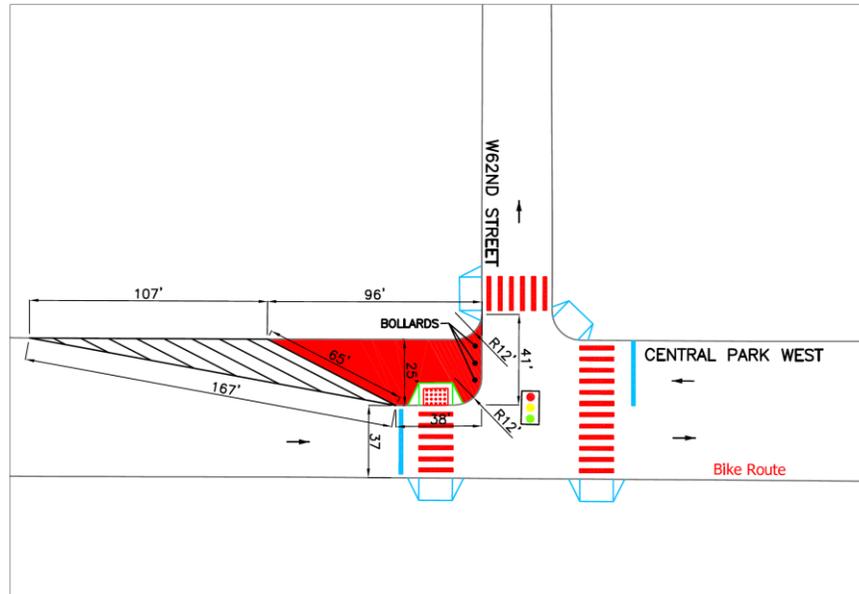
Proposed Recommendations at Central Park West & W 62nd Street Intersection

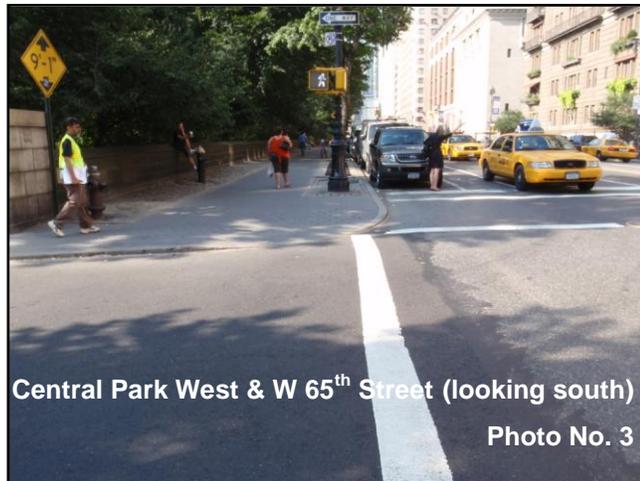
- Under the present condition, this intersection is signalized with standard crosswalks provided on all approaches (Photo No. 3). It is recommended that all existing crosswalk striping be replaced by high-visibility crosswalk striping. This intersection provides direct pedestrian access to Central Park and is subjected to significant pedestrian activity. It is recommended that a neck-down be installed at the southeast corner of this intersection. This measure will help to reduce the pedestrian crossing time and road exposure.

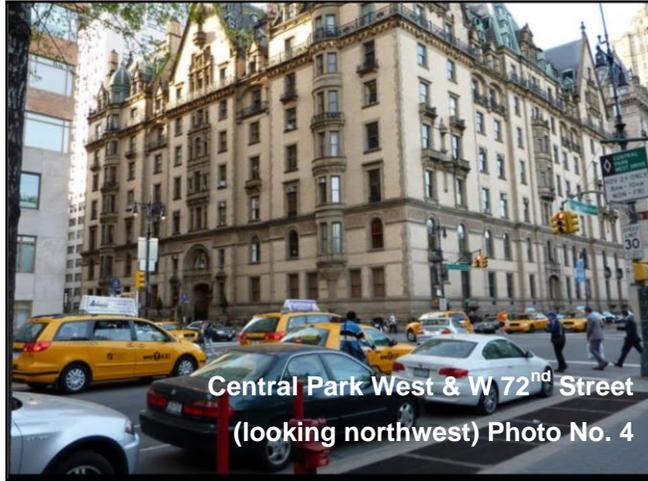
- Under the present condition, this intersection is signalized with standard crosswalks provided on all approaches (Photo No. 4). It is recommended that the existing crosswalk striping be replaced by high-visibility crosswalk striping on all four approaches. This intersection also provides direct pedestrian access to Central Park and is subjected to significant pedestrian activity.

Central Park West & W 72nd Street
(looking northwest) Photo No. 4

It is recommended that neck-downs be installed at the southeast and northwest corners of this intersection. This measure will help to reduce the pedestrian crossing time and road exposure. It is also recommended that oversized street name signs be installed for both Central Park West and W 72nd Street to provide positive guidance for drivers.

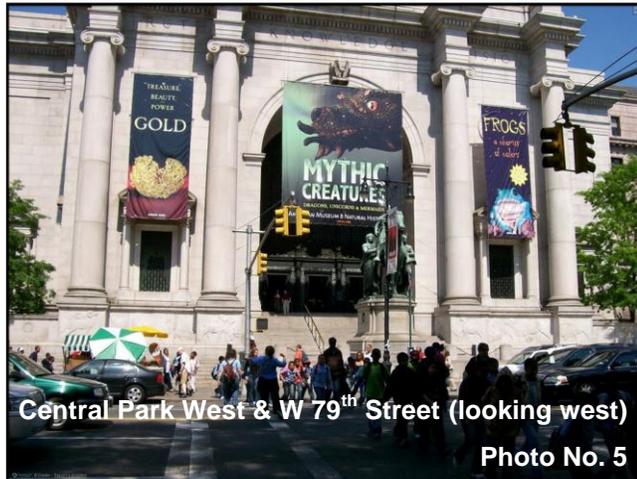
Photo No. 5

- This pedestrian crossing is signalized and is subjected to a significant number of pedestrians (Photo No. 5). It is recommended that the existing crosswalk striping be replaced by high-visibility crosswalk striping. Overhead pedestrian warning signs should be installed on the mast arm of the existing traffic signal facing approaching traffic in each direction.

Central Park West & W 79th Street (looking west)

It is further recommended that neck-downs be installed on both sides of this pedestrian crossing. This will require the existing bus stop (which is located in front of the museum on the southbound approach) to be relocated approximately 50 to 75 feet north of its current location.

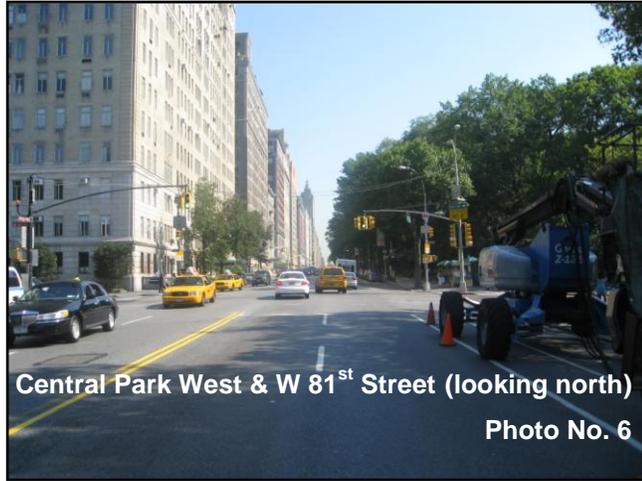
- Under the present condition, this intersection is signalized with standard crosswalks provided on all approaches (Photo No. 6). This intersection provides direct pedestrian access to Central Park and is also located within the immediate vicinity of the American Museum of Natural History and Hayden Planetarium. The traffic counts conducted at

at this intersection show significant pedestrian activity on a daily basis. Turning movement counts performed on 2/10/09 at this intersection for the AM and PM peak periods indicate the need to install LPI's on the east and west crosswalks of this intersection. During the AM peak hour, there are 270 pedestrians crossing W 81st Street, conflicting with 86 vehicles (36 northbound lefts + 50 southbound rights). During the PM peak hour, there are 177 pedestrians crossing W 81st Street, conflicting with 88 vehicles (57 northbound lefts + 31 southbound rights). These traffic counts are presented in Appendix D.

It is important to note that, due to the proximity of this intersection to the above-noted world famous destination points, significantly higher pedestrian activity is anticipated during the summer months. It is therefore recommended that neck-downs be installed at the northwest and southeast corners of this intersection. This measure will help to reduce the pedestrian crossing time and road exposure. In addition, it is recommended that the existing crosswalk striping be replaced by high-visibility crosswalk striping on all four approaches. It is further recommended that oversized street name signs be installed for W 8^{1st} Street. These measures will provide positive guidance to drivers and will improve pedestrian safety at this intersection.

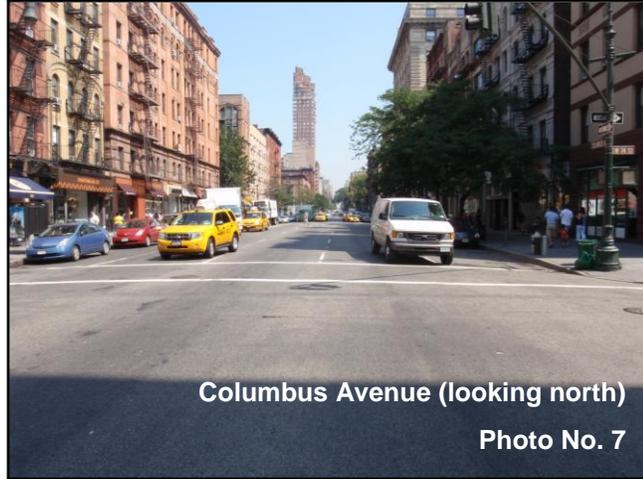
The study segment of Columbus Avenue is located one block west of Central Park West. It is also approximately 1.06 miles long and intersects 21 east-west cross streets. Within the study segment, Columbus Avenue is a one-way urban arterial with three moving lanes and a metered parking lane along each curb side (Photo No. 7). It should be noted, however, that the NYCDOT has recently constructed a protected bike lane along the east side of Columbus Avenue from 77th to 81st Street. This corridor provides southbound access only. Columbus Avenue is a designated local truck route and provides bus services to the M7, M11 and M20 bus lines; cross streets provide bus services to the M79 line. This corridor is surrounded by a broad range of retail and residential land-use activities.

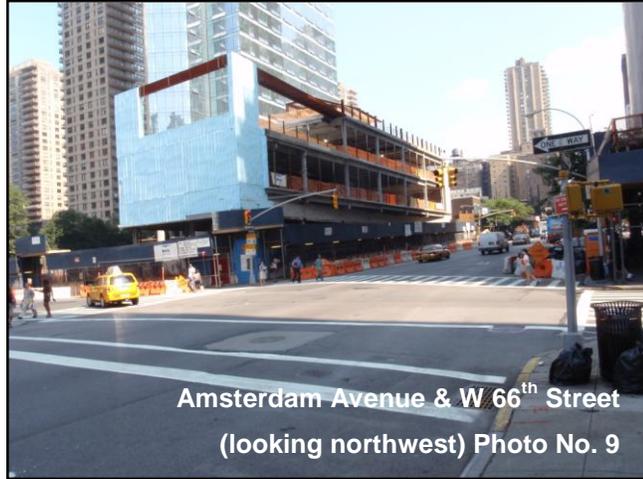
- Under the present condition, this intersection is signalized with school crosswalks provided on the north, east and west approaches and a standard crosswalk on the south approach (Photo No. 9). Due to the proximity of LaGuardia High School, significant pedestrian activity is observed at these intersections. It is therefore recommended that a neck-down be installed on the southwest corner of this intersection. This neck-down installation may require the relocation of a utility manhole which is located near the southwest curb.

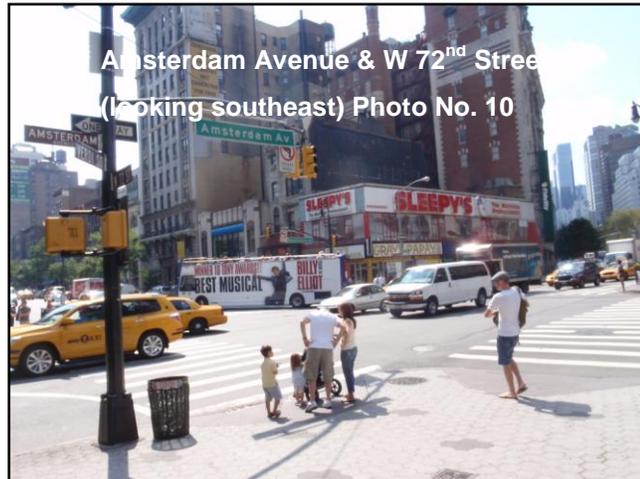
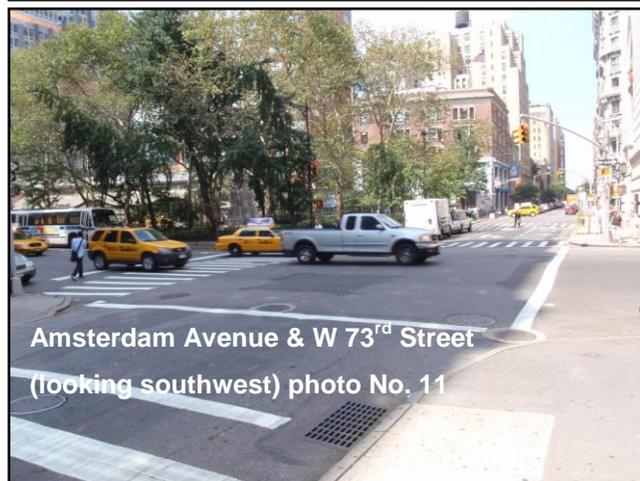
- Under the present condition, both of these intersections are signalized and are provided with a combination of high-visibility and standard crosswalks (Photo Nos. 10 and 11). It is recommended that the north and east crosswalks at the W 73rd Street intersection be restriped as high-visibility crosswalks. In addition, field observations and the traffic counts conducted at these intersections show significant pedestrian activity on a daily basis. Turning movement counts performed on 2/11/09 at the intersection of Amsterdam Avenue and W 72nd Street for the AM and PM peak periods indicate the need to install LPI's on the north

and south crosswalks for Amsterdam Avenue. During the AM peak hour, there are 412 pedestrians crossing Amsterdam Avenue, conflicting with 181 vehicles (10 eastbound lefts + 171 westbound rights). During the PM peak hour, there are 736 pedestrians crossing Amsterdam Avenue, conflicting with 100 vehicles (13 eastbound lefts + 87 westbound rights). Similarly, turning movement counts performed on 2/25/09 at the intersection of Amsterdam Avenue and W 73rd Street for the AM and PM peak periods indicate the need to install LPI's on the east and west crosswalks for W 73rd Street. During the AM peak hour, there are 246 pedestrians crossing W 73rd Street, conflicting with 279 northbound left-turning vehicles. During the PM peak hour, there are 305 pedestrians crossing W 73rd Street, conflicting with 240 northbound left-turning vehicles. These traffic counts are presented in Appendix D. The installation of LPI's at these locations will help to reduce the potential for pedestrian-vehicle conflicts at these busy intersections. It is further recommended that oversized street name signs be installed for W 72nd Street.

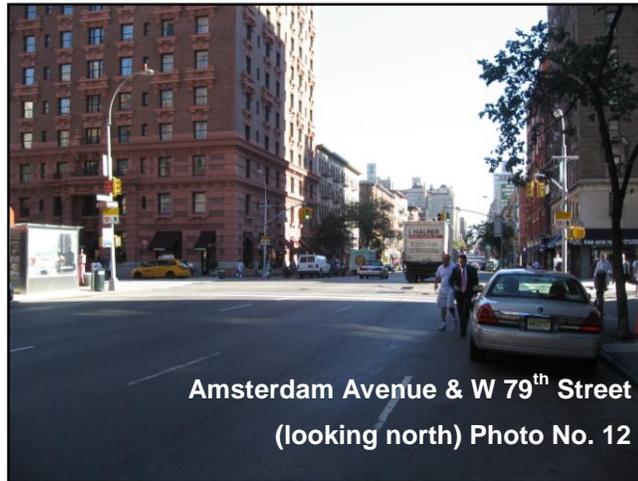
- Under the present condition, this intersection is signalized with school crosswalks located on the east and west approaches and standard crosswalks located on the north and south approaches (Photo No. 12). Consideration should be given to installing neck-downs at the southeast and northwest corners of this intersection. These neck-

down installations would require the relocation of utility manholes which are located near the respective roadside curbs. It is also recommended that oversized street name signs be installed for both Amsterdam Avenue and W 79th Street at this intersection. In order to improve pedestrian/vehicular visibility, it is further recommended that the bus-stop on the westbound W 79th Street approach be relocated 20 feet in advance of its existing location.

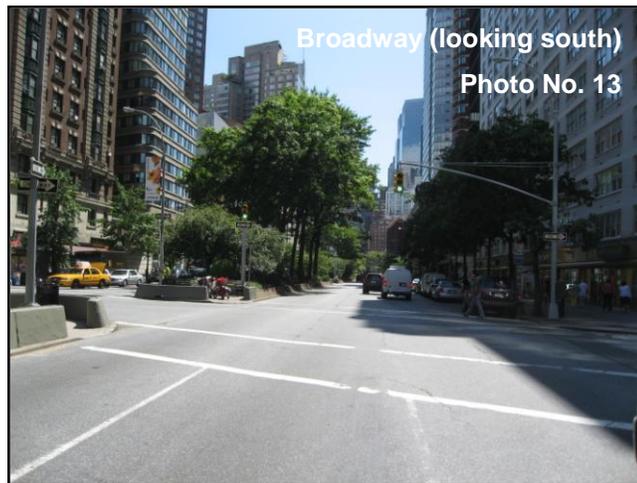
Broadway is the only arterial within the study area that does not follow the typical grid pattern, but instead, intersects all other study area corridors at an angle. The study segment of Broadway is approximately 1.15 miles long and intersects 22 cross streets. Within the study segment, Broadway is mainly a two-way urban roadway with three moving lanes in each direction and a metered parking lane along each curb side. The corridor provides

north-south access, and incorporates a median island which acts as a refuge for pedestrians who may not be able to cross this very wide roadway in one cycle length. The right curb side of each Broadway approach has a parking lane (Photo No. 13). Broadway is a designated local truck route. It provides mass transit services to the M5, M7, M20 and M104 bus lines and the 1, 2, and 3 subway lines. Its cross streets provide bus service to the M73 bus line. The study segment is located adjacent to residential and commercial land use, predominantly surrounded by high-rise buildings.

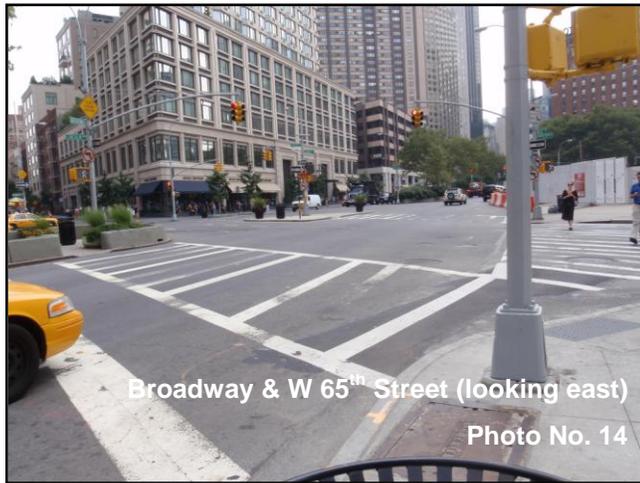
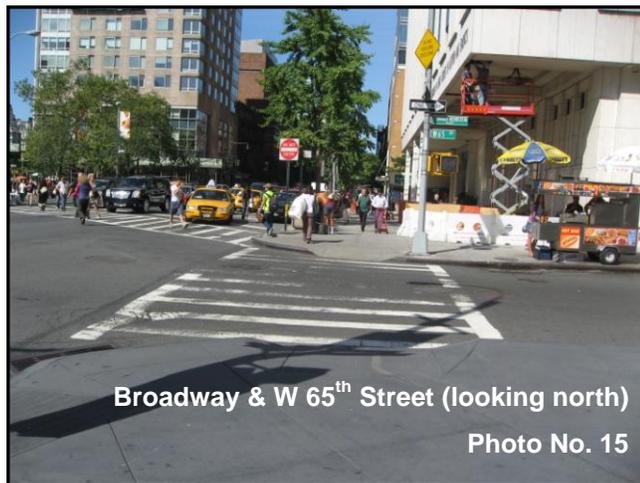
- This is a major, multi-legged, skewed intersection with four approaching legs and five receiving legs. It intersects two major streets and a comparatively minor street, as well as a service road adjacent to the New York Philharmonic and New York State Theatre (or Lincoln Center for the Performing Arts). The intersection geometry is constrained by the diagonally intersecting roadways. As a result, the pedestrian crosswalk layout is not typical of a standard intersection. Under the present condition, this intersection is signalized, with high-visibility crosswalks located on all major approaches. In addition, the receiving leg of the

Service Road is provided with a diagonal high-visibility crosswalk (Photo Nos. 14 & 15). The traffic counts at this intersection show significantly high vehicular and pedestrian activity on a daily basis. These traffic and pedestrian counts are presented in Appendix D. Although the pedestrian counts are significantly high on all of the crosswalks at this intersection,

the main conflicting pedestrian movements are on the east crosswalk at W 65th Street and the south crosswalk at Broadway. It is recommended that neck-downs be installed at the southeast and northeast corners of this intersection. The existing diagonal, high-visibility crosswalk on the receiving leg of the Service Road should be removed, as there is another crosswalk located 50 feet south of this location, facilitating the same pedestrian movement. In addition, it is recommended that oversized street name signs for W 65th Street be installed at this intersection. The south crosswalk also has street signs for Broadway and Columbus Avenue on a pole. It is recommended that these signs be replaced by large letter signs. It is further recommended that three “Yield to Pedestrian” signs with appropriate turn arrows be installed at this intersection. One additional left-turn restriction sign should also be installed for the eastbound W 65th Street traffic to further emphasize the existing left-turn restriction. These measures are anticipated to improve pedestrian safety and provide positive guidance to drivers. The schematics of the proposed intersection recommendations are presented below.

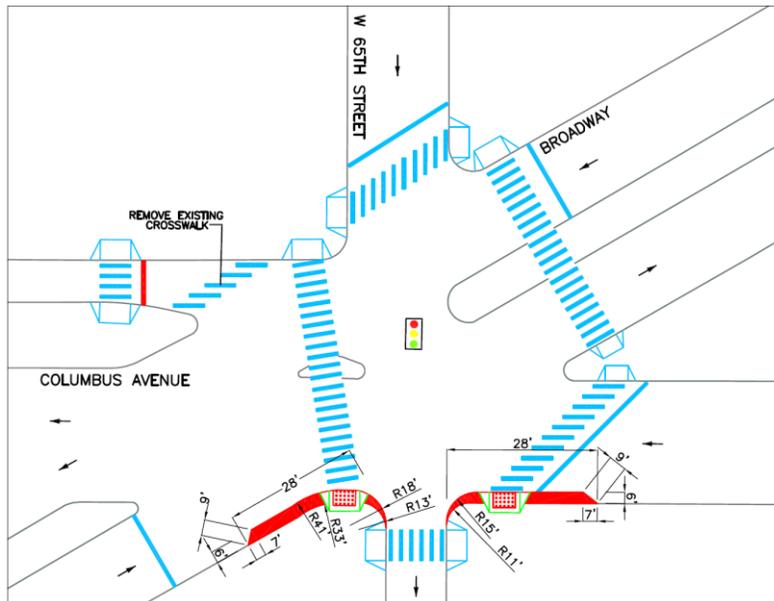
Proposed Recommendations at Broadway/Columbus Avenue & W 65th Street Intersection

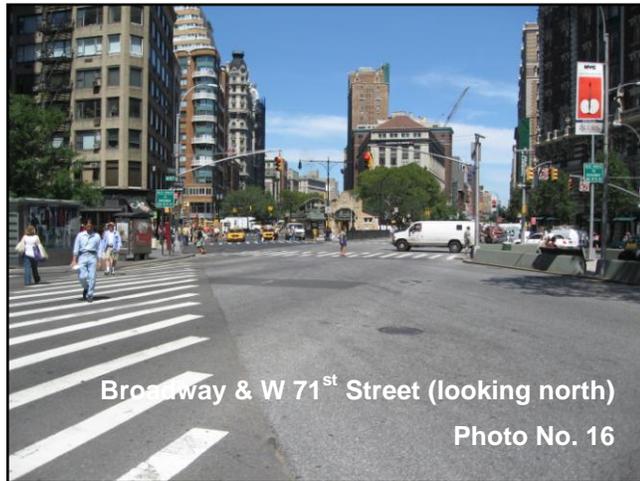
- This is a major, multi-legged skewed intersection with four approaching legs and three receiving legs. It intersects two major streets and a comparatively minor street. The intersection geometry is constrained by the diagonally intersecting roadways. As a result, the pedestrian crosswalk layout is also

skewed. Under the present condition, this intersection is signalized with high-visibility crosswalks located on all approaches (Photo No. 16). It should be noted that curb extensions, new pedestrian ramps and new crosswalks are being evaluated for installation by the DOT at this intersection. These recommended measures are being proposed as a part of the Amsterdam Avenue, Broadway and W 71 Street intersection improvements, designed by the DOT under a separate assignment to improve pedestrian safety. It is further recommended that oversized street name signs for W 71st Street be installed at this intersection. All of these proposed measures are anticipated to improve pedestrian safety and provide positive guidance to drivers.

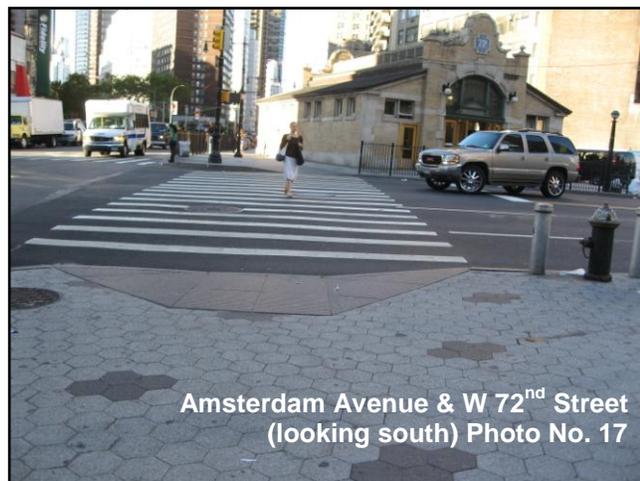
- This subway station provides services to the 1, 2 and 3 subway lines and generates a significant number of pedestrian trips throughout the day. It is located in very busy traffic surroundings, sandwiched between two highly travelled roadways (Amsterdam Avenue and Broadway) and their cross streets (71st Street and 72nd Street) (Photo No. 17). Apart from

was noted that the existing pedestrian railing surrounding the subway station would not be able to stop or deflect an errant vehicle back onto the roadway. Instead, a vehicle could break through these railings and enter the subway station frontage which is subject to significant pedestrian volumes at any given time. This type of errant vehicle accident could potentially result in a significant number of pedestrian injuries. Thus, in order to protect and improve pedestrian safety around this busy subway station, the existing pedestrian railing will be replaced with more impact resistant, closely-spaced, and architecturally attractive bollards.

the recommendations to improve pedestrian safety at the surrounding intersections and pedestrian crossing points, it is important to improve pedestrian safety around the subway station. During various field visits, it

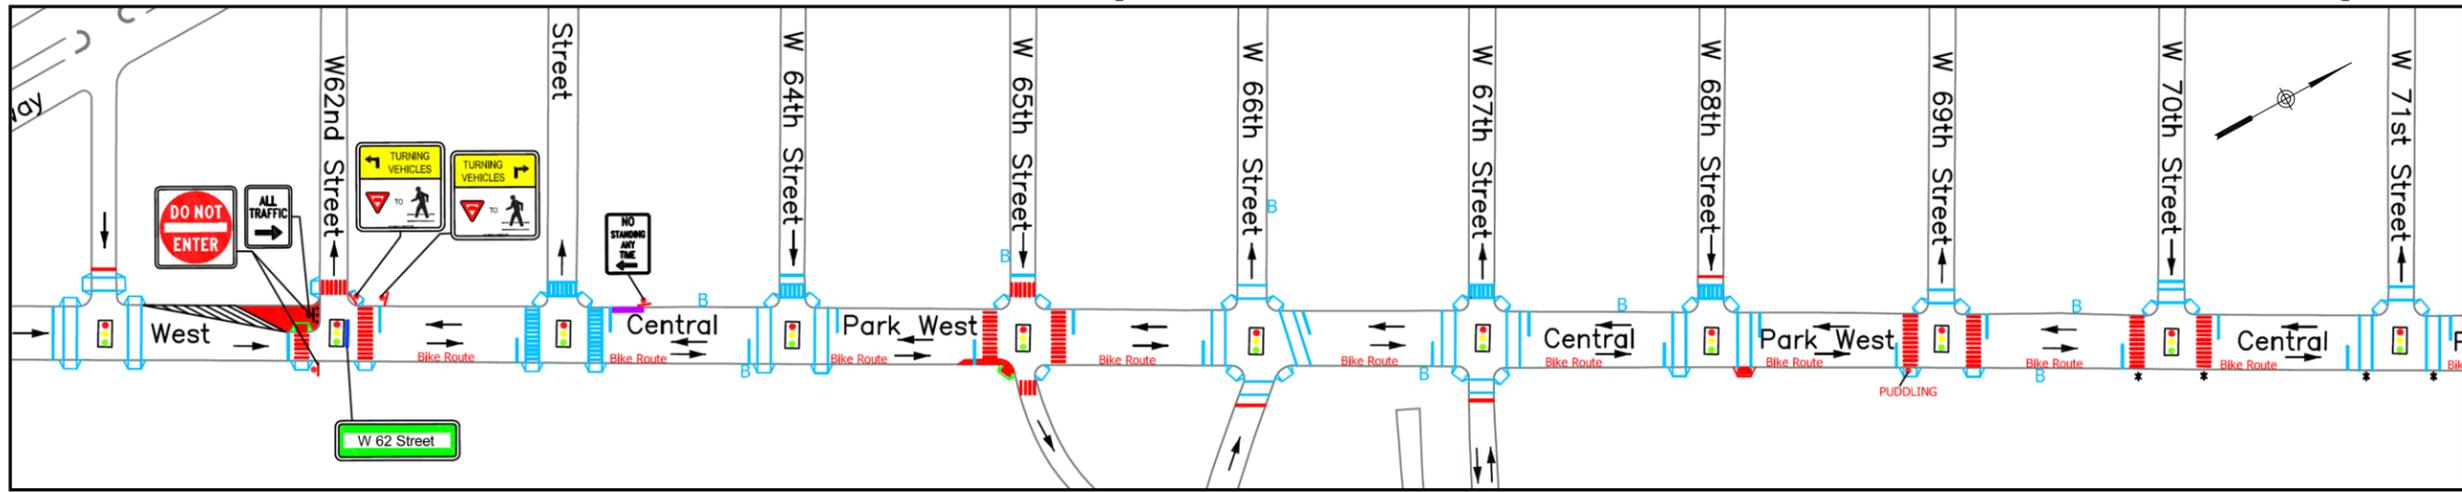
SITE 1: PLAN 1 – CENTRAL PARK WEST (FROM W 61ST STREET TO W 71ST STREET)

Recommended improvements include:

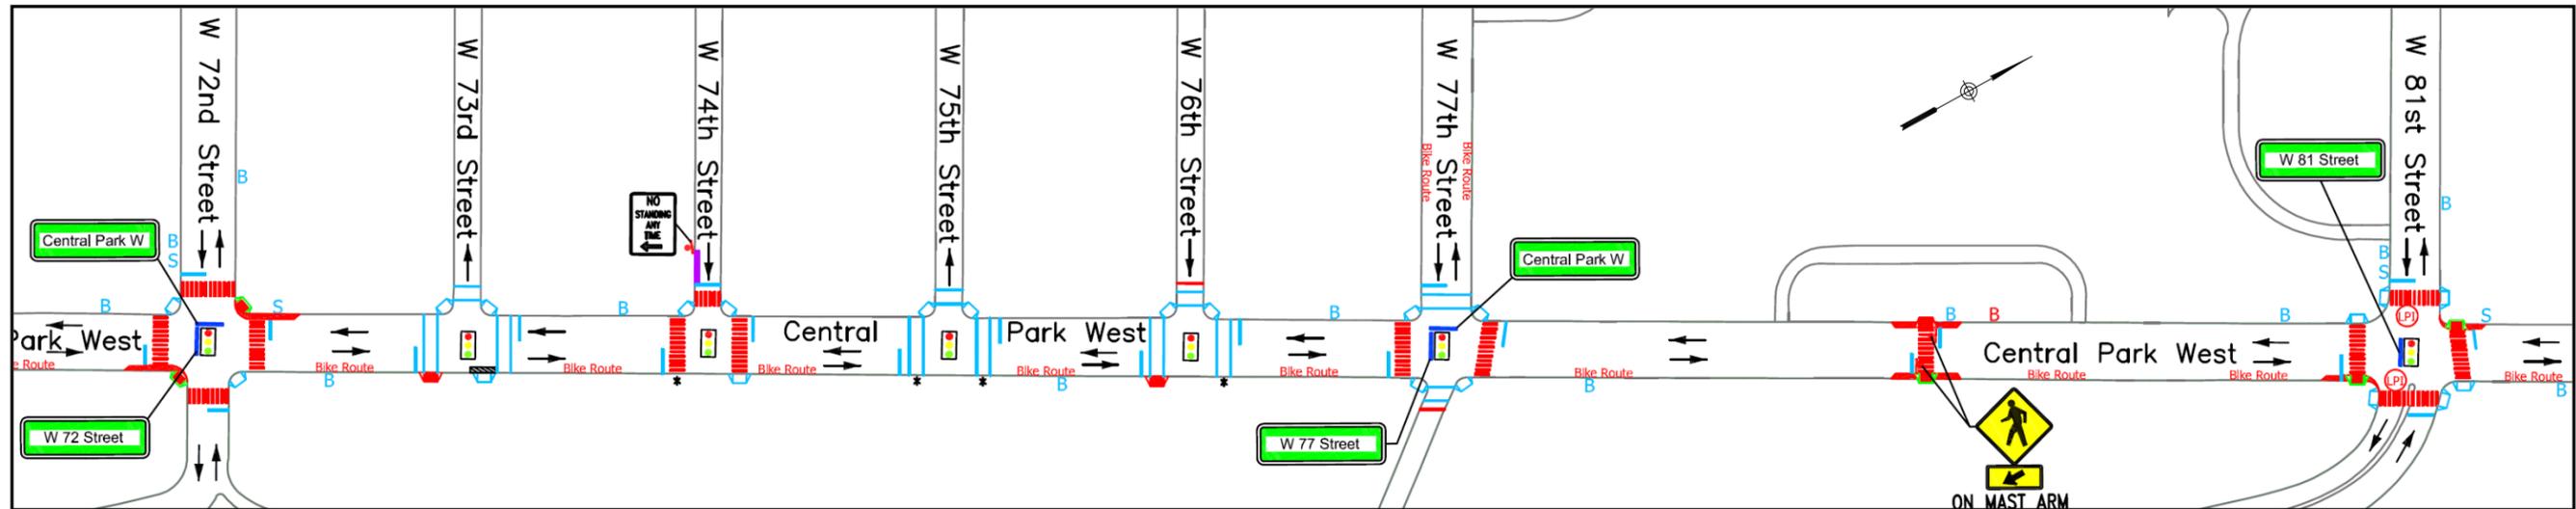
SITE 1: PLAN 2 – CENTRAL PARK WEST (FROM W 72ND STREET TO W 81ST STREET)

- Recommended improvements include:**
- Time all signals for seniors and where feasible, the crossing time will be extended
 - Install new high visibility crosswalks

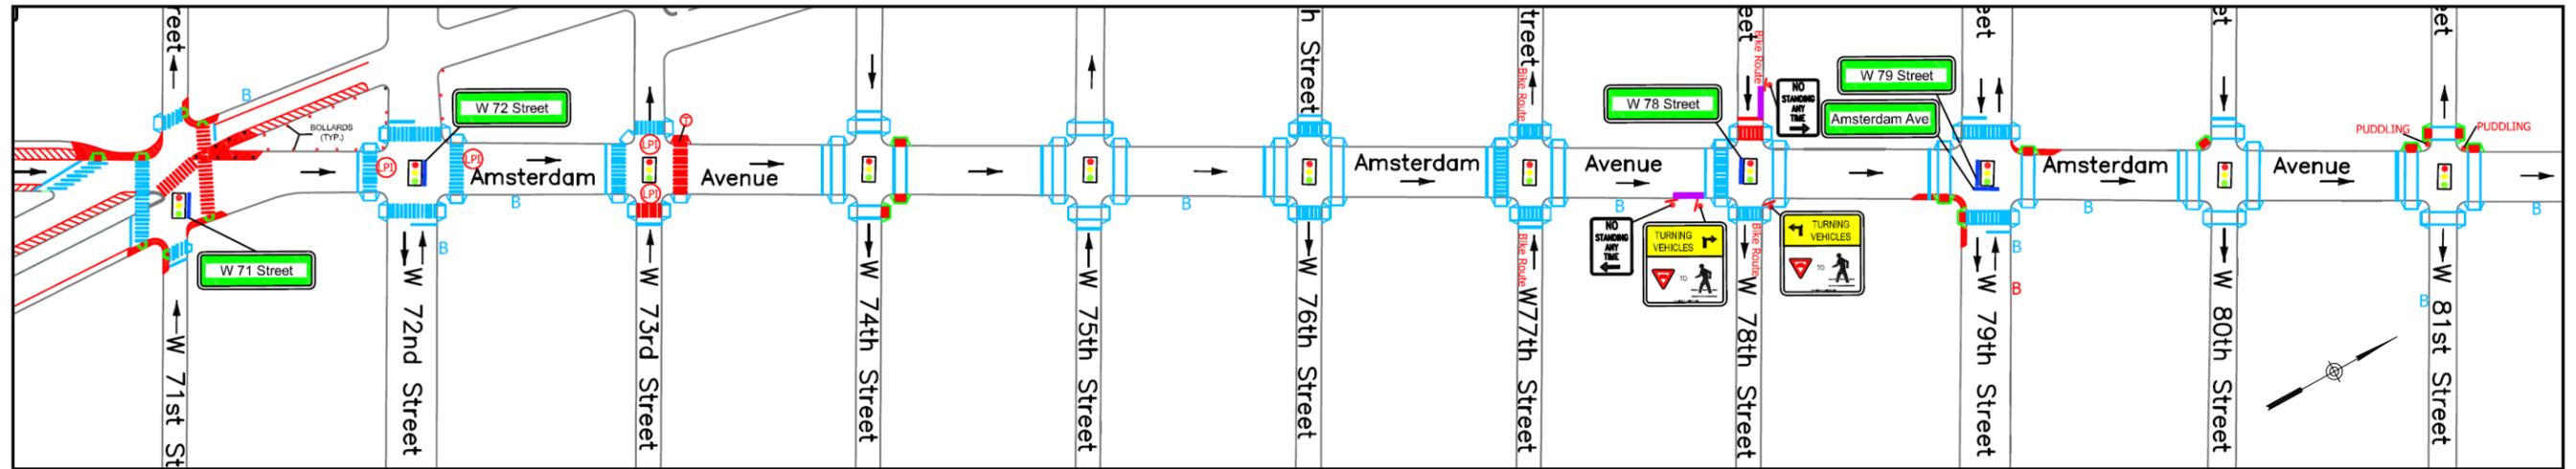
SITE 3: PLAN 2 – AMSTERDAM AVENUE (FROM W 71ST STREET TO W 81ST STREET)

Recommended improvements include:

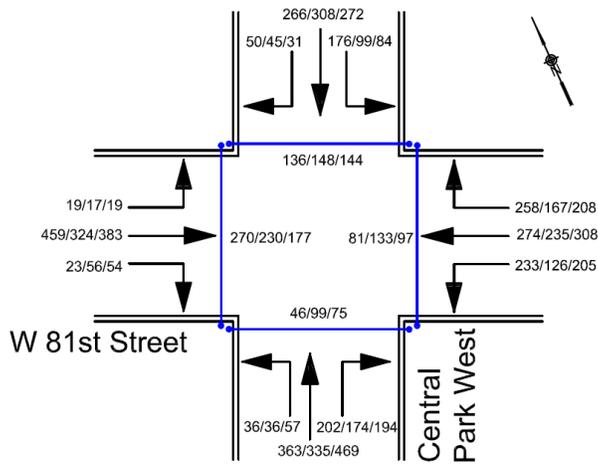
Intersection of Central Park West and West 81st Street

Note: Counts conducted on Tuesday, 02/10/2009.

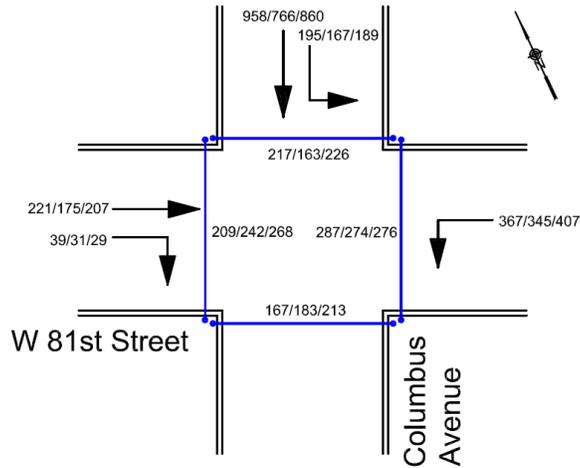
Intersection of Columbus Avenue and West 81st Street

Note: Counts conducted on Tuesday, 02/10/2009.

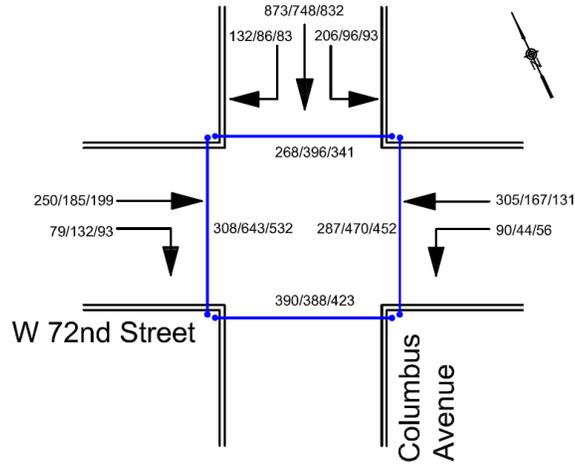
Intersection of Columbus Avenue and West 72nd Street

Note: Counts conducted on Wednesday, 02/11/2009.

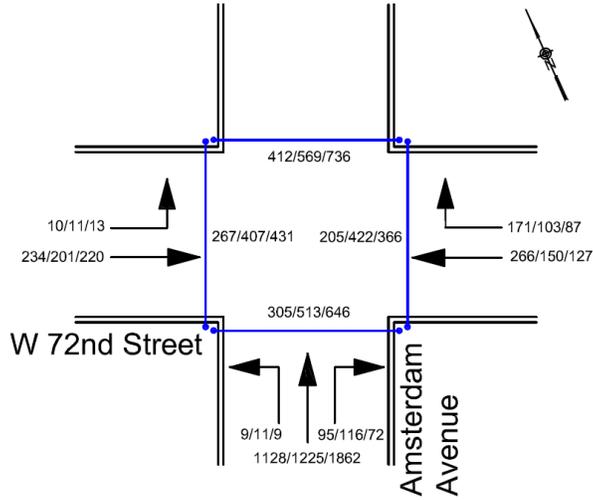
Intersection of Amsterdam Avenue and West 72nd Street

Note: Counts conducted on Wednesday, 02/11/2009.

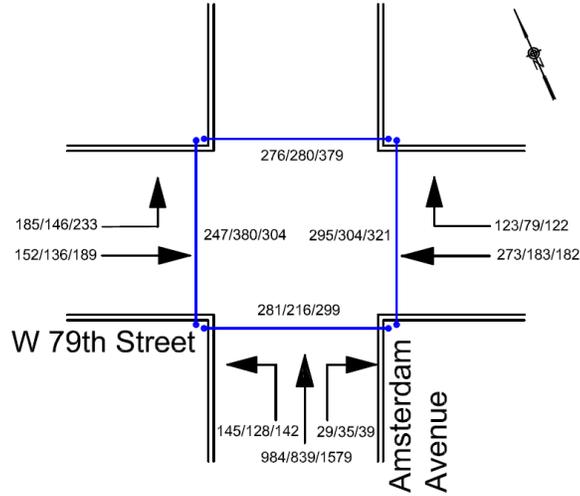
Intersection of Amsterdam Avenue and West 79th Street

Note: Counts conducted on Tuesday, 02/24/2009.

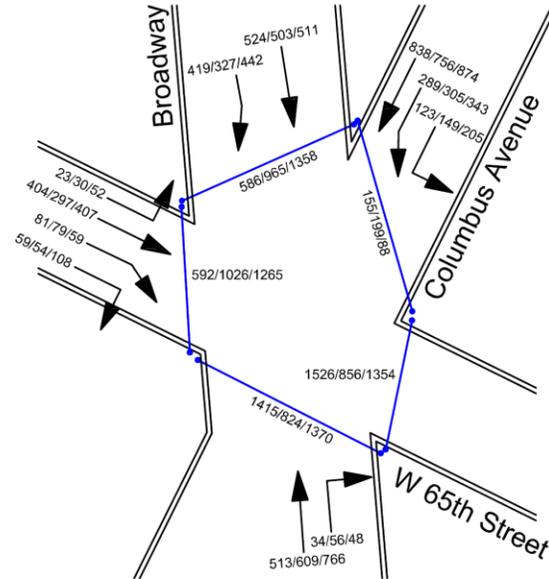
Intersection of Broadway and Columbus Avenue / West 65th Street

Note: Volumes taken from West 61st Street Rezoning Project EIS and increased @ 0.5%/year for 5 year.

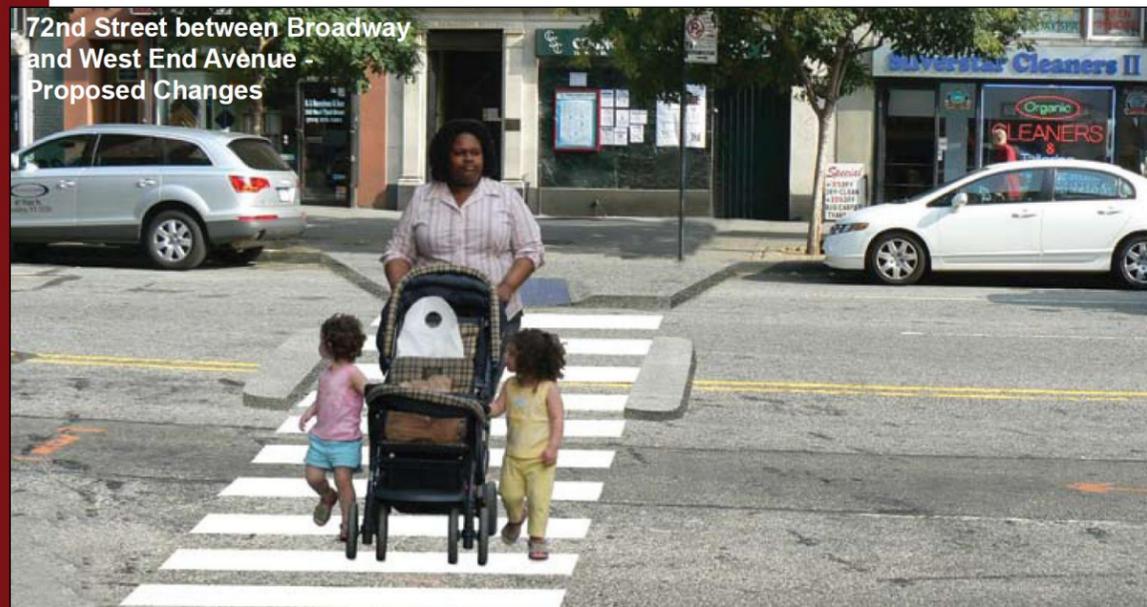
Illustrating the Solution

The following recommendations include:

- Leading pedestrian intervals at all intersections.
- Enforcement of parking regulations.
- Install curb extensions at Broadway and 72nd street on the NW and SW corners.
- "Street Print" pavement treatment at the intersections of West 72nd Street at West End Avenue and at Broadway and Amsterdam between the subway stations.
- Modify all signals to a crossing speed of 2.5 feet per second.
- Move all news boxes and construction materials away from curbs.
- Create mid-block crossing on West 72nd Street between Broadway and West End Avenue.

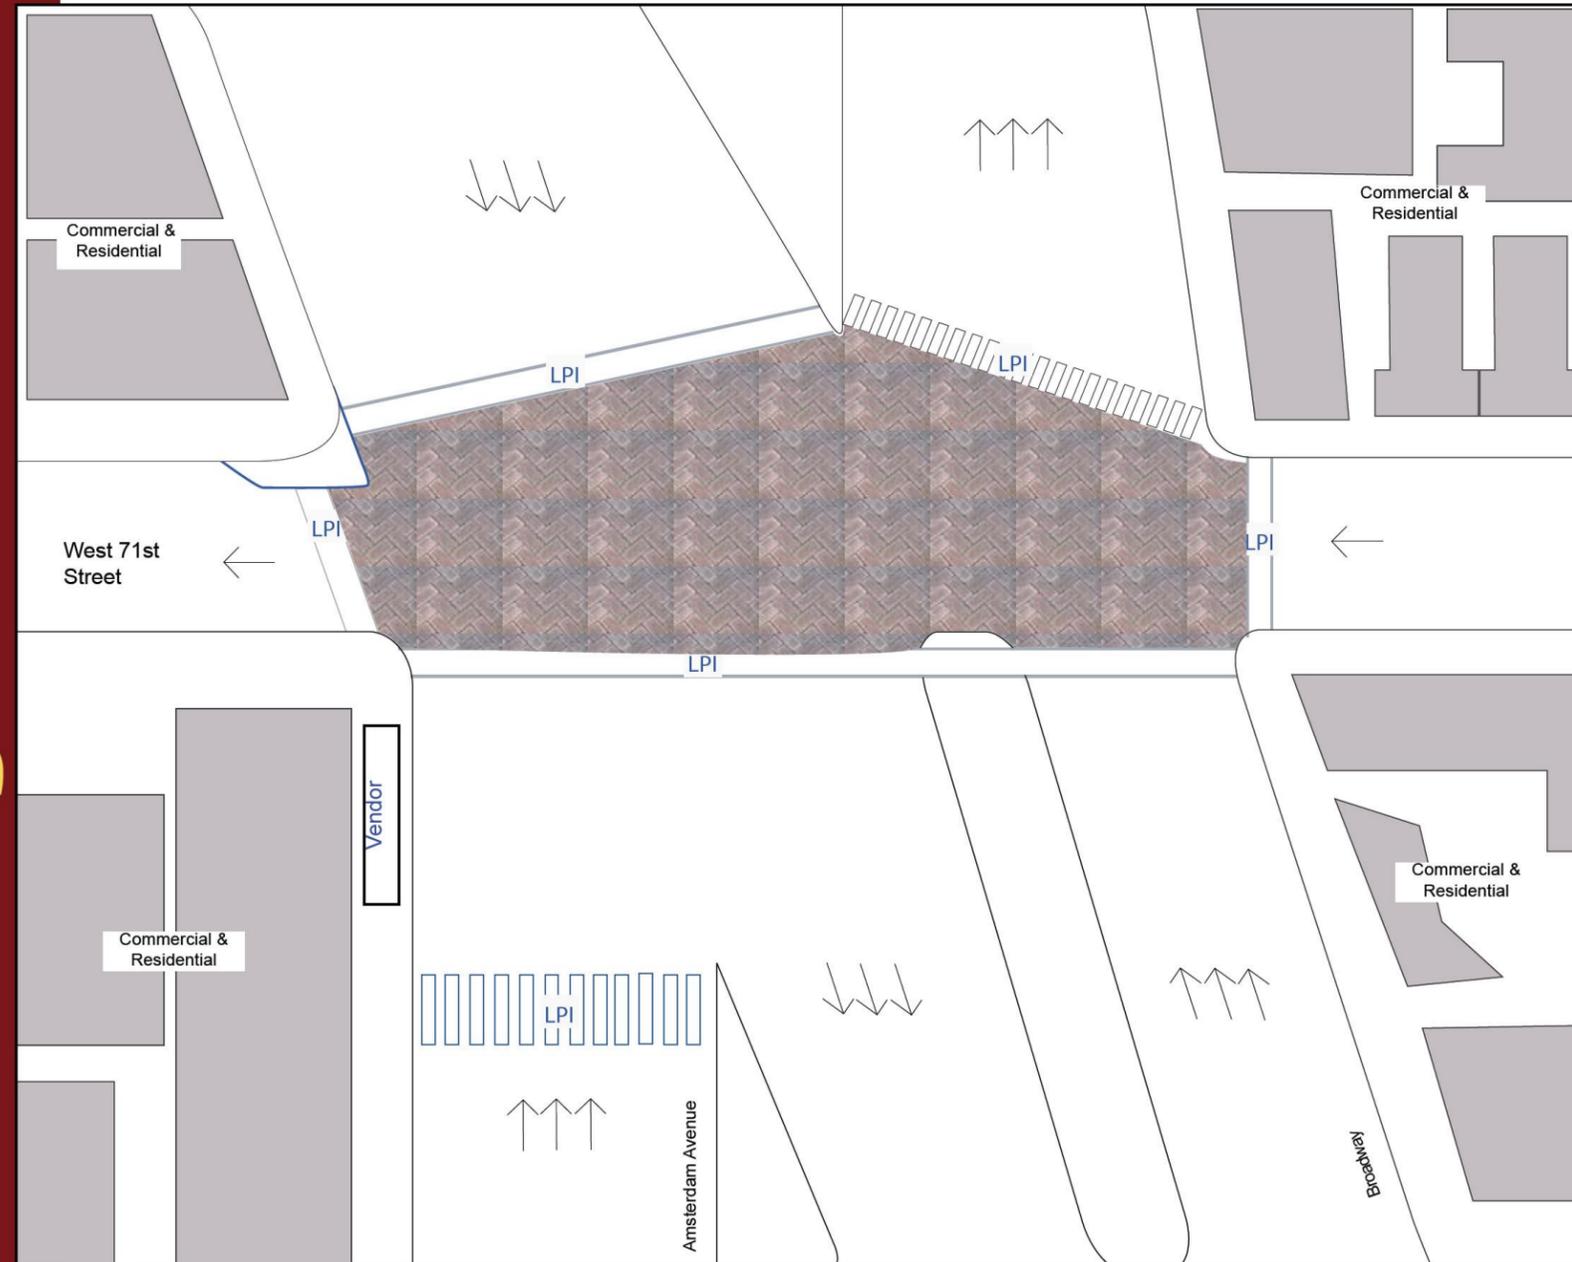
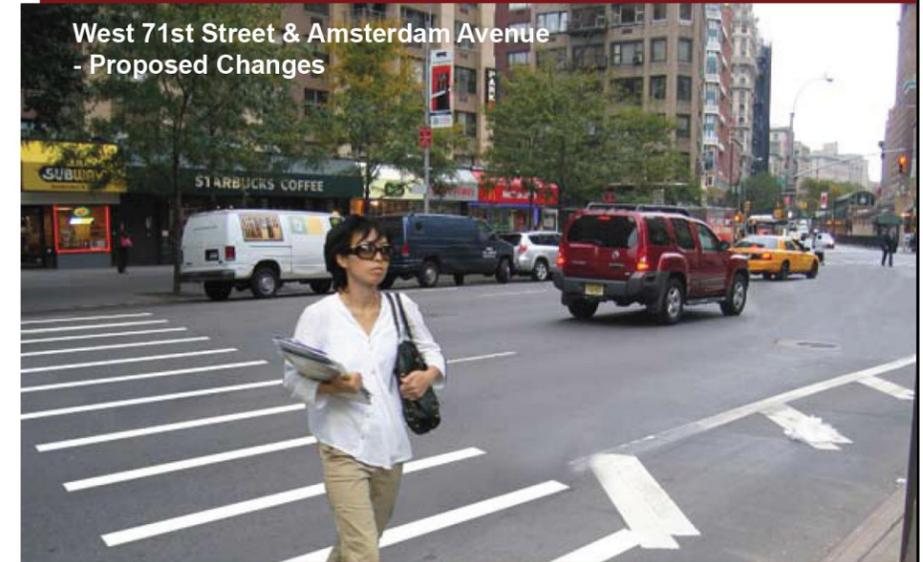
Proposed Changes Broadway & Amsterdam Avenue (West 71st Street)

- Leading pedestrian intervals at every crossing and give adequate time to cross the street.
- Channelize vehicles as much as possible through the intersection.
- Make the diagonal crossing of Amsterdam perpendicular.
- Consider curb extensions on West 71st street on the NW corner.
- Add "Street Print" treatment to the intersection of West 71st Street at Broadway and Amsterdam to slow down motorists and improve the existing quality of the pavement at these intersections.
- Move vendors south of the intersection on Amsterdam, away from West 71st street.
