**New York City Department of Transportation
Office of School Safety Engineering**

School Safety Engineering Project

FINAL REPORT: I.S. 51 (Edwin Markham), Staten Island

**Prepared by
The RBA Group/Urbitran Associates**

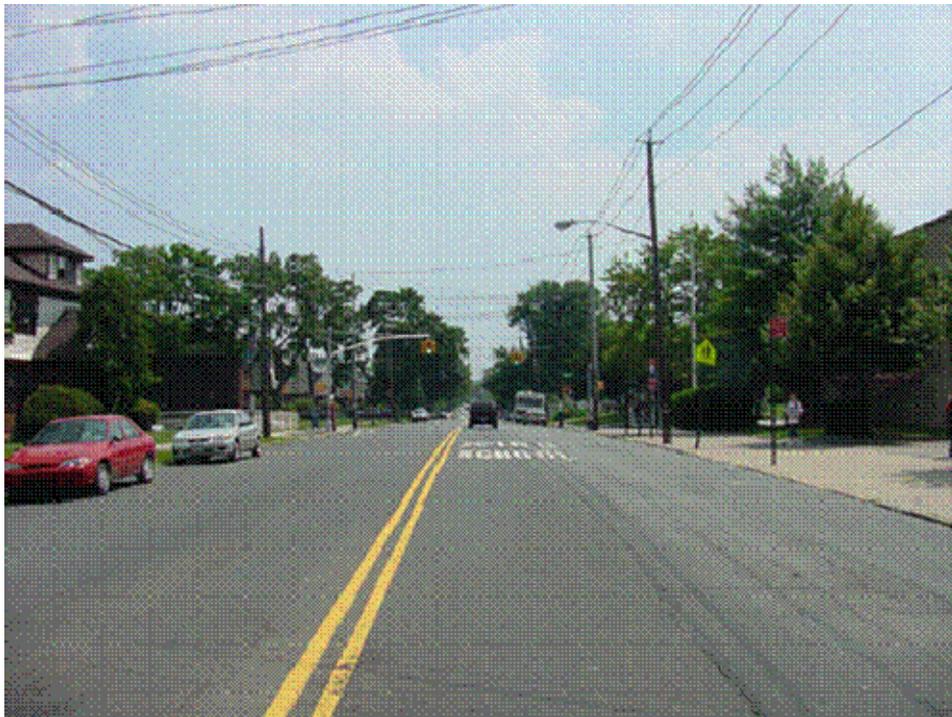
Figure 1: Looking south along Willowbrook Road toward intersection of College Avenue / Houston Street (I.S. 51 is on the right)

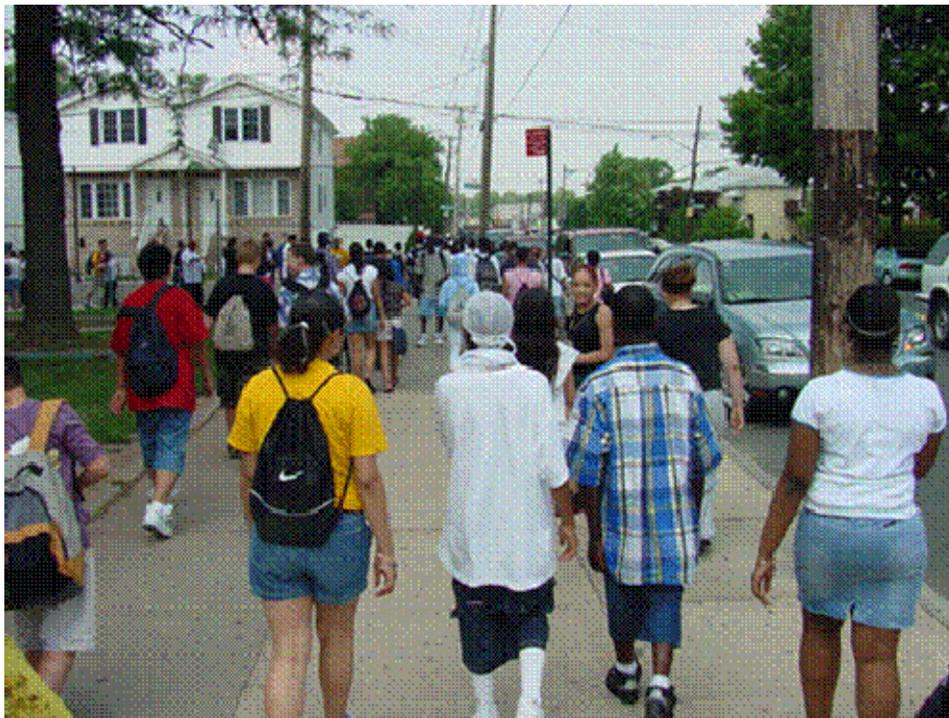
Figure 3: Looking north along the Willowbrook Road sidewalk toward Forest Avenue at dismissal

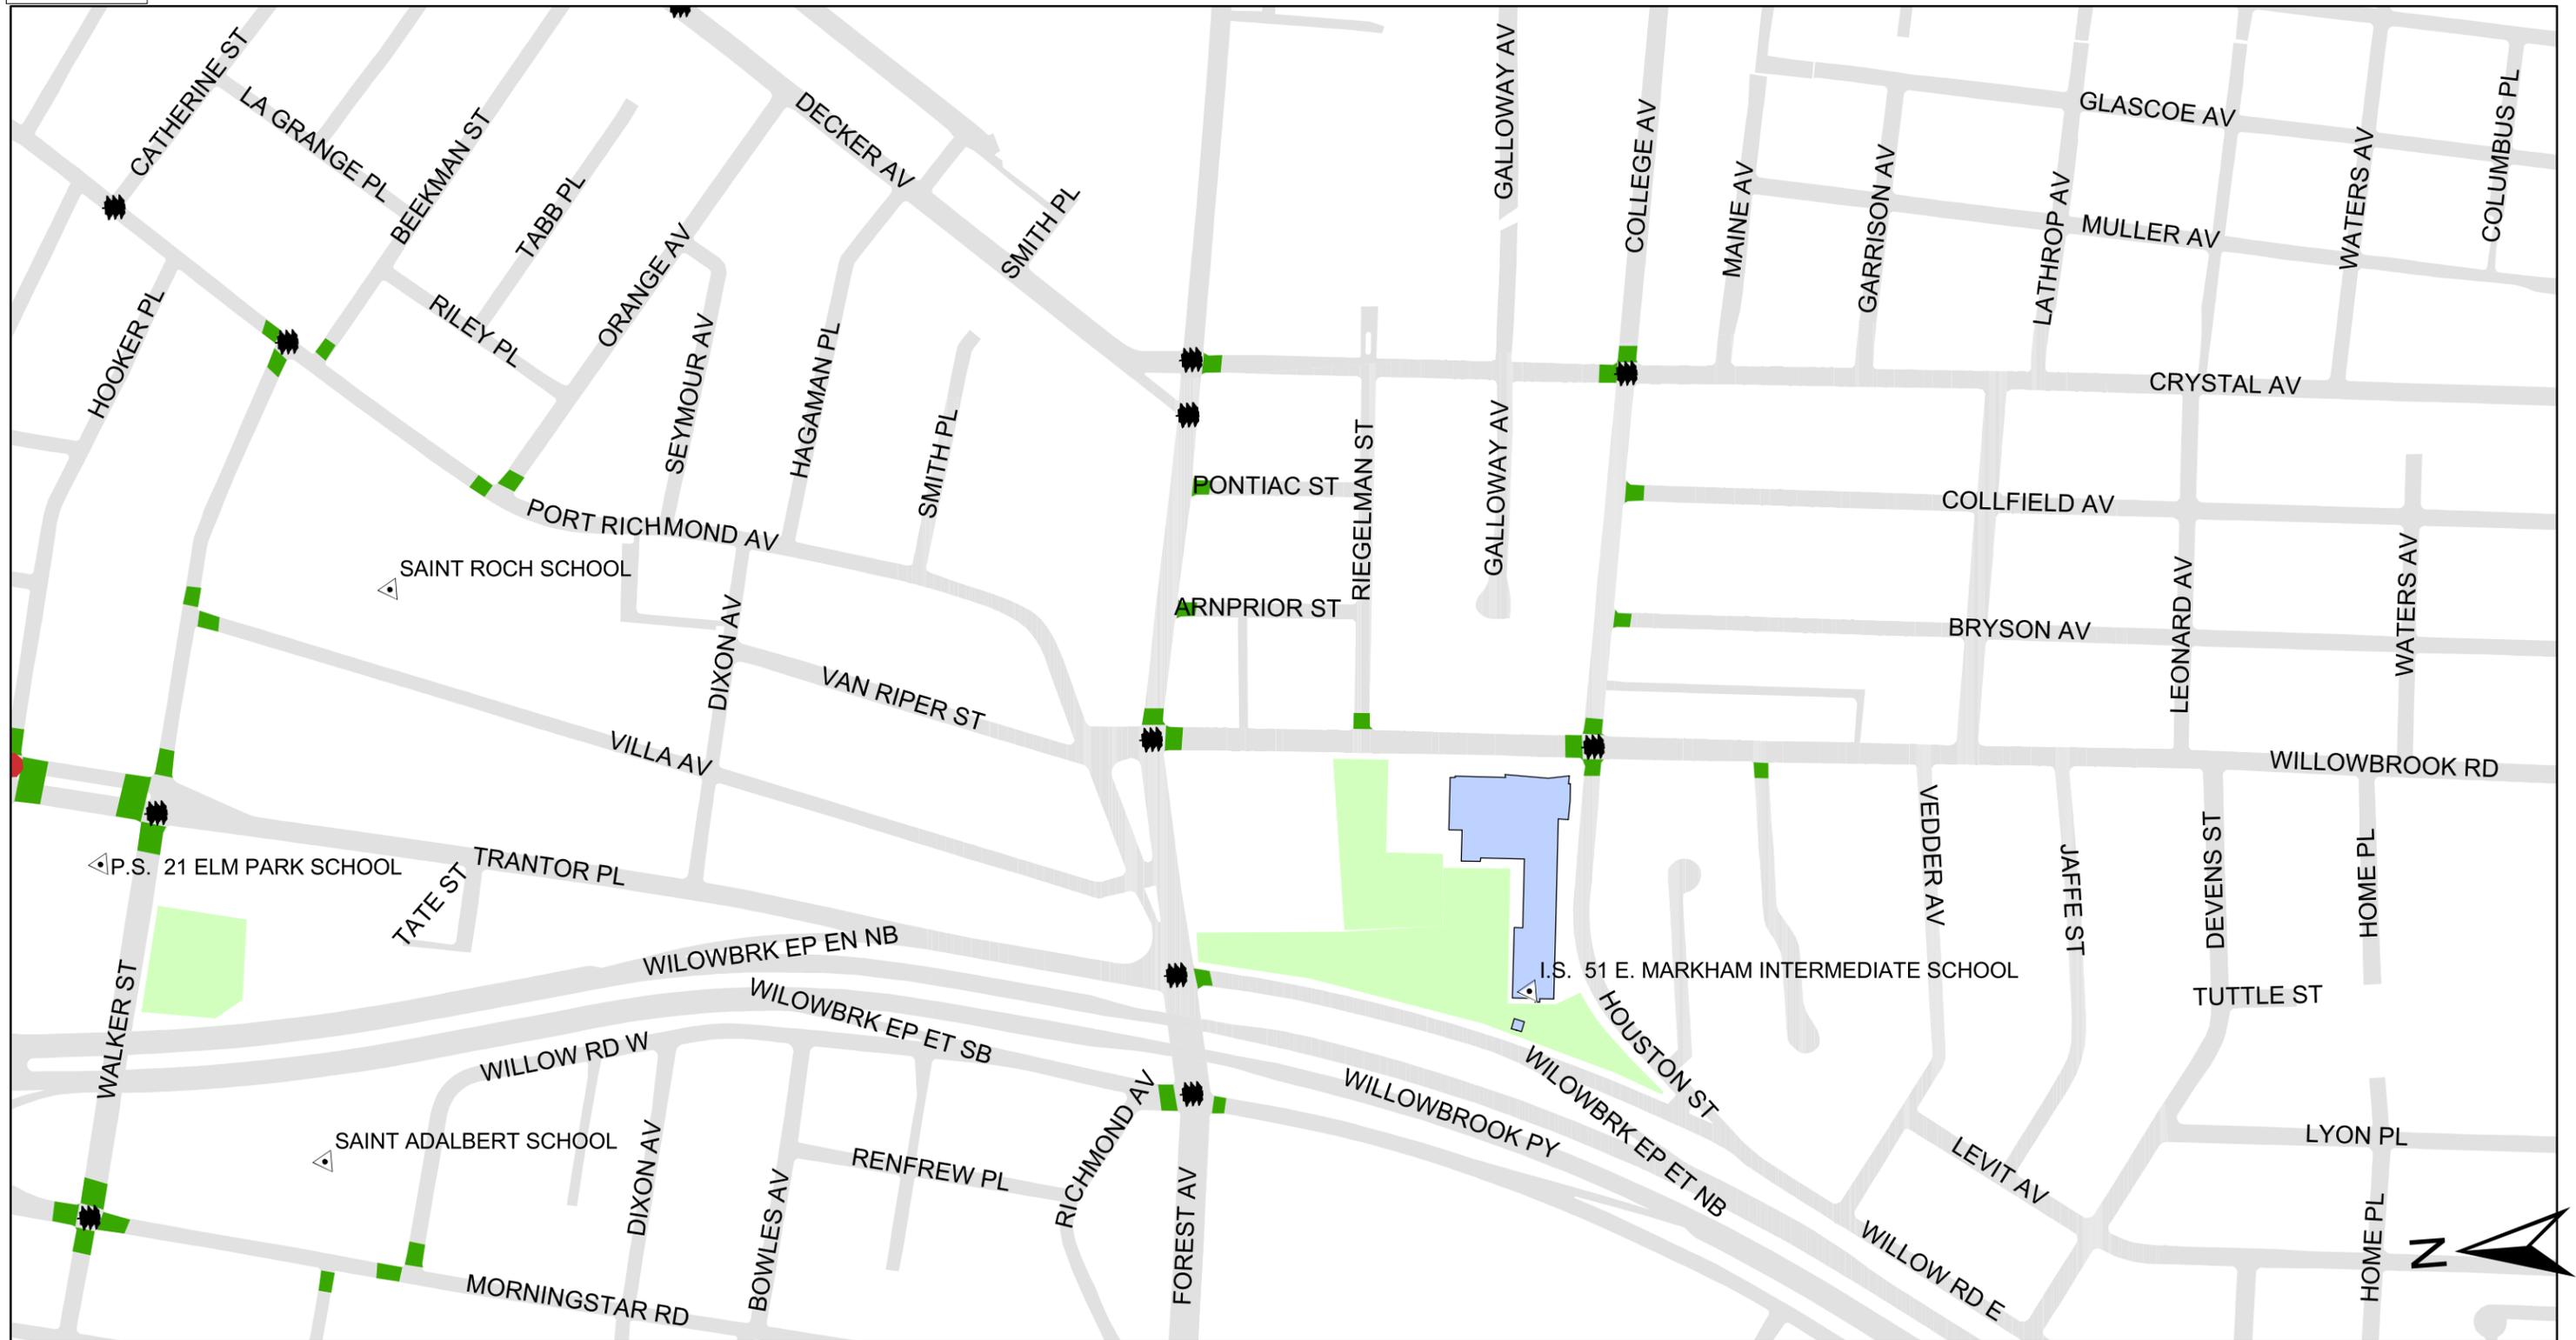
EXHIBIT 3

Exhibit 3 shows the existing signals and school crosswalk pavement markings around the I.S. 51. It should be noted that a citywide signage program is currently underway to upgrade school signage to the current edition of the Federal Manual of Uniform Traffic Control Devices (MUTCD) standards of fluorescent yellow-green signs accompanied by downward pointing arrows. (Signs scheduled to be installed under this program are shown as “existing” in Exhibit 7.)

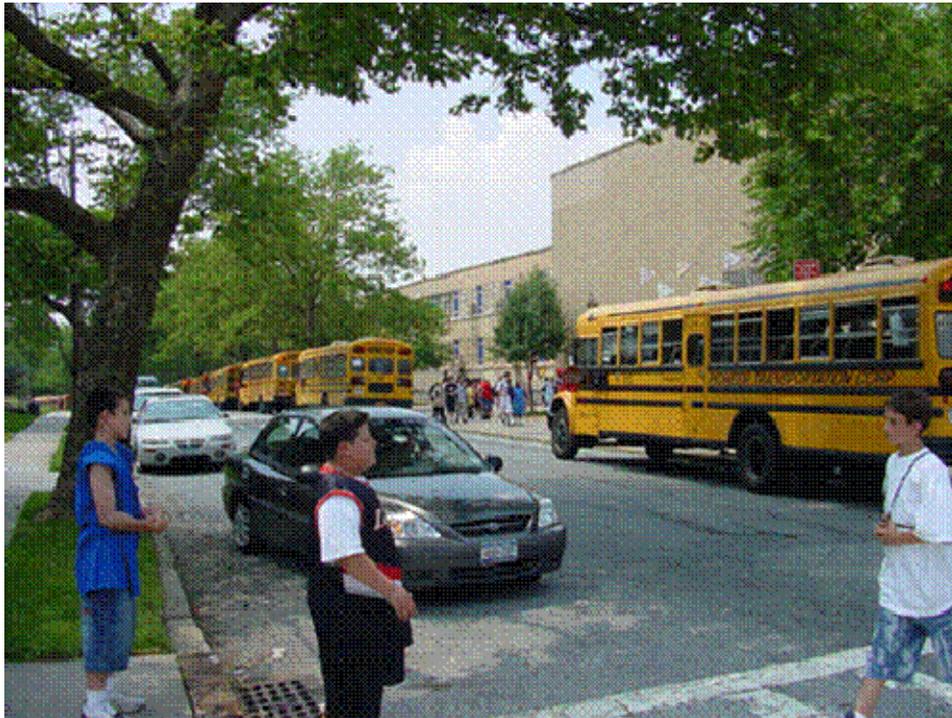
Figure 4: Looking west along Houston Street, showing school bus pick up operations

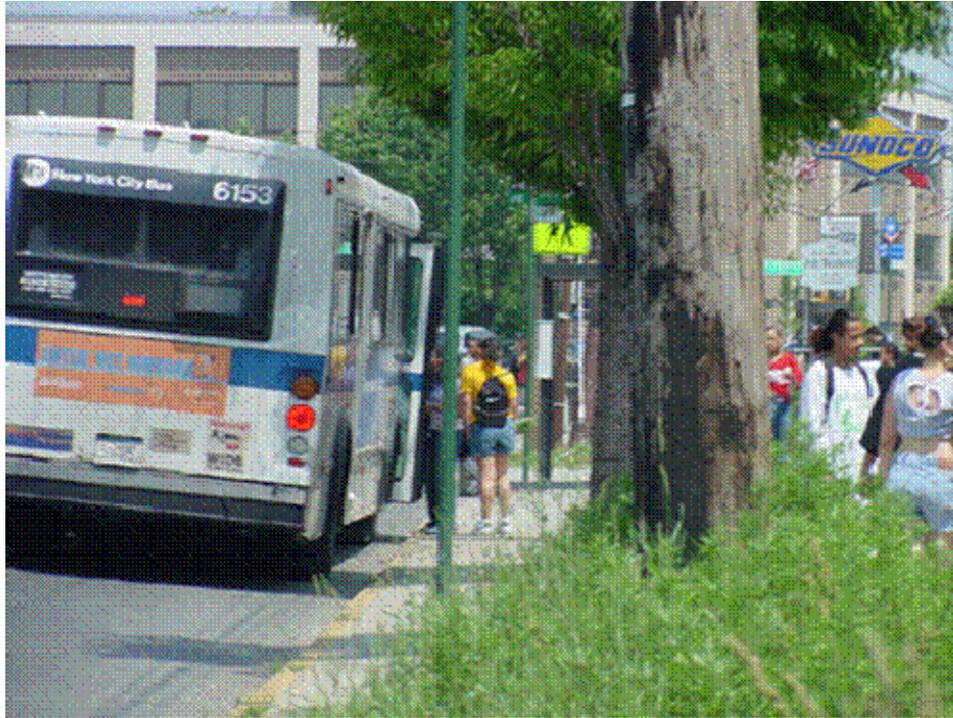
Figure 5: Looking east along Forest Avenue at students boarding a city (MTA) bus, west of Willowbrook Road

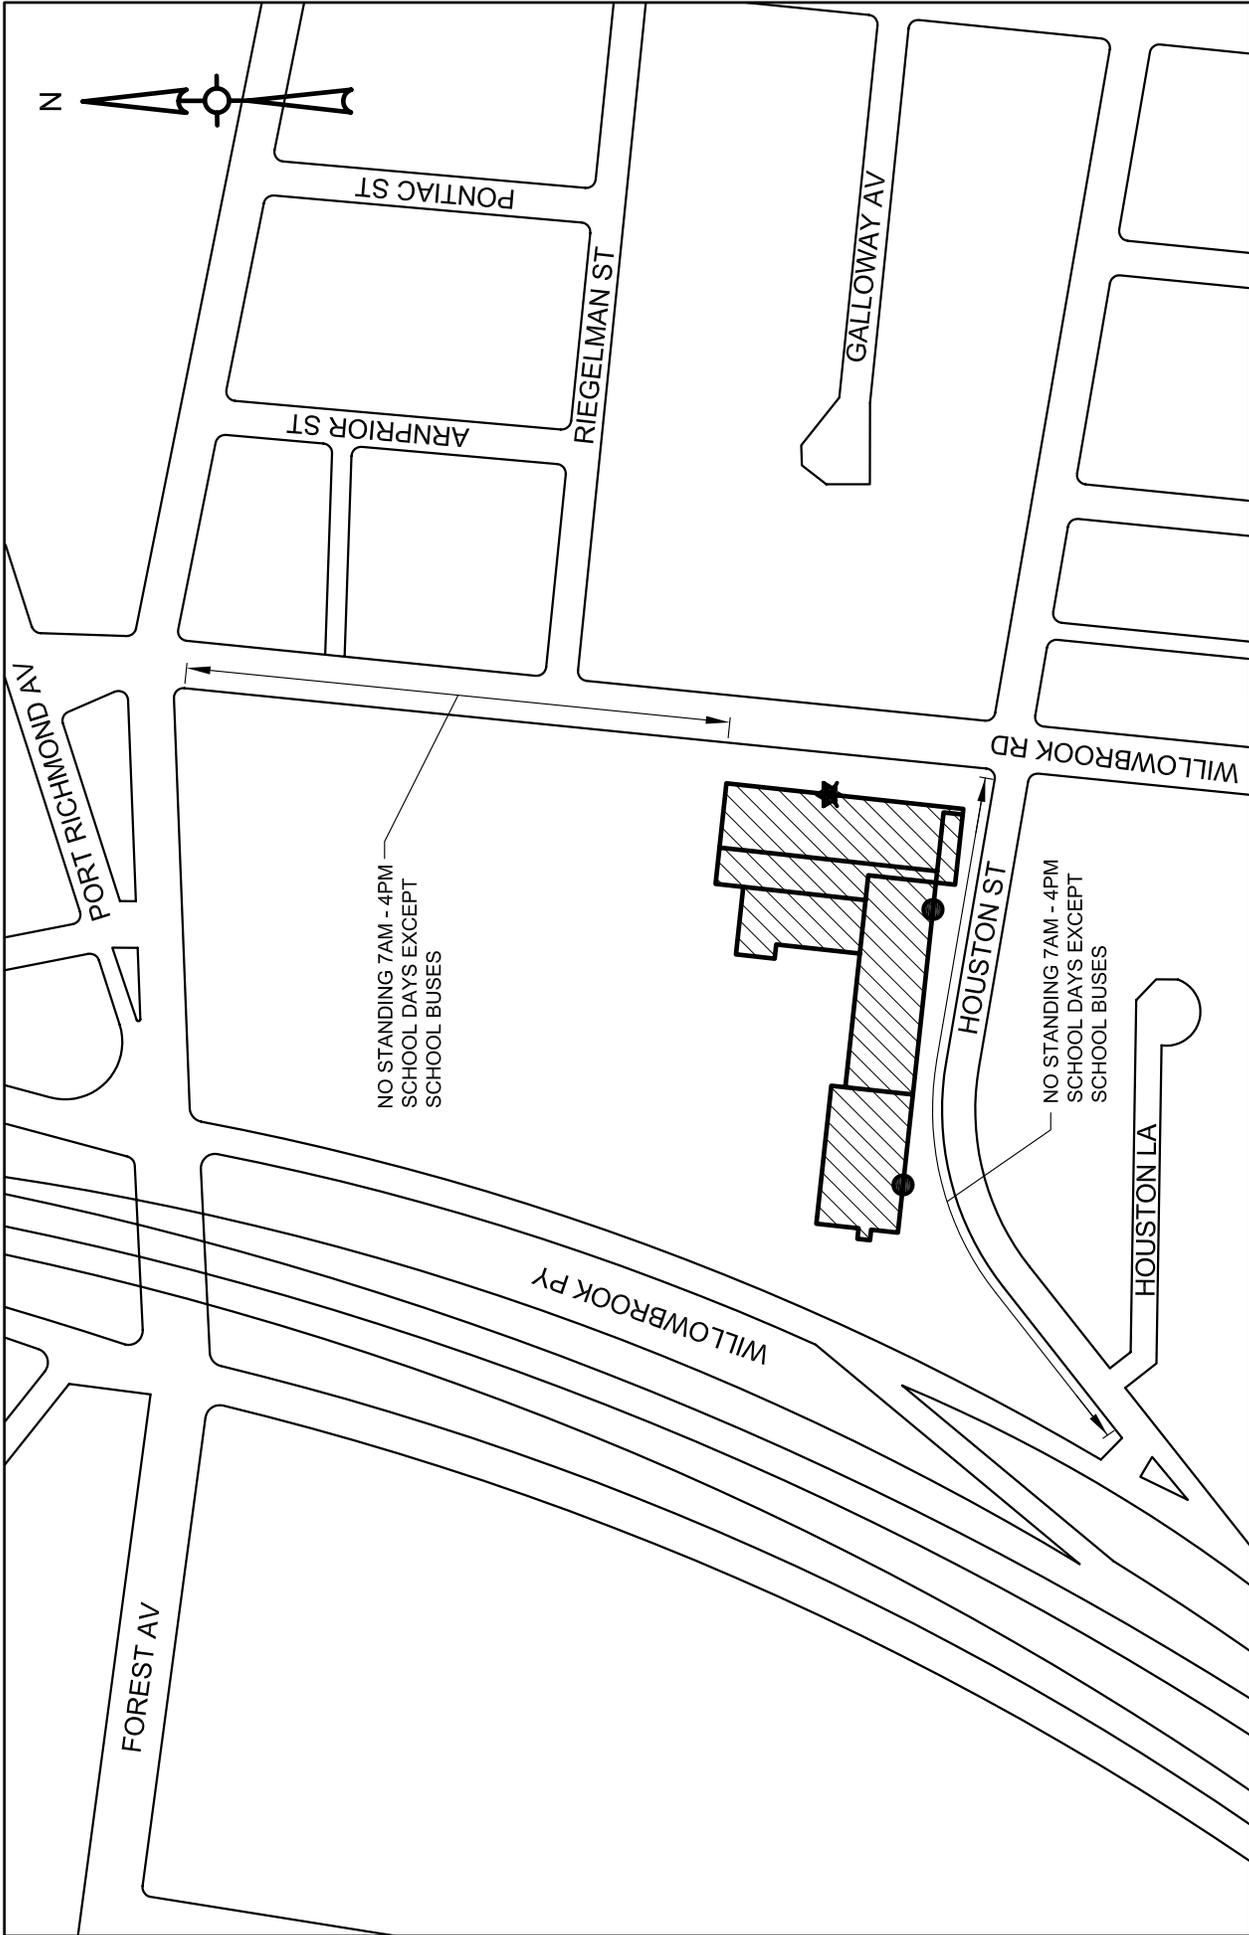
EXHIBIT 5

EXISTING PARKING REGULATIONS

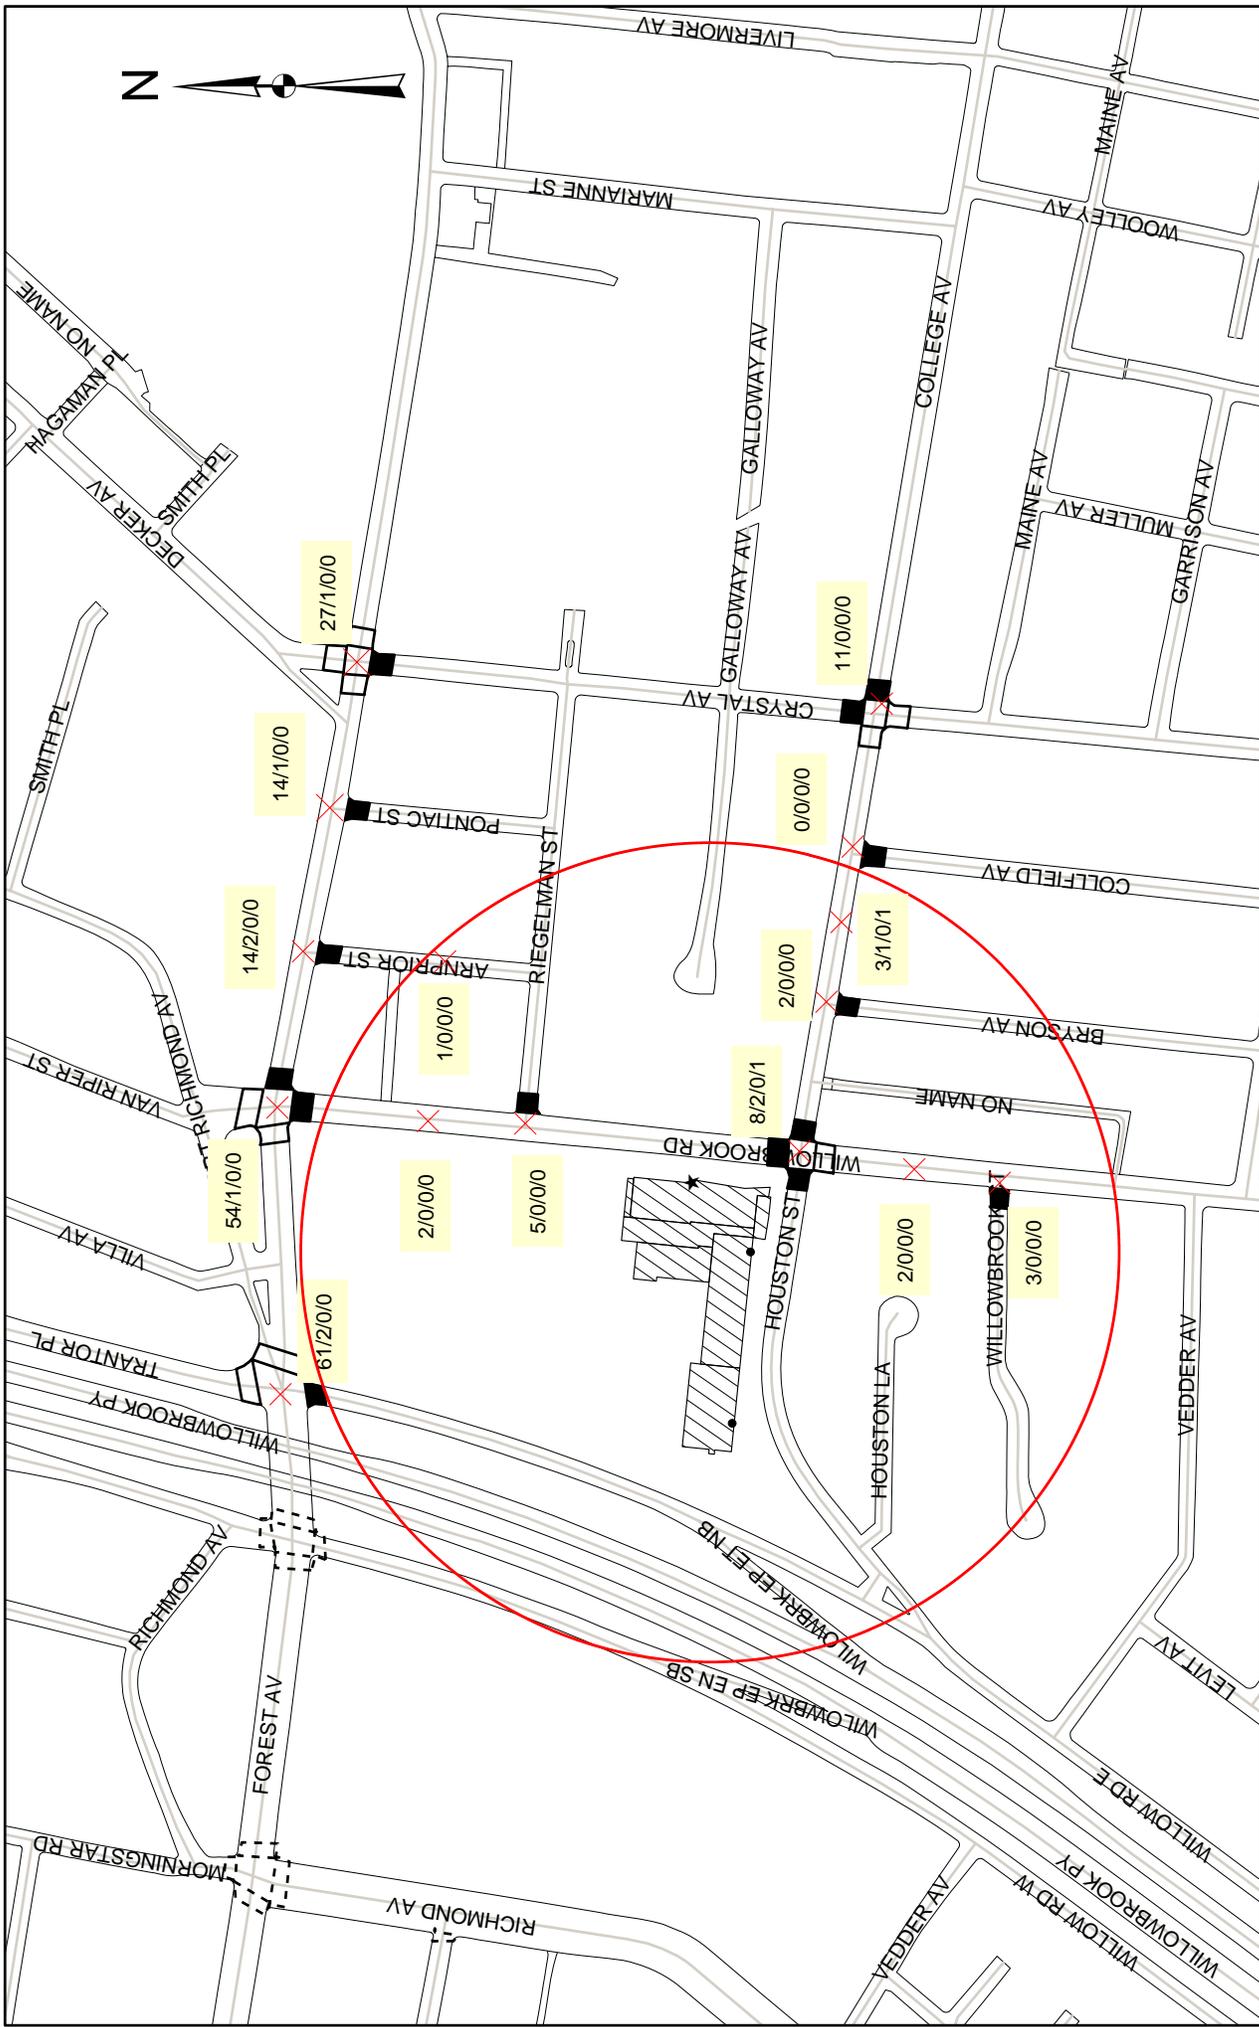
EXHIBIT 6
I.S. 51 STATEN ISLAND
E. MARKHAM I.S. SCHOOL
ACCIDENT SUMMARY (1998-2000)

Exhibit 6 and Table 2 show a summary of accidents, as obtained from the New York State Department of Motor Vehicles (DMV), in the vicinity of I.S. 51 for a three-year period from January 1, 1998 through December 31, 2000. The DMV data provides some detail relating to the circumstances and cause of an accident. Table 3 is a summary of more recent accident data obtained from the NYC Police Department (NYPD). Though current through 2004, the NYPD data does not provide the same level of detail as the DMV data.

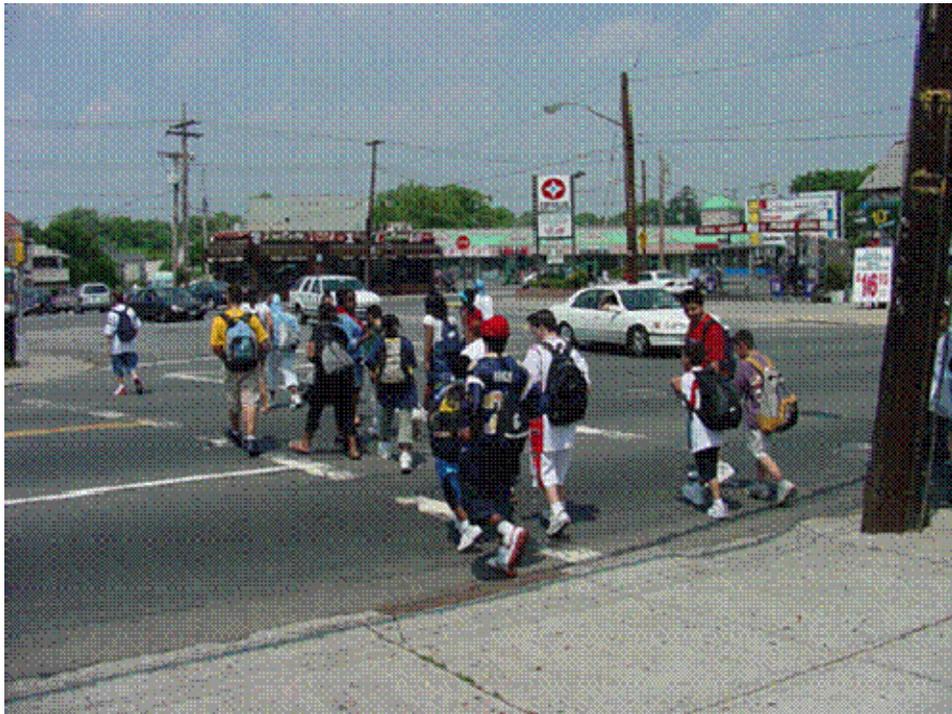
Figure 6: Students crossing the west leg of Forest Avenue at Willowbrook Road during school dismissal

Overall, pedestrian ramps in the vicinity of the school were observed to be standard. One problem location was on the southwest corner of Forest Avenue and Willowbrook Road where the pedestrian ramp is of substandard width and is also immediately adjacent to a utility pole (see Figure 6).

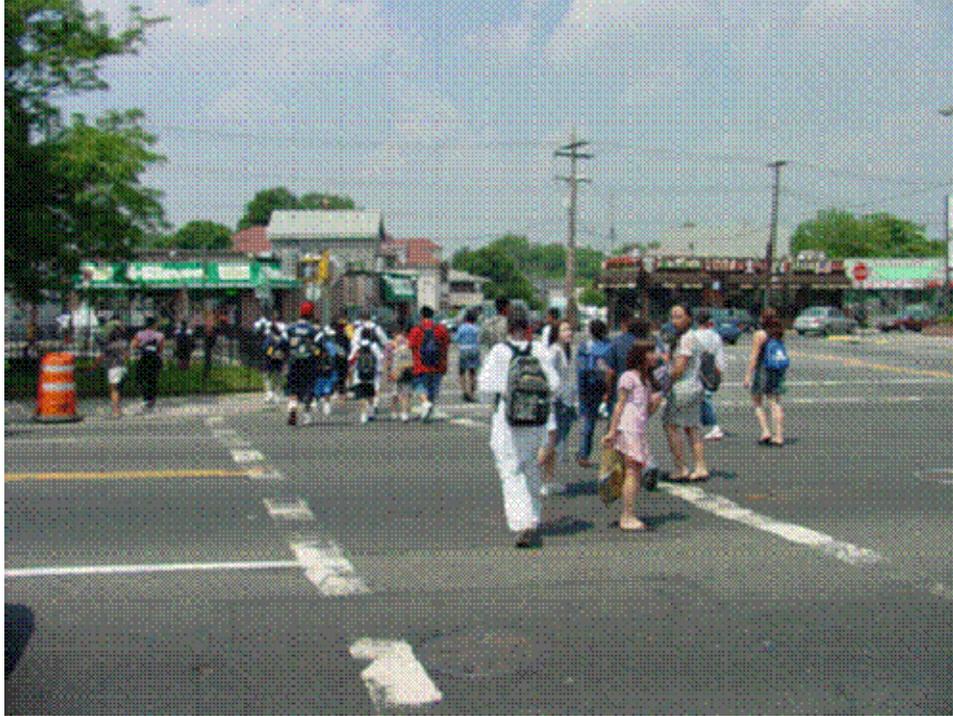
Figure 7: Students crossing the west leg of Forest Avenue at Willowbrook Road during school dismissal

Because significant volumes of students were observed crossing the west leg of the Forest Avenue and Willowbrook Road intersection (see Figures 7 and 8), the following actions are recommended:

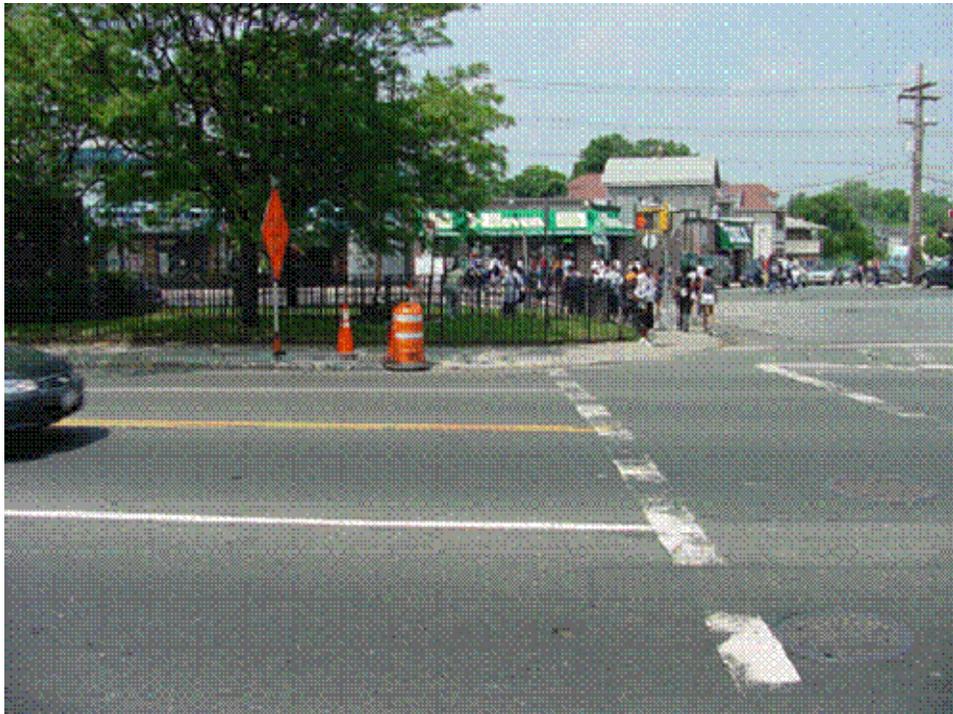
Figure 8: Looking north towards Port Richmond Avenue and Van Riper Street from the intersection of Forest Avenue and Willowbrook Road, showing the wide expanse of pavement students must cross

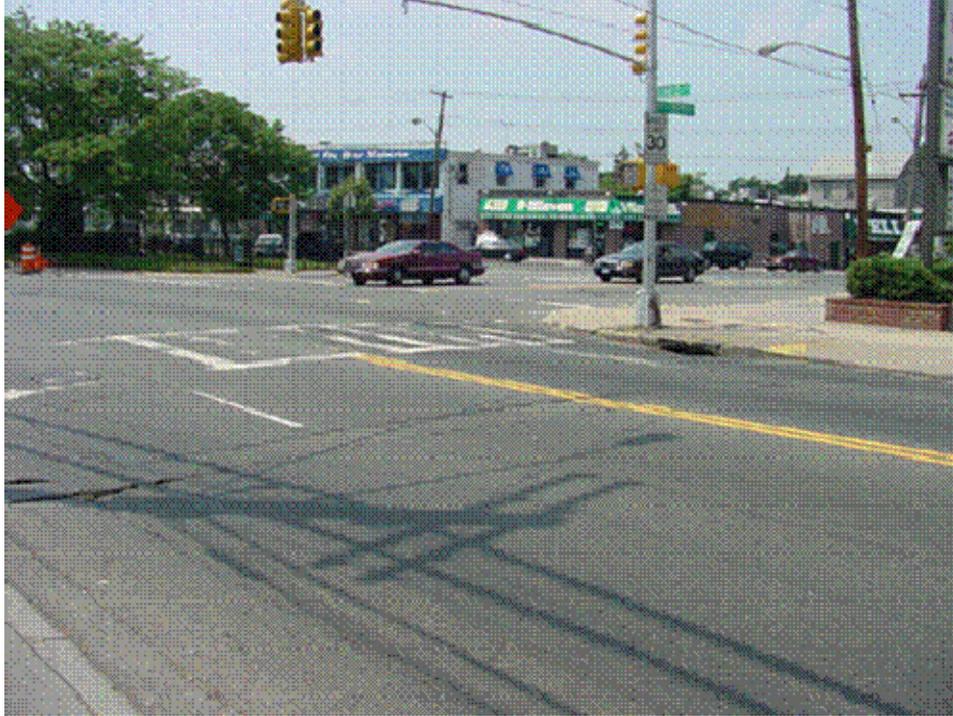
Figure 9: Looking northwest toward Port Richmond Avenue from the intersection of Forest Avenue and Willowbrook Road, showing the large crossing distance for students traveling north-south

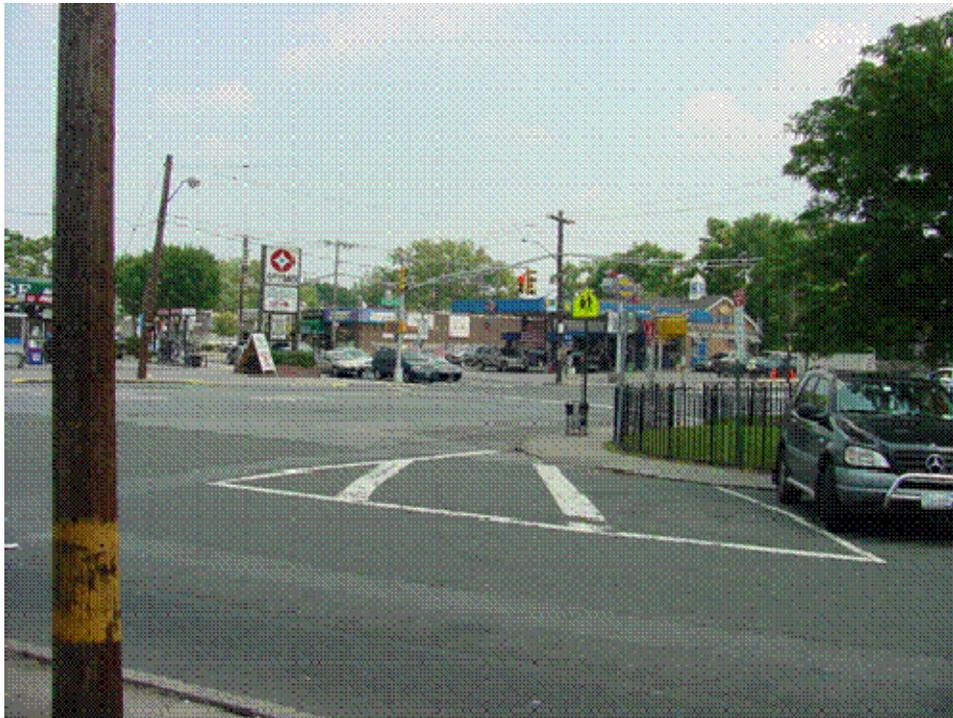
Figure 10: Unmarked pedestrian crossing for I.S. 51 students across Port Richmond Avenue

During the field visit, students were observed crossing Port Richmond Avenue on the west side of the Van Riper Street and Willowbrook Road intersection (see Figures 7 and 8), where no crosswalk currently exists. Therefore, the following actions are recommended:

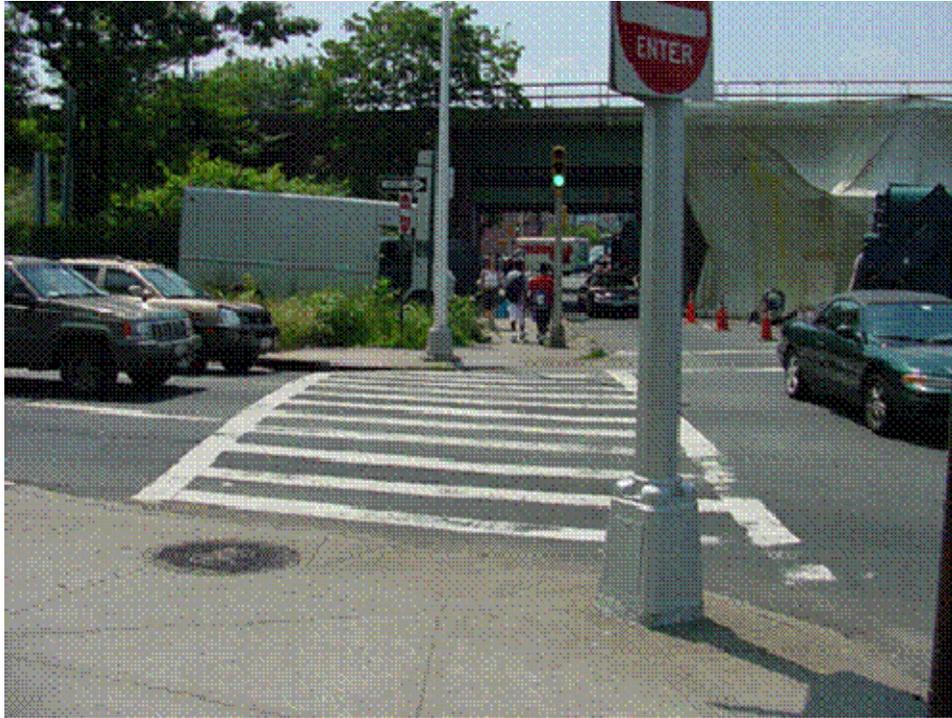
Figure 11: Looking west along Forest Avenue at the intersection of Willow Road East, at the school crosswalk across the south leg of intersection

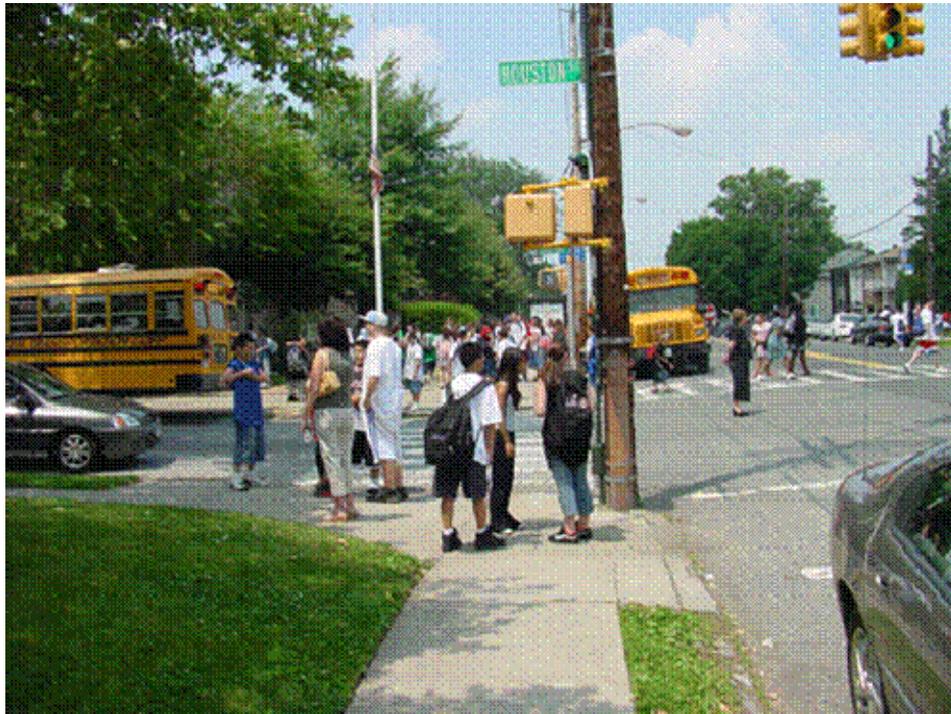
- At dismissal, the school's administrative staff often goes out into the surrounding roadways to stop vehicles while students are crossing the road in the vicinity of the school. The staff also attempts to prevent drivers from passing stopped school buses while flashing lights are operating on the buses (see Figure 12).

Figure 12: Looking north along Willowbrook Road towards Houston Street, showing school principal in the roadway assisting with student crossings during dismissal

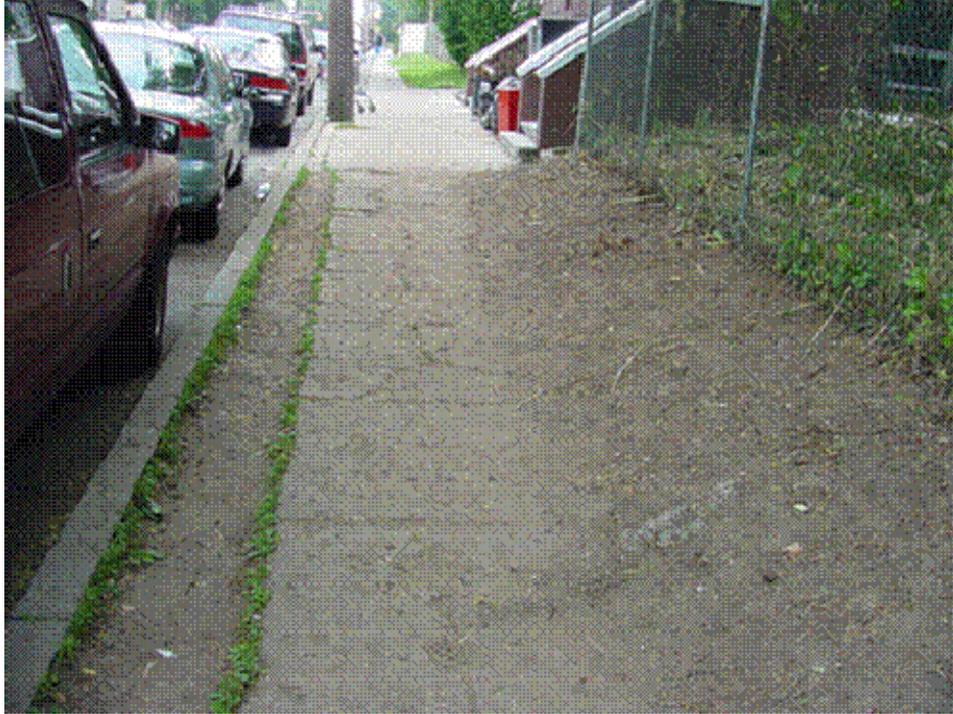
the west side of Willowbrook Road, north of the school and adjacent to the Lake Cemetery (see Figure 13), and along the south side of Forest Avenue, east of Willow Road East (see Figure 14).

Figure 13: Looking south toward I.S. 51, at broken sidewalk along the west side of Willowbrook Road

The sidewalk along the west side of Willowbrook Road, adjacent to the Lake Cemetery, is cracked and broken (see Figure 13). Therefore, the following actions are recommended:

- Replace the sidewalk along the west side of Willowbrook Avenue between I.S. 51 and Forest Avenue, adjacent to the Lake Cemetery, and with a wider sidewalk.

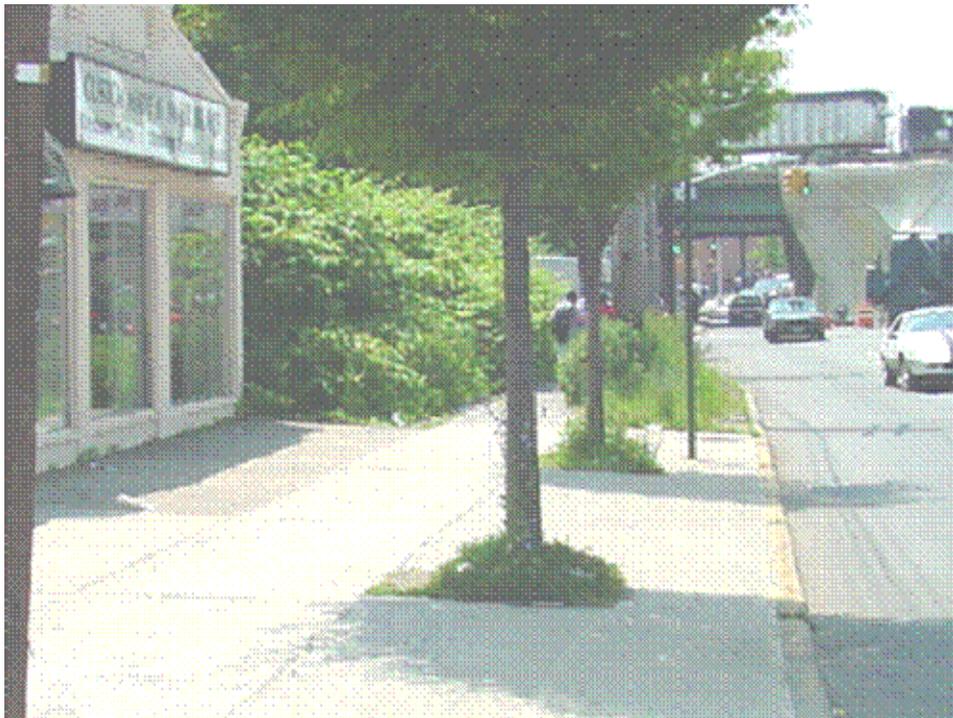
Figure 14: Looking west along Forest Avenue, east of Willow Road East, at the narrow sidewalk on the south side of Forest Avenue

Sidewalk in the vicinity of I.S. 51 is of substandard width (see Figure 14). Therefore, the following action is recommended:

- Widen the existing sidewalk on the south side of Forest Avenue between Willowbrook Road and Willow Road East.

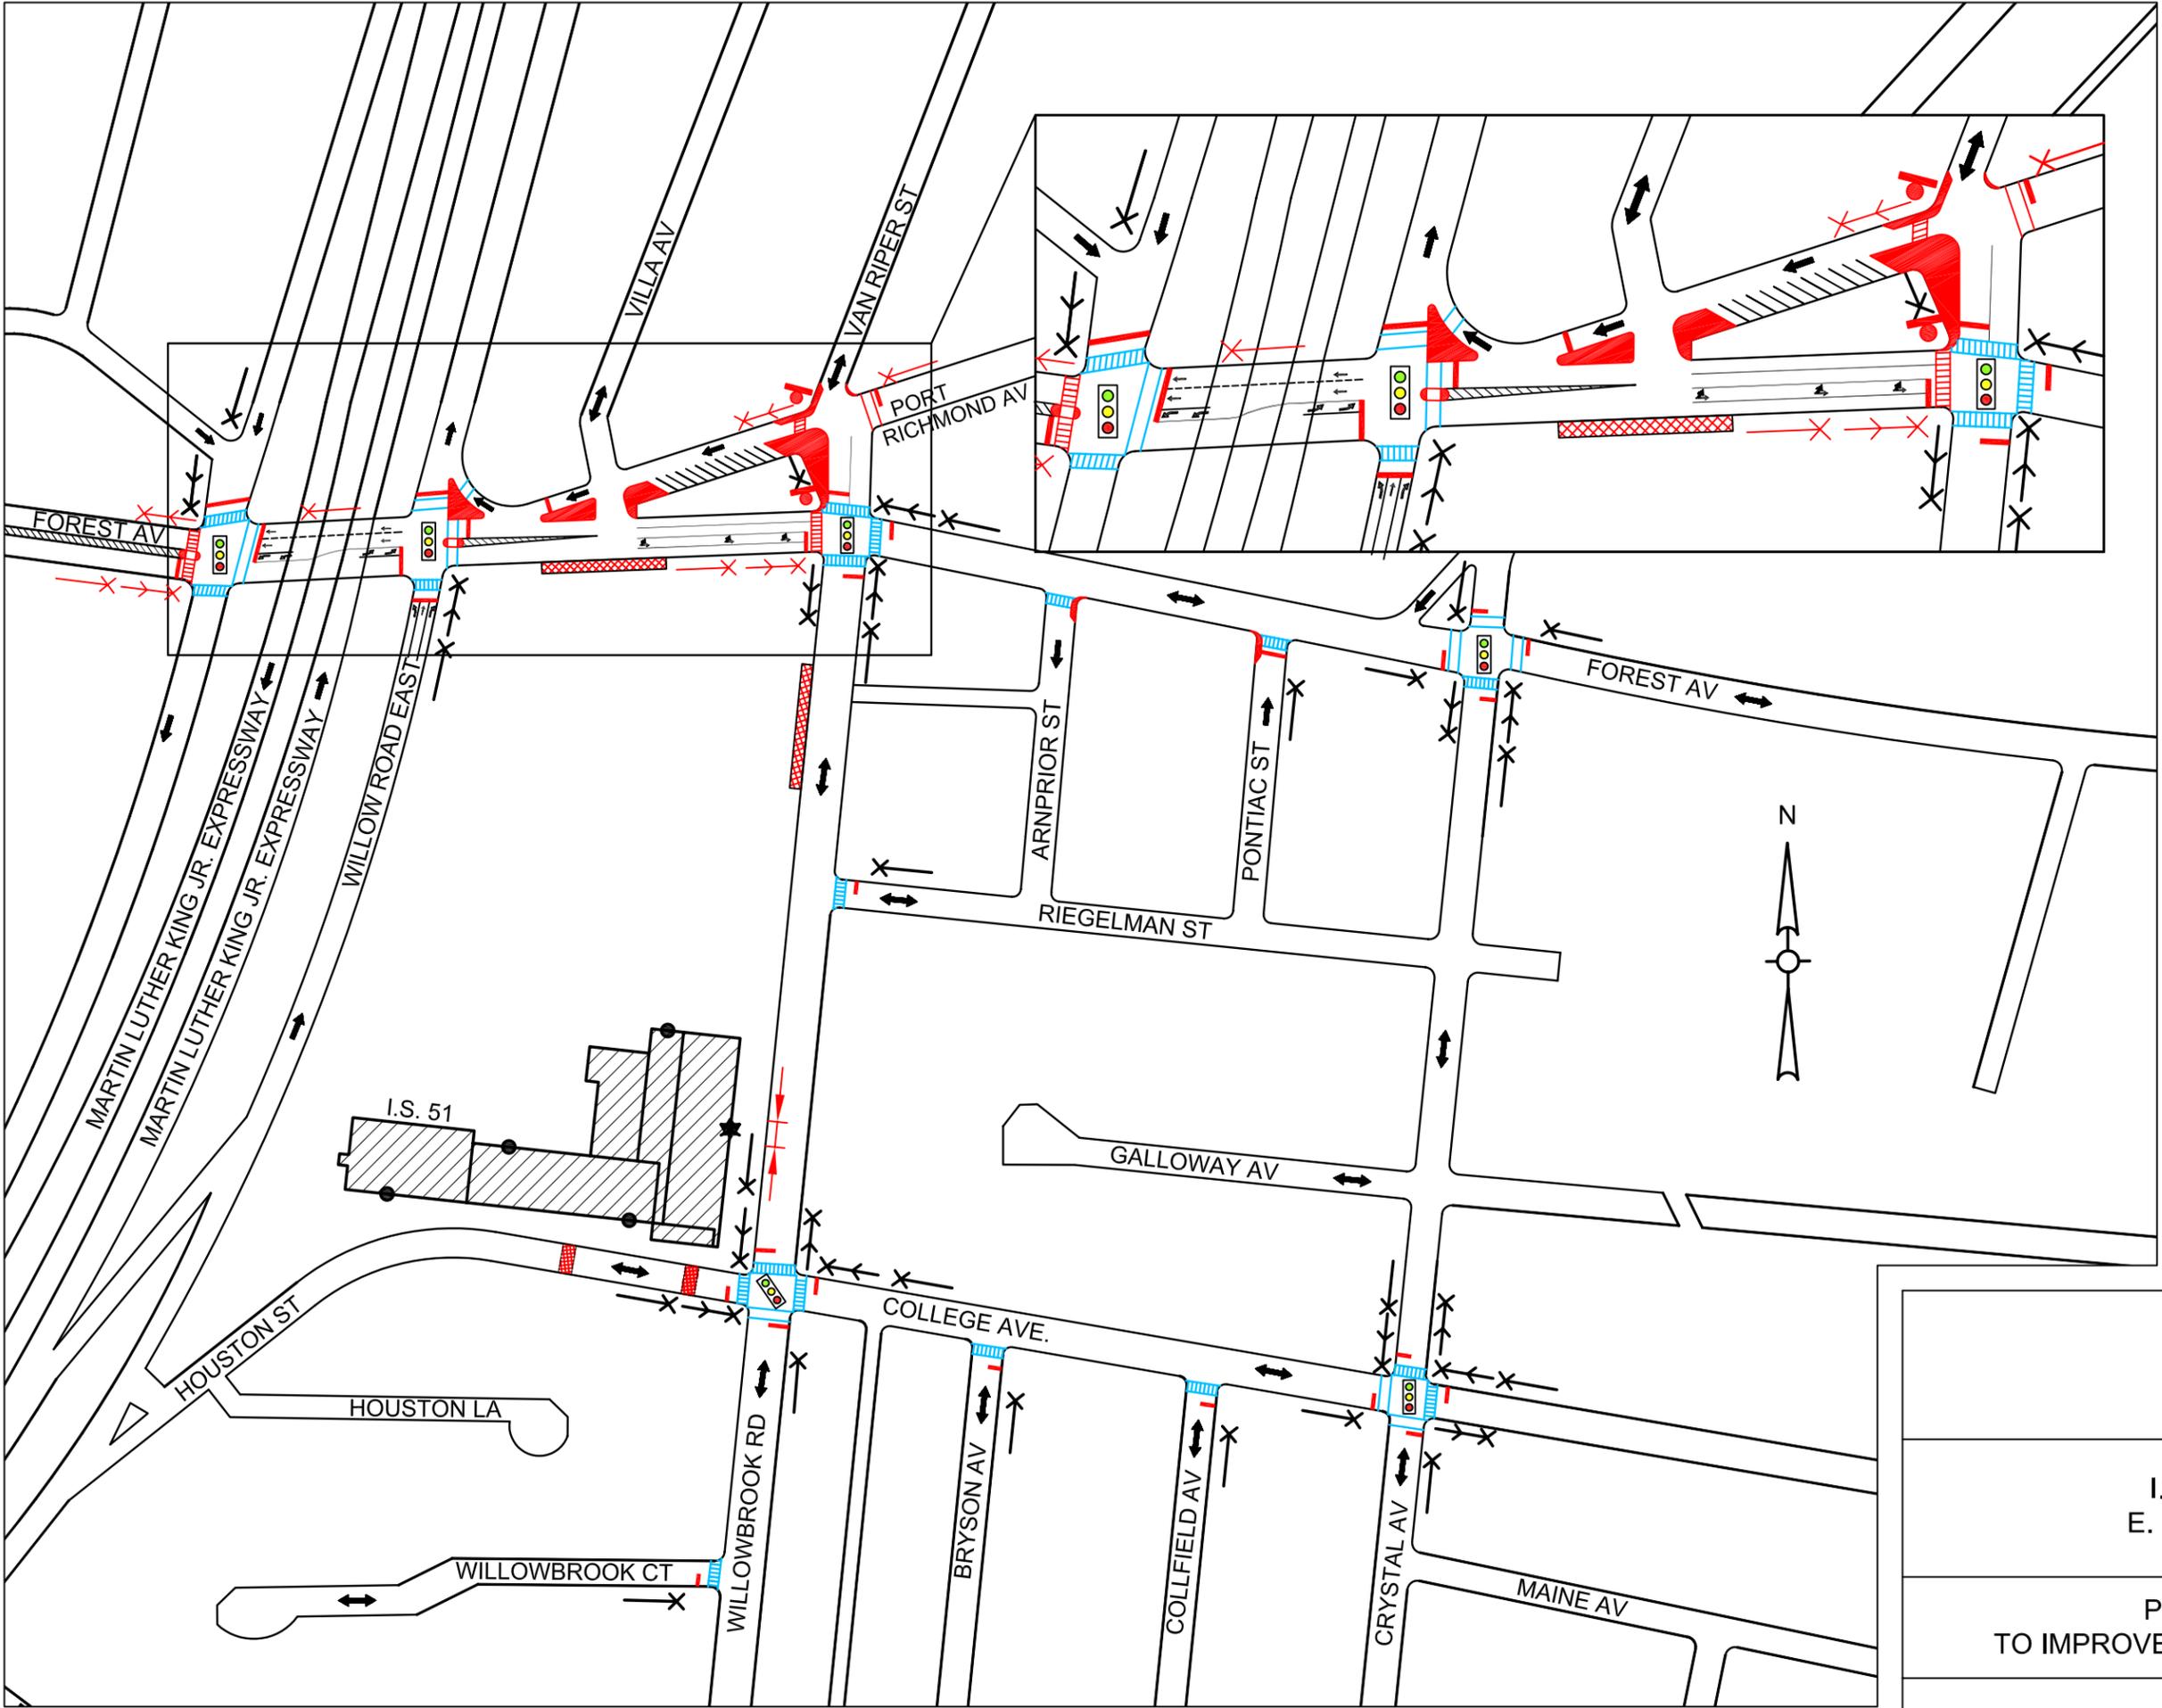
**POTENTIAL MEASURES
TO IMPROVE STUDENT PEDESTRIAN SAFETY**

This section describes the proposed measures to improve school pedestrian safety around I.S. 51. The proposed recommendations are divided into short-term and long-term measures. Short-term measures are those that potentially can be performed in-house. Long-term measures involve capital improvements. Each of the short- and long-term measures recommended for I.S. 51 is discussed as follows, and is shown in more detail in Exhibit 7 at the end of this section.
