**New York City Department of Transportation
Office of School Safety Engineering**

School Safety Engineering Project

FINAL REPORT: I.S. 51 (Edwin Markham), Staten Island

**Prepared by
The RBA Group/Urbitran Associates**

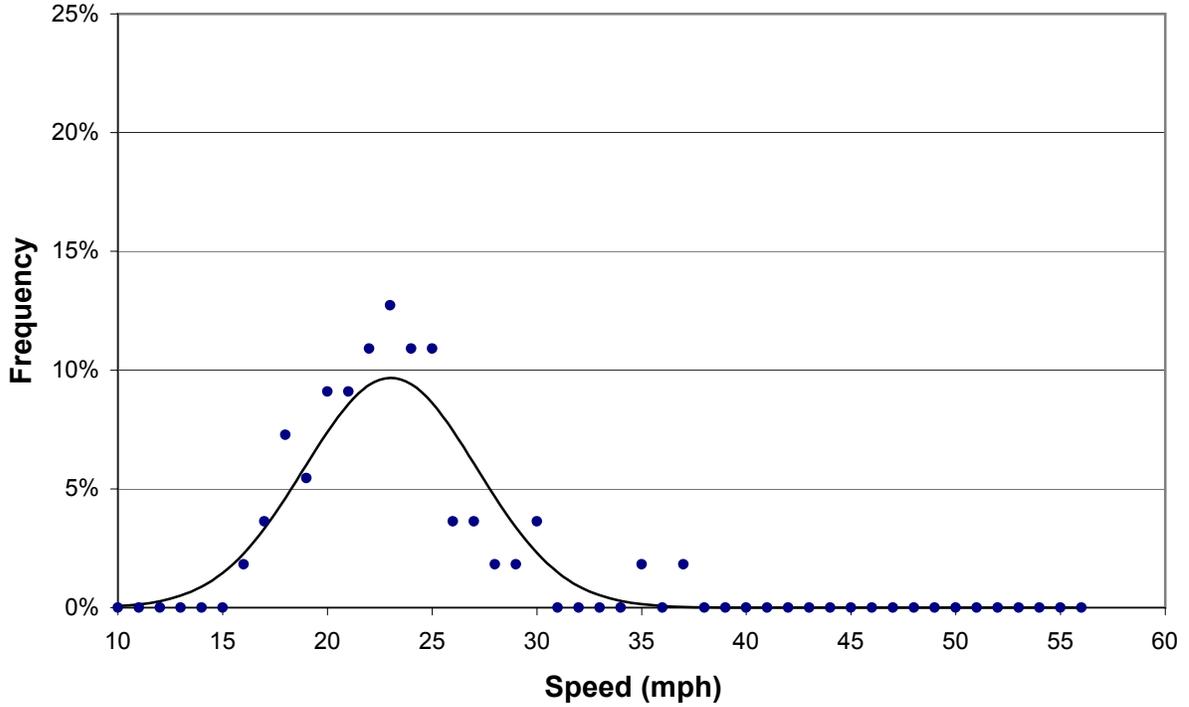
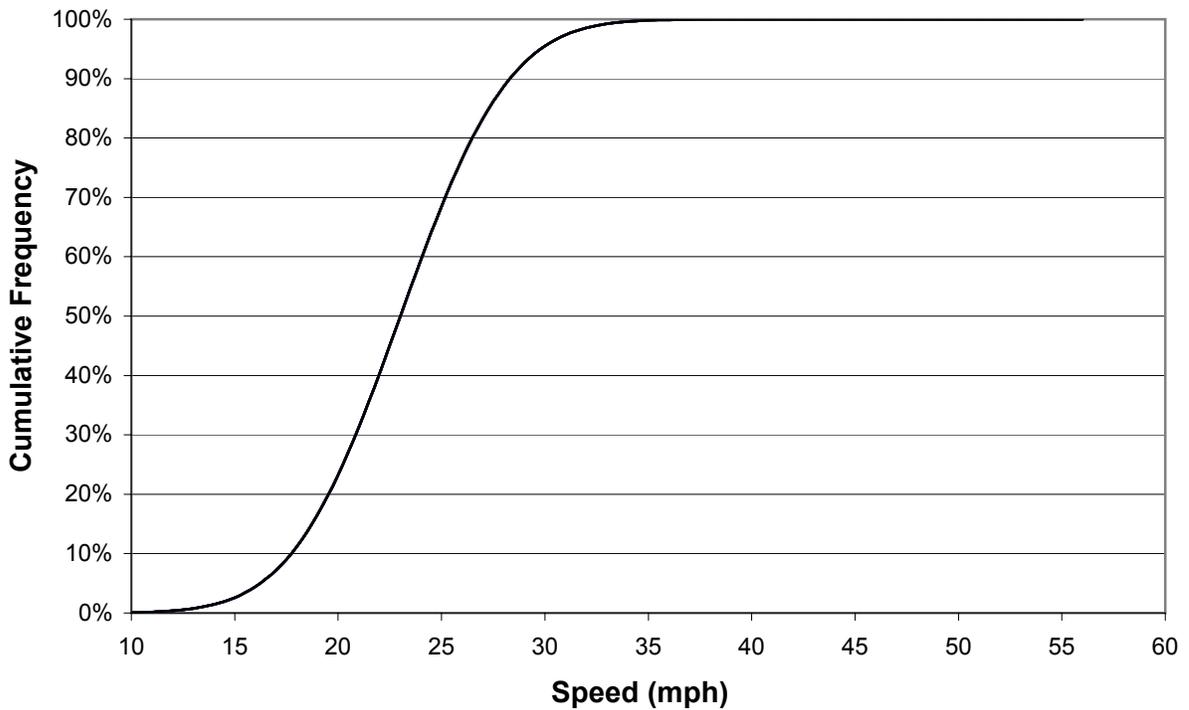
Mean Speed = 23.0 mph
 Standard Deviation = 4.1 mph
 Margin of Error (95% Confidence) = ± 1.1 mph

Median Speed = 23.0 mph
 15th Percentile Speed = 18.7 mph
 85th Percentile Speed = 27.3 mph
