**New York City Department of Transportation
Office of School Safety Engineering**

School Safety Engineering Project

FINAL REPORT: Sacred Heart School, Staten Island

September 21, 2006

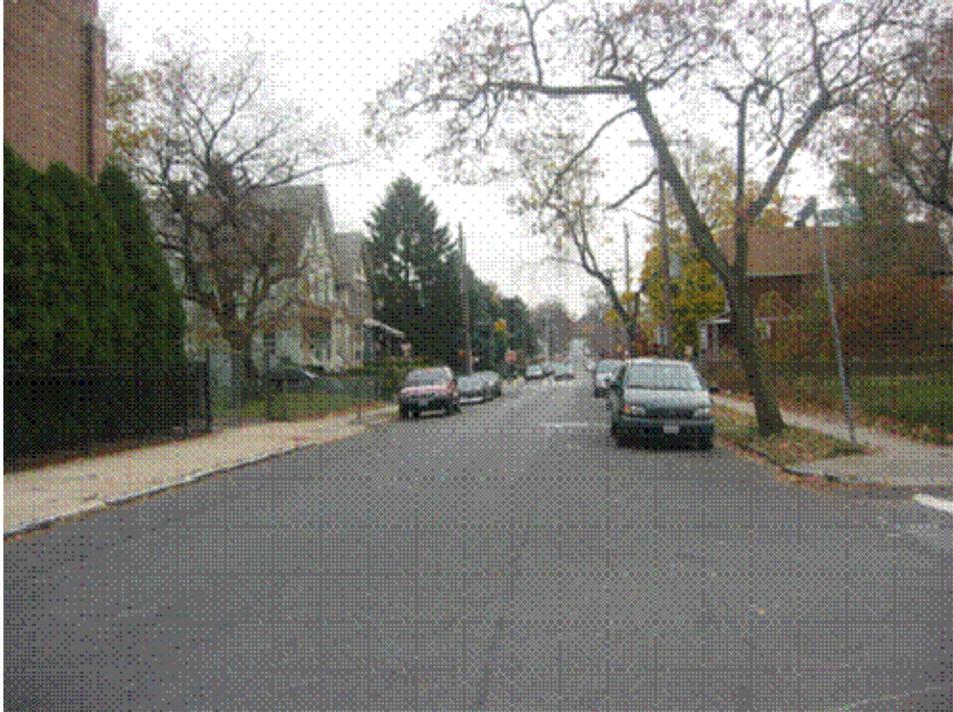
Figure 1: Looking south along North Burgher Avenue, south of Castleton Avenue (Sacred Heart School is to the left)

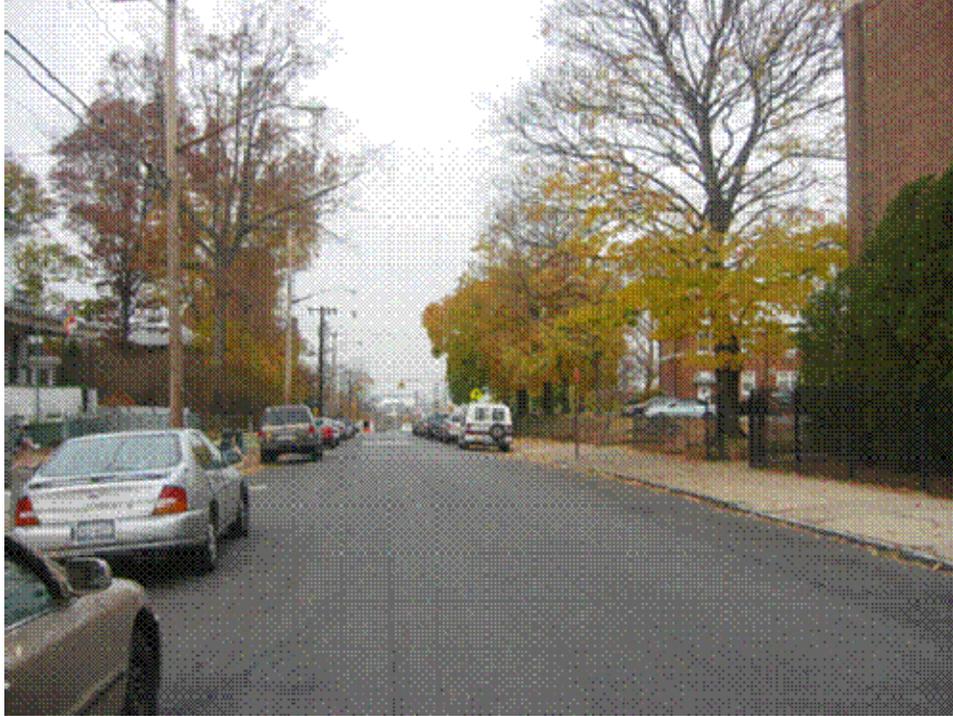
Figure 2: Looking north along North Burgher Avenue toward Castleton Avenue (Sacred Heart School is to the right)

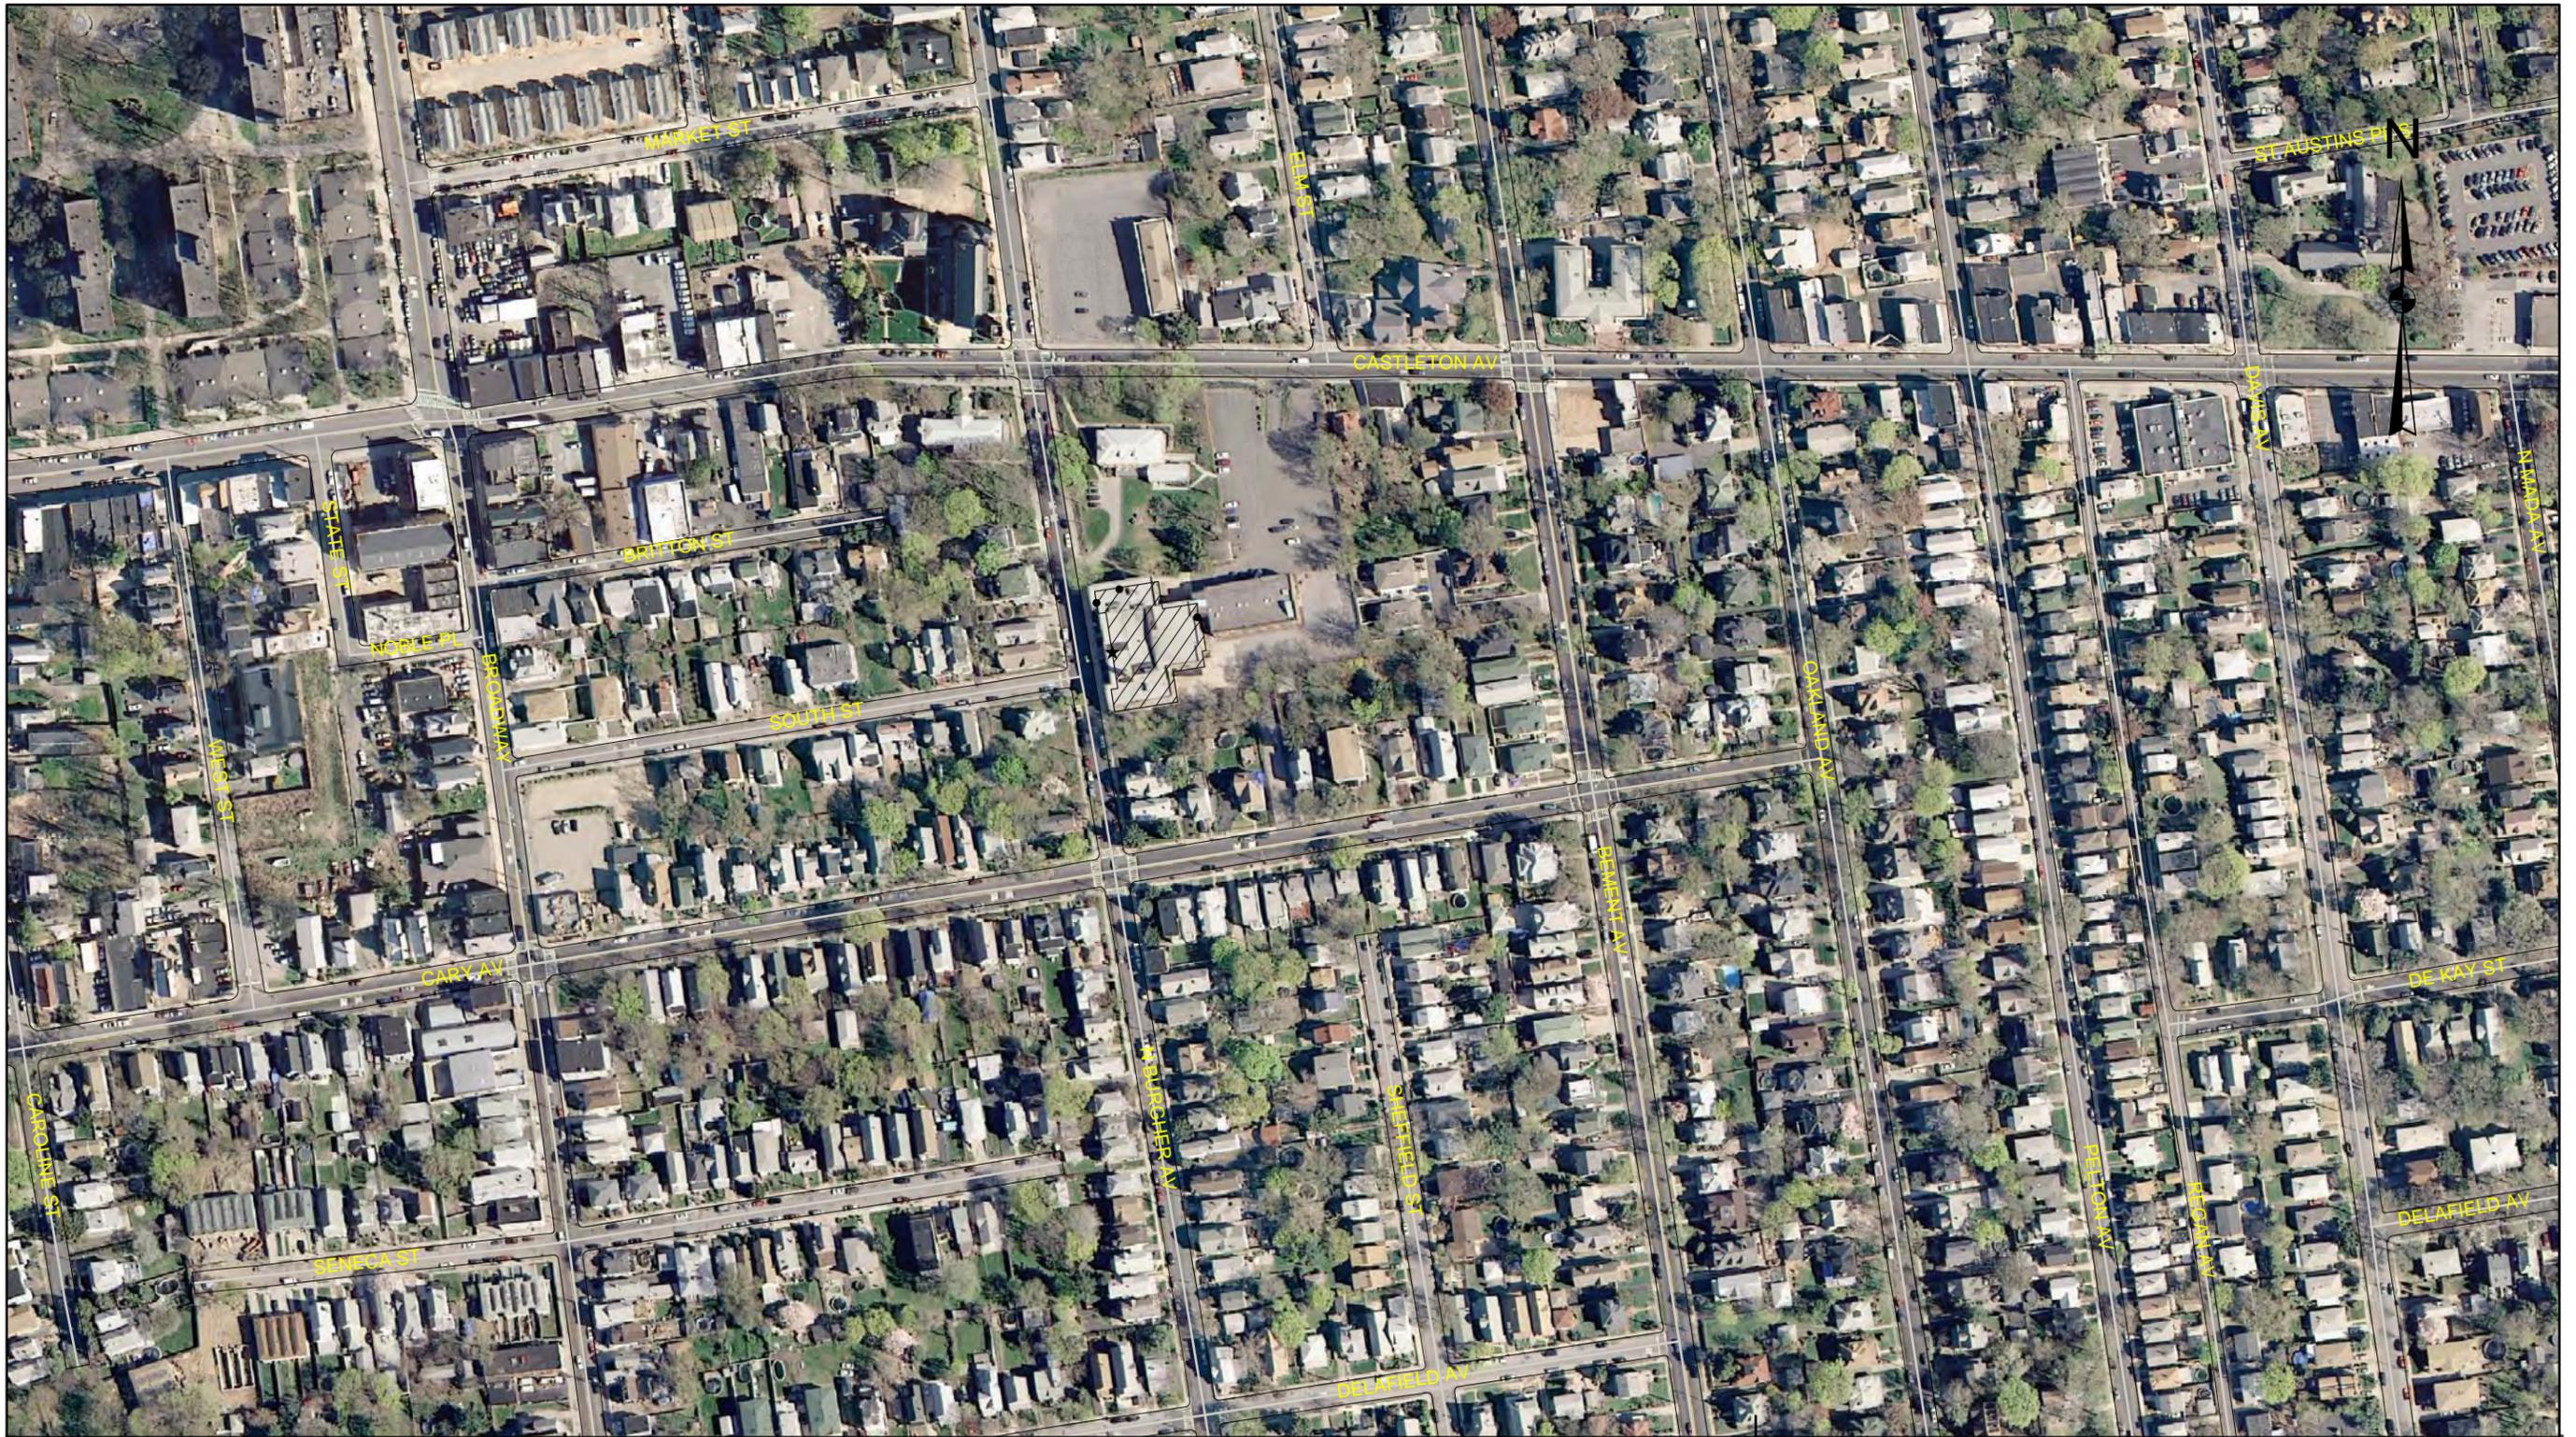
EXHIBIT 1
SACRED HEART SCHOOL
STATEN ISLAND
AERIAL PHOTOGRAPH

Exhibit 1 shows an aerial view of the neighborhood surrounding the school. The Sacred Heart School is bounded by Castleton Avenue to the north, Cary Avenue to the south, Bement Avenue to the east, and North Burgher Avenue to the west. The neighborhood surrounding the school generally consists of residential land uses. Immediately adjacent to the school, there are single-family houses fronting Bement Avenue to the east and Cary Avenue to the south. Castleton Avenue is an major east-west roadway through the neighborhood and carries high volumes of commuter traffic during the weekday morning and evening peak periods. Forest Avenue, another major east-west roadway in Staten Island, is located approximately three blocks the south of the school and also carries high volumes of commuter traffic during the weekday morning and evening peak periods.

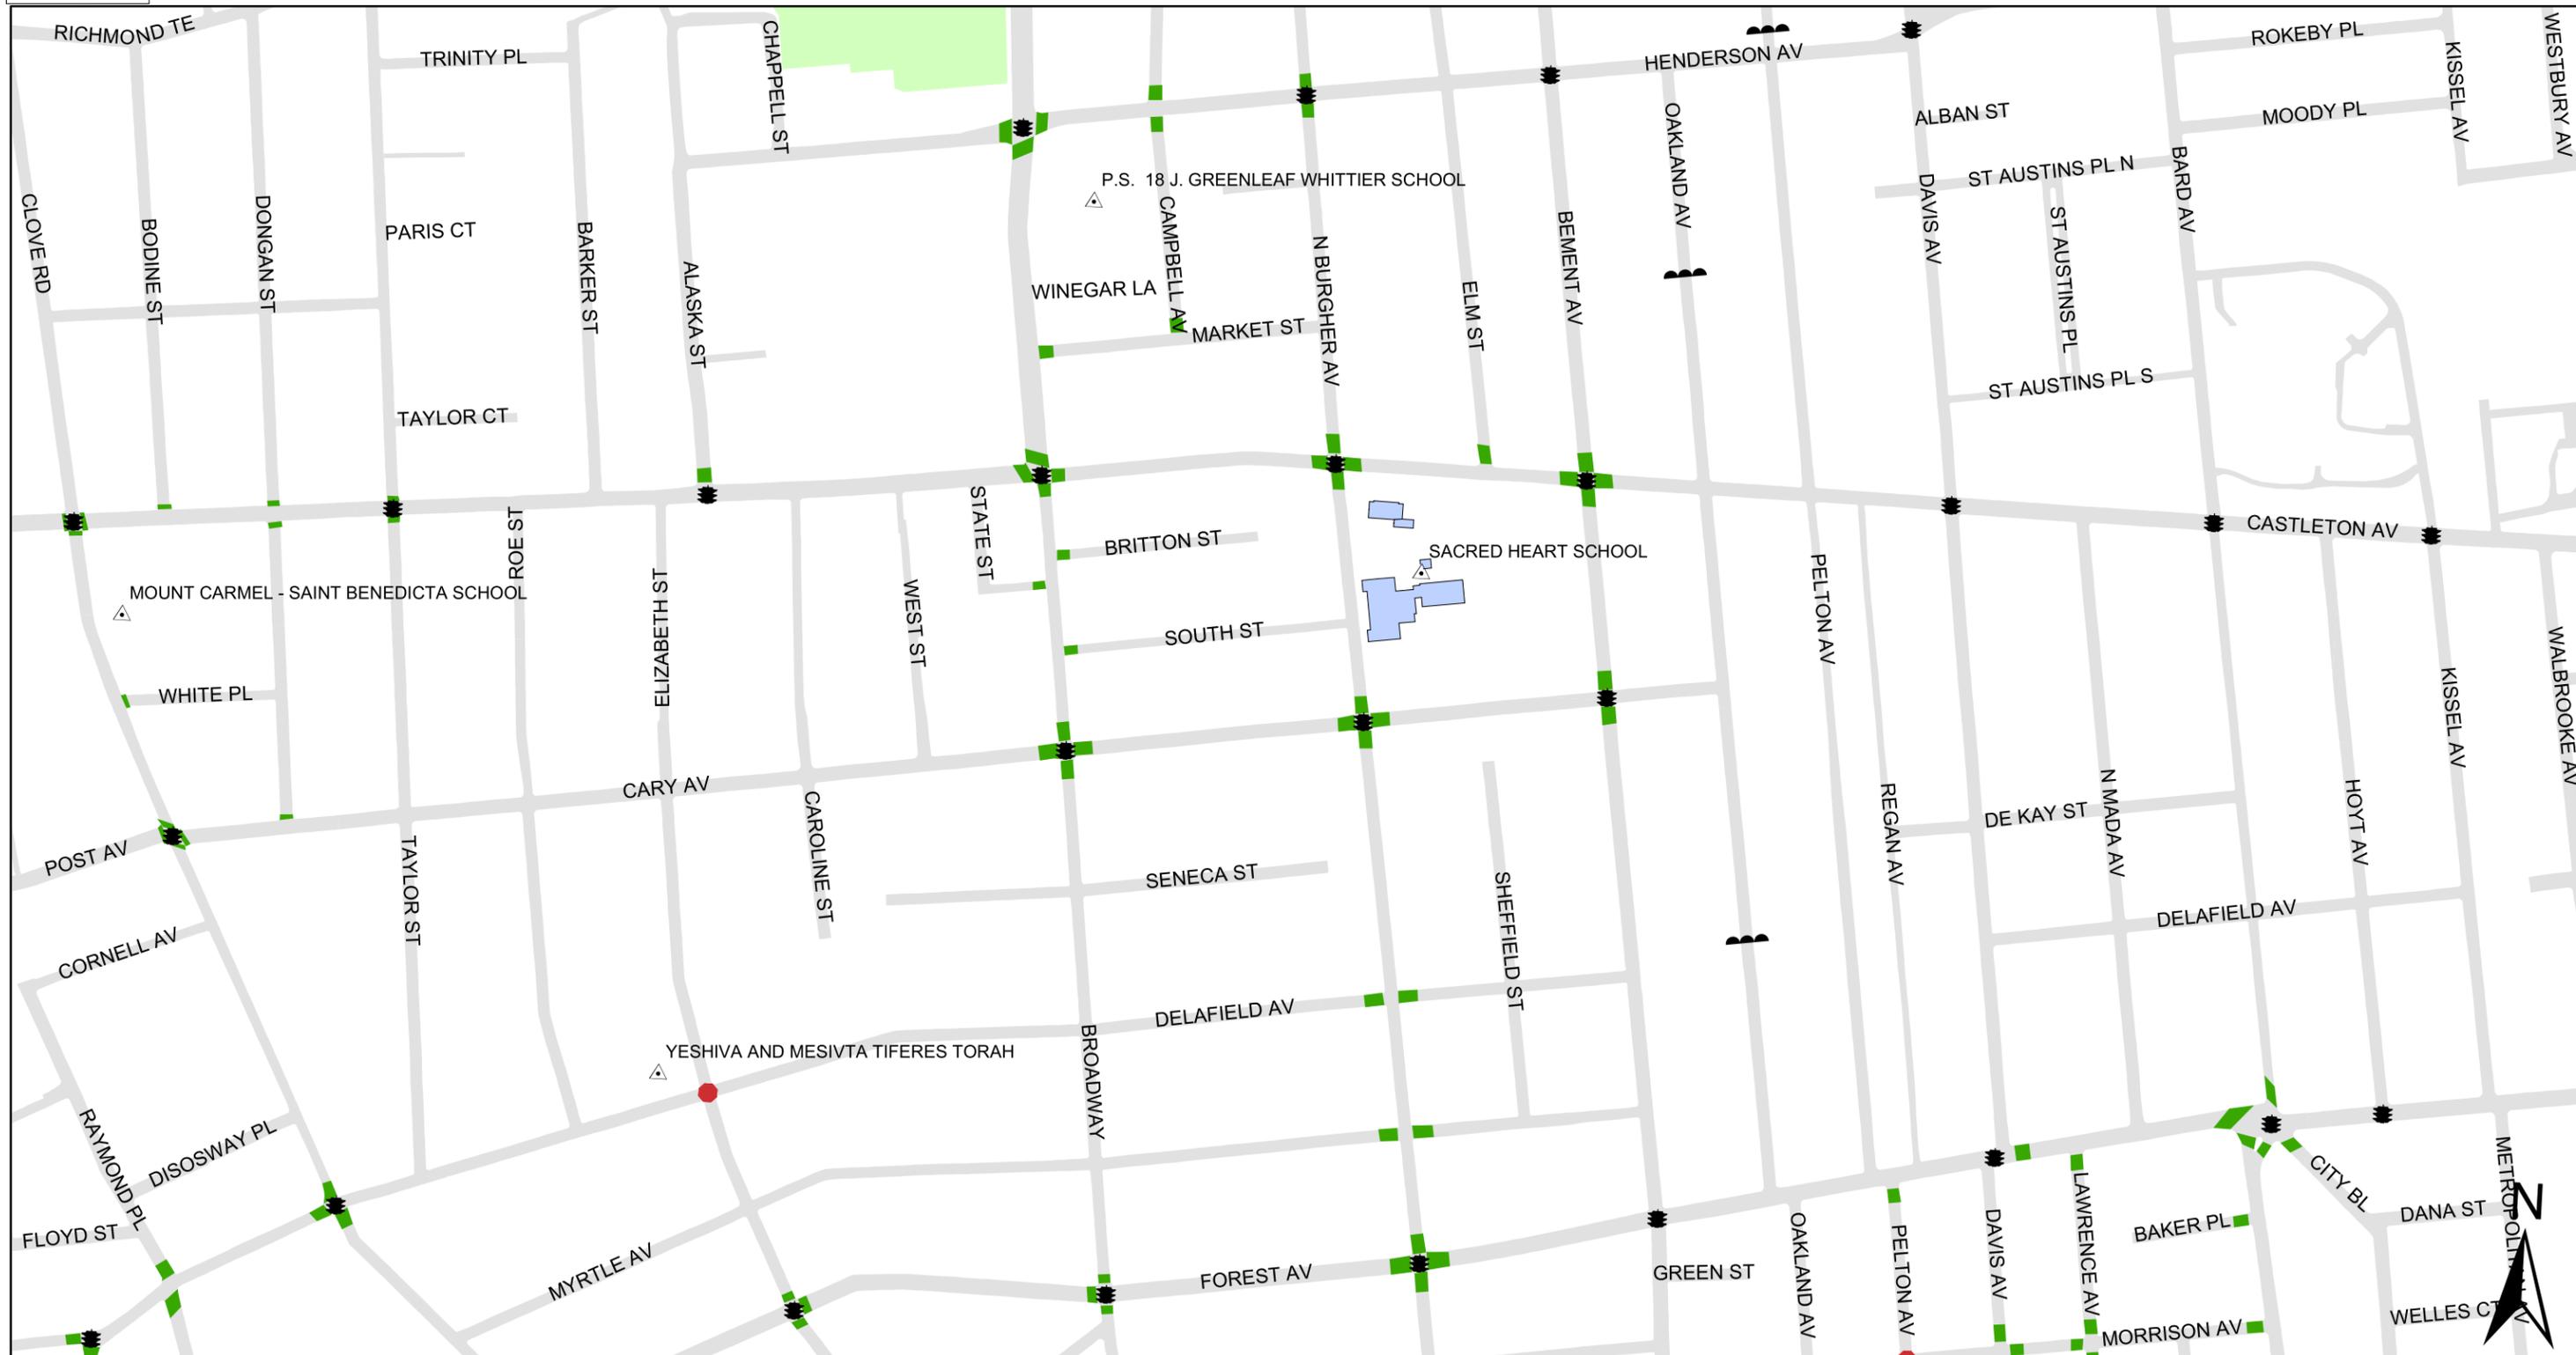
EXHIBIT 2

The School Traffic Safety Map was established to help provide the maximum degree of safety for children going to and from school - by indicating the location of speed reducers, school crosswalks and some traffic control devices. (While virtually all intersections in NYC benefit from traffic control devices - such as stop signs, traffic signals, yield signs, and all way stop signs - this map shows only traffic signals and all way stop signs.) The school crosswalks that are shown are ladder striped and make the crosswalk more visible to drivers and help make the intersection safer. These crosswalks are where school children are recommended to cross.

Exhibit 2 shows the existing school signals and pavement markings around the Sacred Heart School. It should be noted that a citywide signage program is currently underway to upgrade school signage to the current edition of the Federal Manual of Uniform Traffic Control Devices (MUTCD) standards of fluorescent yellow-green signs accompanied by downward pointing arrows. (Signs scheduled to be installed under this program are shown as “existing” in Exhibit 6.)

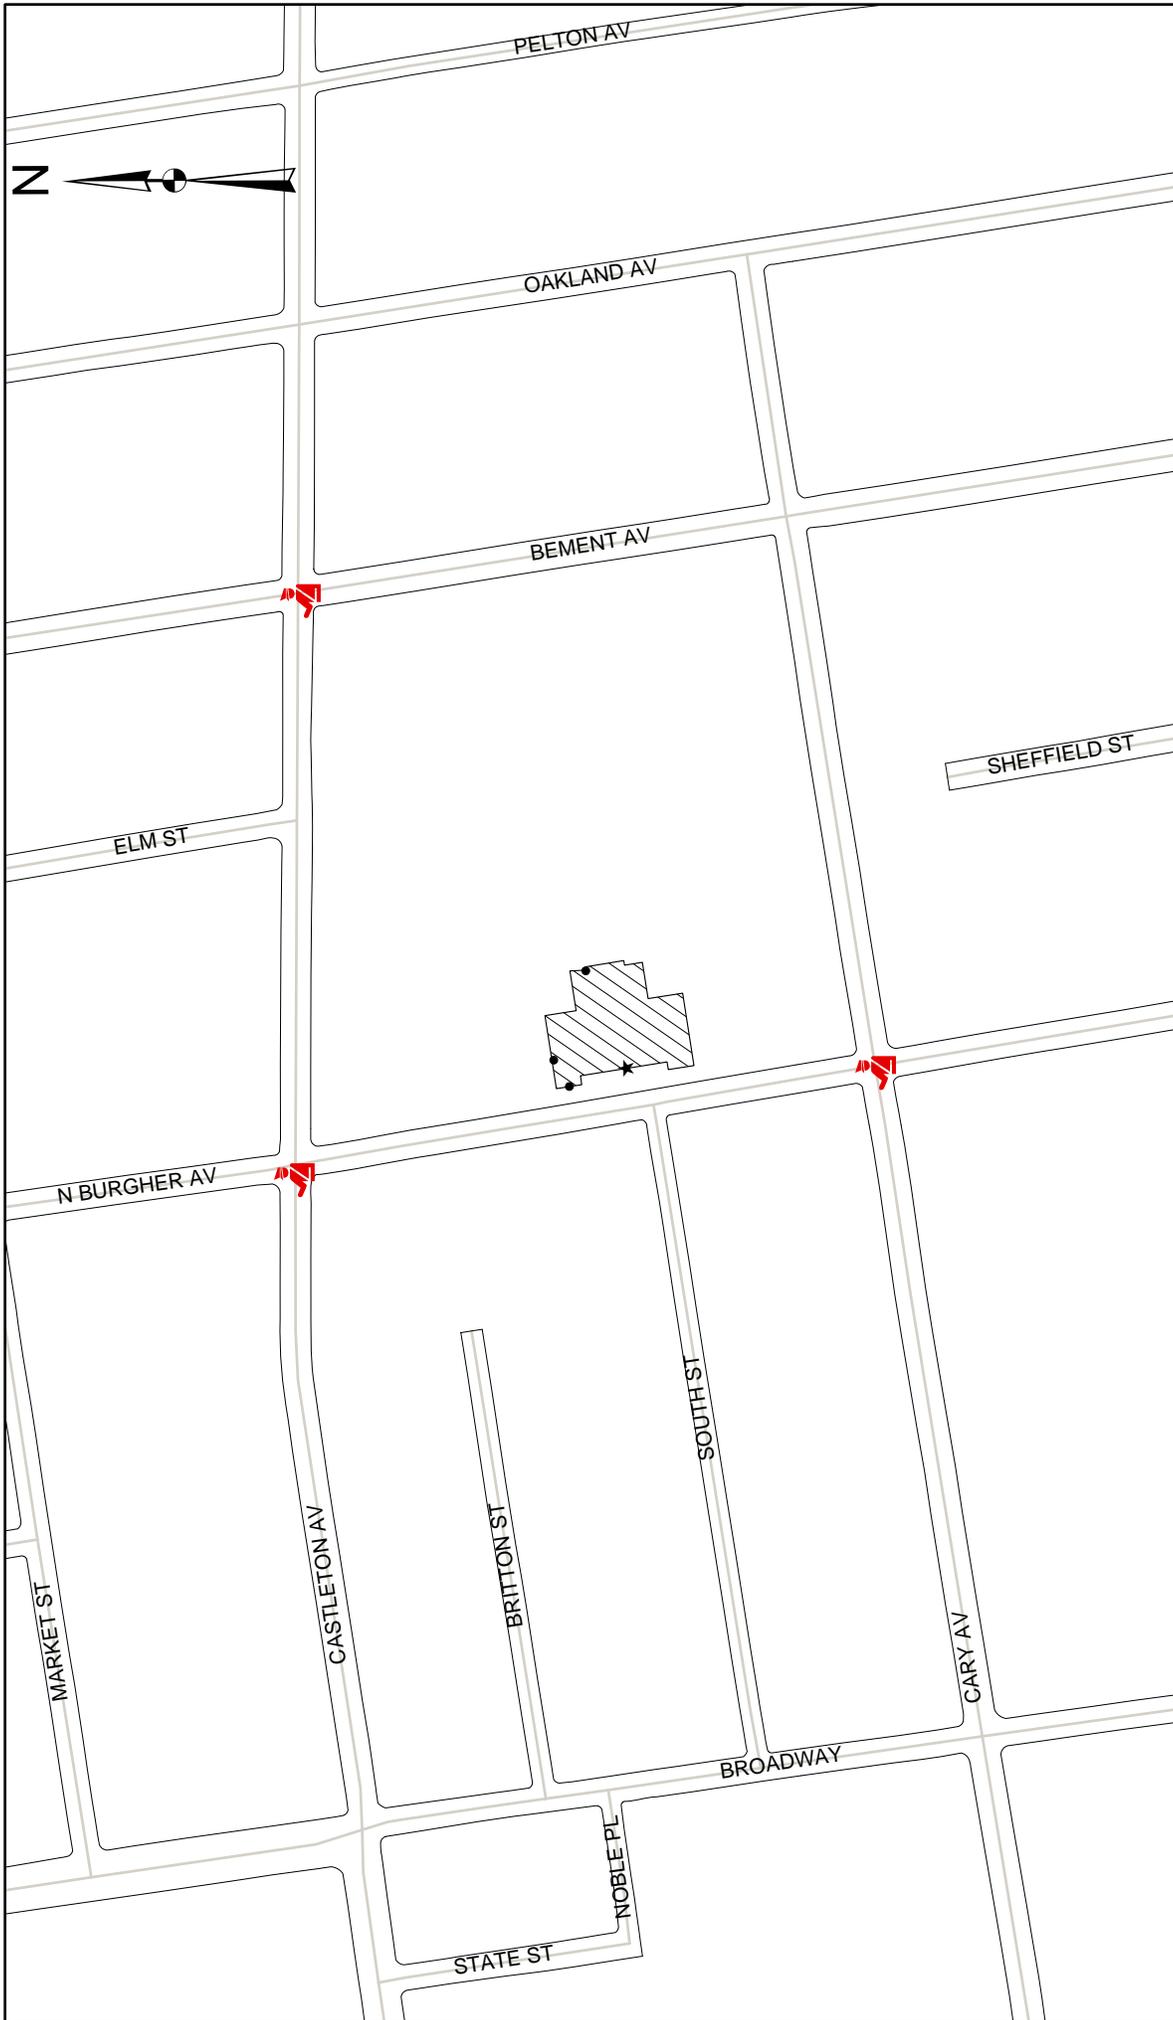
EXHIBIT 3
SACRED HEART SCHOOL
STATEN ISLAND

It should be noted that the school crossing guard for the intersection of Castleton Avenue and Bement Avenue has been removed. There was no school crossing guard assigned to this intersection during the 2004 to 2005 school year. Exhibit 3 shows the school crossing guard locations.

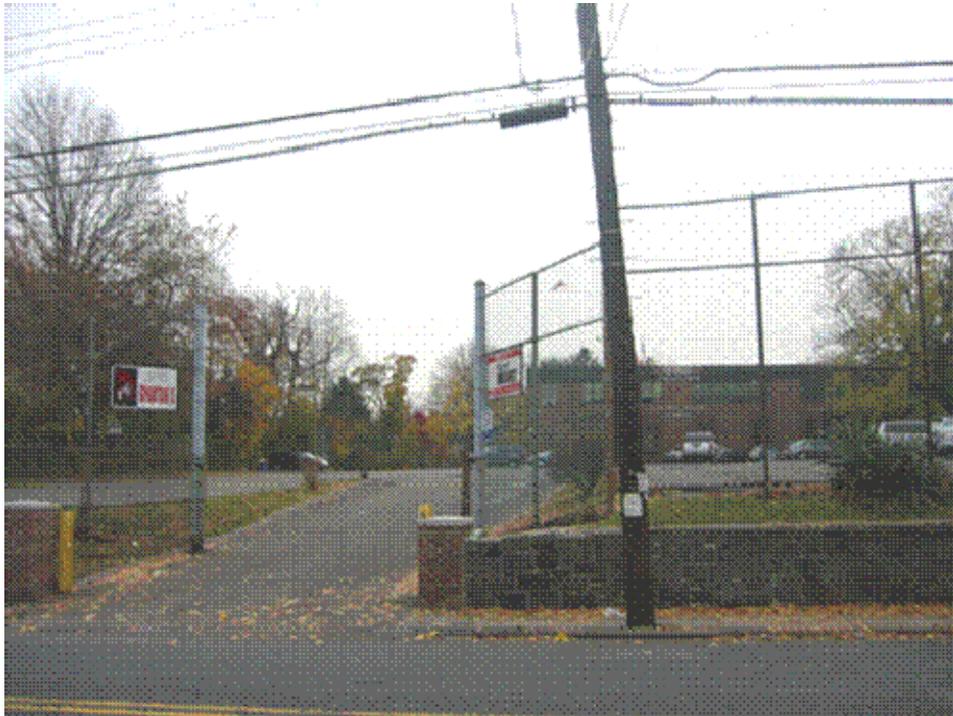
According to school representatives, approximately 79 percent of the students are being dropped off. Typically, parents drop off students on North Burgher Avenue and in the schoolyard, which also used as a parking lot (the school has a large paved area around the back and sides of the school). There is a driveway to the school located on the south side of Castleton Avenue that is used to access the parking lot. Parents enter from Castleton Avenue via the driveway, drop off their children near the school, and exit via the same driveway onto Castleton Avenue. The school has attempted to maintain a circulation pattern within the schoolyard for such drop off operations, but the parents do not always follow it. Field observations revealed that there are remnants of pavement markings and arrows in the parking lot, but they are faded and not very visible. The school also reported that the parking lot becomes quite congested, especially during inclement weather.

Figure 4: Schoolyard/parking lot access driveway on the south side of Castleton Avenue, north of the school building

Sacred Heart School has attempted to maintain a circulation pattern within the schoolyard/parking lot for parent drop-off operations, but the parents do not always follow it. In addition, pavement markings in this area are faded and may not be visible. Therefore, it is recommended that a parent drop-off circulation pattern be formally established for the schoolyard/parking lot in order to reduce congestion during arrival and dismissal times.

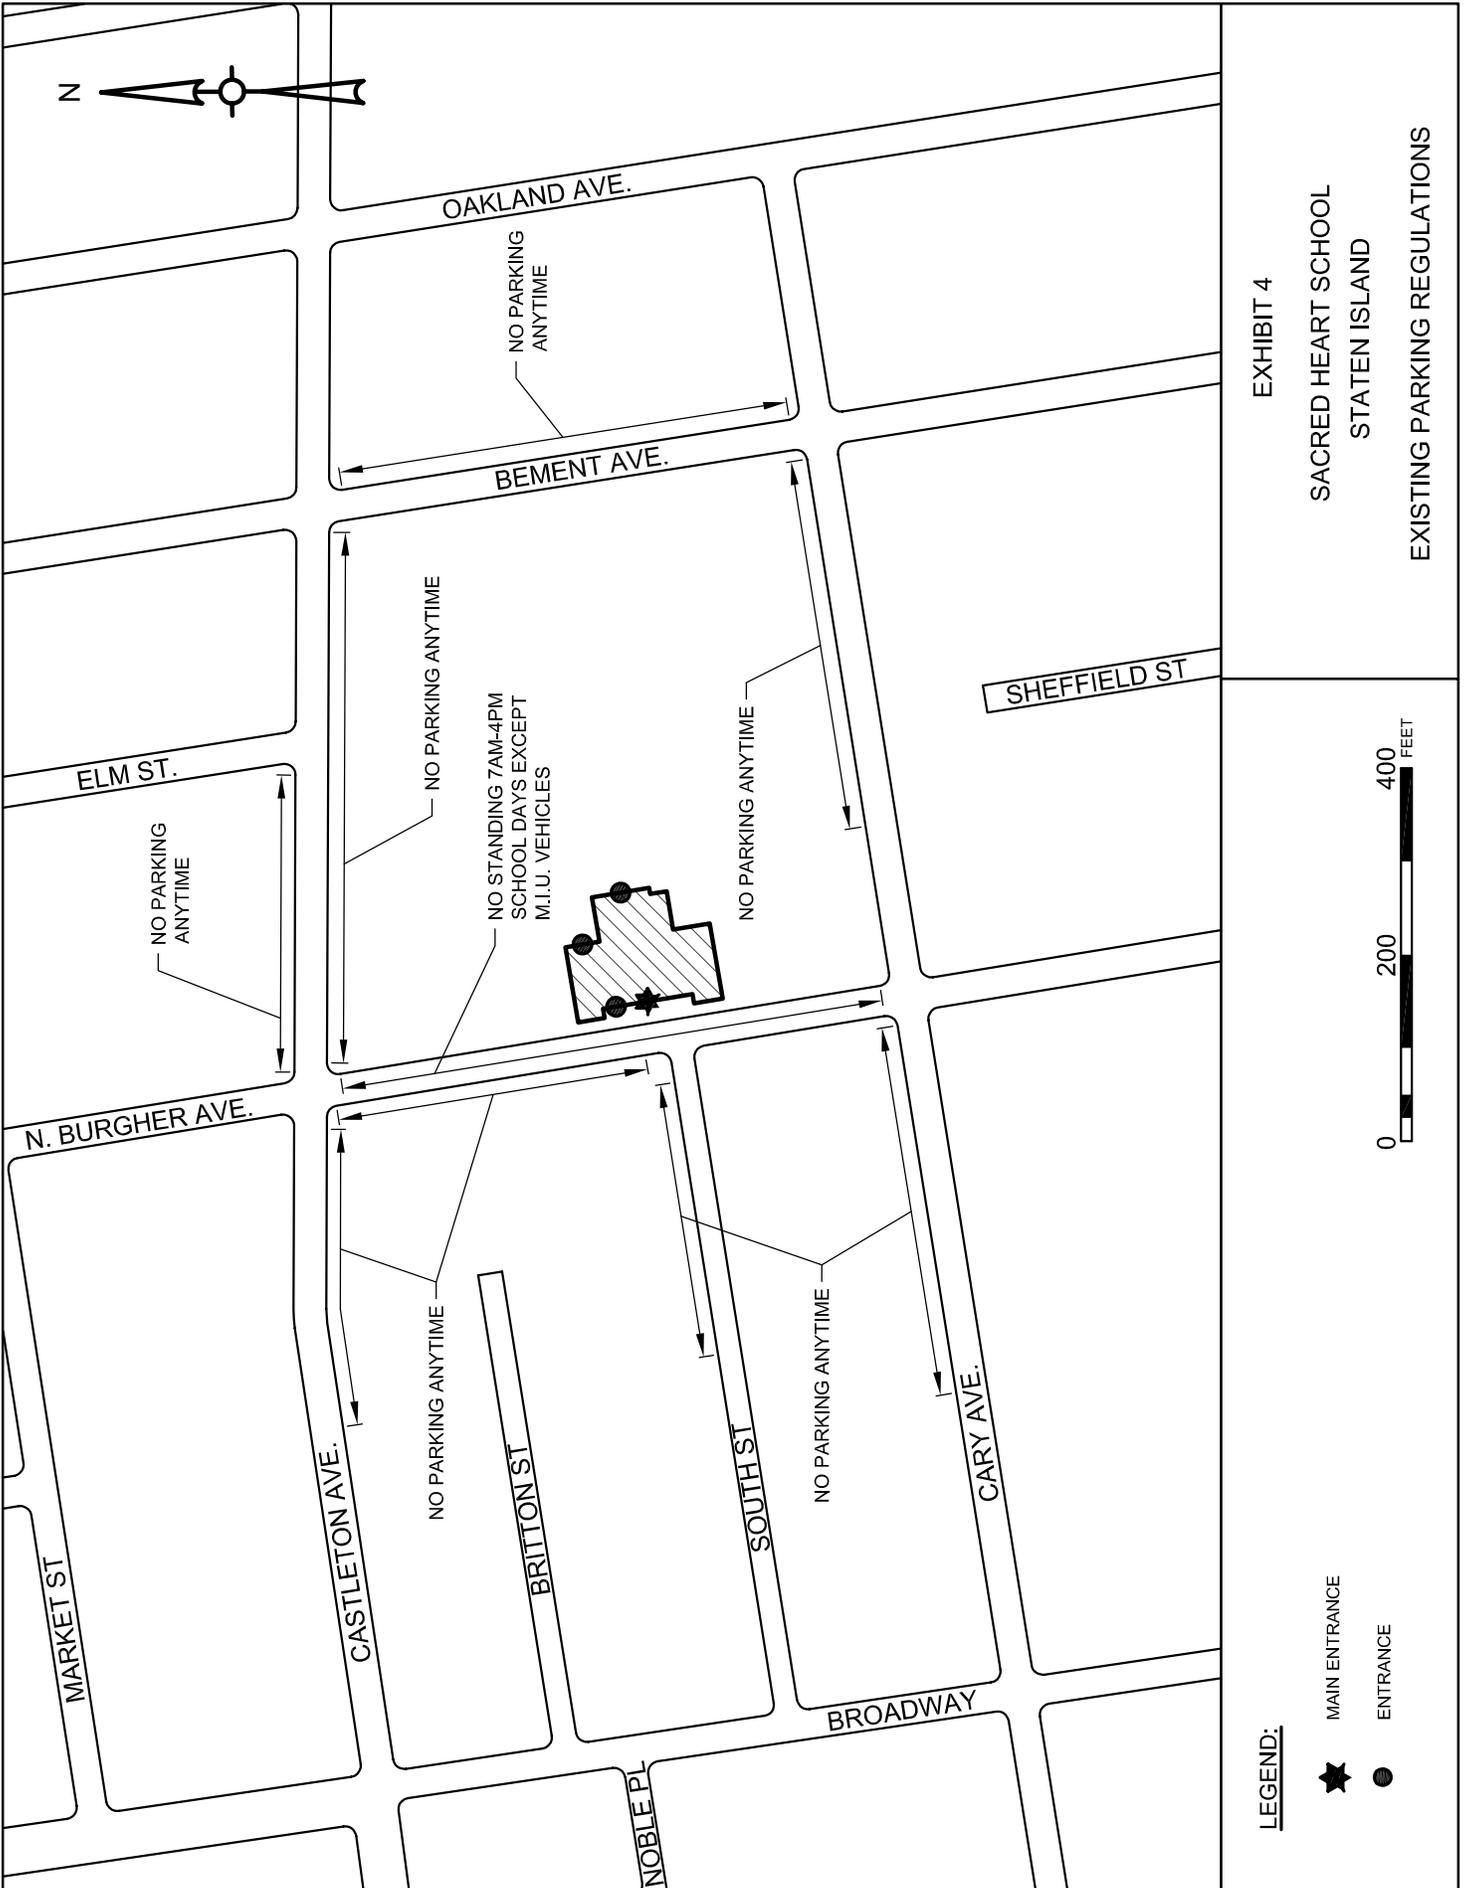
EXHIBIT 4
 SACRED HEART SCHOOL
 STATEN ISLAND
 EXISTING PARKING REGULATIONS

Parking regulations around the school are shown in Exhibit 4.

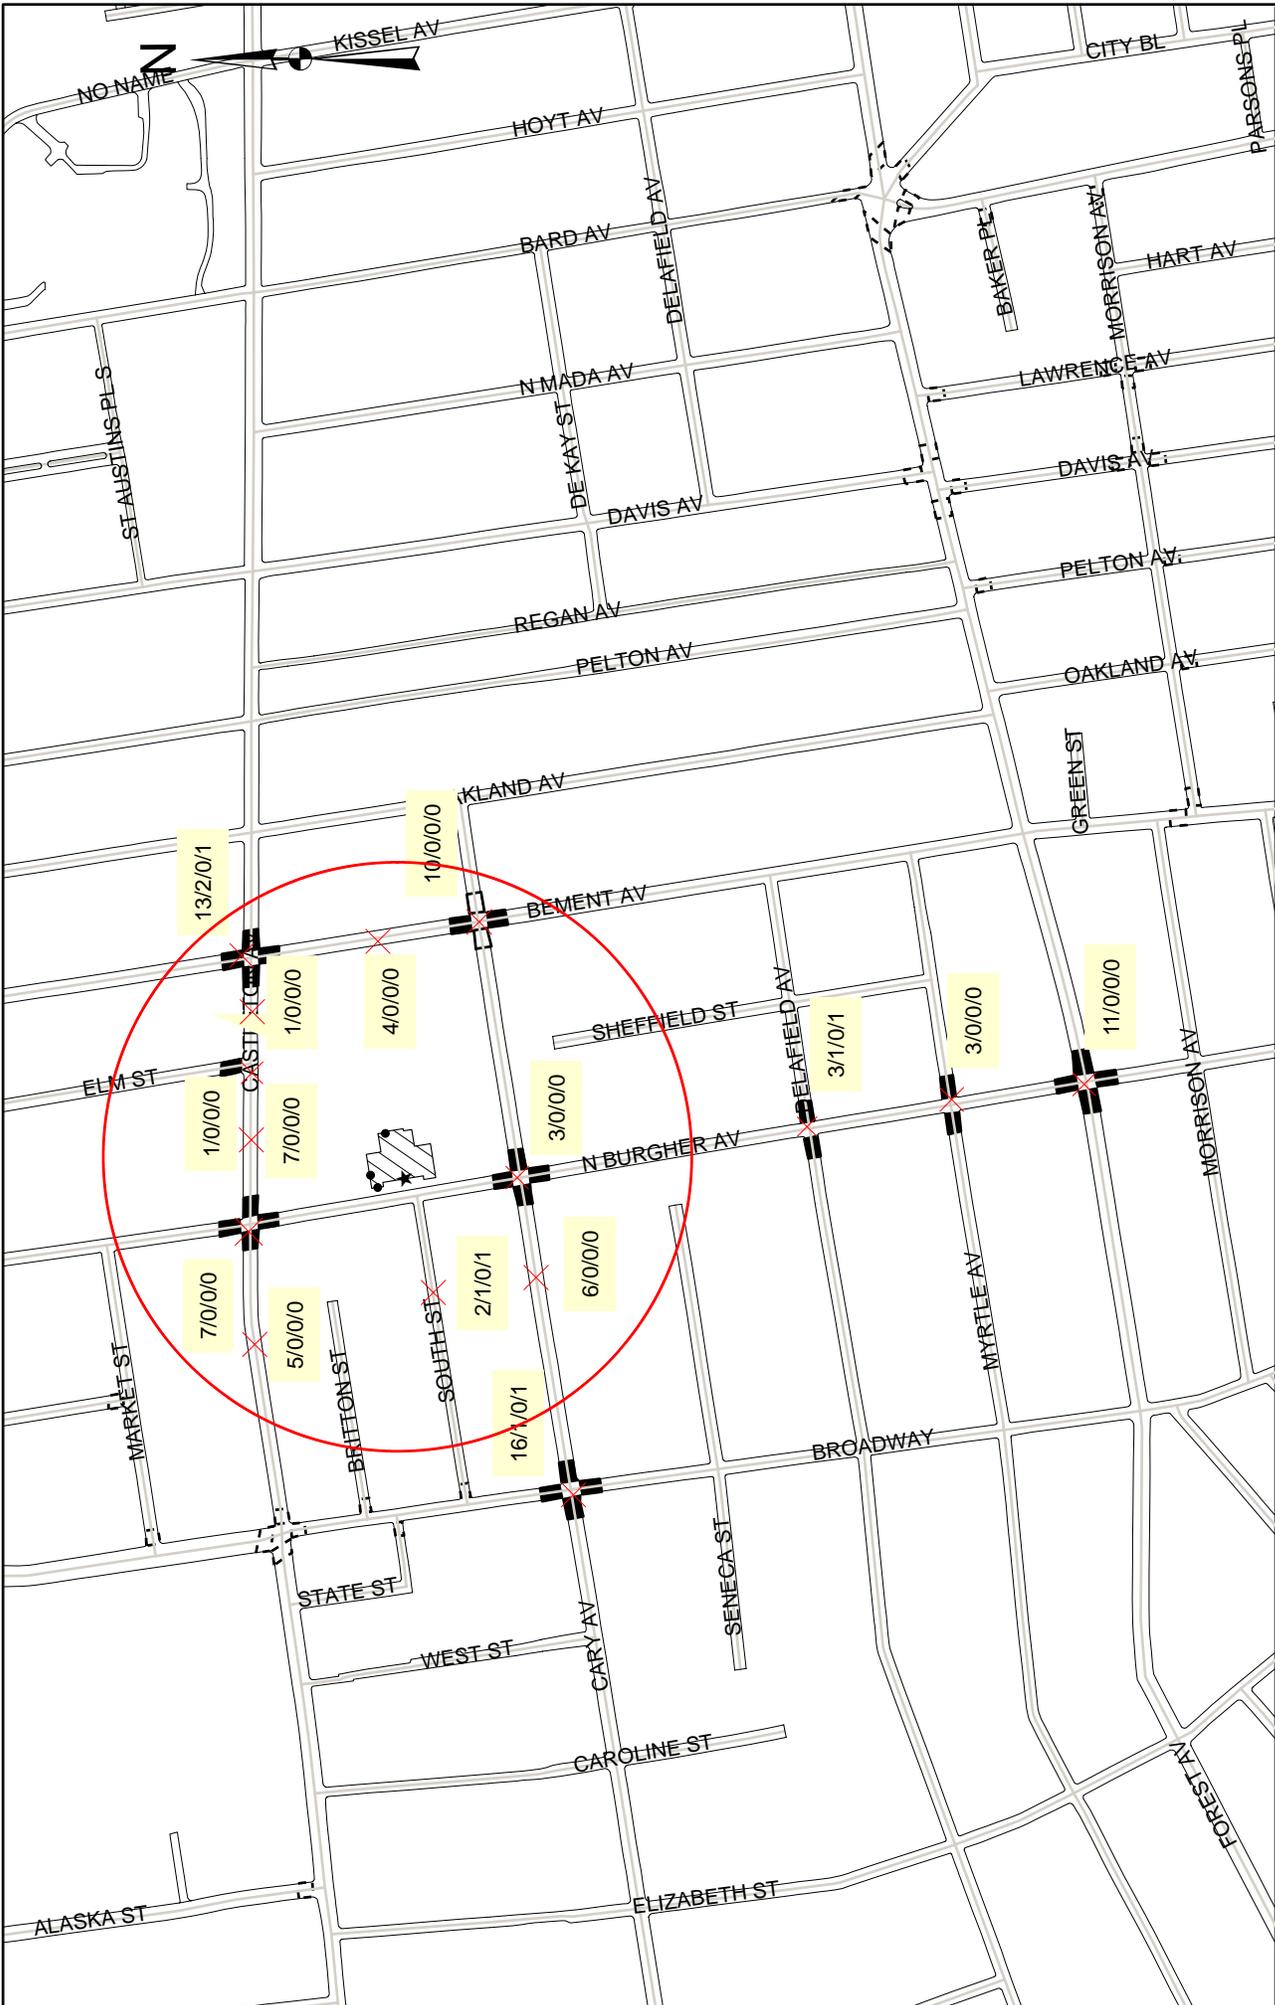
EXHIBIT 5
SACRED HEART SCHOOL
STATEN ISLAND
ACCIDENT SUMMARY (1998-2000)

Exhibit 5 and Table 2 show a summary of accidents, as obtained from the New York State Department of Motor Vehicles (DMV), in the vicinity of Sacred Heart School for a three-year period from January 1, 1998 through December 31, 2000. The DMV data provides some detail relating to the circumstances and cause of an accident. Table 3 is a summary of more recent accident data obtained from the NYC Police Department (NYPD). Though current through 2004, the NYPD data does not provide the same level of detail as the DMV data.

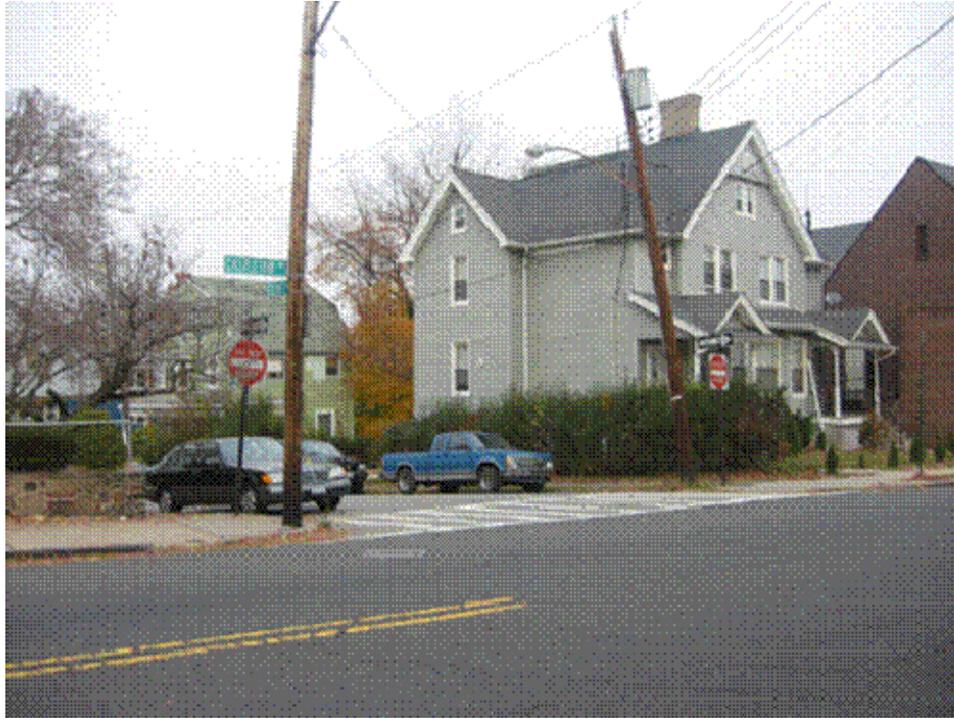
This is an unsignalized “T”-intersection with a school crosswalk located across the north leg of Elm Street (see Figure 6). Castleton Avenue is a two-way street with one travel lane. Elm Street is a one-way southbound street with one travel lane and on-street parking on both sides of the roadway.

Figure 6: Looking northeast across Castleton Avenue toward the intersection with Elm Street

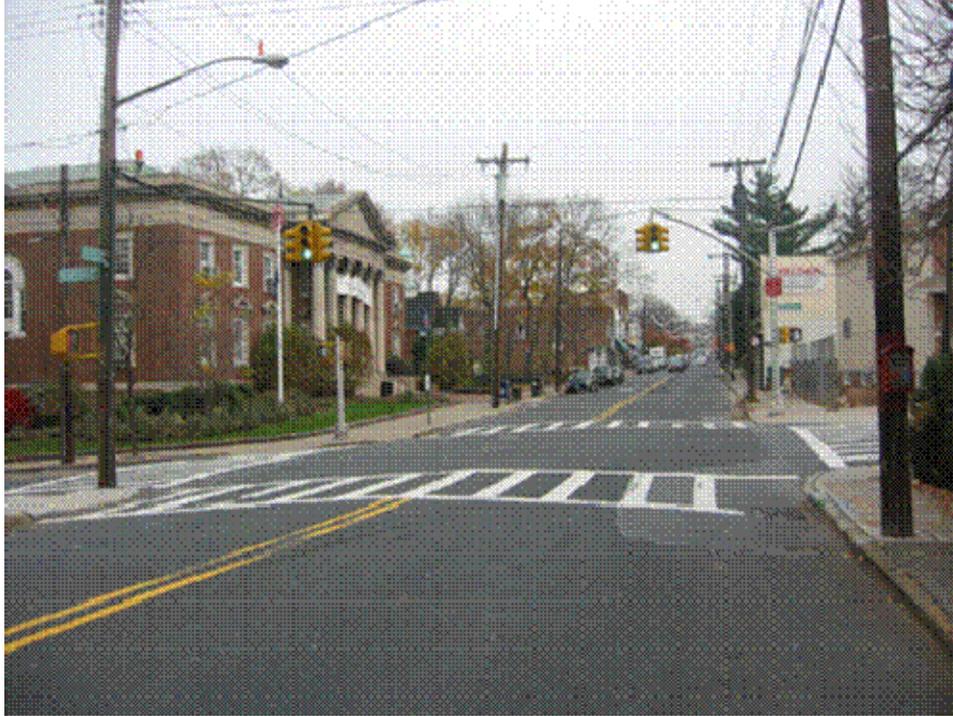
This is a signalized four-leg intersection with school crosswalks located across all legs (see Figure 7). Castleton Avenue is a two-way street with one travel lane and one on-street parking lane on each side of the roadway. Bement Avenue is also a two-way street with one travel lane and one on-street parking lane on the east side of the roadway.

Figure 7: Looking east along Castleton Avenue toward the intersection with Bement Avenue

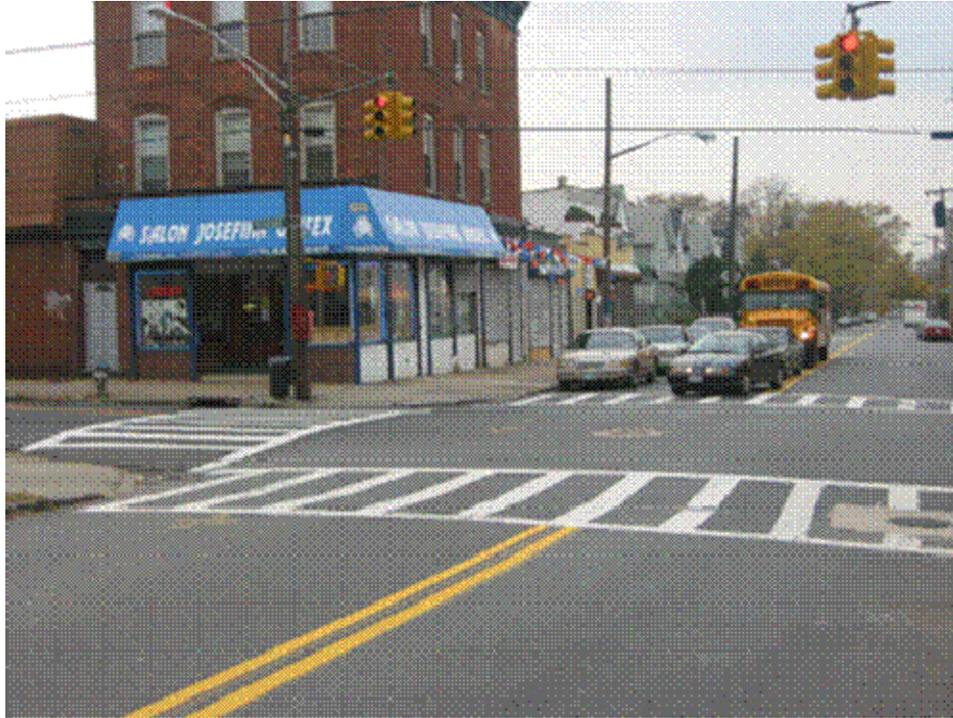
This is a signalized four-legged intersection with school crosswalks located across all legs (see Figure 8). Cary Avenue is a two-way street with one travel lane and one on-street parking lane on each side of the roadway. Broadway is also a two-way street with one travel lane and one on-street parking lane on each side of the roadway.

Figure 8: Looking east along Cary Avenue at its intersection with Broadway

The sidewalk along the east side of Broadway, south of Market Street, is cracked and broken (see Section 3.8.1 and Figure 8) and should be replaced. Therefore, the following action is recommended:

- Replace the broken and cracked section of sidewalk along the east side of Broadway, south of Market Street.

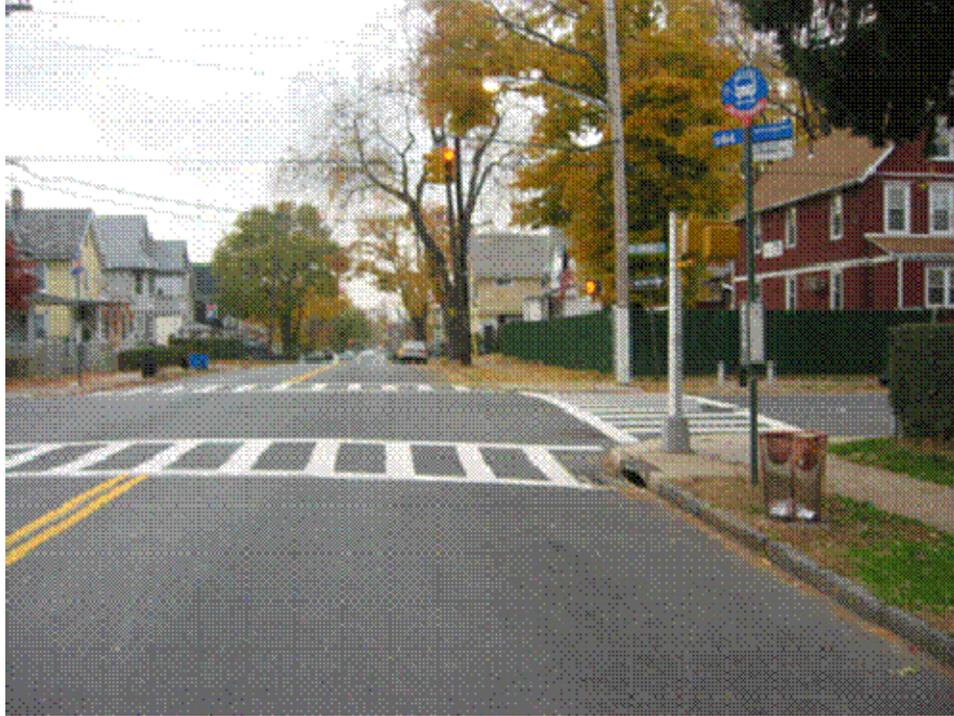
This is a signalized four-leg intersection with school crosswalks located across all legs (see Figure 9). North Burgher Avenue is a one-way northbound street with one travel lane and on-street parking on both sides of the roadway, except for “NO PARKING ANYTIME” at the west leg of the section between Castleton Avenue and South Street. Cary Avenue is a two-way street with one travel lane and on-street parking lane on the south side of the roadway.

Figure 9: Looking west along Cary Avenue toward North Burgher Avenue

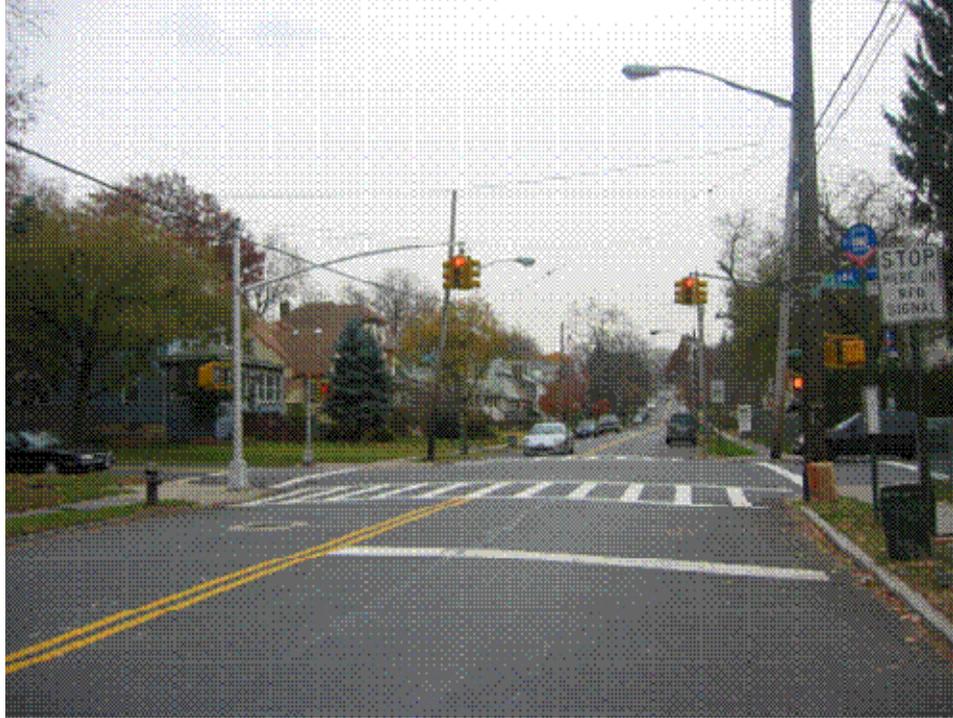
This is a signalized four-leg intersection with school crosswalks across the north and south legs of Bement Avenue, and pedestrian crosswalks across the east and west legs of Cary Avenue (see Figure 10). Cary Avenue is a two-way street with one travel lane and on-street parking lane on the south side of the roadway. Bement Avenue is also a two-way street with one travel lane and on-street parking lane on the west side of the roadway.

The stop bars on the southbound and eastbound approaches to this intersection are both set back from the crosswalk, apparently to accommodate the turning path of buses at the intersection. Both stop bars have adjacent signs posted that read: “STOP HERE ON RED SIGNAL”.

Figure 10: Looking south along Bement Avenue toward the intersection with Cary Avenue

The MUTCD and New York City DOT standard for placement of a stop bar is four feet in advance of a marked crosswalk. At signalized (or stop controlled) crosswalks, the vehicle stop line can be placed farther back from the crosswalk in order to maximize visibility of pedestrians and to minimize the potential for pedestrian/vehicle conflicts. Therefore, it is recommended that stop bars be placed ten feet in advance of all school crosswalks.
