**New York City Department of Transportation
Office of School Safety Engineering**

School Safety Engineering Project

FINAL REPORT: Sacred Heart School, Staten Island

September 21, 2006

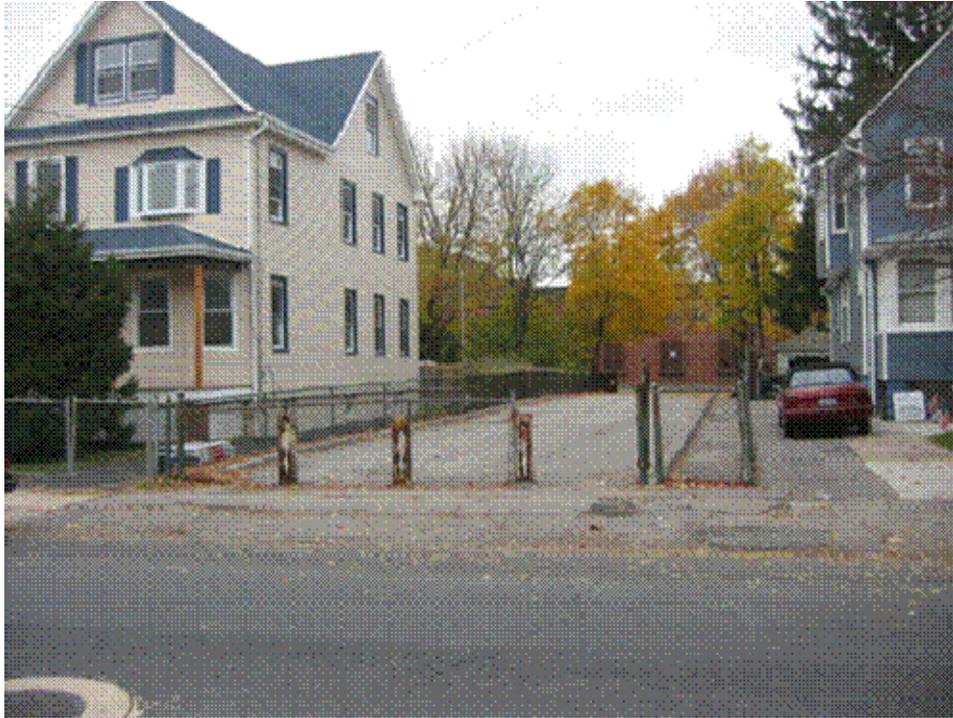
Roadways in the vicinity of the Sacred Heart School were observed to be in good condition. Sidewalks are approximately four to eight feet wide on the block faces adjacent to the school (a sidewalk less than five feet wide is considered substandard), and were observed to be in fair condition, except along the north side of Cary Avenue at the driveway to the Sacred Heart School. This sidewalk is showing signs of some deterioration (see Figure 11).

Figure 11: Looking north across Cary Avenue toward the Sacred Heart School driveway serving the parking lot and schoolyard on the south side of school

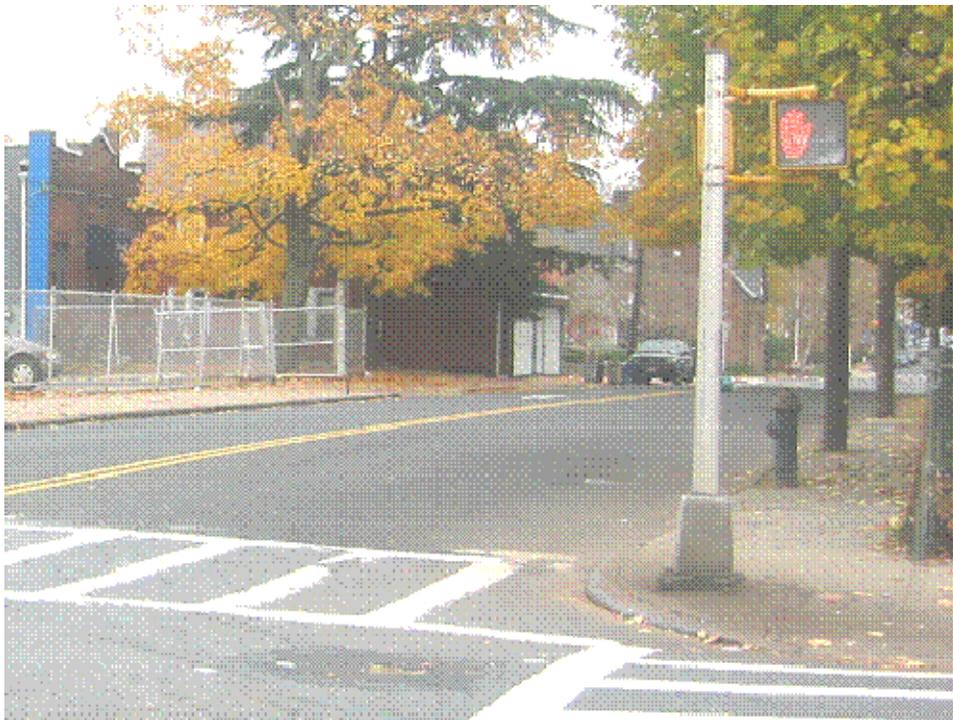
- A pedestrian ramp is missing on the southeast corner of the North Burgher Avenue and Castleton Avenue intersection (see Figure 12).
- A pedestrian signal pole obstructs the pedestrian area on the southeast corner of the North Burgher Avenue and Castleton Avenue intersection (see Figure 12).
- A catch basin on the northeast corner of the Cary Avenue and North Burgher Avenue intersection is located within the easterly crosswalk.
- A pedestrian signal pole obstructs the pedestrian area on the northeast corner of the North Burgher Avenue and Cary Avenue intersection.
- A pedestrian ramp is missing on the northeast corner of the Cary Avenue and Broadway intersection.
- A utility pole obstructs the pedestrian area on the northeast corner of the Cary Avenue and Broadway intersection.

Figure 12: Looking east at the pedestrian signal pole on the southeast corner of the North Burgher Avenue and Castleton Avenue intersection

The following actions are recommended to address the deficiencies described in Section 3.8.2:

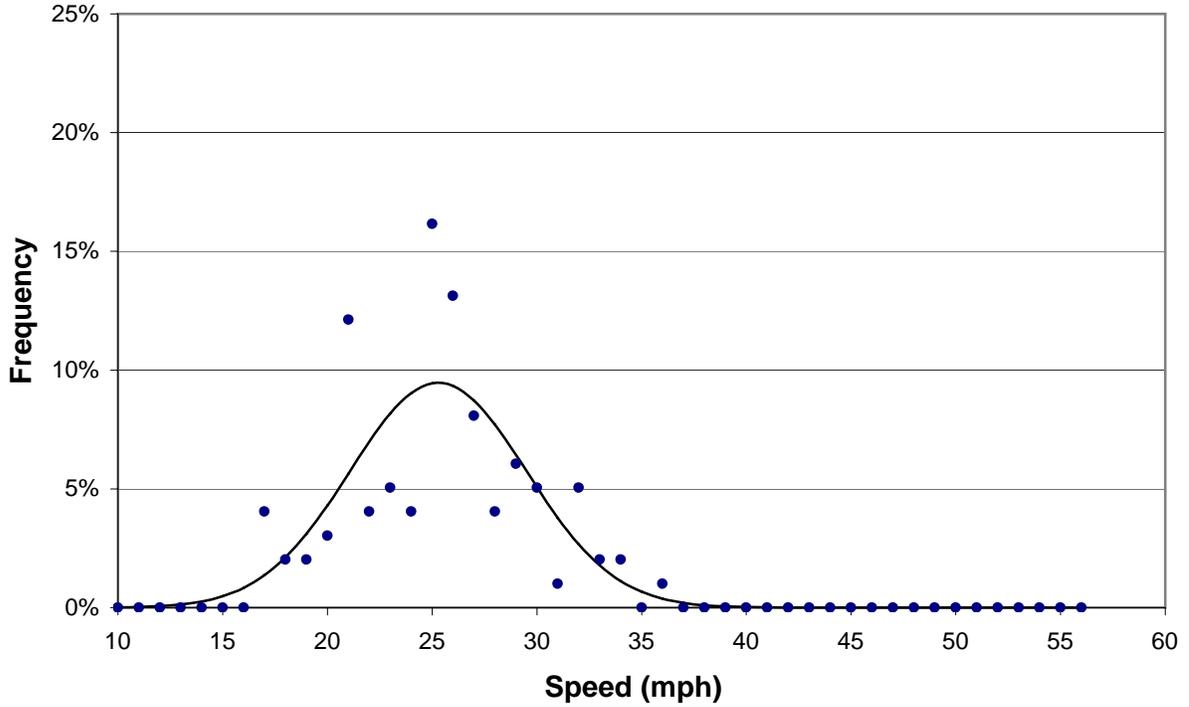
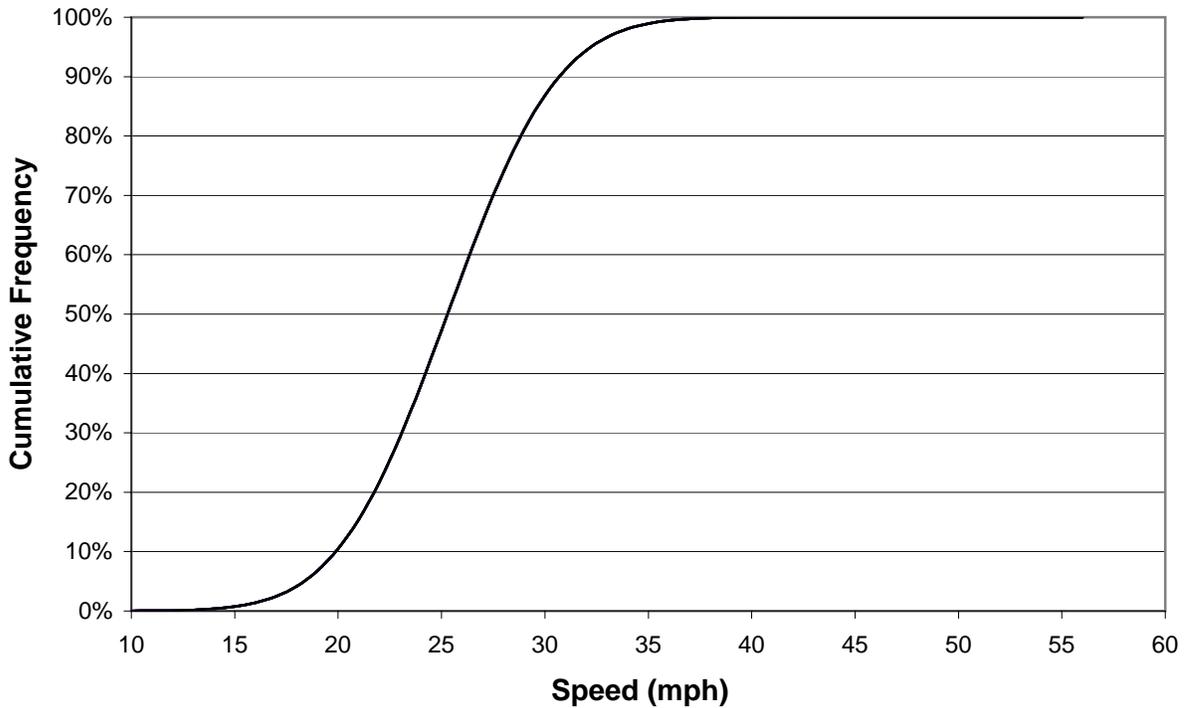
Mean Speed = 25.3 mph Median Speed = 25.3 mph
 Standard Deviation = 4.2 mph 15th Percentile Speed = 20.9 mph
 Margin of Error (95% Confidence) = ± 0.8 mph 85th Percentile Speed = 29.7 mph

Eastbound vehicles on Castleton Avenue, between North Burgher Avenue and Elm Street, were found to be traveling at an 85th percentile speed of 30 mph. Westbound vehicles traveling along this same section of Castleton Avenue were found to be traveling at an 85th percentile speed of 31 mph. The 85th percentile speed is considered to be the representative speed for the street segment. Speeds above a 30 mph threshold indicate a speeding problem that may require appropriate traffic calming measures. A preliminary check concluded that it is not feasible to install a speed reducer on Castleton Avenue between North Burgher and Elm Street as it is a bus route for the S-46 line.

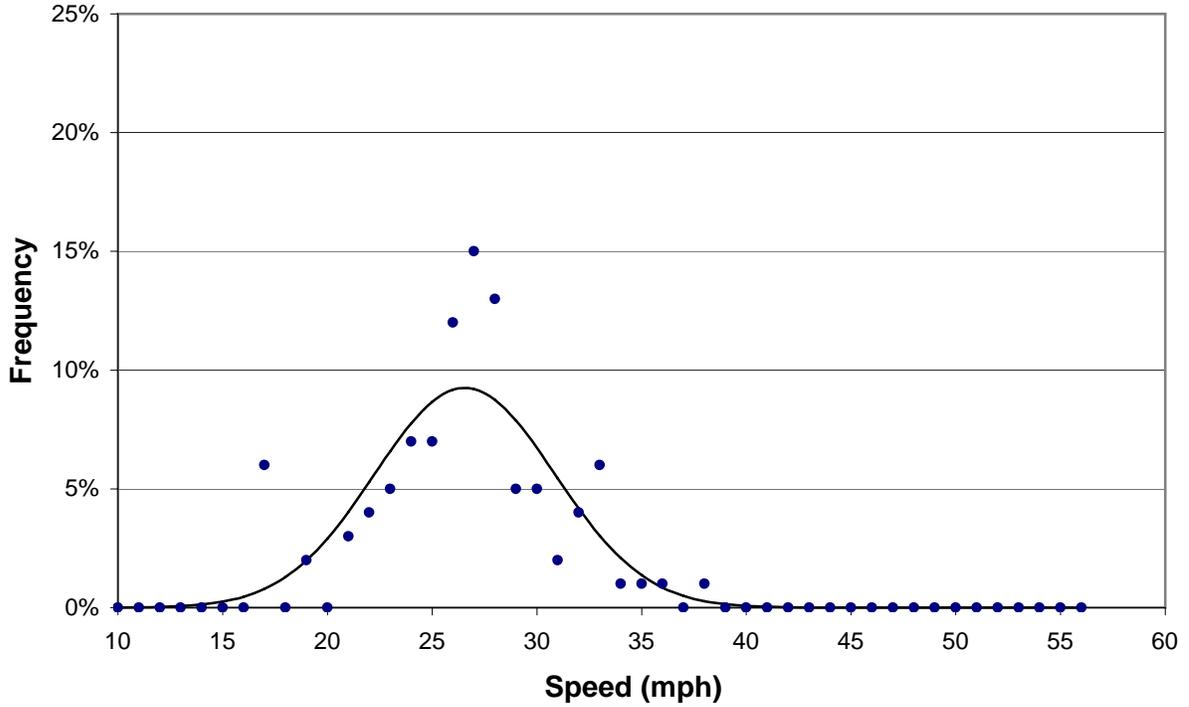
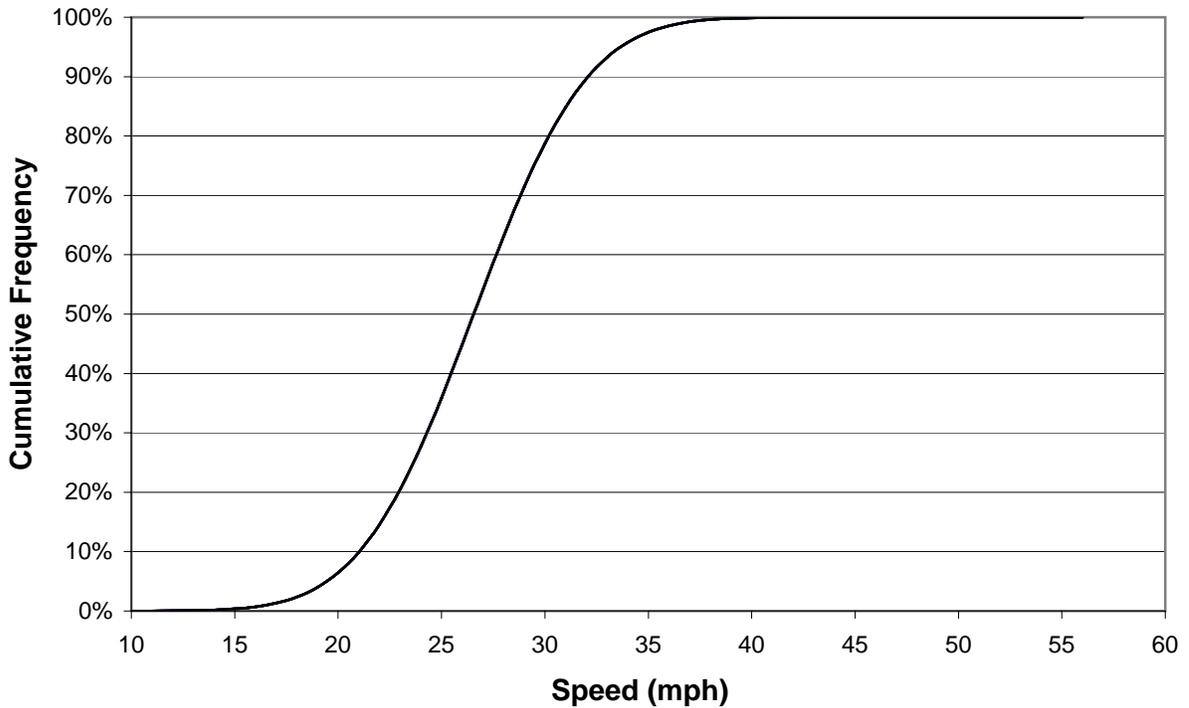
Mean Speed = 26.6 mph Median Speed = 26.6 mph
 Standard Deviation = 4.3 mph 15th Percentile Speed = 22.1 mph
 Margin of Error (95% Confidence) = ± 0.8 mph 85th Percentile Speed = 31.0 mph
