839 ST. MARK'S AVENUE

EXTERIOR RESTORATION AND REAR/SIDE YARD ADDITION

CROWN HEIGHTS HISTORIC ASSOCIATION
FEBRUARY 25, 2016

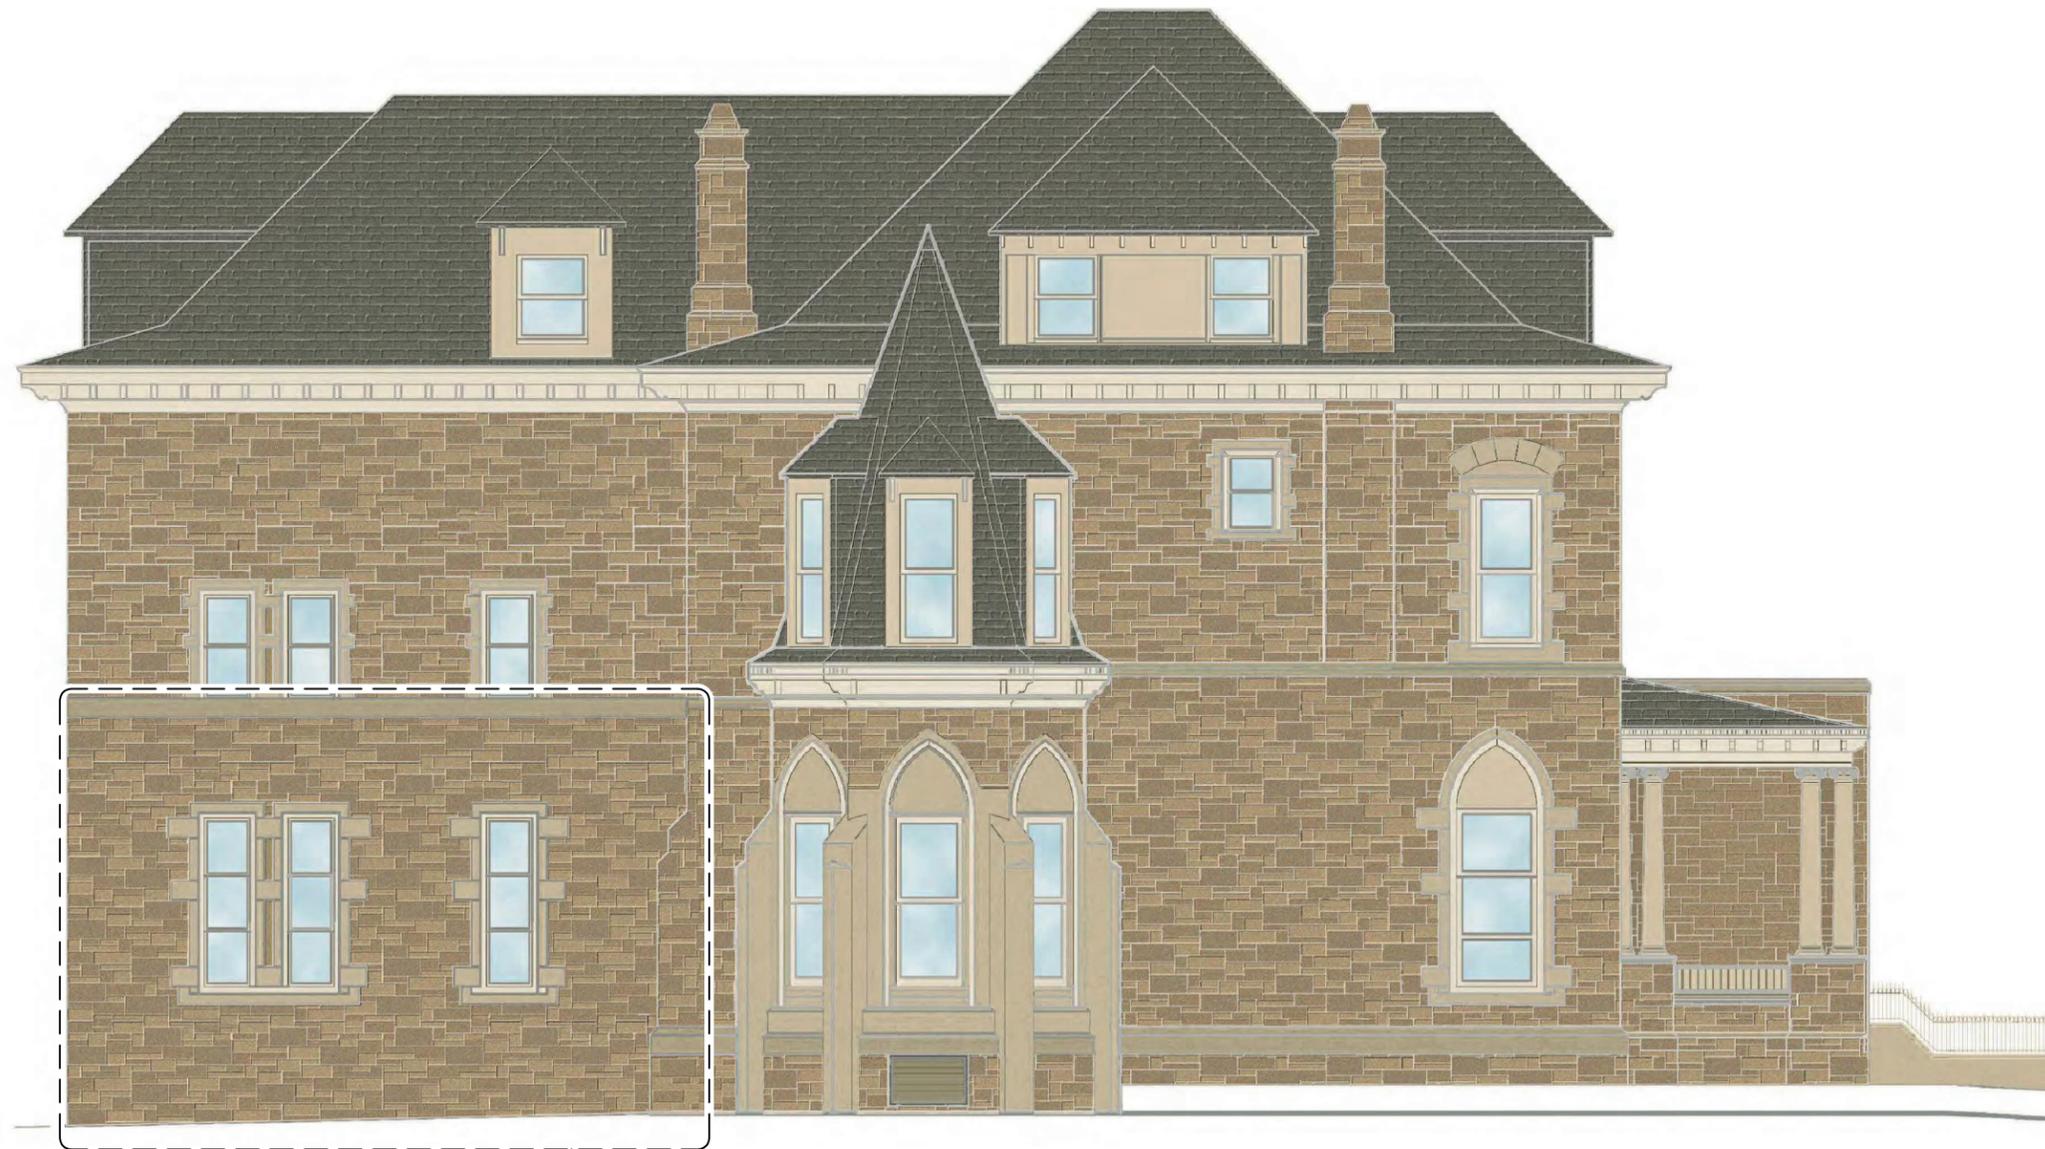
① WEST ELEVATION
 SCALE: 1/8" = 1'-0"

AREA OF ADDITION REMOVED

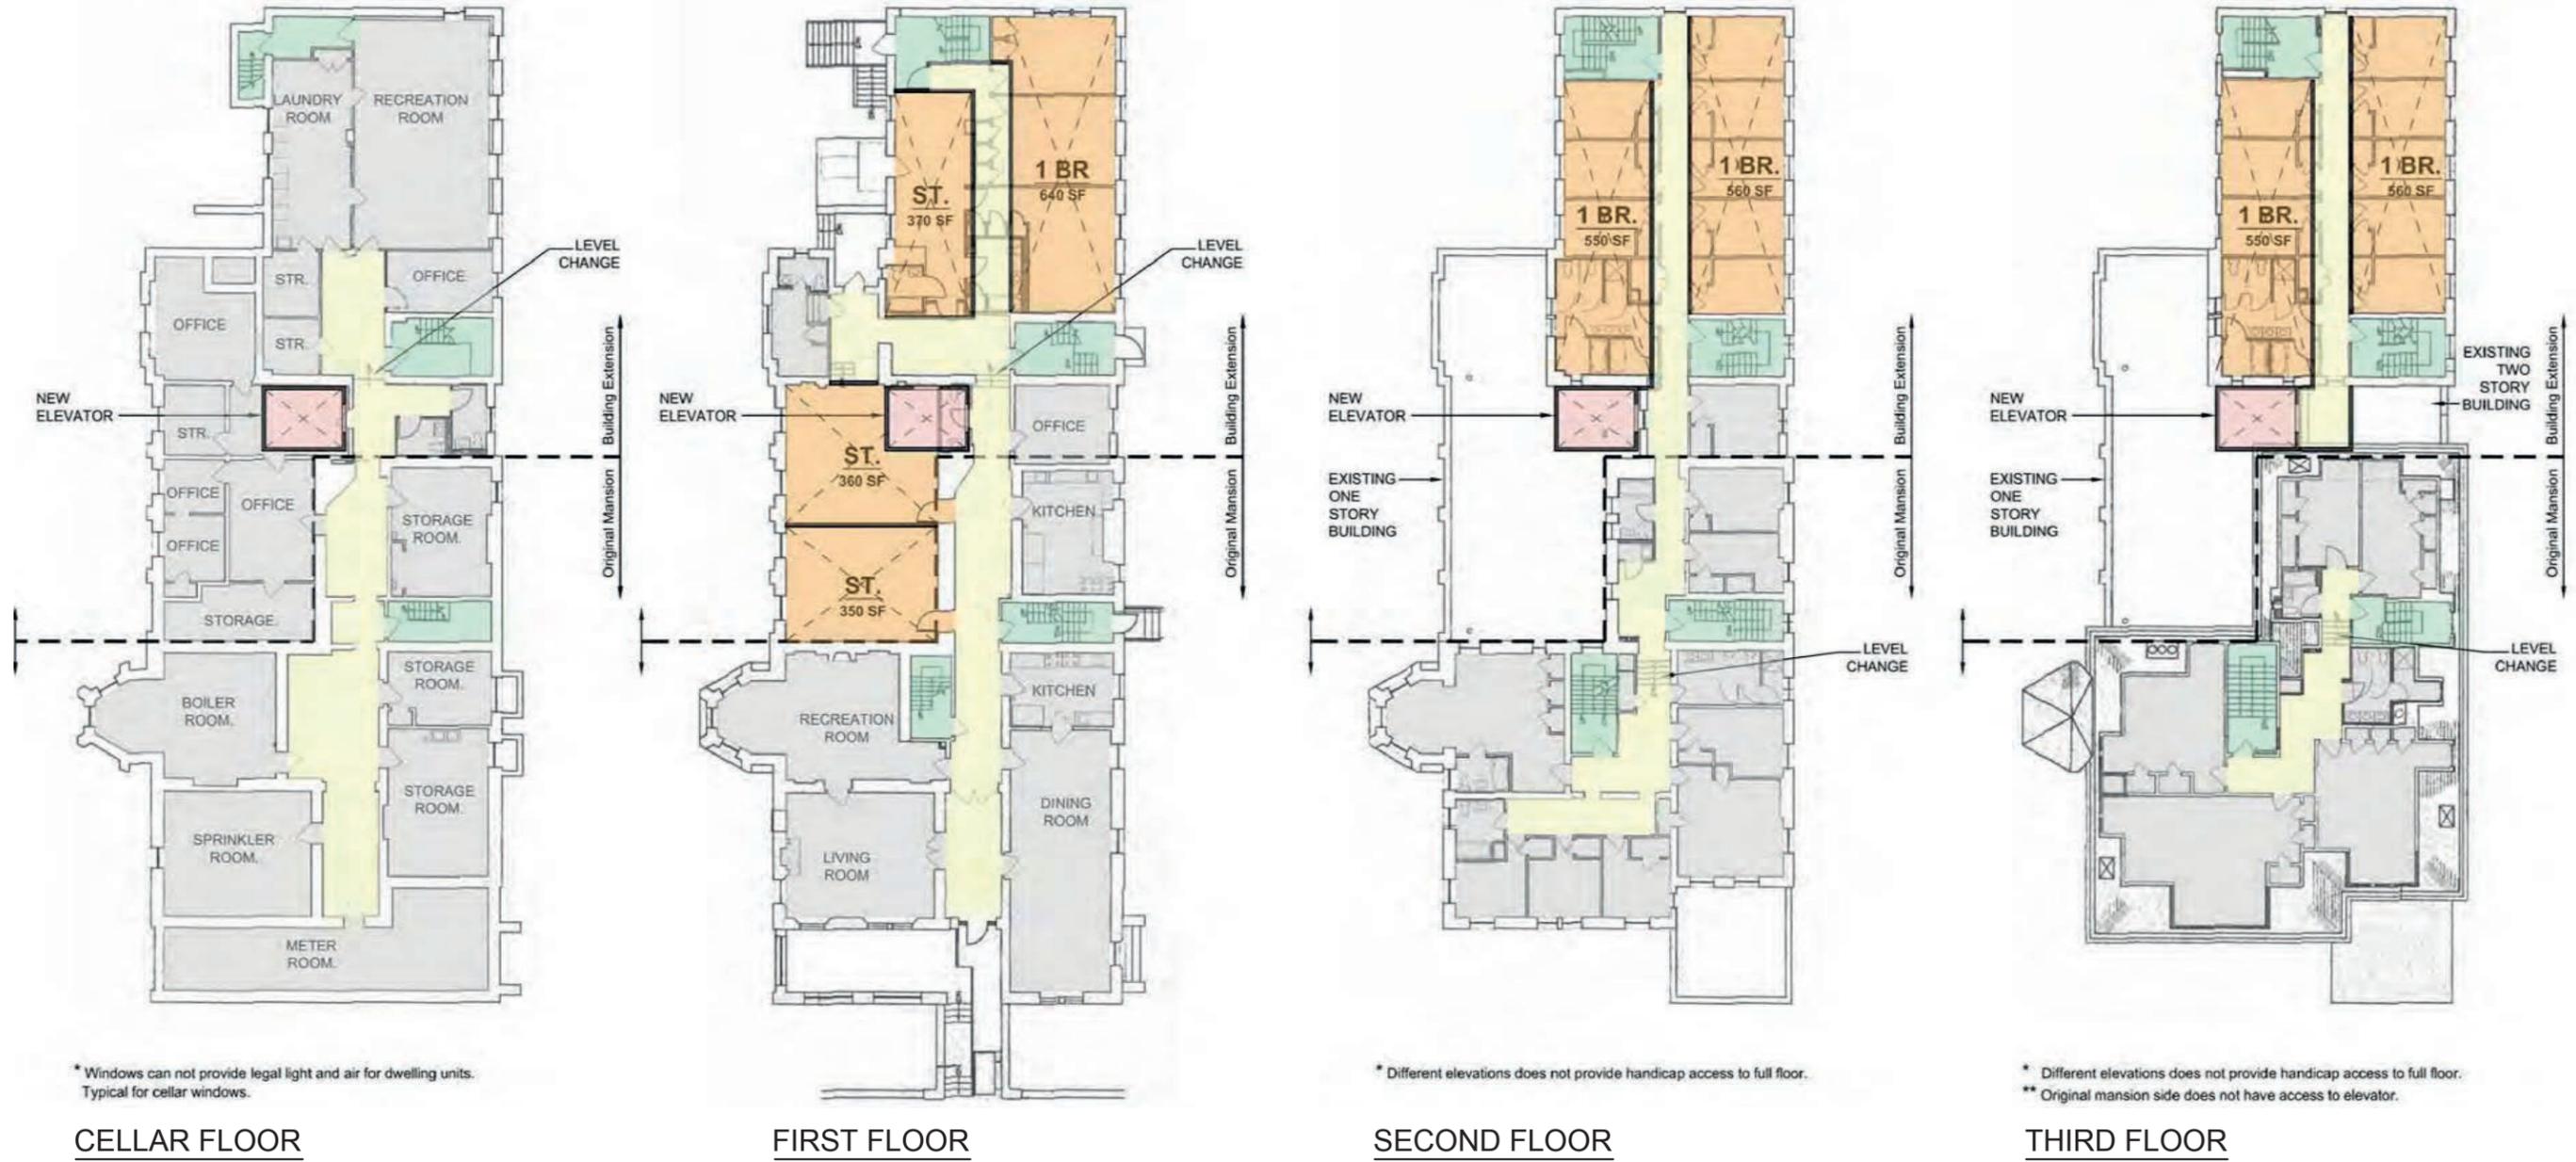
* Windows can not provide legal light and air for dwelling units. Typical for cellar windows.

* Different elevations does not provide handicap access to full floor.

* Different elevations does not provide handicap access to full floor.
 ** Original mansion side does not have access to elevator.

FLOOR	STUDIO	1 BEDROOM	TOTAL
CELLAR	0	0	0
FIRST FLOOR	3	1	4
SECOND FLOOR	0	2	2
THIRD FLOOR	0	2	2
TOTAL	3	5	8 UNITS

* TOTAL BUILDING EXTENSION SQUARE FOOTAGE = 10,639 SF
 ** TOTAL MANSION SQUARE FOOTAGE = 8,390 SF

1. ONLY 8 UNITS CAN BE PROVIDED
2. NOT HANDICAP ACCESSIBLE AT CELLAR, SECOND AND THIRD FLOOR
3. UNITS ARE NOT VERY EFFICIENT DUE TO EXISTING BUILDING SIZE

DUE TO EXISTING BUILDING SIZE/CONFIGUARTION IT WAS DEEMED TOO INEFFICIENT TO RENOVATE THE EXISTING EXTENSIONS.

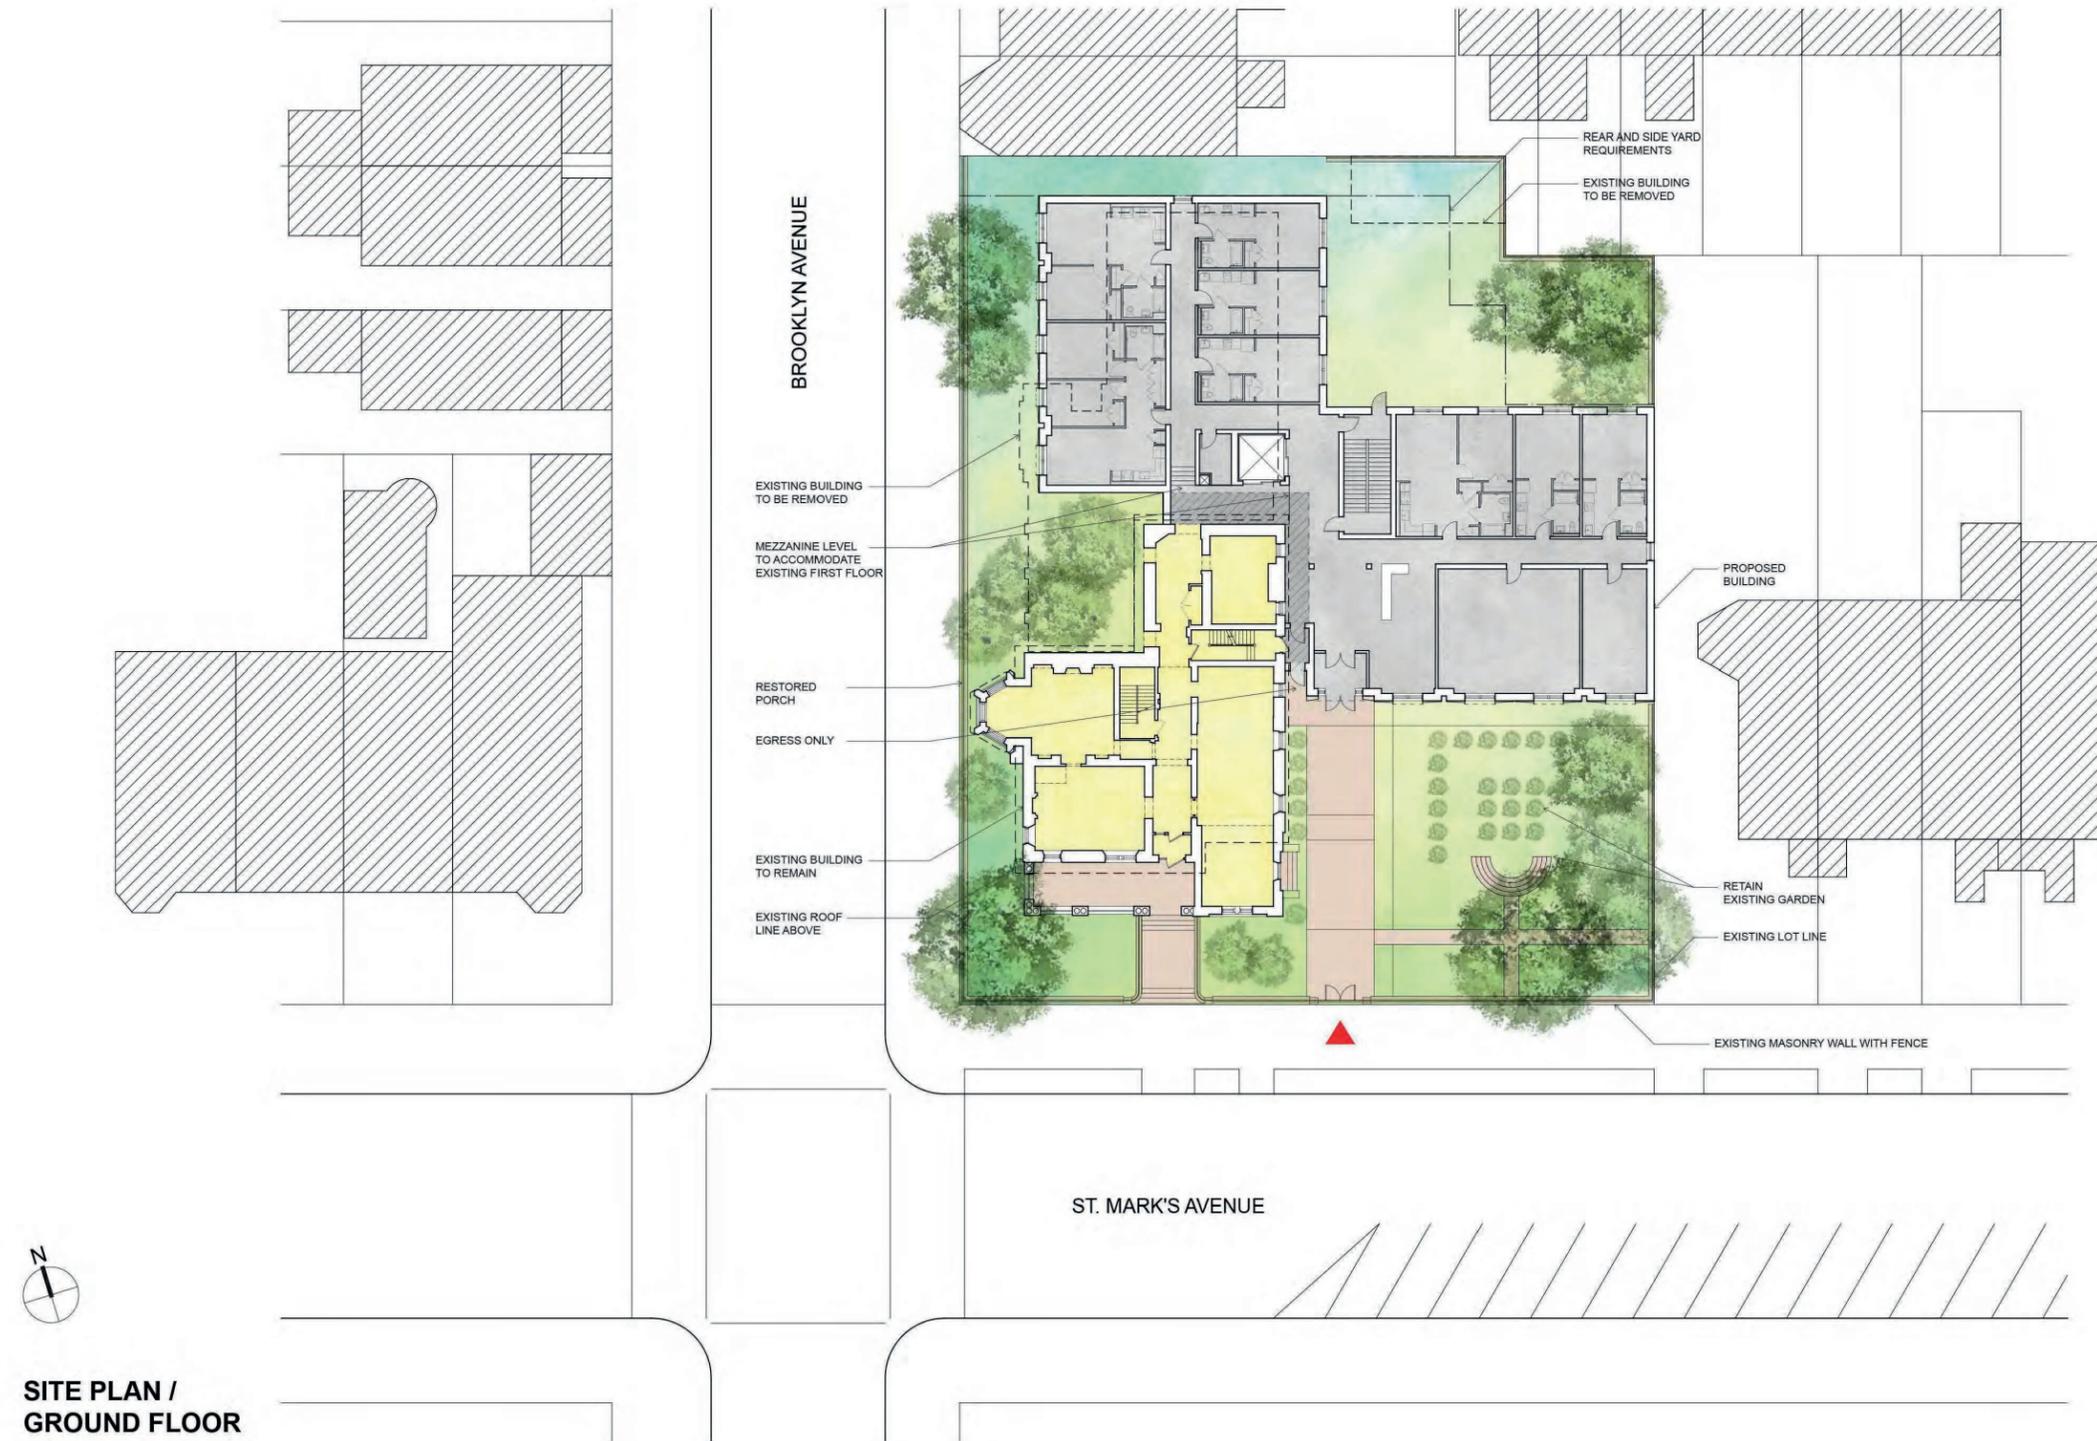
**SITE PLAN /
GROUND FLOOR**

ZONING INFORMATION	
EXISTING LOT SIZE	23,270 SF
FLOOR AREA RATIO (FAR) AT R-6 DISTRICT	2.43
ALLOWABLE SQUARE FOOTAGE	56,546 SF
EXISTING BUILDING TO REMAIN	8,390 SF
NEW ALLOWABLE ZONING SF	48,156 SF
NEW BUILDING GROSS SF	41,421 SF
NEW BUILDING ZONING SF (1.5% DEDUCTION)	40,800 SF
ALLOWABLE BUILDING HEIGHT	60 FT OR 6 STORIES
PROPOSED BUILDING HEIGHT	52 FT AND 5.5 STORIES

DWELLING UNIT COUNT							
FLOOR	RENOVATION			NEW			TOTAL UNITS
	ST	1BR	2BR	ST	1BR	2BR	
6	-	-	-	5	1	-	6
5	-	-	-	10	2	1	13
4	-	-	-	10	2	1	13
3	2	-	-	10	2	1	15
2	4	-	-	10	2	1	17
1	-	-	-	6	2	1	9
BASE	-	-	-	-	-	-	-
TOTAL	6	-	-	51	11	5	73
