Building Modernization & 5th Floor Addition 61-63 Crosby Street

Filing to NYC Landmarks Preservation in preparation for Public Hearing
Supplement to NYC DOB Alt I Application Job #122784923
Aug 10, 2016

61-63 Crosby Street - Proposed Elevation

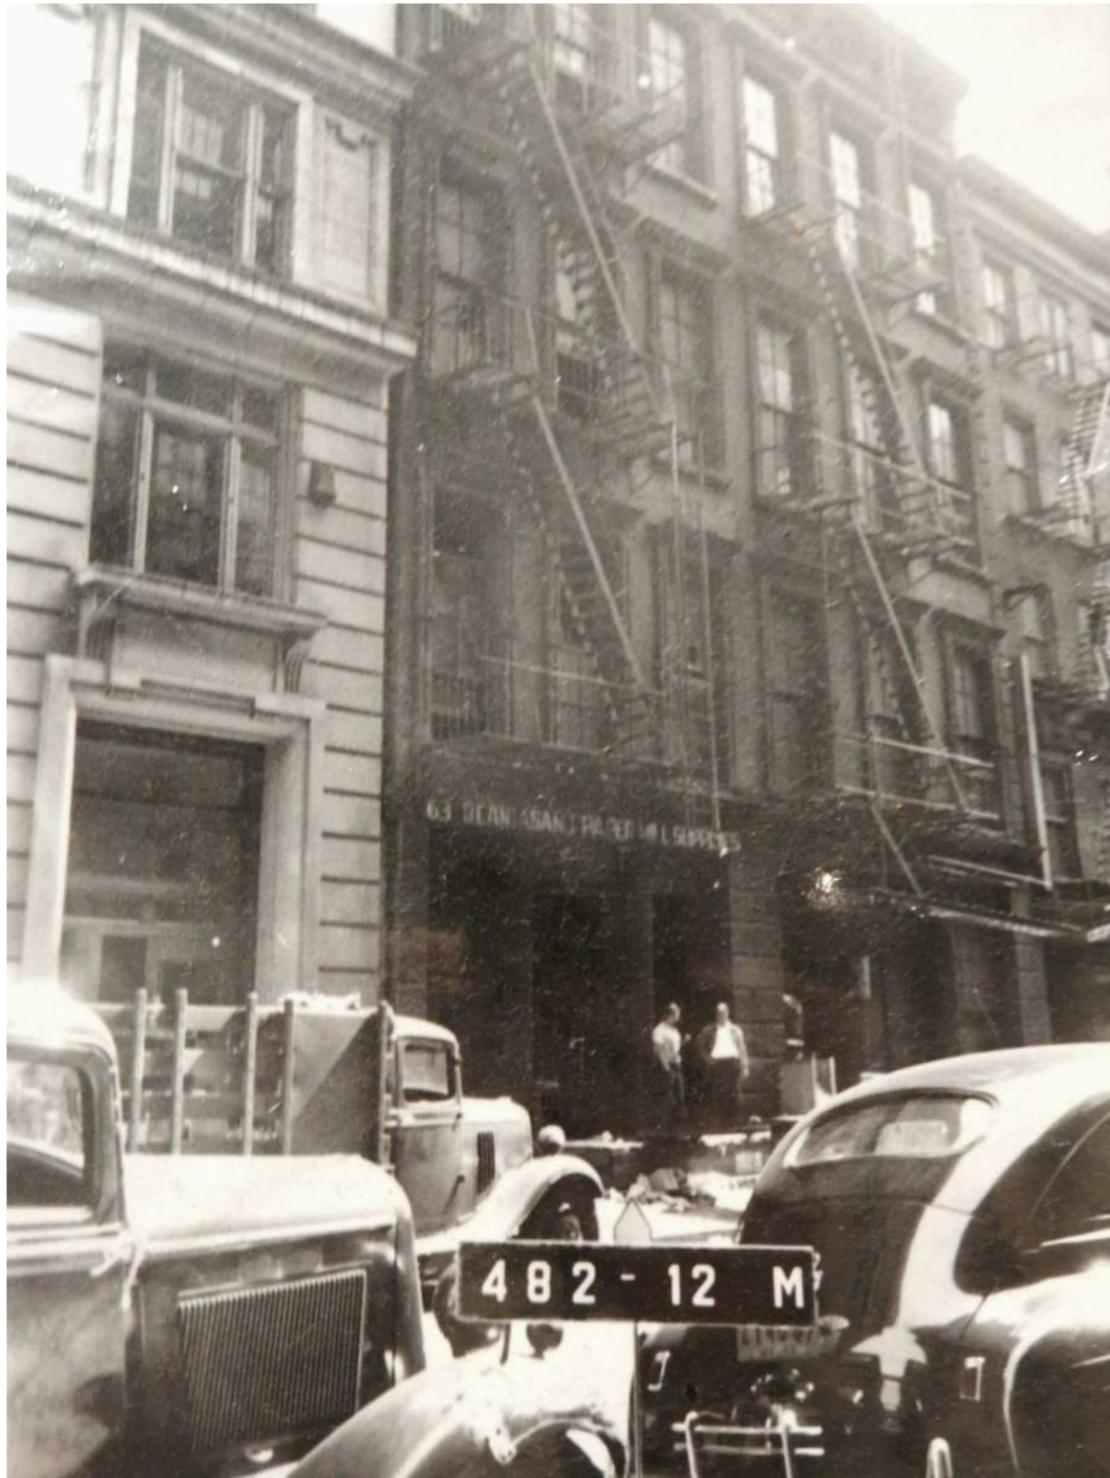
Historic Tax Photo (1940s est.); note 4 over 4 window design, and projecting cornices over window openings since removed

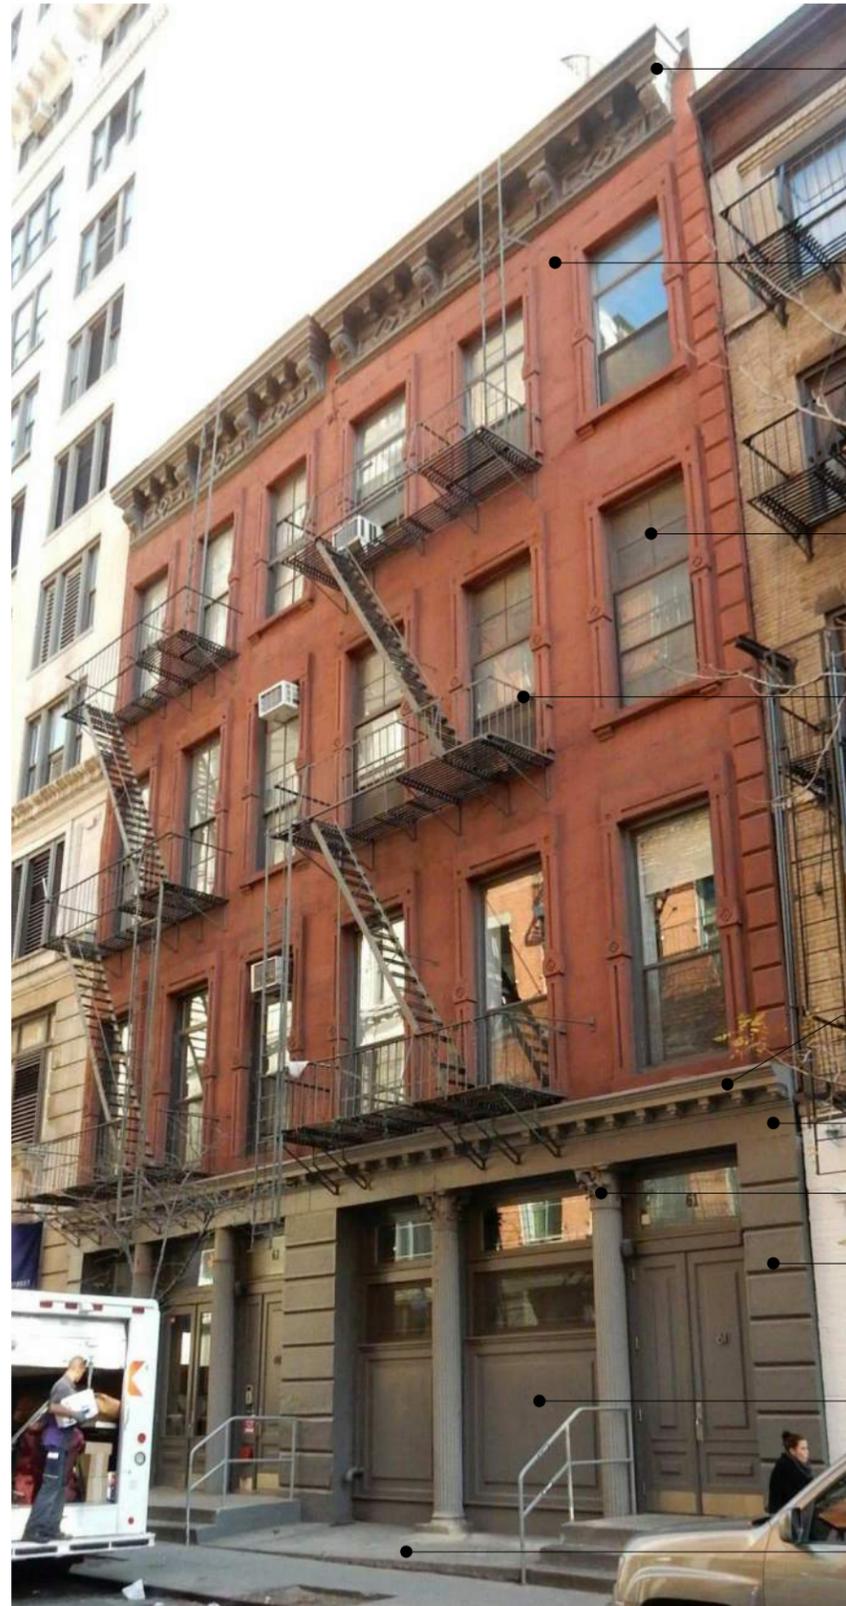
61-63 Crosby Street - Photo of Crosby Street Facade

- Painted metal cornice (typ.)
- 4" Brownstone veneer over load bearing brick masonry wall coated with sanded paint (typ.)
- Non-historic window (typ. for all windows)
- Non-historic fire escapes (appear to have been added to building in 1930s)
- Painted metal cornice (typ.)
- Painted cast iron girder (typ.)
- Painted cast iron column (typ.)
- Rusticated Brownstone pier with sanded paint finish (typ.)
- Non-historic wood storefront (typ.)
- Non-historic sidewalk (typ.)

- 5. Removal of Fire Escapes:** We are proposing to remove the existing non-historic fire escapes as illustrated in this package. We are seeking a staff-level review at LPC for this work, and will note that it is being done in connection with the provision of a modern interior egress system, in full compliance with NYC 2014 Construction Codes, including two new fire stairs and a new passenger elevator.

- 6. Contributing Facade Repairs:** We are proposing to repair and recoat the existing brownstone contributing facade as illustrated in this package. We are seeking a staff-level review at LPC and are not proposing any alterations to existing details or masonry openings. We are proposing a change of color from the existing, and are working with Jablonski Building Conservation to establish the original color of the stone and what coatings were used in the past as means of informing the new color palette.

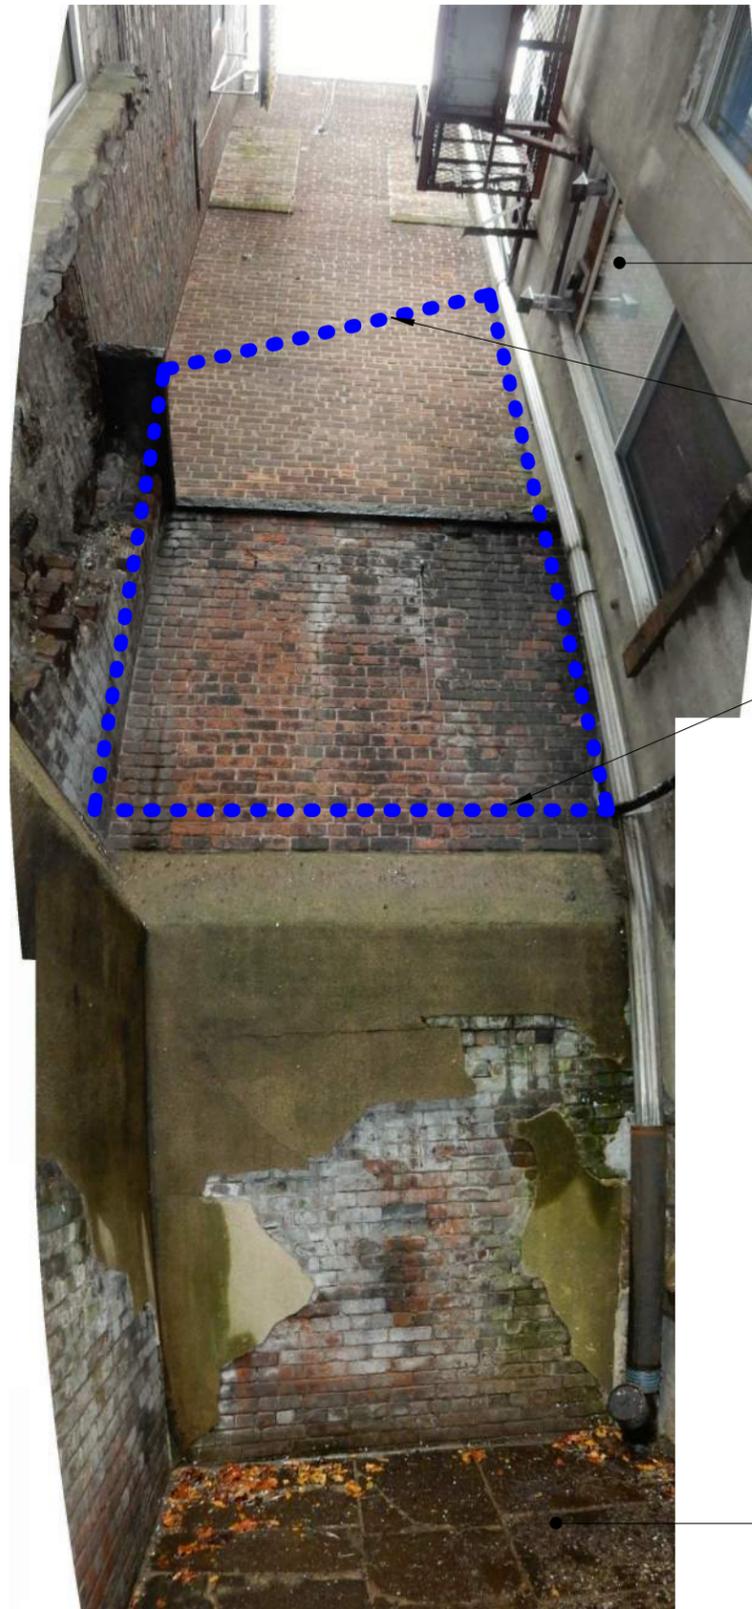
61-63 Crosby Street - Photo of south face of existing Rear Yard

1st Fl Windows
(not historic)

Approx. line of
proposed skylight
at 1st fl extension

Approx. line of
proposed
1st fl extension

- 3. 1st Fl Rear Yard Extension:** We are proposing to enclose the 1st fl of the rear yard of 61 Crosby (the south half of the building) for occupied space as illustrated in this package. The new bulk of this 1st floor extension is as-of-right in reference to NYC Zoning. We are seeking a staff-level review at LPC and note that it will only affect a rear (non-contributing) facade and will not be visible from any public way or space.

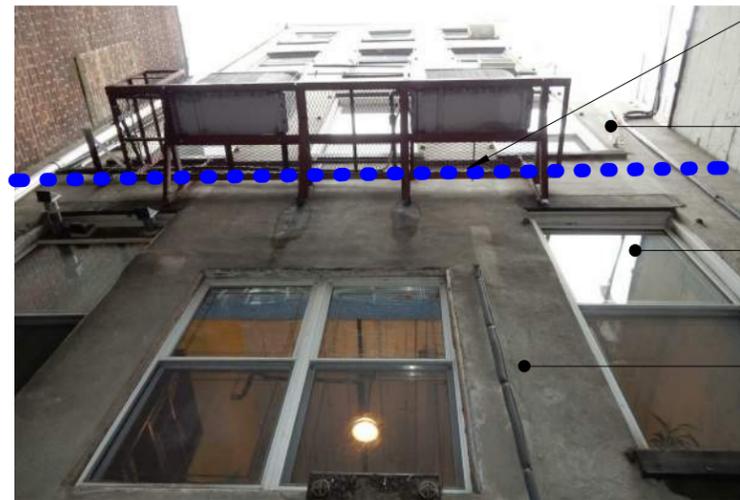
61-63 Crosby Street - Photo of west face of existing Rear Yard

Approx. line of
proposed skylight
at 1st fl extension

Rear wall of
61 Crosby

Non-historic
windows
(typ.)

1st fl portion of
rear wall to be
removed for
proposed 1st fl
extension

Yard at
Cellar Level

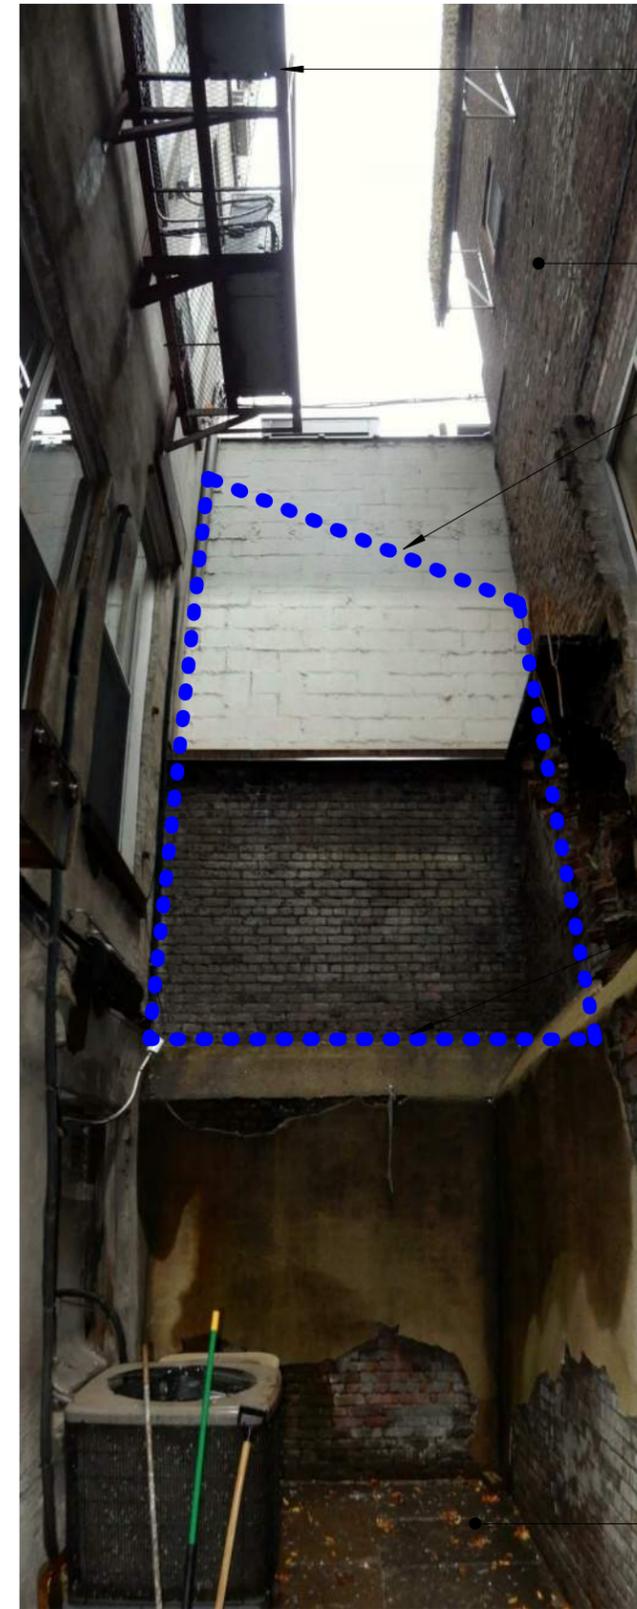
61-63 Crosby Street - Photo of north face of existing Rear Yard

Non-historic
equipment
platform to be
removed (typ.)

Face of rear wall of
220 Lafayette (built
to lot line)

Approx. line of
proposed skylight
at 1st fl extension

Approx. line of
proposed
1st fl extension

Yard at
Cellar Level

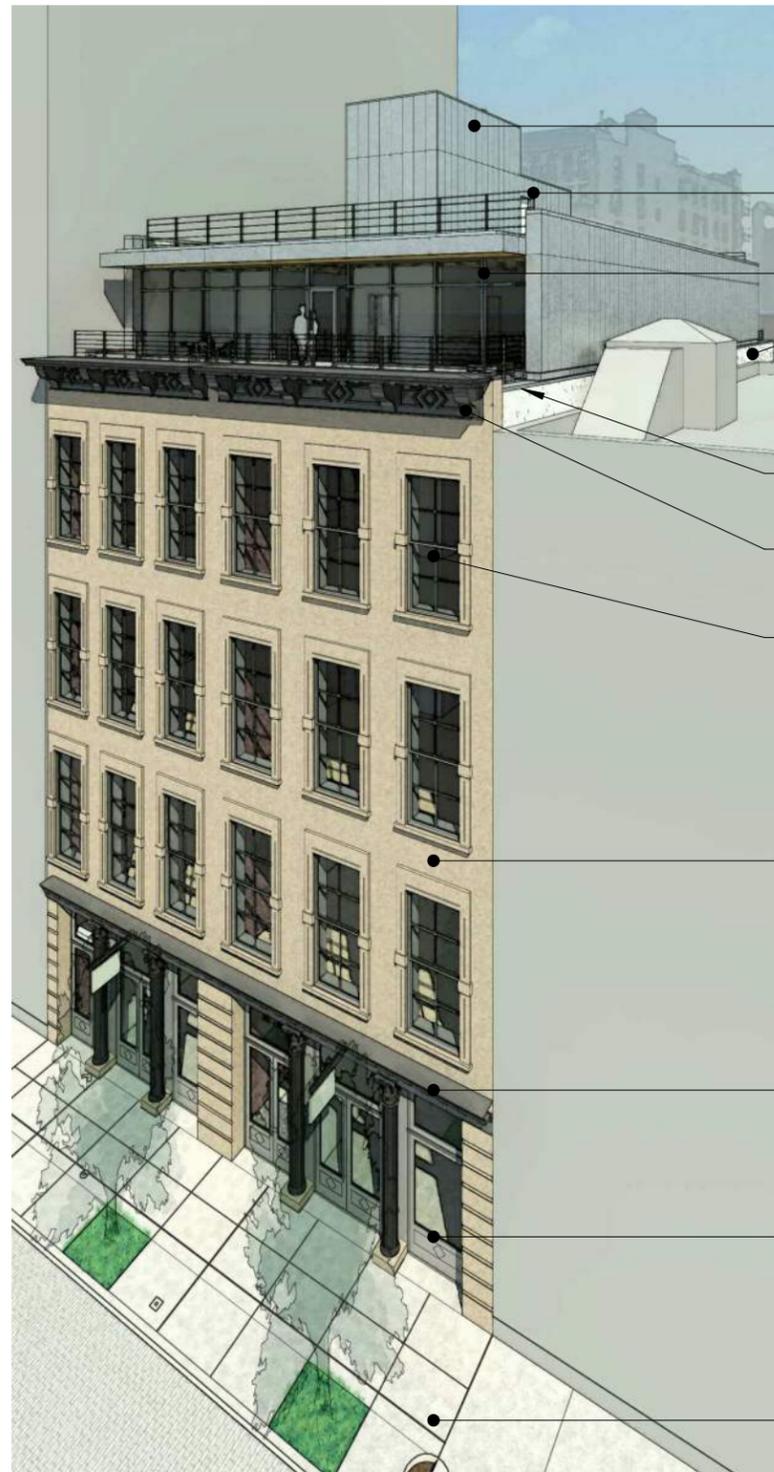
61-63 Crosby Street - Proposed Facade

- Flat seam metal cladding (typ.)
- New painted steel guardrails (typ.)
- New painted aluminum curtain wall (typ.)
- Selectively repair & repaint to match stucco at side & rear walls (typ.)
- New bluestone copings and trim (typ.)
- Restore sheet metal cornice (typ.)
- Selective replacement of existing windows under separate application (typ.)
- Repair & recoat Brownstone
- Restore painted cast iron columns, girder, and sheet metal cornice
- New painted mahogany storefront
- New sidewalk and tree pits under separate application (typ.)

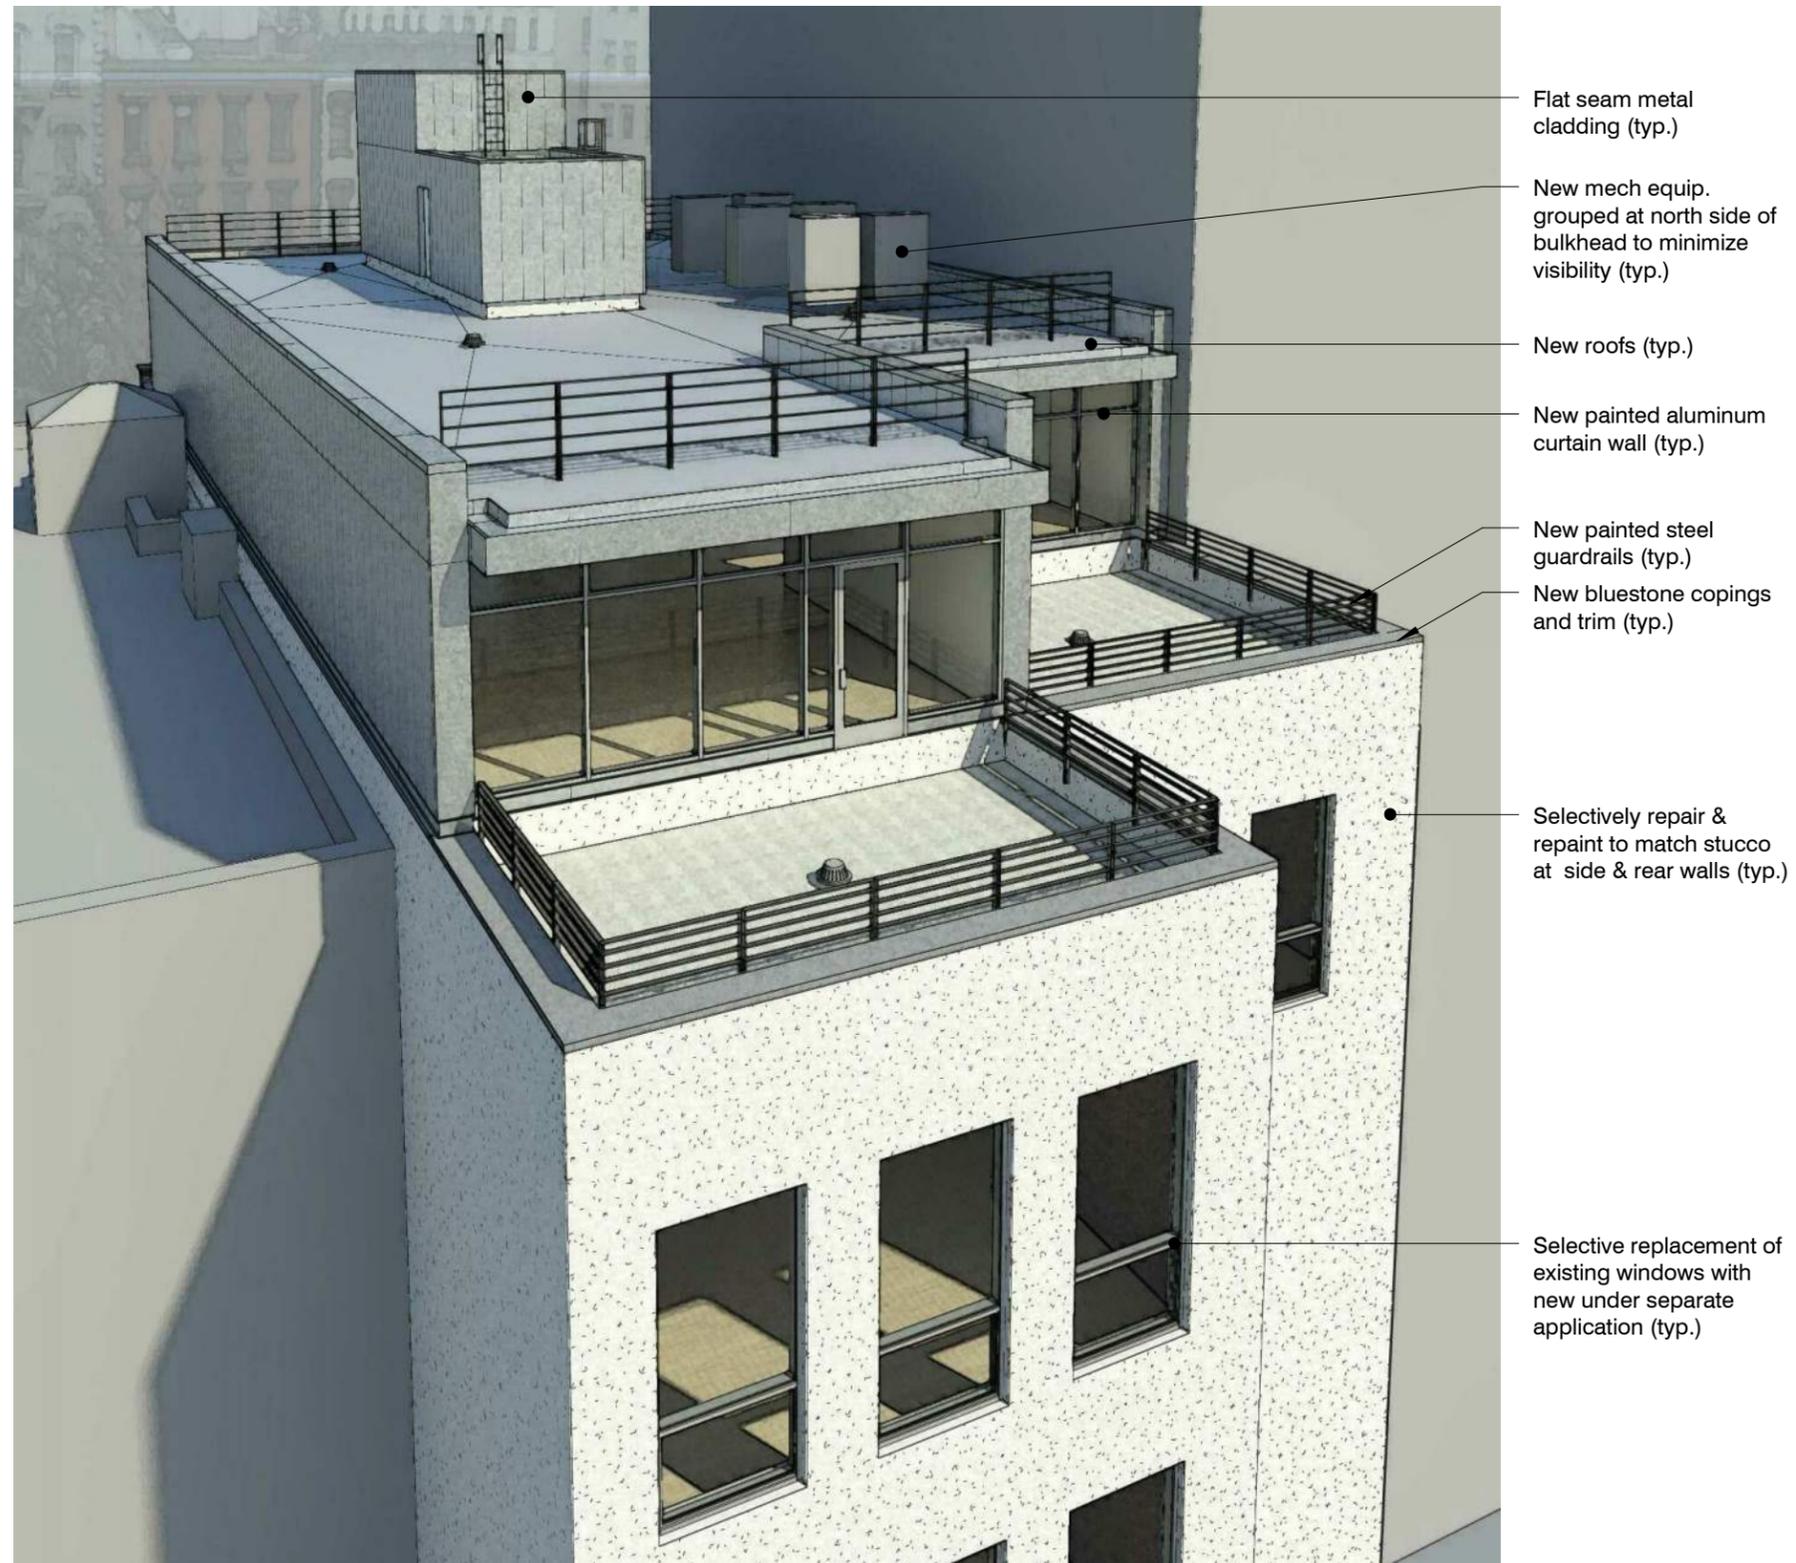
61-63 Crosby Street - View of Proposed Rooftop Addition at Rear of Property

- Flat seam metal cladding (typ.)
- New mech equip. grouped at north side of bulkhead to minimize visibility (typ.)
- New roofs (typ.)
- New painted aluminum curtain wall (typ.)
- New painted steel guardrails (typ.)
- New bluestone copings and trim (typ.)
- Selectively repair & repaint to match stucco at side & rear walls (typ.)
- Selective replacement of existing windows with new under separate application (typ.)

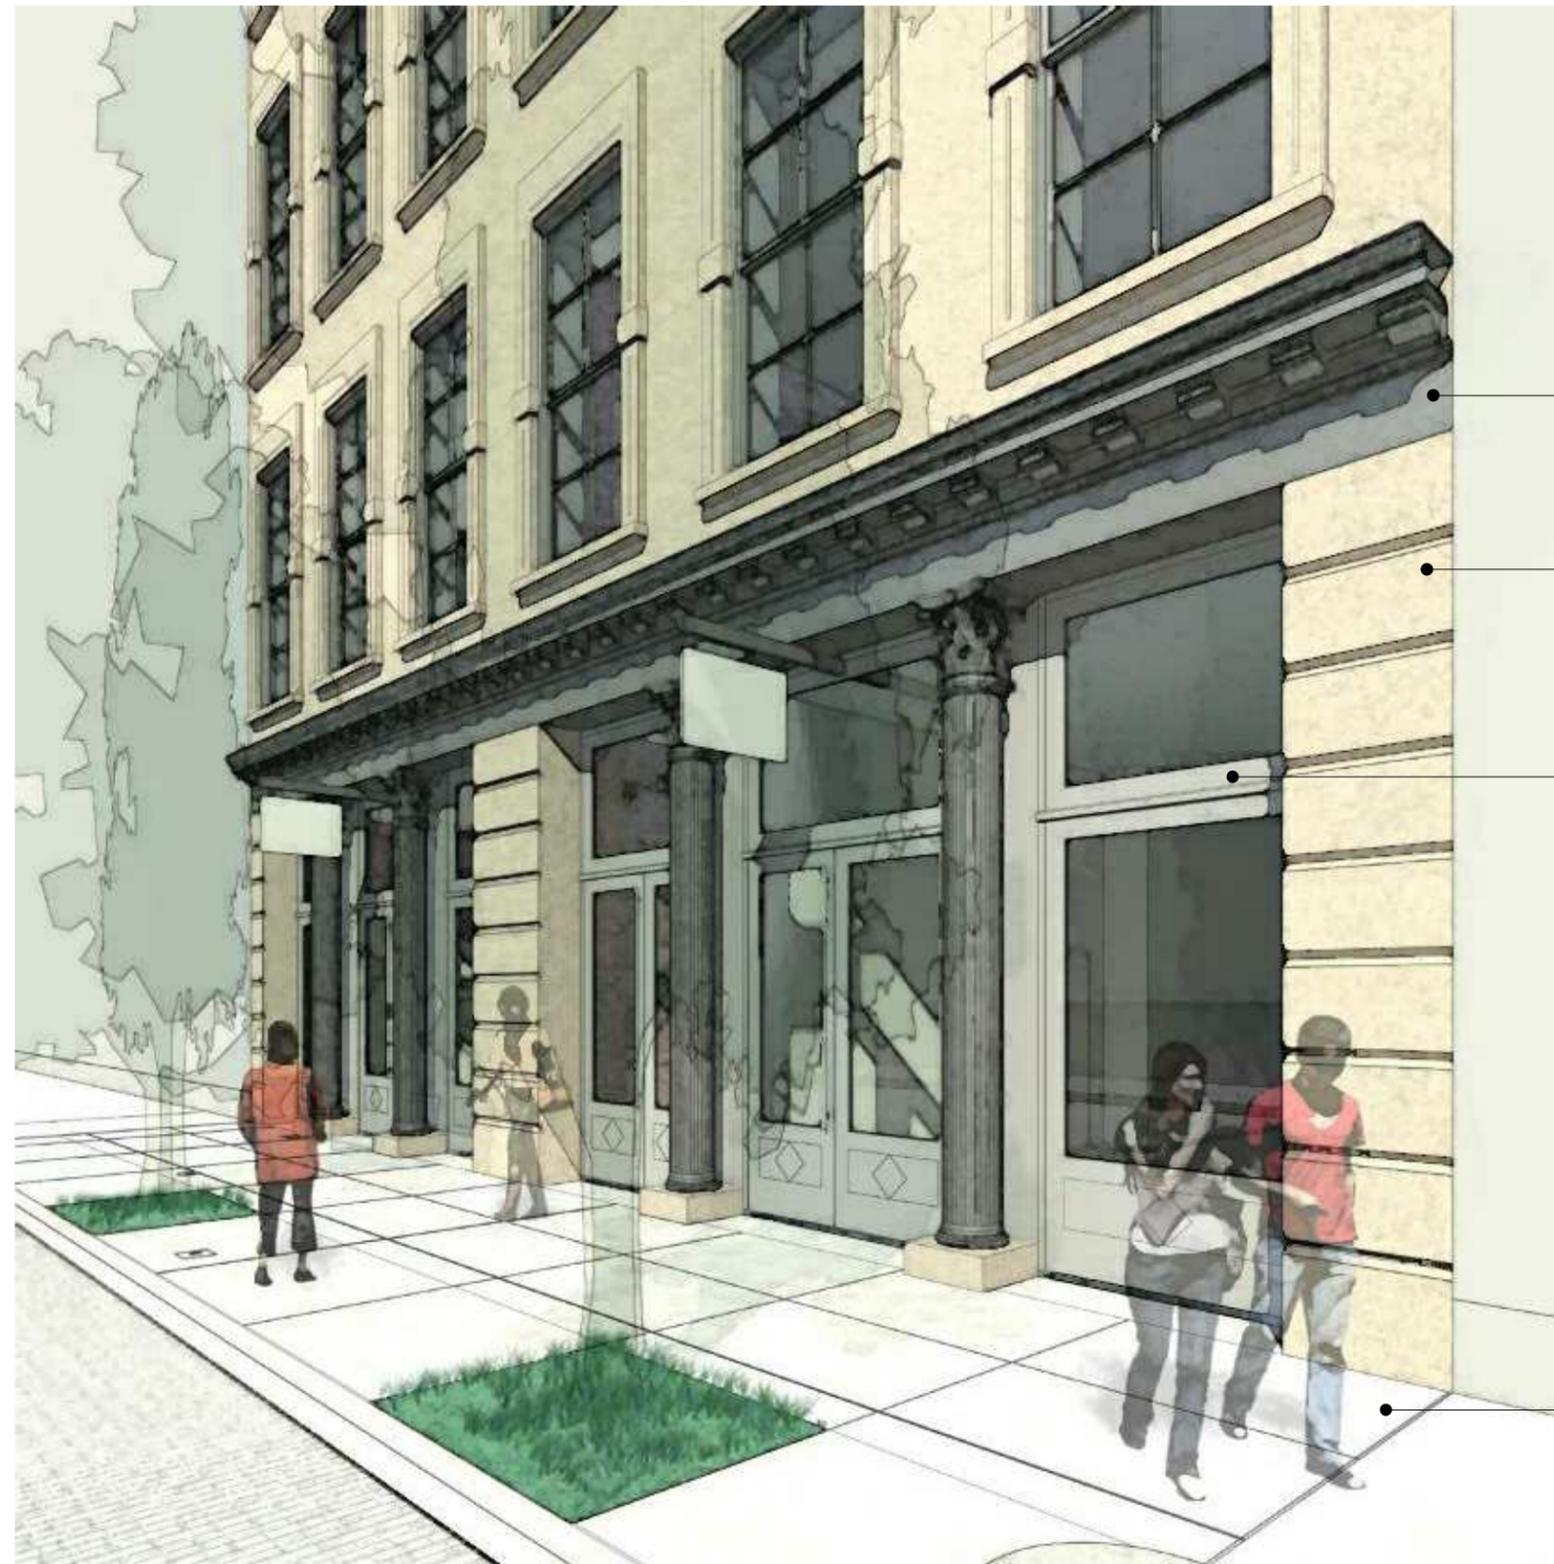
61-63 Crosby Street - Proposed Storefront

Restore painted cast iron columns, girder, and sheet metal cornice

Repair & recoat Brownstone

New painted mahogany storefront

New sidewalk and tree pits under separate application (typ.)

- 4. Ground Floor Storefront Replacement:** We are proposing to replace the existing non-historic storefront with a new wood & glass storefront as illustrated in this package. We are seeking a staff-level review at LPC and, accordingly, have designed the new storefront with reference to LPC's prescriptive guidelines and in context with the building's historic details.

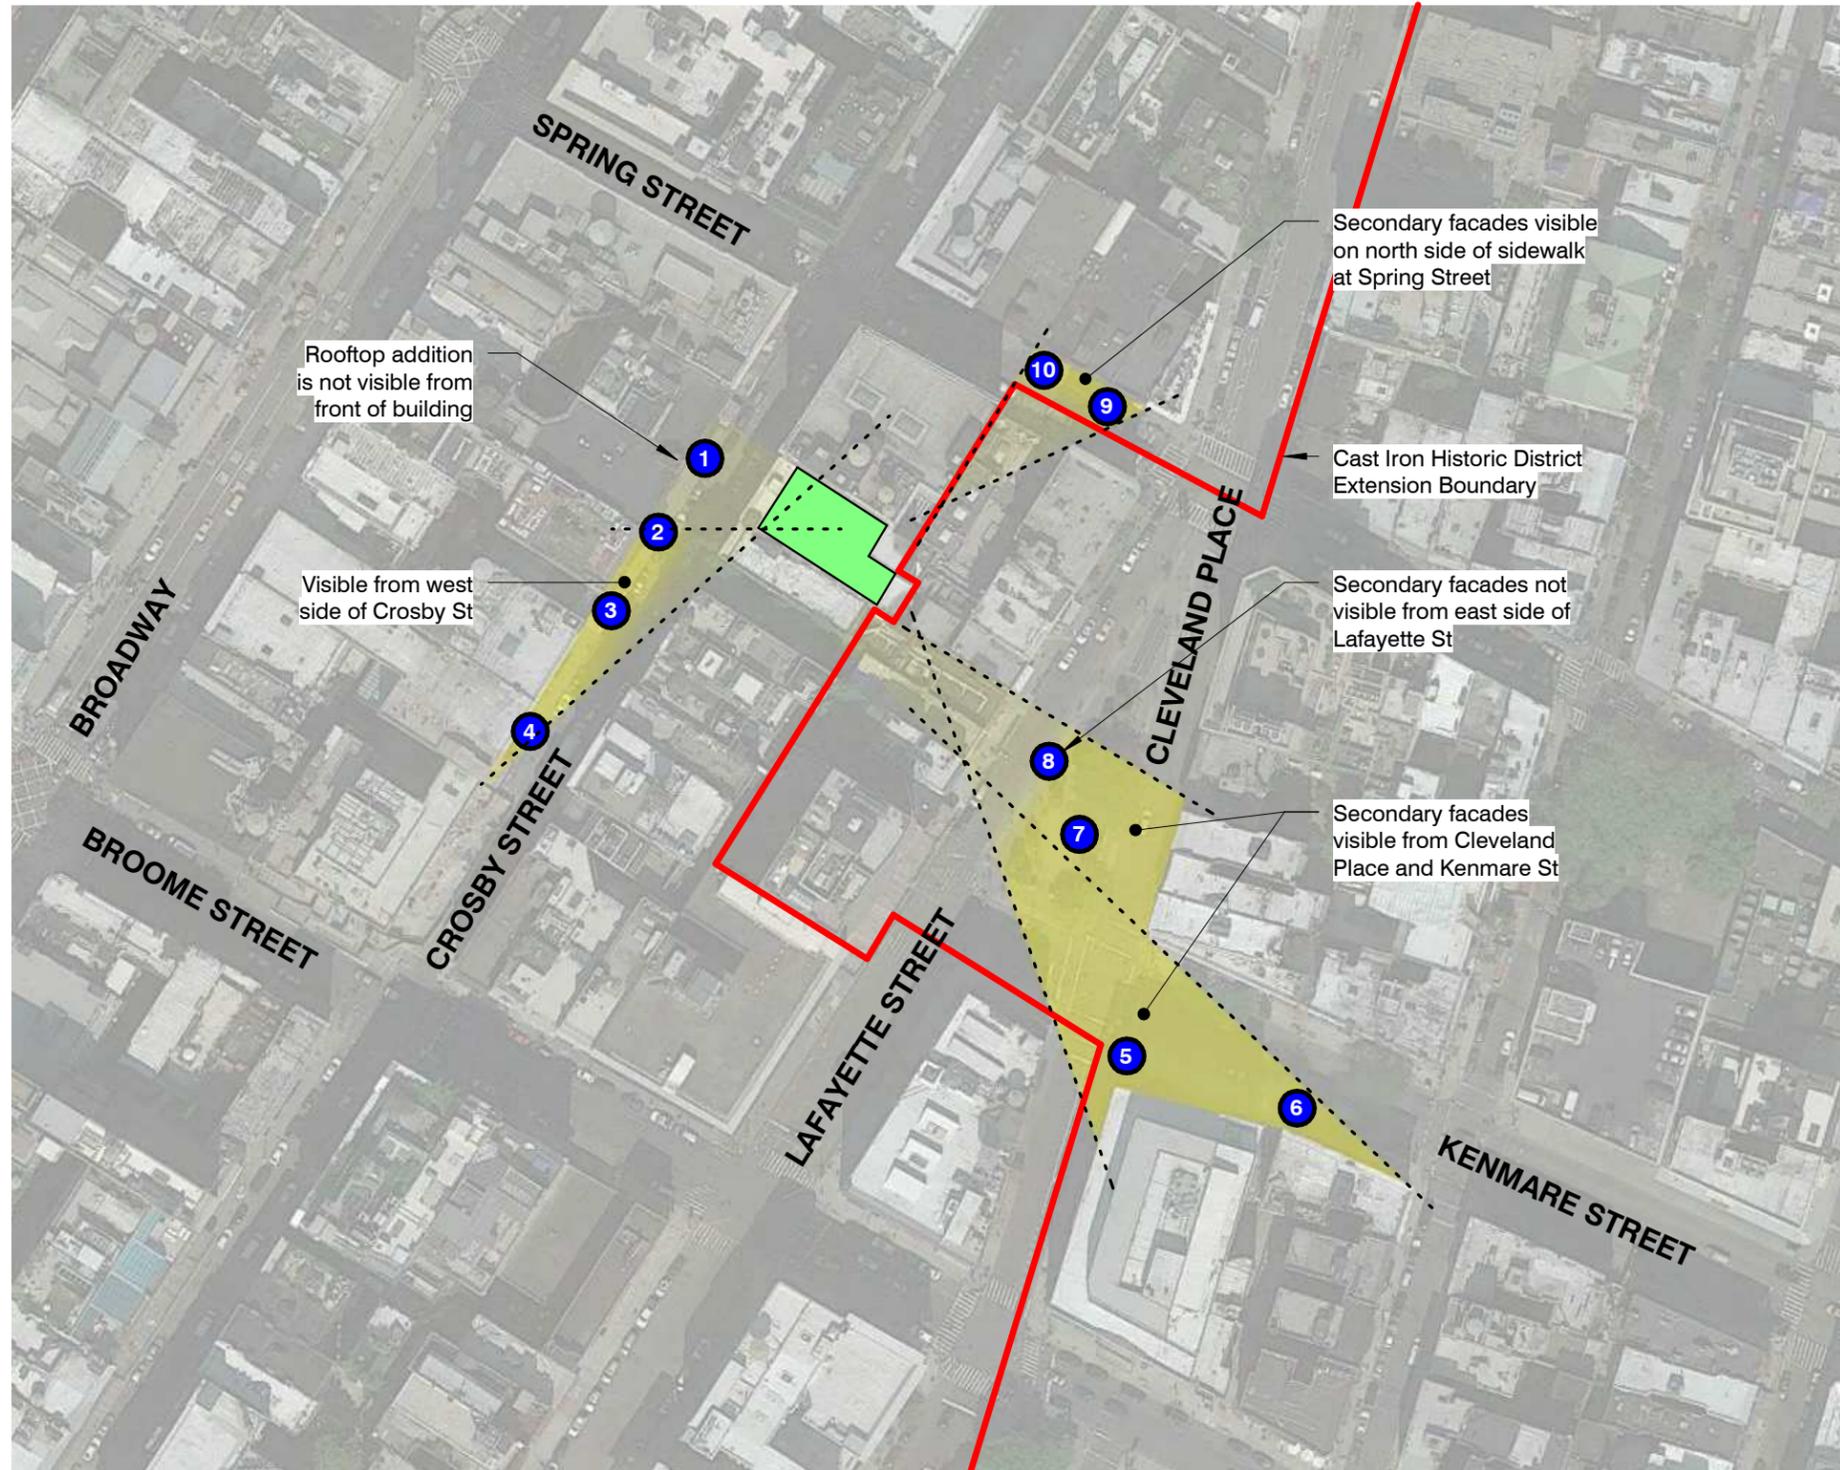
Site Diagram showing areas where Rooftop Addition is visible from sidewalk; see site photos for additional information

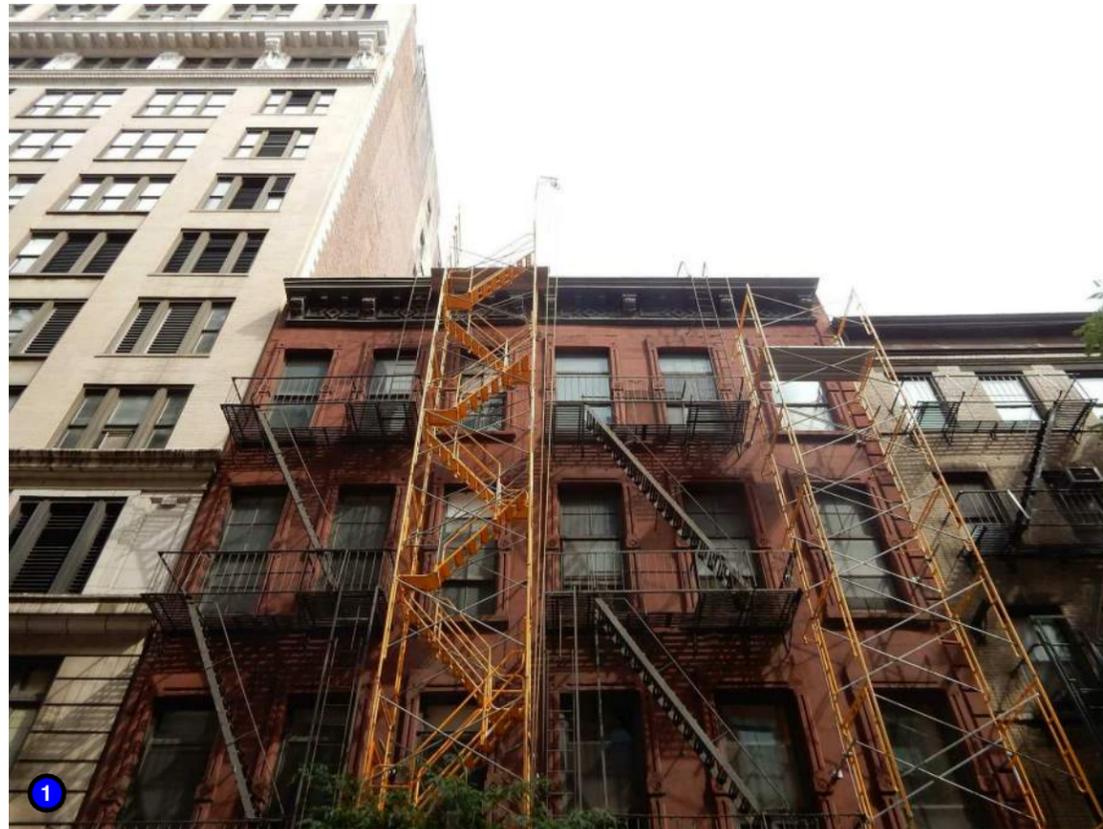
FIG 1: 61-63 CROSBY ST LKG EAST, ROOFTOP ADDITION IS NOT VISIBLE FROM FRONT OF BUILDING

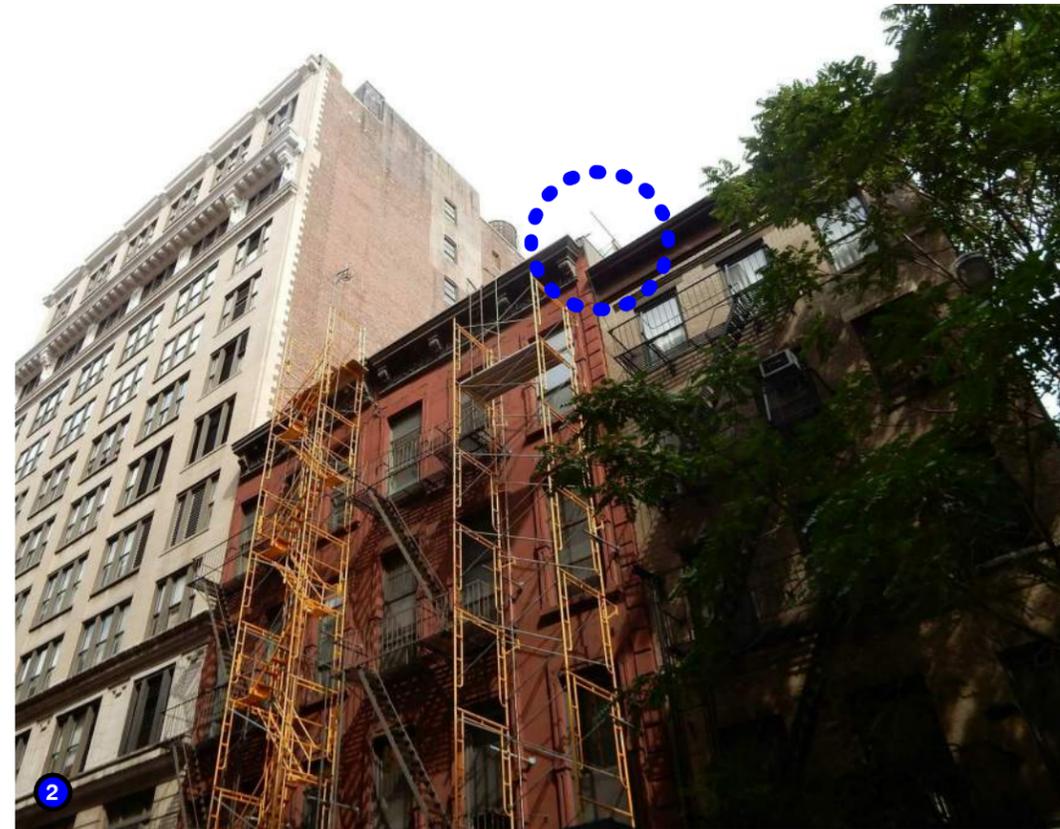
FIG 2: 59 CROSBY LKG NE, SW CORNER OF ROOFTOP ADDITION IS VISIBLE

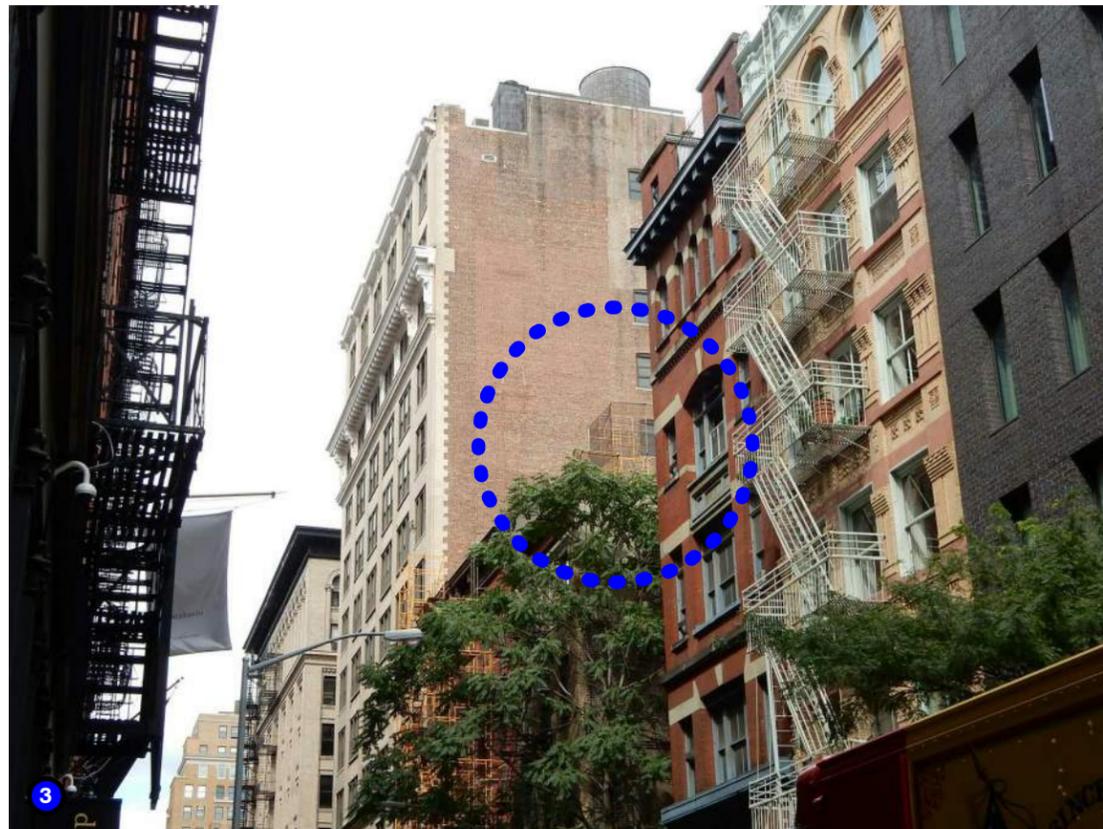
FIG 3: 49 CROSBY ST LKG NE, ROOFTOP ADDITION IS VISIBLE

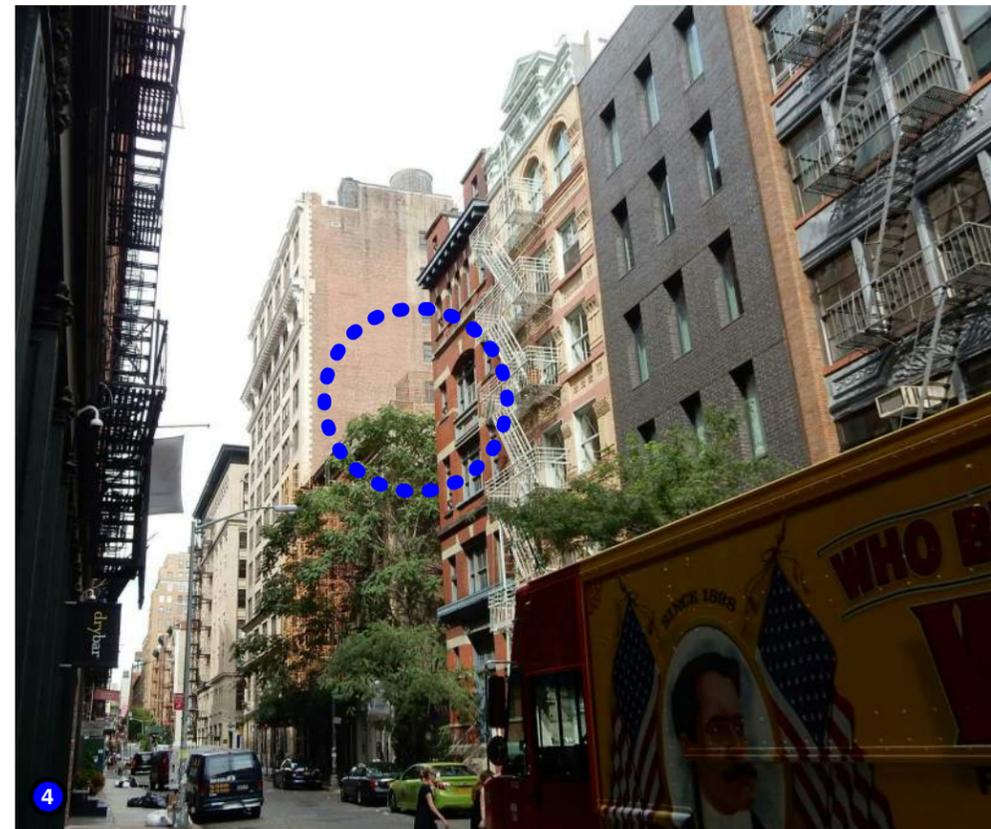
FIG 4: 43 CROSBY ST LKG NE, ROOFTOP ADDITION IS BECOMING LESS VISIBLE

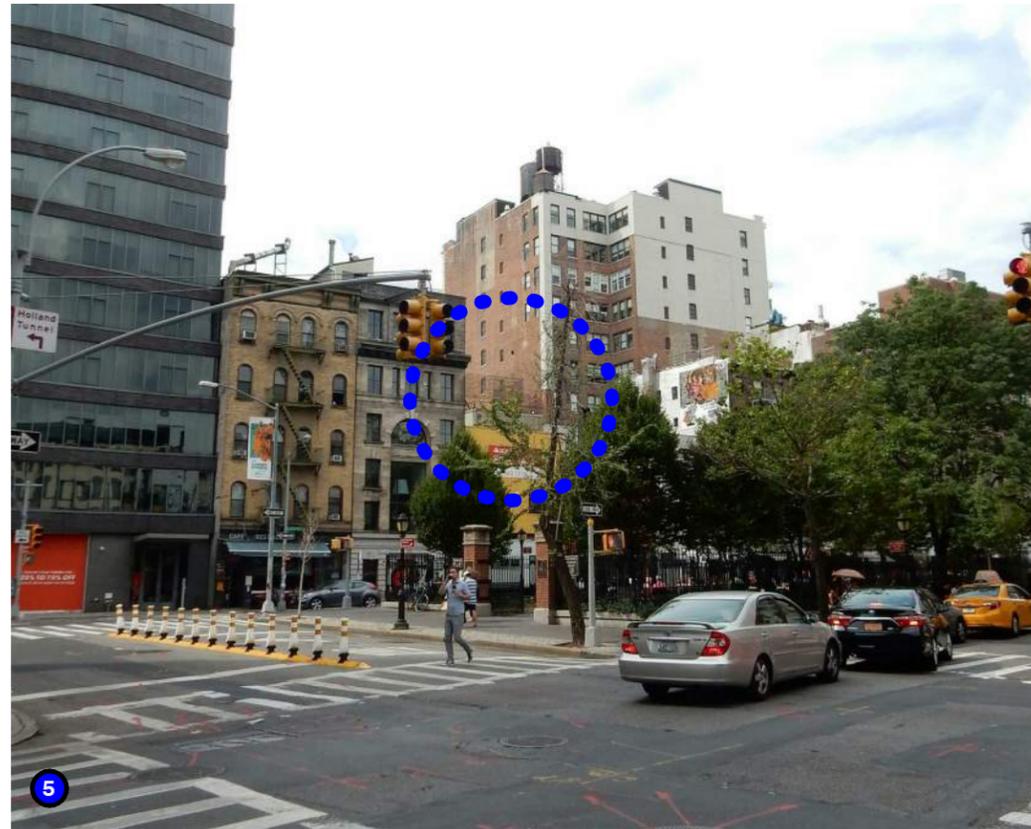
FIG 5: KENMARE & CLEVELAND PL LKG NW, ROOFTOP ADDITION VISIBLE (SECONDARY FACADE)

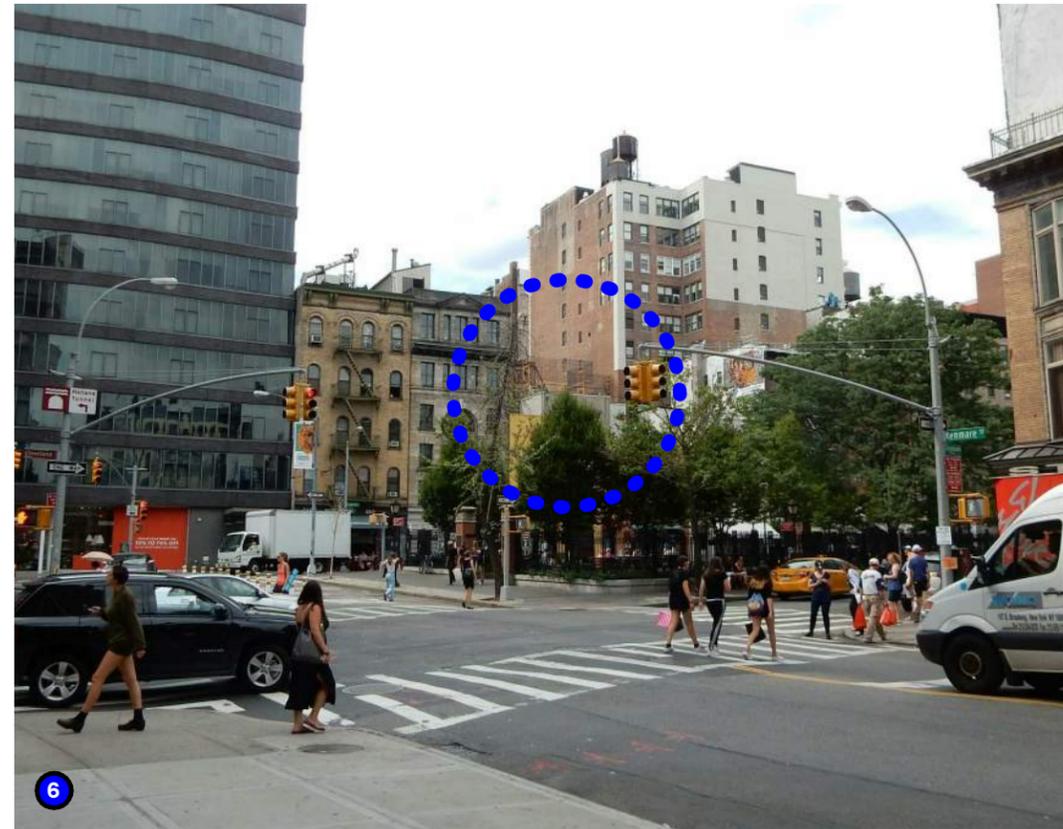
FIG 6: MIDBLOCK ON KENMARE LKG W, ROOFTOP ADDITION VISIBLE (SECONDARY FACADE)

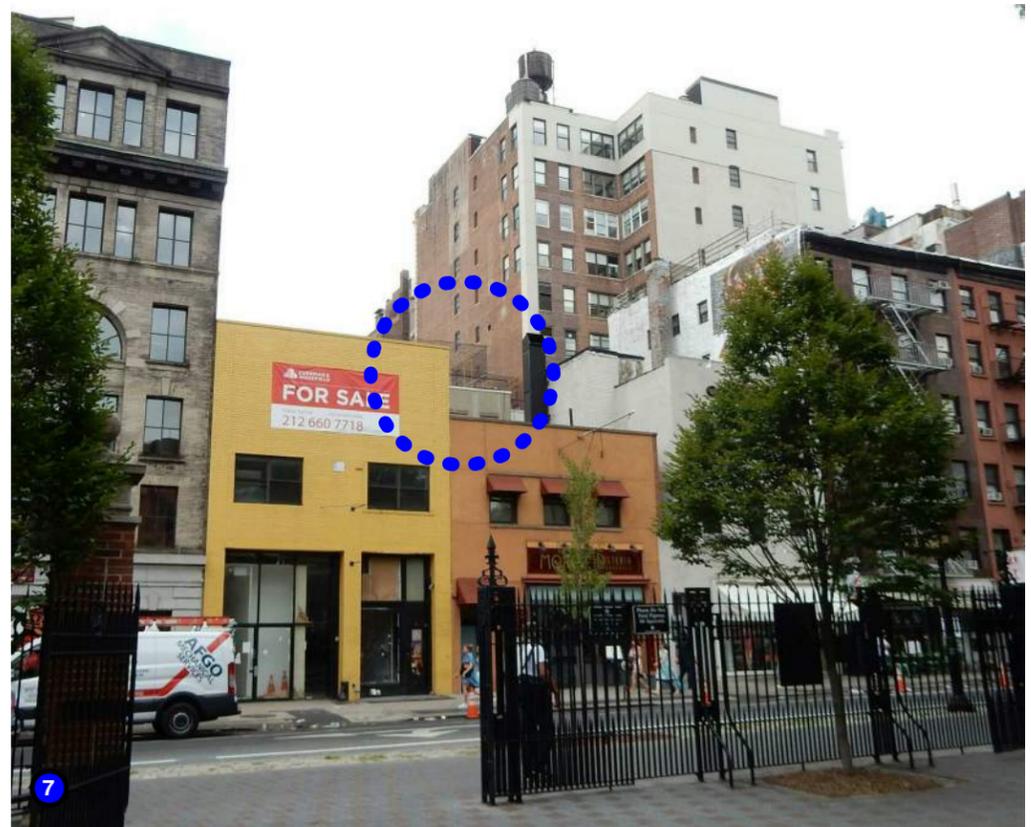
FIG 7: PETROSINO SQUARE LKG W, ROOFTOP ADDITION VISIBLE (SECONDARY FACADE)

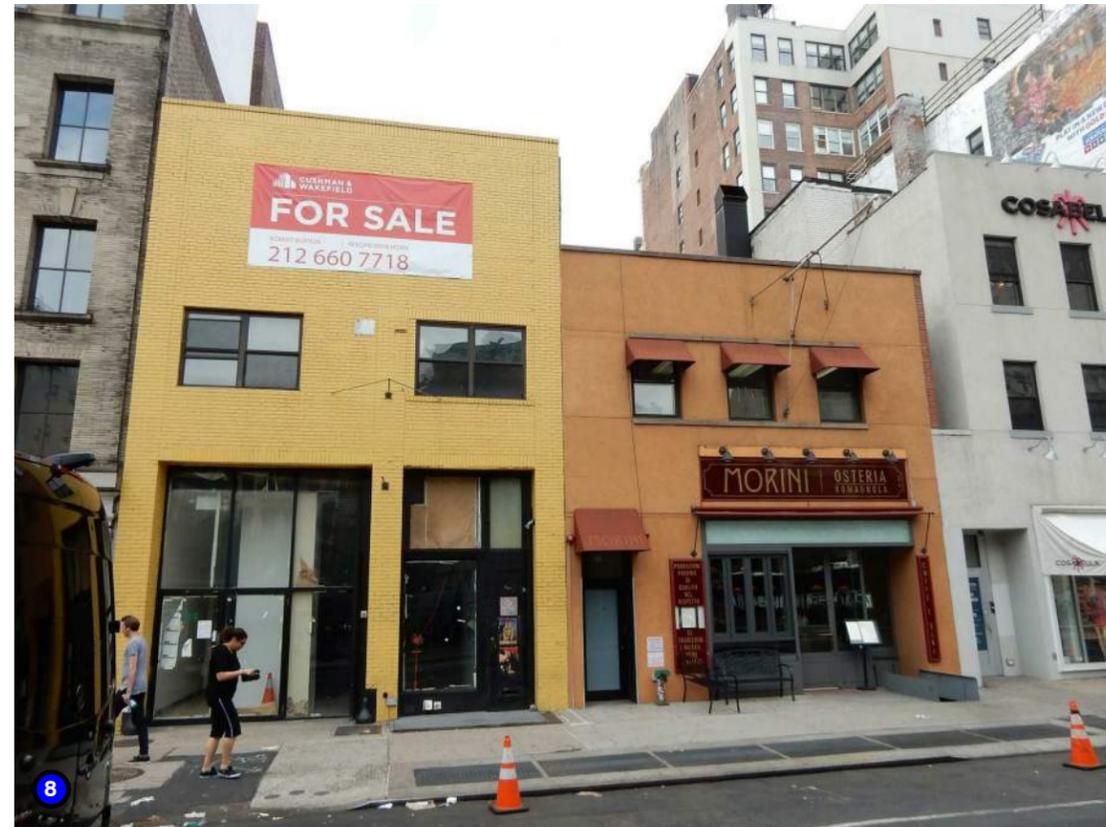
FIG 8: EAST SIDE OF LAFAYETTE ST, ROOFTOP ADDITION NOT VISIBLE
