Building Modernization & 5th Floor Addition 61-63 Crosby Street

Filing to NYC Landmarks Preservation in preparation for Public Hearing
Supplement to NYC DOB Alt I Application Job #122784923
Aug 10, 2016

61-63 Crosby Street - Proposed Elevation

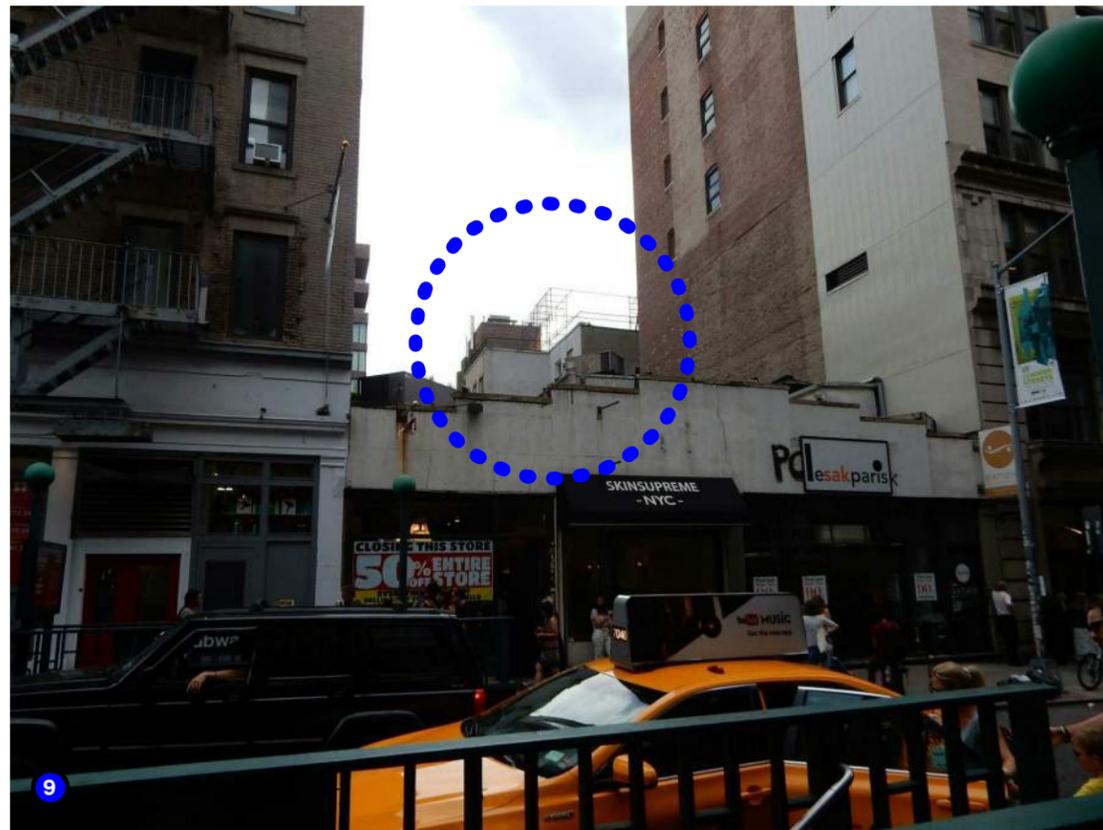
FIG 9: SPRING ST LKG S, ROOFTOP ADDITION VISIBLE (SECONDAY FACADE)

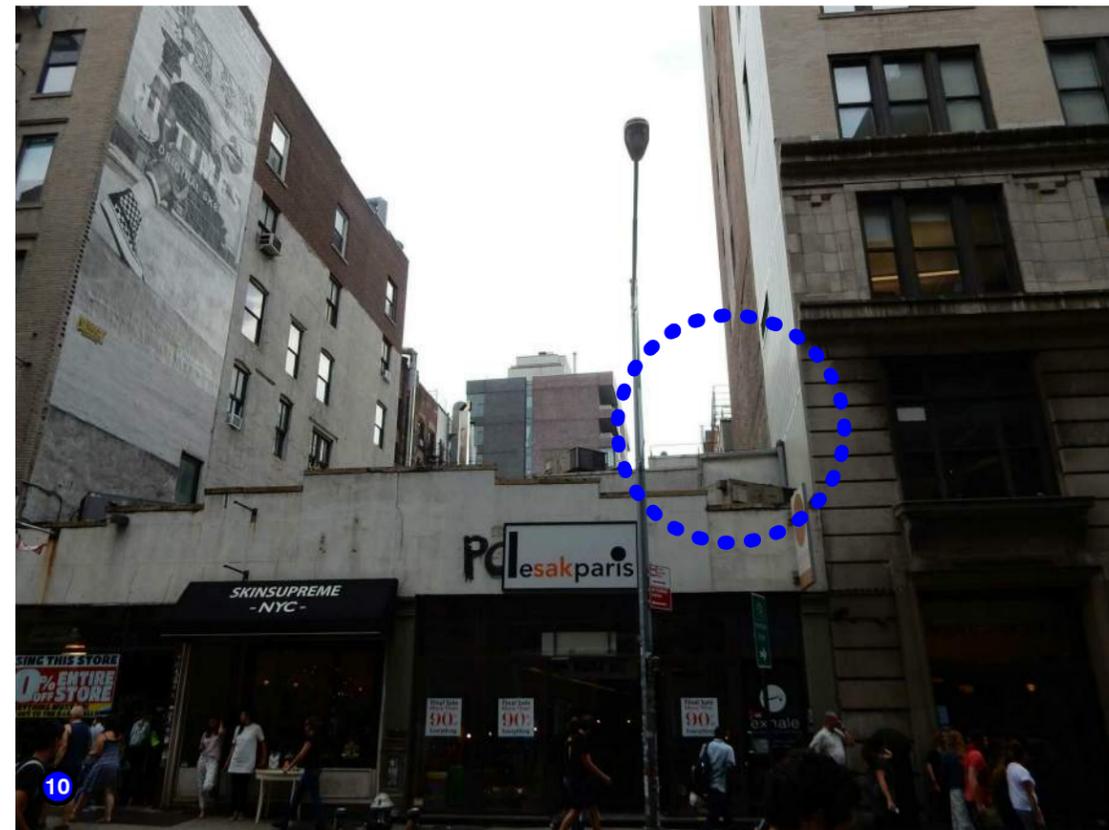
FIG 10: SPRING ST LKG S, ROOFTOP ADDITION BARELY VISIBLE (SECONDAY FACADE)
