44 UNION SQUARE EAST - TAMMANY HALL

HIGGINS QUASEBARTH & PARTNERS, LLC
CONSULTANTS IN THE PRESERVATION AND REHABILITATION OF HISTORIC PROPERTIES

BKSK

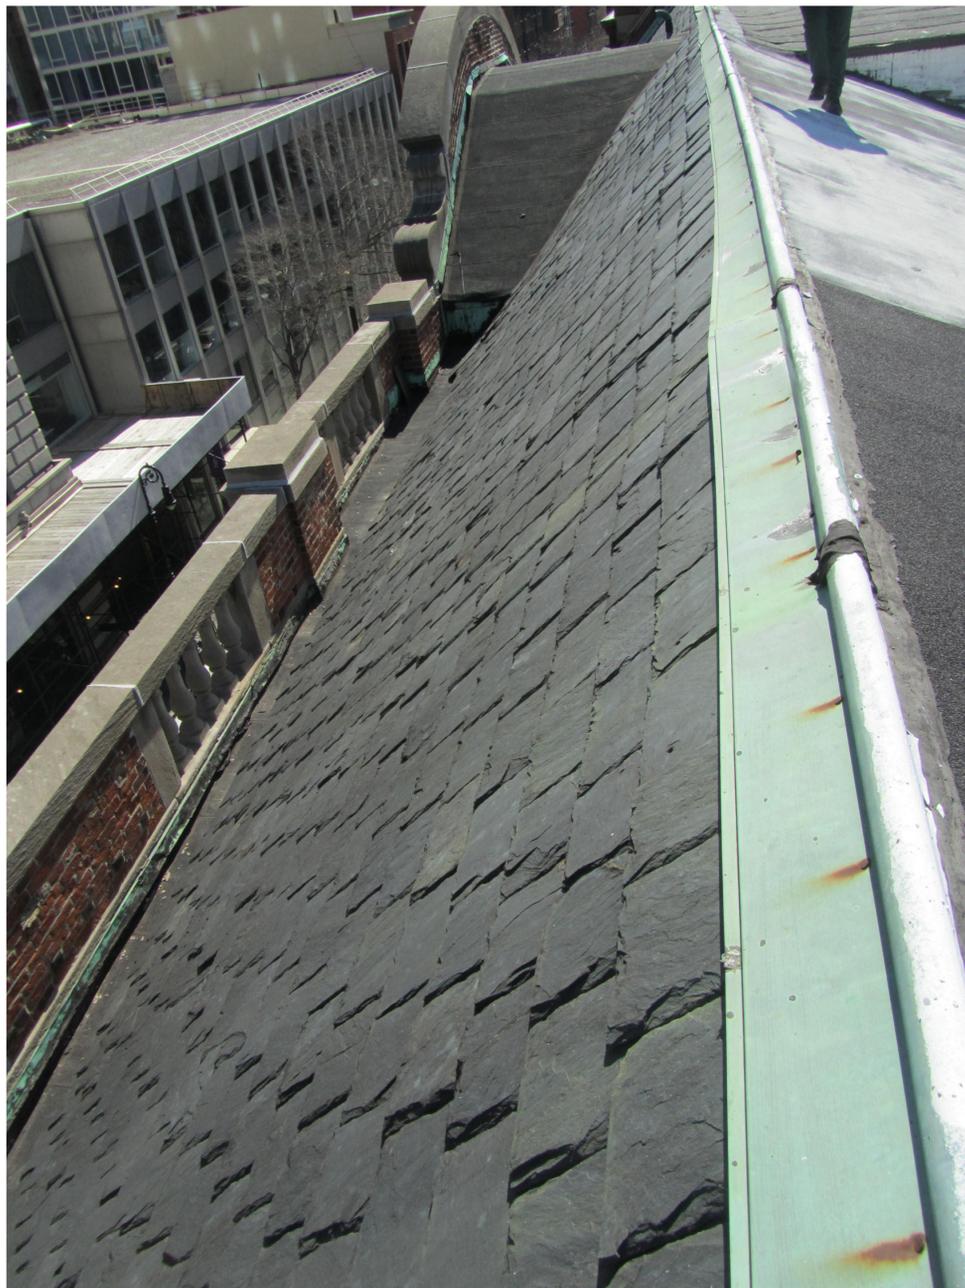
VIEW OF EXISTING SLATE CONDITION ON NORTH FACING HIP ROOF

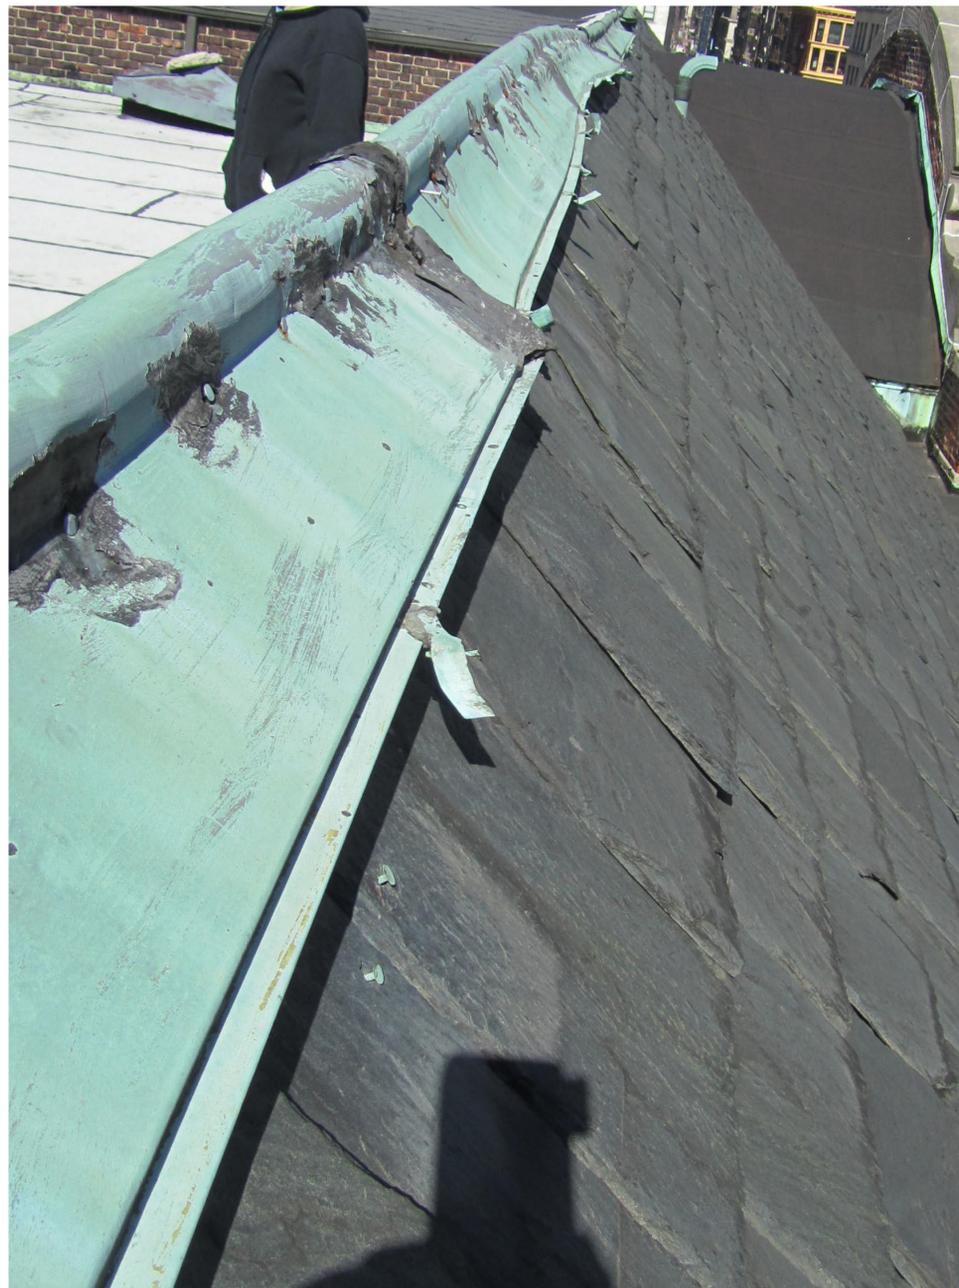
VIEW OF EXISTING COPPER RIDGE CAP ON NORTH FACING HIP

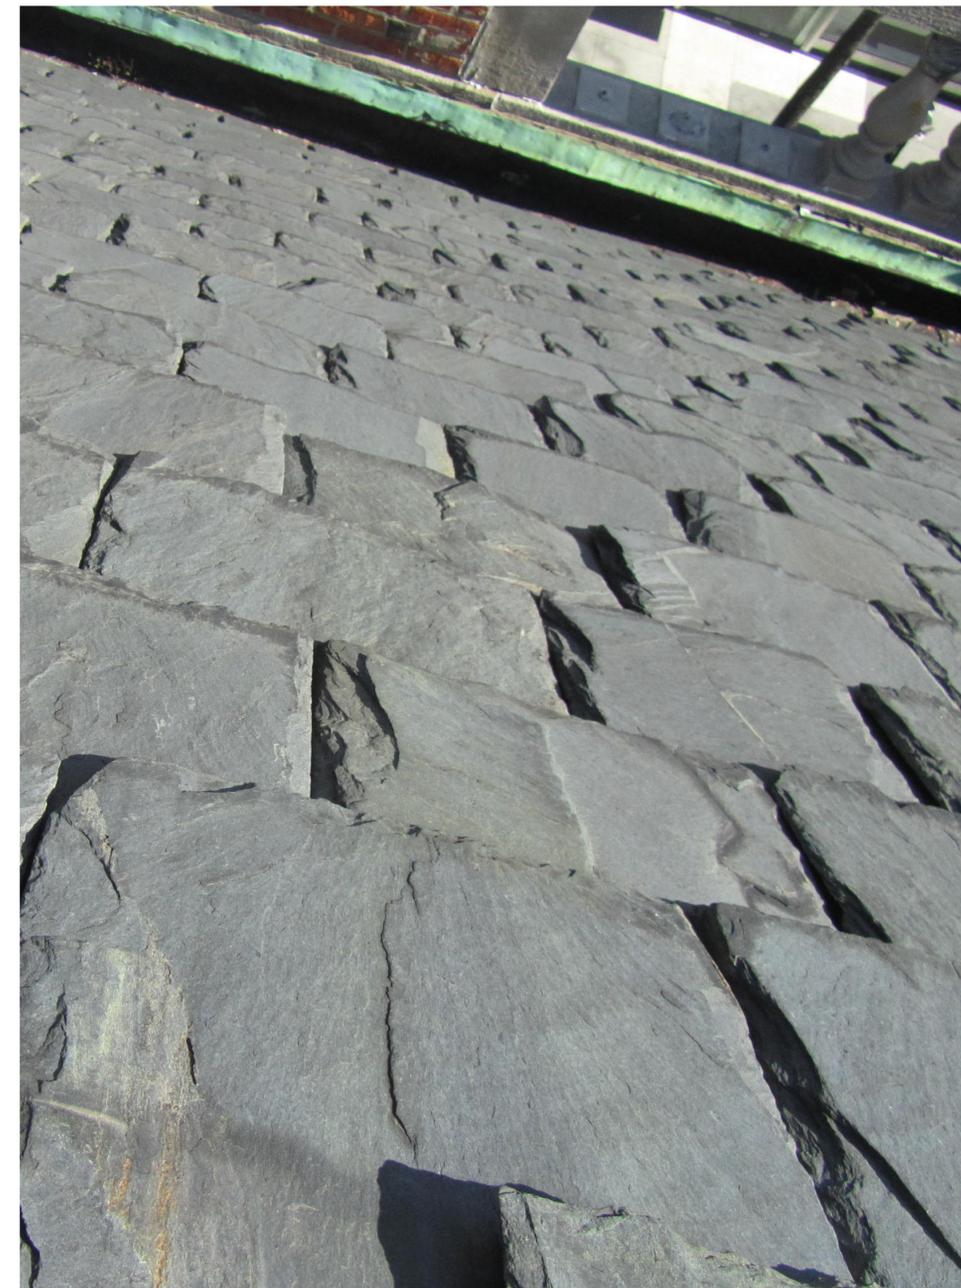
VIEW OF EXISTING DELAMINATING SLATE TILES

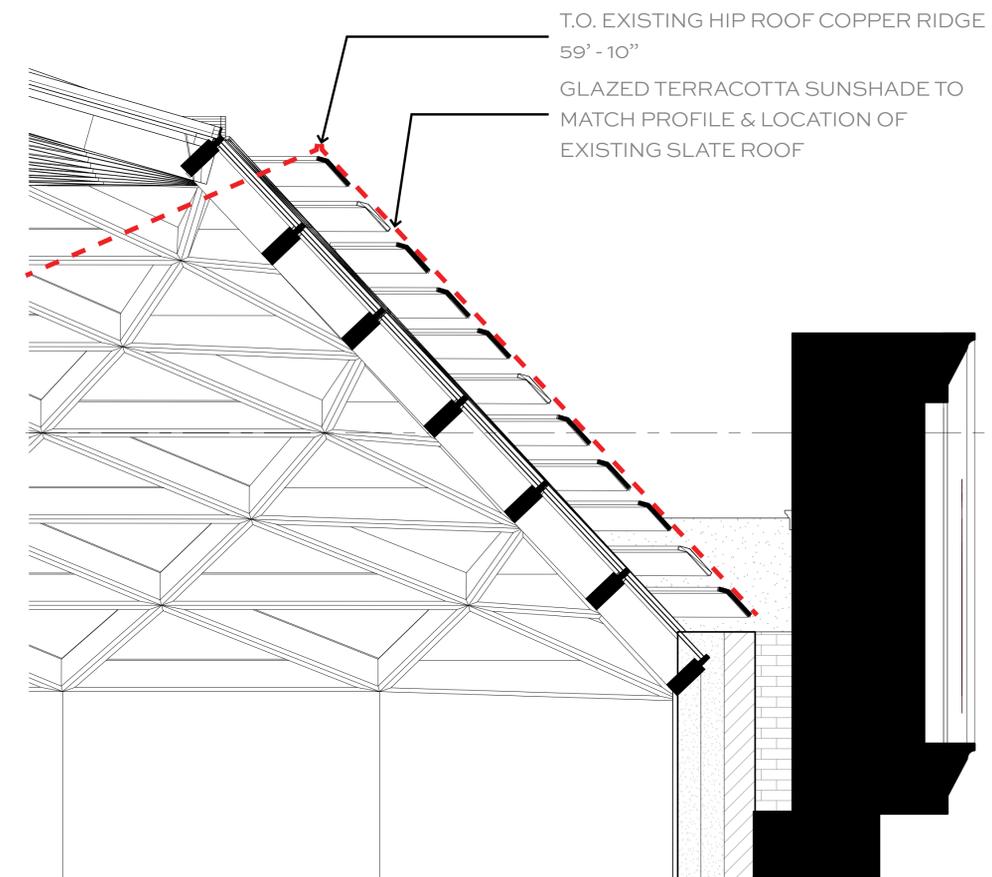
ROOF REPLACEMENT LOCATION DIAGRAM

PROPOSED HIP ROOF REPLACEMENT

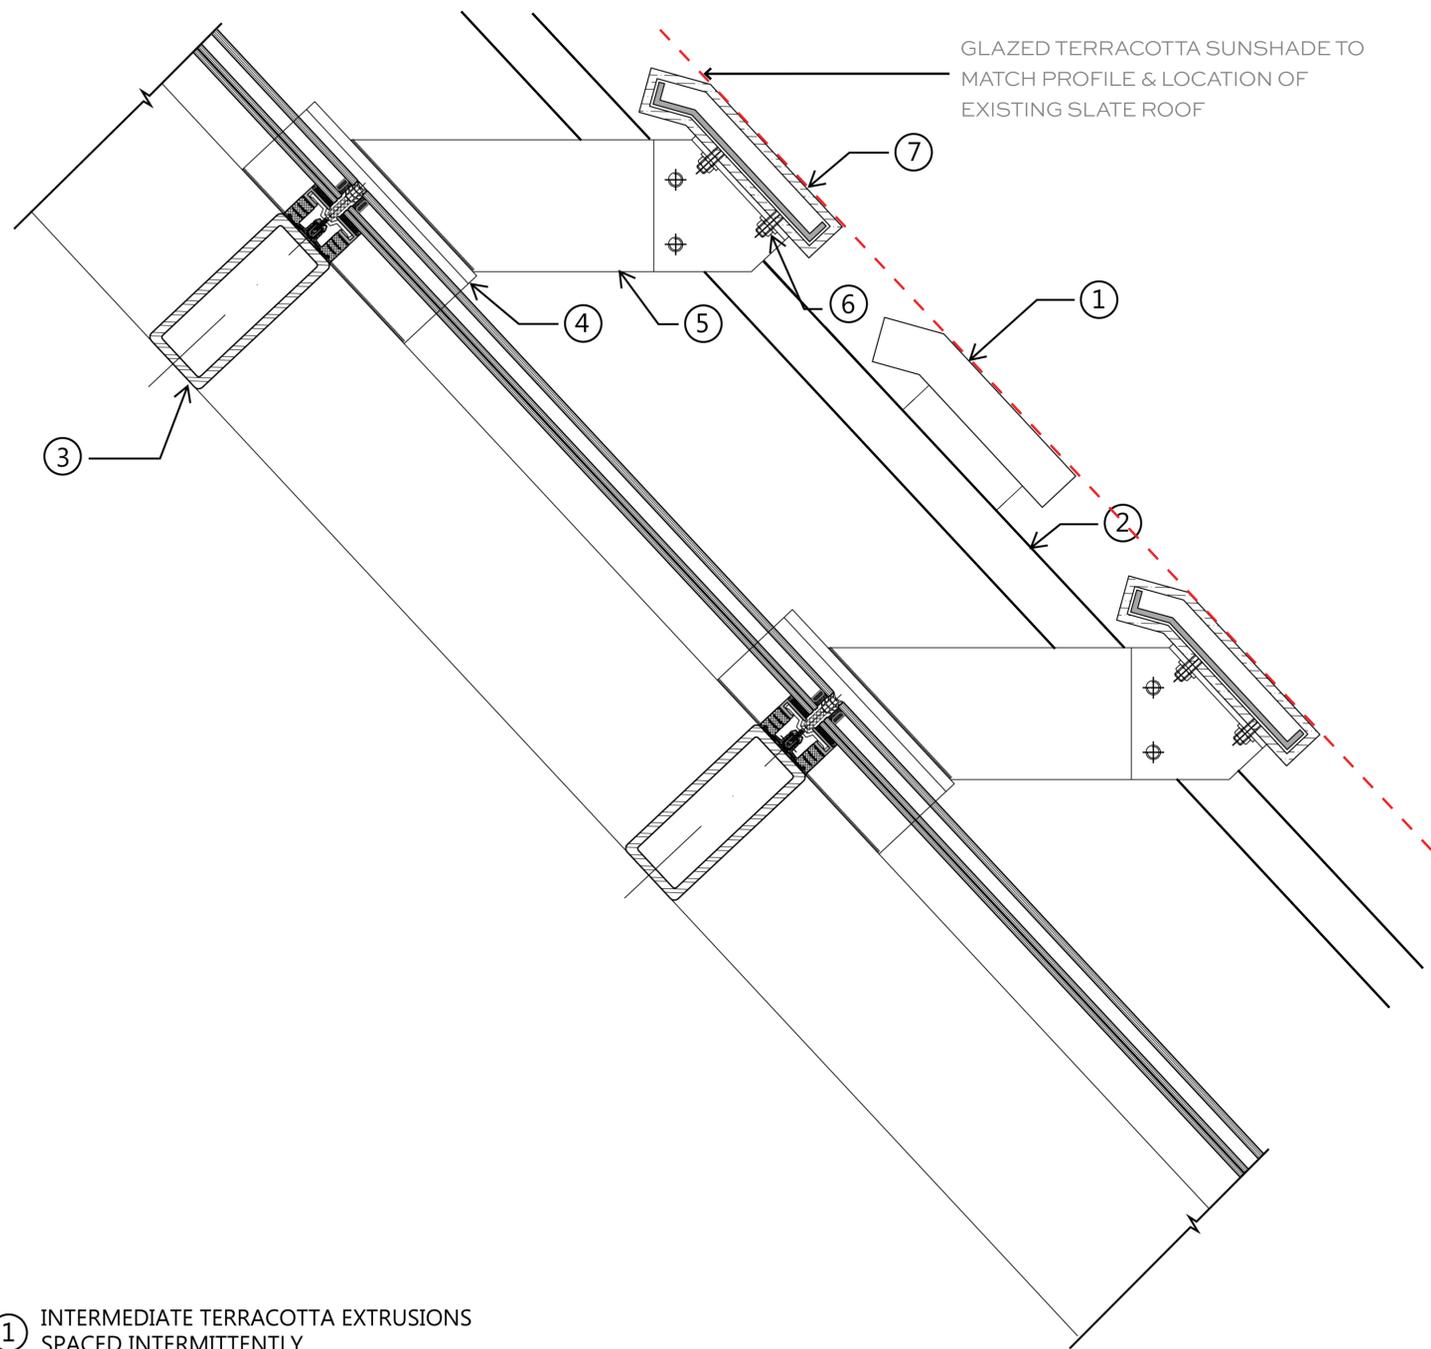
GLAZED TERRACOTTA SUNSHADE TO MATCH PROFILE & LOCATION OF EXISTING SLATE ROOF

- ① INTERMEDIATE TERRACOTTA EXTRUSIONS SPACED INTERMITTENTLY
- ② SUPPORT BRACKET FOR INTERMEDIATE TERRACOTTA
- ③ PRIMARY STRUCTURE
- ④ CONNECTION TO PRIMARY STRUCTURE
- ⑤ OUTRIGGER TUBE STEEL BRACKET TO SUPPORT TERRACOTTA
- ⑥ BACK SUPPORTED ANCHOR FOR TERRACOTTA
- ⑦ TERRACOTTA EXTRUSIONS

RECONSTRUCTED HIP DETAILS

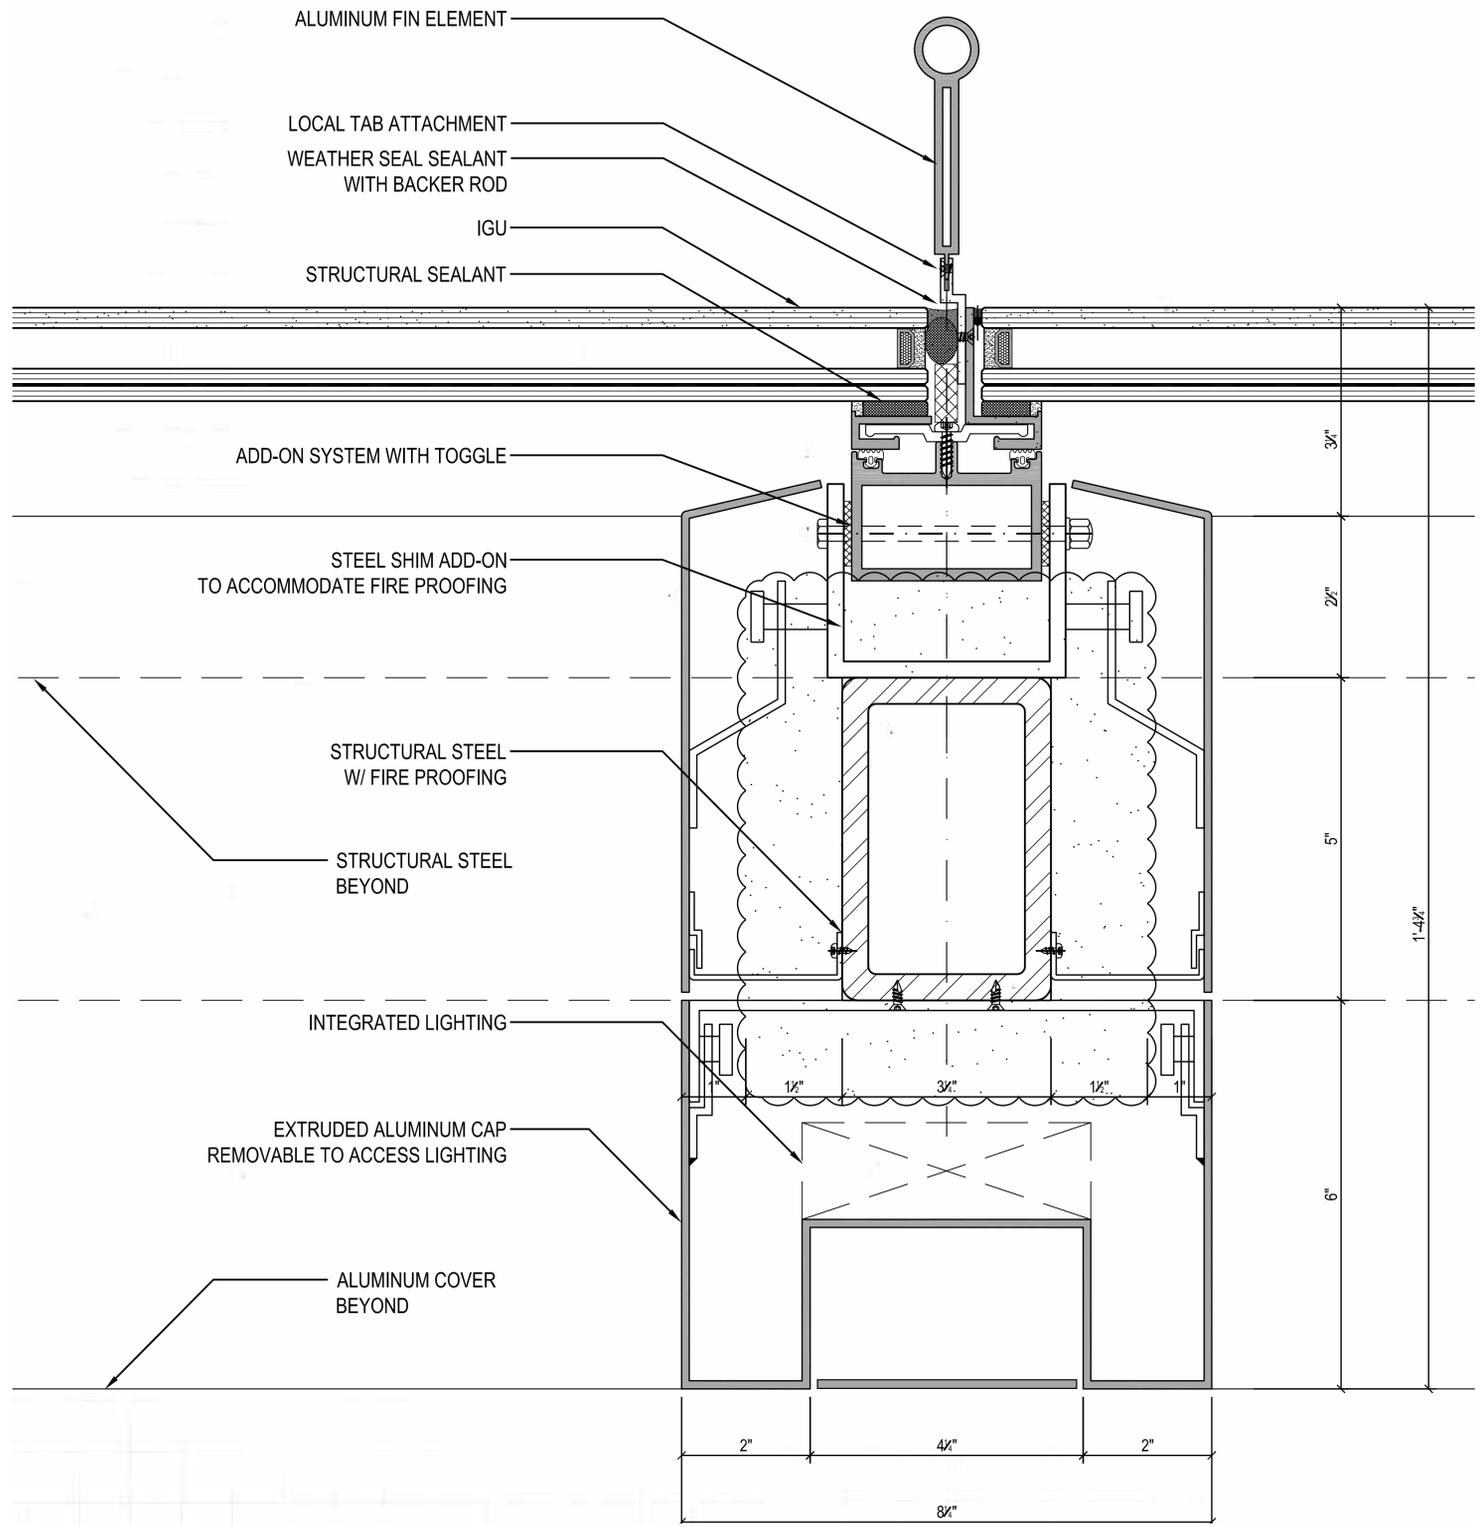
DETAIL VIEW OF PROPOSED GRIDSHELL

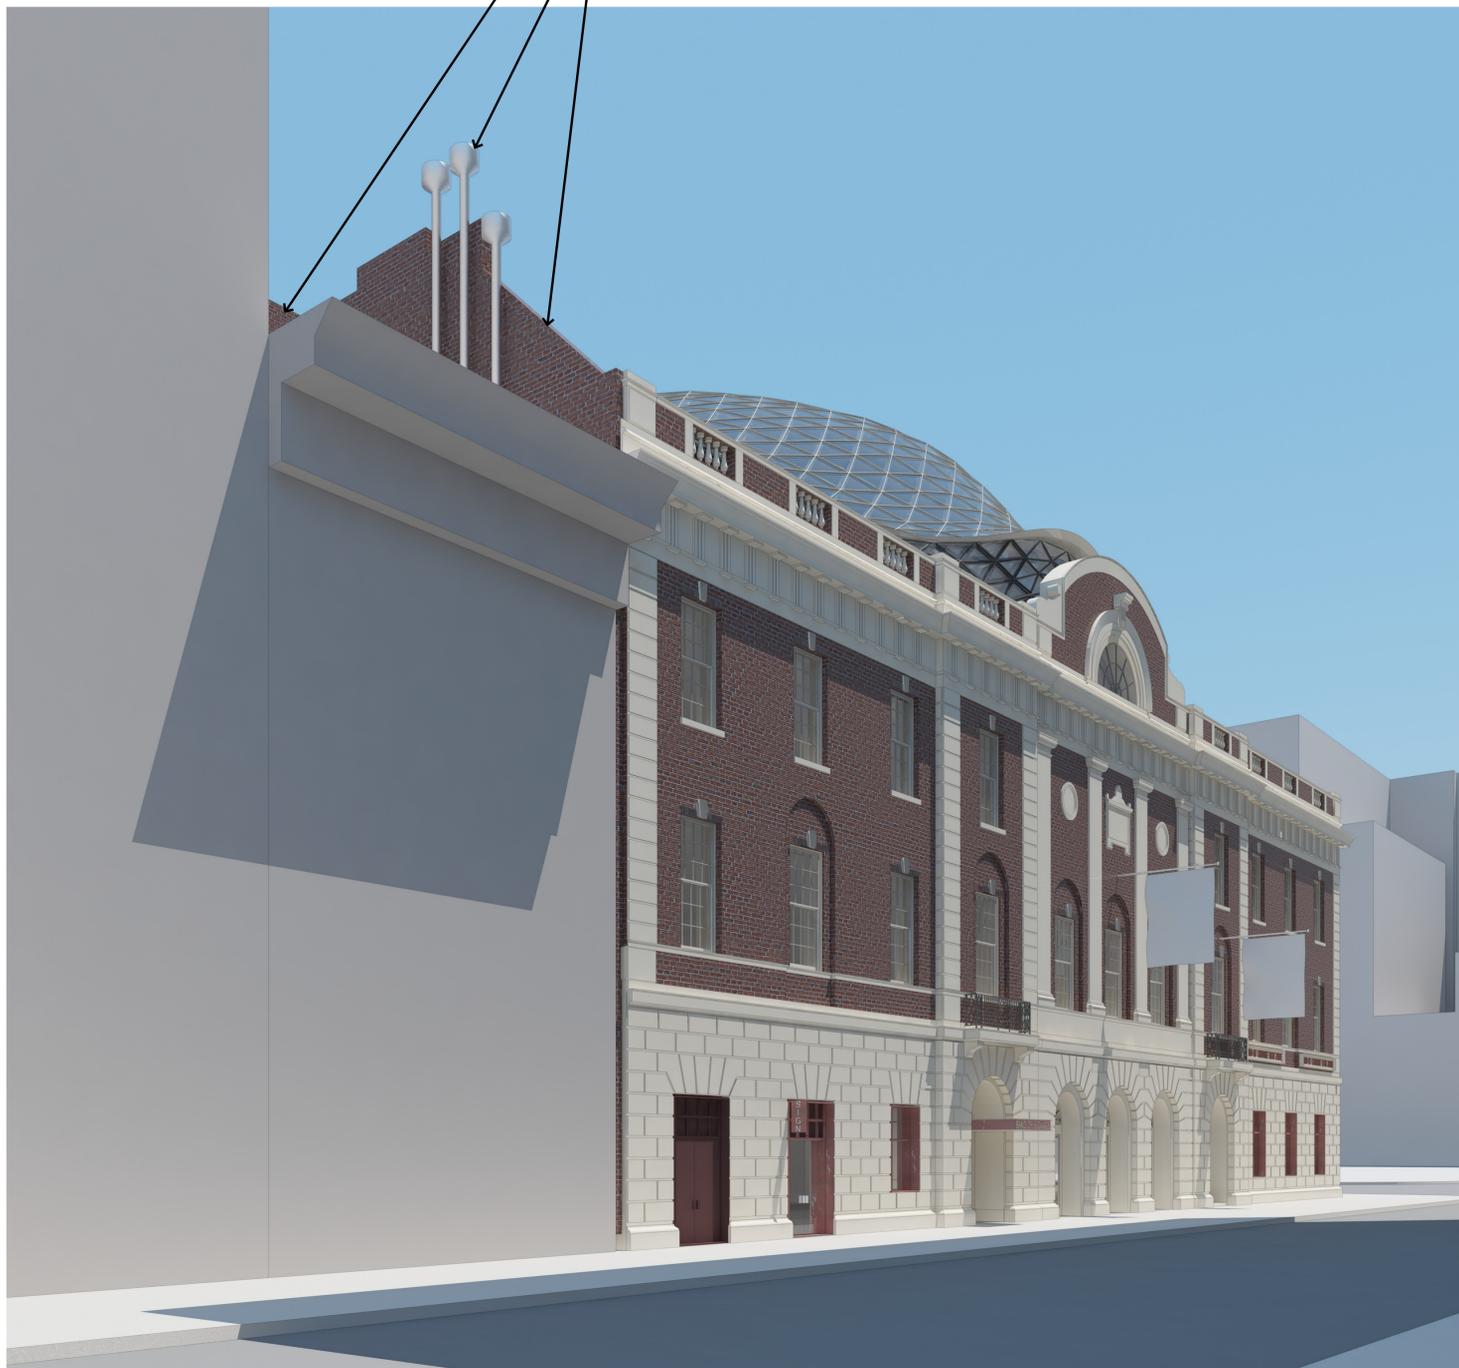
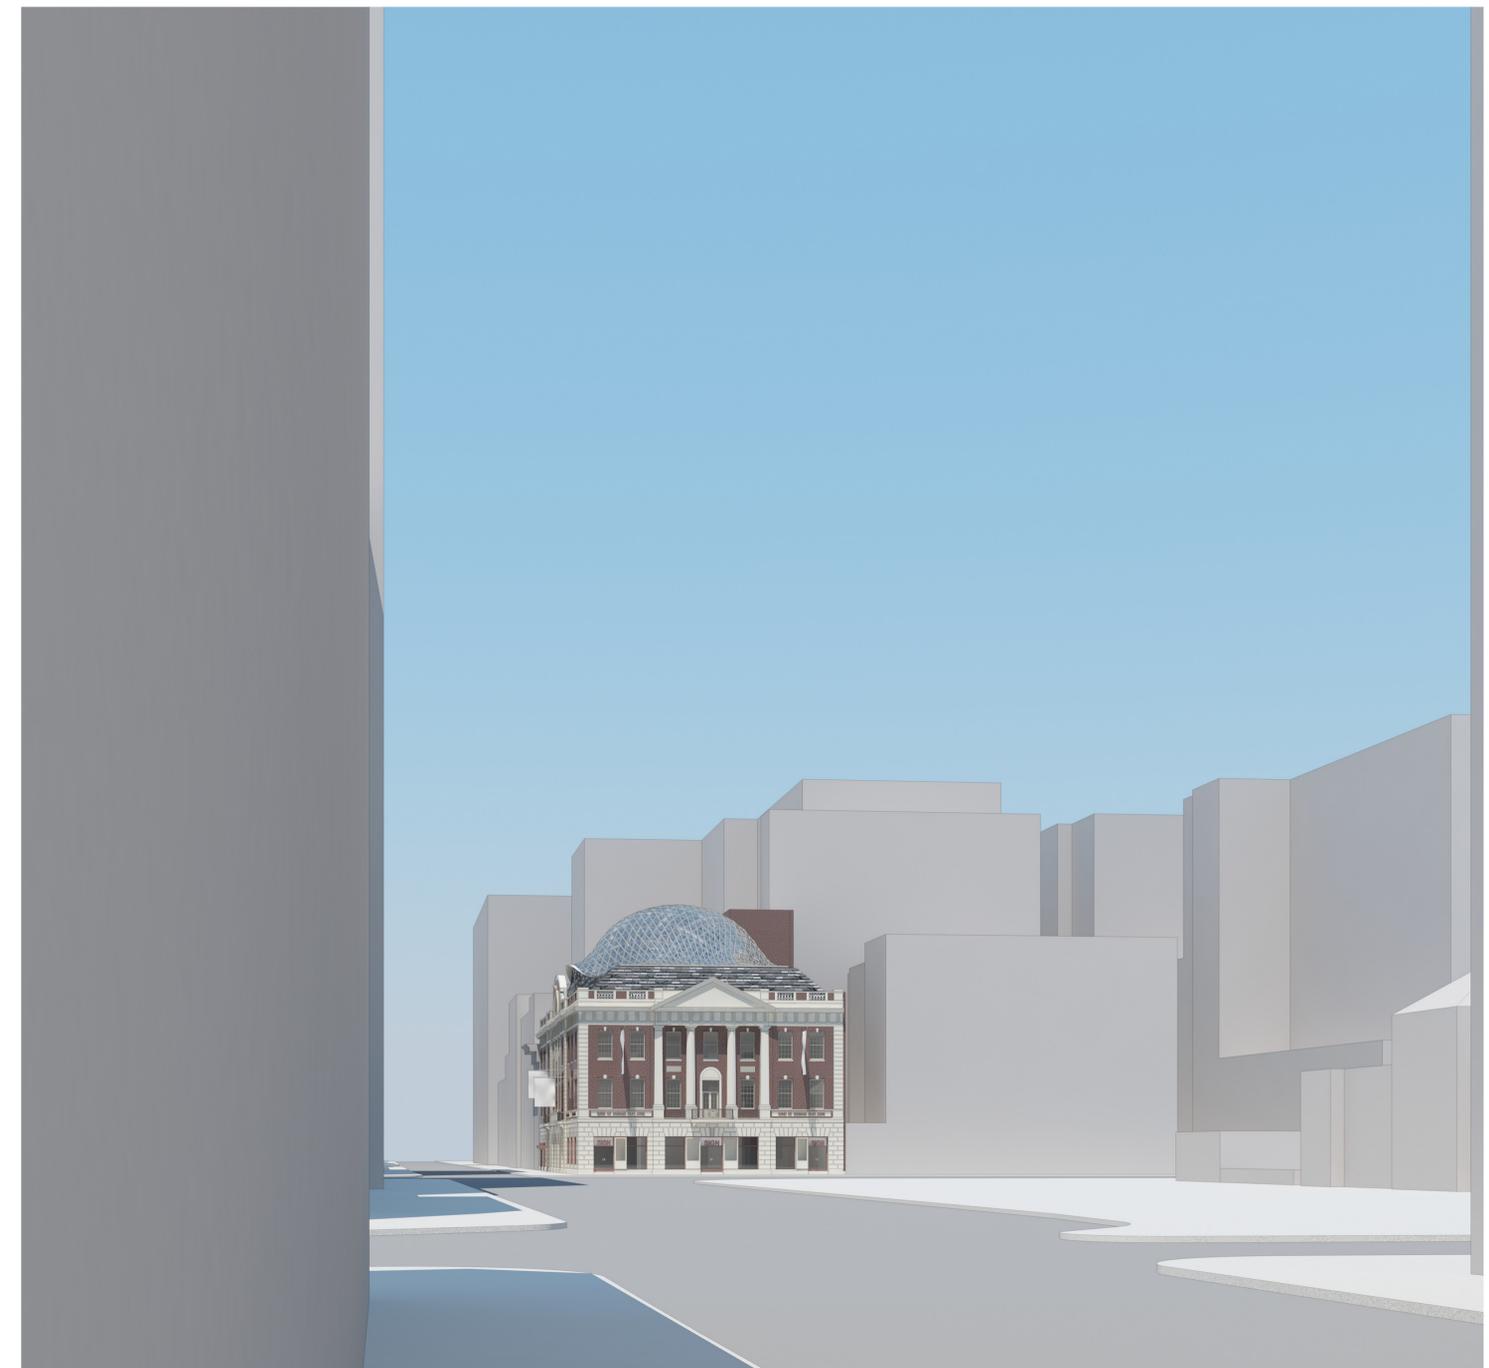
EXTENT OF VISIBILITY OF NEW MECHANICAL BULKHEAD

EXISTING FLUES TO REMAIN

PROFILE OF EXISTING EAST WALL TO REMAIN

VISIBLE MECHANICAL BULKHEAD ON EAST 17TH STREET

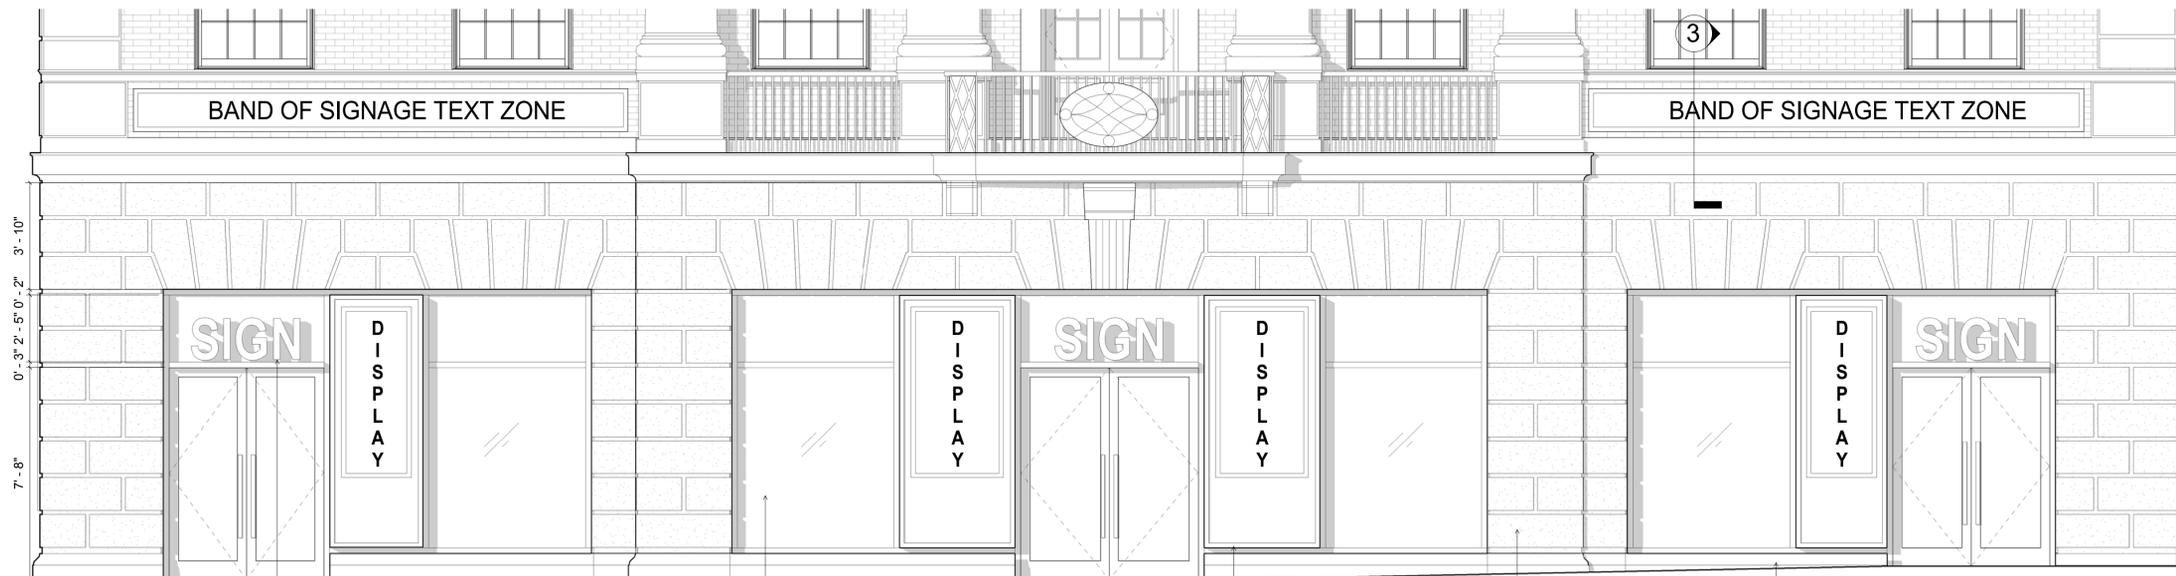
PROPOSED STOREFRONT ELEVATION

- 1'-6" TALL RETAIL SIGNAGE TYP.
- STOREFRONT GLASS DISPLAY WINDOW TYP.
- METAL VITRINE W/ DISPLAY CASE
- RE-POINTED RUSTICATED LIMESTONE
- NEW STONE BASE TO MATCH HISTORIC PROFILE IN EXISTING OPENINGS TYP.

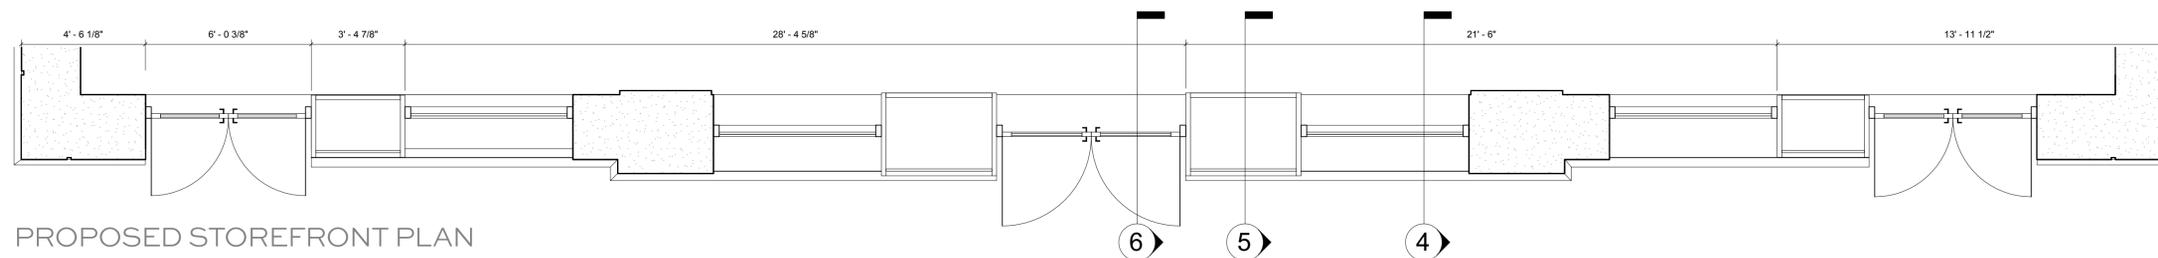
PROPOSED STOREFRONT PLAN

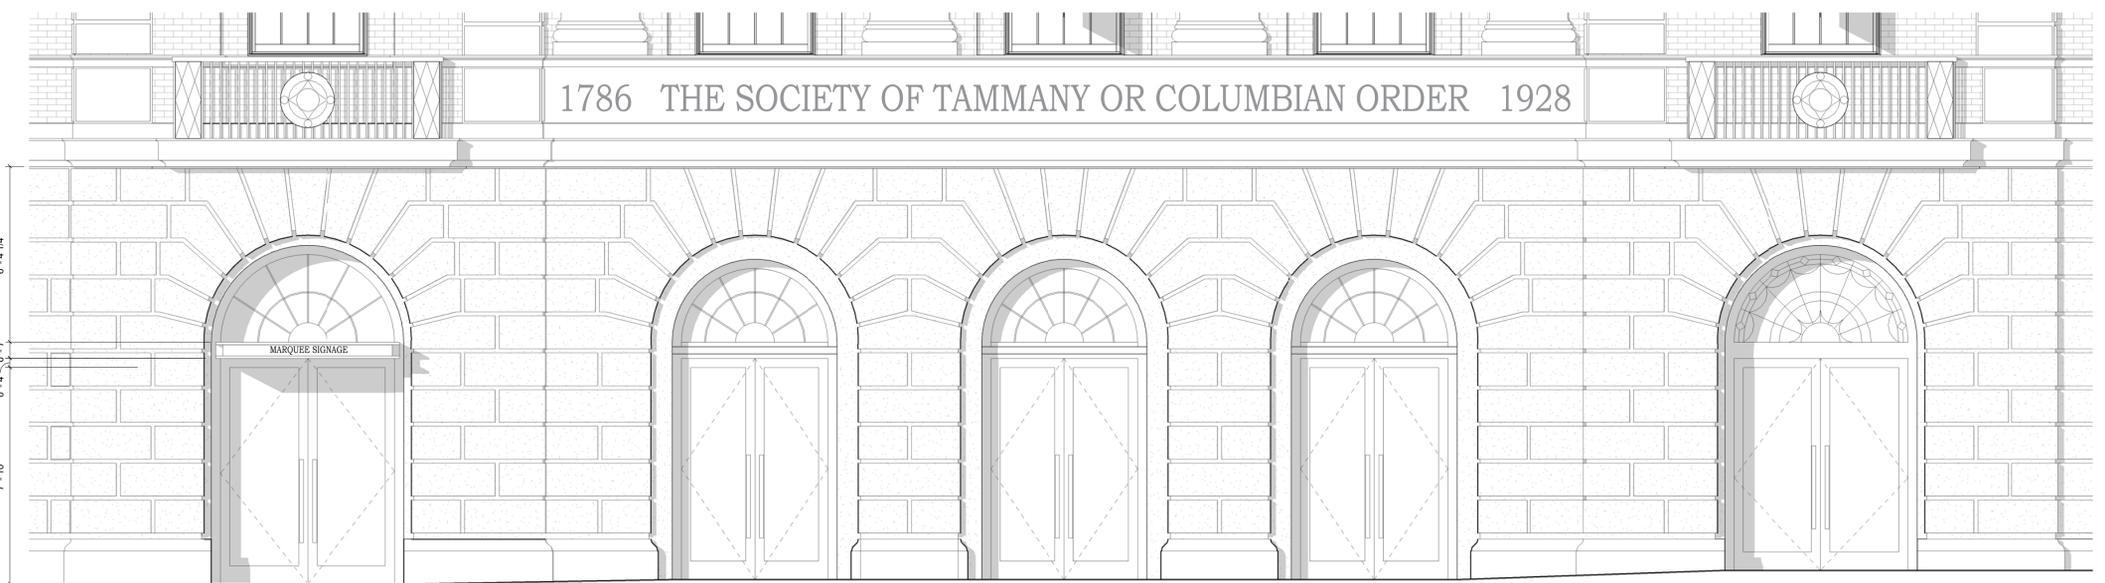
PROPOSED CENTER BAY GROUND FLOOR ELEVATION

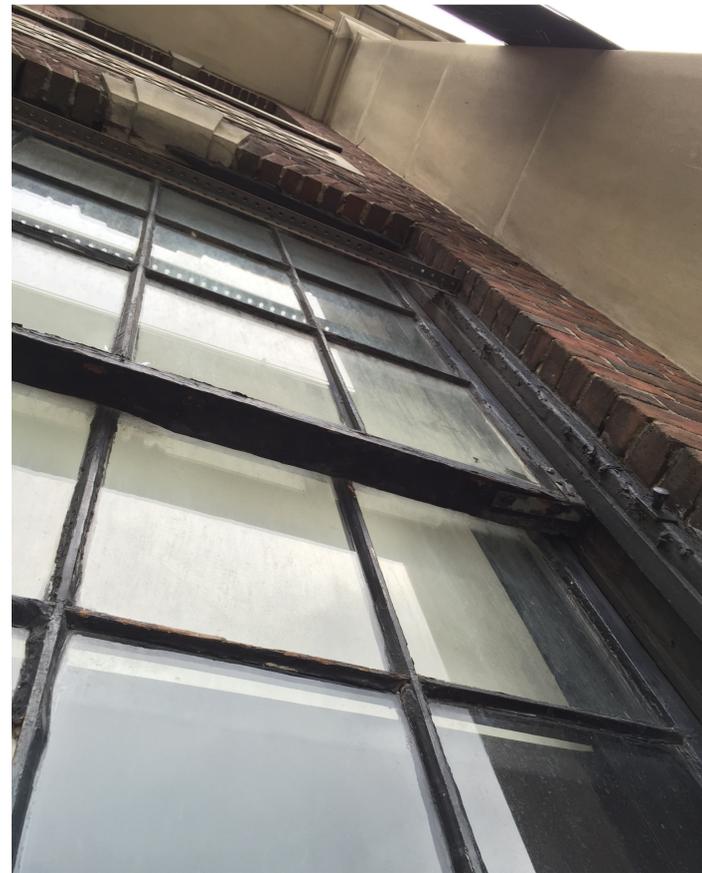
EXISTING WINDOW LITE CONDITION

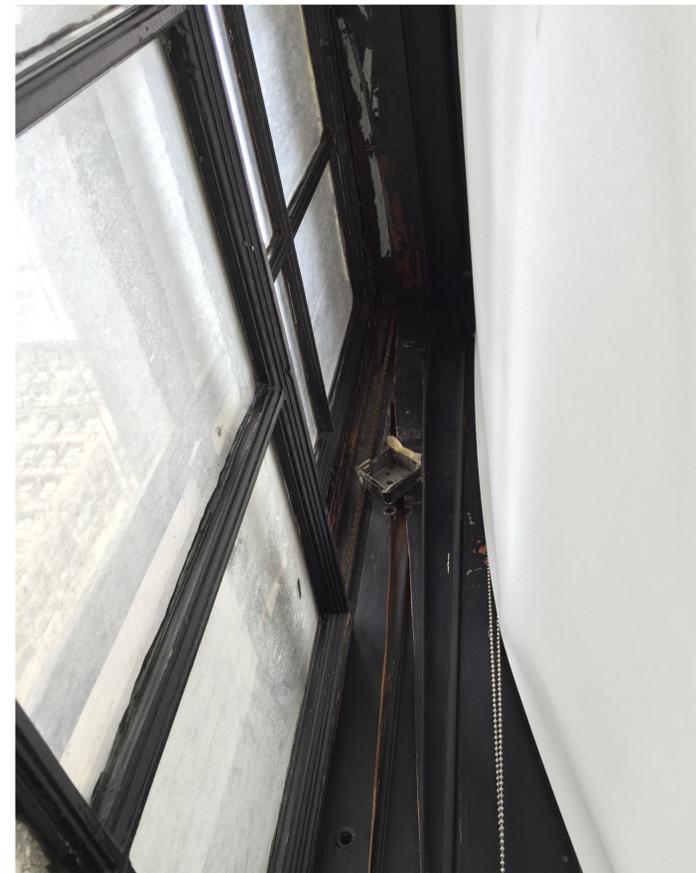
EXISTING WINDOW FRAME CONDITION

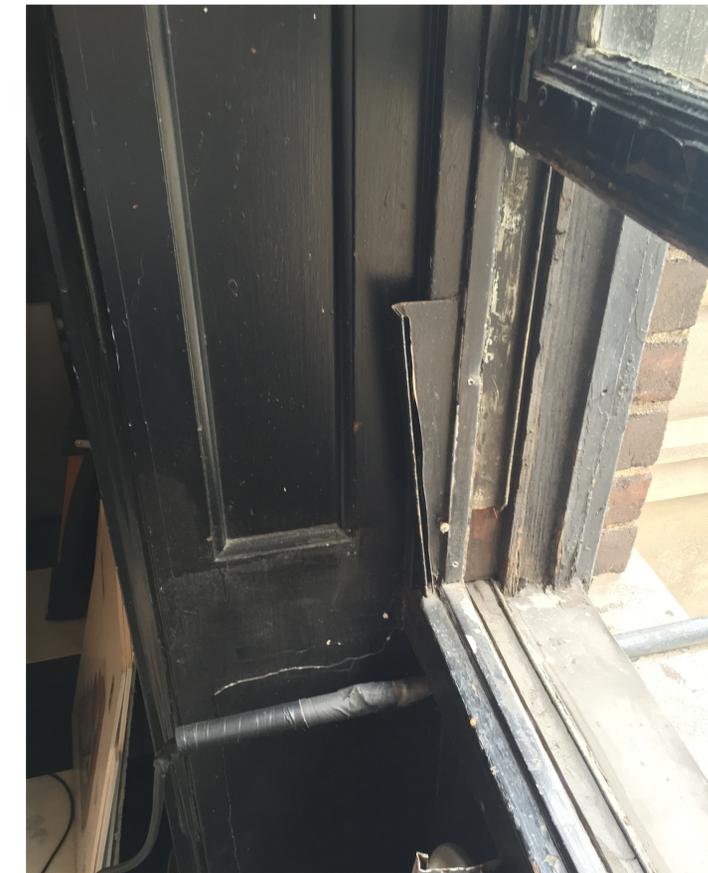
EXISTING WINDOW SILL CONDITION

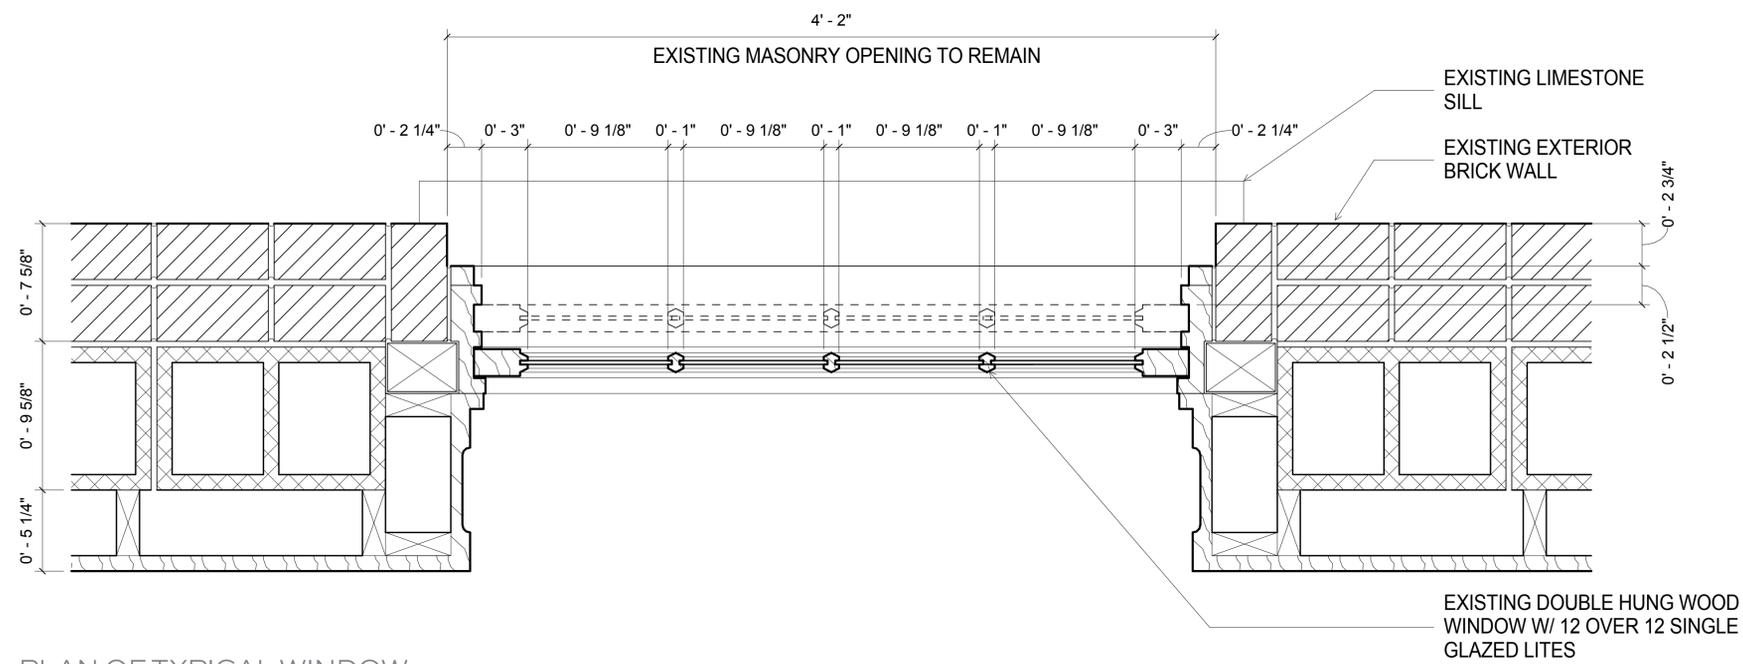
PLAN OF TYPICAL WINDOW

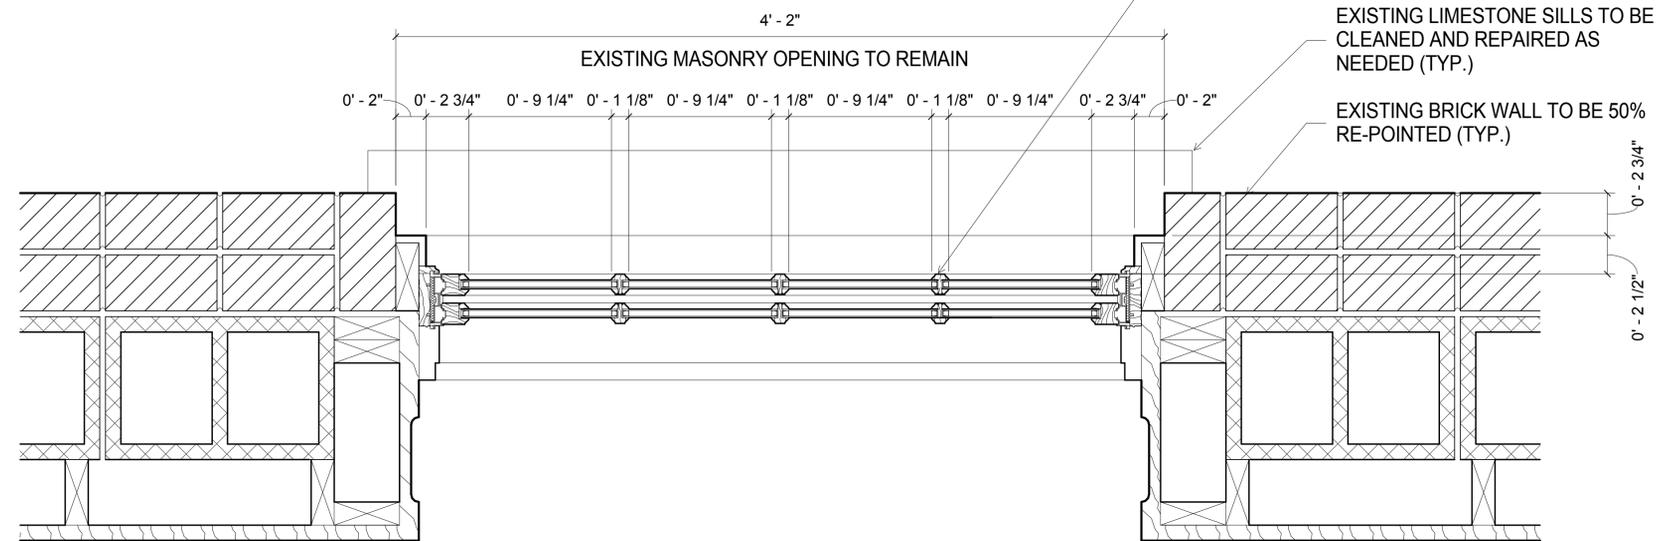
NEW WOOD FRAME DOUBLE HUNG WINDOW W/ INSULATED TRUE DIVIDED LITE 12 OVER 12 PATTERN TO BE PAINTED CREAM COLOR TO MATCH HISTORIC COLOR

EXISTING LIMESTONE SILLS TO BE CLEANED AND REPAIRED AS NEEDED (TYP.)

EXISTING BRICK WALL TO BE 50% RE-POINTED (TYP.)

SECTION THROUGH PROPOSED WINDOW PLAN OF PROPOSED WINDOW

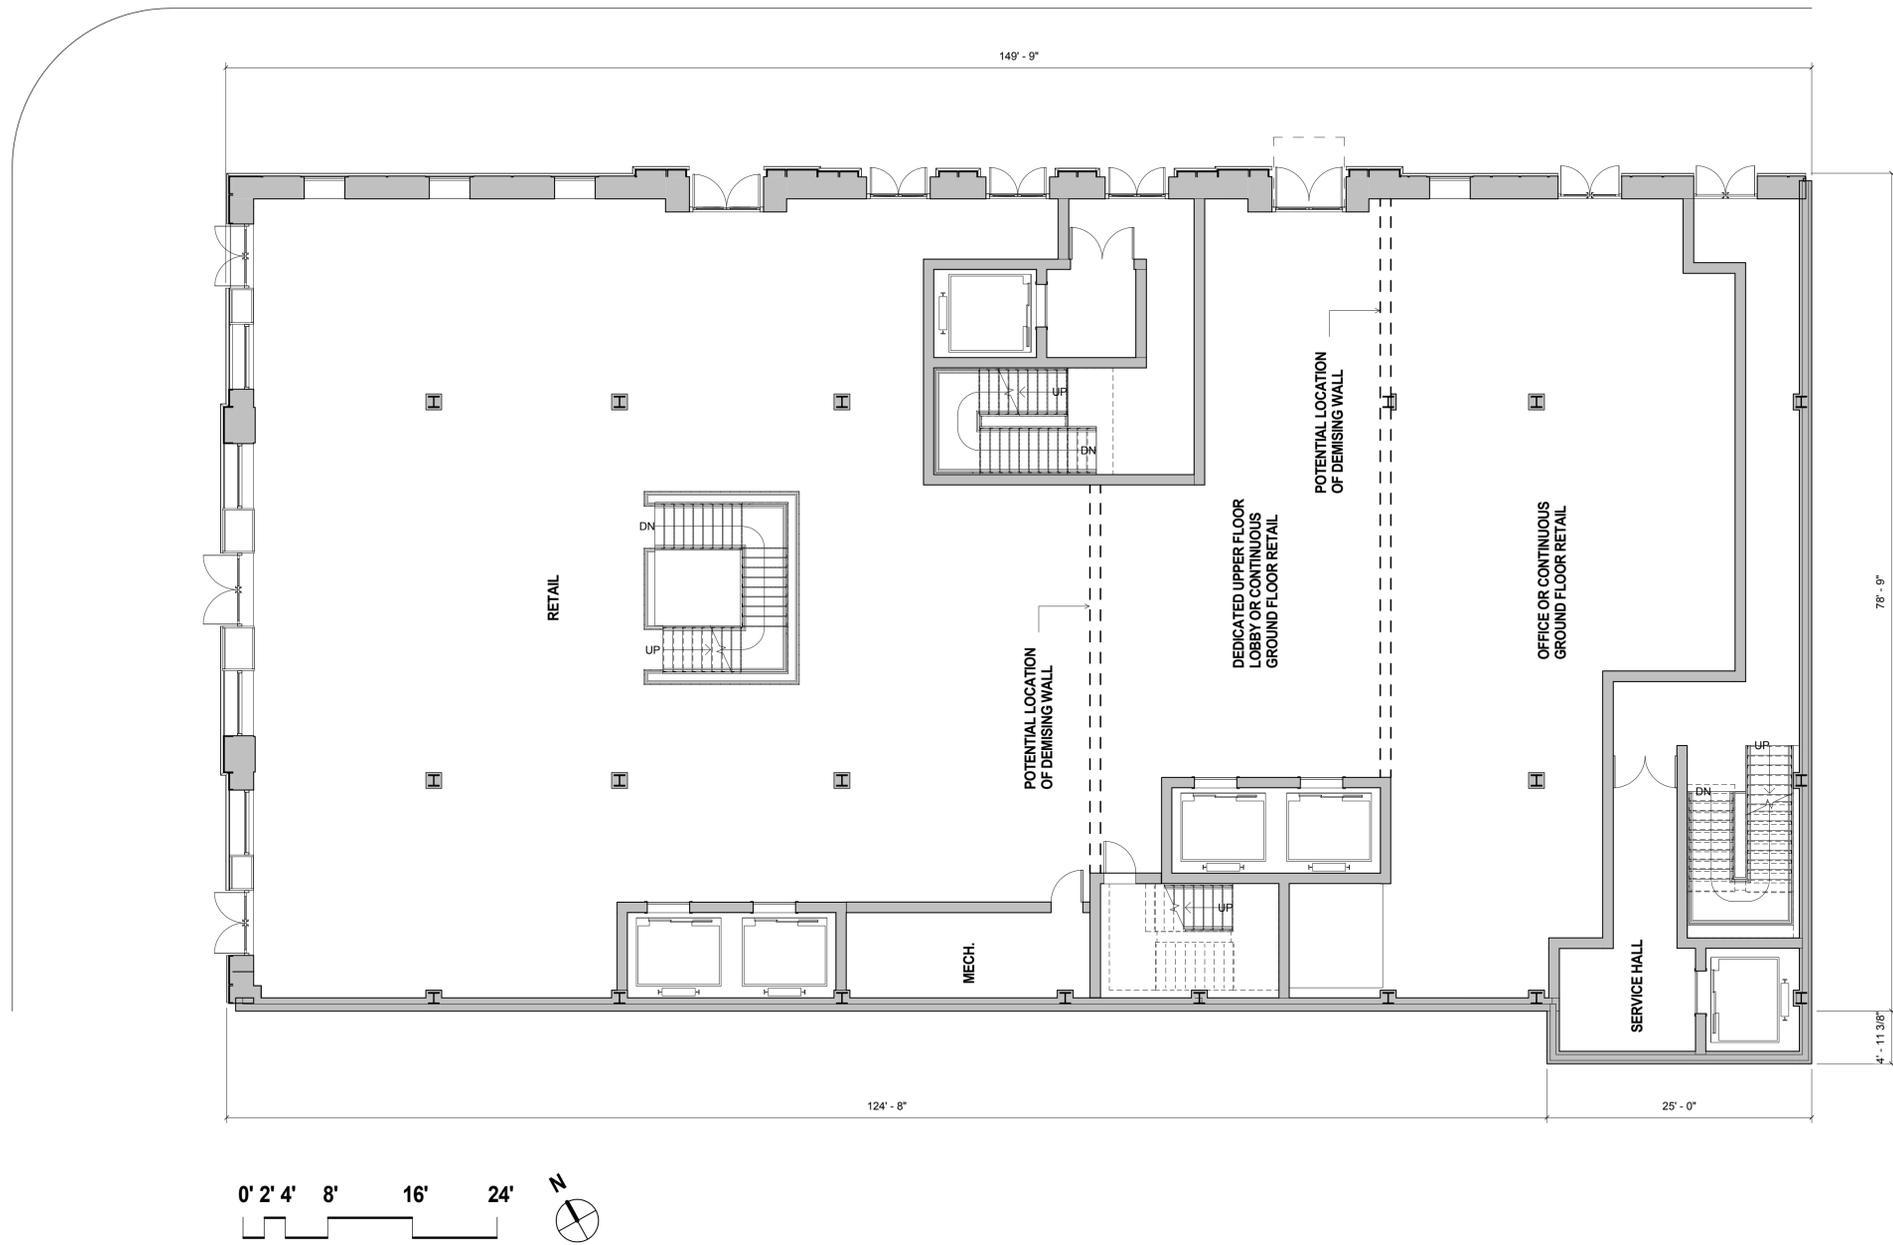
PROPOSED GROUND FLOOR PLAN

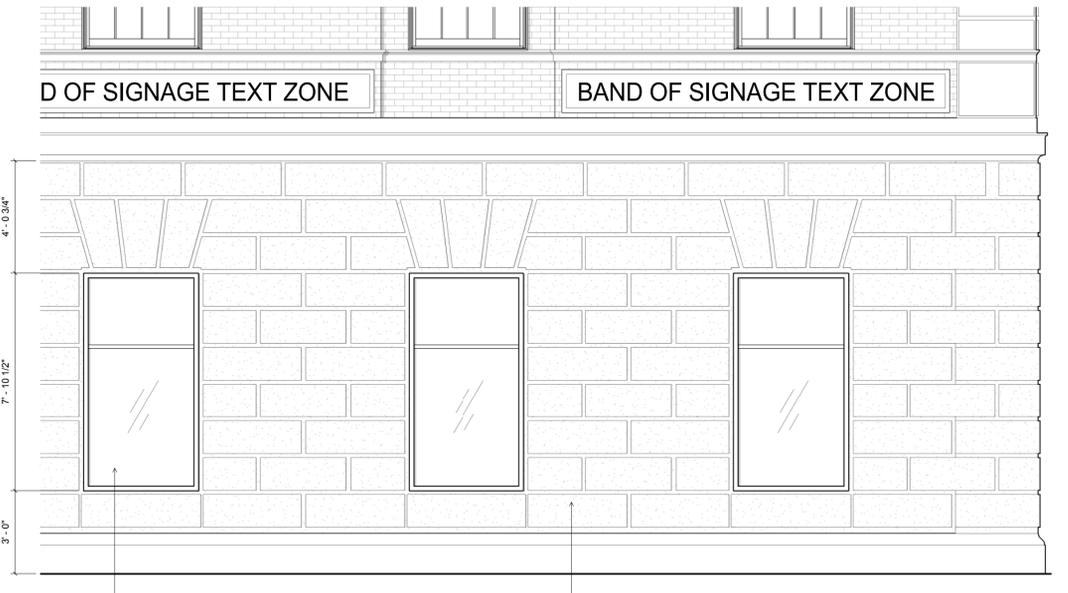
STOREFRONT GLASS DISPLAY WINDOW TYP. RE-POINTED RUSTICATED LIMESTONE

3 17TH STREET - WEST BAY
3/8" = 1'-0"
