44 UNION SQUARE EAST - TAMMANY HALL

HIGGINS QUASEBARTH & PARTNERS, LLC
CONSULTANTS IN THE PRESERVATION AND REHABILITATION OF HISTORIC PROPERTIES

BKSK

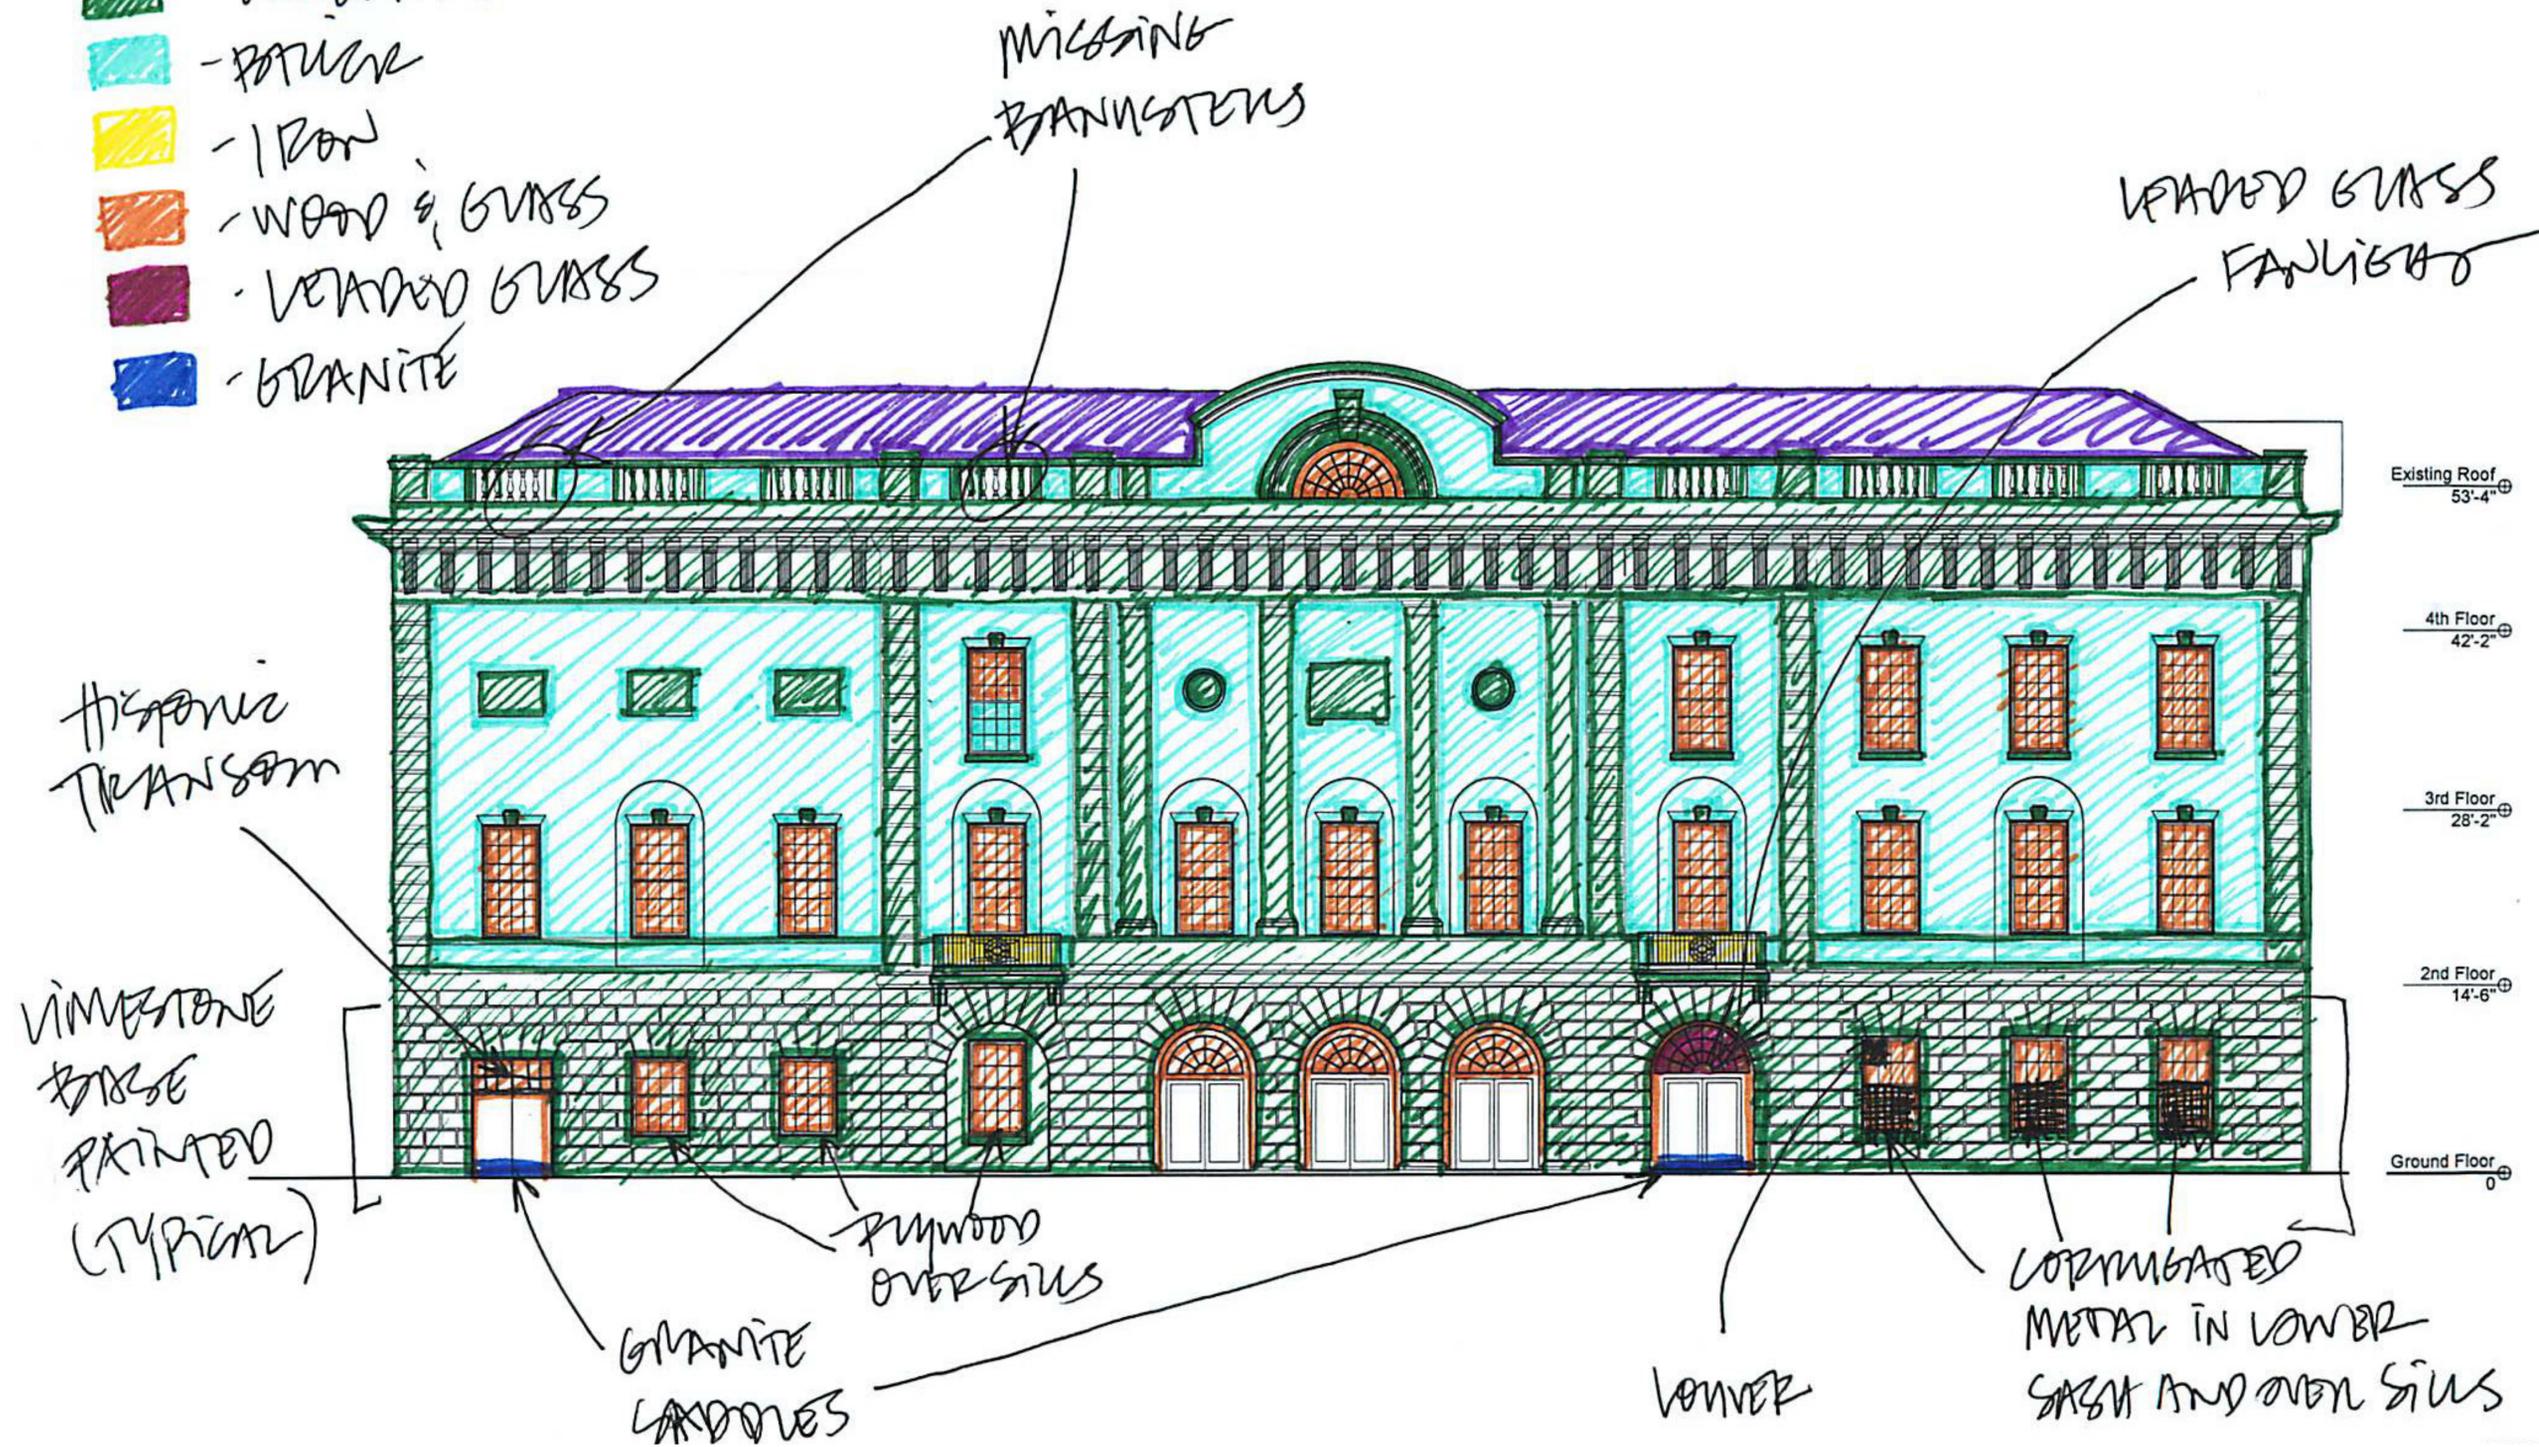
- GATE
- LIMESTONE
- PORCELAIN
- IRON
- WOOD & GLASS
- LEADED GLASS
- GRANITE

ANNOTATED EXISTING ELEVATION - NORTH

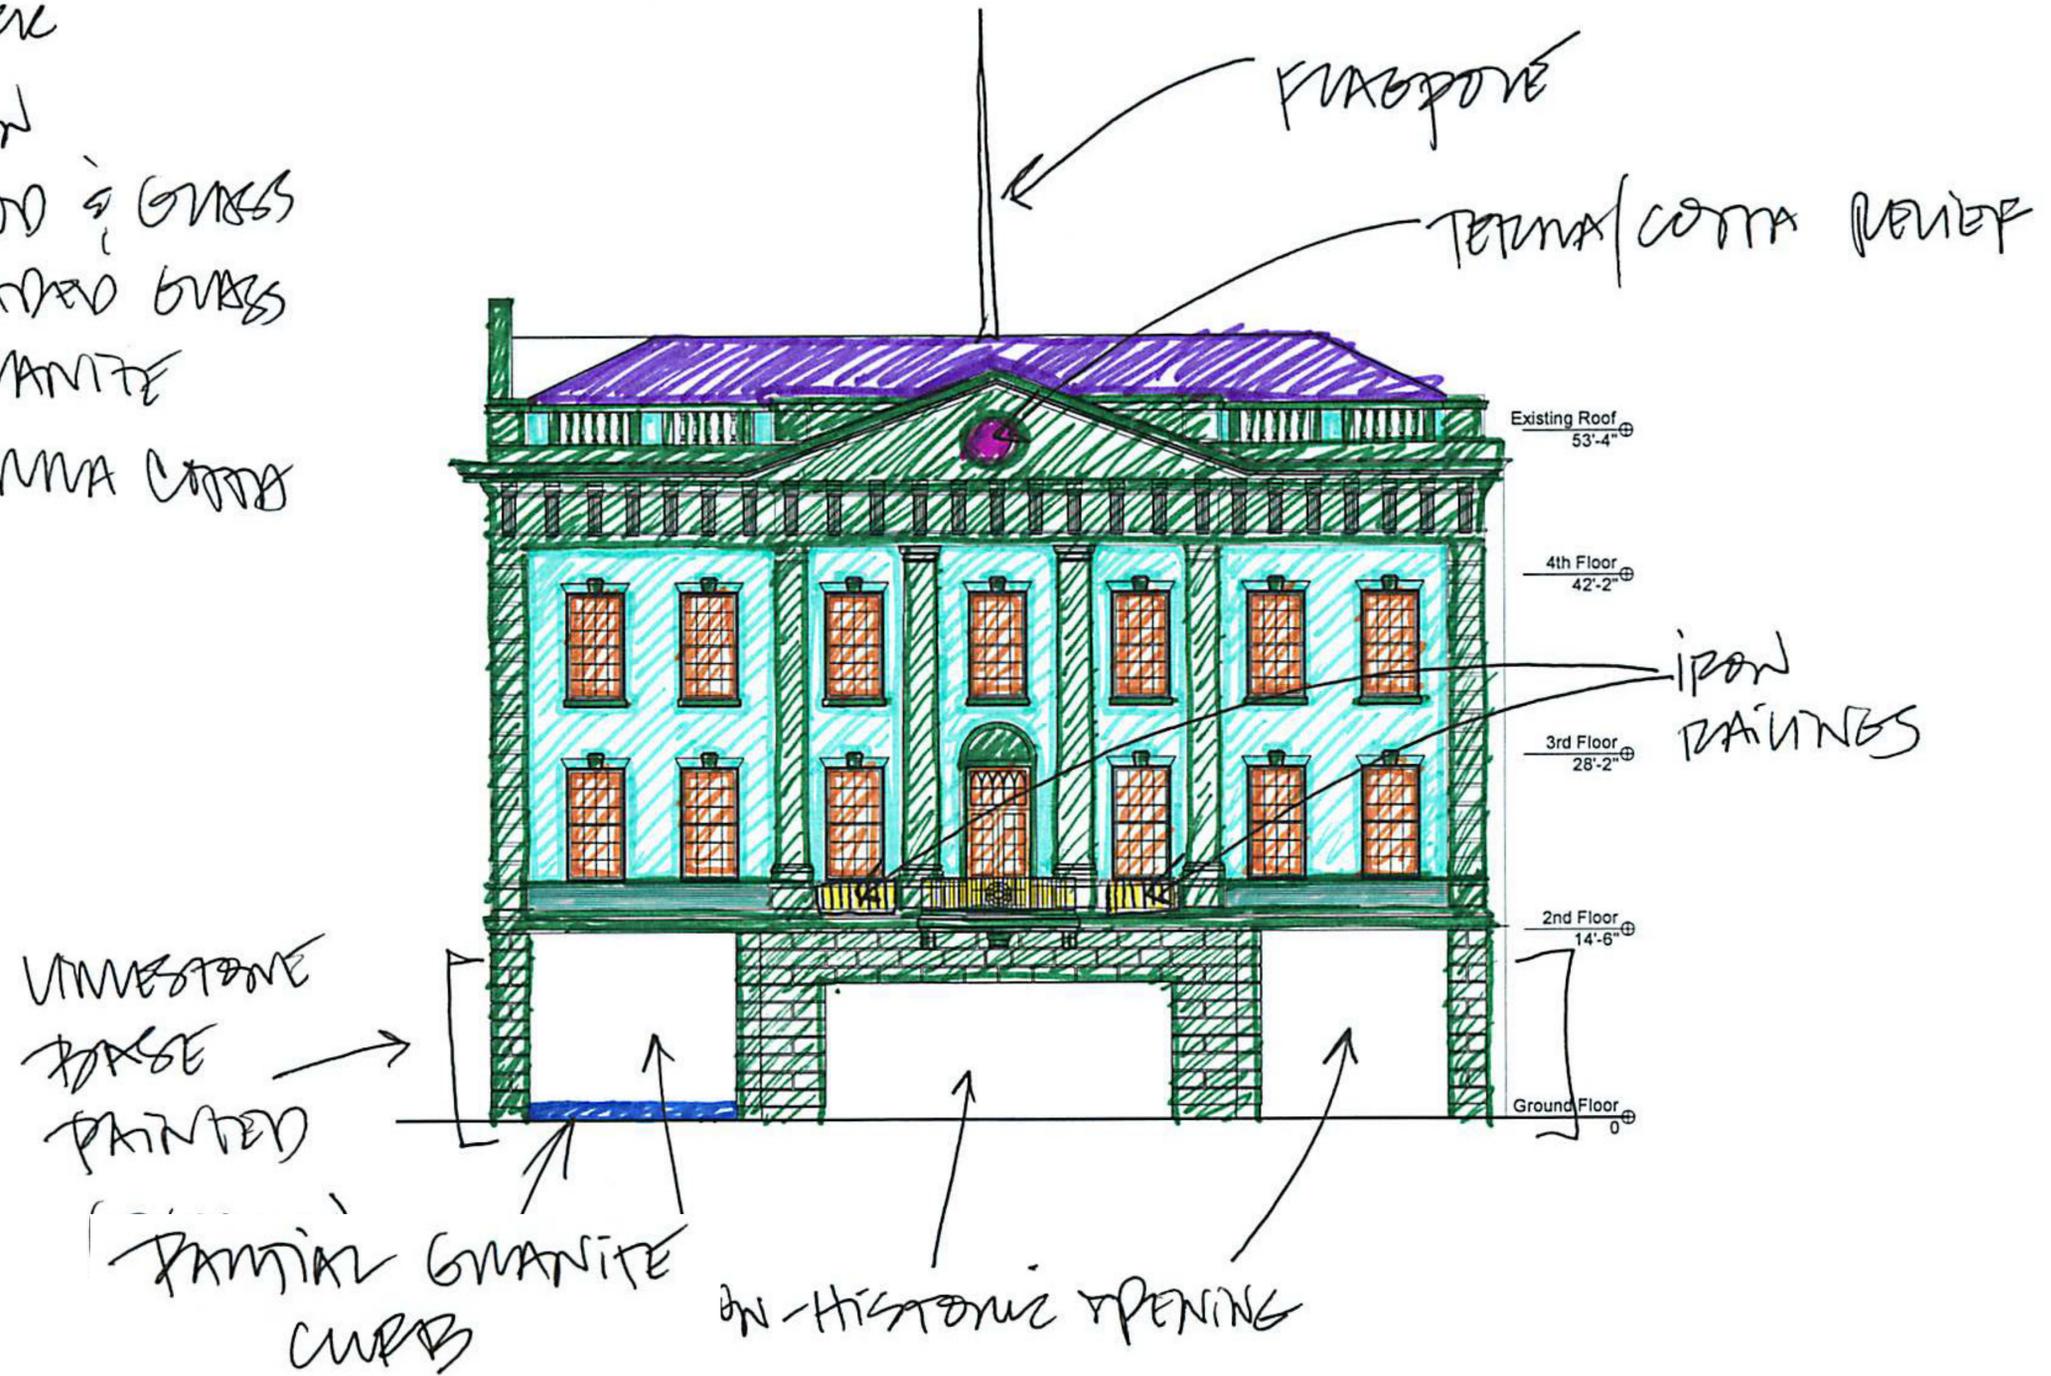
ANNOTATED EXISTING ELEVATION - WEST
