**PROJECT: DOLLAR SAVING BANK
 CLOCK TOWER BUILDING**

**LOCATION: 2516 Grand Concourse
 Bronx, New York**

PROJECT:
DOLLAR SAVINGS BANK INTERIOR
 2526 GRAND CONCOURSE
 BRONX, NY

ARCHITECTURAL CONSERVATOR:
 JABLONSKI BUILDING CONSERVATION, INC.
 40 WEST 27TH STREET, SUITE 1201
 NEW YORK, NY 10001
 TEL: (212) 532-7775
 FAX: (212) 532-2188

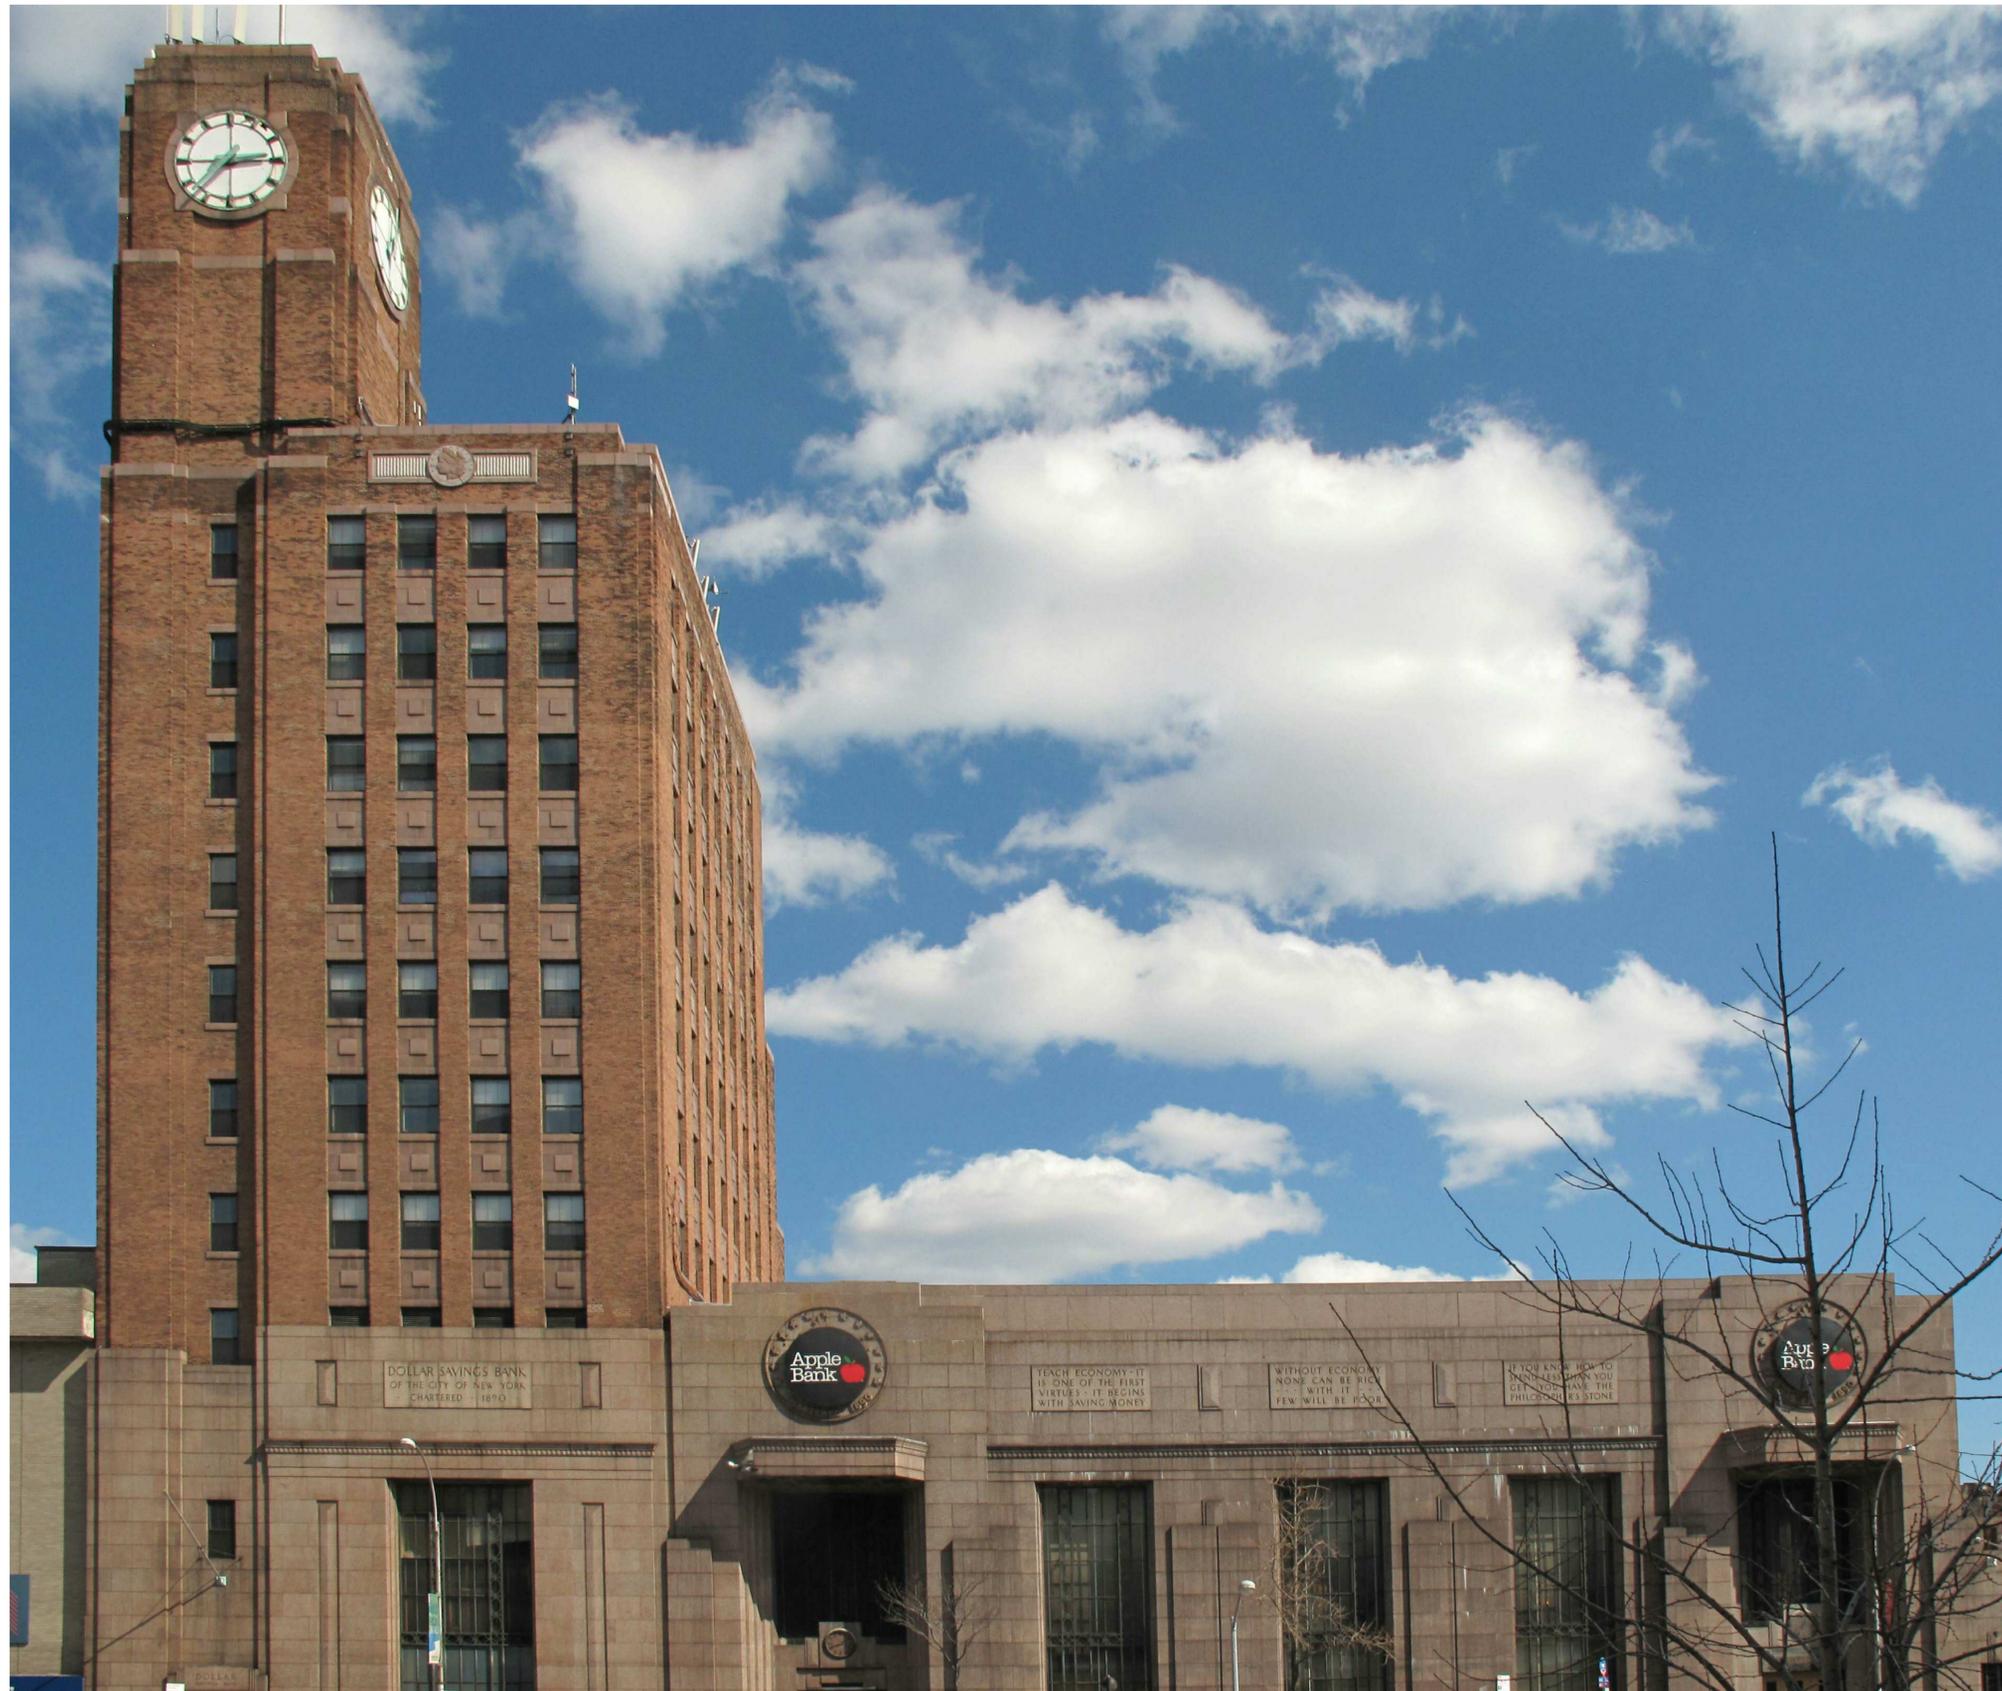
Drawing Title:
**CONSTRUCTION PHASE
TIMELINE**
Drawing No.:
G-020.00
Issued: 04-14-14

GRAND CONCOURSE LOOKING NORTH

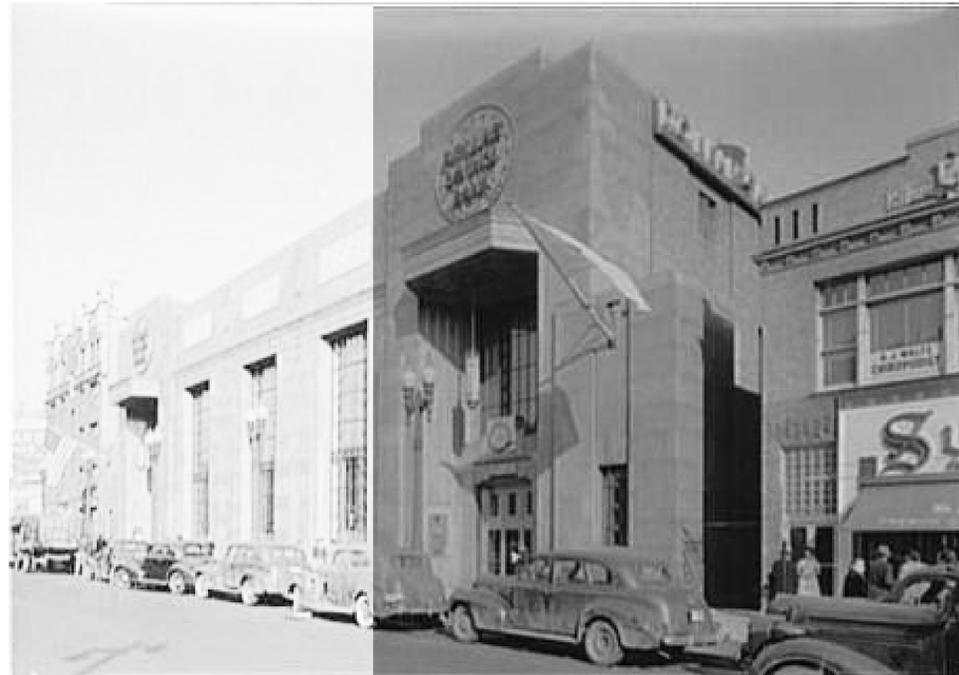
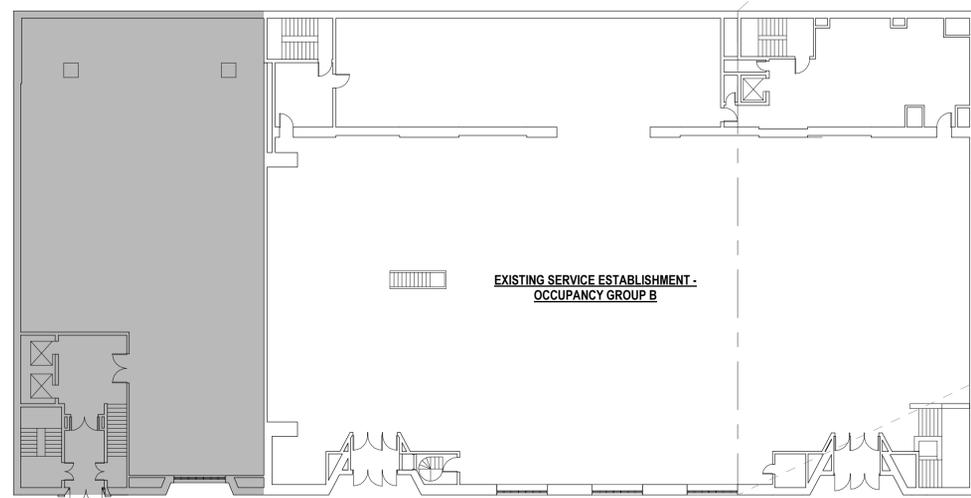
EXISTING FIRST FLOOR PLAN

← PHASE II (c. 1938) → ← PHASE I (c. 1932 - 1933) →

← PHASE III (c. 1949 - 1950) → ← PHASE II (c. 1938) → ← PHASE I (c. 1932 - 1933) →

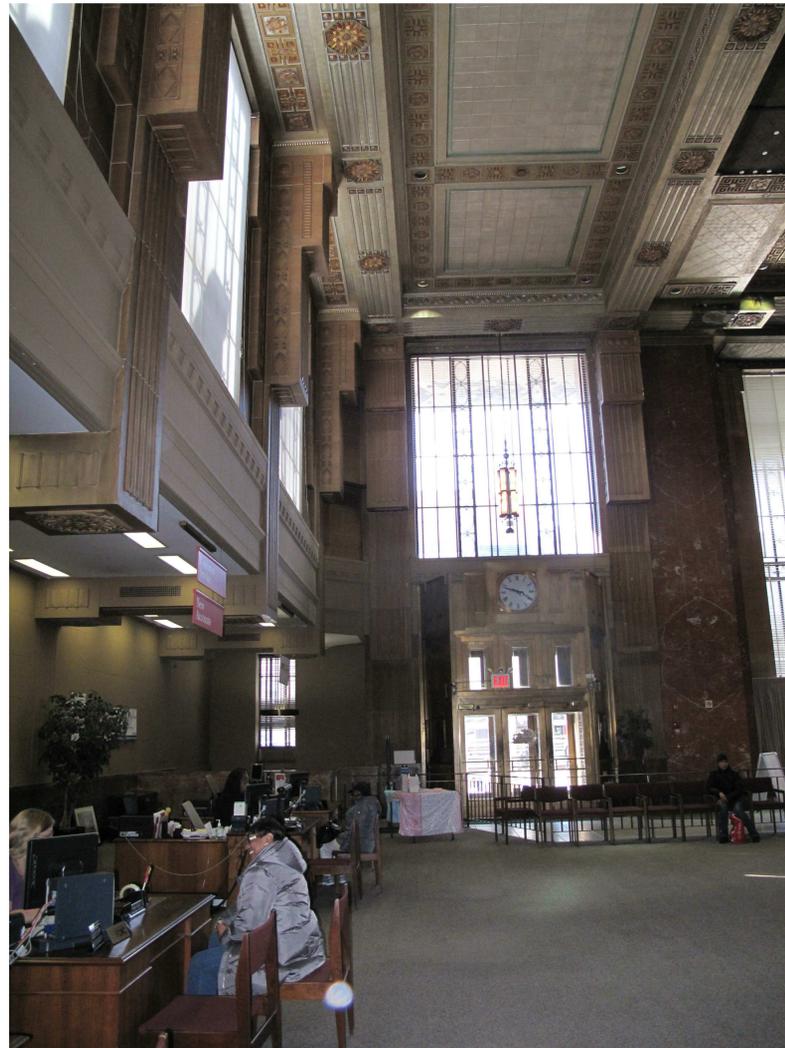
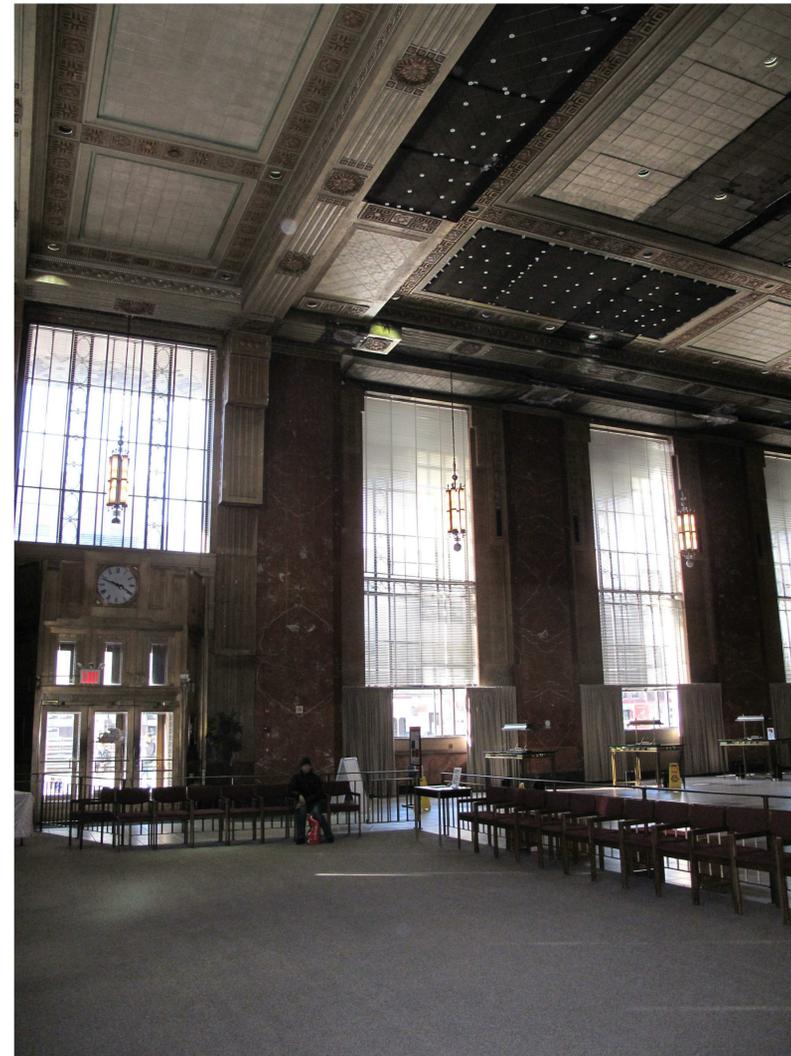
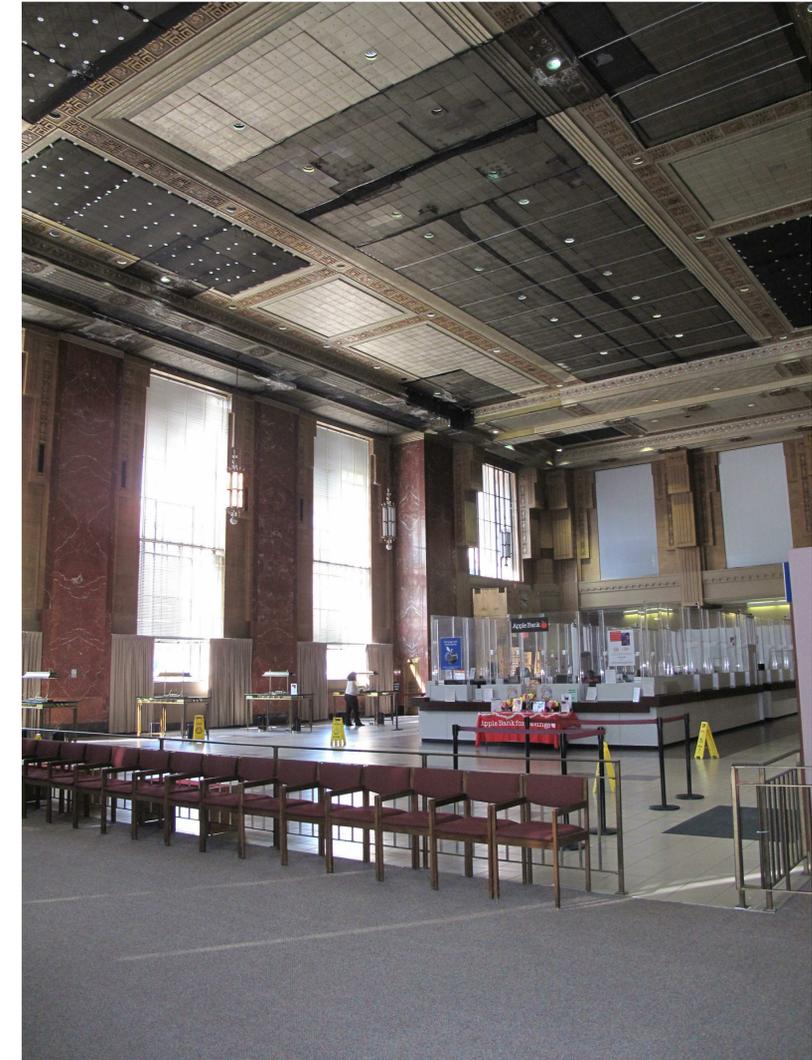
Drawing Title:
**EXISTING WESTERLY BANKING
HALL PHOTOGRAPHS**
Drawing No.:
G-040.00
Issued: 04-14-14

← PHASE I (c. 1932 - 1933) →

← PHASE I (c. 1932 - 1933) → PHASE II (c. 1938) →

← PHASE II (c. 1938) →

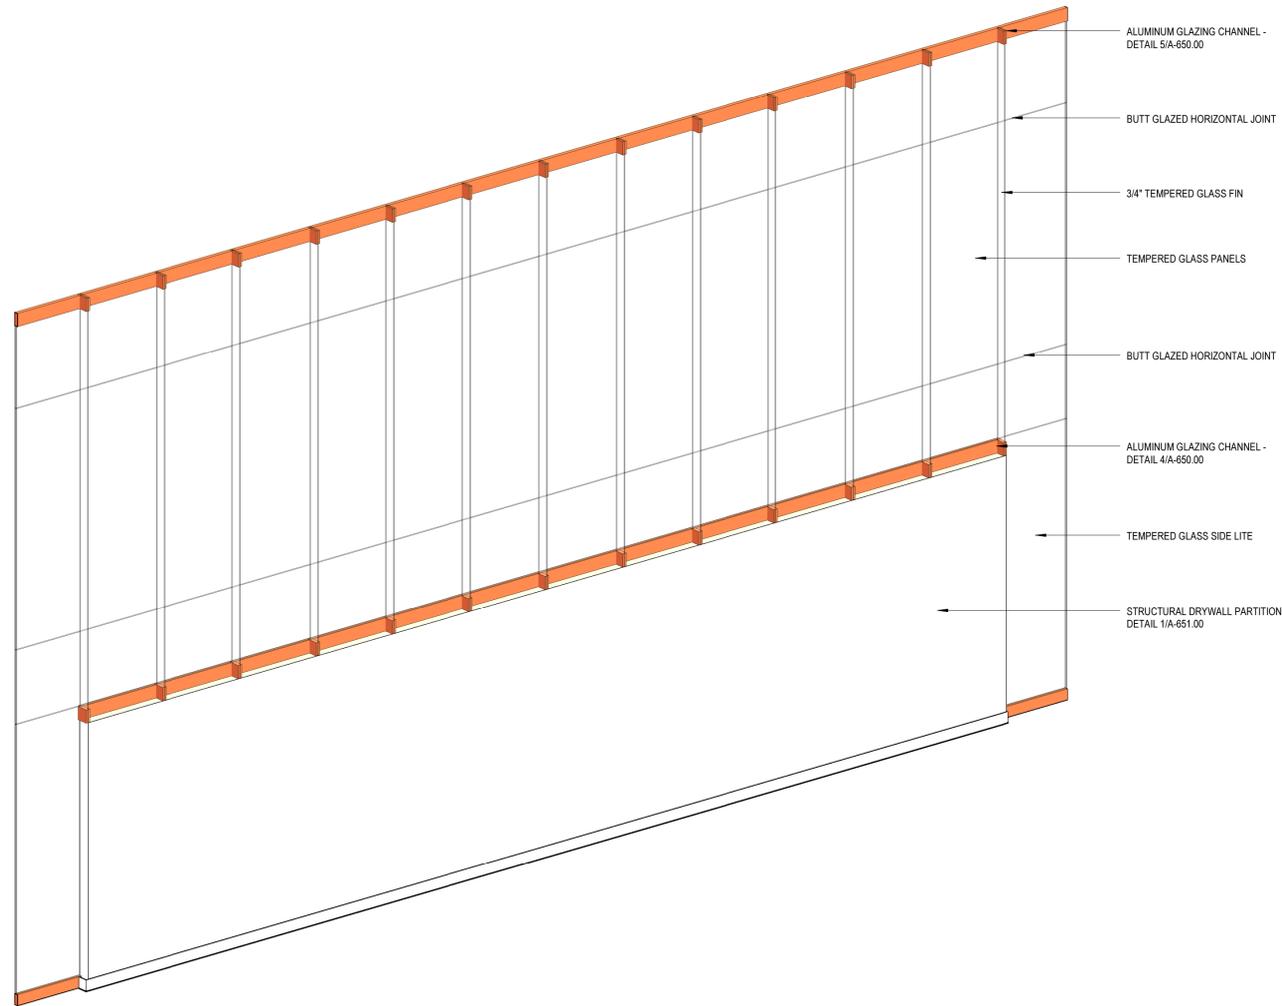
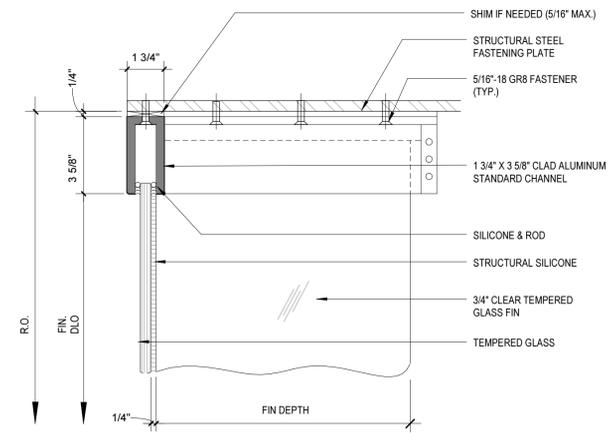
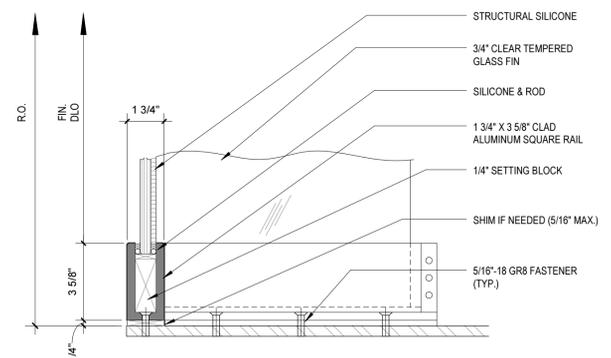
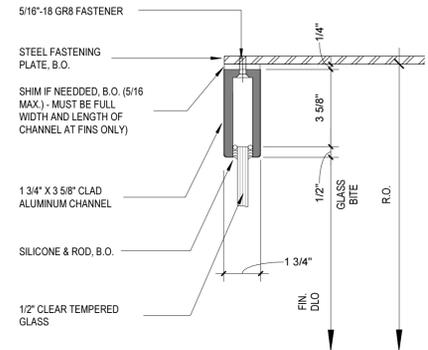
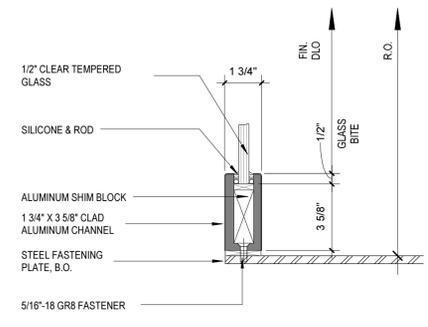
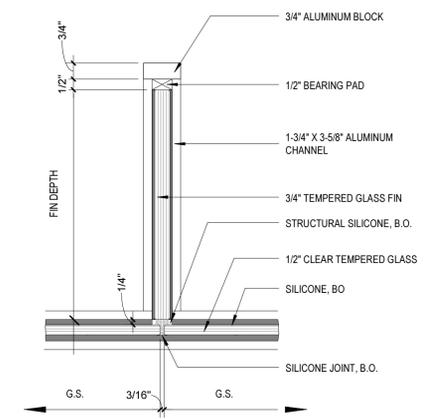
Drawing Title:
**PROPOSED DEMISING WALL
DETAILS**
Drawing No.:
A-650.00
Issued: 04-14-14

5 MAINPLATE HEAD SECTION
3" = 1'-0"

4 MAINPLATE SILL SECTION
3" = 1'-0"

3 FIN MAINPLATE
3" = 1'-0"

1 DEMISING WALL

2 MAINPLATE FIN ELEVATION
3" = 1'-0"

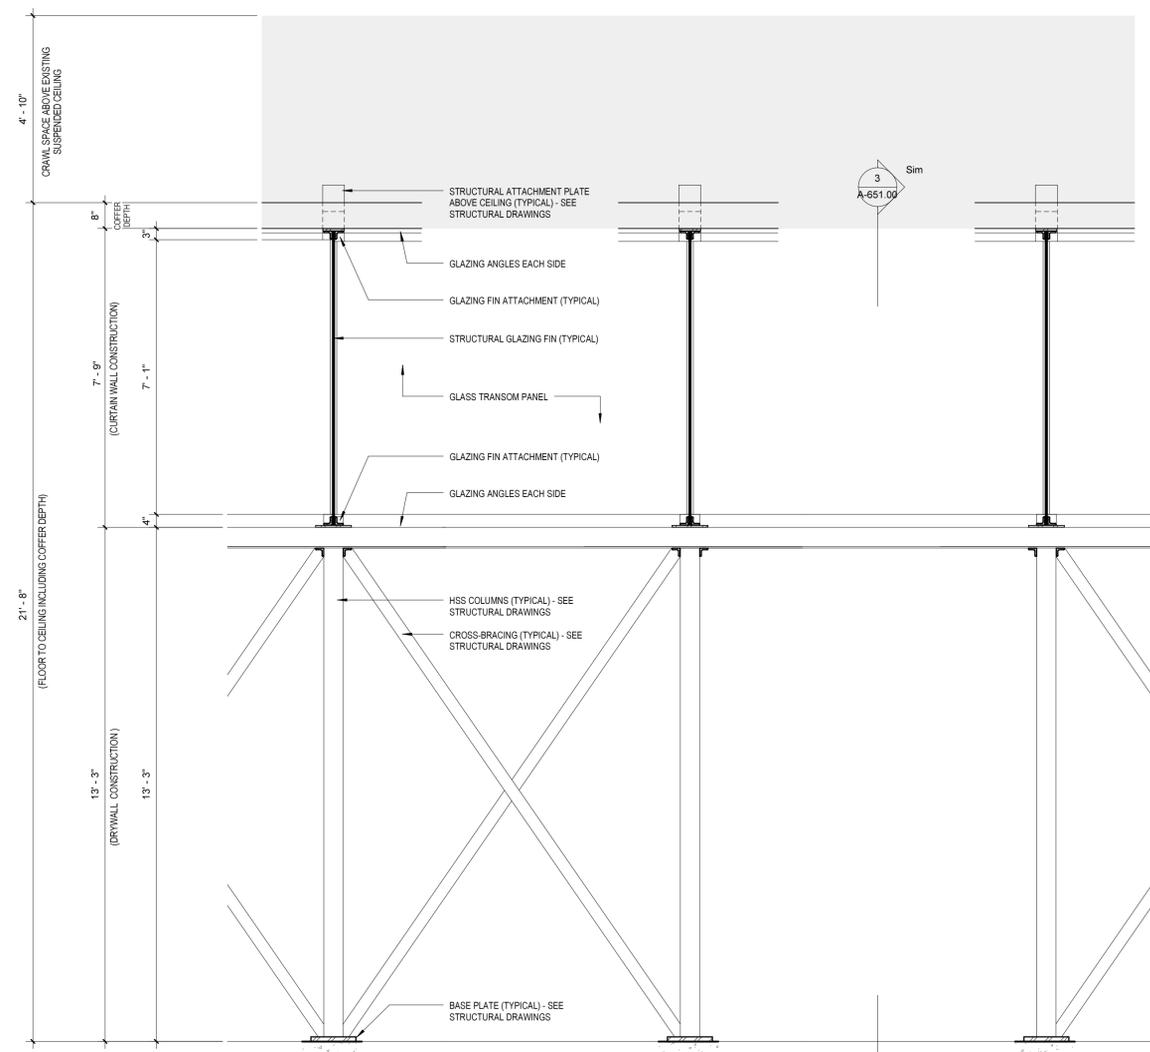
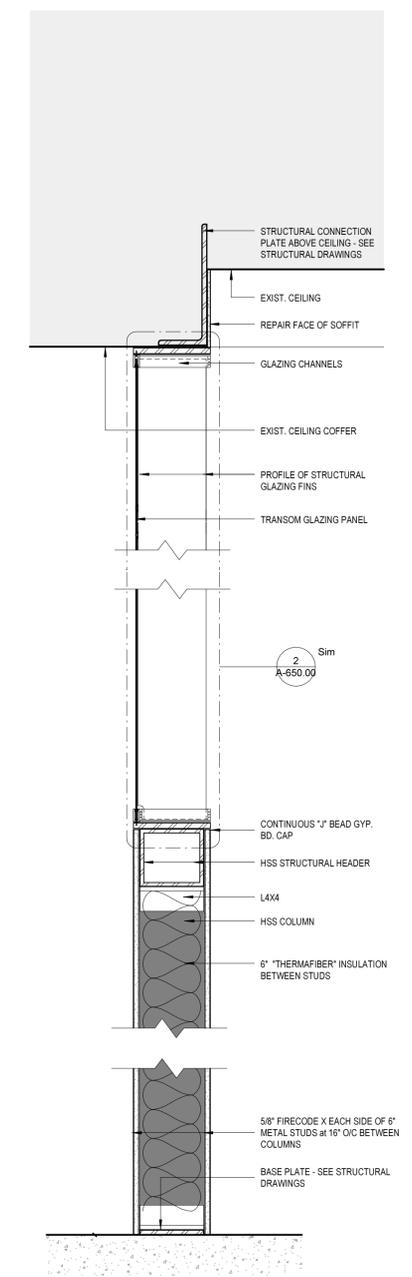
Drawing Title: **BANKING HALL DEMISING WALL DETAILS**

1 DEMISING WALL PARTIAL FRAMING ELEVATION
1/2" = 1'-0"

2 DEMISING WALL COLUMN PLAN
1/4" = 1'-0"

3 DEMISING WALL SECTION
1 1/2" = 1'-0"

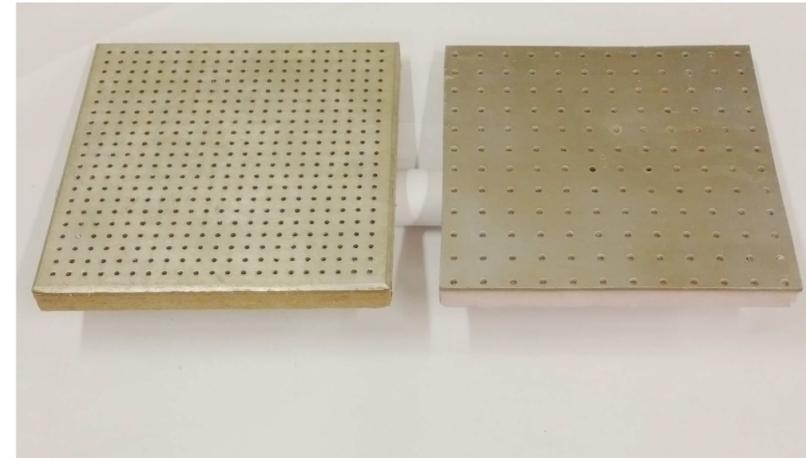
ORIGINAL and PREVIOUS REPAIR CEILING TILES

MISSING CEILING TILES WILL BE REPLACED USING PERFORATED VENEER LAMINATED TO RIGID INSULATION BOARD, SIMILAR TO PRIOR REPAIRS, WITH PERFORATIONS OF REPLACEMENT TILES WILL MATCH EXISTING.

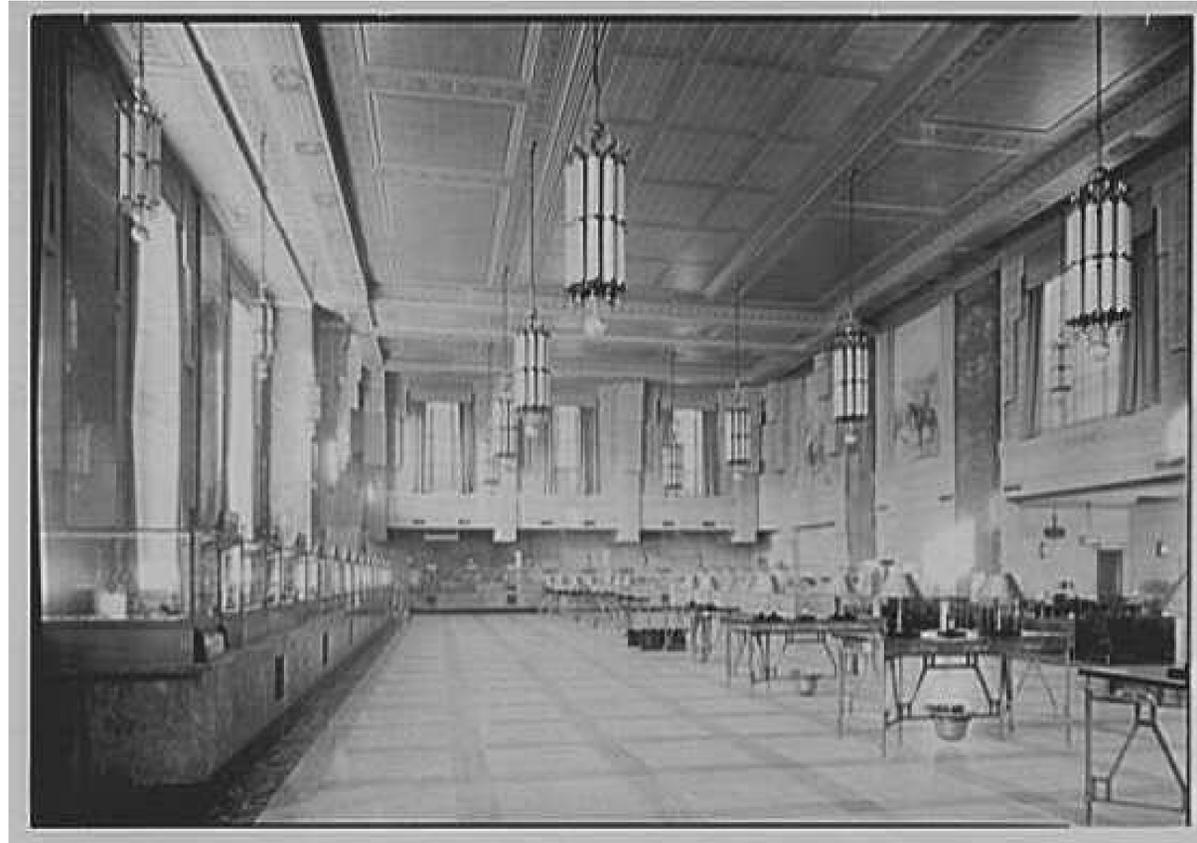
ORIGINAL BANKING HALL INTERIOR

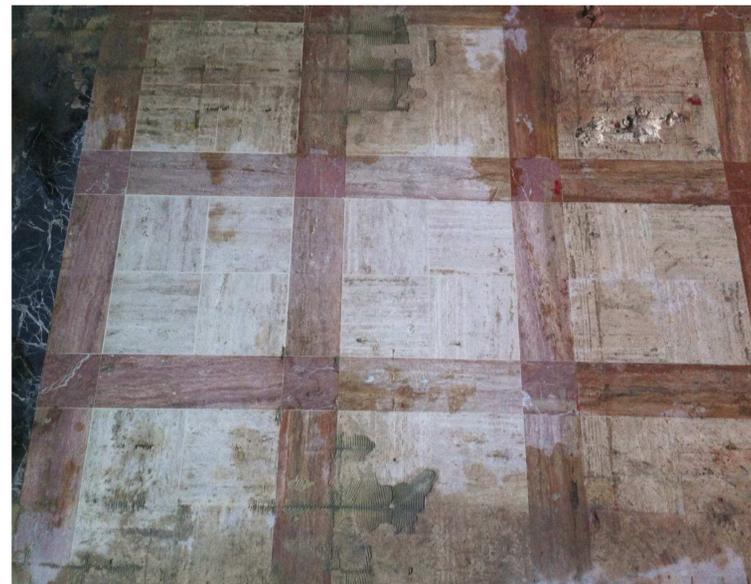
PROPOSED EPOXY TERRAZZO PATCHING

ORIGINAL BANKING HALL TERRAZZO FLOORING

EPOXY TERRAZZO IS PROPOSED TO MATCH DAMAGED AREAS OF EXISTING FLOORING, WITH A .25" CLEAR COAT, SLIGHTLY TINTED TO EVEN THE APPEARANCE BETWEEN EXISTING AND NEW MATERIALS

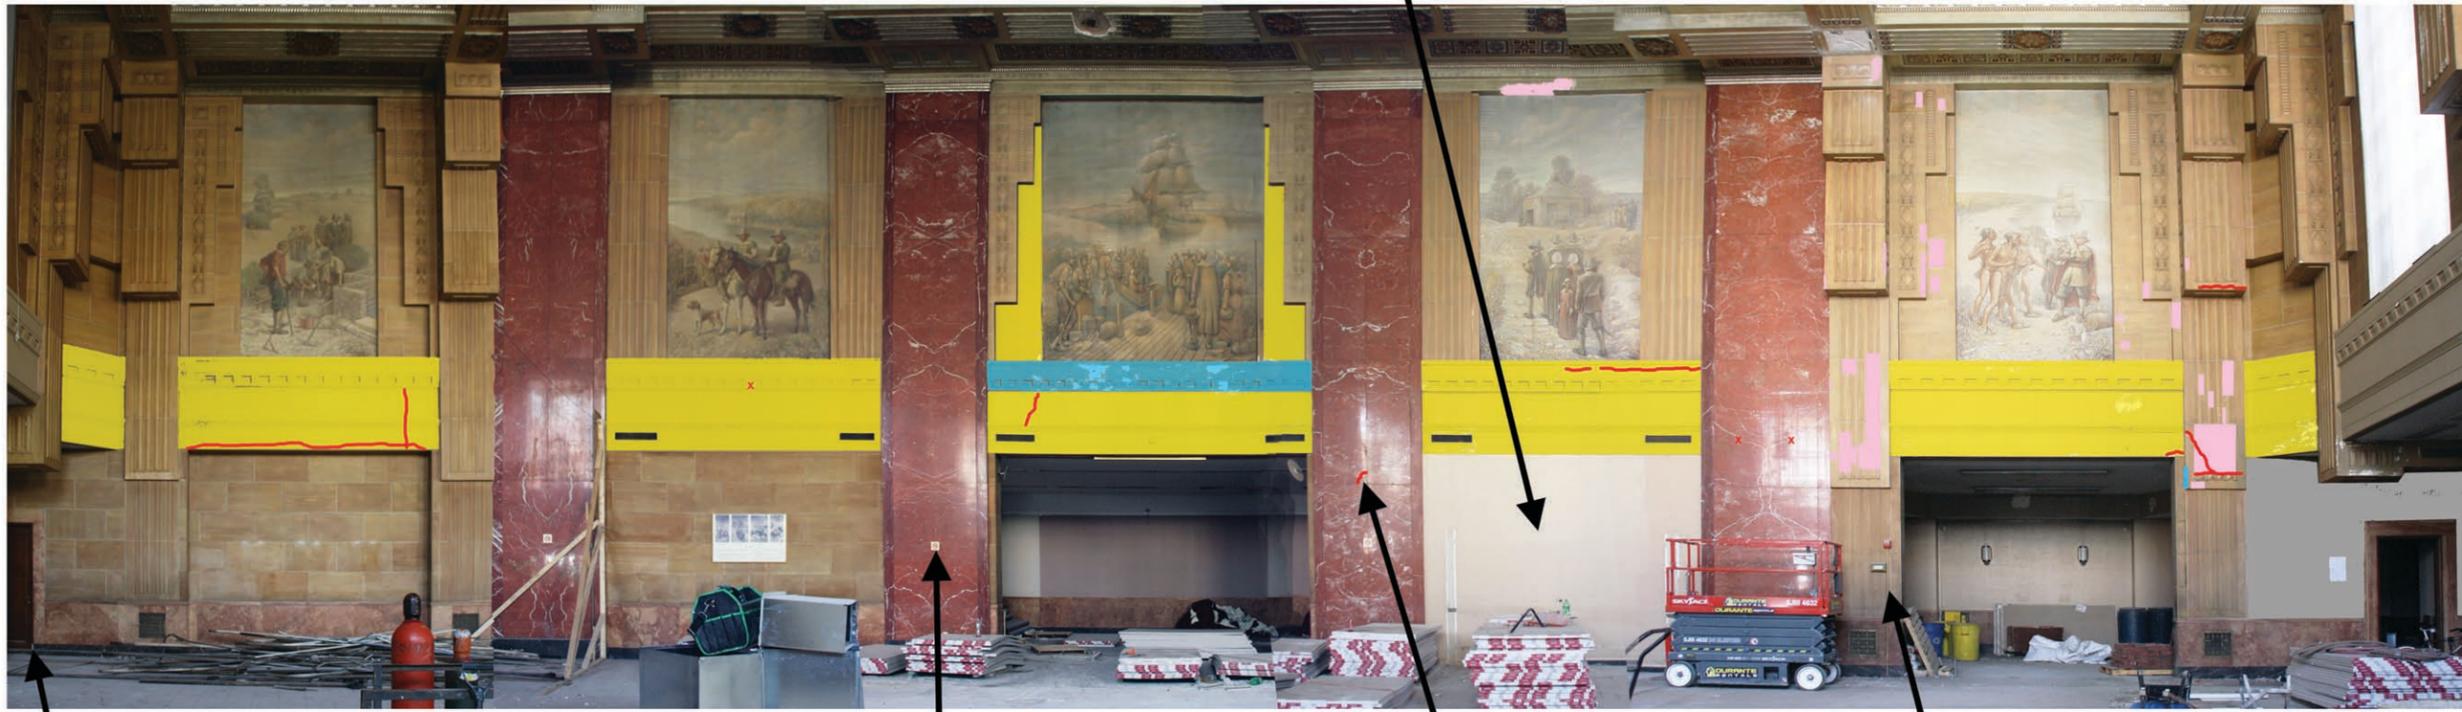
EAST ELEVATION

Remove gypsum board and repair masonry as necessary.

Replace missing baseboard piece.

Remove "No Smoking" signs (Typ.)

Incipient spall. Panels may be displaced.

Remove security/fire boxes if unnecessary. Patch holes.

- Replace missing decorative plaster with new to match original. Paint to match original decorative scheme.
- Replace missing acoustical tiles with salvaged tiles or new tiles to match original.
- Replace deteriorated plaster with new plaster to match the original shapes and profiles. Paint to match original decorative scheme.
- Grout and patch crack.
- Re-adhere loose decorative plaster.
- Repaint areas of missing or flaking paint to match original.
- Repaint areas of overpainting to match original decorative painting.
- Remove paint and plaster skim coat from masonry. Patch and repair masonry as necessary.
- X Remove abandoned anchor.

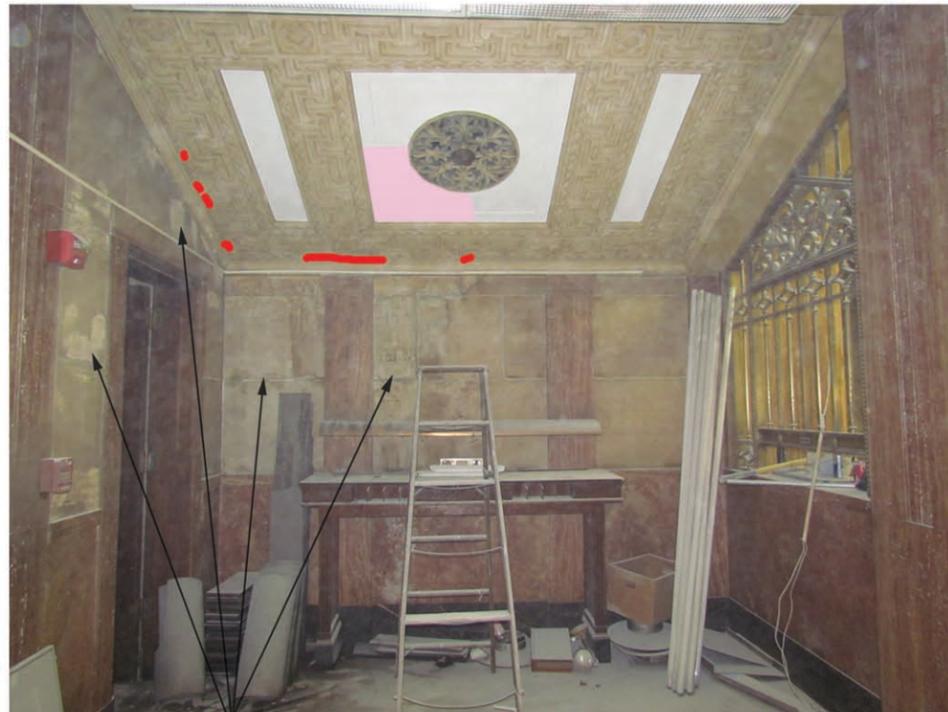
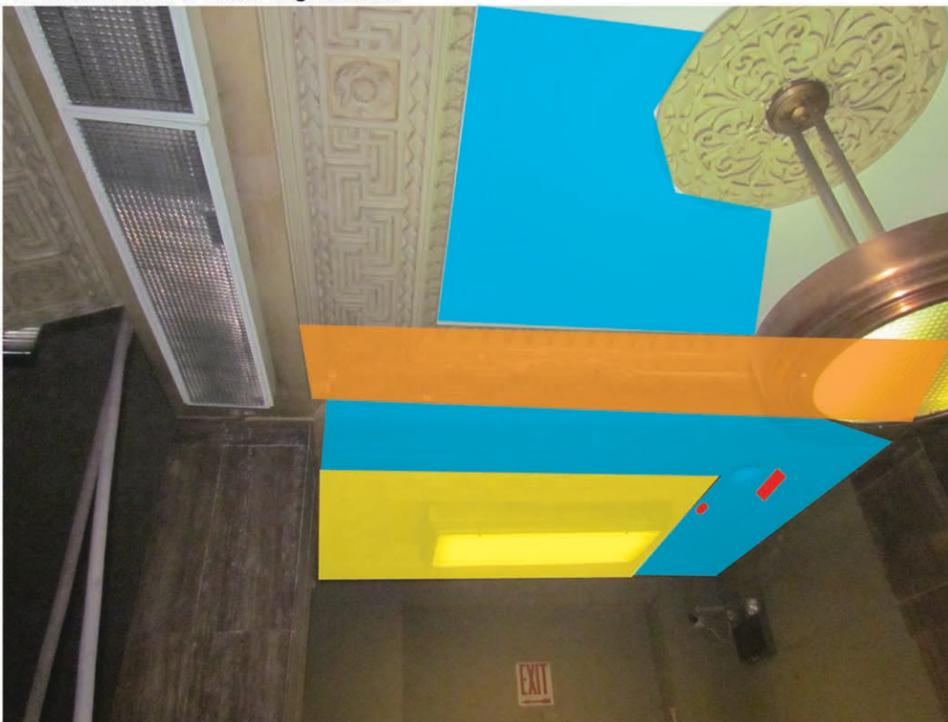
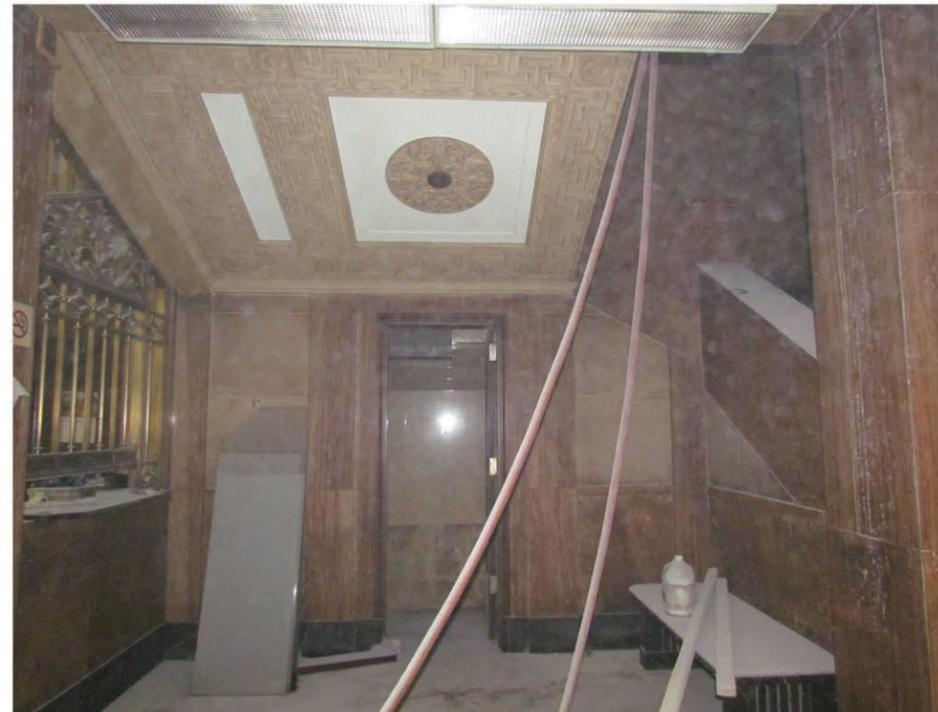
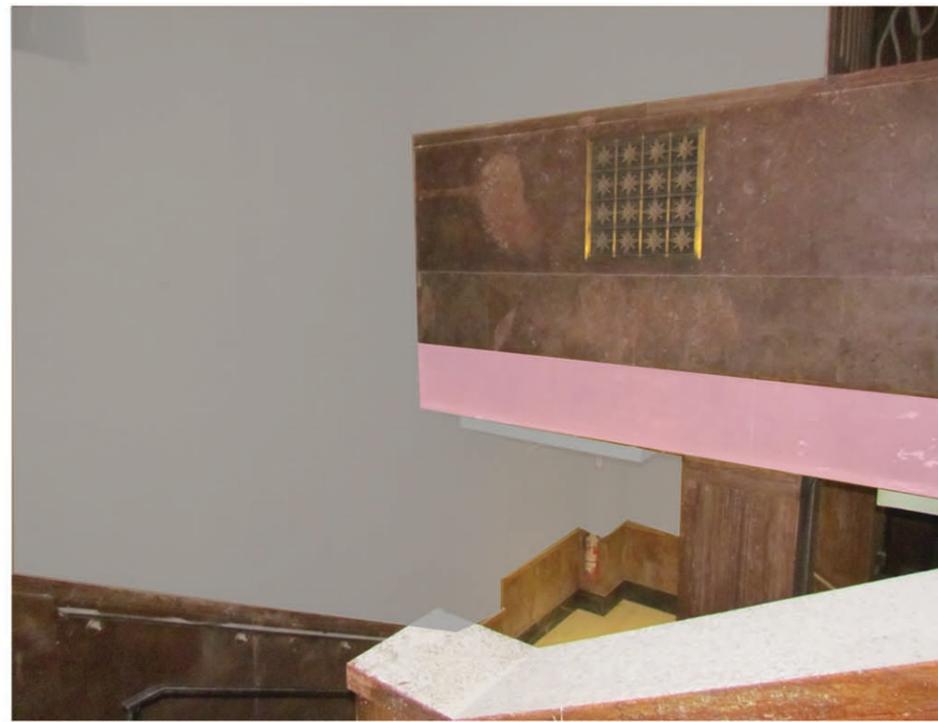
VAULT LOBBY

Clean walls and over-paint areas of patching and deterioration to match original stone

- Replace missing decorative plaster with new to match original. Paint to match original decorative scheme.
- Replace missing acoustical tiles with salvaged tiles or new tiles to match original.
- Replace deteriorated plaster with new plaster to match the original shapes and profiles. Paint to match original decorative scheme.
- Grout and patch crack.
- Re-adhere loose decorative plaster.
- Repaint areas of missing or flaking paint to match original.
- Repaint areas of overpainting to match original decorative painting.
- Remove paint and plaster skim coat from masonry. Patch and repair masonry as necessary.
- X Remove abandoned anchor.
