170 Bleeker Street

170 Bleeker Street: Existing Conditions

170 Bleeker Street Historic Conditions

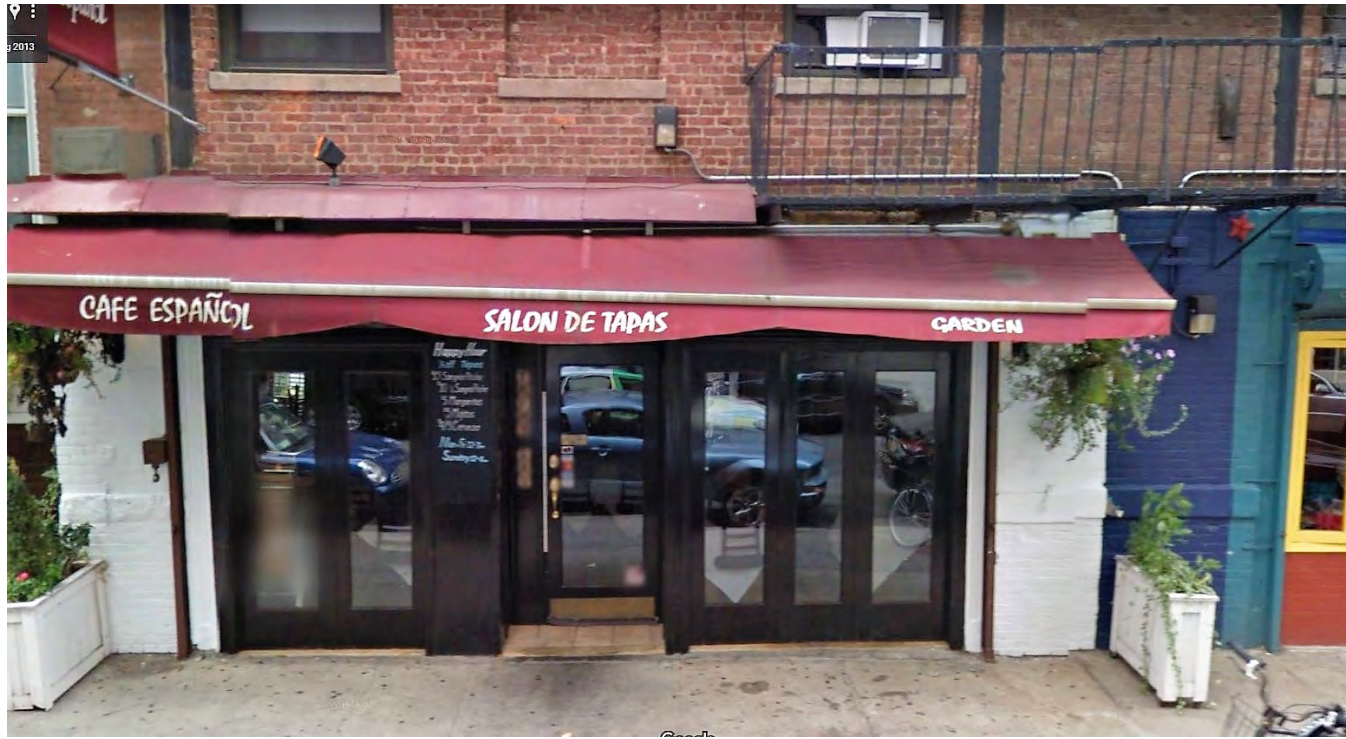
South Storefront 2014 (same today)

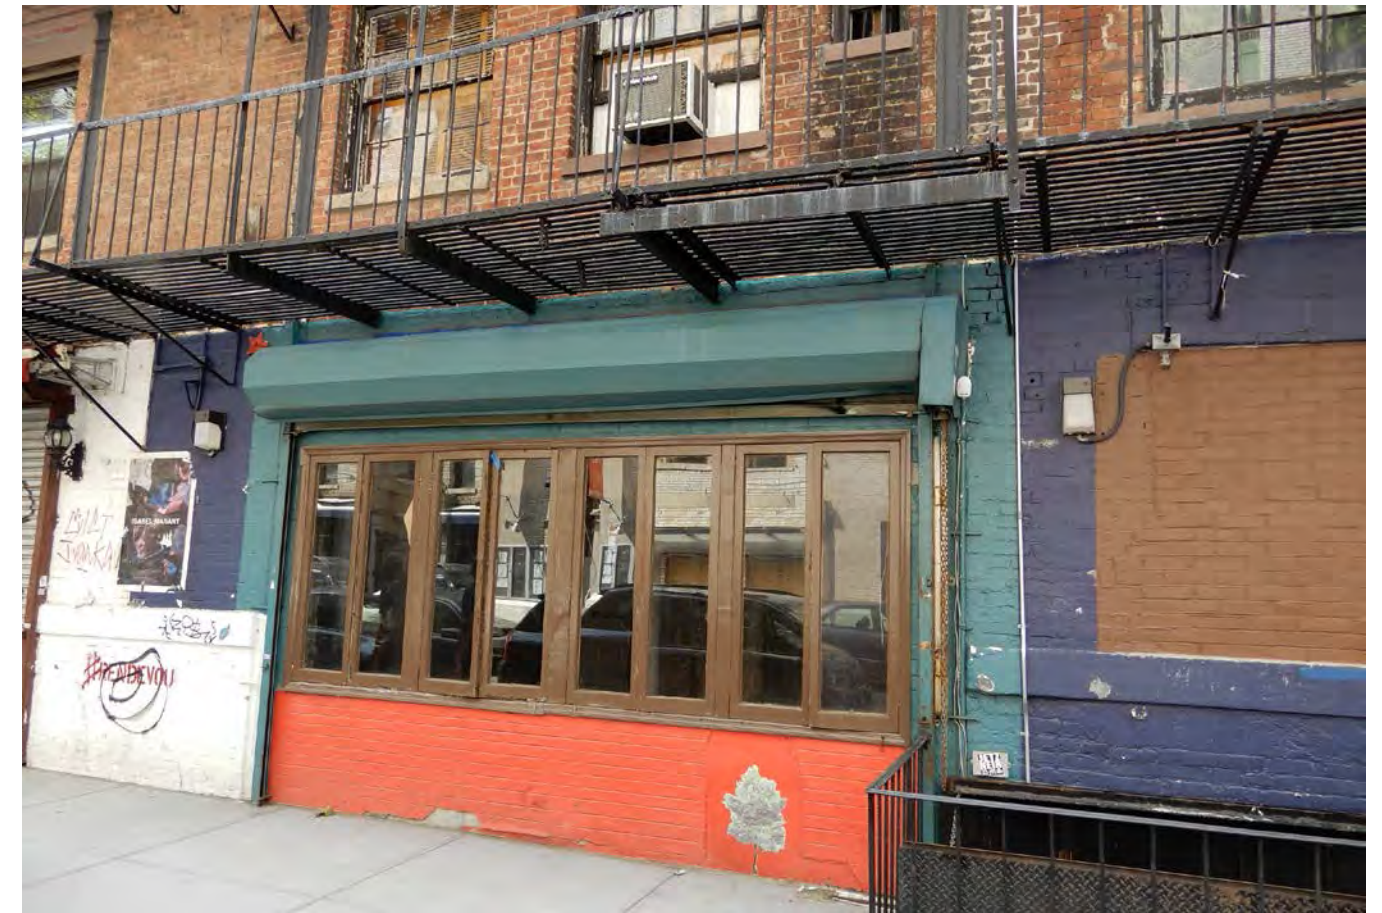
Storefront 2nd Opening from South

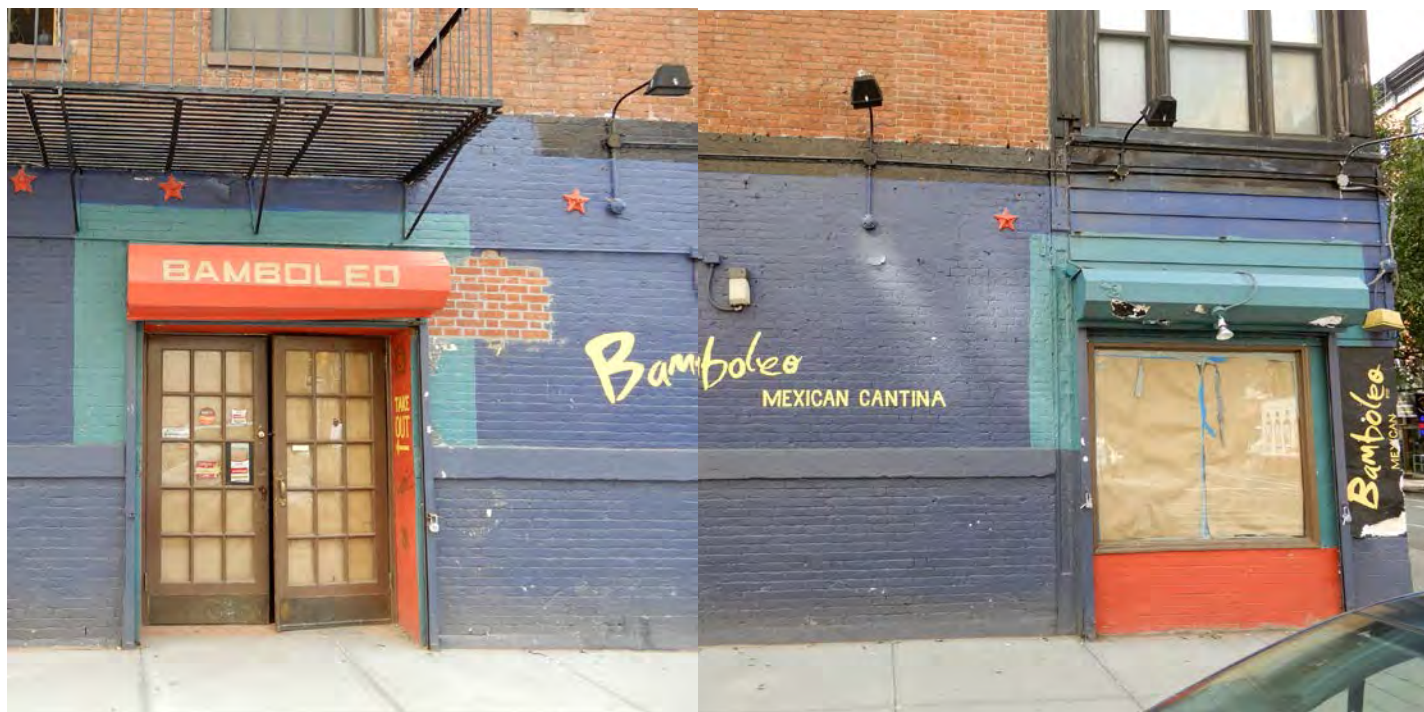
Corner Storefront at North & Double Doors

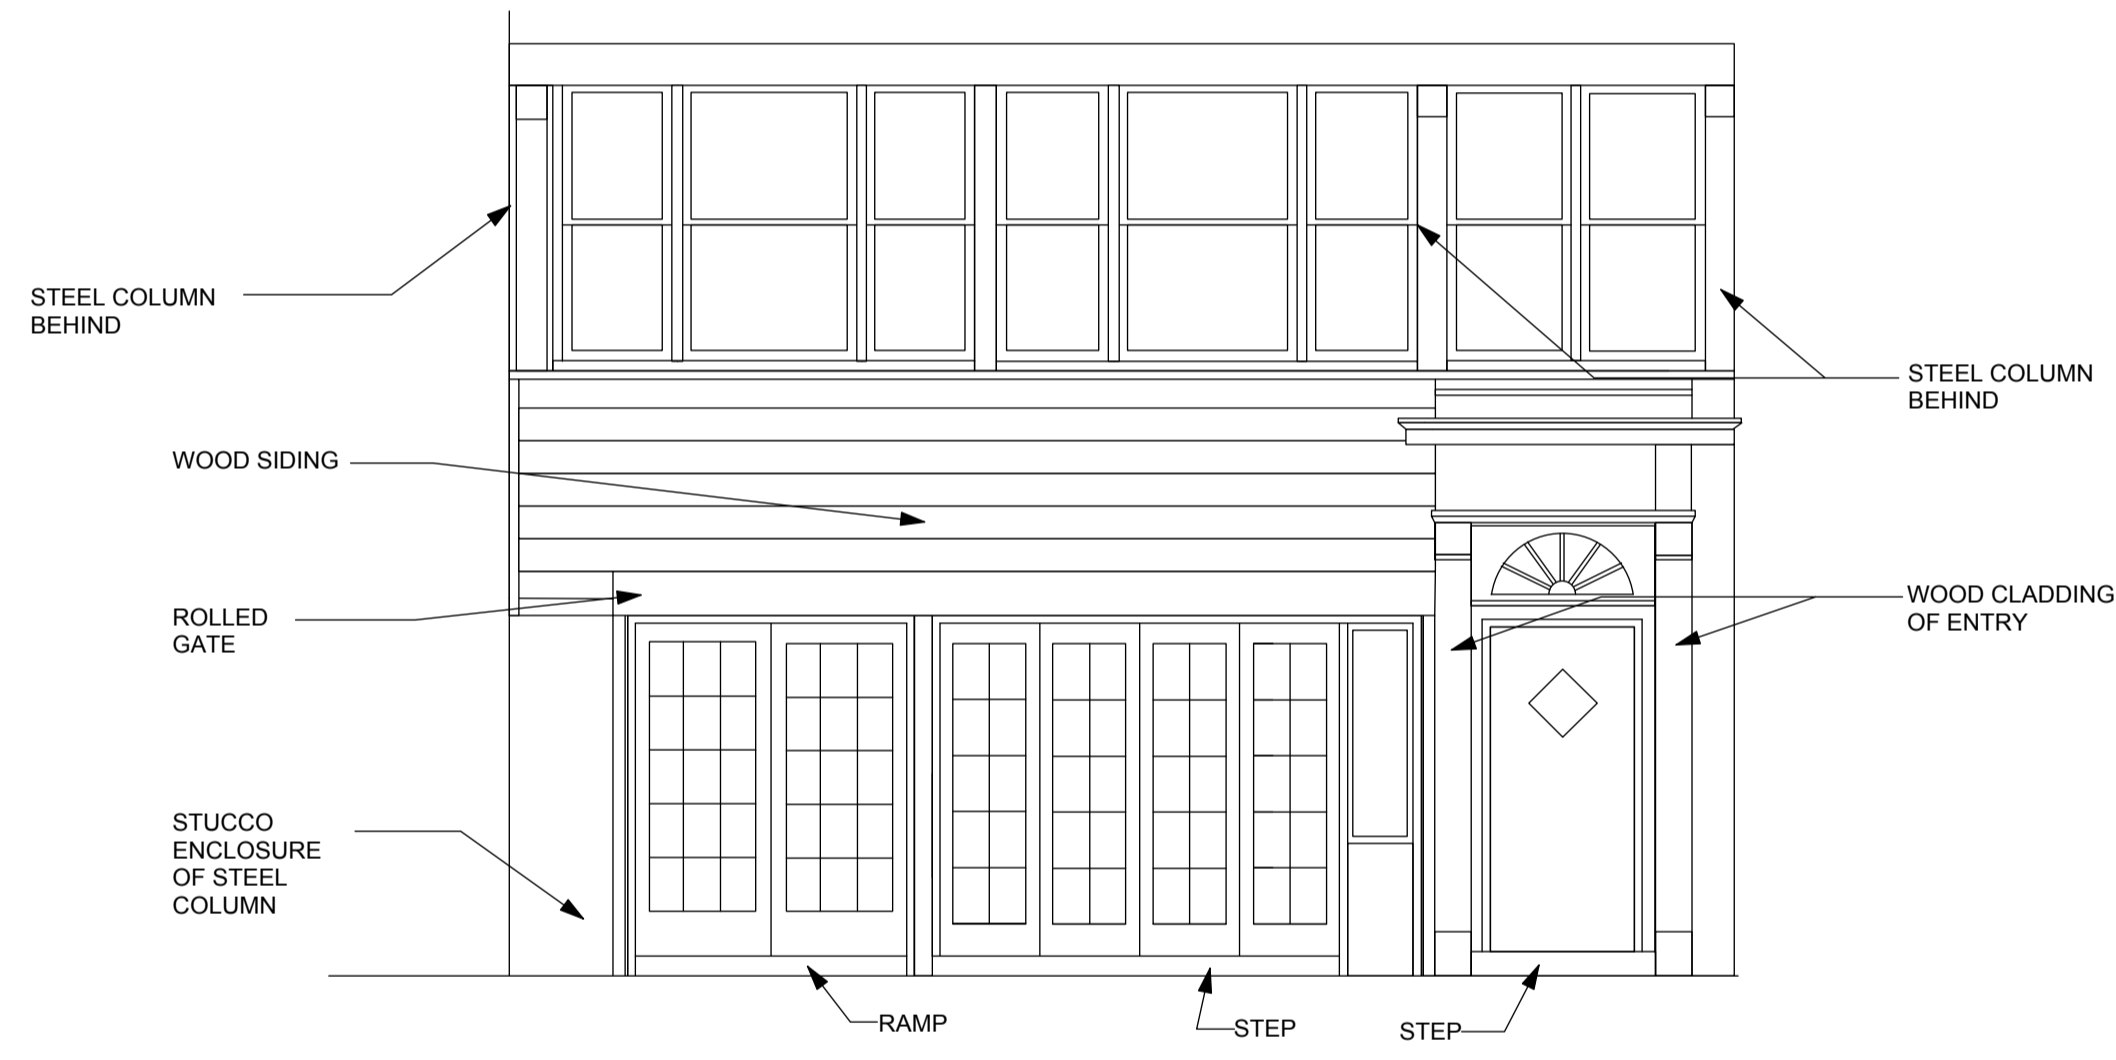
1 EXISTING BLEECKER STREET ELEVATION
Scale: 1/4" = 1'-0"

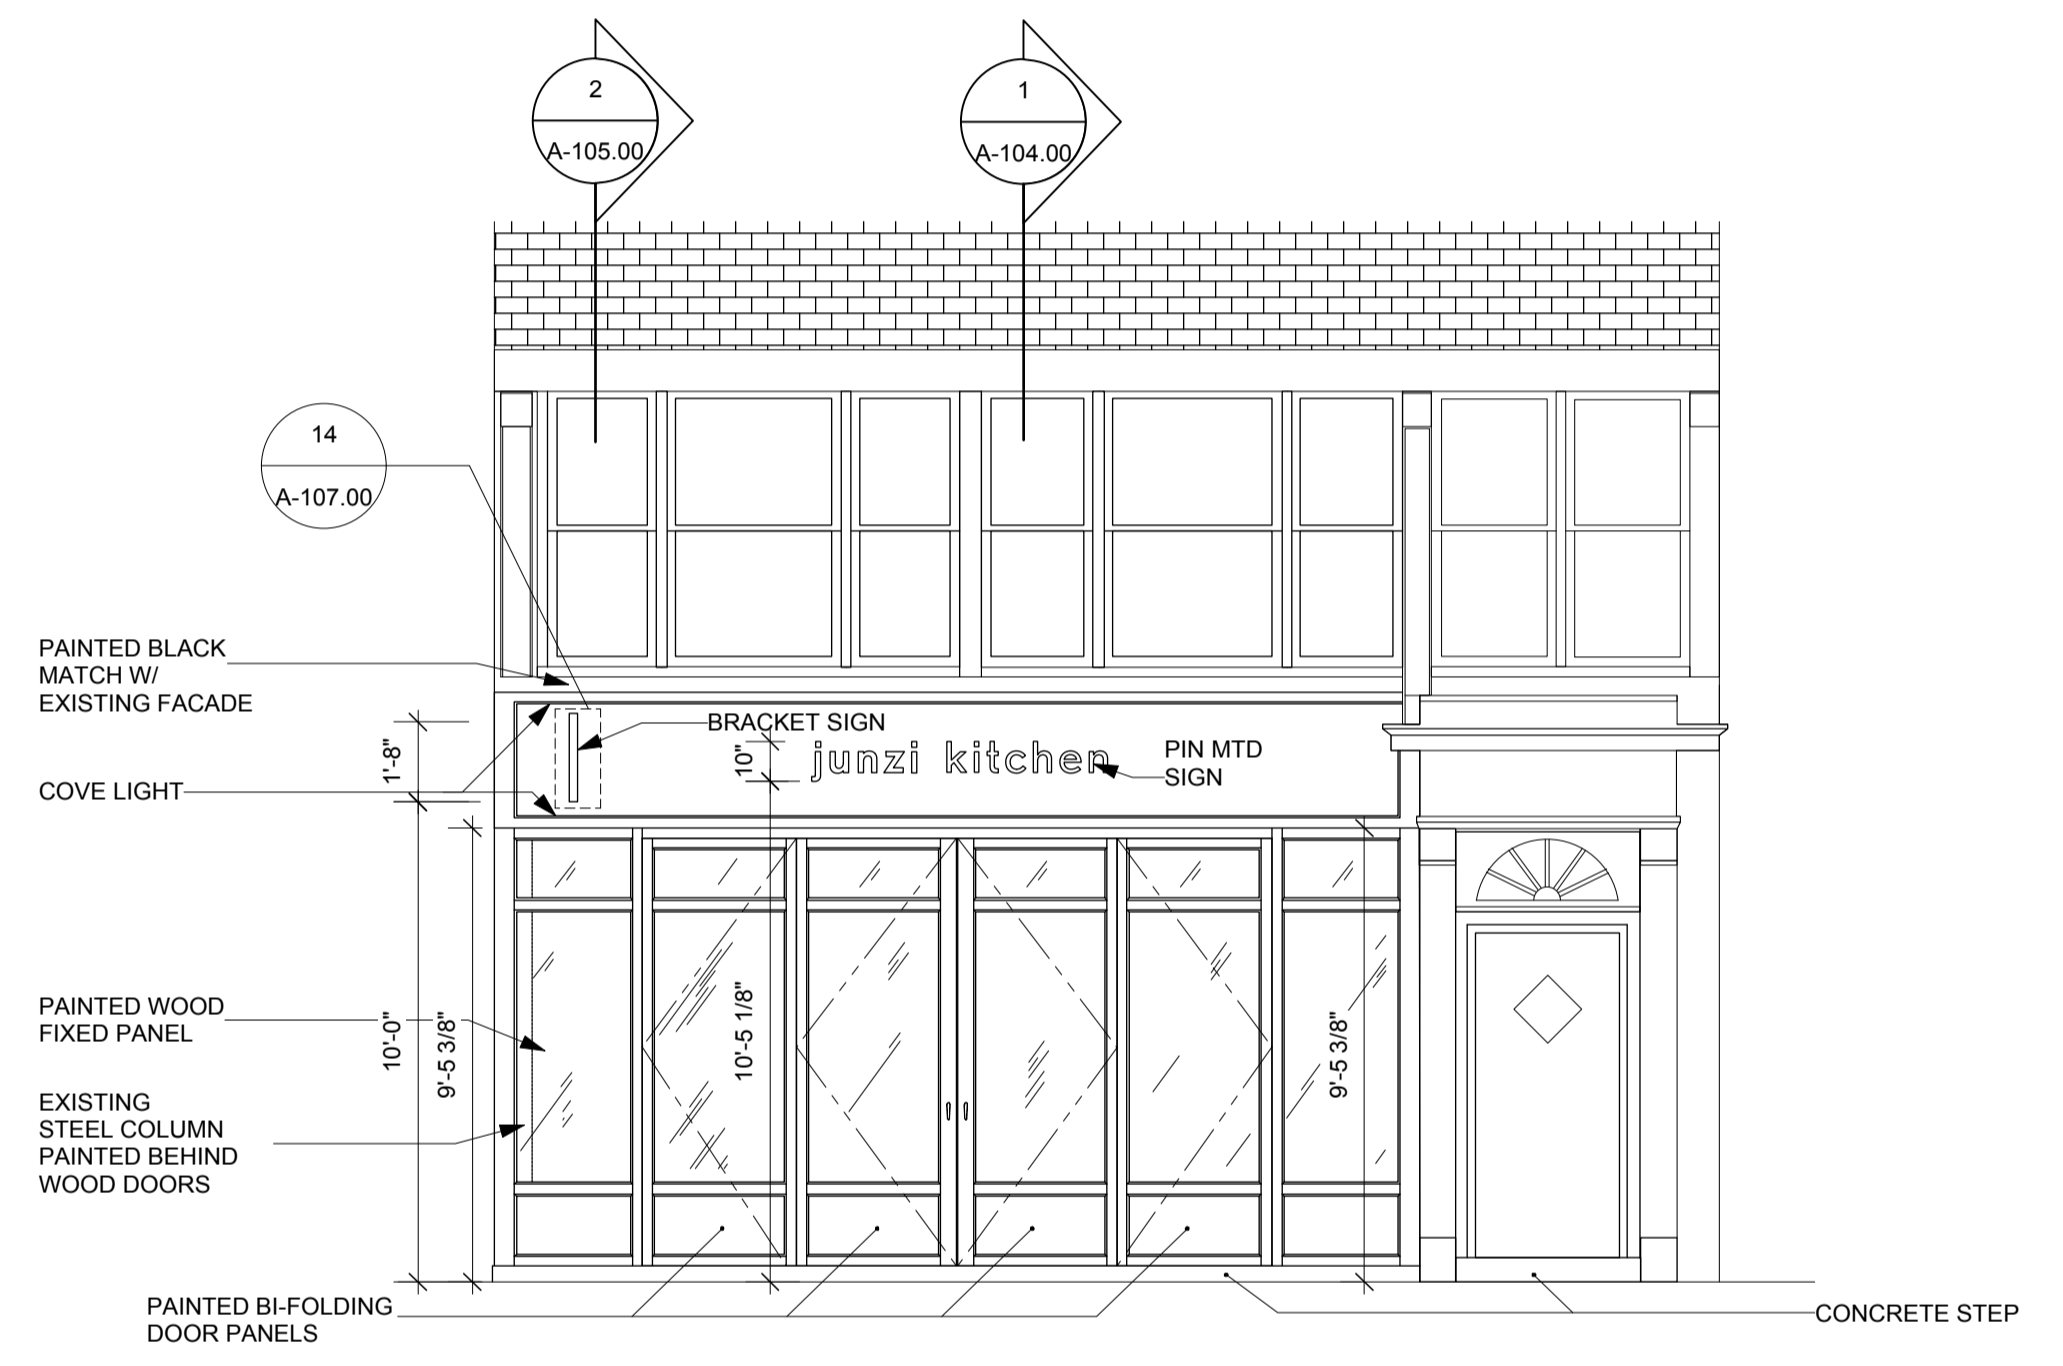
2 NEW BLEECKER ELEVATION
Scale: 1/4" = 1'-0"

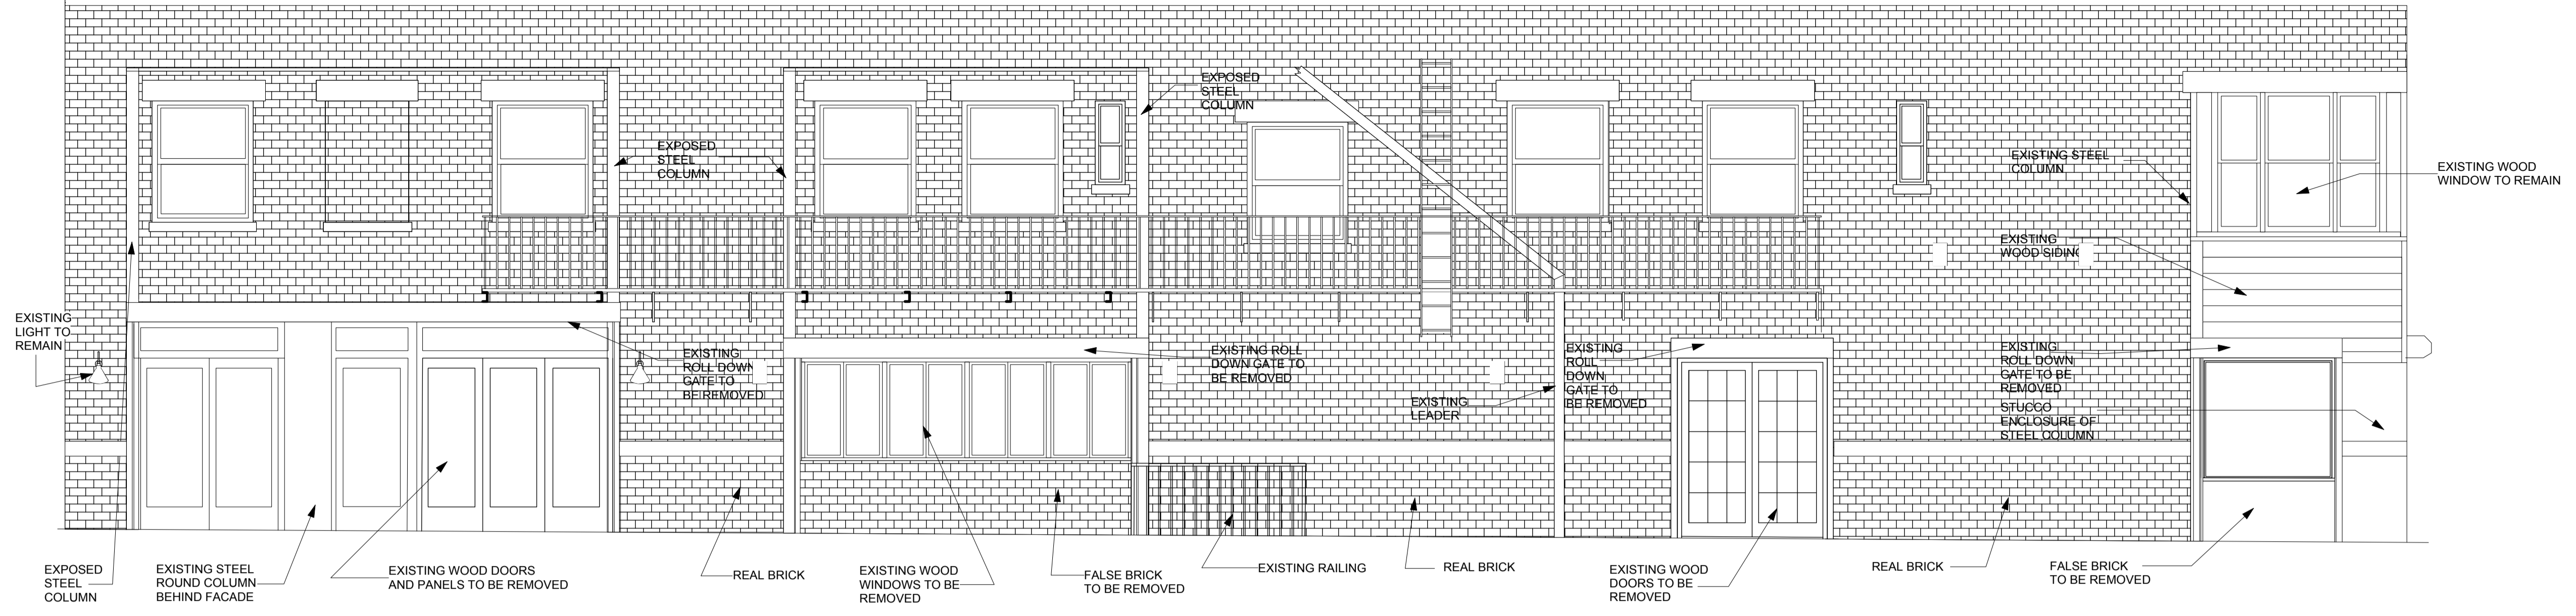
1 EXISTING SULLIVAN STREET ELEVATION
Scale: 1/4" = 1'-0"

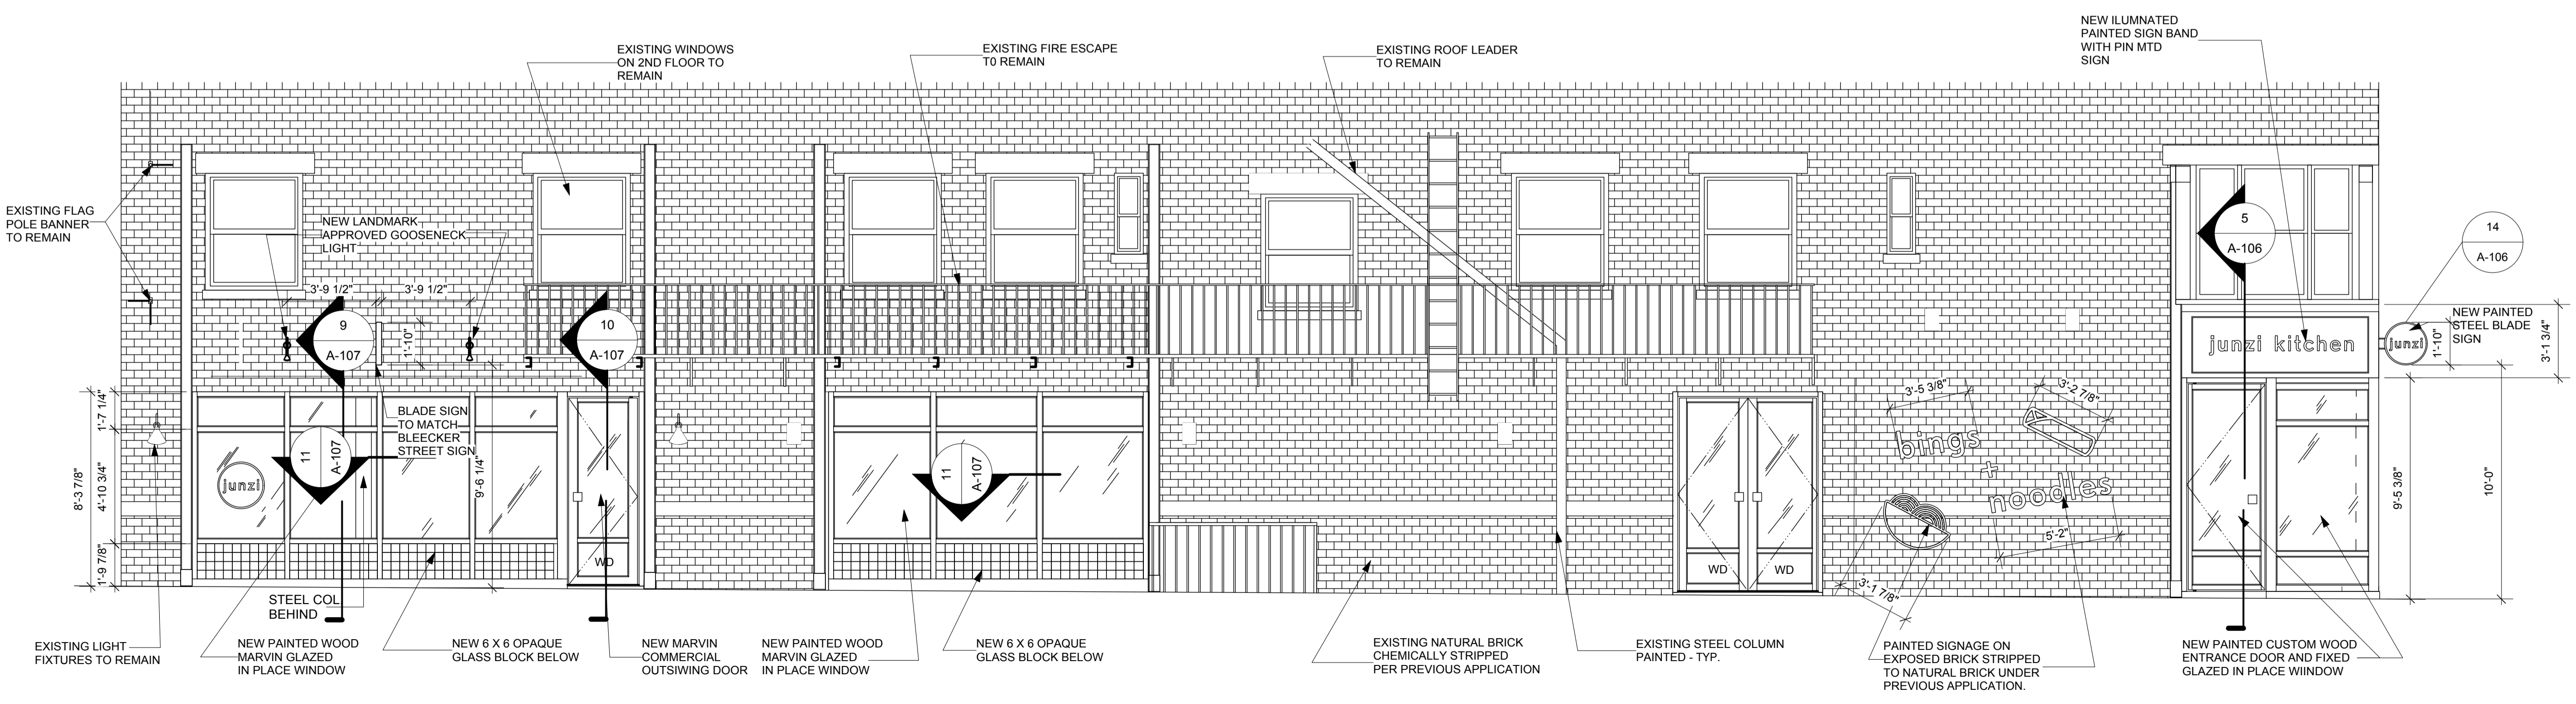
2 NEW ELEVATION SULLIVAN STREET
Scale: 1/4" = 1'-0"

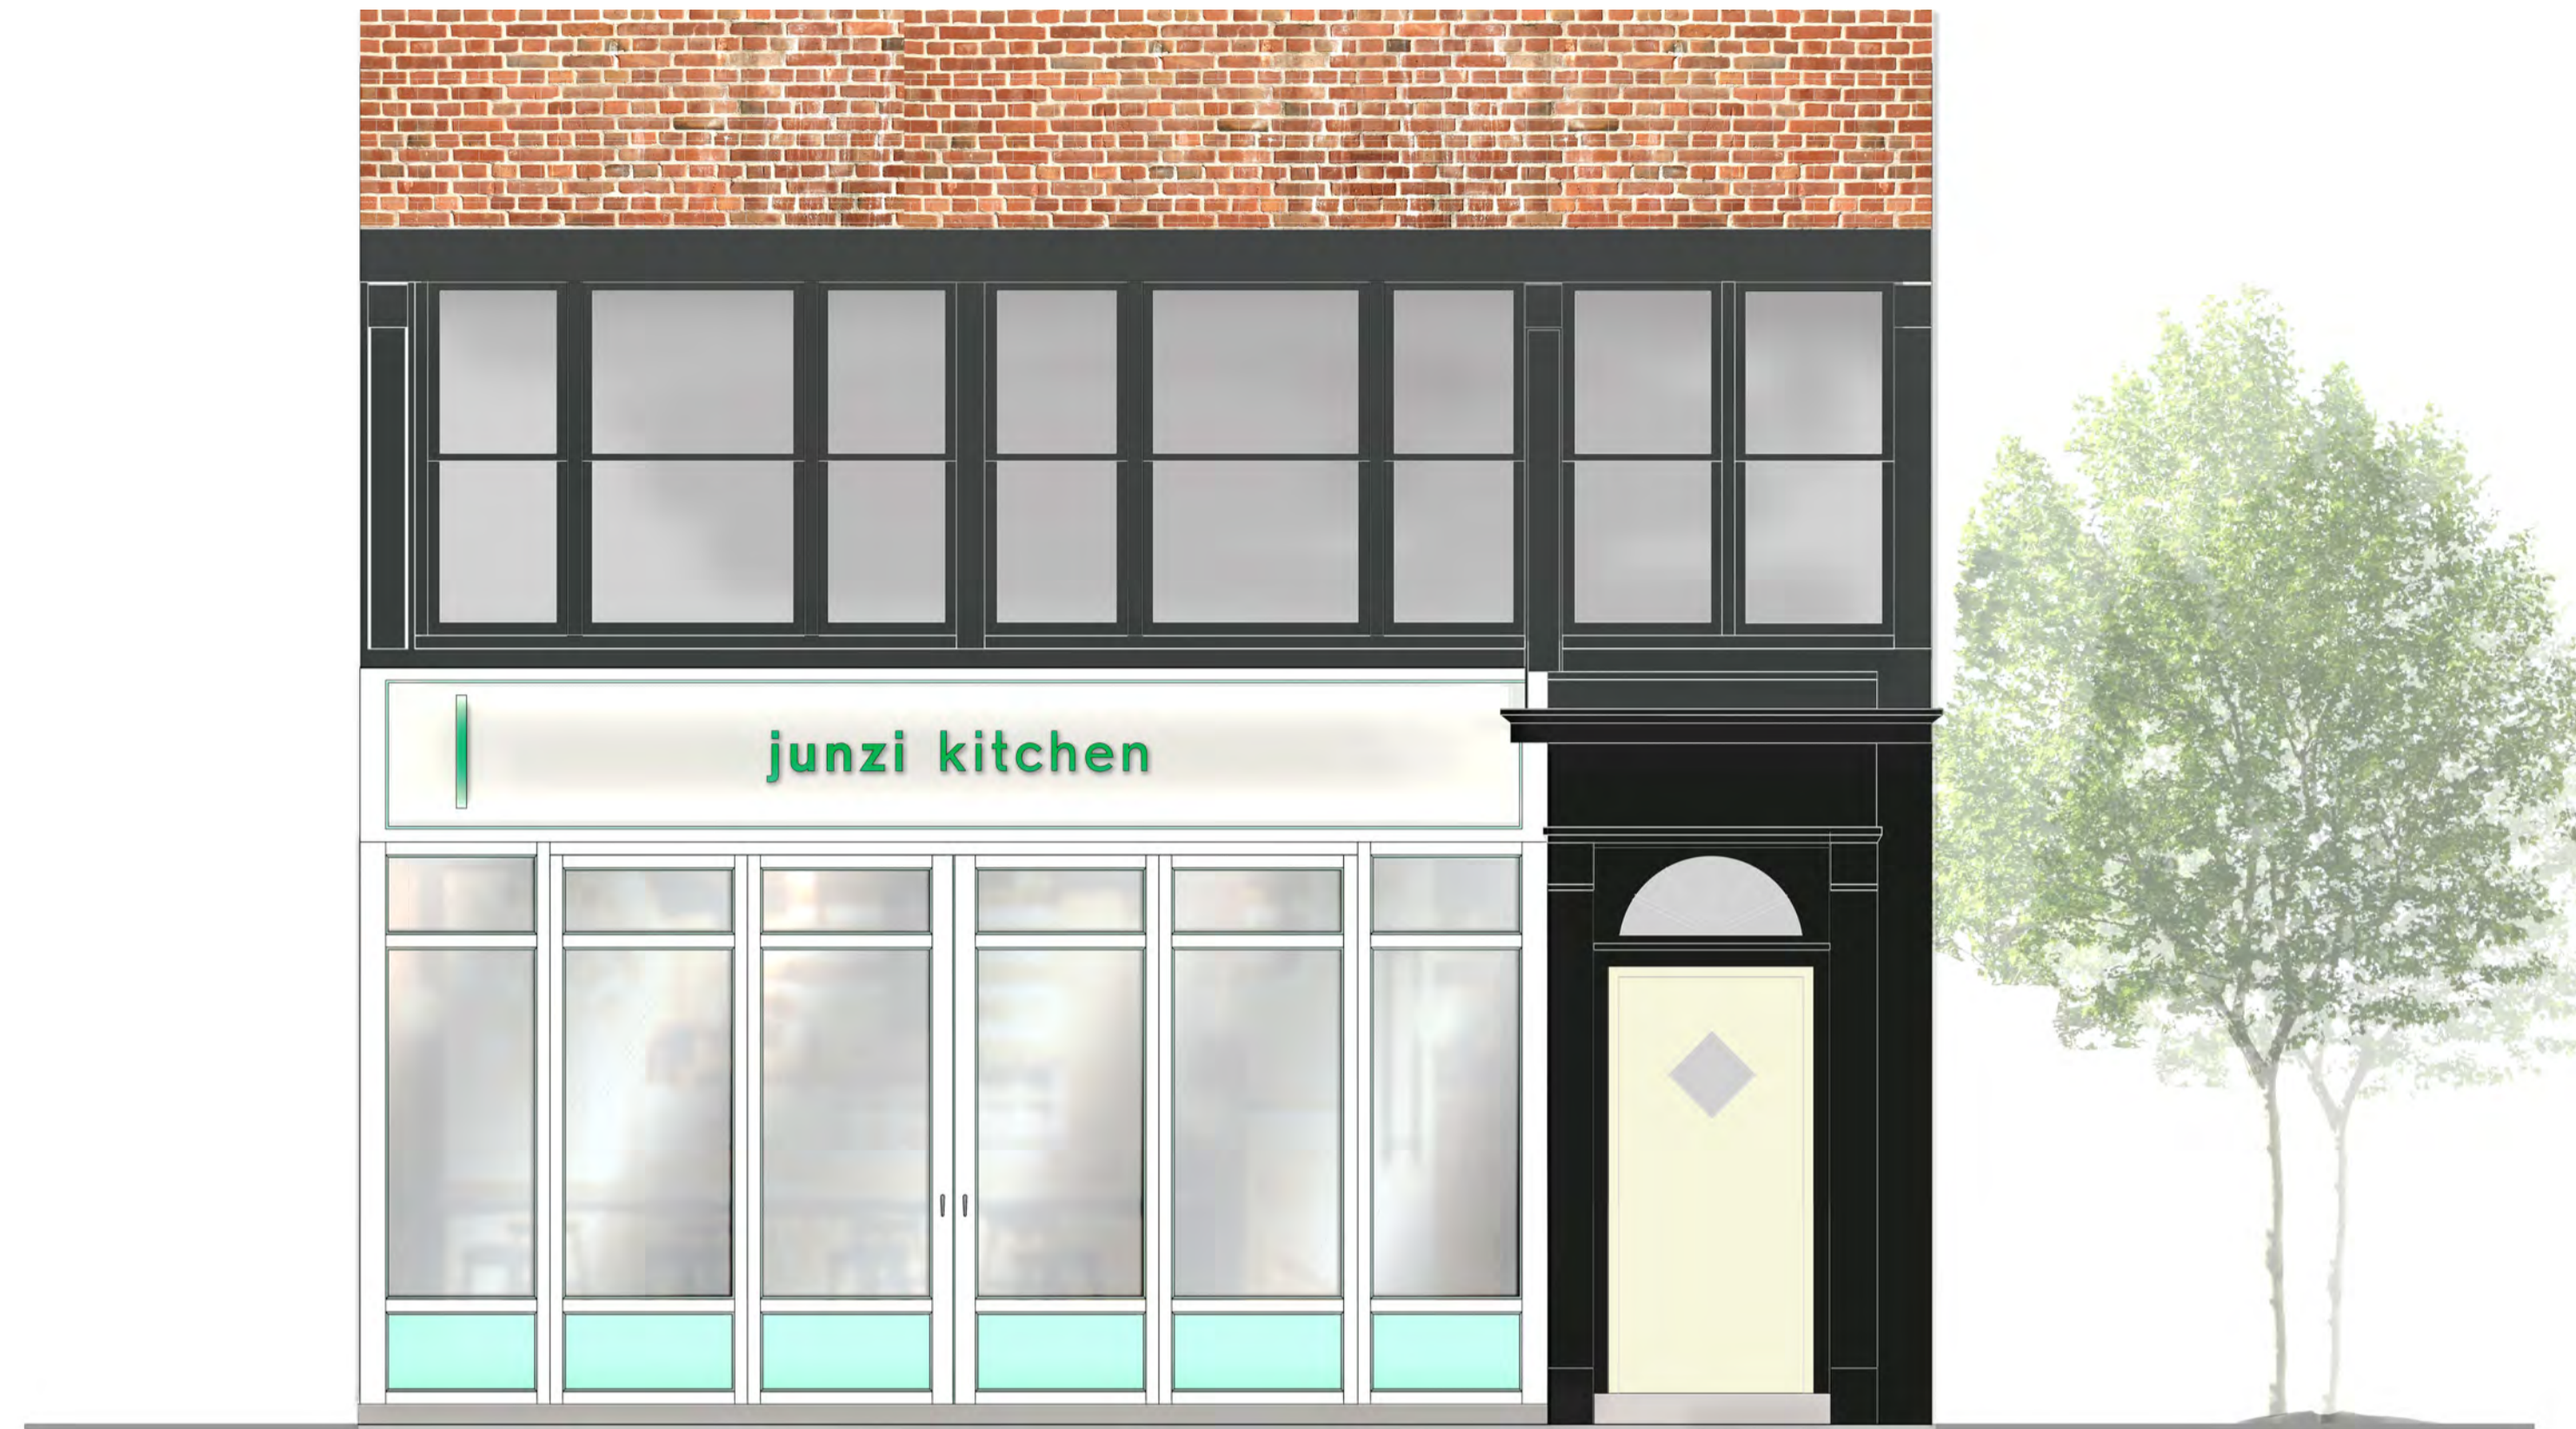
1 BLEECKER STREET RENDERING
Scale: Actual Size

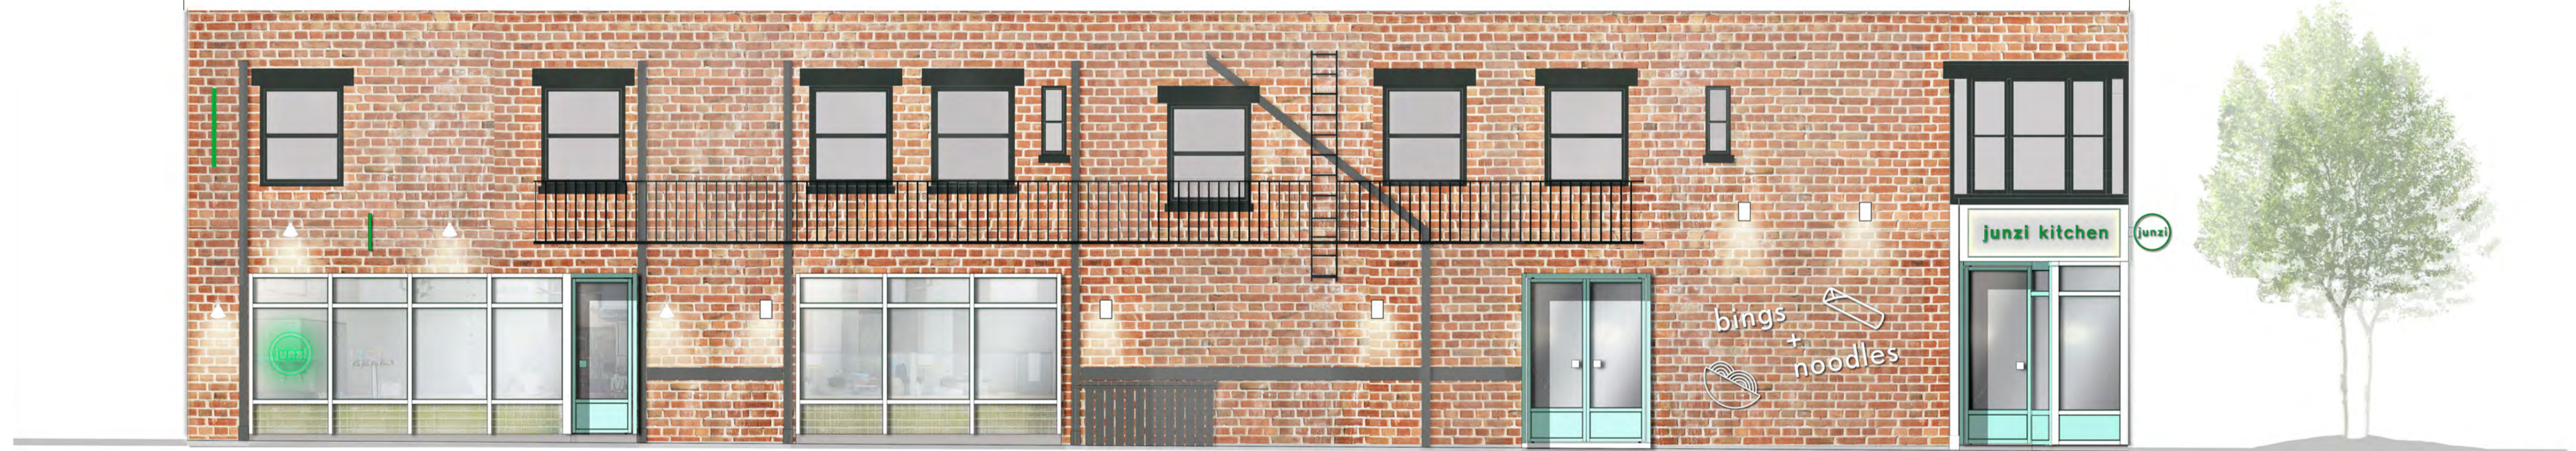
2 SULLIVAN STREET RENDERING
Scale: Actual Size

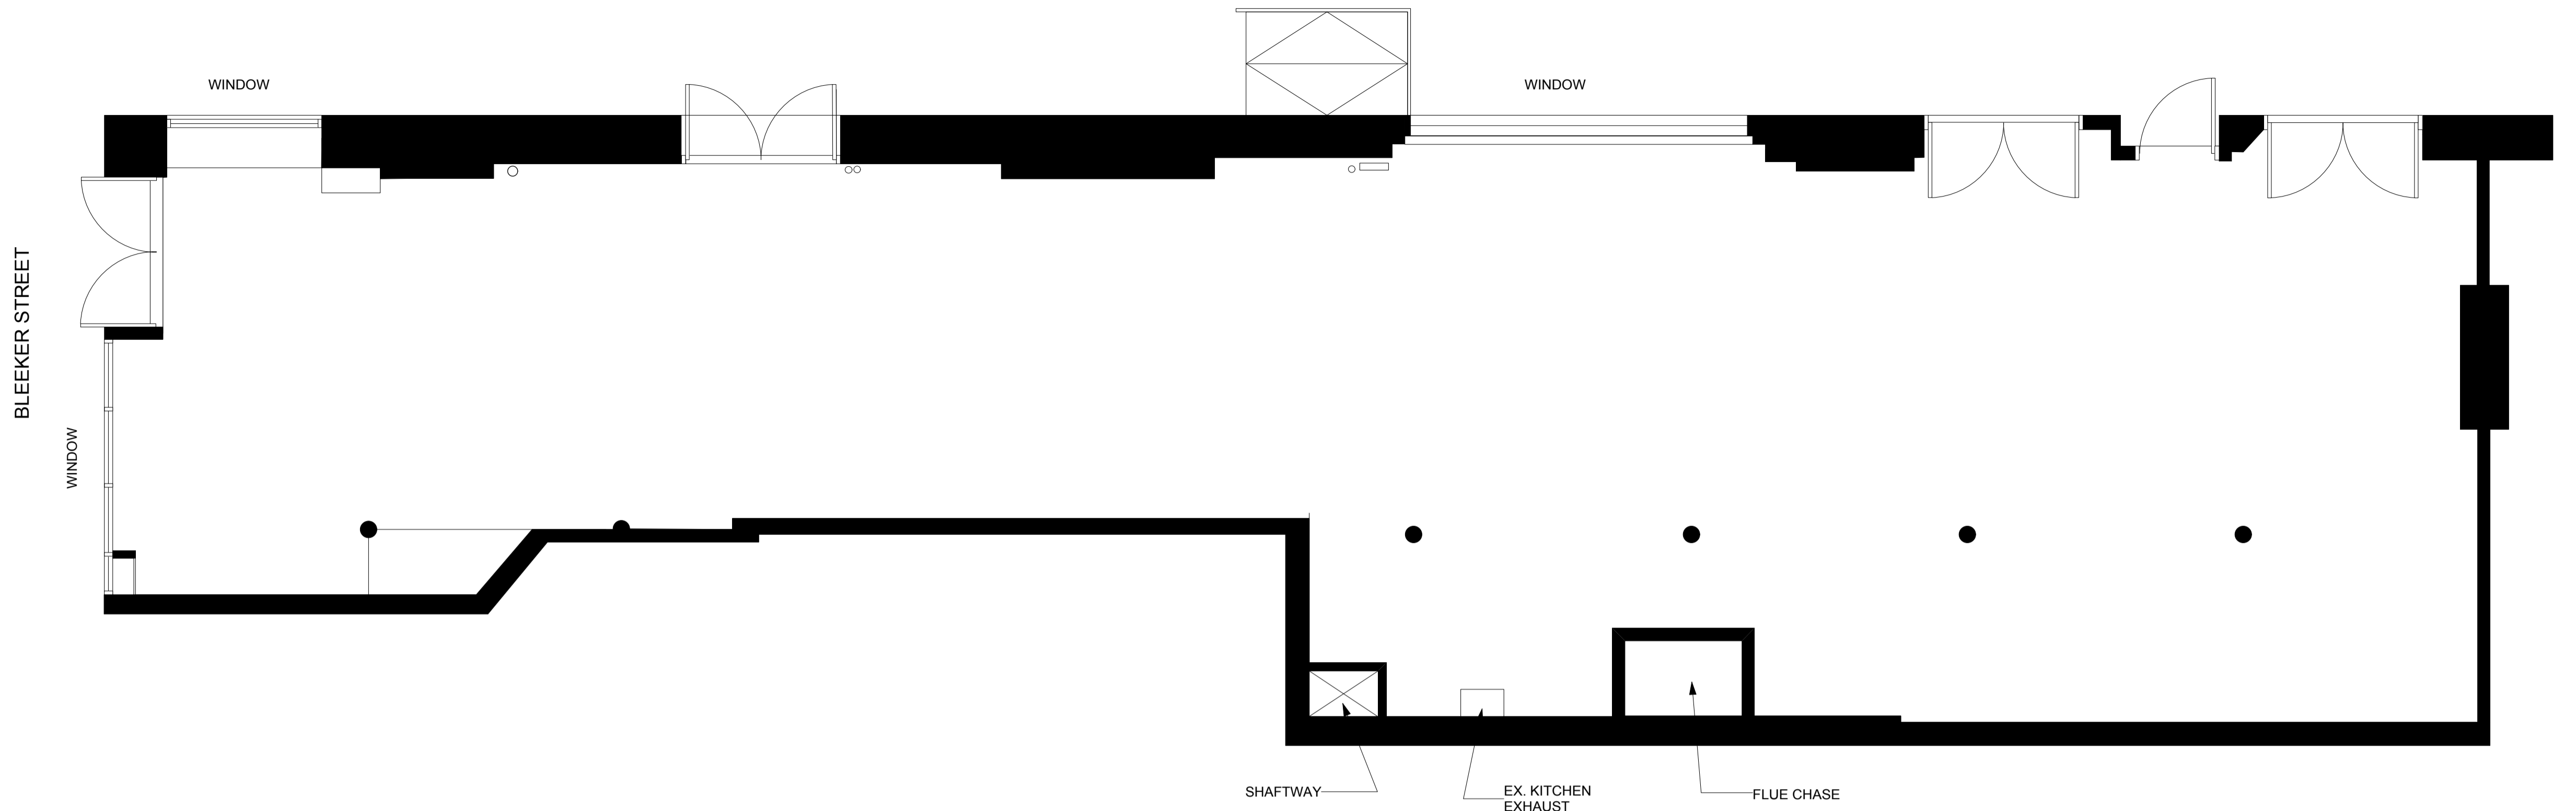
1 EXISTING 1ST FLOOR PLAN
Scale: 1/4" = 1'-0"

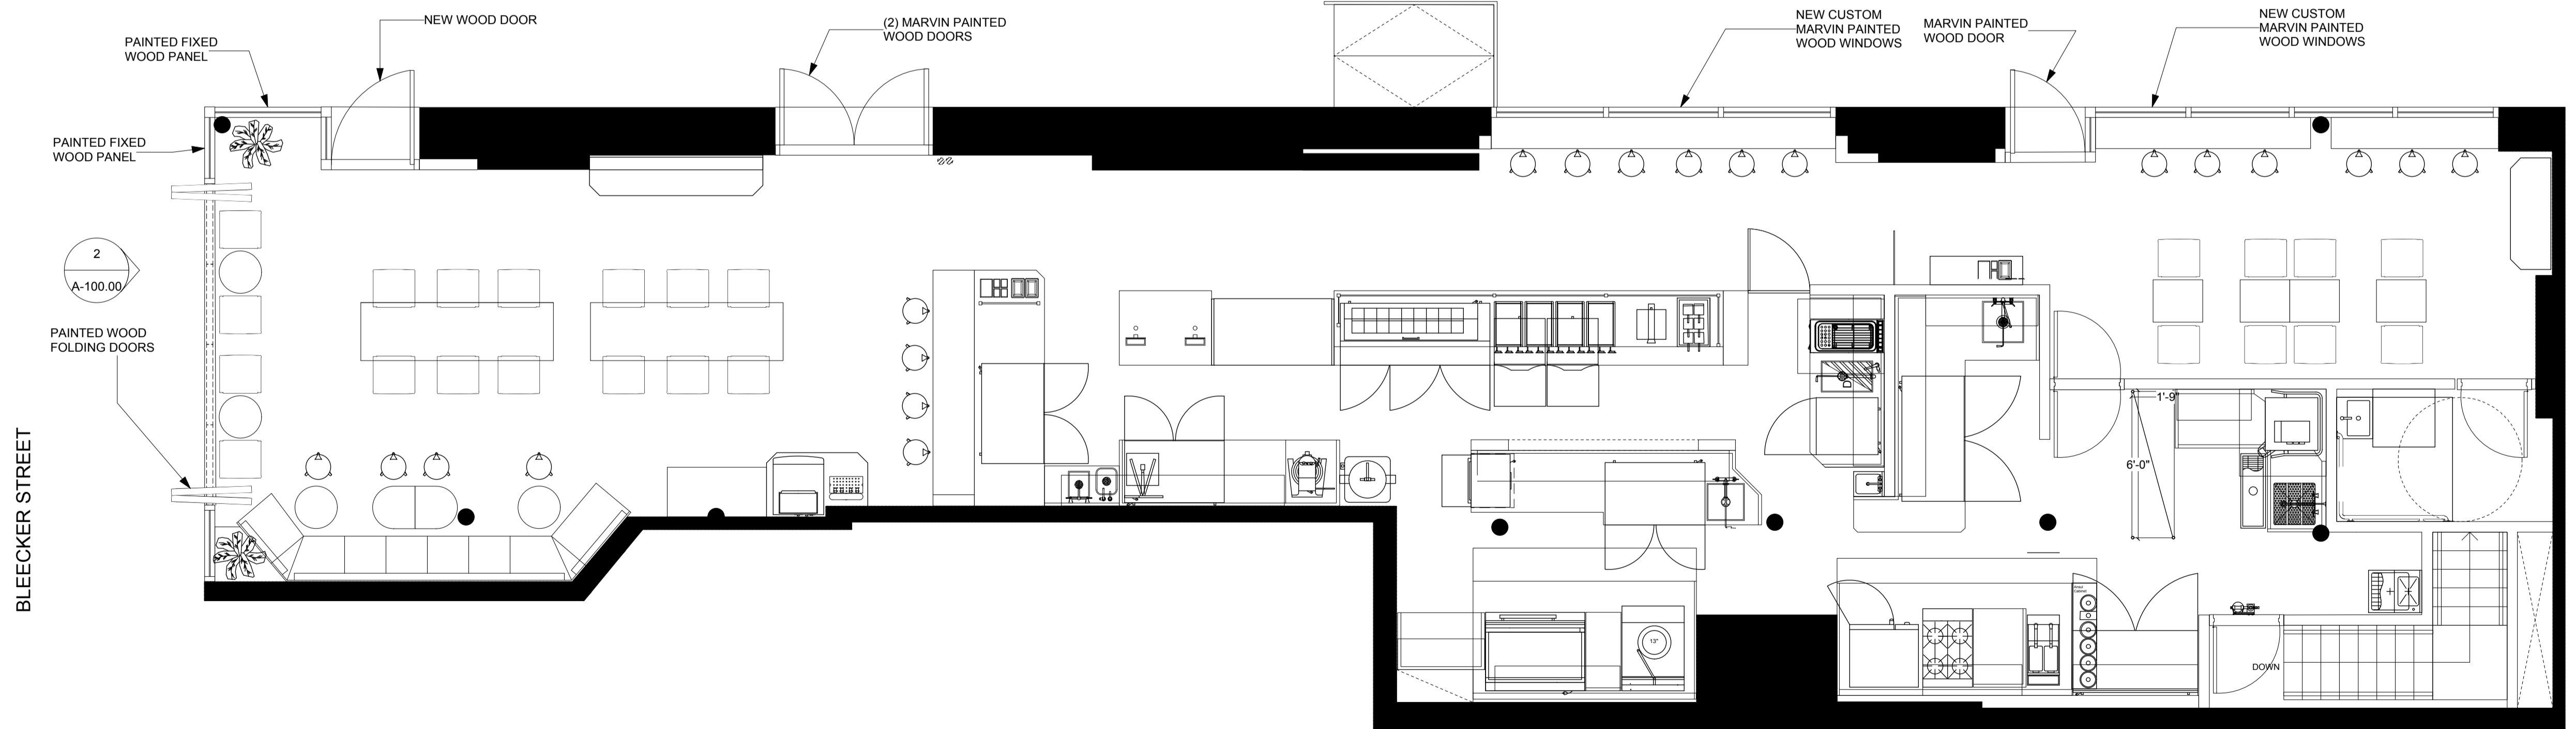
3 PROPOSED 1ST FLOOR PLAN
Scale: 1/4" = 1'-0"
