170 Bleeker Street

170 Bleeker Street: Existing Conditions

170 Bleeker Street Historic Conditions

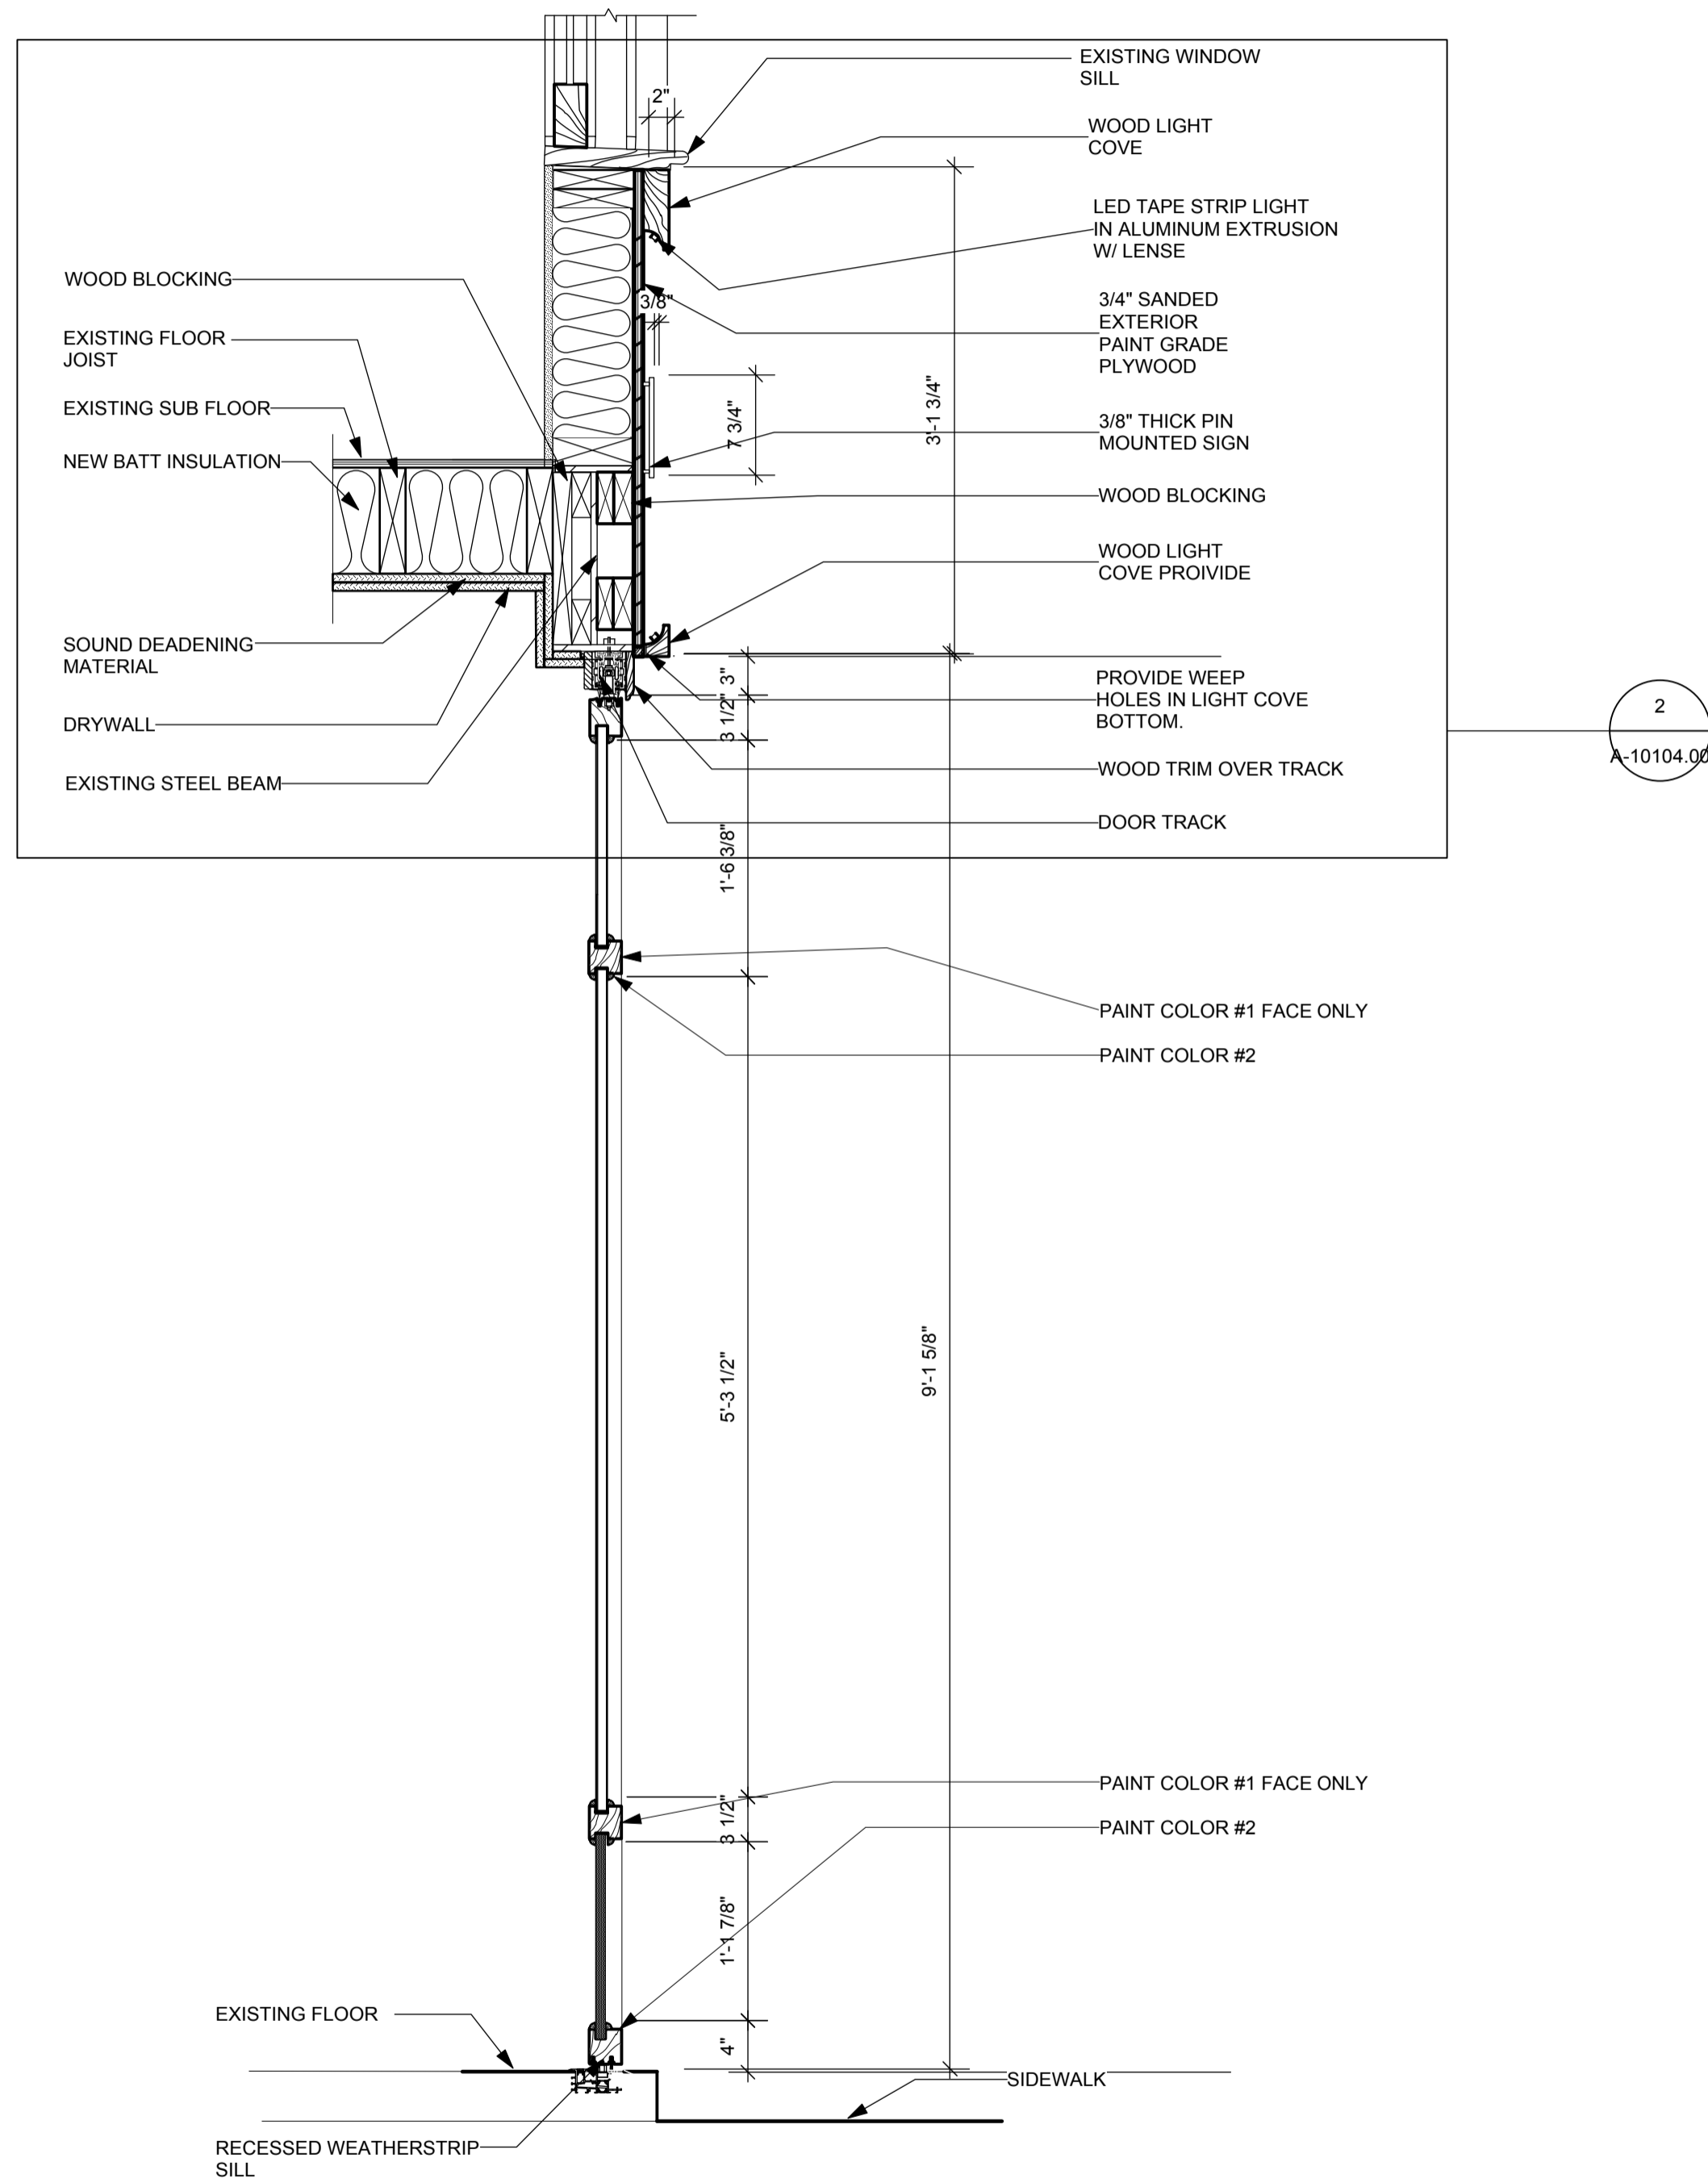
1 SECTION THROUGH BLEEKER STREET DOORS
Scale: 1" = 1'-0"

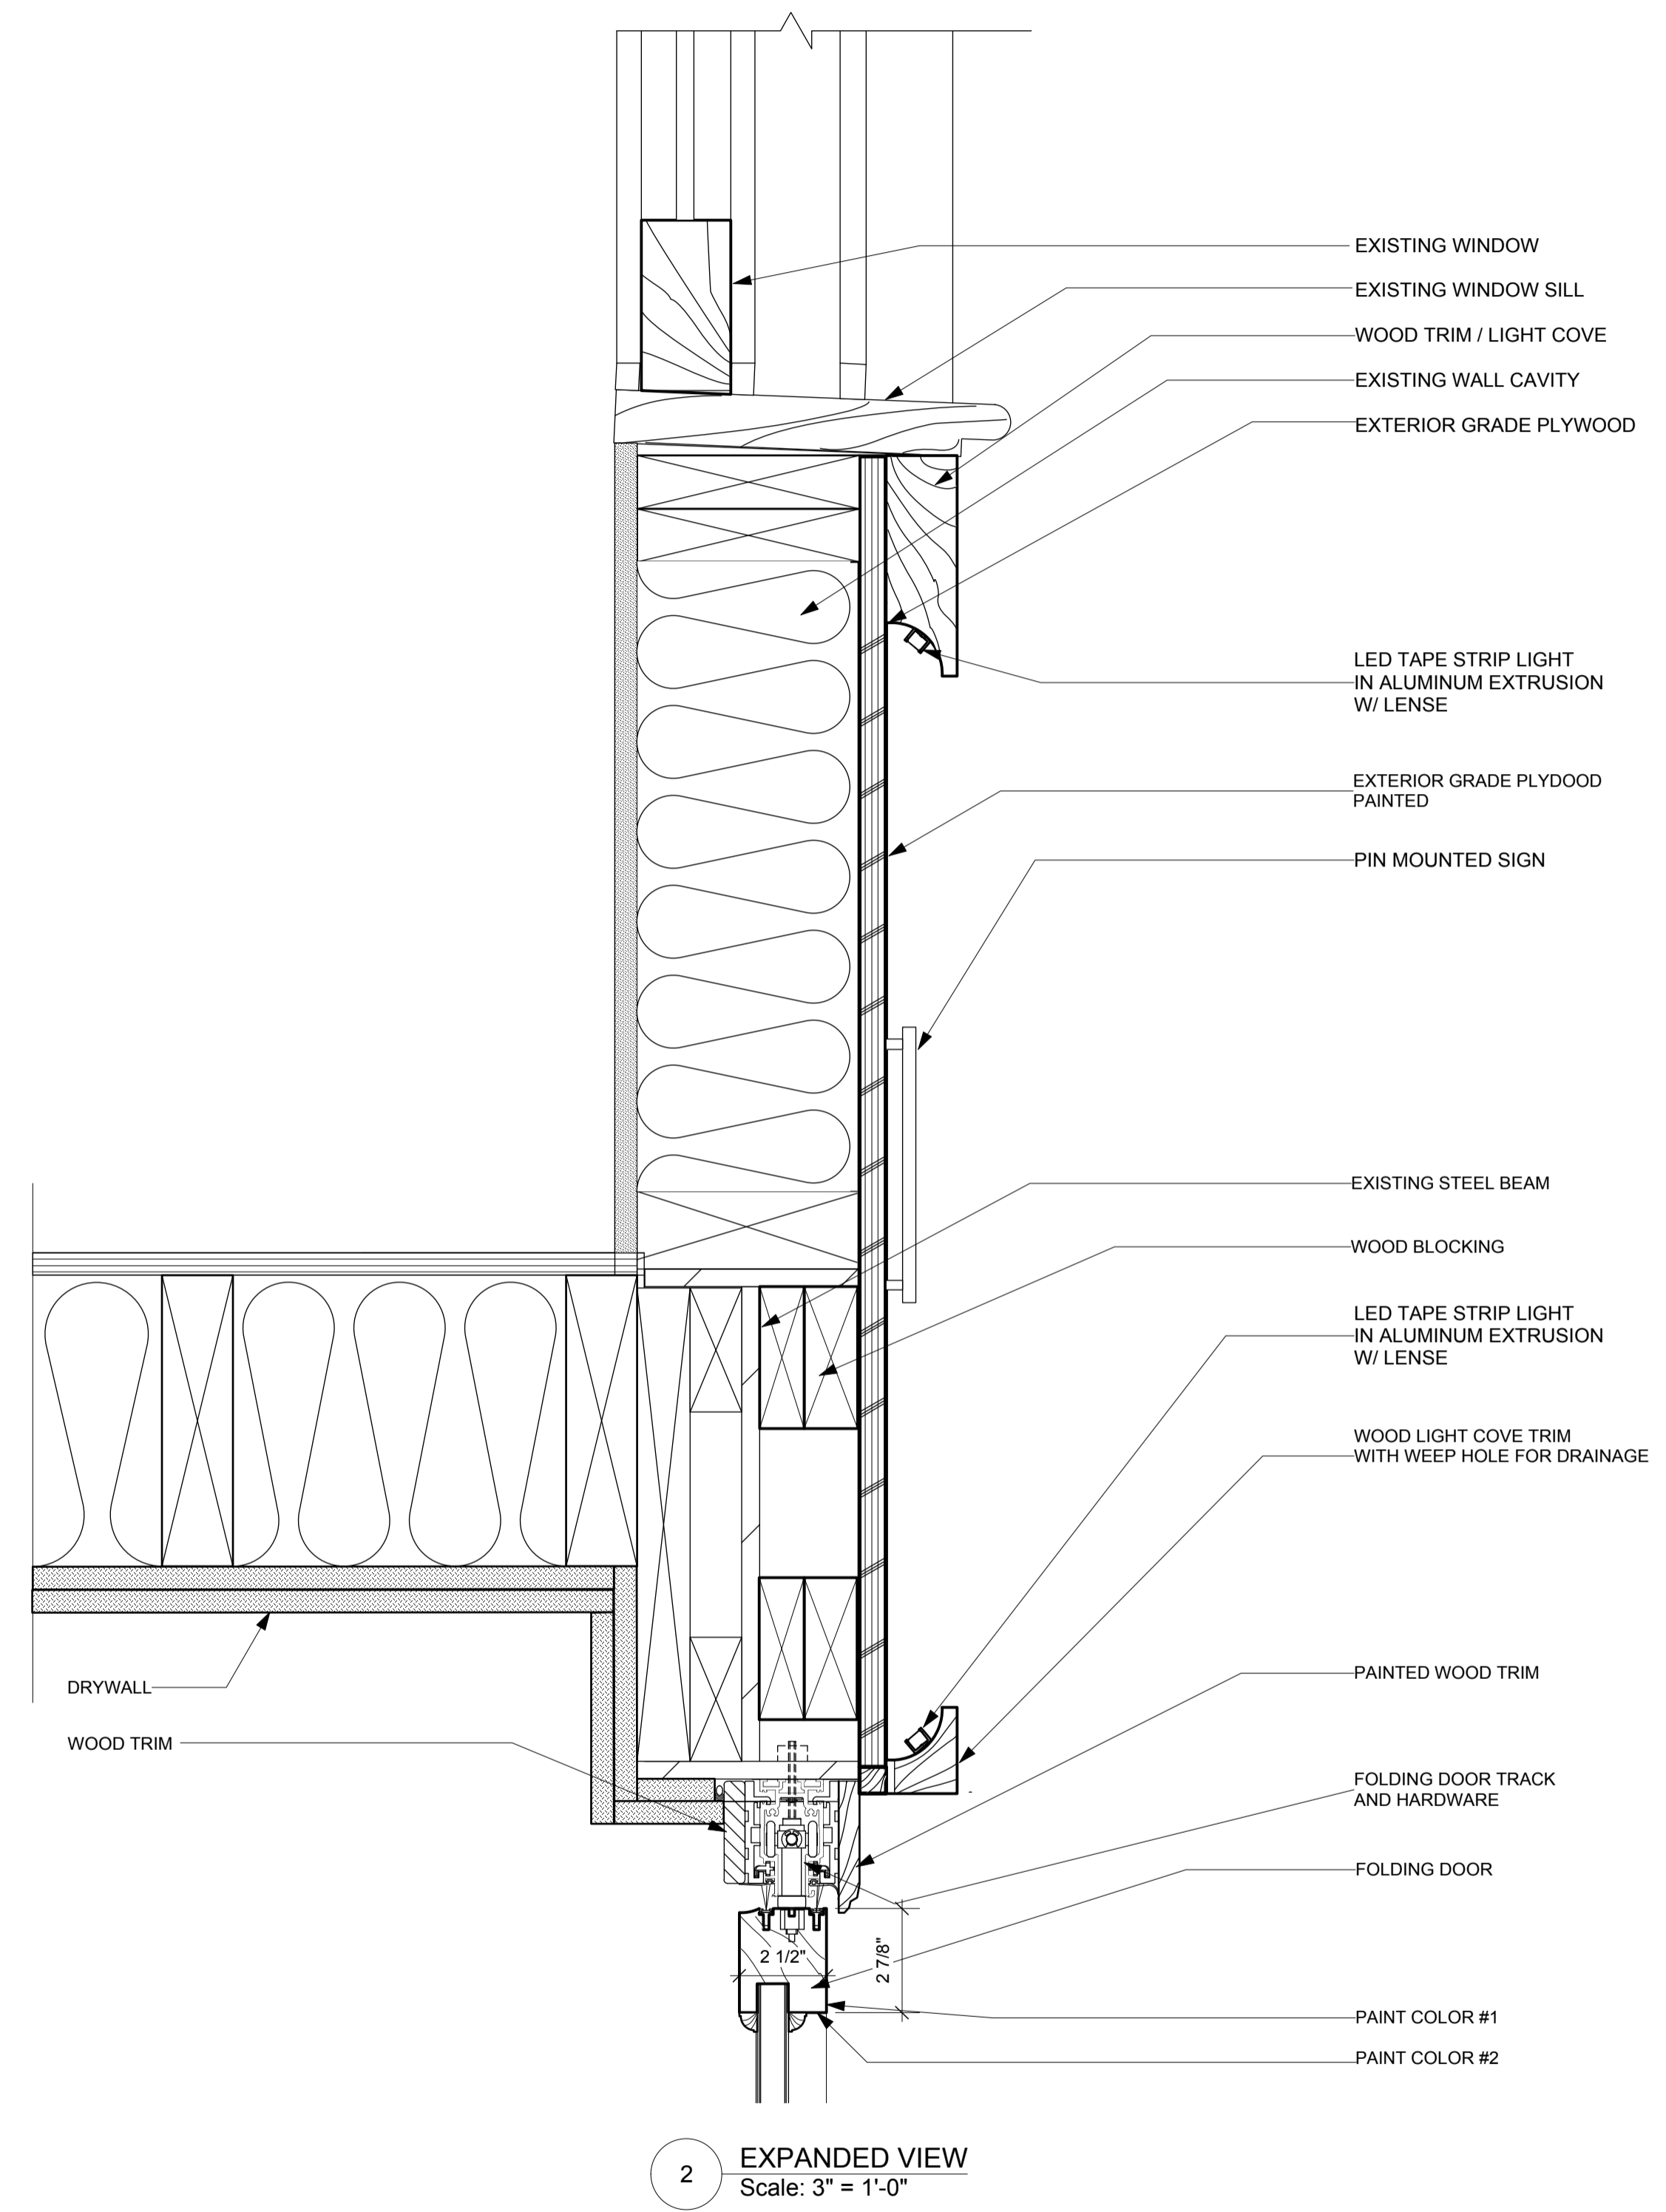
2 EXPANDED VIEW
Scale: 3" = 1'-0"

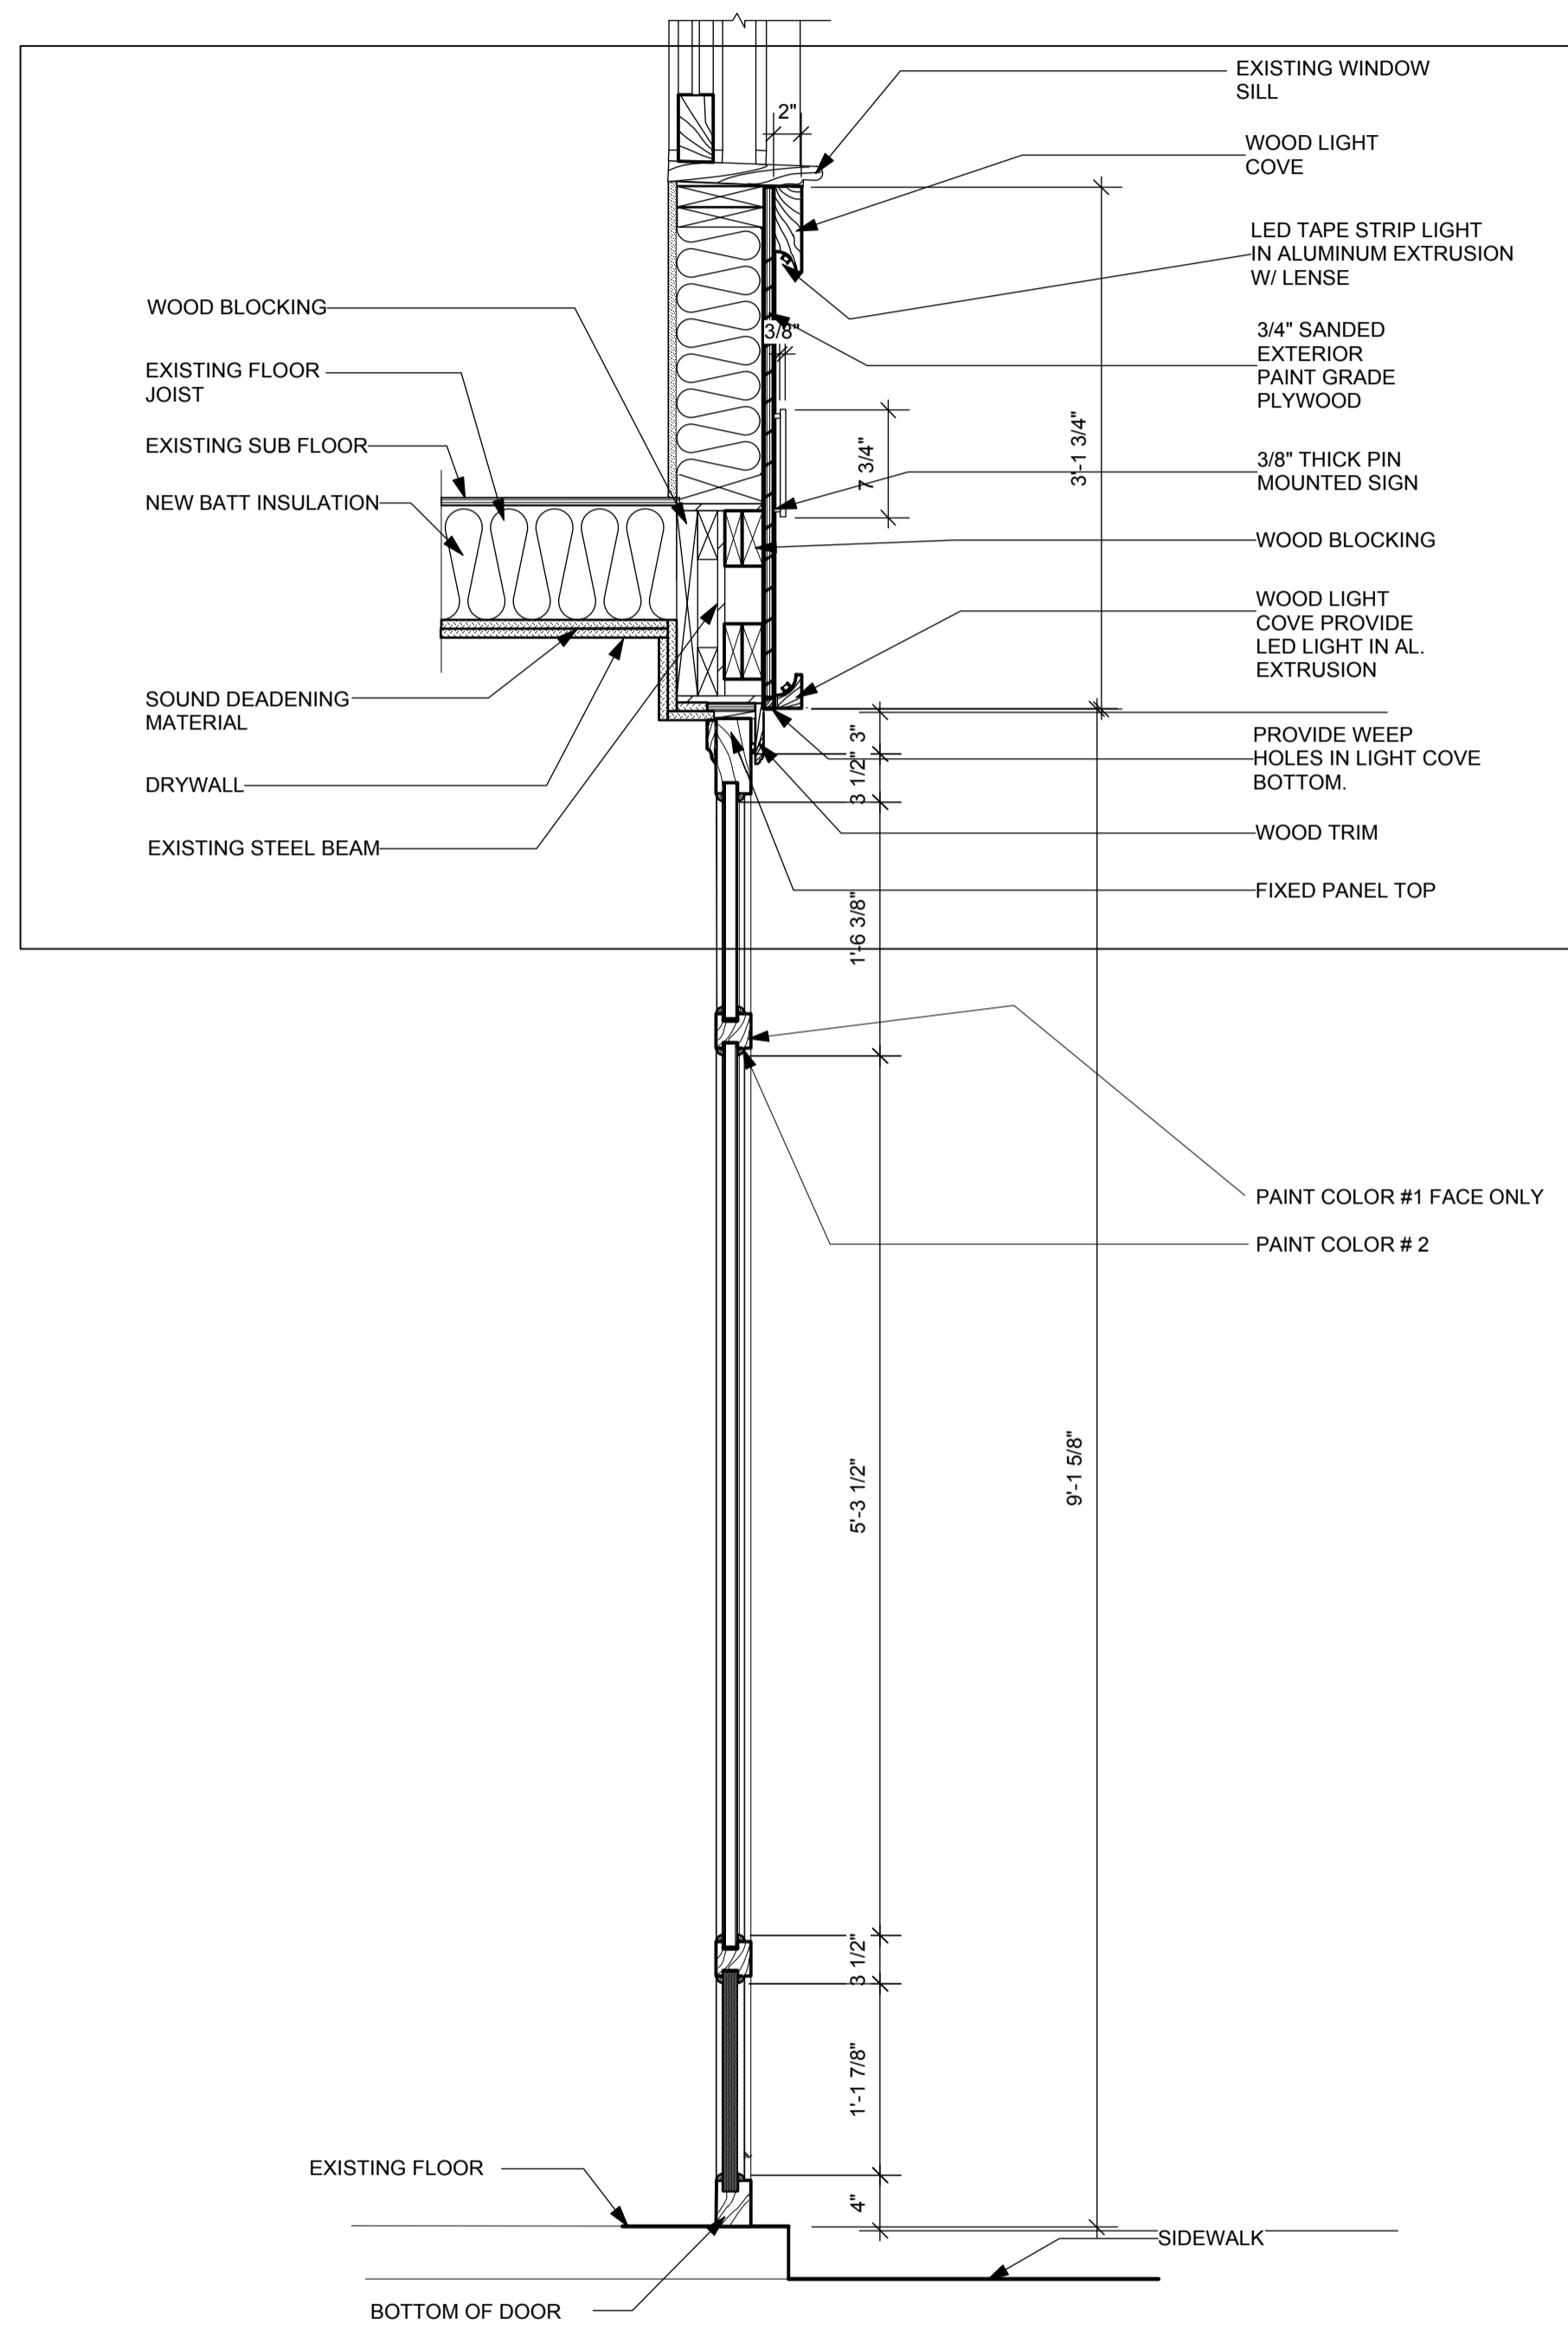
3 SECTION THROUGH FIXED GLAZING
Scale: 1" = 1'-0"

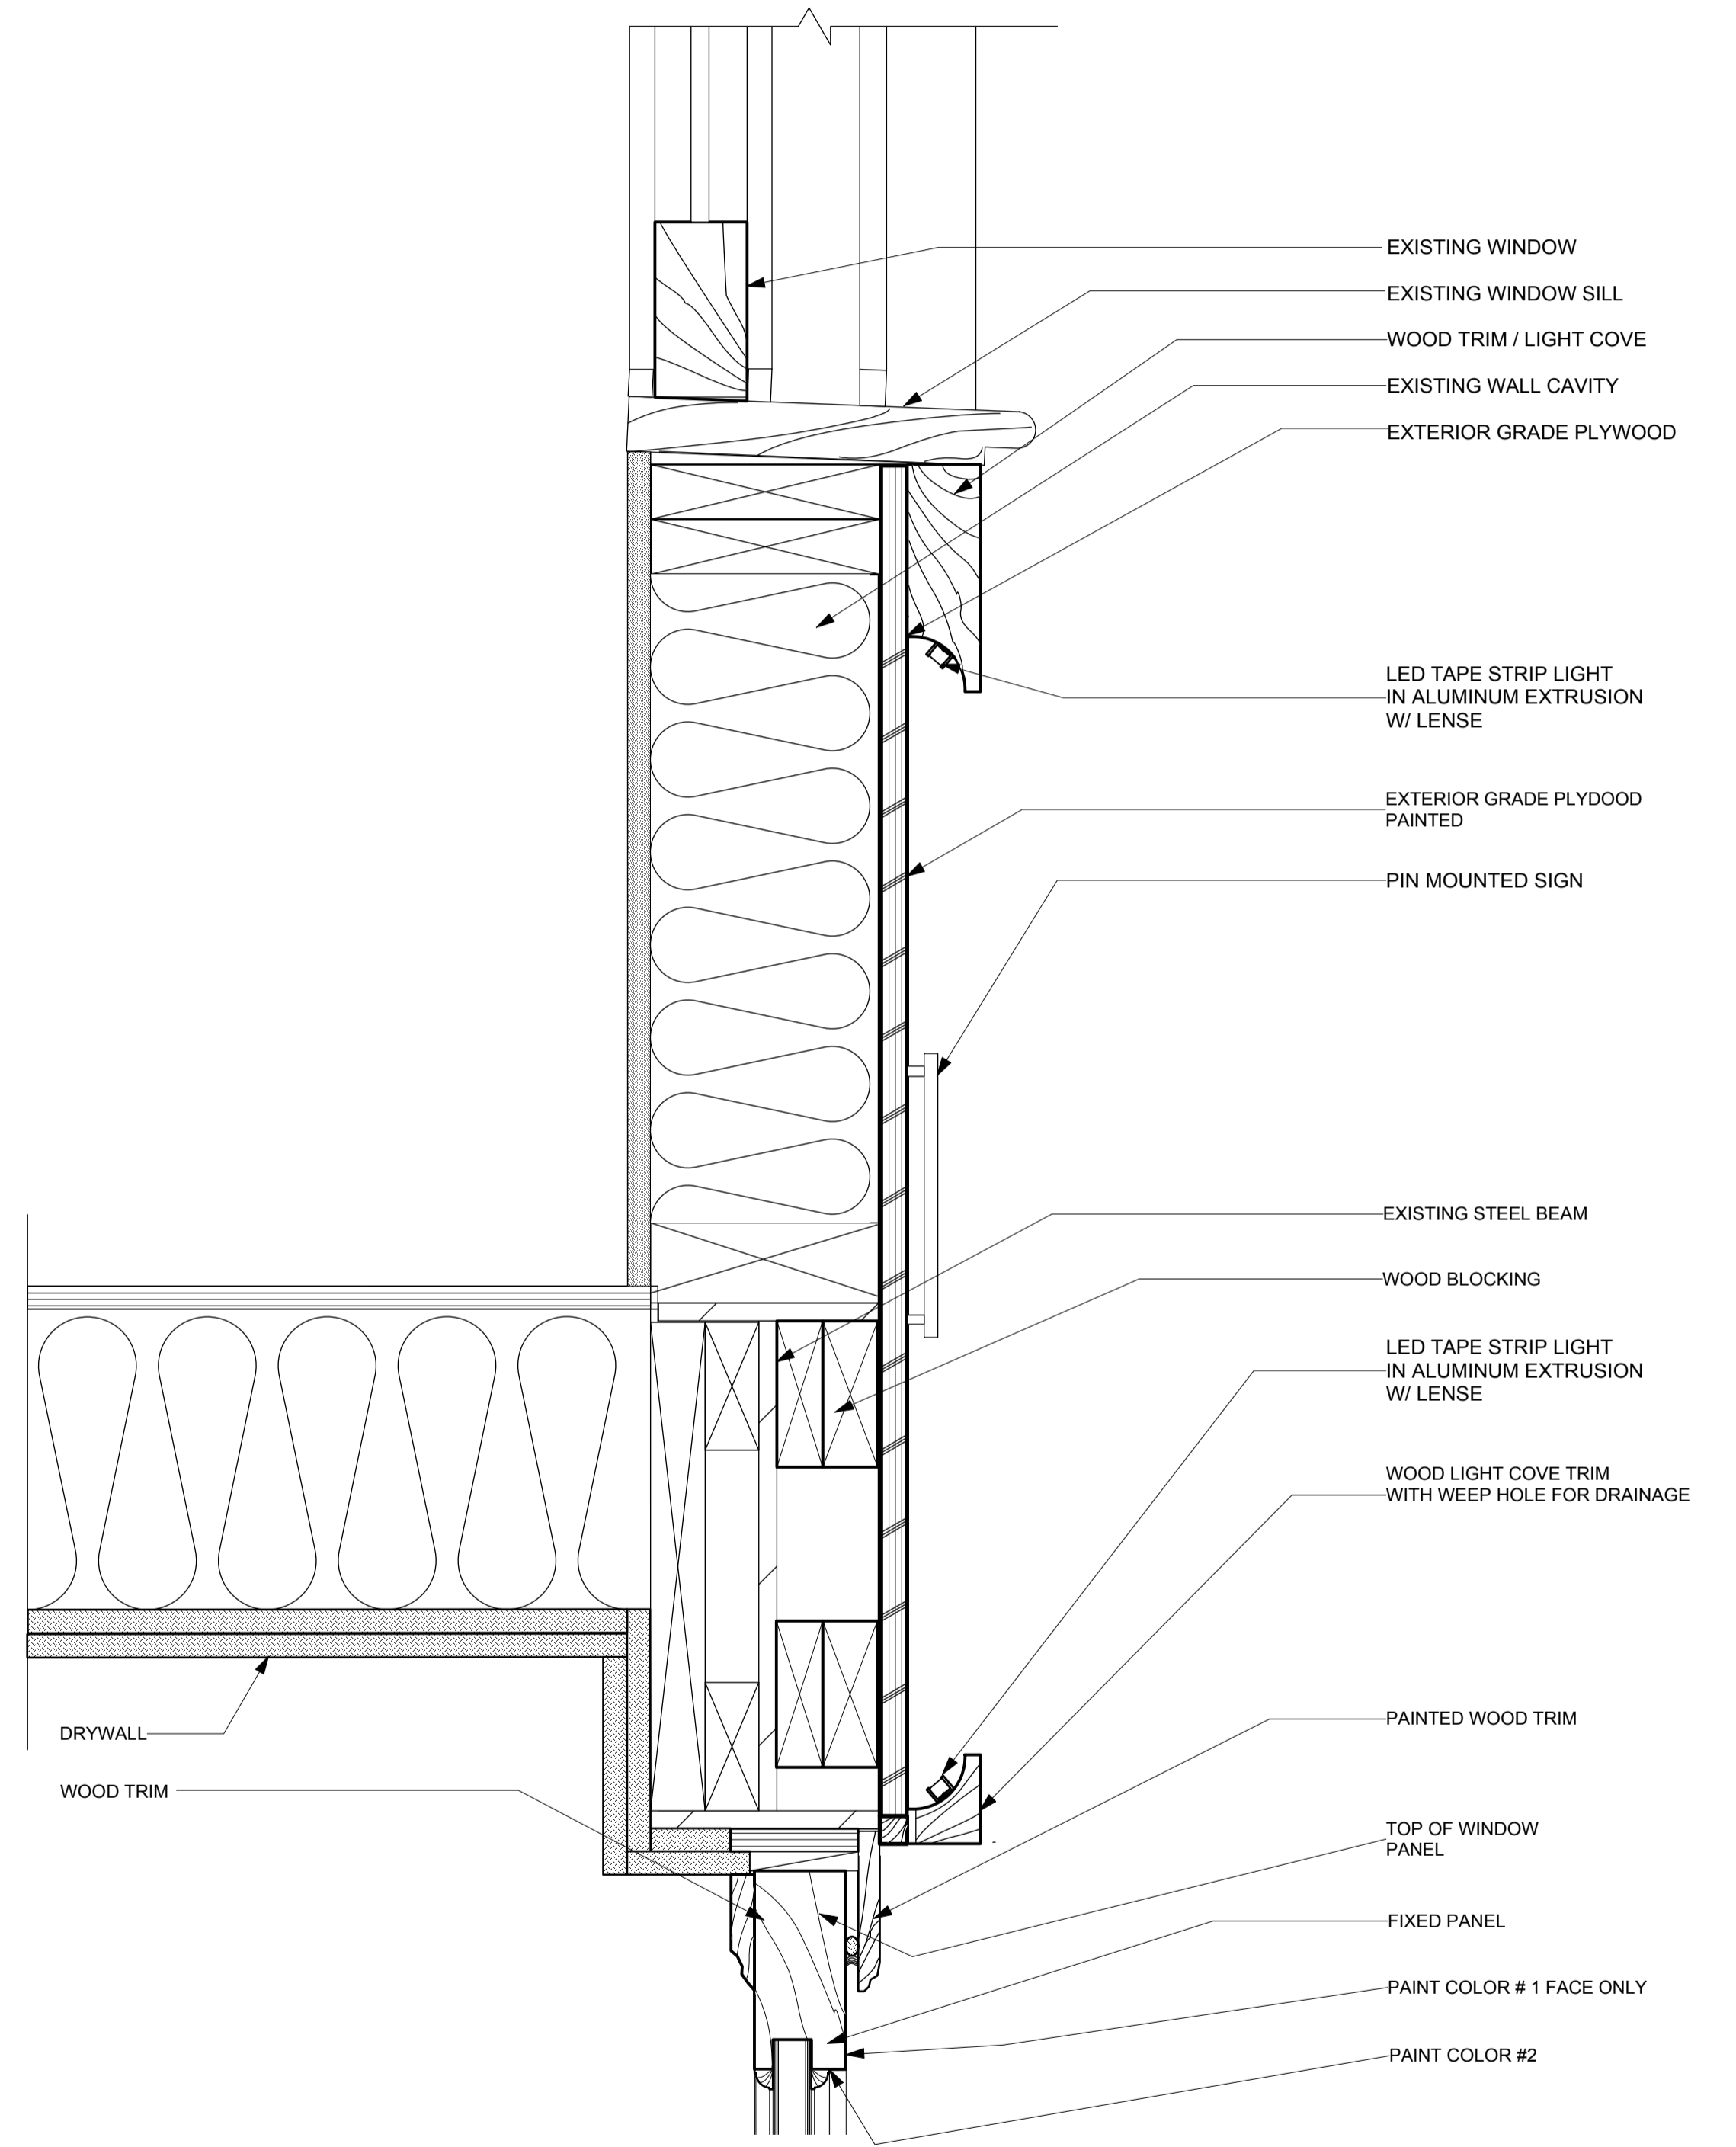
4 EXPANDED VEIW
Scale: 3" = 1'-0"

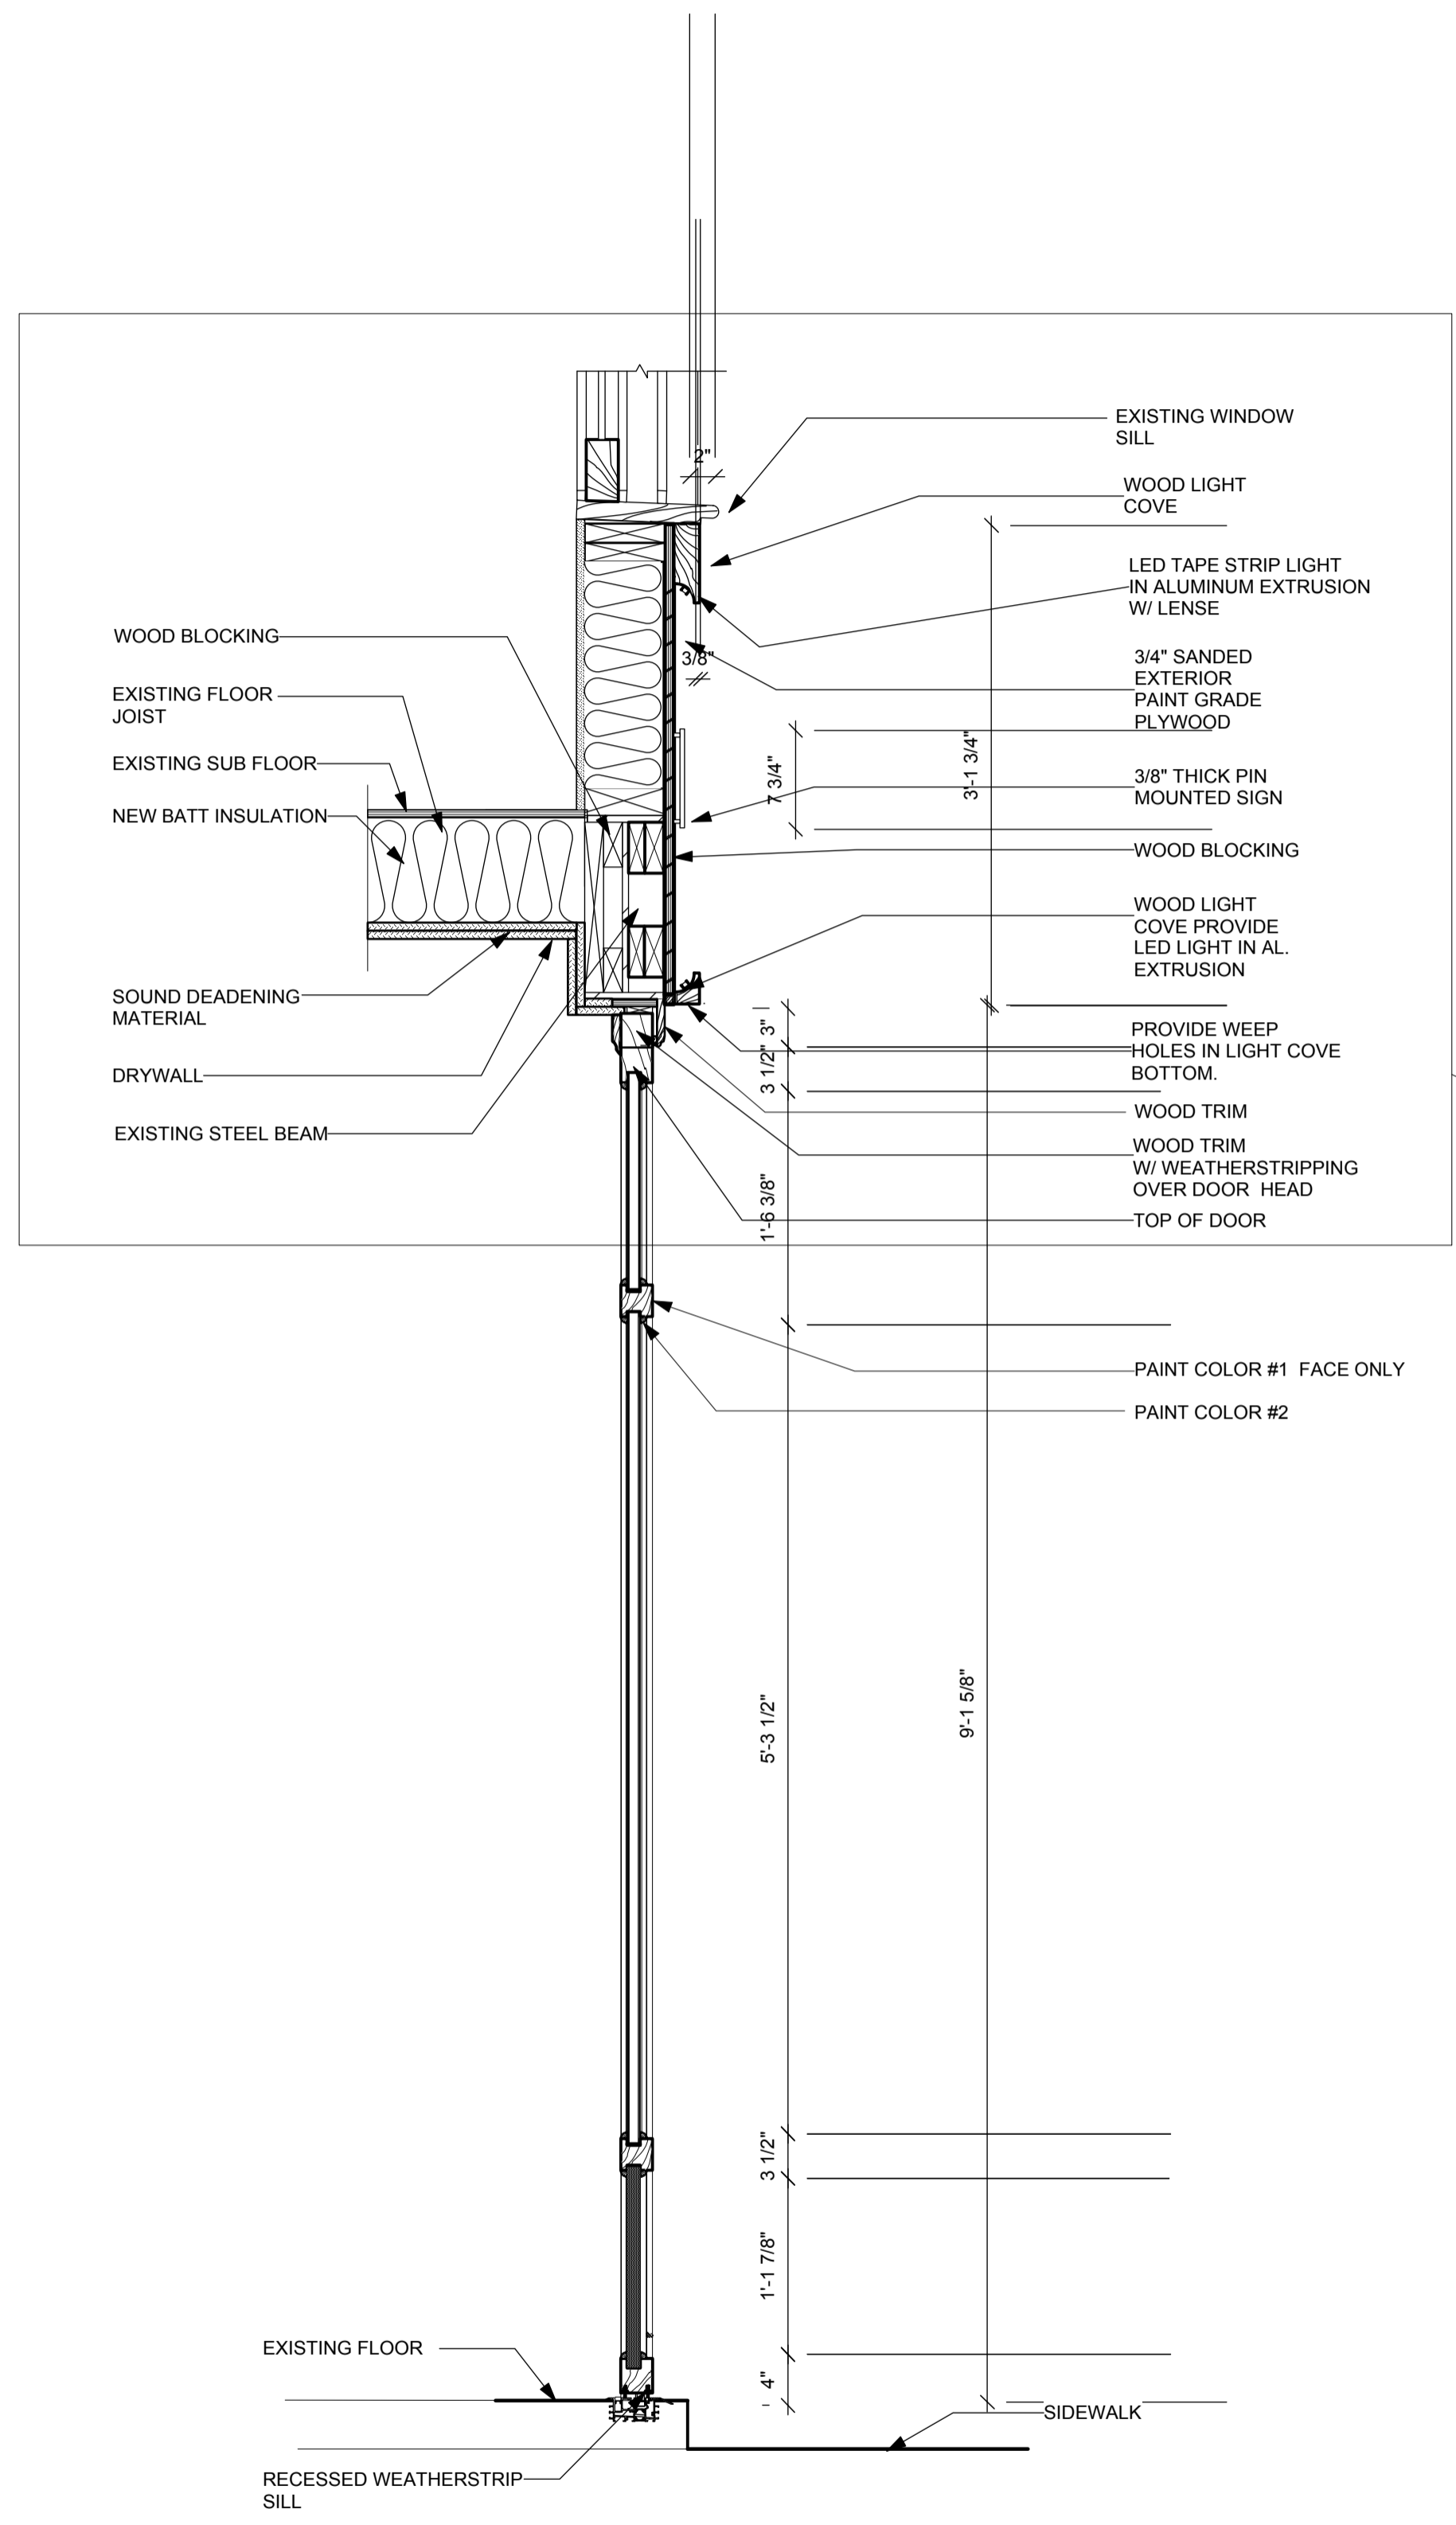
5 SECTION THROUGH SULLIVAN CUSTOM DOOR
Scale: 1" = 1'-0"

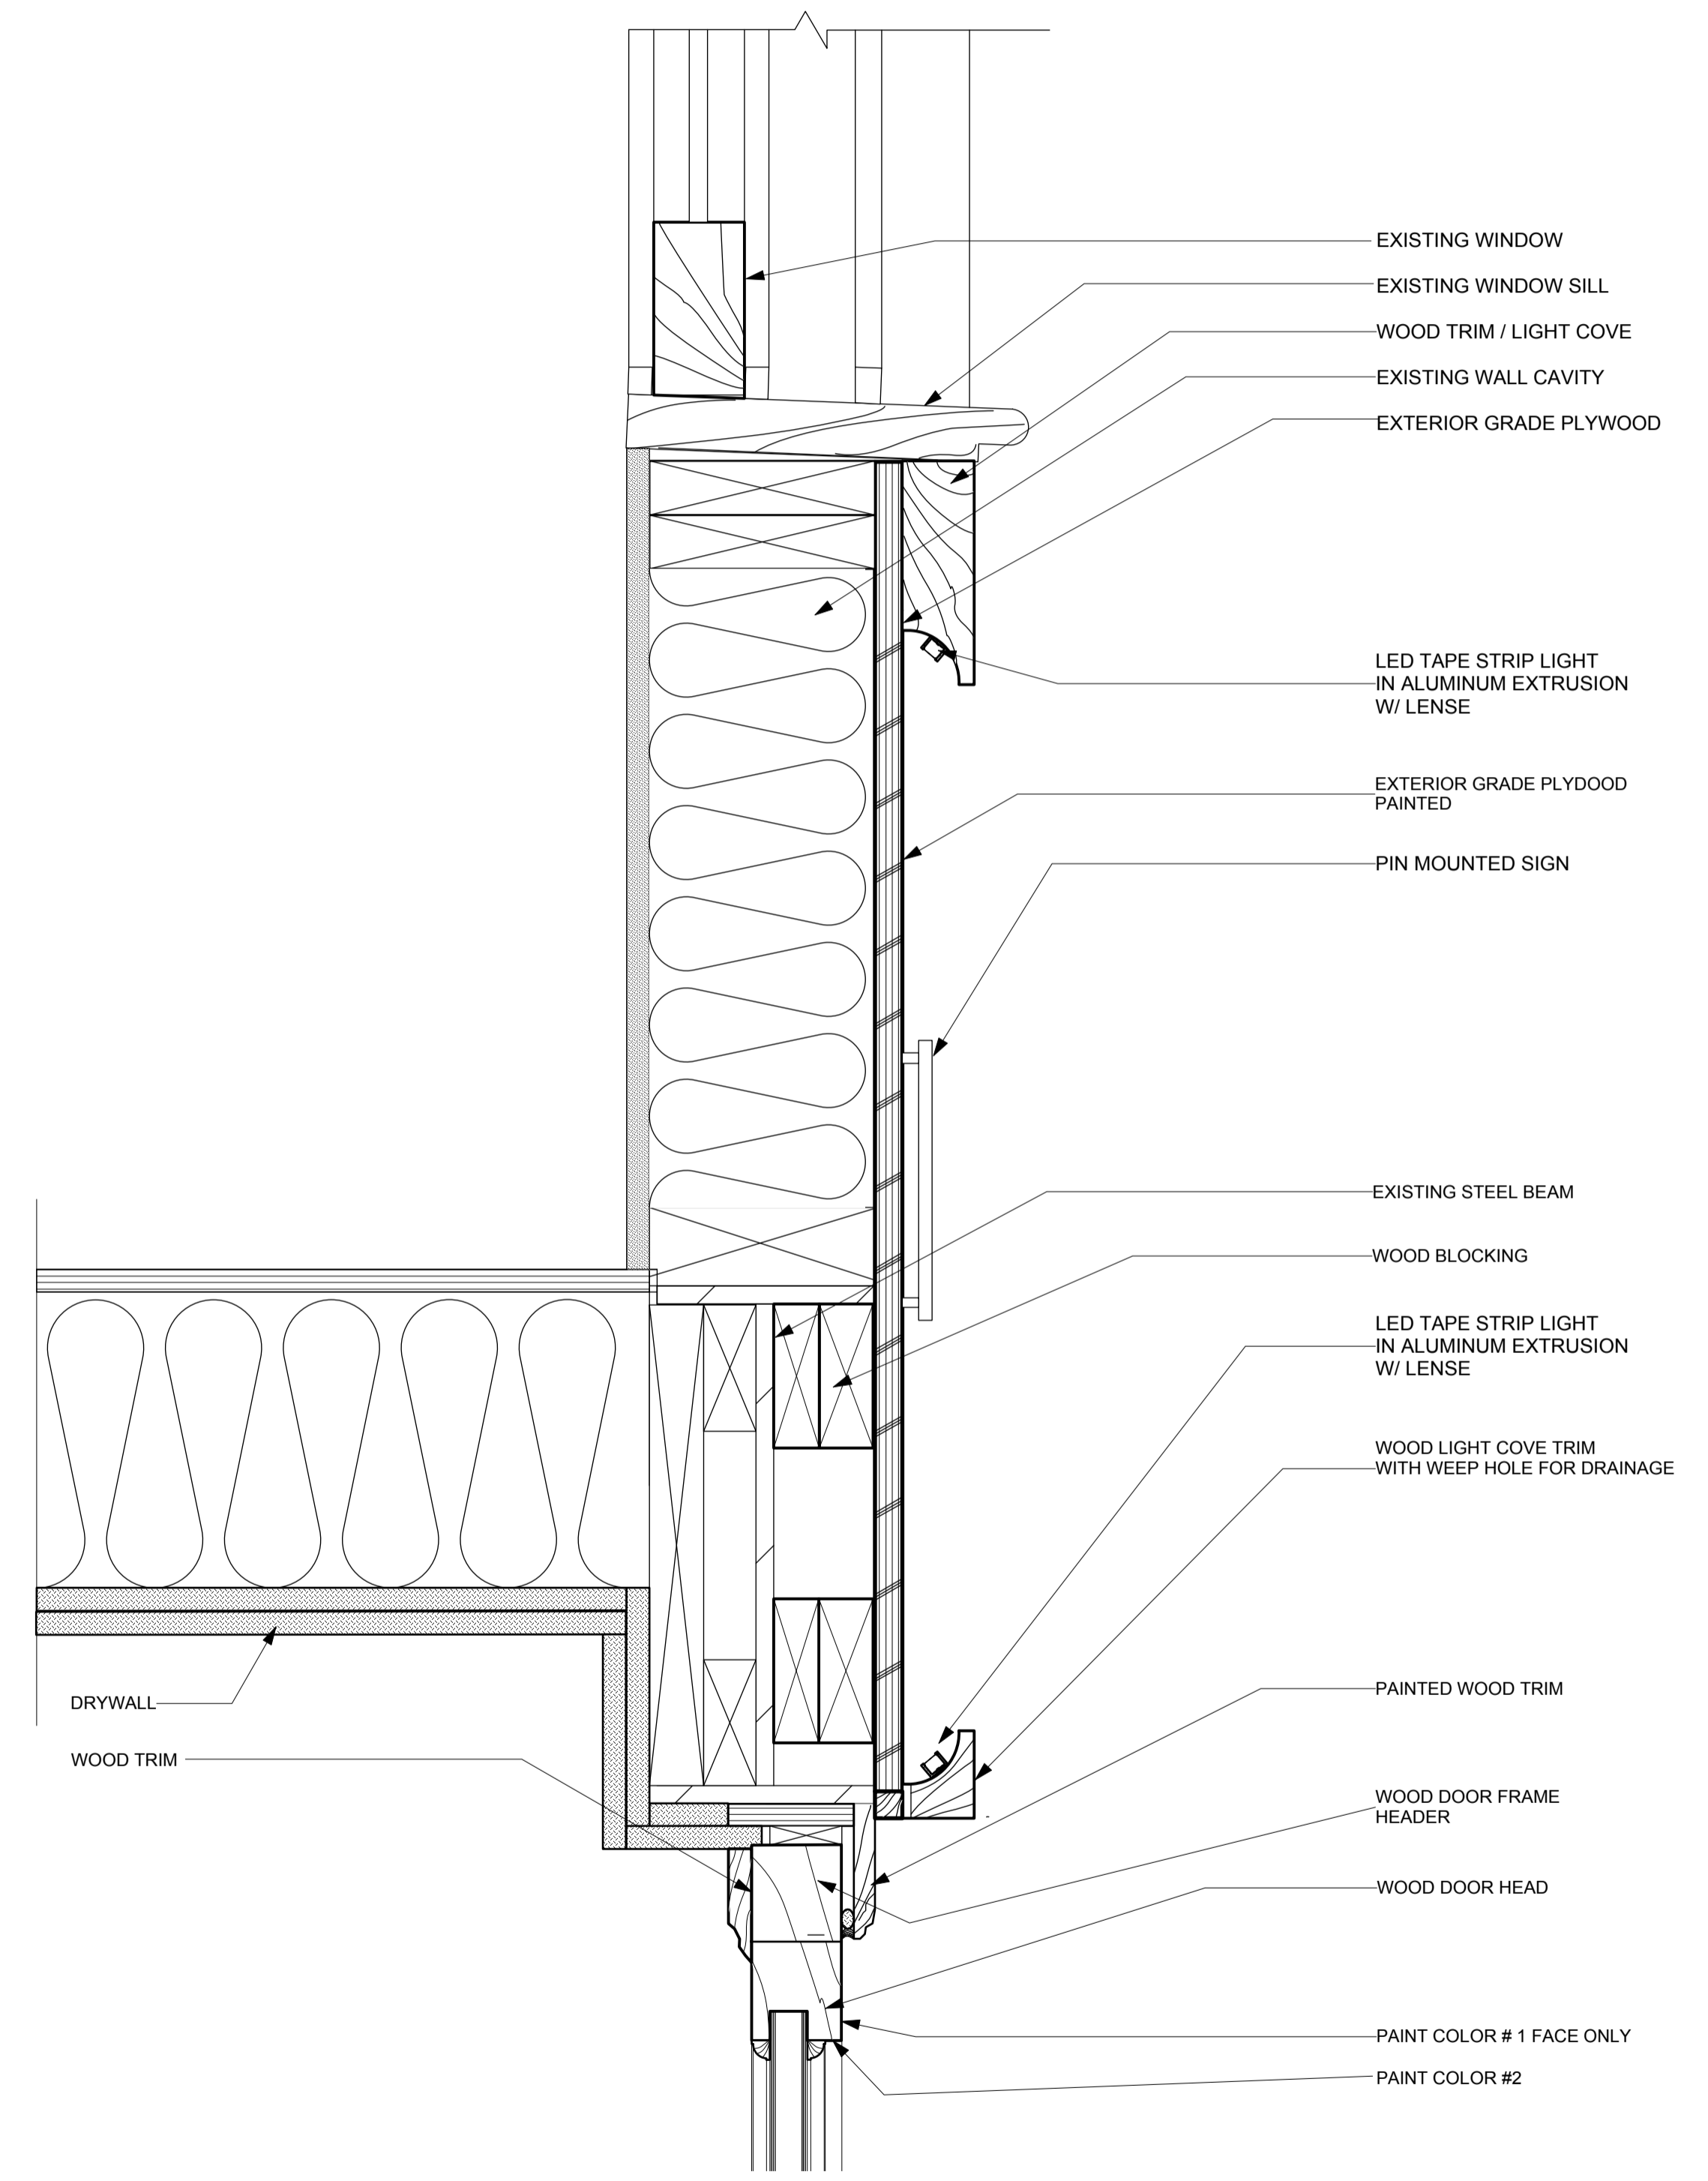
6 EXPANDED VIEW
Scale: 3" = 1'-0"
